**Intra Railway Safety Audit inspection of GUNA-Bina section of Bhopal Division by
SAG team of WCR on 27.06.2025**

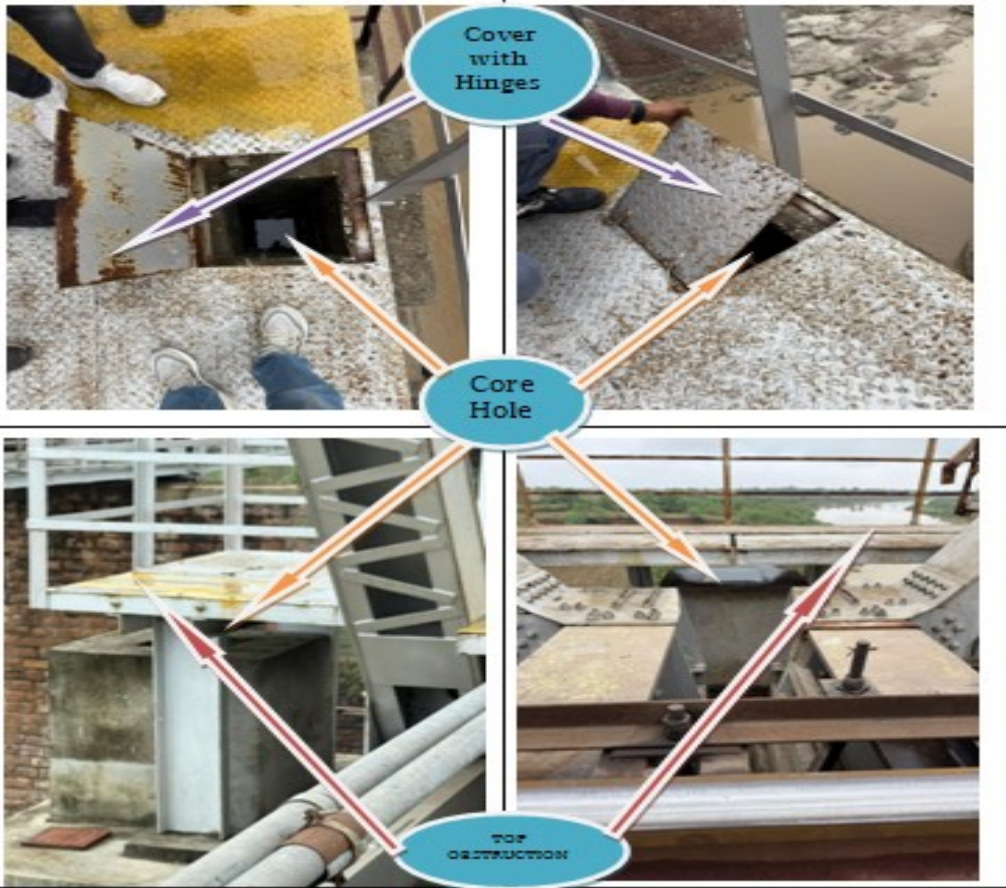
<ul style="list-style-type: none"> • Pitching provided around Abutments is found in good condition. • Ballast wall provided in approaches may be planned widening and in alignment with return wall so that in both approaches additional ballast provision and space for maintenance can be created. • 7 nos of hook bolts found loose must be tightened. • 12 nos of rubber pad were crushed needs to be replaced. 	
1.2	<p>i. Core holes do exist on bridge pier but covered from TOP & not available ready to use. Top obstruction on core holes i.e. platform should have cover openings with hinges as available at some locations 1075/13 on the same bridge.</p>

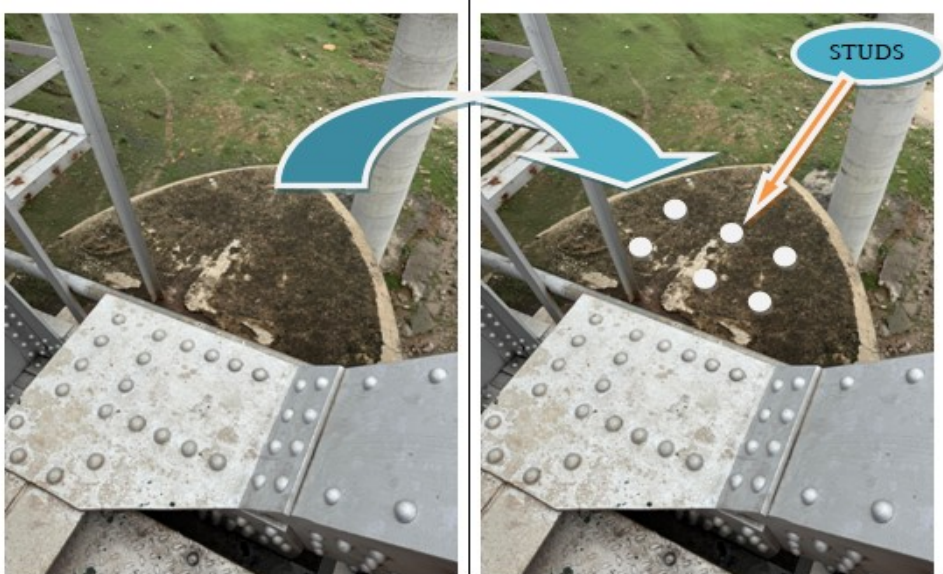
<p>ii. Spare studs with but nut-bolts are not grouted on bridge pier for erection of emergency masts.</p>

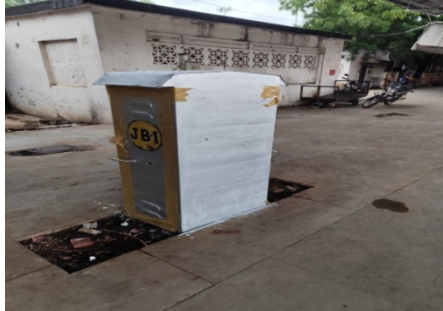
3.24	<p>On platform circulating area Half case location of S&T on platform no-1 is buried in soil of platform needs to lift up properly.</p>

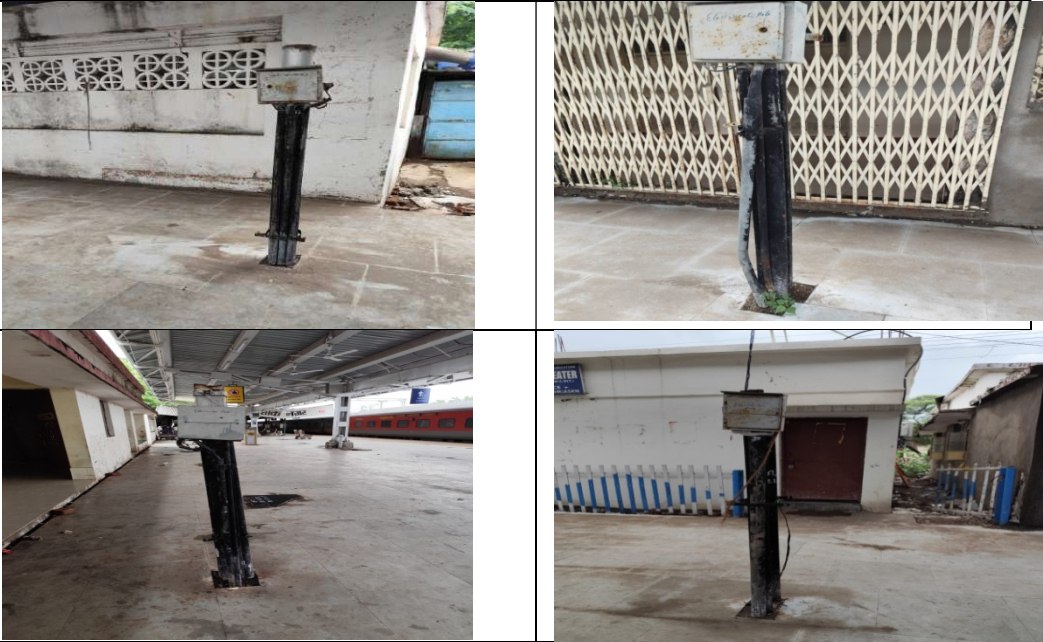
3.25	<p>On platform circulating area many half cut poles of electricity located on platform no-1 need to be removed from platform and cable should be connected under ground for public safety.</p>

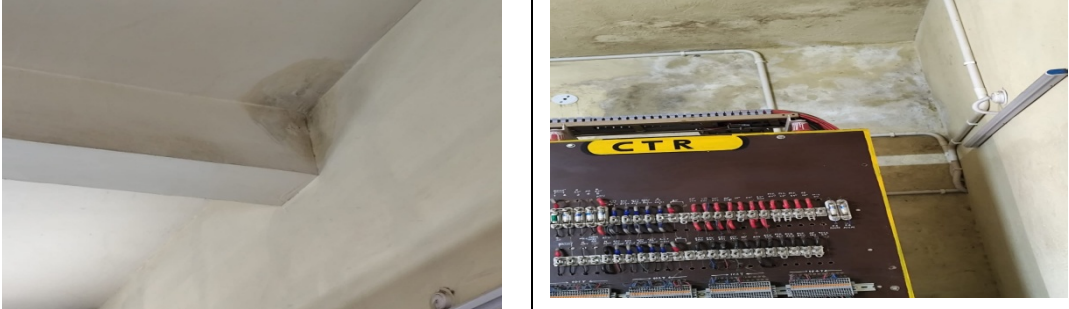
3.26	<p>Seepage found in roof of relay room .</p>

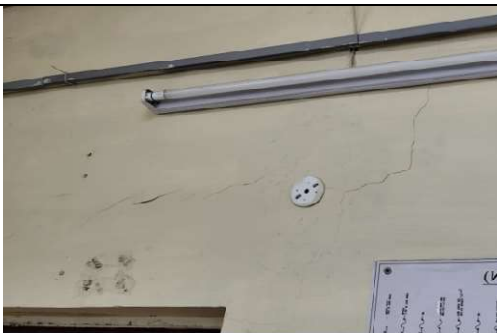
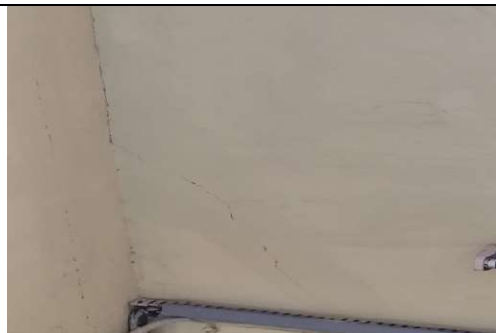
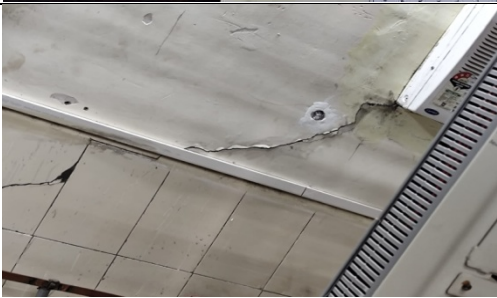
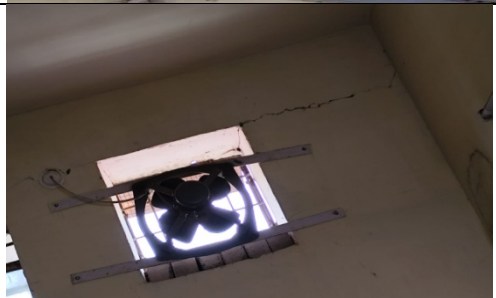
There are many cracks found in wall of relay room.	DRM/BPL

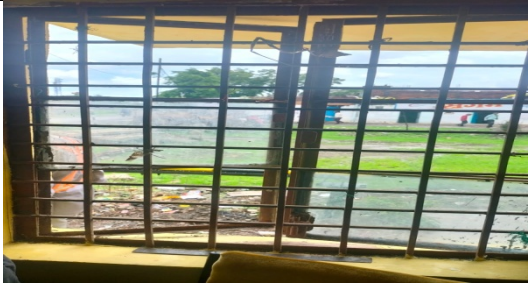
6.8	Window glass of the Gateman Gumti is broken and cannot be closed. Rain water comes inside the gumti from window.

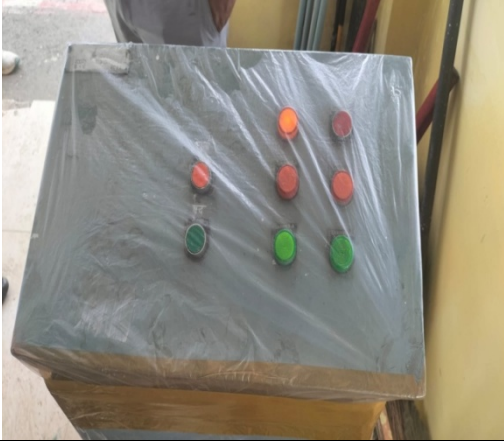
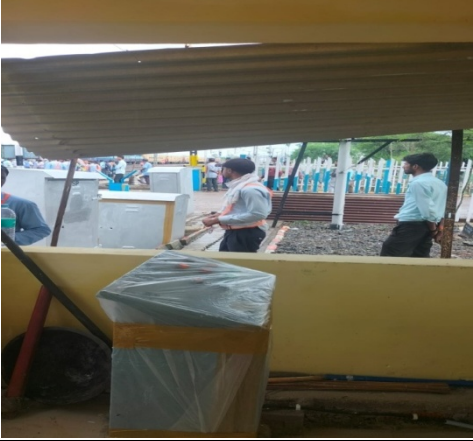
DRM/BPL
6.9	Rain water comes on Gate boom operational panel so it has been covered by polythene. Proper shed over the Gate boom operational panel is required to protect it from rain water.

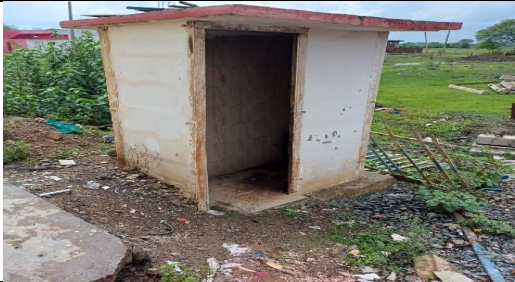
6.10	1. Stop board provided on gate boom was not retro reflective type. 2. A toilet has been constructed at the gate but the water facility is not available. This renders the facility unusable and causes inconvenience to the staff posted at the gate.

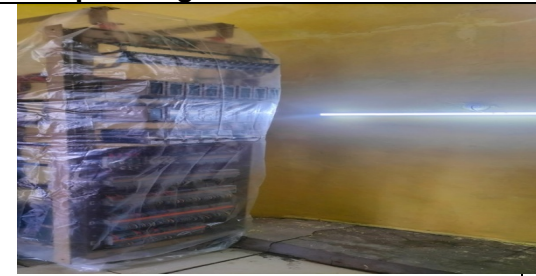
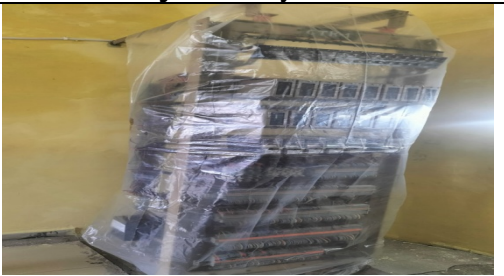
6.11	There is seepage in the Gate Relay Room, due to which relays have been temporarily covered with polythene to protect them from moisture. Proper waterproofing measures be undertaken immediately to rectify the issue.

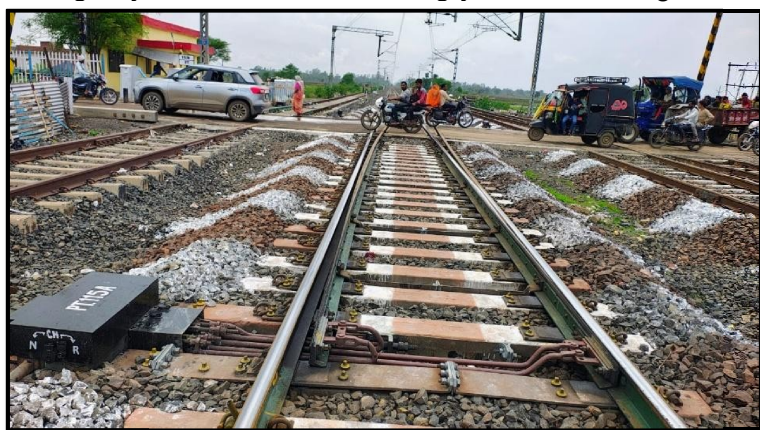
6.15	<p>Point No. 115A was inspected & subjected to 5-mm obstruction test. The readings measured as well as other details & deficiencies were as mentioned hereunder:</p> <table><tr><th colspan="2" rowspan="2">Point No.</th><th colspan="2">Voltage</th><th colspan="3">Current</th></tr><tr><th>Initial</th><th>Obstruction</th><th>Initial</th><th>Operating</th><th>Obstruction</th></tr><tr><td rowspan="2">101B</td><td>N-R</td><td>107</td><td>97</td><td>2.2</td><td>1.8</td><td>4.2</td></tr><tr><td>R-N</td><td>107</td><td>96</td><td>2.2</td><td>1.9</td><td>4.1</td></tr></table> <p>1) Point machine has been installed on LH side which is not in conformity with item No. 19.3.1(a) of IRSEM which clearly lays down that “Normally the machine shall be installed beside the close switch leading to high-speed movements clear of all infringements.” Accordingly, this point machine is required to be shifted to RH side for preventing the possibility of outside interference through foot-pressing of locking rod when the point is flashing due to any obstruction between its Tongue &Stock Rails.</p> <p>2) Opening: LH – 115mm; RH – 118mm.</p> <p>3) WJR timing was 11 sec, which was within permissible limit.</p> <p>4) Availability of NX switch in crank-handle circuit was checked & found to be working satisfactorily.</p> <p>5) Track locking was tested and found to be effective.</p> <p>It is not desirable to lay any turn-out over level crossing, as difficulty is noticed in maintaining track circuits at LC area. Some instructions were issued long back by Rly Board which prohibited laying of turn-outs at such locations. This may be kept in view while planning any work in future involving yard-remodeling.</p>
