**Intra Railway Safety Audit inspection of GUNA-Bina section of Bhopal Division by
SAG team of WCR on 27.06.2025**

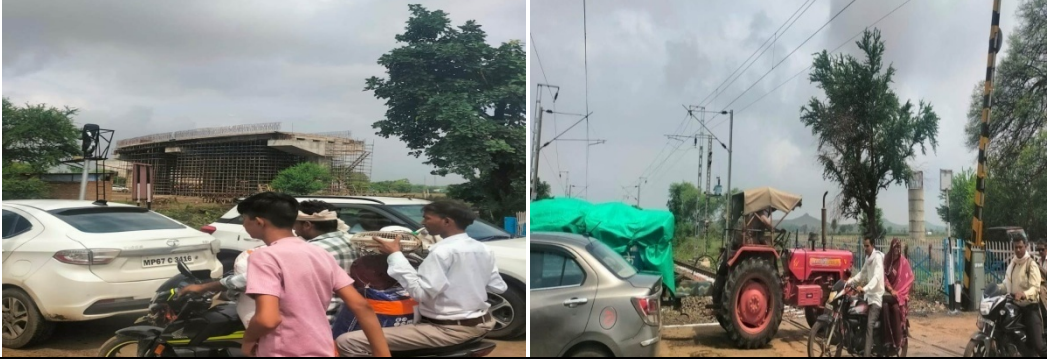
type. Necessary action needs to be taken in this regard so as to ensure its proper working thereby prevent entry of power-line surges into signalling equipment.																
2.8	UP side boom height from road surface in closed condition is 1.10M and Dn side is 1.0M.	DRM/BPL															
2.9	Casing required below CLS panel.	DRM/BPL															
2.10	Auto changeover of the CLS panel was found defective (Not working in AUTO mode) requires attention for rectification as UP AT supply contactor malfunctioning.	DRM/BPL															
2.11	Emergency key was not available on Gate gumti.	DRM/BPL															
2.12	25kV danger board (fastened at one end) need to be shifted at the center of the height gauge.	DRM/BPL															
2.13	ROB work is under construction at gate. As per the information received from the AEN, the work has been stopped due to land issues.

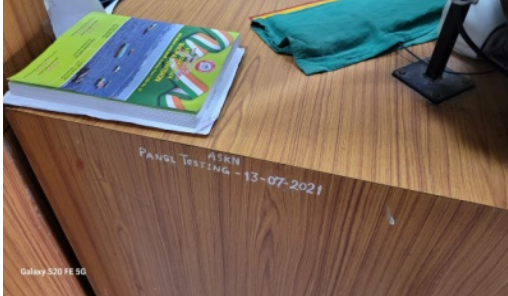
3.18	Date of installation not written on VDU & Panel Room Only Testing date mentioned.
