# Coach Rehabilitation Workshop, WC Railway, Bhopal

(An IMS and ISO 50001 Certified Workshop)  
Final Inspection Sheet - Details of Corrosion Repair

Coach No. :ECO04102  
Form No. F/BR/ICF/002

Type : WGACCN

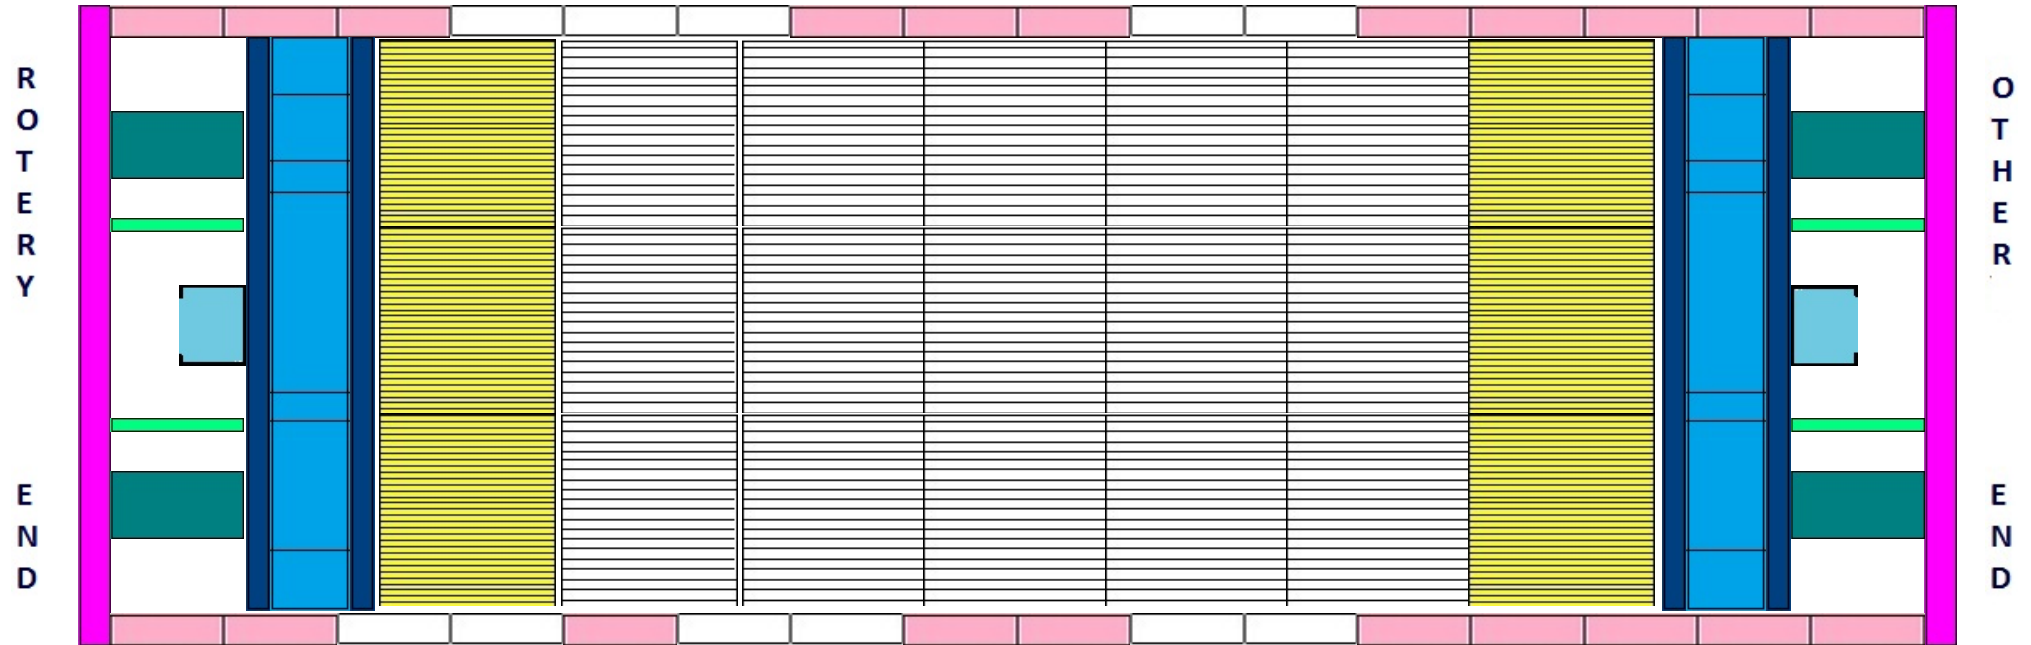
Rotary Side

Color	Particulars	Qty	Per%	Color	Particulars	Qty	Per%	Color	Particulars	Qty	Per%
	Headstock Beam	2	100%		Centre Stiffner for Headstock	4	100%		Floor Stiffner for Headstock	4	100%
	Aux. Head stock	4	100%		Sole Bar	10.5	66%		Draft Gear Bracket	2	100%
	Trough floor	2	29%		Centre plate	2	100%		SoleBar Stiffner	4	100%
	Bottom Wall Part	10.5	66%		Body panel/patch		100%		Door Top/Roof Patch		0%
	Window Module		0%		Window Sill	0	0%		Window Bar	0	0%
	Seat pillar/lav. Partition		100%		UIC end construction		0%

End Drooping: Rotary End - EAST : 0, WEST : 3 Other End - EAST : -10, WEST : -7  
Start Date : 15-Jan-2019, Completion Date : 21-Jan-2019, Net Repair Days : 6, Total Man Hours : 1528

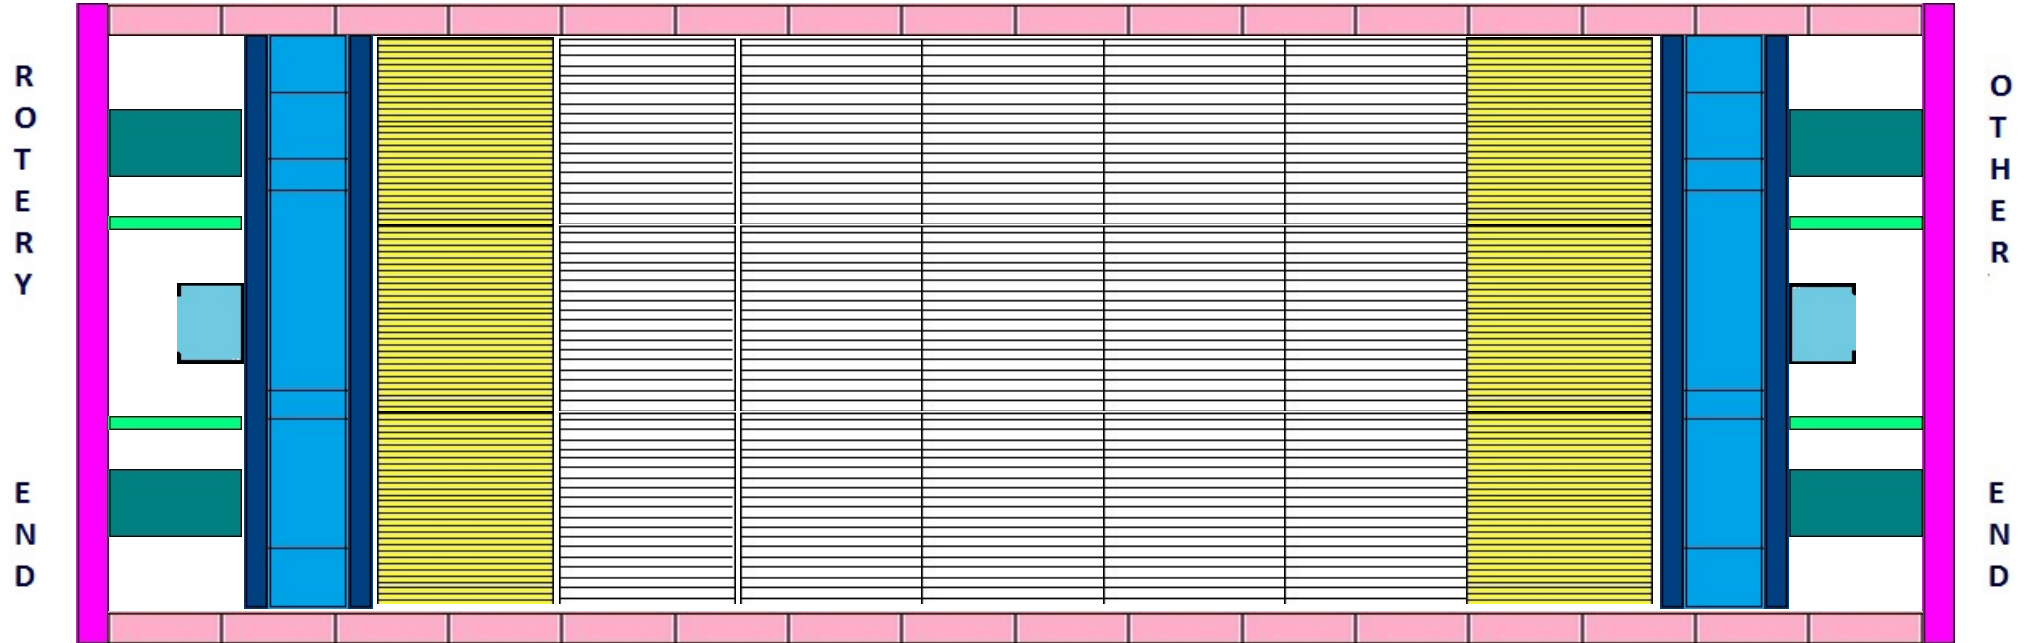
Rotary Side

Color	Particulars	Qty	Per%	Color	Particulars	Qty	Per%	Color	Particulars	Qty	Per%
	Headstock Beam	2	100%		Centre Stiffner for Headstock	4	100%		Floor Stiffner for Headstock	4	100%
	Aux. Head stock	4	100%		Sole Bar	32	100%		Draft Gear Bracket	2	100%
	Trough floor	2	29%		Centre plate	2	100%		SoleBar Stiffner	4	100%
	Bottom Wall Part	32	100%		Body panel/patch		100%		Door Top/Roof Patch		0%
	Window Module		0%		Window Sill	10	25%		Window Bar	44	24%
	Seat pillar/lav. Partition		100%		UIC end construction		0%

End Drooping: Rotary End - EAST : 2, WEST : 3 Other End - EAST : 0, WEST : 0  
Start Date : 05-Apr-2018, Completion Date : 13-Apr-2018, Net Repair Days : 8, Total Man Hours : 1868

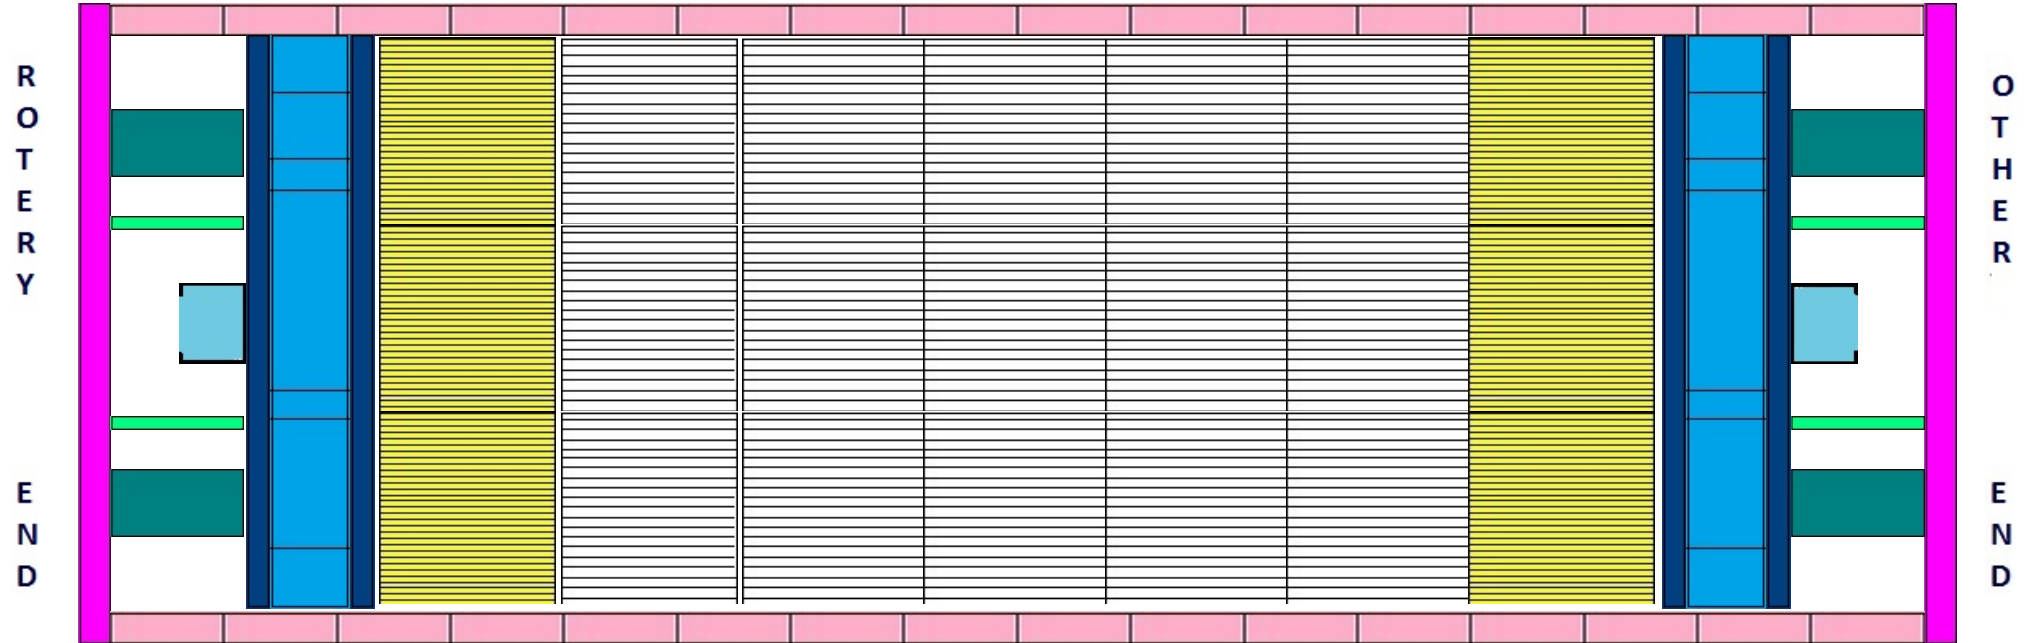
Rotary Side

Color	Particulars	Qty	Per%	Color	Particulars	Qty	Per%	Color	Particulars	Qty	Per%
	Headstock Beam	2	100%		Centre Stiffner for Headstock	4	100%		Floor Stiffner for Headstock	4	100%
	Aux. Head stock	4	100%		Sole Bar	16	100%		Draft Gear Bracket	2	100%
	Trough floor	2	29%		Centre plate	2	100%		SoleBar Stiffner	4	100%
	Bottom Wall Part	16	100%		Body panel/patch		100%		Door Top/Roof Patch		0%
	Window Module		0%		Window Sill	14	35%		Window Bar	48	26%
	Seat pillar/lav. Partition		100%		UIC end construction		0%

End Drooping: Rotary End - EAST : -5, WEST : 0 Other End - EAST : -10, WEST : -8  
Start Date : 06-Apr-2018, Completion Date : 19-Apr-2018, Net Repair Days : 12, Total Man Hours : 1748

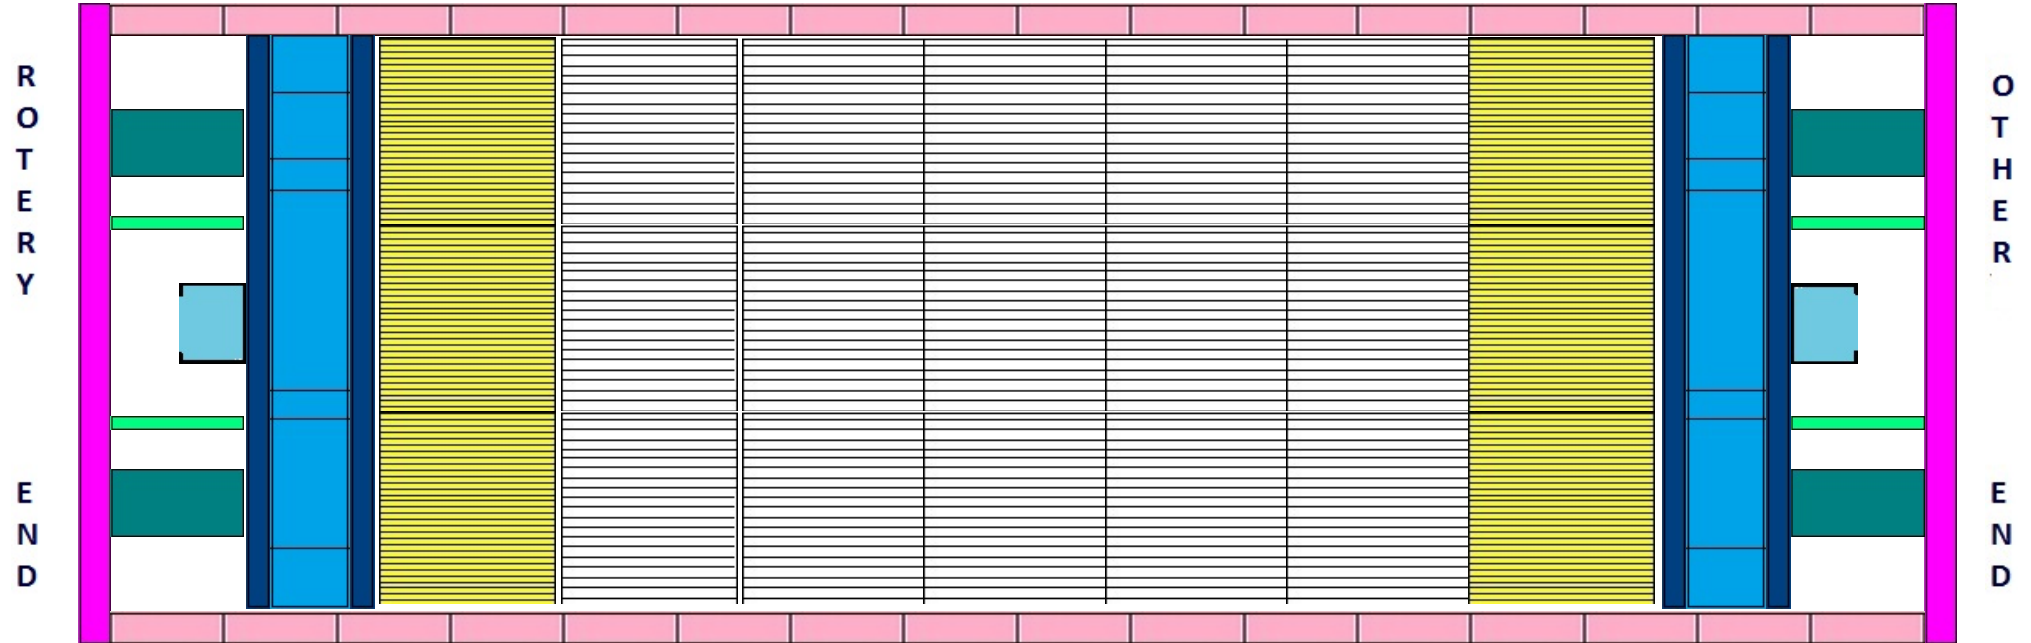
Rotary Side

Color	Particulars	Qty	Per%	Color	Particulars	Qty	Per%	Color	Particulars	Qty	Per%
	Headstock Beam	2	100%		Centre Stiffner for Headstock	4	100%		Floor Stiffner for Headstock	4	100%
	Aux. Head stock	4	100%		Sole Bar	16	100%		Draft Gear Bracket	2	100%
	Trough floor	2	29%		Centre plate	2	100%		SoleBar Stiffner	4	100%
	Bottom Wall Part	16	100%		Body panel/patch		100%		Door Top/Roof Patch		0%
	Window Module		0%		Window Sill	20	50%		Window Bar	48	26%
	Seat pillar/lav. Partition		100%		UIC end construction		0%

End Drooping: Rotary End - EAST : -2, WEST : -6 Other End - EAST : -8, WEST : -8  
Start Date : 04-Apr-2018, Completion Date : 11-Apr-2018, Net Repair Days : 7, Total Man Hours : 1904

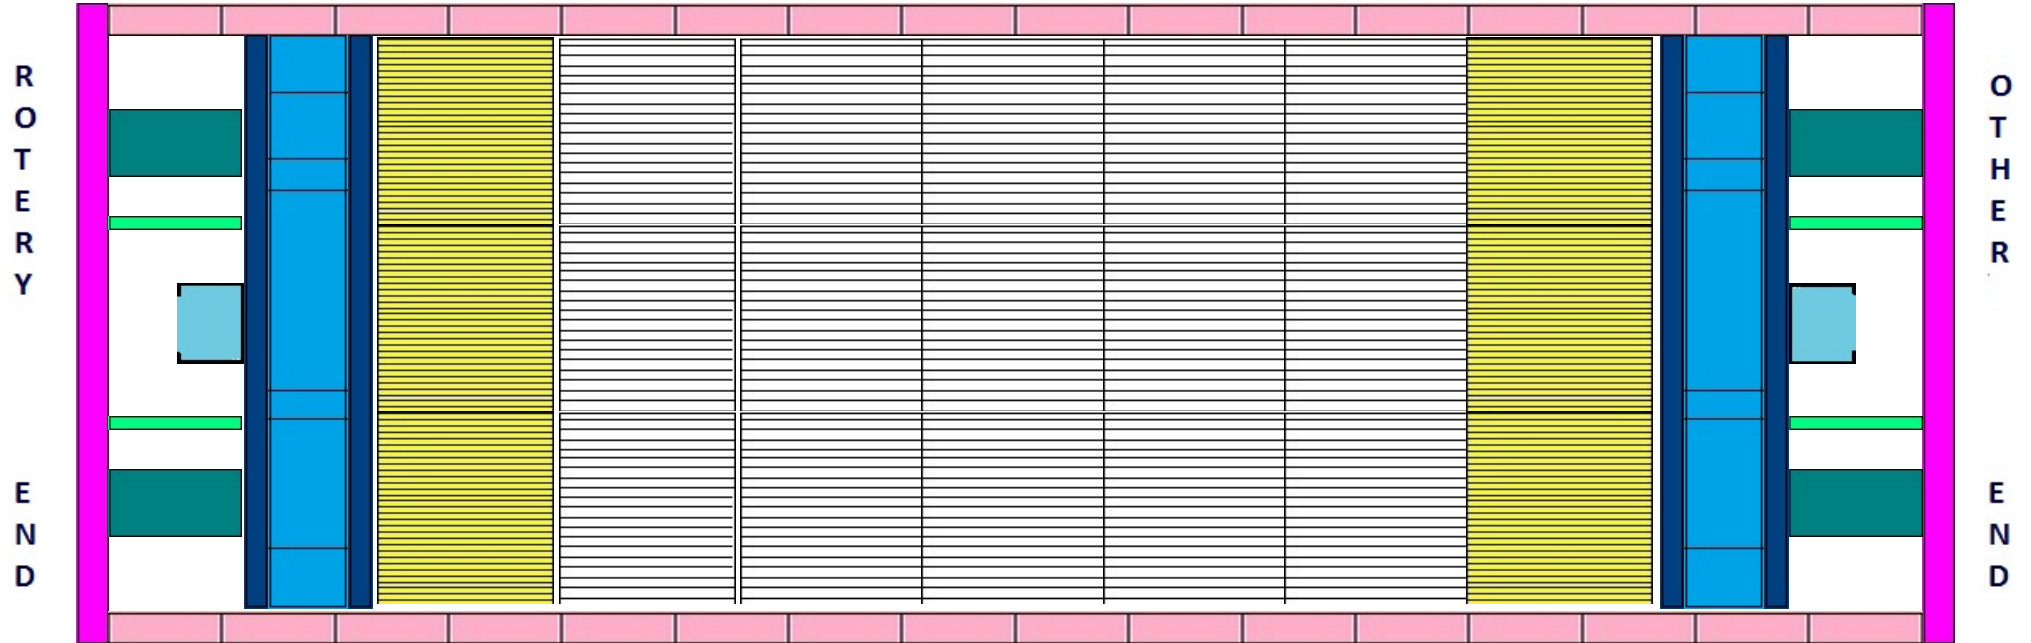
Rotary Side

Color	Particulars	Qty	Per%	Color	Particulars	Qty	Per%	Color	Particulars	Qty	Per%
	Headstock Beam	2	100%		Centre Stiffner for Headstock	4	100%		Floor Stiffner for Headstock	4	100%
	Aux. Head stock	4	100%		Sole Bar	16	100%		Draft Gear Bracket	2	100%
	Trough floor	2	29%		Centre plate	2	100%		SoleBar Stiffner	4	100%
	Bottom Wall Part	16	100%		Body panel/patch		100%		Door Top/Roof Patch		0%
	Window Module		0%		Window Sill	40	100%		Window Bar	48	26%
	Seat pillar/lav. Partition		100%		UIC end construction		0%

End Drooping: Rotary End - EAST : -5, WEST : -4 Other End - EAST : -4, WEST : -4  
Start Date : 29-Aug-2018, Completion Date : 08-Sep-2018, Net Repair Days : 10, Total Man Hours : 1700

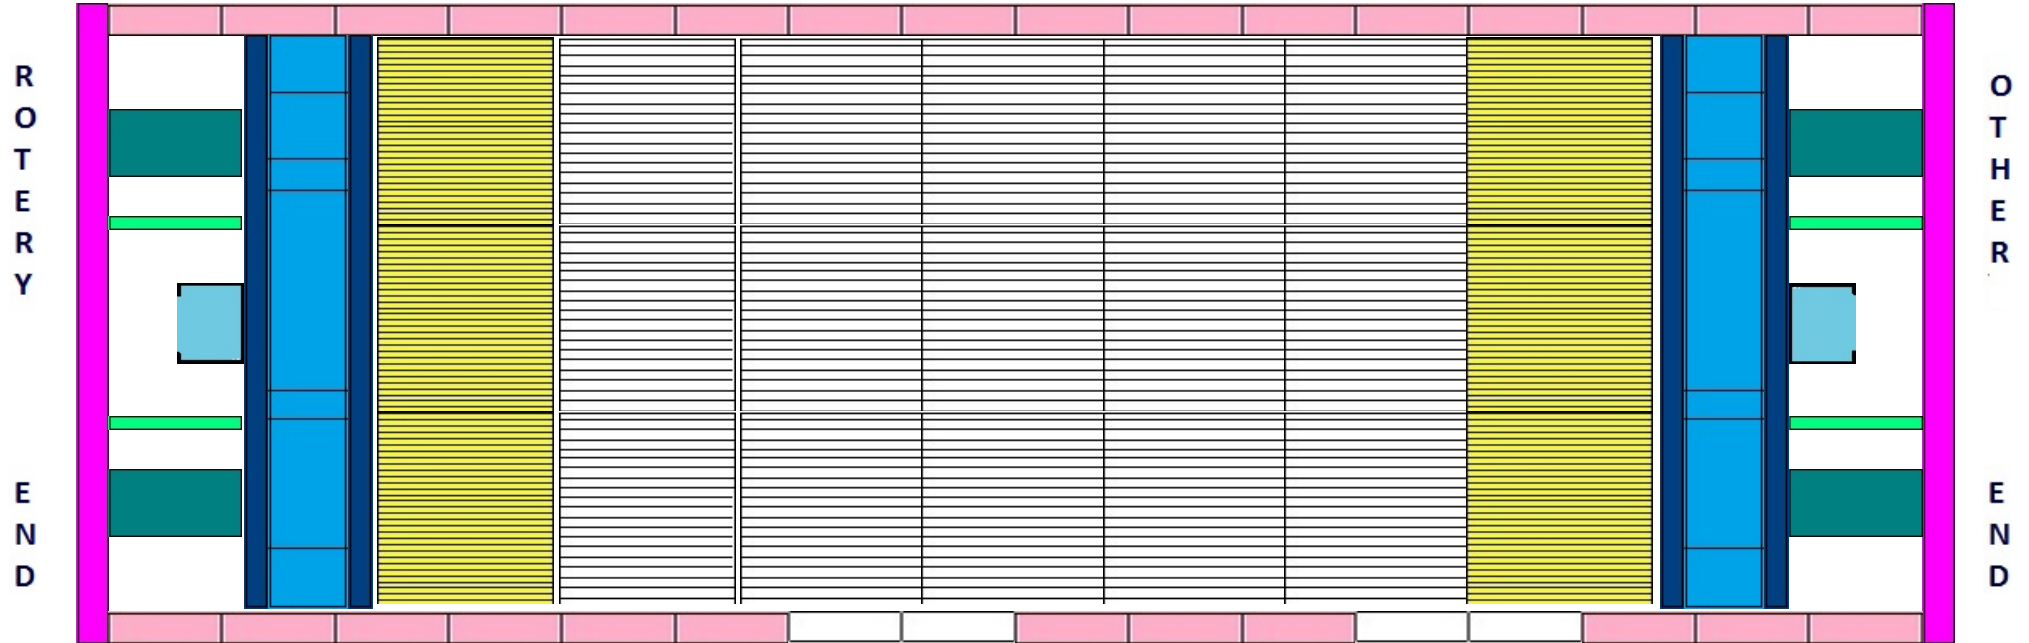
Rotary Side

Color	Particulars	Qty	Per%	Color	Particulars	Qty	Per%	Color	Particulars	Qty	Per%
	Headstock Beam	2	100%		Centre Stiffner for Headstock	4	100%		Floor Stiffner for Headstock	4	100%
	Aux. Head stock	4	100%		Sole Bar	14	88%		Draft Gear Bracket	2	100%
	Trough floor	2	29%		Centre plate	2	100%		SoleBar Stiffner	4	100%
	Bottom Wall Part	14	88%		Body panel/patch		100%		Door Top/Roof Patch		0%
	Window Module		0%		Window Sill	14	74%		Window Bar	24	29%
	Seat pillar/lav. Partition		100%		UIC end construction		0%

End Drooping: Rotary End - EAST : -8, WEST : -6 Other End - EAST : 5, WEST : 2  
Start Date : 13-Jul-2018, Completion Date : 21-Jul-2018, Net Repair Days : 8, Total Man Hours : 2052

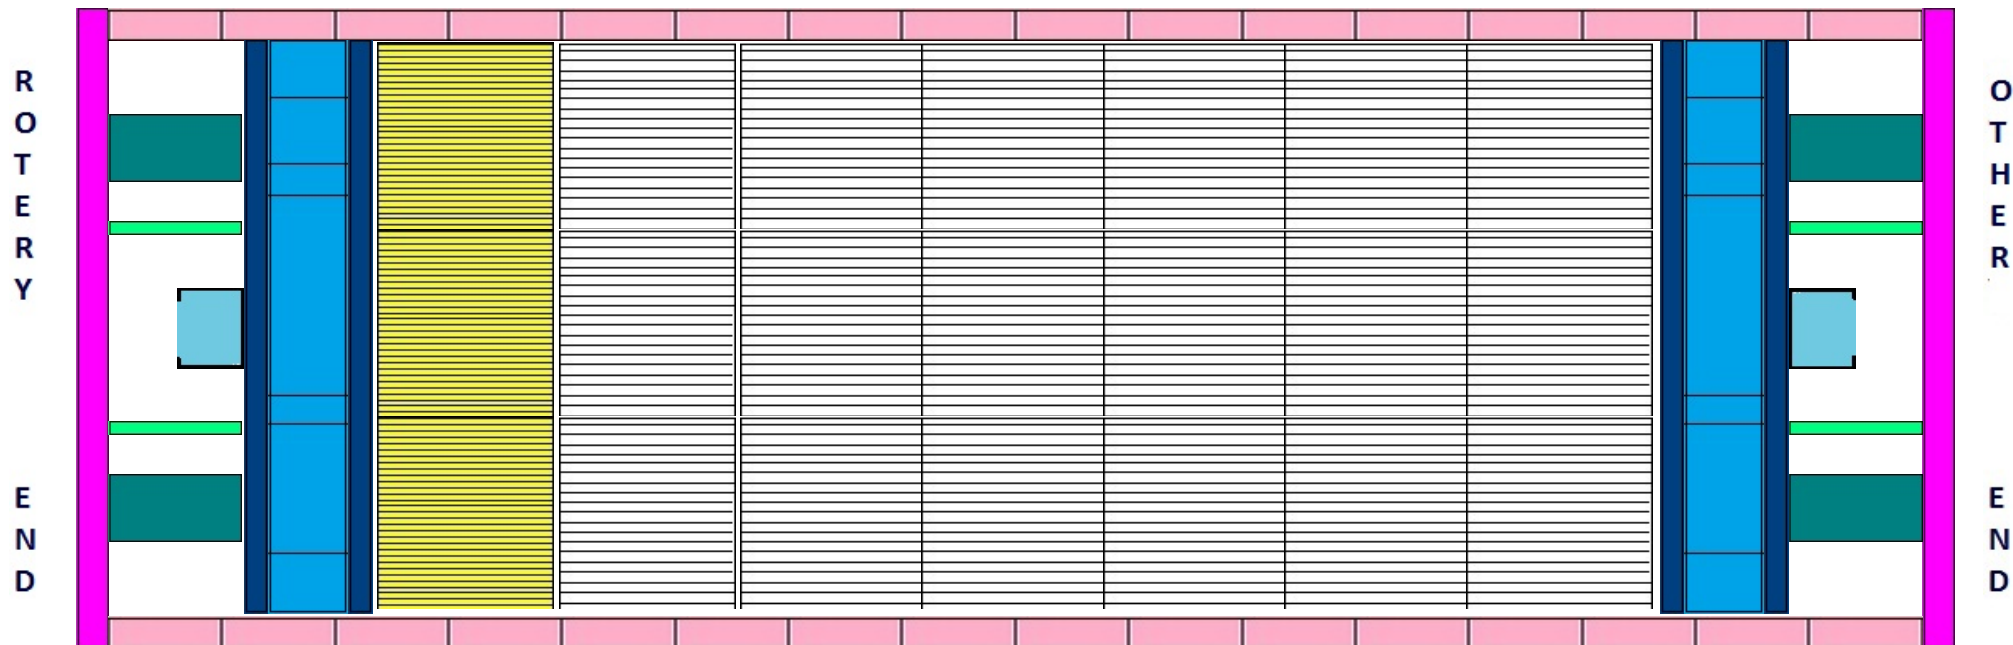
Rotary Side

Color	Particulars	Qty	Per%	Color	Particulars	Qty	Per%	Color	Particulars	Qty	Per%
Yellow	Headstock Beam	2	100%	Blue	Centre Stiffner for Headstock	4	100%	Green	Floor Stiffner for Headstock	4	100%
Dark Blue	Aux. Head stock	4	100%	Pink	Sole Bar	16	100%	Light Blue	Draft Gear Bracket	2	100%
Yellow	Trough floor	1	14%	Blue	Centre plate	2	100%		SoleBar Stiffner	4	100%
	Bottom Wall Part	16	100%		Body panel/patch		100%		Door Top/Roof Patch		0%
	Window Module		0%		Window Sill	10	53%		Window Bar	20	24%
	Seat pillar/lav. Partition		100%		UIC end construction		0%

End Drooping: Rotary End - EAST : -10, WEST : -8 Other End - EAST : 2, WEST : 10  
Start Date : 04-Sep-2018, Completion Date : 12-Sep-2018, Net Repair Days : 8, Total Man Hours : 1776

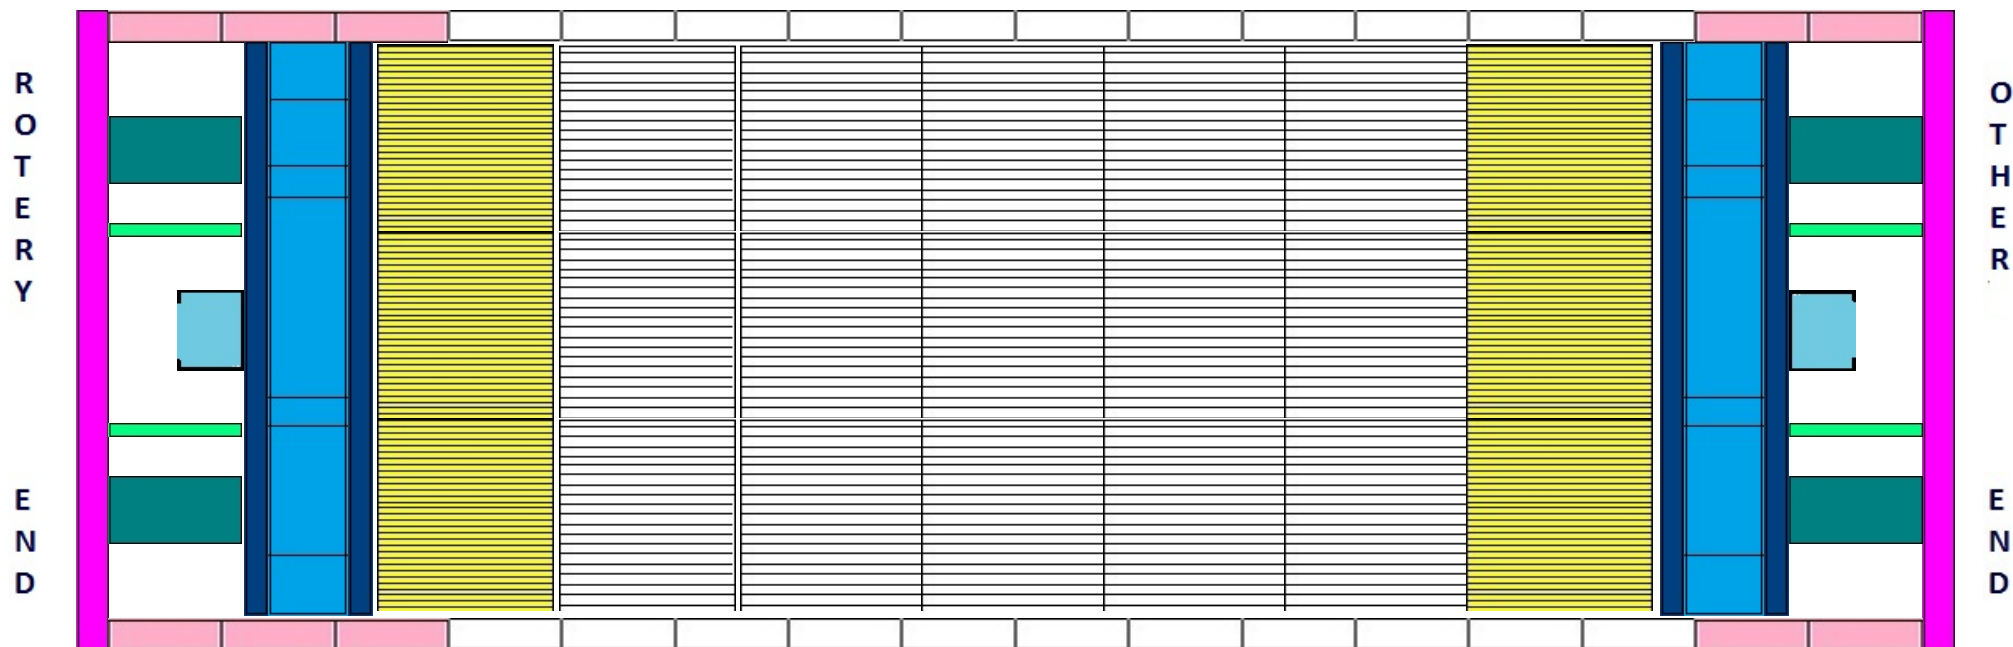
Rotary Side

Color	Particulars	Qty	Per%	Color	Particulars	Qty	Per%	Color	Particulars	Qty	Per%
	Headstock Beam	2	100%		Centre Stiffner for Headstock	4	100%		Floor Stiffner for Headstock	4	100%
	Aux. Head stock	4	100%		Sole Bar	5	31%		Draft Gear Bracket	2	100%
	Trough floor	2	29%		Centre plate	2	100%		SoleBar Stiffner	4	100%
	Bottom Wall Part	5	31%		Body panel/patch		100%		Door Top/Roof Patch		0%
	Window Module		0%		Window Sill	0	0%		Window Bar	0	0%
	Seat pillar/lav. Partition		100%		UIC end construction		0%

Start Date : 12-Feb-2019, Completion Date : 22-Feb-2019, Net Repair Days : 10, Total Man Hours : 1312

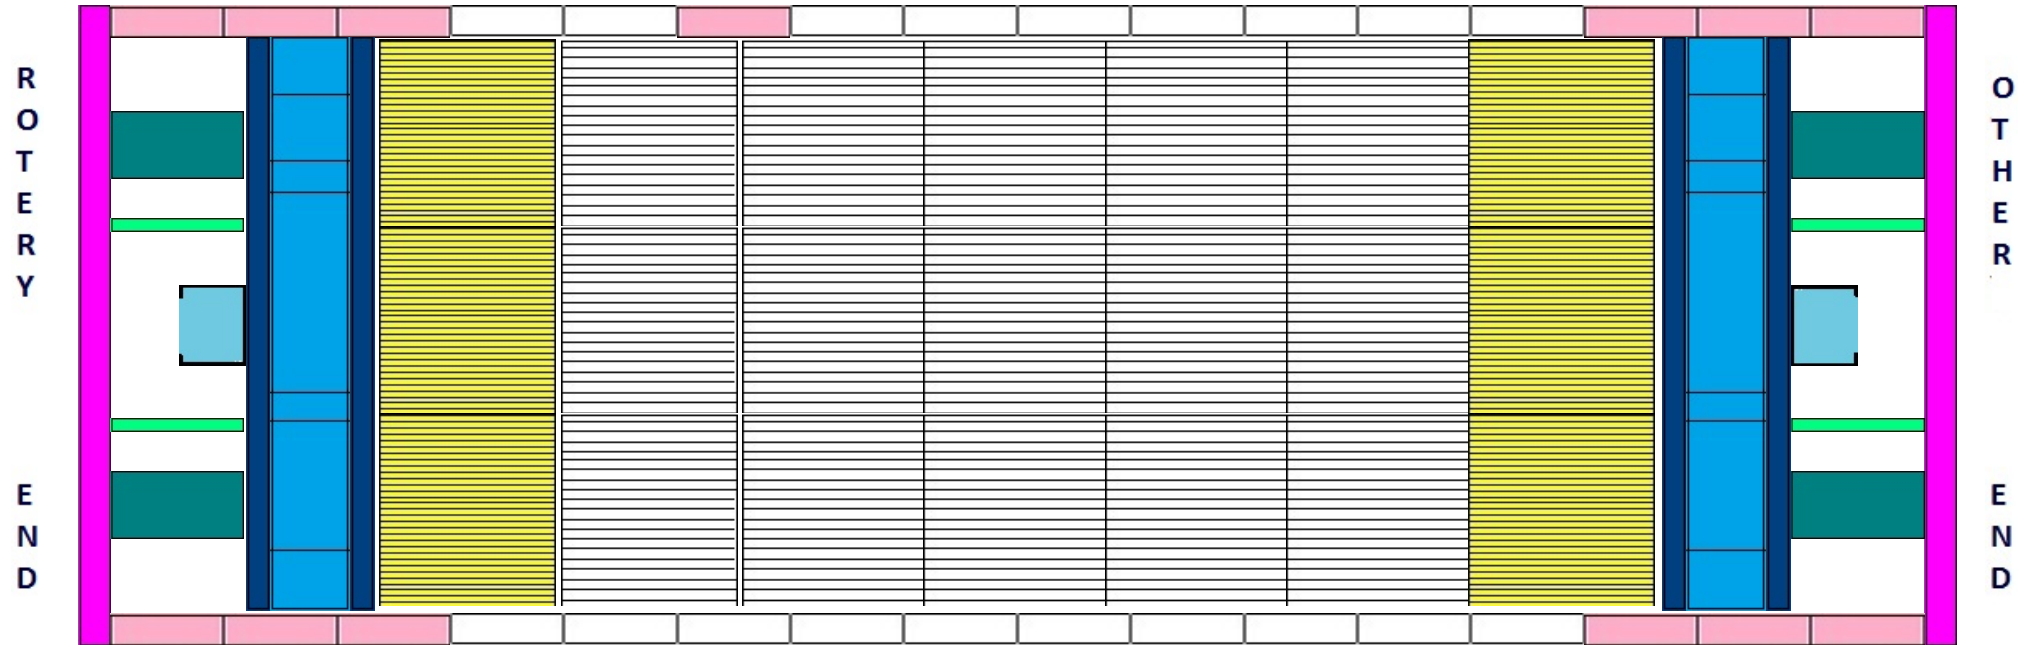
Rotary Side

Color	Particulars	Qty	Per%	Color	Particulars	Qty	Per%	Color	Particulars	Qty	Per%
	Headstock Beam	2	100%		Centre Stiffner for Headstock	4	100%		Floor Stiffner for Headstock	4	100%
	Aux. Head stock	4	100%		Sole Bar	6.5	41%		Draft Gear Bracket	2	100%
	Trough floor	2	29%		Centre plate	2	100%		SoleBar Stiffner	4	100%
	Bottom Wall Part	6.5	41%		Body panel/patch		100%		Door Top/Roof Patch		0%
	Window Module		4%		Window Sill	0	0%		Window Bar	0	0%
	Seat pillar/lav. Partition		100%		UIC end construction		0%

Start Date : 25-Feb-2019, Completion Date : 08-Mar-2019, Net Repair Days : 11, Total Man Hours : 1296

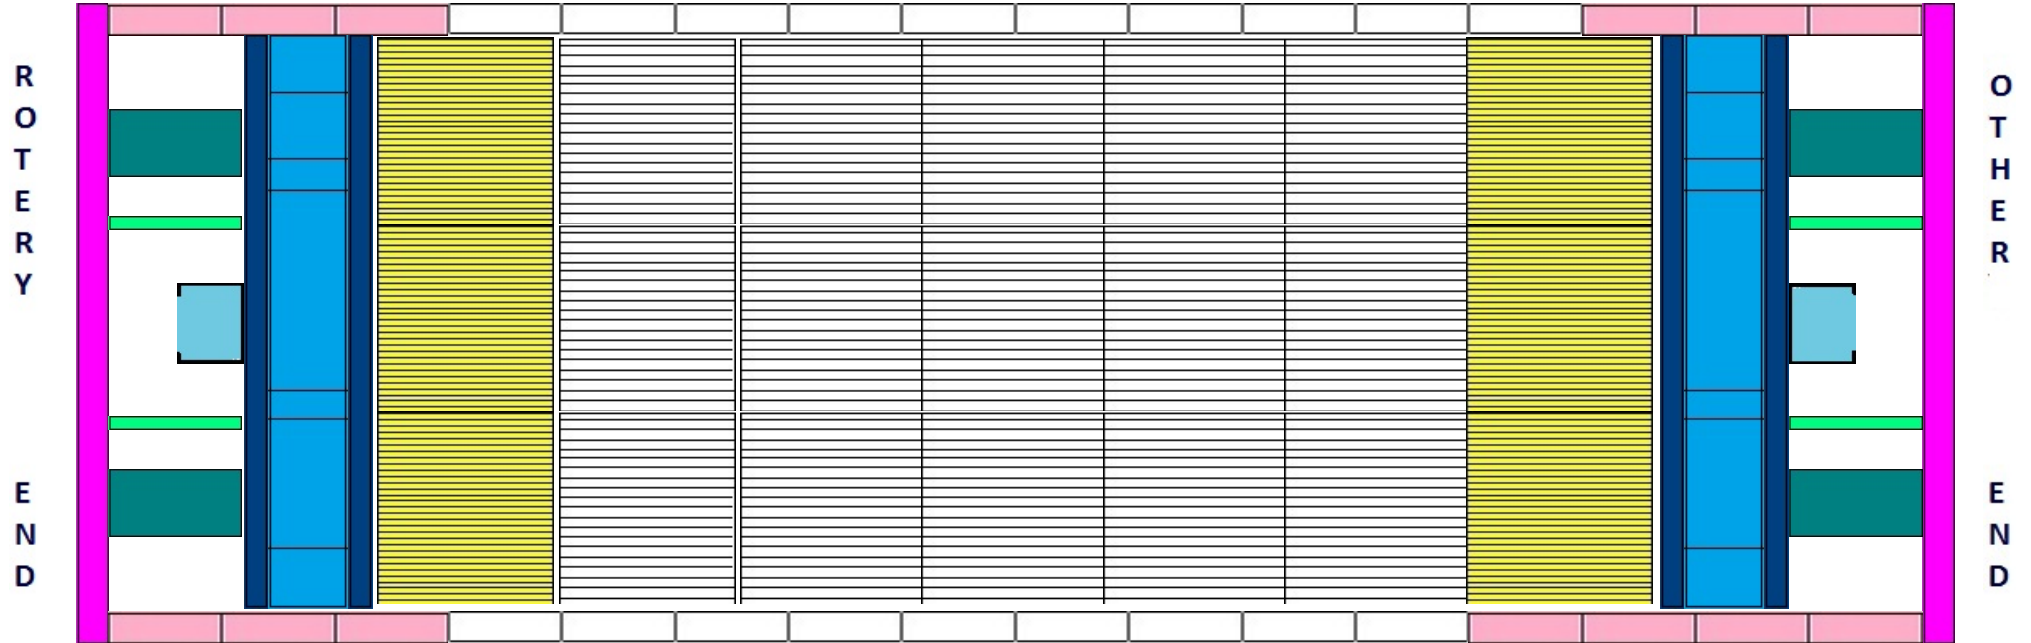
Rotary Side

Color	Particulars	Qty	Per%	Color	Particulars	Qty	Per%	Color	Particulars	Qty	Per%
Yellow	Headstock Beam	2	100%	Blue	Centre Stiffner for Headstock	4	100%	Green	Floor Stiffner for Headstock	4	100%
Dark Blue	Aux. Head stock	4	100%	Red	Sole Bar	6.5	41%	Light Blue	Draft Gear Bracket	2	100%
Yellow	Trough floor	2	29%	Blue	Centre plate	2	100%		SoleBar Stiffner	4	100%
	Bottom Wall Part	6.5	41%		Body panel/patch		100%		Door Top/Roof Patch		0%
	Window Module		100%		Window Sill	0	0%		Window Bar	0	0%
	Seat pillar/lav. Partition		100%		UIC end construction		0%

End Drooping: Rotary End - EAST : -5, WEST : 5 Other End - EAST : -7, WEST : -3  
Start Date : 29-Sep-2018, Completion Date : 13-Oct-2018, Net Repair Days : 13, Total Man Hours : 1288

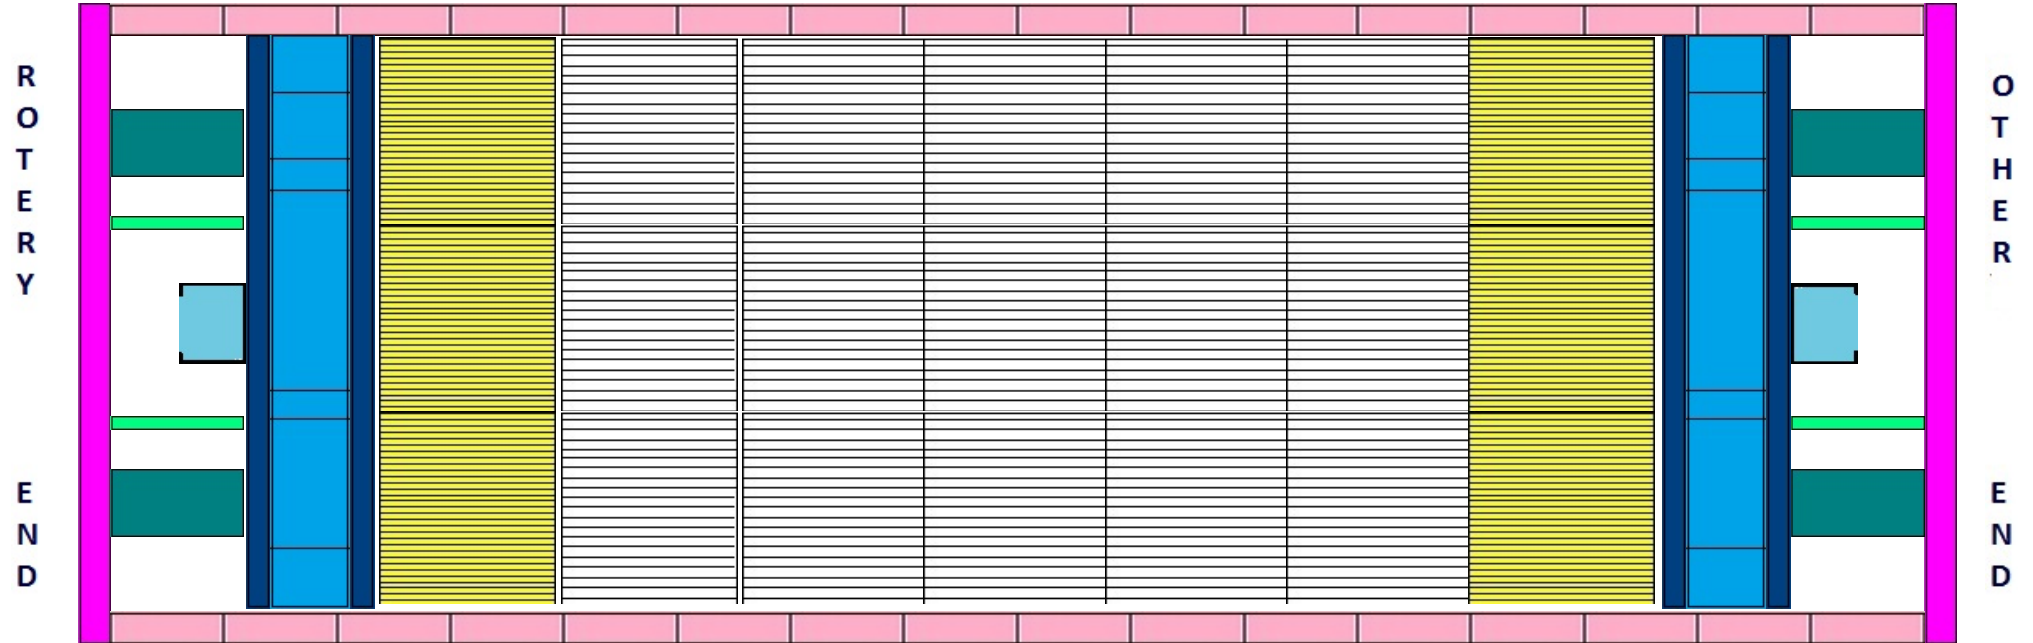
Rotary Side

Color	Particulars	Qty	Per%	Color	Particulars	Qty	Per%	Color	Particulars	Qty	Per%
Pink	Headstock Beam	2	100%	Dark Blue	Centre Stiffner for Headstock	4	100%	Light Green	Floor Stiffner for Headstock	4	100%
Blue	Aux. Head stock	4	100%	Light Green	Sole Bar	16	100%	Light Blue	Draft Gear Bracket	2	100%
Yellow	Trough floor	2	29%	Light Yellow	Centre plate	2	100%		SoleBar Stiffner	4	100%
	Bottom Wall Part	16	100%		Body panel/patch		100%		Door Top/Roof Patch		0%
	Window Module		0%		Window Sill	29	73%		Window Bar	50	27%
	Seat pillar/lav. Partition		100%		UIC end construction		0%

End Drooping: Rotary End - EAST : -10, WEST : -5 Other End - EAST : -3, WEST : -4  
Start Date : 23-May-2018, Completion Date : 31-May-2018, Net Repair Days : 8, Total Man Hours : 1756

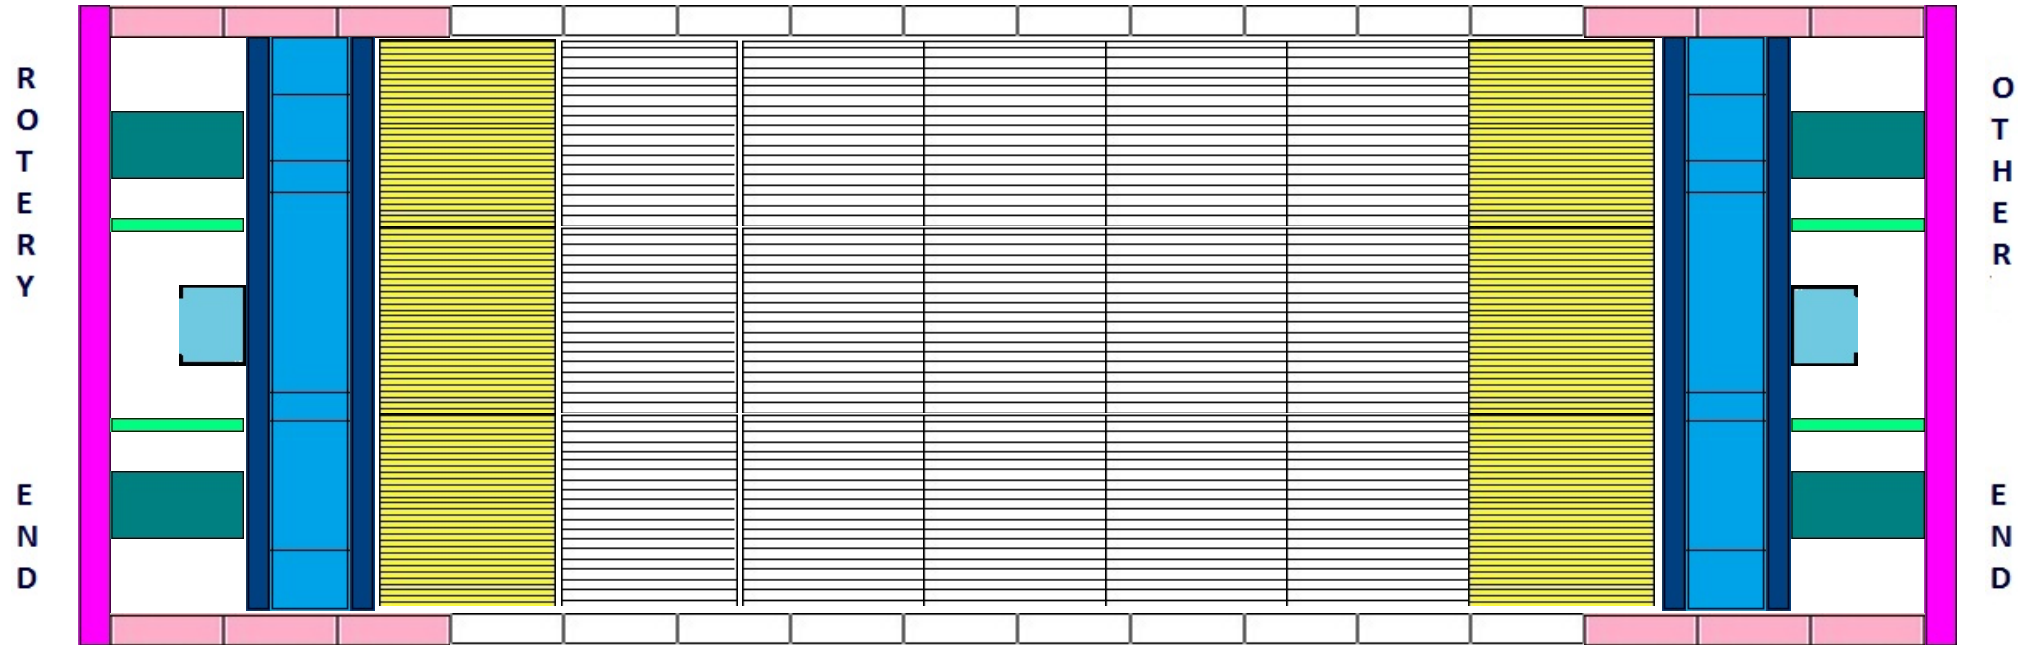
Rotary Side

Color	Particulars	Qty	Per%	Color	Particulars	Qty	Per%	Color	Particulars	Qty	Per%
	Headstock Beam	2	100%		Centre Stiffner for Headstock	4	100%		Floor Stiffner for Headstock	4	100%
	Aux. Head stock	4	100%		Sole Bar	6	38%		Draft Gear Bracket	2	100%
	Trough floor	2	29%		Centre plate	2	100%		SoleBar Stiffner	4	100%
	Bottom Wall Part	6	38%		Body panel/patch		100%		Door Top/Roof Patch		0%
	Window Module		0%		Window Sill	22	55%		Window Bar	48	26%
	Seat pillar/lav. Partition		100%		UIC end construction		0%

End Drooping: Rotary End - EAST : -3, WEST : -5 Other End - EAST : 3, WEST : 5  
Start Date : 02-Apr-2018, Completion Date : 16-Apr-2018, Net Repair Days : 13, Total Man Hours : 1260

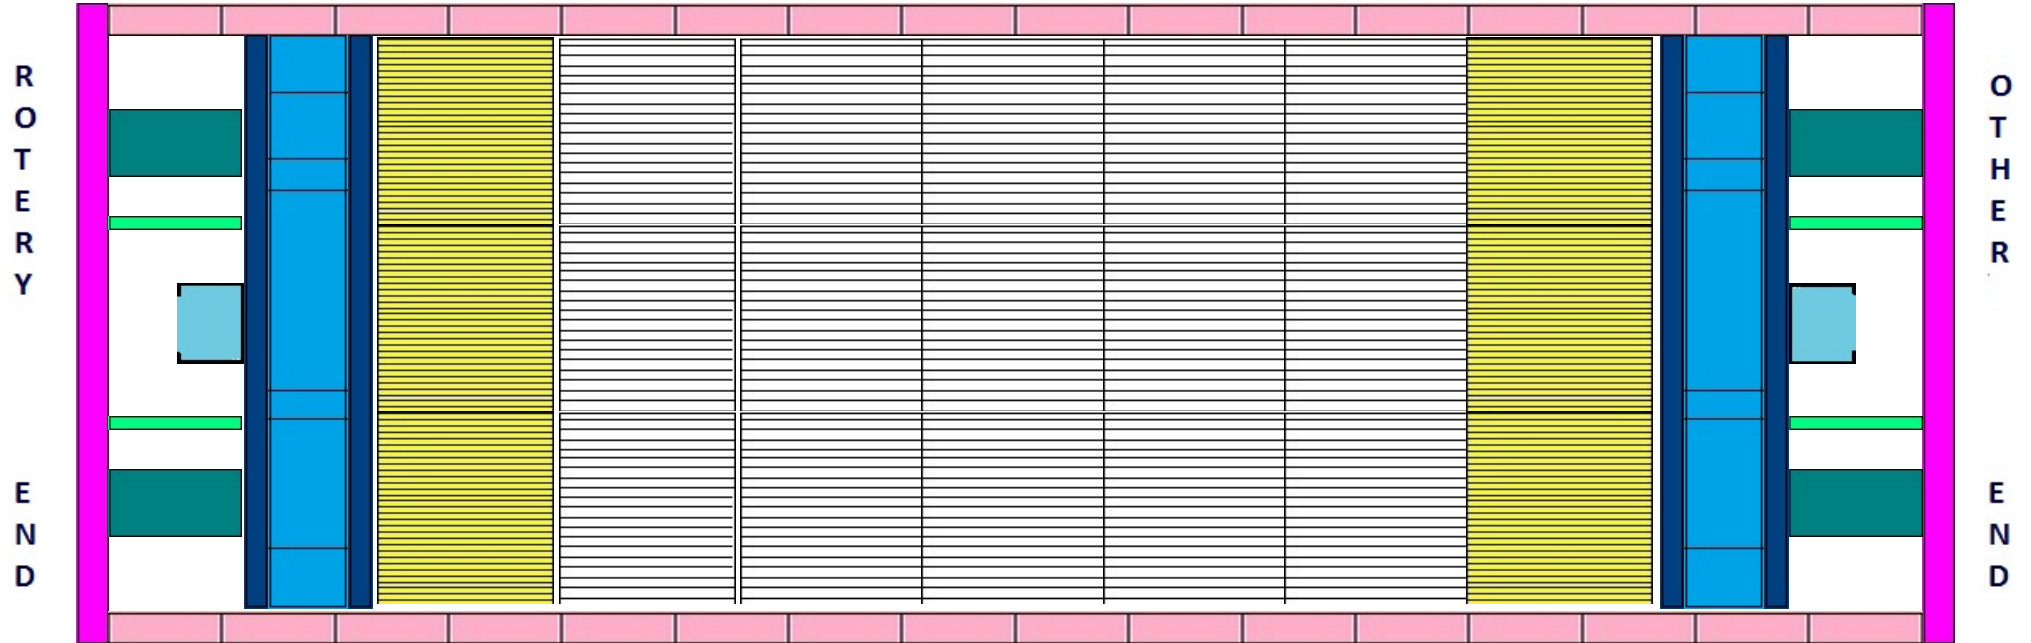
Rotary Side

Color	Particulars	Qty	Per%	Color	Particulars	Qty	Per%	Color	Particulars	Qty	Per%
Pink	Headstock Beam	2	100%	Blue	Centre Stiffner for Headstock	4	100%	Green	Floor Stiffner for Headstock	4	100%
Blue	Aux. Head stock	4	100%	Pink	Sole Bar	16	100%	Light Blue	Draft Gear Bracket	2	100%
Yellow	Trough floor	2	29%	Light Blue	Centre plate	2	100%		SoleBar Stiffner	4	100%
	Bottom Wall Part	16	100%		Body panel/patch		100%		Door Top/Roof Patch		0%
	Window Module		0%		Window Sill	32	80%		Window Bar	58	32%
	Seat pillar/lav. Partition		100%		UIC end construction		0%

End Drooping: Rotary End - EAST : 5, WEST : 5 Other End - EAST : -2, WEST : 3  
Start Date : 04-Sep-2018, Completion Date : 13-Sep-2018, Net Repair Days : 9, Total Man Hours : 1852

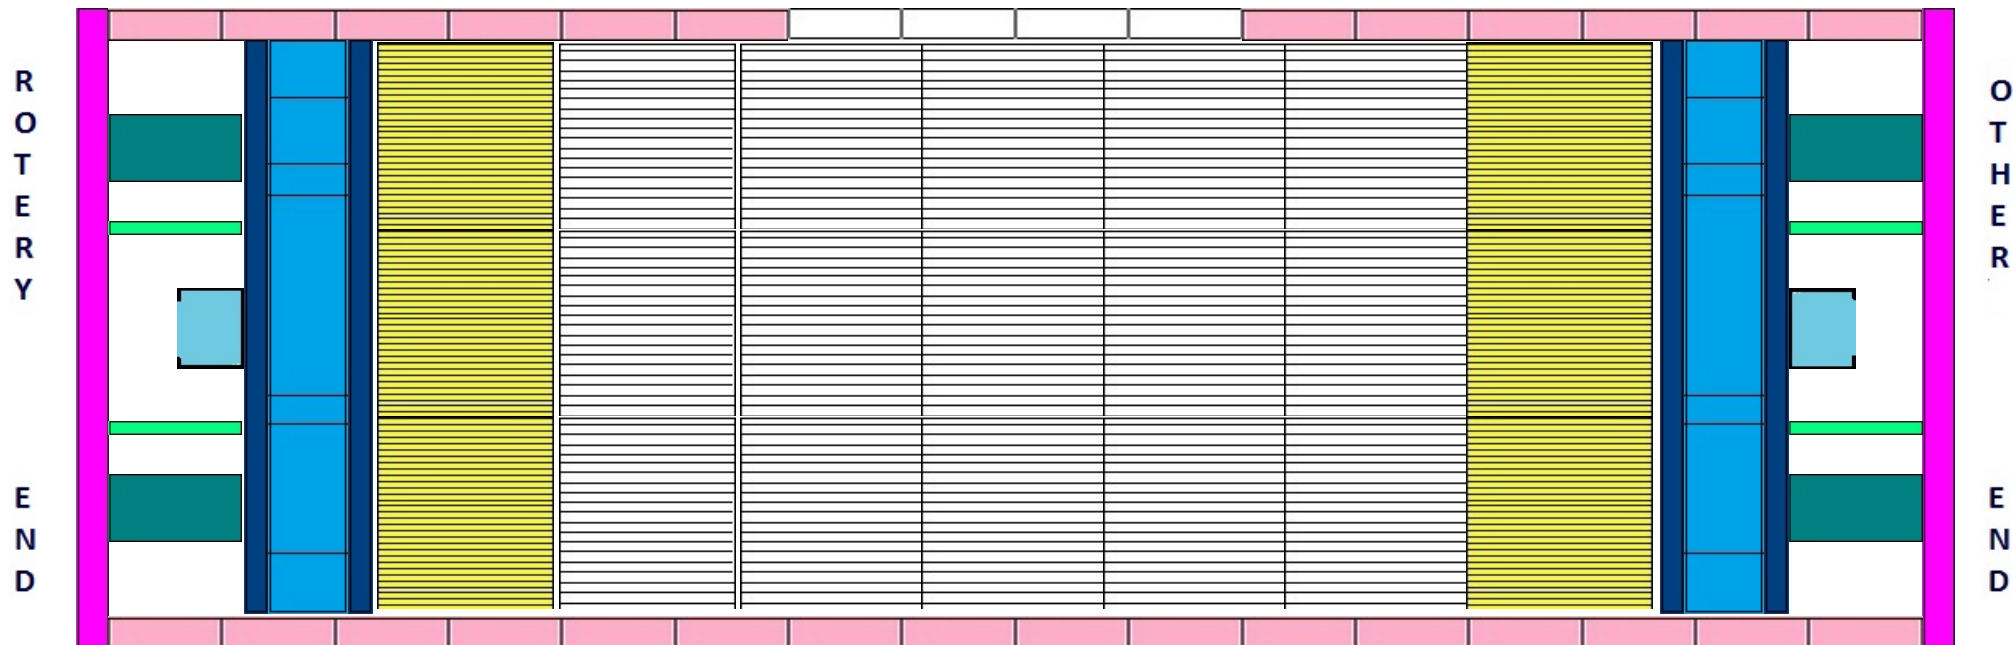
Rotary Side

Color	Particulars	Qty	Per%	Color	Particulars	Qty	Per%	Color	Particulars	Qty	Per%
	Headstock Beam	2	100%		Centre Stiffner for Headstock	4	100%		Floor Stiffner for Headstock	4	100%
	Aux. Head stock	4	100%		Sole Bar	14	88%		Draft Gear Bracket	2	100%
	Trough floor	2	29%		Centre plate	2	100%		SoleBar Stiffner	4	100%
	Bottom Wall Part	14	88%		Body panel/patch		100%		Door Top/Roof Patch		0%
	Window Module		0%		Window Sill	14	35%		Window Bar	42	23%
	Seat pillar/lav. Partition		100%		UIC end construction		0%

End Drooping: Rotary End - EAST : -2, WEST : 3 Other End - EAST : 2, WEST : -5  
Start Date : 21-Jun-2018, Completion Date : 29-Jun-2018, Net Repair Days : 8, Total Man Hours : 1732

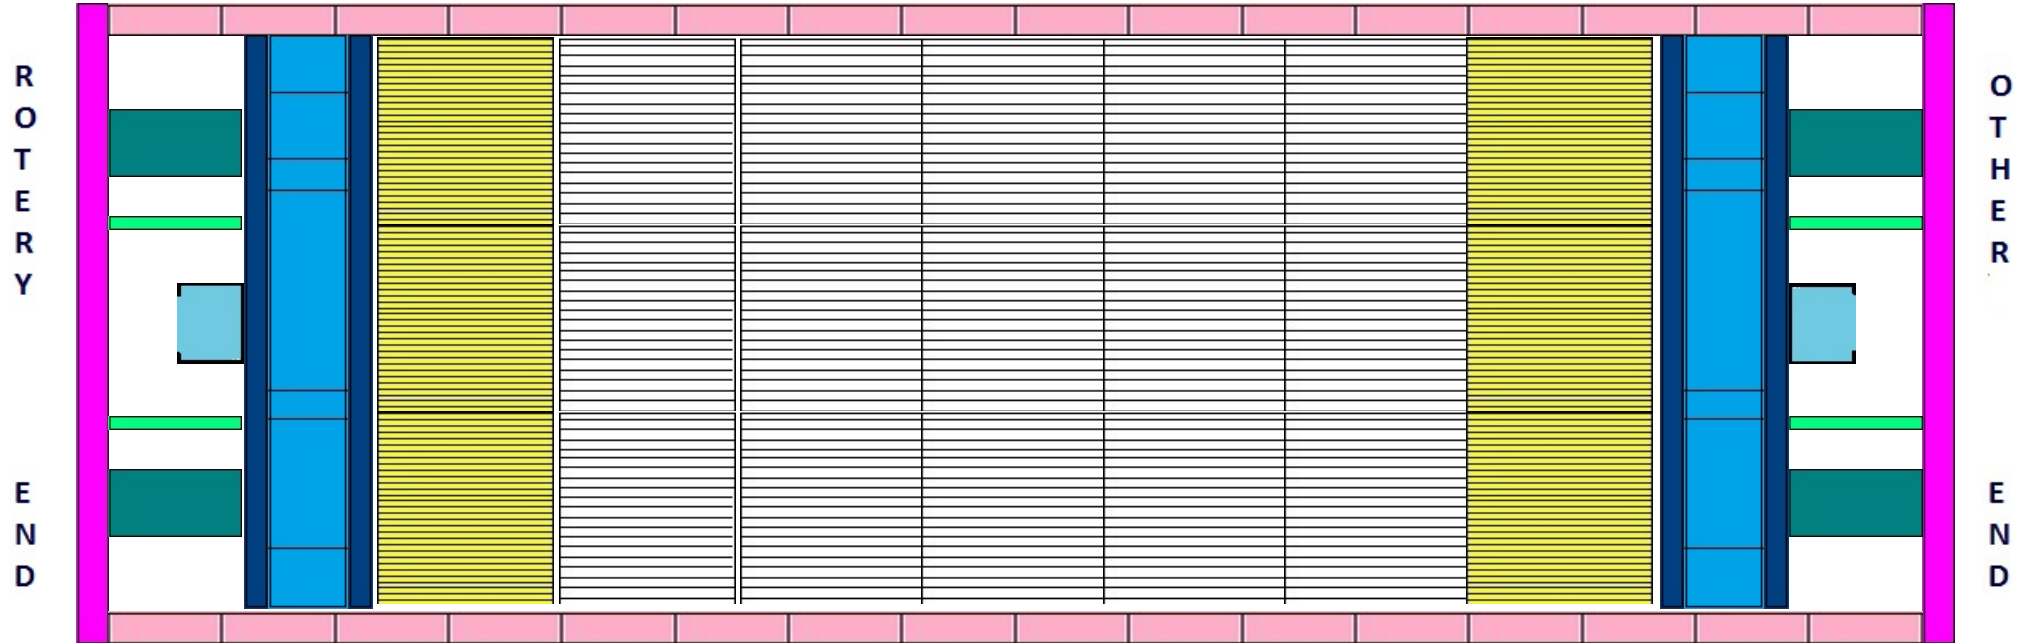
Rotary Side

Color	Particulars	Qty	Per%	Color	Particulars	Qty	Per%	Color	Particulars	Qty	Per%
	Headstock Beam	2	100%		Centre Stiffner for Headstock	4	100%		Floor Stiffner for Headstock	4	100%
	Aux. Head stock	4	100%		Sole Bar	16	100%		Draft Gear Bracket	2	100%
	Trough floor	2	29%		Centre plate	2	100%		SoleBar Stiffner	4	100%
	Bottom Wall Part	16	100%		Body panel/patch		0%		Door Top/Roof Patch		100%
	Window Module		0%		Window Sill	0	0%		Window Bar	0	0%
	Seat pillar/lav. Partition		100%		UIC end construction		0%

End Drooping: Rotary End - EAST : 0, WEST : 5 Other End - EAST : -5, WEST : -5  
Start Date : 13-Dec-2018, Completion Date : 21-Dec-2018, Net Repair Days : 8, Total Man Hours : 1776
