# Coach Rehabilitation Workshop, WC Railway, Bhopal

(An IMS and ISO 50001 Certified Workshop)  
Final Inspection Sheet - Details of Corrosion Repair

Coach No. :ECO04102  
Form No. F/BR/ICF/002

Type : WGACCN

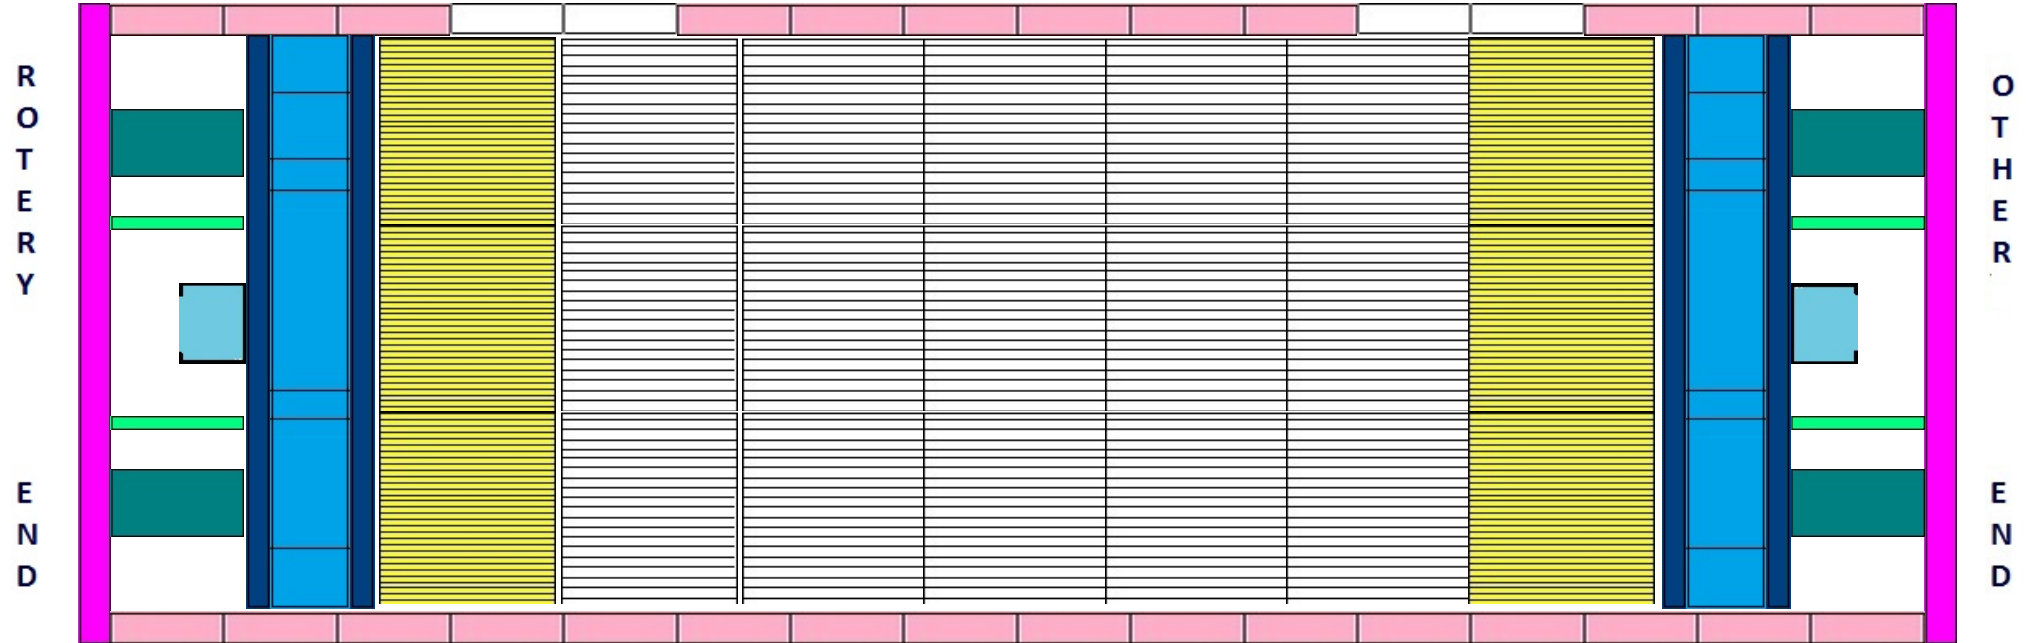
Rotary Side

Color	Particulars	Qty	Per%	Color	Particulars	Qty	Per%	Color	Particulars	Qty	Per%
	Headstock Beam	2	100%		Centre Stiffner for Headstock	4	100%		Floor Stiffner for Headstock	4	100%
	Aux. Head stock	4	100%		Sole Bar	14	88%		Draft Gear Bracket	2	100%
	Trough floor	2	29%		Centre plate	2	100%		SoleBar Stiffner	4	100%
	Bottom Wall Part	14	88%		Body panel/patch		100%		Door Top/Roof Patch		0%
	Window Module		0%		Window Sill	28	70%		Window Bar	52	28%
	Seat pillar/lav. Partition		100%		UIC end construction		0%

End Drooping: Rotary End - EAST : -10, WEST : -6 Other End - EAST : -10, WEST : -6  
Start Date : 28-Mar-2018, Completion Date : 06-Apr-2018, Net Repair Days : 9, Total Man Hours : 1816

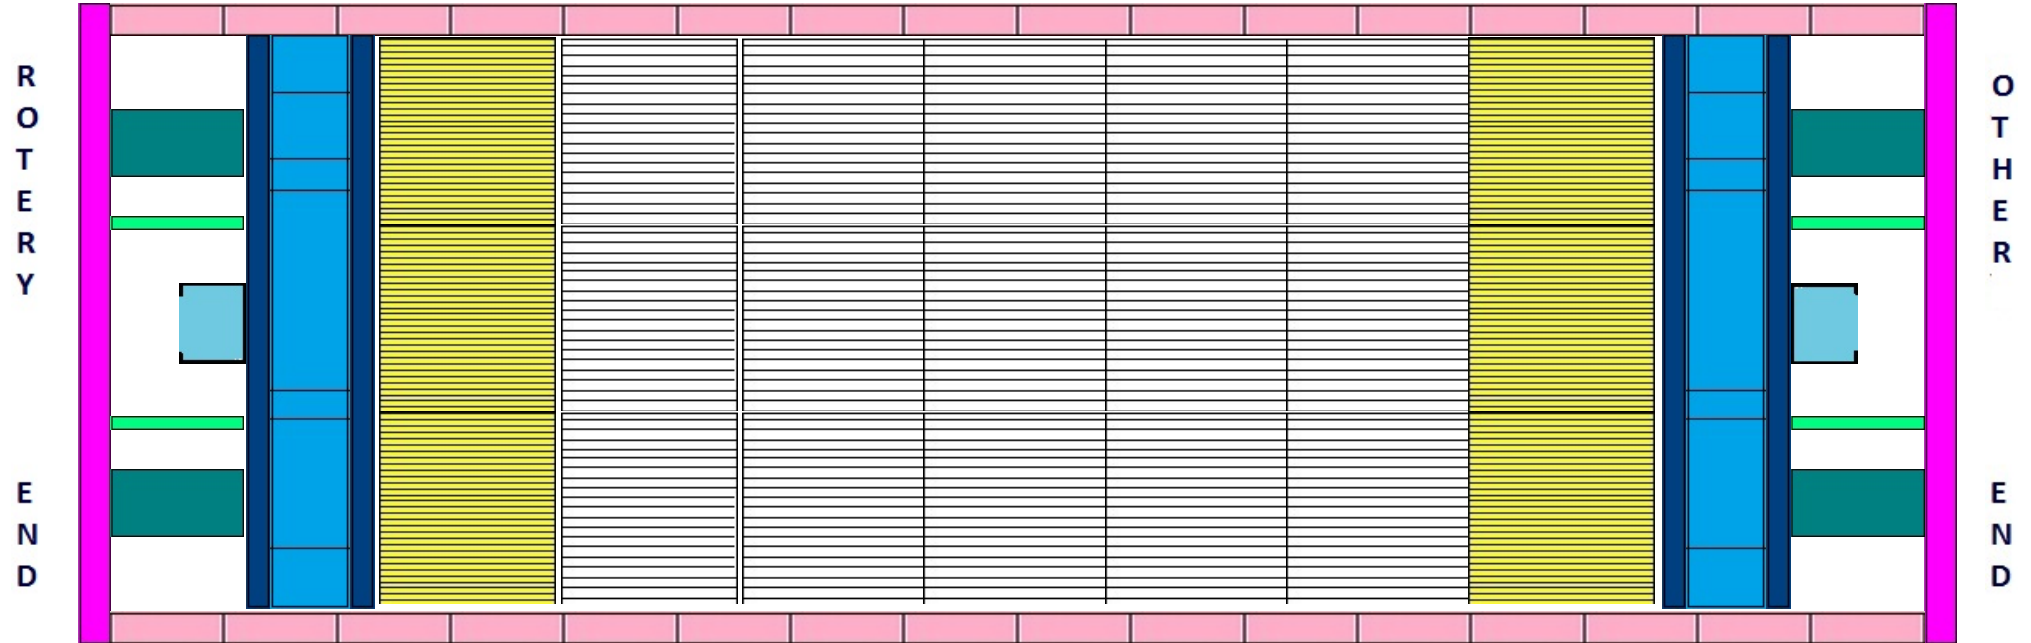
Rotary Side

Color	Particulars	Qty	Per%	Color	Particulars	Qty	Per%	Color	Particulars	Qty	Per%
	Headstock Beam	2	100%		Centre Stiffner for Headstock	4	100%		Floor Stiffner for Headstock	4	100%
	Aux. Head stock	4	100%		Sole Bar	16	100%		Draft Gear Bracket	2	100%
	Trough floor	2	29%		Centre plate	2	100%		SoleBar Stiffner	4	100%
	Bottom Wall Part	16	100%		Body panel/patch		100%		Door Top/Roof Patch		0%
	Window Module		0%		Window Sill	40	100%		Window Bar	50	27%
	Seat pillar/lav. Partition		100%		UIC end construction		0%

End Drooping: Rotary End - EAST : 5, WEST : -5 Other End - EAST : -10, WEST : -5  
Start Date : 22-Dec-2018, Completion Date : 03-Jan-2019, Net Repair Days : 6, Total Man Hours : 1940

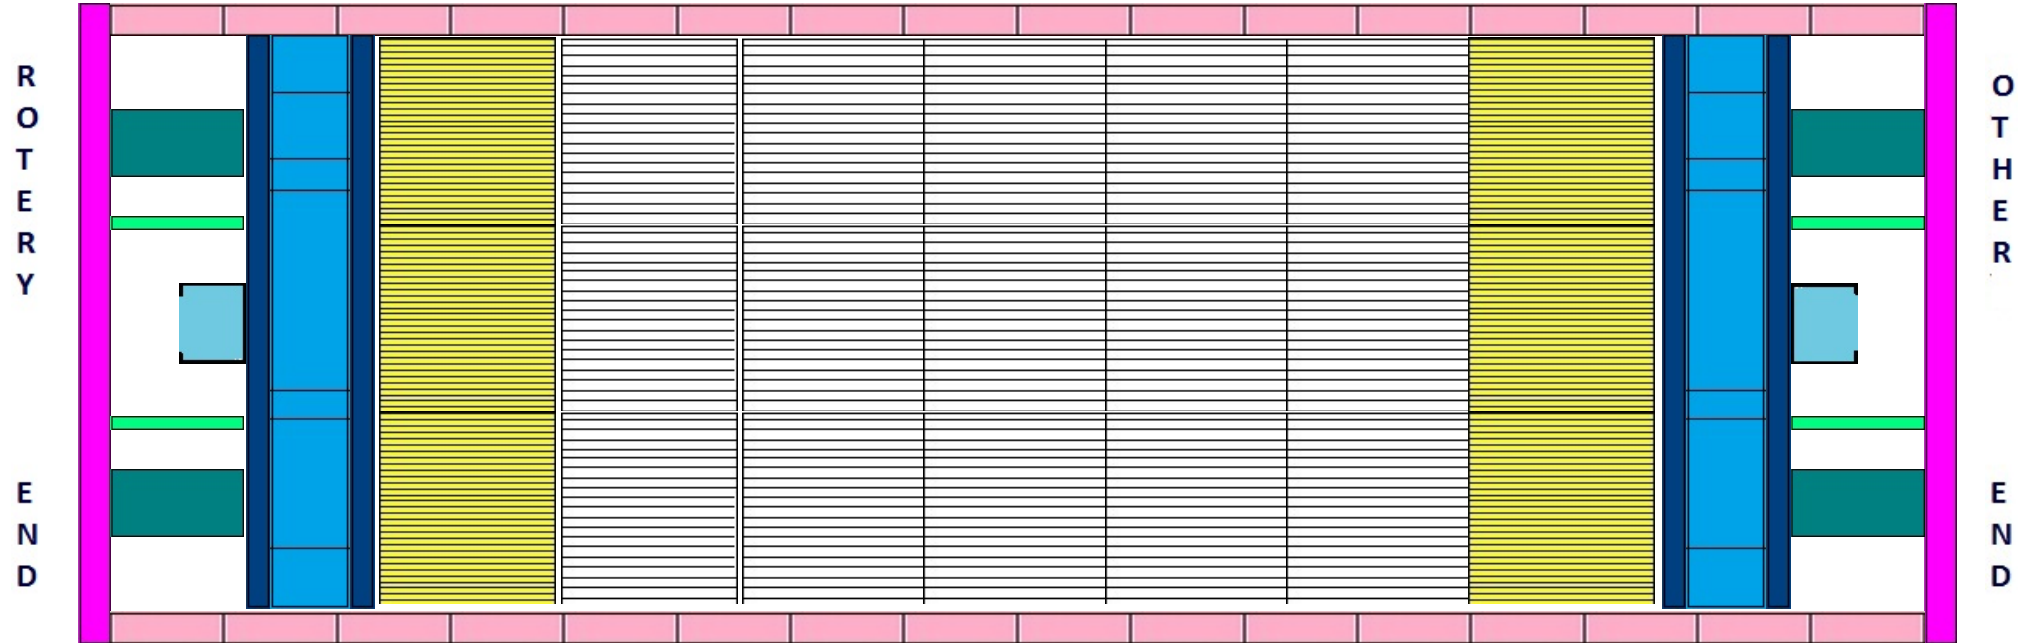
Rotary Side

Color	Particulars	Qty	Per%	Color	Particulars	Qty	Per%	Color	Particulars	Qty	Per%
	Headstock Beam	2	100%		Centre Stiffner for Headstock	4	100%		Floor Stiffner for Headstock	4	100%
	Aux. Head stock	4	100%		Sole Bar	16	100%		Draft Gear Bracket	2	100%
	Trough floor	2	29%		Centre plate	2	100%		SoleBar Stiffner	6	100%
	Bottom Wall Part	16	100%		Body panel/patch		100%		Door Top/Roof Patch		0%
	Window Module		0%		Window Sill	40	100%		Window Bar	68	38%
	Seat pillar/lav. Partition		100%		UIC end construction		0%

End Drooping: Rotary End - EAST : -3, WEST : -10 Other End - EAST : -8, WEST : -3  
Start Date : 10-Apr-2018, Completion Date : 24-Apr-2018, Net Repair Days : 13, Total Man Hours : 2100

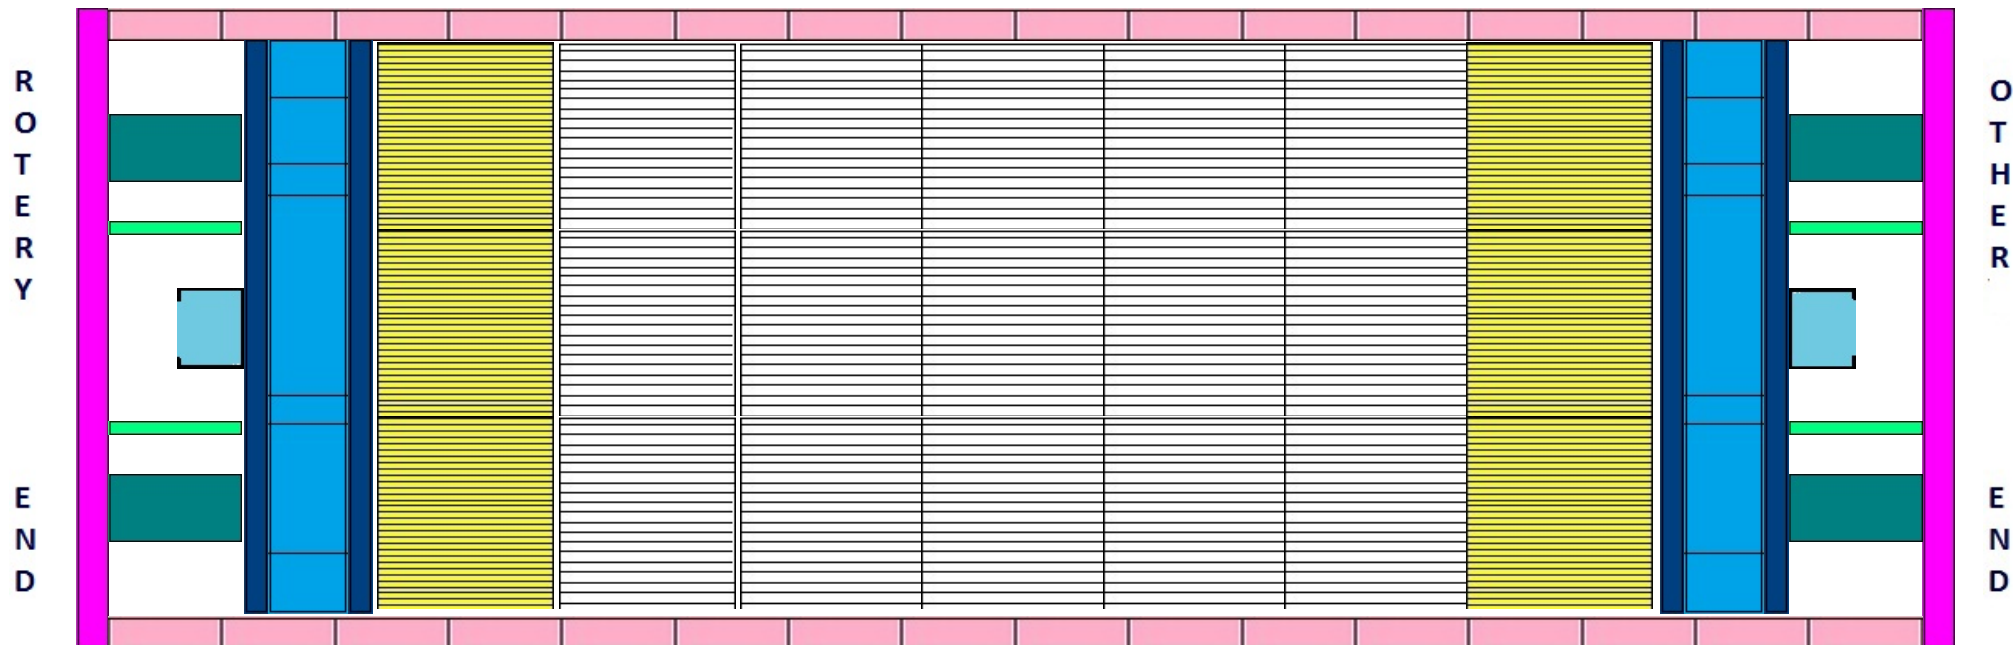
Rotary Side

Color	Particulars	Qty	Per%	Color	Particulars	Qty	Per%	Color	Particulars	Qty	Per%
	Headstock Beam	2	100%		Centre Stiffner for Headstock	4	100%		Floor Stiffner for Headstock	4	100%
	Aux. Head stock	4	100%		Sole Bar	16	100%		Draft Gear Bracket	2	100%
	Trough floor	2	29%		Centre plate	2	100%		SoleBar Stiffner	4	100%
	Bottom Wall Part	16	100%		Body panel/patch		100%		Door Top/Roof Patch		0%
	Window Module		0%		Window Sill	8	42%		Window Bar	22	26%
	Seat pillar/lav. Partition		100%		UIC end construction		0%

End Drooping: Rotary End - EAST : -6, WEST : -2 Other End - EAST : -7, WEST : -10  
Start Date : 28-May-2018, Completion Date : 09-Jun-2018, Net Repair Days : 12, Total Man Hours : 2296

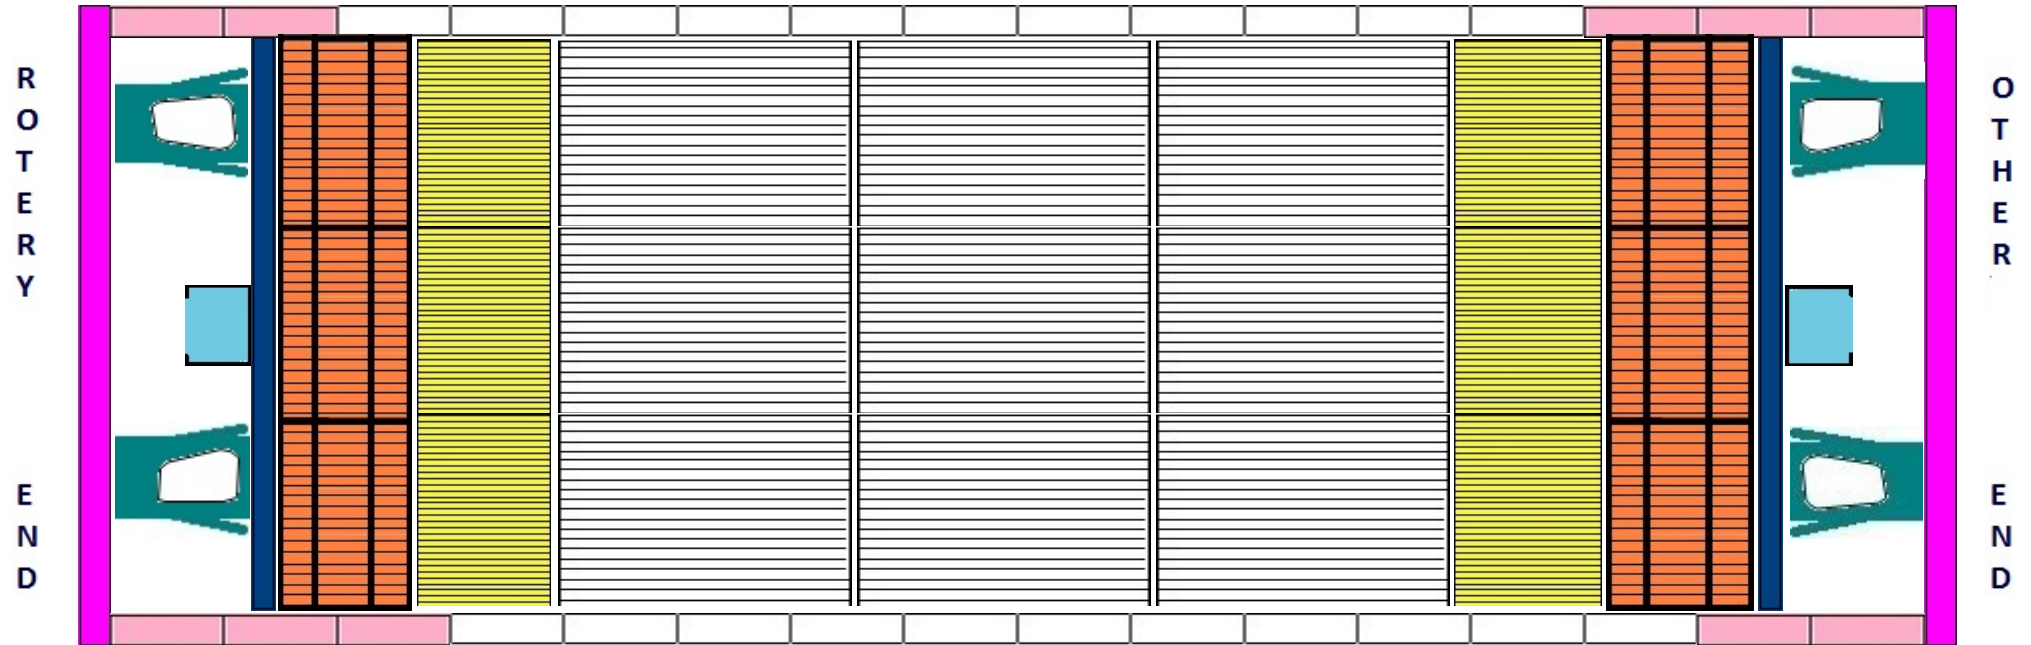
Rotary Side

Color	Particulars	Qty	Per%	Color	Particulars	Qty	Per%	Color	Particulars	Qty	Per%
Pink	Headstock Beam	2	100%	Green	Diagonal	4	100%	Orange	Logitudinal Channel Structure	2	100%
Dark Blue	Aux. Head stock	2	100%	Pink	Sole Bar	5	31%	Light Blue	Draft Gear Bracket	2	100%
Yellow	Trough floor	2	40%		Bottom Wall Part	5	31%		Body panel/patch		100%
	Door Top/Roof Patch		0%		Seat Bracket Rail		0%		Window Sill	12	30%
	Window Bar	34	18%		Seat pillar/lav. Partition		100%		UIC end construction		0%
	Body Pillar Part	28	100%

End Drooping: Rotary End - EAST : -8, WEST : -7 Other End - EAST : 5, WEST : -5  
Start Date : 11-Jun-2018, Completion Date : 19-Jun-2018, Net Repair Days : 8, Total Man Hours : 1384

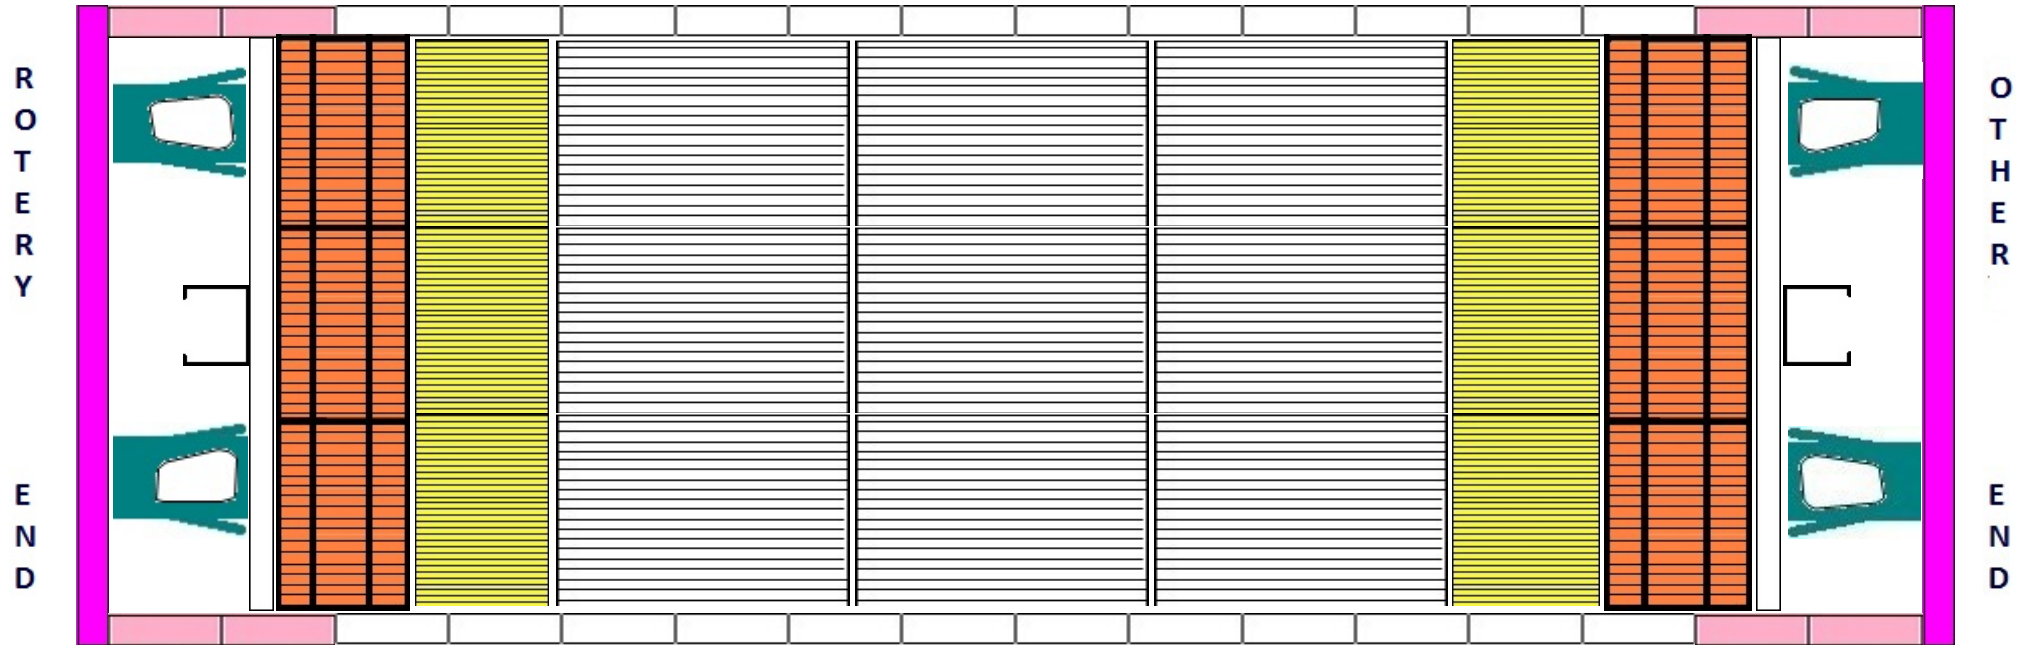
Rotary Side

Color	Particulars	Qty	Per%	Color	Particulars	Qty	Per%	Color	Particulars	Qty	Per%
Pink	Headstock Beam	2	100%	Teal	Diagonal	4	100%	Orange	Logitudinal Channel Structure	2	100%
Dark Blue	Aux. Head stock	0	0%	Pink	Sole Bar	4	25%	Blue	Draft Gear Bracket	0	0%
Yellow	Trough floor	2	40%		Bottom Wall Part	4	25%		Body panel/patch		100%
	Door Top/Roof Patch		0%		Seat Bracket Rail		0%		Window Sill	3	8%
	Window Bar	22	12%		Seat pillar/lav. Partition		100%		UIC end construction		0%
	Body Pillar Part	22	100%

Start Date : 16-Apr-2018, Completion Date : 27-Apr-2018, Net Repair Days : 11, Total Man Hours : 1480

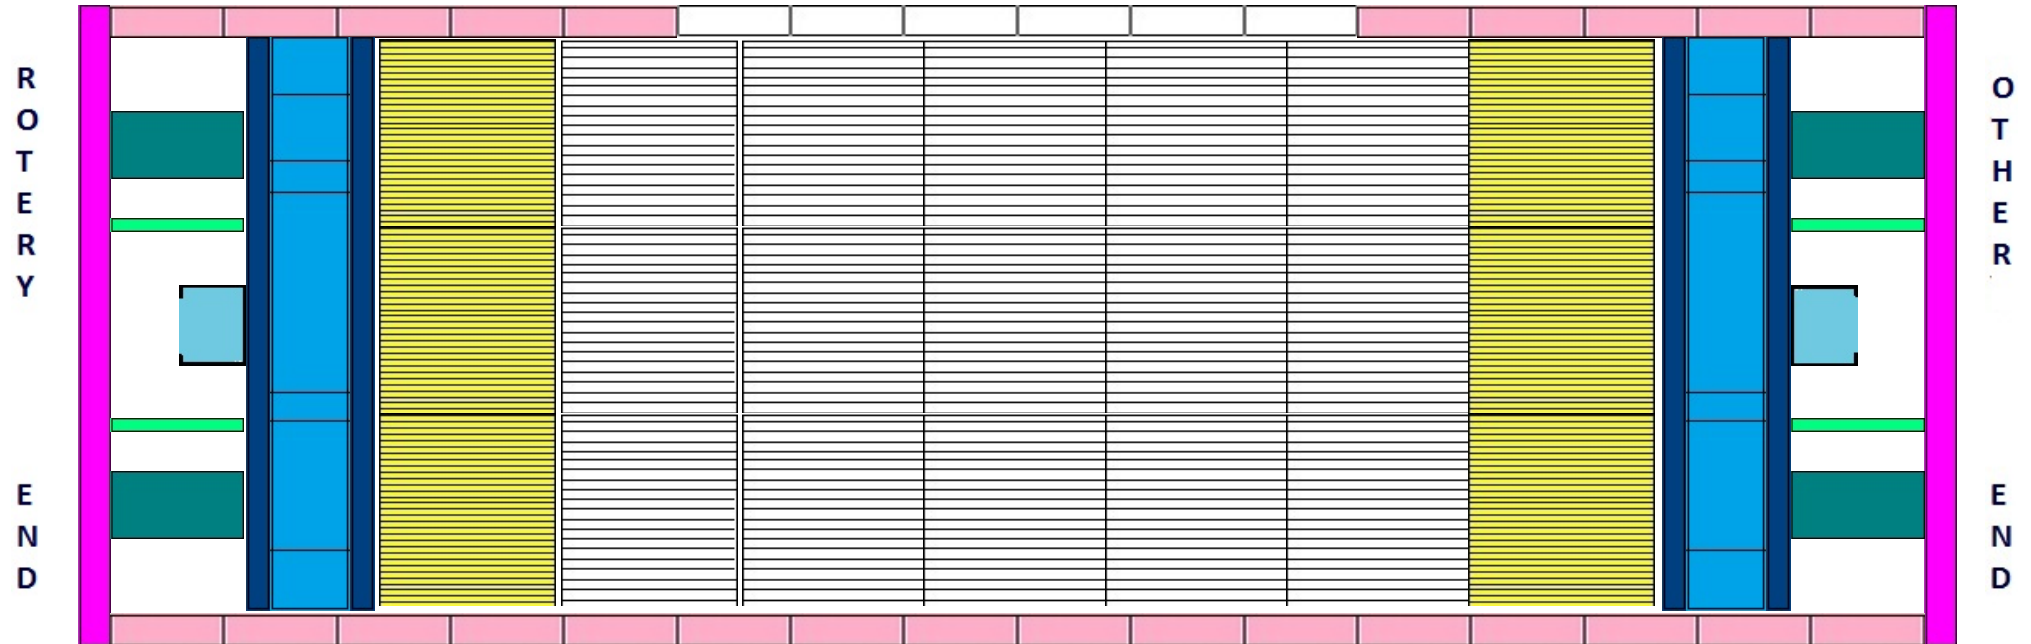
Rotary Side

Color	Particulars	Qty	Per%	Color	Particulars	Qty	Per%	Color	Particulars	Qty	Per%
Pink	Headstock Beam	2	100%	Blue	Centre Stiffner for Headstock	4	100%	Green	Floor Stiffner for Headstock	4	100%
Dark Blue	Aux. Head stock	4	100%	Pink	Sole Bar	13	81%	Light Blue	Draft Gear Bracket	2	100%
Yellow	Trough floor	2	29%	Light Blue	Centre plate	2	100%		SoleBar Stiffner	4	100%
	Bottom Wall Part	13	81%		Body panel/patch		100%		Door Top/Roof Patch		0%
	Window Module		0%		Window Sill	20	50%		Window Bar	40	22%
	Seat pillar/lav. Partition		100%		UIC end construction		0%

End Drooping: Rotary End - EAST : 10, WEST : 8 Other End - EAST : -7, WEST : -10  
Start Date : 08-Jun-2018, Completion Date : 15-Jun-2018, Net Repair Days : 7, Total Man Hours : 1673

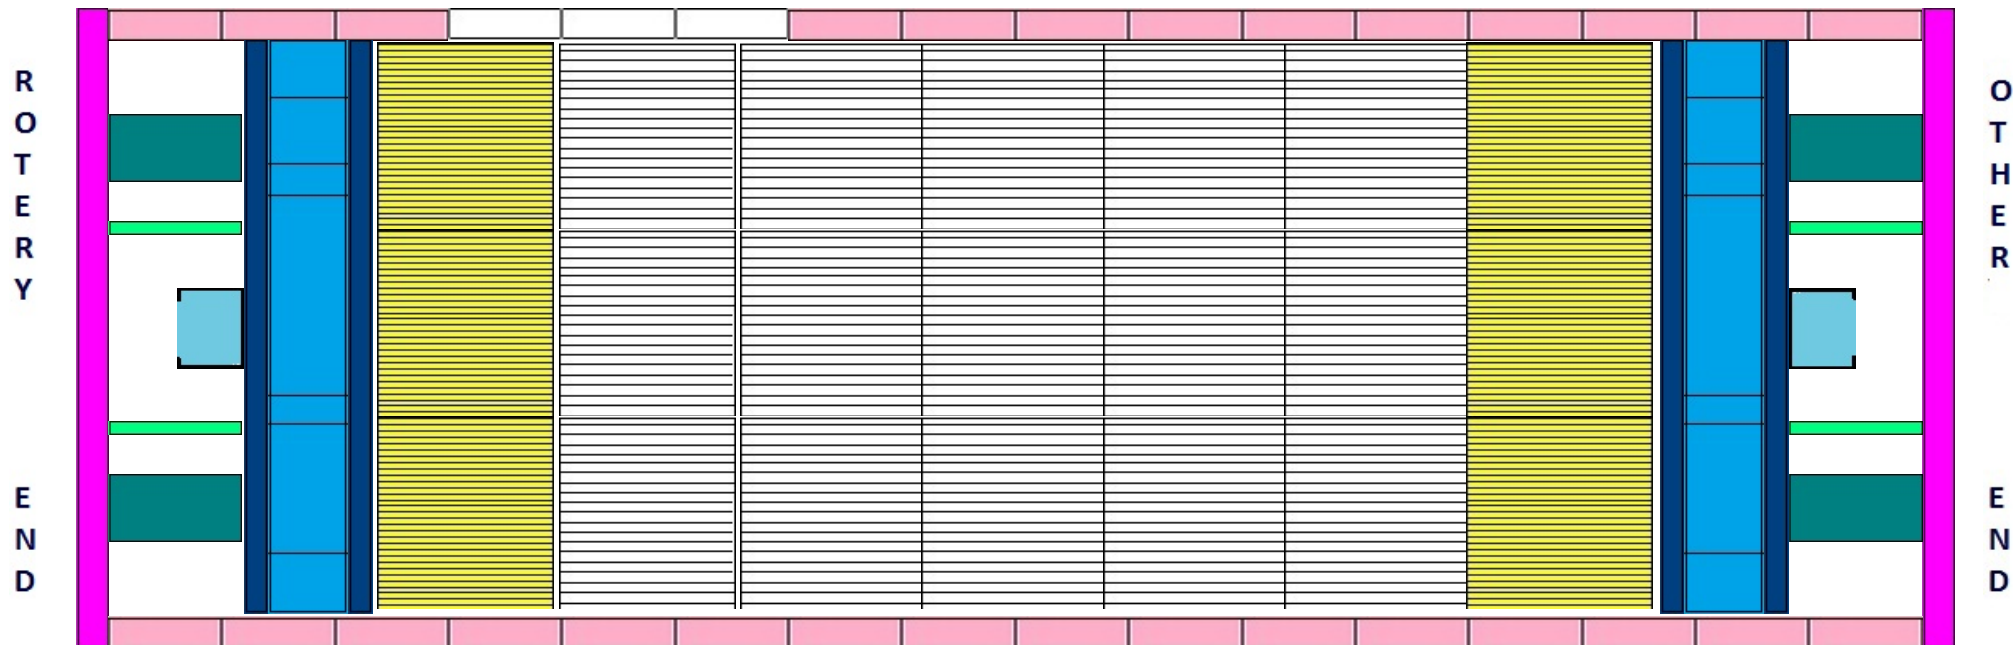
Rotary Side

Color	Particulars	Qty	Per%	Color	Particulars	Qty	Per%	Color	Particulars	Qty	Per%
	Headstock Beam	2	100%		Centre Stiffner for Headstock	4	100%		Floor Stiffner for Headstock	4	100%
	Aux. Head stock	4	100%		Sole Bar	14.5	91%		Draft Gear Bracket	2	100%
	Trough floor	2	29%		Centre plate	2	100%		SoleBar Stiffner	4	100%
	Bottom Wall Part	14.5	91%		Body panel/patch		100%		Door Top/Roof Patch		0%
	Window Module		0%		Window Sill	7	18%		Window Bar	44	24%
	Seat pillar/lav. Partition		100%		UIC end construction		0%

End Drooping: Rotary End - EAST : 4, WEST : 0 Other End - EAST : 6, WEST : 6  
Start Date : 07-Jun-2018, Completion Date : 13-Jun-2018, Net Repair Days : 6, Total Man Hours : 1600

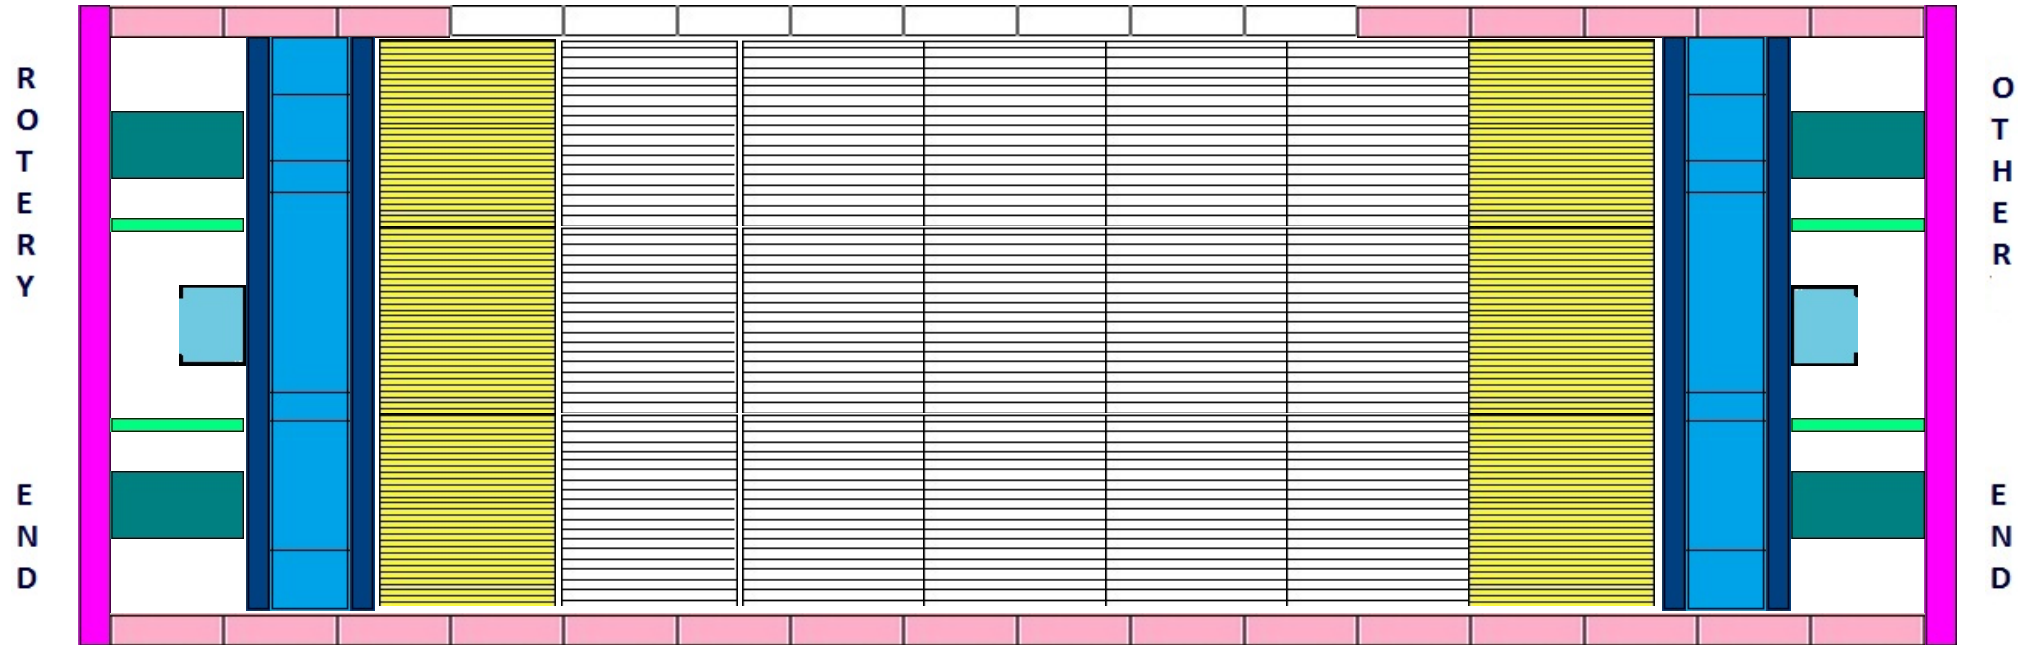
Rotary Side

Color	Particulars	Qty	Per%	Color	Particulars	Qty	Per%	Color	Particulars	Qty	Per%
Pink	Headstock Beam	2	100%	Blue	Centre Stiffner for Headstock	4	100%	Green	Floor Stiffner for Headstock	4	100%
Dark Blue	Aux. Head stock	4	100%	Pink	Sole Bar	12	75%	Light Blue	Draft Gear Bracket	2	100%
Yellow	Trough floor	2	29%	Light Blue	Centre plate	2	100%		SoleBar Stiffner	4	100%
	Bottom Wall Part	12	75%		Body panel/patch		100%		Door Top/Roof Patch		0%
	Window Module		0%		Window Sill	20	50%		Window Bar	50	27%
	Seat pillar/lav. Partition		100%		UIC end construction		0%

End Drooping: Rotary End - EAST : 0, WEST : 4 Other End - EAST : 0, WEST : 6  
Start Date : 27-Mar-2018, Completion Date : 07-Apr-2018, Net Repair Days : 11, Total Man Hours : 1492

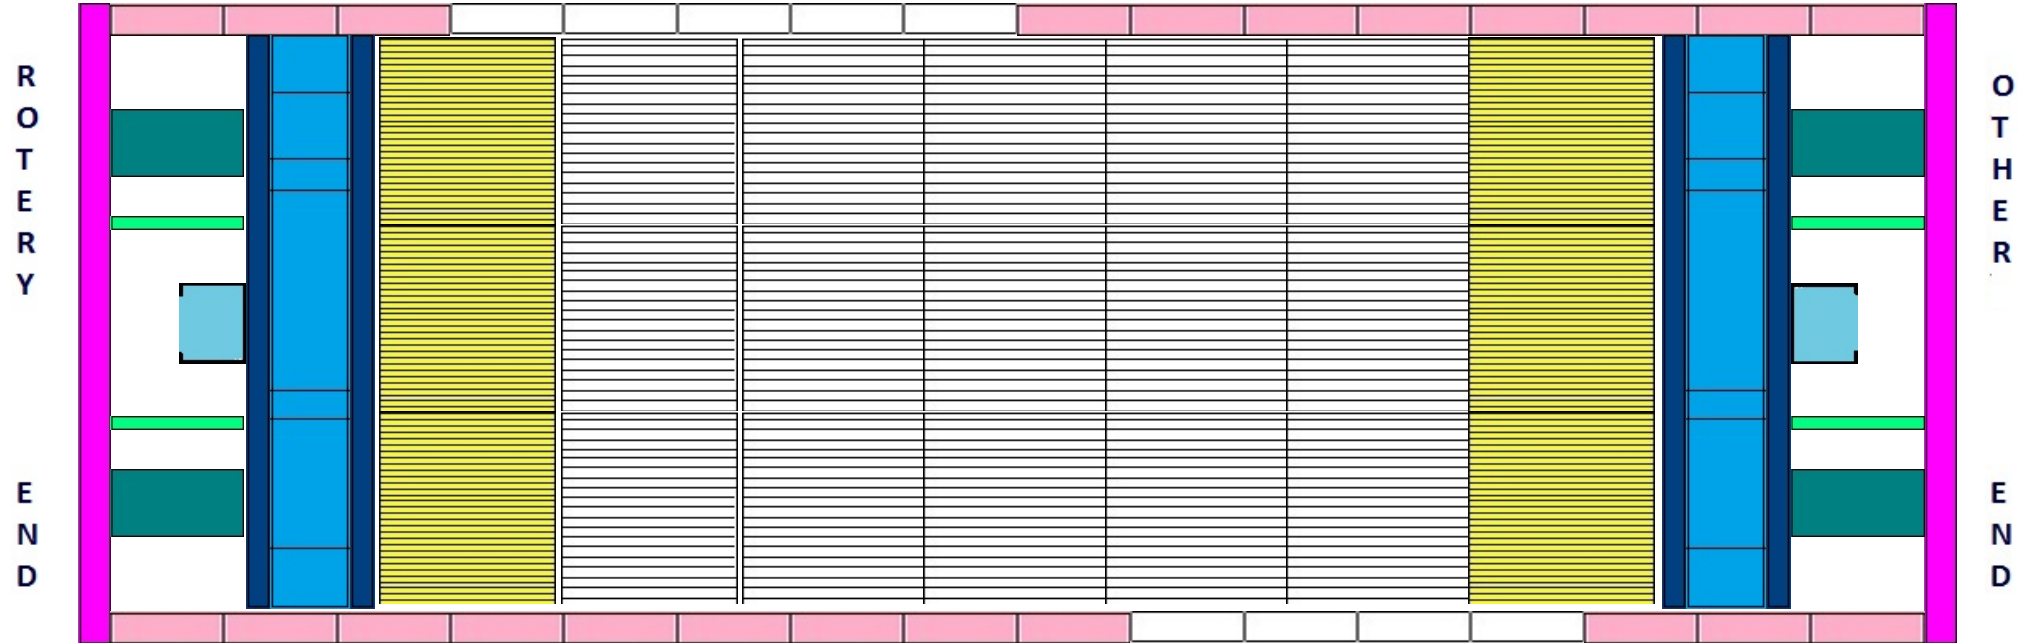
Rotary Side

Color	Particulars	Qty	Per%	Color	Particulars	Qty	Per%	Color	Particulars	Qty	Per%
	Headstock Beam	2	100%		Centre Stiffner for Headstock	4	100%		Floor Stiffner for Headstock	4	100%
	Aux. Head stock	4	100%		Sole Bar	11.5	72%		Draft Gear Bracket	2	100%
	Trough floor	2	29%		Centre plate	2	100%		SoleBar Stiffner	6	100%
	Bottom Wall Part	11.5	72%		Body panel/patch		100%		Door Top/Roof Patch		0%
	Window Module		0%		Window Sill	14	35%		Window Bar	48	27%
	Seat pillar/lav. Partition		100%		UIC end construction		0%

Start Date : 28-Aug-2018, Completion Date : 07-Sep-2018, Net Repair Days : 10, Total Man Hours : 1600

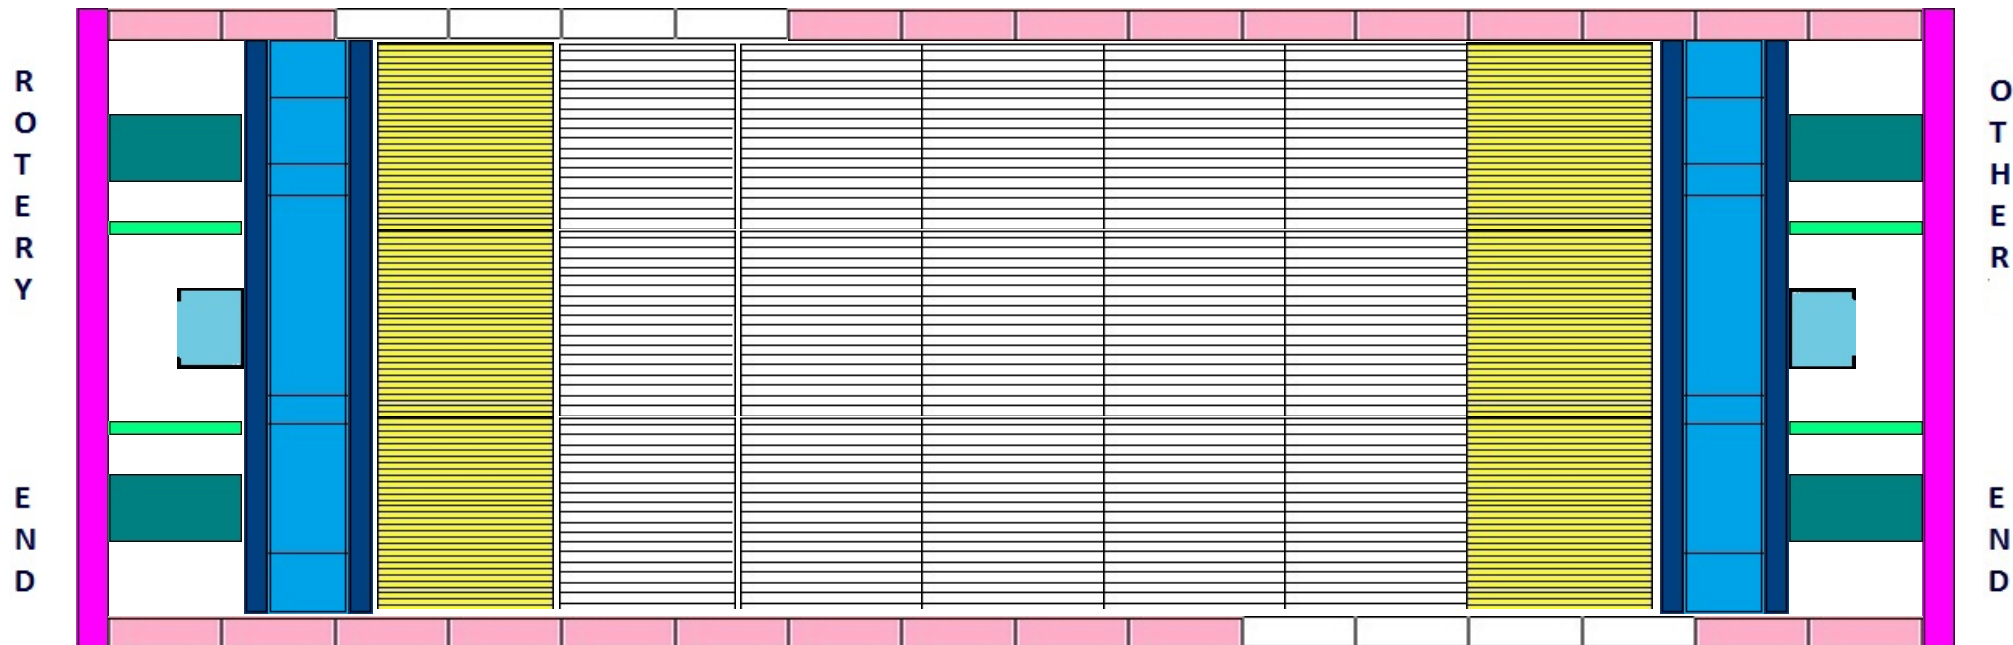
Rotary Side

Color	Particulars	Qty	Per%	Color	Particulars	Qty	Per%	Color	Particulars	Qty	Per%
	Headstock Beam	2	100%		Centre Stiffner for Headstock	4	100%		Floor Stiffner for Headstock	4	100%
	Aux. Head stock	4	100%		Sole Bar	12	75%		Draft Gear Bracket	2	100%
	Trough floor	2	29%		Centre plate	2	100%		SoleBar Stiffner	6	100%
	Bottom Wall Part	12	75%		Body panel/patch		100%		Door Top/Roof Patch		0%
	Window Module		0%		Window Sill	14	35%		Window Bar	54	30%
	Seat pillar/lav. Partition		100%		UIC end construction		0%

End Drooping: Rotary End - EAST : 0, WEST : -2 Other End - EAST : -4, WEST : -5  
Start Date : 03-Oct-2018, Completion Date : 12-Oct-2018, Net Repair Days : 9, Total Man Hours : 1496

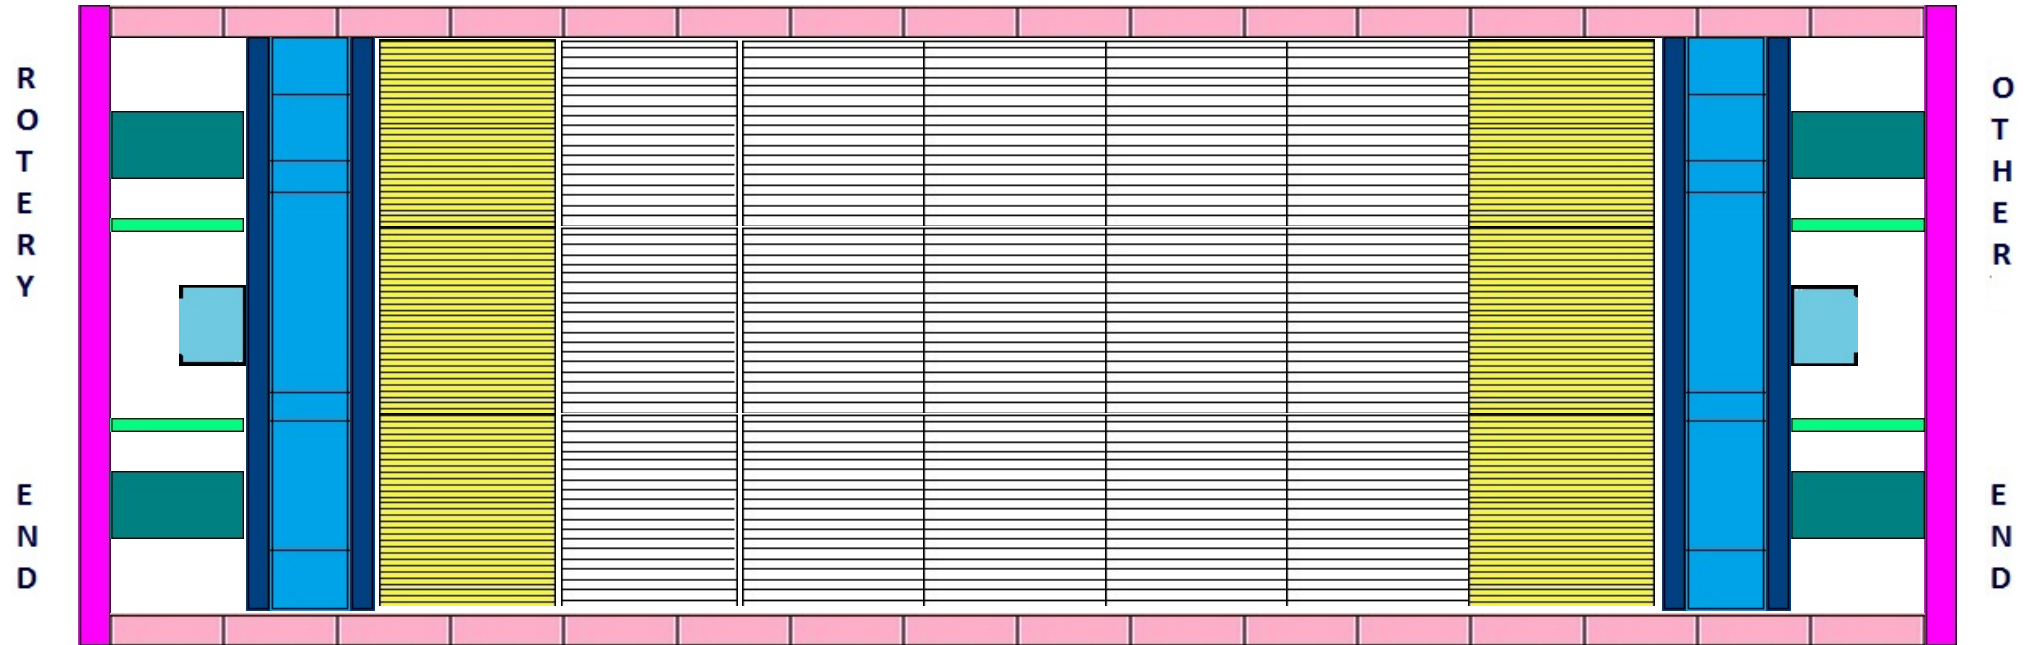
Rotary Side

Color	Particulars	Qty	Per%	Color	Particulars	Qty	Per%	Color	Particulars	Qty	Per%
Pink	Headstock Beam	2	100%	Blue	Centre Stiffner for Headstock	4	100%	Green	Floor Stiffner for Headstock	4	100%
Dark Blue	Aux. Head stock	4	100%	Pink	Sole Bar	16	100%	Light Blue	Draft Gear Bracket	2	100%
Yellow	Trough floor	2	29%	Blue	Centre plate	2	100%		SoleBar Stiffner	6	100%
	Bottom Wall Part	16	100%		Body panel/patch		100%		Door Top/Roof Patch		0%
	Window Module		0%		Window Sill	24	60%		Window Bar	62	35%
	Seat pillar/lav. Partition		100%		UIC end construction		0%

End Drooping: Rotary End - EAST : -8, WEST : -8 Other End - EAST : 10, WEST : 10  
Start Date : 04-Jun-2018, Completion Date : 09-Jun-2018, Net Repair Days : 6, Total Man Hours : 2186

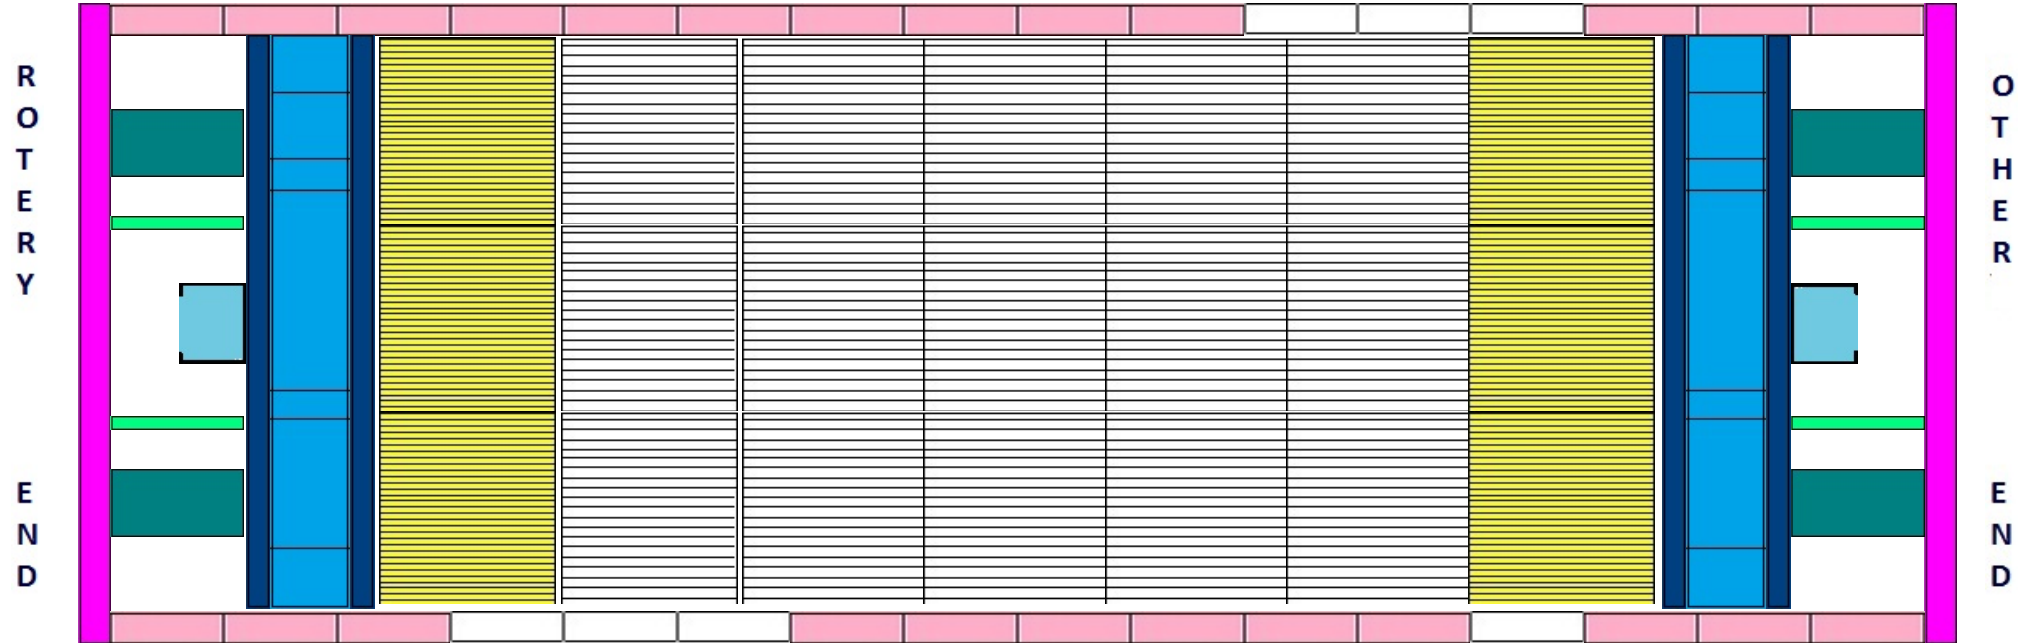
Rotary Side

Color	Particulars	Qty	Per%	Color	Particulars	Qty	Per%	Color	Particulars	Qty	Per%
Yellow	Headstock Beam	2	100%	Green	Centre Stiffner for Headstock	4	100%	Blue	Floor Stiffner for Headstock	4	100%
Dark Blue	Aux. Head stock	4	100%	Pink	Sole Bar	12.5	78%	Light Blue	Draft Gear Bracket	2	100%
Yellow	Trough floor	2	29%	Blue	Centre plate	2	100%		SoleBar Stiffner	6	100%
	Bottom Wall Part	12.5	78%		Body panel/patch		100%		Door Top/Roof Patch		0%
	Window Module		0%		Window Sill	40	100%		Window Bar	48	27%
	Seat pillar/lav. Partition		100%		UIC end construction		0%

Start Date : 21-Apr-2018, Completion Date : 28-Apr-2018, Net Repair Days : 7, Total Man Hours : 1672

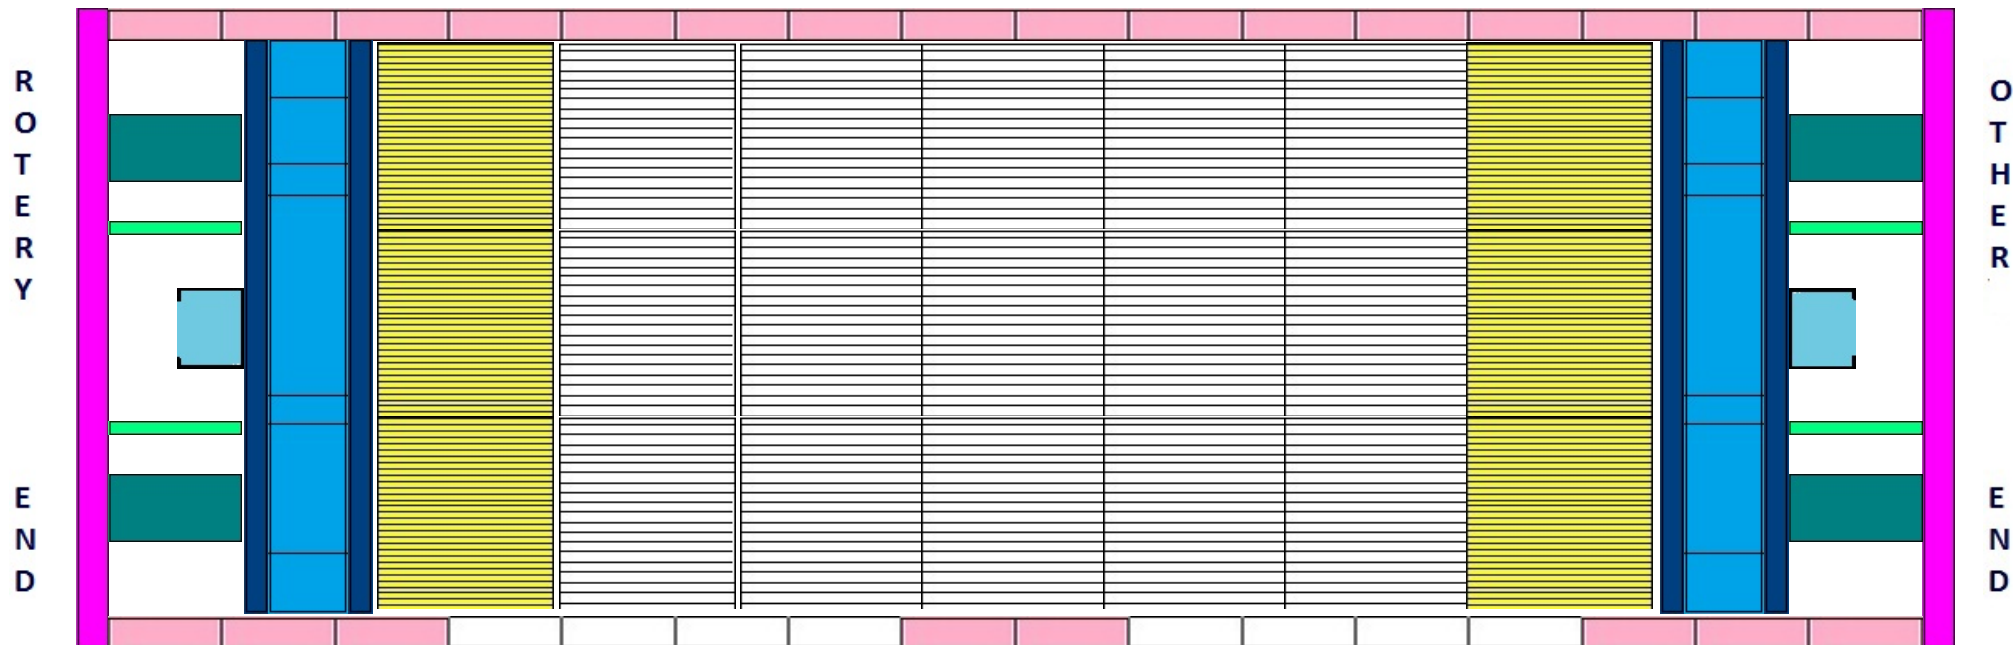
Rotary Side

Color	Particulars	Qty	Per%	Color	Particulars	Qty	Per%	Color	Particulars	Qty	Per%
Pink	Headstock Beam	2	100%	Green	Centre Stiffner for Headstock	4	100%	Yellow	Floor Stiffner for Headstock	4	100%
Blue	Aux. Head stock	4	100%	Pink	Sole Bar	12	75%	Blue	Draft Gear Bracket	2	100%
Yellow	Trough floor	2	29%	Blue	Centre plate	2	100%		SoleBar Stiffner	6	100%
	Bottom Wall Part	12	75%		Body panel/patch		100%		Door Top/Roof Patch		0%
	Window Module		0%		Window Sill	20	50%		Window Bar	50	28%
	Seat pillar/lav. Partition		100%		UIC end construction		0%

End Drooping: Rotary End - EAST : -10, WEST : -10 Other End - EAST : -10, WEST : -8  
Start Date : 26-Apr-2018, Completion Date : 08-May-2018, Net Repair Days : 11, Total Man Hours : 1754

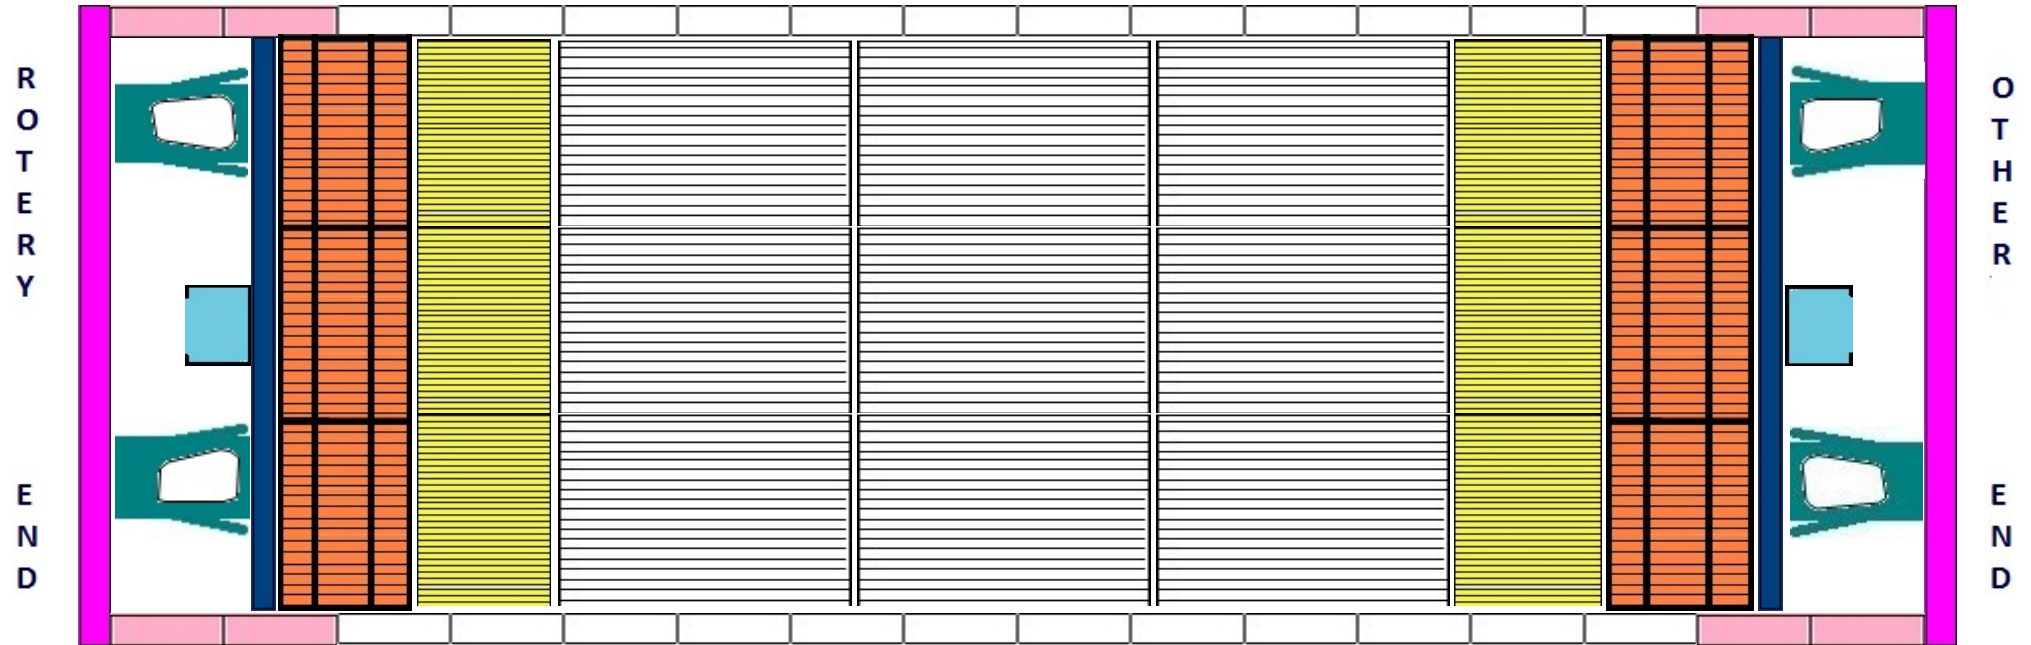
Rotary Side

Color	Particulars	Qty	Per%	Color	Particulars	Qty	Per%	Color	Particulars	Qty	Per%
	Headstock Beam	2	100%		Diagonal	4	100%		Logitudinal Channel Structure	2	100%
	Aux. Head stock	2	100%		Sole Bar	4	25%		Draft Gear Bracket	2	100%
	Trough floor	2	40%		Bottom Wall Part	4	25%		Body panel/patch		100%
	Door Top/Roof Patch		0%		Seat Bracket Rail		0%		Window Sill	4	10%
	Window Bar	14	8%		Seat pillar/lav. Partition		100%		UIC end construction		0%
	Body Pillar Part	22	100%

Start Date : 11-Jun-2018, Completion Date : 19-Jun-2018, Net Repair Days : 8, Total Man Hours : 1016
