# Coach Rehabilitation Workshop, WC Railway, Bhopal

(An IMS and ISO 50001 Certified Workshop)  
Final Inspection Sheet - Details of Corrosion Repair

Coach No. :ECO04102  
Form No. F/BR/ICF/002

Type : WGACCN

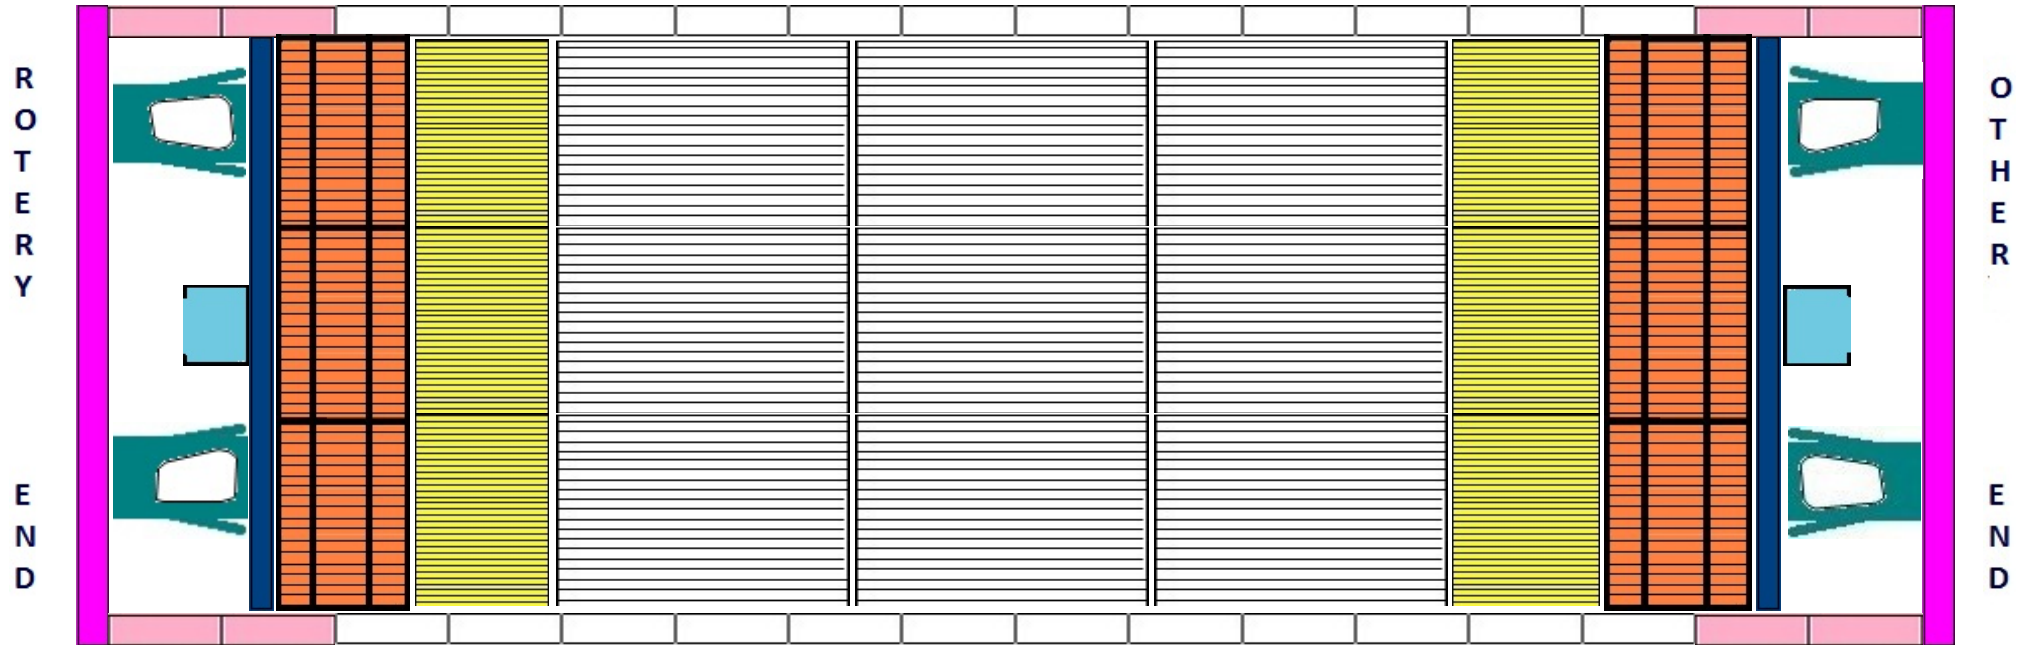
Rotary Side

Color	Particulars	Qty	Per%	Color	Particulars	Qty	Per%	Color	Particulars	Qty	Per%
	Headstock Beam	2	100%		Diagonal	4	100%		Logitudinal Channel Structure	2	100%
	Aux. Head stock	2	100%		Sole Bar	4	25%		Draft Gear Bracket	2	100%
	Trough floor	2	40%		Bottom Wall Part	4	25%		Body panel/patch		100%
	Door Top/Roof Patch		0%		Seat Bracket Rail		0%		Window Sill	14	35%
	Window Bar	48	26%		Seat pillar/lav. Partition		100%		UIC end construction		0%
	Body Pillar Part	22	100%

Start Date : 12-May-2018, Completion Date : 19-May-2018, Net Repair Days : 7, Total Man Hours : 1320

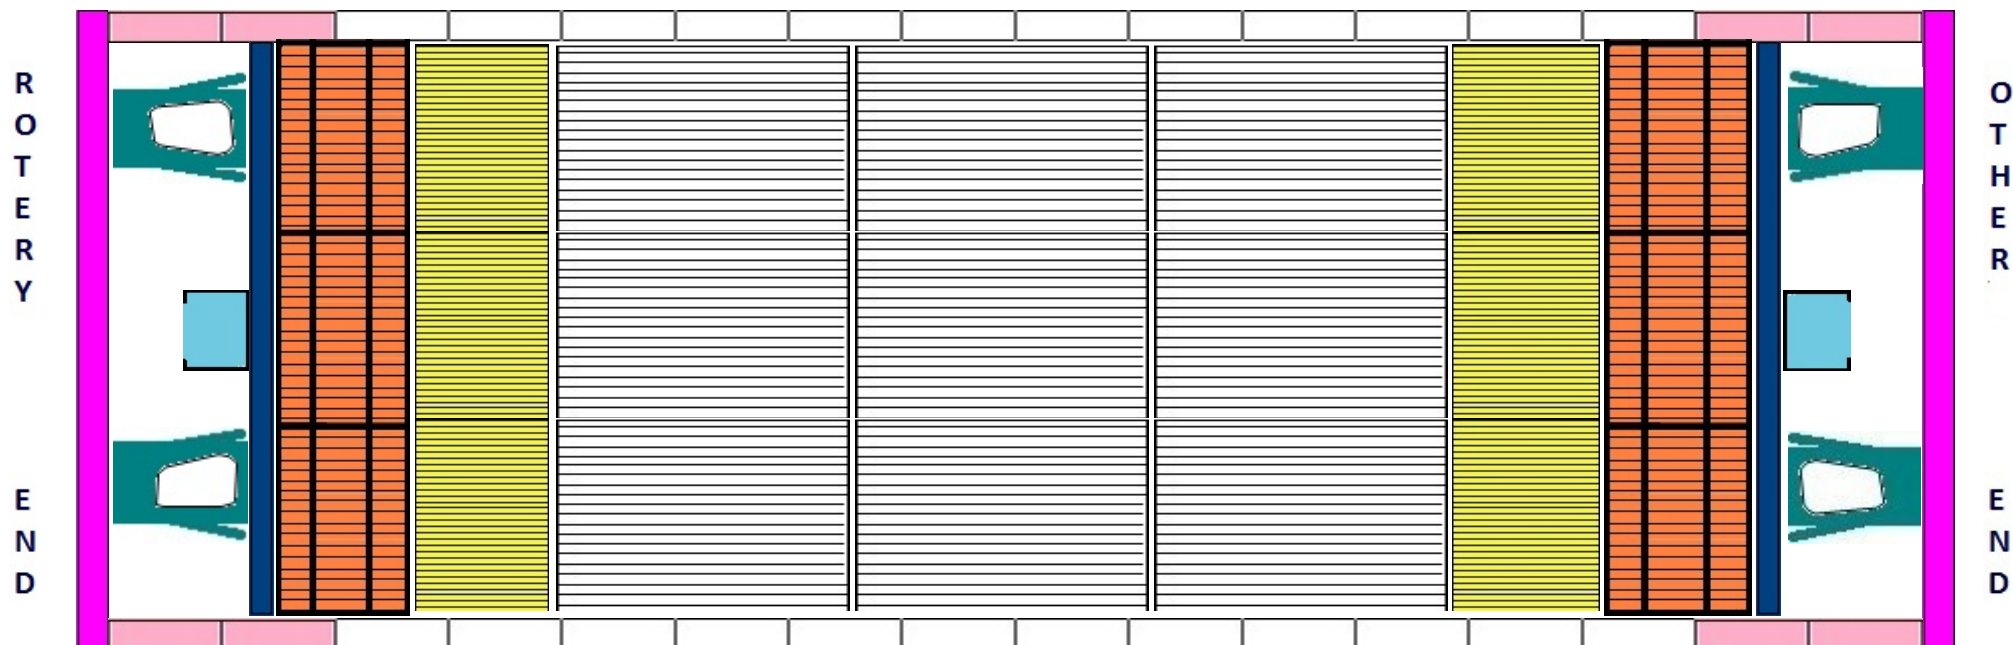
Rotary Side

Color	Particulars	Qty	Per%	Color	Particulars	Qty	Per%	Color	Particulars	Qty	Per%
	Headstock Beam	2	100%		Diagonal	4	100%		Logitudinal Channel Structure	2	100%
	Aux. Head stock	2	100%		Sole Bar	4	25%		Draft Gear Bracket	2	100%
	Trough floor	2	40%		Bottom Wall Part	4	25%		Body panel/patch		100%
	Door Top/Roof Patch		0%		Seat Bracket Rail		0%		Window Sill	10	25%
	Window Bar	9	23%		Seat pillar/lav. Partition		100%		UIC end construction		0%
	Body Pillar Part	22	100%

Start Date : 23-May-2018, Completion Date : 30-May-2018, Net Repair Days : 7, Total Man Hours : 1392

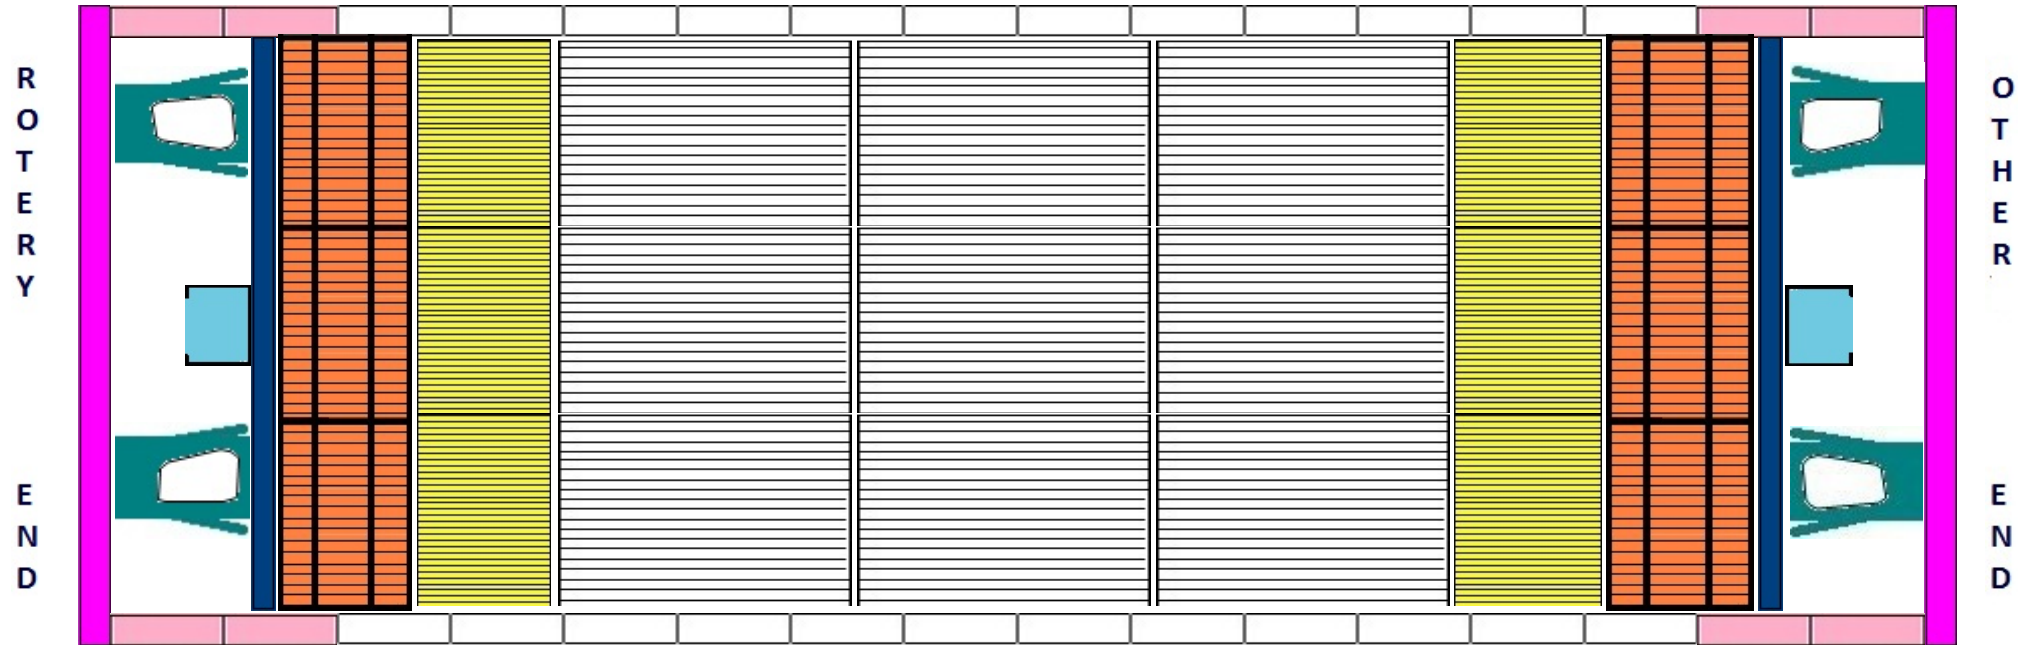
Rotary Side

Color	Particulars	Qty	Per%	Color	Particulars	Qty	Per%	Color	Particulars	Qty	Per%
	Headstock Beam	2	100%		Diagonal	4	100%		Logitudinal Channel Structure	2	100%
	Aux. Head stock	2	100%		Sole Bar	4	25%		Draft Gear Bracket	2	100%
	Trough floor	2	40%		Bottom Wall Part	4	25%		Body panel/patch		100%
	Door Top/Roof Patch		0%		Seat Bracket Rail		0%		Window Sill	14	35%
	Window Bar	36	20%		Seat pillar/lav. Partition		100%		UIC end construction		0%
	Body Pillar Part	22	100%

Start Date : 02-Jul-2018, Completion Date : 06-Jul-2018, Net Repair Days : 5, Total Man Hours : 1336

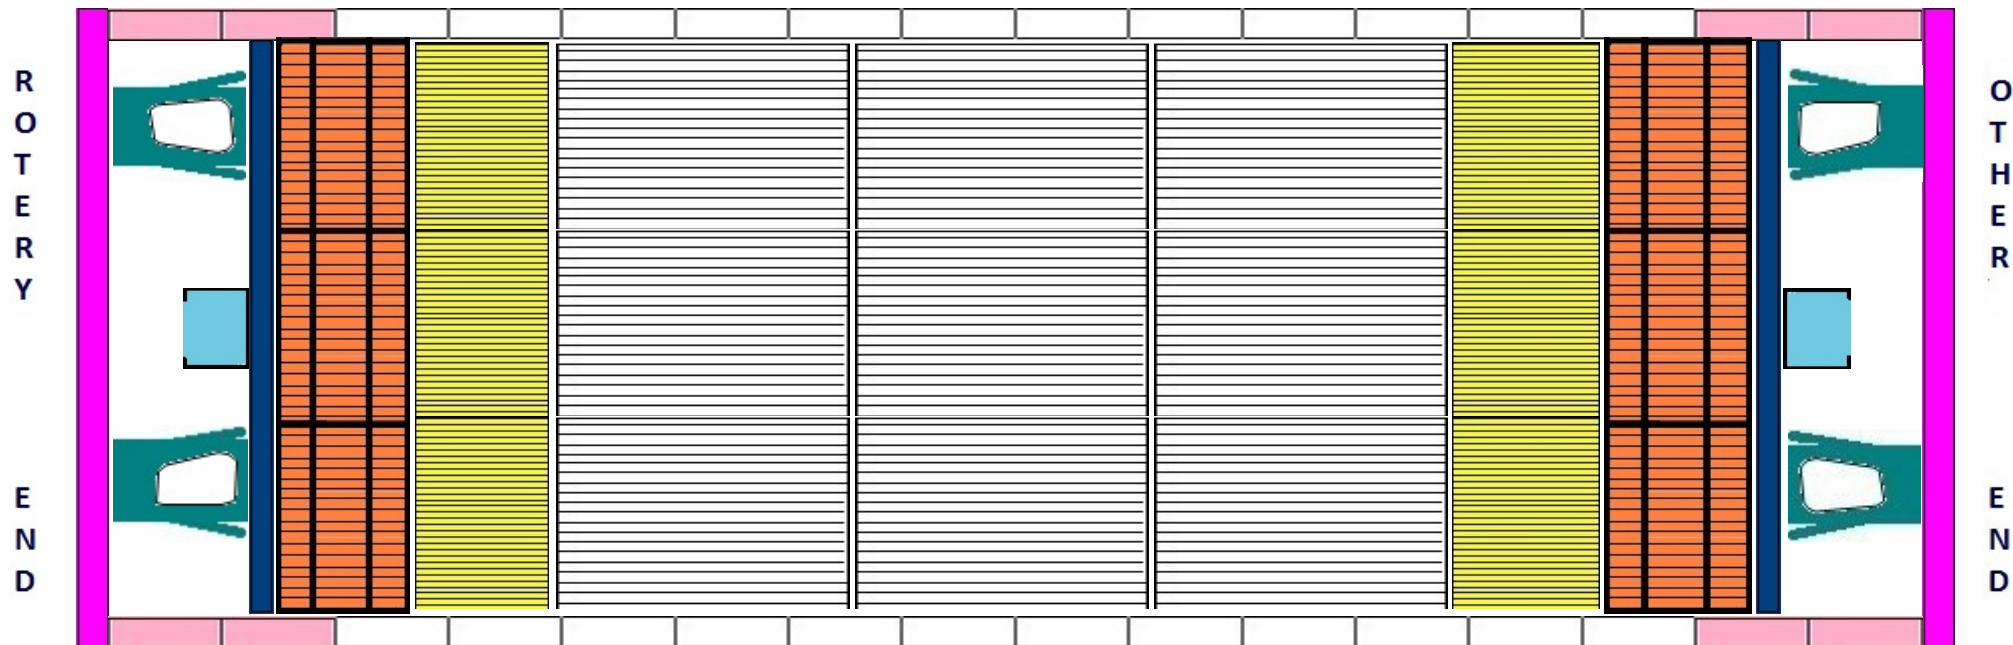
Rotary Side

Color	Particulars	Qty	Per%	Color	Particulars	Qty	Per%	Color	Particulars	Qty	Per%
	Headstock Beam	2	100%		Diagonal	4	100%		Logitudinal Channel Structure	2	100%
	Aux. Head stock	2	100%		Sole Bar	4	25%		Draft Gear Bracket	2	100%
	Trough floor	2	40%		Bottom Wall Part	4	25%		Body panel/patch		100%
	Door Top/Roof Patch		0%		Seat Bracket Rail		0%		Window Sill	7	18%
	Window Bar	28	15%		Seat pillar/lav. Partition		100%		UIC end construction		0%
	Body Pillar Part	22	100%

Start Date : 24-May-2018, Completion Date : 31-May-2018, Net Repair Days : 7, Total Man Hours : 1288

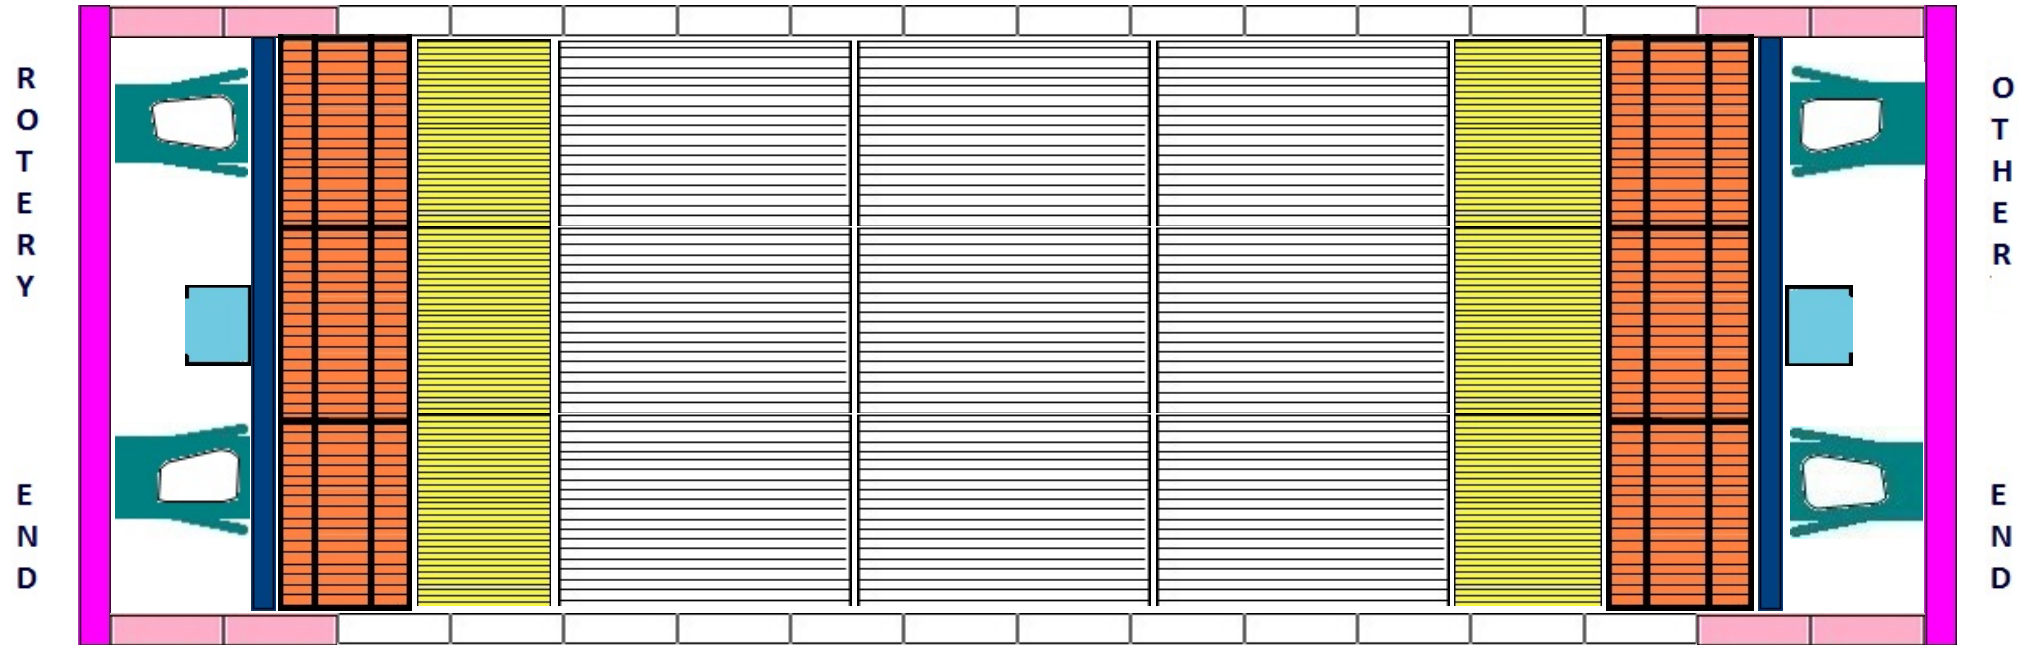
Rotary Side

Color	Particulars	Qty	Per%	Color	Particulars	Qty	Per%	Color	Particulars	Qty	Per%
	Headstock Beam	2	100%		Diagonal	4	100%		Logitudinal Channel Structure	2	100%
	Aux. Head stock	2	100%		Sole Bar	4	25%		Draft Gear Bracket	2	100%
	Trough floor	2	40%		Bottom Wall Part	4	25%		Body panel/patch		100%
	Door Top/Roof Patch		0%		Seat Bracket Rail		0%		Window Sill	9	23%
	Window Bar	20	11%		Seat pillar/lav. Partition		100%		UIC end construction		0%
	Body Pillar Part	22	100%

Start Date : 11-Jun-2018, Completion Date : 18-Jun-2018, Net Repair Days : 7, Total Man Hours : 1316

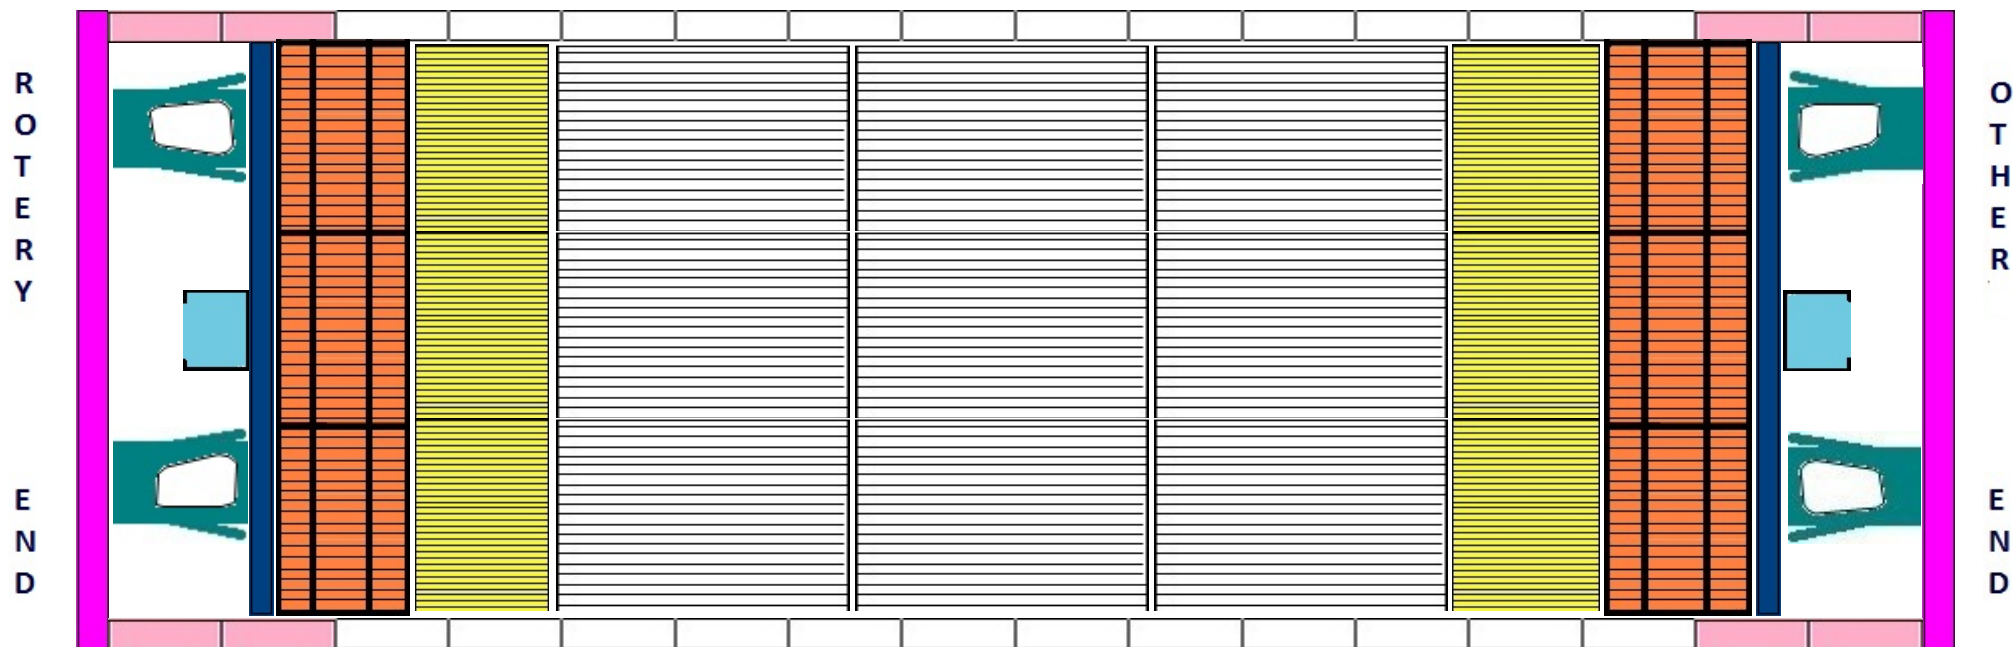
Rotary Side

Color	Particulars	Qty	Per%	Color	Particulars	Qty	Per%	Color	Particulars	Qty	Per%
Pink	Headstock Beam	2	100%	Green	Diagonal	4	100%	Orange	Logitudinal Channel Structure	2	100%
Blue	Aux. Head stock	2	100%	Pink	Sole Bar	4	25%	Light Blue	Draft Gear Bracket	2	100%
Yellow	Trough floor	2	40%		Bottom Wall Part	4	25%		Body panel/patch		100%
	Door Top/Roof Patch		0%		Seat Bracket Rail		0%		Window Sill	14	35%
	Window Bar	36	20%		Seat pillar/lav. Partition		100%		UIC end construction		0%
	Body Pillar Part	22	100%

Start Date : 09-Jul-2018, Completion Date : 14-Jul-2018, Net Repair Days : 6, Total Man Hours : 1156

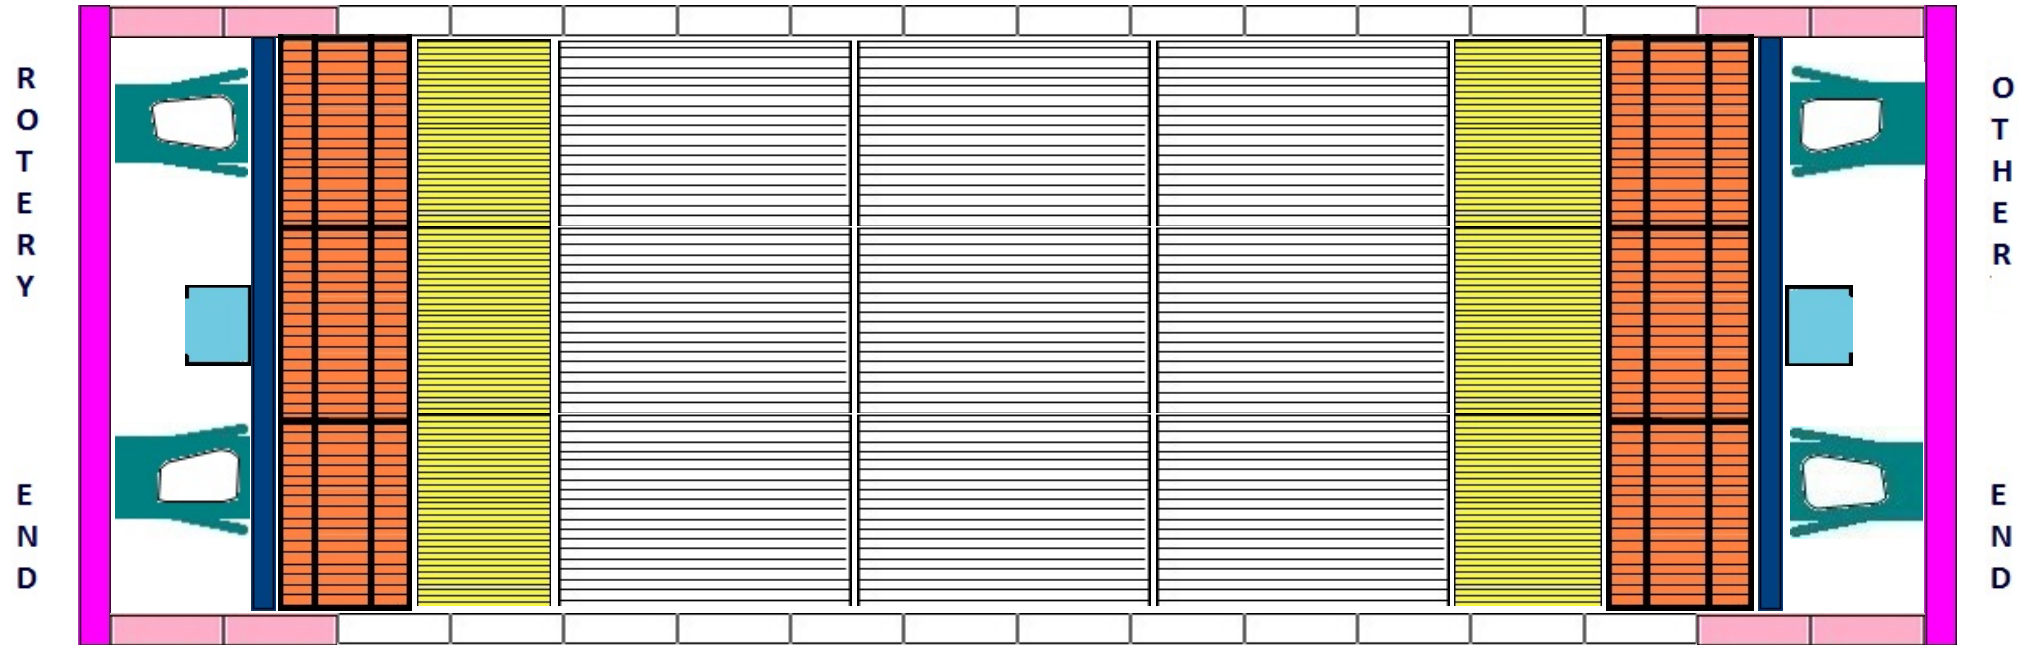
Rotary Side

Color	Particulars	Qty	Per%	Color	Particulars	Qty	Per%	Color	Particulars	Qty	Per%
	Headstock Beam	2	100%		Diagonal	4	100%		Logitudinal Channel Structure	2	100%
	Aux. Head stock	2	100%		Sole Bar	4	25%		Draft Gear Bracket	2	100%
	Trough floor	2	40%		Bottom Wall Part	4	25%		Body panel/patch		100%
	Door Top/Roof Patch		0%		Seat Bracket Rail		0%		Window Sill	10	25%
	Window Bar	36	20%		Seat pillar/lav. Partition		100%		UIC end construction		0%
	Body Pillar Part	22	100%

Start Date : 25-May-2018, Completion Date : 02-Jun-2018, Net Repair Days : 8, Total Man Hours : 1300

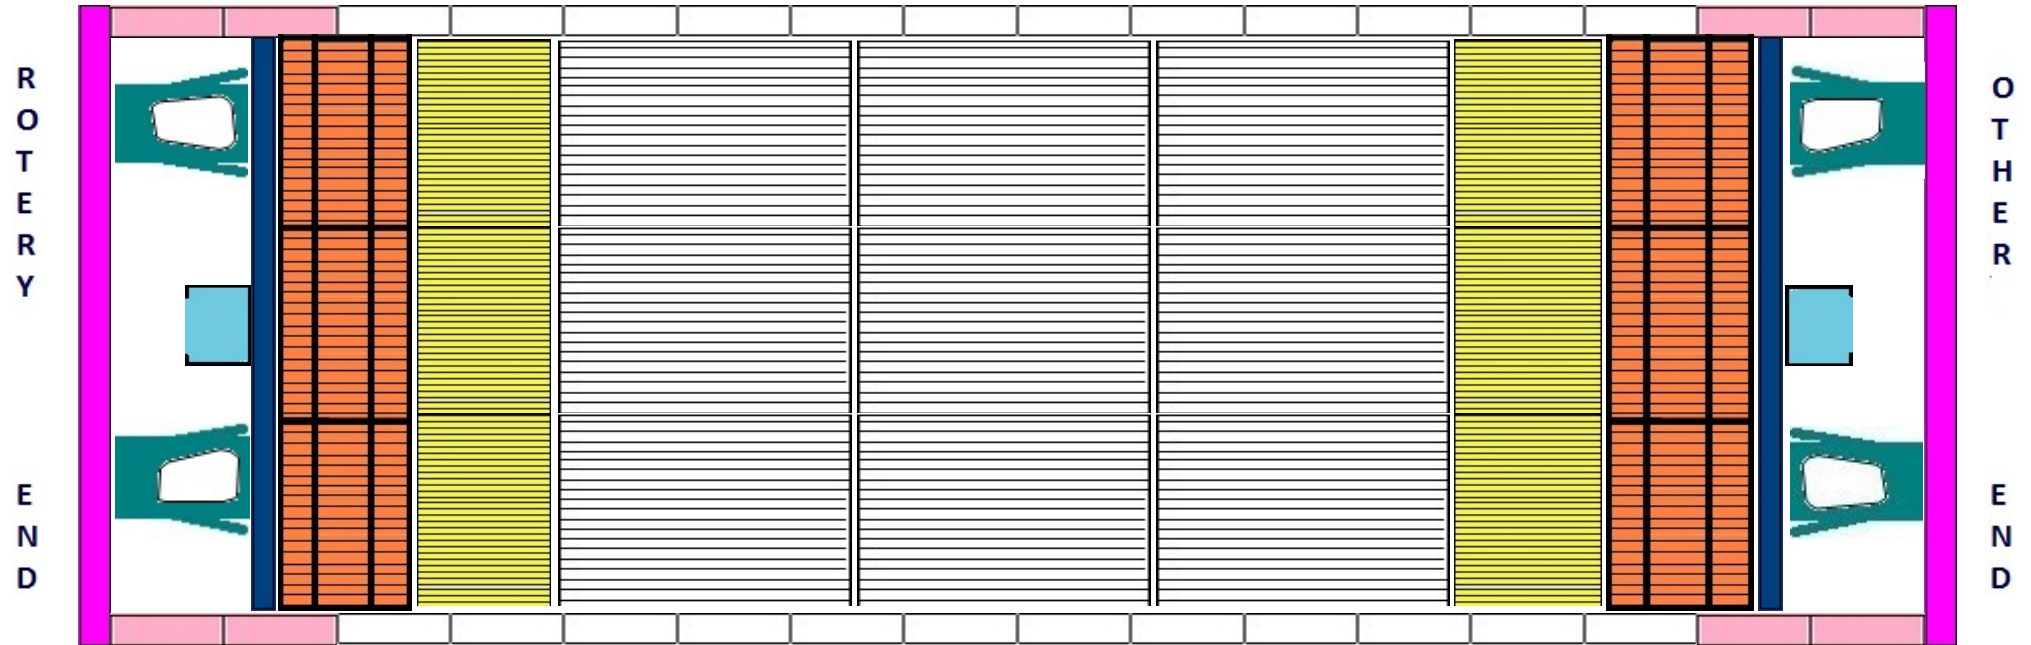
Rotary Side

Color	Particulars	Qty	Per%	Color	Particulars	Qty	Per%	Color	Particulars	Qty	Per%
Pink	Headstock Beam	2	100%	Green	Diagonal	4	100%	Orange	Logitudinal Channel Structure	2	100%
Blue	Aux. Head stock	2	100%	Pink	Sole Bar	4	25%	Light Blue	Draft Gear Bracket	2	100%
Yellow	Trough floor	2	40%		Bottom Wall Part	4	25%		Body panel/patch		100%
	Door Top/Roof Patch		0%		Seat Bracket Rail		0%		Window Sill	11	28%
	Window Bar	28	15%		Seat pillar/lav. Partition		100%		UIC end construction		0%
	Body Pillar Part	22	100%

Start Date : 26-May-2018, Completion Date : 02-Jun-2018, Net Repair Days : 7, Total Man Hours : 1228

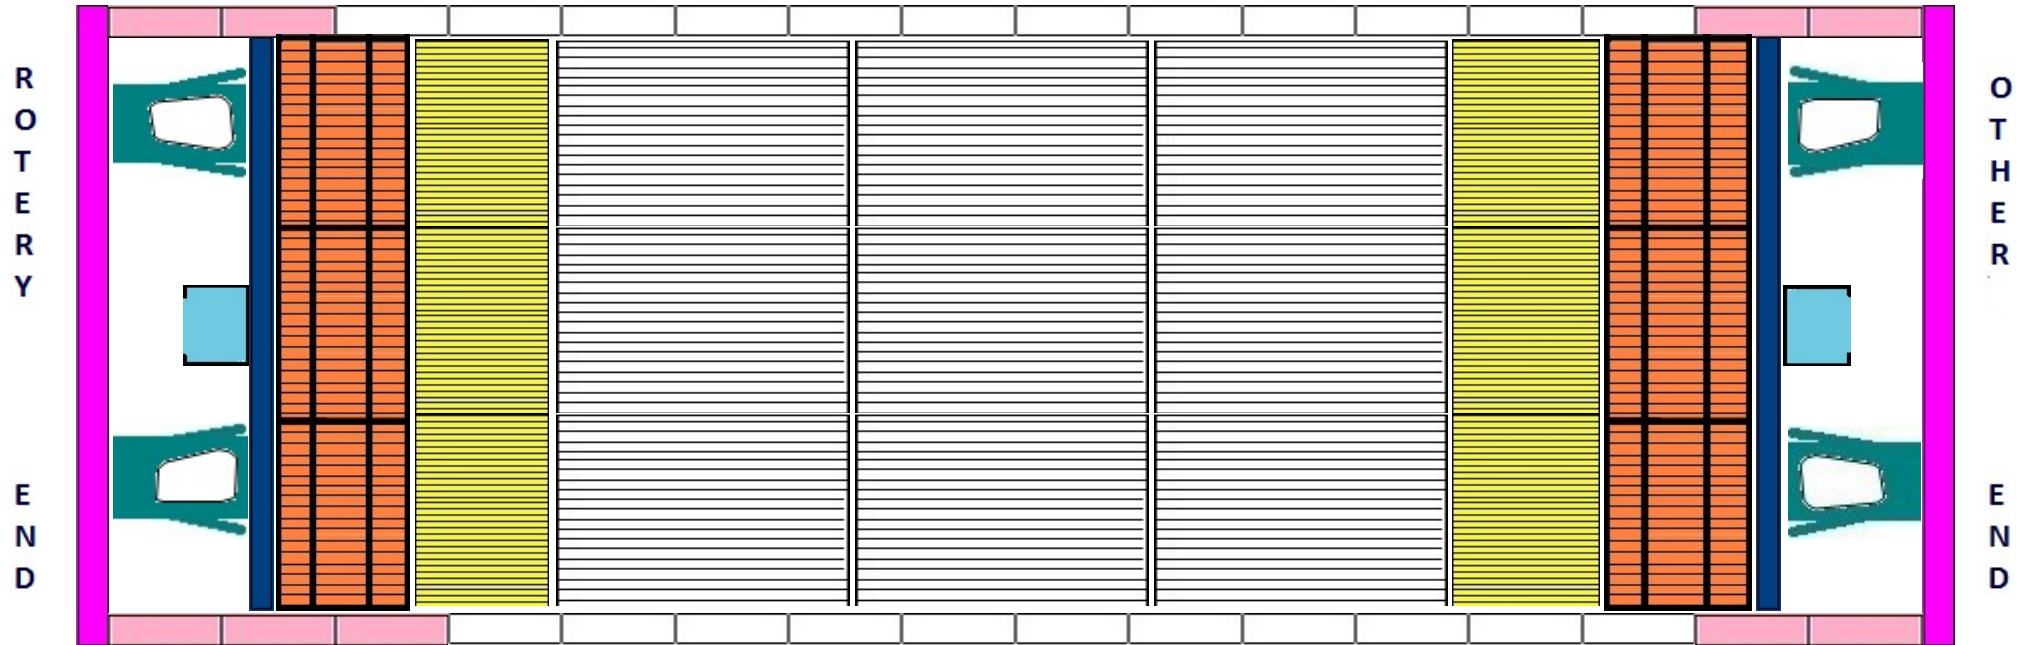
Rotary Side

Color	Particulars	Qty	Per%	Color	Particulars	Qty	Per%	Color	Particulars	Qty	Per%
	Headstock Beam	2	100%		Diagonal	4	100%		Logitudinal Channel Structure	2	100%
	Aux. Head stock	2	100%		Sole Bar	4.5	28%		Draft Gear Bracket	2	100%
	Trough floor	2	40%		Bottom Wall Part	4.5	28%		Body panel/patch		0%
	Door Top/Roof Patch		100%		Seat Bracket Rail		0%		Window Sill	12	30%
	Window Bar	20	11%		Seat pillar/lav. Partition		100%		UIC end construction		0%
	Body Pillar Part	25	100%

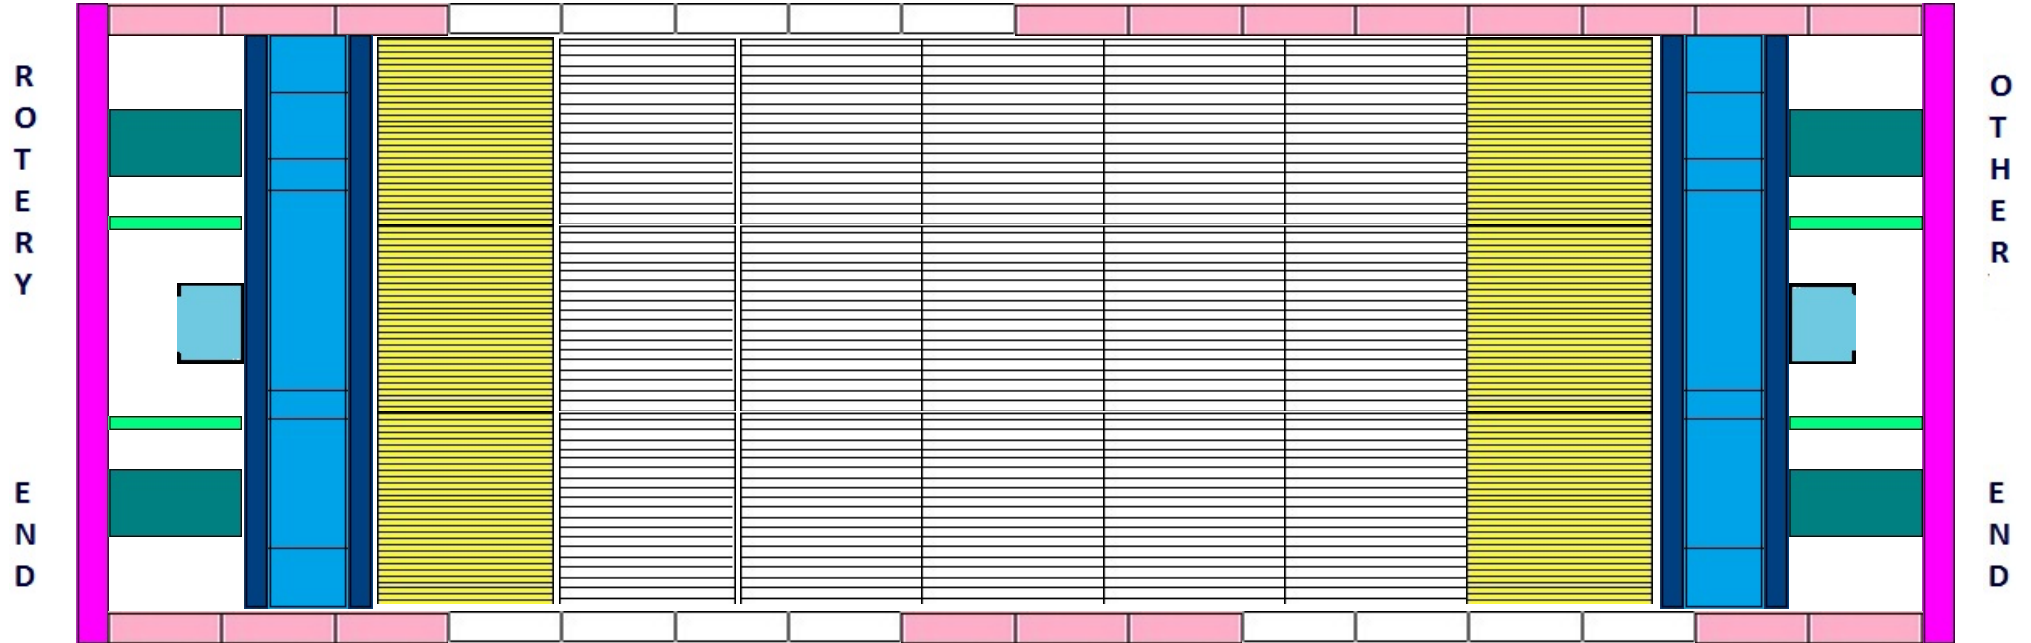
Rotary Side

Color	Particulars	Qty	Per%	Color	Particulars	Qty	Per%	Color	Particulars	Qty	Per%
	Headstock Beam	2	100%		Centre Stiffner for Headstock	4	100%		Floor Stiffner for Headstock	4	100%
	Aux. Head stock	4	100%		Sole Bar	9.5	59%		Draft Gear Bracket	2	100%
	Trough floor	2	29%		Centre plate	2	100%		SoleBar Stiffner	6	100%
	Bottom Wall Part	9.5	59%		Body panel/patch		100%		Door Top/Roof Patch		0%
	Window Module		0%		Window Sill	21	53%		Window Bar	60	34%
	Seat pillar/lav. Partition		100%		UIC end construction		0%

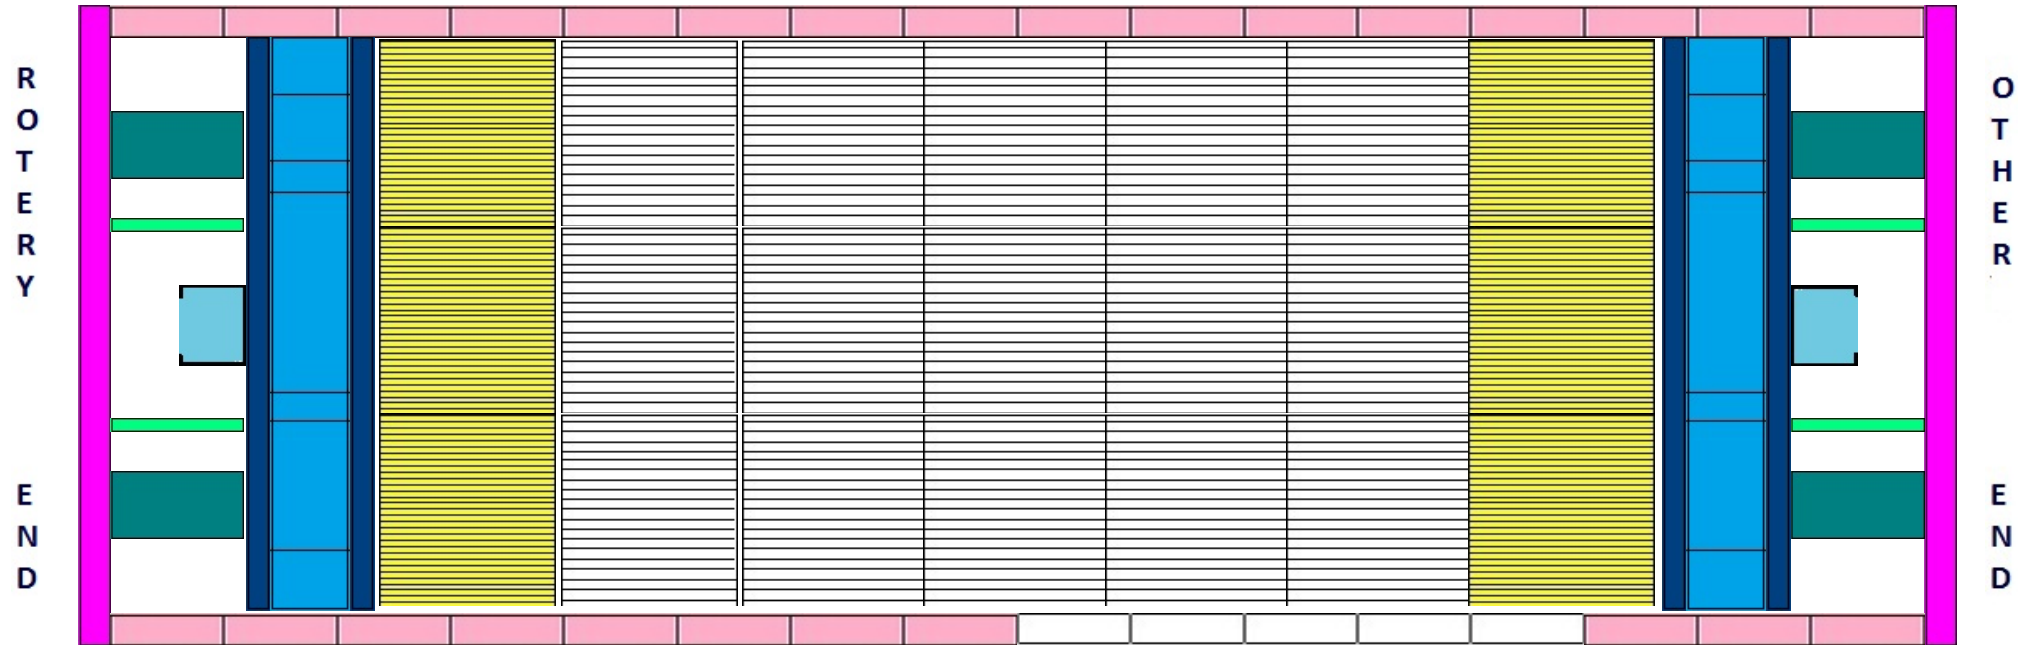
Rotary Side

Color	Particulars	Qty	Per%	Color	Particulars	Qty	Per%	Color	Particulars	Qty	Per%
	Headstock Beam	2	100%		Centre Stiffner for Headstock	4	100%		Floor Stiffner for Headstock	4	100%
	Aux. Head stock	4	100%		Sole Bar	13.5	84%		Draft Gear Bracket	2	100%
	Trough floor	2	29%		Centre plate	2	100%		SoleBar Stiffner	6	100%
	Bottom Wall Part	13.5	84%		Body panel/patch		100%		Door Top/Roof Patch		0%
	Window Module		0%		Window Sill	26	65%		Window Bar	62	35%
	Seat pillar/lav. Partition		100%		UIC end construction		0%
