Coach Rehabilitation Workshop, WC Railway, Bhopal

(An IMS and ISO 50001 Certified Workshop)
Final Inspection Sheet - Details of Corrosion Repair

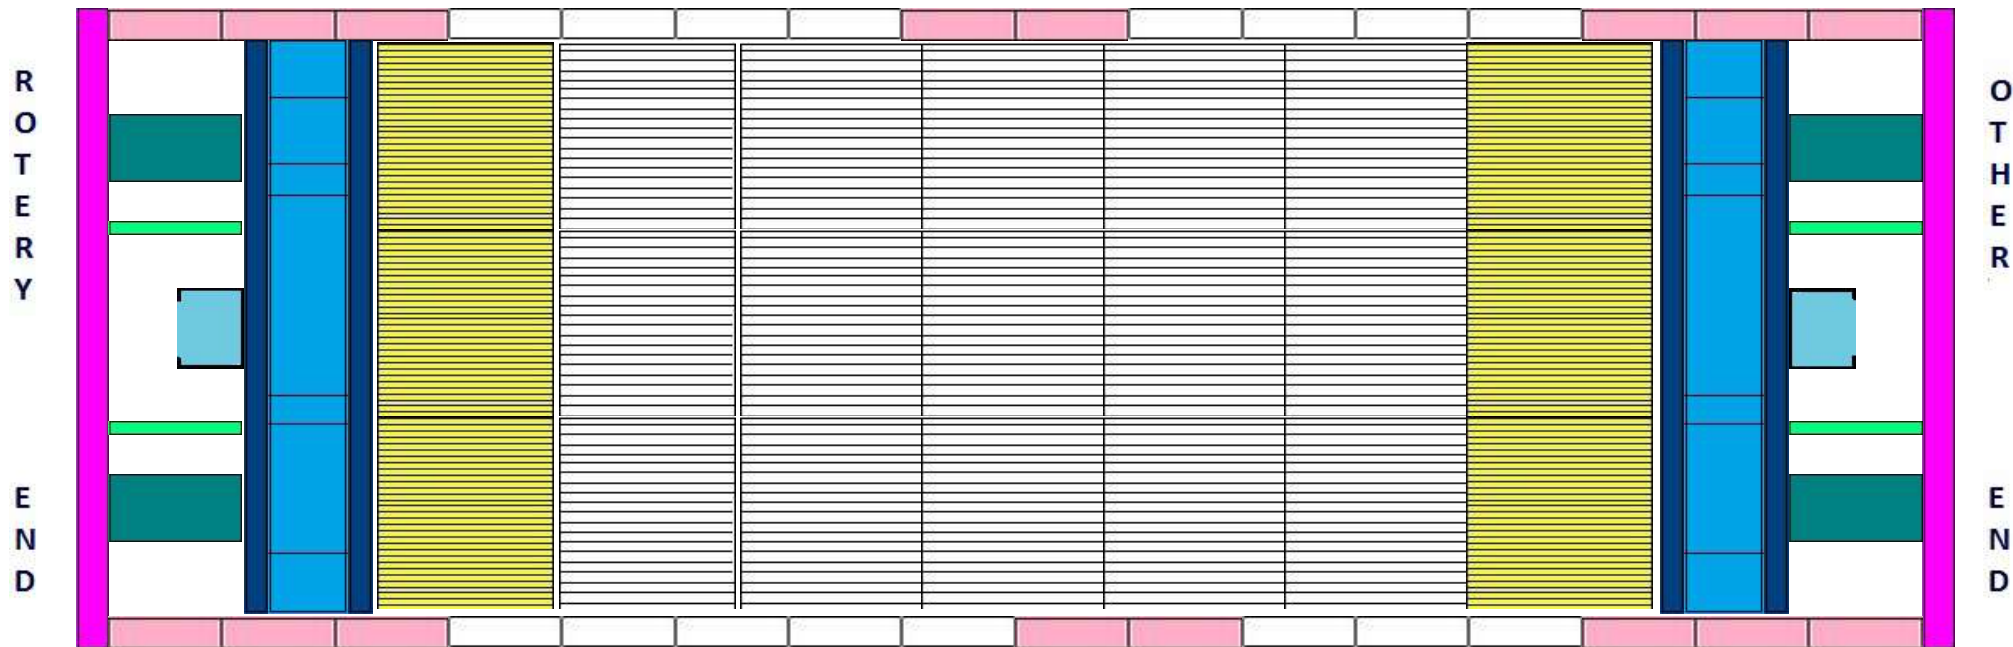
Coach No. :NR06455

Color	Particulars	Qty	Per%	Color	Particulars	Qty	Per%	Color	Particulars	Qty	Per%
	Headstock Beam	2	100%		Centre Stiffner for Headstock	4	100%		Floor Stiffner for Headstock	4	100%
	Aux. Head stock	4	100%		Sole Bar	8	50%		Draft Gear Bracket	2	100%
	Trough floor	2	29%		Centre plate	2	100%		SoleBar Stiffner	6	100%
	Bottom Wall Part	8	50%		Body panel/patch		100%		Door Top/Roof Patch		0%
	Window Module		0%		Window Sill	28	70%		Window Bar	52	29%
	Seat pillar/lav. Partition		100%		UIC end construction		0%

End Drooping: Rotary End - EAST : 0, WEST : 2 Other End - EAST : 5, WEST : 6
Start Date : 26-Mar-2019, Completion Date : 02-Apr-2019, Net Repair Days : 7, Total Man Hours : 1445

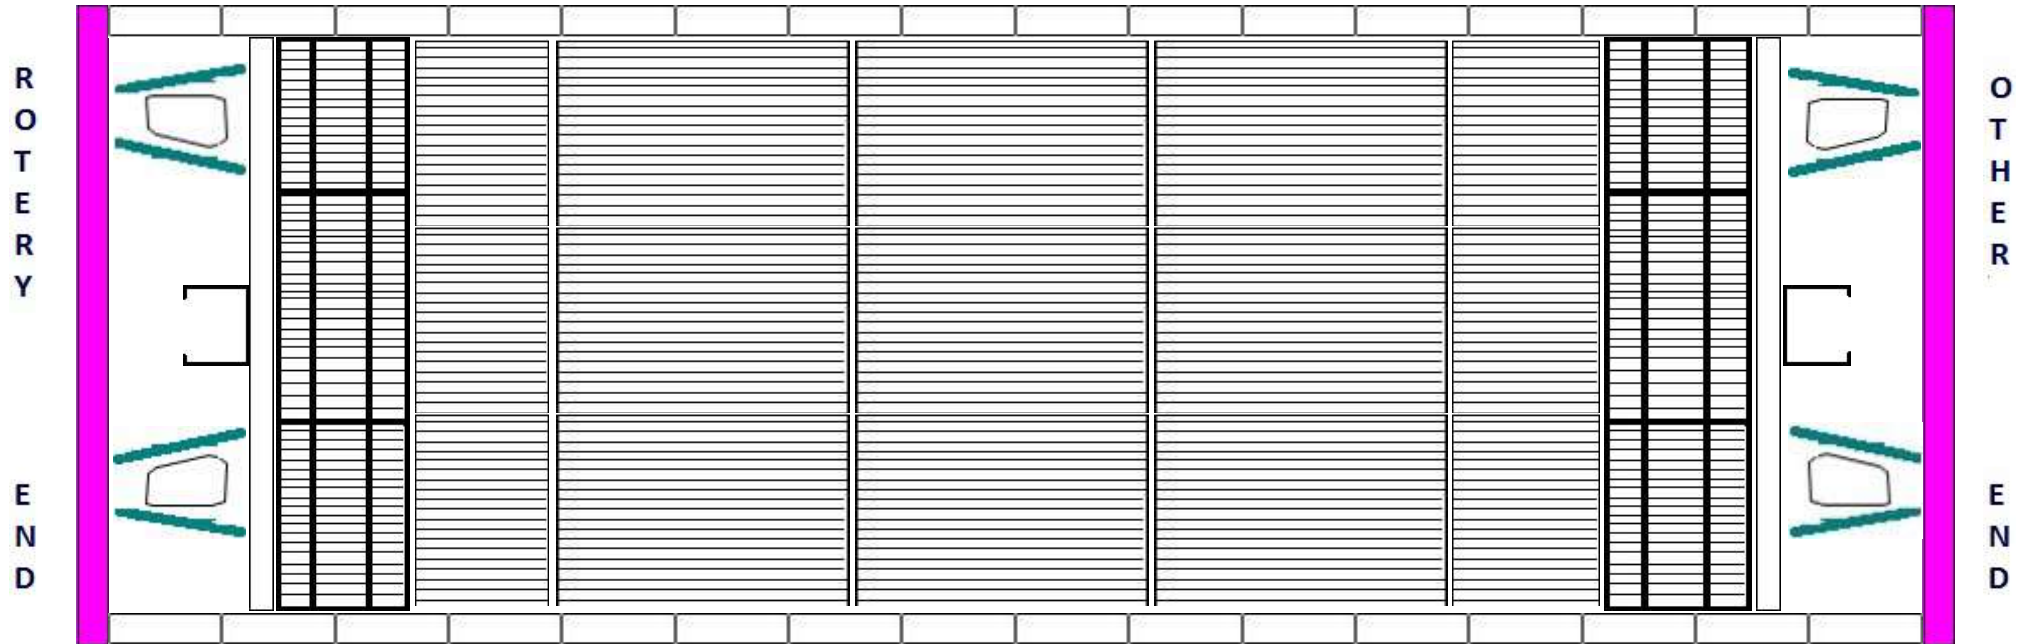
Coach No. :NR05245

Color	Particulars	Qty	Per%	Color	Particulars	Qty	Per%	Color	Particulars	Qty	Per%
	Headstock Beam	2	100%		Diagonal	4	100%		Logitudinal Channel Structure	0	0%
	Aux. Head stock	0	0%		Sole Bar	0	0%		Draft Gear Bracket	0	0%
	Trough floor	0	0%		Bottom Wall Part	0	0%		Body panel/patch		100%
	Door Top/Roof Patch		0%		Seat Bracket Rail		0%		Window Sill	14	35%
	Window Bar	15	8%		Seat pillar/lav. Partition		100%		UIC end construction		0%
	Body Pillar Part	0	100%

End Drooping: Rotary End - EAST : -10, WEST : -8 Other End - EAST : -10, WEST : -9
Start Date : 12-Apr-2019, Completion Date : 22-Apr-2019, Net Repair Days : 9, Total Man Hours : 824

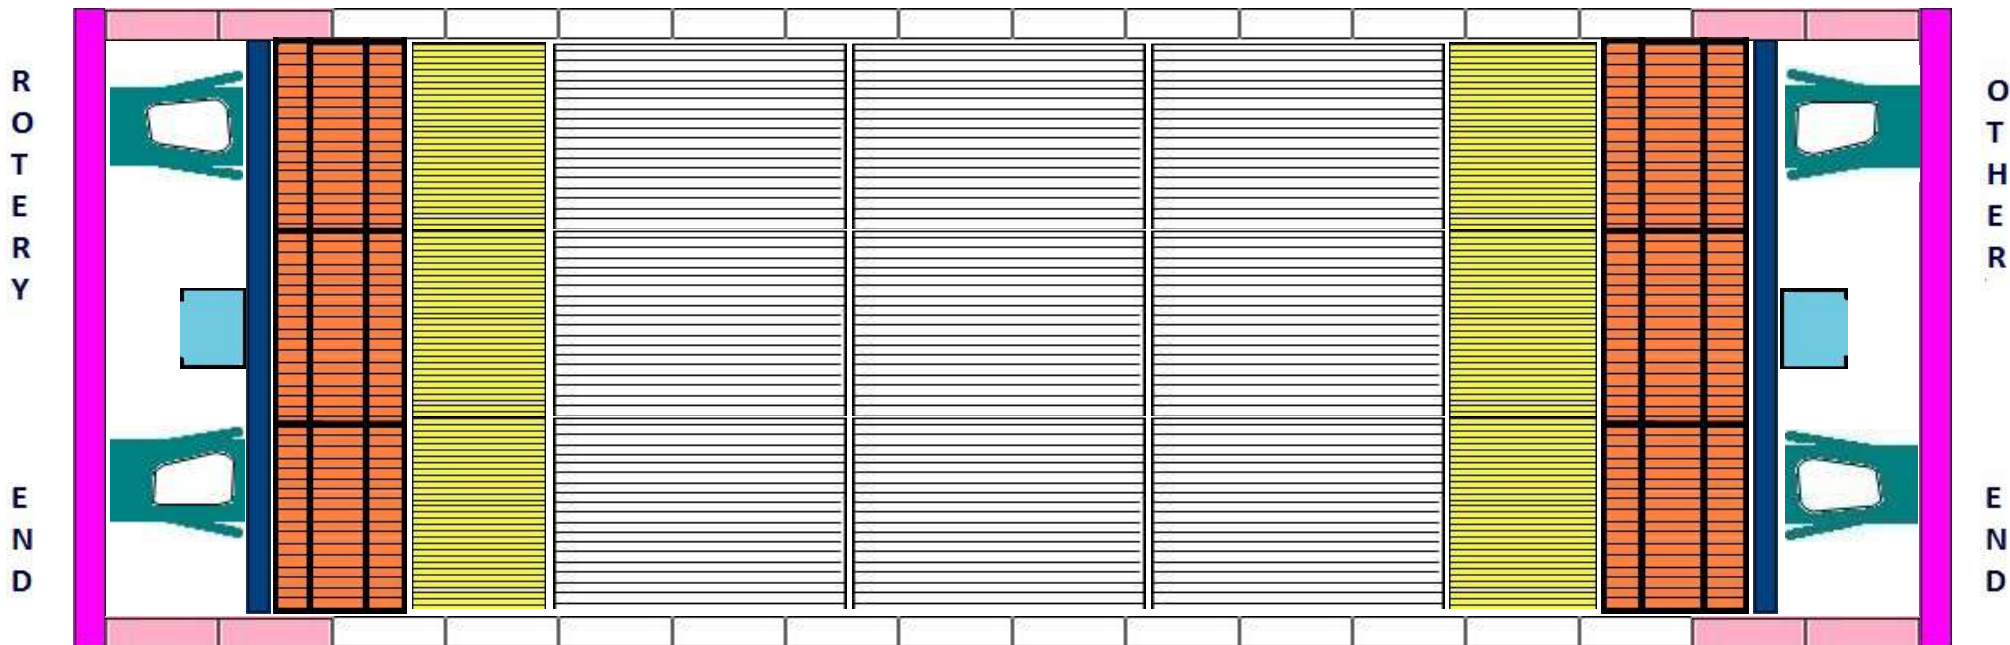
Rotary Side

Color	Particulars	Qty	Per%	Color	Particulars	Qty	Per%	Color	Particulars	Qty	Per%
	Headstock Beam	2	100%		Diagonal	4	100%		Logitudinal Channel Structure	2	100%
	Aux. Head stock	2	100%		Sole Bar	4	25%		Draft Gear Bracket	2	100%
	Trough floor	2	40%		Bottom Wall Part	4	25%		Body panel/patch		100%
	Door Top/Roof Patch		0%		Seat Bracket Rail		0%		Window Sill	30	75%
	Window Bar	48	26%		Seat pillar/lav. Partition		100%		UIC end construction		0%
	Body Pillar Part	22	100%

End Drooping: Rotary End - EAST : -10, WEST : -8 Other End - EAST : -8, WEST : -10
Start Date : 25-Apr-2019, Completion Date : 02-May-2019, Net Repair Days : 7, Total Man Hours : 1090

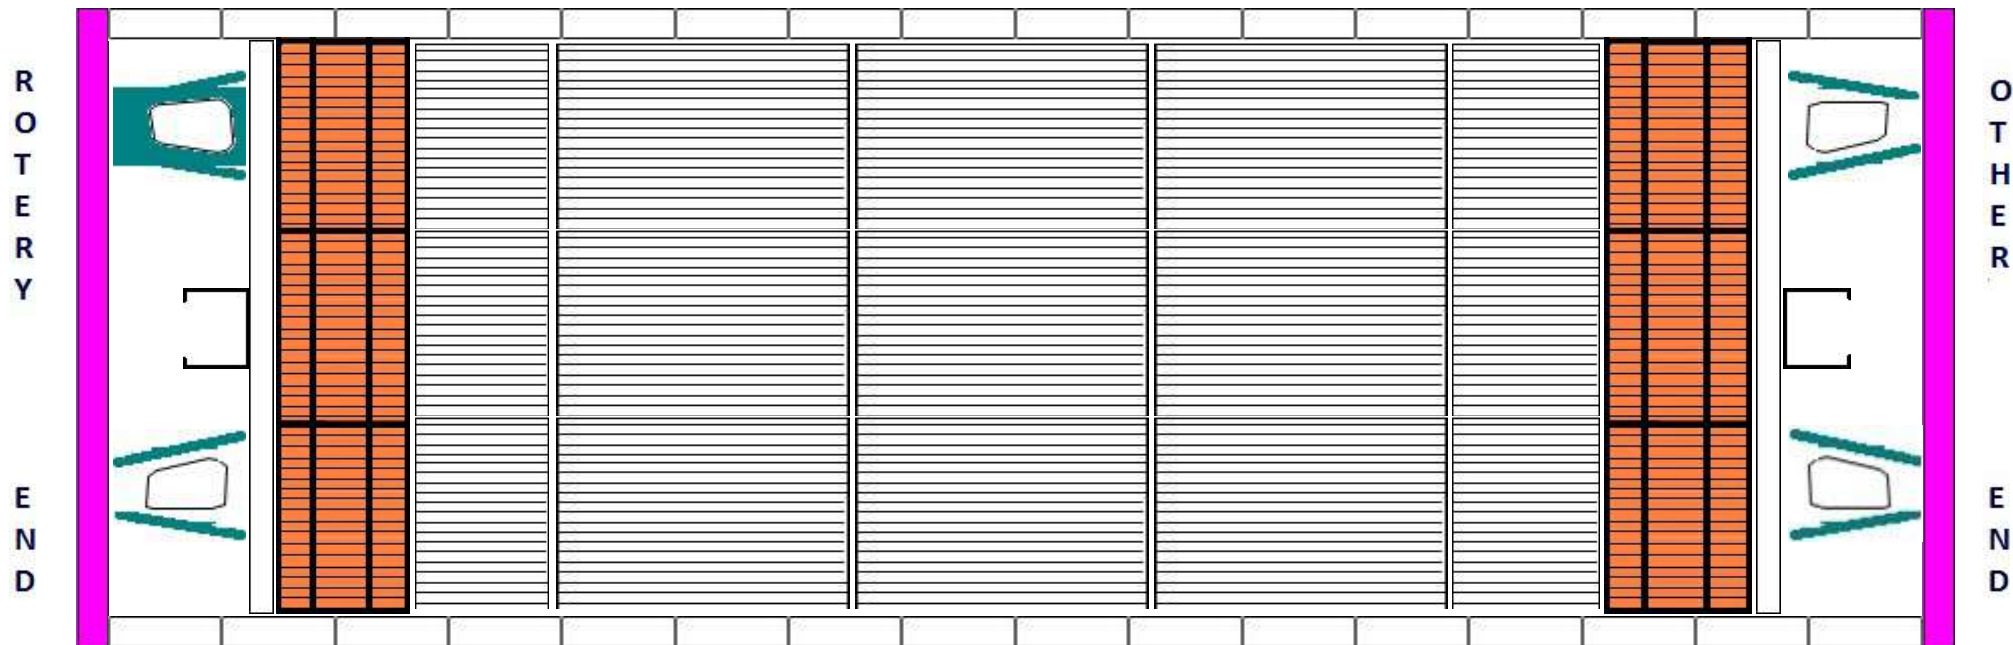
Rotary Side

Color	Particulars	Qty	Per%	Color	Particulars	Qty	Per%	Color	Particulars	Qty	Per%
	Headstock Beam	0	0%		Diagonal	4	100%		Logitudinal Channel Structure	2	100%
	Aux. Head stock	0	0%		Sole Bar	0	0%		Draft Gear Bracket	0	0%
	Trough floor	0	0%		Bottom Wall Part	0	0%		Body panel/patch		100%
	Door Top/Roof Patch		0%		Seat Bracket Rail		0%		Window Sill	0	0%
	Window Bar	0	0%		Seat pillar/lav. Partition		100%		UIC end construction		0%
	Body Pillar Part	0	100%

End Drooping: Rotary End - EAST : -5, WEST : -7 Other End - EAST : -7, WEST : -6
Start Date : 20-May-2019, Completion Date : 24-May-2019, Net Repair Days : 5, Total Man Hours : 0

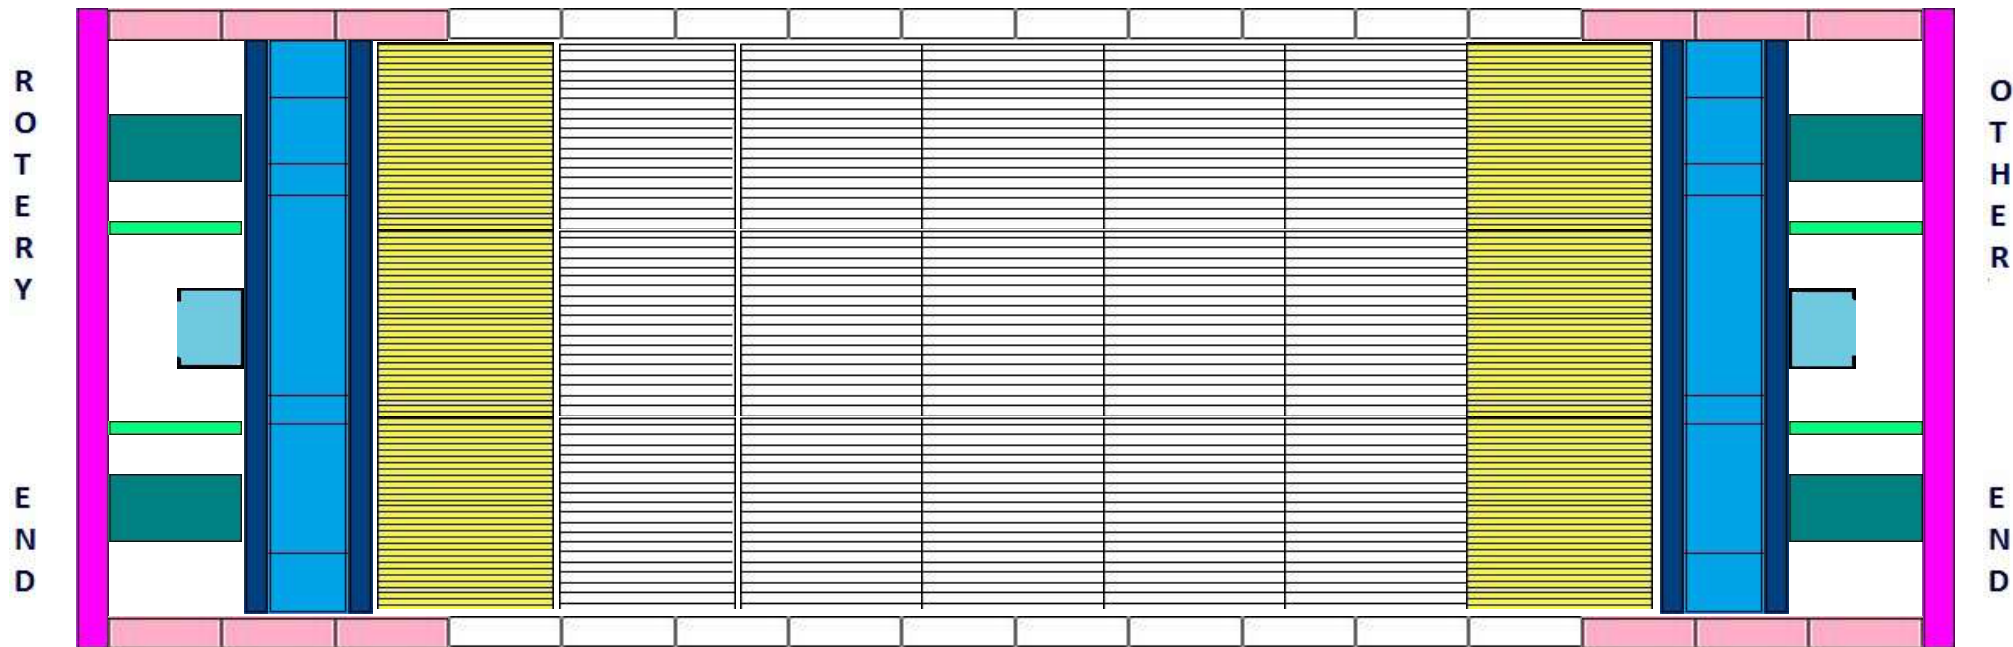
Color	Particulars	Qty	Per%	Color	Particulars	Qty	Per%	Color	Particulars	Qty	Per%
Yellow	Headstock Beam	2	100%	Dark Green	Centre Stiffner for Headstock	4	100%	Light Green	Floor Stiffner for Headstock	4	100%
Dark Blue	Aux. Head stock	4	100%	Pink	Sole Bar	6	38%	Light Blue	Draft Gear Bracket	2	100%
Yellow	Trough floor	2	29%	Light Blue	Centre plate	2	100%		SoleBar Stiffner	4	100%
	Bottom Wall Part	6	38%		Body panel/patch		100%		Door Top/Roof Patch		0%
	Window Module		0%		Window Sill	40	100%		Window Bar	72	39%
	Seat pillar/lav. Partition		100%		UIC end construction		0%

End Drooping: Rotary End - EAST : 2, WEST : 4 Other End - EAST : -2, WEST : 5
Start Date : 07-Sep-2019, Completion Date : 14-Sep-2019, Net Repair Days : 7, Total Man Hours : 1072

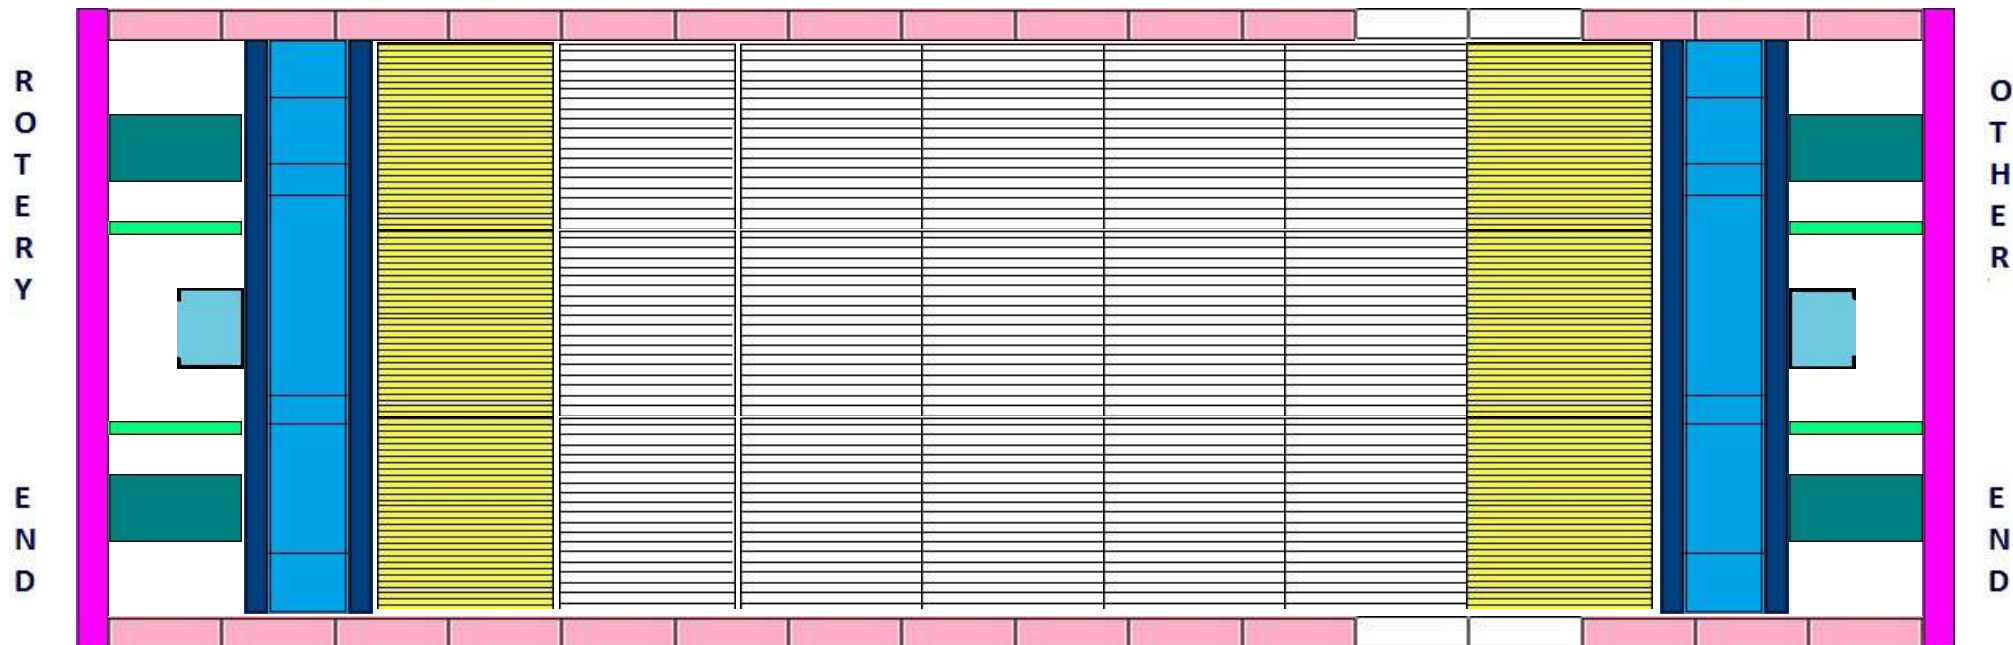
Rotary Side

Color	Particulars	Qty	Per%	Color	Particulars	Qty	Per%	Color	Particulars	Qty	Per%
	Headstock Beam	2	100%		Centre Stiffner for Headstock	4	100%		Floor Stiffner for Headstock	4	100%
	Aux. Head stock	4	100%		Sole Bar	14	88%		Draft Gear Bracket	2	100%
	Trough floor	2	29%		Centre plate	2	100%		SoleBar Stiffner	4	100%
	Bottom Wall Part	14	88%		Body panel/patch		100%		Door Top/Roof Patch		0%
	Window Module		0%		Window Sill	10	53%		Window Bar	16	19%
	Seat pillar/lav. Partition		100%		UIC end construction		0%

End Drooping: Rotary End - EAST : 3, WEST : 7 Other End - EAST : -4, WEST : -8
Start Date : 04-Jun-2019, Completion Date : 14-Jun-2019, Net Repair Days : 10, Total Man Hours : 1592

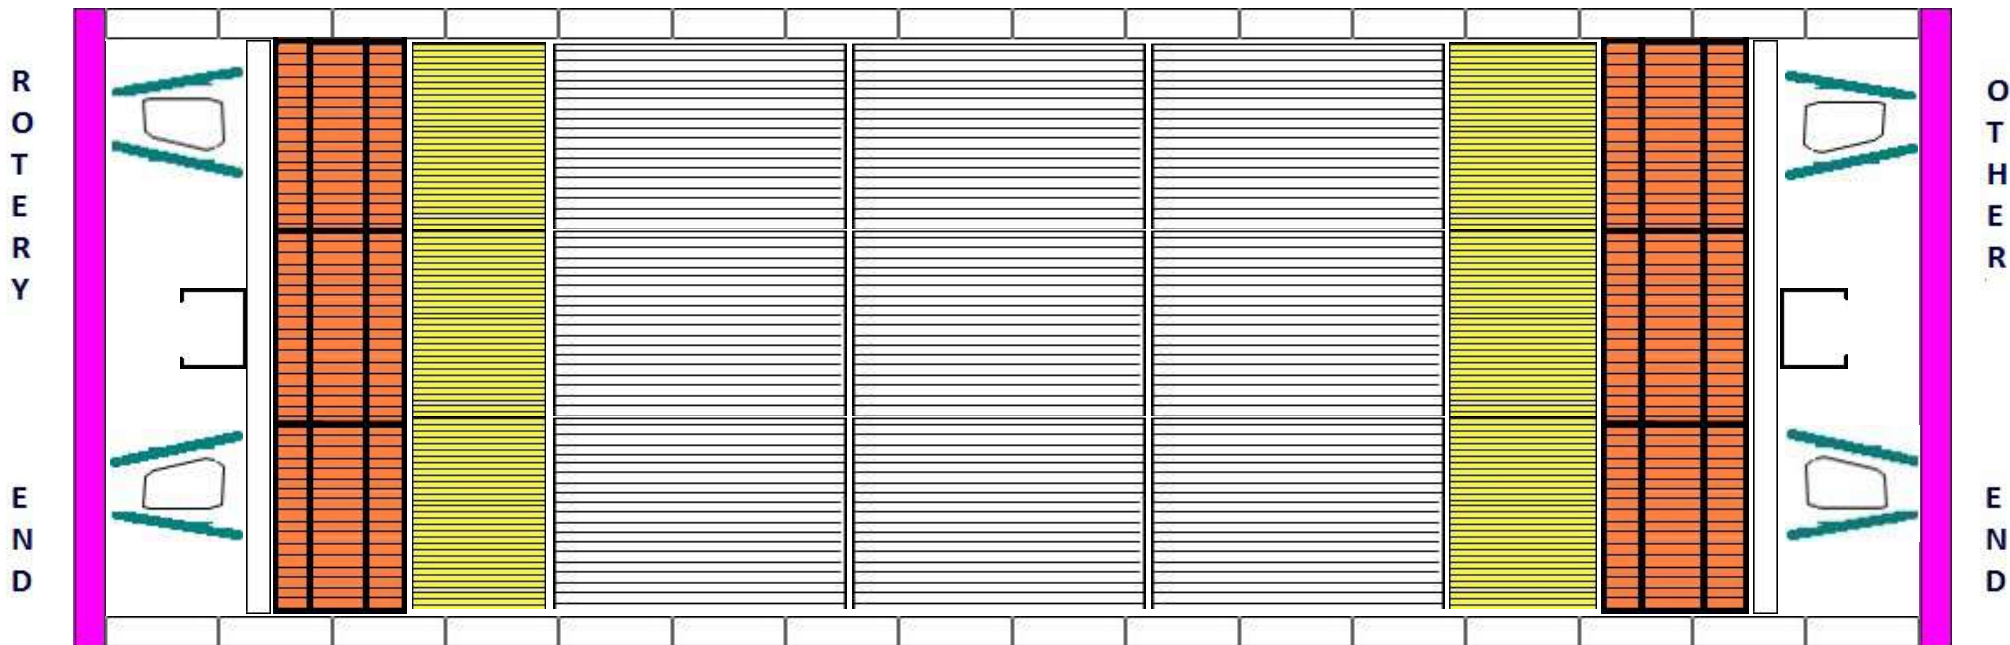
Rotary Side

Color	Particulars	Qty	Per%	Color	Particulars	Qty	Per%	Color	Particulars	Qty	Per%
	Headstock Beam	0	0%		Diagonal	4	100%		Logitudinal Channel Structure	2	100%
	Aux. Head stock	0	0%		Sole Bar	0	0%		Draft Gear Bracket	0	0%
	Trough floor	2	40%		Bottom Wall Part	0	0%		Body panel/patch		100%
	Door Top/Roof Patch		0%		Seat Bracket Rail		0%		Window Sill	0	0%
	Window Bar	0	0%		Seat pillar/lav. Partition		100%		UIC end construction		0%
	Body Pillar Part	0	100%

Start Date : 15-Jun-2019, Completion Date : 25-Jun-2019, Net Repair Days : 9, Total Man Hours : 584

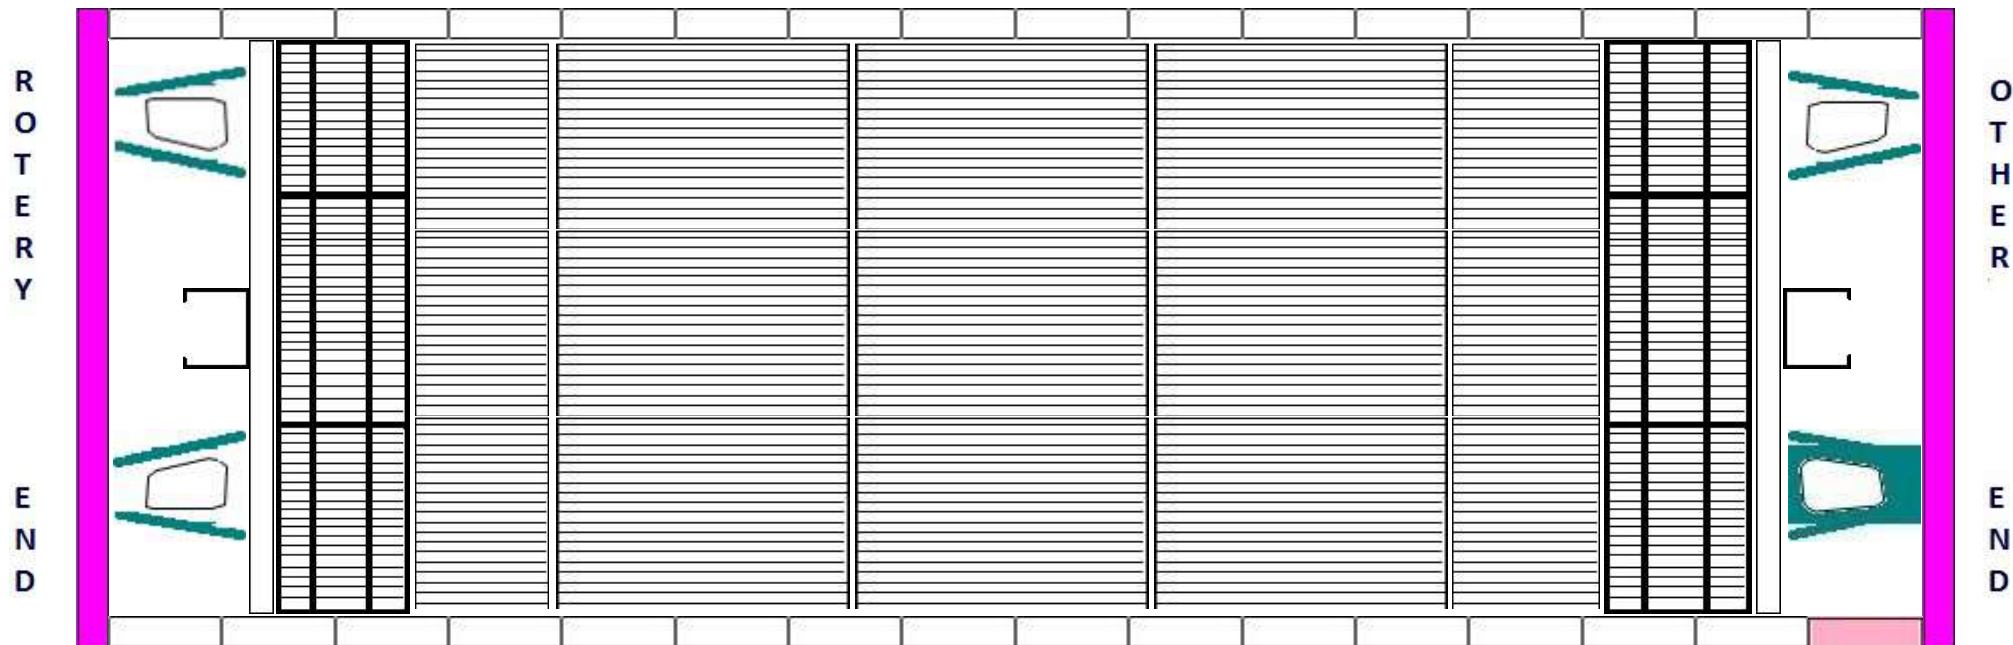
Rotary Side

Color	Particulars	Qty	Per%	Color	Particulars	Qty	Per%	Color	Particulars	Qty	Per%
Blue	Headstock Beam	0	0%	Red	Diagonal	4	100%	Green	Logitudinal Channel Structure	0	0%
Black	Aux. Head stock	0	0%	Yellow	Sole Bar	0.5	3%	Light Blue	Draft Gear Bracket	0	0%
Orange	Trough floor	0	0%		Bottom Wall Part	0.5	3%		Body panel/patch		100%
	Door Top/Roof Patch		0%		Seat Bracket Rail		0%		Window Sill	12	30%
	Window Bar	50	27%		Seat pillar/lav. Partition		100%		UIC end construction		0%
	Body Pillar Part	3	100%

End Drooping: Rotary End - EAST : 0, WEST : 3 Other End - EAST : -5, WEST : -4
Start Date : 11-Jul-2019, Completion Date : 19-Jul-2019, Net Repair Days : 8, Total Man Hours : 968

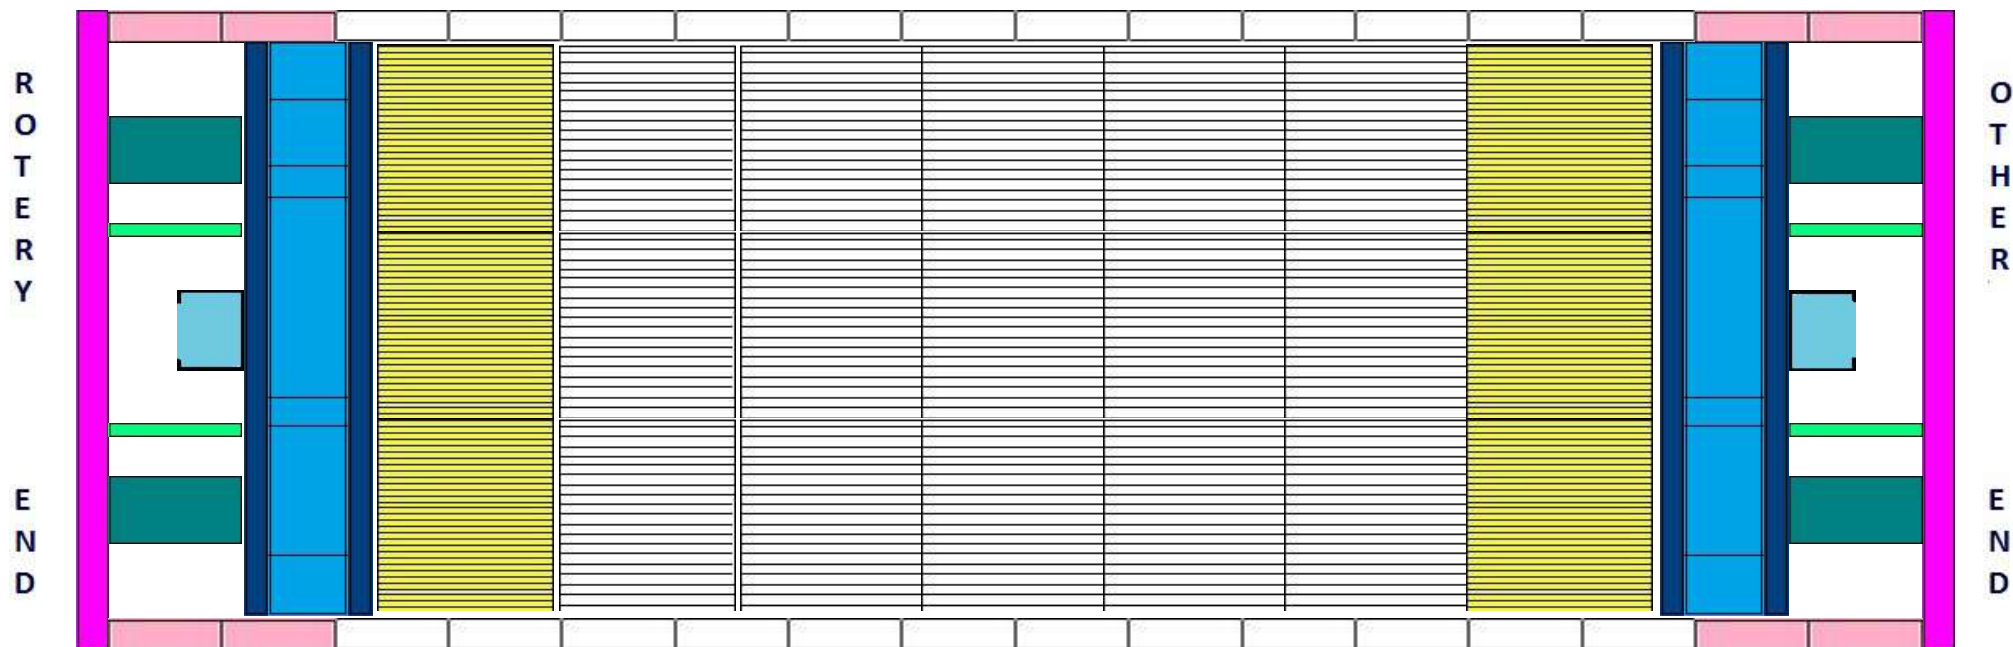
Color	Particulars	Qty	Per%	Color	Particulars	Qty	Per%	Color	Particulars	Qty	Per%
	Headstock Beam	2	100%		Centre Stiffner for Headstock	4	100%		Floor Stiffner for Headstock	4	100%
	Aux. Head stock	4	100%		Sole Bar	4	25%		Draft Gear Bracket	2	100%
	Trough floor	2	29%		Centre plate	2	100%		SoleBar Stiffner	4	100%
	Bottom Wall Part	4	25%		Body panel/patch		100%		Door Top/Roof Patch		0%
	Window Module		3%		Window Sill	0	0%		Window Bar	0	0%
	Seat pillar/lav. Partition		100%		UIC end construction		0%

End Drooping: Rotary End - EAST : 3, WEST : 3 Other End - EAST : 5, WEST : 3
Start Date : 21-Oct-2019, Completion Date : 30-Oct-2019, Net Repair Days : 9, Total Man Hours : 1248

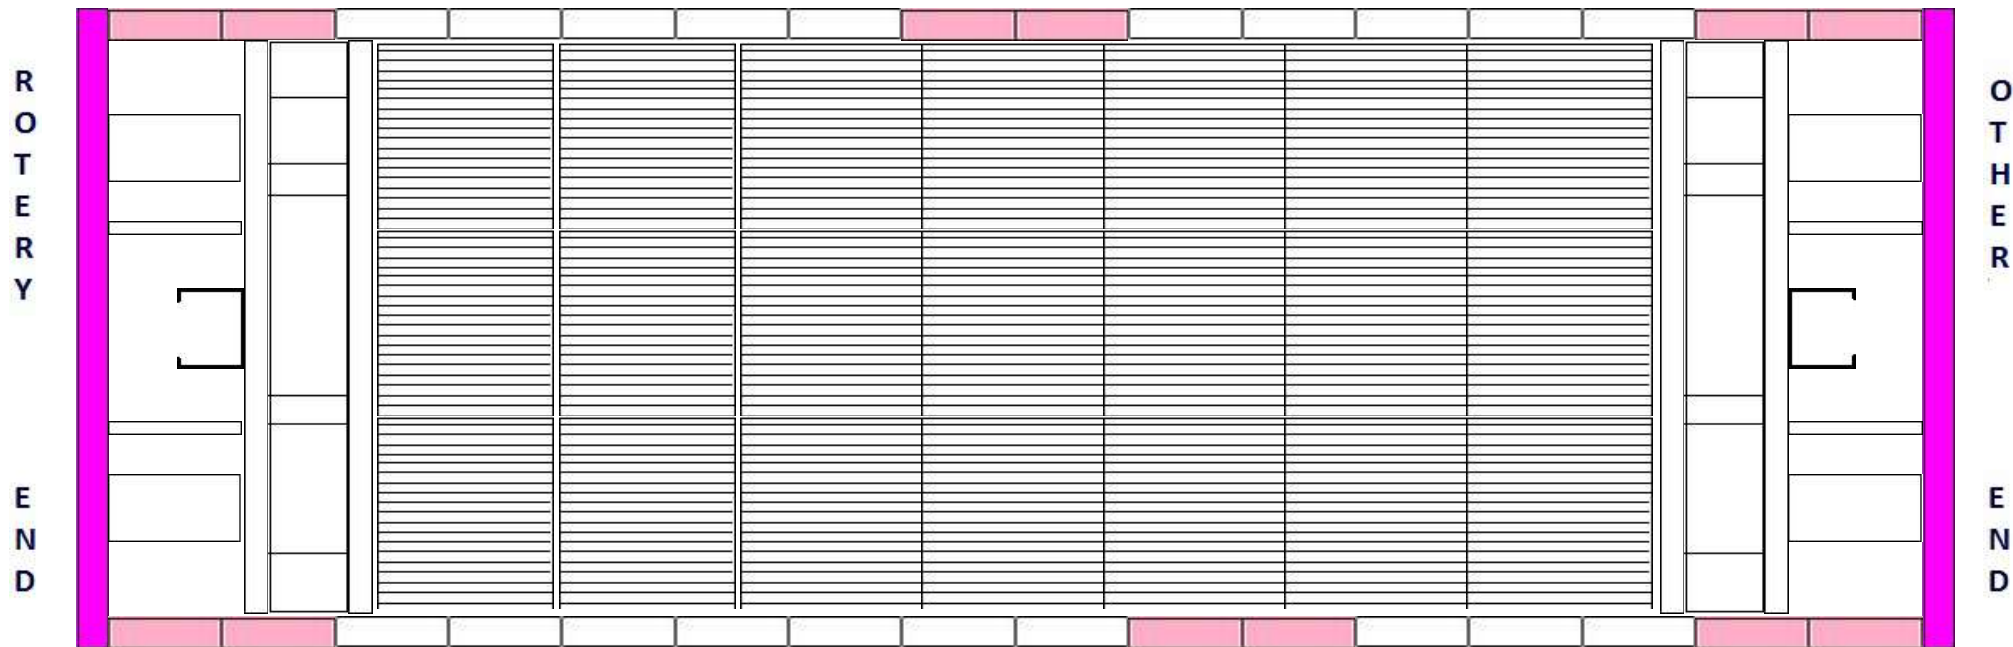
Color	Particulars	Qty	Per%	Color	Particulars	Qty	Per%	Color	Particulars	Qty	Per%
Yellow	Headstock Beam	0	0%	Blue	Centre Stiffner for Headstock	0	0%	Blue	Floor Stiffner for Headstock	0	0%
Blue	Aux. Head stock	0	0%	Yellow	Sole Bar	6	38%	Blue	Draft Gear Bracket	0	0%
Yellow	Trough floor	0	0%	Blue	Centre plate	0	0%		SoleBar Stiffner	4	100%
	Bottom Wall Part	6	38%		Body panel/patch		100%		Door Top/Roof Patch		0%
	Window Module		0%		Window Sill	12	30%		Window Bar	22	26%
	Seat pillar/lav. Partition		100%		UIC end construction		0%

End Drooping: Rotary End - EAST : -6, WEST : -7 Other End - EAST : -7, WEST : -80
Start Date : 25-Oct-2019, Completion Date : 05-Nov-2019, Net Repair Days : 10, Total Man Hours : 936

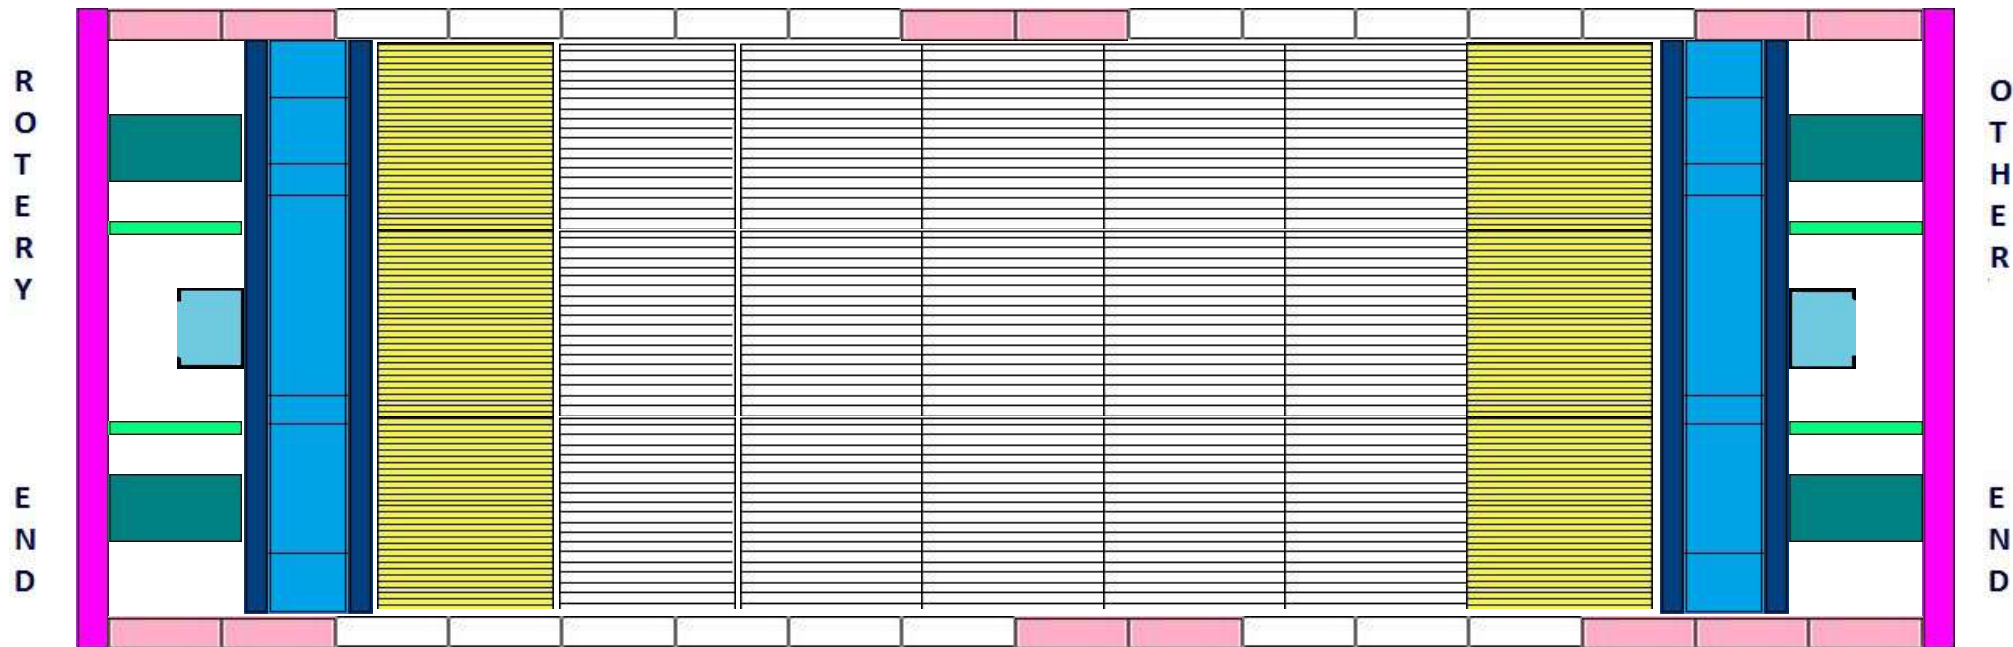
Color	Particulars	Qty	Per%	Color	Particulars	Qty	Per%	Color	Particulars	Qty	Per%
	Headstock Beam	2	100%		Centre Stiffner for Headstock	4	100%		Floor Stiffner for Headstock	4	100%
	Aux. Head stock	4	100%		Sole Bar	6.5	41%		Draft Gear Bracket	2	100%
	Trough floor	2	29%		Centre plate	2	100%		SoleBar Stiffner	6	100%
	Bottom Wall Part	6.5	41%		Body panel/patch		100%		Door Top/Roof Patch		0%
	Window Module		0%		Window Sill	40	100%		Window Bar	40	23%
	Seat pillar/lav. Partition		100%		UIC end construction		0%

End Drooping: Rotary End - EAST : 2, WEST : 4 Other End - EAST : -3, WEST : -5
Start Date : 23-Oct-2019, Completion Date : 02-Nov-2019, Net Repair Days : 10, Total Man Hours : 0

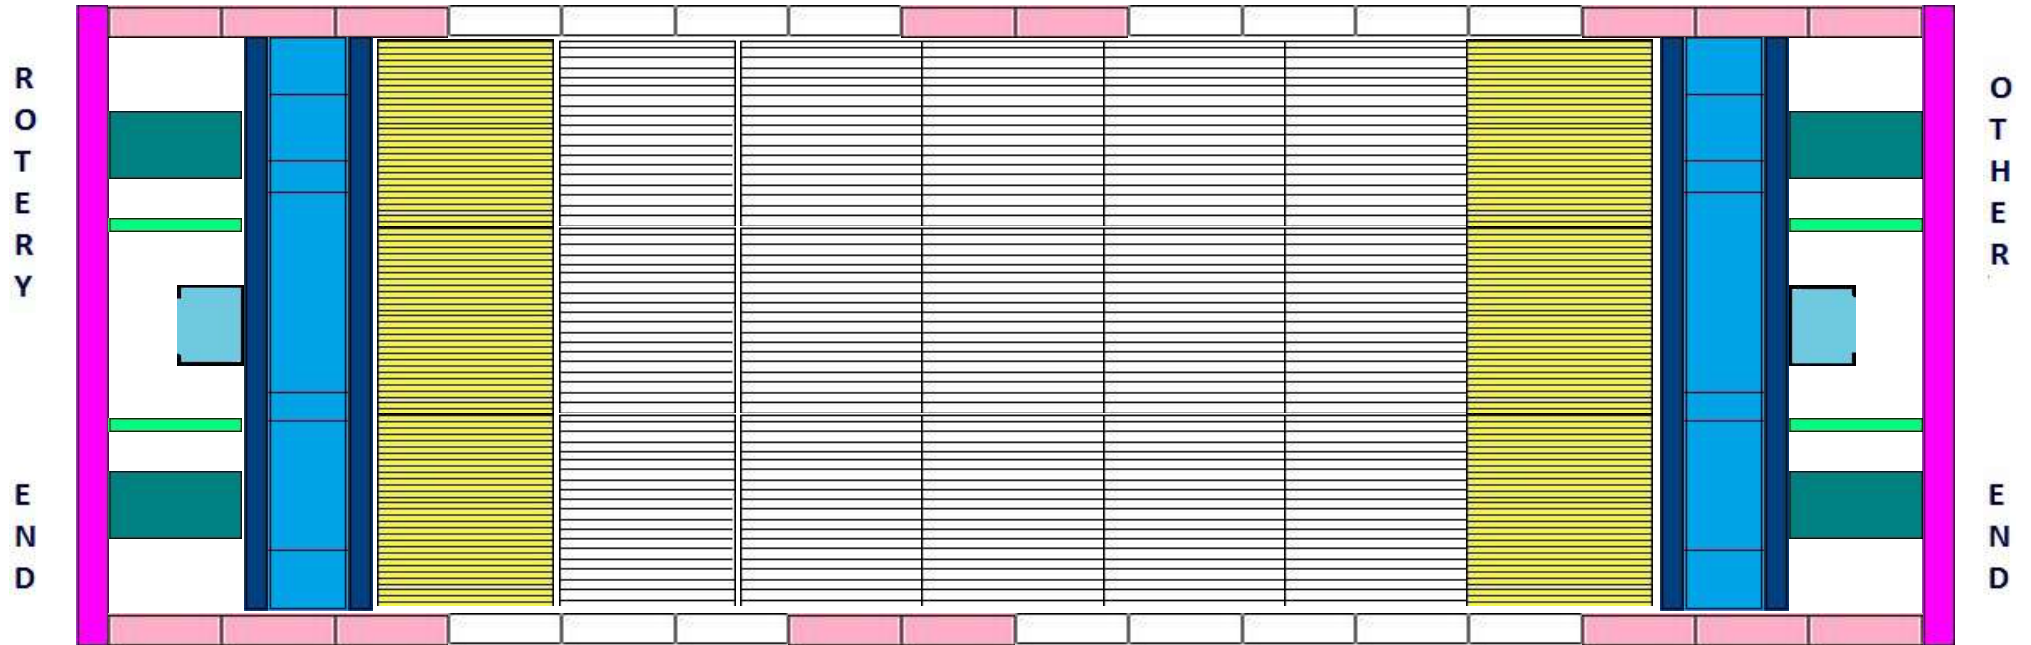
Color	Particulars	Qty	Per%	Color	Particulars	Qty	Per%	Color	Particulars	Qty	Per%
	Headstock Beam	2	100%		Centre Stiffner for Headstock	4	100%		Floor Stiffner for Headstock	4	100%
	Aux. Head stock	4	100%		Sole Bar	8	50%		Draft Gear Bracket	2	100%
	Trough floor	2	29%		Centre plate	2	100%		SoleBar Stiffner	6	100%
	Bottom Wall Part	8	50%		Body panel/patch		100%		Door Top/Roof Patch		0%
	Window Module		0%		Window Sill	20	50%		Window Bar	40	23%
	Seat pillar/lav. Partition		100%		UIC end construction		0%

End Drooping: Rotary End - EAST : -3, WEST : 5 Other End - EAST : -7, WEST : 3
Start Date : 25-Oct-2019, Completion Date : 05-Nov-2019, Net Repair Days : 10, Total Man Hours : 1176

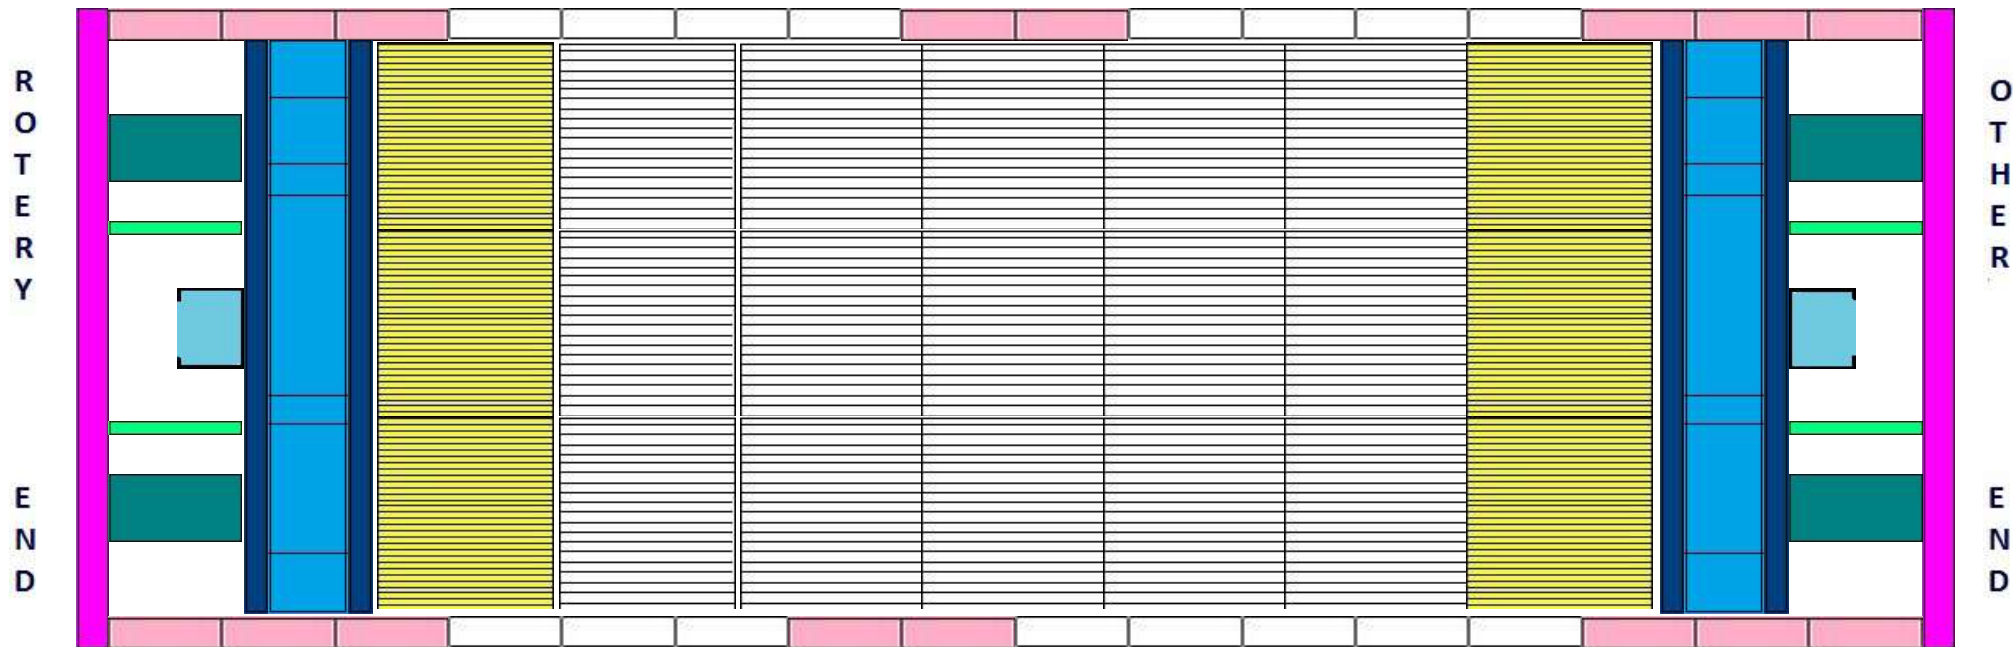
Color	Particulars	Qty	Per%	Color	Particulars	Qty	Per%	Color	Particulars	Qty	Per%
	Headstock Beam	2	100%		Centre Stiffner for Headstock	4	100%		Floor Stiffner for Headstock	4	100%
	Aux. Head stock	4	100%		Sole Bar	8	50%		Draft Gear Bracket	2	100%
	Trough floor	2	29%		Centre plate	2	100%		SoleBar Stiffner	6	100%
	Bottom Wall Part	8	50%		Body panel/patch		100%		Door Top/Roof Patch		0%
	Window Module		0%		Window Sill	40	100%		Window Bar	40	23%
	Seat pillar/lav. Partition		100%		UIC end construction		0%

End Drooping: Rotary End - EAST : -8, WEST : -2 Other End - EAST : 8, WEST : 6
Start Date : 30-Oct-2019, Completion Date : 08-Nov-2019, Net Repair Days : 9, Total Man Hours : 1003

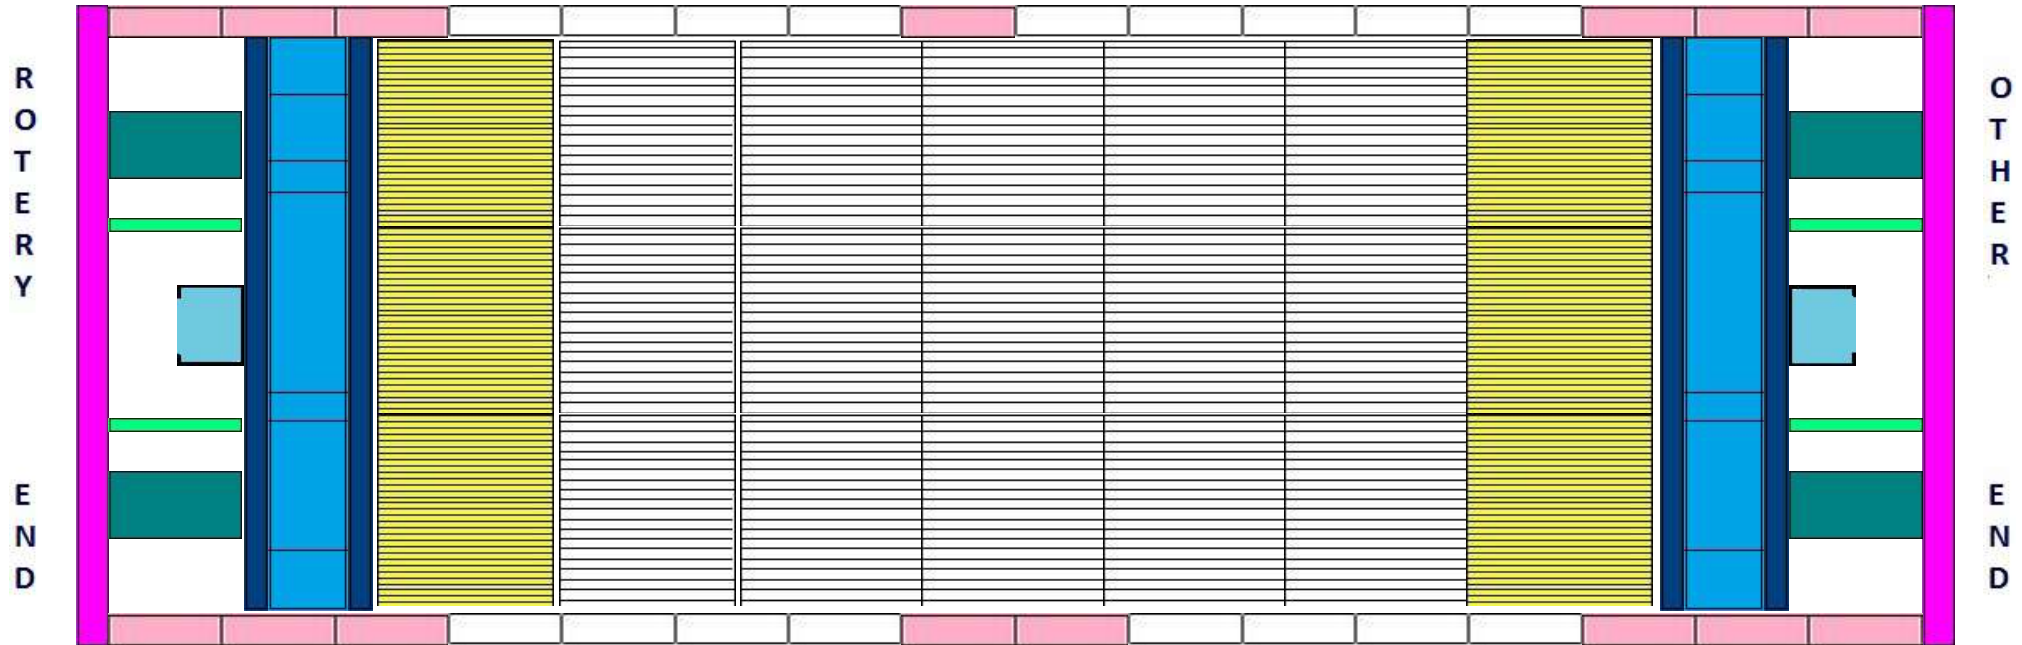
Color	Particulars	Qty	Per%	Color	Particulars	Qty	Per%	Color	Particulars	Qty	Per%
	Headstock Beam	2	100%		Centre Stiffner for Headstock	4	100%		Floor Stiffner for Headstock	4	100%
	Aux. Head stock	4	100%		Sole Bar	7.5	47%		Draft Gear Bracket	2	100%
	Trough floor	2	29%		Centre plate	2	100%		SoleBar Stiffner	6	100%
	Bottom Wall Part	7.5	47%		Body panel/patch		100%		Door Top/Roof Patch		0%
	Window Module		0%		Window Sill	40	100%		Window Bar	44	25%
	Seat pillar/lav. Partition		100%		UIC end construction		0%

End Drooping: Rotary End - EAST : -4, WEST : 2 Other End - EAST : -2, WEST : 6
Start Date : 25-Oct-2019, Completion Date : 04-Nov-2019, Net Repair Days : 9, Total Man Hours : 0

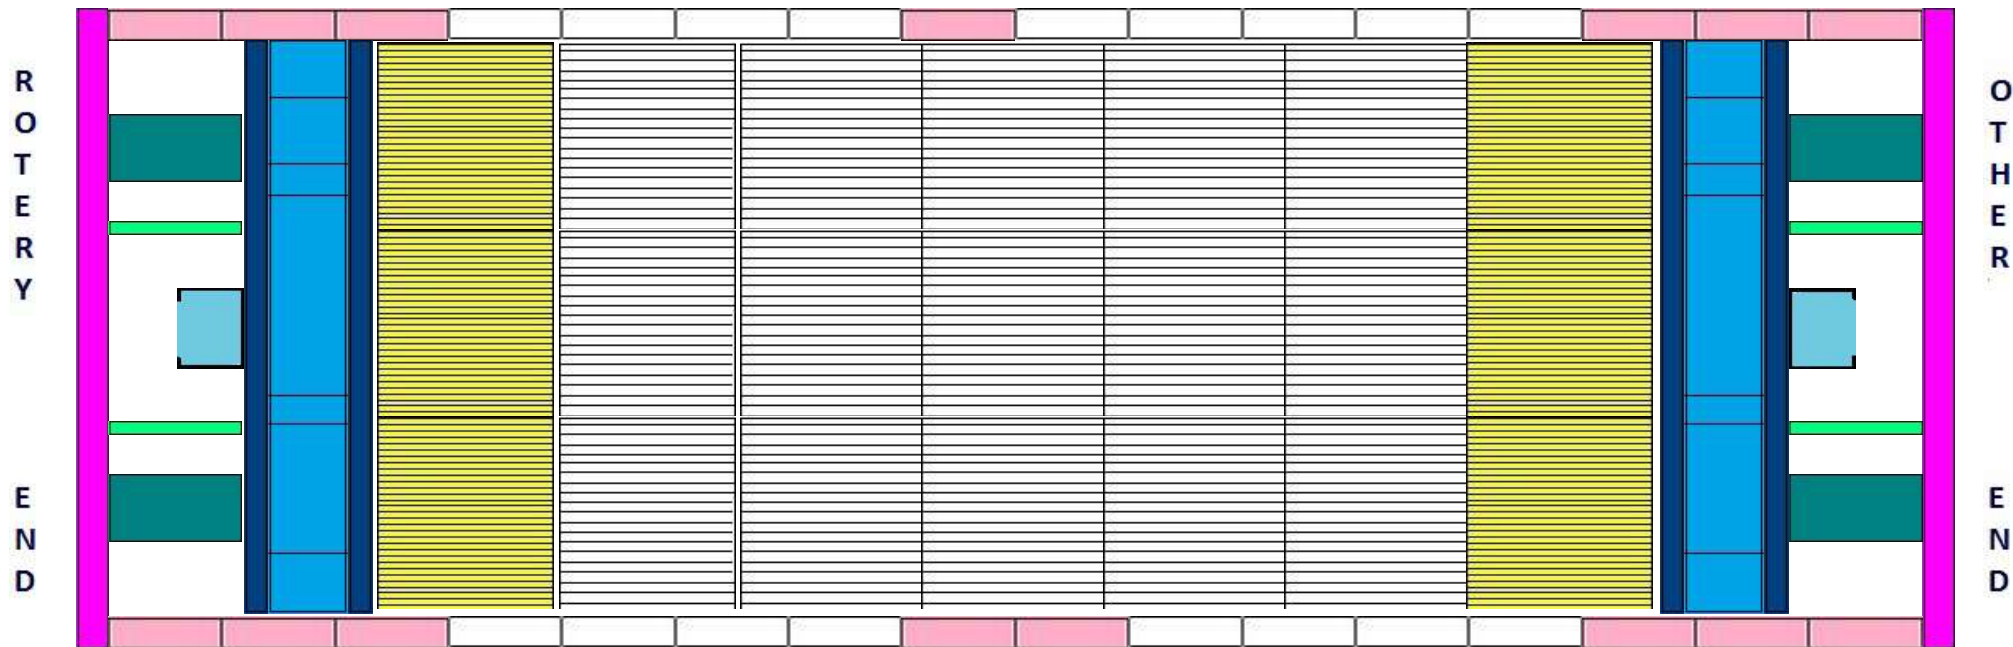
Color	Particulars	Qty	Per%	Color	Particulars	Qty	Per%	Color	Particulars	Qty	Per%
	Headstock Beam	2	100%		Centre Stiffner for Headstock	4	100%		Floor Stiffner for Headstock	4	100%
	Aux. Head stock	4	100%		Sole Bar	7.5	47%		Draft Gear Bracket	2	100%
	Trough floor	2	29%		Centre plate	2	100%		SoleBar Stiffner	6	100%
	Bottom Wall Part	7.5	47%		Body panel/patch		100%		Door Top/Roof Patch		0%
	Window Module		0%		Window Sill	40	100%		Window Bar	48	27%
	Seat pillar/lav. Partition		100%		UIC end construction		0%

End Drooping: Rotary End - EAST : -3, WEST : -7 Other End - EAST : -6, WEST : -4
Start Date : 26-Oct-2019, Completion Date : 06-Nov-2019, Net Repair Days : 10, Total Man Hours : 1064
