Coach Rehabilitation Workshop, WC Railway, Bhopal

(An IMS and ISO 50001 Certified Workshop)
Final Inspection Sheet - Details of Corrosion Repair

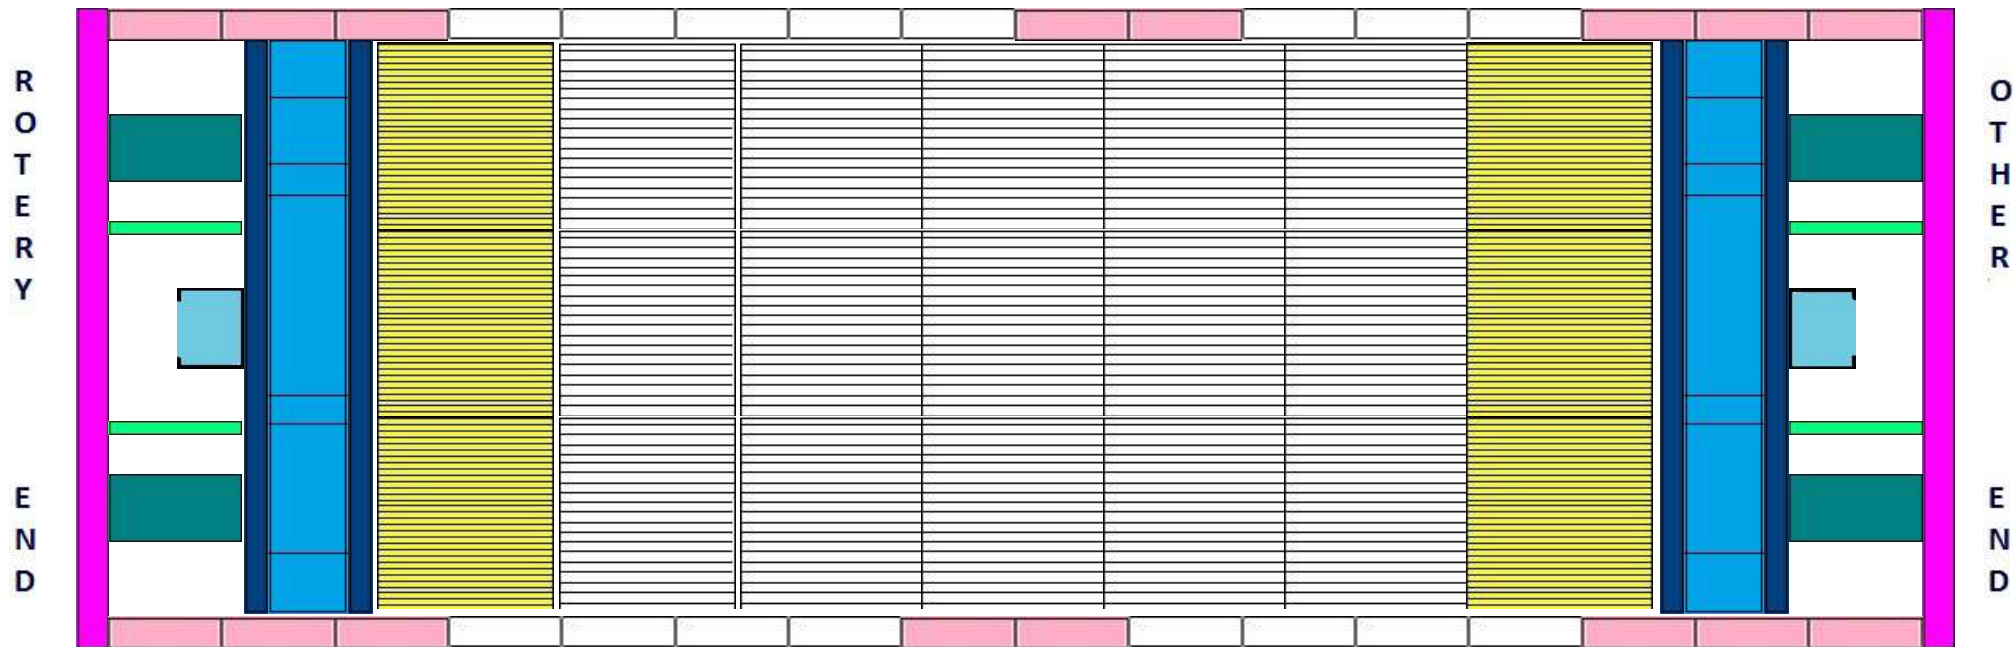
Color	Particulars	Qty	Per%	Color	Particulars	Qty	Per%	Color	Particulars	Qty	Per%
	Headstock Beam	2	100%		Centre Stiffner for Headstock	4	100%		Floor Stiffner for Headstock	4	100%
	Aux. Head stock	4	100%		Sole Bar	8	50%		Draft Gear Bracket	2	100%
	Trough floor	2	29%		Centre plate	2	100%		SoleBar Stiffner	6	100%
	Bottom Wall Part	8	50%		Body panel/patch		100%		Door Top/Roof Patch		0%
	Window Module		0%		Window Sill	40	100%		Window Bar	44	25%
	Seat pillar/lav. Partition		100%		UIC end construction		0%

End Drooping: Rotary End - EAST : 4, WEST : 2 Other End - EAST : 3, WEST : 0
Start Date : 30-Oct-2019, Completion Date : 06-Nov-2019, Net Repair Days : 7, Total Man Hours : 1296

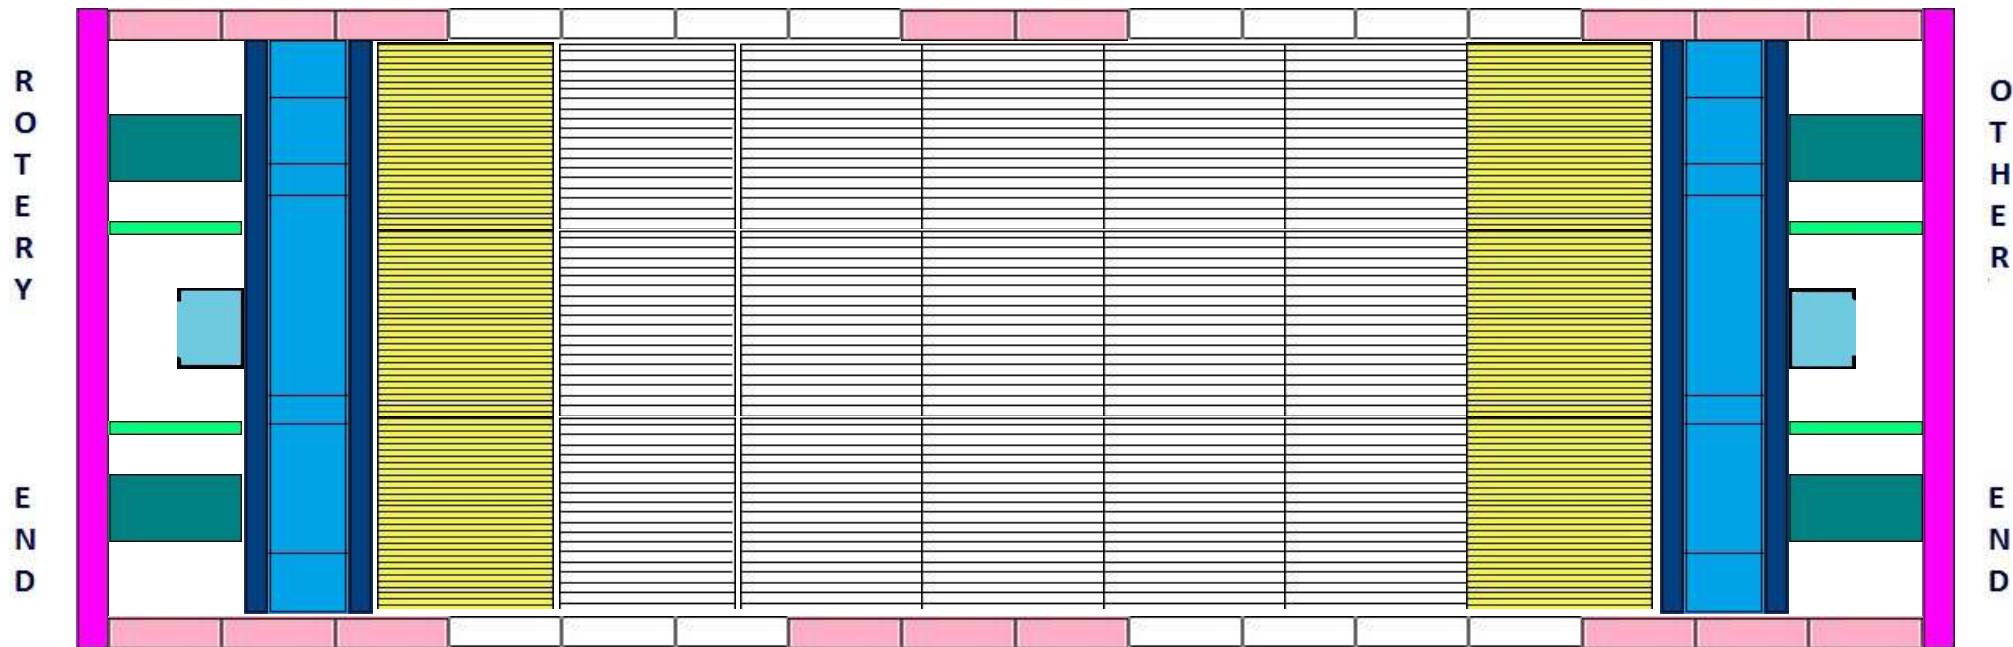
Color	Particulars	Qty	Per%	Color	Particulars	Qty	Per%	Color	Particulars	Qty	Per%
	Headstock Beam	2	100%		Centre Stiffner for Headstock	4	100%		Floor Stiffner for Headstock	4	100%
	Aux. Head stock	4	100%		Sole Bar	8.5	53%		Draft Gear Bracket	2	100%
	Trough floor	2	29%		Centre plate	2	100%		SoleBar Stiffner	6	100%
	Bottom Wall Part	8.5	53%		Body panel/patch		100%		Door Top/Roof Patch		0%
	Window Module		0%		Window Sill	28	70%		Window Bar	46	26%
	Seat pillar/lav. Partition		100%		UIC end construction		0%

End Drooping: Rotary End - EAST : -3, WEST : 0 Other End - EAST : -4, WEST : -3
Start Date : 26-Nov-2019, Completion Date : 05-Dec-2019, Net Repair Days : 9, Total Man Hours : 1536

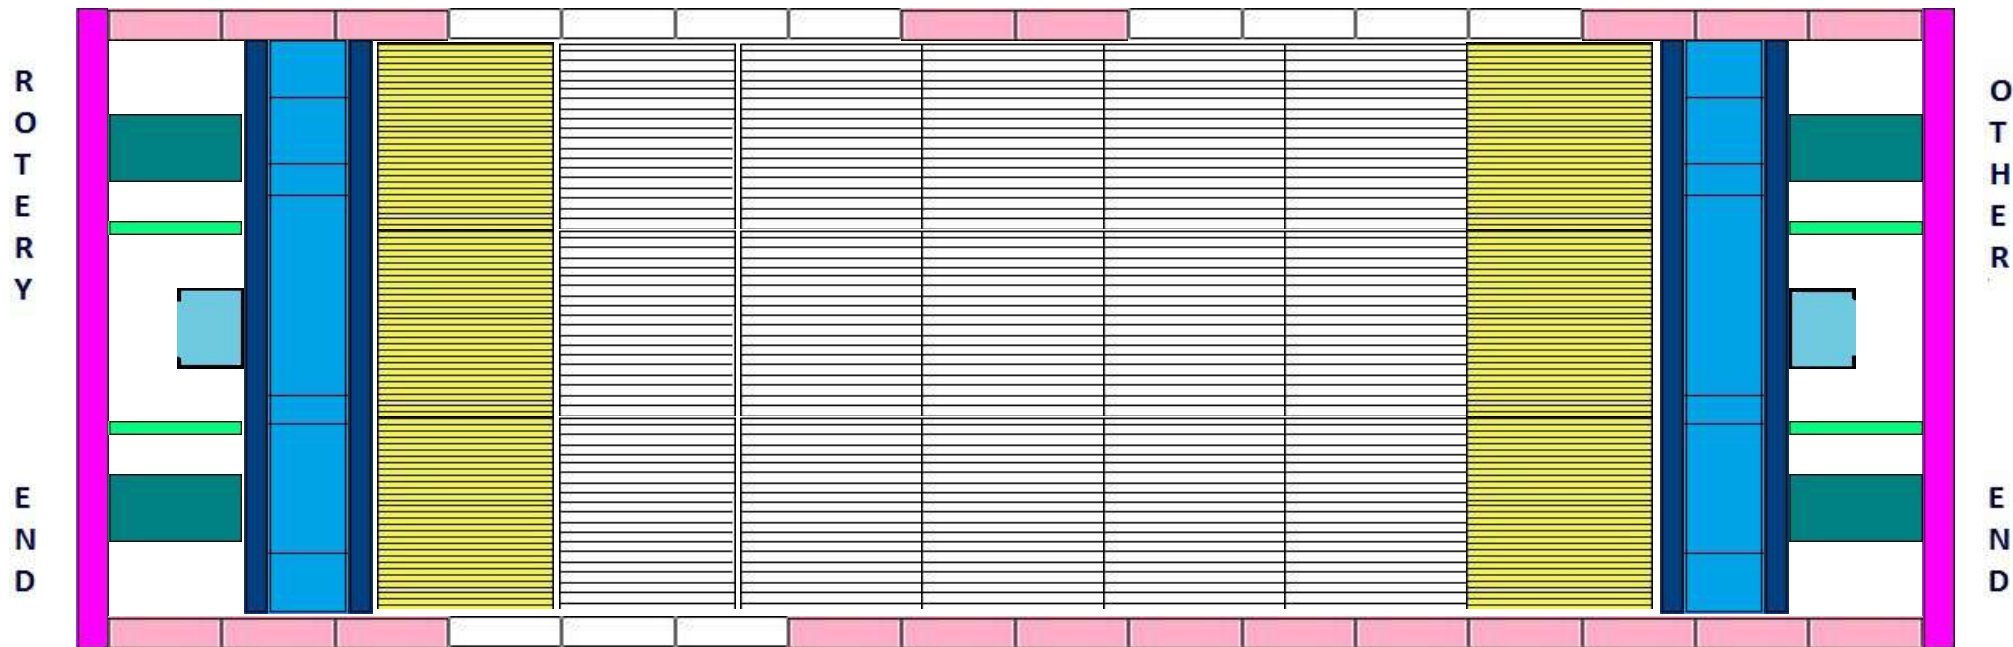
Color	Particulars	Qty	Per%	Color	Particulars	Qty	Per%	Color	Particulars	Qty	Per%
Yellow	Headstock Beam	2	100%	Dark Green	Centre Stiffner for Headstock	4	100%	Light Green	Floor Stiffner for Headstock	4	100%
Dark Blue	Aux. Head stock	4	100%	Pink	Sole Bar	10.5	66%	Light Blue	Draft Gear Bracket	2	100%
Yellow	Trough floor	2	29%	Light Blue	Centre plate	2	100%		SoleBar Stiffner	4	100%
	Bottom Wall Part	10.5	66%		Body panel/patch		100%		Door Top/Roof Patch		0%
	Window Module		0%		Window Sill	24	60%		Window Bar	46	25%
	Seat pillar/lav. Partition		100%		UIC end construction		0%

Start Date : 03-Dec-2019, Completion Date : 10-Dec-2019, Net Repair Days : 7, Total Man Hours : 1616

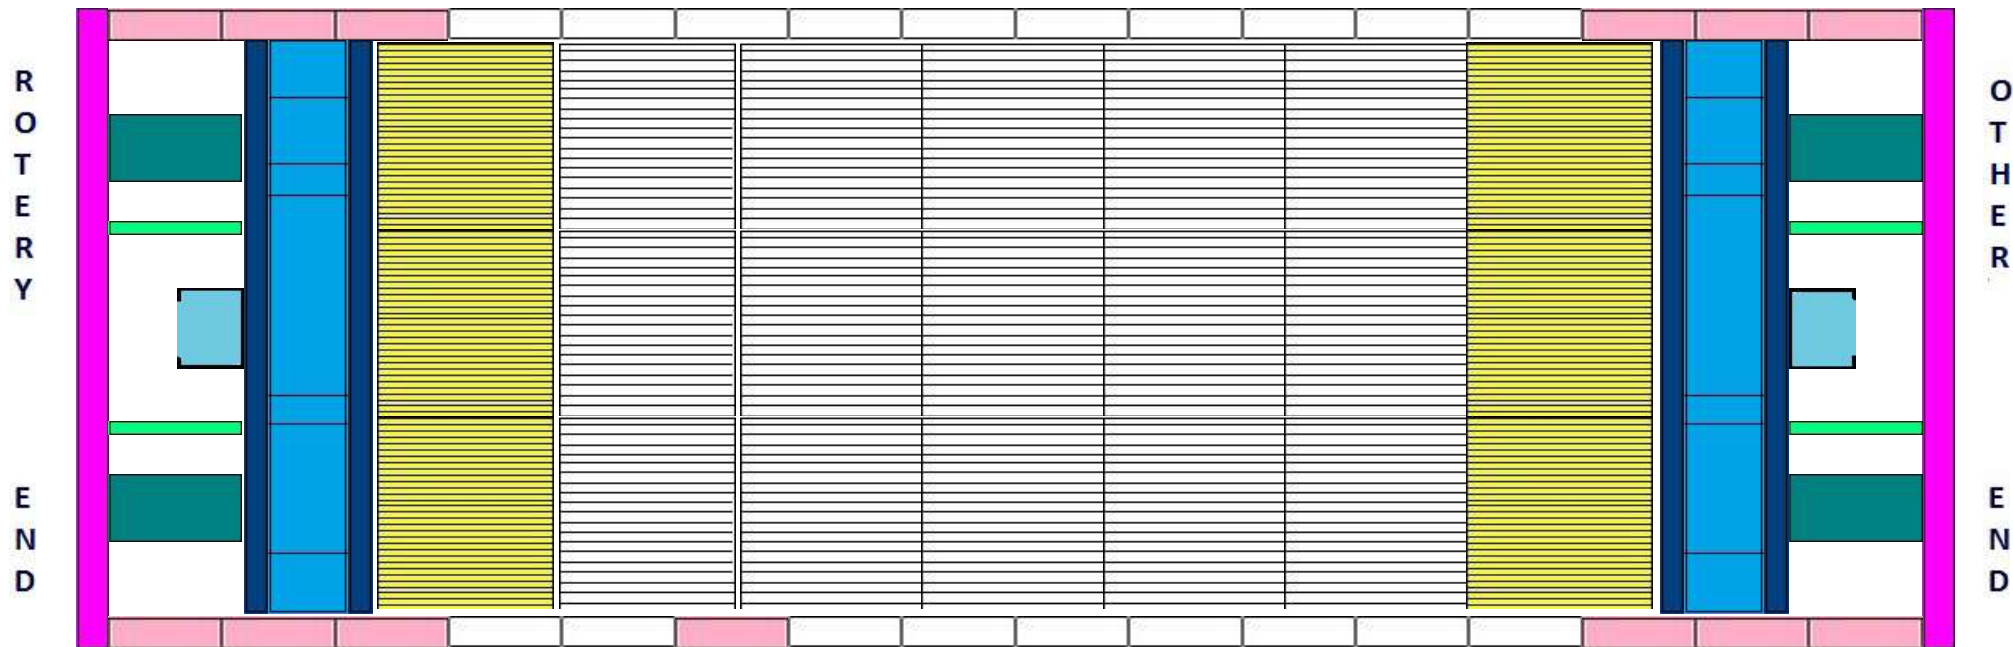
Color	Particulars	Qty	Per%	Color	Particulars	Qty	Per%	Color	Particulars	Qty	Per%
	Headstock Beam	2	100%		Centre Stiffner for Headstock	4	100%		Floor Stiffner for Headstock	4	100%
	Aux. Head stock	4	100%		Sole Bar	6.5	41%		Draft Gear Bracket	2	100%
	Trough floor	2	29%		Centre plate	2	100%		SoleBar Stiffner	4	100%
	Bottom Wall Part	6.5	41%		Body panel/patch		100%		Door Top/Roof Patch		0%
	Window Module		12%		Window Sill	0	0%		Window Bar	0	0%
	Seat pillar/lav. Partition		100%		UIC end construction		0%

End Drooping: Rotary End - EAST : 2, WEST : 0 Other End - EAST : 5, WEST : 3
Start Date : 20-Dec-2019, Completion Date : 01-Jan-2020, Net Repair Days : 11, Total Man Hours : 1076

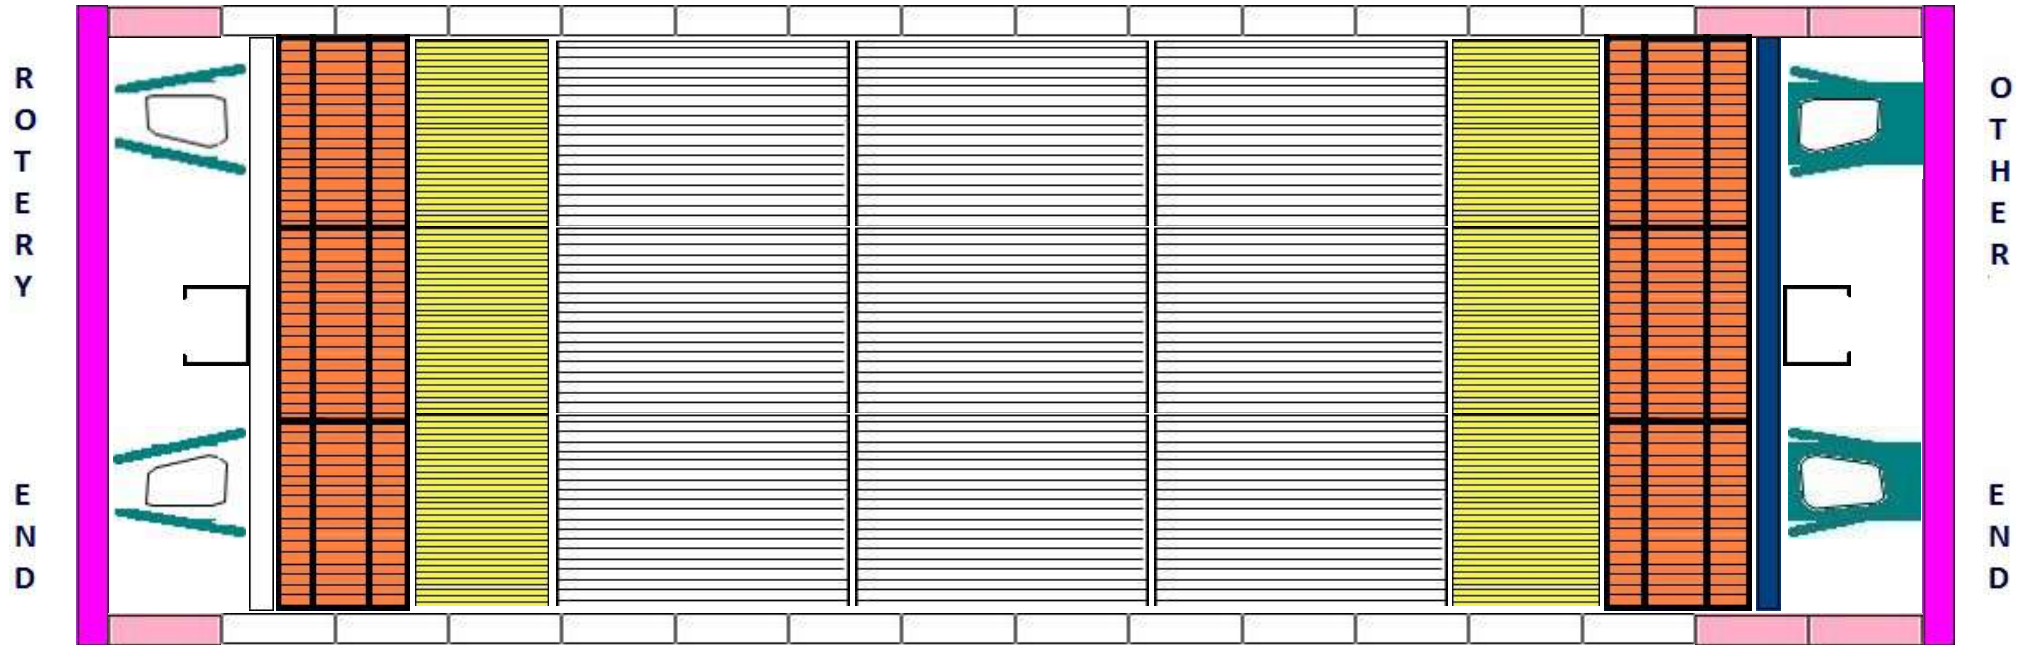
Color	Particulars	Qty	Per%	Color	Particulars	Qty	Per%	Color	Particulars	Qty	Per%
	Headstock Beam	1	50%		Diagonal	4	100%		Logitudinal Channel Structure	2	100%
	Aux. Head stock	1	50%		Sole Bar	3	19%		Draft Gear Bracket	1	50%
	Trough floor	2	40%		Bottom Wall Part	3	19%		Body panel/patch		100%
	Door Top/Roof Patch		0%		Seat Bracket Rail		0%		Window Sill	10	25%
	Window Bar	22	12%		Seat pillar/lav. Partition		100%		UIC end construction		0%
	Body Pillar Part	17	100%

End Drooping: Rotary End - EAST : -6, WEST : -2 Other End - EAST : -8, WEST : -6
Start Date : 29-Mar-2019, Completion Date : 06-Apr-2019, Net Repair Days : 8, Total Man Hours : 1096

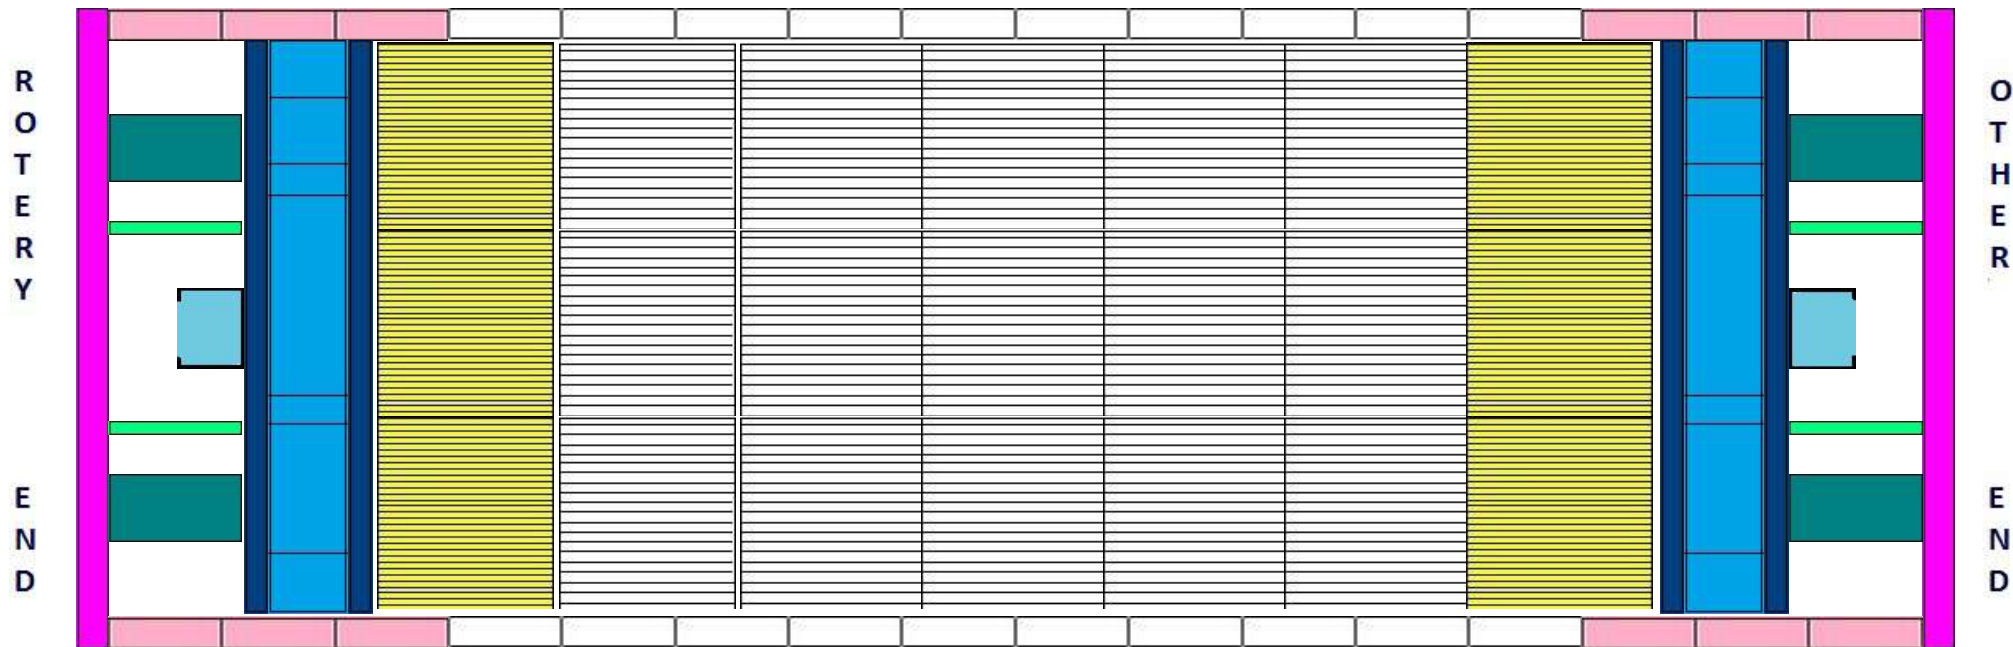
Color	Particulars	Qty	Per%	Color	Particulars	Qty	Per%	Color	Particulars	Qty	Per%
	Headstock Beam	2	100%		Centre Stiffner for Headstock	4	100%		Floor Stiffner for Headstock	4	100%
	Aux. Head stock	4	100%		Sole Bar	6	38%		Draft Gear Bracket	2	100%
	Trough floor	2	29%		Centre plate	2	100%		SoleBar Stiffner	4	100%
	Bottom Wall Part	6	38%		Body panel/patch		100%		Door Top/Roof Patch		0%
	Window Module		0%		Window Sill	40	100%		Window Bar	48	26%
	Seat pillar/lav. Partition		100%		UIC end construction		0%

End Drooping: Rotary End - EAST : -2, WEST : -2 Other End - EAST : -3, WEST : -6
Start Date : 01-Apr-2019, Completion Date : 08-Apr-2019, Net Repair Days : 7, Total Man Hours : 1551

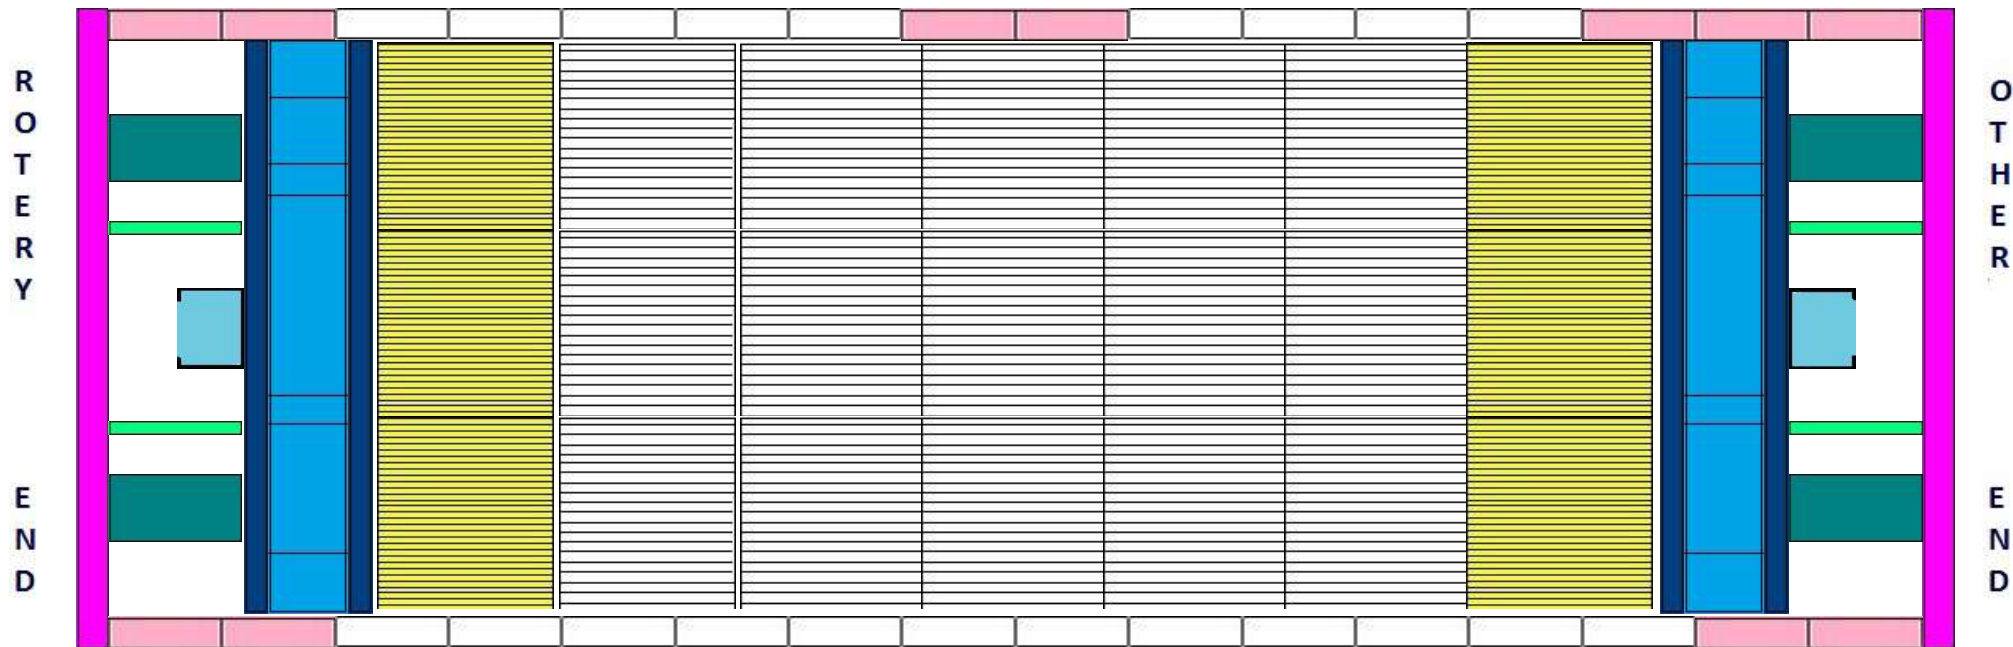
Color	Particulars	Qty	Per%	Color	Particulars	Qty	Per%	Color	Particulars	Qty	Per%
	Headstock Beam	2	100%		Centre Stiffner for Headstock	4	100%		Floor Stiffner for Headstock	4	100%
	Aux. Head stock	4	100%		Sole Bar	5.5	34%		Draft Gear Bracket	2	100%
	Trough floor	2	29%		Centre plate	2	100%		SoleBar Stiffner	4	100%
	Bottom Wall Part	5.5	34%		Body panel/patch		100%		Door Top/Roof Patch		0%
	Window Module		5%		Window Sill	0	0%		Window Bar	0	0%
	Seat pillar/lav. Partition		100%		UIC end construction		0%

End Drooping: Rotary End - EAST : -2, WEST : -3 Other End - EAST : -5, WEST : -3
Start Date : 06-Apr-2019, Completion Date : 18-Apr-2019, Net Repair Days : 11, Total Man Hours : 1048

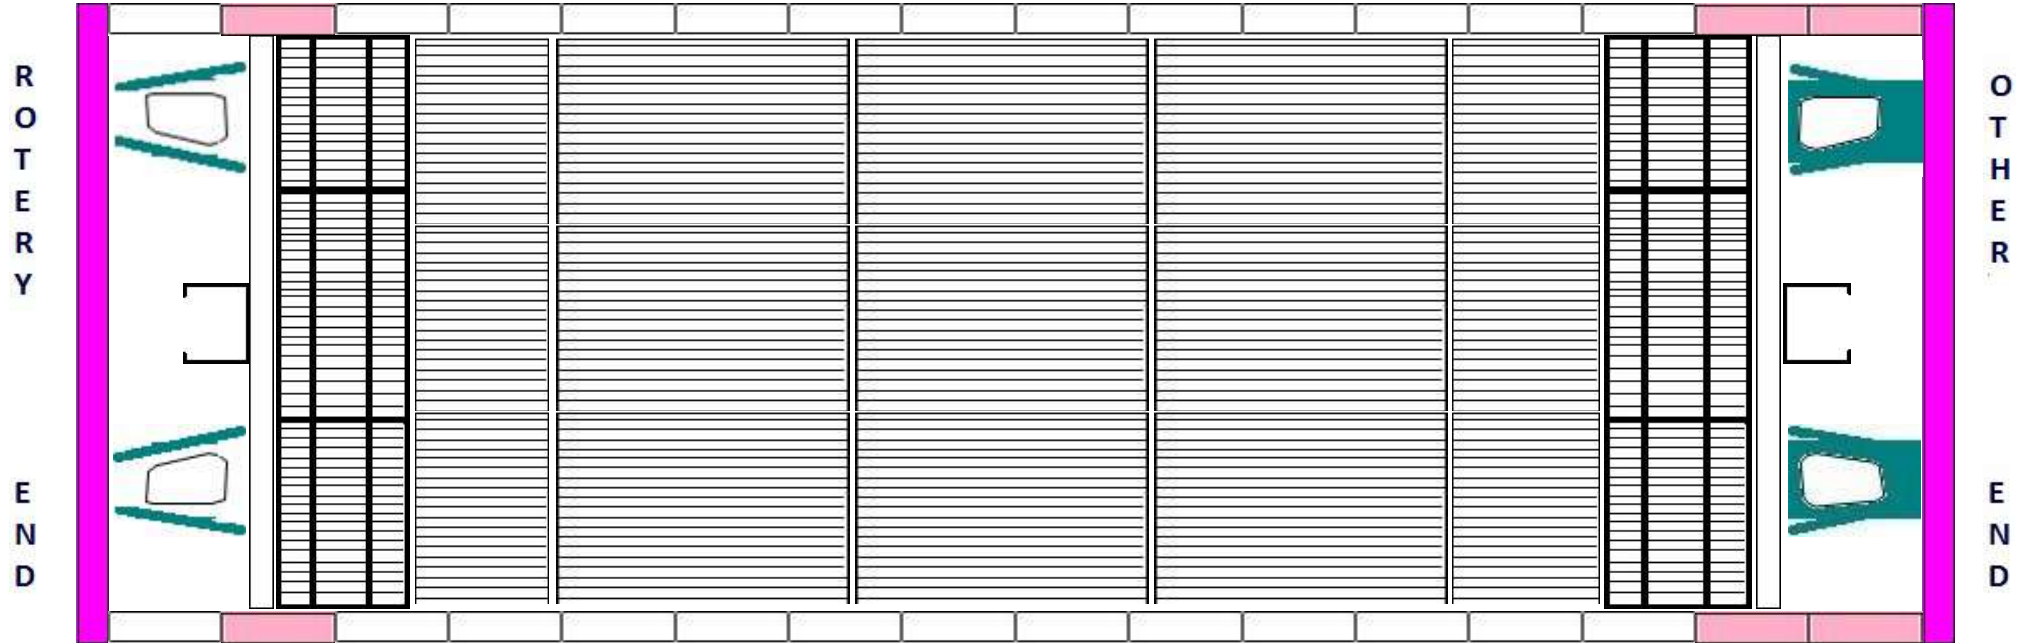
Rotary Side

Color	Particulars	Qty	Per%	Color	Particulars	Qty	Per%	Color	Particulars	Qty	Per%
	Headstock Beam	1	50%		Diagonal	4	100%		Logitudinal Channel Structure	0	0%
	Aux. Head stock	0	0%		Sole Bar	3	19%		Draft Gear Bracket	0	0%
	Trough floor	0	0%		Bottom Wall Part	3	19%		Body panel/patch		100%
	Door Top/Roof Patch		0%		Seat Bracket Rail		0%		Window Sill	0	0%
	Window Bar	6	3%		Seat pillar/lav. Partition		100%		UIC end construction		0%
	Body Pillar Part	17	100%

End Drooping: Rotary End - EAST : -6, WEST : -8 Other End - EAST : -8, WEST : -8
Start Date : 16-May-2019, Completion Date : 25-May-2019, Net Repair Days : 9, Total Man Hours : 880

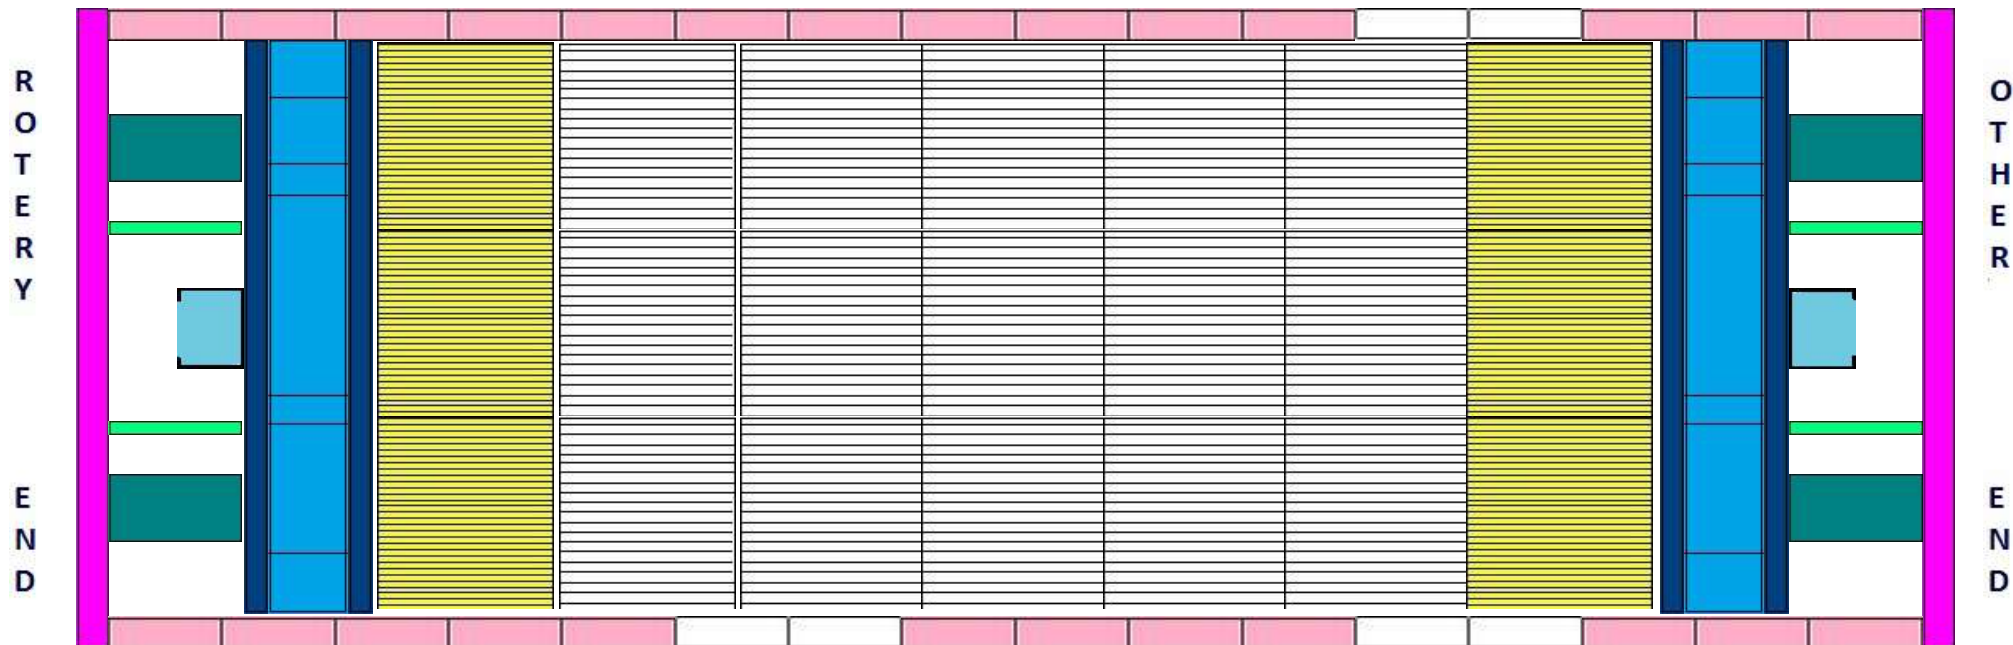
Color	Particulars	Qty	Per%	Color	Particulars	Qty	Per%	Color	Particulars	Qty	Per%
Yellow	Headstock Beam	2	100%	Dark Green	Centre Stiffner for Headstock	4	100%	Light Green	Floor Stiffner for Headstock	4	100%
Dark Blue	Aux. Head stock	4	100%	Pink	Sole Bar	13	81%	Light Blue	Draft Gear Bracket	2	100%
Yellow	Trough floor	2	29%	Blue	Centre plate	2	100%		SoleBar Stiffner	4	100%
	Bottom Wall Part	13	81%		Body panel/patch		100%		Door Top/Roof Patch		0%
	Window Module		0%		Window Sill	10	53%		Window Bar	14	17%
	Seat pillar/lav. Partition		100%		UIC end construction		0%

End Drooping: Rotary End - EAST : 0, WEST : -3 Other End - EAST : -5, WEST : 0
Start Date : 01-Jun-2019, Completion Date : 13-Jun-2019, Net Repair Days : 11, Total Man Hours : 1456

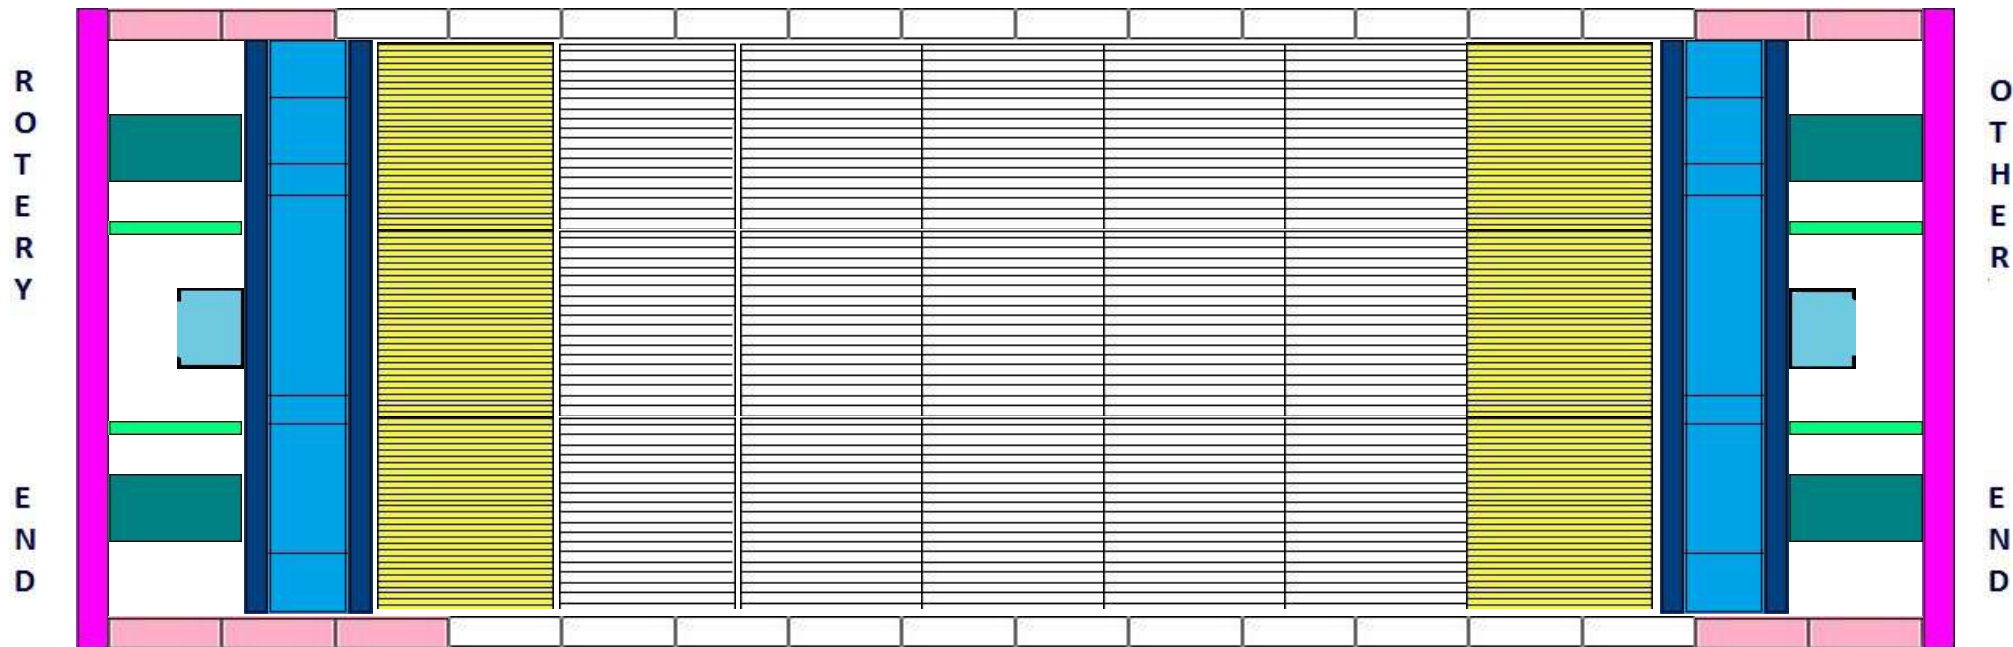
Color	Particulars	Qty	Per%	Color	Particulars	Qty	Per%	Color	Particulars	Qty	Per%
	Headstock Beam	2	100%		Centre Stiffner for Headstock	4	100%		Floor Stiffner for Headstock	4	100%
	Aux. Head stock	4	100%		Sole Bar	4.5	28%		Draft Gear Bracket	2	100%
	Trough floor	2	29%		Centre plate	2	100%		SoleBar Stiffner	4	100%
	Bottom Wall Part	4.5	28%		Body panel/patch		100%		Door Top/Roof Patch		0%
	Window Module		2%		Window Sill	0	0%		Window Bar	0	0%
	Seat pillar/lav. Partition		100%		UIC end construction		0%

End Drooping: Rotary End - EAST : 0, WEST : 6 Other End - EAST : 4, WEST : 6
Start Date : 07-Dec-2019, Completion Date : 17-Dec-2019, Net Repair Days : 9, Total Man Hours : 1440

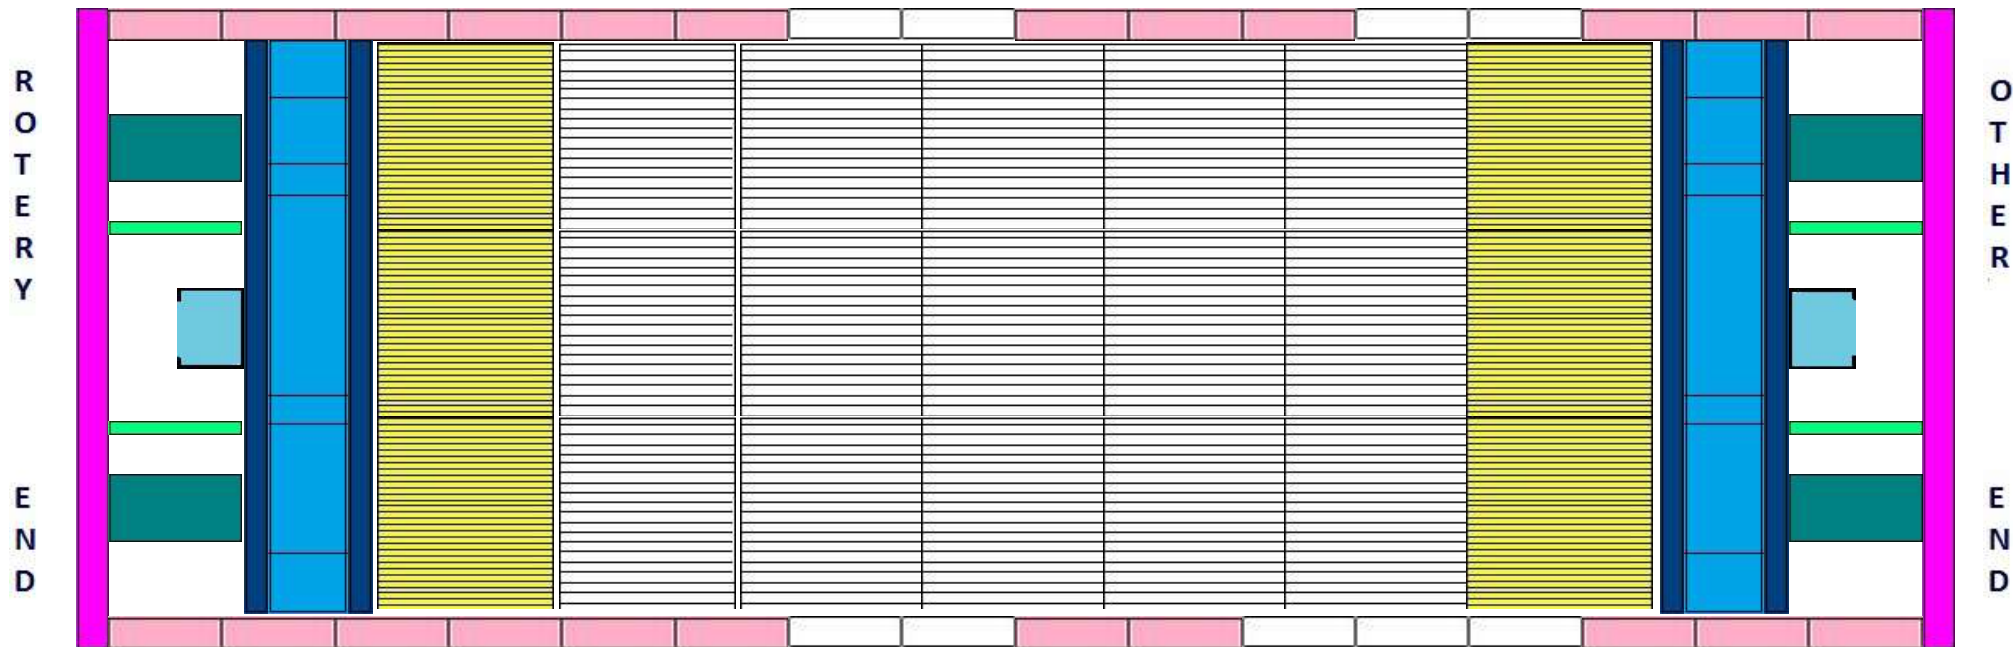
Color	Particulars	Qty	Per%	Color	Particulars	Qty	Per%	Color	Particulars	Qty	Per%
	Headstock Beam	2	100%		Centre Stiffner for Headstock	4	100%		Floor Stiffner for Headstock	4	100%
	Aux. Head stock	4	100%		Sole Bar	11.5	72%		Draft Gear Bracket	2	100%
	Trough floor	2	29%		Centre plate	2	100%		SoleBar Stiffner	4	100%
	Bottom Wall Part	11.5	72%		Body panel/patch		100%		Door Top/Roof Patch		0%
	Window Module		0%		Window Sill	12	63%		Window Bar	22	26%
	Seat pillar/lav. Partition		100%		UIC end construction		0%

Start Date : 12-Dec-2019, Completion Date : 20-Dec-2019, Net Repair Days : 8, Total Man Hours : 1840

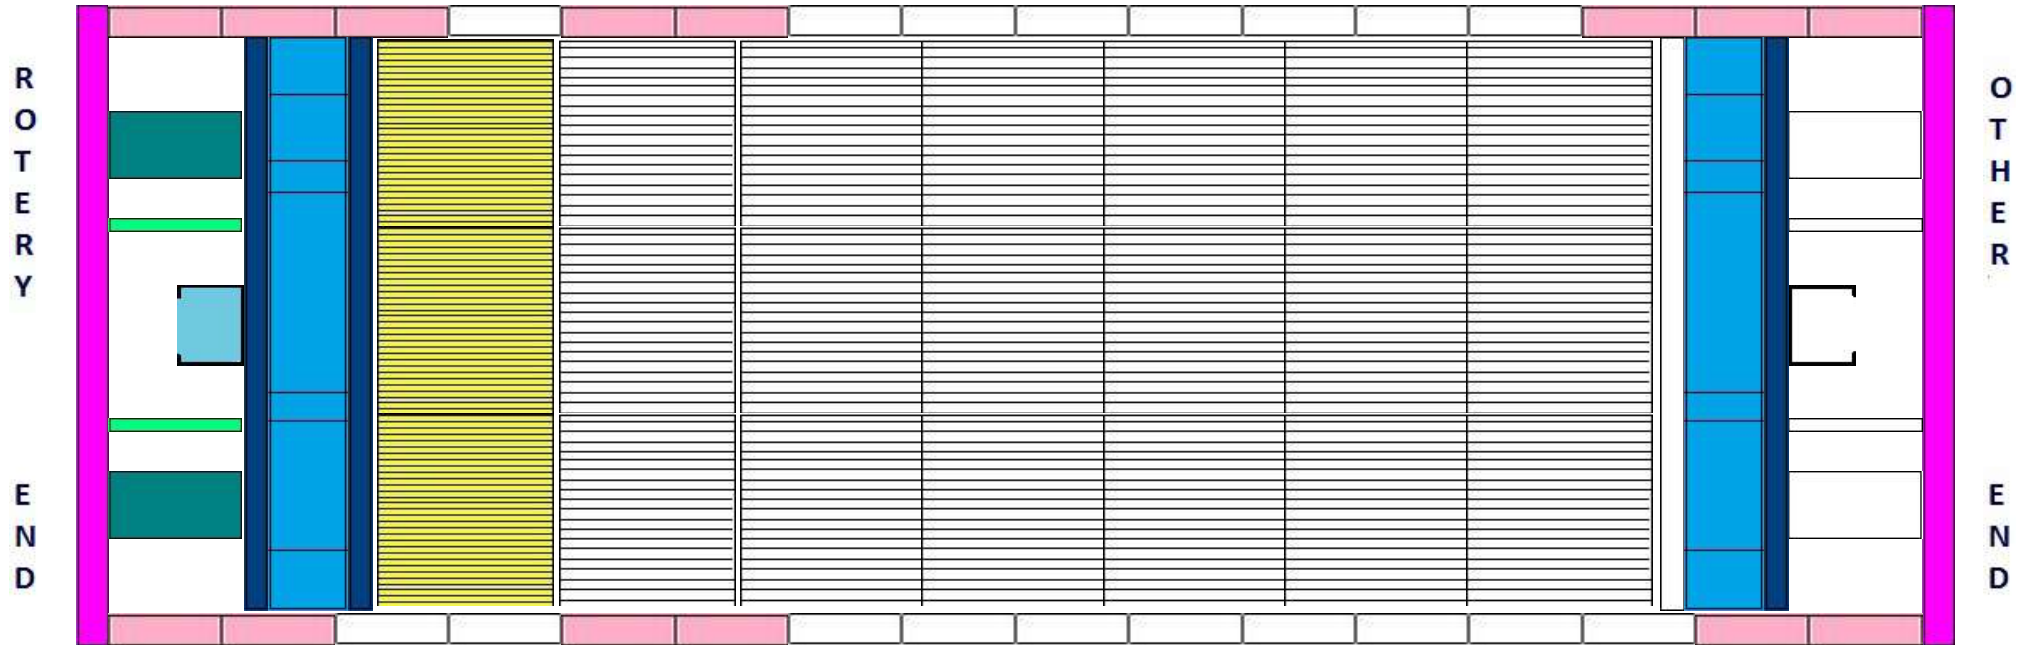
Color	Particulars	Qty	Per%	Color	Particulars	Qty	Per%	Color	Particulars	Qty	Per%
	Headstock Beam	2	100%		Centre Stiffner for Headstock	2	50%		Floor Stiffner for Headstock	2	50%
	Aux. Head stock	2	50%		Sole Bar	7	44%		Draft Gear Bracket	1	50%
	Trough floor	1	14%		Centre plate	1	50%		SoleBar Stiffner	4	100%
	Bottom Wall Part	7	44%		Body panel/patch		100%		Door Top/Roof Patch		0%
	Window Module		0%		Window Sill	28	78%		Window Bar	48	28%
	Seat pillar/lav. Partition		100%		UIC end construction		0%

End Drooping: Rotary End - EAST : -2, WEST : 0 Other End - EAST : 0, WEST : -2
Start Date : 20-Dec-2019, Completion Date : 01-Jan-2020, Net Repair Days : 11, Total Man Hours : 860

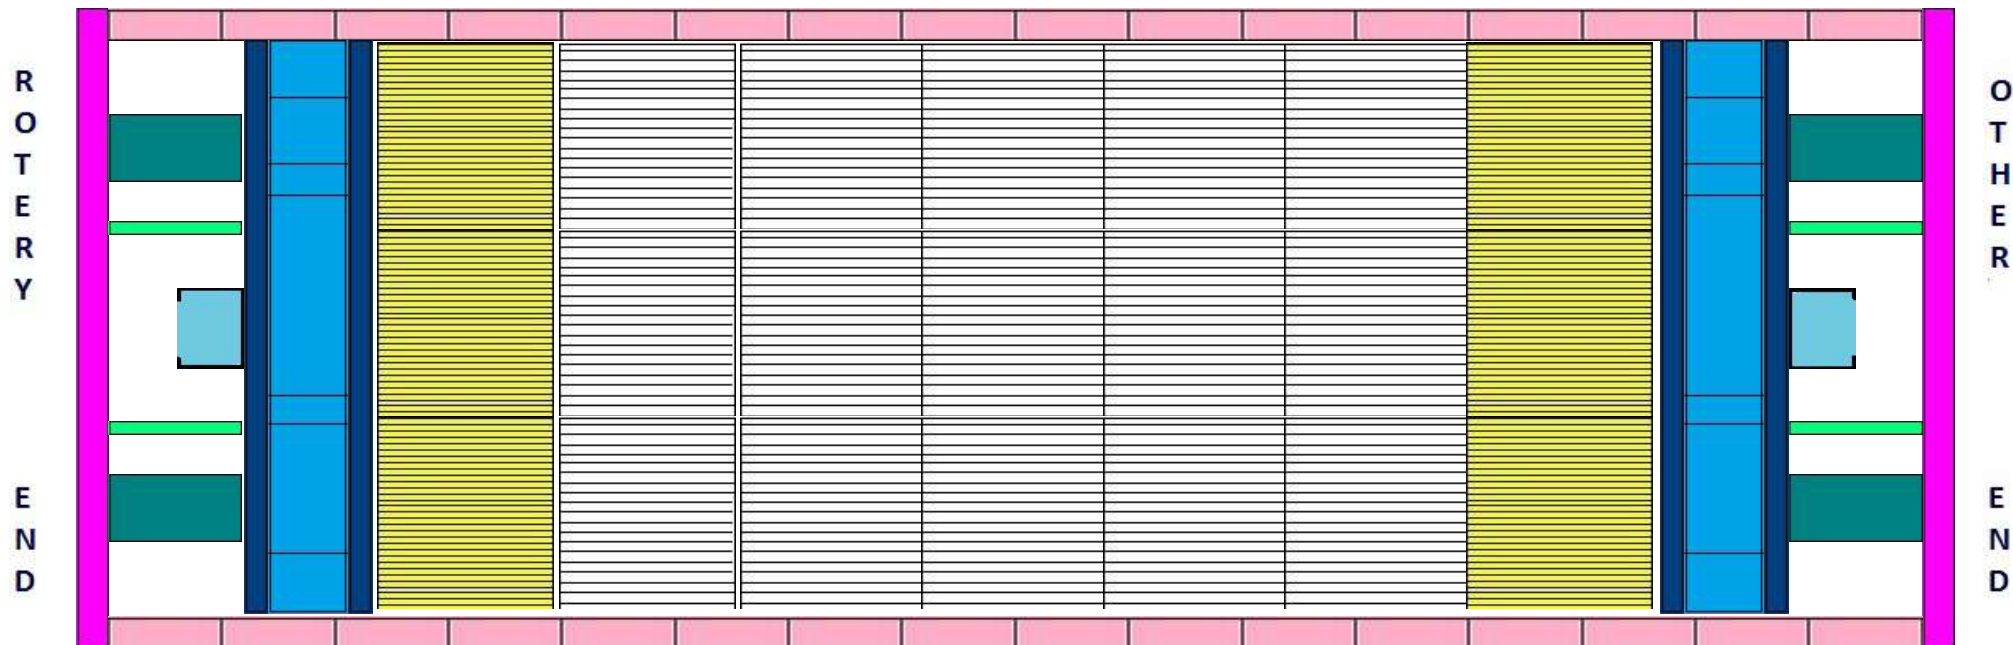
Rotary Side

Color	Particulars	Qty	Per%	Color	Particulars	Qty	Per%	Color	Particulars	Qty	Per%
Pink	Headstock Beam	2	100%	Dark Green	Centre Stiffner for Headstock	4	100%	Light Green	Floor Stiffner for Headstock	4	100%
Dark Blue	Aux. Head stock	4	100%	Pink	Sole Bar	16	100%	Blue	Draft Gear Bracket	2	100%
Yellow	Trough floor	2	29%	Light Blue	Centre plate	2	100%		SoleBar Stiffner	6	100%
	Bottom Wall Part	16	100%		Body panel/patch		100%		Door Top/Roof Patch		0%
	Window Module		0%		Window Sill	28	70%		Window Bar	48	27%
	Seat pillar/lav. Partition		100%		UIC end construction		0%

End Drooping: Rotary End - EAST : 5, WEST : 1 Other End - EAST : -2, WEST : -5
Start Date : 26-Dec-2019, Completion Date : 03-Jan-2020, Net Repair Days : 8, Total Man Hours : 1204

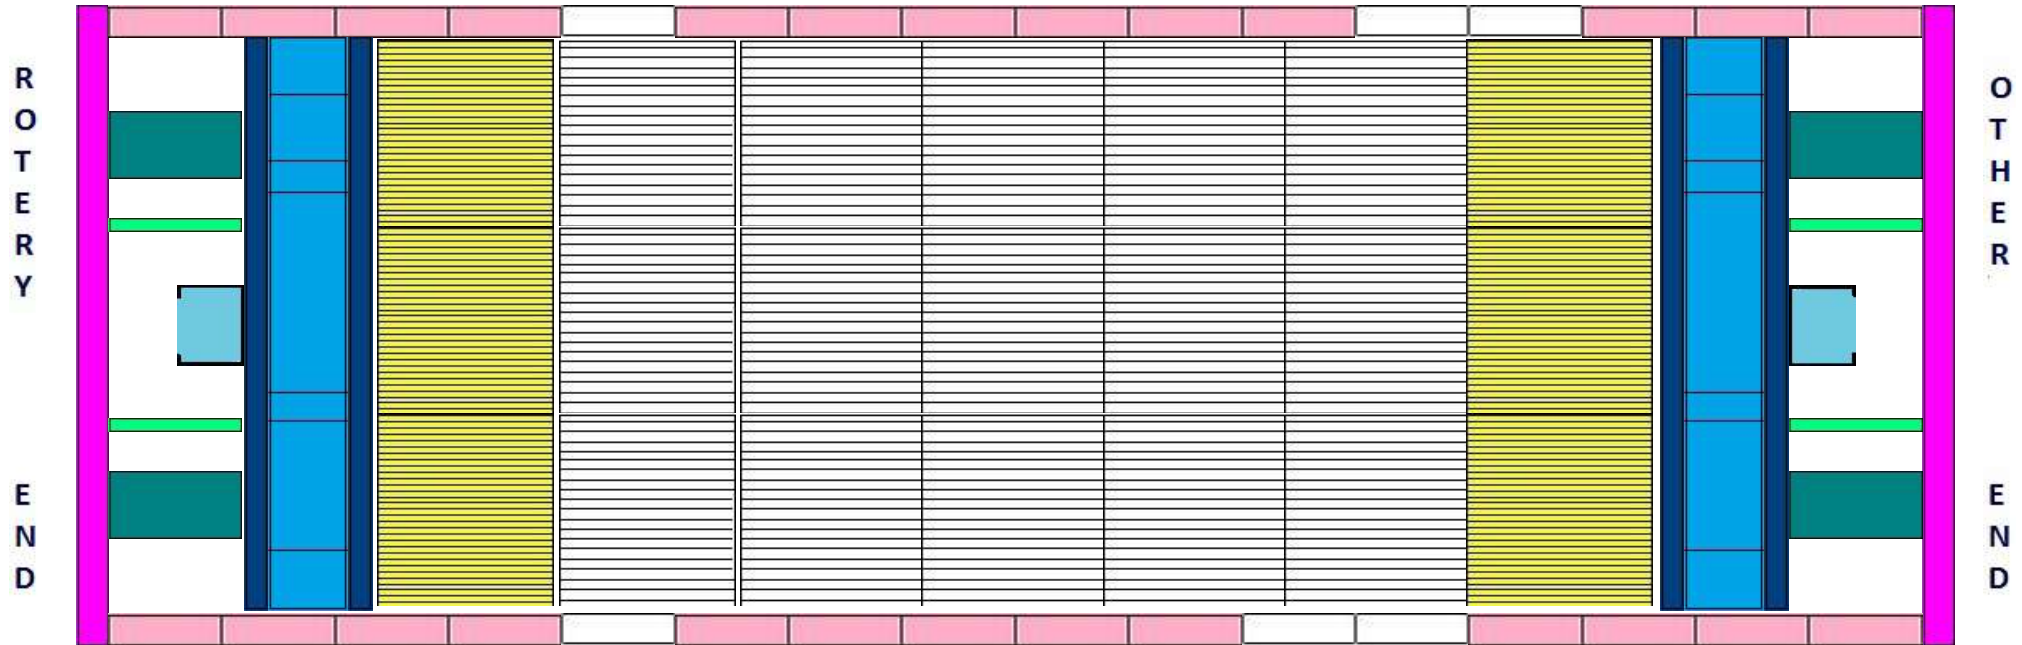
Rotary Side

Color	Particulars	Qty	Per%	Color	Particulars	Qty	Per%	Color	Particulars	Qty	Per%
	Headstock Beam	2	100%		Centre Stiffner for Headstock	4	100%		Floor Stiffner for Headstock	4	100%
	Aux. Head stock	4	100%		Sole Bar	13	81%		Draft Gear Bracket	2	100%
	Trough floor	2	29%		Centre plate	2	100%		SoleBar Stiffner	4	100%
	Bottom Wall Part	13	81%		Body panel/patch		100%		Door Top/Roof Patch		0%
	Window Module		0%		Window Sill	9	47%		Window Bar	16	19%
	Seat pillar/lav. Partition		100%		UIC end construction		0%

End Drooping: Rotary End - EAST : 4, WEST : 5 Other End - EAST : 5, WEST : 4
Start Date : 07-May-2019, Completion Date : 21-May-2019, Net Repair Days : 13, Total Man Hours : 1640

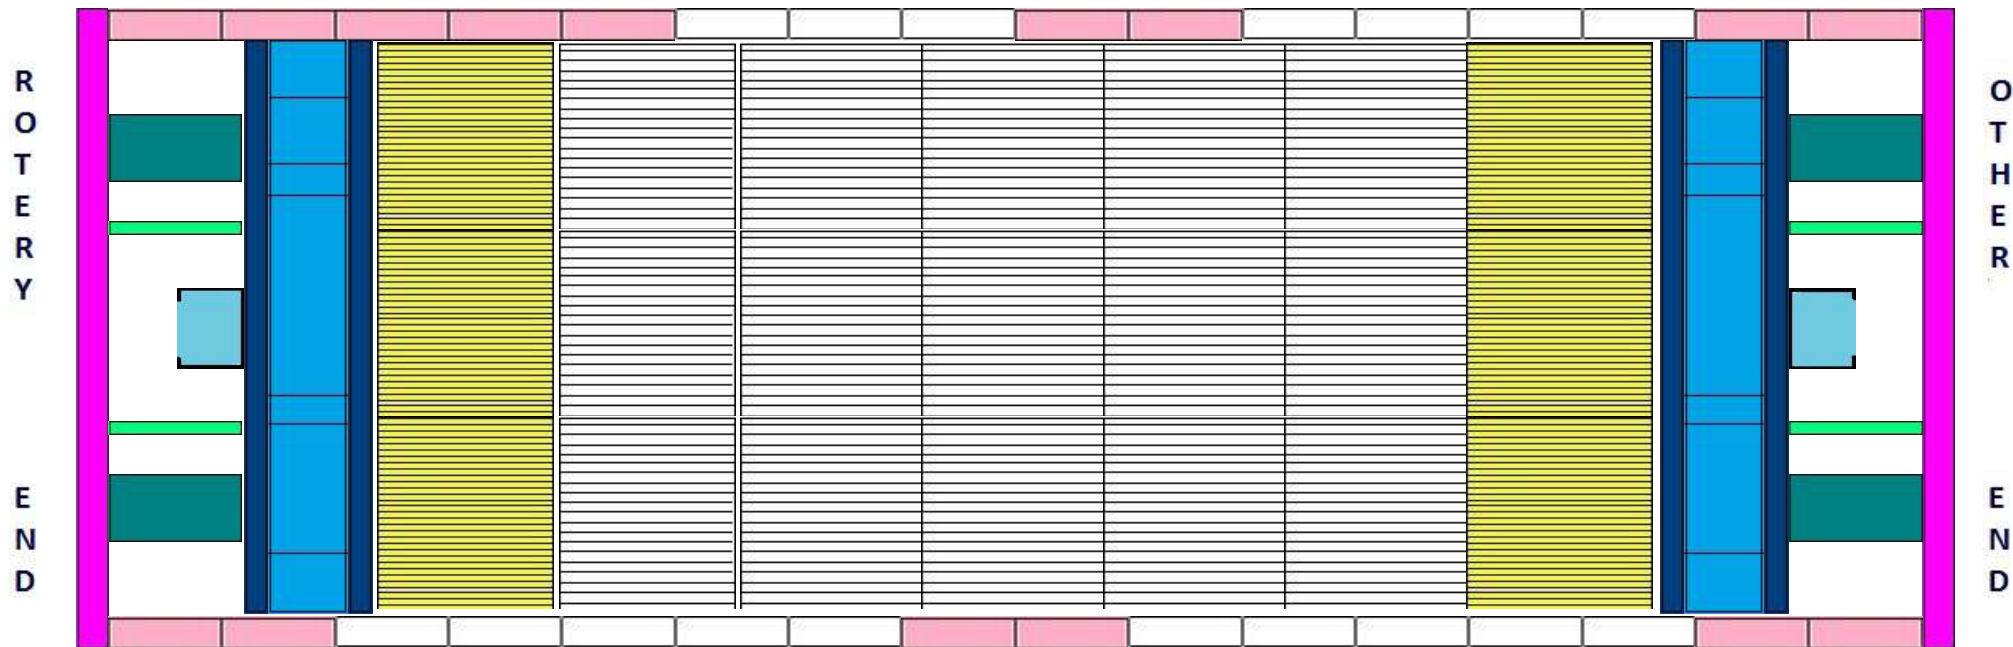
Color	Particulars	Qty	Per%	Color	Particulars	Qty	Per%	Color	Particulars	Qty	Per%
Yellow	Headstock Beam	2	100%	Dark Green	Centre Stiffner for Headstock	4	100%	Light Green	Floor Stiffner for Headstock	4	100%
Dark Blue	Aux. Head stock	4	100%	Pink	Sole Bar	7.5	47%	Light Blue	Draft Gear Bracket	2	100%
Yellow	Trough floor	2	29%	Light Blue	Centre plate	2	100%		SoleBar Stiffner	6	100%
	Bottom Wall Part	7.5	47%		Body panel/patch		100%		Door Top/Roof Patch		0%
	Window Module		0%		Window Sill	40	100%		Window Bar	48	28%
	Seat pillar/lav. Partition		100%		UIC end construction		0%

End Drooping: Rotary End - EAST : 5, WEST : 4 Other End - EAST : -3, WEST : -2
Start Date : 26-Apr-2019, Completion Date : 03-May-2019, Net Repair Days : 7, Total Man Hours : 0
