Coach Rehabilitation Workshop, WC Railway, Bhopal

(An IMS and ISO 50001 Certified Workshop)
Final Inspection Sheet - Details of Corrosion Repair

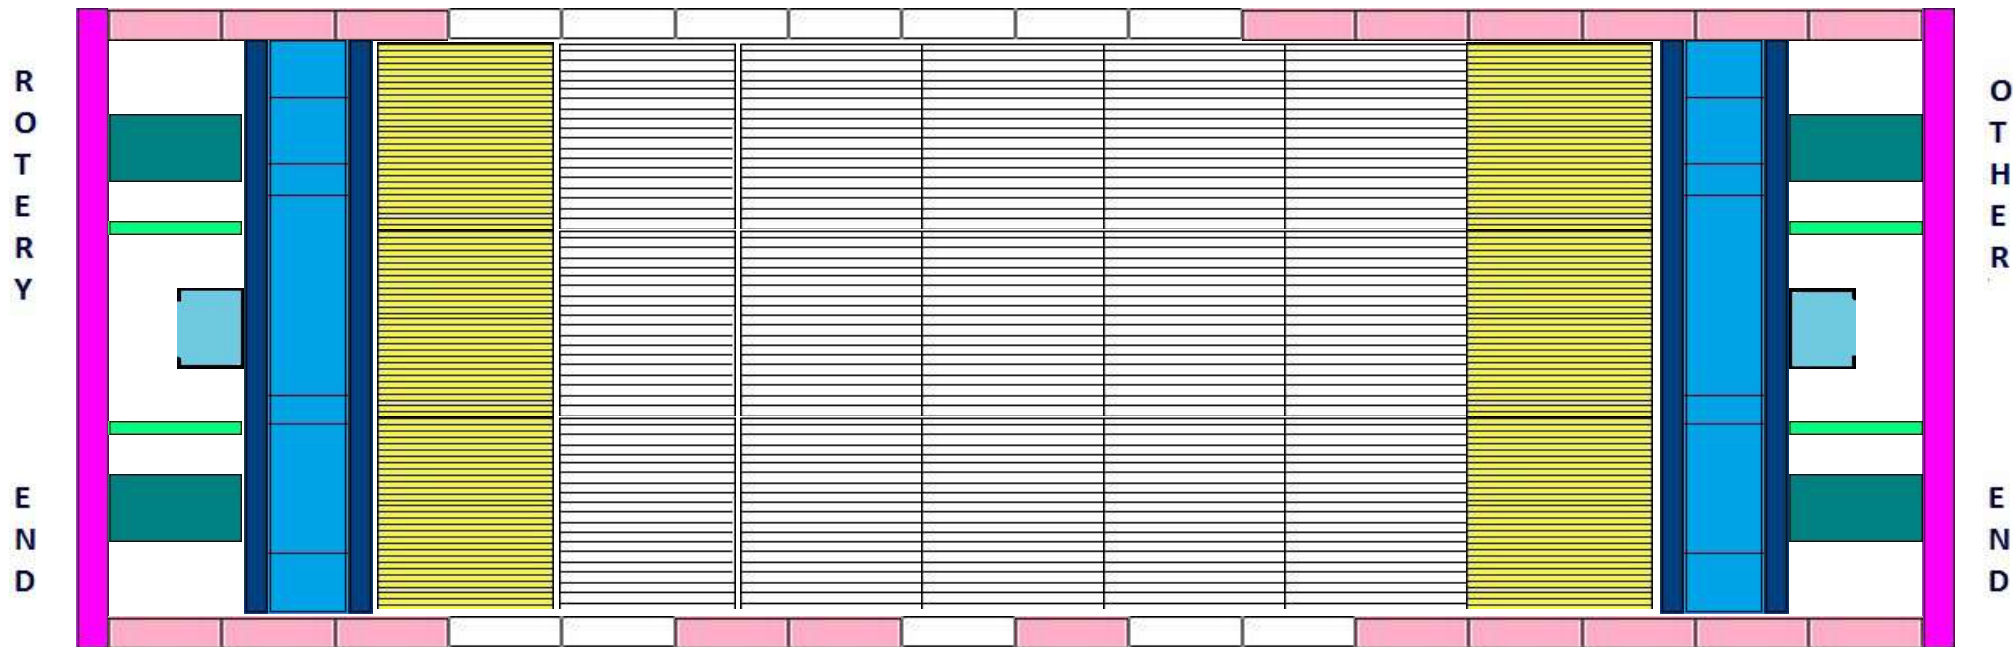
Color	Particulars	Qty	Per%	Color	Particulars	Qty	Per%	Color	Particulars	Qty	Per%
Yellow	Headstock Beam	2	100%	Dark Green	Centre Stiffner for Headstock	4	100%	Light Green	Floor Stiffner for Headstock	4	100%
Dark Blue	Aux. Head stock	4	100%	Pink	Sole Bar	10	63%	Light Blue	Draft Gear Bracket	2	100%
Yellow	Trough floor	2	29%	Light Blue	Centre plate	2	100%		SoleBar Stiffner	4	100%
	Bottom Wall Part	10	63%		Body panel/patch		100%		Door Top/Roof Patch		0%
	Window Module		0%		Window Sill	20	50%		Window Bar	44	24%
	Seat pillar/lav. Partition		100%		UIC end construction		0%

End Drooping: Rotary End - EAST : 2, WEST : 0 Other End - EAST : -10, WEST : -8
Start Date : 01-Apr-2019, Completion Date : 09-Apr-2019, Net Repair Days : 11, Total Man Hours : 1268

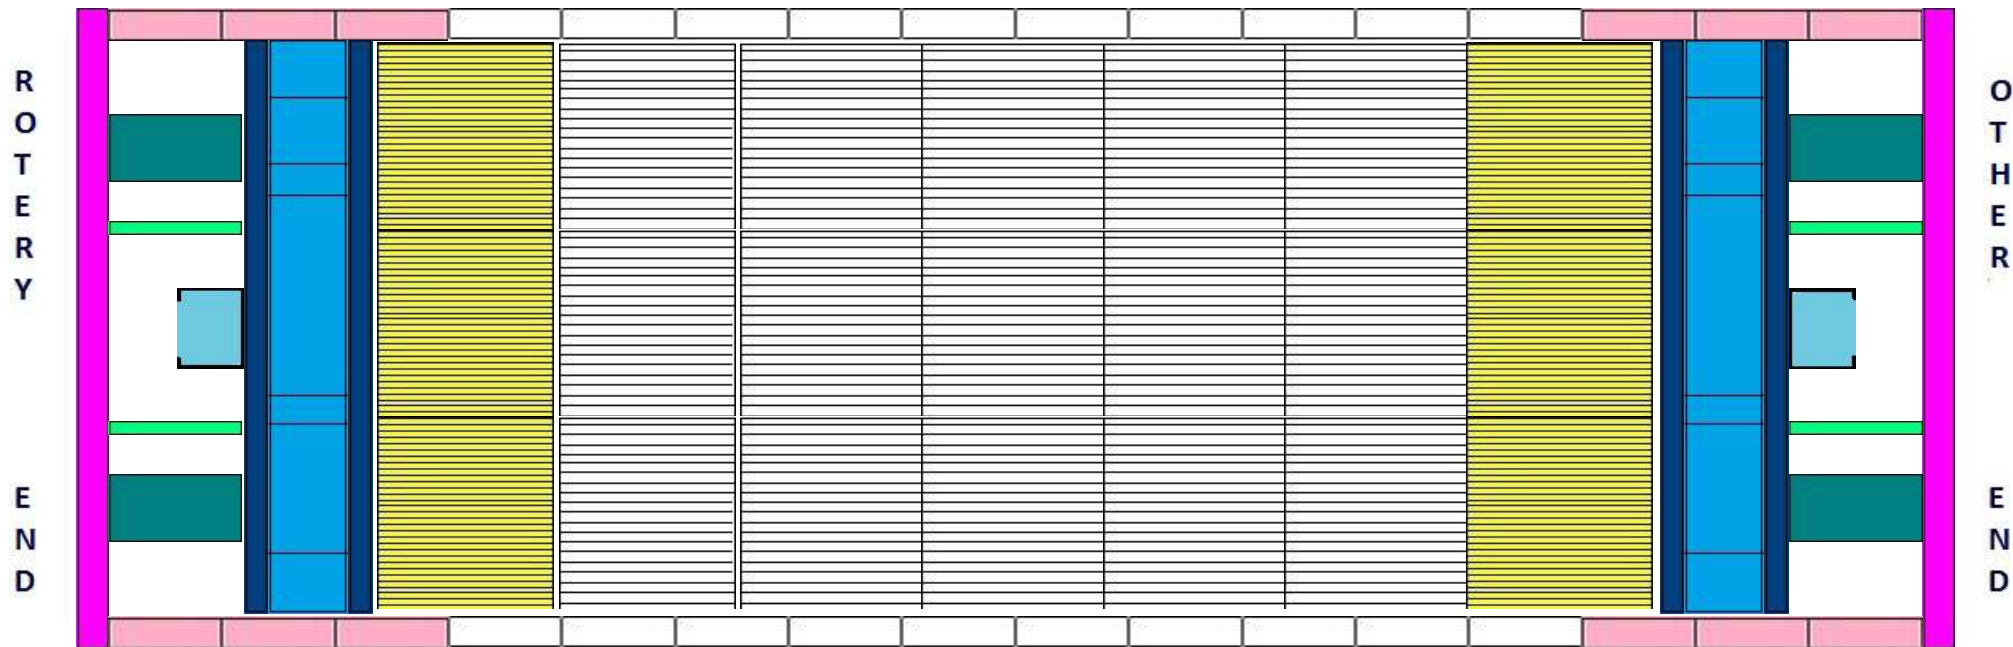
Color	Particulars	Qty	Per%	Color	Particulars	Qty	Per%	Color	Particulars	Qty	Per%
Yellow	Headstock Beam	2	100%	Dark Green	Centre Stiffner for Headstock	4	100%	Light Green	Floor Stiffner for Headstock	4	100%
Dark Blue	Aux. Head stock	4	100%	Pink	Sole Bar	6	38%	Light Blue	Draft Gear Bracket	2	100%
Yellow	Trough floor	2	29%	Light Blue	Centre plate	2	100%		SoleBar Stiffner	4	100%
	Bottom Wall Part	6	38%		Body panel/patch		100%		Door Top/Roof Patch		0%
	Window Module		7%		Window Sill	0	0%		Window Bar	0	0%
	Seat pillar/lav. Partition		100%		UIC end construction		0%

End Drooping: Rotary End - EAST : -10, WEST : -8 Other End - EAST : -7, WEST : -9
Start Date : 30-Mar-2019, Completion Date : 06-Apr-2019, Net Repair Days : 7, Total Man Hours : 1524

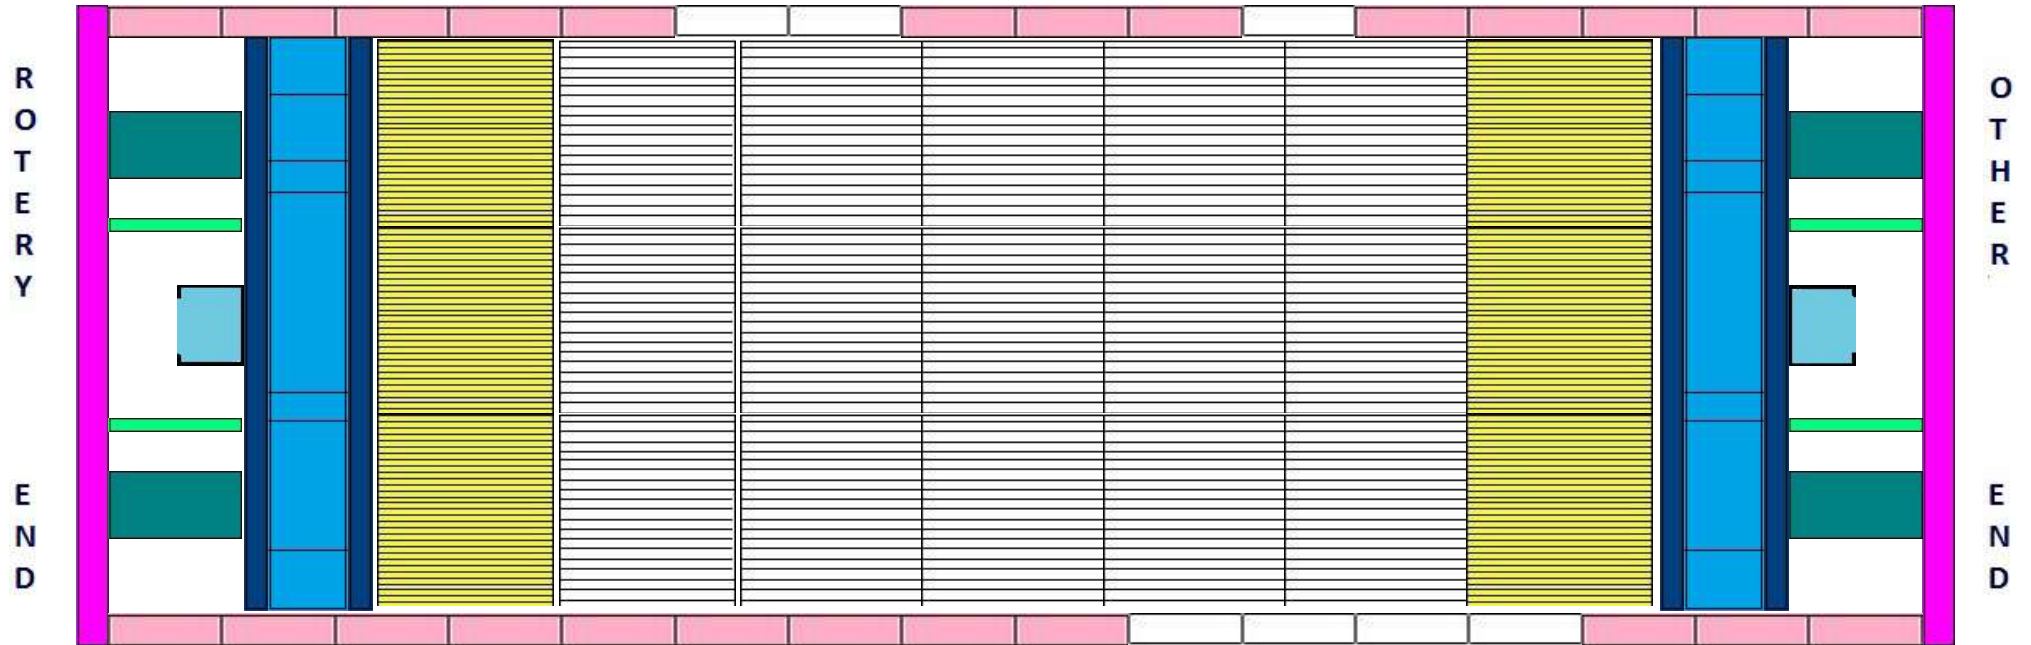
Color	Particulars	Qty	Per%	Color	Particulars	Qty	Per%	Color	Particulars	Qty	Per%
Yellow	Headstock Beam	2	100%	Dark Green	Centre Stiffner for Headstock	4	100%	Light Green	Floor Stiffner for Headstock	4	100%
Dark Blue	Aux. Head stock	4	100%	Pink	Sole Bar	12.5	78%	Light Blue	Draft Gear Bracket	2	100%
Yellow	Trough floor	2	29%	Light Blue	Centre plate	2	100%		SoleBar Stiffner	6	100%
	Bottom Wall Part	12.5	78%		Body panel/patch		100%		Door Top/Roof Patch		0%
	Window Module		0%		Window Sill	40	100%		Window Bar	44	25%
	Seat pillar/lav. Partition		100%		UIC end construction		0%

End Drooping: Rotary End - EAST : 0, WEST : -2 Other End - EAST : -4, WEST : -5
Start Date : 08-May-2019, Completion Date : 21-May-2019, Net Repair Days : 12, Total Man Hours : 0

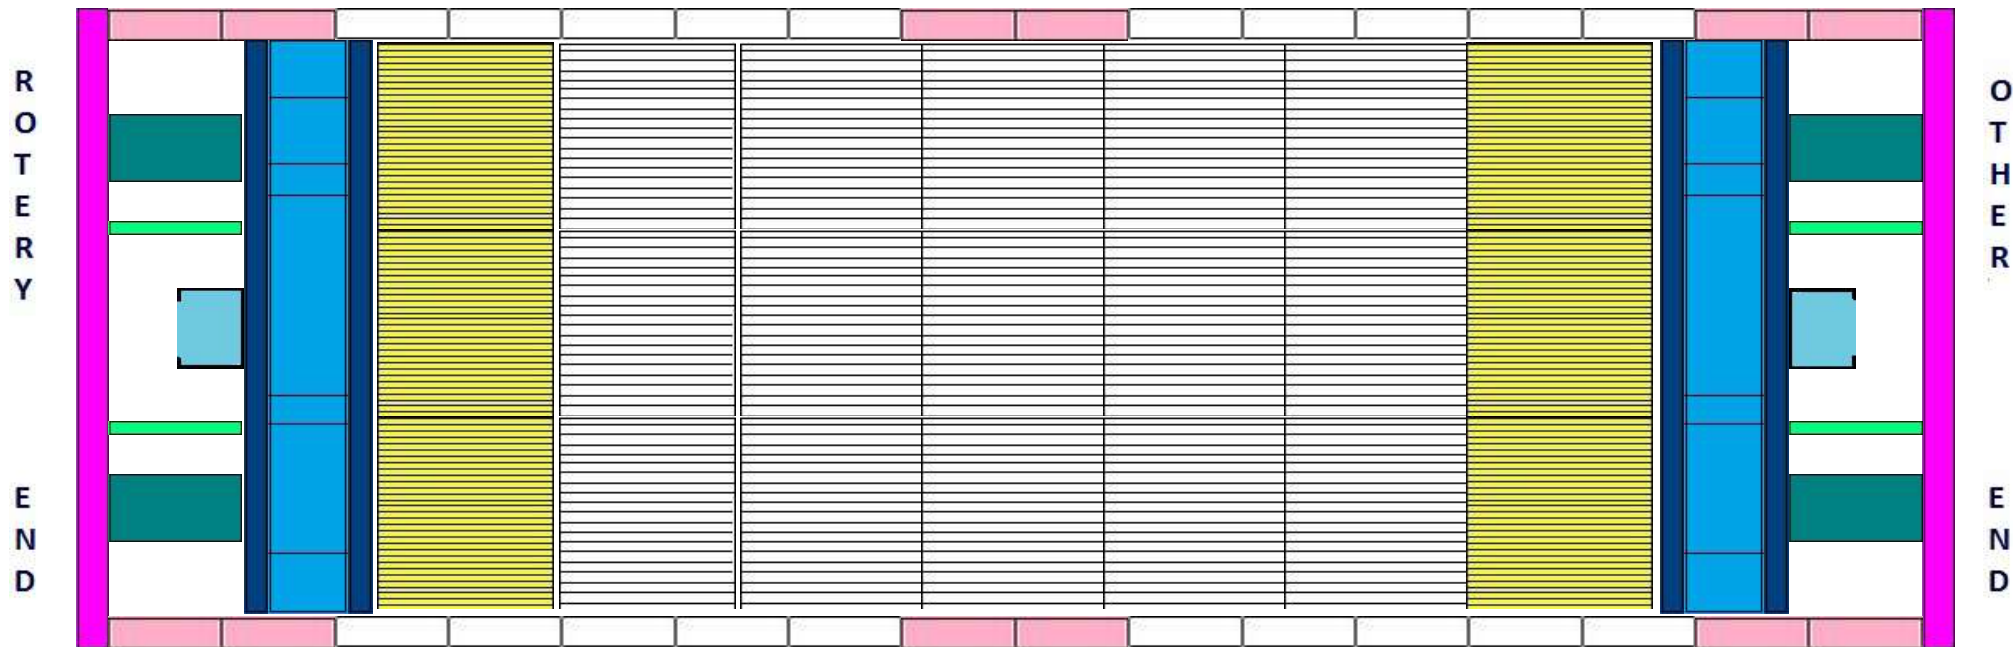
Rotary Side

Color	Particulars	Qty	Per%	Color	Particulars	Qty	Per%	Color	Particulars	Qty	Per%
	Headstock Beam	2	100%		Centre Stiffner for Headstock	4	100%		Floor Stiffner for Headstock	4	100%
	Aux. Head stock	4	100%		Sole Bar	6	38%		Draft Gear Bracket	2	100%
	Trough floor	2	29%		Centre plate	2	100%		SoleBar Stiffner	6	100%
	Bottom Wall Part	6	38%		Body panel/patch		100%		Door Top/Roof Patch		100%
	Window Module		0%		Window Sill	26	65%		Window Bar	46	26%
	Seat pillar/lav. Partition		100%		UIC end construction		0%

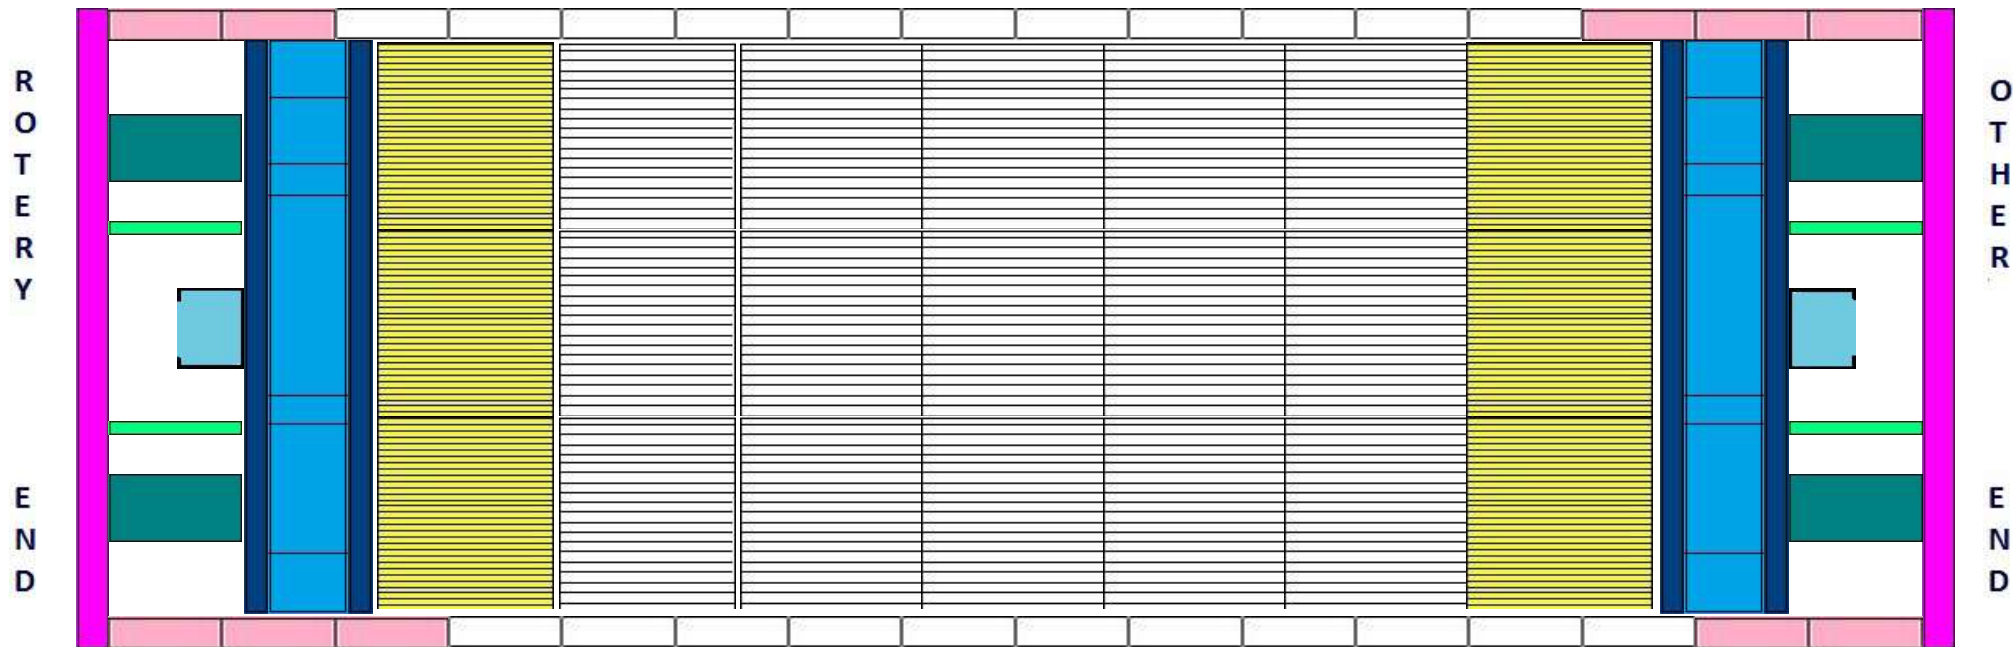
Color	Particulars	Qty	Per%	Color	Particulars	Qty	Per%	Color	Particulars	Qty	Per%
Yellow	Headstock Beam	2	100%	Dark Green	Centre Stiffner for Headstock	4	100%	Light Green	Floor Stiffner for Headstock	4	100%
Dark Blue	Aux. Head stock	4	100%	Pink	Sole Bar	5	31%	Light Blue	Draft Gear Bracket	2	100%
Yellow	Trough floor	2	29%	Light Blue	Centre plate	2	100%		SoleBar Stiffner	4	100%
	Bottom Wall Part	5	31%		Body panel/patch		100%		Door Top/Roof Patch		0%
	Window Module		4%		Window Sill	0	0%		Window Bar	0	0%
	Seat pillar/lav. Partition		100%		UIC end construction		0%

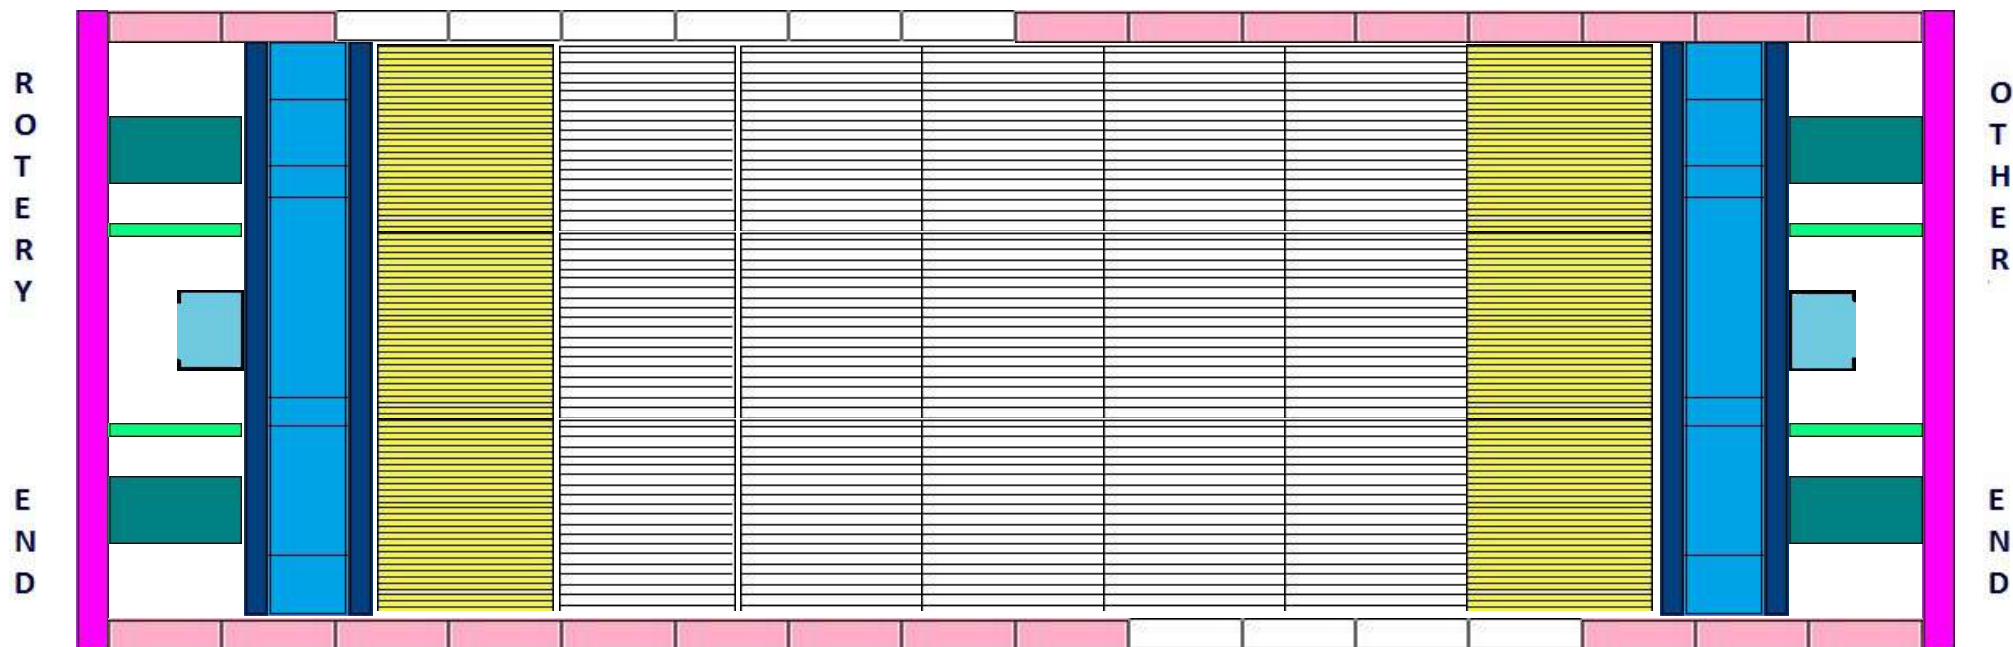
Rotary Side

Color	Particulars	Qty	Per%	Color	Particulars	Qty	Per%	Color	Particulars	Qty	Per%
Yellow	Headstock Beam	2	100%	Dark Green	Centre Stiffner for Headstock	4	100%	Light Green	Floor Stiffner for Headstock	4	100%
Dark Blue	Aux. Head stock	4	100%	Pink	Sole Bar	11	69%	Light Blue	Draft Gear Bracket	2	100%
Yellow	Trough floor	2	29%	Light Blue	Centre plate	2	100%		SoleBar Stiffner	6	100%
	Bottom Wall Part	11	69%		Body panel/patch		100%		Door Top/Roof Patch		0%
	Window Module		0%		Window Sill	14	35%		Window Bar	40	22%
	Seat pillar/lav. Partition		100%		UIC end construction		0%

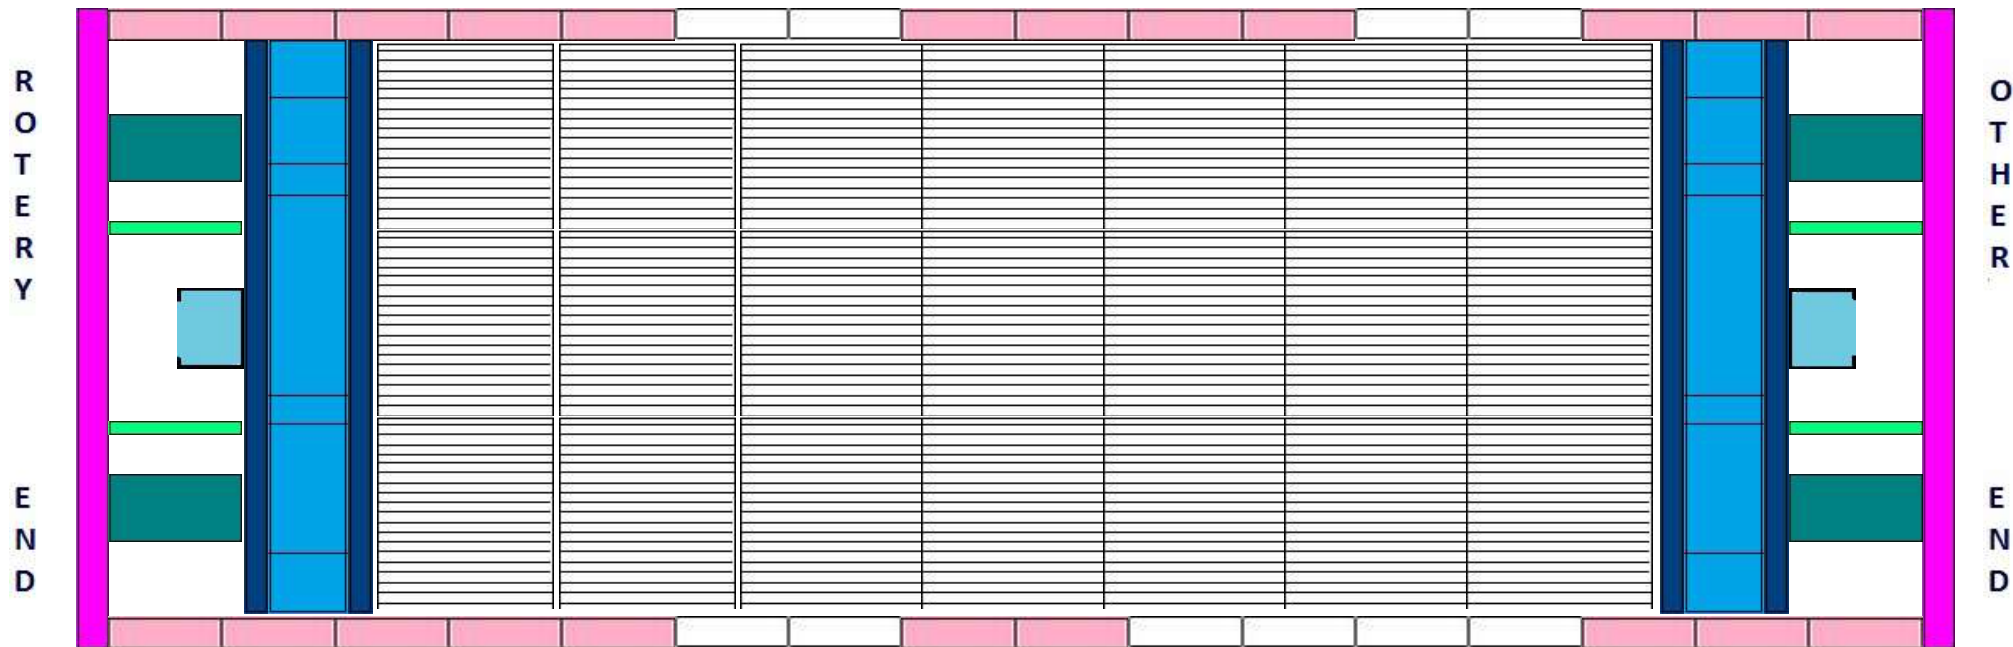
Rotary Side

Color	Particulars	Qty	Per%	Color	Particulars	Qty	Per%	Color	Particulars	Qty	Per%
	Headstock Beam	2	100%		Centre Stiffner for Headstock	4	100%		Floor Stiffner for Headstock	4	100%
	Aux. Head stock	4	100%		Sole Bar	11	69%		Draft Gear Bracket	2	100%
	Trough floor	0	0%		Centre plate	2	100%		SoleBar Stiffner	4	100%
	Bottom Wall Part	11	69%		Body panel/patch		100%		Door Top/Roof Patch		0%
	Window Module		0%		Window Sill	10	53%		Window Bar	16	19%
	Seat pillar/lav. Partition		100%		UIC end construction		0%

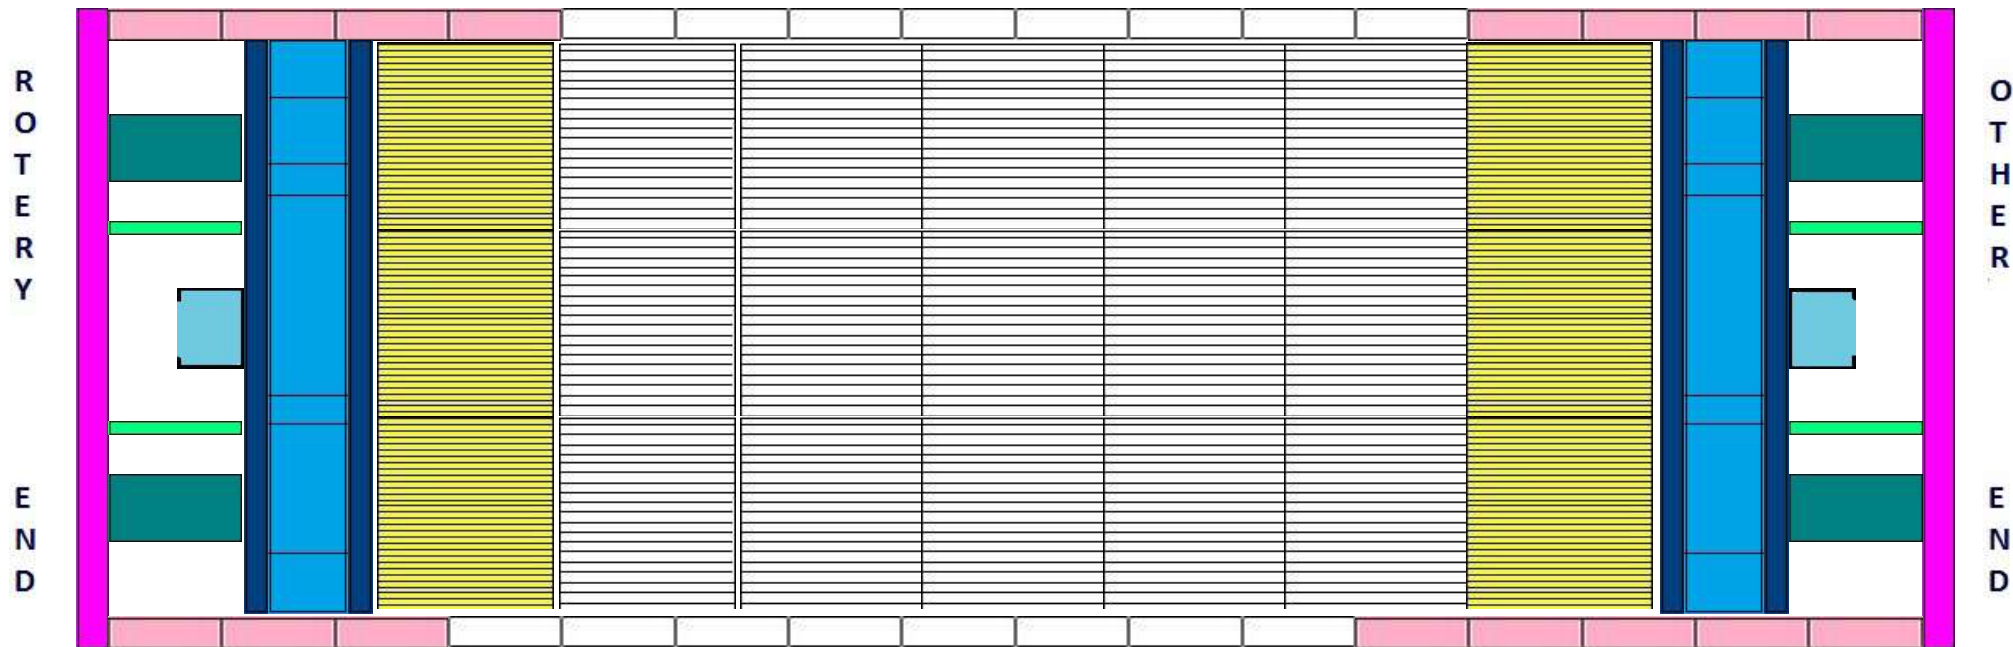
Rotary Side

Color	Particulars	Qty	Per%	Color	Particulars	Qty	Per%	Color	Particulars	Qty	Per%
Yellow	Headstock Beam	2	100%	Green	Centre Stiffner for Headstock	4	100%	Red	Floor Stiffner for Headstock	4	100%
Blue	Aux. Head stock	4	100%	Yellow	Sole Bar	8	50%	Blue	Draft Gear Bracket	2	100%
Red	Trough floor	2	29%	Red	Centre plate	2	100%		SoleBar Stiffner	4	100%
	Bottom Wall Part	8	50%		Body panel/patch		100%		Door Top/Roof Patch		0%
	Window Module		4%		Window Sill	0	0%		Window Bar	0	0%
	Seat pillar/lav. Partition		100%		UIC end construction		0%

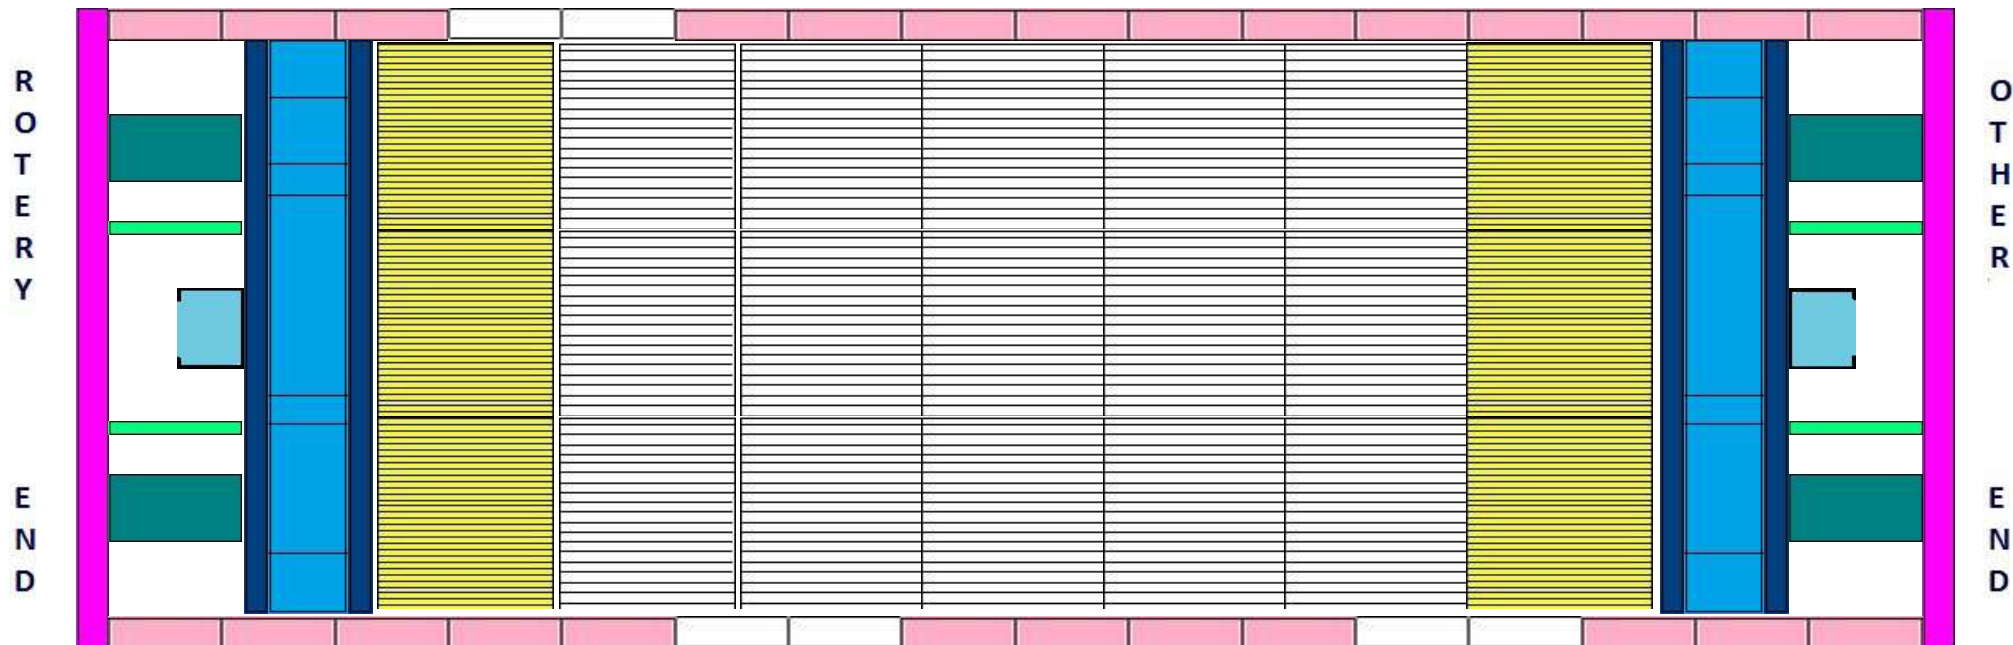
Rotary Side

Color	Particulars	Qty	Per%	Color	Particulars	Qty	Per%	Color	Particulars	Qty	Per%
Yellow	Headstock Beam	2	100%	Dark Green	Centre Stiffner for Headstock	4	100%	Light Green	Floor Stiffner for Headstock	4	100%
Dark Blue	Aux. Head stock	4	100%	Pink	Sole Bar	13	81%	Light Blue	Draft Gear Bracket	2	100%
Yellow	Trough floor	2	29%	Light Blue	Centre plate	2	100%		SoleBar Stiffner	4	100%
	Bottom Wall Part	13	81%		Body panel/patch		100%		Door Top/Roof Patch		0%
	Window Module		0%		Window Sill	10	53%		Window Bar	14	17%
	Seat pillar/lav. Partition		100%		UIC end construction		0%

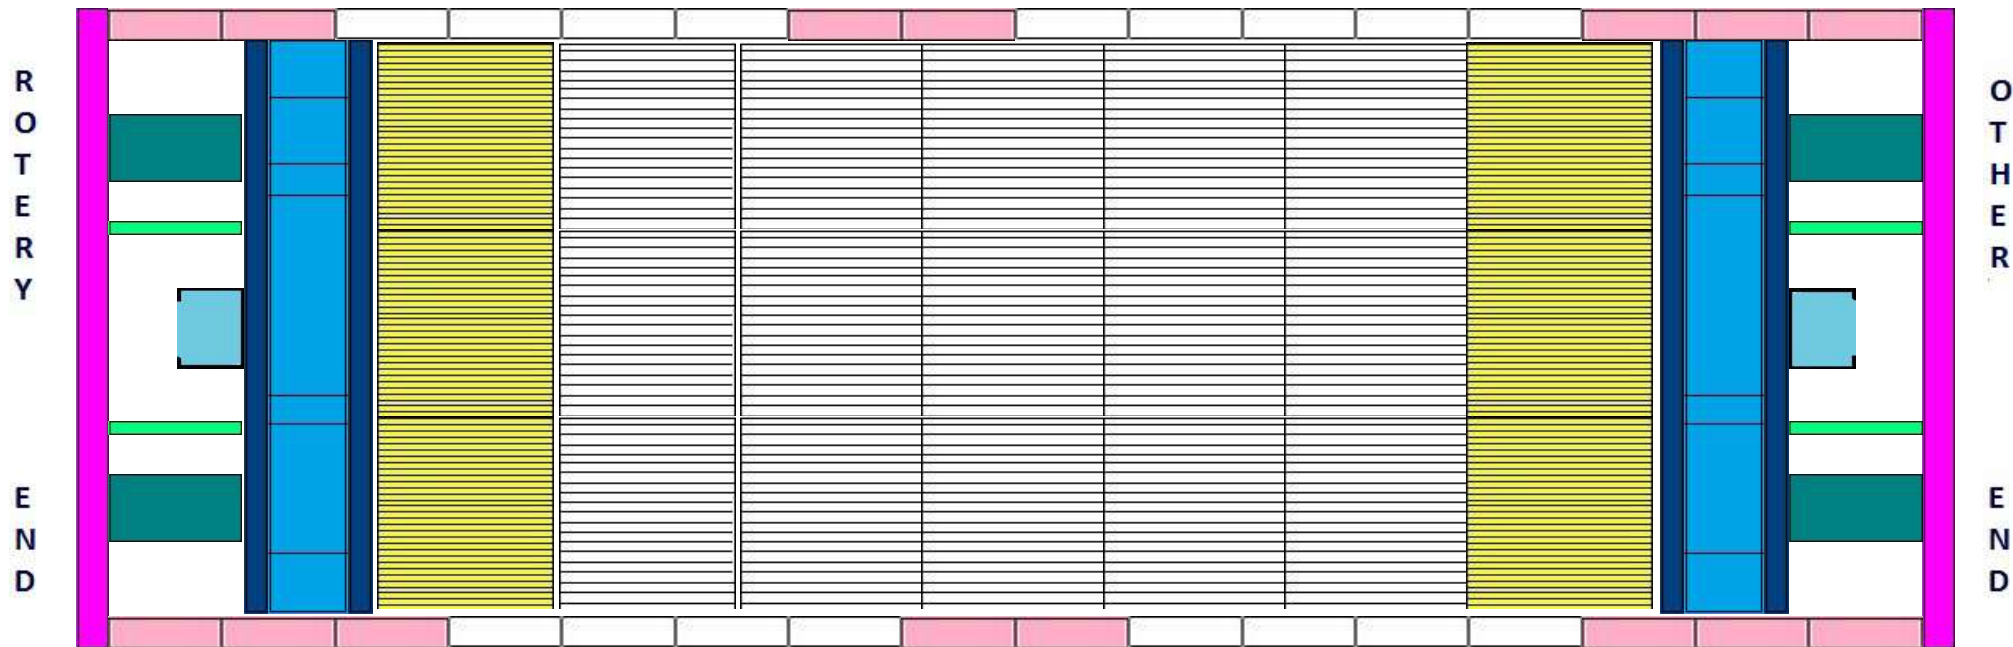
Color	Particulars	Qty	Per%	Color	Particulars	Qty	Per%	Color	Particulars	Qty	Per%
Yellow	Headstock Beam	2	100%	Dark Green	Centre Stiffner for Headstock	4	100%	Light Green	Floor Stiffner for Headstock	4	100%
Dark Blue	Aux. Head stock	4	100%	Pink	Sole Bar	7.5	47%	Light Blue	Draft Gear Bracket	2	100%
Yellow	Trough floor	2	29%	Light Blue	Centre plate	2	100%		SoleBar Stiffner	6	100%
	Bottom Wall Part	7.5	47%		Body panel/patch		100%		Door Top/Roof Patch		0%
	Window Module		0%		Window Sill	40	100%		Window Bar	46	26%
	Seat pillar/lav. Partition		100%		UIC end construction		0%

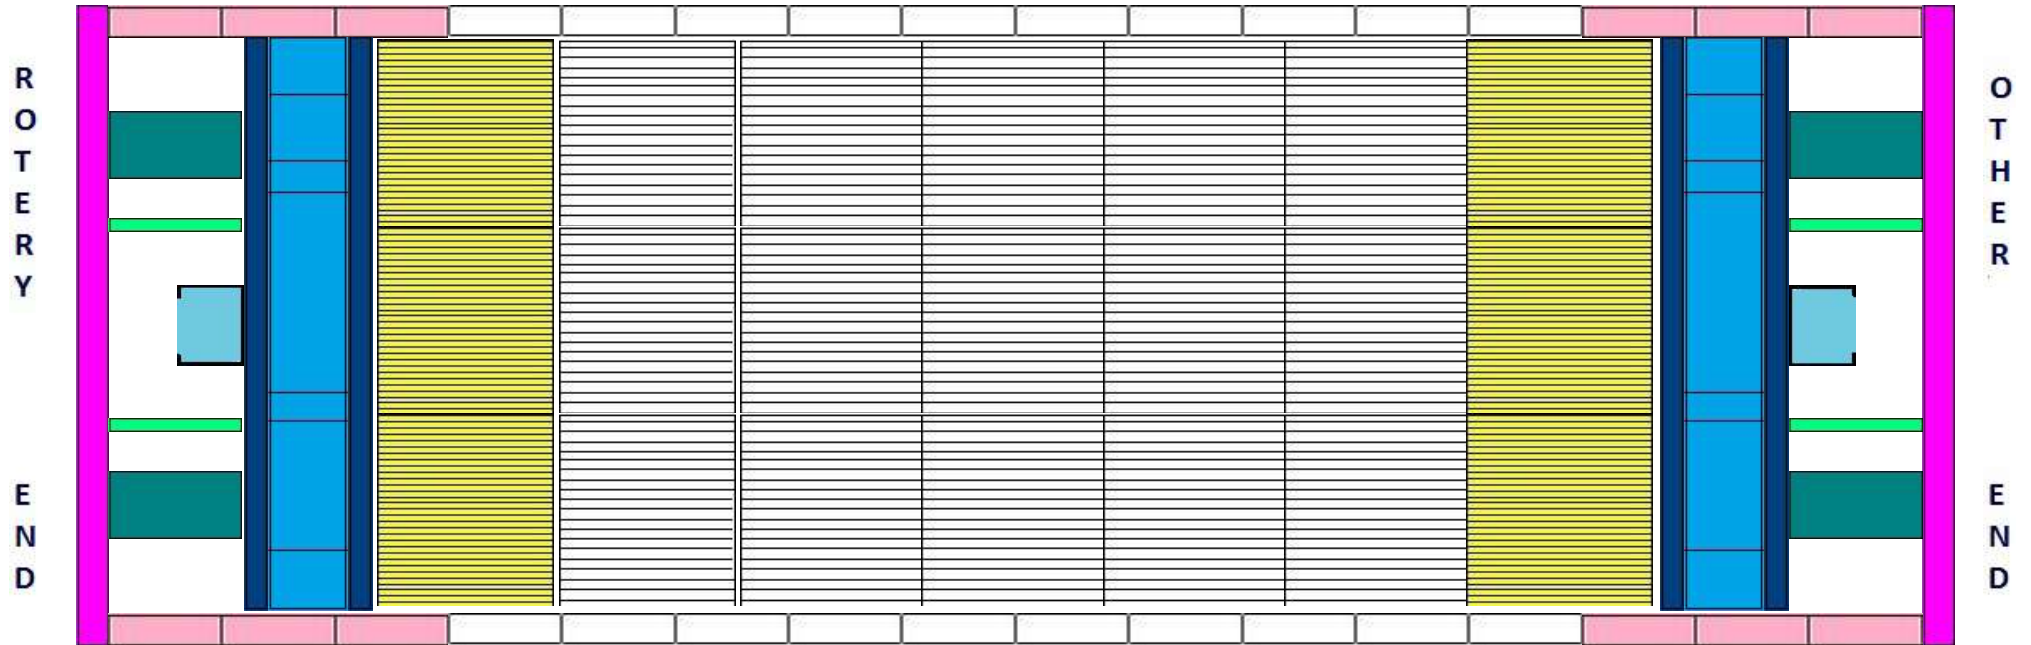
Rotary Side

Color	Particulars	Qty	Per%	Color	Particulars	Qty	Per%	Color	Particulars	Qty	Per%
	Headstock Beam	2	100%		Centre Stiffner for Headstock	4	100%		Floor Stiffner for Headstock	4	100%
	Aux. Head stock	4	100%		Sole Bar	6	38%		Draft Gear Bracket	2	100%
	Trough floor	2	29%		Centre plate	2	100%		SoleBar Stiffner	4	100%
	Bottom Wall Part	6	38%		Body panel/patch		100%		Door Top/Roof Patch		0%
	Window Module		0%		Window Sill	14	35%		Window Bar	44	24%
	Seat pillar/lav. Partition		100%		UIC end construction		0%

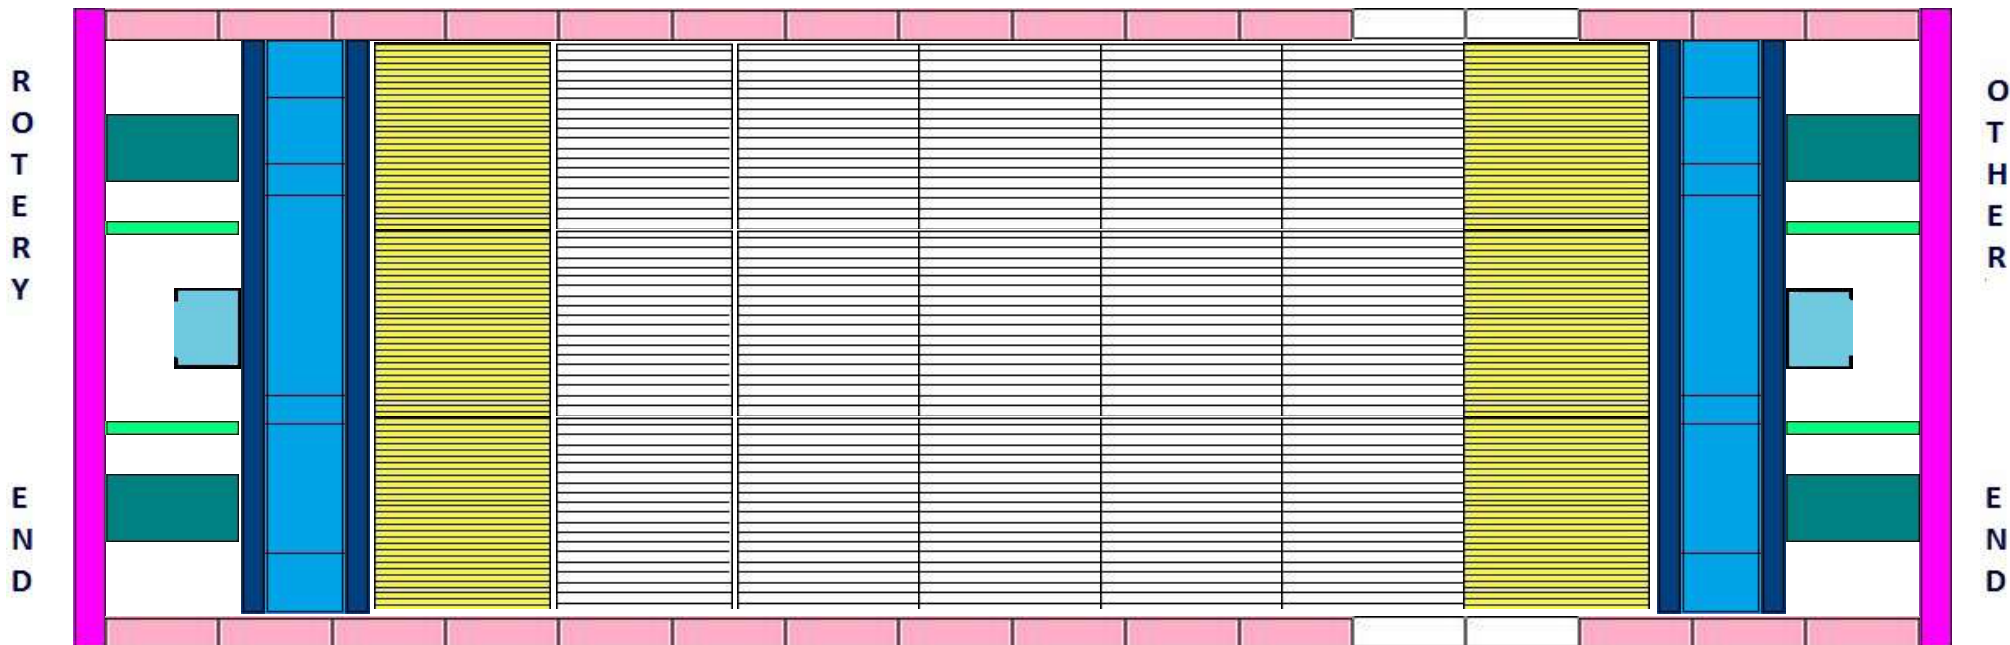
Color	Particulars	Qty	Per%	Color	Particulars	Qty	Per%	Color	Particulars	Qty	Per%
Yellow	Headstock Beam	2	100%	Dark Green	Centre Stiffner for Headstock	4	100%	Light Green	Floor Stiffner for Headstock	4	100%
Dark Blue	Aux. Head stock	4	100%	Pink	Sole Bar	14	88%	Light Blue	Draft Gear Bracket	2	100%
Yellow	Trough floor	2	29%	Light Blue	Centre plate	2	100%		SoleBar Stiffner	4	100%
	Bottom Wall Part	14	88%		Body panel/patch		100%		Door Top/Roof Patch		0%
	Window Module		0%		Window Sill	9	47%		Window Bar	12	14%
	Seat pillar/lav. Partition		100%		UIC end construction		0%

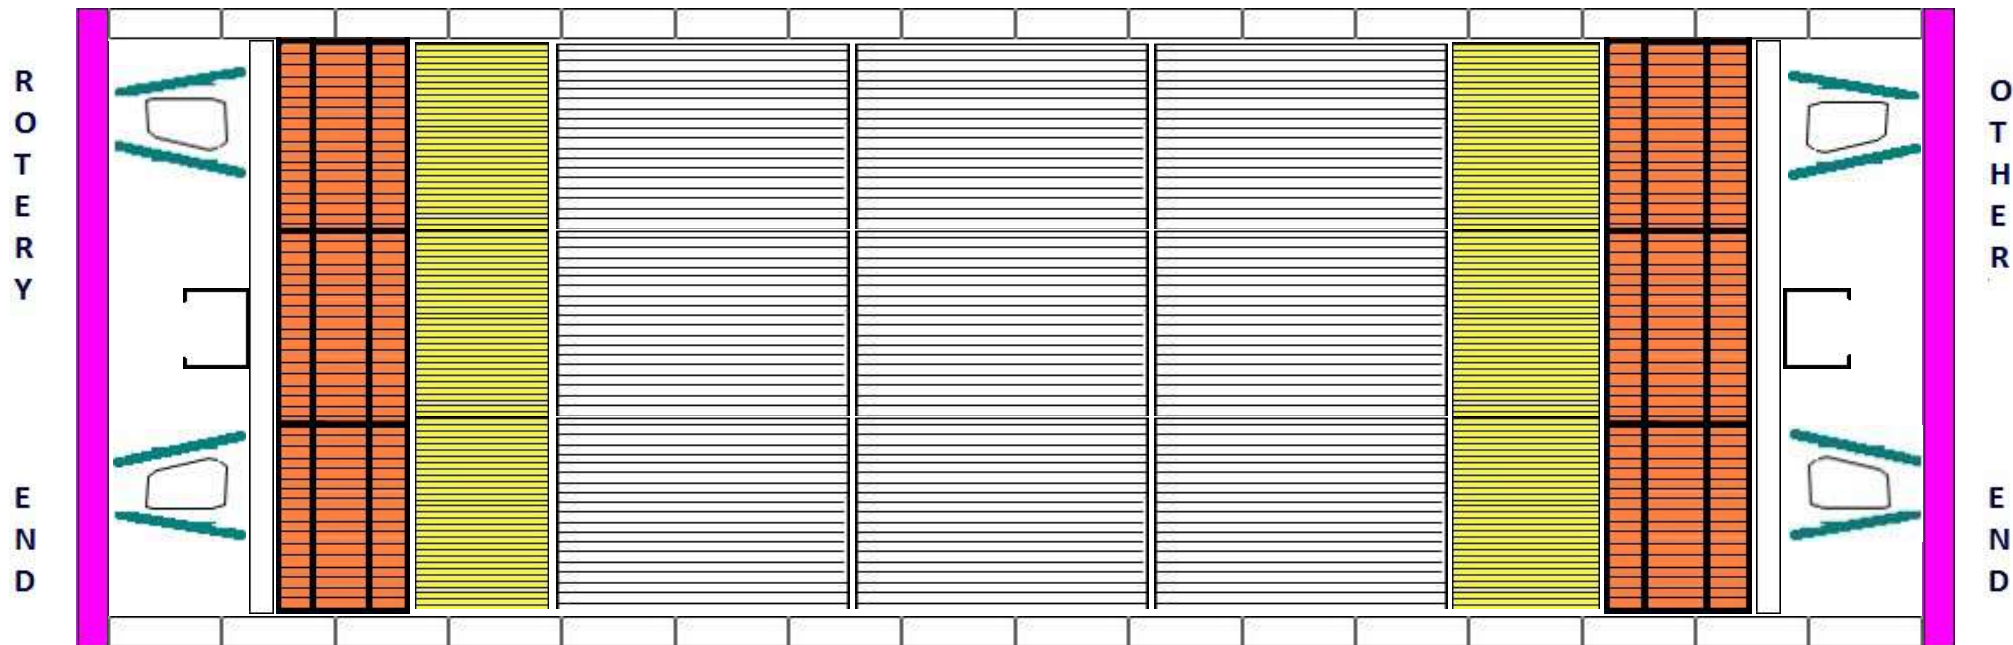
Rotary Side

Color	Particulars	Qty	Per%	Color	Particulars	Qty	Per%	Color	Particulars	Qty	Per%
	Headstock Beam	2	100%		Diagonal	4	100%		Logitudinal Channel Structure	2	100%
	Aux. Head stock	0	0%		Sole Bar	0	0%		Draft Gear Bracket	0	0%
	Trough floor	2	40%		Bottom Wall Part	0	0%		Body panel/patch		100%
	Door Top/Roof Patch		0%		Seat Bracket Rail		0%		Window Sill	20	50%
	Window Bar	14	8%		Seat pillar/lav. Partition		100%		UIC end construction		0%
	Body Pillar Part	0	100%

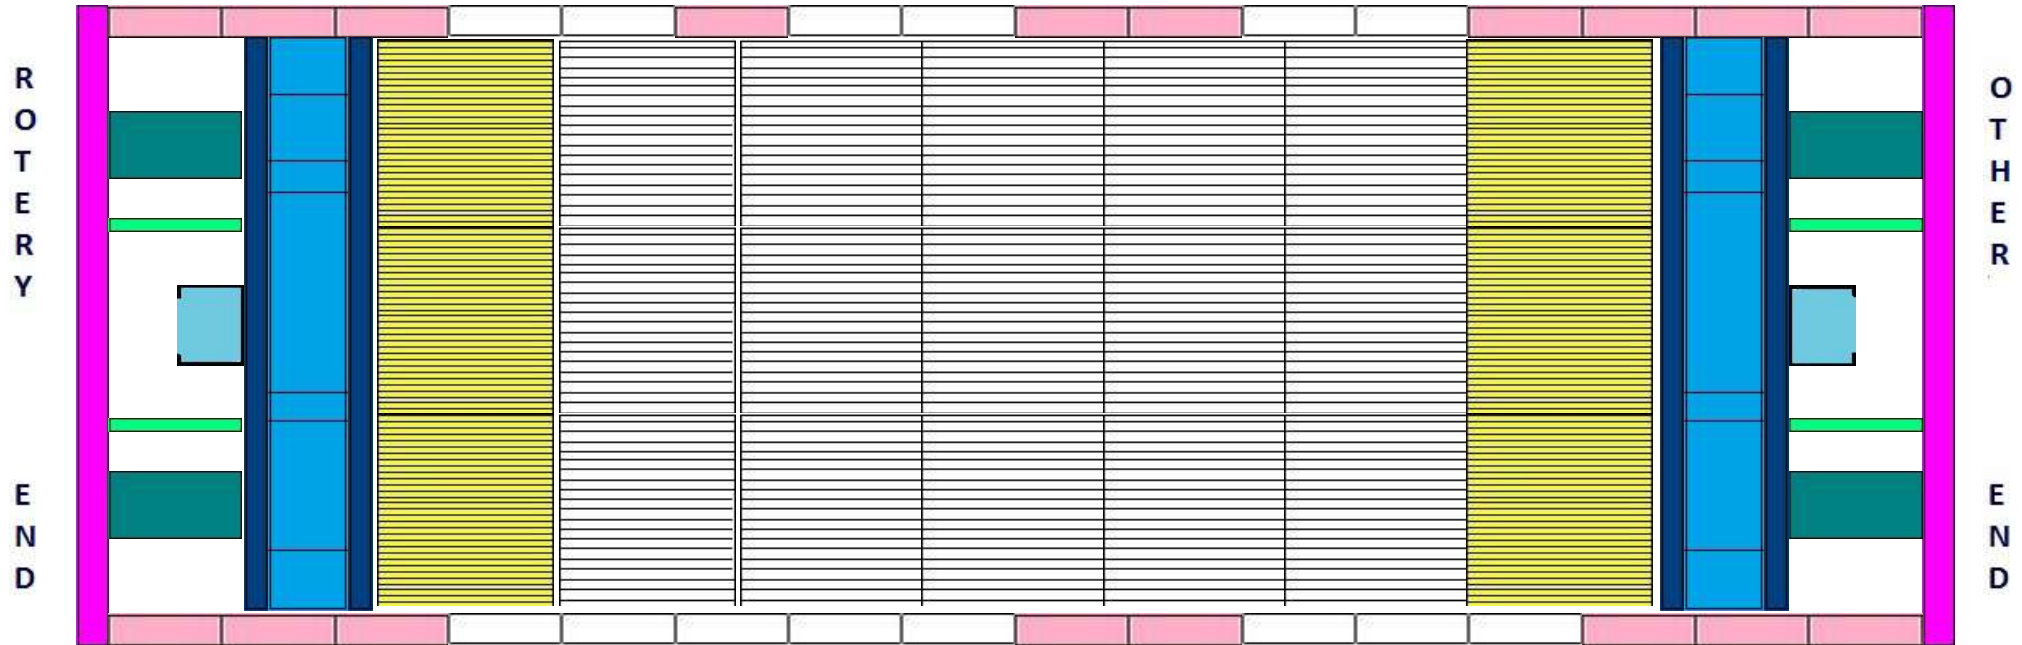
Rotary Side

Color	Particulars	Qty	Per%	Color	Particulars	Qty	Per%	Color	Particulars	Qty	Per%
	Headstock Beam	2	100%		Centre Stiffner for Headstock	4	100%		Floor Stiffner for Headstock	4	100%
	Aux. Head stock	4	100%		Sole Bar	9	56%		Draft Gear Bracket	2	100%
	Trough floor	2	29%		Centre plate	2	100%		SoleBar Stiffner	6	100%
	Bottom Wall Part	9	56%		Body panel/patch		100%		Door Top/Roof Patch		0%
	Window Module		0%		Window Sill	32	80%		Window Bar	44	25%
	Seat pillar/lav. Partition		100%		UIC end construction		0%

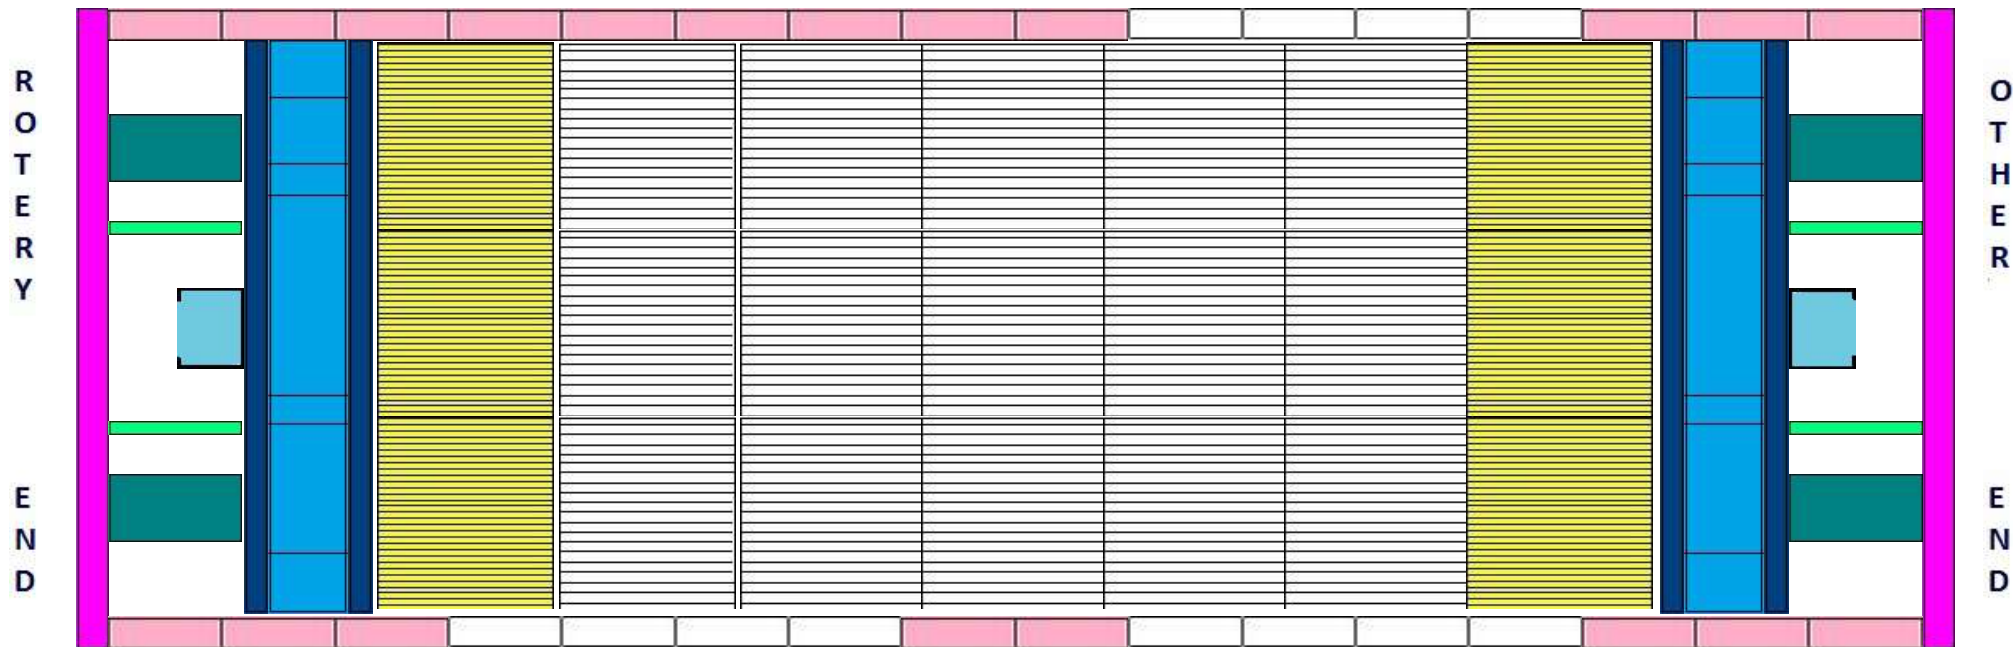
Rotary Side

Color	Particulars	Qty	Per%	Color	Particulars	Qty	Per%	Color	Particulars	Qty	Per%
Pink	Headstock Beam	2	100%	Dark Green	Centre Stiffner for Headstock	4	100%	Bright Green	Floor Stiffner for Headstock	4	100%
Dark Blue	Aux. Head stock	4	100%	Pink	Sole Bar	10	63%	Light Blue	Draft Gear Bracket	2	100%
Yellow	Trough floor	2	29%	Blue	Centre plate	2	100%		SoleBar Stiffner	6	100%
	Bottom Wall Part	10	63%		Body panel/patch		100%		Door Top/Roof Patch		0%
	Window Module		0%		Window Sill	28	70%		Window Bar	40	23%
	Seat pillar/lav. Partition		100%		UIC end construction		0%
