Coach Rehabilitation Workshop, WC Railway, Bhopal

(An IMS and ISO 50001 Certified Workshop)
Final Inspection Sheet - Details of Corrosion Repair

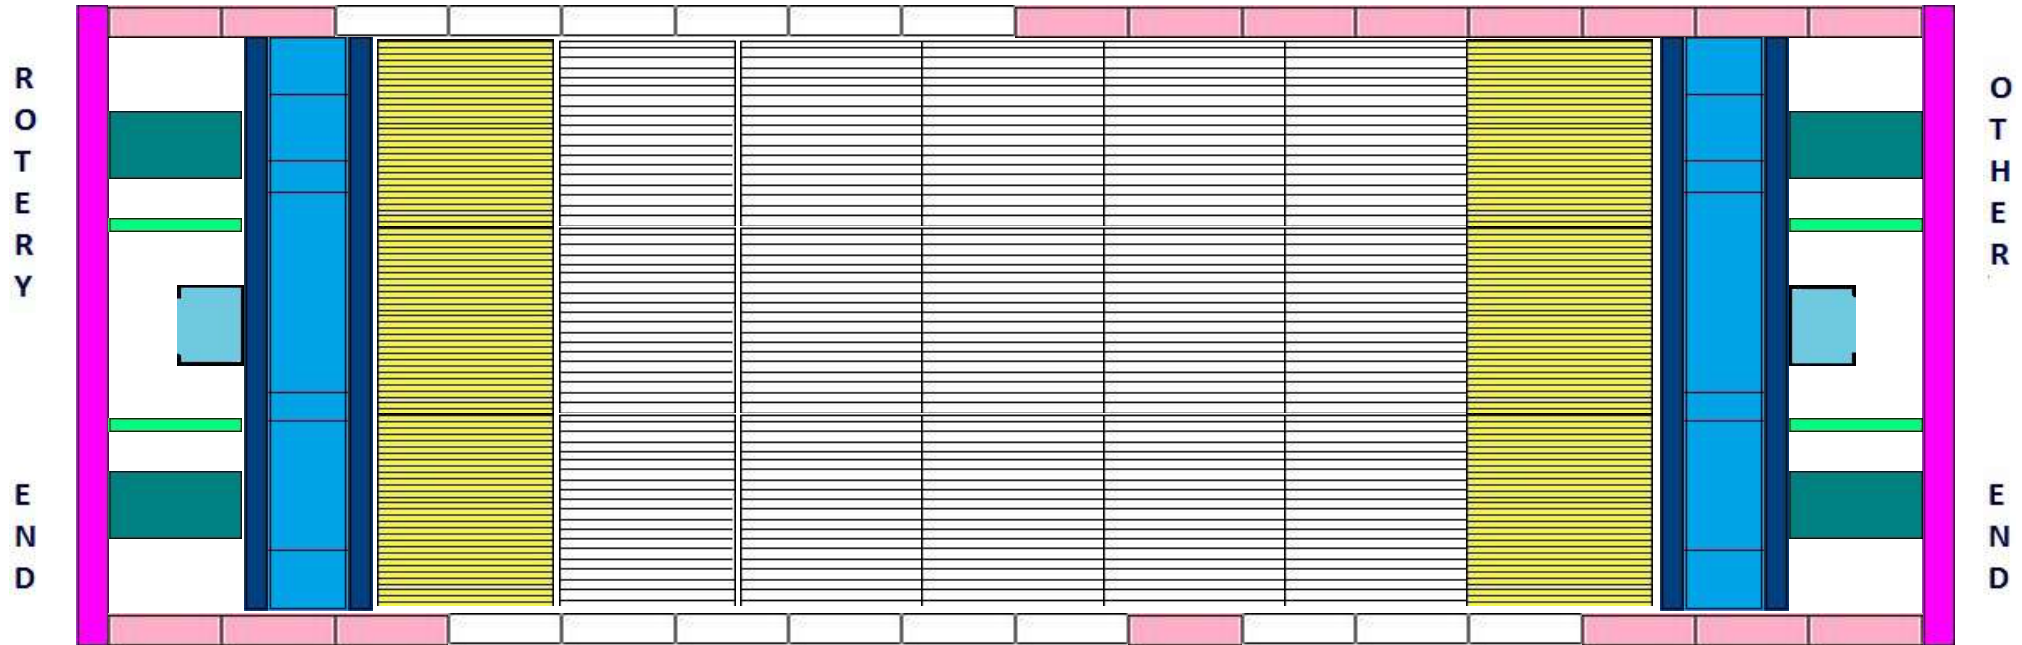
Rotary Side

Color	Particulars	Qty	Per%	Color	Particulars	Qty	Per%	Color	Particulars	Qty	Per%
	Headstock Beam	2	100%		Centre Stiffner for Headstock	4	100%		Floor Stiffner for Headstock	4	100%
	Aux. Head stock	4	100%		Sole Bar	8.5	53%		Draft Gear Bracket	2	100%
	Trough floor	2	29%		Centre plate	2	100%		SoleBar Stiffner	6	100%
	Bottom Wall Part	8.5	53%		Body panel/patch		100%		Door Top/Roof Patch		0%
	Window Module		0%		Window Sill	40	100%		Window Bar	48	27%
	Seat pillar/lav. Partition		100%		UIC end construction		0%

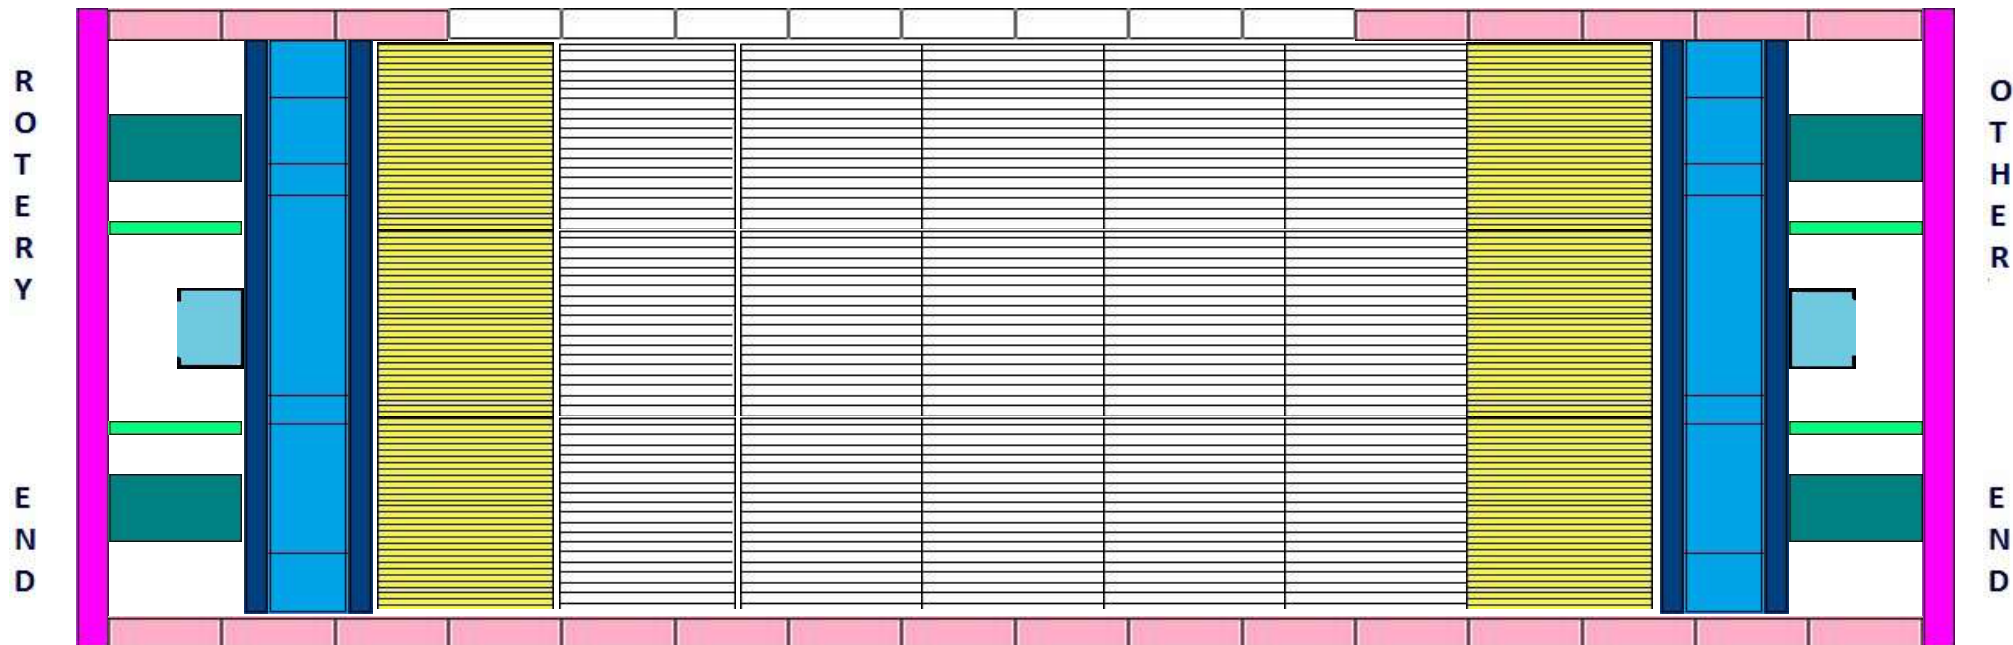
Rotary Side

Color	Particulars	Qty	Per%	Color	Particulars	Qty	Per%	Color	Particulars	Qty	Per%
	Headstock Beam	2	100%		Centre Stiffner for Headstock	4	100%		Floor Stiffner for Headstock	4	100%
	Aux. Head stock	4	100%		Sole Bar	12	75%		Draft Gear Bracket	2	100%
	Trough floor	2	29%		Centre plate	2	100%		SoleBar Stiffner	4	100%
	Bottom Wall Part	12	75%		Body panel/patch		100%		Door Top/Roof Patch		0%
	Window Module		0%		Window Sill	40	100%		Window Bar	46	25%
	Seat pillar/lav. Partition		100%		UIC end construction		0%

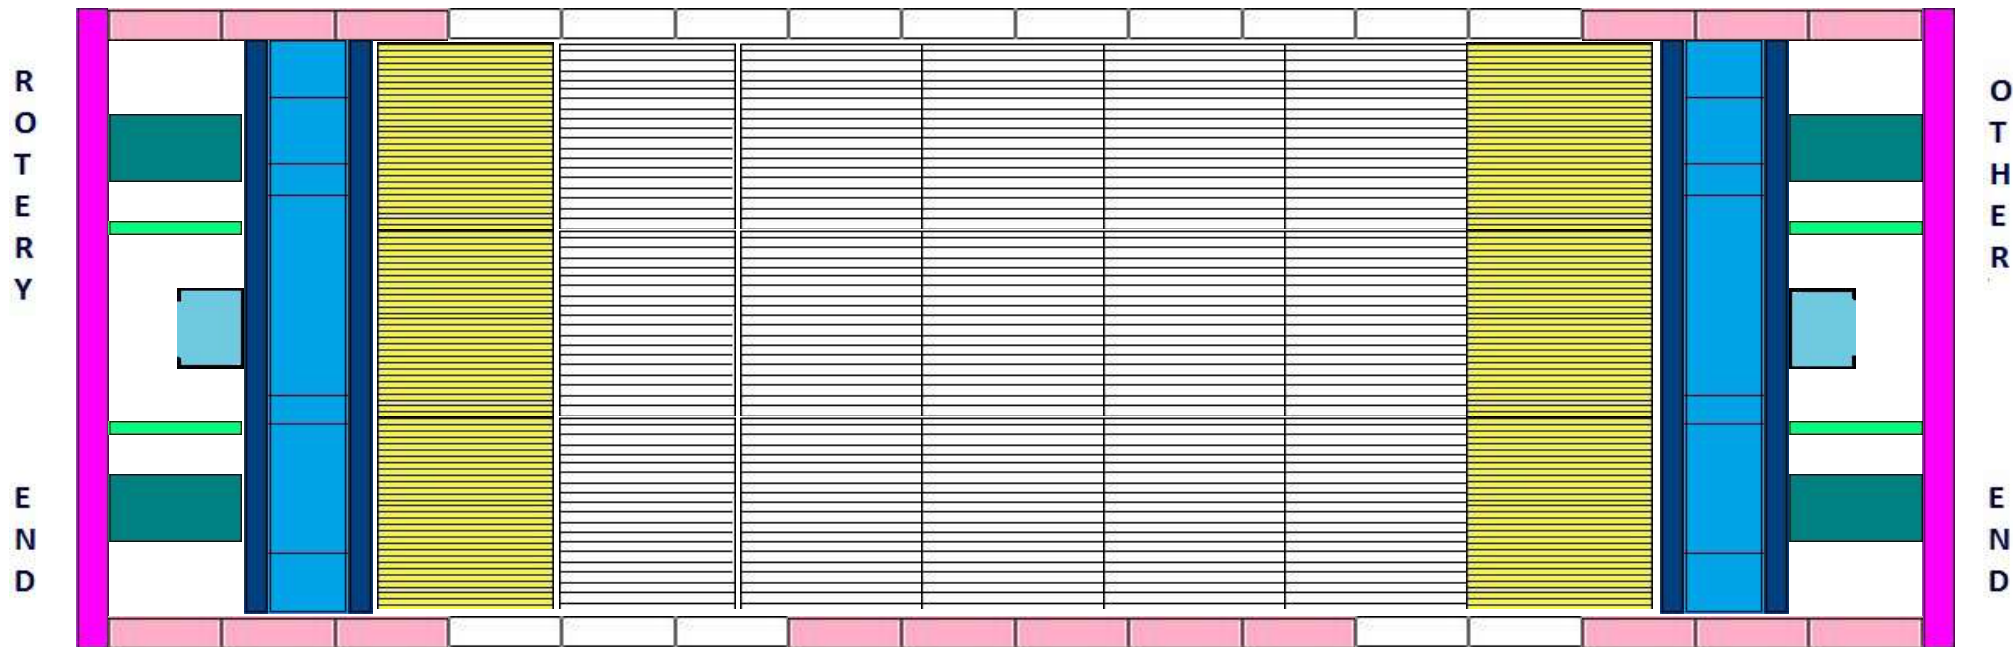
Color	Particulars	Qty	Per%	Color	Particulars	Qty	Per%	Color	Particulars	Qty	Per%
Yellow	Headstock Beam	2	100%	Dark Green	Centre Stiffner for Headstock	4	100%	Light Green	Floor Stiffner for Headstock	4	100%
Dark Blue	Aux. Head stock	4	100%	Pink	Sole Bar	8.5	53%	Light Blue	Draft Gear Bracket	2	100%
Yellow	Trough floor	2	29%	Light Blue	Centre plate	2	100%		SoleBar Stiffner	4	100%
	Bottom Wall Part	8.5	53%		Body panel/patch		100%		Door Top/Roof Patch		0%
	Window Module		0%		Window Sill	20	50%		Window Bar	46	26%
	Seat pillar/lav. Partition		100%		UIC end construction		0%

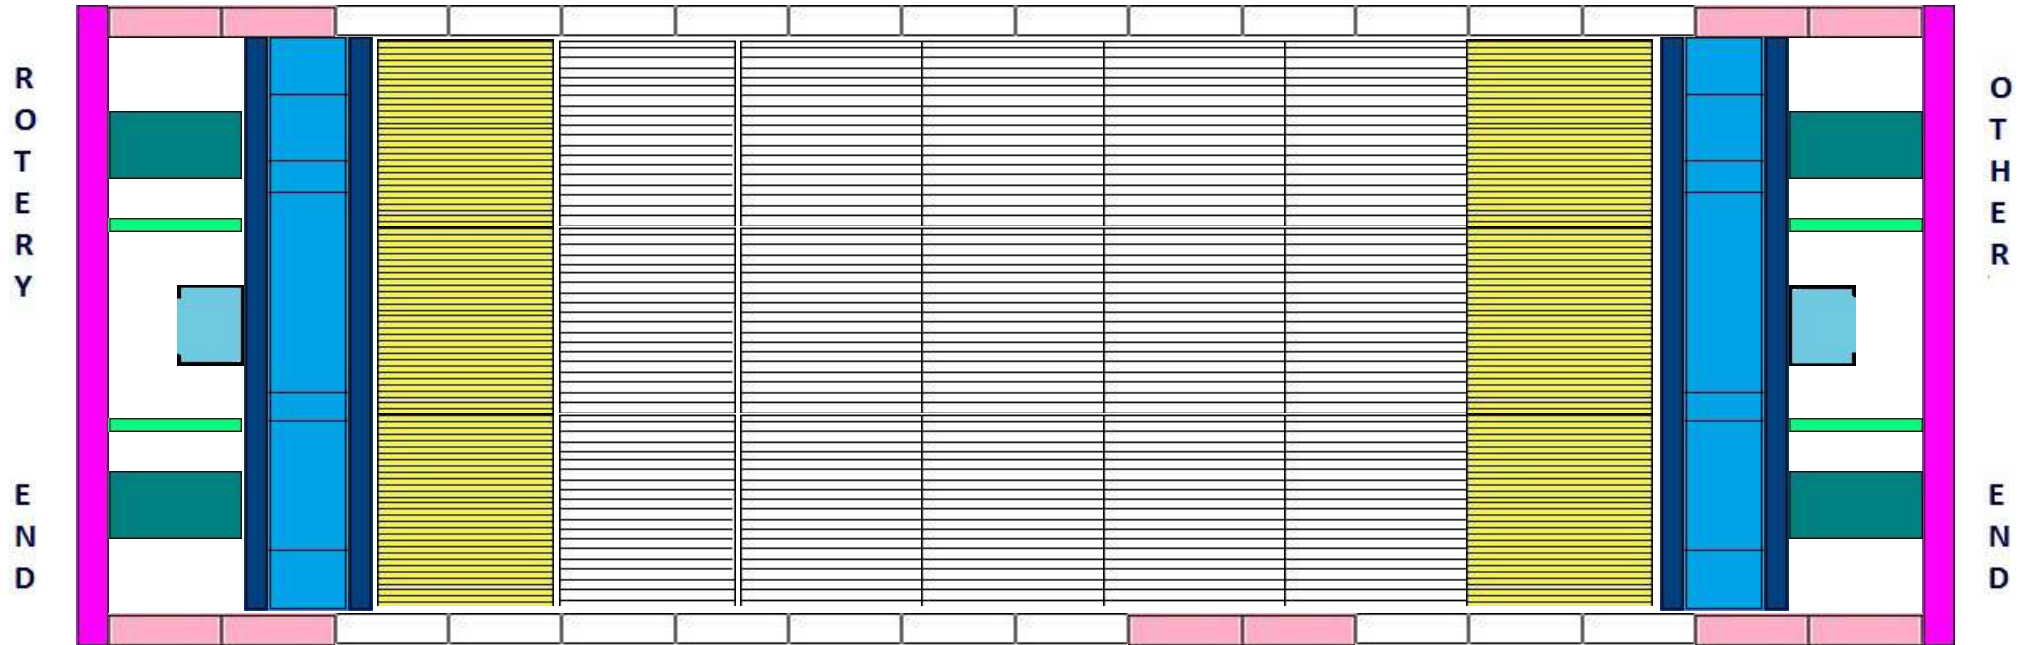
Rotary Side

Color	Particulars	Qty	Per%	Color	Particulars	Qty	Per%	Color	Particulars	Qty	Per%
Pink	Headstock Beam	2	100%	Dark Blue	Centre Stiffner for Headstock	4	100%	Light Green	Floor Stiffner for Headstock	4	100%
Dark Blue	Aux. Head stock	4	100%	Pink	Sole Bar	5	31%	Light Blue	Draft Gear Bracket	2	100%
Yellow	Trough floor	2	29%	Light Blue	Centre plate	2	100%		SoleBar Stiffner	4	100%
	Bottom Wall Part	5	31%		Body panel/patch		100%		Door Top/Roof Patch		0%
	Window Module		0%		Window Sill	32	80%		Window Bar	44	24%
	Seat pillar/lav. Partition		100%		UIC end construction		0%

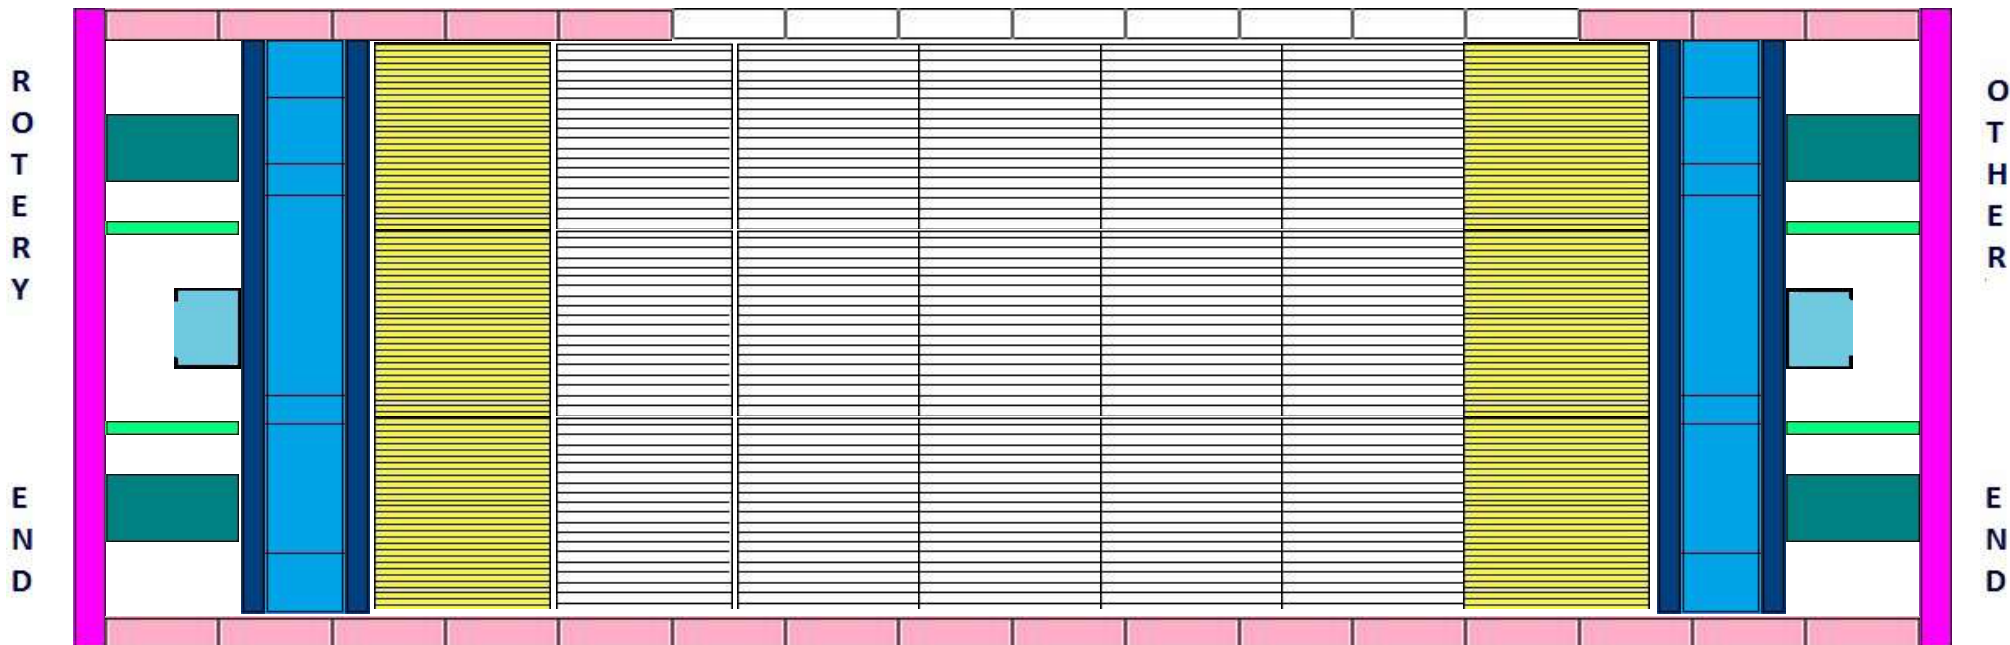
Rotary Side

Color	Particulars	Qty	Per%	Color	Particulars	Qty	Per%	Color	Particulars	Qty	Per%
Yellow	Headstock Beam	2	100%	Dark Green	Centre Stiffner for Headstock	4	100%	Light Green	Floor Stiffner for Headstock	4	100%
Dark Blue	Aux. Head stock	4	100%	Pink	Sole Bar	12	75%	Light Blue	Draft Gear Bracket	2	100%
Yellow	Trough floor	2	29%	Light Blue	Centre plate	2	100%		SoleBar Stiffner	4	100%
	Bottom Wall Part	12	75%		Body panel/patch		100%		Door Top/Roof Patch		0%
	Window Module		0%		Window Sill	40	100%		Window Bar	100	54%
	Seat pillar/lav. Partition		100%		UIC end construction		0%

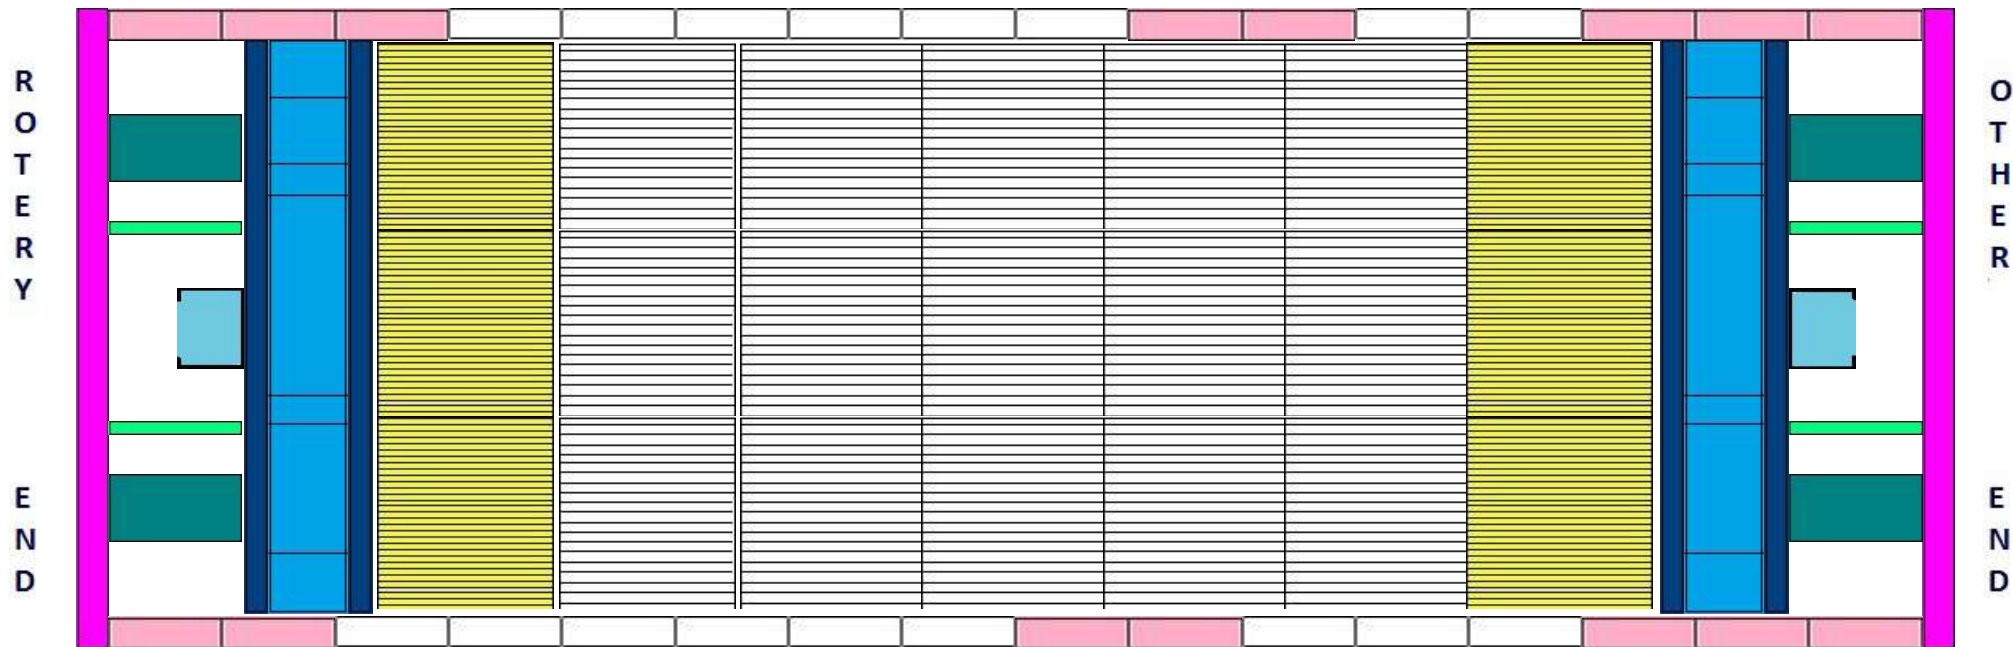
Rotary Side

Color	Particulars	Qty	Per%	Color	Particulars	Qty	Per%	Color	Particulars	Qty	Per%
Pink	Headstock Beam	2	100%	Dark Blue	Centre Stiffner for Headstock	4	100%	Green	Floor Stiffner for Headstock	4	100%
Dark Blue	Aux. Head stock	4	100%	Pink	Sole Bar	7.5	47%	Light Blue	Draft Gear Bracket	2	100%
Yellow	Trough floor	2	29%	Light Blue	Centre plate	2	100%		SoleBar Stiffner	4	100%
	Bottom Wall Part	7.5	47%		Body panel/patch		100%		Door Top/Roof Patch		0%
	Window Module		0%		Window Sill	24	60%		Window Bar	44	24%
	Seat pillar/lav. Partition		100%		UIC end construction		0%

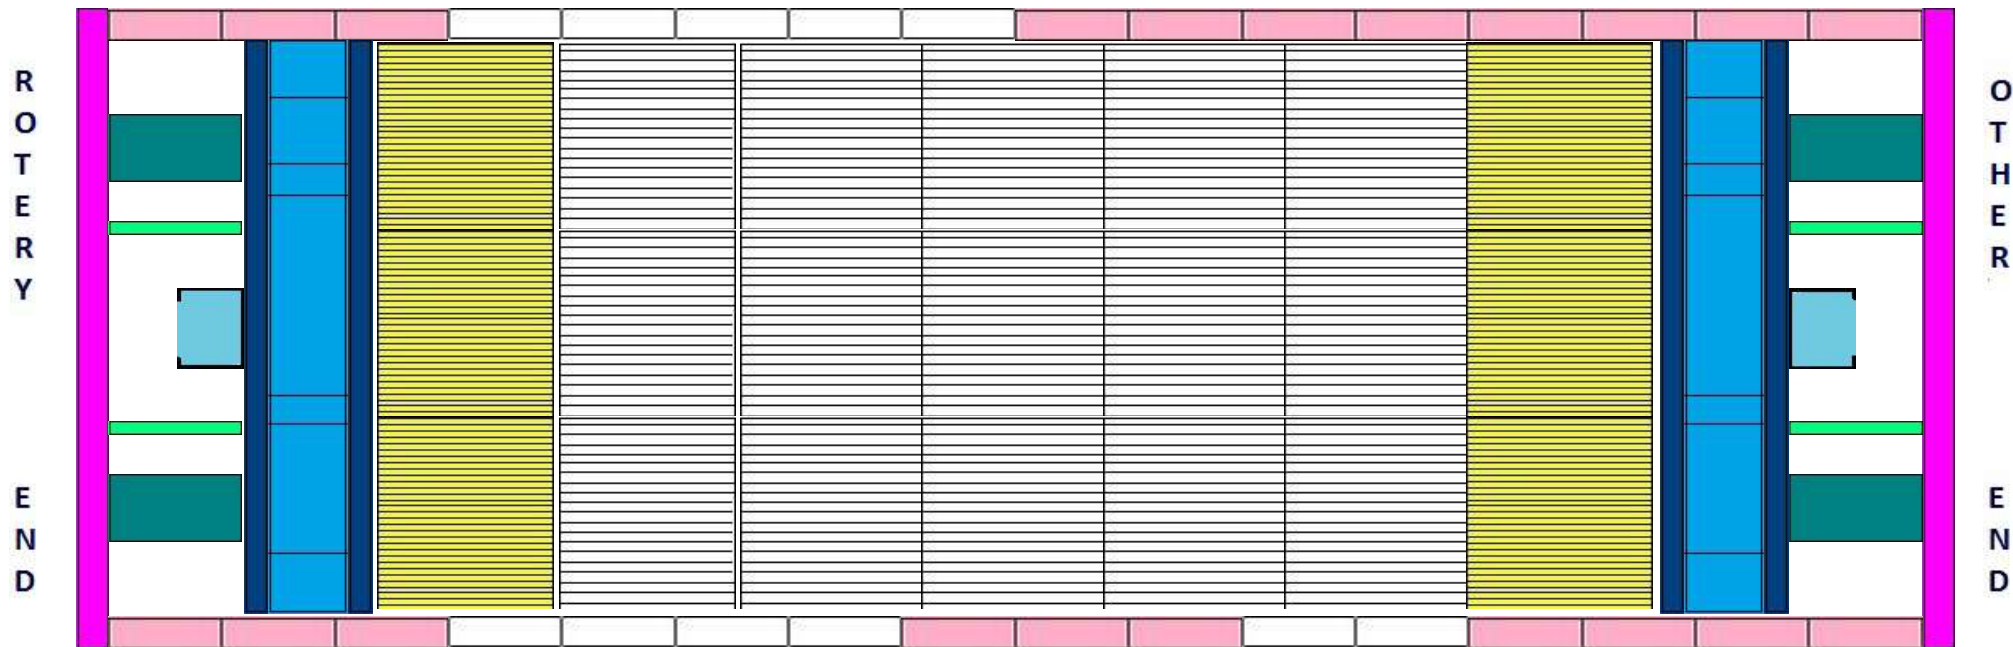
Color	Particulars	Qty	Per%	Color	Particulars	Qty	Per%	Color	Particulars	Qty	Per%
Yellow	Headstock Beam	2	100%	Dark Green	Centre Stiffner for Headstock	4	100%	Light Green	Floor Stiffner for Headstock	4	100%
Dark Blue	Aux. Head stock	4	100%	Pink	Sole Bar	10.5	66%	Light Blue	Draft Gear Bracket	2	100%
Yellow	Trough floor	2	29%	Light Blue	Centre plate	2	100%		SoleBar Stiffner	6	100%
	Bottom Wall Part	10.5	66%		Body panel/patch		100%		Door Top/Roof Patch		0%
	Window Module		0%		Window Sill	40	100%		Window Bar	44	25%
	Seat pillar/lav. Partition		100%		UIC end construction		0%

End Drooping: Rotary End - EAST : 4, WEST : 5 Other End - EAST : -3, WEST : -4

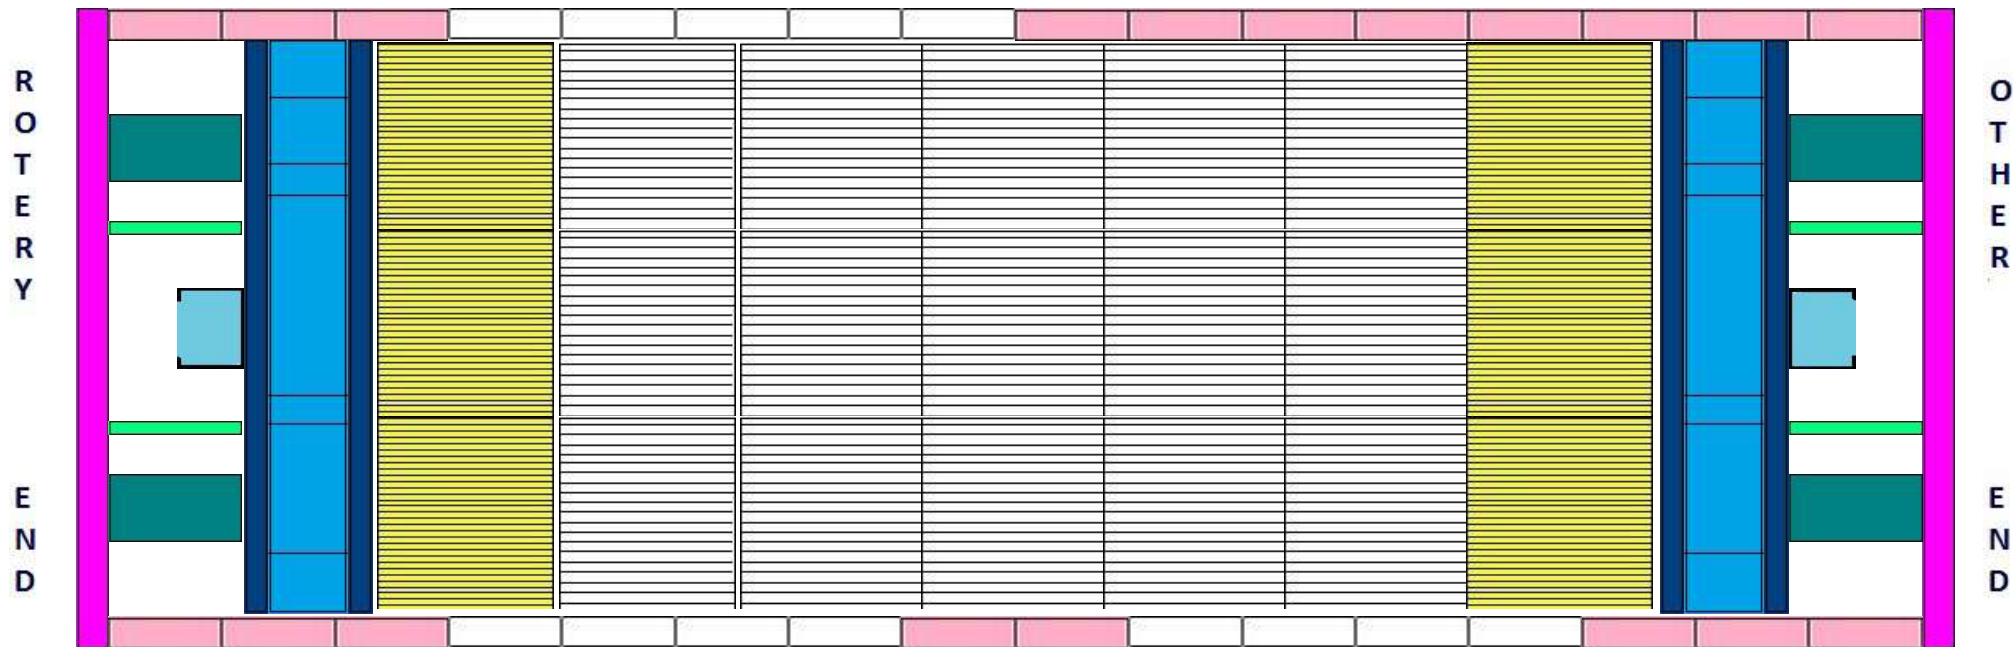
Color	Particulars	Qty	Per%	Color	Particulars	Qty	Per%	Color	Particulars	Qty	Per%
Yellow	Headstock Beam	2	100%	Dark Green	Centre Stiffner for Headstock	4	100%	Light Green	Floor Stiffner for Headstock	4	100%
Dark Blue	Aux. Head stock	4	100%	Pink	Sole Bar	9.5	59%	Light Blue	Draft Gear Bracket	2	100%
Yellow	Trough floor	2	29%	Light Blue	Centre plate	2	100%		SoleBar Stiffner	6	100%
	Bottom Wall Part	9.5	59%		Body panel/patch		100%		Door Top/Roof Patch		0%
	Window Module		0%		Window Sill	28	70%		Window Bar	48	27%
	Seat pillar/lav. Partition		100%		UIC end construction		0%

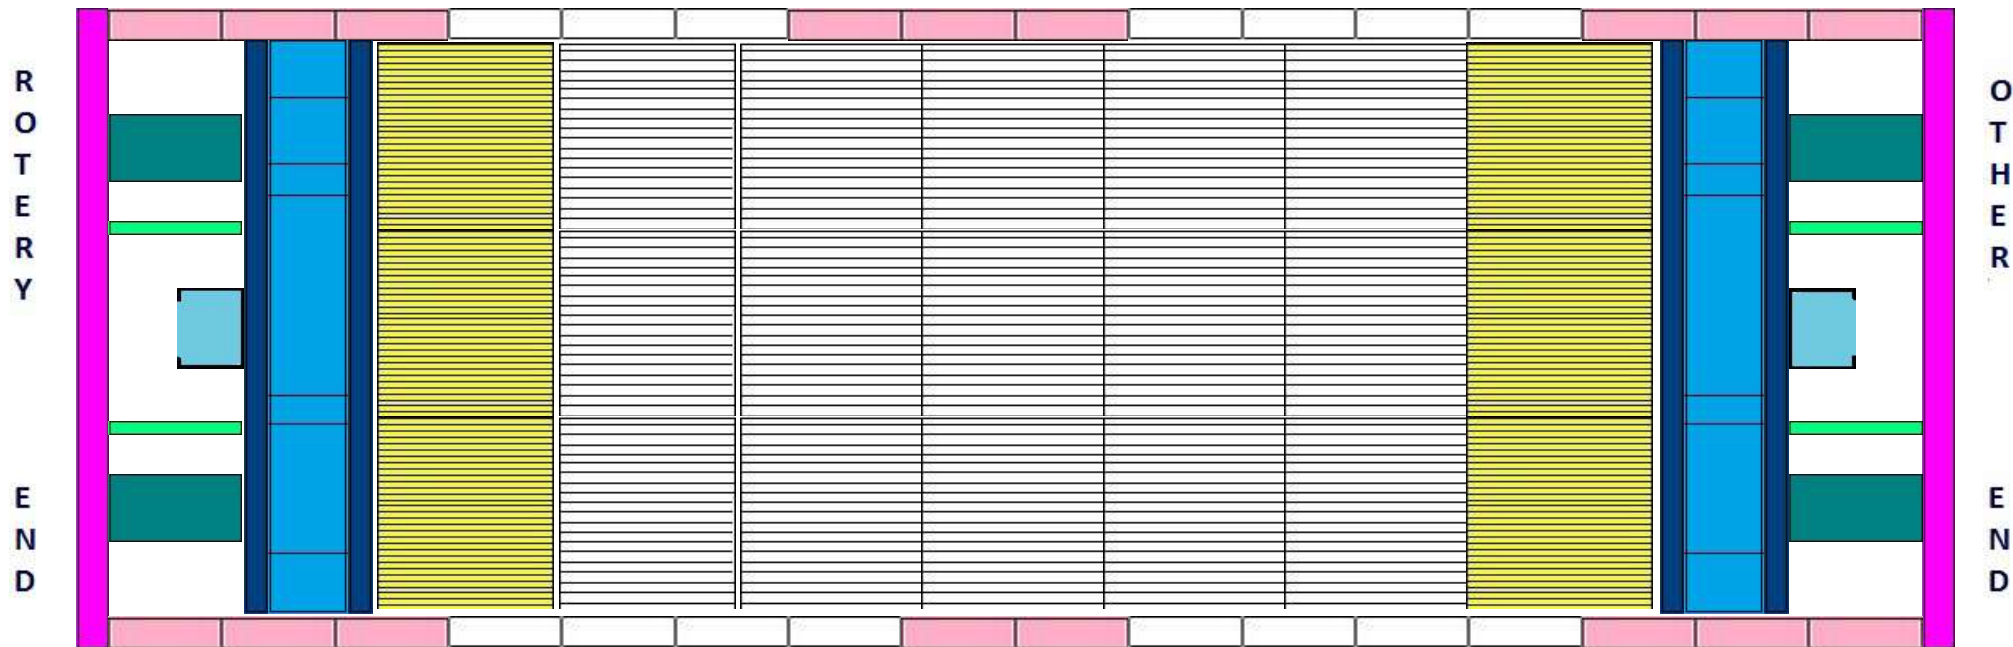
Rotary Side

Color	Particulars	Qty	Per%	Color	Particulars	Qty	Per%	Color	Particulars	Qty	Per%
	Headstock Beam	2	100%		Centre Stiffner for Headstock	4	100%		Floor Stiffner for Headstock	4	100%
	Aux. Head stock	4	100%		Sole Bar	8.5	53%		Draft Gear Bracket	2	100%
	Trough floor	2	29%		Centre plate	2	100%		SoleBar Stiffner	6	100%
	Bottom Wall Part	8.5	53%		Body panel/patch		100%		Door Top/Roof Patch		0%
	Window Module		0%		Window Sill	40	100%		Window Bar	44	25%
	Seat pillar/lav. Partition		100%		UIC end construction		0%

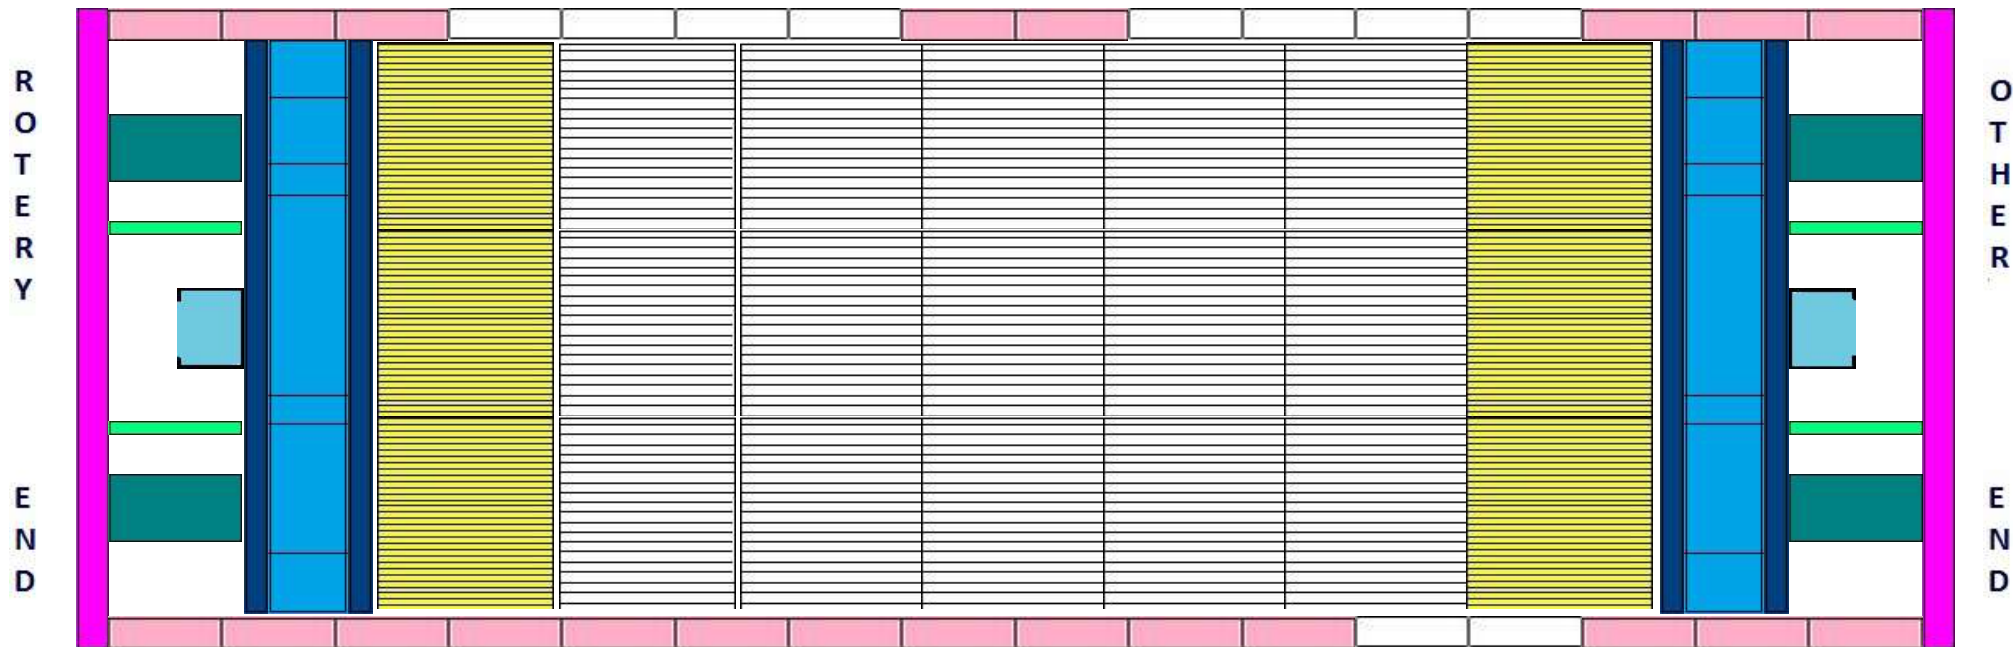
Rotary Side

Color	Particulars	Qty	Per%	Color	Particulars	Qty	Per%	Color	Particulars	Qty	Per%
Pink	Headstock Beam	2	100%	Dark Blue	Centre Stiffner for Headstock	4	100%	Light Blue	Floor Stiffner for Headstock	4	100%
Dark Blue	Aux. Head stock	4	100%	Pink	Sole Bar	11	69%	Light Blue	Draft Gear Bracket	2	100%
Yellow	Trough floor	2	29%	Light Blue	Centre plate	2	100%		SoleBar Stiffner	6	100%
	Bottom Wall Part	11	69%		Body panel/patch		100%		Door Top/Roof Patch		0%
	Window Module		0%		Window Sill	40	100%		Window Bar	48	27%
	Seat pillar/lav. Partition		100%		UIC end construction		0%

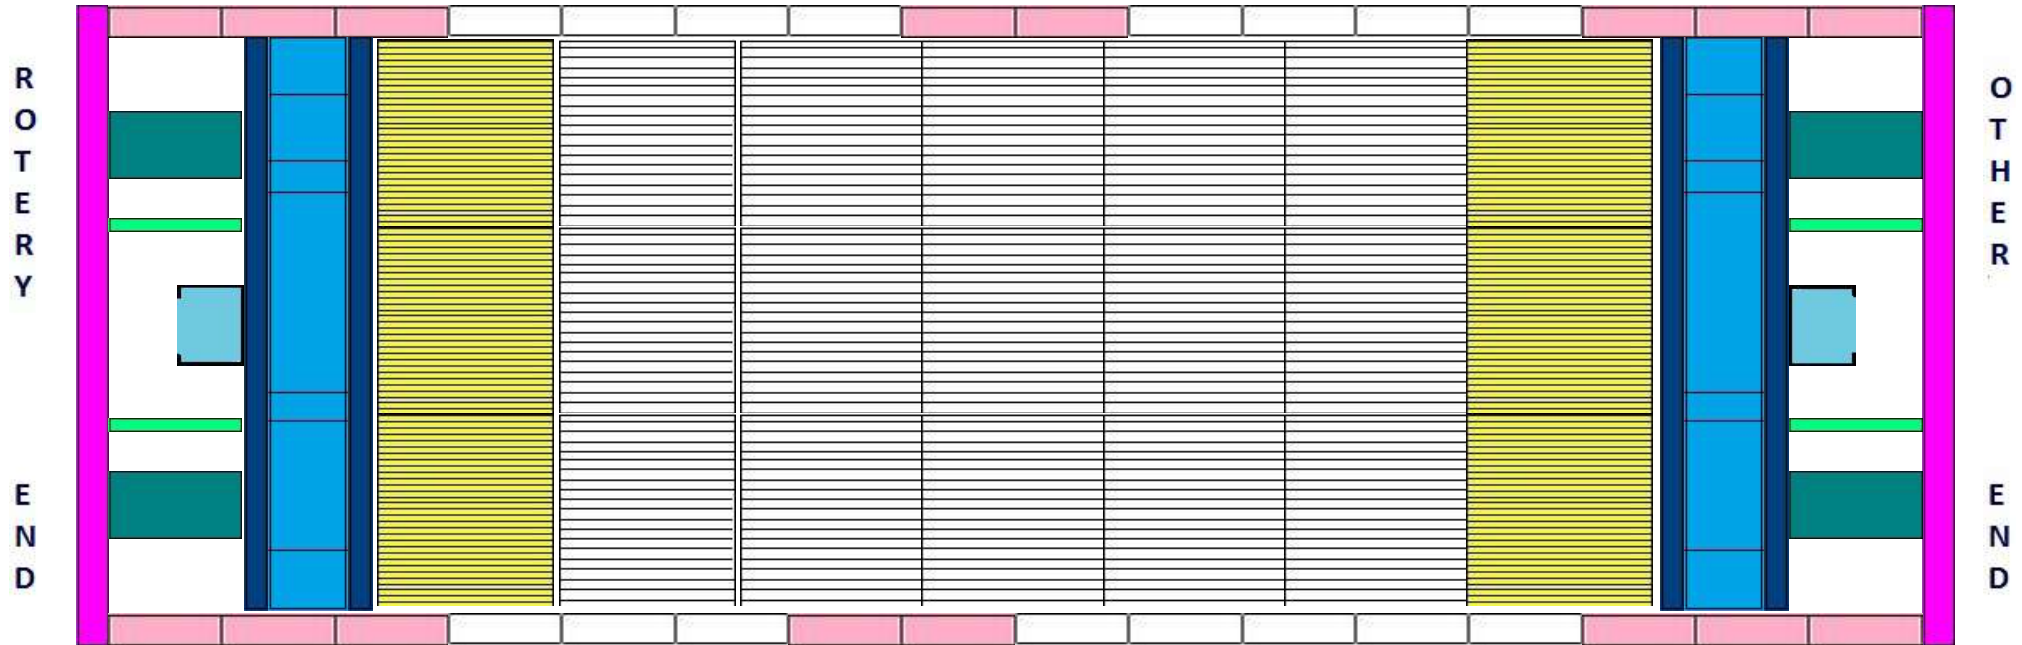
Rotary Side

Color	Particulars	Qty	Per%	Color	Particulars	Qty	Per%	Color	Particulars	Qty	Per%
	Headstock Beam	2	100%		Centre Stiffner for Headstock	4	100%		Floor Stiffner for Headstock	4	100%
	Aux. Head stock	4	100%		Sole Bar	8	50%		Draft Gear Bracket	2	100%
	Trough floor	2	29%		Centre plate	2	100%		SoleBar Stiffner	6	100%
	Bottom Wall Part	8	50%		Body panel/patch		100%		Door Top/Roof Patch		0%
	Window Module		0%		Window Sill	28	70%		Window Bar	48	27%
	Seat pillar/lav. Partition		100%		UIC end construction		0%

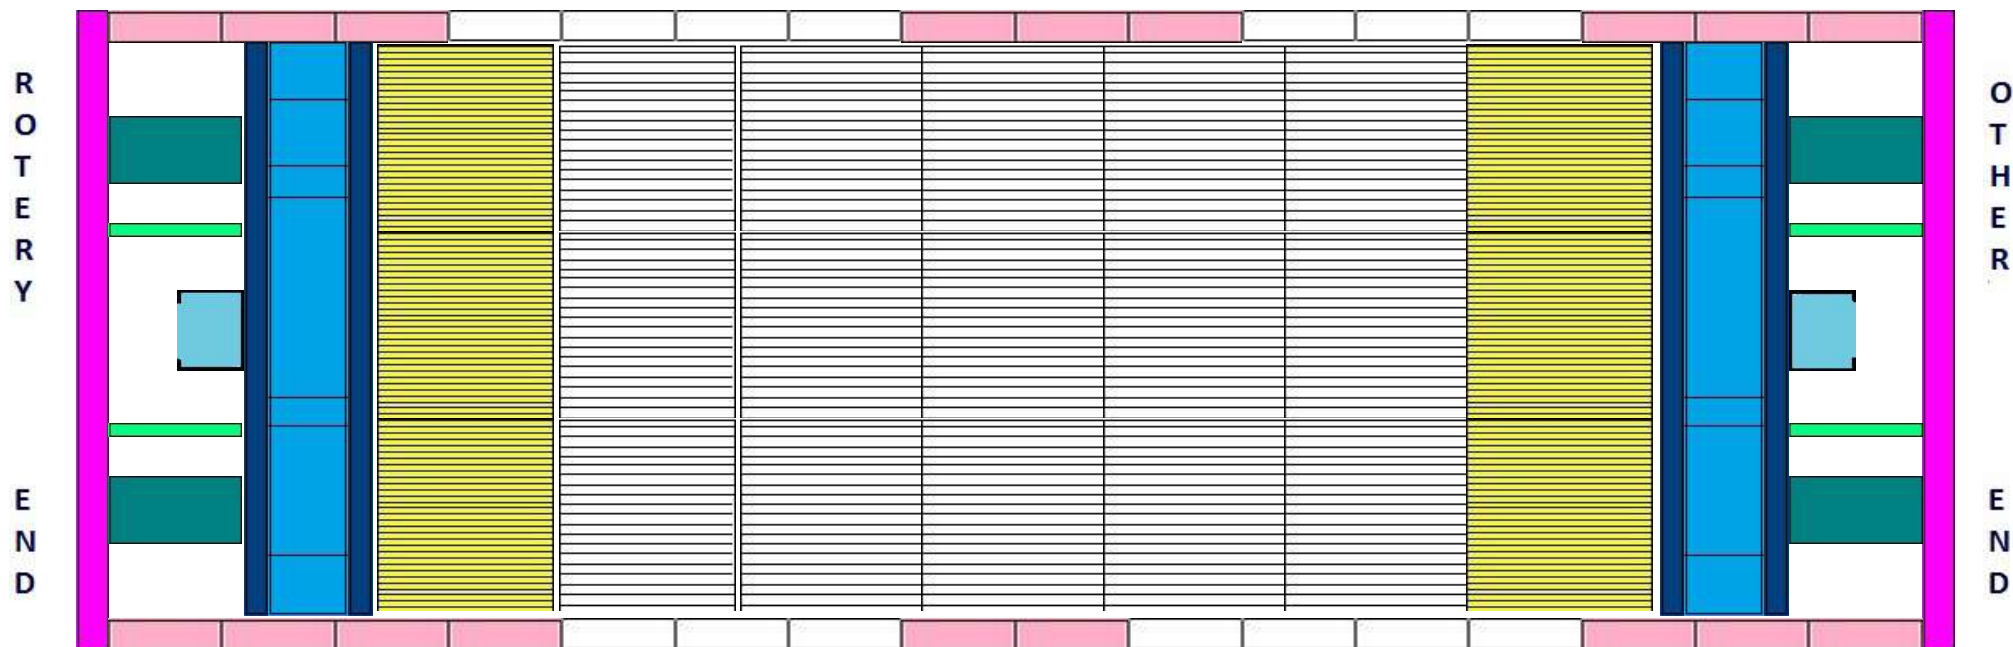
Rotary Side

Color	Particulars	Qty	Per%	Color	Particulars	Qty	Per%	Color	Particulars	Qty	Per%
Pink	Headstock Beam	2	100%	Dark Green	Centre Stiffner for Headstock	4	100%	Light Green	Floor Stiffner for Headstock	4	100%
Dark Blue	Aux. Head stock	4	100%	Pink	Sole Bar	9	56%	Blue	Draft Gear Bracket	2	100%
Yellow	Trough floor	2	29%	Light Blue	Centre plate	2	100%		SoleBar Stiffner	6	100%
	Bottom Wall Part	9	56%		Body panel/patch		100%		Door Top/Roof Patch		0%
	Window Module		0%		Window Sill	22	55%		Window Bar	48	27%
	Seat pillar/lav. Partition		100%		UIC end construction		0%

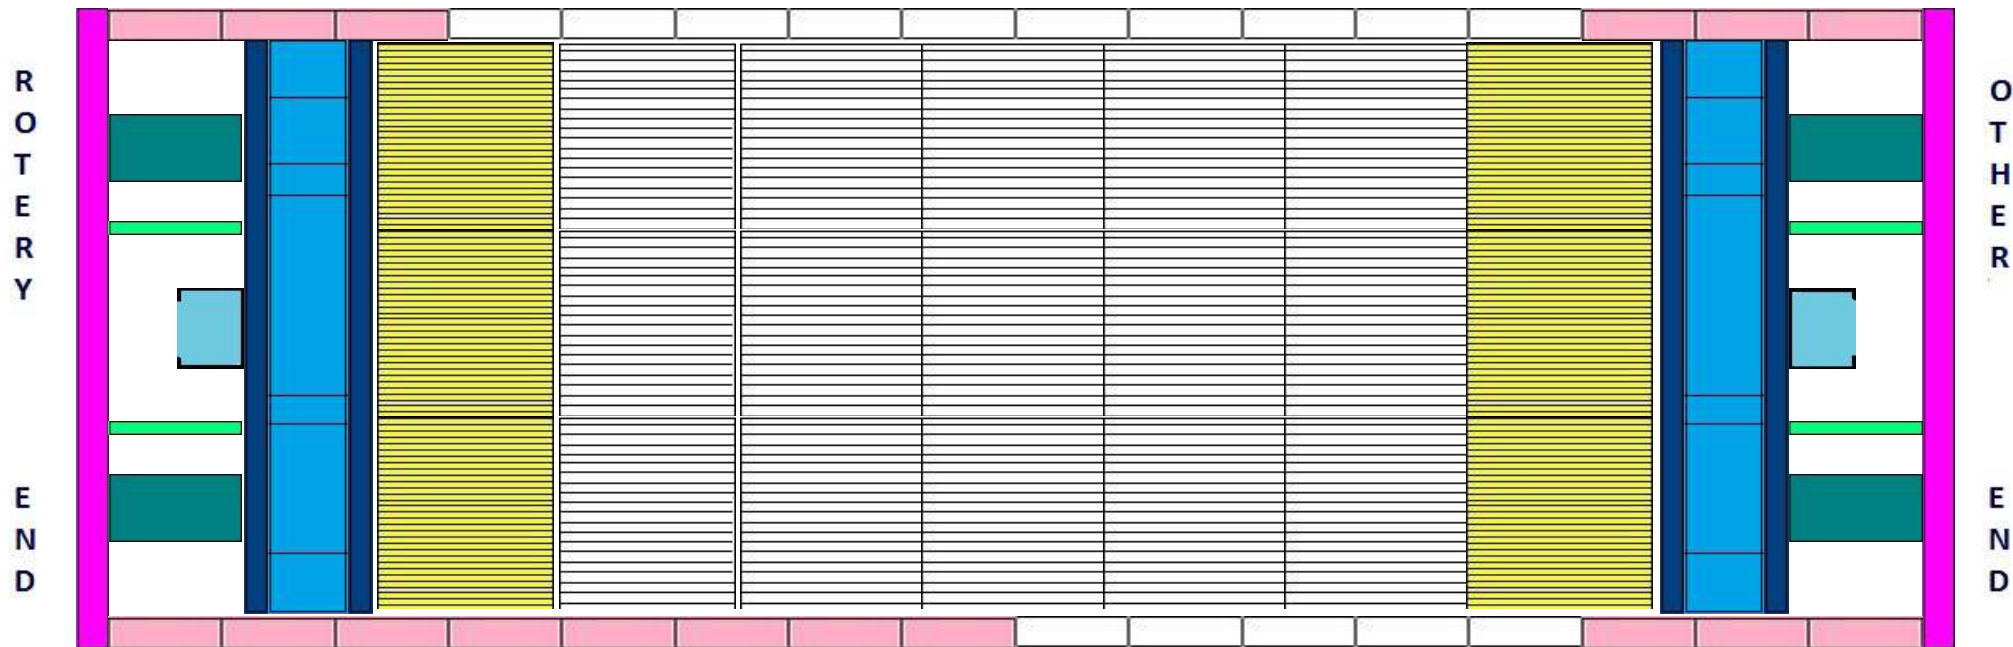
Color	Particulars	Qty	Per%	Color	Particulars	Qty	Per%	Color	Particulars	Qty	Per%
Yellow	Headstock Beam	2	100%	Dark Green	Centre Stiffner for Headstock	4	100%	Light Green	Floor Stiffner for Headstock	4	100%
Dark Blue	Aux. Head stock	4	100%	Pink	Sole Bar	8.5	53%	Light Blue	Draft Gear Bracket	2	100%
Yellow	Trough floor	2	29%	Light Blue	Centre plate	2	100%		SoleBar Stiffner	4	100%
	Bottom Wall Part	8.5	53%		Body panel/patch		100%		Door Top/Roof Patch		0%
	Window Module		0%		Window Sill	40	100%		Window Bar	44	24%
	Seat pillar/lav. Partition		100%		UIC end construction		0%

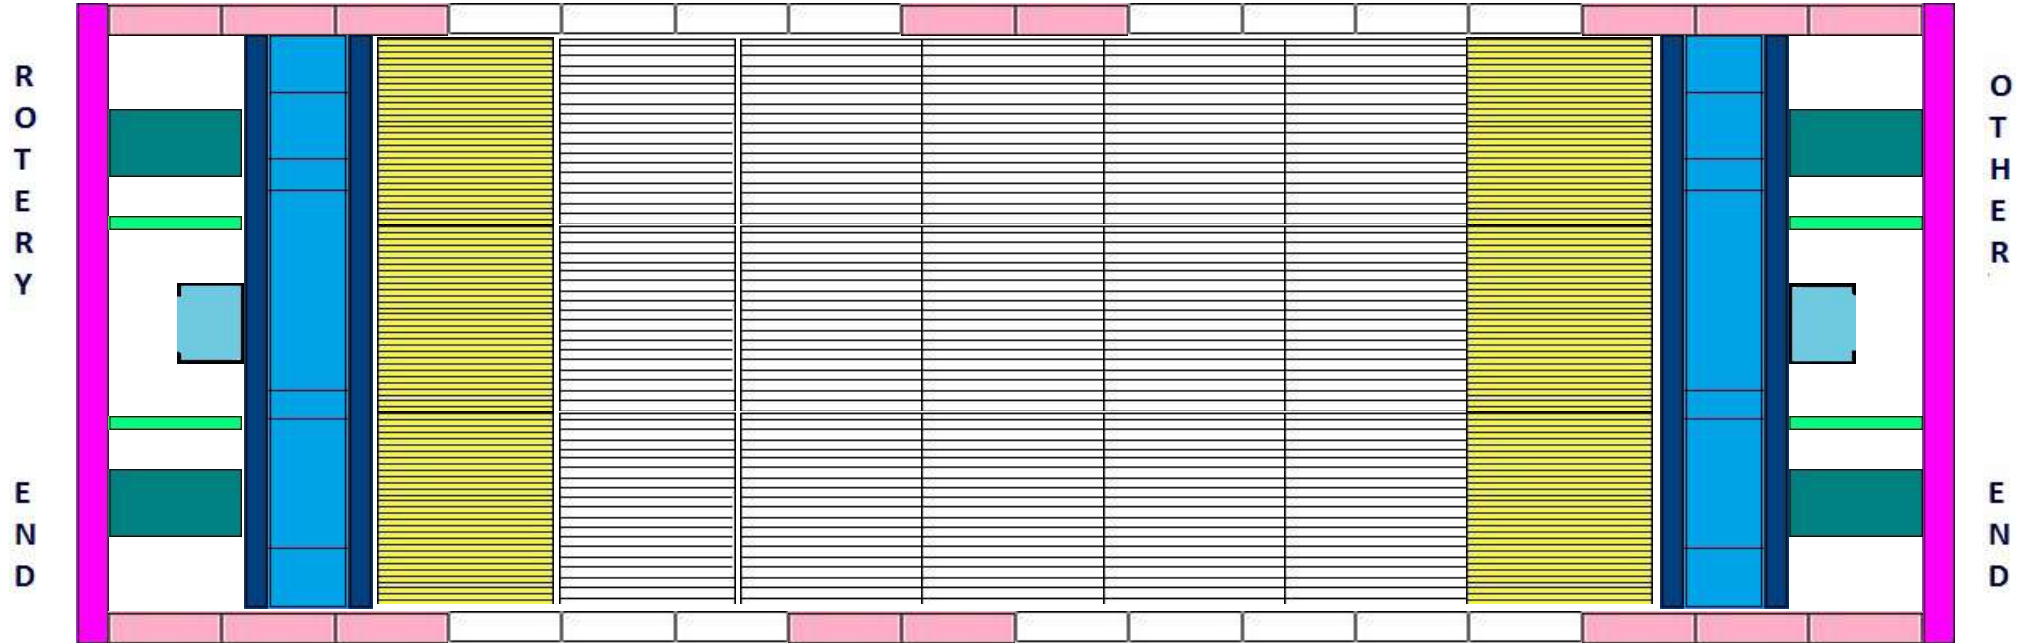
Rotary Side

Color	Particulars	Qty	Per%	Color	Particulars	Qty	Per%	Color	Particulars	Qty	Per%
	Headstock Beam	2	100%		Centre Stiffner for Headstock	4	100%		Floor Stiffner for Headstock	4	100%
	Aux. Head stock	4	100%		Sole Bar	8	50%		Draft Gear Bracket	2	100%
	Trough floor	2	29%		Centre plate	2	100%		SoleBar Stiffner	6	100%
	Bottom Wall Part	8	50%		Body panel/patch		100%		Door Top/Roof Patch		0%
	Window Module		0%		Window Sill	40	100%		Window Bar	58	33%
	Seat pillar/lav. Partition		100%		UIC end construction		0%

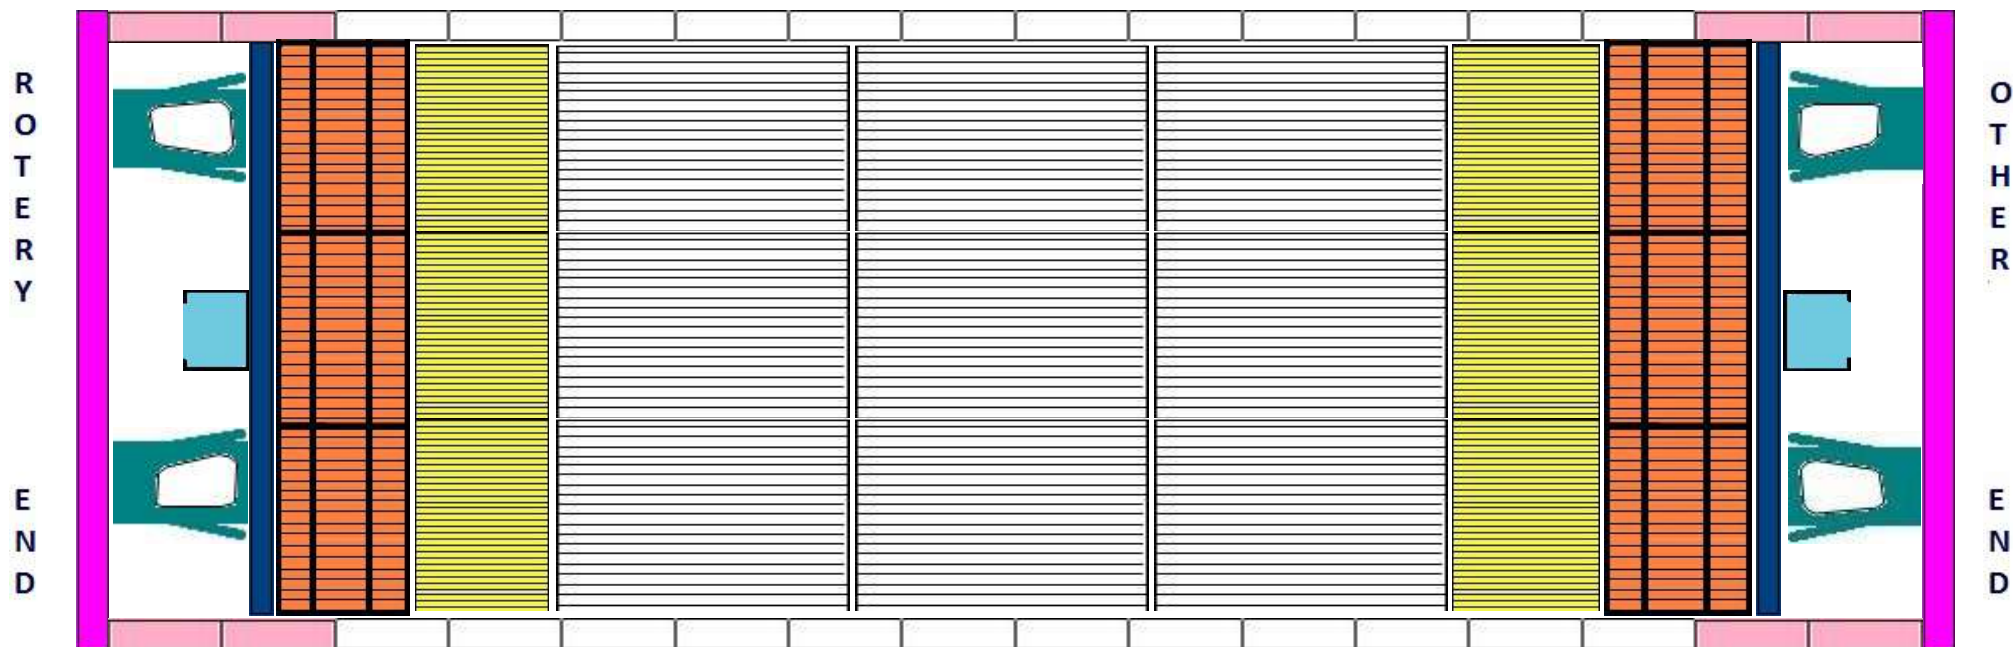
Rotary Side

Color	Particulars	Qty	Per%	Color	Particulars	Qty	Per%	Color	Particulars	Qty	Per%
	Headstock Beam	2	100%		Diagonal	4	100%		Logitudinal Channel Structure	2	100%
	Aux. Head stock	2	100%		Sole Bar	4	25%		Draft Gear Bracket	2	100%
	Trough floor	2	40%		Bottom Wall Part	4	25%		Body panel/patch		100%
	Door Top/Roof Patch		0%		Seat Bracket Rail		0%		Window Sill	8	20%
	Window Bar	24	13%		Seat pillar/lav. Partition		100%		UIC end construction		0%
	Body Pillar Part	22	100%

End Drooping: Rotary End - EAST : -2, WEST : -3 Other End - EAST : -2, WEST : -5
Start Date : 05-Apr-2019, Completion Date : 15-Apr-2019, Net Repair Days : 9, Total Man Hours : 1032
