Coach Rehabilitation Workshop, WC Railway, Bhopal

(An IMS and ISO 50001 Certified Workshop)
Final Inspection Sheet - Details of Corrosion Repair

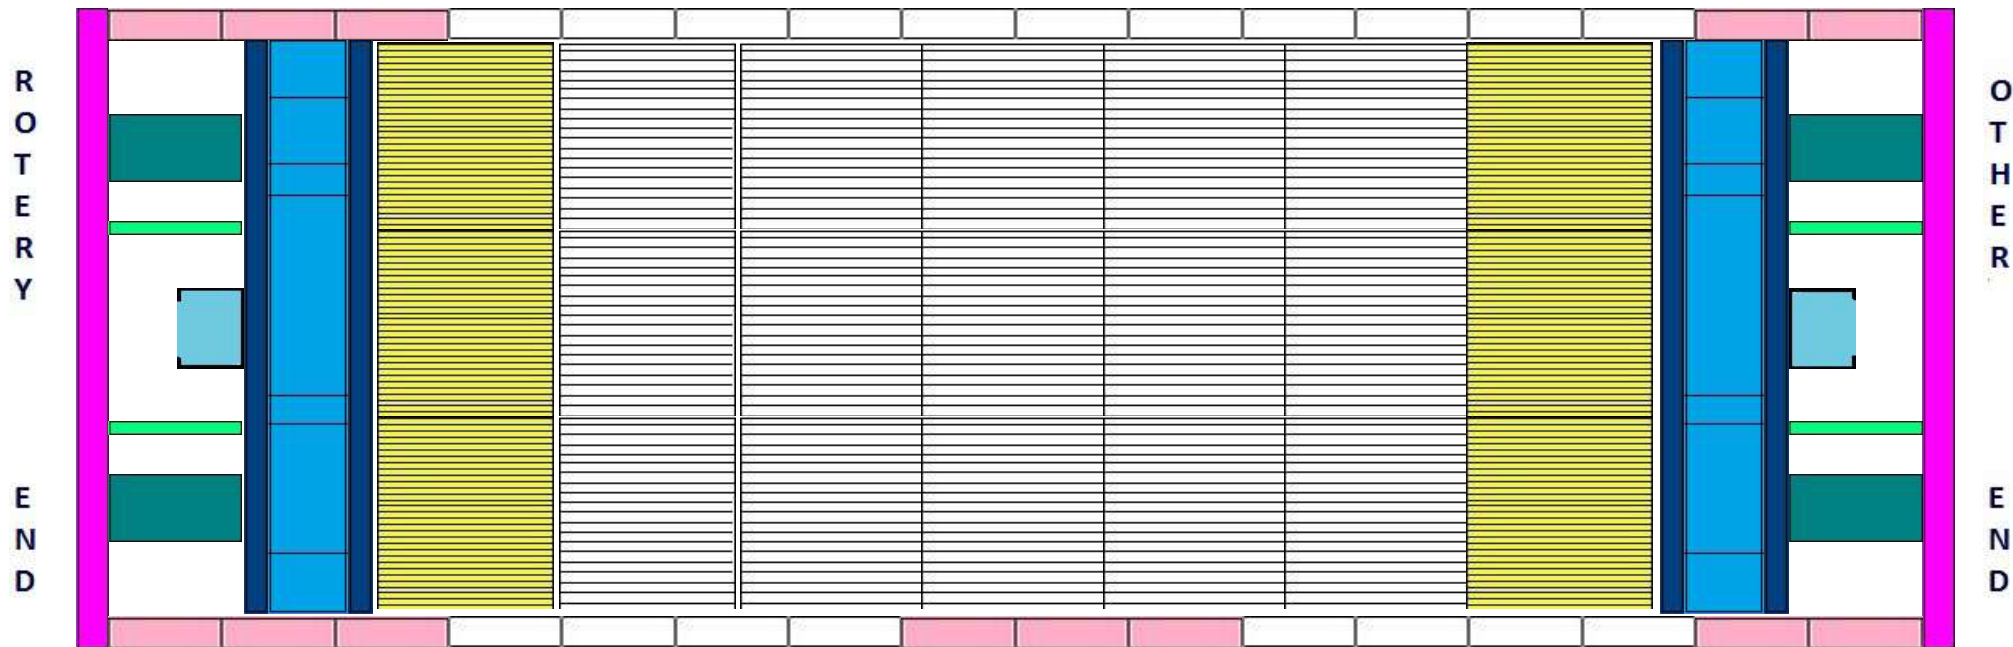
Rotary Side

Color	Particulars	Qty	Per%	Color	Particulars	Qty	Per%	Color	Particulars	Qty	Per%
	Headstock Beam	2	100%		Centre Stiffner for Headstock	4	100%		Floor Stiffner for Headstock	4	100%
	Aux. Head stock	4	100%		Sole Bar	6.5	41%		Draft Gear Bracket	2	100%
	Trough floor	2	29%		Centre plate	2	100%		SoleBar Stiffner	4	100%
	Bottom Wall Part	6.5	41%		Body panel/patch		100%		Door Top/Roof Patch		0%
	Window Module		3%		Window Sill	0	0%		Window Bar	0	0%
	Seat pillar/lav. Partition		100%		UIC end construction		0%

End Drooping: Rotary End - EAST : -7, WEST : -5 Other End - EAST : -4, WEST : -4
Start Date : 17-May-2019, Completion Date : 28-May-2019, Net Repair Days : 10, Total Man Hours : 0

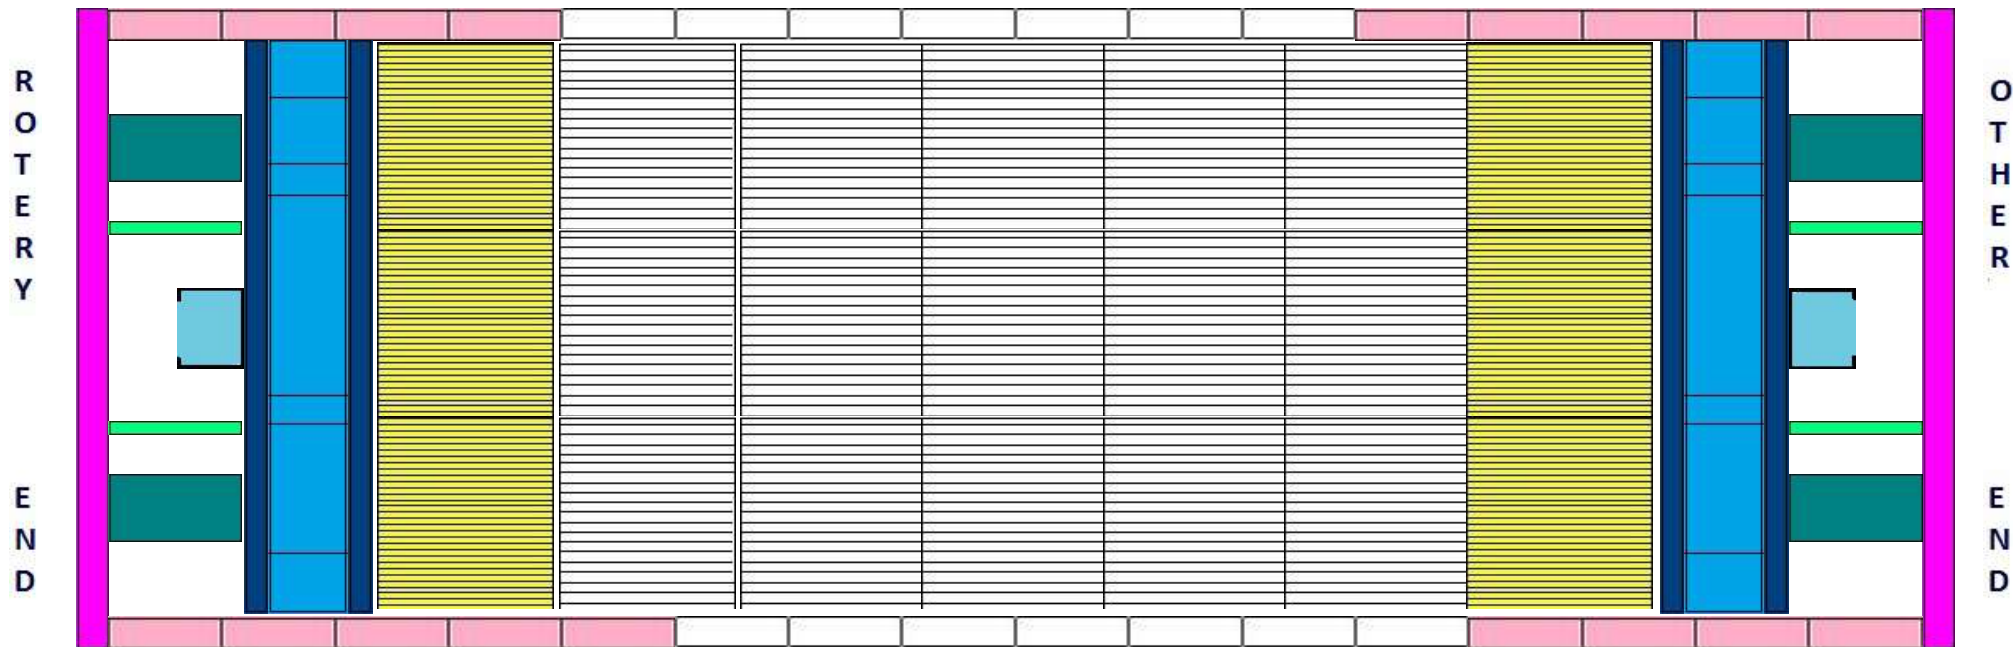
Rotary Side

Color	Particulars	Qty	Per%	Color	Particulars	Qty	Per%	Color	Particulars	Qty	Per%
Pink	Headstock Beam	2	100%	Dark Blue	Centre Stiffner for Headstock	4	100%	Green	Floor Stiffner for Headstock	4	100%
Dark Blue	Aux. Head stock	4	100%	Pink	Sole Bar	9	56%	Light Blue	Draft Gear Bracket	2	100%
Yellow	Trough floor	2	29%	Light Blue	Centre plate	2	100%		SoleBar Stiffner	4	100%
	Bottom Wall Part	9	56%		Body panel/patch		100%		Door Top/Roof Patch		0%
	Window Module		6%		Window Sill	0	0%		Window Bar	0	0%
	Seat pillar/lav. Partition		100%		UIC end construction		0%

End Drooping: Rotary End - EAST : 5, WEST : 5 Other End - EAST : 2, WEST : 6
Start Date : 09-May-2019, Completion Date : 24-May-2019, Net Repair Days : 14, Total Man Hours : 1376

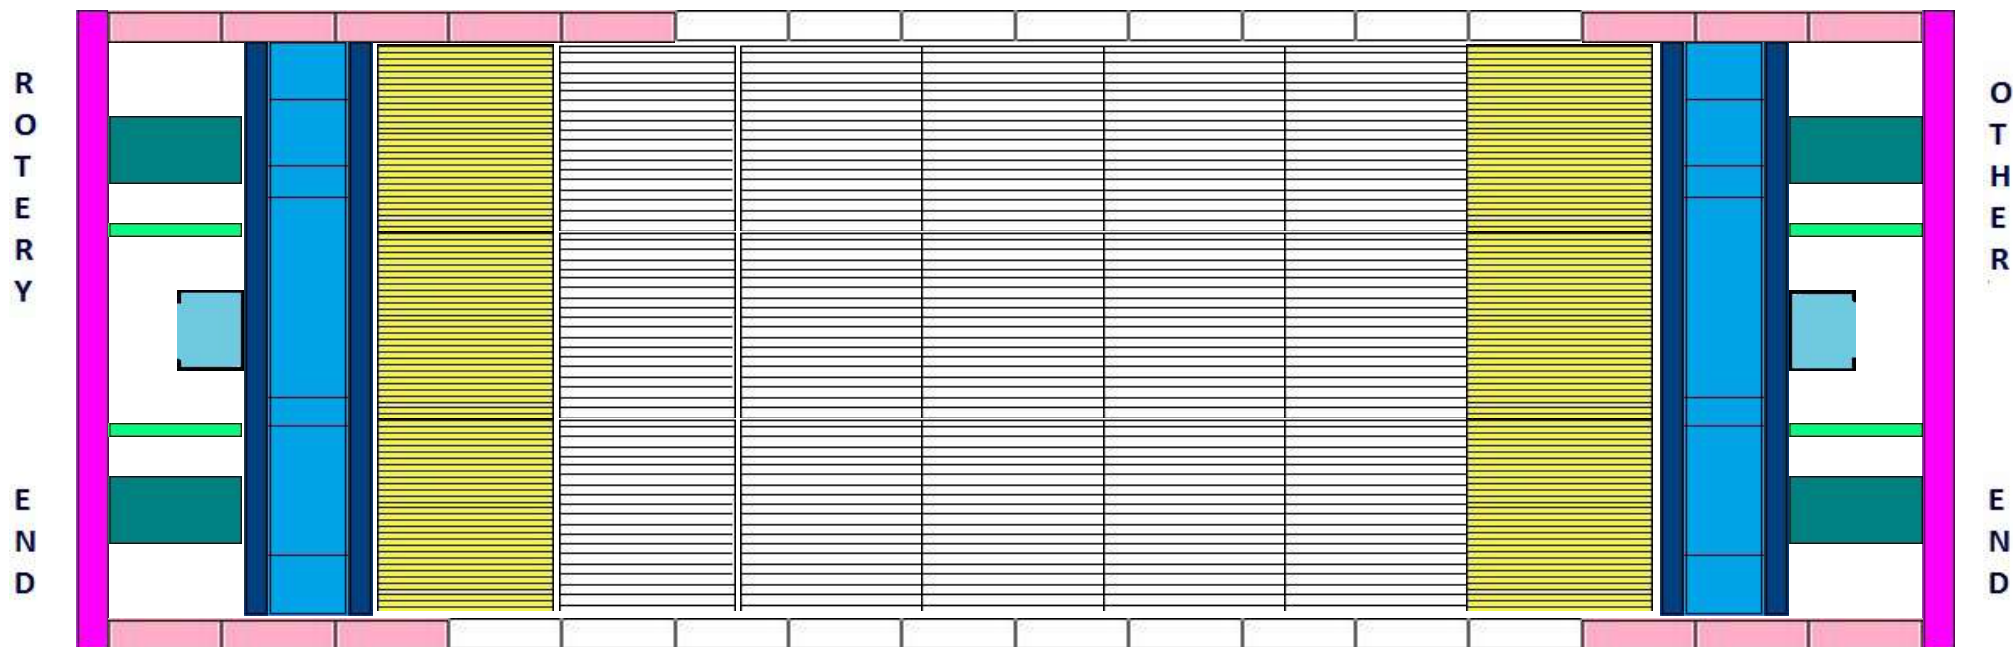
Rotary Side

Color	Particulars	Qty	Per%	Color	Particulars	Qty	Per%	Color	Particulars	Qty	Per%
Pink	Headstock Beam	2	100%	Dark Green	Centre Stiffner for Headstock	4	100%	Light Green	Floor Stiffner for Headstock	4	100%
Dark Blue	Aux. Head stock	4	100%	Pink	Sole Bar	7	44%	Light Blue	Draft Gear Bracket	2	100%
Yellow	Trough floor	2	29%	Blue	Centre plate	2	100%		SoleBar Stiffner	4	100%
	Bottom Wall Part	7	44%		Body panel/patch		100%		Door Top/Roof Patch		0%
	Window Module		0%		Window Sill	28	70%		Window Bar	40	22%
	Seat pillar/lav. Partition		100%		UIC end construction		0%

End Drooping: Rotary End - EAST : 5, WEST : 5 Other End - EAST : 7, WEST : 5
Start Date : 02-May-2019, Completion Date : 10-May-2019, Net Repair Days : 8, Total Man Hours : 1076

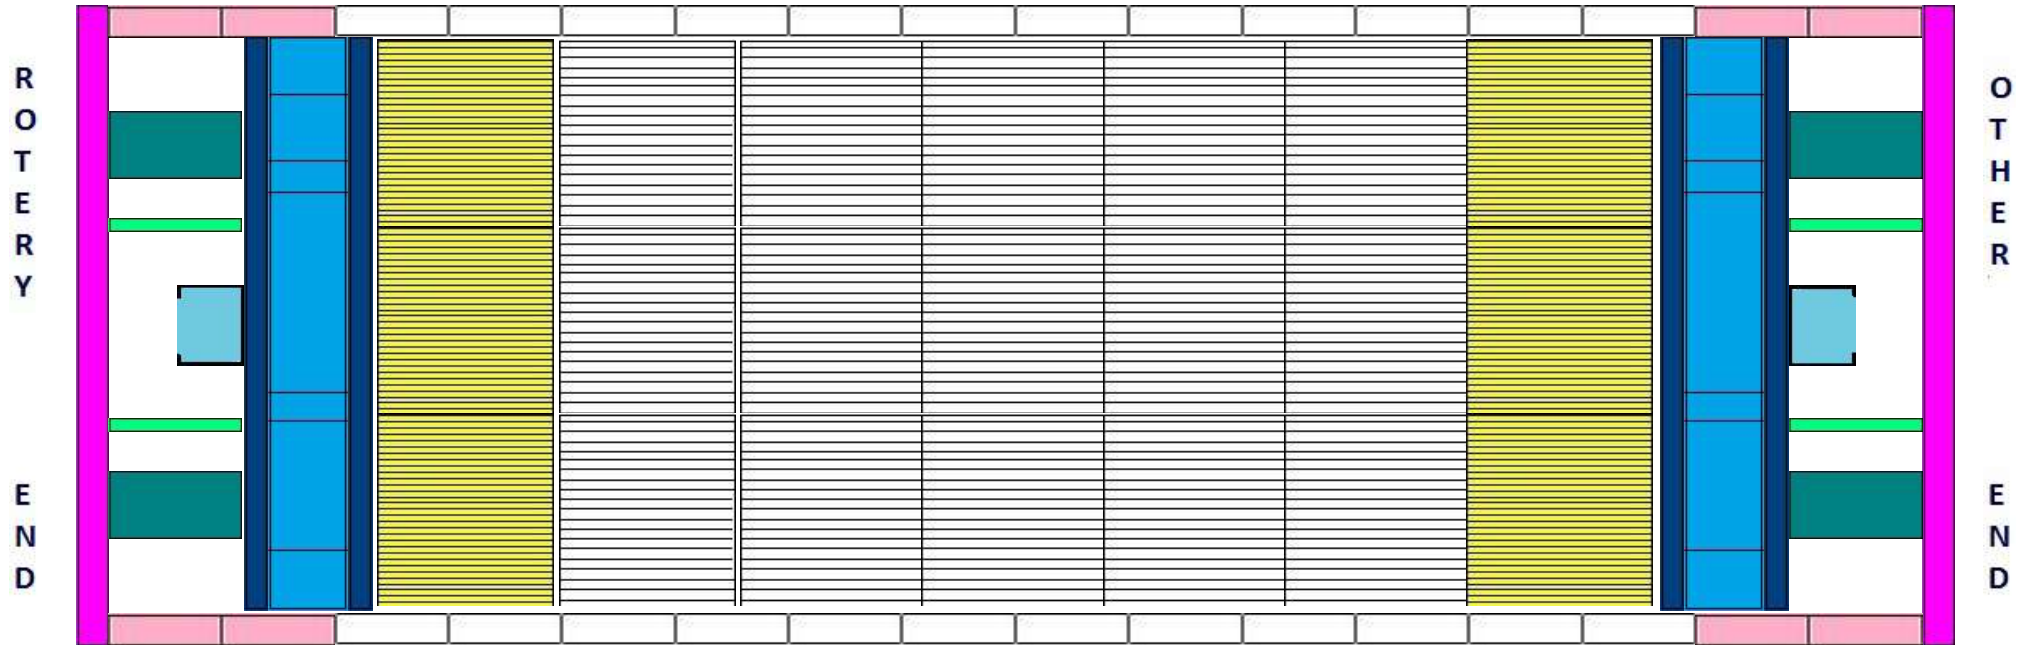
Rotary Side

Color	Particulars	Qty	Per%	Color	Particulars	Qty	Per%	Color	Particulars	Qty	Per%
Pink	Headstock Beam	2	100%	Dark Blue	Centre Stiffner for Headstock	4	100%	Light Green	Floor Stiffner for Headstock	4	100%
Dark Blue	Aux. Head stock	4	100%	Pink	Sole Bar	4	25%	Light Blue	Draft Gear Bracket	2	100%
Yellow	Trough floor	2	29%	Light Blue	Centre plate	2	100%		SoleBar Stiffner	4	100%
	Bottom Wall Part	4	25%		Body panel/patch		100%		Door Top/Roof Patch		0%
	Window Module		0%		Window Sill	40	100%		Window Bar	44	24%
	Seat pillar/lav. Partition		100%		UIC end construction		0%

End Drooping: Rotary End - EAST : -4, WEST : -6 Other End - EAST : 5, WEST : 2
Start Date : 30-Apr-2019, Completion Date : 09-May-2019, Net Repair Days : 9, Total Man Hours : 940

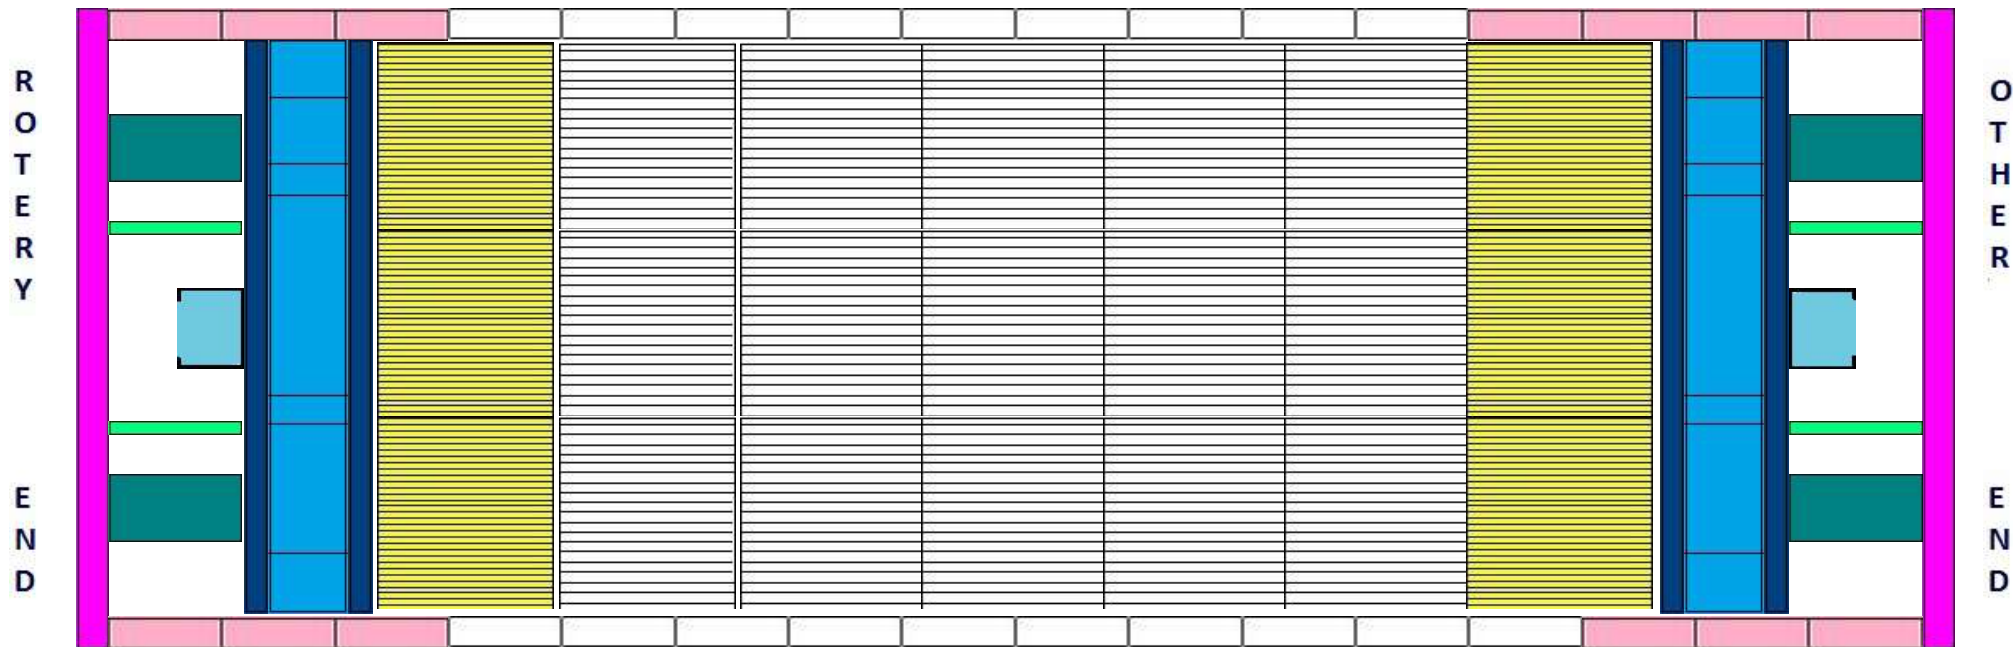
Color	Particulars	Qty	Per%	Color	Particulars	Qty	Per%	Color	Particulars	Qty	Per%
Yellow	Headstock Beam	2	100%	Dark Green	Centre Stiffner for Headstock	4	100%	Light Green	Floor Stiffner for Headstock	4	100%
Dark Blue	Aux. Head stock	4	100%	Pink	Sole Bar	6.5	41%	Light Blue	Draft Gear Bracket	2	100%
Yellow	Trough floor	2	29%	Light Blue	Centre plate	2	100%		SoleBar Stiffner	4	100%
	Bottom Wall Part	6.5	41%		Body panel/patch		100%		Door Top/Roof Patch		0%
	Window Module		4%		Window Sill	0	0%		Window Bar	0	0%
	Seat pillar/lav. Partition		100%		UIC end construction		0%

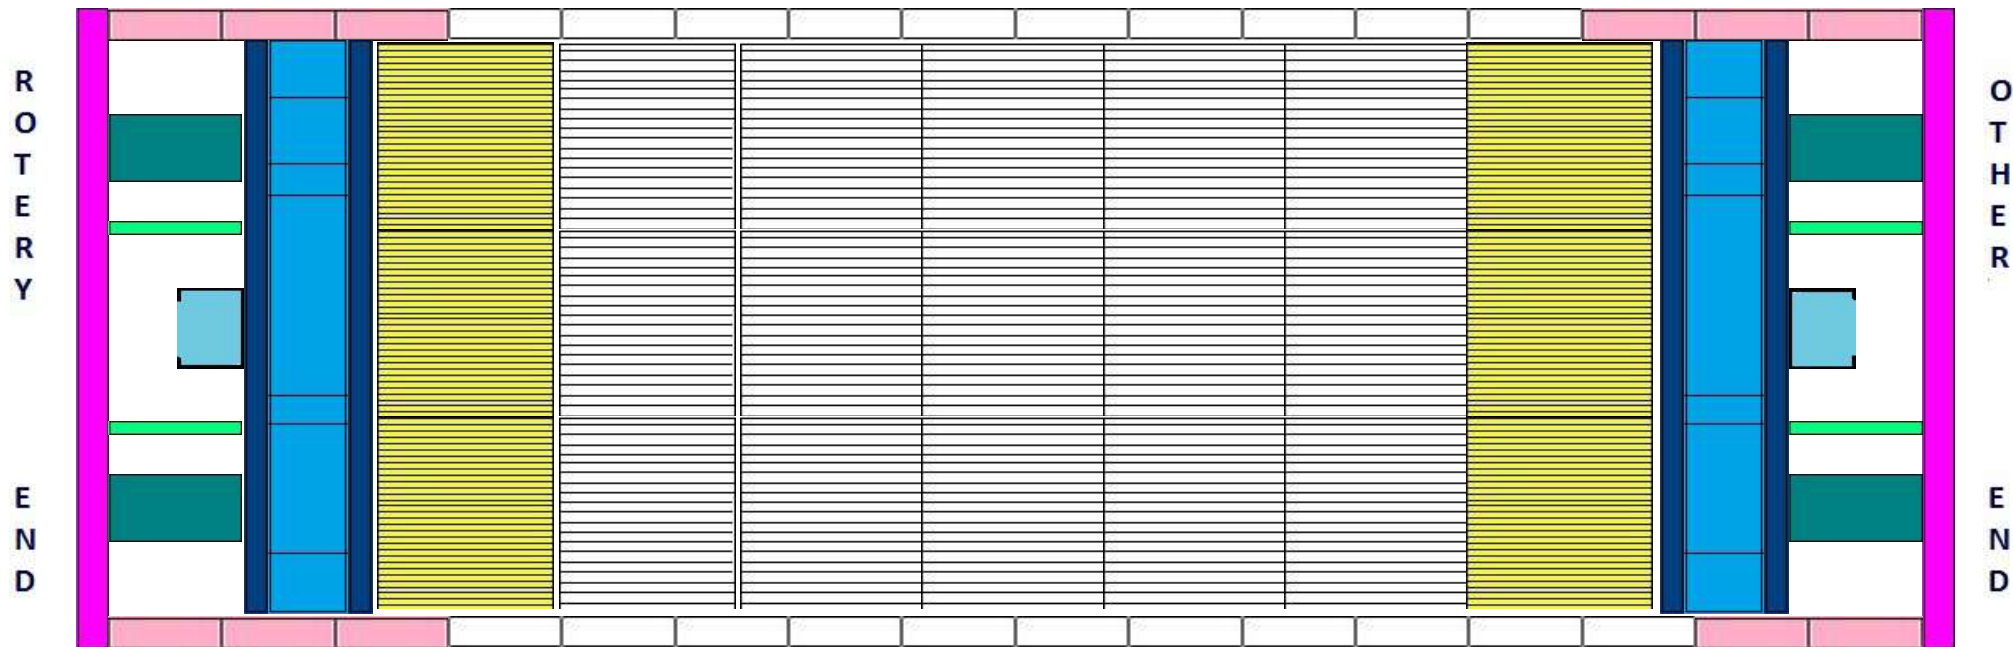
Rotary Side

Color	Particulars	Qty	Per%	Color	Particulars	Qty	Per%	Color	Particulars	Qty	Per%
	Headstock Beam	2	100%		Centre Stiffner for Headstock	4	100%		Floor Stiffner for Headstock	4	100%
	Aux. Head stock	4	100%		Sole Bar	5.5	34%		Draft Gear Bracket	2	100%
	Trough floor	2	29%		Centre plate	2	100%		SoleBar Stiffner	4	100%
	Bottom Wall Part	5.5	34%		Body panel/patch		100%		Door Top/Roof Patch		0%
	Window Module		0%		Window Sill	40	100%		Window Bar	40	22%
	Seat pillar/lav. Partition		100%		UIC end construction		0%

End Drooping: Rotary End - EAST : -2, WEST : -6 Other End - EAST : 6, WEST : 2
Start Date : 06-Sep-2019, Completion Date : 17-Sep-2019, Net Repair Days : 10, Total Man Hours : 1068

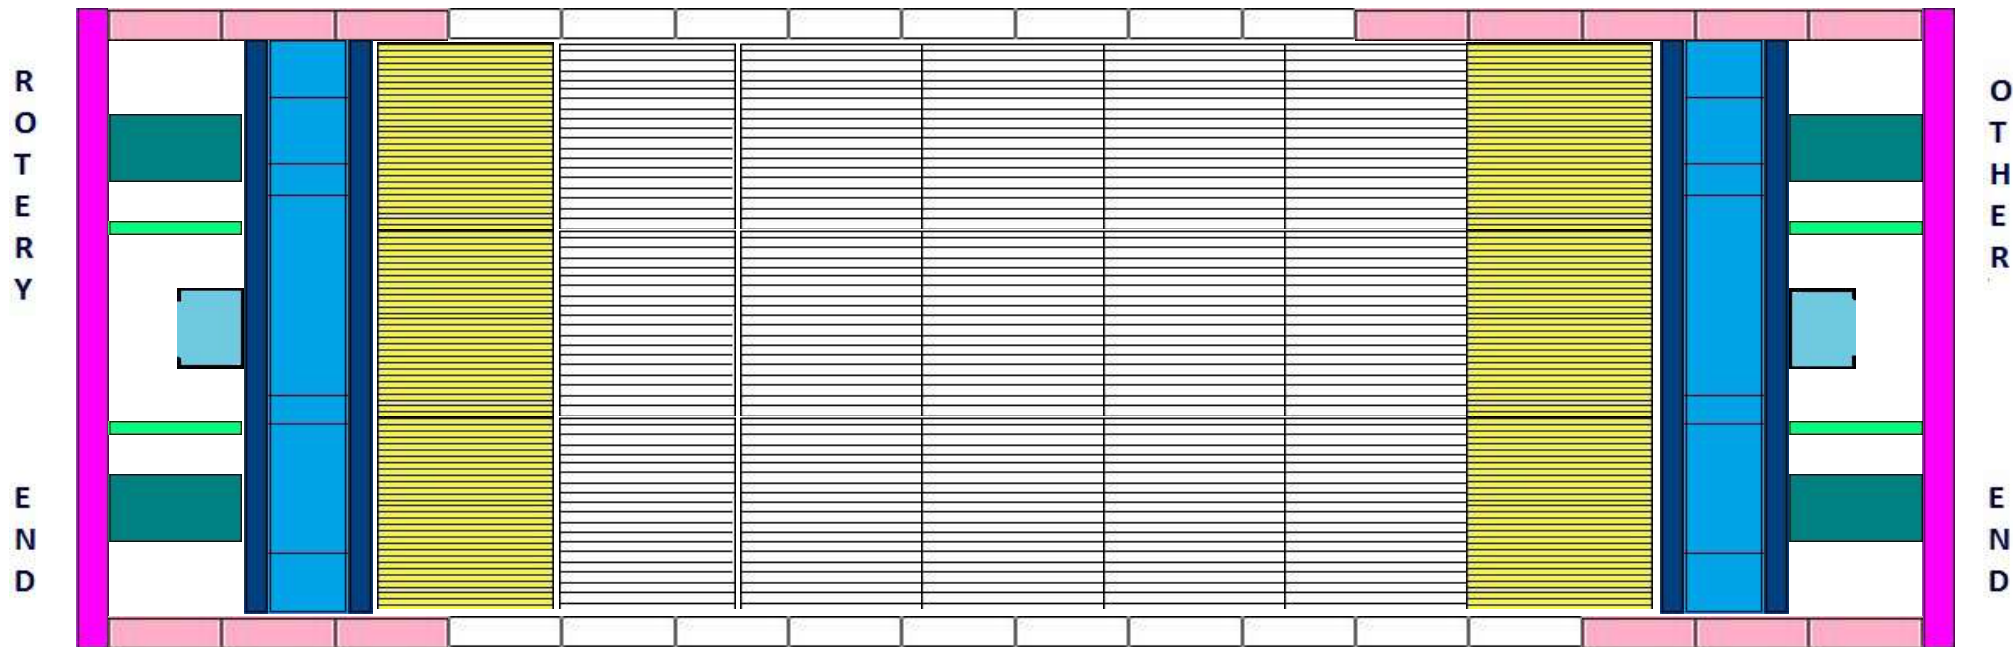
Rotary Side

Color	Particulars	Qty	Per%	Color	Particulars	Qty	Per%	Color	Particulars	Qty	Per%
	Headstock Beam	2	100%		Centre Stiffner for Headstock	4	100%		Floor Stiffner for Headstock	4	100%
	Aux. Head stock	4	100%		Sole Bar	7	44%		Draft Gear Bracket	2	100%
	Trough floor	2	29%		Centre plate	2	100%		SoleBar Stiffner	4	100%
	Bottom Wall Part	7	44%		Body panel/patch		100%		Door Top/Roof Patch		0%
	Window Module		0%		Window Sill	28	70%		Window Bar	40	22%
	Seat pillar/lav. Partition		100%		UIC end construction		0%

End Drooping: Rotary End - EAST : 6, WEST : 4 Other End - EAST : 0, WEST : 3
Start Date : 07-Sep-2019, Completion Date : 18-Sep-2019, Net Repair Days : 10, Total Man Hours : 1232

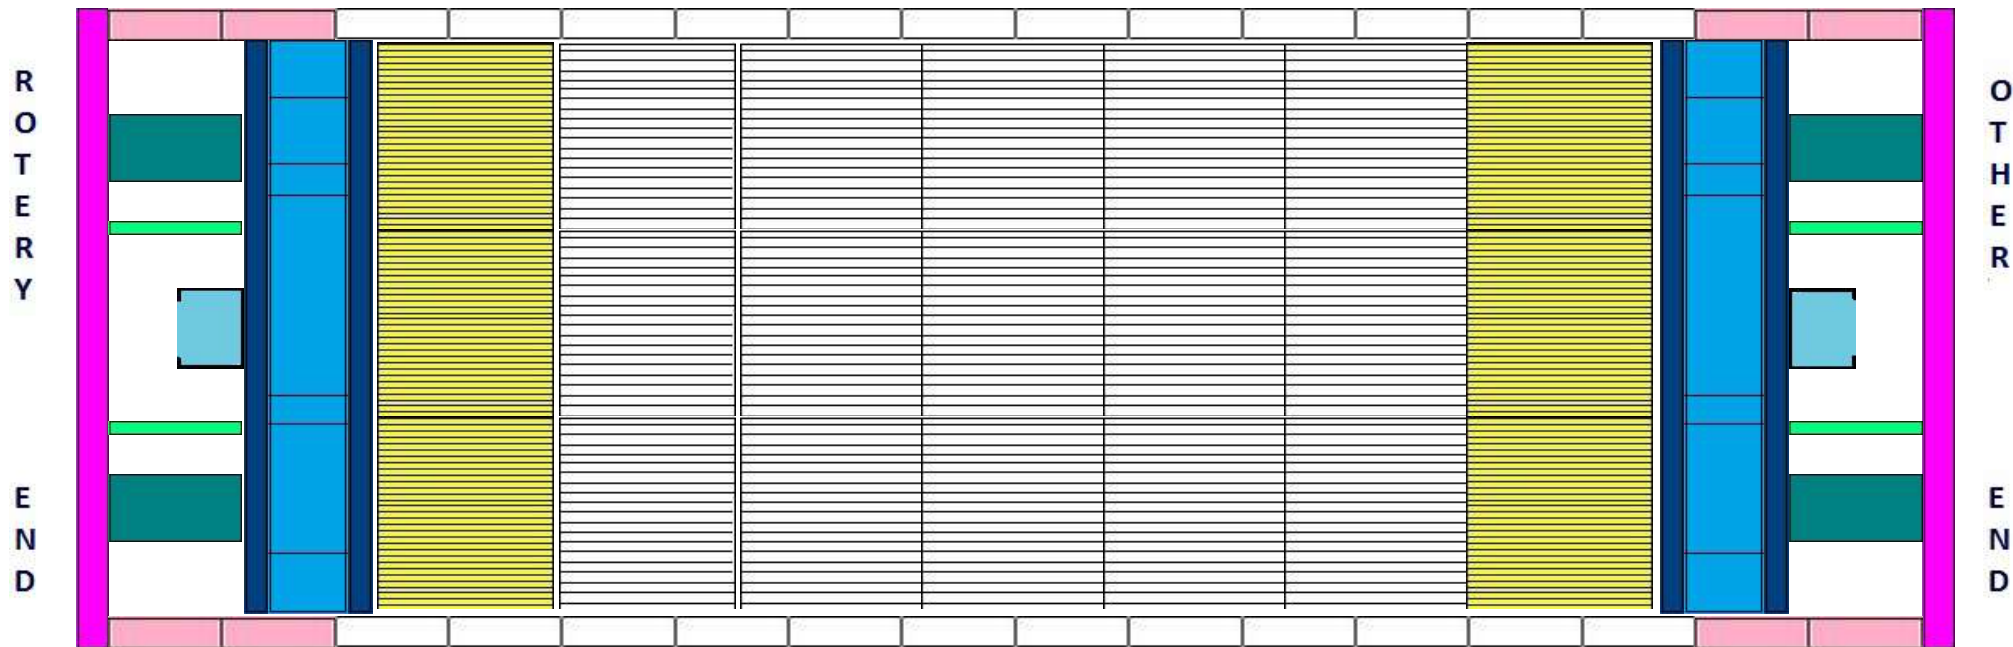
Rotary Side

Color	Particulars	Qty	Per%	Color	Particulars	Qty	Per%	Color	Particulars	Qty	Per%
	Headstock Beam	2	100%		Centre Stiffner for Headstock	4	100%		Floor Stiffner for Headstock	4	100%
	Aux. Head stock	4	100%		Sole Bar	4	25%		Draft Gear Bracket	2	100%
	Trough floor	2	29%		Centre plate	2	100%		SoleBar Stiffner	4	100%
	Bottom Wall Part	4	25%		Body panel/patch		100%		Door Top/Roof Patch		0%
	Window Module		0%		Window Sill	24	60%		Window Bar	42	23%
	Seat pillar/lav. Partition		100%		UIC end construction		0%

End Drooping: Rotary End - EAST : 2, WEST : 5 Other End - EAST : -3, WEST : -6
Start Date : 07-Sep-2019, Completion Date : 16-Sep-2019, Net Repair Days : 8, Total Man Hours : 1136

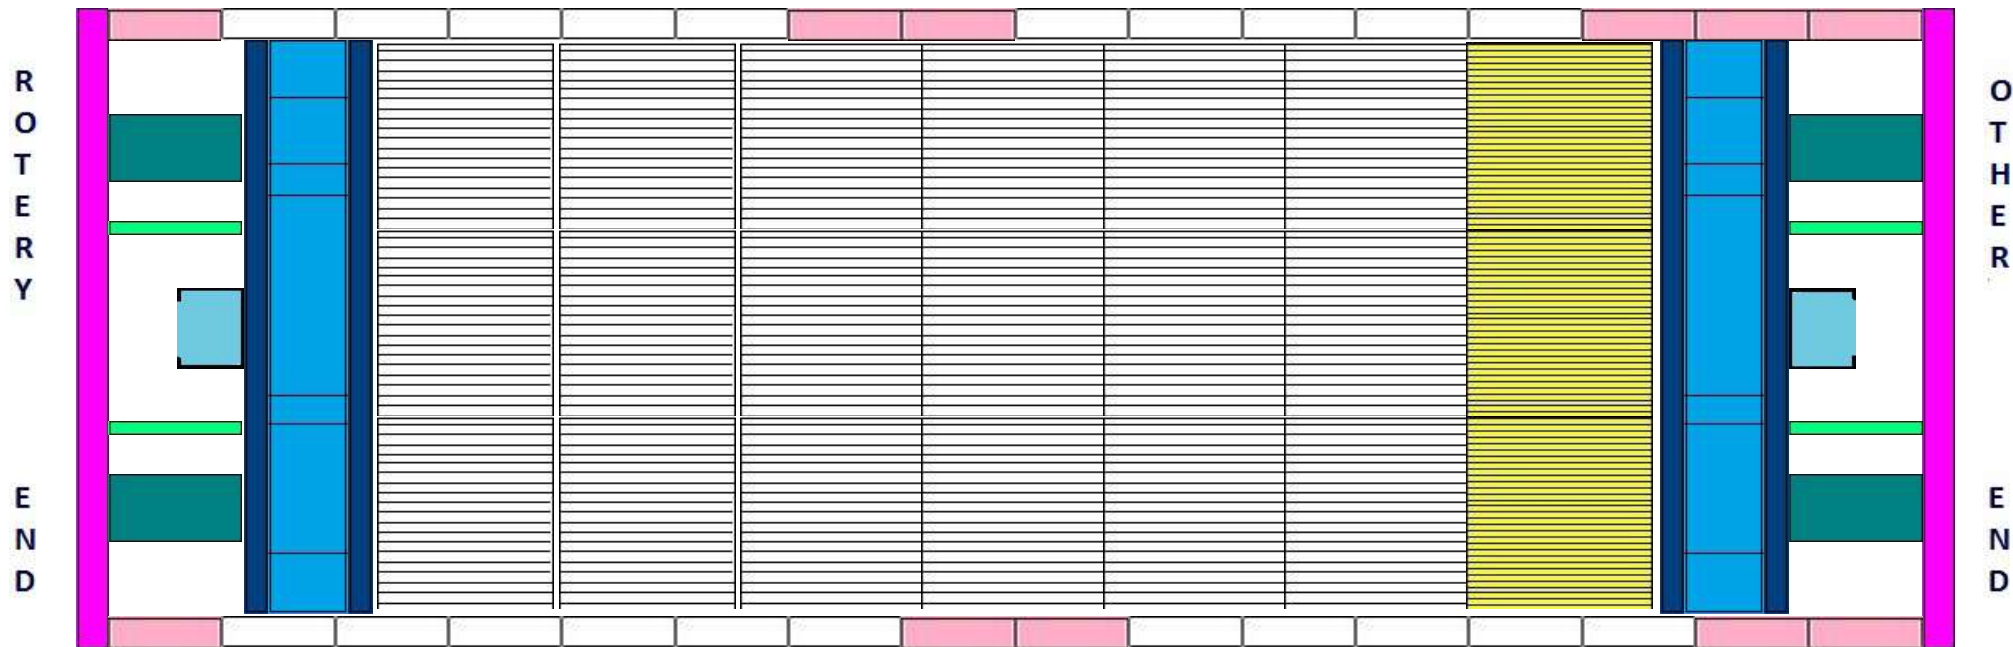
Rotary Side

Color	Particulars	Qty	Per%	Color	Particulars	Qty	Per%	Color	Particulars	Qty	Per%
Yellow	Headstock Beam	2	100%	Blue	Centre Stiffner for Headstock	4	100%	Red	Floor Stiffner for Headstock	4	100%
Green	Aux. Head stock	4	100%	Orange	Sole Bar	5.5	34%	Light Blue	Draft Gear Bracket	2	100%
Purple	Trough floor	1	14%	Dark Blue	Centre plate	2	100%		SoleBar Stiffner	4	100%
	Bottom Wall Part	5.5	34%		Body panel/patch		100%		Door Top/Roof Patch		0%
	Window Module		0%		Window Sill	10	28%		Window Bar	20	12%
	Seat pillar/lav. Partition		100%		UIC end construction		0%

End Drooping: Rotary End - EAST : 5, WEST : 5 Other End - EAST : 5, WEST : 2
Start Date : 06-Sep-2019, Completion Date : 12-Sep-2019, Net Repair Days : 6, Total Man Hours : 1040

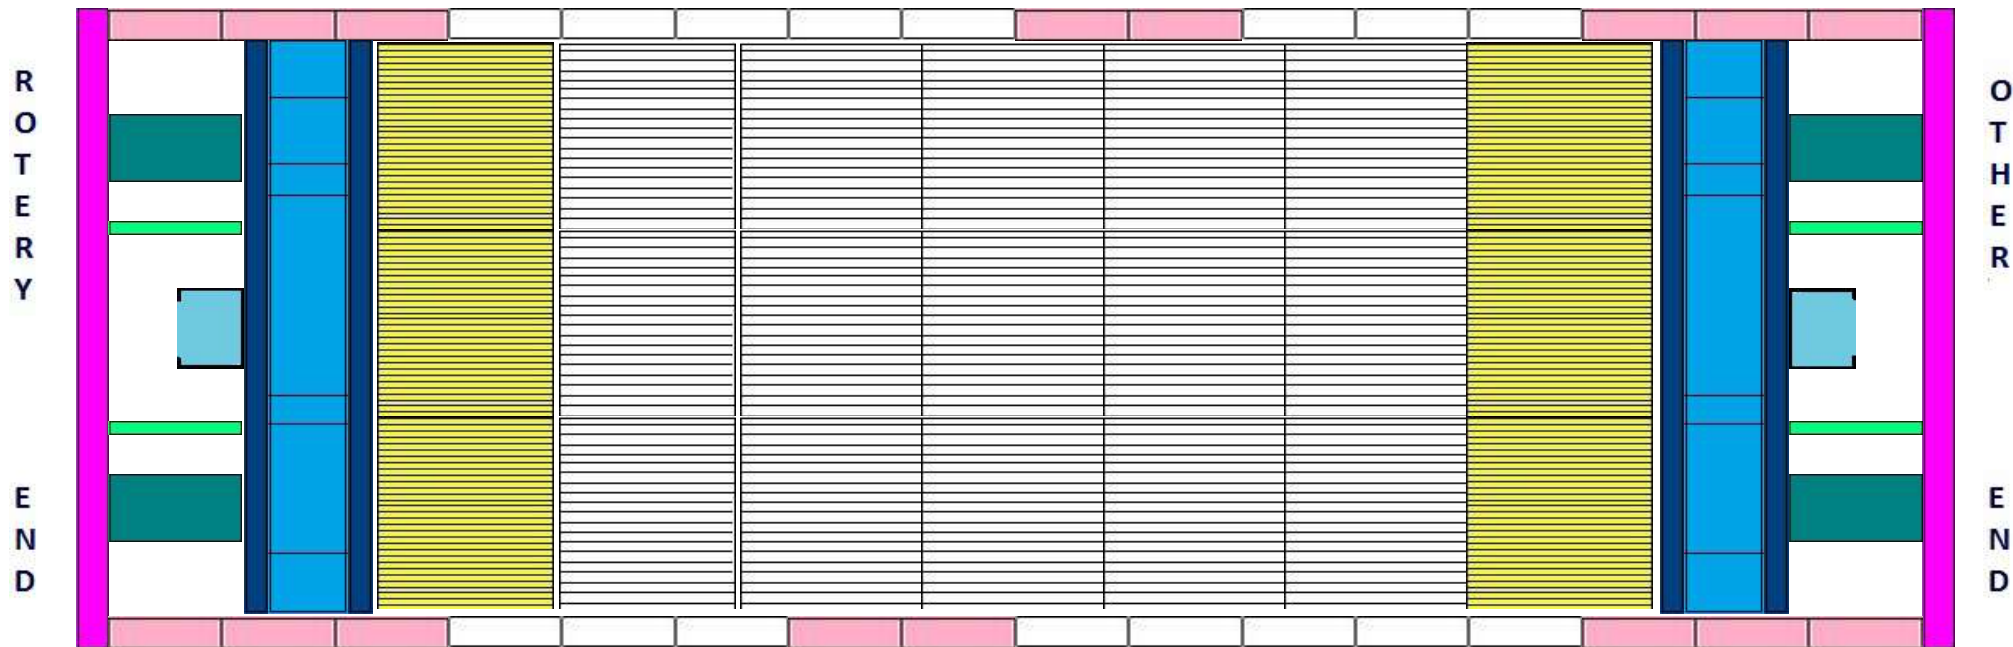
Rotary Side

Color	Particulars	Qty	Per%	Color	Particulars	Qty	Per%	Color	Particulars	Qty	Per%
Yellow	Headstock Beam	2	100%	Dark Green	Centre Stiffner for Headstock	4	100%	Light Green	Floor Stiffner for Headstock	4	100%
Dark Blue	Aux. Head stock	4	100%	Pink	Sole Bar	8	50%	Light Blue	Draft Gear Bracket	2	100%
Yellow	Trough floor	2	29%	Light Blue	Centre plate	2	100%		SoleBar Stiffner	6	100%
	Bottom Wall Part	8	50%		Body panel/patch		100%		Door Top/Roof Patch		0%
	Window Module		0%		Window Sill	40	100%		Window Bar	42	24%
	Seat pillar/lav. Partition		100%		UIC end construction		0%

Start Date : 05-Sep-2019, Completion Date : 12-Sep-2019, Net Repair Days : 7, Total Man Hours : 1328

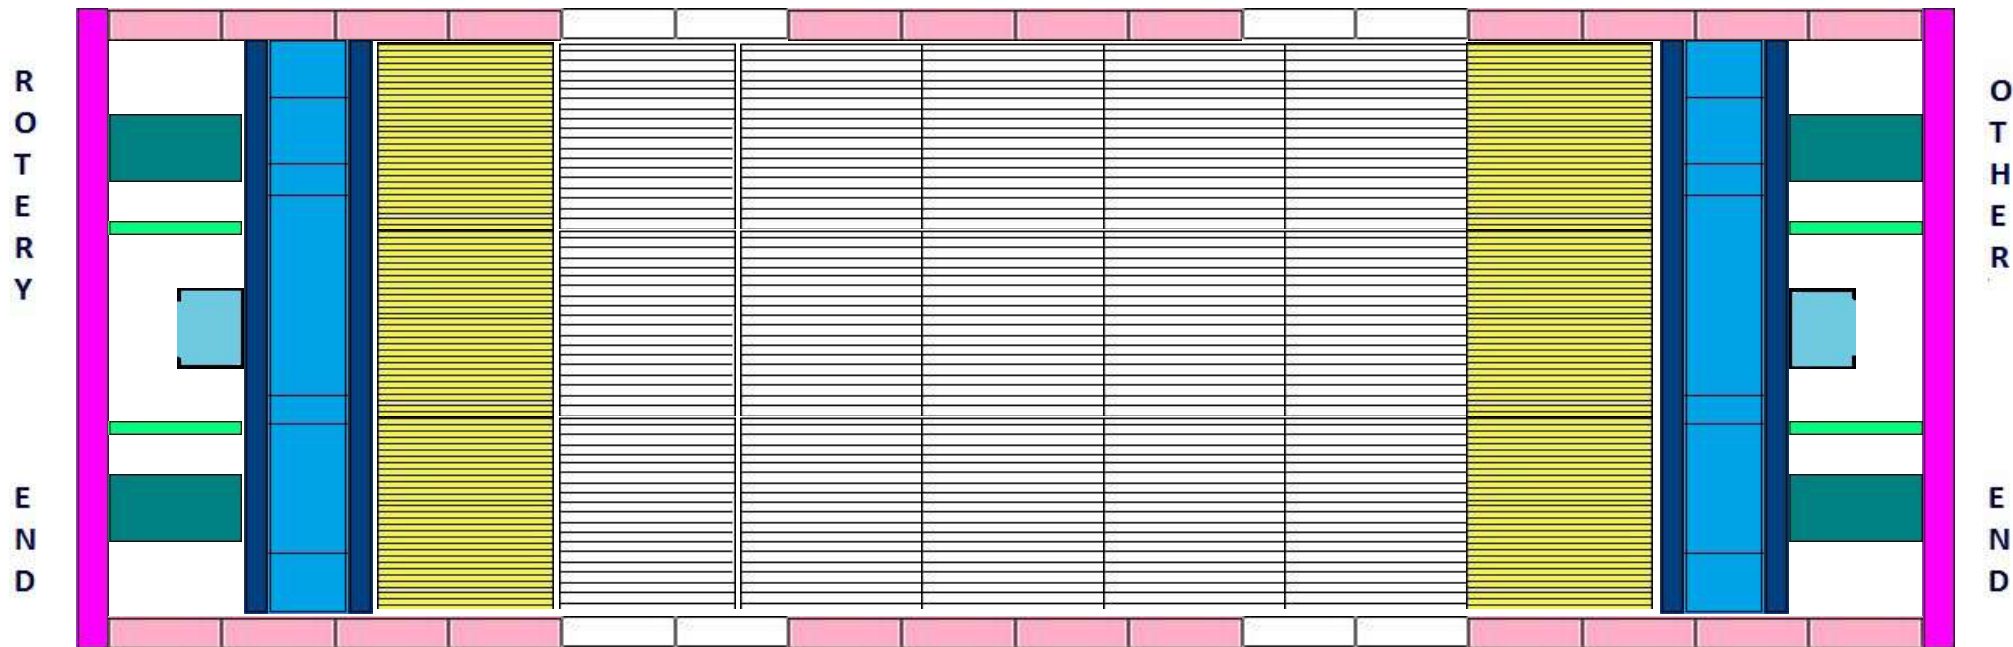
Color	Particulars	Qty	Per%	Color	Particulars	Qty	Per%	Color	Particulars	Qty	Per%
Yellow	Headstock Beam	2	100%	Dark Green	Centre Stiffner for Headstock	4	100%	Light Green	Floor Stiffner for Headstock	4	100%
Dark Blue	Aux. Head stock	4	100%	Pink	Sole Bar	12	75%	Light Blue	Draft Gear Bracket	2	100%
Yellow	Trough floor	2	29%	Light Blue	Centre plate	2	100%		SoleBar Stiffner	4	100%
	Bottom Wall Part	12	75%		Body panel/patch		100%		Door Top/Roof Patch		0%
	Window Module		0%		Window Sill	14	74%		Window Bar	20	24%
	Seat pillar/lav. Partition		100%		UIC end construction		0%

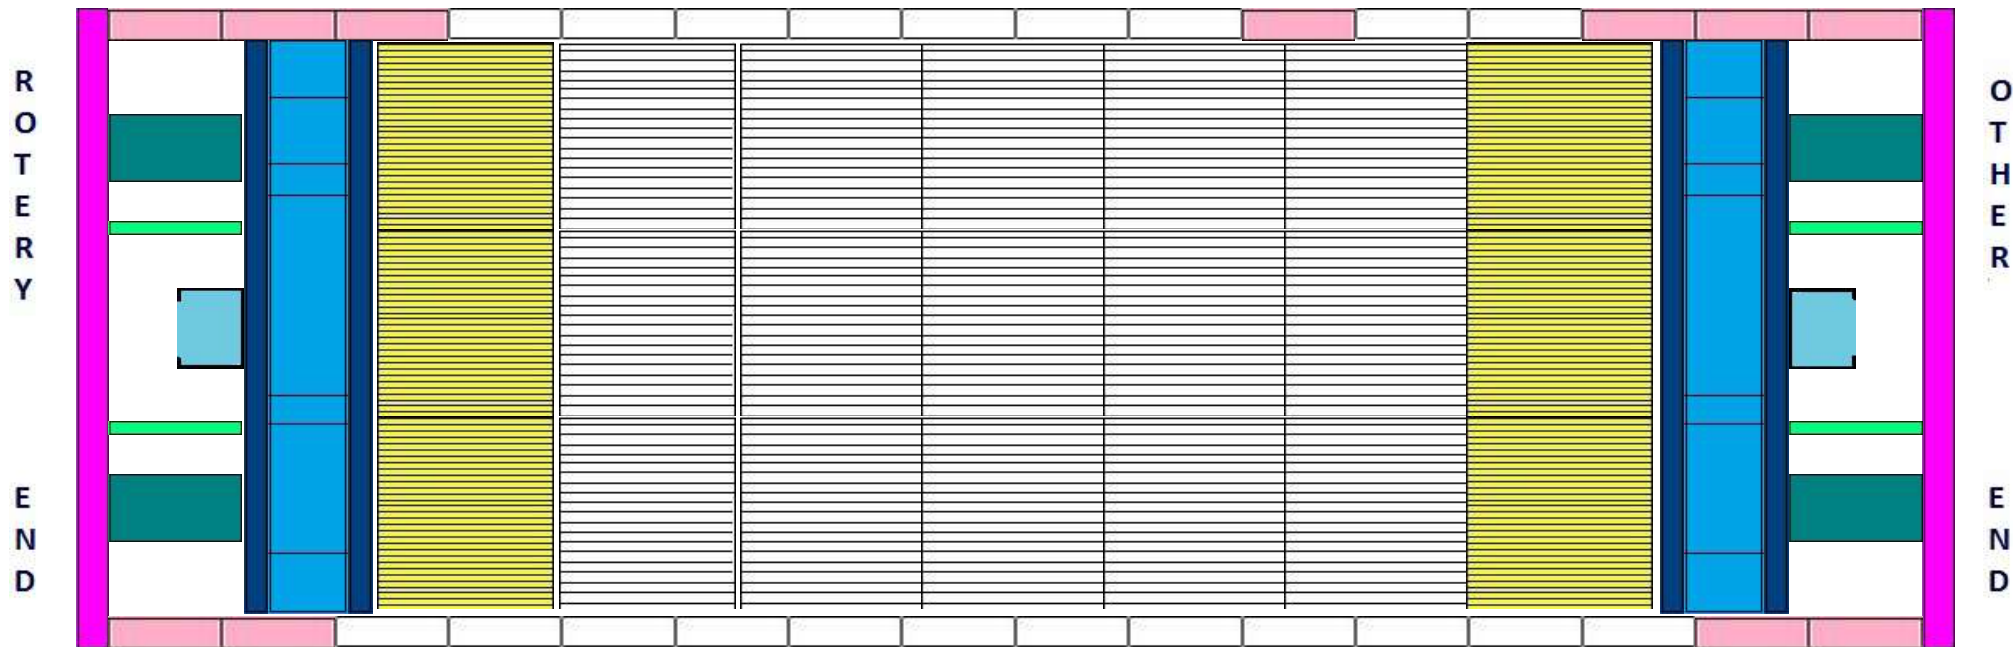
Rotary Side

Color	Particulars	Qty	Per%	Color	Particulars	Qty	Per%	Color	Particulars	Qty	Per%
	Headstock Beam	2	100%		Centre Stiffner for Headstock	4	100%		Floor Stiffner for Headstock	4	100%
	Aux. Head stock	4	100%		Sole Bar	5.5	34%		Draft Gear Bracket	2	100%
	Trough floor	2	29%		Centre plate	2	100%		SoleBar Stiffner	4	100%
	Bottom Wall Part	5.5	34%		Body panel/patch		100%		Door Top/Roof Patch		0%
	Window Module		0%		Window Sill	14	35%		Window Bar	40	22%
	Seat pillar/lav. Partition		100%		UIC end construction		0%

End Drooping: Rotary End - EAST : 5, WEST : 0 Other End - EAST : 2, WEST : 4
Start Date : 04-Sep-2019, Completion Date : 11-Sep-2019, Net Repair Days : 7, Total Man Hours : 976

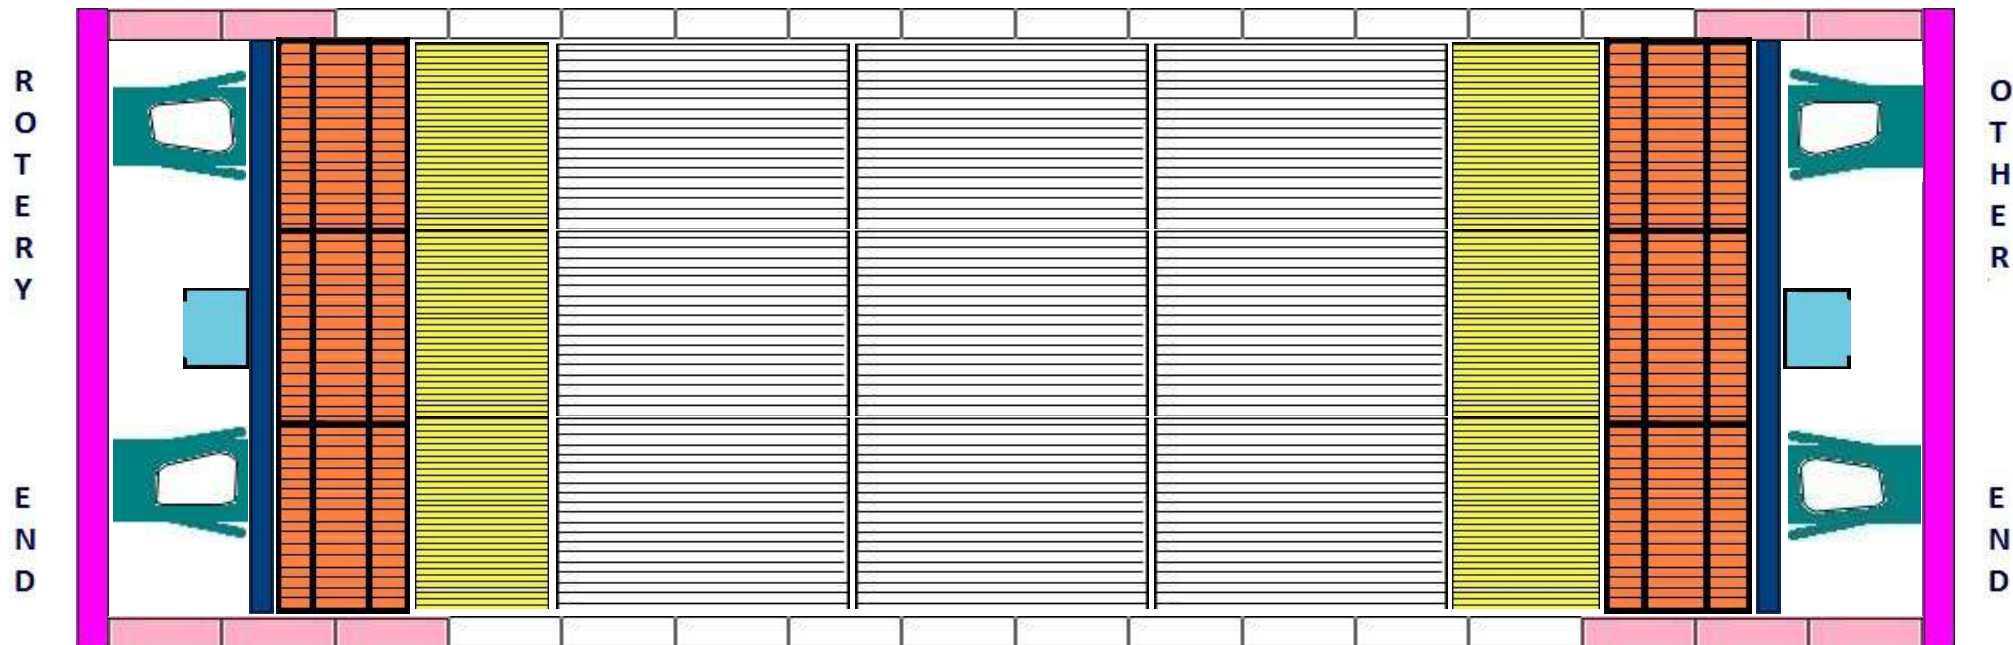
Rotary Side

Color	Particulars	Qty	Per%	Color	Particulars	Qty	Per%	Color	Particulars	Qty	Per%
	Headstock Beam	2	100%		Diagonal	4	100%		Logitudinal Channel Structure	2	100%
	Aux. Head stock	2	100%		Sole Bar	5	31%		Draft Gear Bracket	2	100%
	Trough floor	2	40%		Bottom Wall Part	5	31%		Body panel/patch		100%
	Door Top/Roof Patch		0%		Seat Bracket Rail		0%		Window Sill	40	100%
	Window Bar	50	27%		Seat pillar/lav. Partition		100%		UIC end construction		0%
	Body Pillar Part	28	100%

End Drooping: Rotary End - EAST : -6, WEST : -5 Other End - EAST : -10, WEST : -8
Start Date : 23-Jul-2019, Completion Date : 30-Jul-2019, Net Repair Days : 7, Total Man Hours : 1256

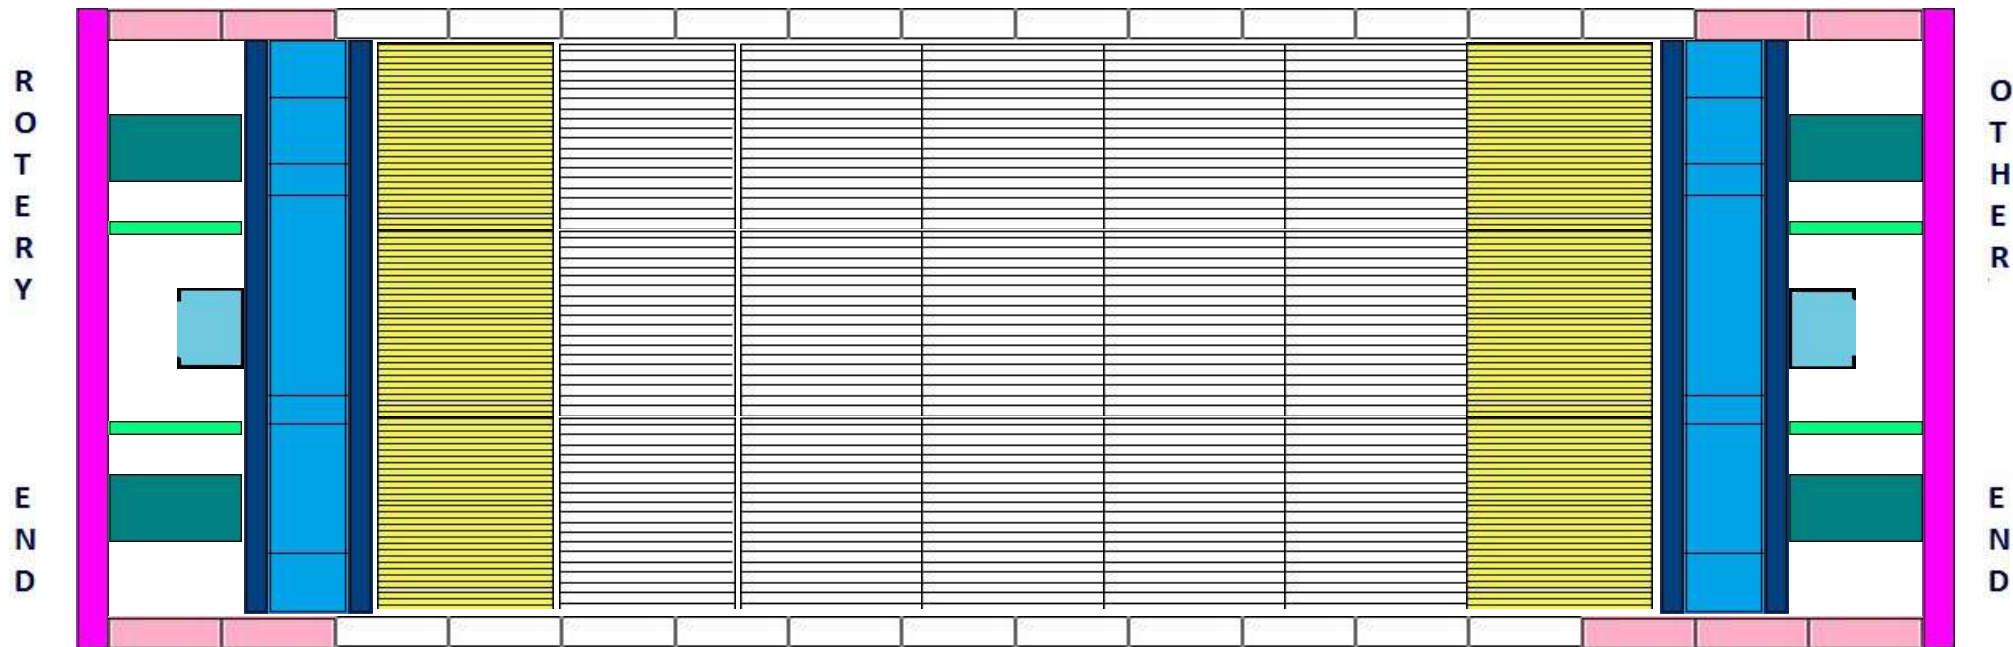
Rotary Side

Color	Particulars	Qty	Per%	Color	Particulars	Qty	Per%	Color	Particulars	Qty	Per%
	Headstock Beam	2	100%		Centre Stiffner for Headstock	4	100%		Floor Stiffner for Headstock	4	100%
	Aux. Head stock	4	100%		Sole Bar	4.5	28%		Draft Gear Bracket	2	100%
	Trough floor	2	29%		Centre plate	2	100%		SoleBar Stiffner	4	100%
	Bottom Wall Part	4.5	28%		Body panel/patch		100%		Door Top/Roof Patch		0%
	Window Module		5%		Window Sill	0	0%		Window Bar	0	0%
	Seat pillar/lav. Partition		100%		UIC end construction		0%

End Drooping: Rotary End - EAST : 3, WEST : 6 Other End - EAST : 2, WEST : 0
Start Date : 11-Sep-2019, Completion Date : 23-Sep-2019, Net Repair Days : 11, Total Man Hours : 1056

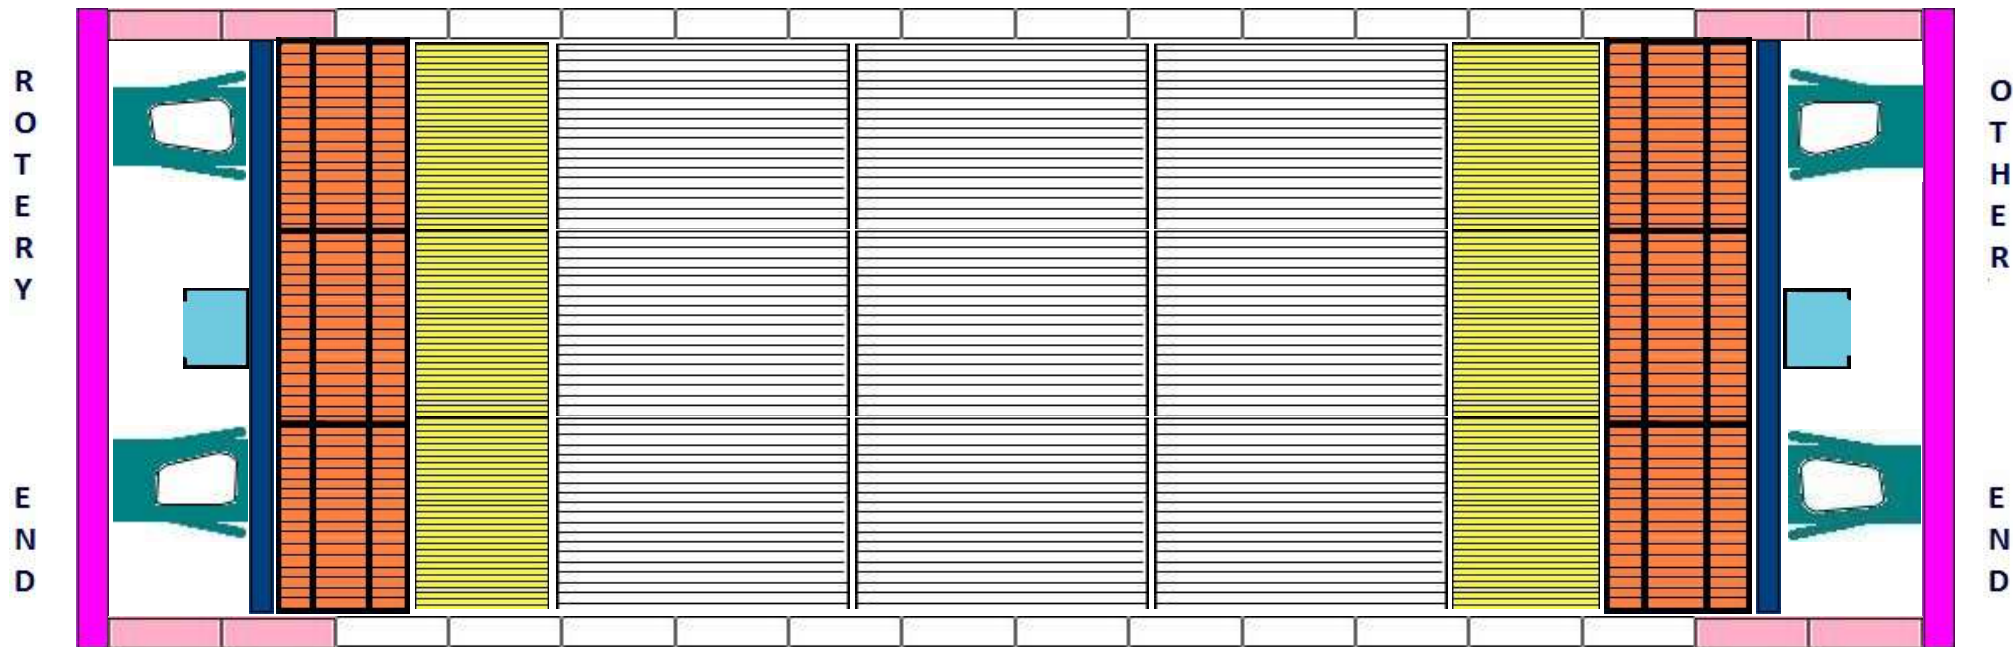
Rotary Side

Color	Particulars	Qty	Per%	Color	Particulars	Qty	Per%	Color	Particulars	Qty	Per%
	Headstock Beam	2	100%		Diagonal	4	100%		Logitudinal Channel Structure	2	100%
	Aux. Head stock	2	100%		Sole Bar	4	25%		Draft Gear Bracket	2	100%
	Trough floor	2	40%		Bottom Wall Part	4	25%		Body panel/patch		100%
	Door Top/Roof Patch		0%		Seat Bracket Rail		0%		Window Sill	10	25%
	Window Bar	28	15%		Seat pillar/lav. Partition		100%		UIC end construction		0%
	Body Pillar Part	22	100%

End Drooping: Rotary End - EAST : -10, WEST : -4 Other End - EAST : -10, WEST : -6
Start Date : 07-Oct-2019, Completion Date : 16-Oct-2019, Net Repair Days : 9, Total Man Hours : 1139
