Coach Rehabilitation Workshop, WC Railway, Bhopal

(An IMS and ISO 50001 Certified Workshop)
Final Inspection Sheet - Details of Corrosion Repair

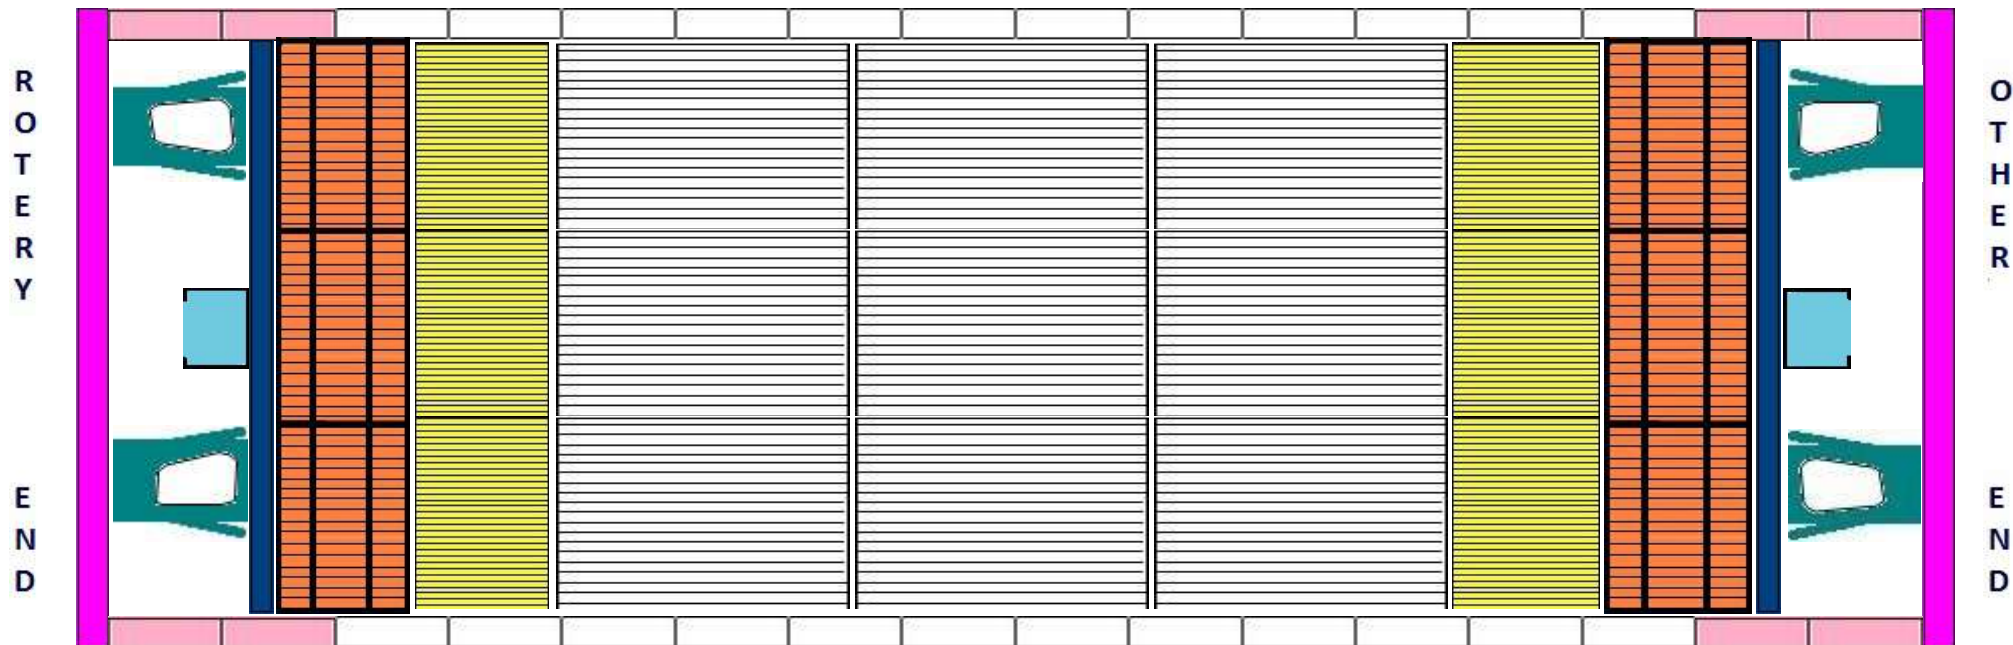
Rotary Side

Color	Particulars	Qty	Per%	Color	Particulars	Qty	Per%	Color	Particulars	Qty	Per%
	Headstock Beam	2	100%		Diagonal	4	100%		Logitudinal Channel Structure	2	100%
	Aux. Head stock	2	100%		Sole Bar	4	25%		Draft Gear Bracket	2	100%
	Trough floor	2	40%		Bottom Wall Part	4	25%		Body panel/patch		100%
	Door Top/Roof Patch		0%		Seat Bracket Rail		0%		Window Sill	18	45%
	Window Bar	28	15%		Seat pillar/lav. Partition		100%		UIC end construction		0%
	Body Pillar Part	22	100%

End Drooping: Rotary End - EAST : -6, WEST : -10 Other End - EAST : 0, WEST : 0
Start Date : 01-Oct-2019, Completion Date : 11-Oct-2019, Net Repair Days : 10, Total Man Hours : 1205

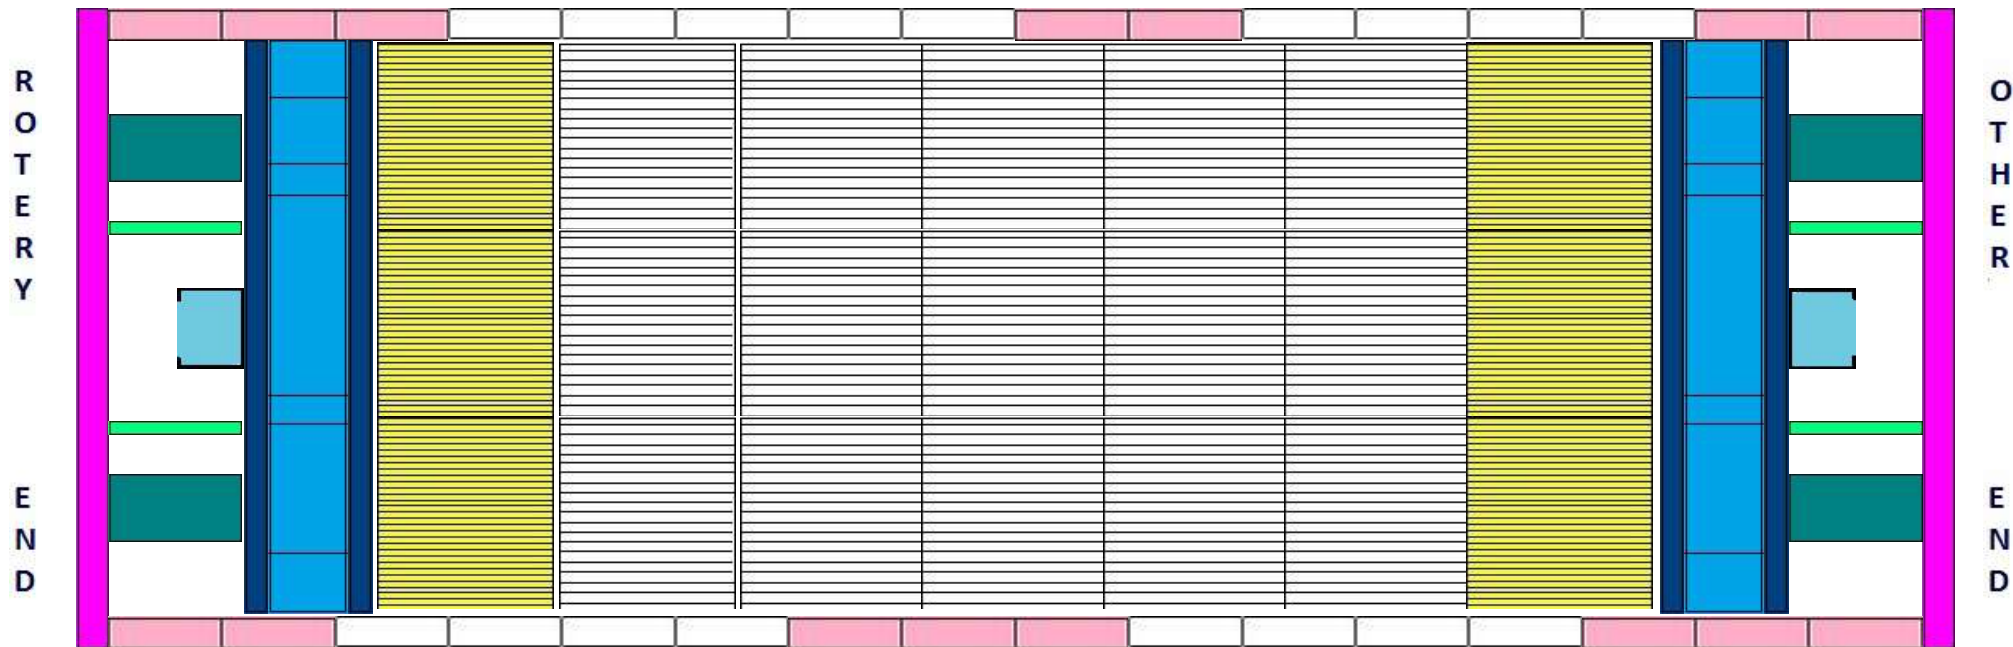
Rotary Side

Color	Particulars	Qty	Per%	Color	Particulars	Qty	Per%	Color	Particulars	Qty	Per%
	Headstock Beam	2	100%		Centre Stiffner for Headstock	4	100%		Floor Stiffner for Headstock	4	100%
	Aux. Head stock	4	100%		Sole Bar	7.5	47%		Draft Gear Bracket	2	100%
	Trough floor	2	29%		Centre plate	2	100%		SoleBar Stiffner	6	100%
	Bottom Wall Part	7.5	47%		Body panel/patch		100%		Door Top/Roof Patch		0%
	Window Module		0%		Window Sill	40	100%		Window Bar	48	27%
	Seat pillar/lav. Partition		100%		UIC end construction		0%

End Drooping: Rotary End - EAST : -3, WEST : -3 Other End - EAST : 2, WEST : -2
Start Date : 12-Dec-2019, Completion Date : 18-Dec-2019, Net Repair Days : 6, Total Man Hours : 1612

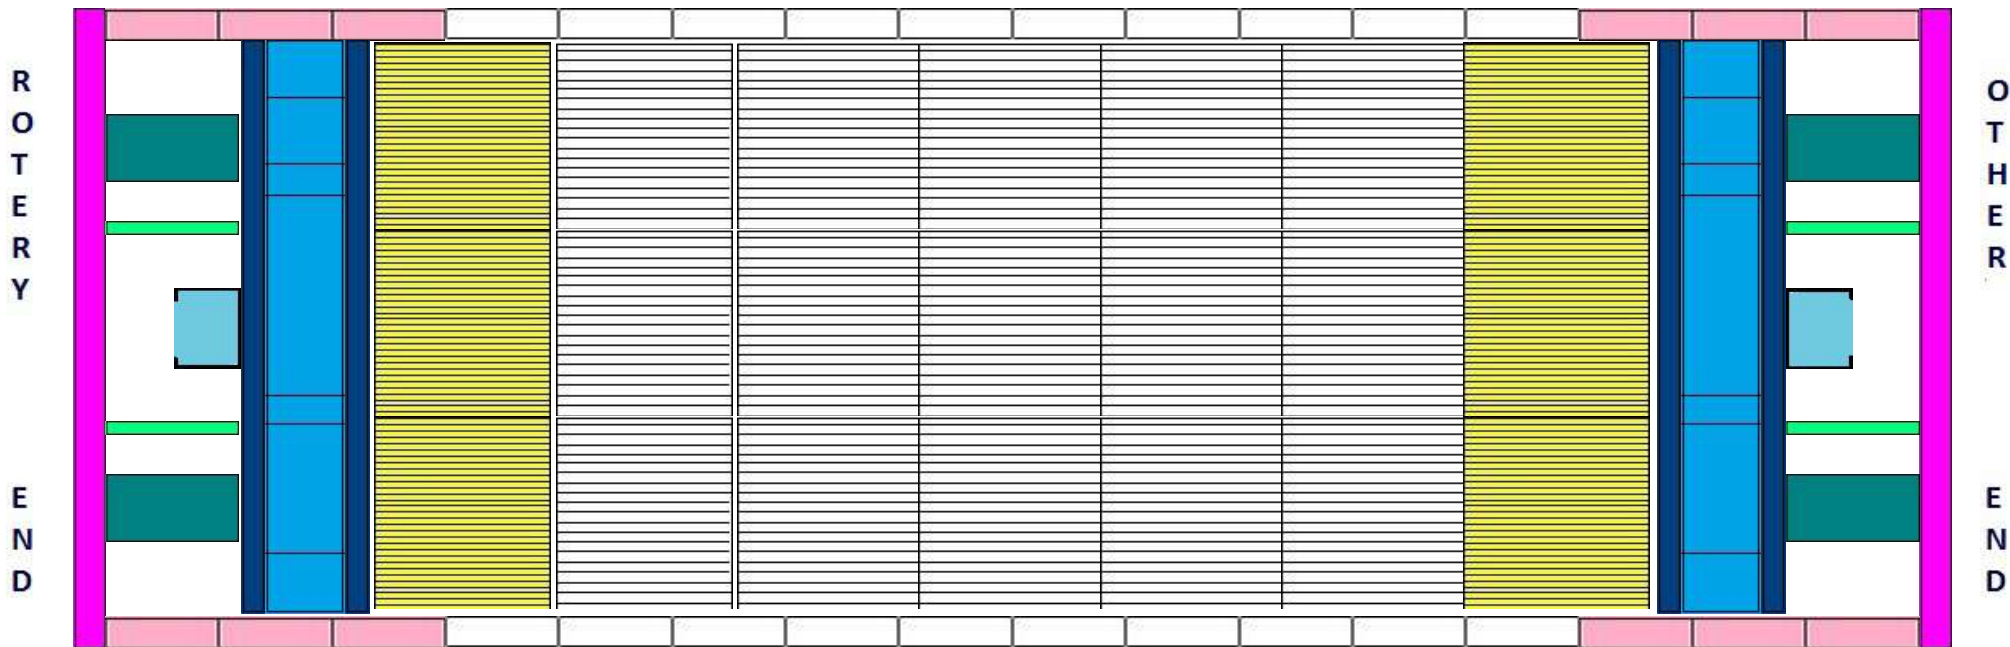
Rotary Side

Color	Particulars	Qty	Per%	Color	Particulars	Qty	Per%	Color	Particulars	Qty	Per%
	Headstock Beam	2	100%		Centre Stiffner for Headstock	4	100%		Floor Stiffner for Headstock	4	100%
	Aux. Head stock	4	100%		Sole Bar	6	38%		Draft Gear Bracket	2	100%
	Trough floor	2	29%		Centre plate	2	100%		SoleBar Stiffner	4	100%
	Bottom Wall Part	6	38%		Body panel/patch		100%		Door Top/Roof Patch		0%
	Window Module		0%		Window Sill	20	50%		Window Bar	44	24%
	Seat pillar/lav. Partition		100%		UIC end construction		0%

End Drooping: Rotary End - EAST : 0, WEST : 5 Other End - EAST : 0, WEST : 0
Start Date : 03-Dec-2019, Completion Date : 09-Dec-2019, Net Repair Days : 6, Total Man Hours : 1208

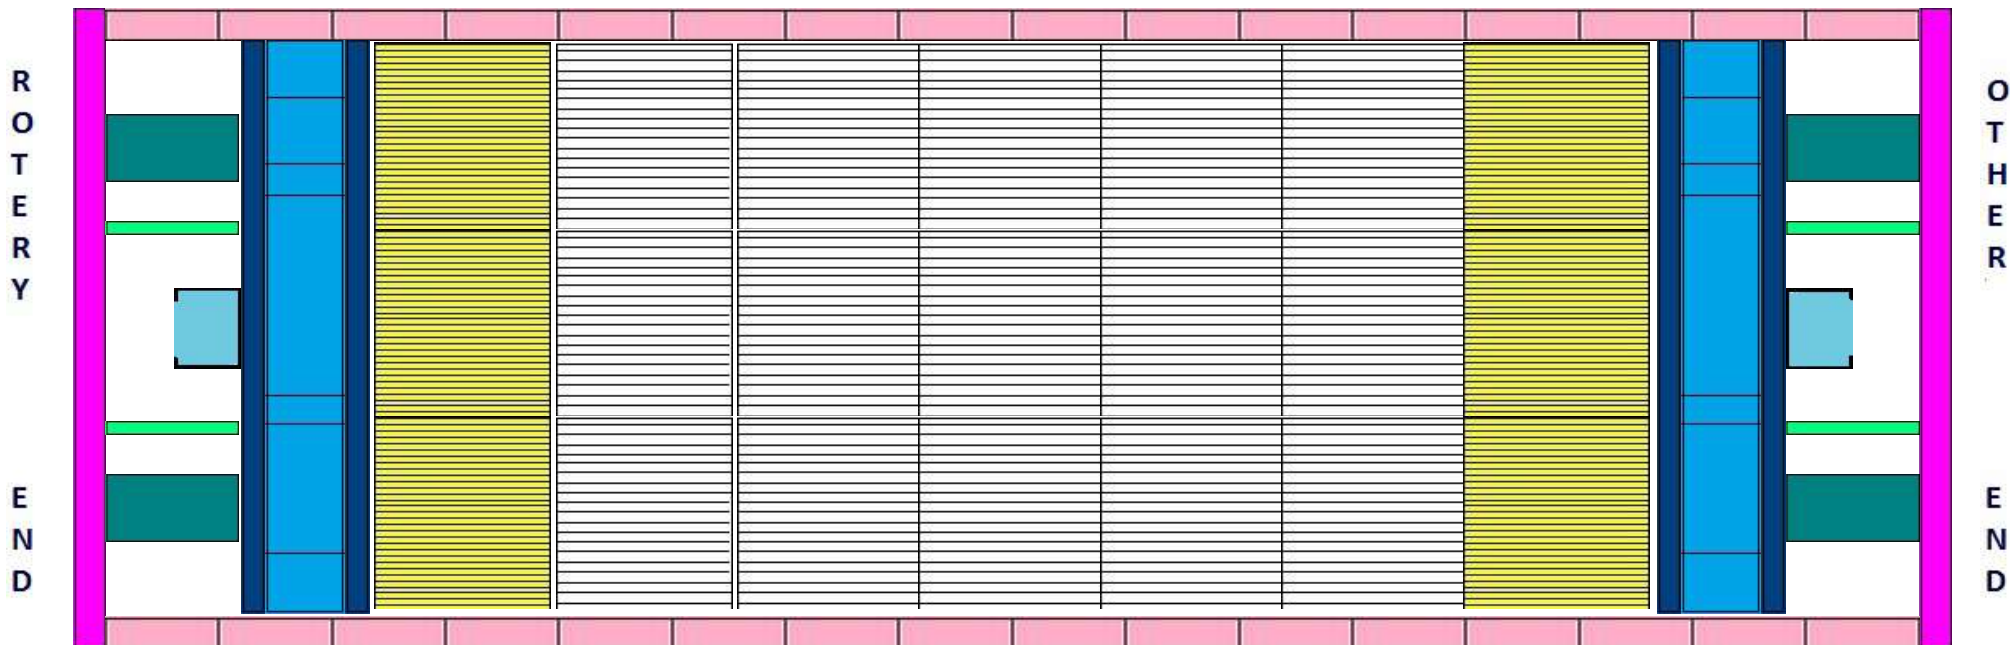
Rotary Side

Color	Particulars	Qty	Per%	Color	Particulars	Qty	Per%	Color	Particulars	Qty	Per%
	Headstock Beam	2	100%		Centre Stiffner for Headstock	4	100%		Floor Stiffner for Headstock	4	100%
	Aux. Head stock	4	100%		Sole Bar	16	100%		Draft Gear Bracket	2	100%
	Trough floor	2	29%		Centre plate	2	100%		SoleBar Stiffner	4	100%
	Bottom Wall Part	16	100%		Body panel/patch		100%		Door Top/Roof Patch		0%
	Window Module		0%		Window Sill	40	100%		Window Bar	112	61%
	Seat pillar/lav. Partition		100%		UIC end construction		0%

Start Date : 09-Dec-2019, Completion Date : 14-Dec-2019, Net Repair Days : 6, Total Man Hours : 2236

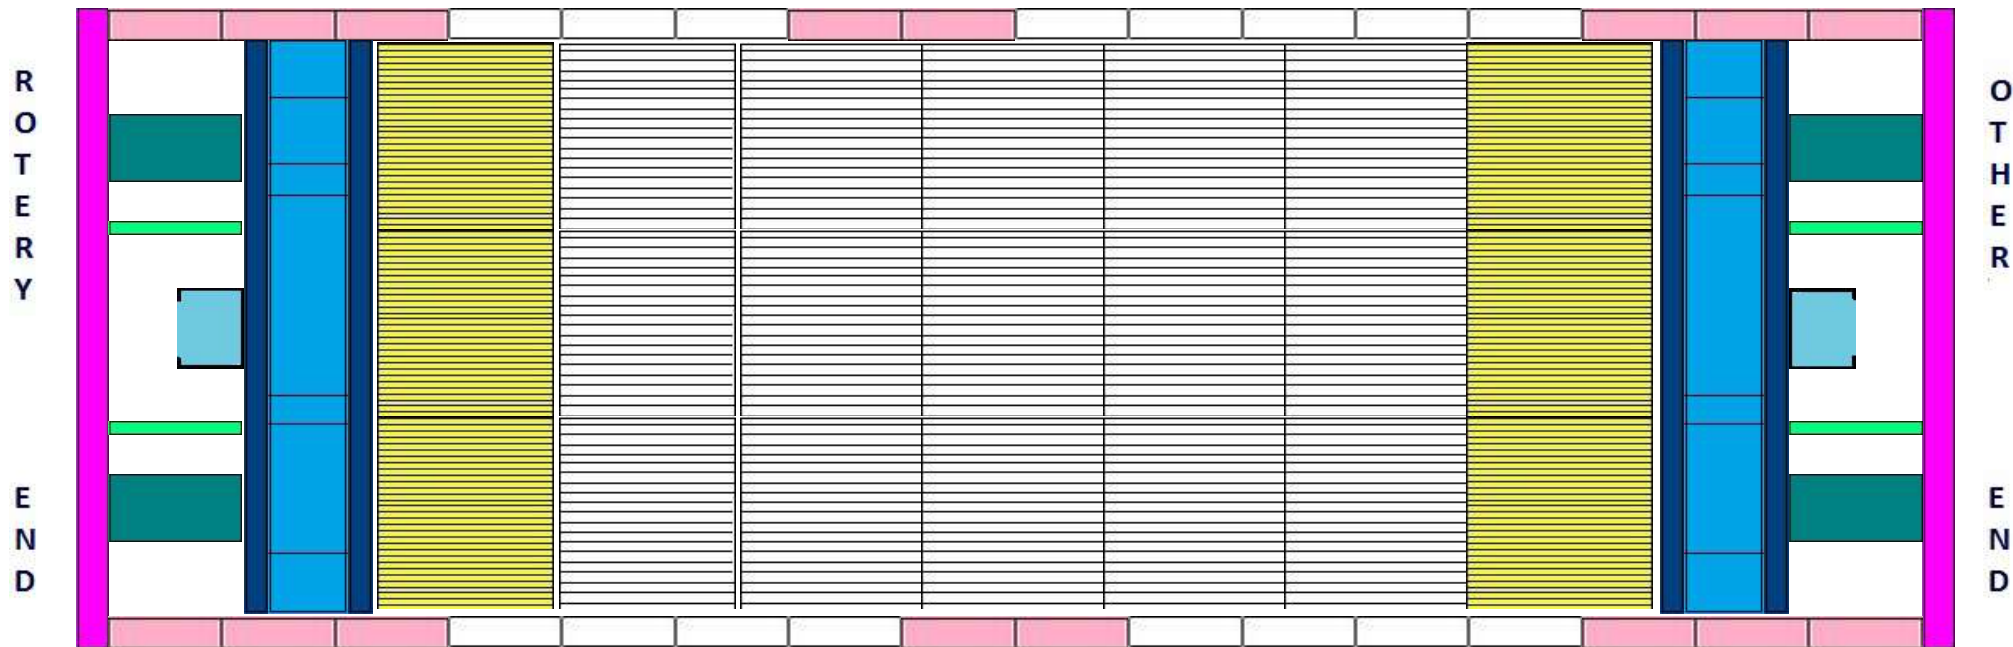
Rotary Side

Color	Particulars	Qty	Per%	Color	Particulars	Qty	Per%	Color	Particulars	Qty	Per%
Yellow	Headstock Beam	2	100%	Dark Green	Centre Stiffner for Headstock	4	100%	Light Green	Floor Stiffner for Headstock	4	100%
Dark Blue	Aux. Head stock	4	100%	Pink	Sole Bar	8	50%	Light Blue	Draft Gear Bracket	2	100%
Yellow	Trough floor	2	29%	Light Blue	Centre plate	2	100%		SoleBar Stiffner	6	100%
	Bottom Wall Part	8	50%		Body panel/patch		100%		Door Top/Roof Patch		0%
	Window Module		0%		Window Sill	40	100%		Window Bar	46	26%
	Seat pillar/lav. Partition		100%		UIC end construction		0%

End Drooping: Rotary End - EAST : 0, WEST : 6 Other End - EAST : 6, WEST : 4
Start Date : 20-Dec-2019, Completion Date : 01-Jan-2020, Net Repair Days : 11, Total Man Hours : 720

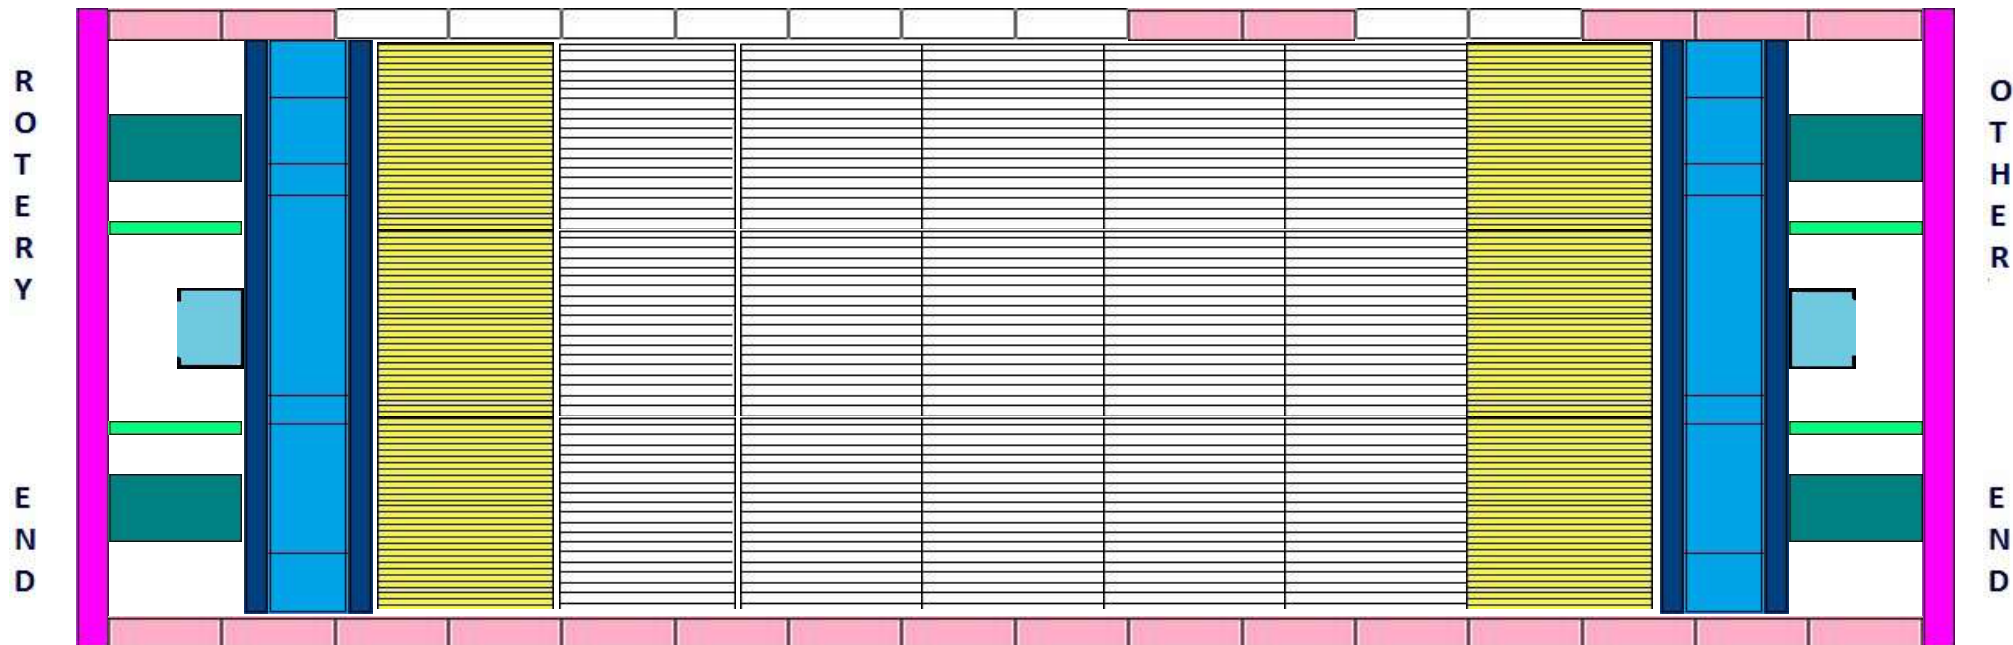
Rotary Side

Color	Particulars	Qty	Per%	Color	Particulars	Qty	Per%	Color	Particulars	Qty	Per%
	Headstock Beam	2	100%		Centre Stiffner for Headstock	4	100%		Floor Stiffner for Headstock	4	100%
	Aux. Head stock	4	100%		Sole Bar	11.5	72%		Draft Gear Bracket	2	100%
	Trough floor	2	29%		Centre plate	2	100%		SoleBar Stiffner	4	100%
	Bottom Wall Part	11.5	72%		Body panel/patch		100%		Door Top/Roof Patch		0%
	Window Module		0%		Window Sill	34	85%		Window Bar	44	24%
	Seat pillar/lav. Partition		100%		UIC end construction		0%

End Drooping: Rotary End - EAST : 0, WEST : -5 Other End - EAST : -6, WEST : -5
Start Date : 28-Nov-2019, Completion Date : 04-Dec-2019, Net Repair Days : 6, Total Man Hours : 1896

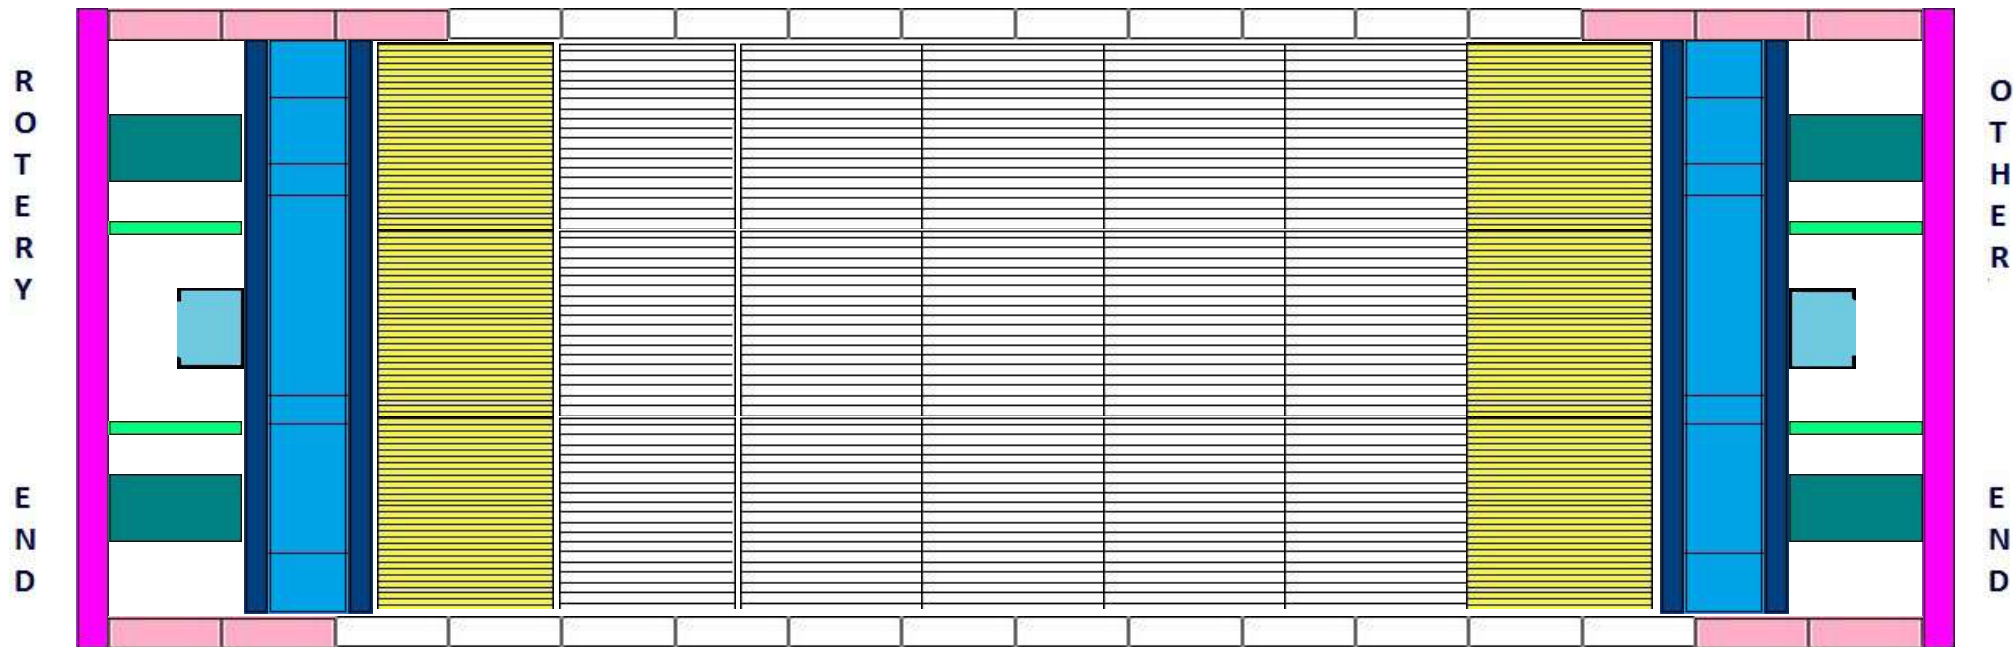
Rotary Side

Color	Particulars	Qty	Per%	Color	Particulars	Qty	Per%	Color	Particulars	Qty	Per%
Yellow	Headstock Beam	2	100%	Green	Centre Stiffner for Headstock	4	100%	Red	Floor Stiffner for Headstock	4	100%
Blue	Aux. Head stock	4	100%	Yellow	Sole Bar	5	31%	Blue	Draft Gear Bracket	2	100%
Red	Trough floor	2	29%	Blue	Centre plate	2	100%		SoleBar Stiffner	4	100%
	Bottom Wall Part	5	31%		Body panel/patch		100%		Door Top/Roof Patch		0%
	Window Module		0%		Window Sill	14	35%		Window Bar	40	22%
	Seat pillar/lav. Partition		100%		UIC end construction		0%

End Drooping: Rotary End - EAST : 3, WEST : 3 Other End - EAST : 10, WEST : 10
Start Date : 22-Nov-2019, Completion Date : 29-Nov-2019, Net Repair Days : 7, Total Man Hours : 1084

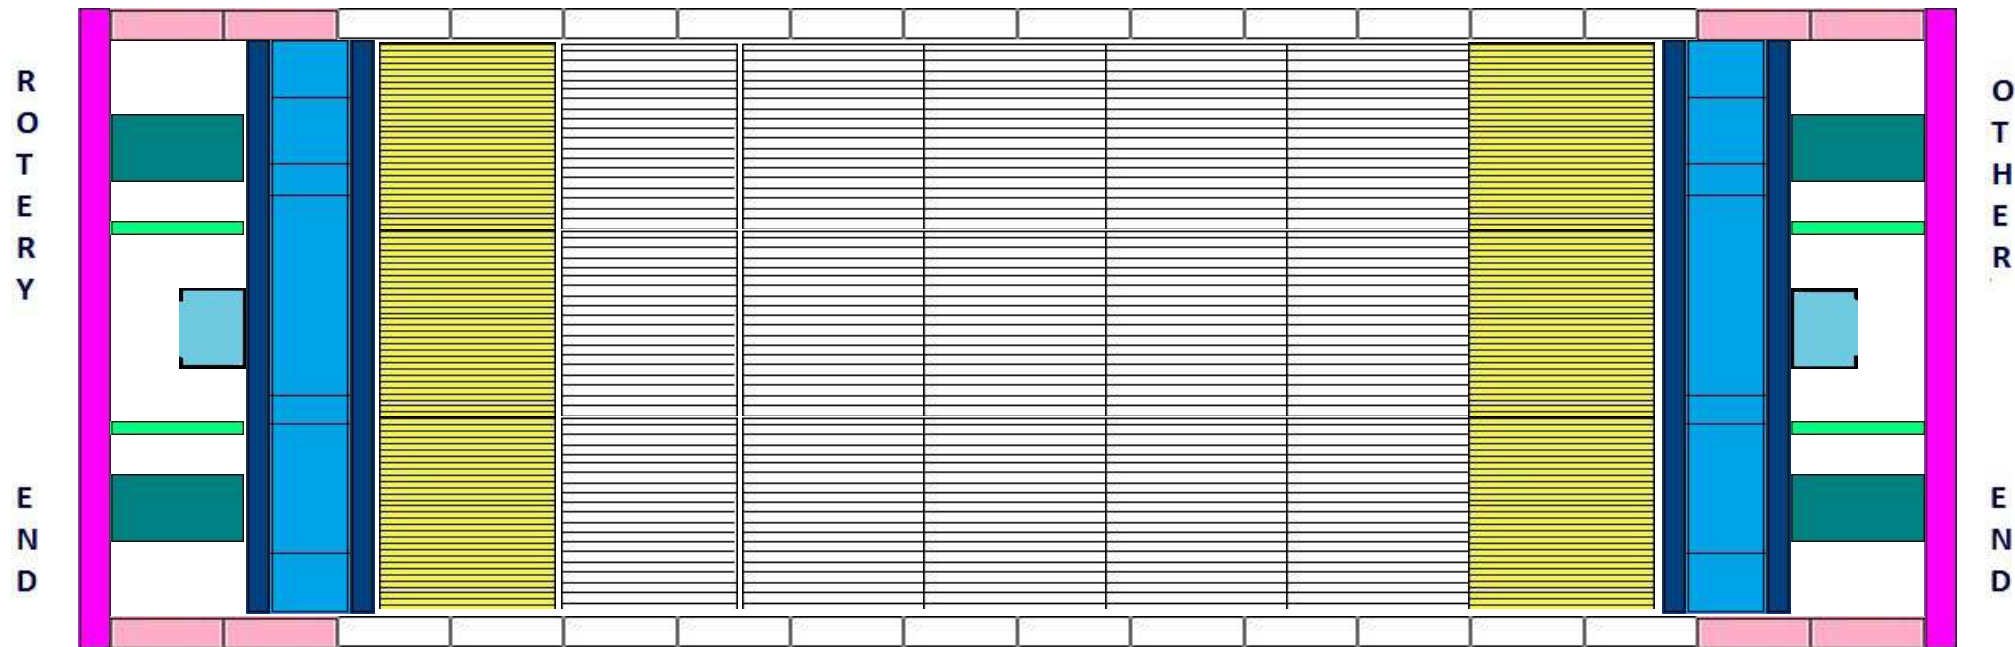
Rotary Side

Color	Particulars	Qty	Per%	Color	Particulars	Qty	Per%	Color	Particulars	Qty	Per%
	Headstock Beam	2	100%		Centre Stiffner for Headstock	4	100%		Floor Stiffner for Headstock	4	100%
	Aux. Head stock	4	100%		Sole Bar	4	25%		Draft Gear Bracket	2	100%
	Trough floor	2	29%		Centre plate	2	100%		SoleBar Stiffner	4	100%
	Bottom Wall Part	4	25%		Body panel/patch		100%		Door Top/Roof Patch		0%
	Window Module		0%		Window Sill	40	100%		Window Bar	100	54%
	Seat pillar/lav. Partition		100%		UIC end construction		0%

End Drooping: Rotary End - EAST : 5, WEST : 10 Other End - EAST : -6, WEST : -3
Start Date : 12-Dec-2019, Completion Date : 23-Dec-2019, Net Repair Days : 10, Total Man Hours : 1684

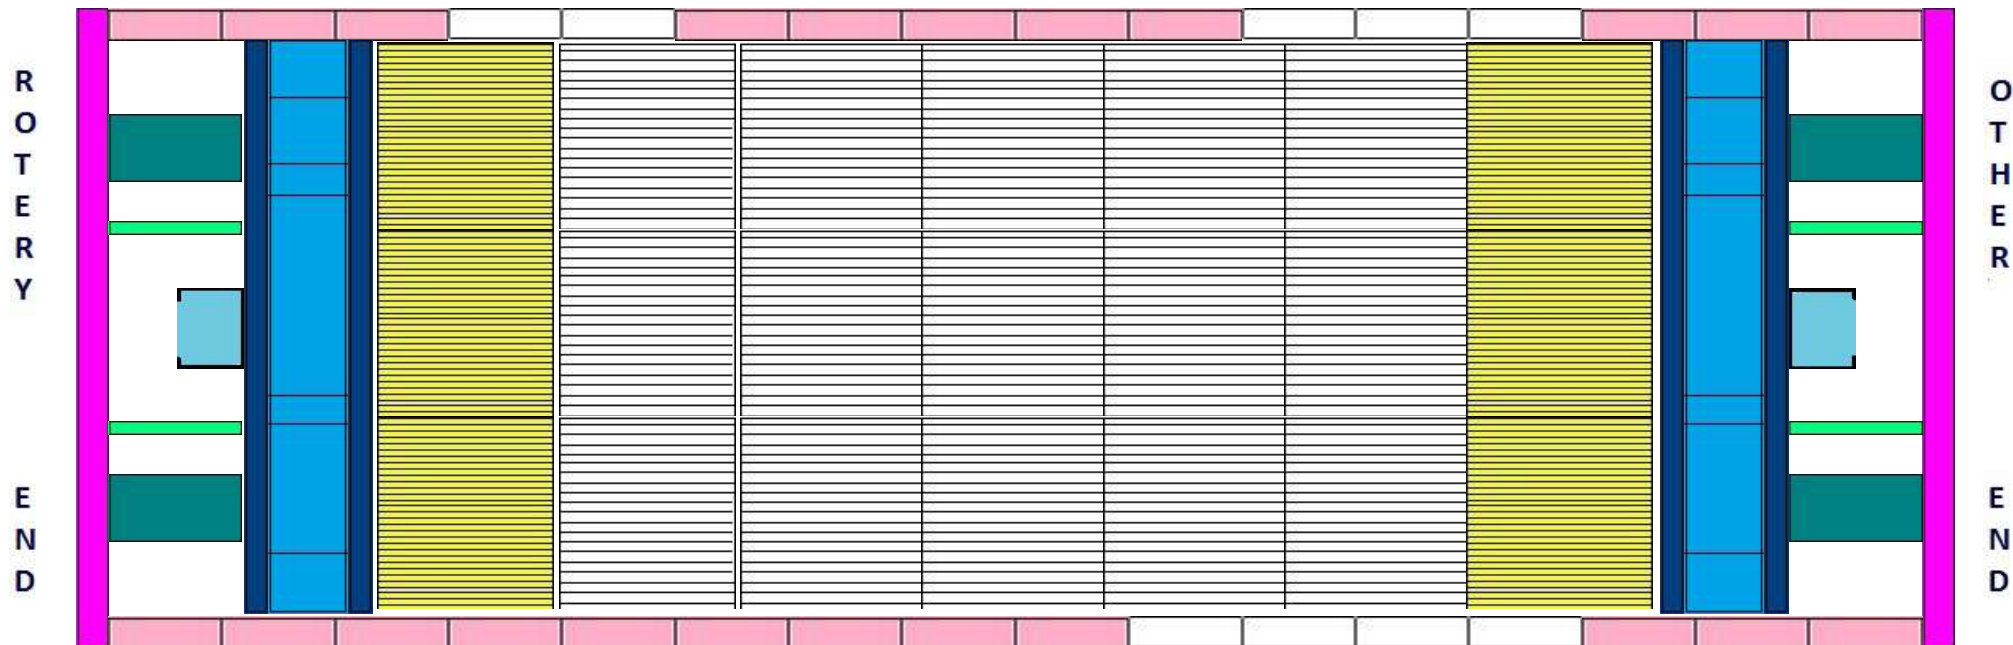
Color	Particulars	Qty	Per%	Color	Particulars	Qty	Per%	Color	Particulars	Qty	Per%
Yellow	Headstock Beam	2	100%	Dark Green	Centre Stiffner for Headstock	4	100%	Light Green	Floor Stiffner for Headstock	4	100%
Dark Blue	Aux. Head stock	4	100%	Pink	Sole Bar	11.5	72%	Light Blue	Draft Gear Bracket	2	100%
Yellow	Trough floor	2	29%	Light Blue	Centre plate	2	100%		SoleBar Stiffner	4	100%
	Bottom Wall Part	11.5	72%		Body panel/patch		100%		Door Top/Roof Patch		0%
	Window Module		0%		Window Sill	7	37%		Window Bar	18	21%
	Seat pillar/lav. Partition		100%		UIC end construction		0%

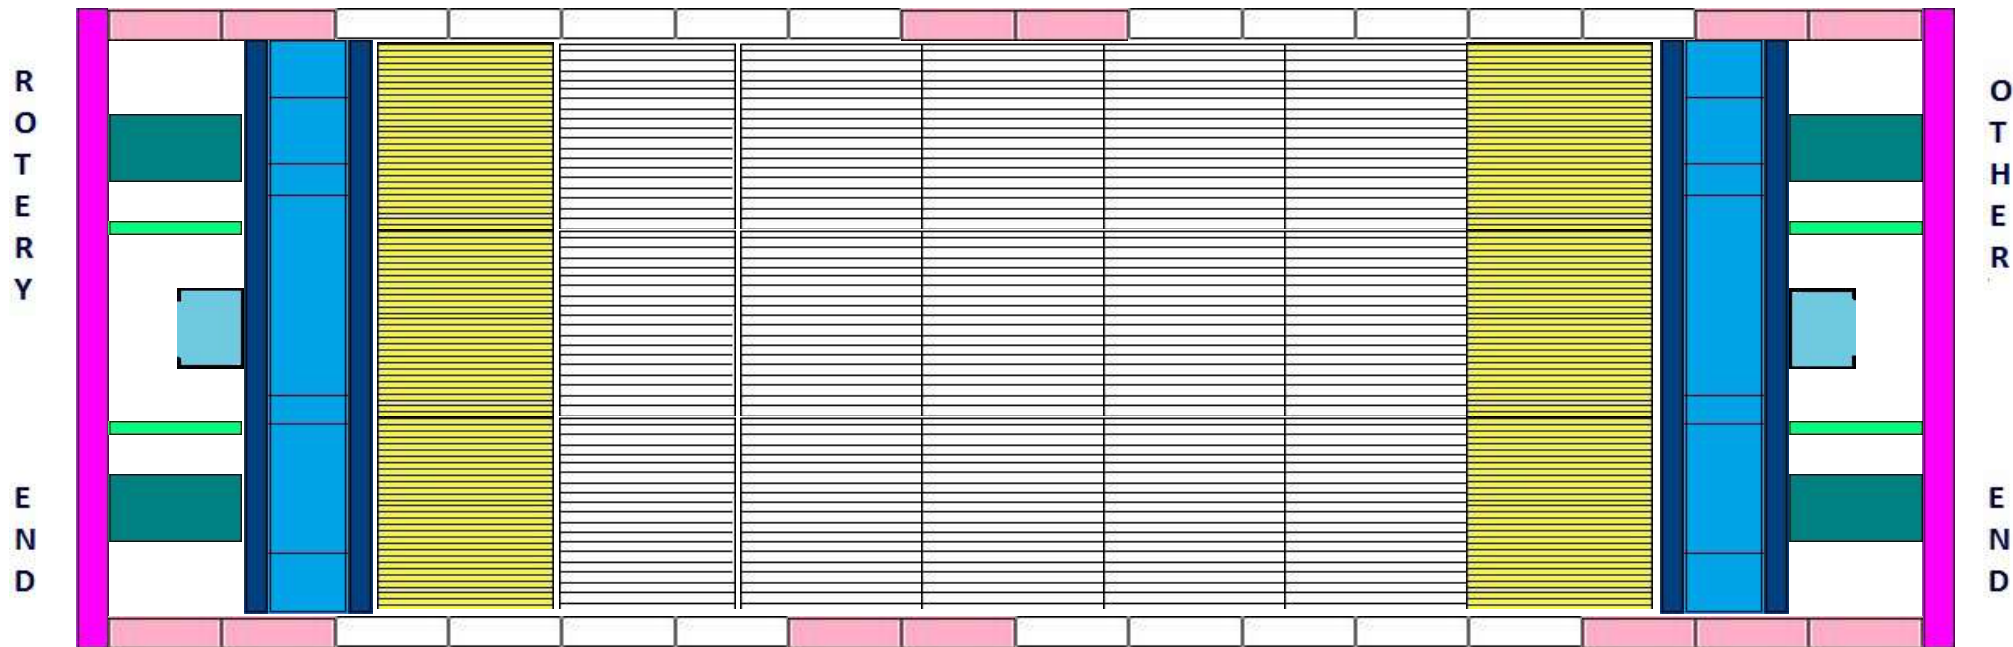
Rotary Side

Color	Particulars	Qty	Per%	Color	Particulars	Qty	Per%	Color	Particulars	Qty	Per%
	Headstock Beam	2	100%		Centre Stiffner for Headstock	4	100%		Floor Stiffner for Headstock	4	100%
	Aux. Head stock	4	100%		Sole Bar	6.5	41%		Draft Gear Bracket	2	100%
	Trough floor	2	29%		Centre plate	2	100%		SoleBar Stiffner	6	100%
	Bottom Wall Part	6.5	41%		Body panel/patch		100%		Door Top/Roof Patch		0%
	Window Module		0%		Window Sill	40	100%		Window Bar	48	27%
	Seat pillar/lav. Partition		100%		UIC end construction		0%

End Drooping: Rotary End - EAST : 2, WEST : 0 Other End - EAST : -2, WEST : -5
Start Date : 16-Dec-2019, Completion Date : 23-Dec-2019, Net Repair Days : 7, Total Man Hours : 1840

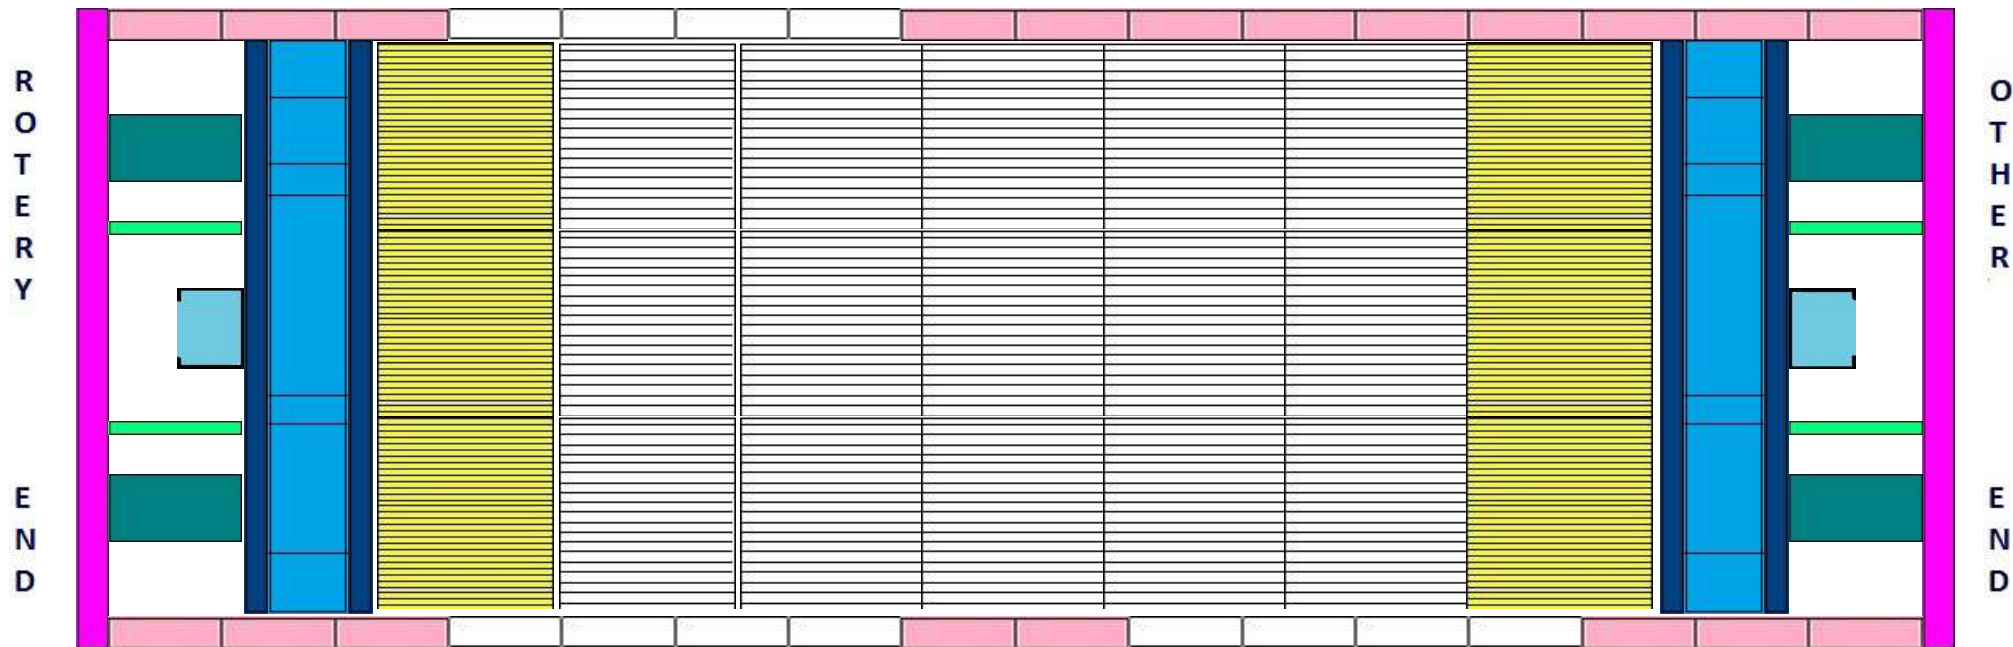
Color	Particulars	Qty	Per%	Color	Particulars	Qty	Per%	Color	Particulars	Qty	Per%
Yellow	Headstock Beam	2	100%	Dark Green	Centre Stiffner for Headstock	4	100%	Light Green	Floor Stiffner for Headstock	4	100%
Dark Blue	Aux. Head stock	4	100%	Pink	Sole Bar	10	63%	Light Blue	Draft Gear Bracket	2	100%
Yellow	Trough floor	2	29%	Light Blue	Centre plate	2	100%		SoleBar Stiffner	6	100%
	Bottom Wall Part	10	63%		Body panel/patch		100%		Door Top/Roof Patch		0%
	Window Module		0%		Window Sill	14	35%		Window Bar	44	25%
	Seat pillar/lav. Partition		100%		UIC end construction		0%

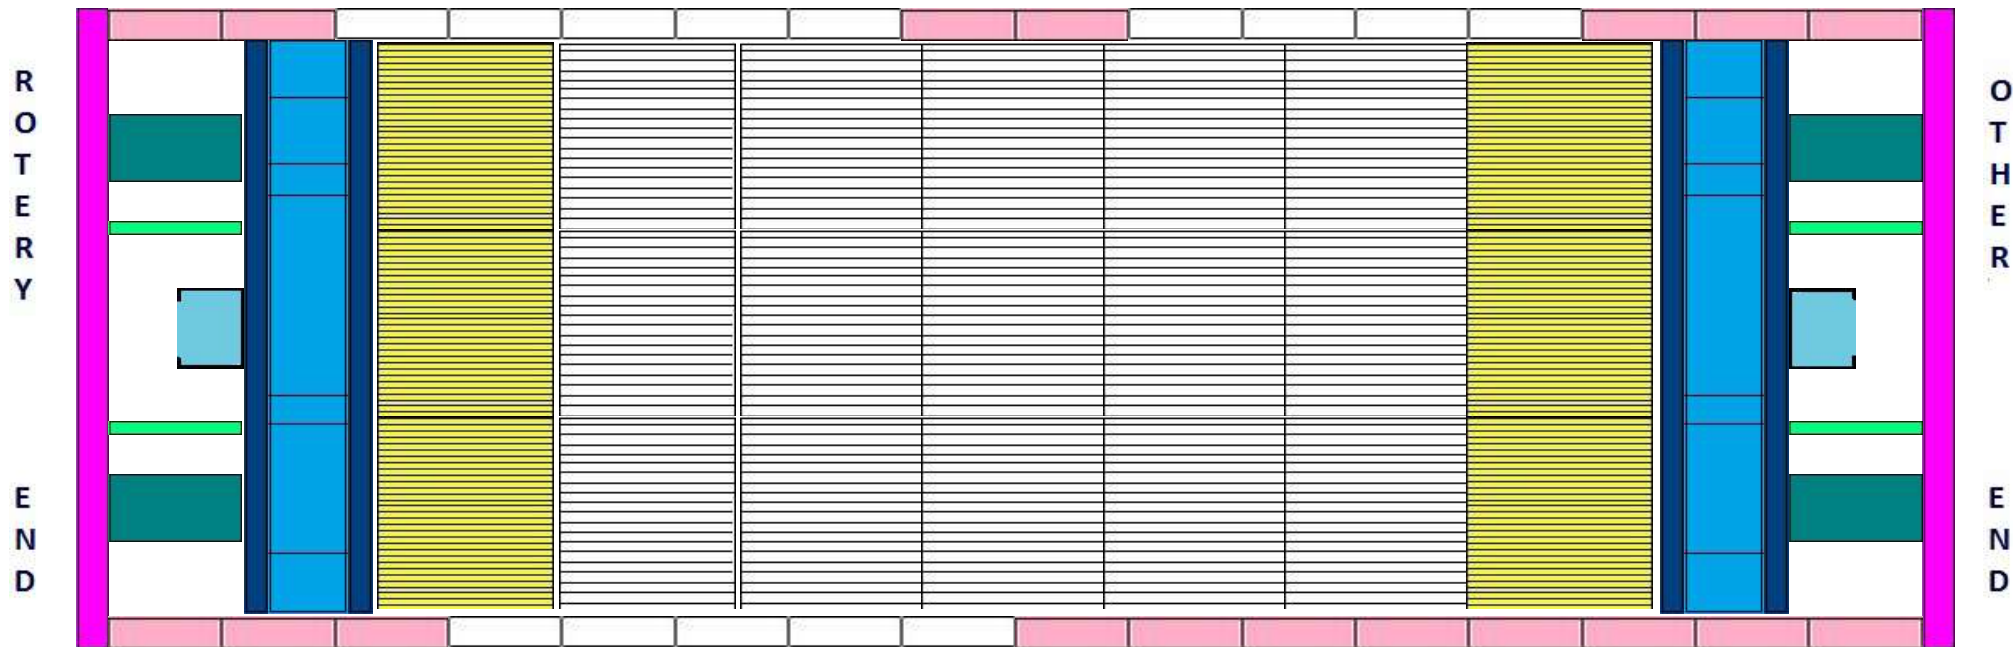
Rotary Side

Color	Particulars	Qty	Per%	Color	Particulars	Qty	Per%	Color	Particulars	Qty	Per%
Yellow	Headstock Beam	2	100%	Dark Green	Centre Stiffner for Headstock	4	100%	Light Green	Floor Stiffner for Headstock	4	100%
Dark Blue	Aux. Head stock	4	100%	Pink	Sole Bar	9	56%	Light Blue	Draft Gear Bracket	2	100%
Yellow	Trough floor	2	29%	Light Blue	Centre plate	2	100%		SoleBar Stiffner	6	100%
	Bottom Wall Part	9	56%		Body panel/patch		100%		Door Top/Roof Patch		0%
	Window Module		0%		Window Sill	14	35%		Window Bar	40	23%
	Seat pillar/lav. Partition		100%		UIC end construction		0%

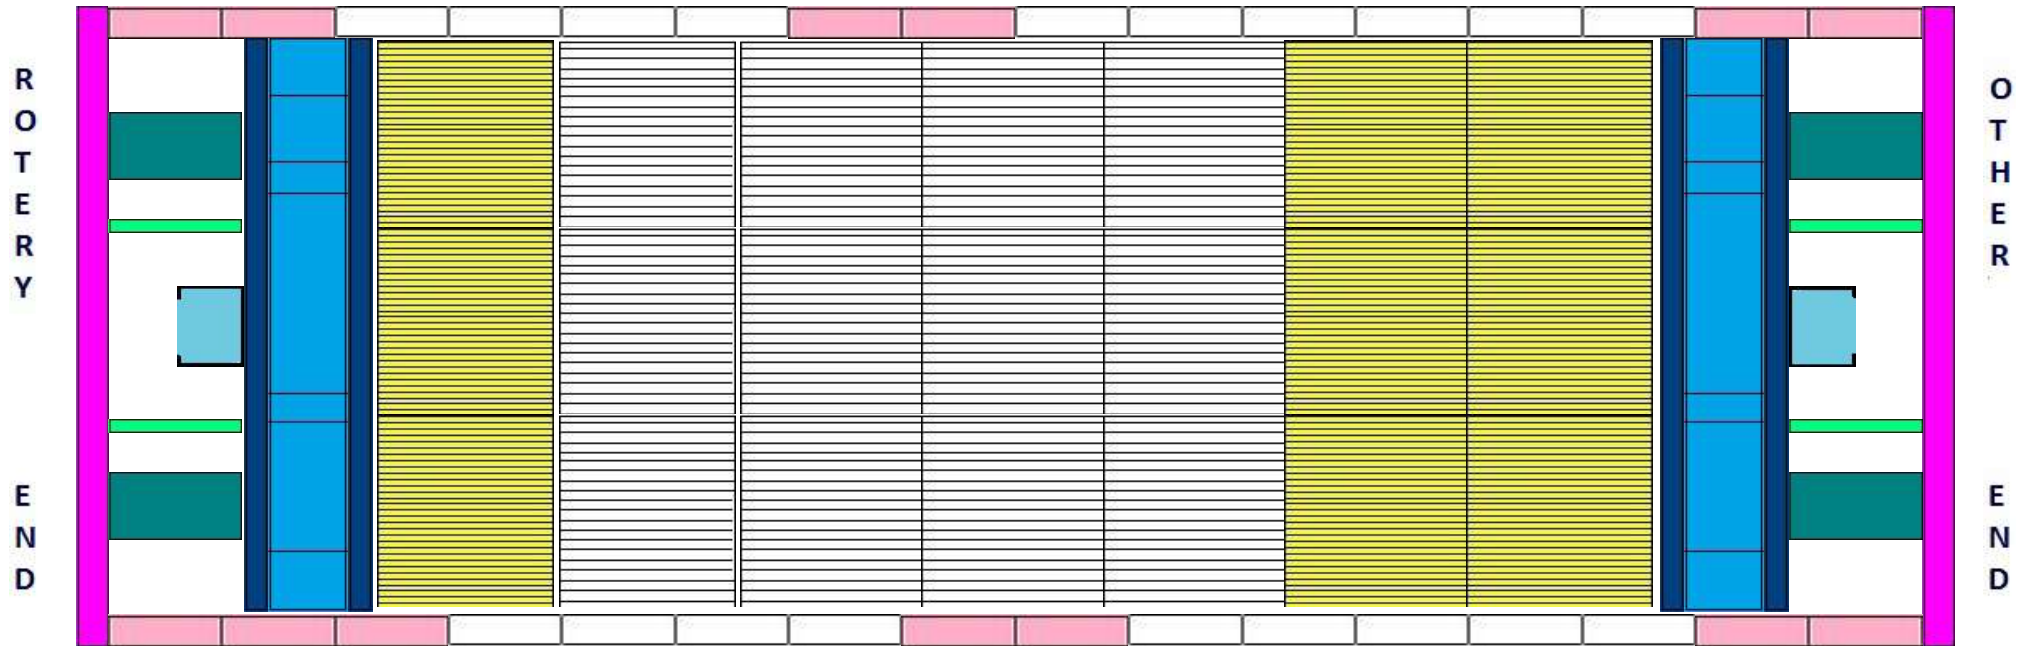
Rotary Side

Color	Particulars	Qty	Per%	Color	Particulars	Qty	Per%	Color	Particulars	Qty	Per%
 	Headstock Beam	2	100%	 	Centre Stiffner for Headstock	4	100%	 	Floor Stiffner for Headstock	4	100%
 	Aux. Head stock	4	100%	 	Sole Bar	6.5	41%	 	Draft Gear Bracket	2	100%
 	Trough floor	3	43%	 	Centre plate	2	100%		SoleBar Stiffner	6	100%
	Bottom Wall Part	6.5	41%		Body panel/patch		100%		Door Top/Roof Patch		0%
	Window Module		0%		Window Sill	22	55%		Window Bar	44	25%
	Seat pillar/lav. Partition		100%		UIC end construction		0%
