Coach Rehabilitation Workshop, WC Railway, Bhopal

(An IMS and ISO 50001 Certified Workshop)
Final Inspection Sheet - Details of Corrosion Repair

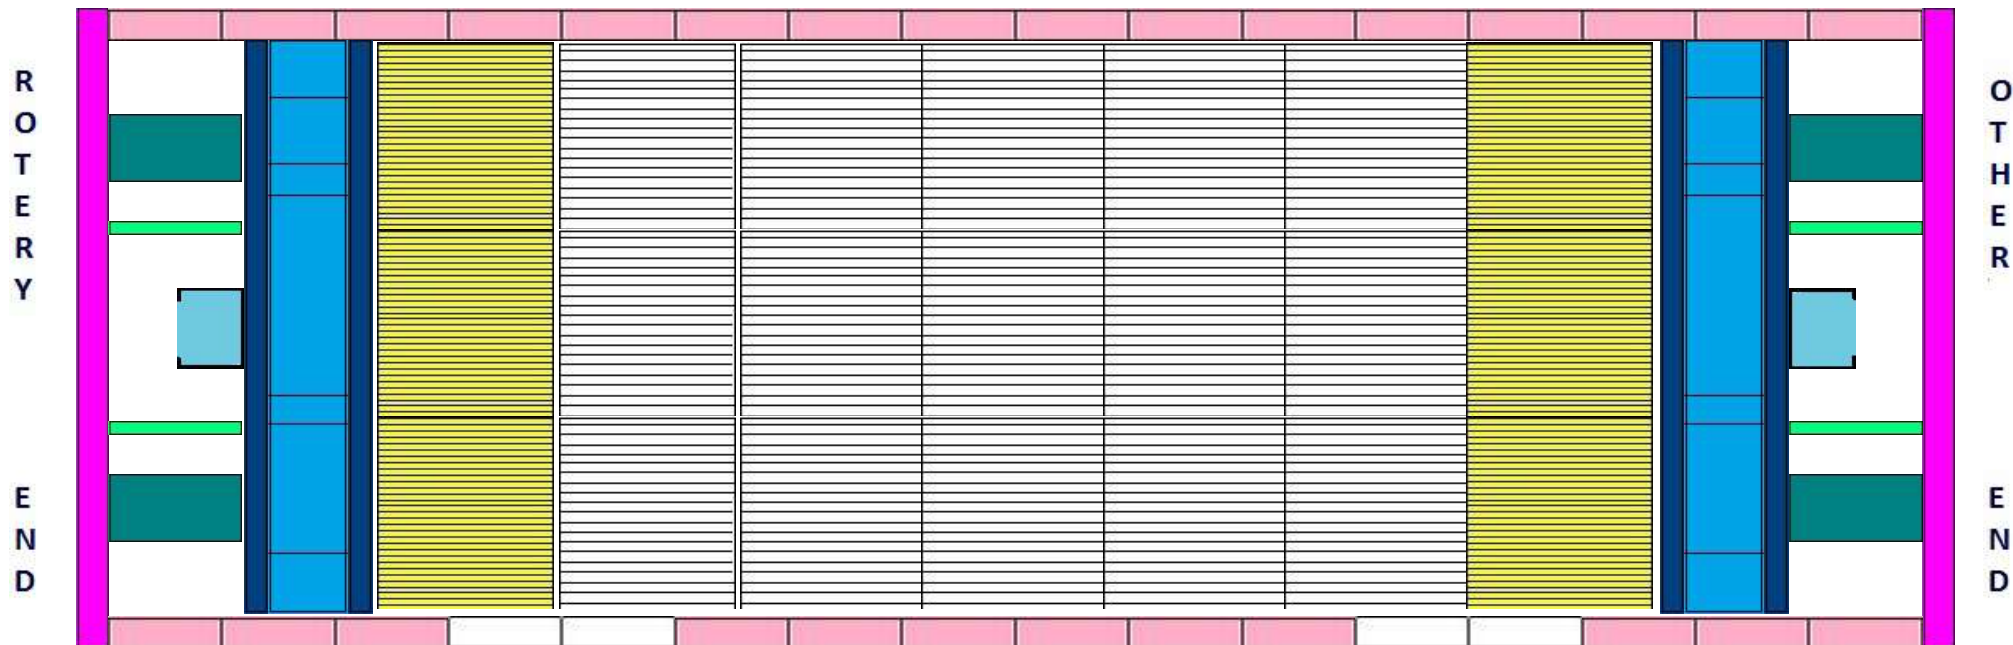
Coach No. :SR06288

Color	Particulars	Qty	Per%	Color	Particulars	Qty	Per%	Color	Particulars	Qty	Per%
	Headstock Beam	2	100%		Centre Stiffner for Headstock	4	100%		Floor Stiffner for Headstock	4	100%
	Aux. Head stock	4	100%		Sole Bar	14	88%		Draft Gear Bracket	2	100%
	Trough floor	2	29%		Centre plate	2	100%		SoleBar Stiffner	4	100%
	Bottom Wall Part	14	88%		Body panel/patch		100%		Door Top/Roof Patch		0%
	Window Module		0%		Window Sill	40	100%		Window Bar	74	40%
	Seat pillar/lav. Partition		100%		UIC end construction		0%

End Drooping: Rotary End - EAST : -6, WEST : -7 Other End - EAST : -3, WEST : 0
Start Date : 02-Apr-2019, Completion Date : 13-Apr-2019, Net Repair Days : 11, Total Man Hours : 1760

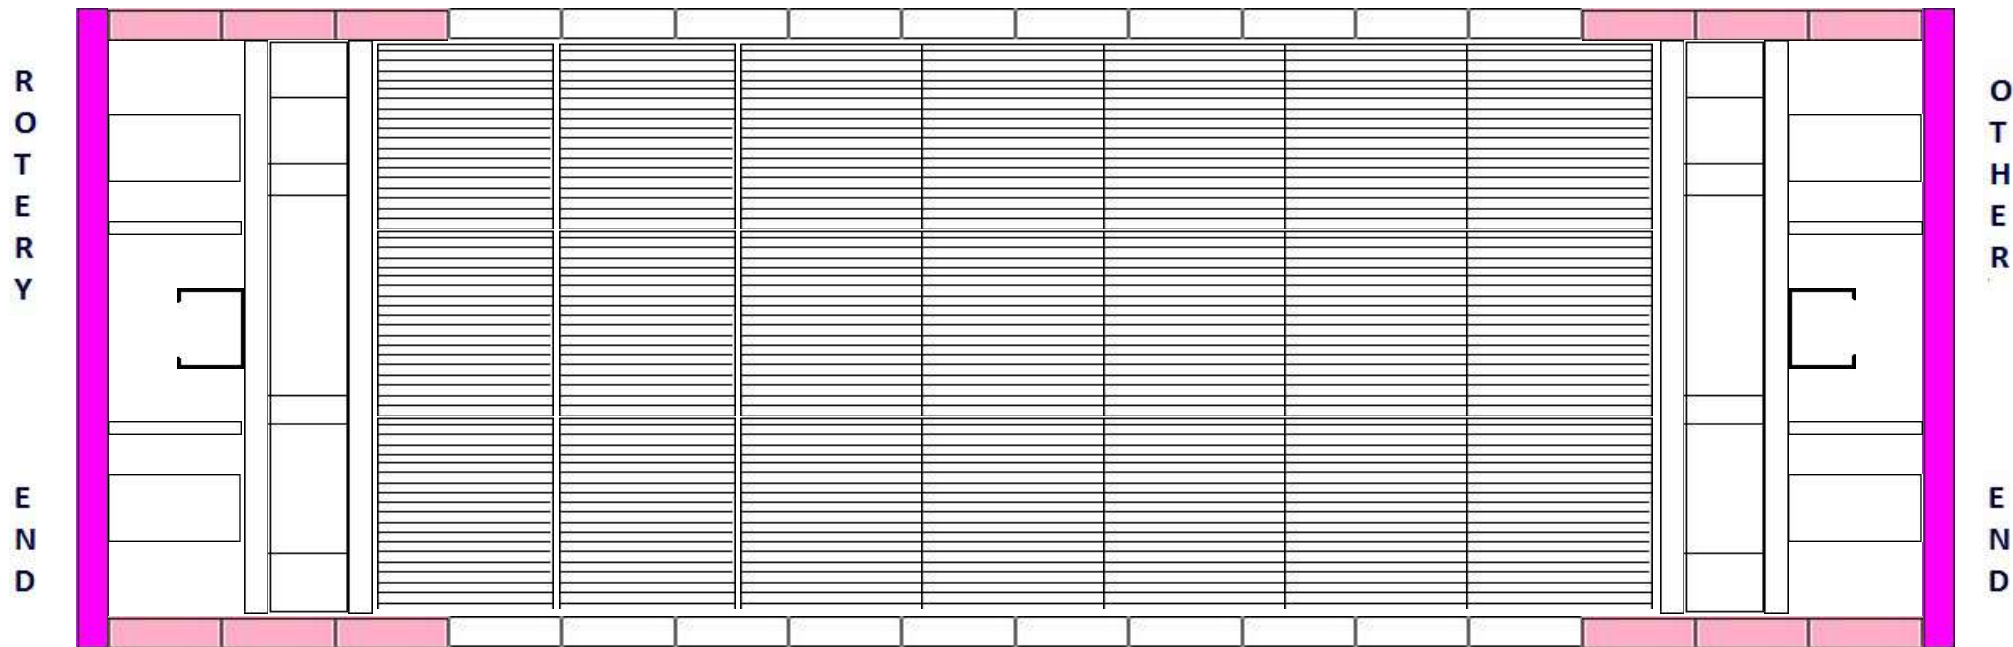
Coach No. :SR08115

Color	Particulars	Qty	Per%	Color	Particulars	Qty	Per%	Color	Particulars	Qty	Per%
	Headstock Beam	0	0%		Centre Stiffner for Headstock	0	0%		Floor Stiffner for Headstock	0	0%
	Aux. Head stock	0	0%		Sole Bar	6	38%		Draft Gear Bracket	0	0%
	Trough floor	0	0%		Centre plate	0	0%		SoleBar Stiffner	4	100%
	Bottom Wall Part	6	38%		Body panel/patch		100%		Door Top/Roof Patch		0%
	Window Module		0%		Window Sill	0	0%		Window Bar	0	0%
	Seat pillar/lav. Partition		100%		UIC end construction		0%

End Drooping: Rotary End - EAST : -7, WEST : -6 Other End - EAST : -5, WEST : -4
Start Date : 15-Apr-2019, Completion Date : 23-Apr-2019, Net Repair Days : 8, Total Man Hours : 1408

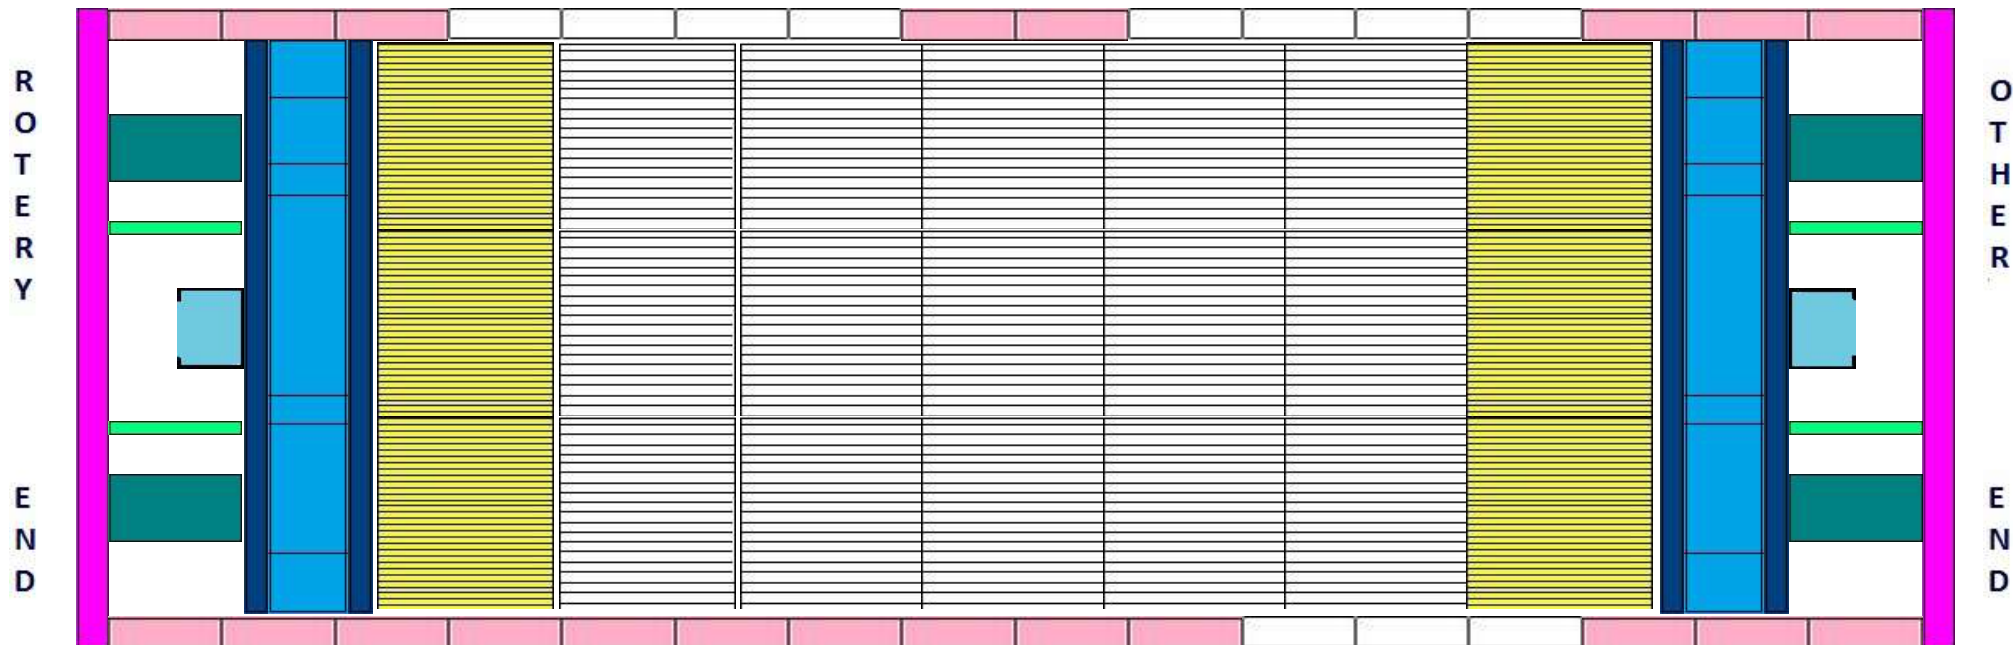
Color	Particulars	Qty	Per%	Color	Particulars	Qty	Per%	Color	Particulars	Qty	Per%
	Headstock Beam	2	100%		Centre Stiffner for Headstock	4	100%		Floor Stiffner for Headstock	4	100%
	Aux. Head stock	4	100%		Sole Bar	10.5	66%		Draft Gear Bracket	2	100%
	Trough floor	2	29%		Centre plate	2	100%		SoleBar Stiffner	6	100%
	Bottom Wall Part	10.5	66%		Body panel/patch		100%		Door Top/Roof Patch		0%
	Window Module		0%		Window Sill	40	100%		Window Bar	52	29%
	Seat pillar/lav. Partition		100%		UIC end construction		0%

End Drooping: Rotary End - EAST : 0, WEST : -4 Other End - EAST : -6, WEST : -7
Start Date : 18-Apr-2019, Completion Date : 24-Apr-2019, Net Repair Days : 6, Total Man Hours : 1660

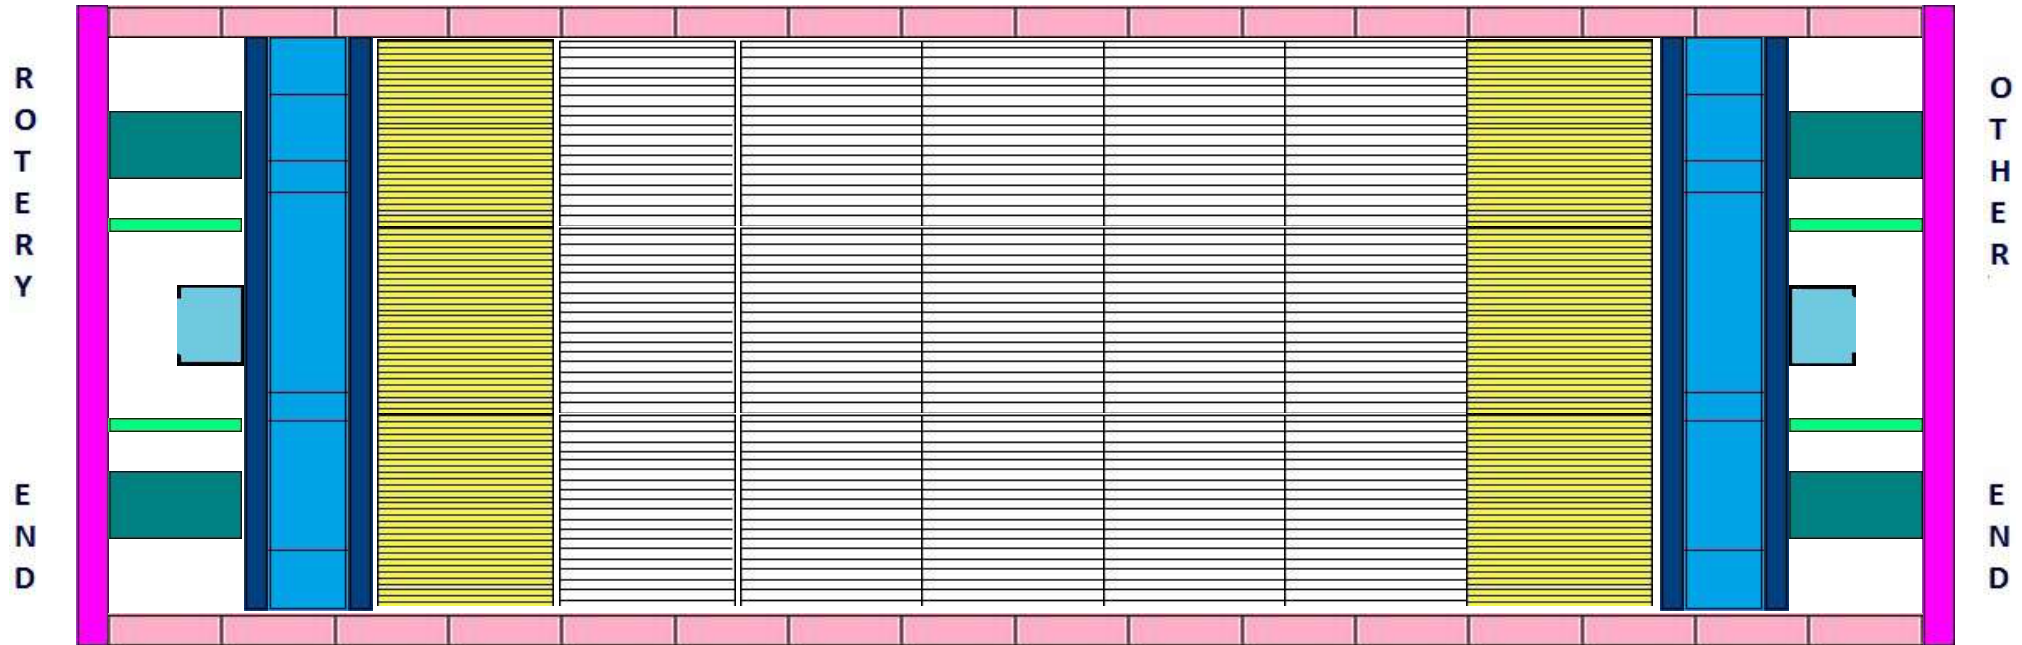
Color	Particulars	Qty	Per%	Color	Particulars	Qty	Per%	Color	Particulars	Qty	Per%
	Headstock Beam	2	100%		Centre Stiffner for Headstock	4	100%		Floor Stiffner for Headstock	4	100%
	Aux. Head stock	4	100%		Sole Bar	16	100%		Draft Gear Bracket	2	100%
	Trough floor	2	29%		Centre plate	2	100%		SoleBar Stiffner	4	100%
	Bottom Wall Part	16	100%		Body panel/patch		100%		Door Top/Roof Patch		0%
	Window Module		0%		Window Sill	28	70%		Window Bar	44	24%
	Seat pillar/lav. Partition		100%		UIC end construction		0%

Start Date : 08-Apr-2019, Completion Date : 26-Apr-2019, Net Repair Days : 17, Total Man Hours : 1780

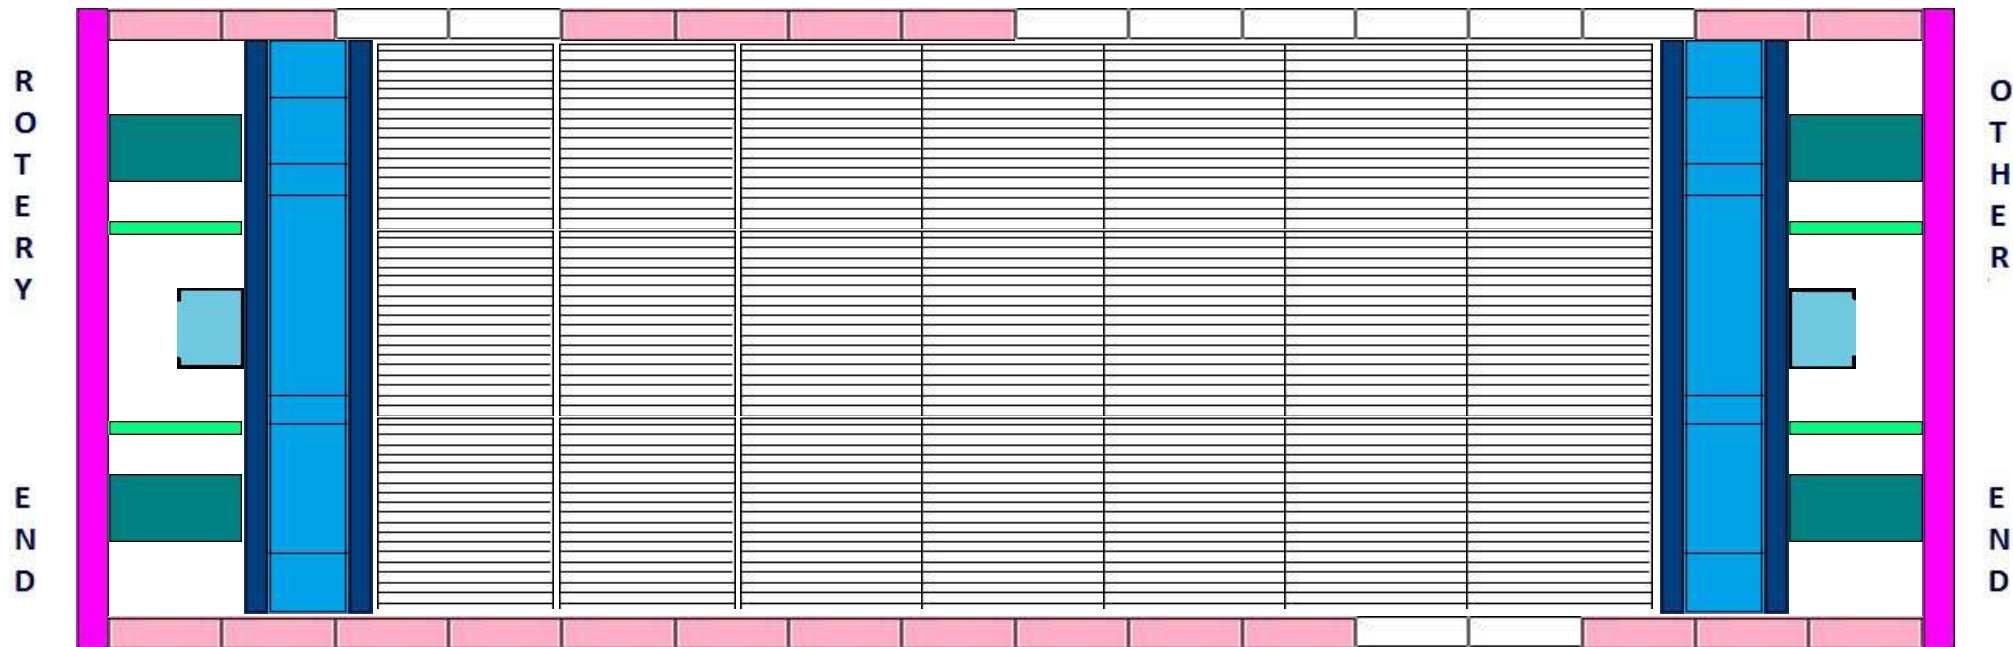
Color	Particulars	Qty	Per%	Color	Particulars	Qty	Per%	Color	Particulars	Qty	Per%
	Headstock Beam	2	100%		Centre Stiffner for Headstock	4	100%		Floor Stiffner for Headstock	4	100%
	Aux. Head stock	4	100%		Sole Bar	11	69%		Draft Gear Bracket	2	100%
	Trough floor	0	0%		Centre plate	2	100%		SoleBar Stiffner	4	100%
	Bottom Wall Part	11	69%		Body panel/patch		100%		Door Top/Roof Patch		0%
	Window Module		0%		Window Sill	28	70%		Window Bar	44	25%
	Seat pillar/lav. Partition		100%		UIC end construction		0%

End Drooping: Rotary End - EAST : -7, WEST : 0 Other End - EAST : -8, WEST : -6
Start Date : 20-Mar-2019, Completion Date : 02-Apr-2019, Net Repair Days : 12, Total Man Hours : 1520

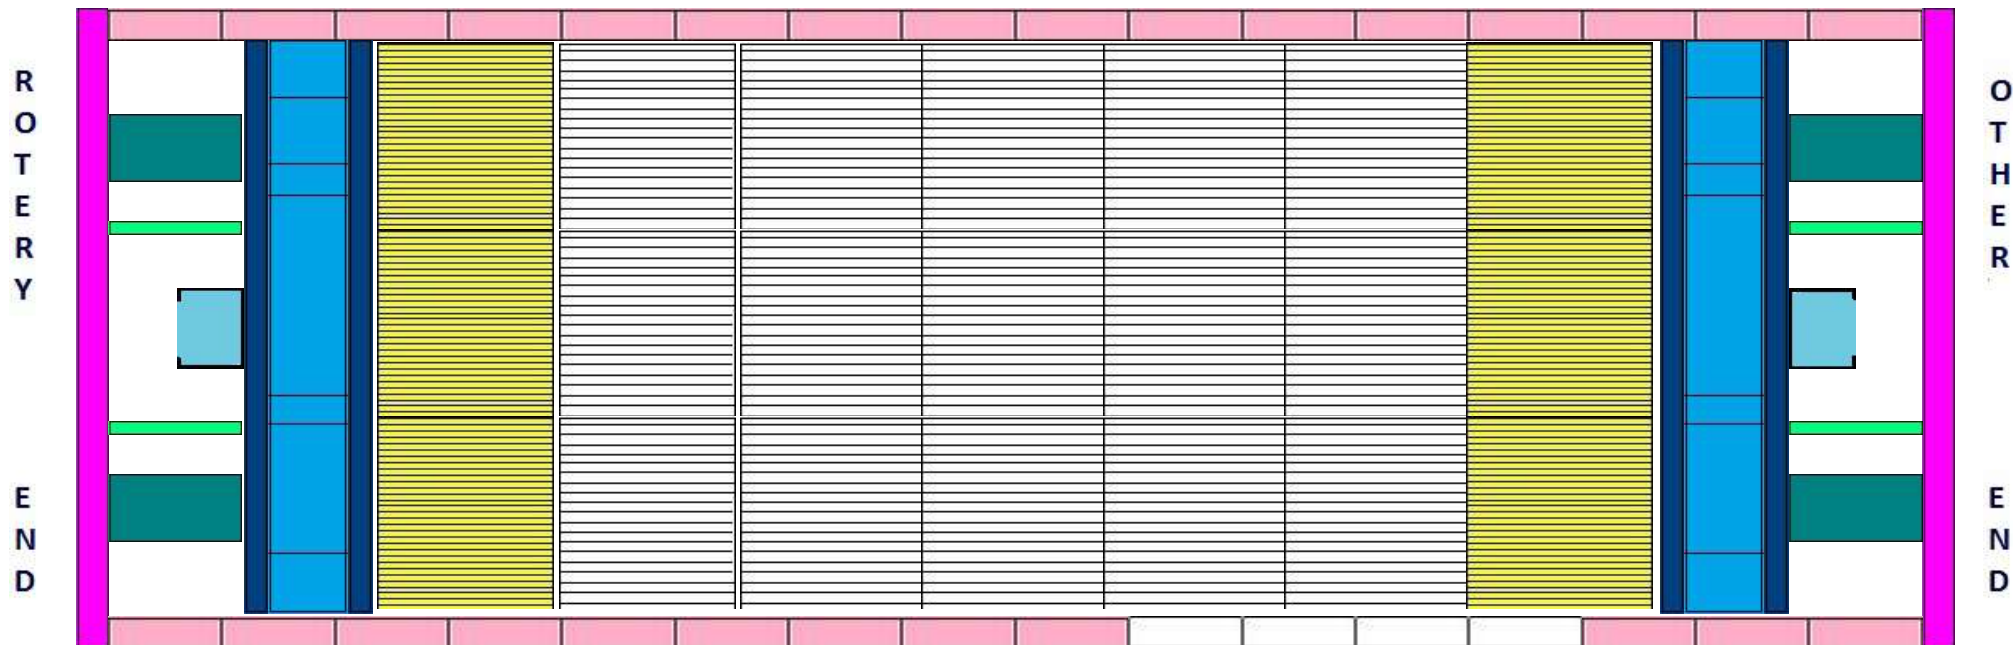
Color	Particulars	Qty	Per%	Color	Particulars	Qty	Per%	Color	Particulars	Qty	Per%
Yellow	Headstock Beam	2	100%	Dark Green	Centre Stiffner for Headstock	4	100%	Light Green	Floor Stiffner for Headstock	4	100%
Dark Blue	Aux. Head stock	4	100%	Pink	Sole Bar	14	88%	Light Blue	Draft Gear Bracket	2	100%
Yellow	Trough floor	2	29%	Light Blue	Centre plate	2	100%		SoleBar Stiffner	6	100%
	Bottom Wall Part	14	88%		Body panel/patch		100%		Door Top/Roof Patch		0%
	Window Module		0%		Window Sill	36	90%		Window Bar	50	28%
	Seat pillar/lav. Partition		100%		UIC end construction		0%

End Drooping: Rotary End - EAST : -5, WEST : 5 Other End - EAST : 4, WEST : 0
Start Date : 05-Apr-2019, Completion Date : 13-Apr-2019, Net Repair Days : 8, Total Man Hours : 1540

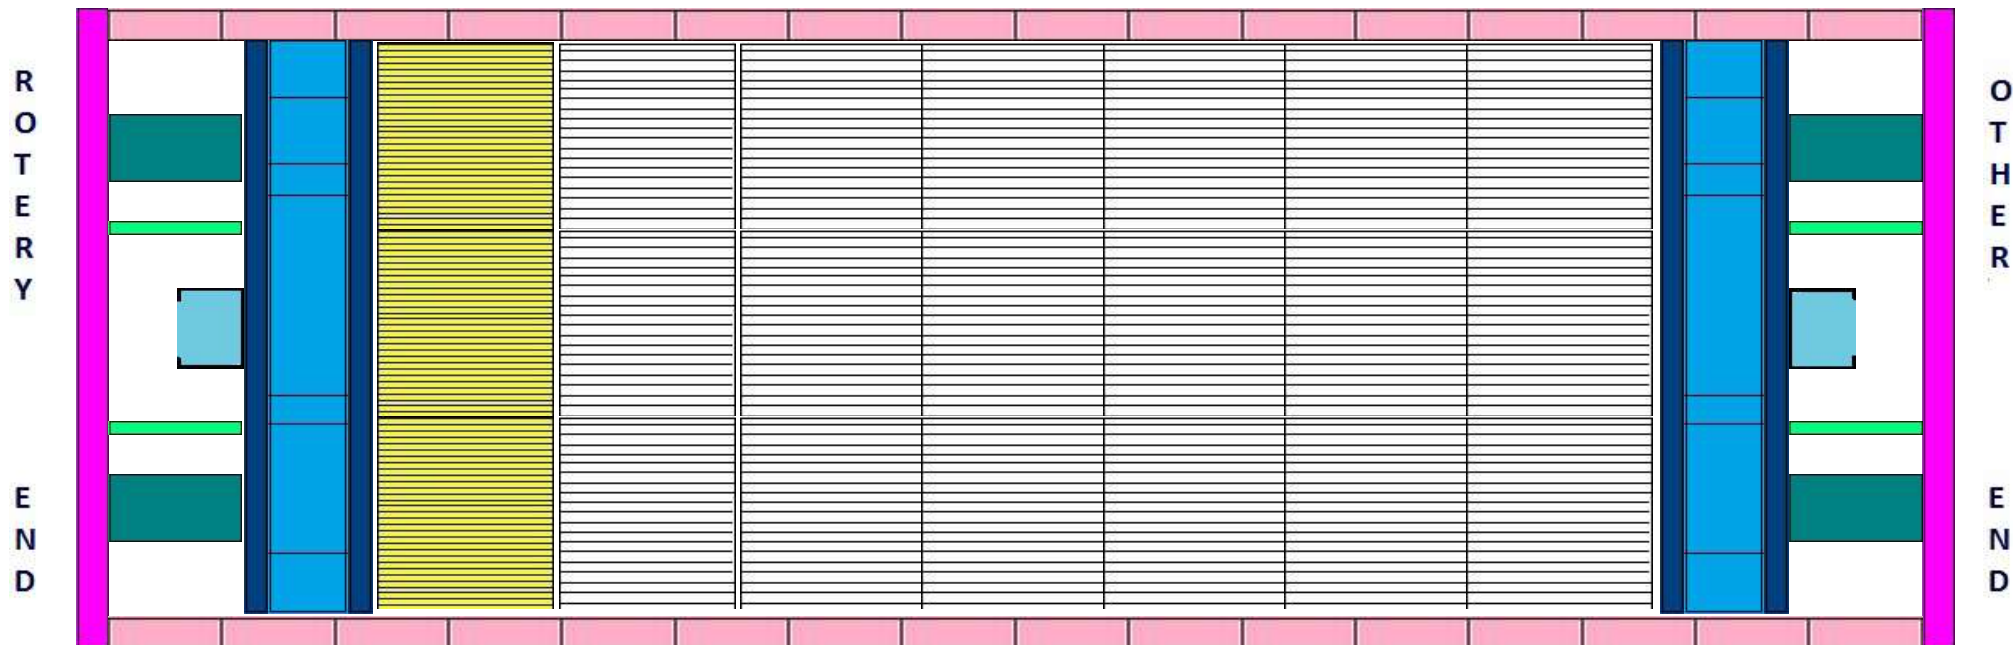
Color	Particulars	Qty	Per%	Color	Particulars	Qty	Per%	Color	Particulars	Qty	Per%
	Headstock Beam	2	100%		Centre Stiffner for Headstock	4	100%		Floor Stiffner for Headstock	4	100%
	Aux. Head stock	4	100%		Sole Bar	16	100%		Draft Gear Bracket	2	100%
	Trough floor	1	14%		Centre plate	2	100%		SoleBar Stiffner	4	100%
	Bottom Wall Part	16	100%		Body panel/patch		100%		Door Top/Roof Patch		0%
	Window Module		0%		Window Sill	40	100%		Window Bar	74	40%
	Seat pillar/lav. Partition		100%		UIC end construction		0%

End Drooping: Rotary End - EAST : 8, WEST : 6 Other End - EAST : 0, WEST : 0
Start Date : 29-Mar-2019, Completion Date : 06-Apr-2019, Net Repair Days : 8, Total Man Hours : 1956

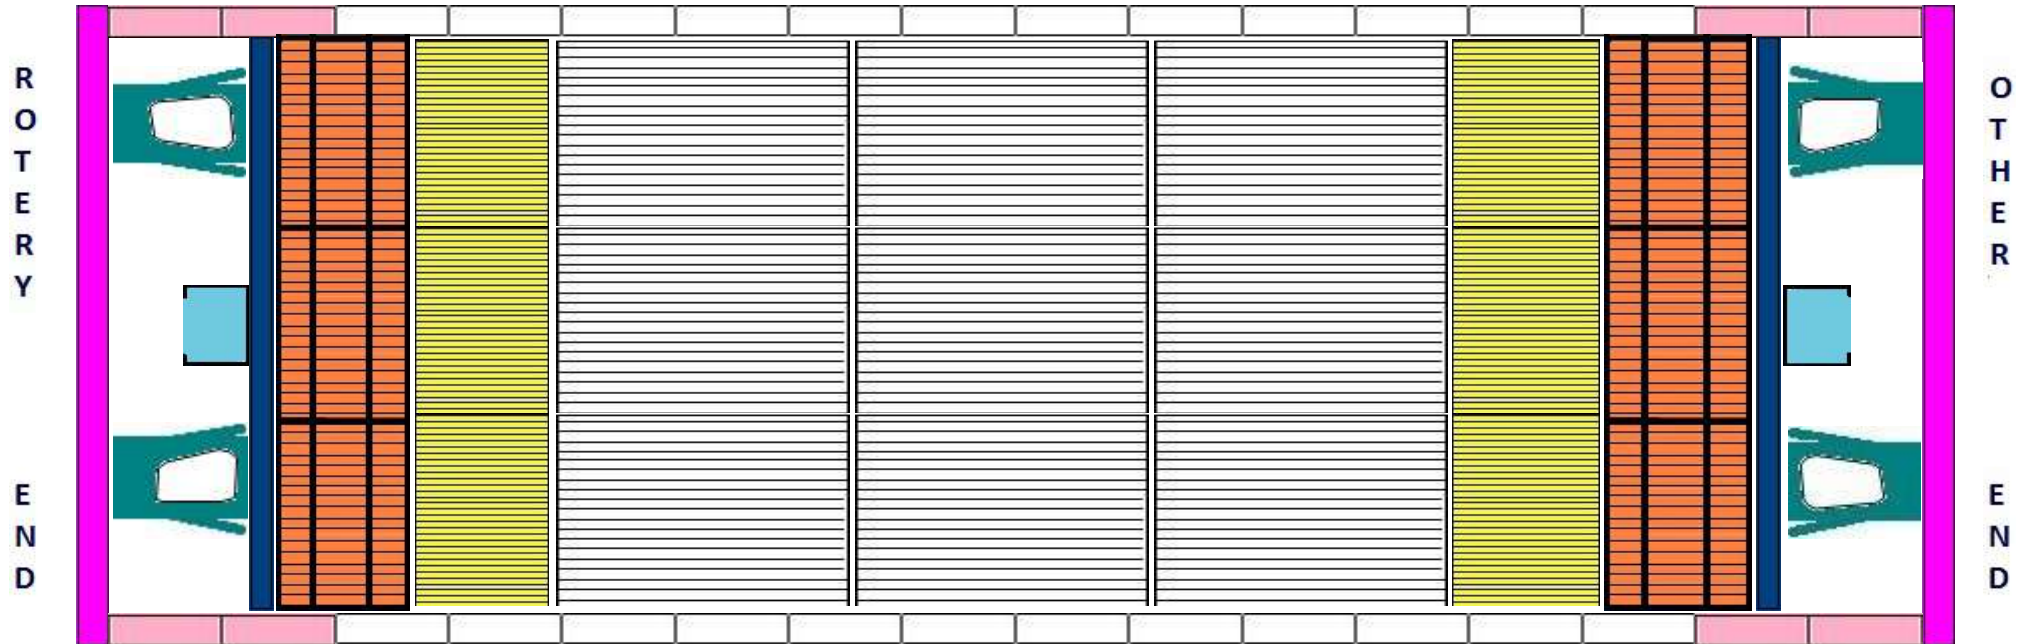
Color	Particulars	Qty	Per%	Color	Particulars	Qty	Per%	Color	Particulars	Qty	Per%
	Headstock Beam	2	100%		Diagonal	4	100%		Logitudinal Channel Structure	2	100%
	Aux. Head stock	2	100%		Sole Bar	4	25%		Draft Gear Bracket	2	100%
	Trough floor	2	40%		Bottom Wall Part	4	25%		Body panel/patch		100%
	Door Top/Roof Patch		0%		Seat Bracket Rail		0%		Window Sill	0	0%
	Window Bar	0	0%		Seat pillar/lav. Partition		100%		UIC end construction		0%
	Body Pillar Part	22	100%

End Drooping: Rotary End - EAST : 3, WEST : 0 Other End - EAST : 3, WEST : 2
Start Date : 01-Oct-2019, Completion Date : 07-Oct-2019, Net Repair Days : 6, Total Man Hours : 1068

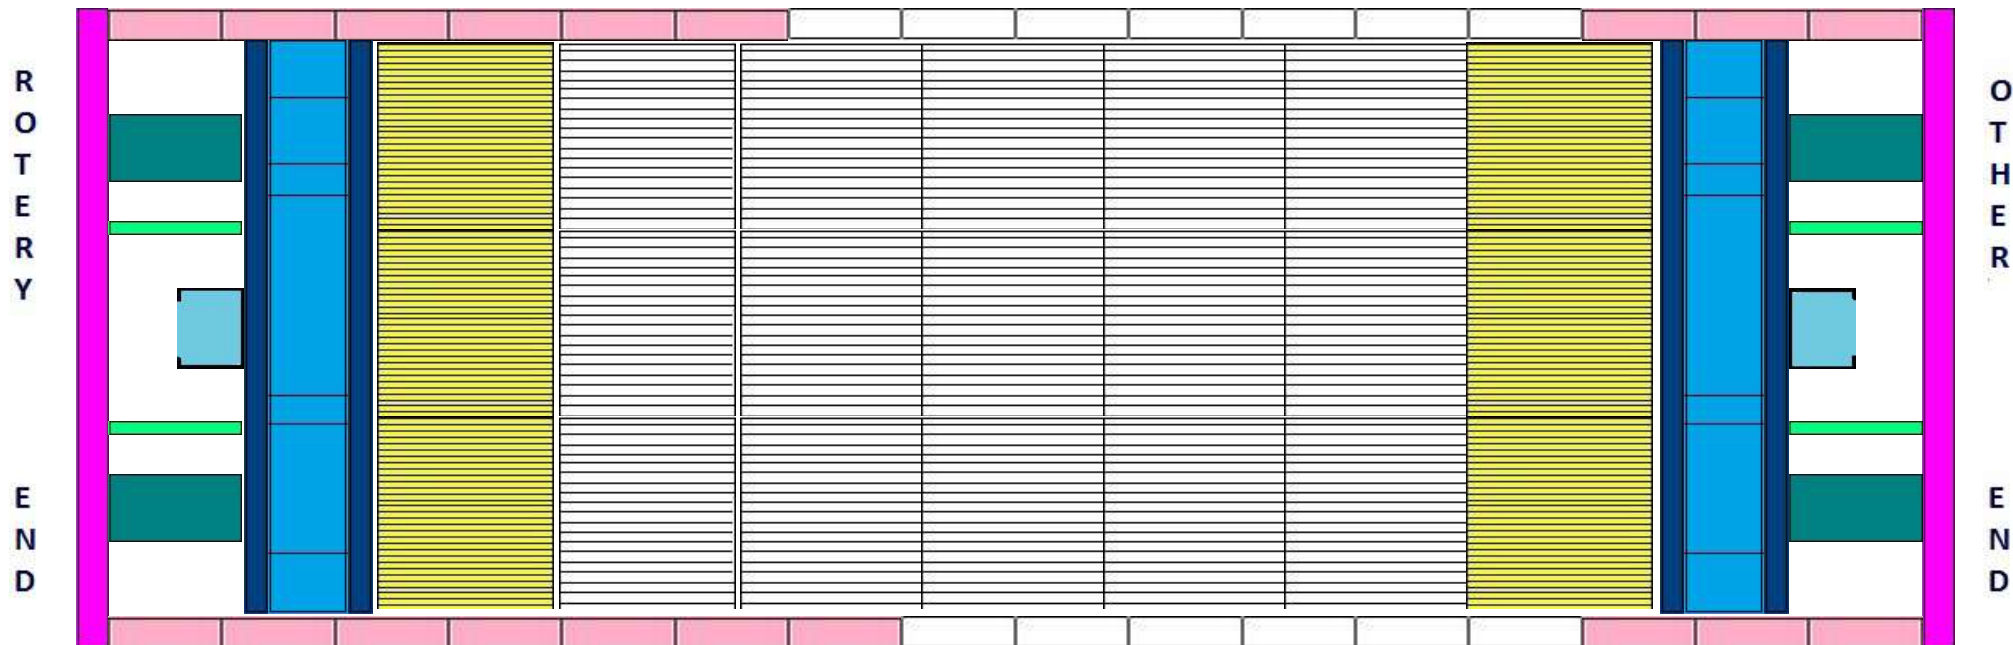
Color	Particulars	Qty	Per%	Color	Particulars	Qty	Per%	Color	Particulars	Qty	Per%
Yellow	Headstock Beam	2	100%	Dark Green	Centre Stiffner for Headstock	4	100%	Light Green	Floor Stiffner for Headstock	4	100%
Dark Blue	Aux. Head stock	4	100%	Pink	Sole Bar	9.5	59%	Light Blue	Draft Gear Bracket	2	100%
Yellow	Trough floor	2	29%	Light Blue	Centre plate	2	100%		SoleBar Stiffner	4	100%
	Bottom Wall Part	9.5	59%		Body panel/patch		100%		Door Top/Roof Patch		0%
	Window Module		0%		Window Sill	7	37%		Window Bar	16	19%
	Seat pillar/lav. Partition		100%		UIC end construction		0%

End Drooping: Rotary End - EAST : -6, WEST : -7 Other End - EAST : -4, WEST : -8
Start Date : 26-Sep-2019, Completion Date : 07-Oct-2019, Net Repair Days : 10, Total Man Hours : 1136

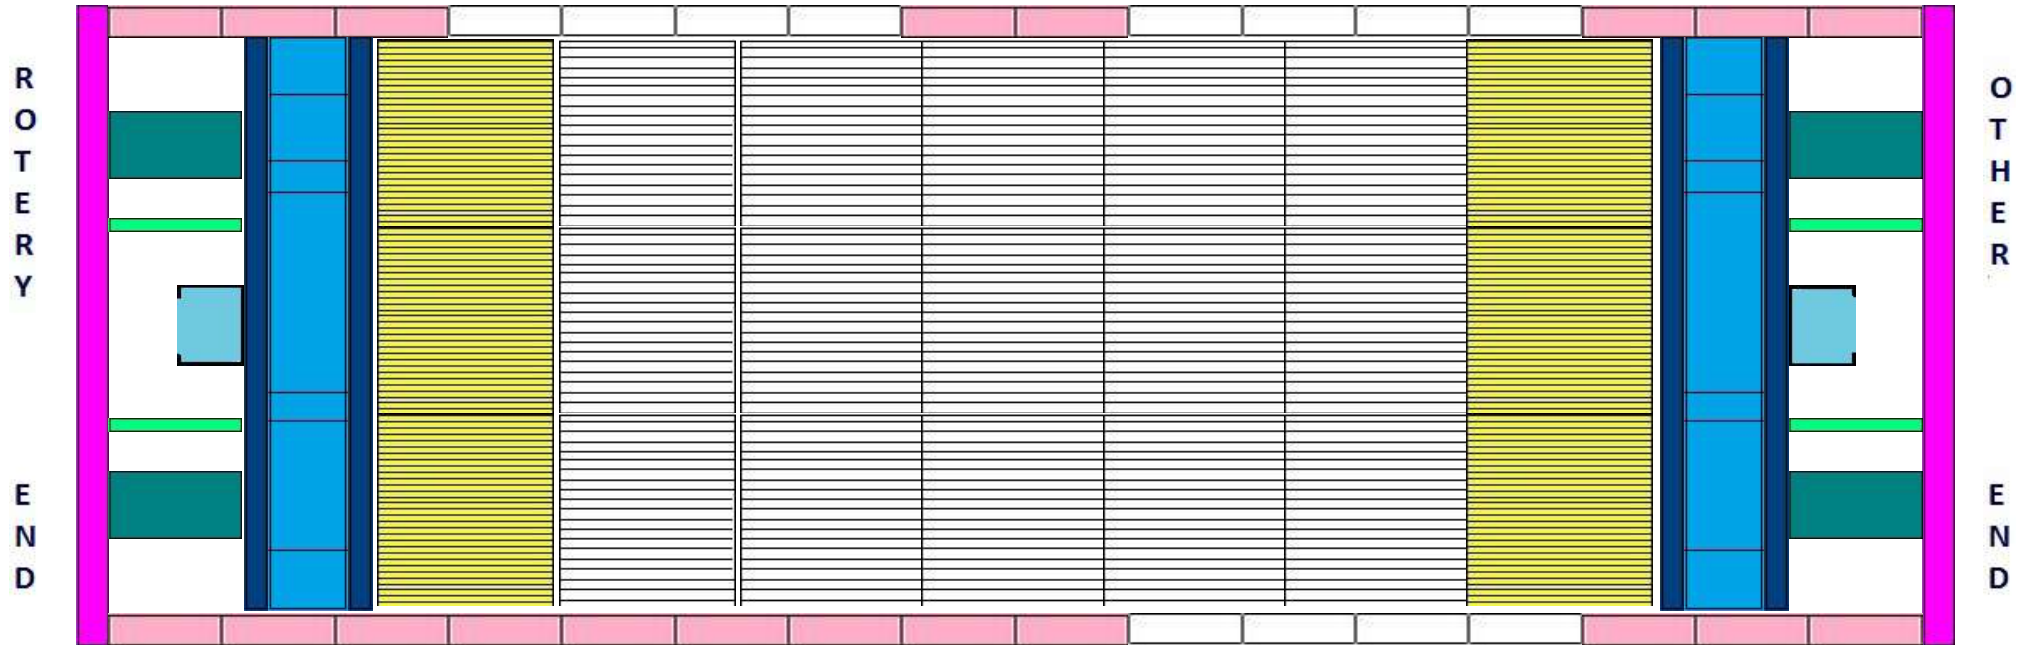
Color	Particulars	Qty	Per%	Color	Particulars	Qty	Per%	Color	Particulars	Qty	Per%
	Headstock Beam	2	100%		Centre Stiffner for Headstock	4	100%		Floor Stiffner for Headstock	4	100%
	Aux. Head stock	4	100%		Sole Bar	10	63%		Draft Gear Bracket	2	100%
	Trough floor	2	29%		Centre plate	2	100%		SoleBar Stiffner	6	100%
	Bottom Wall Part	10	63%		Body panel/patch		100%		Door Top/Roof Patch		0%
	Window Module		0%		Window Sill	28	70%		Window Bar	44	25%
	Seat pillar/lav. Partition		100%		UIC end construction		0%

End Drooping: Rotary End - EAST : -7, WEST : -3 Other End - EAST : -2, WEST : -3
Start Date : 04-Oct-2019, Completion Date : 14-Oct-2019, Net Repair Days : 9, Total Man Hours : 1340

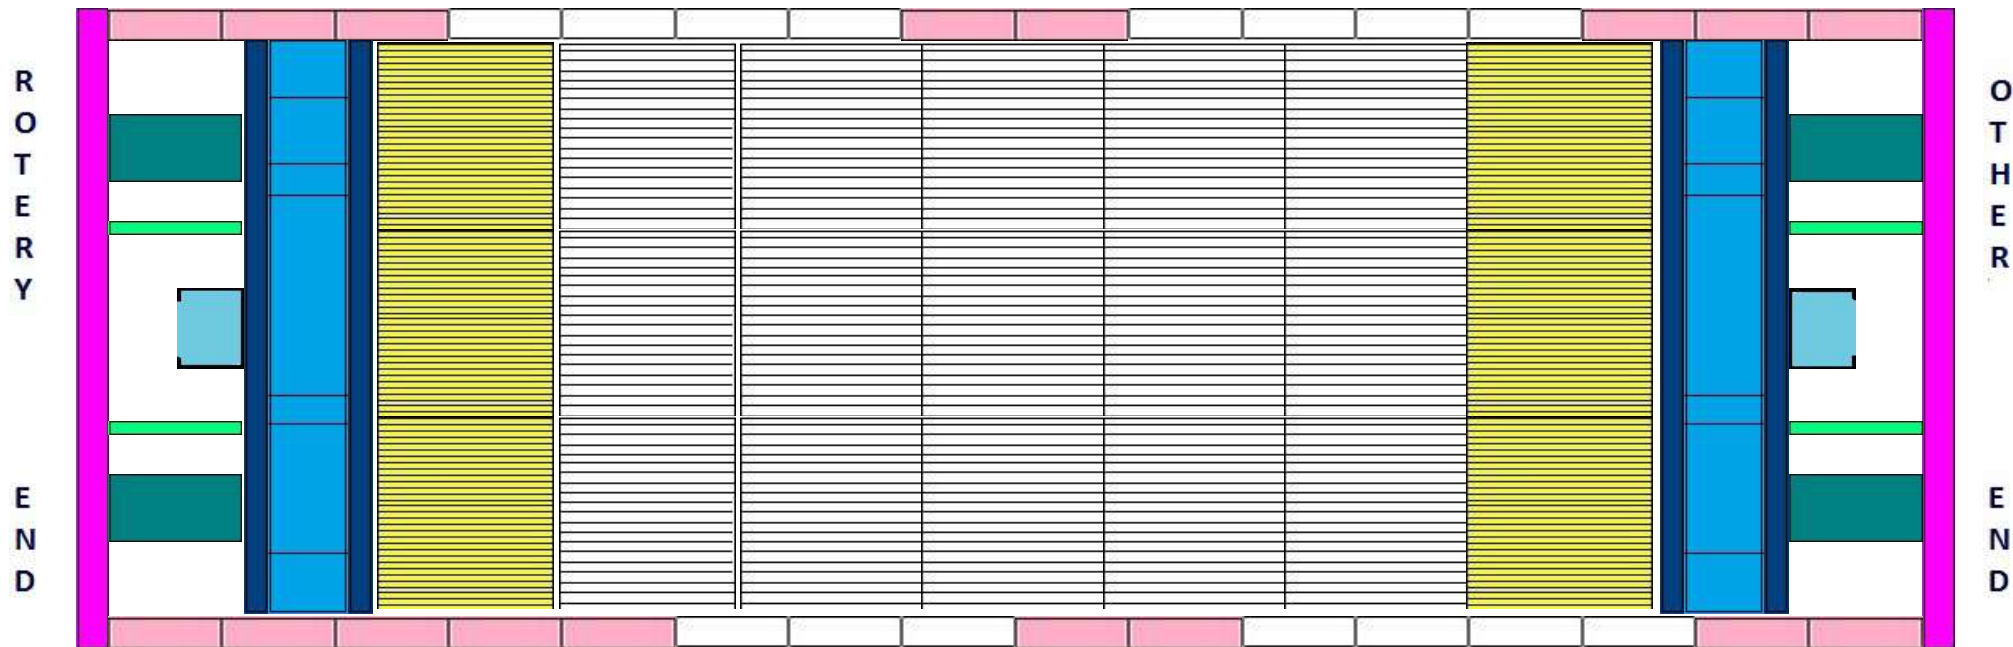
End Drooping: Rotary End - EAST : -10, WEST : -10 Other End - EAST : -3, WEST : 0
Start Date : 24-May-2019, Completion Date : 01-Jun-2019, Net Repair Days : 8, Total Man Hours : 1304

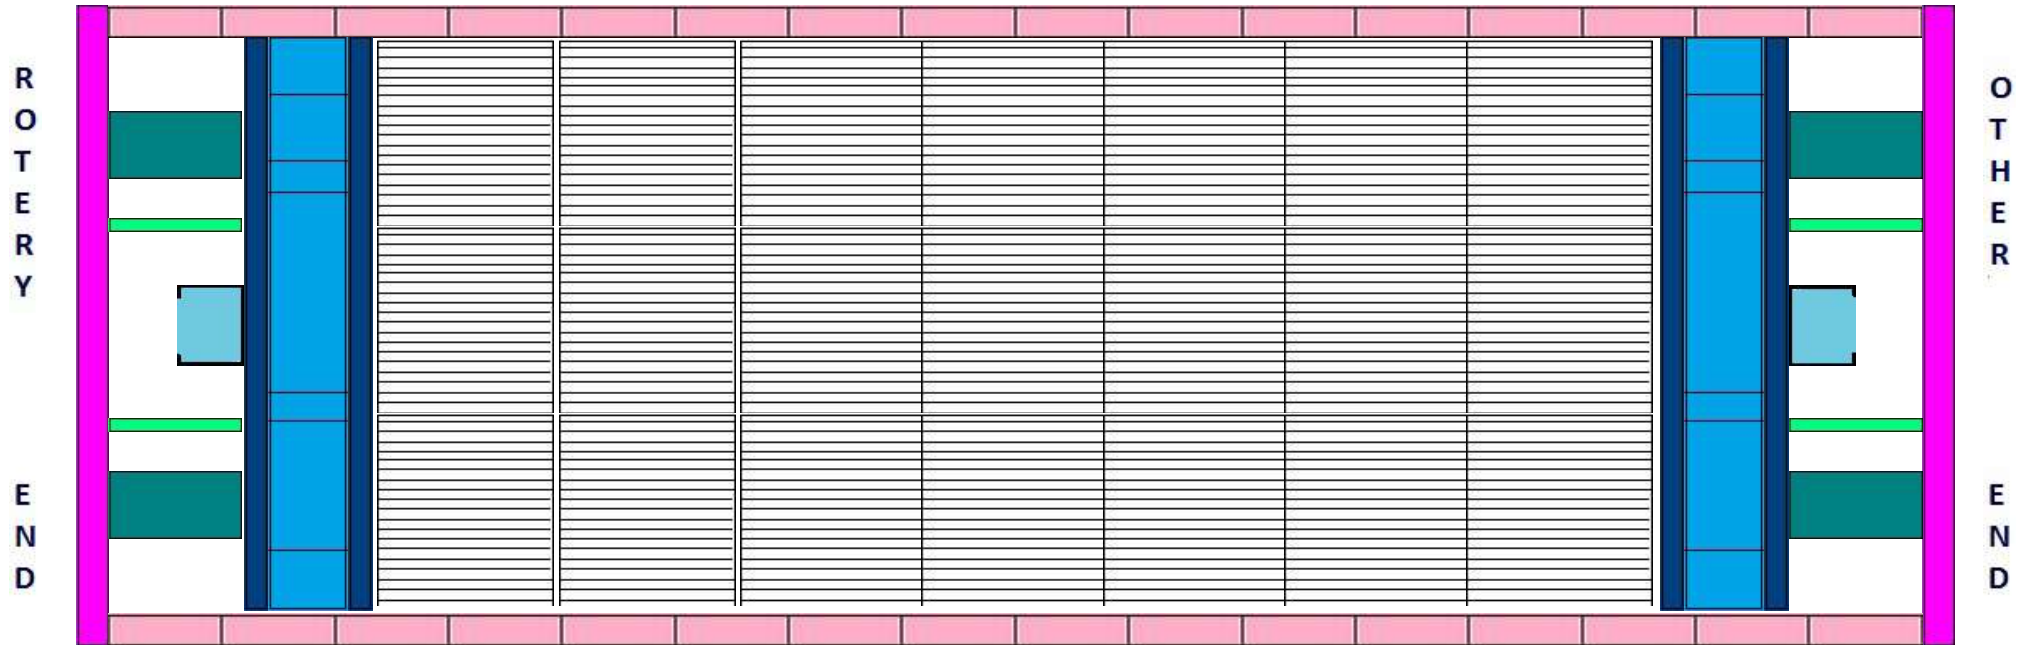
End Drooping: Rotary End - EAST : -5, WEST : -3 Other End - EAST : -6, WEST : -5
Start Date : 18-Apr-2019, Completion Date : 27-Apr-2019, Net Repair Days : 9, Total Man Hours : 1548

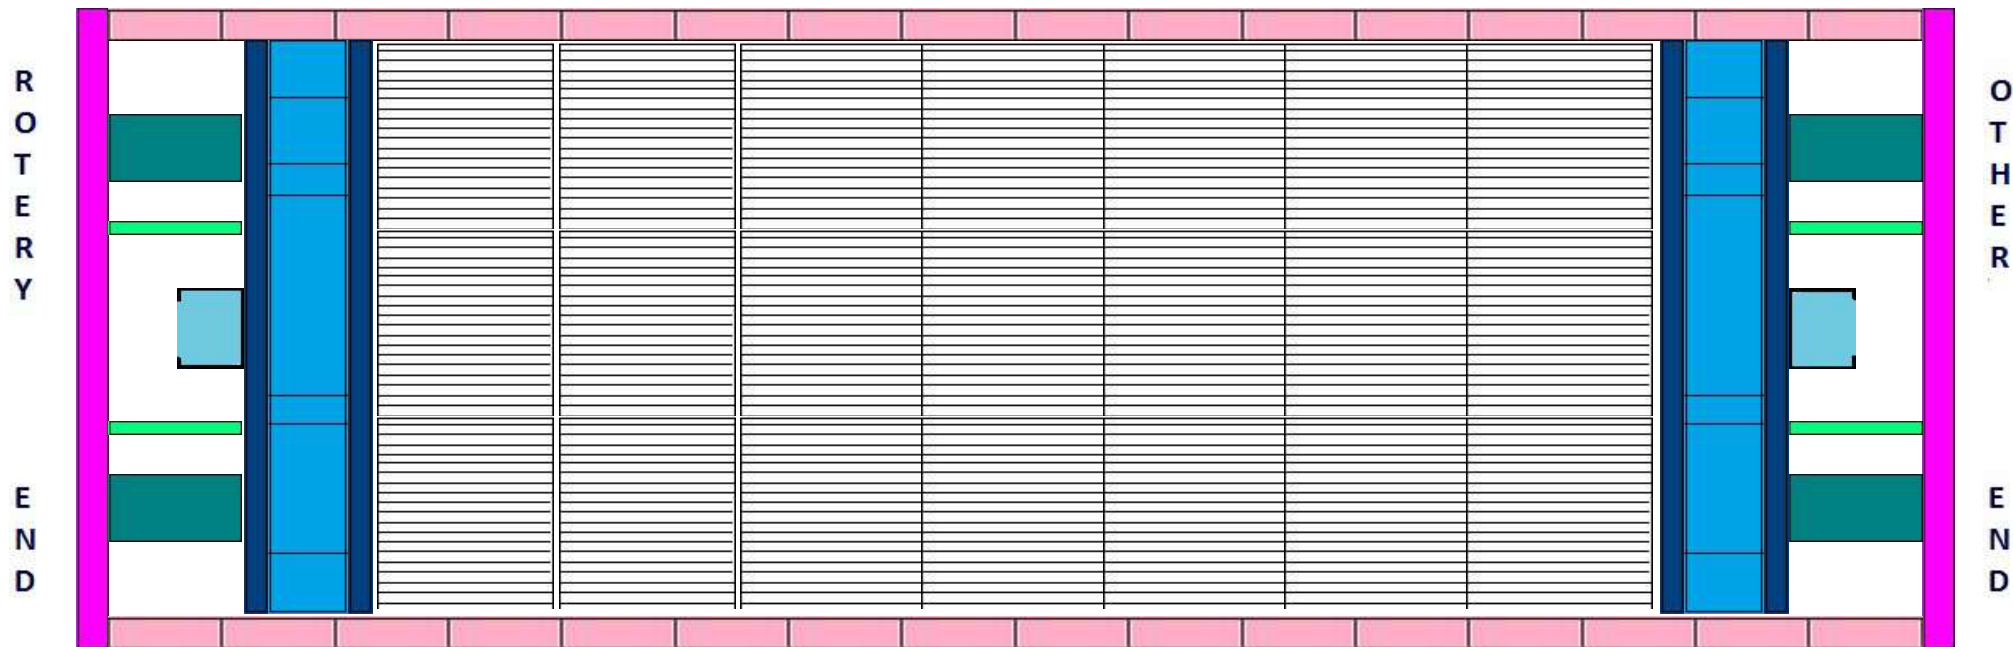
End Drooping: Rotary End - EAST : -2, WEST : -5 Other End - EAST : -3, WEST : -2
Start Date : 25-Mar-2019, Completion Date : 04-Apr-2019, Net Repair Days : 10, Total Man Hours : 2005

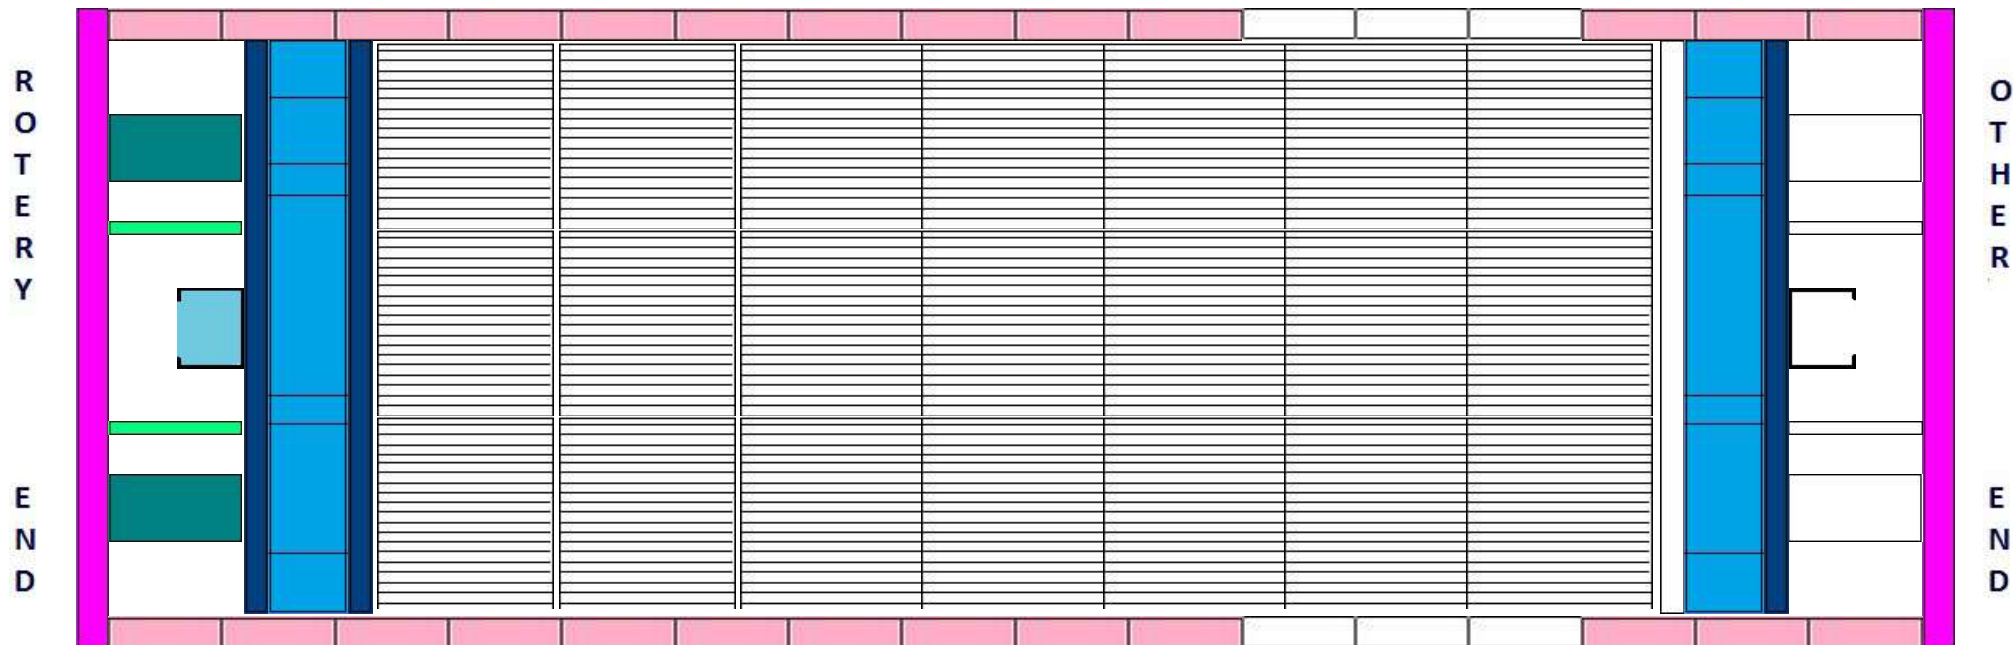
Color	Particulars	Qty	Per%	Color	Particulars	Qty	Per%	Color	Particulars	Qty	Per%
Blue	Headstock Beam	1	50%	Green	Centre Stiffner for Headstock	2	50%	Red	Floor Stiffner for Headstock	2	50%
Black	Aux. Head stock	2	50%	Yellow	Sole Bar	13	81%	Light Blue	Draft Gear Bracket	1	50%
Orange	Trough floor	0	0%	Dark Blue	Centre plate	1	50%		SoleBar Stiffner	4	100%
	Bottom Wall Part	13	81%		Body panel/patch		100%		Door Top/Roof Patch		0%
	Window Module		0%		Window Sill	40	100%		Window Bar	64	35%
	Seat pillar/lav. Partition		100%		UIC end construction		0%

End Drooping: Rotary End - EAST : -8, WEST : -10 Other End - EAST : 0, WEST : -5
Start Date : 01-Apr-2019, Completion Date : 08-Apr-2019, Net Repair Days : 7, Total Man Hours : 1800

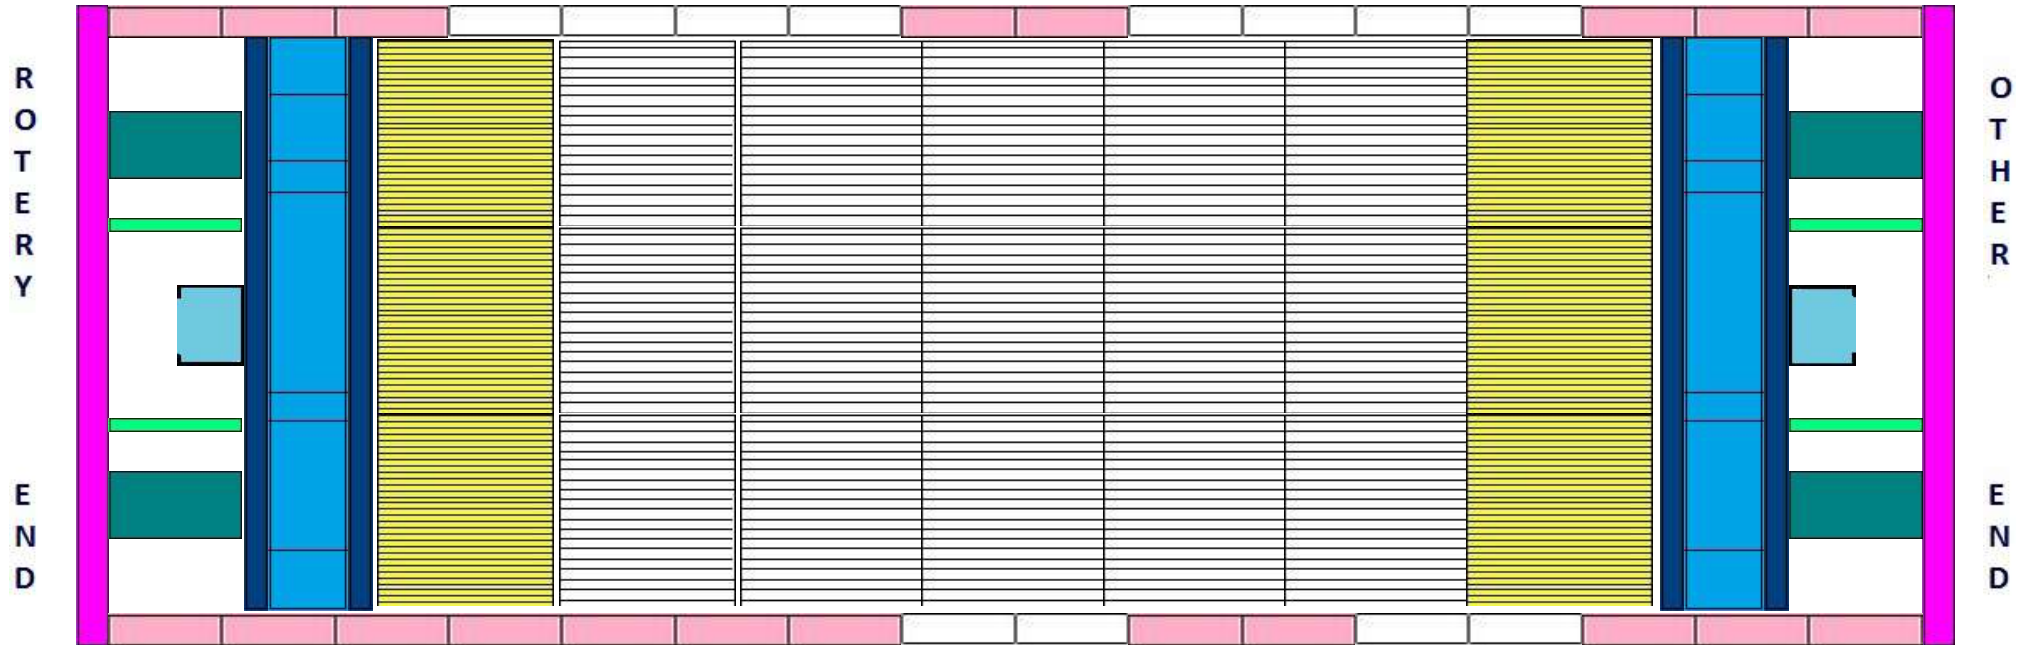
Color	Particulars	Qty	Per%	Color	Particulars	Qty	Per%	Color	Particulars	Qty	Per%
Yellow	Headstock Beam	2	100%	Dark Green	Centre Stiffner for Headstock	4	100%	Light Green	Floor Stiffner for Headstock	4	100%
Dark Blue	Aux. Head stock	4	100%	Pink	Sole Bar	10	63%	Light Blue	Draft Gear Bracket	2	100%
Yellow	Trough floor	2	29%	Light Blue	Centre plate	2	100%		SoleBar Stiffner	6	100%
	Bottom Wall Part	10	63%		Body panel/patch		100%		Door Top/Roof Patch		0%
	Window Module		0%		Window Sill	40	100%		Window Bar	48	27%
	Seat pillar/lav. Partition		100%		UIC end construction		0%

End Drooping: Rotary End - EAST : 8, WEST : 7 Other End - EAST : 6, WEST : 9
Start Date : 15-Jul-2019, Completion Date : 22-Jul-2019, Net Repair Days : 7, Total Man Hours : 1408
