Coach Rehabilitation Workshop, WC Railway, Bhopal

(An IMS and ISO 50001 Certified Workshop)
Final Inspection Sheet - Details of Corrosion Repair

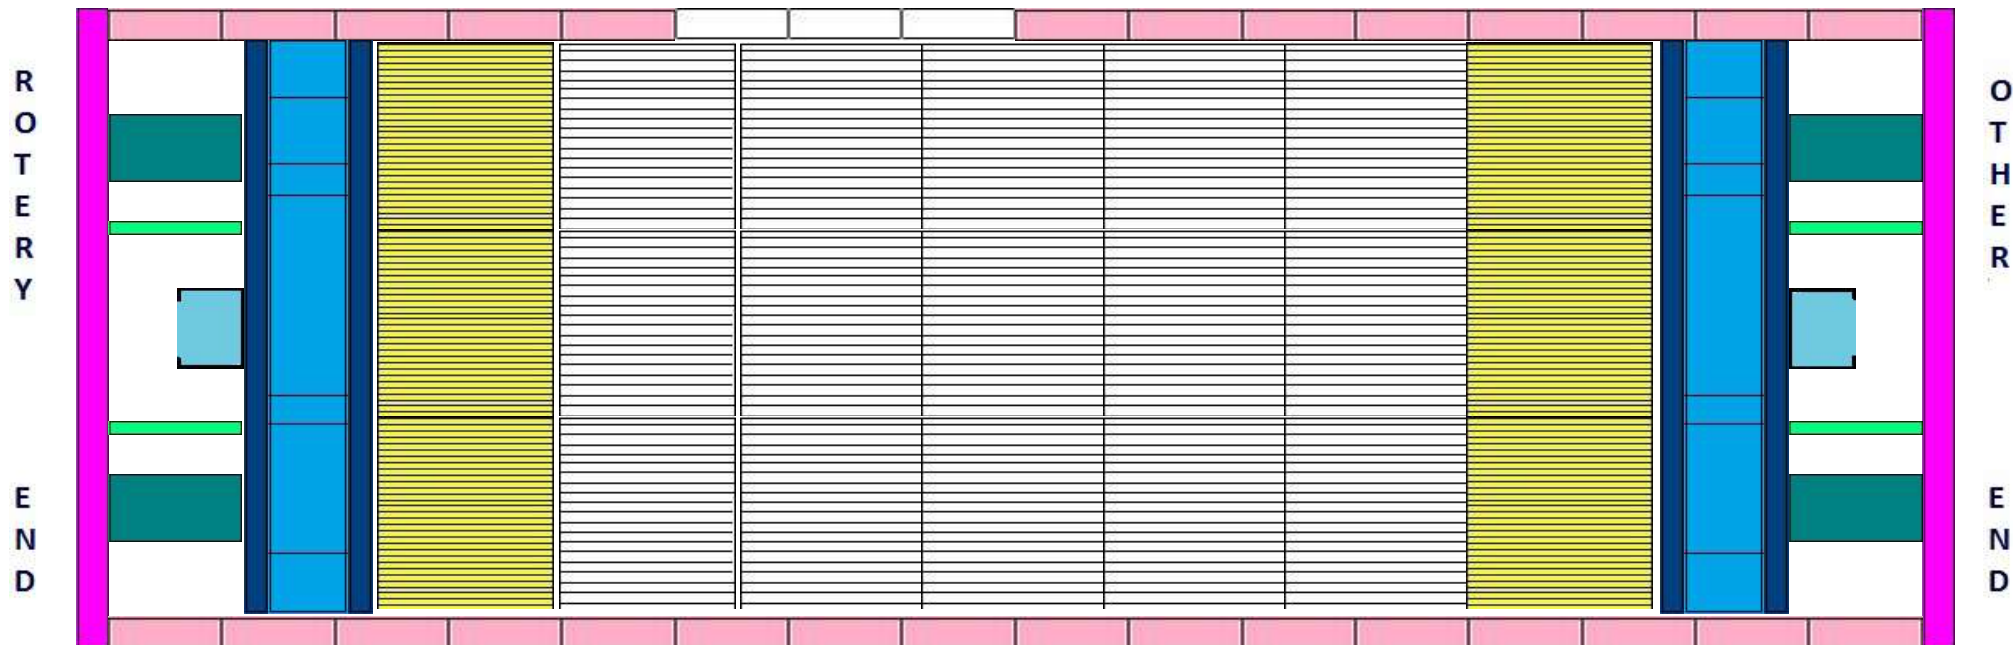
End Drooping: Rotary End - EAST : -5, WEST : -4 Other End - EAST : -8, WEST : -3
Start Date : 12-Jul-2019, Completion Date : 18-Jul-2019, Net Repair Days : 6, Total Man Hours : 1384

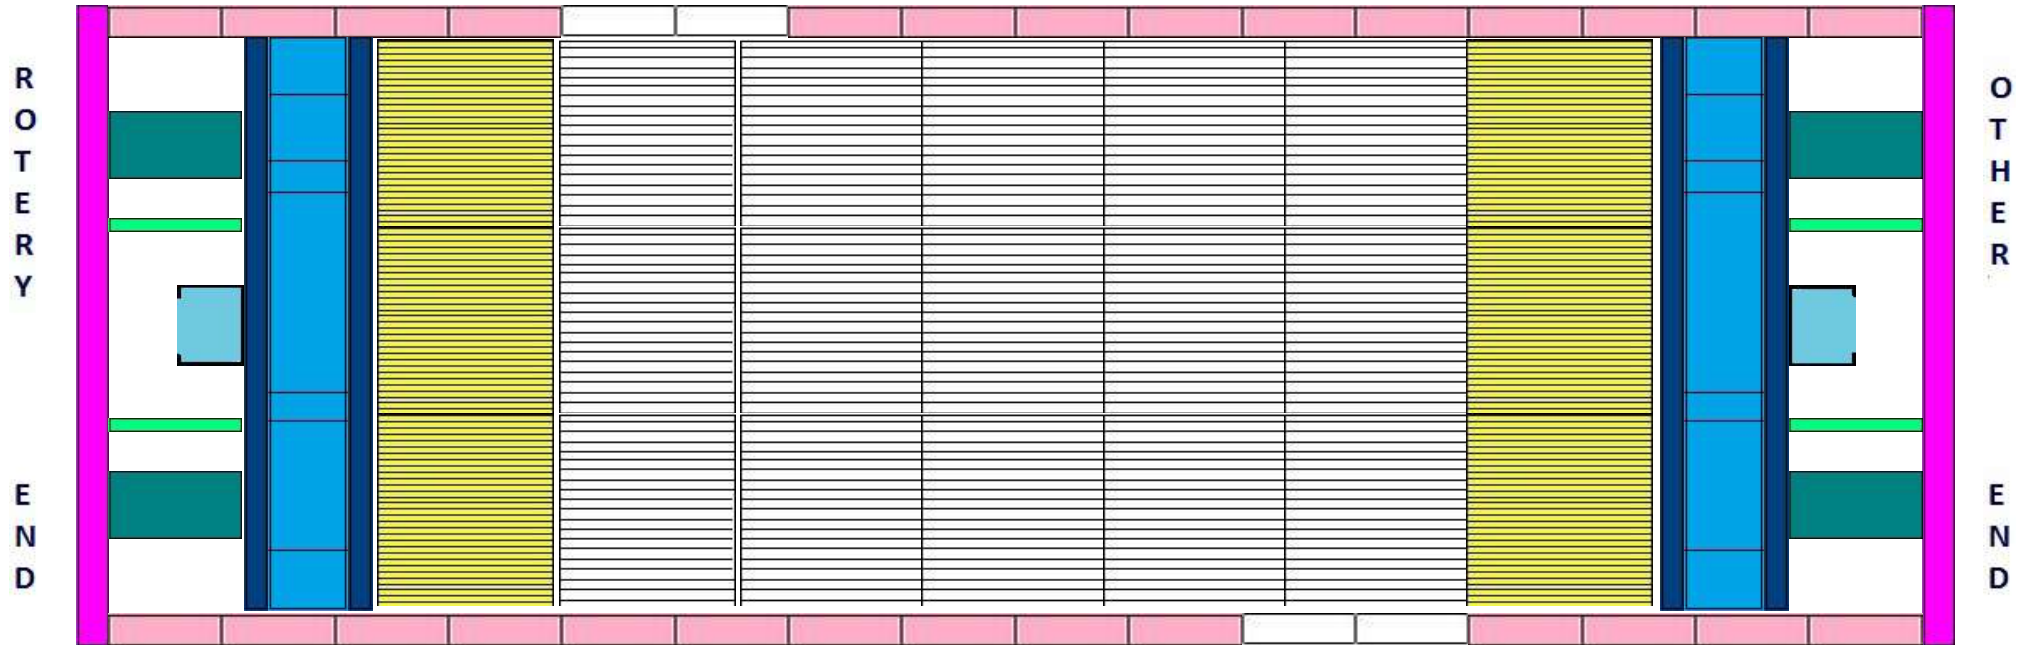
Color	Particulars	Qty	Per%	Color	Particulars	Qty	Per%	Color	Particulars	Qty	Per%
Yellow	Headstock Beam	2	100%	Dark Green	Centre Stiffner for Headstock	4	100%	Light Green	Floor Stiffner for Headstock	4	100%
Dark Blue	Aux. Head stock	4	100%	Pink	Sole Bar	14	88%	Light Blue	Draft Gear Bracket	2	100%
Yellow	Trough floor	2	29%	Light Blue	Centre plate	2	100%		SoleBar Stiffner	4	100%
	Bottom Wall Part	14	88%		Body panel/patch		100%		Door Top/Roof Patch		0%
	Window Module		0%		Window Sill	40	100%		Window Bar	42	23%
	Seat pillar/lav. Partition		100%		UIC end construction		0%

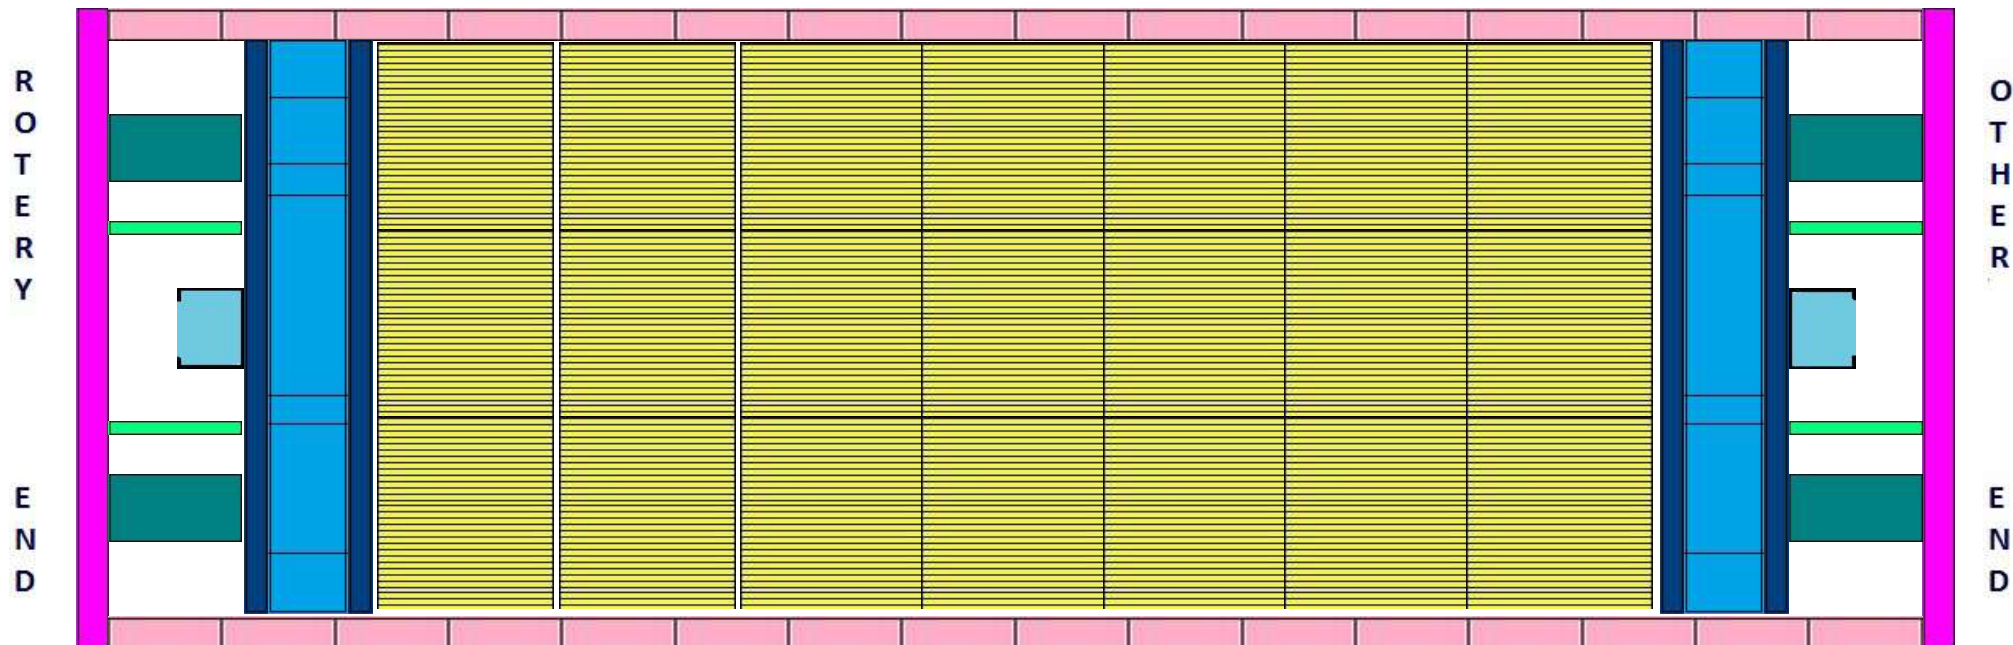
Rotary Side

Color	Particulars	Qty	Per%	Color	Particulars	Qty	Per%	Color	Particulars	Qty	Per%
	Headstock Beam	2	100%		Centre Stiffner for Headstock	4	100%		Floor Stiffner for Headstock	4	100%
	Aux. Head stock	4	100%		Sole Bar	16	100%		Draft Gear Bracket	2	100%
	Trough floor	7	100%		Centre plate	2	100%		SoleBar Stiffner	4	100%
	Bottom Wall Part	16	100%		Body panel/patch		100%		Door Top/Roof Patch		0%
	Window Module		0%		Window Sill	40	100%		Window Bar	42	23%
	Seat pillar/lav. Partition		100%		UIC end construction		0%

End Drooping: Rotary End - EAST : 5, WEST : 5 Other End - EAST : -7, WEST : -8
Start Date : 19-Jul-2019, Completion Date : 25-Jul-2019, Net Repair Days : 6, Total Man Hours : 1732

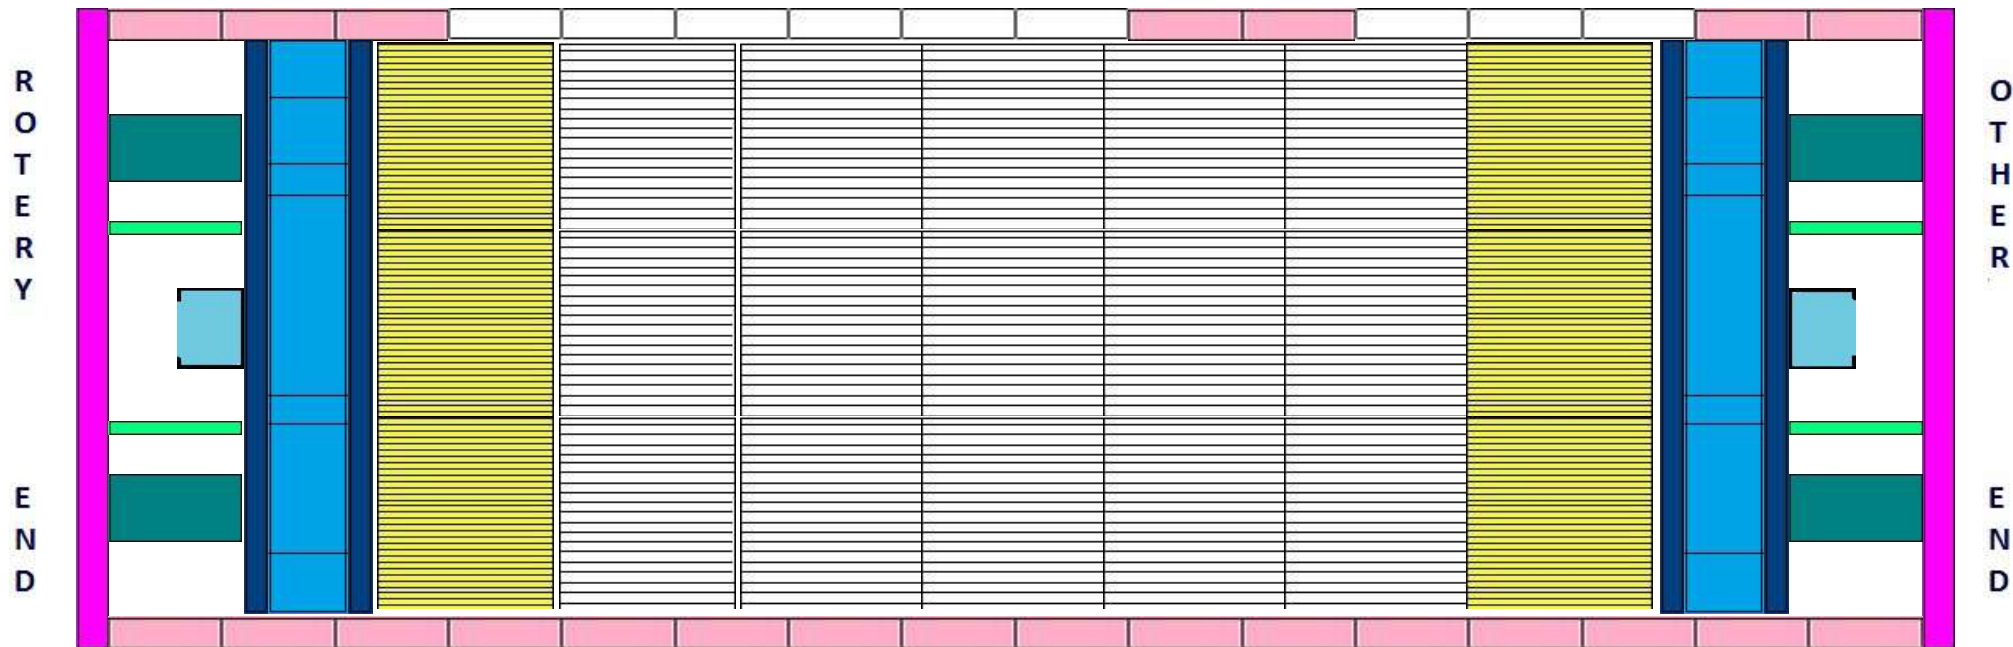
Rotary Side

Color	Particulars	Qty	Per%	Color	Particulars	Qty	Per%	Color	Particulars	Qty	Per%
Yellow	Headstock Beam	2	100%	Green	Centre Stiffner for Headstock	4	100%	Red	Floor Stiffner for Headstock	4	100%
Blue	Aux. Head stock	4	100%	Yellow	Sole Bar	11.5	72%	Blue	Draft Gear Bracket	2	100%
Red	Trough floor	2	29%	Blue	Centre plate	2	100%		SoleBar Stiffner	4	100%
	Bottom Wall Part	11.5	72%		Body panel/patch		100%		Door Top/Roof Patch		100%
	Window Module		0%		Window Sill	40	100%		Window Bar	44	24%
	Seat pillar/lav. Partition		100%		UIC end construction		0%

End Drooping: Rotary End - EAST : -6, WEST : -5 Other End - EAST : -8, WEST : 0
Start Date : 05-Jul-2019, Completion Date : 13-Jul-2019, Net Repair Days : 8, Total Man Hours : 1416

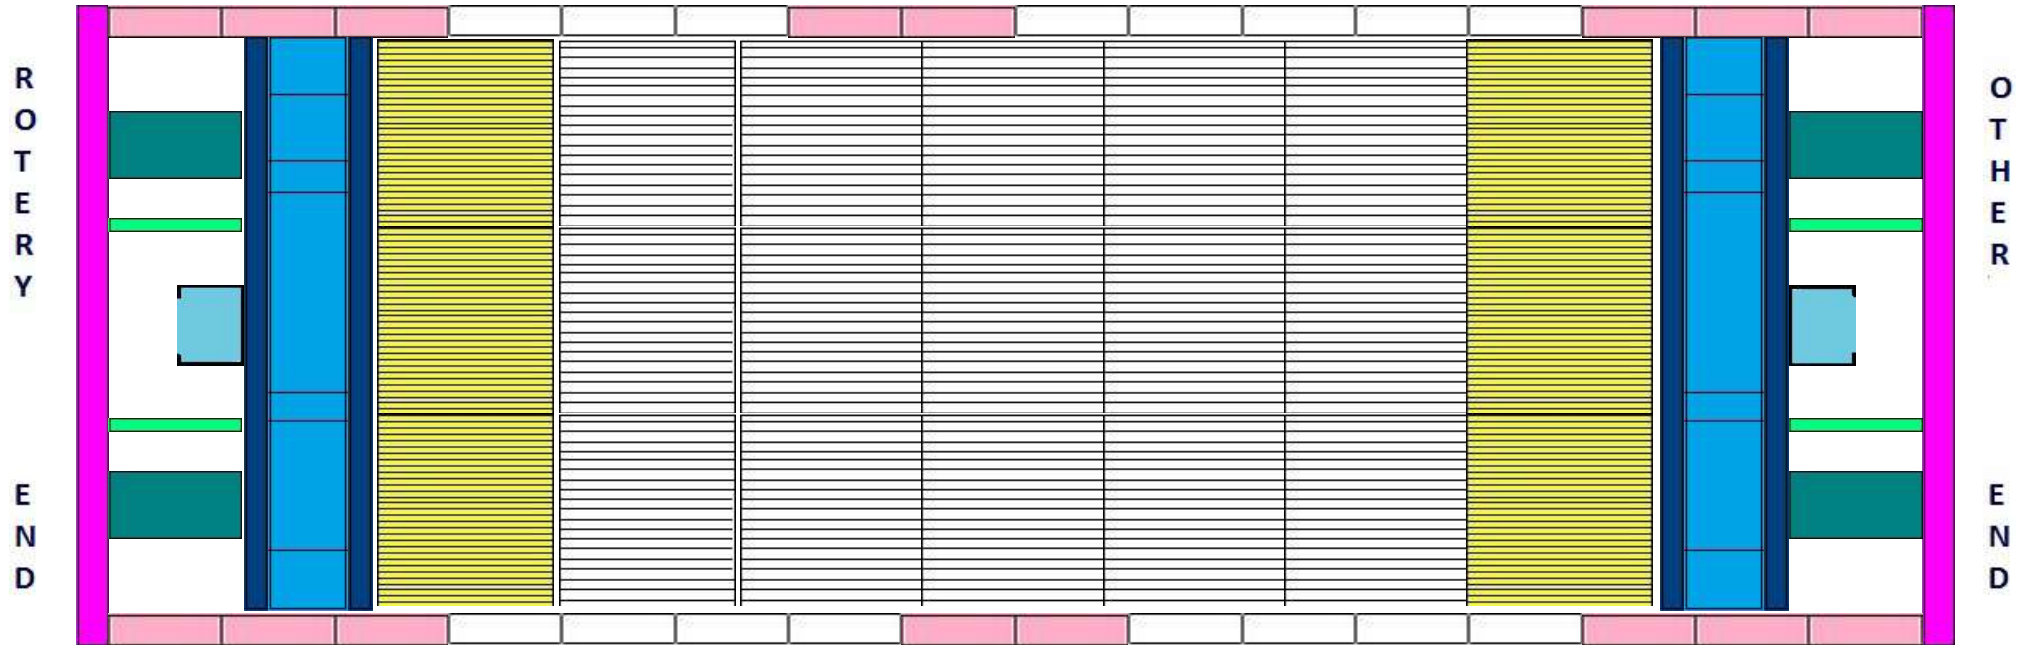
Color	Particulars	Qty	Per%	Color	Particulars	Qty	Per%	Color	Particulars	Qty	Per%
Yellow	Headstock Beam	2	100%	Dark Green	Centre Stiffner for Headstock	4	100%	Light Green	Floor Stiffner for Headstock	4	100%
Dark Blue	Aux. Head stock	4	100%	Pink	Sole Bar	8	50%	Light Blue	Draft Gear Bracket	2	100%
Yellow	Trough floor	2	29%	Light Blue	Centre plate	2	100%		SoleBar Stiffner	4	100%
	Bottom Wall Part	8	50%		Body panel/patch		100%		Door Top/Roof Patch		0%
	Window Module		0%		Window Sill	32	80%		Window Bar	42	23%
	Seat pillar/lav. Partition		100%		UIC end construction		0%

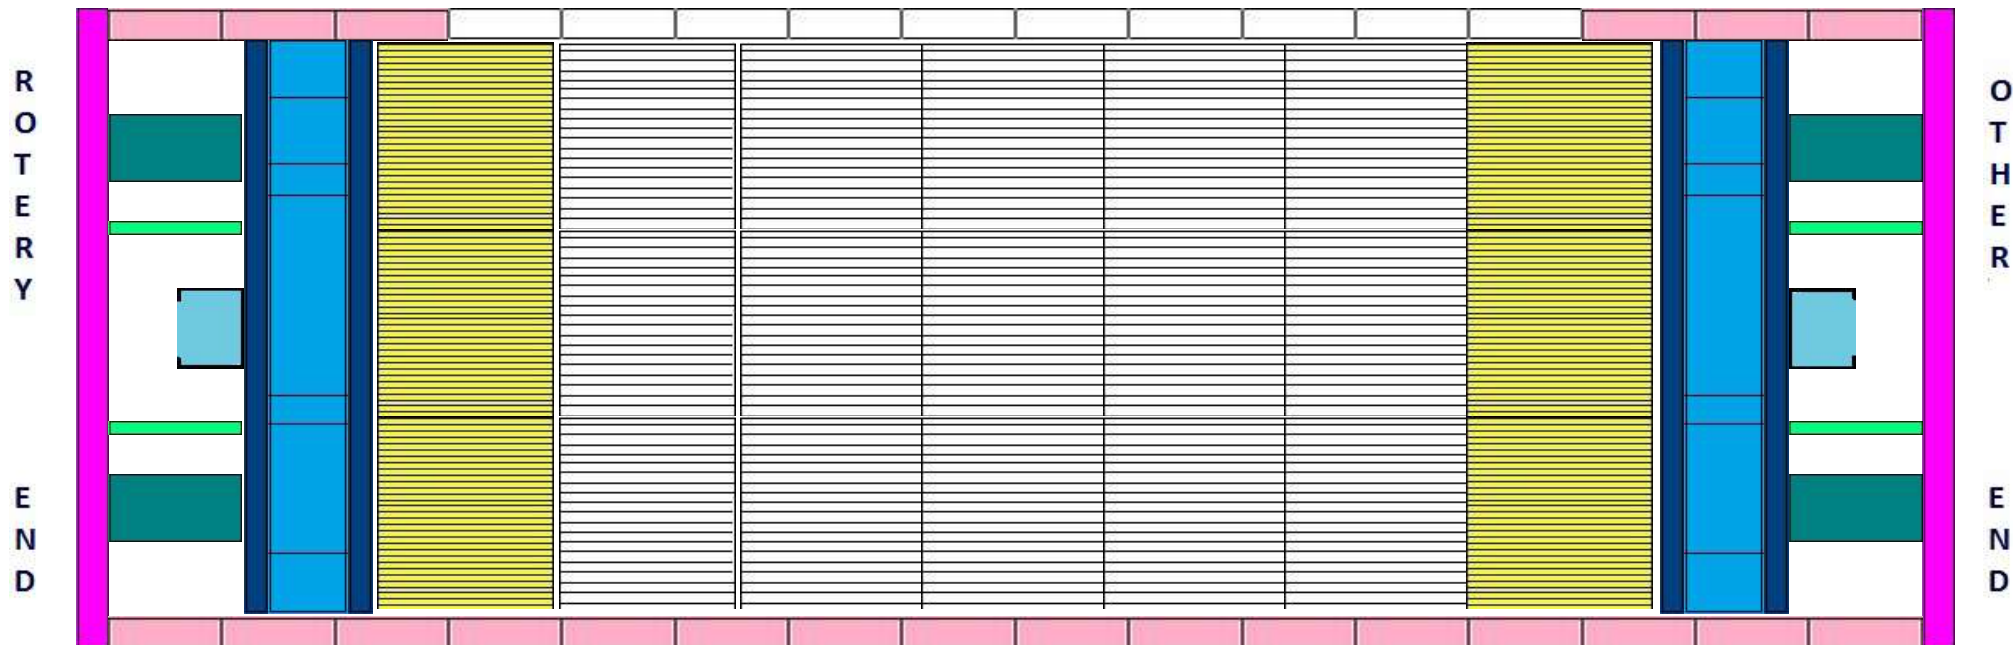
Rotary Side

Color	Particulars	Qty	Per%	Color	Particulars	Qty	Per%	Color	Particulars	Qty	Per%
	Headstock Beam	2	100%		Centre Stiffner for Headstock	4	100%		Floor Stiffner for Headstock	4	100%
	Aux. Head stock	4	100%		Sole Bar	11	69%		Draft Gear Bracket	2	100%
	Trough floor	2	29%		Centre plate	2	100%		SoleBar Stiffner	4	100%
	Bottom Wall Part	11	69%		Body panel/patch		100%		Door Top/Roof Patch		0%
	Window Module		0%		Window Sill	32	80%		Window Bar	48	26%
	Seat pillar/lav. Partition		100%		UIC end construction		0%

End Drooping: Rotary End - EAST : -5, WEST : -3 Other End - EAST : -5, WEST : 0
Start Date : 19-Jul-2019, Completion Date : 27-Jul-2019, Net Repair Days : 8, Total Man Hours : 1472

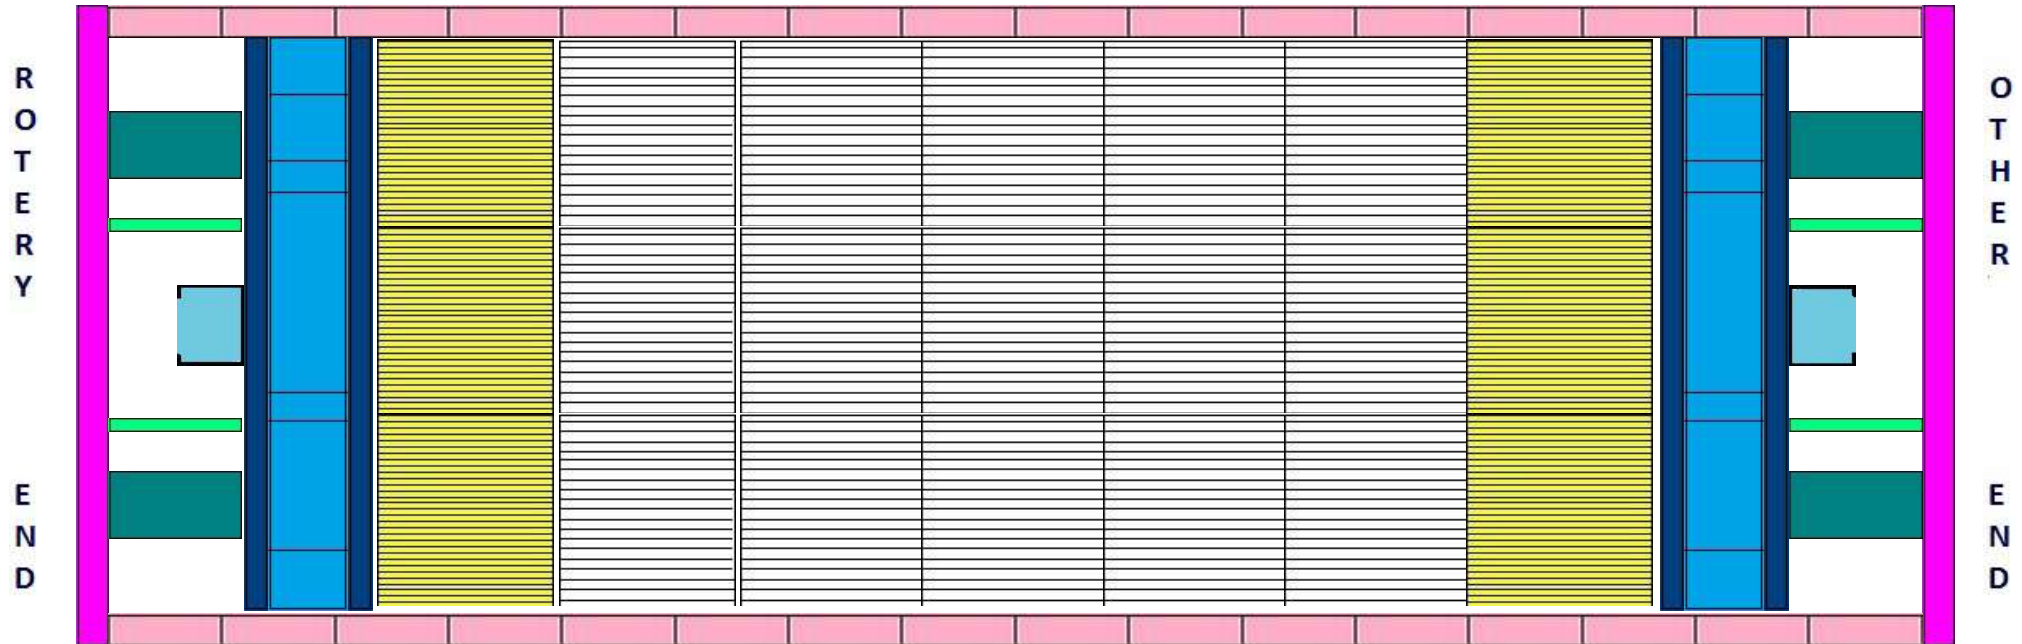
Rotary Side

Color	Particulars	Qty	Per%	Color	Particulars	Qty	Per%	Color	Particulars	Qty	Per%
	Headstock Beam	2	100%		Centre Stiffner for Headstock	4	100%		Floor Stiffner for Headstock	4	100%
	Aux. Head stock	4	100%		Sole Bar	16	100%		Draft Gear Bracket	2	100%
	Trough floor	2	29%		Centre plate	2	100%		SoleBar Stiffner	4	100%
	Bottom Wall Part	16	100%		Body panel/patch		100%		Door Top/Roof Patch		0%
	Window Module		0%		Window Sill	40	100%		Window Bar	44	24%
	Seat pillar/lav. Partition		100%		UIC end construction		0%

End Drooping: Rotary End - EAST : -8, WEST : -7 Other End - EAST : -7, WEST : -6
Start Date : 20-Jul-2019, Completion Date : 29-Jul-2019, Net Repair Days : 8, Total Man Hours : 1749

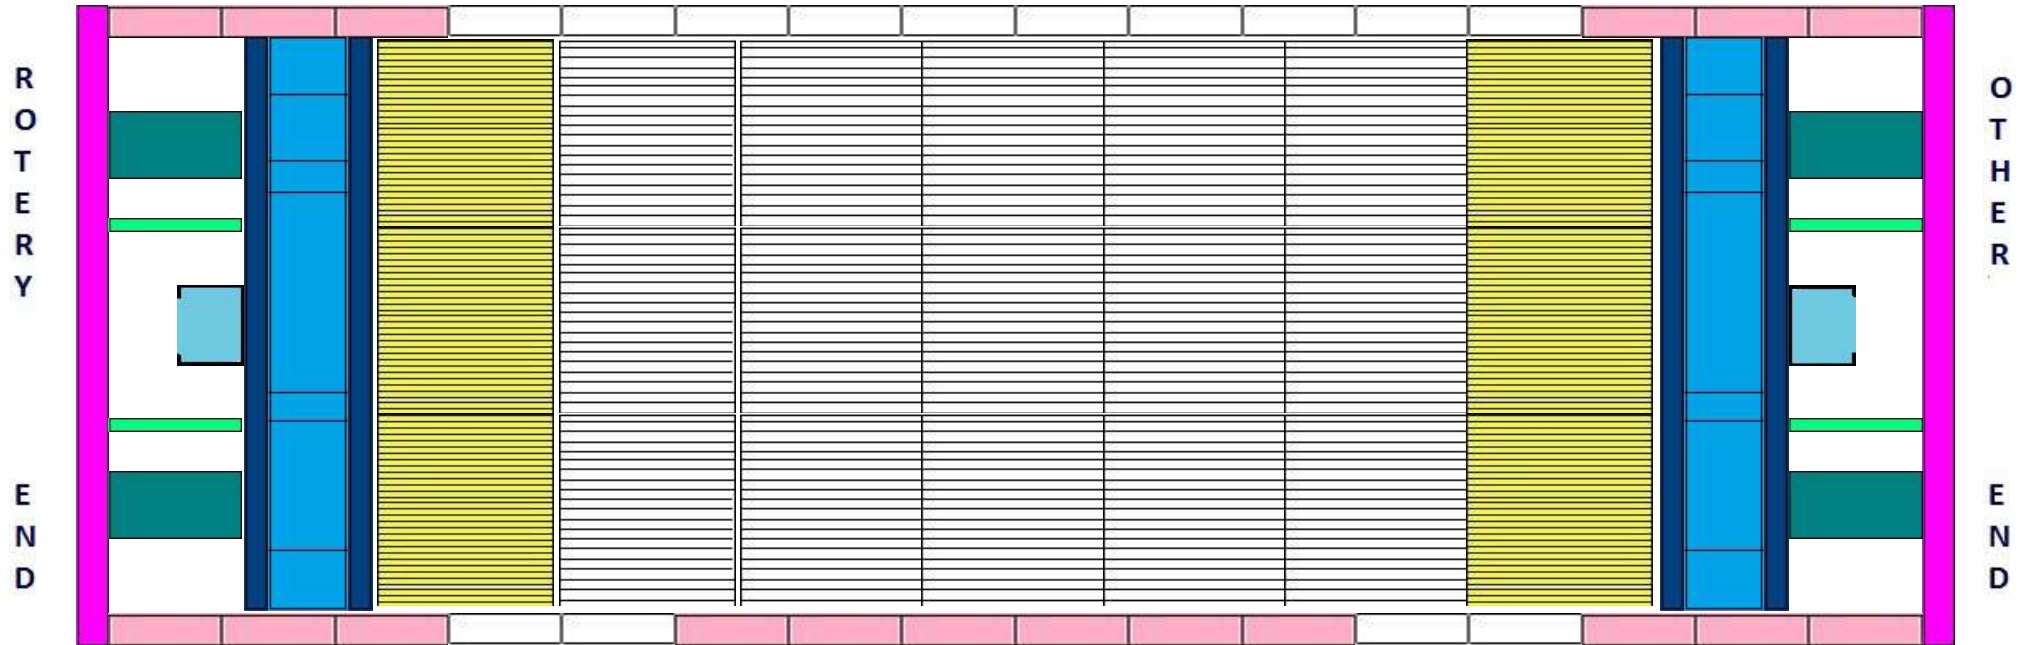
Rotary Side

Color	Particulars	Qty	Per%	Color	Particulars	Qty	Per%	Color	Particulars	Qty	Per%
	Headstock Beam	2	100%		Centre Stiffner for Headstock	4	100%		Floor Stiffner for Headstock	4	100%
	Aux. Head stock	4	100%		Sole Bar	9	56%		Draft Gear Bracket	2	100%
	Trough floor	2	29%		Centre plate	2	100%		SoleBar Stiffner	4	100%
	Bottom Wall Part	9	56%		Body panel/patch		100%		Door Top/Roof Patch		0%
	Window Module		0%		Window Sill	40	100%		Window Bar	44	24%
	Seat pillar/lav. Partition		100%		UIC end construction		0%

End Drooping: Rotary End - EAST : 7, WEST : 5 Other End - EAST : 3, WEST : 4
Start Date : 09-Jul-2019, Completion Date : 13-Jul-2019, Net Repair Days : 5, Total Man Hours : 1334

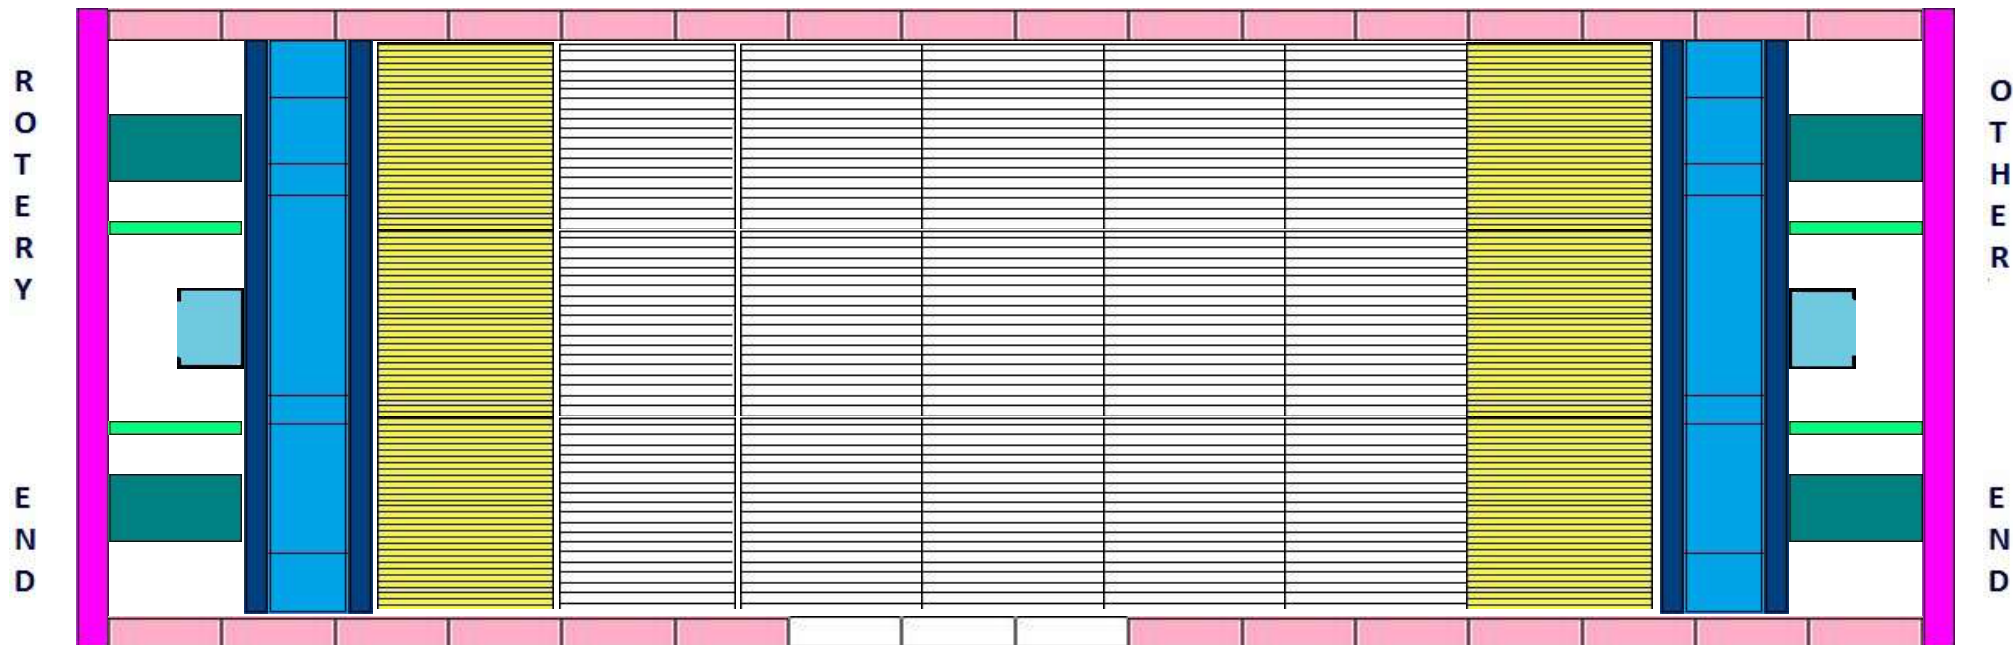
Rotary Side

Color	Particulars	Qty	Per%	Color	Particulars	Qty	Per%	Color	Particulars	Qty	Per%
Pink	Headstock Beam	2	100%	Dark Green	Centre Stiffner for Headstock	4	100%	Bright Green	Floor Stiffner for Headstock	4	100%
Dark Blue	Aux. Head stock	4	100%	Pink	Sole Bar	14.5	91%	Light Blue	Draft Gear Bracket	2	100%
Yellow	Trough floor	2	29%	Blue	Centre plate	2	100%		SoleBar Stiffner	4	100%
	Bottom Wall Part	14.5	91%		Body panel/patch		100%		Door Top/Roof Patch		0%
	Window Module		0%		Window Sill	28	70%		Window Bar	44	24%
	Seat pillar/lav. Partition		100%		UIC end construction		0%

End Drooping: Rotary End - EAST : 0, WEST : 2 Other End - EAST : -3, WEST : 3
Start Date : 06-Jul-2019, Completion Date : 15-Jul-2019, Net Repair Days : 8, Total Man Hours : 1384

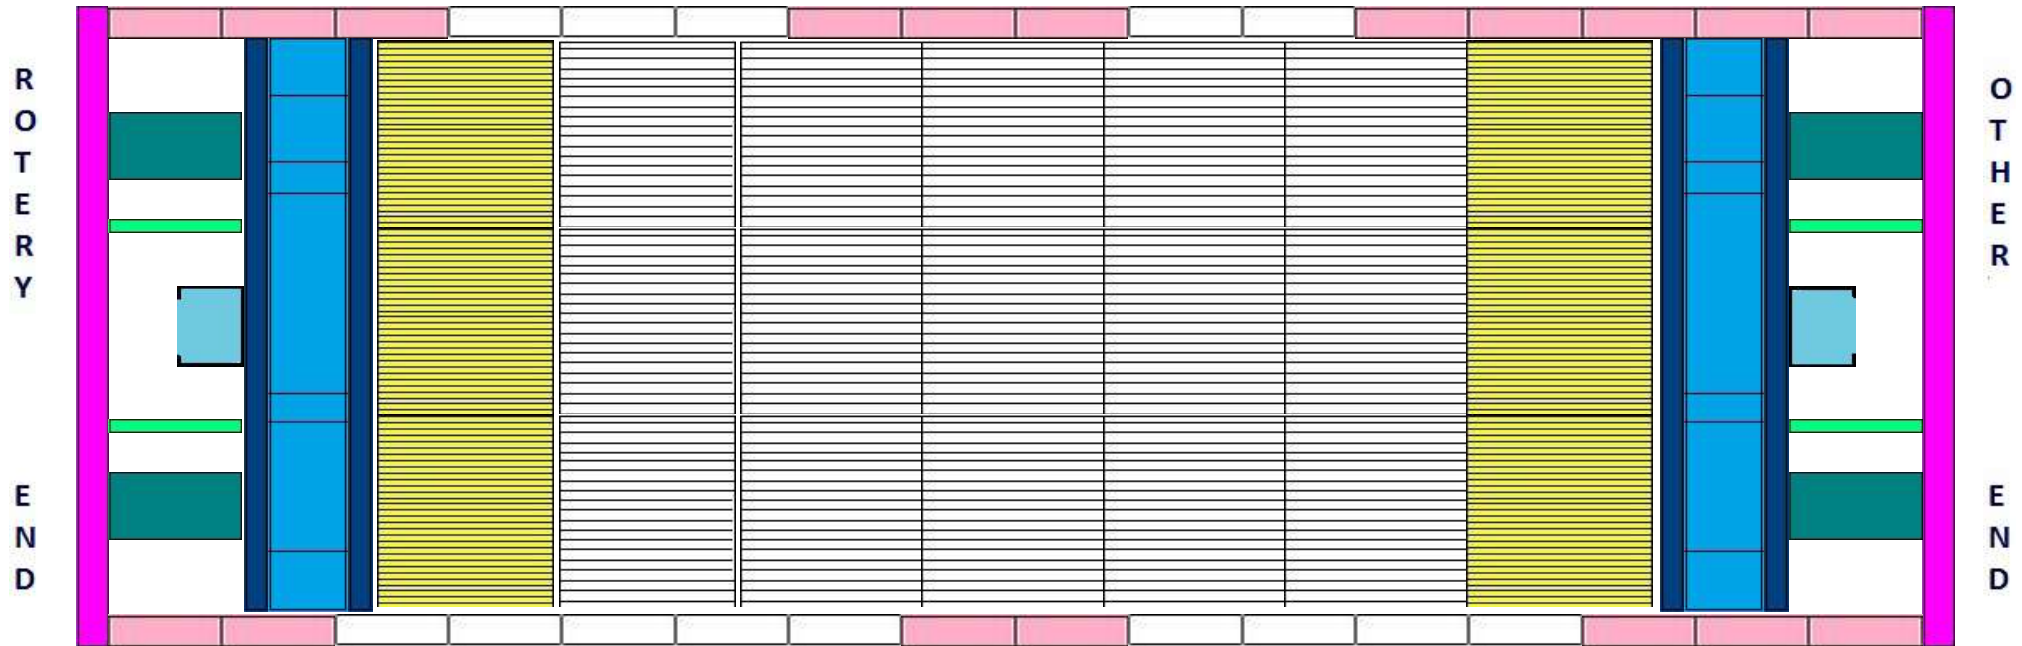
Color	Particulars	Qty	Per%	Color	Particulars	Qty	Per%	Color	Particulars	Qty	Per%
Yellow	Headstock Beam	2	100%	Dark Green	Centre Stiffner for Headstock	4	100%	Light Green	Floor Stiffner for Headstock	4	100%
Dark Blue	Aux. Head stock	4	100%	Pink	Sole Bar	9	56%	Light Blue	Draft Gear Bracket	2	100%
Yellow	Trough floor	2	29%	Light Blue	Centre plate	2	100%		SoleBar Stiffner	6	100%
	Bottom Wall Part	9	56%		Body panel/patch		100%		Door Top/Roof Patch		0%
	Window Module		0%		Window Sill	40	100%		Window Bar	48	27%
	Seat pillar/lav. Partition		100%		UIC end construction		0%

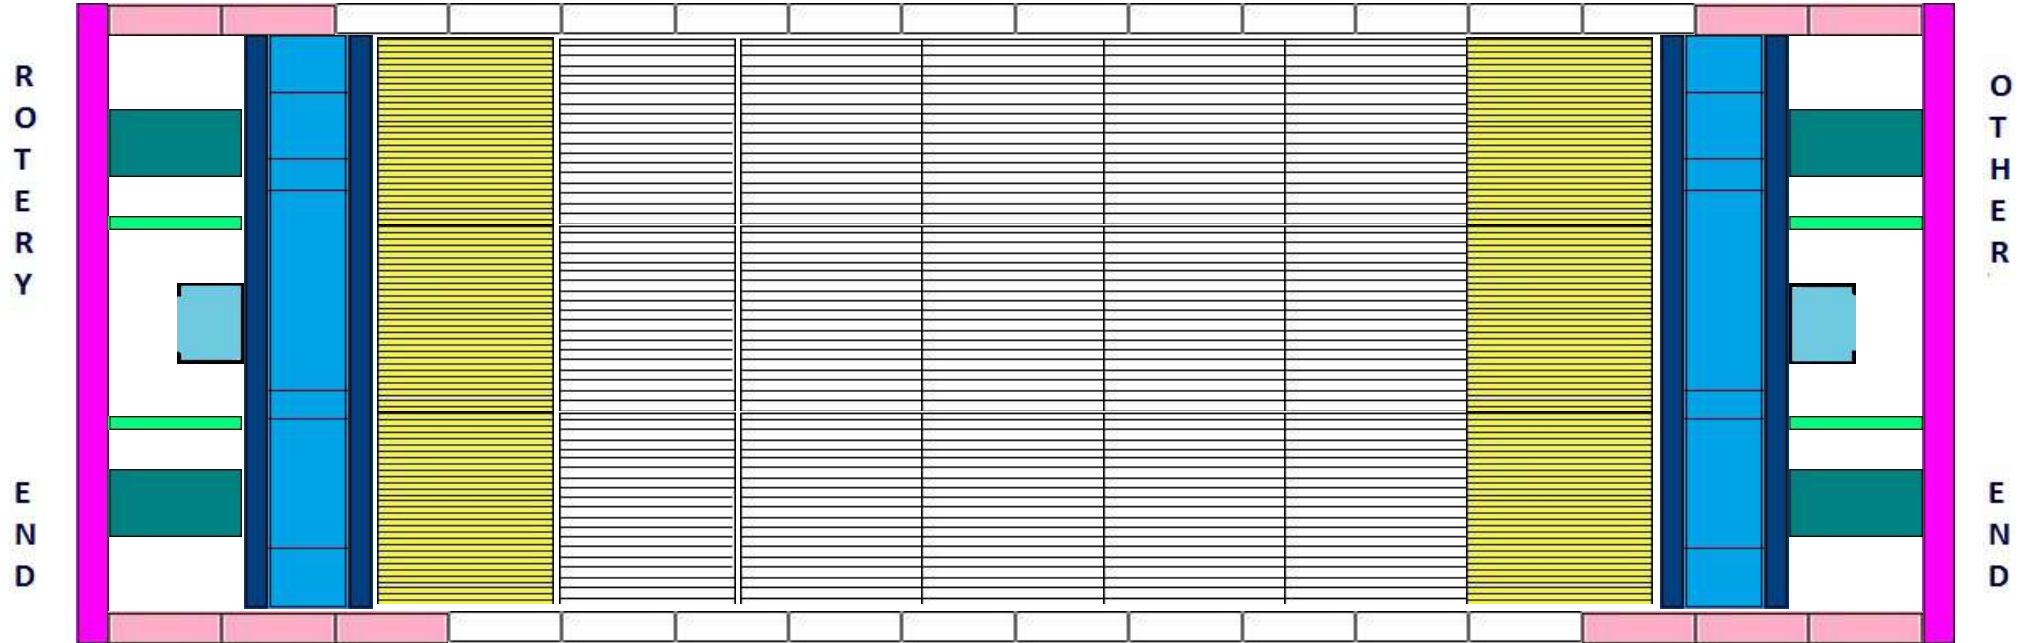
Rotary Side

Color	Particulars	Qty	Per%	Color	Particulars	Qty	Per%	Color	Particulars	Qty	Per%
Pink	Headstock Beam	2	100%	Dark Blue	Centre Stiffner for Headstock	4	100%	Light Green	Floor Stiffner for Headstock	4	100%
Dark Blue	Aux. Head stock	4	100%	Pink	Sole Bar	5	31%	Light Blue	Draft Gear Bracket	2	100%
Yellow	Trough floor	2	29%	Light Blue	Centre plate	2	100%		SoleBar Stiffner	4	100%
	Bottom Wall Part	5	31%		Body panel/patch		100%		Door Top/Roof Patch		0%
	Window Module		4%		Window Sill	0	0%		Window Bar	0	0%
	Seat pillar/lav. Partition		100%		UIC end construction		0%

End Drooping: Rotary End - EAST : -6, WEST : -3 Other End - EAST : 4, WEST : 10
Start Date : 24-Jul-2019, Completion Date : 05-Aug-2019, Net Repair Days : 11, Total Man Hours : 1224

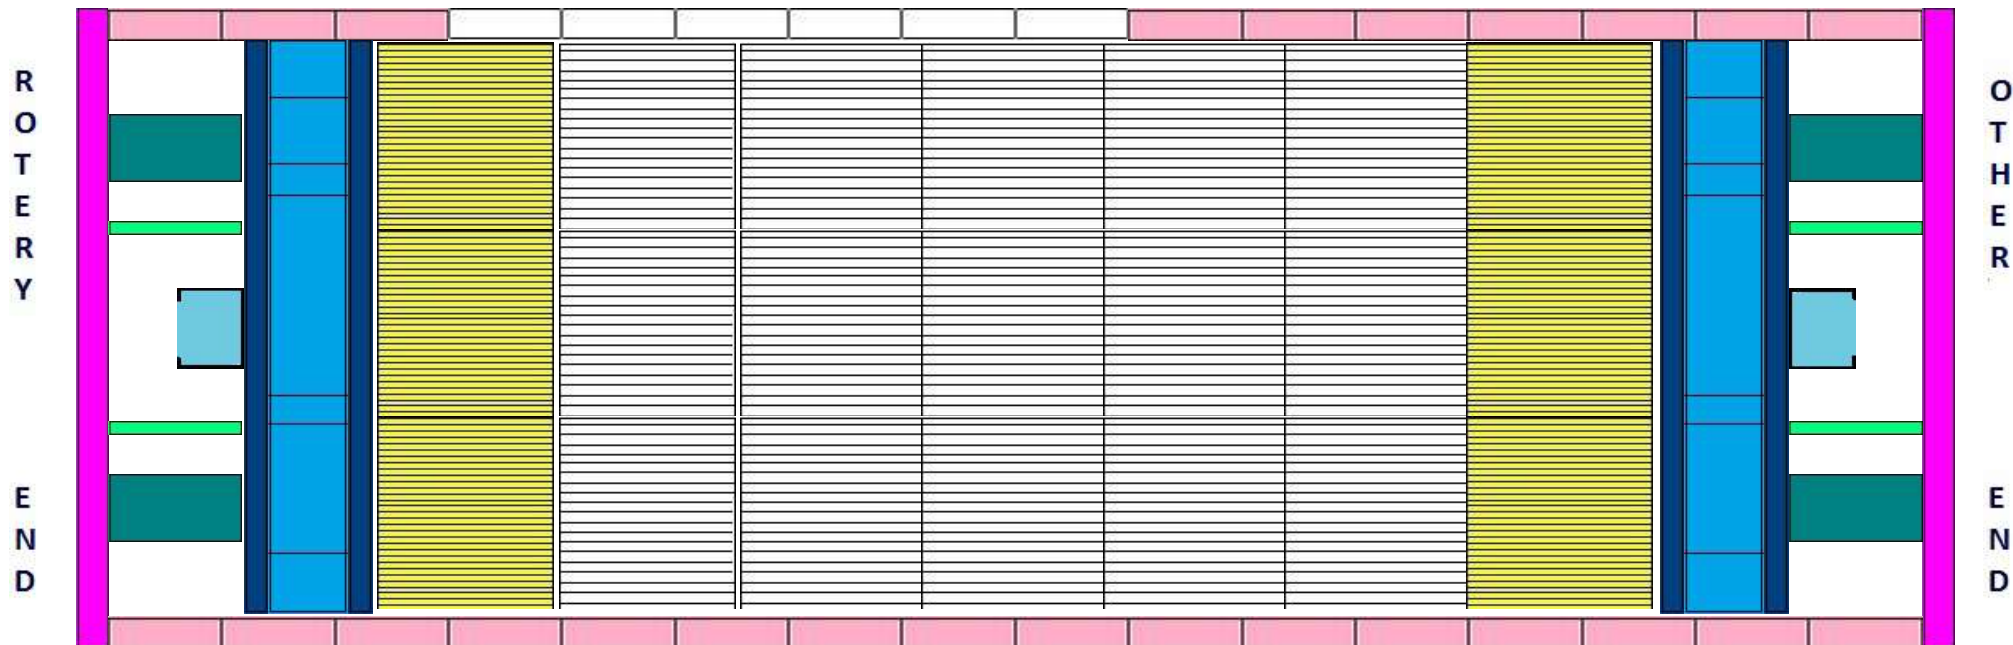
Rotary Side

Color	Particulars	Qty	Per%	Color	Particulars	Qty	Per%	Color	Particulars	Qty	Per%
Pink	Headstock Beam	2	100%	Dark Green	Centre Stiffner for Headstock	4	100%	Light Green	Floor Stiffner for Headstock	4	100%
Dark Blue	Aux. Head stock	4	100%	Pink	Sole Bar	13	81%	Light Blue	Draft Gear Bracket	2	100%
Yellow	Trough floor	2	29%	Light Blue	Centre plate	2	100%		SoleBar Stiffner	4	100%
	Bottom Wall Part	13	81%		Body panel/patch		100%		Door Top/Roof Patch		0%
	Window Module		0%		Window Sill	40	100%		Window Bar	44	24%
	Seat pillar/lav. Partition		100%		UIC end construction		0%

End Drooping: Rotary End - EAST : 3, WEST : 8 Other End - EAST : 4, WEST : -2
Start Date : 16-Jul-2019, Completion Date : 23-Jul-2019, Net Repair Days : 7, Total Man Hours : 1708

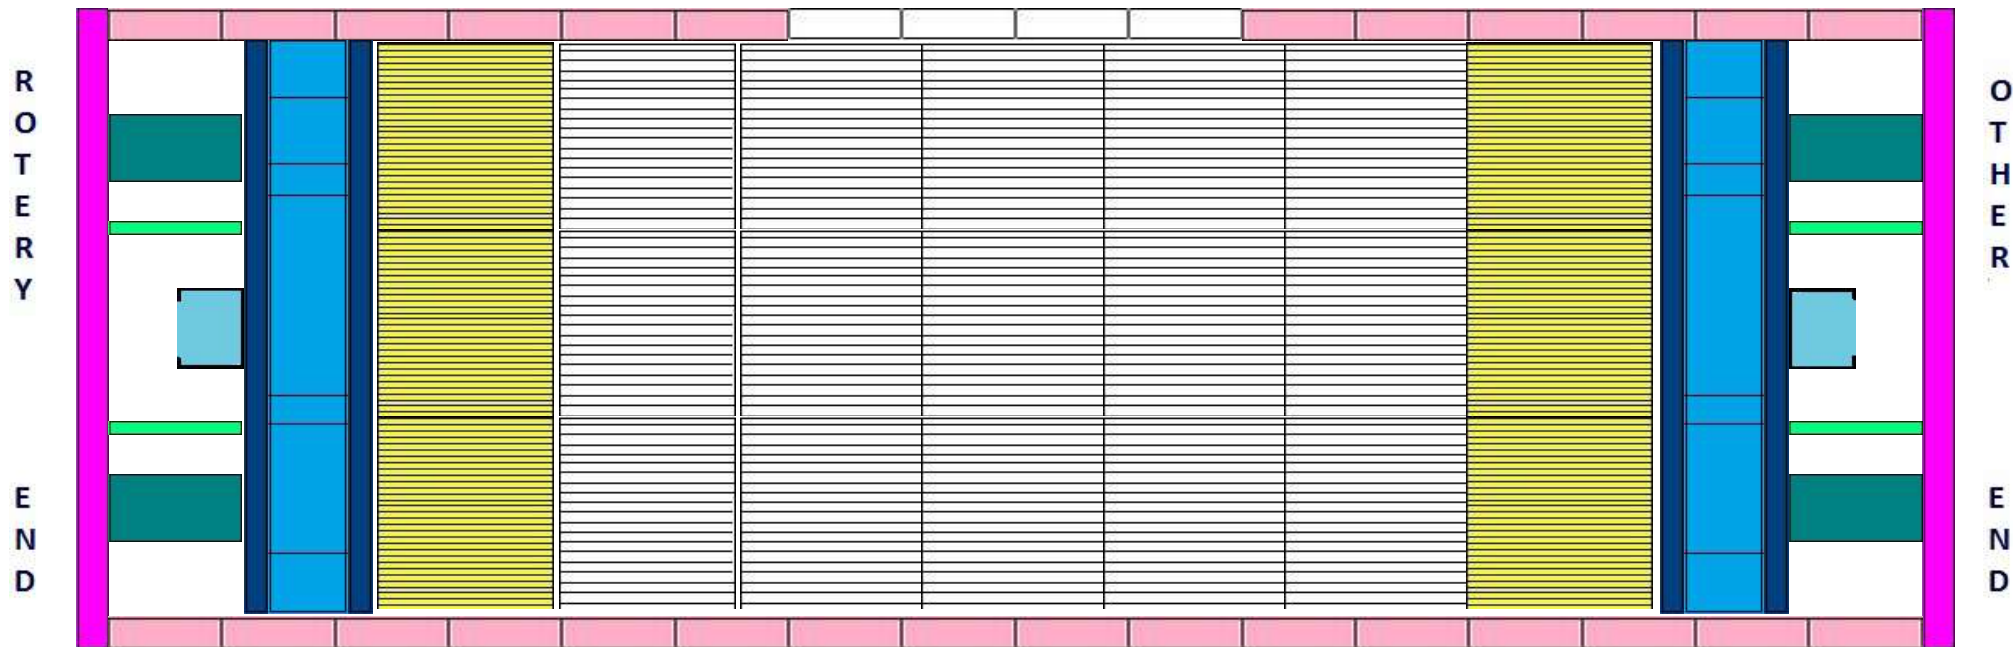
Rotary Side

Color	Particulars	Qty	Per%	Color	Particulars	Qty	Per%	Color	Particulars	Qty	Per%
Pink	Headstock Beam	2	100%	Dark Blue	Centre Stiffner for Headstock	4	100%	Green	Floor Stiffner for Headstock	4	100%
Dark Blue	Aux. Head stock	4	100%	Pink	Sole Bar	14	88%	Light Blue	Draft Gear Bracket	2	100%
Yellow	Trough floor	2	29%	Light Blue	Centre plate	2	100%		SoleBar Stiffner	4	100%
	Bottom Wall Part	14	88%		Body panel/patch		100%		Door Top/Roof Patch		0%
	Window Module		0%		Window Sill	28	70%		Window Bar	44	24%
	Seat pillar/lav. Partition		100%		UIC end construction		0%

End Drooping: Rotary End - EAST : 6, WEST : 5 Other End - EAST : -4, WEST : -5
Start Date : 22-Apr-2019, Completion Date : 29-Apr-2019, Net Repair Days : 7, Total Man Hours : 1656

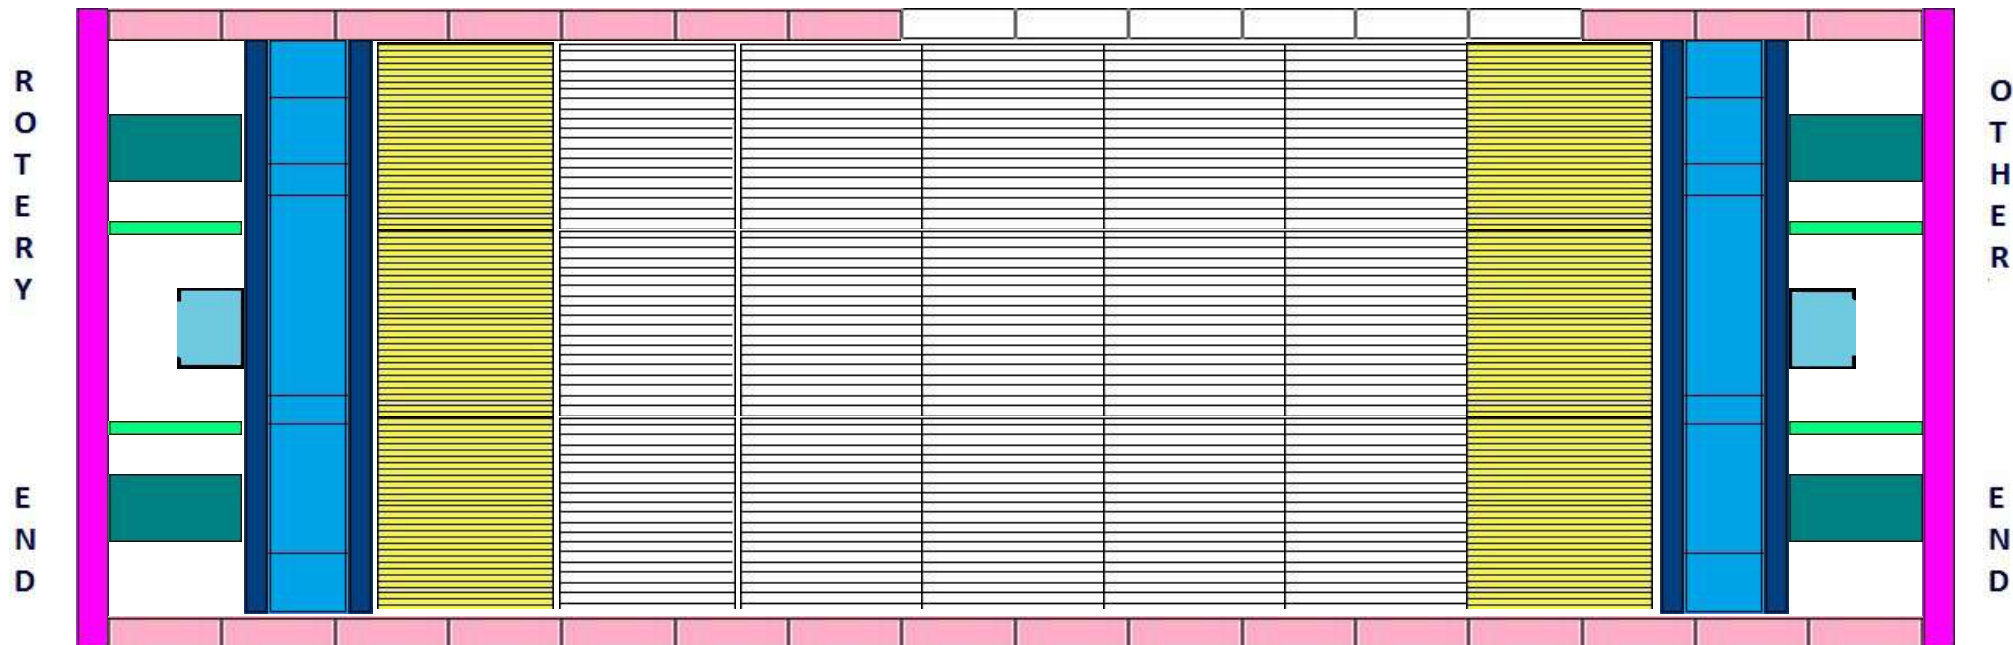
Rotary Side

Color	Particulars	Qty	Per%	Color	Particulars	Qty	Per%	Color	Particulars	Qty	Per%
	Headstock Beam	2	100%		Centre Stiffner for Headstock	4	100%		Floor Stiffner for Headstock	4	100%
	Aux. Head stock	4	100%		Sole Bar	13	81%		Draft Gear Bracket	2	100%
	Trough floor	2	29%		Centre plate	2	100%		SoleBar Stiffner	4	100%
	Bottom Wall Part	13	81%		Body panel/patch		100%		Door Top/Roof Patch		0%
	Window Module		0%		Window Sill	40	100%		Window Bar	44	24%
	Seat pillar/lav. Partition		100%		UIC end construction		0%

End Drooping: Rotary End - EAST : 2, WEST : 3 Other End - EAST : -8, WEST : -8
Start Date : 25-Apr-2019, Completion Date : 30-Apr-2019, Net Repair Days : 5, Total Man Hours : 1712

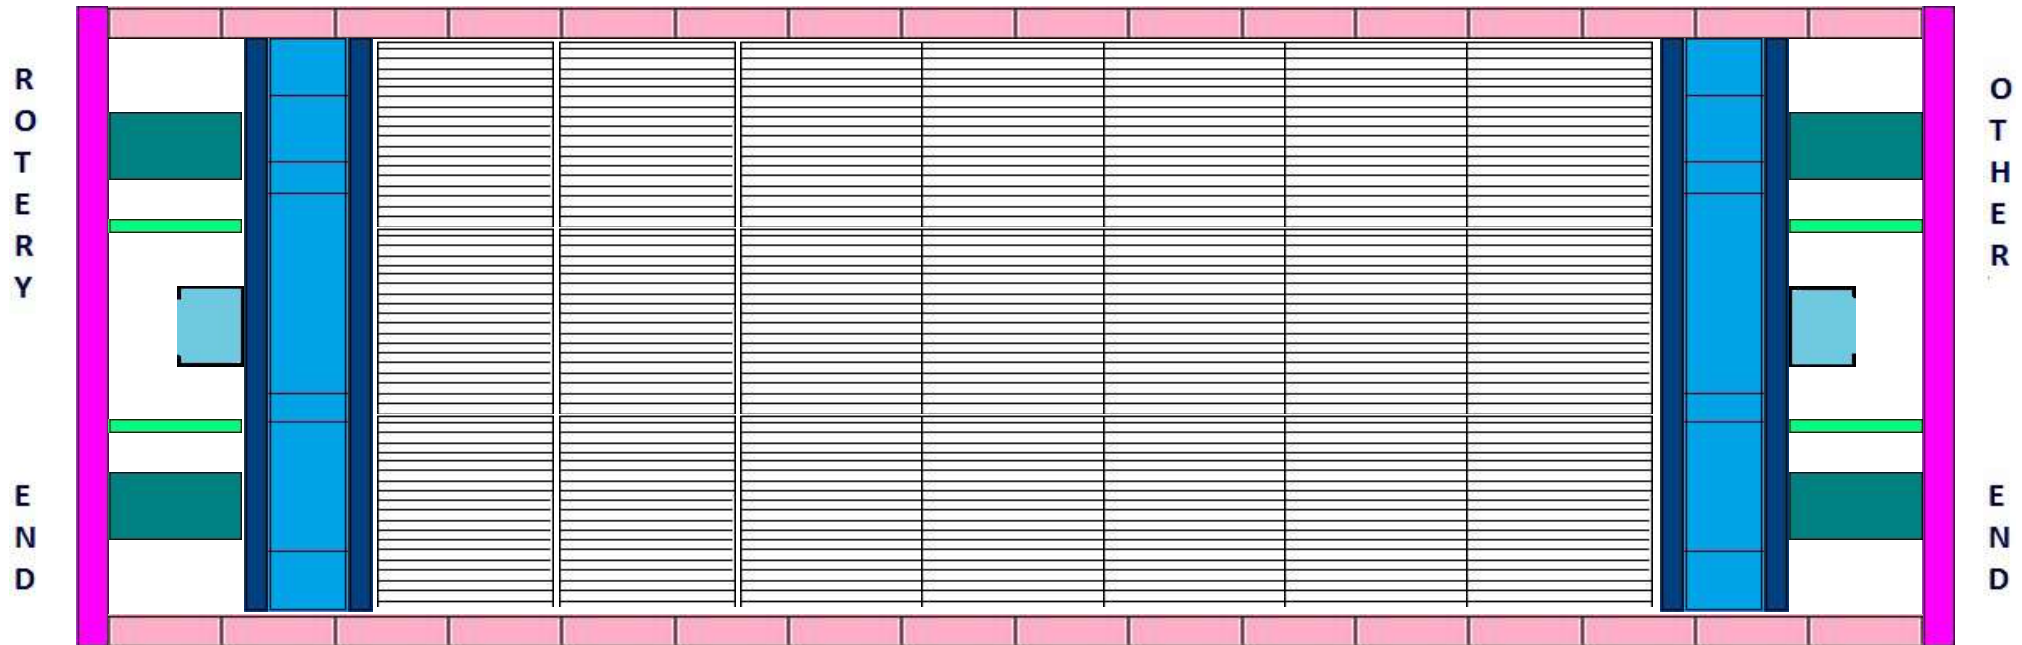
Rotary Side

Color	Particulars	Qty	Per%	Color	Particulars	Qty	Per%	Color	Particulars	Qty	Per%
Blue	Headstock Beam	2	100%	Red	Centre Stiffner for Headstock	4	100%	Green	Floor Stiffner for Headstock	4	100%
Black	Aux. Head stock	4	100%	Yellow	Sole Bar	16	100%	Light Blue	Draft Gear Bracket	2	100%
Orange	Trough floor	0	0%	Dark Blue	Centre plate	2	100%		SoleBar Stiffner	4	100%
	Bottom Wall Part	16	100%		Body panel/patch		100%		Door Top/Roof Patch		0%
	Window Module		0%		Window Sill	40	100%		Window Bar	44	24%
	Seat pillar/lav. Partition		100%		UIC end construction		0%

End Drooping: Rotary End - EAST : -6, WEST : -2 Other End - EAST : -2, WEST : -3
Start Date : 22-Apr-2019, Completion Date : 04-May-2019, Net Repair Days : 12, Total Man Hours : 1492
