Coach Rehabilitation Workshop, WC Railway, Bhopal

(An IMS and ISO 50001 Certified Workshop)
Final Inspection Sheet - Details of Corrosion Repair

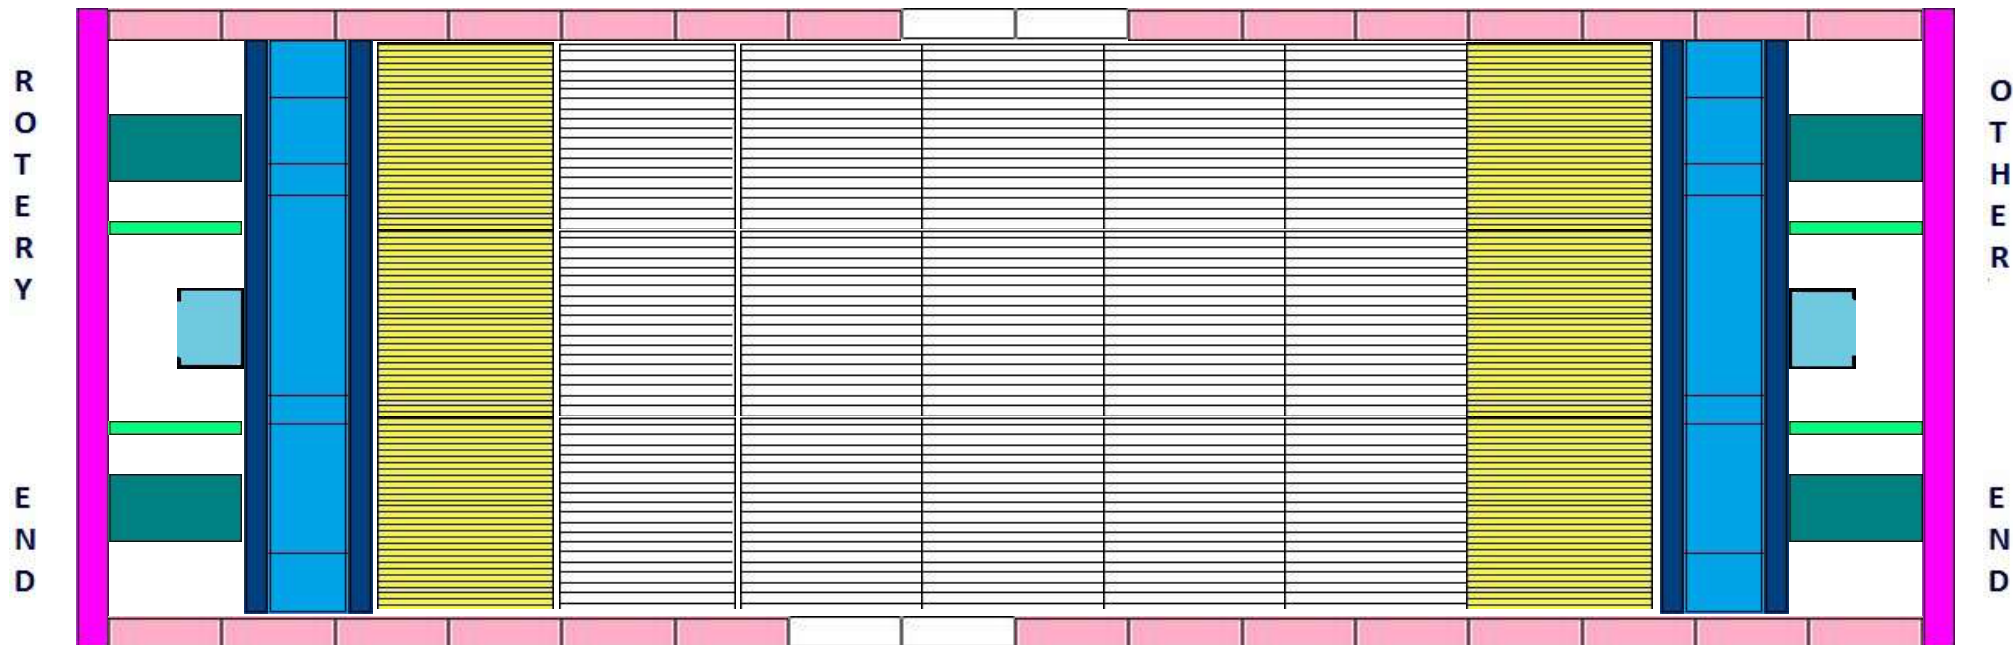
Rotary Side

Color	Particulars	Qty	Per%	Color	Particulars	Qty	Per%	Color	Particulars	Qty	Per%
	Headstock Beam	2	100%		Centre Stiffner for Headstock	4	100%		Floor Stiffner for Headstock	4	100%
	Aux. Head stock	4	100%		Sole Bar	14	88%		Draft Gear Bracket	2	100%
	Trough floor	2	29%		Centre plate	2	100%		SoleBar Stiffner	4	100%
	Bottom Wall Part	14	88%		Body panel/patch		100%		Door Top/Roof Patch		0%
	Window Module		0%		Window Sill	22	55%		Window Bar	44	24%
	Seat pillar/lav. Partition		100%		UIC end construction		0%

End Drooping: Rotary End - EAST : -4, WEST : -2 Other End - EAST : -5, WEST : 0
Start Date : 16-Apr-2019, Completion Date : 29-Apr-2019, Net Repair Days : 12, Total Man Hours : 1688

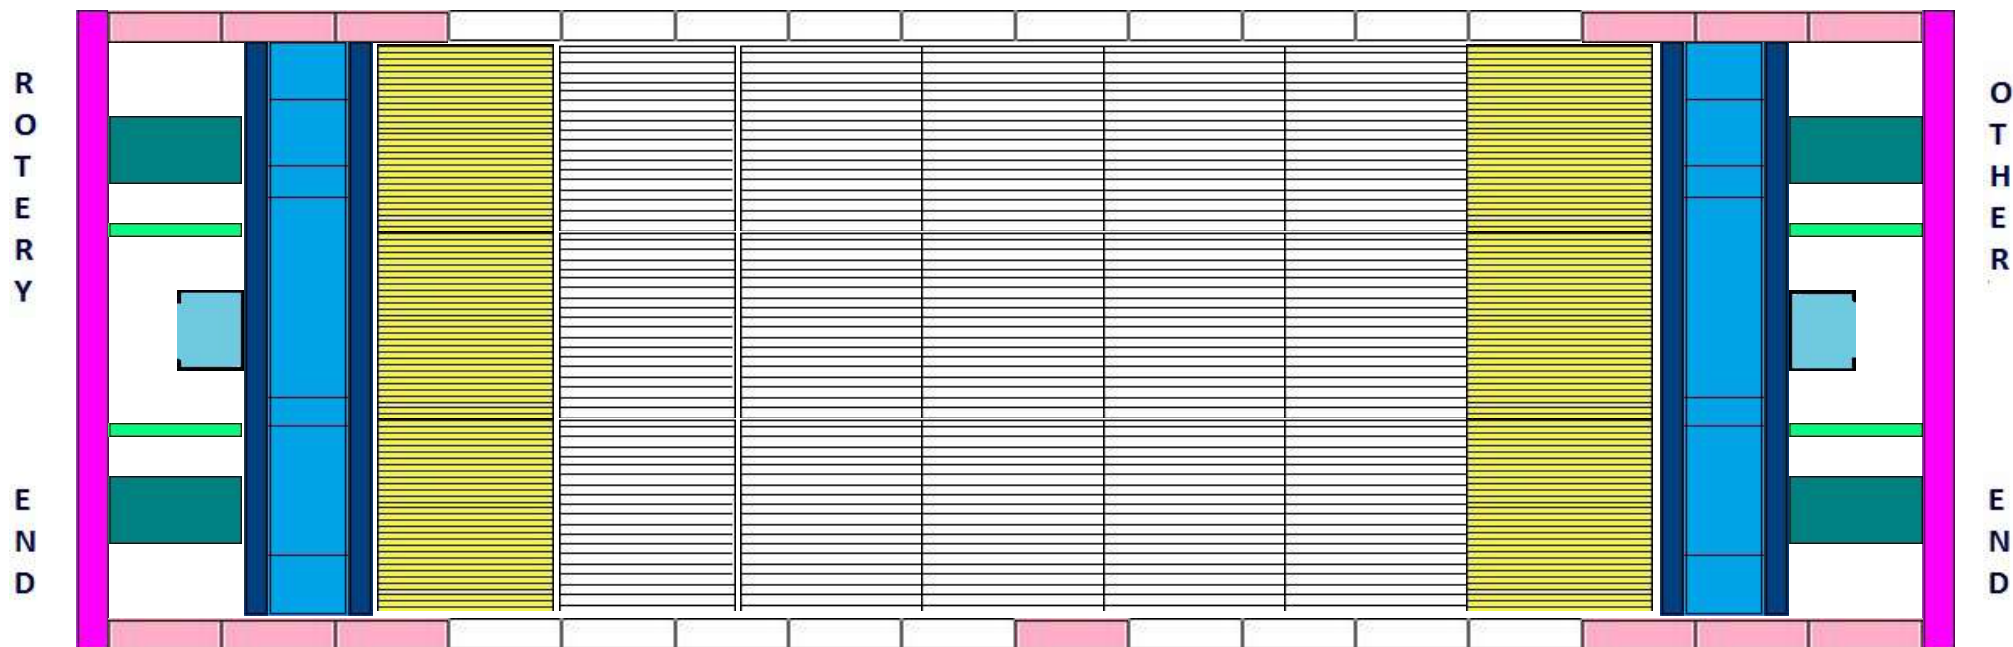
Color	Particulars	Qty	Per%	Color	Particulars	Qty	Per%	Color	Particulars	Qty	Per%
Yellow	Headstock Beam	2	100%	Blue	Centre Stiffner for Headstock	4	100%	Red	Floor Stiffner for Headstock	4	100%
Green	Aux. Head stock	4	100%	Yellow	Sole Bar	6.5	41%	Blue	Draft Gear Bracket	2	100%
Red	Trough floor	2	29%	Red	Centre plate	2	100%		SoleBar Stiffner	4	100%
	Bottom Wall Part	6.5	41%		Body panel/patch		100%		Door Top/Roof Patch		0%
	Window Module		8%		Window Sill	0	0%		Window Bar	0	0%
	Seat pillar/lav. Partition		100%		UIC end construction		0%

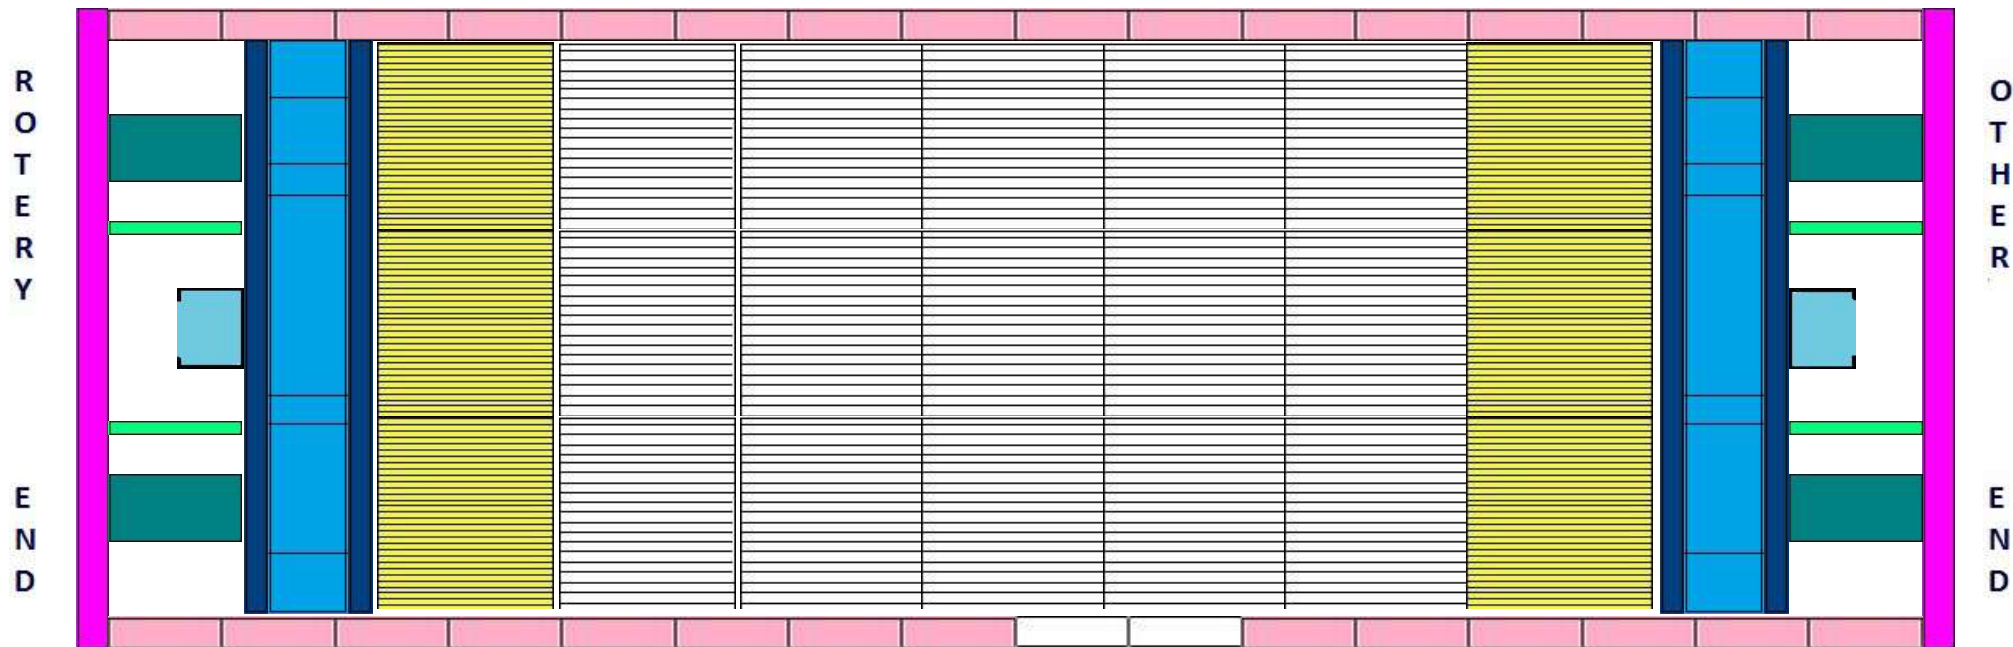
Rotary Side

Color	Particulars	Qty	Per%	Color	Particulars	Qty	Per%	Color	Particulars	Qty	Per%
Pink	Headstock Beam	2	100%	Dark Blue	Centre Stiffner for Headstock	4	100%	Green	Floor Stiffner for Headstock	4	100%
Dark Blue	Aux. Head stock	4	100%	Pink	Sole Bar	15	94%	Light Blue	Draft Gear Bracket	2	100%
Yellow	Trough floor	2	29%	Light Blue	Centre plate	2	100%		SoleBar Stiffner	4	100%
	Bottom Wall Part	15	94%		Body panel/patch		100%		Door Top/Roof Patch		0%
	Window Module		0%		Window Sill	30	75%		Window Bar	44	24%
	Seat pillar/lav. Partition		100%		UIC end construction		0%

End Drooping: Rotary End - EAST : -3, WEST : 0 Other End - EAST : 0, WEST : 4
Start Date : 22-Apr-2019, Completion Date : 02-May-2019, Net Repair Days : 10, Total Man Hours : 0

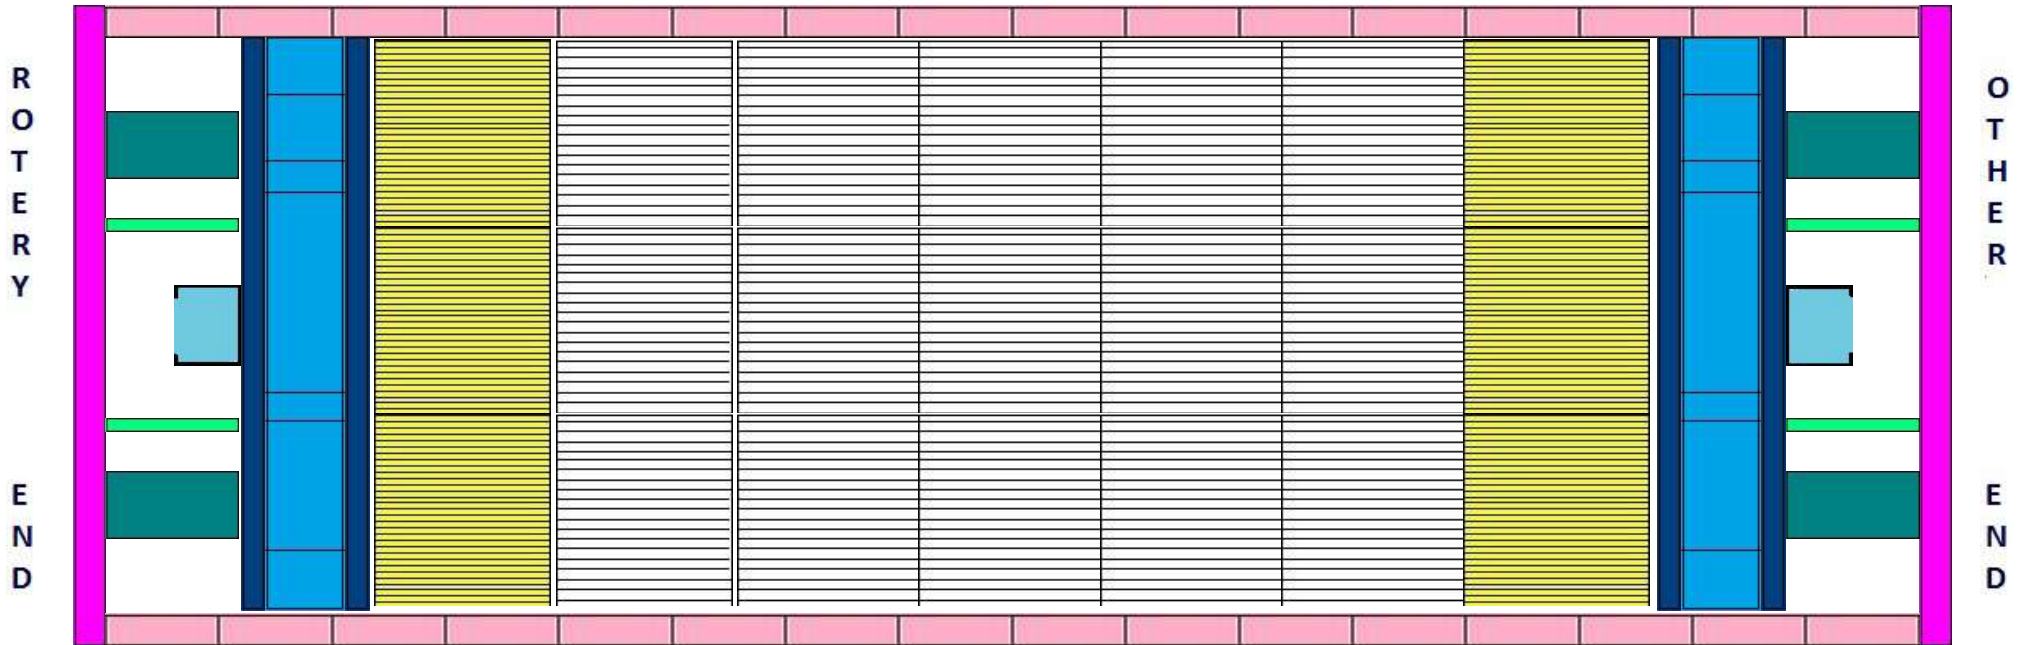
Rotary Side

Color	Particulars	Qty	Per%	Color	Particulars	Qty	Per%	Color	Particulars	Qty	Per%
Yellow	Headstock Beam	2	100%	Dark Green	Centre Stiffner for Headstock	4	100%	Light Green	Floor Stiffner for Headstock	4	100%
Dark Blue	Aux. Head stock	4	100%	Pink	Sole Bar	16	100%	Light Blue	Draft Gear Bracket	2	100%
Yellow	Trough floor	2	29%	Light Blue	Centre plate	2	100%		SoleBar Stiffner	4	100%
	Bottom Wall Part	16	100%		Body panel/patch		100%		Door Top/Roof Patch		0%
	Window Module		0%		Window Sill	32	80%		Window Bar	46	25%
	Seat pillar/lav. Partition		100%		UIC end construction		0%

Start Date : 13-Apr-2019, Completion Date : 26-Apr-2019, Net Repair Days : 12, Total Man Hours : 1648

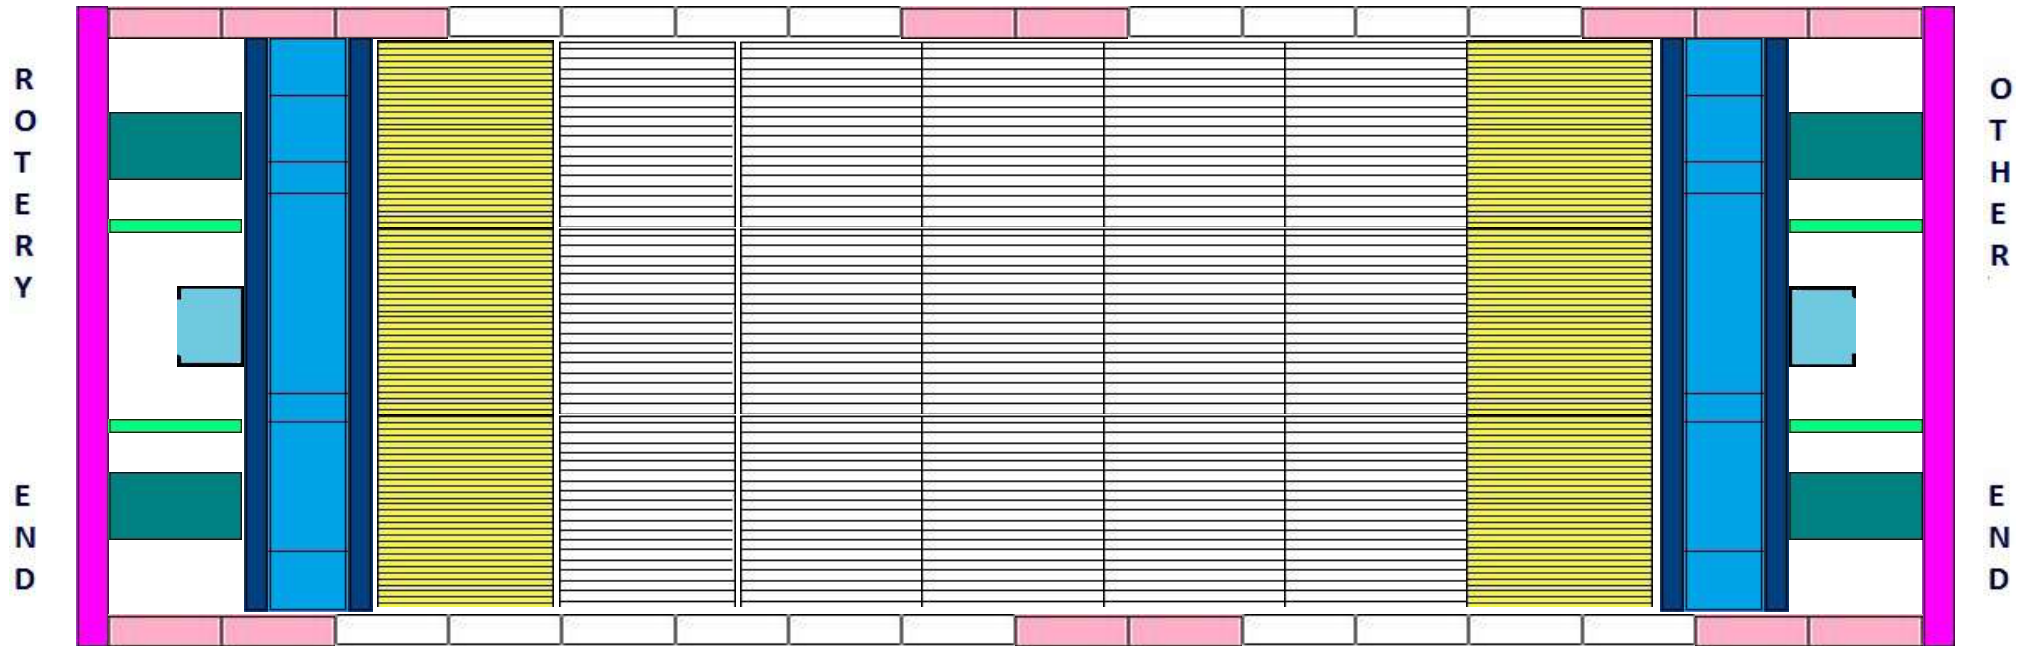
Rotary Side

Color	Particulars	Qty	Per%	Color	Particulars	Qty	Per%	Color	Particulars	Qty	Per%
Pink	Headstock Beam	2	100%	Dark Green	Centre Stiffner for Headstock	4	100%	Light Green	Floor Stiffner for Headstock	4	100%
Dark Blue	Aux. Head stock	4	100%	Pink	Sole Bar	7	44%	Blue	Draft Gear Bracket	2	100%
Yellow	Trough floor	2	29%	Light Blue	Centre plate	2	100%		SoleBar Stiffner	6	100%
	Bottom Wall Part	7	44%		Body panel/patch		100%		Door Top/Roof Patch		0%
	Window Module		0%		Window Sill	32	80%		Window Bar	46	26%
	Seat pillar/lav. Partition		100%		UIC end construction		0%

End Drooping: Rotary End - EAST : -7, WEST : -5 Other End - EAST : -6, WEST : -8
Start Date : 09-Apr-2019, Completion Date : 12-Apr-2019, Net Repair Days : 4, Total Man Hours : 1390

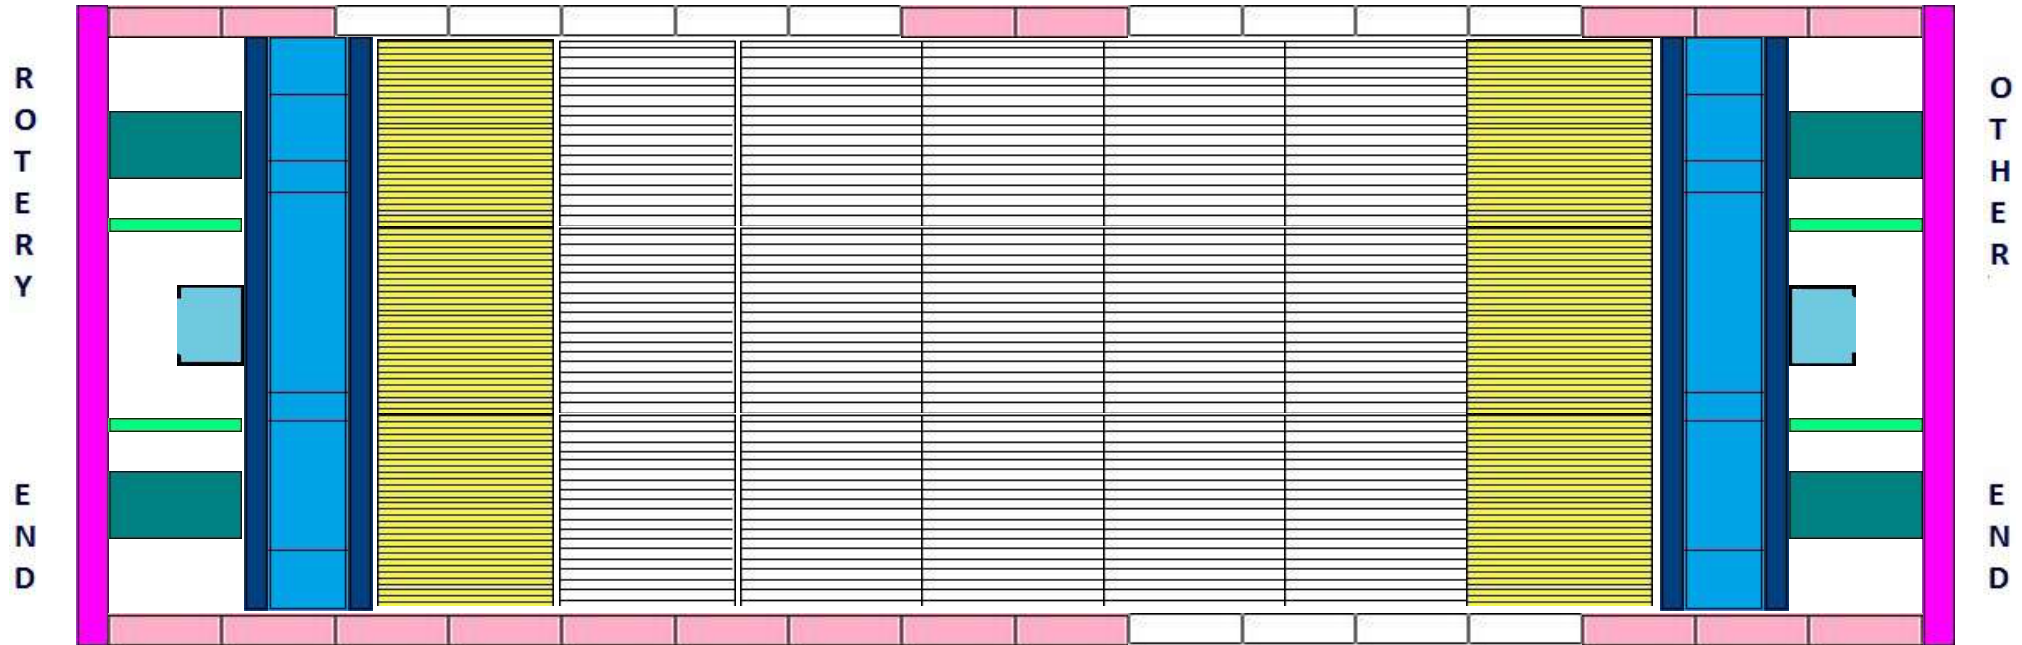
Color	Particulars	Qty	Per%	Color	Particulars	Qty	Per%	Color	Particulars	Qty	Per%
 	Headstock Beam	2	100%	 	Centre Stiffner for Headstock	4	100%	 	Floor Stiffner for Headstock	4	100%
 	Aux. Head stock	4	100%	 	Sole Bar	9.5	59%	 	Draft Gear Bracket	2	100%
 	Trough floor	2	29%	 	Centre plate	2	100%		SoleBar Stiffner	6	100%
	Bottom Wall Part	9.5	59%		Body panel/patch		100%		Door Top/Roof Patch		0%
	Window Module		0%		Window Sill	28	70%		Window Bar	46	26%
	Seat pillar/lav. Partition		100%		UIC end construction		0%

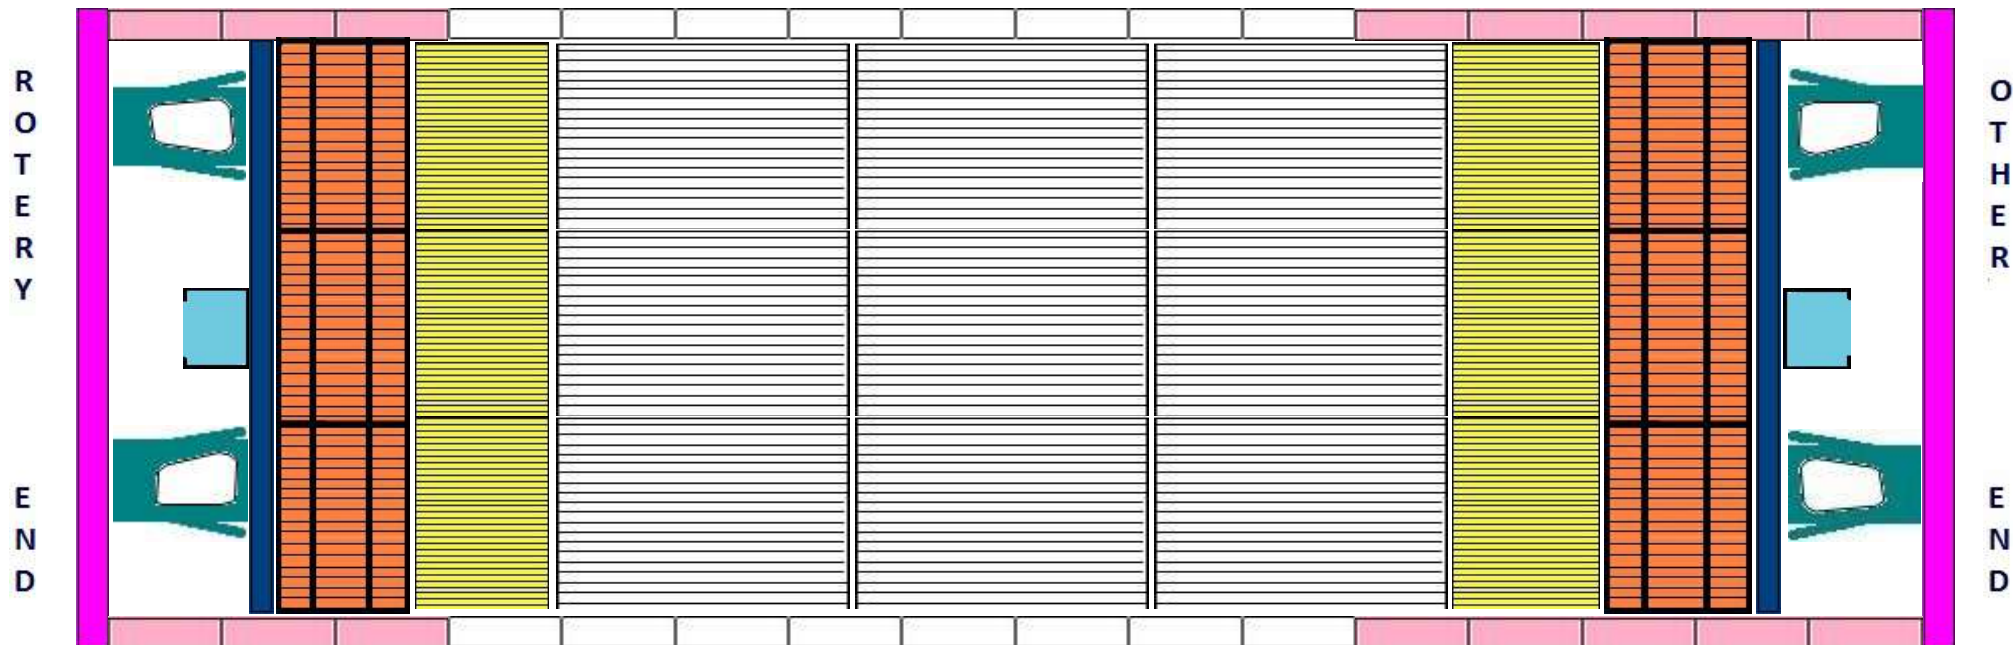
Rotary Side

Color	Particulars	Qty	Per%	Color	Particulars	Qty	Per%	Color	Particulars	Qty	Per%
	Headstock Beam	2	100%		Diagonal	4	100%		Logitudinal Channel Structure	2	100%
	Aux. Head stock	2	100%		Sole Bar	8	50%		Draft Gear Bracket	2	100%
	Trough floor	2	40%		Bottom Wall Part	8	50%		Body panel/patch		100%
	Door Top/Roof Patch		0%		Seat Bracket Rail		0%		Window Sill	7	18%
	Window Bar	26	14%		Seat pillar/lav. Partition		100%		UIC end construction		0%
	Body Pillar Part	44	100%

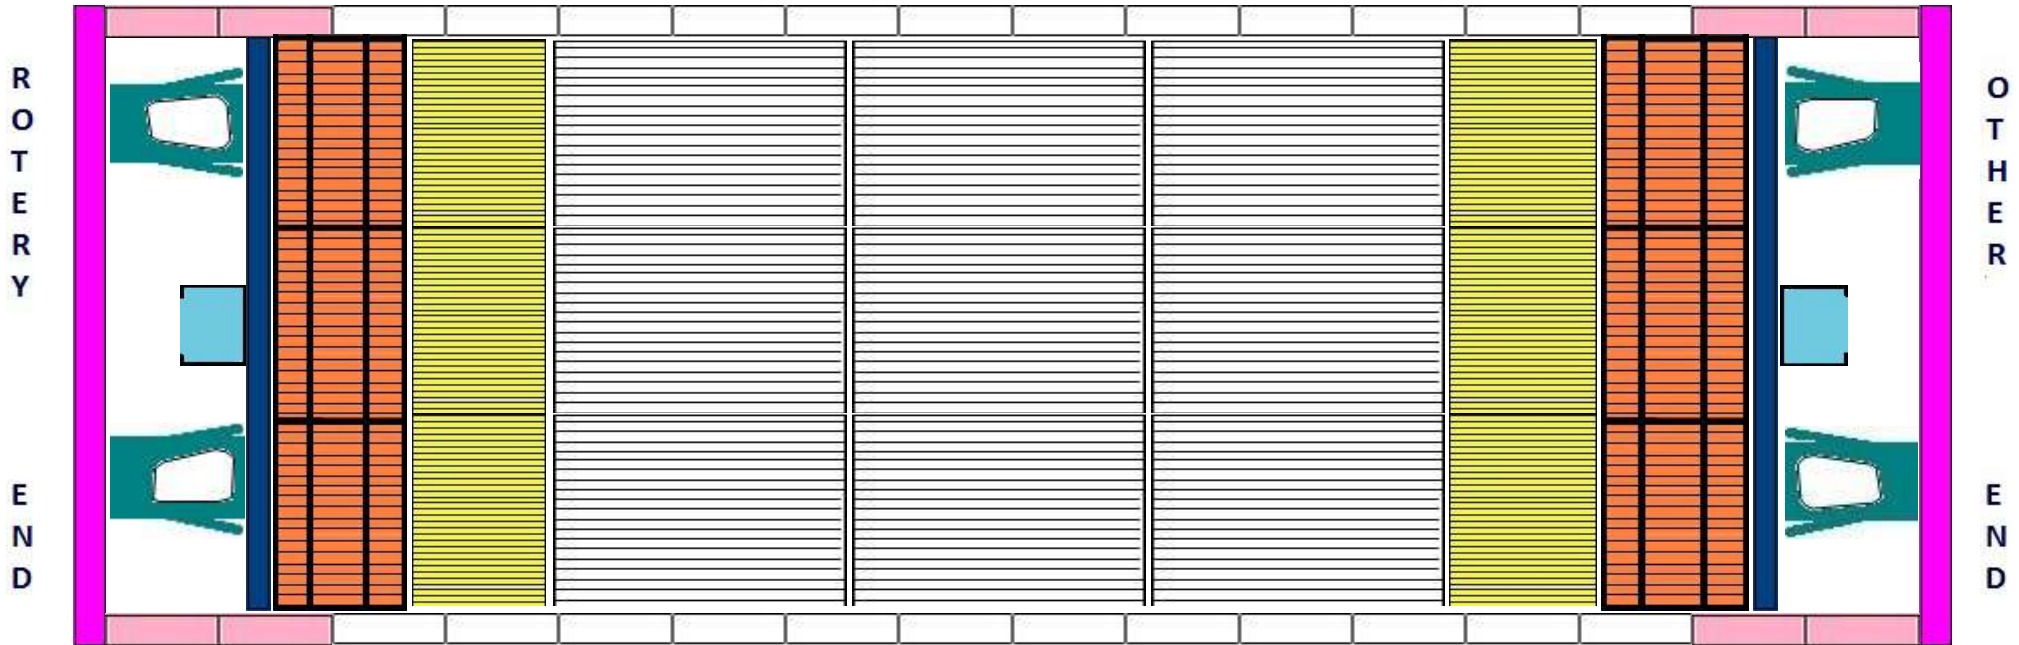
Rotary Side

Color	Particulars	Qty	Per%	Color	Particulars	Qty	Per%	Color	Particulars	Qty	Per%
	Headstock Beam	2	100%		Diagonal	4	100%		Logitudinal Channel Structure	2	100%
	Aux. Head stock	2	100%		Sole Bar	4	25%		Draft Gear Bracket	2	100%
	Trough floor	2	40%		Bottom Wall Part	4	25%		Body panel/patch		100%
	Door Top/Roof Patch		0%		Seat Bracket Rail		0%		Window Sill	20	50%
	Window Bar	40	22%		Seat pillar/lav. Partition		100%		UIC end construction		0%
	Body Pillar Part	22	100%

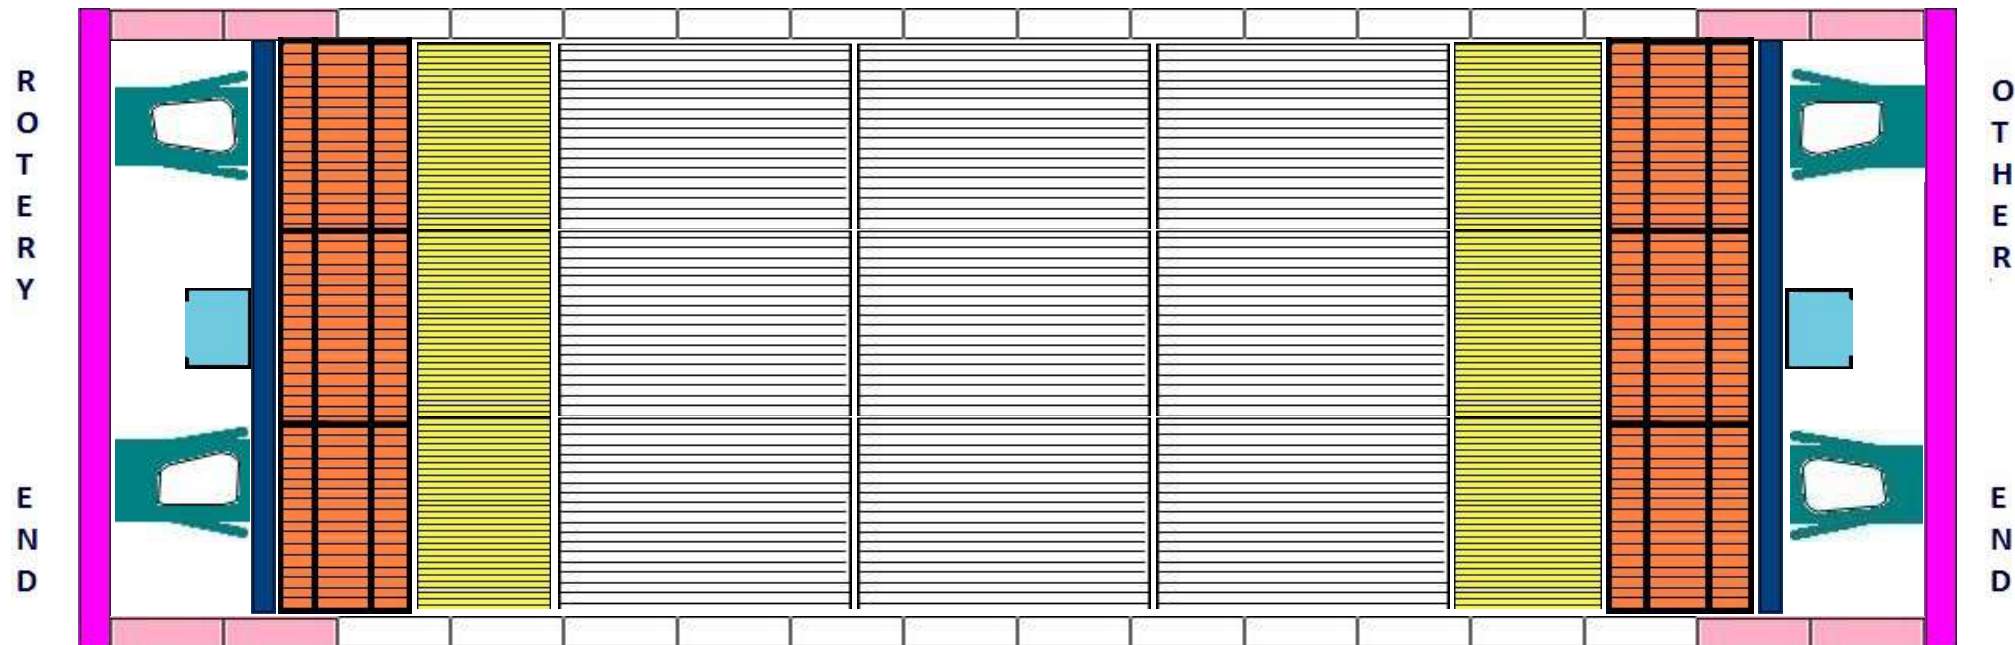
Rotary Side

Color	Particulars	Qty	Per%	Color	Particulars	Qty	Per%	Color	Particulars	Qty	Per%
	Headstock Beam	2	100%		Diagonal	4	100%		Logitudinal Channel Structure	2	100%
	Aux. Head stock	2	100%		Sole Bar	4	25%		Draft Gear Bracket	2	100%
	Trough floor	2	40%		Bottom Wall Part	4	25%		Body panel/patch		100%
	Door Top/Roof Patch		0%		Seat Bracket Rail		0%		Window Sill	20	50%
	Window Bar	40	22%		Seat pillar/lav. Partition		100%		UIC end construction		0%
	Body Pillar Part	22	100%

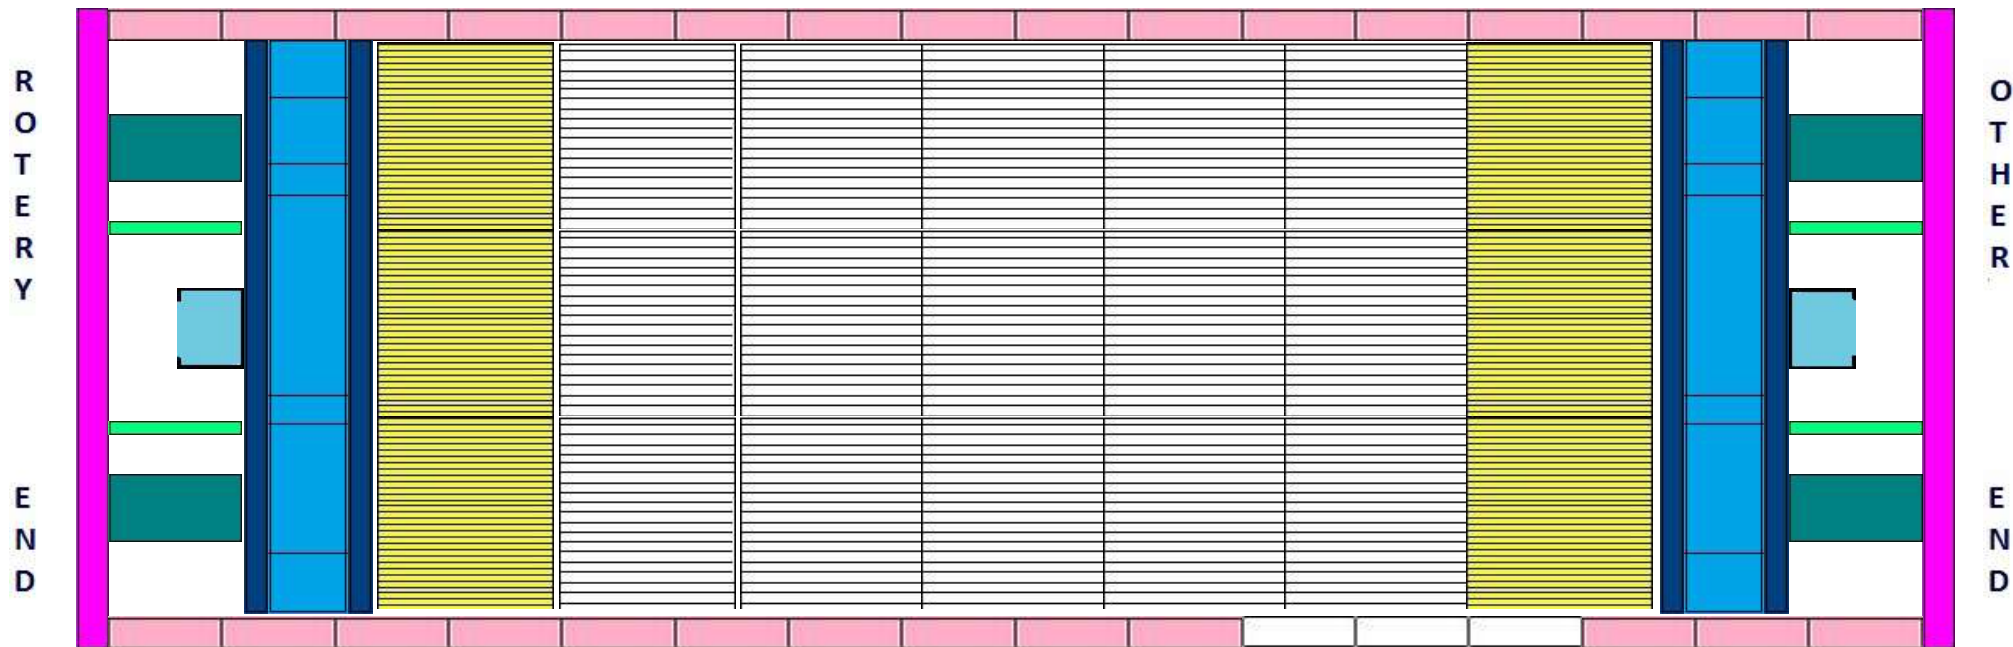
Rotary Side

Color	Particulars	Qty	Per%	Color	Particulars	Qty	Per%	Color	Particulars	Qty	Per%
Yellow	Headstock Beam	2	100%	Dark Green	Centre Stiffner for Headstock	4	100%	Light Green	Floor Stiffner for Headstock	4	100%
Dark Blue	Aux. Head stock	4	100%	Pink	Sole Bar	14.5	91%	Light Blue	Draft Gear Bracket	2	100%
Yellow	Trough floor	2	29%	Blue	Centre plate	2	100%		SoleBar Stiffner	4	100%
	Bottom Wall Part	14.5	91%		Body panel/patch		100%		Door Top/Roof Patch		0%
	Window Module		0%		Window Sill	40	100%		Window Bar	46	25%
	Seat pillar/lav. Partition		100%		UIC end construction		0%

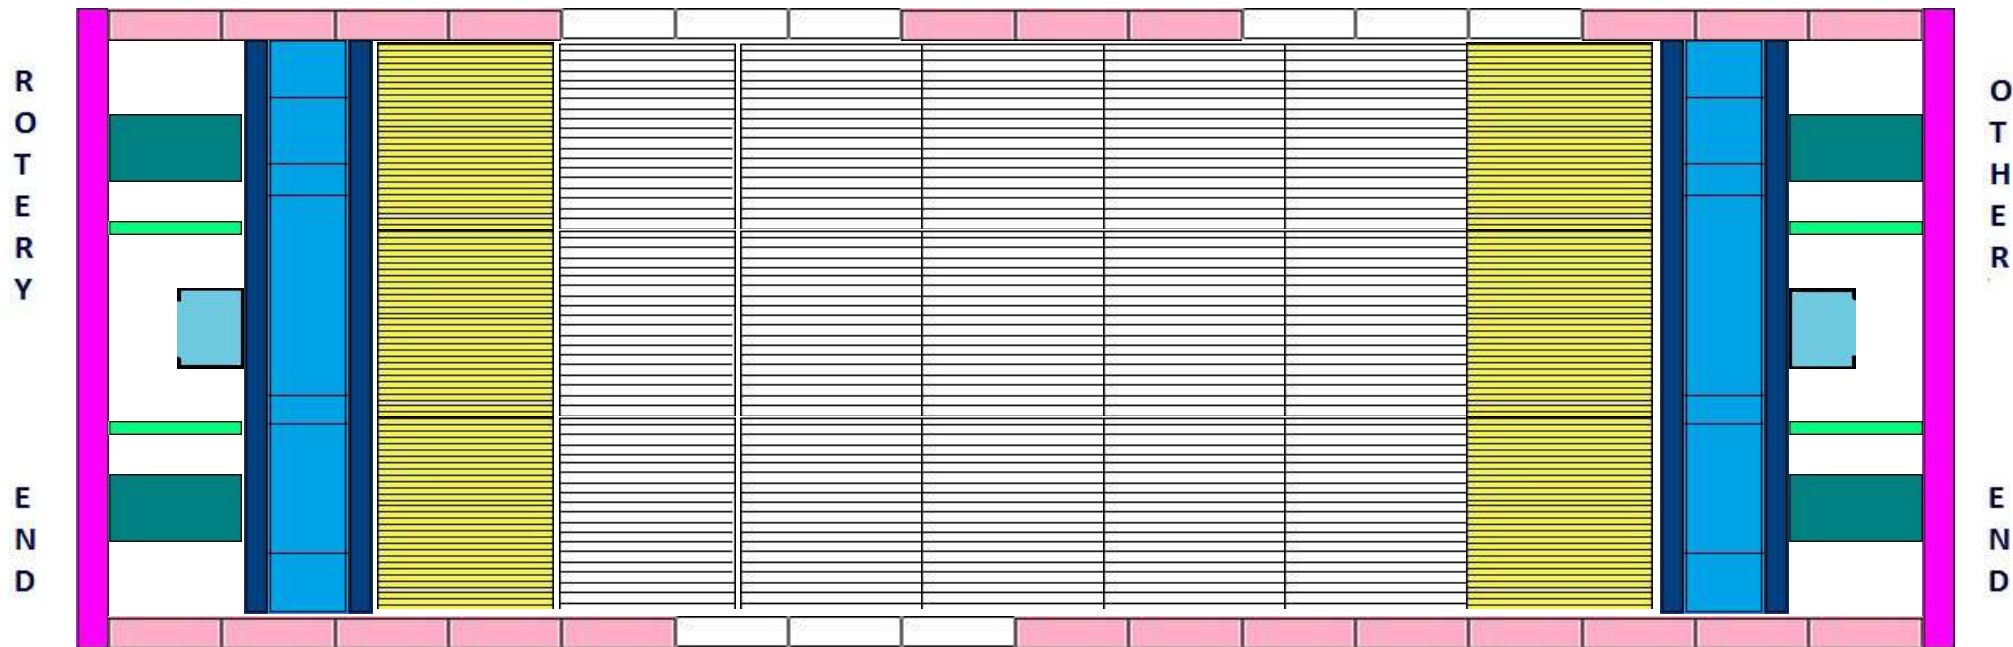
Rotary Side

Color	Particulars	Qty	Per%	Color	Particulars	Qty	Per%	Color	Particulars	Qty	Per%
Yellow	Headstock Beam	2	100%	Dark Green	Centre Stiffner for Headstock	4	100%	Light Green	Floor Stiffner for Headstock	4	100%
Dark Blue	Aux. Head stock	4	100%	Pink	Sole Bar	11.5	72%	Light Blue	Draft Gear Bracket	2	100%
Yellow	Trough floor	2	29%	Light Blue	Centre plate	2	100%		SoleBar Stiffner	4	100%
	Bottom Wall Part	11.5	72%		Body panel/patch		100%		Door Top/Roof Patch		0%
	Window Module		0%		Window Sill	12	63%		Window Bar	16	19%
	Seat pillar/lav. Partition		100%		UIC end construction		0%

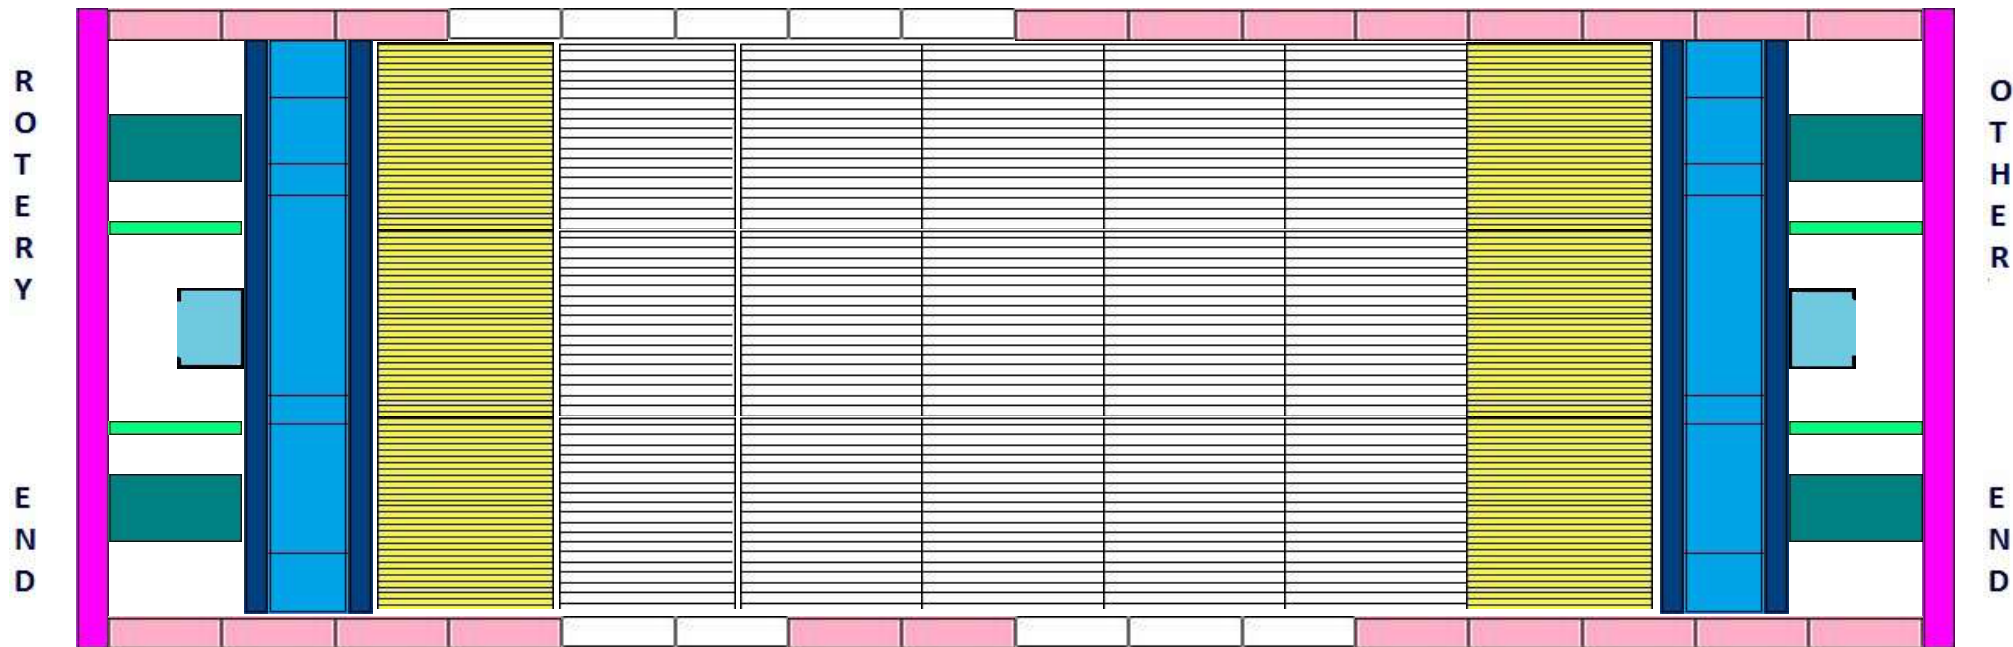
Rotary Side

Color	Particulars	Qty	Per%	Color	Particulars	Qty	Per%	Color	Particulars	Qty	Per%
Yellow	Headstock Beam	2	100%	Dark Green	Centre Stiffner for Headstock	4	100%	Light Green	Floor Stiffner for Headstock	4	100%
Dark Blue	Aux. Head stock	4	100%	Pink	Sole Bar	11	69%	Light Blue	Draft Gear Bracket	2	100%
Yellow	Trough floor	2	29%	Light Blue	Centre plate	2	100%		SoleBar Stiffner	6	100%
	Bottom Wall Part	11	69%		Body panel/patch		100%		Door Top/Roof Patch		0%
	Window Module		0%		Window Sill	14	35%		Window Bar	42	24%
	Seat pillar/lav. Partition		100%		UIC end construction		0%

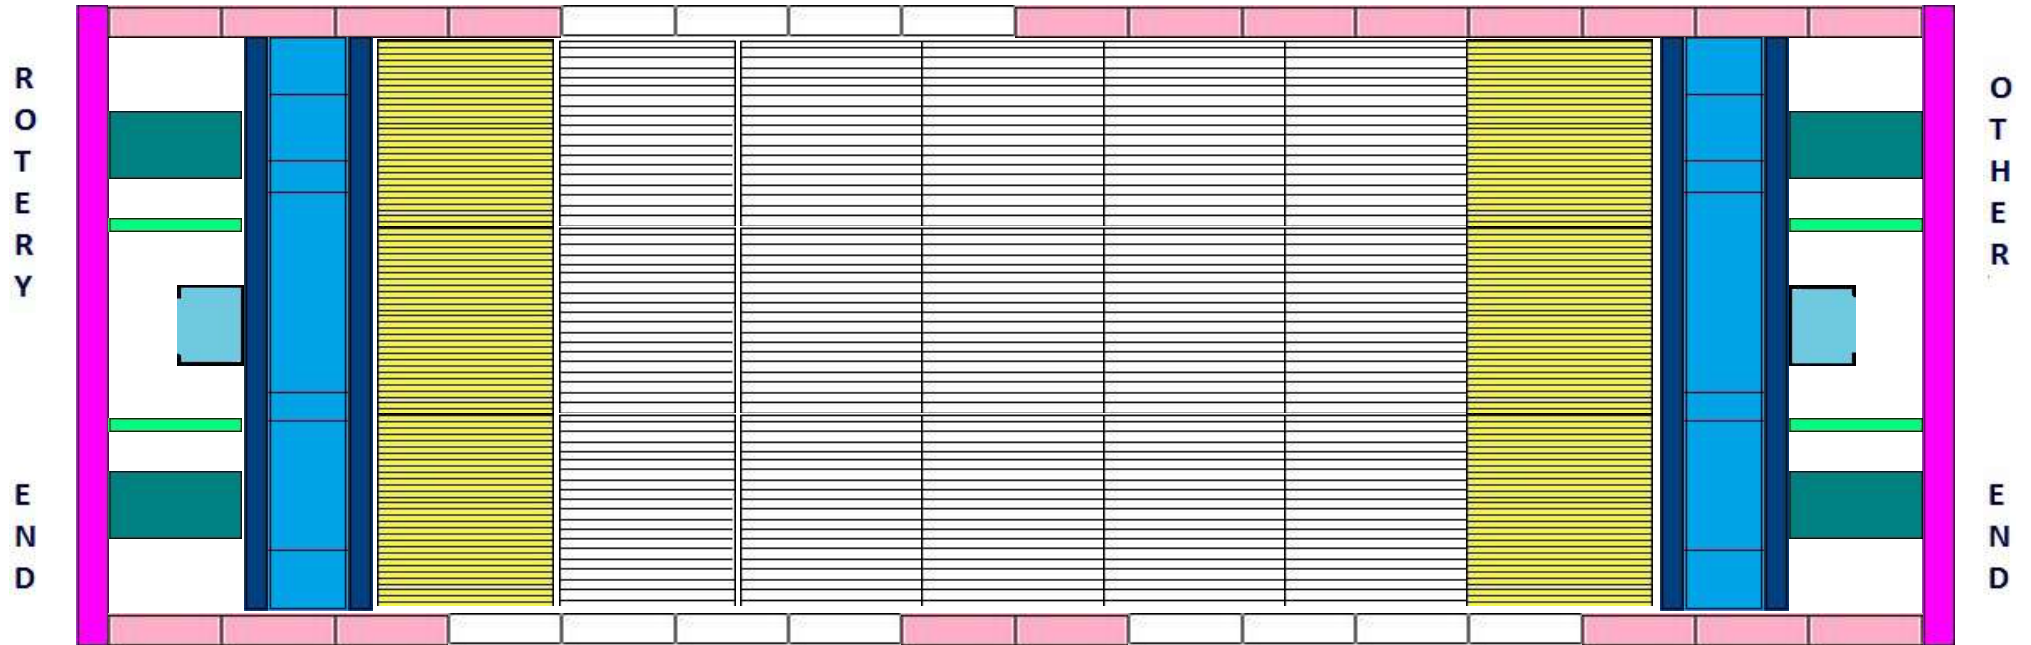
Color	Particulars	Qty	Per%	Color	Particulars	Qty	Per%	Color	Particulars	Qty	Per%
Yellow	Headstock Beam	2	100%	Dark Green	Centre Stiffner for Headstock	4	100%	Light Green	Floor Stiffner for Headstock	4	100%
Dark Blue	Aux. Head stock	4	100%	Pink	Sole Bar	10	63%	Light Blue	Draft Gear Bracket	2	100%
Yellow	Trough floor	2	29%	Light Blue	Centre plate	2	100%		SoleBar Stiffner	6	100%
	Bottom Wall Part	10	63%		Body panel/patch		100%		Door Top/Roof Patch		0%
	Window Module		0%		Window Sill	20	50%		Window Bar	44	25%
	Seat pillar/lav. Partition		100%		UIC end construction		0%

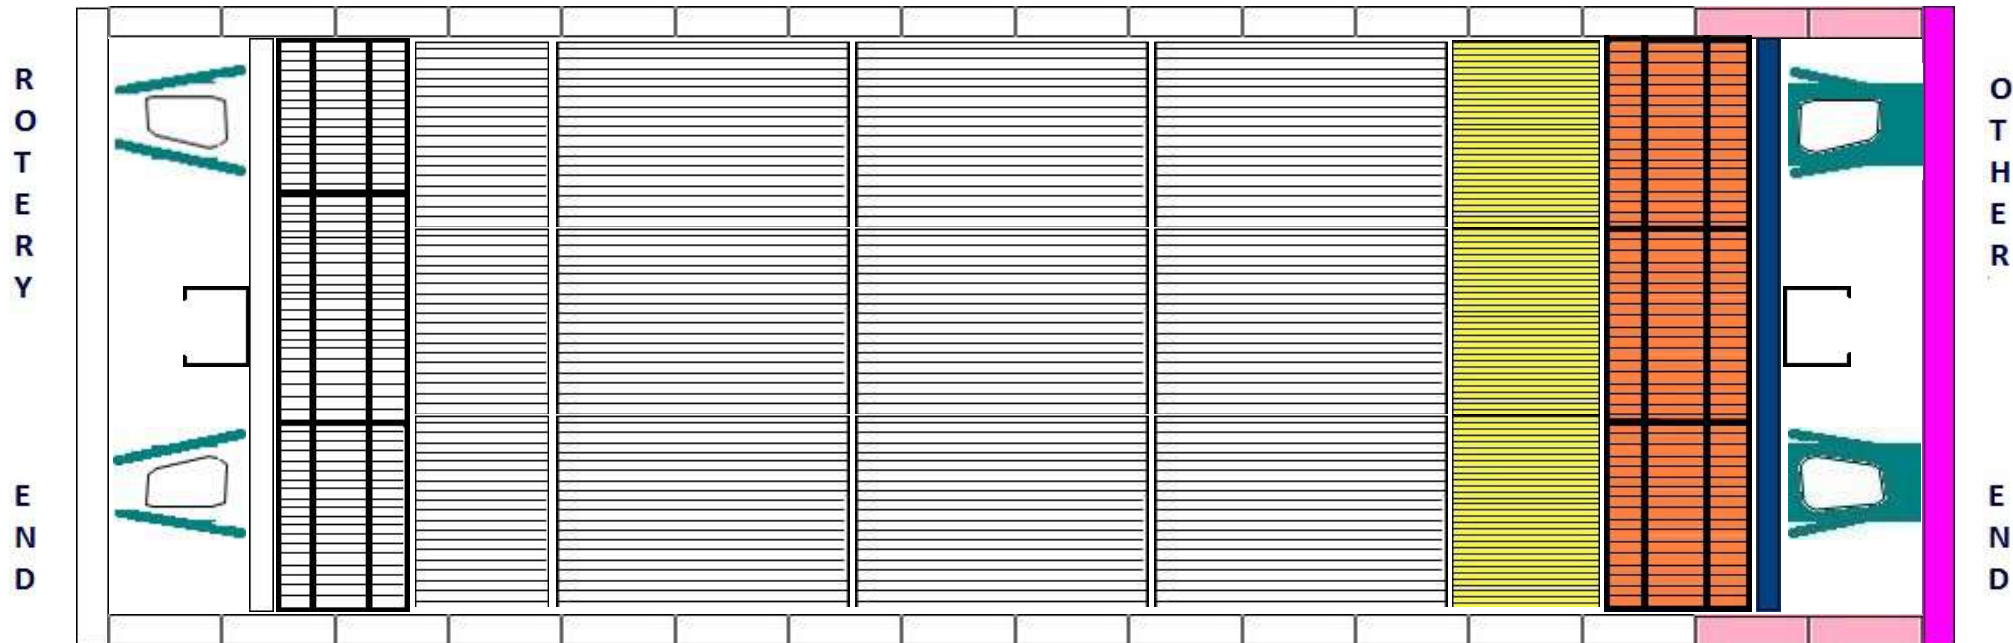
Rotary Side

Color	Particulars	Qty	Per%	Color	Particulars	Qty	Per%	Color	Particulars	Qty	Per%
	Headstock Beam	1	50%		Diagonal	4	100%		Logitudinal Channel Structure	1	50%
	Aux. Head stock	1	50%		Sole Bar	2	13%		Draft Gear Bracket	1	50%
	Trough floor	1	20%		Bottom Wall Part	2	13%		Body panel/patch		100%
	Door Top/Roof Patch		0%		Seat Bracket Rail		0%		Window Sill	20	50%
	Window Bar	36	20%		Seat pillar/lav. Partition		100%		UIC end construction		0%
	Body Pillar Part	11	100%

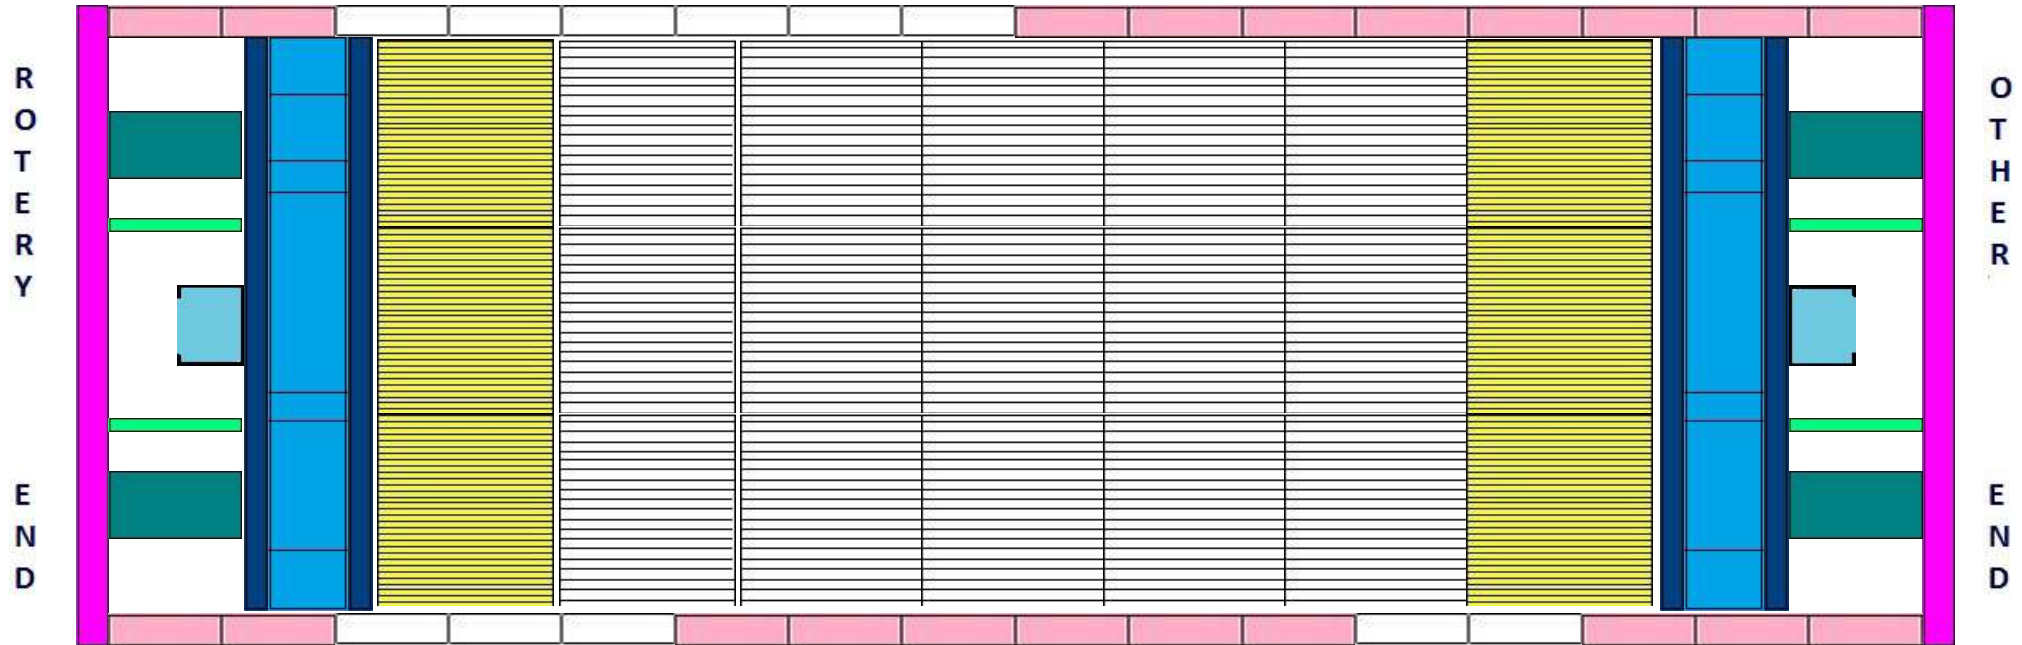
Rotary Side

Color	Particulars	Qty	Per%	Color	Particulars	Qty	Per%	Color	Particulars	Qty	Per%
	Headstock Beam	2	100%		Centre Stiffner for Headstock	4	100%		Floor Stiffner for Headstock	4	100%
	Aux. Head stock	4	100%		Sole Bar	10.5	66%		Draft Gear Bracket	2	100%
	Trough floor	2	29%		Centre plate	2	100%		SoleBar Stiffner	6	100%
	Bottom Wall Part	10.5	66%		Body panel/patch		100%		Door Top/Roof Patch		0%
	Window Module		0%		Window Sill	40	100%		Window Bar	48	27%
	Seat pillar/lav. Partition		100%		UIC end construction		0%
