Coach Rehabilitation Workshop, WC Railway, Bhopal

(An IMS and ISO 50001 Certified Workshop)
Final Inspection Sheet - Details of Corrosion Repair

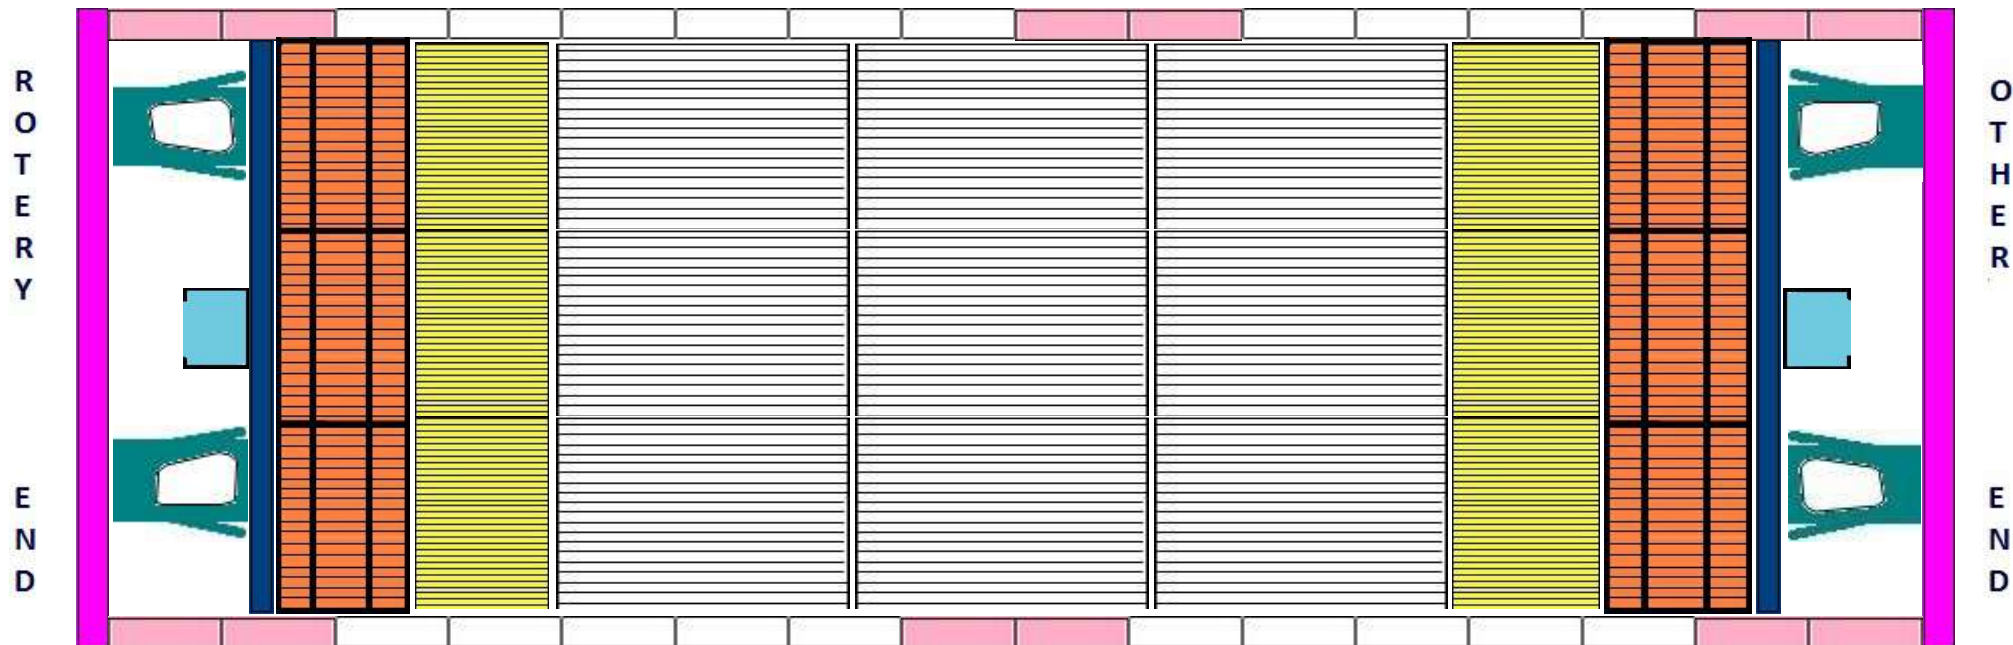
Rotary Side

Color	Particulars	Qty	Per%	Color	Particulars	Qty	Per%	Color	Particulars	Qty	Per%
	Headstock Beam	2	100%		Diagonal	4	100%		Logitudinal Channel Structure	2	100%
	Aux. Head stock	2	100%		Sole Bar	6	38%		Draft Gear Bracket	2	100%
	Trough floor	2	40%		Bottom Wall Part	6	38%		Body panel/patch		100%
	Door Top/Roof Patch		0%		Seat Bracket Rail		0%		Window Sill	14	35%
	Window Bar	30	17%		Seat pillar/lav. Partition		100%		UIC end construction		0%
	Body Pillar Part	33	100%

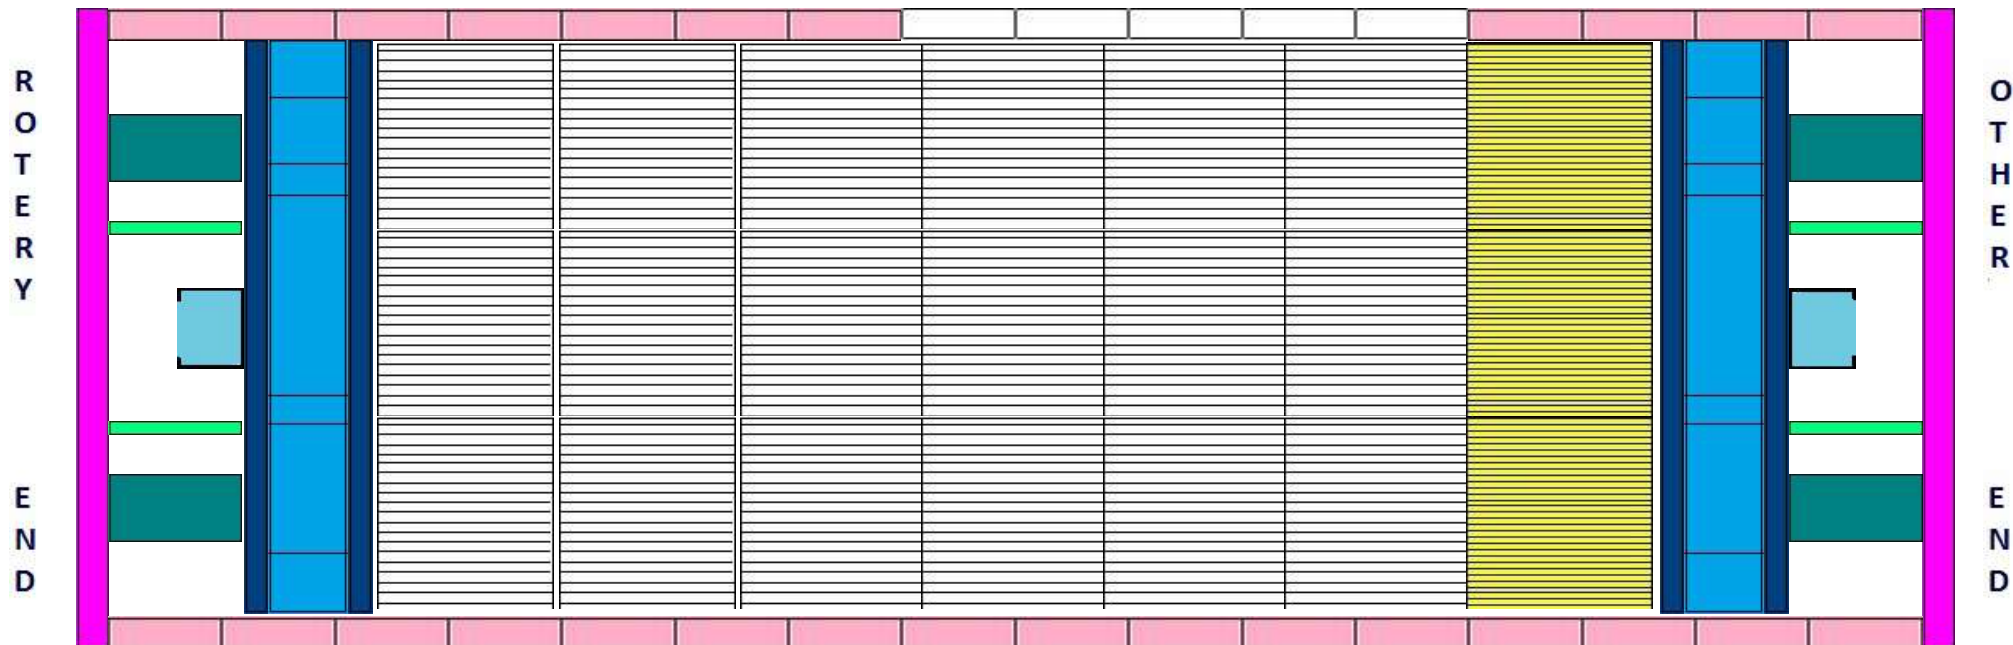
Rotary Side

Color	Particulars	Qty	Per%	Color	Particulars	Qty	Per%	Color	Particulars	Qty	Per%
	Headstock Beam	2	100%		Centre Stiffner for Headstock	4	100%		Floor Stiffner for Headstock	4	100%
	Aux. Head stock	4	100%		Sole Bar	13.5	84%		Draft Gear Bracket	2	100%
	Trough floor	1	14%		Centre plate	2	100%		SoleBar Stiffner	4	100%
	Bottom Wall Part	13.5	84%		Body panel/patch		100%		Door Top/Roof Patch		0%
	Window Module		0%		Window Sill	10	53%		Window Bar	18	21%
	Seat pillar/lav. Partition		100%		UIC end construction		0%

End Drooping: Rotary End - EAST : -3, WEST : 0 Other End - EAST : -5, WEST : -3
Start Date : 30-Aug-2019, Completion Date : 06-Sep-2019, Net Repair Days : 7, Total Man Hours : 1532
