Coach Rehabilitation Workshop, WC Railway, Bhopal

(An IMS and ISO 50001 Certified Workshop)
Final Inspection Sheet - Details of Corrosion Repair

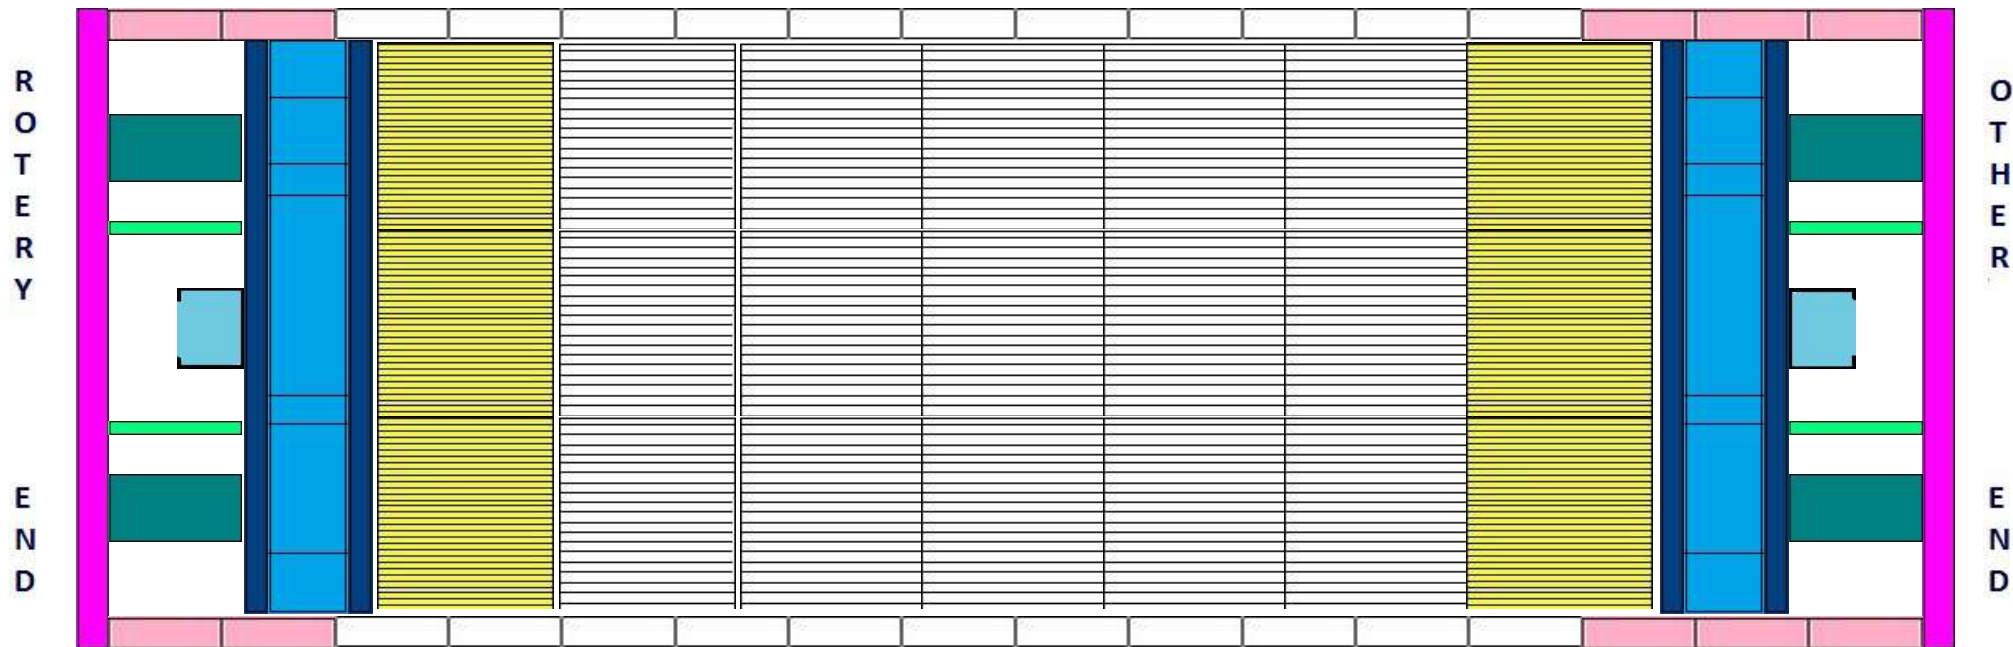
Coach No. :SC04116

Color	Particulars	Qty	Per%	Color	Particulars	Qty	Per%	Color	Particulars	Qty	Per%
	Headstock Beam	2	100%		Centre Stiffner for Headstock	4	100%		Floor Stiffner for Headstock	4	100%
	Aux. Head stock	4	100%		Sole Bar	5	31%		Draft Gear Bracket	2	100%
	Trough floor	2	29%		Centre plate	2	100%		SoleBar Stiffner	4	100%
	Bottom Wall Part	5	31%		Body panel/patch		100%		Door Top/Roof Patch		0%
	Window Module		6%		Window Sill	0	0%		Window Bar	0	0%
	Seat pillar/lav. Partition		100%		UIC end construction		0%

End Drooping: Rotary End - EAST : 5, WEST : 4 Other End - EAST : 5, WEST : 5
Start Date : 07-May-2019, Completion Date : 16-May-2019, Net Repair Days : 9, Total Man Hours : 0

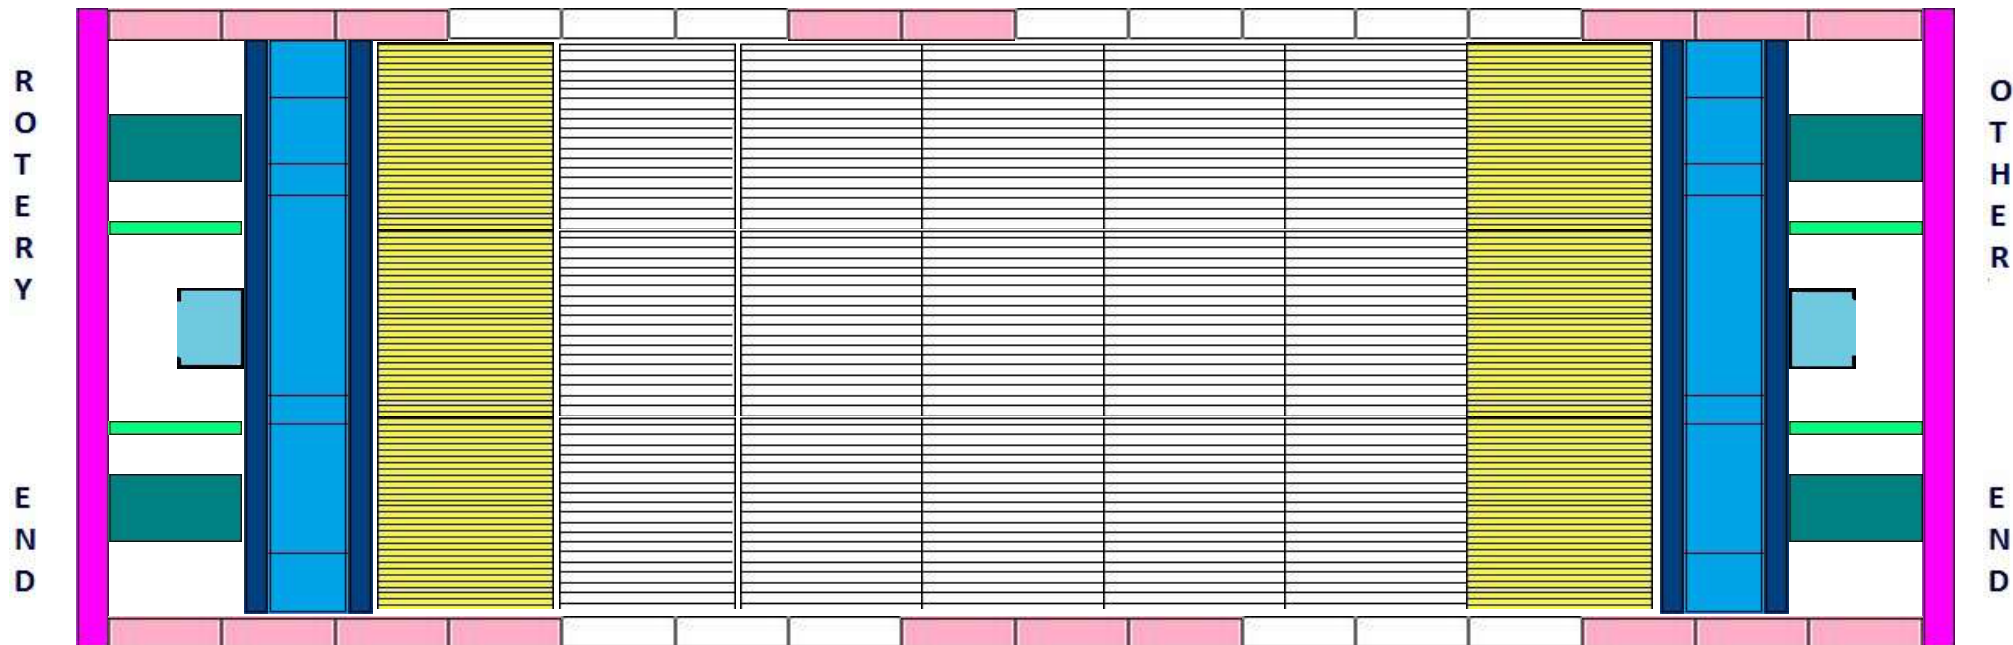
Coach No. :SC06604

Color	Particulars	Qty	Per%	Color	Particulars	Qty	Per%	Color	Particulars	Qty	Per%
Yellow	Headstock Beam	2	100%	Blue	Centre Stiffner for Headstock	4	100%	Red	Floor Stiffner for Headstock	4	100%
Black	Aux. Head stock	4	100%	Green	Sole Bar	9	56%	Orange	Draft Gear Bracket	2	100%
Blue	Trough floor	2	29%	Red	Centre plate	2	100%		SoleBar Stiffner	6	100%
	Bottom Wall Part	9	56%		Body panel/patch		100%		Door Top/Roof Patch		0%
	Window Module		0%		Window Sill	30	75%		Window Bar	40	22%
	Seat pillar/lav. Partition		100%		UIC end construction		0%

End Drooping: Rotary End - EAST : -10, WEST : -10 Other End - EAST : -9, WEST : -7
Start Date : 12-Jun-2019, Completion Date : 20-Jun-2019, Net Repair Days : 8, Total Man Hours : 1232

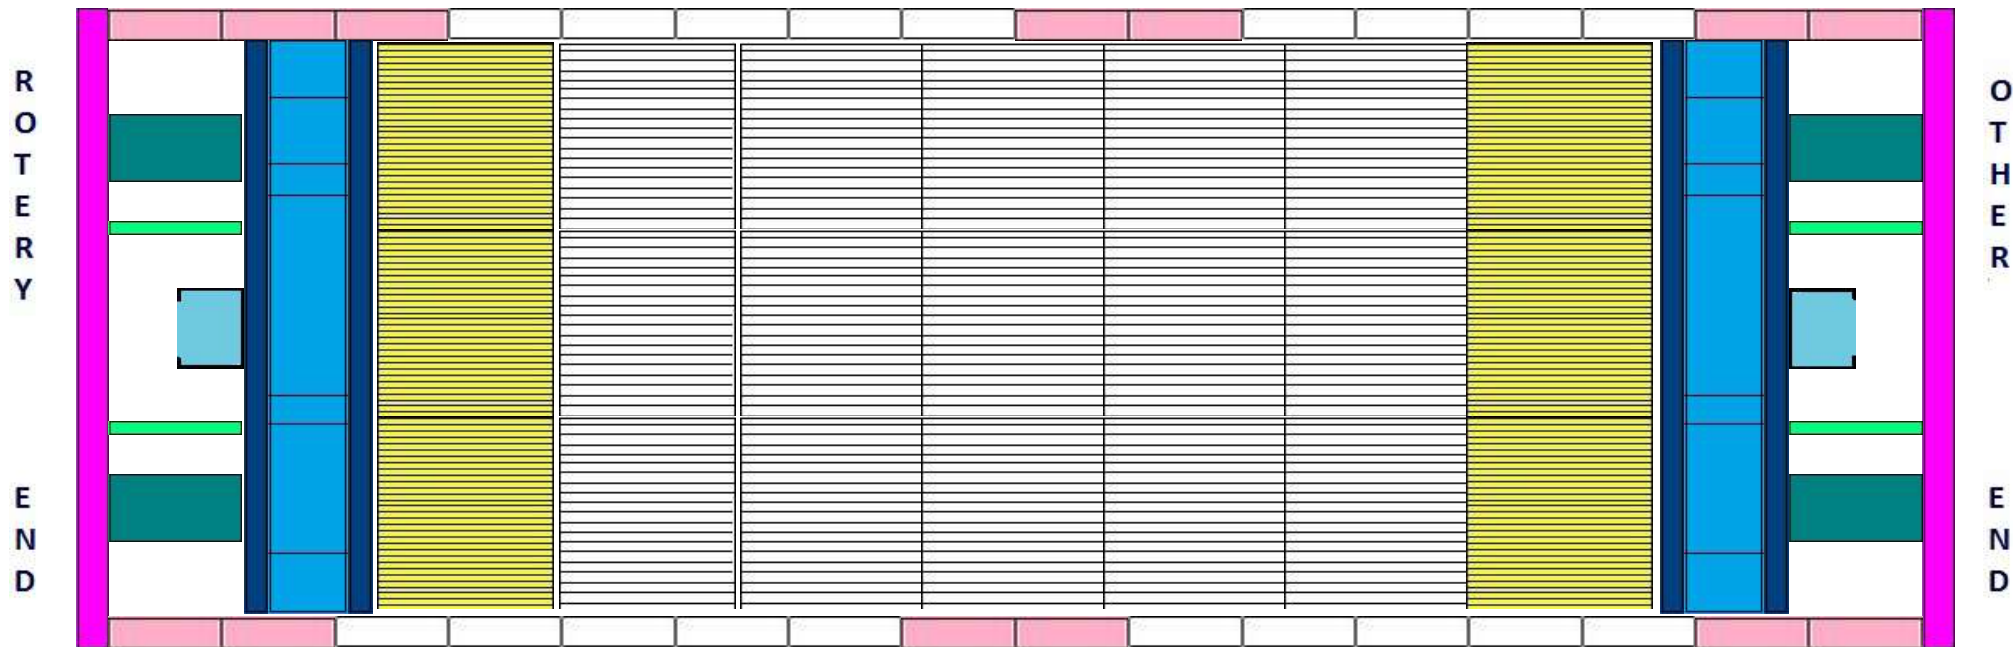
Coach No. :SC06606

Color	Particulars	Qty	Per%	Color	Particulars	Qty	Per%	Color	Particulars	Qty	Per%
	Headstock Beam	2	100%		Centre Stiffner for Headstock	4	100%		Floor Stiffner for Headstock	4	100%
	Aux. Head stock	4	100%		Sole Bar	6.5	41%		Draft Gear Bracket	2	100%
	Trough floor	2	29%		Centre plate	2	100%		SoleBar Stiffner	6	100%
	Bottom Wall Part	6.5	41%		Body panel/patch		100%		Door Top/Roof Patch		0%
	Window Module		0%		Window Sill	16	40%		Window Bar	46	26%
	Seat pillar/lav. Partition		100%		UIC end construction		0%

End Drooping: Rotary End - EAST : 4, WEST : 0 Other End - EAST : 0, WEST : 5
Start Date : 03-Jul-2019, Completion Date : 10-Jul-2019, Net Repair Days : 7, Total Man Hours : 1456

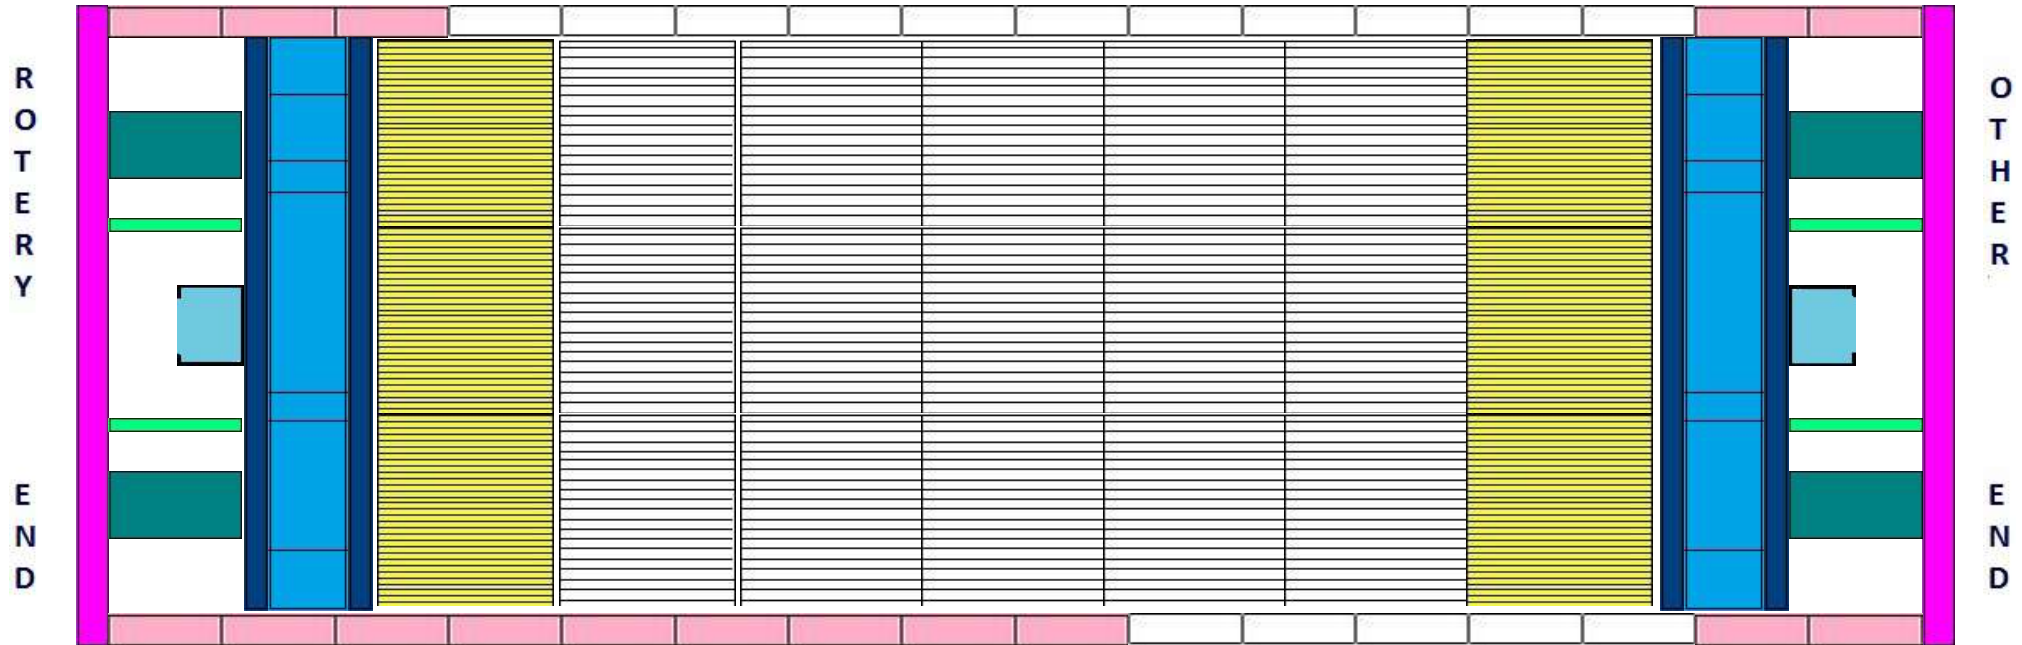
Coach No. :SC05414

Color	Particulars	Qty	Per%	Color	Particulars	Qty	Per%	Color	Particulars	Qty	Per%
	Headstock Beam	2	100%		Centre Stiffner for Headstock	4	100%		Floor Stiffner for Headstock	4	100%
	Aux. Head stock	4	100%		Sole Bar	8	50%		Draft Gear Bracket	2	100%
	Trough floor	2	29%		Centre plate	2	100%		SoleBar Stiffner	6	100%
	Bottom Wall Part	8	50%		Body panel/patch		100%		Door Top/Roof Patch		0%
	Window Module		0%		Window Sill	40	100%		Window Bar	58	33%
	Seat pillar/lav. Partition		100%		UIC end construction		0%

End Drooping: Rotary End - EAST : -4, WEST : 0 Other End - EAST : -4, WEST : -6
Start Date : 02-Jul-2019, Completion Date : 08-Jul-2019, Net Repair Days : 6, Total Man Hours : 1288

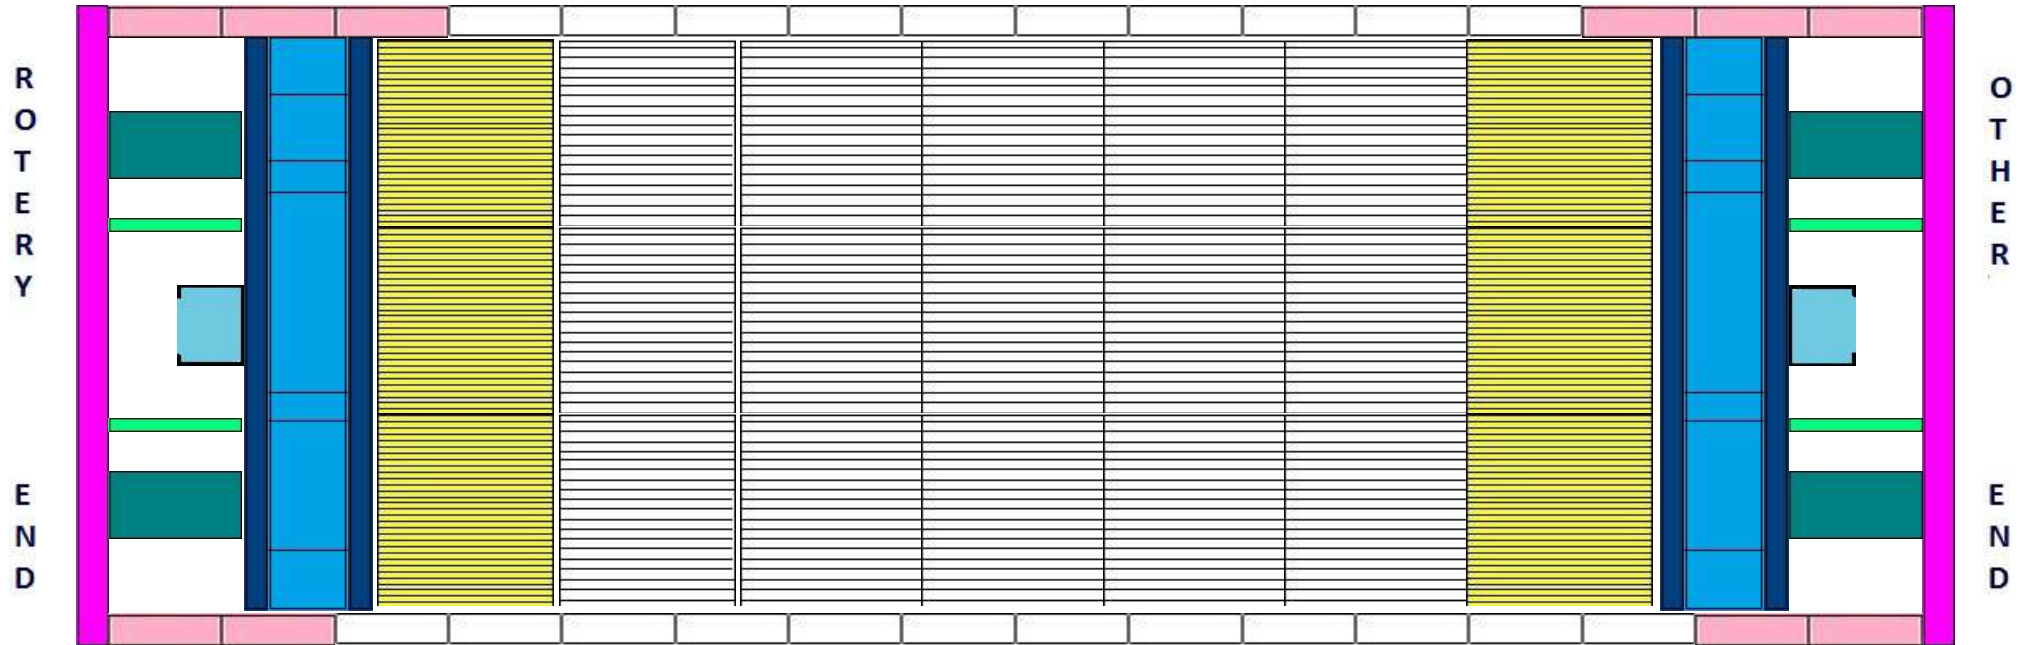
Coach No. :SC05151

Color	Particulars	Qty	Per%	Color	Particulars	Qty	Per%	Color	Particulars	Qty	Per%
Yellow	Headstock Beam	2	100%	Blue	Centre Stiffner for Headstock	4	100%	Red	Floor Stiffner for Headstock	4	100%
Black	Aux. Head stock	4	100%	Green	Sole Bar	5	31%	Orange	Draft Gear Bracket	2	100%
Blue	Trough floor	2	29%	Red	Centre plate	2	100%	Black	SoleBar Stiffner	4	100%
	Bottom Wall Part	5	31%		Body panel/patch		100%		Door Top/Roof Patch		0%
	Window Module		0%		Window Sill	0	0%		Window Bar	0	0%
	Seat pillar/lav. Partition		100%		UIC end construction		0%

End Drooping: Rotary End - EAST : -3, WEST : 8 Other End - EAST : 0, WEST : -6
Start Date : 08-Jul-2019, Completion Date : 15-Jul-2019, Net Repair Days : 7, Total Man Hours : 1196

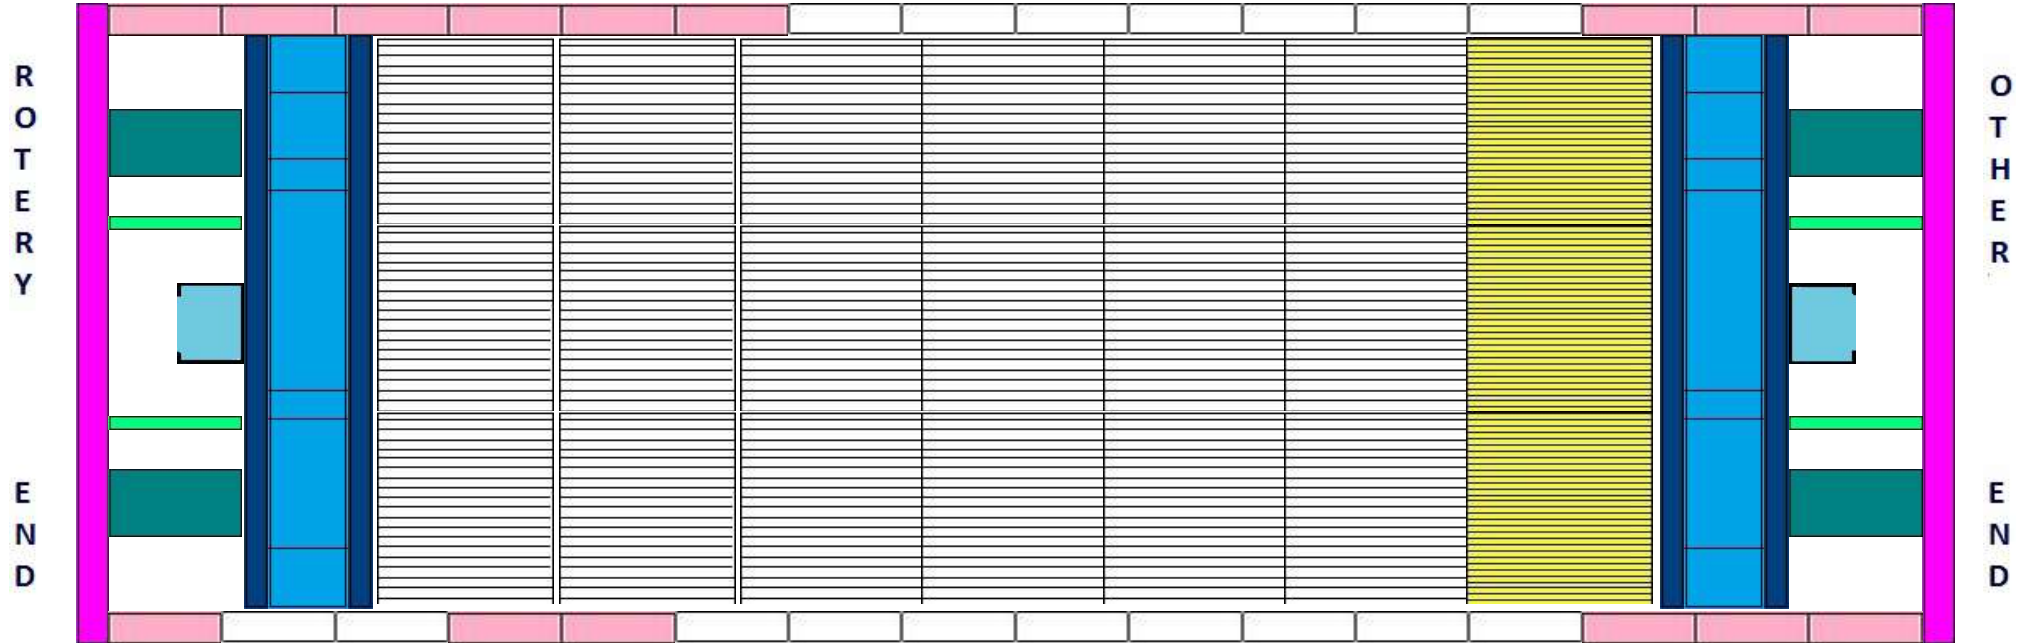
Color	Particulars	Qty	Per%	Color	Particulars	Qty	Per%	Color	Particulars	Qty	Per%
Yellow	Headstock Beam	2	100%	Blue	Centre Stiffner for Headstock	4	100%	Red	Floor Stiffner for Headstock	4	100%
Green	Aux. Head stock	4	100%	Yellow	Sole Bar	7.5	47%	Blue	Draft Gear Bracket	2	100%
Red	Trough floor	1	14%	Blue	Centre plate	2	100%		SoleBar Stiffner	4	100%
	Bottom Wall Part	7.5	47%		Body panel/patch		100%		Door Top/Roof Patch		0%
	Window Module		0%		Window Sill	8	42%		Window Bar	12	14%
	Seat pillar/lav. Partition		100%		UIC end construction		0%

End Drooping: Rotary End - EAST : 5, WEST : 3 Other End - EAST : -5, WEST : -8
Start Date : 18-Jun-2019, Completion Date : 25-Jun-2019, Net Repair Days : 7, Total Man Hours : 1184

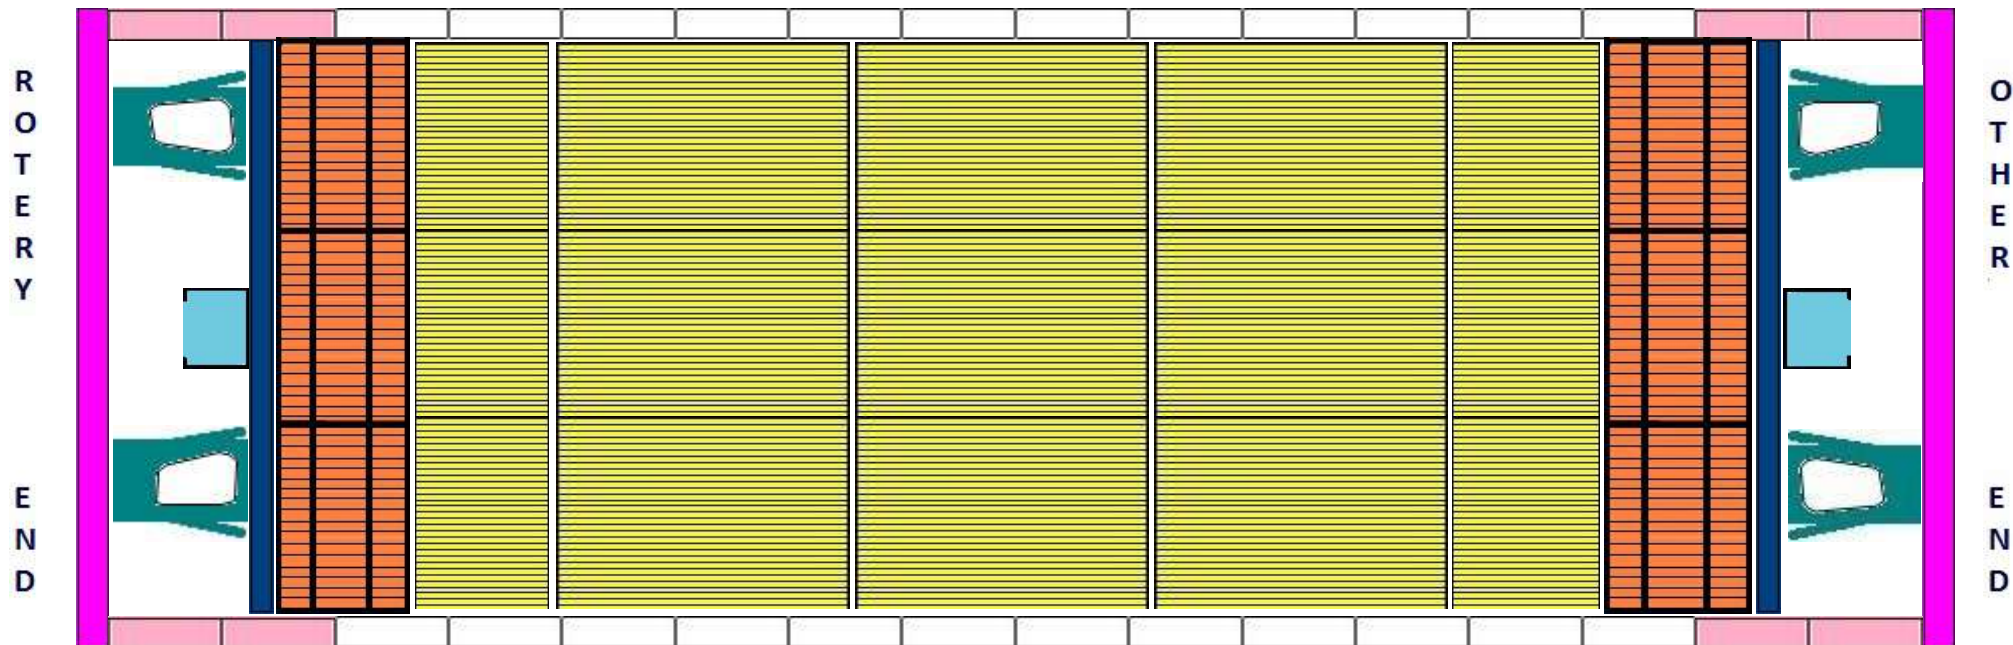
Color	Particulars	Qty	Per%	Color	Particulars	Qty	Per%	Color	Particulars	Qty	Per%
	Headstock Beam	2	100%		Diagonal	4	100%		Logitudinal Channel Structure	2	100%
	Aux. Head stock	2	100%		Sole Bar	4	25%		Draft Gear Bracket	2	100%
	Trough floor	7	100%		Bottom Wall Part	4	25%		Body panel/patch		100%
	Door Top/Roof Patch		0%		Seat Bracket Rail		0%		Window Sill	24	60%
	Window Bar	32	17%		Seat pillar/lav. Partition		100%		UIC end construction		0%
	Body Pillar Part	22	100%

End Drooping: Rotary End - EAST : -10, WEST : -10 Other End - EAST : -8, WEST : -8
Start Date : 21-Jun-2019, Completion Date : 29-Jun-2019, Net Repair Days : 8, Total Man Hours : 1448

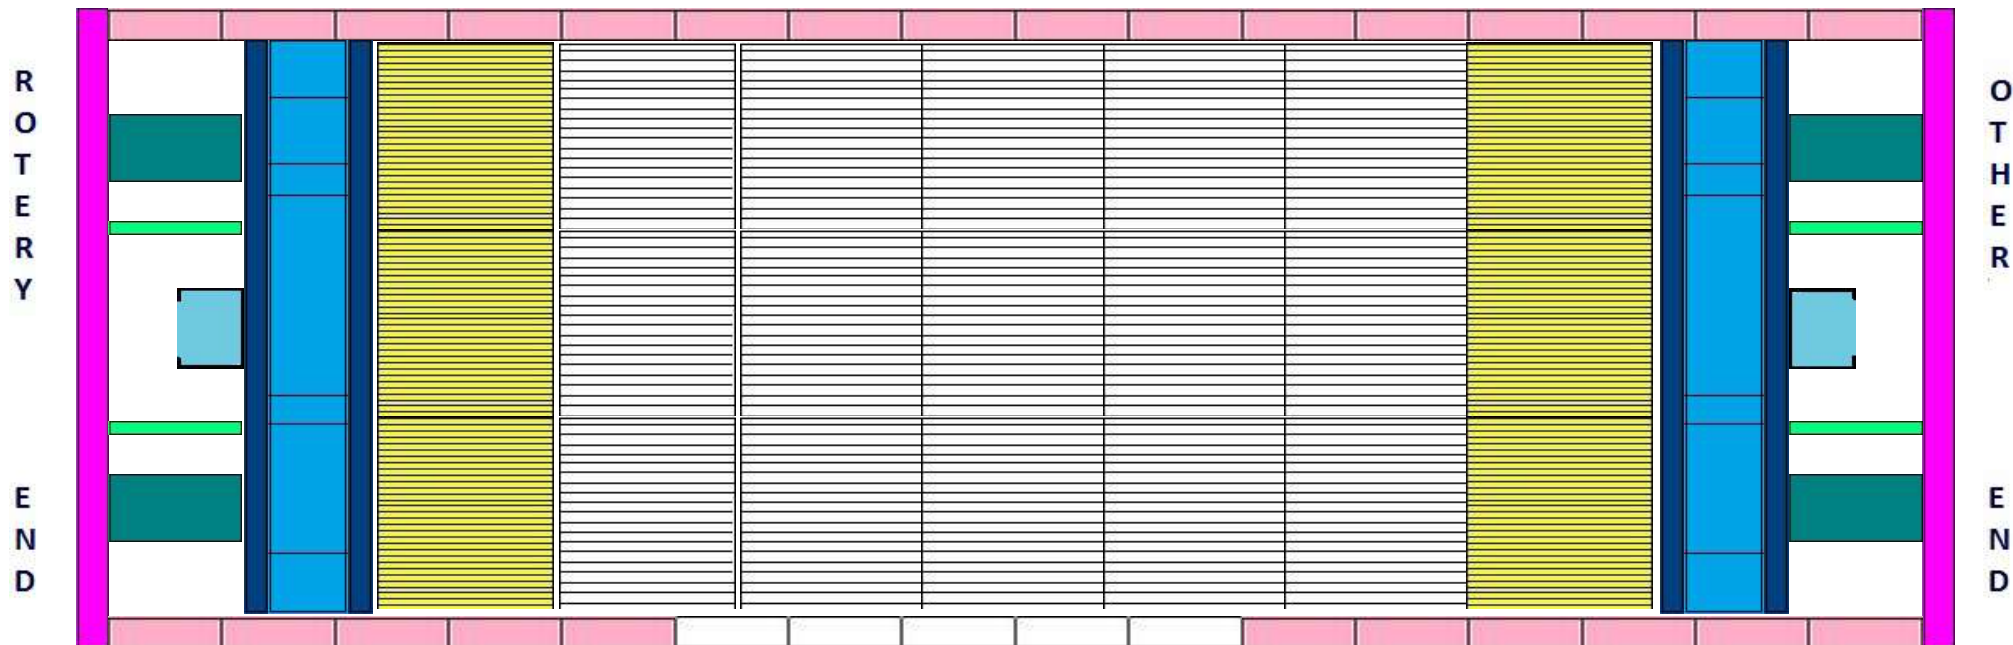
Color	Particulars	Qty	Per%	Color	Particulars	Qty	Per%	Color	Particulars	Qty	Per%
	Headstock Beam	2	100%		Centre Stiffner for Headstock	4	100%		Floor Stiffner for Headstock	4	100%
	Aux. Head stock	4	100%		Sole Bar	13.5	84%		Draft Gear Bracket	2	100%
	Trough floor	2	29%		Centre plate	2	100%		SoleBar Stiffner	4	100%
	Bottom Wall Part	13.5	84%		Body panel/patch		100%		Door Top/Roof Patch		0%
	Window Module		0%		Window Sill	40	100%		Window Bar	70	38%
	Seat pillar/lav. Partition		100%		UIC end construction		0%

End Drooping: Rotary End - EAST : -5, WEST : -7 Other End - EAST : -5, WEST : -6
Start Date : 07-May-2019, Completion Date : 17-May-2019, Net Repair Days : 10, Total Man Hours : 0

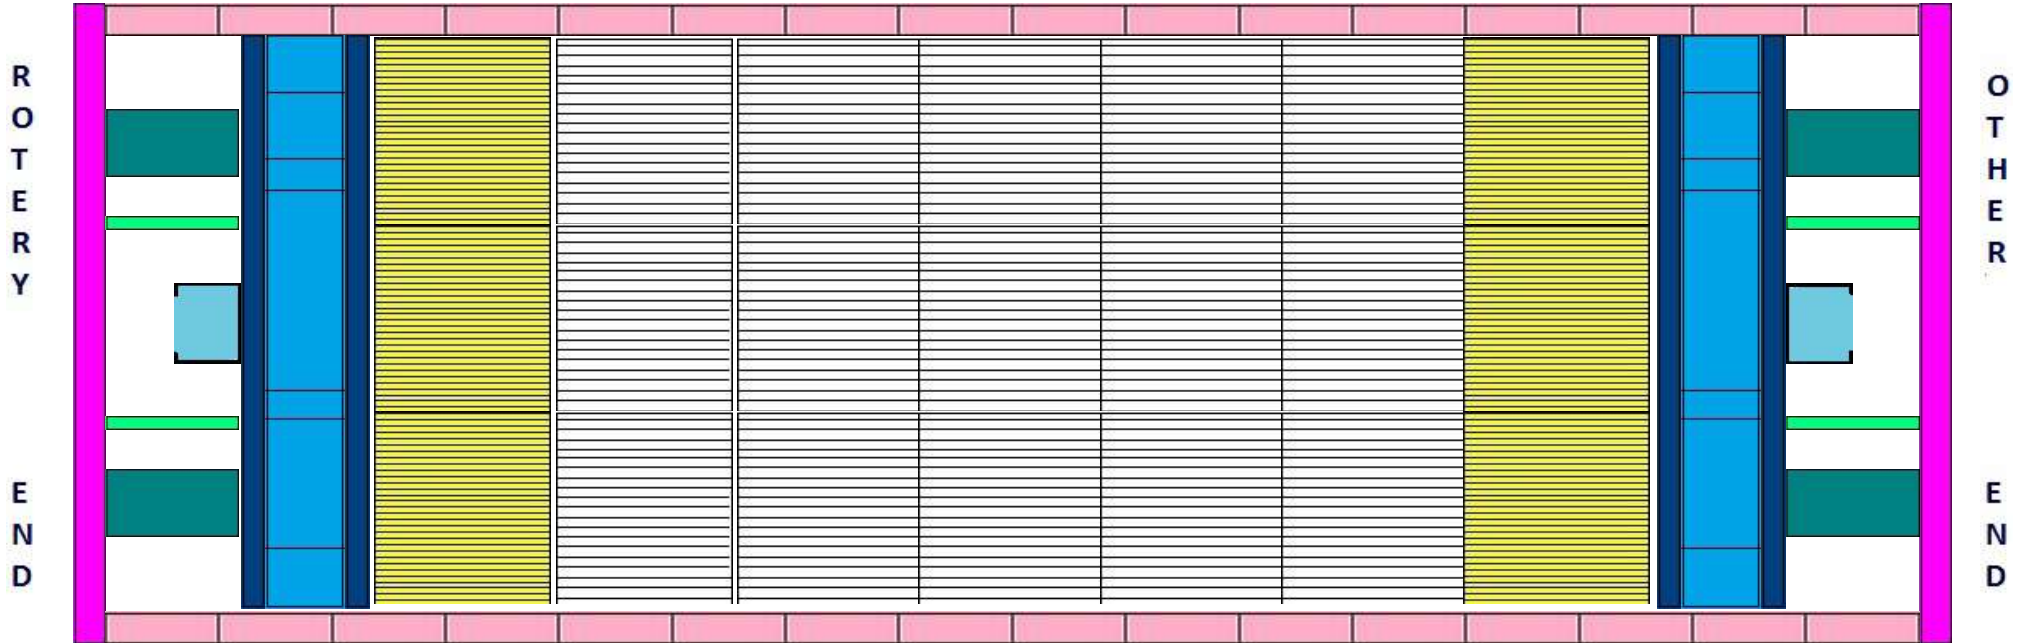
Color	Particulars	Qty	Per%	Color	Particulars	Qty	Per%	Color	Particulars	Qty	Per%
Yellow	Headstock Beam	2	100%	Dark Green	Centre Stiffner for Headstock	4	100%	Light Green	Floor Stiffner for Headstock	4	100%
Dark Blue	Aux. Head stock	4	100%	Pink	Sole Bar	16	100%	Light Blue	Draft Gear Bracket	2	100%
Yellow	Trough floor	2	29%	Light Blue	Centre plate	2	100%		SoleBar Stiffner	4	100%
	Bottom Wall Part	16	100%		Body panel/patch		100%		Door Top/Roof Patch		0%
	Window Module		0%		Window Sill	40	100%		Window Bar	48	27%
	Seat pillar/lav. Partition		100%		UIC end construction		0%

End Drooping: Rotary End - EAST : -8, WEST : -8 Other End - EAST : -6, WEST : -3
Start Date : 08-Jun-2019, Completion Date : 18-Jun-2019, Net Repair Days : 9, Total Man Hours : 1348

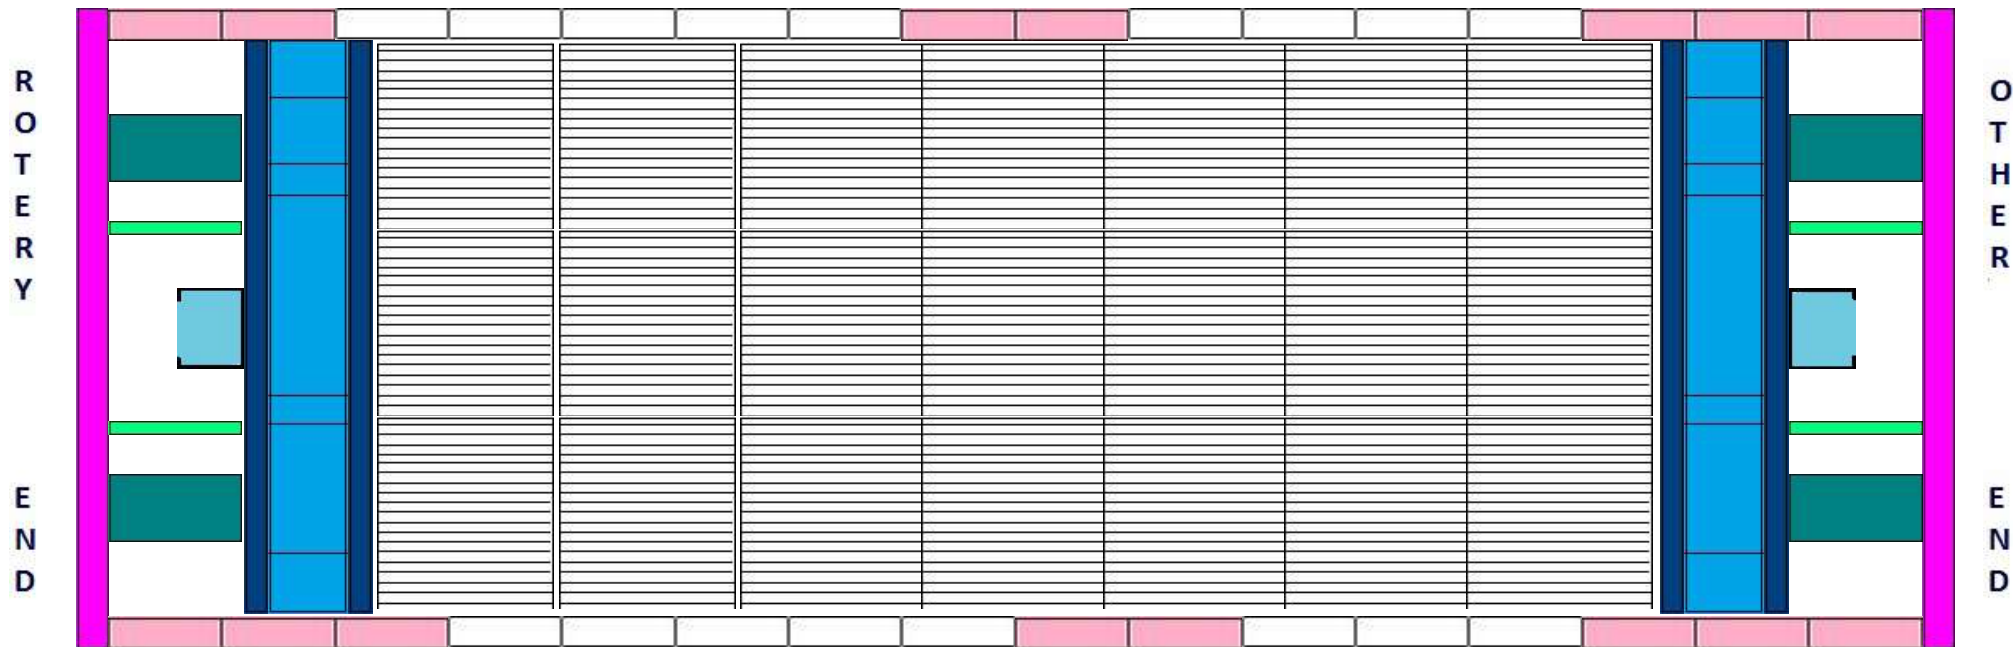
Color	Particulars	Qty	Per%	Color	Particulars	Qty	Per%	Color	Particulars	Qty	Per%
	Headstock Beam	2	100%		Centre Stiffner for Headstock	4	100%		Floor Stiffner for Headstock	4	100%
	Aux. Head stock	4	100%		Sole Bar	7.5	47%		Draft Gear Bracket	2	100%
	Trough floor	0	0%		Centre plate	2	100%		SoleBar Stiffner	6	100%
	Bottom Wall Part	7.5	47%		Body panel/patch		100%		Door Top/Roof Patch		0%
	Window Module		0%		Window Sill	28	70%		Window Bar	44	25%
	Seat pillar/lav. Partition		100%		UIC end construction		0%

End Drooping: Rotary End - EAST : 8, WEST : 10 Other End - EAST : 0, WEST : 10
Start Date : 21-Jun-2019, Completion Date : 29-Jun-2019, Net Repair Days : 8, Total Man Hours : 1096

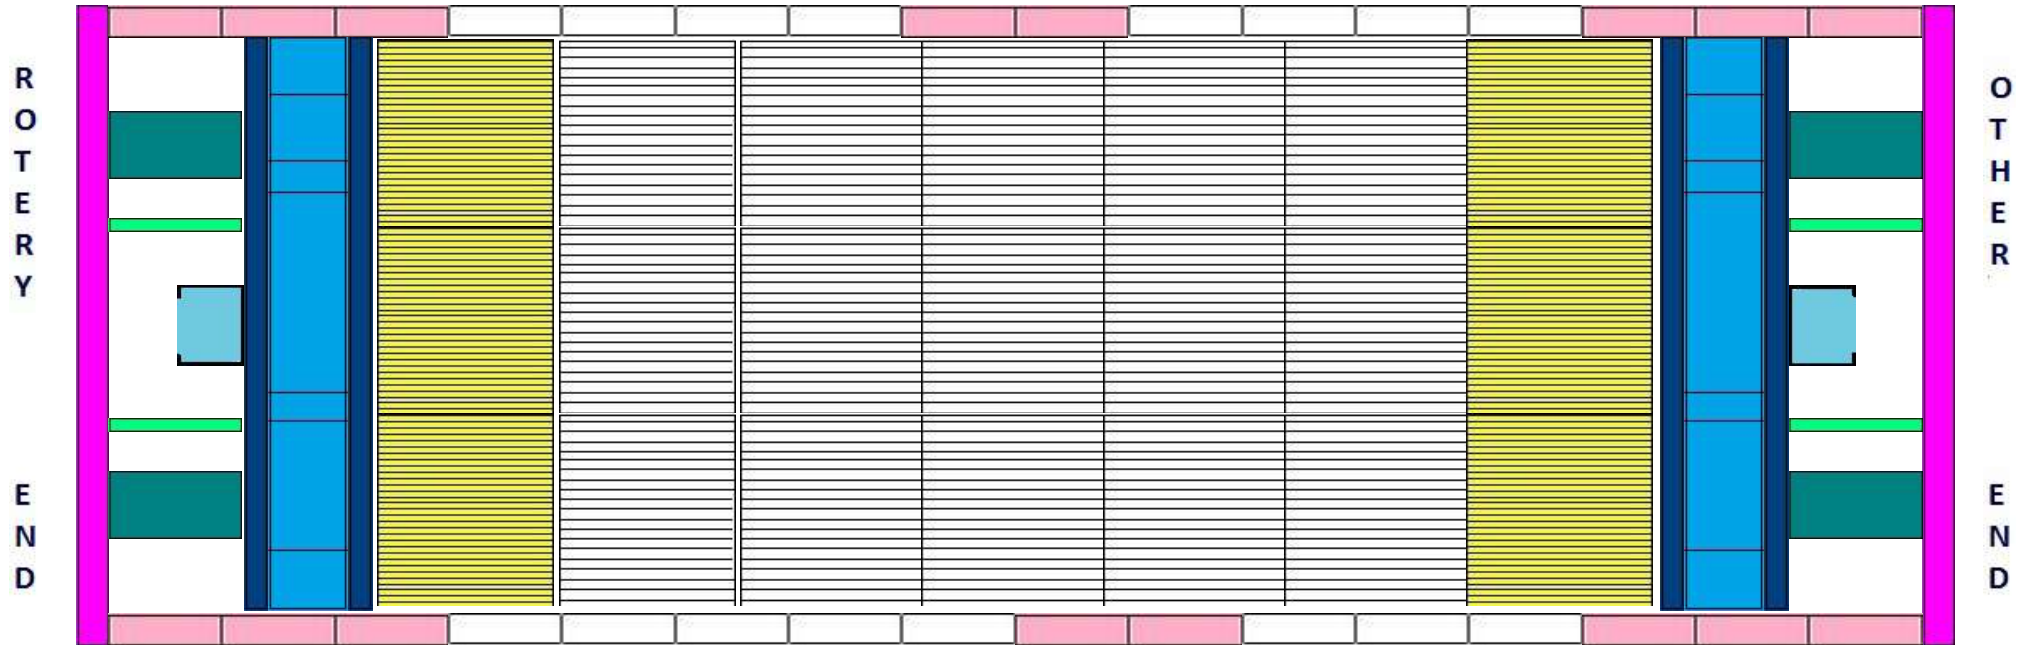
Color	Particulars	Qty	Per%	Color	Particulars	Qty	Per%	Color	Particulars	Qty	Per%
	Headstock Beam	2	100%		Centre Stiffner for Headstock	4	100%		Floor Stiffner for Headstock	4	100%
	Aux. Head stock	4	100%		Sole Bar	8	50%		Draft Gear Bracket	2	100%
	Trough floor	2	29%		Centre plate	2	100%		SoleBar Stiffner	6	100%
	Bottom Wall Part	8	50%		Body panel/patch		100%		Door Top/Roof Patch		0%
	Window Module		0%		Window Sill	40	22%		Window Bar	44	25%
	Seat pillar/lav. Partition		100%		UIC end construction		0%

End Drooping: Rotary End - EAST : 3, WEST : 10 Other End - EAST : 8, WEST : 10
Start Date : 03-Aug-2019, Completion Date : 10-Aug-2019, Net Repair Days : 7, Total Man Hours : 1304

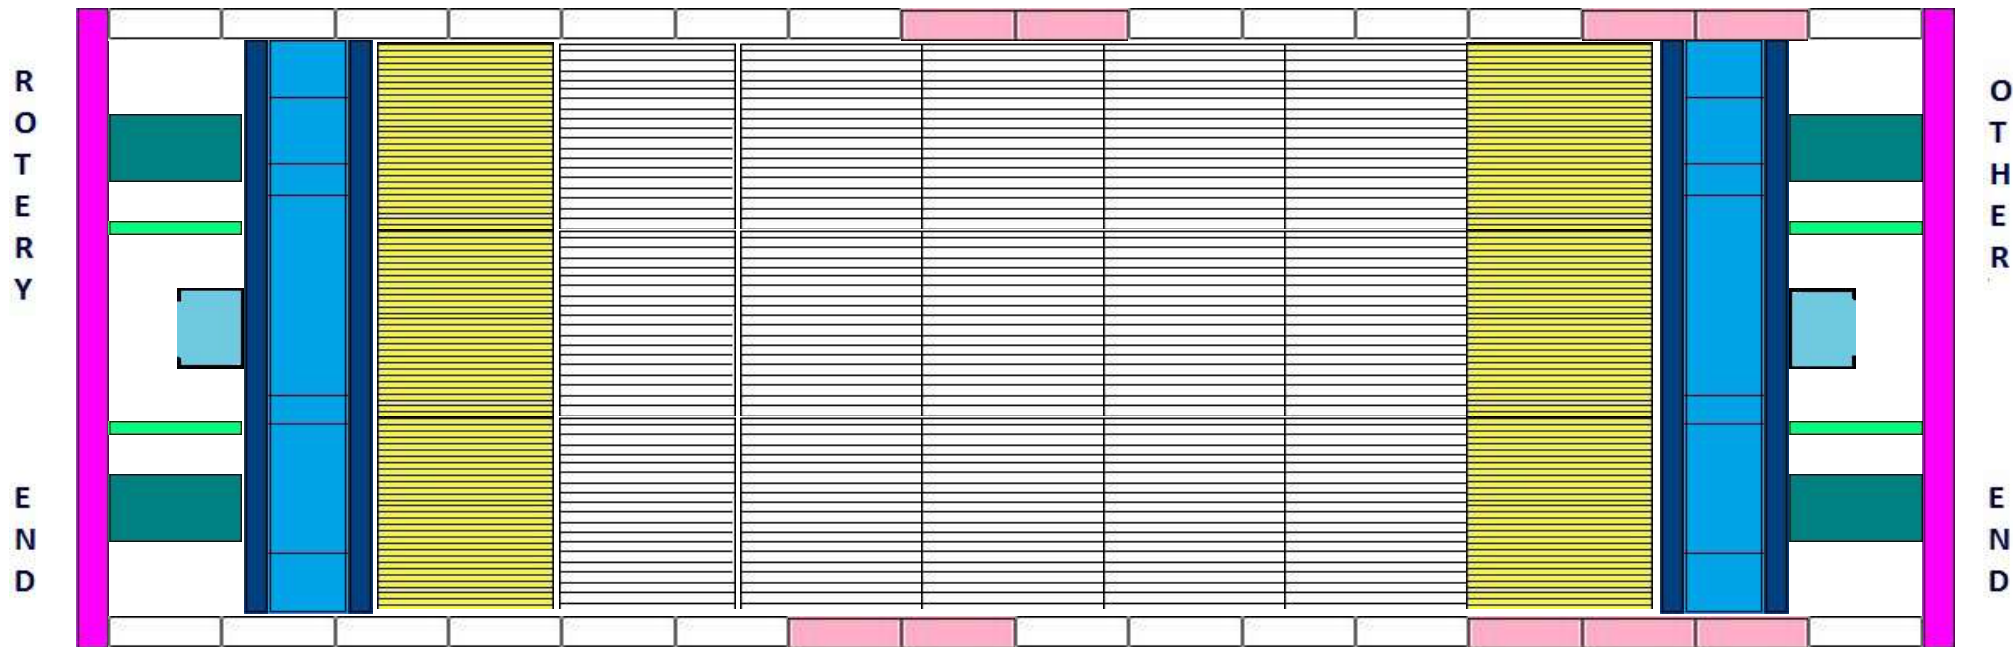
Color	Particulars	Qty	Per%	Color	Particulars	Qty	Per%	Color	Particulars	Qty	Per%
Pink	Headstock Beam	2	100%	Dark Green	Centre Stiffner for Headstock	4	100%	Light Green	Floor Stiffner for Headstock	4	100%
Dark Blue	Aux. Head stock	4	100%	Pink	Sole Bar	4.5	28%	Blue	Draft Gear Bracket	2	100%
Yellow	Trough floor	2	29%	Light Blue	Centre plate	2	100%		SoleBar Stiffner	6	100%
	Bottom Wall Part	4.5	28%		Body panel/patch		100%		Door Top/Roof Patch		0%
	Window Module		0%		Window Sill	28	70%		Window Bar	46	26%
	Seat pillar/lav. Partition		100%		UIC end construction		0%

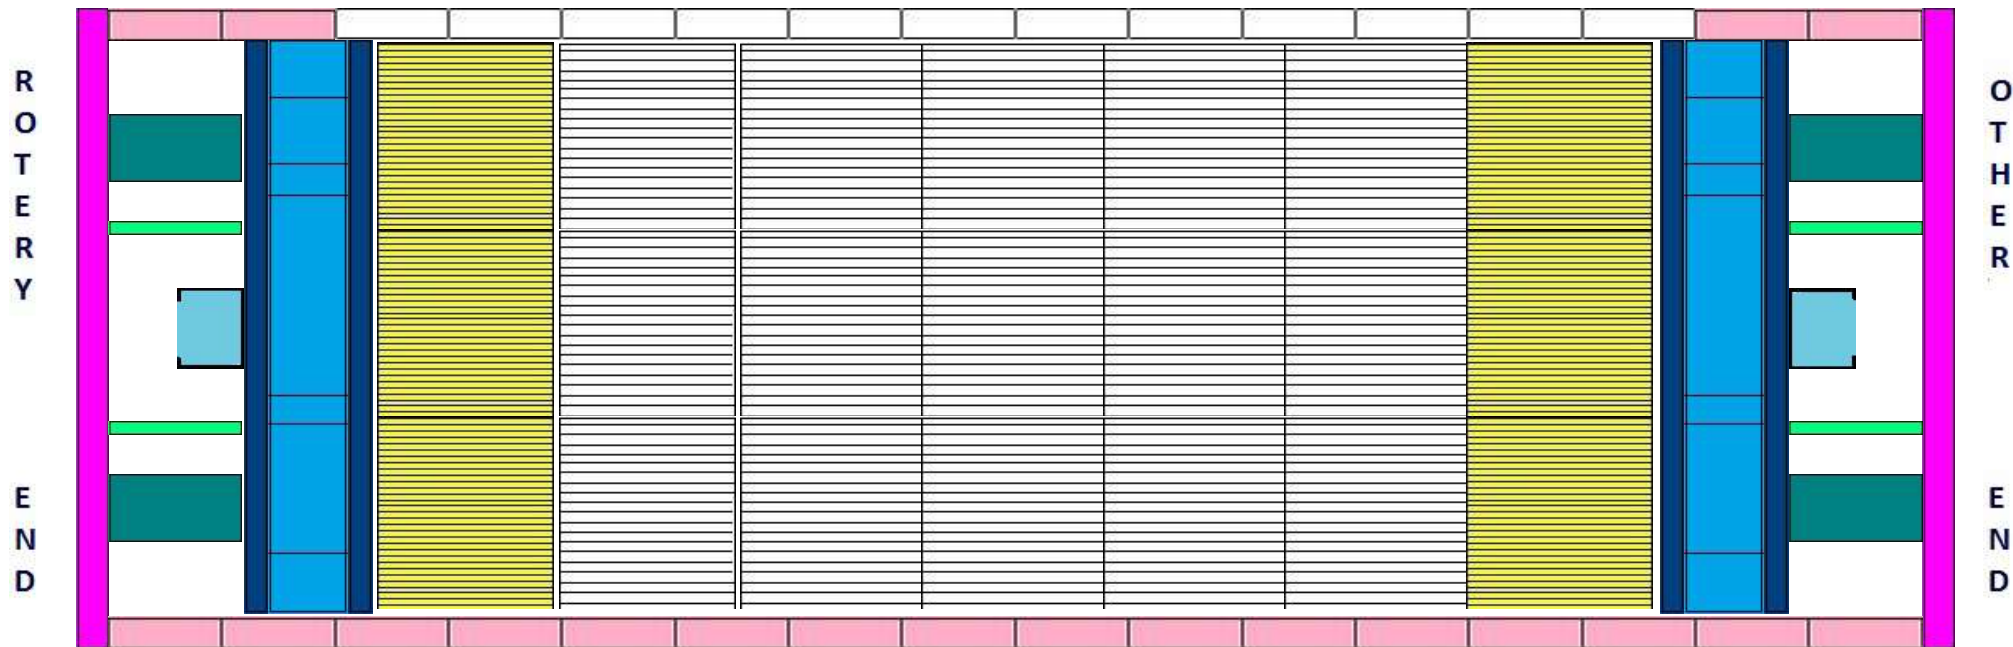
Color	Particulars	Qty	Per%	Color	Particulars	Qty	Per%	Color	Particulars	Qty	Per%
Yellow	Headstock Beam	2	100%	Dark Green	Centre Stiffner for Headstock	4	100%	Light Green	Floor Stiffner for Headstock	4	100%
Dark Blue	Aux. Head stock	4	100%	Pink	Sole Bar	10	63%	Light Blue	Draft Gear Bracket	2	100%
Yellow	Trough floor	2	29%	Light Blue	Centre plate	2	100%		SoleBar Stiffner	4	100%
	Bottom Wall Part	10	63%		Body panel/patch		100%		Door Top/Roof Patch		0%
	Window Module		0%		Window Sill	18	45%		Window Bar	38	21%
	Seat pillar/lav. Partition		100%		UIC end construction		0%

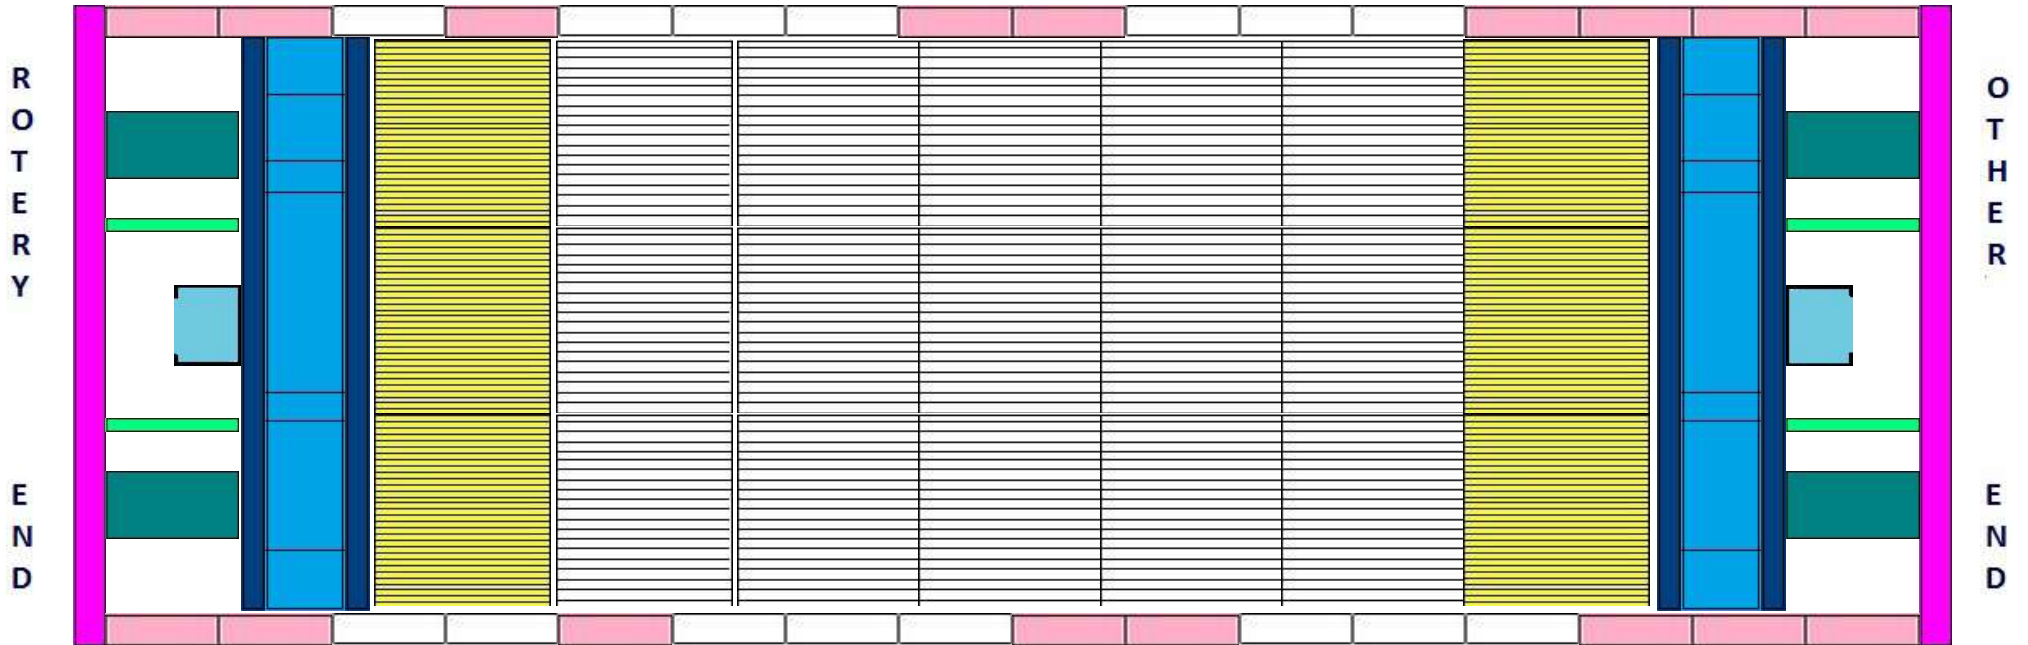
Color	Particulars	Qty	Per%	Color	Particulars	Qty	Per%	Color	Particulars	Qty	Per%
	Headstock Beam	2	100%		Centre Stiffner for Headstock	4	100%		Floor Stiffner for Headstock	4	100%
	Aux. Head stock	4	100%		Sole Bar	8.5	53%		Draft Gear Bracket	2	100%
	Trough floor	2	29%		Centre plate	2	100%		SoleBar Stiffner	6	100%
	Bottom Wall Part	8.5	53%		Body panel/patch		100%		Door Top/Roof Patch		0%
	Window Module		0%		Window Sill	28	70%		Window Bar	38	21%
	Seat pillar/lav. Partition		100%		UIC end construction		0%

End Drooping: Rotary End - EAST : 0, WEST : 3 Other End - EAST : 3, WEST : -4
Start Date : 31-Jul-2019, Completion Date : 07-Aug-2019, Net Repair Days : 7, Total Man Hours : 0

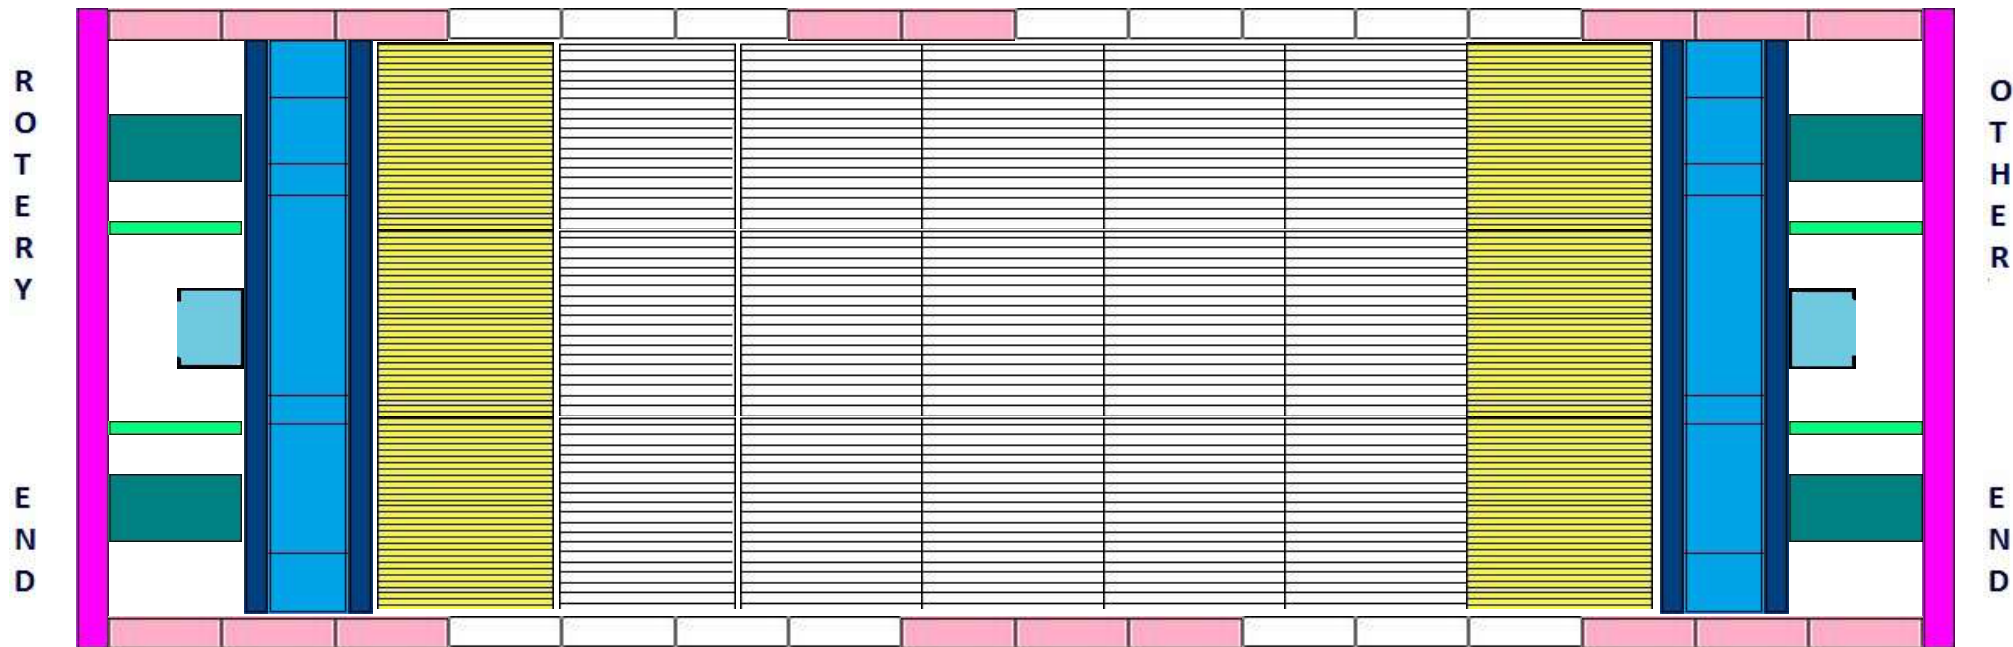
Color	Particulars	Qty	Per%	Color	Particulars	Qty	Per%	Color	Particulars	Qty	Per%
	Headstock Beam	2	100%		Centre Stiffner for Headstock	4	100%		Floor Stiffner for Headstock	4	100%
	Aux. Head stock	4	100%		Sole Bar	8.5	53%		Draft Gear Bracket	2	100%
	Trough floor	2	29%		Centre plate	2	100%		SoleBar Stiffner	4	100%
	Bottom Wall Part	8.5	53%		Body panel/patch		100%		Door Top/Roof Patch		0%
	Window Module		0%		Window Sill	30	75%		Window Bar	44	24%
	Seat pillar/lav. Partition		100%		UIC end construction		0%
