Coach Rehabilitation Workshop, WC Railway, Bhopal

(An IMS and ISO 50001 Certified Workshop)
Final Inspection Sheet - Details of Corrosion Repair

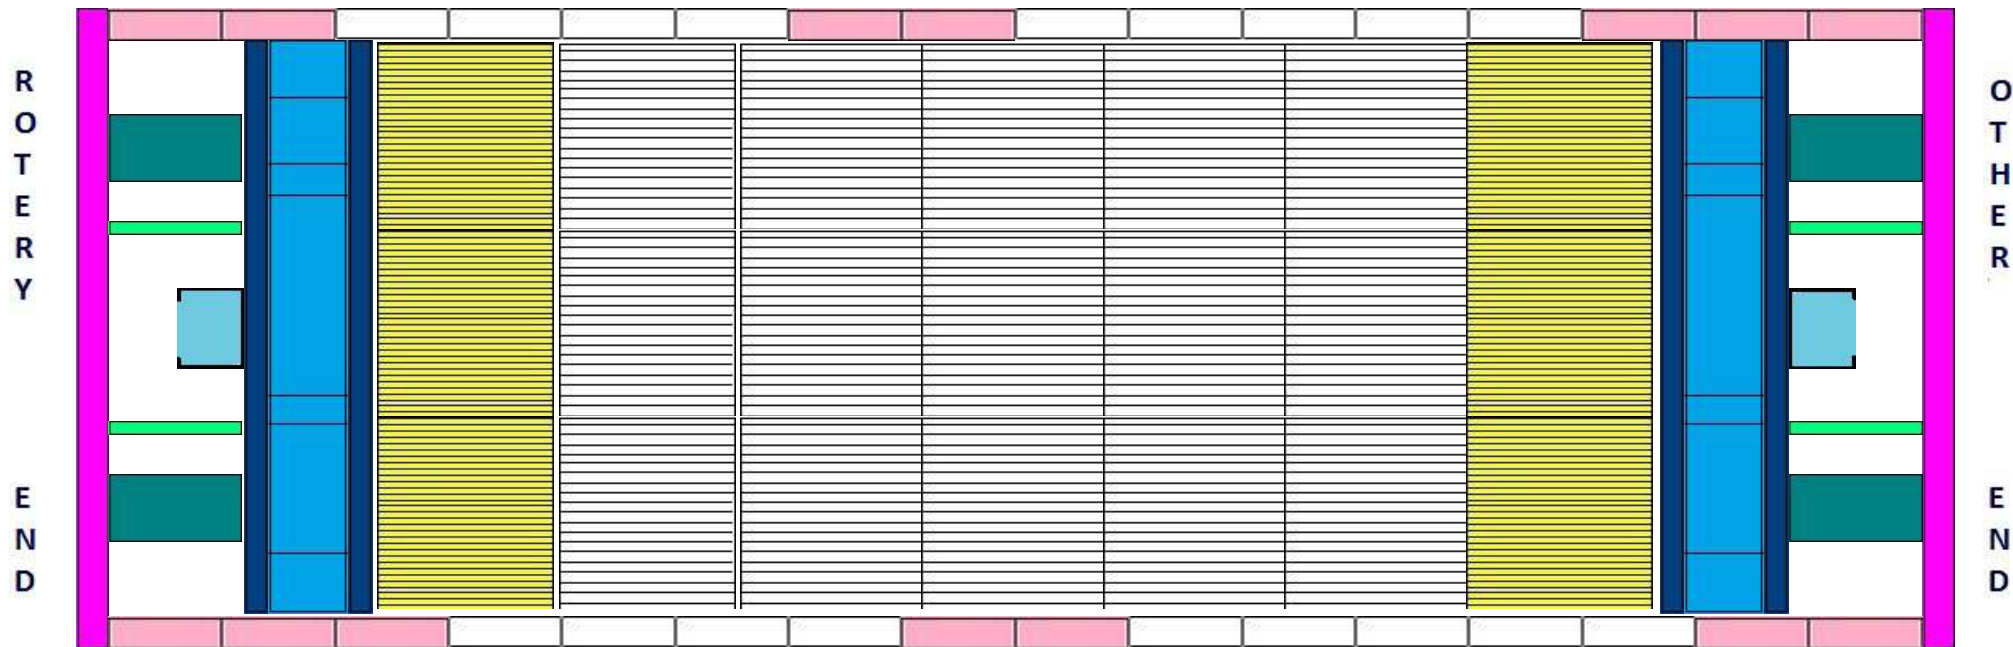
Color	Particulars	Qty	Per%	Color	Particulars	Qty	Per%	Color	Particulars	Qty	Per%
	Headstock Beam	2	100%		Centre Stiffner for Headstock	4	100%		Floor Stiffner for Headstock	4	100%
	Aux. Head stock	4	100%		Sole Bar	7	44%		Draft Gear Bracket	2	100%
	Trough floor	2	29%		Centre plate	2	100%		SoleBar Stiffner	6	100%
	Bottom Wall Part	7	44%		Body panel/patch		100%		Door Top/Roof Patch		0%
	Window Module		0%		Window Sill	40	100%		Window Bar	44	25%
	Seat pillar/lav. Partition		100%		UIC end construction		0%

End Drooping: Rotary End - EAST : 4, WEST : 3 Other End - EAST : 0, WEST : -3
Start Date : 01-Aug-2019, Completion Date : 08-Aug-2019, Net Repair Days : 7, Total Man Hours : 1328

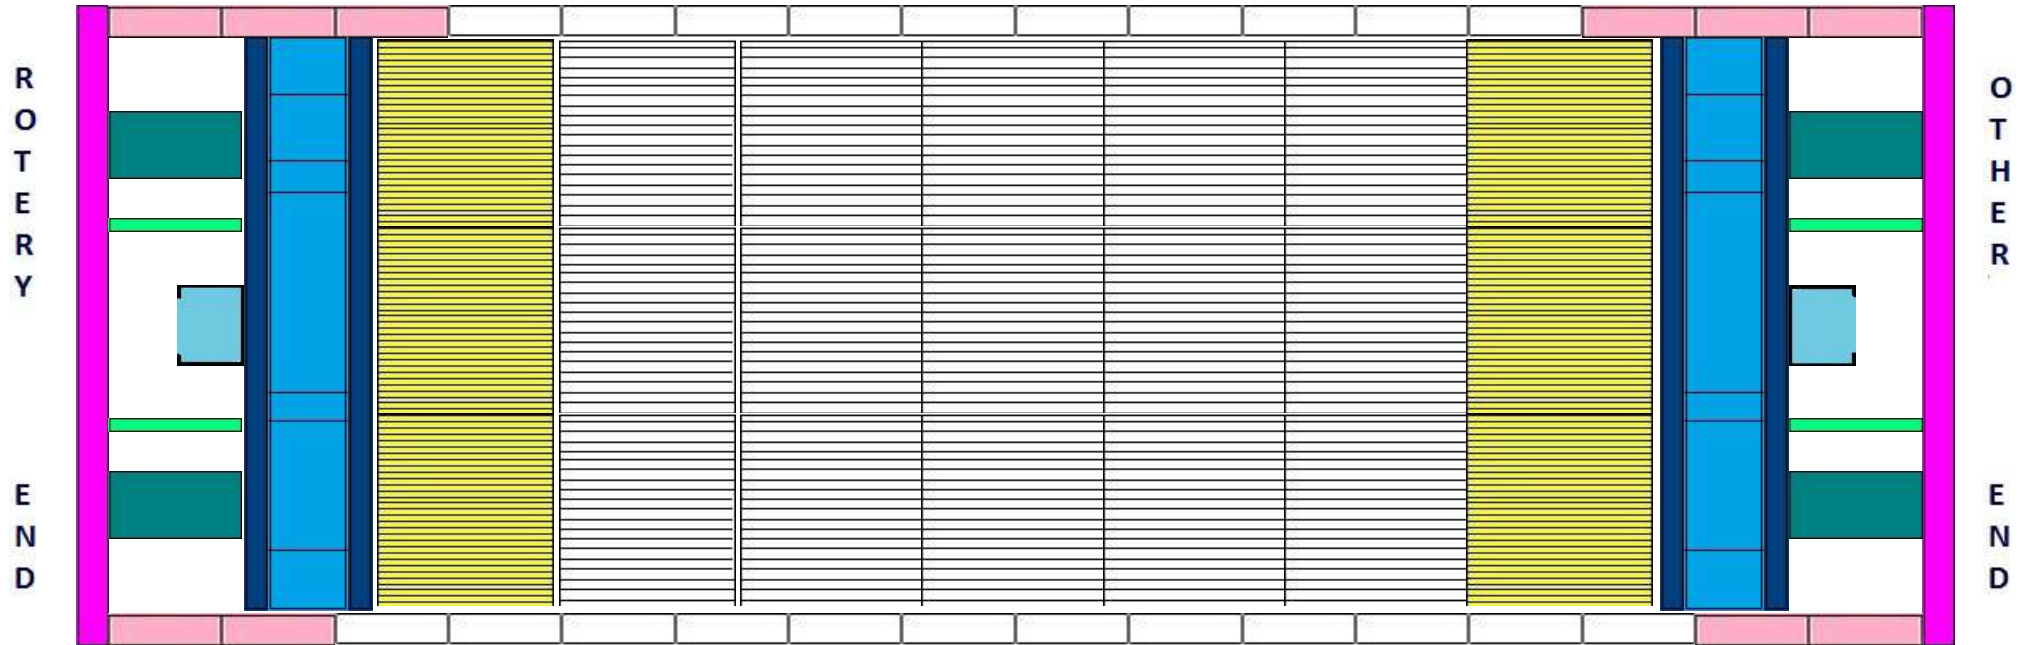
Color	Particulars	Qty	Per%	Color	Particulars	Qty	Per%	Color	Particulars	Qty	Per%
Pink	Headstock Beam	2	100%	Dark Blue	Centre Stiffner for Headstock	4	100%	Green	Floor Stiffner for Headstock	4	100%
Dark Blue	Aux. Head stock	4	100%	Pink	Sole Bar	5	31%	Light Blue	Draft Gear Bracket	2	100%
Yellow	Trough floor	2	29%	Light Blue	Centre plate	2	100%		SoleBar Stiffner	4	100%
	Bottom Wall Part	5	31%		Body panel/patch		100%		Door Top/Roof Patch		0%
	Window Module		4%		Window Sill	0	0%		Window Bar	0	0%
	Seat pillar/lav. Partition		100%		UIC end construction		0%

End Drooping: Rotary End - EAST : 6, WEST : 2 Other End - EAST : -6, WEST : 3
Start Date : 24-Aug-2019, Completion Date : 03-Sep-2019, Net Repair Days : 9, Total Man Hours : 1224

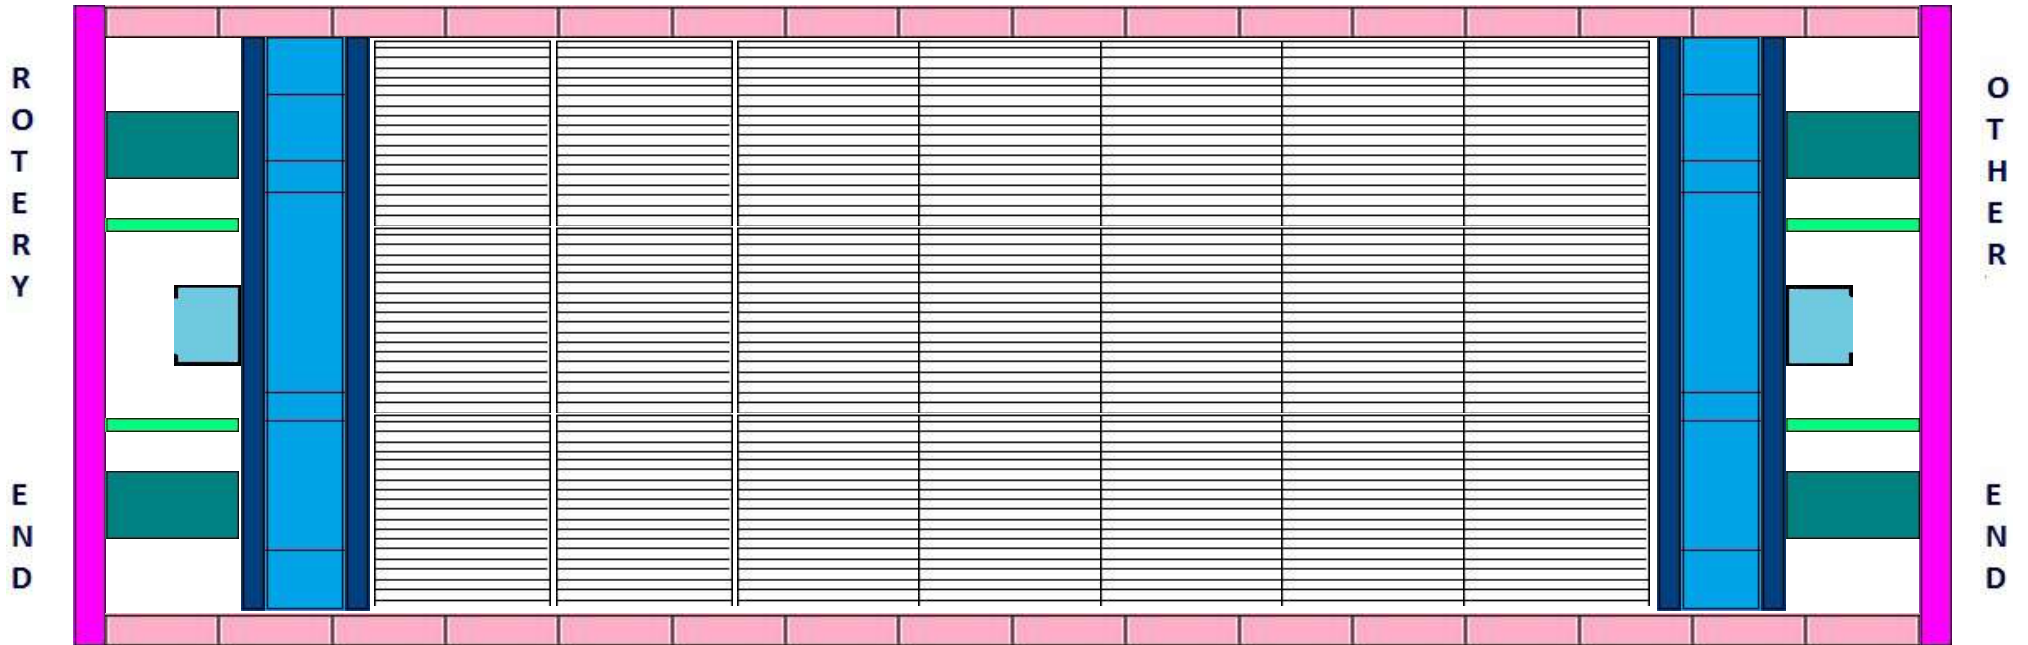
Color	Particulars	Qty	Per%	Color	Particulars	Qty	Per%	Color	Particulars	Qty	Per%
Yellow	Headstock Beam	2	100%	Dark Green	Centre Stiffner for Headstock	4	100%	Light Green	Floor Stiffner for Headstock	4	100%
Dark Blue	Aux. Head stock	4	100%	Pink	Sole Bar	16	100%	Light Blue	Draft Gear Bracket	2	100%
Yellow	Trough floor	0	0%	Light Blue	Centre plate	2	100%		SoleBar Stiffner	4	100%
	Bottom Wall Part	16	100%		Body panel/patch		100%		Door Top/Roof Patch		0%
	Window Module		0%		Window Sill	7	18%		Window Bar	40	22%
	Seat pillar/lav. Partition		100%		UIC end construction		0%

End Drooping: Rotary End - EAST : 7, WEST : 3 Other End - EAST : 3, WEST : -4
Start Date : 03-Aug-2019, Completion Date : 10-Aug-2019, Net Repair Days : 7, Total Man Hours : 1672
