Coach Rehabilitation Workshop, WC Railway, Bhopal

(An IMS and ISO 50001 Certified Workshop)
Final Inspection Sheet - Details of Corrosion Repair

Coach No. :WR017041

Type : GSLRD

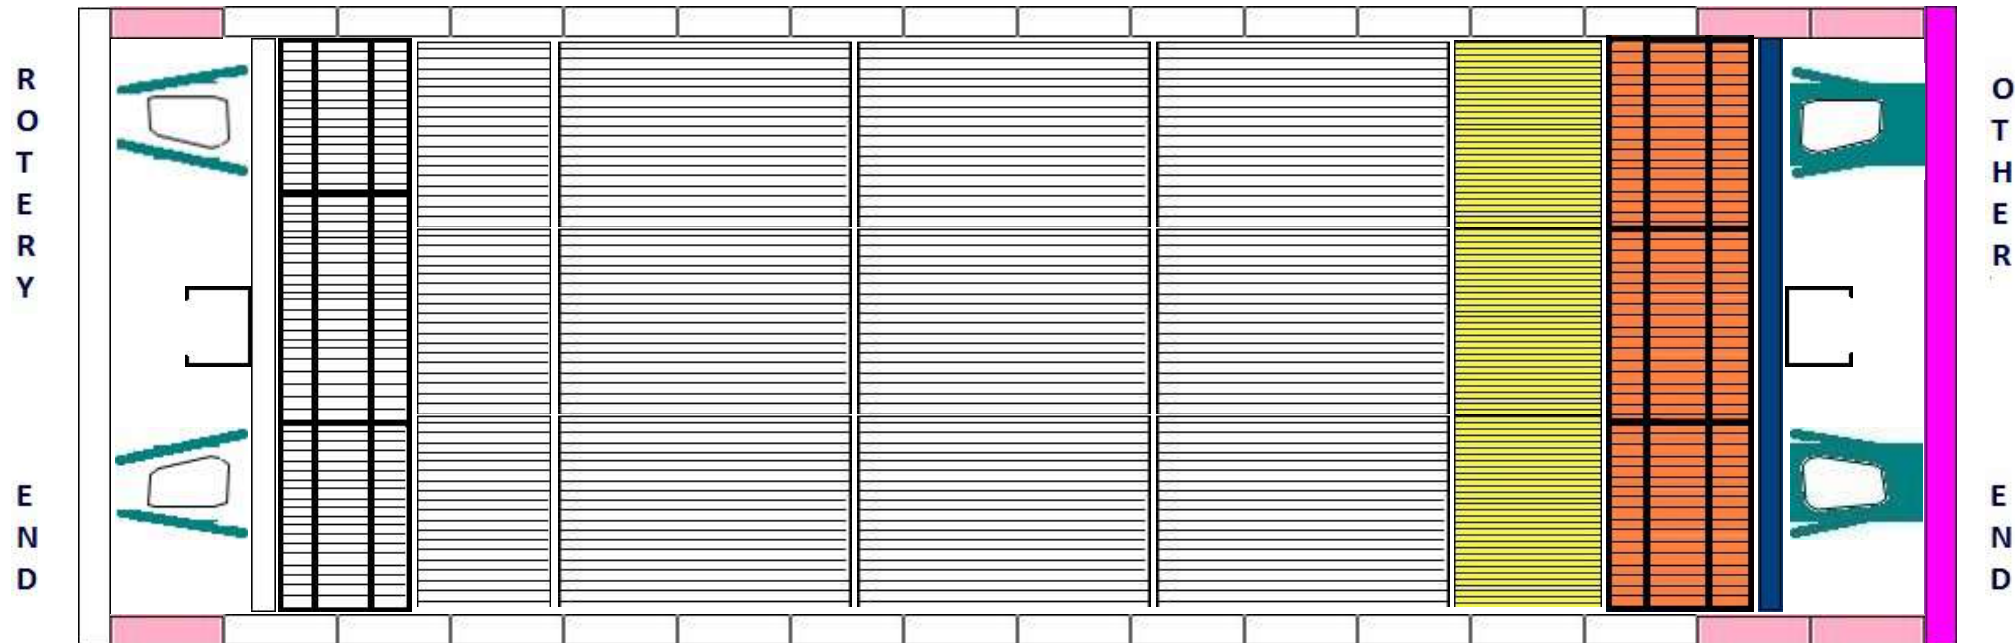
Rotary Side

Color	Particulars	Qty	Per%	Color	Particulars	Qty	Per%	Color	Particulars	Qty	Per%
	Headstock Beam	1	50%		Diagonal	4	100%		Logitudinal Channel Structure	1	50%
	Aux. Head stock	1	50%		Sole Bar	3	19%		Draft Gear Bracket	1	50%
	Trough floor	1	20%		Bottom Wall Part	3	19%		Body panel/patch		100%
	Door Top/Roof Patch		0%		Seat Bracket Rail		0%		Window Sill	7	18%
	Window Bar	14	8%		Seat pillar/lav. Partition		100%		UIC end construction		0%
	Body Pillar Part	17	100%

End Drooping: Rotary End - EAST : 0, WEST : 0 Other End - EAST : -7, WEST : -5
Start Date : 16-Oct-2019, Completion Date : 22-Oct-2019, Net Repair Days : 6, Total Man Hours : 932

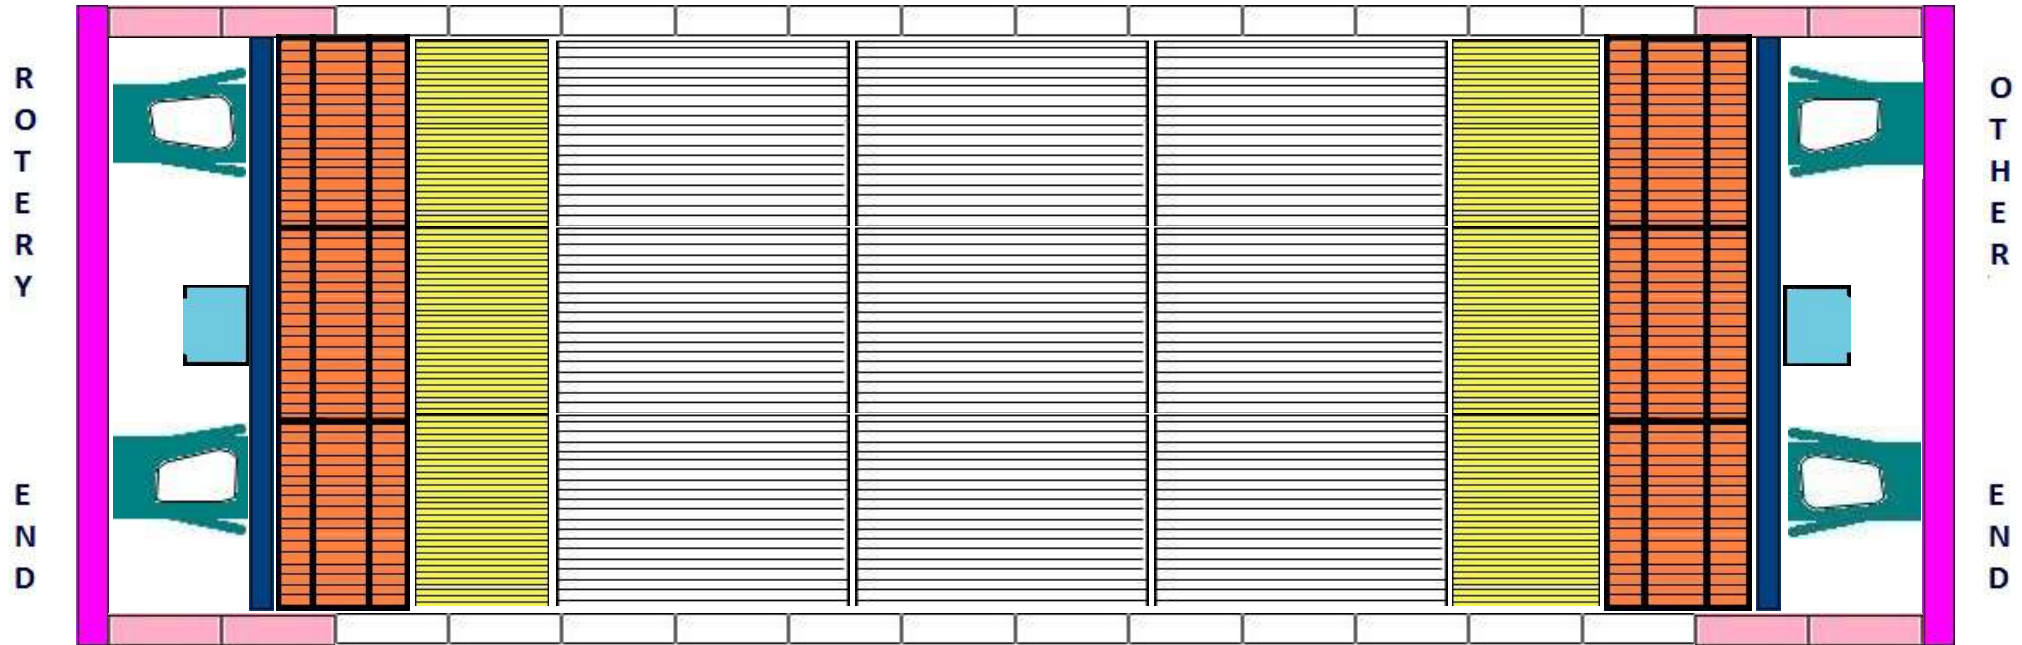
Rotary Side

Color	Particulars	Qty	Per%	Color	Particulars	Qty	Per%	Color	Particulars	Qty	Per%
	Headstock Beam	2	100%		Diagonal	4	100%		Logitudinal Channel Structure	2	100%
	Aux. Head stock	2	100%		Sole Bar	4	25%		Draft Gear Bracket	2	100%
	Trough floor	2	40%		Bottom Wall Part	4	25%		Body panel/patch		100%
	Door Top/Roof Patch		0%		Seat Bracket Rail		0%		Window Sill	7	18%
	Window Bar	30	16%		Seat pillar/lav. Partition		100%		UIC end construction		0%
	Body Pillar Part	22	100%

End Drooping: Rotary End - EAST : 0, WEST : 0 Other End - EAST : 0, WEST : 0
Start Date : 07-Nov-2019, Completion Date : 16-Nov-2019, Net Repair Days : 9, Total Man Hours : 912

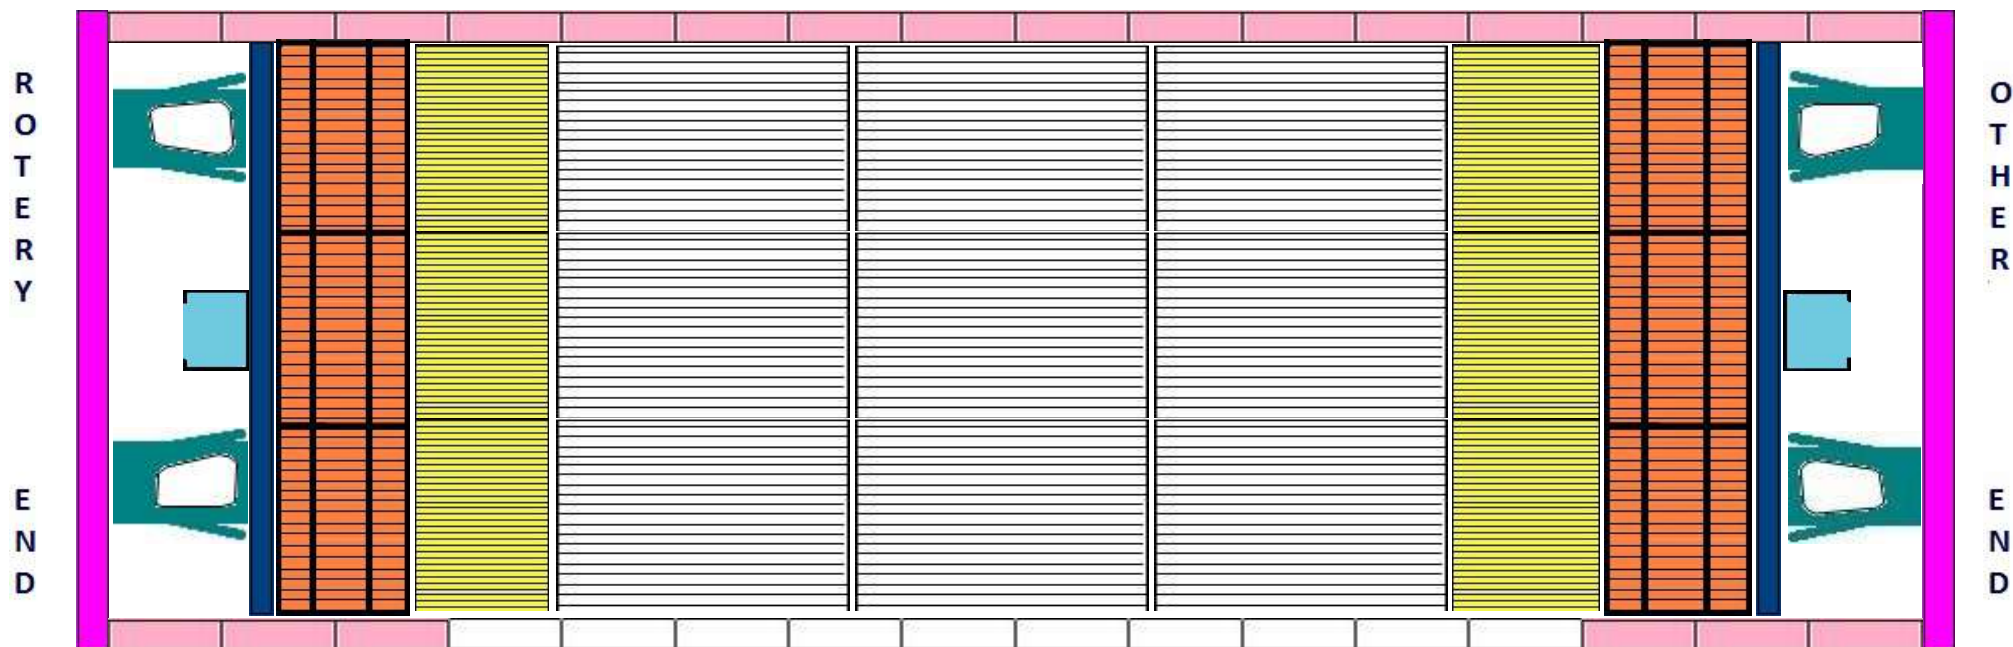
Rotary Side

Color	Particulars	Qty	Per%	Color	Particulars	Qty	Per%	Color	Particulars	Qty	Per%
	Headstock Beam	2	100%		Diagonal	4	100%		Logitudinal Channel Structure	2	100%
	Aux. Head stock	2	100%		Sole Bar	11	69%		Draft Gear Bracket	2	100%
	Trough floor	2	40%		Bottom Wall Part	11	69%		Body panel/patch		100%
	Door Top/Roof Patch		0%		Seat Bracket Rail		0%		Window Sill	7	18%
	Window Bar	26	14%		Seat pillar/lav. Partition		100%		UIC end construction		0%
	Body Pillar Part	61	100%

Start Date : 18-Nov-2019, Completion Date : 25-Nov-2019, Net Repair Days : 7, Total Man Hours : 1348

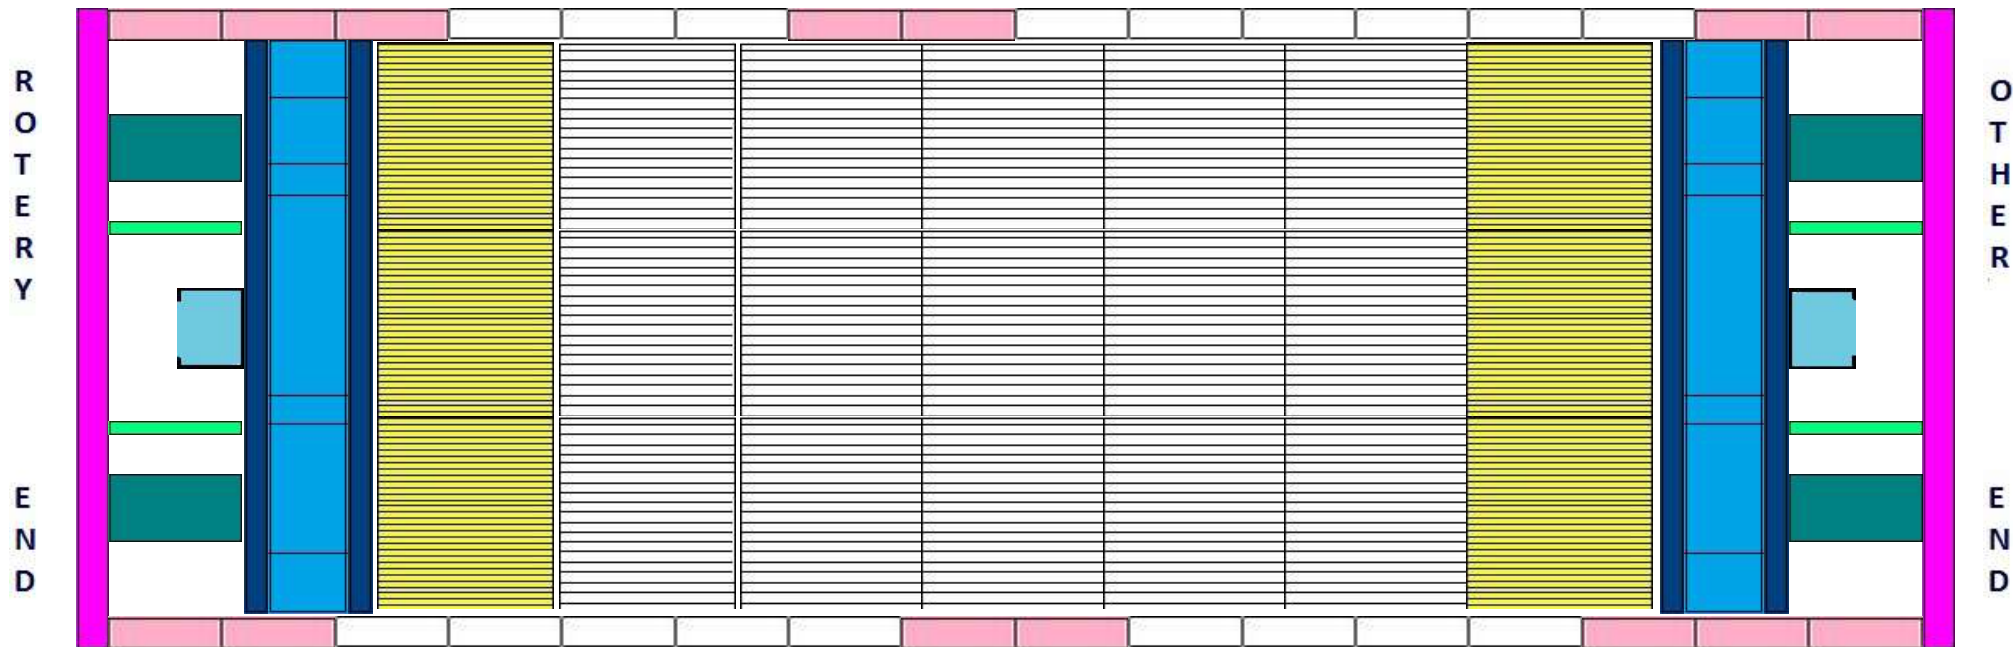
Rotary Side

Color	Particulars	Qty	Per%	Color	Particulars	Qty	Per%	Color	Particulars	Qty	Per%
	Headstock Beam	2	100%		Centre Stiffner for Headstock	4	100%		Floor Stiffner for Headstock	4	100%
	Aux. Head stock	4	100%		Sole Bar	7	44%		Draft Gear Bracket	2	100%
	Trough floor	2	29%		Centre plate	2	100%		SoleBar Stiffner	6	100%
	Bottom Wall Part	7	44%		Body panel/patch		100%		Door Top/Roof Patch		0%
	Window Module		0%		Window Sill	40	100%		Window Bar	50	28%
	Seat pillar/lav. Partition		100%		UIC end construction		0%

End Drooping: Rotary End - EAST : -3, WEST : -6 Other End - EAST : 0, WEST : 0
Start Date : 09-Dec-2019, Completion Date : 19-Dec-2019, Net Repair Days : 10, Total Man Hours : 1632

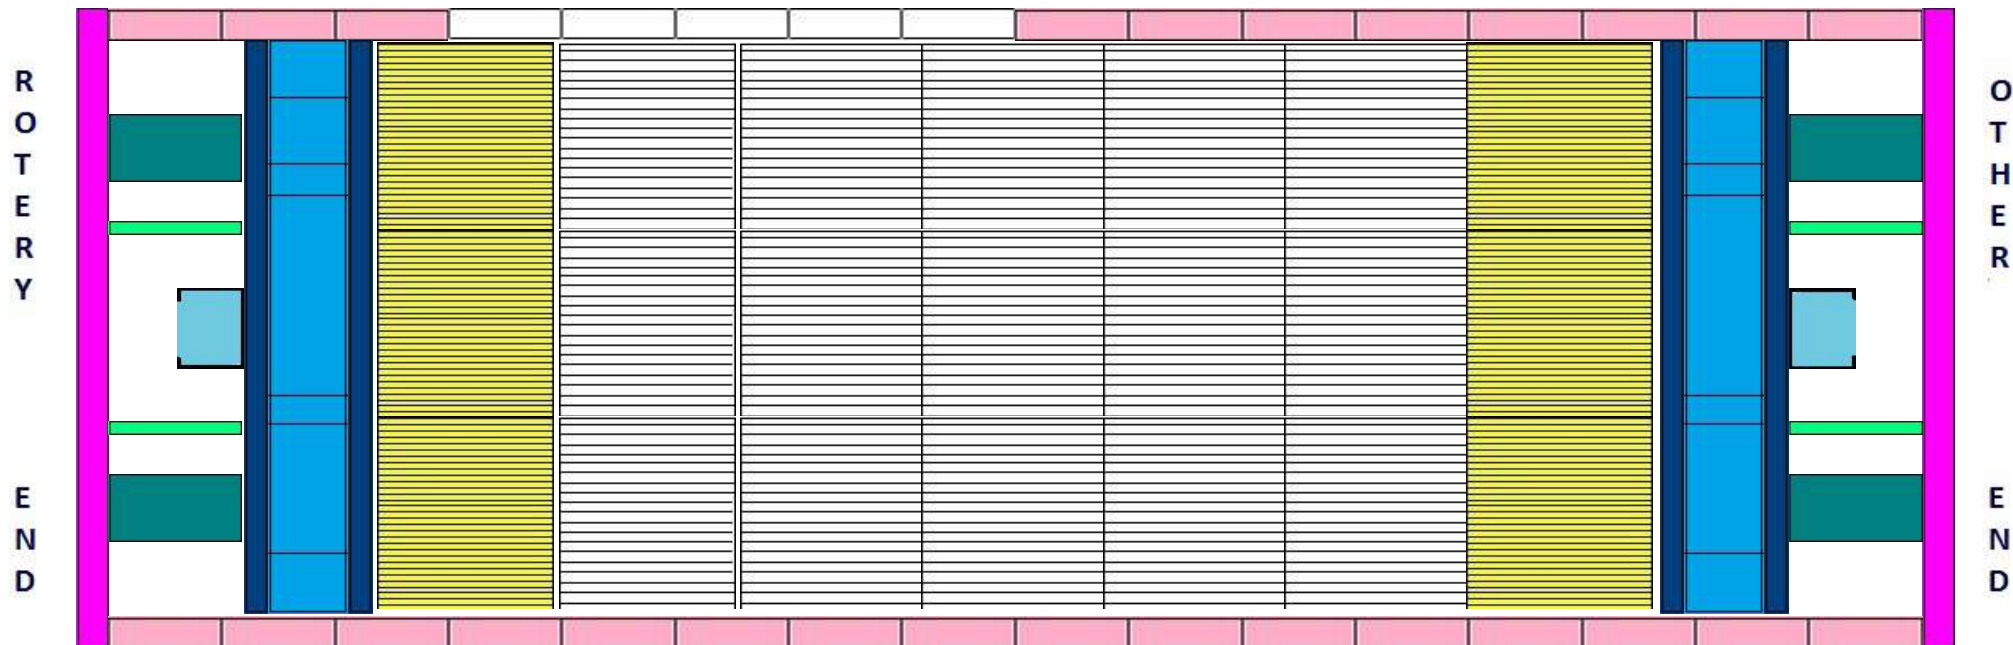
Rotary Side

Color	Particulars	Qty	Per%	Color	Particulars	Qty	Per%	Color	Particulars	Qty	Per%
Yellow	Headstock Beam	2	100%	Dark Green	Centre Stiffner for Headstock	4	100%	Light Green	Floor Stiffner for Headstock	4	100%
Dark Blue	Aux. Head stock	4	100%	Pink	Sole Bar	13.5	84%	Light Blue	Draft Gear Bracket	2	100%
Yellow	Trough floor	2	29%	Light Blue	Centre plate	2	100%		SoleBar Stiffner	4	100%
	Bottom Wall Part	13.5	84%		Body panel/patch		100%		Door Top/Roof Patch		0%
	Window Module		0%		Window Sill	40	100%		Window Bar	48	27%
	Seat pillar/lav. Partition		100%		UIC end construction		0%

Start Date : 13-Dec-2019, Completion Date : 19-Dec-2019, Net Repair Days : 6, Total Man Hours : 1956

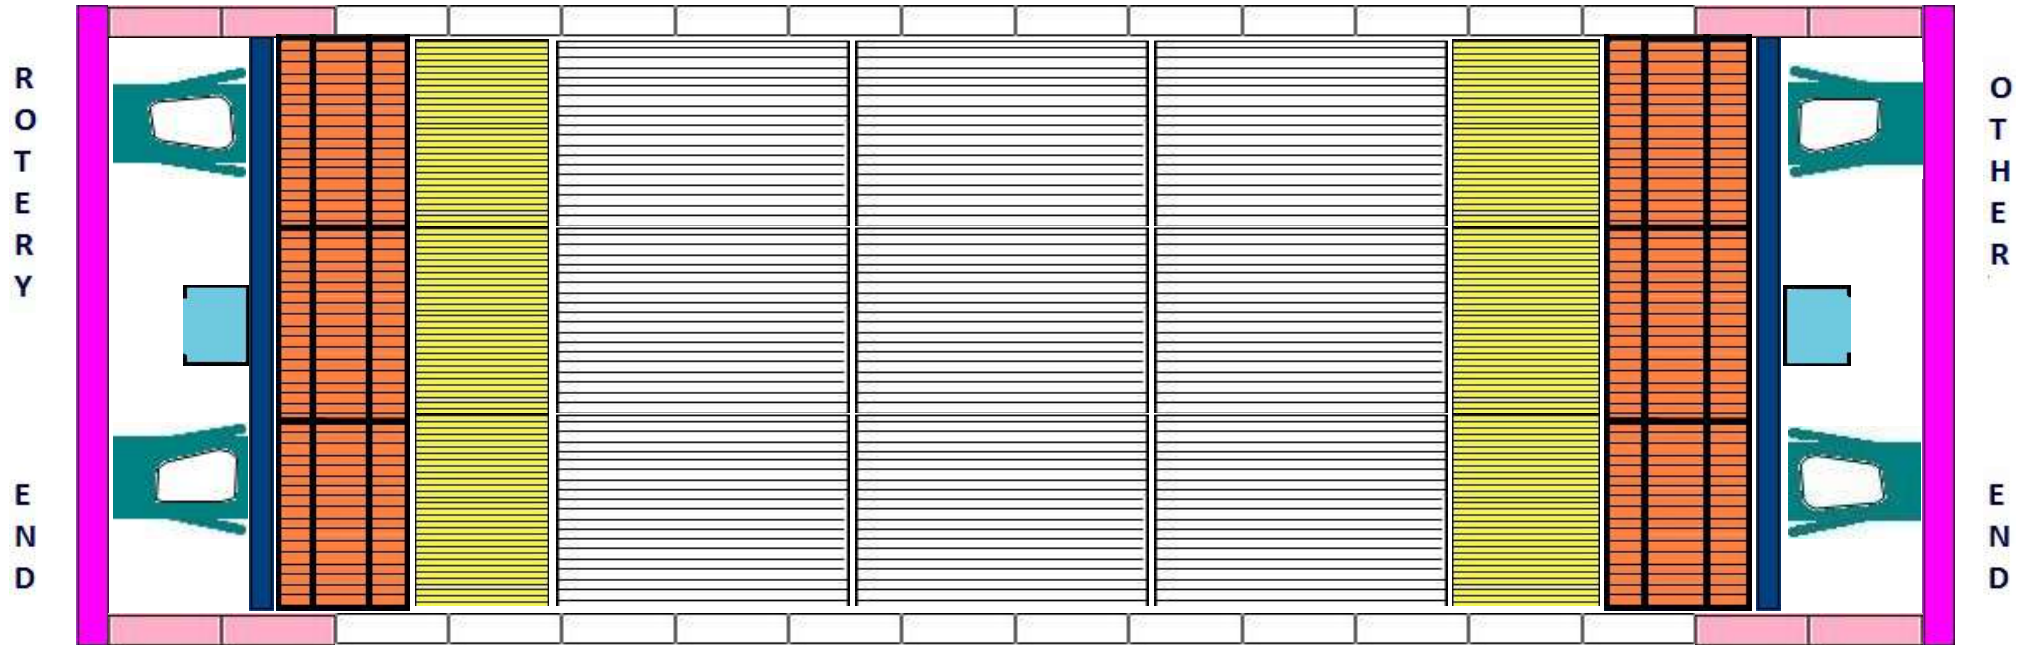
Rotary Side

Color	Particulars	Qty	Per%	Color	Particulars	Qty	Per%	Color	Particulars	Qty	Per%
	Headstock Beam	2	100%		Diagonal	4	100%		Logitudinal Channel Structure	2	100%
	Aux. Head stock	2	100%		Sole Bar	4	25%		Draft Gear Bracket	2	100%
	Trough floor	2	40%		Bottom Wall Part	4	25%		Body panel/patch		100%
	Door Top/Roof Patch		0%		Seat Bracket Rail		0%		Window Sill	0	0%
	Window Bar	32	17%		Seat pillar/lav. Partition		100%		UIC end construction		0%
	Body Pillar Part	22	100%

End Drooping: Rotary End - EAST : -7, WEST : -10 Other End - EAST : -10, WEST : -10
Start Date : 09-Dec-2019, Completion Date : 14-Dec-2019, Net Repair Days : 6, Total Man Hours : 1416

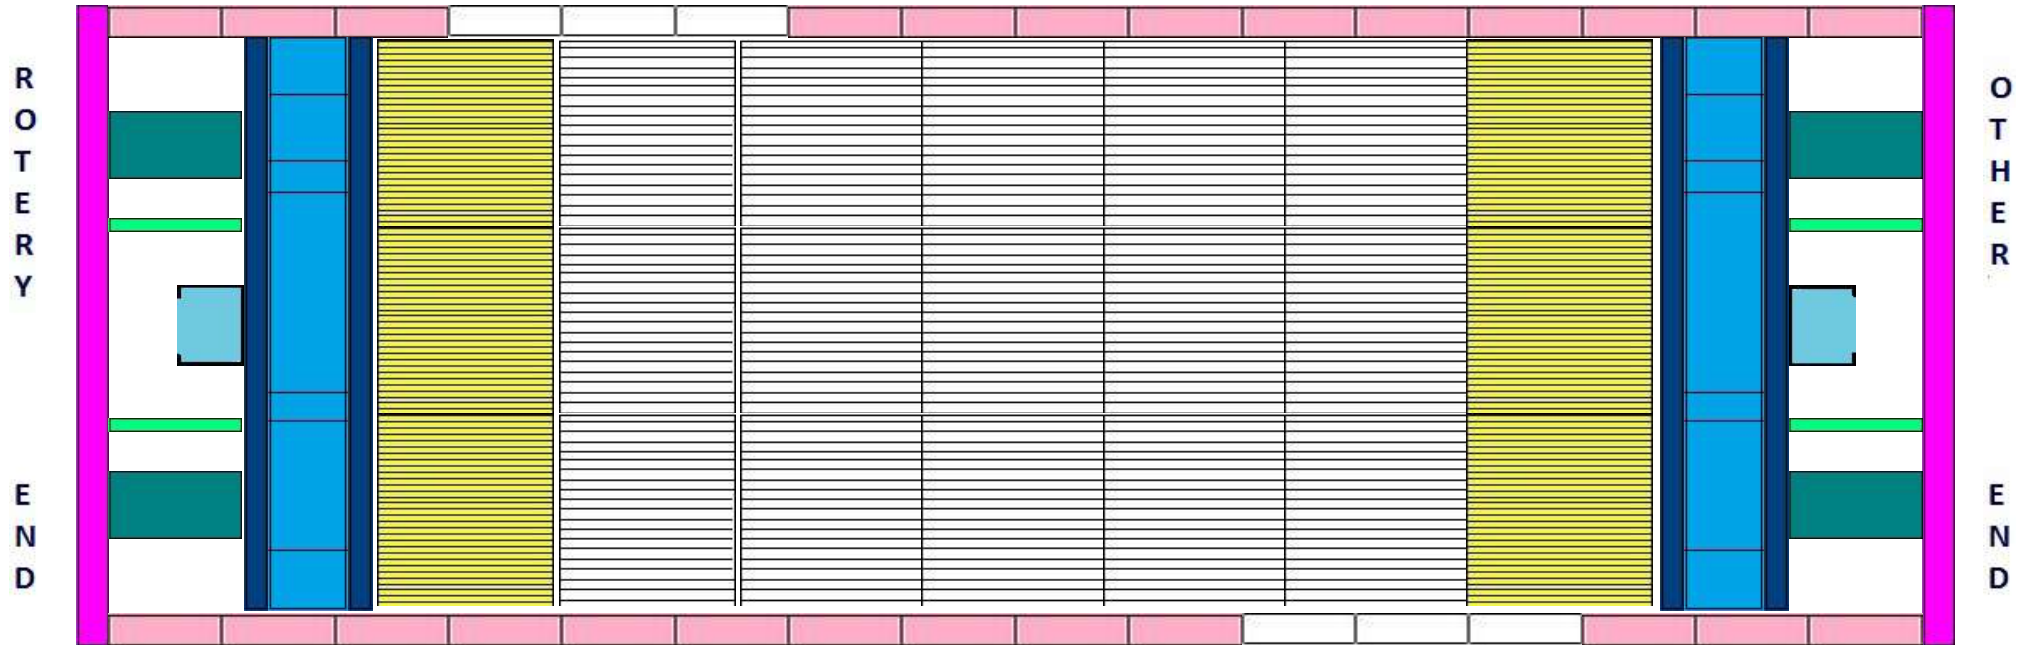
Color	Particulars	Qty	Per%	Color	Particulars	Qty	Per%	Color	Particulars	Qty	Per%
Yellow	Headstock Beam	2	100%	Dark Green	Centre Stiffner for Headstock	4	100%	Light Green	Floor Stiffner for Headstock	4	100%
Dark Blue	Aux. Head stock	4	100%	Pink	Sole Bar	13	81%	Light Blue	Draft Gear Bracket	2	100%
Yellow	Trough floor	2	29%	Light Blue	Centre plate	2	100%		SoleBar Stiffner	6	100%
	Bottom Wall Part	13	81%		Body panel/patch		100%		Door Top/Roof Patch		0%
	Window Module		0%		Window Sill	30	75%		Window Bar	48	27%
	Seat pillar/lav. Partition		100%		UIC end construction		0%

End Drooping: Rotary End - EAST : -6, WEST : -5 Other End - EAST : -3, WEST : -10
Start Date : 06-Jun-2019, Completion Date : 14-Jun-2019, Net Repair Days : 8, Total Man Hours : 1428

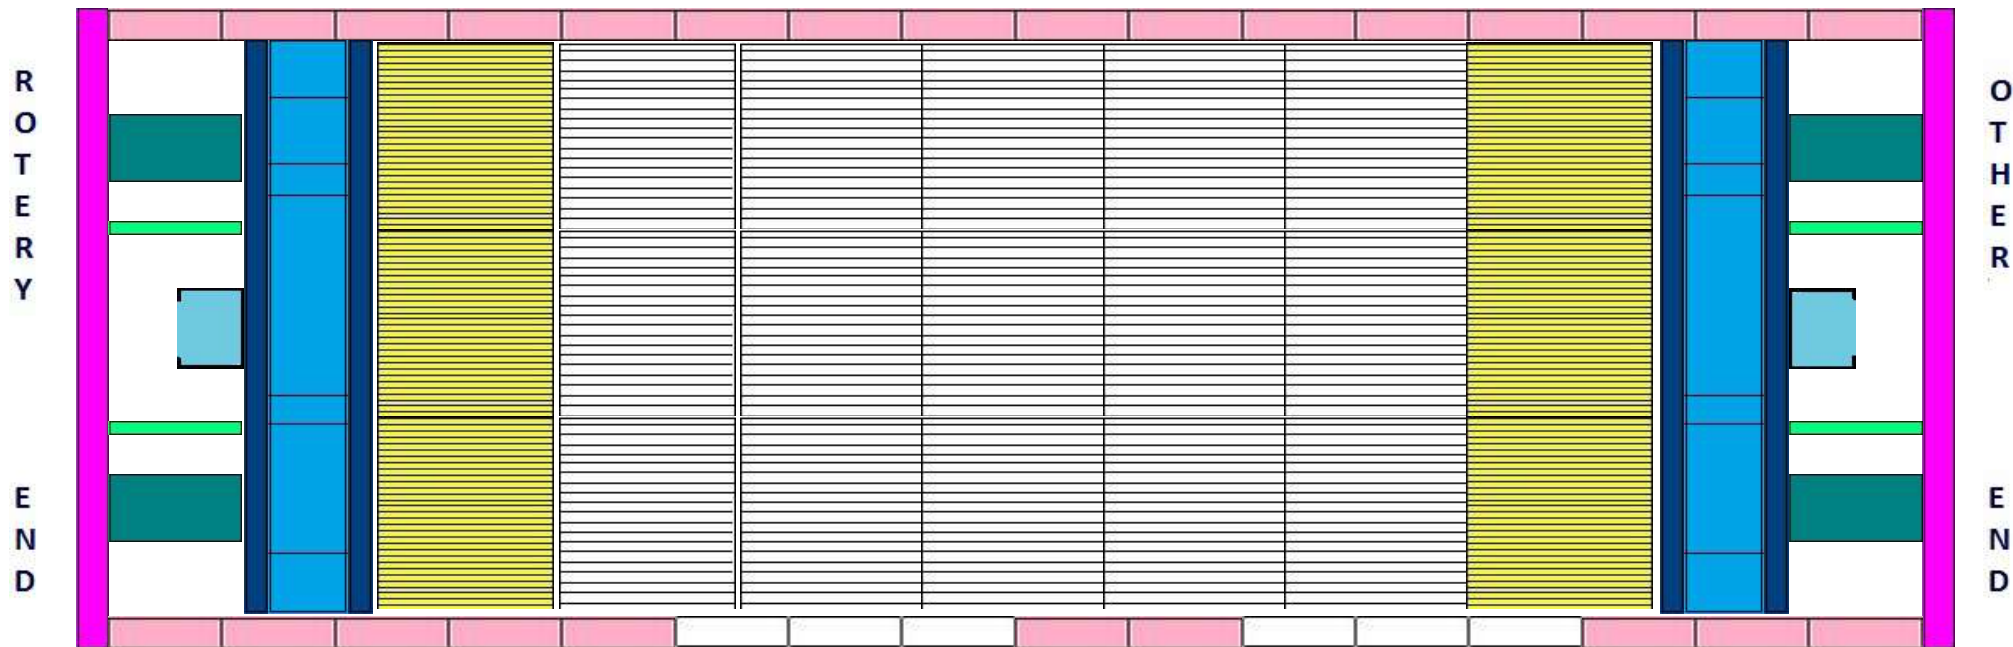
Rotary Side

Color	Particulars	Qty	Per%	Color	Particulars	Qty	Per%	Color	Particulars	Qty	Per%
Yellow	Headstock Beam	2	100%	Dark Green	Centre Stiffner for Headstock	4	100%	Light Green	Floor Stiffner for Headstock	4	100%
Dark Blue	Aux. Head stock	4	100%	Pink	Sole Bar	13	81%	Light Blue	Draft Gear Bracket	2	100%
Yellow	Trough floor	2	29%	Light Blue	Centre plate	2	100%		SoleBar Stiffner	6	100%
	Bottom Wall Part	13	81%		Body panel/patch		100%		Door Top/Roof Patch		0%
	Window Module		0%		Window Sill	14	35%		Window Bar	46	26%
	Seat pillar/lav. Partition		100%		UIC end construction		0%

End Drooping: Rotary End - EAST : -4, WEST : 9 Other End - EAST : 5, WEST : 4
Start Date : 31-May-2019, Completion Date : 11-Jun-2019, Net Repair Days : 10, Total Man Hours : 1144

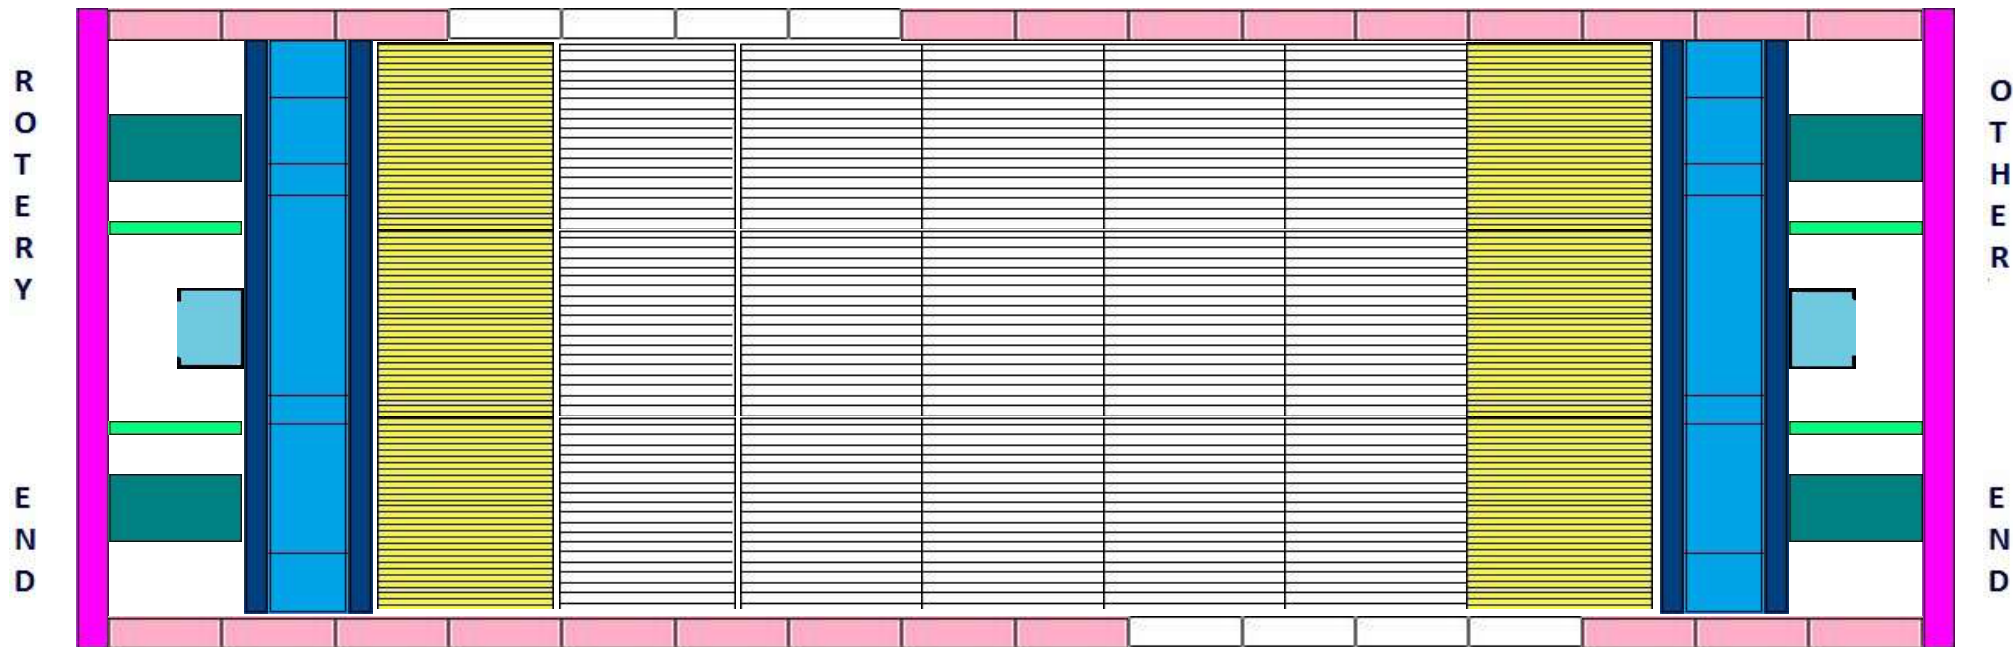
Color	Particulars	Qty	Per%	Color	Particulars	Qty	Per%	Color	Particulars	Qty	Per%
Yellow	Headstock Beam	2	100%	Dark Green	Centre Stiffner for Headstock	4	100%	Light Green	Floor Stiffner for Headstock	4	100%
Dark Blue	Aux. Head stock	4	100%	Pink	Sole Bar	12	75%	Light Blue	Draft Gear Bracket	2	100%
Yellow	Trough floor	2	29%	Light Blue	Centre plate	2	100%		SoleBar Stiffner	6	100%
	Bottom Wall Part	12	75%		Body panel/patch		100%		Door Top/Roof Patch		0%
	Window Module		0%		Window Sill	28	70%		Window Bar	48	27%
	Seat pillar/lav. Partition		100%		UIC end construction		0%

End Drooping: Rotary End - EAST : 6, WEST : 5 Other End - EAST : 5, WEST : 5
Start Date : 07-Jun-2019, Completion Date : 18-Jun-2019, Net Repair Days : 10, Total Man Hours : 1456

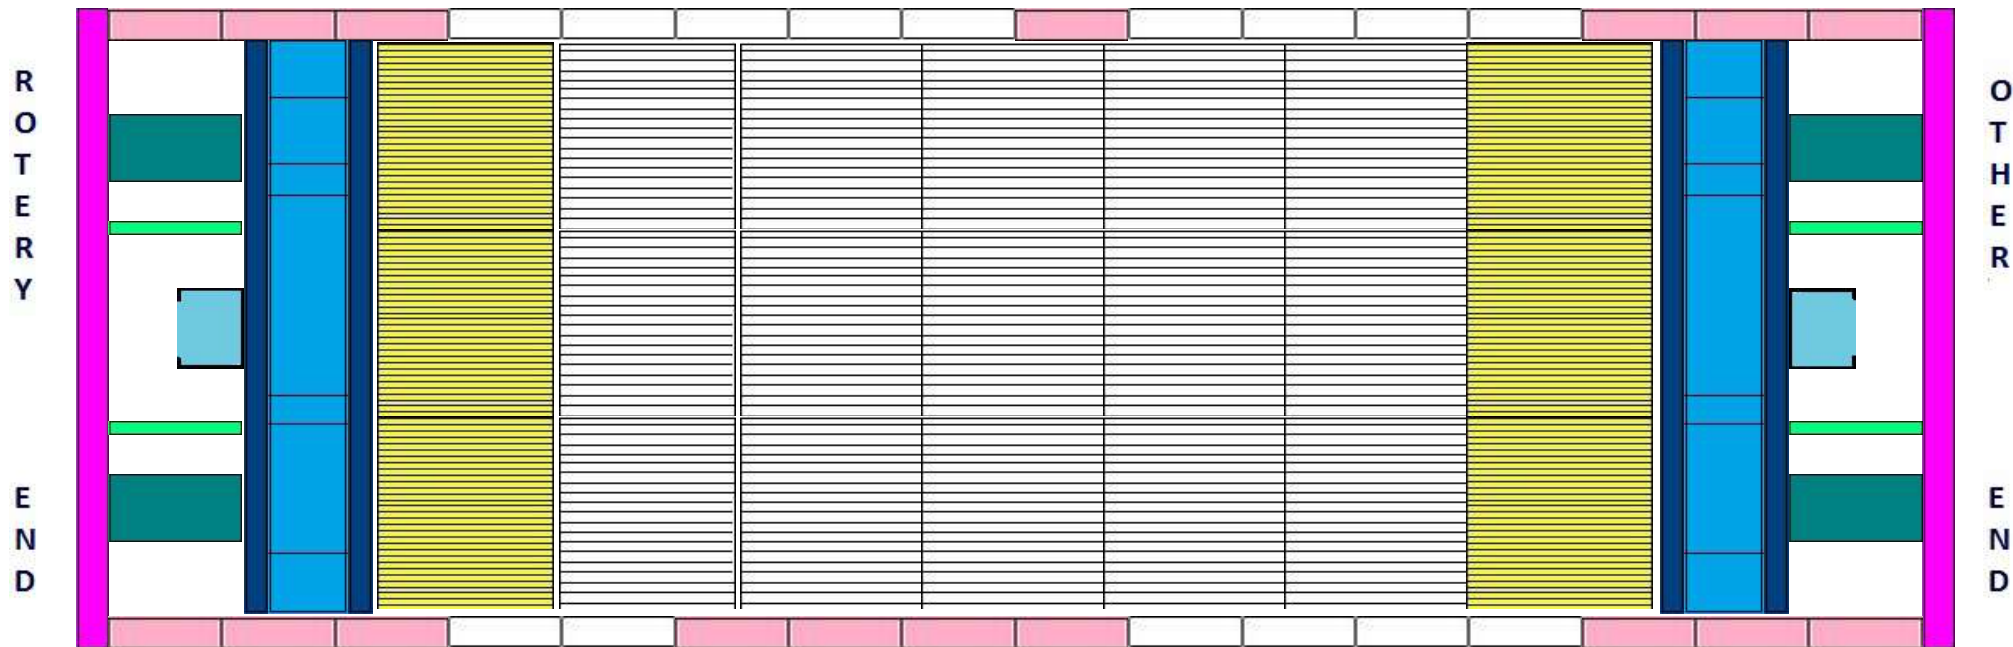
Rotary Side

Color	Particulars	Qty	Per%	Color	Particulars	Qty	Per%	Color	Particulars	Qty	Per%
Yellow	Headstock Beam	2	100%	Dark Green	Centre Stiffner for Headstock	4	100%	Light Green	Floor Stiffner for Headstock	4	100%
Dark Blue	Aux. Head stock	4	100%	Pink	Sole Bar	8.5	53%	Light Blue	Draft Gear Bracket	2	100%
Yellow	Trough floor	2	29%	Light Blue	Centre plate	2	100%		SoleBar Stiffner	4	100%
	Bottom Wall Part	8.5	53%		Body panel/patch		100%		Door Top/Roof Patch		100%
	Window Module		0%		Window Sill	40	100%		Window Bar	48	26%
	Seat pillar/lav. Partition		100%		UIC end construction		0%

End Drooping: Rotary End - EAST : -6, WEST : -2 Other End - EAST : 5, WEST : 5
Start Date : 11-Dec-2019, Completion Date : 17-Dec-2019, Net Repair Days : 6, Total Man Hours : 1784

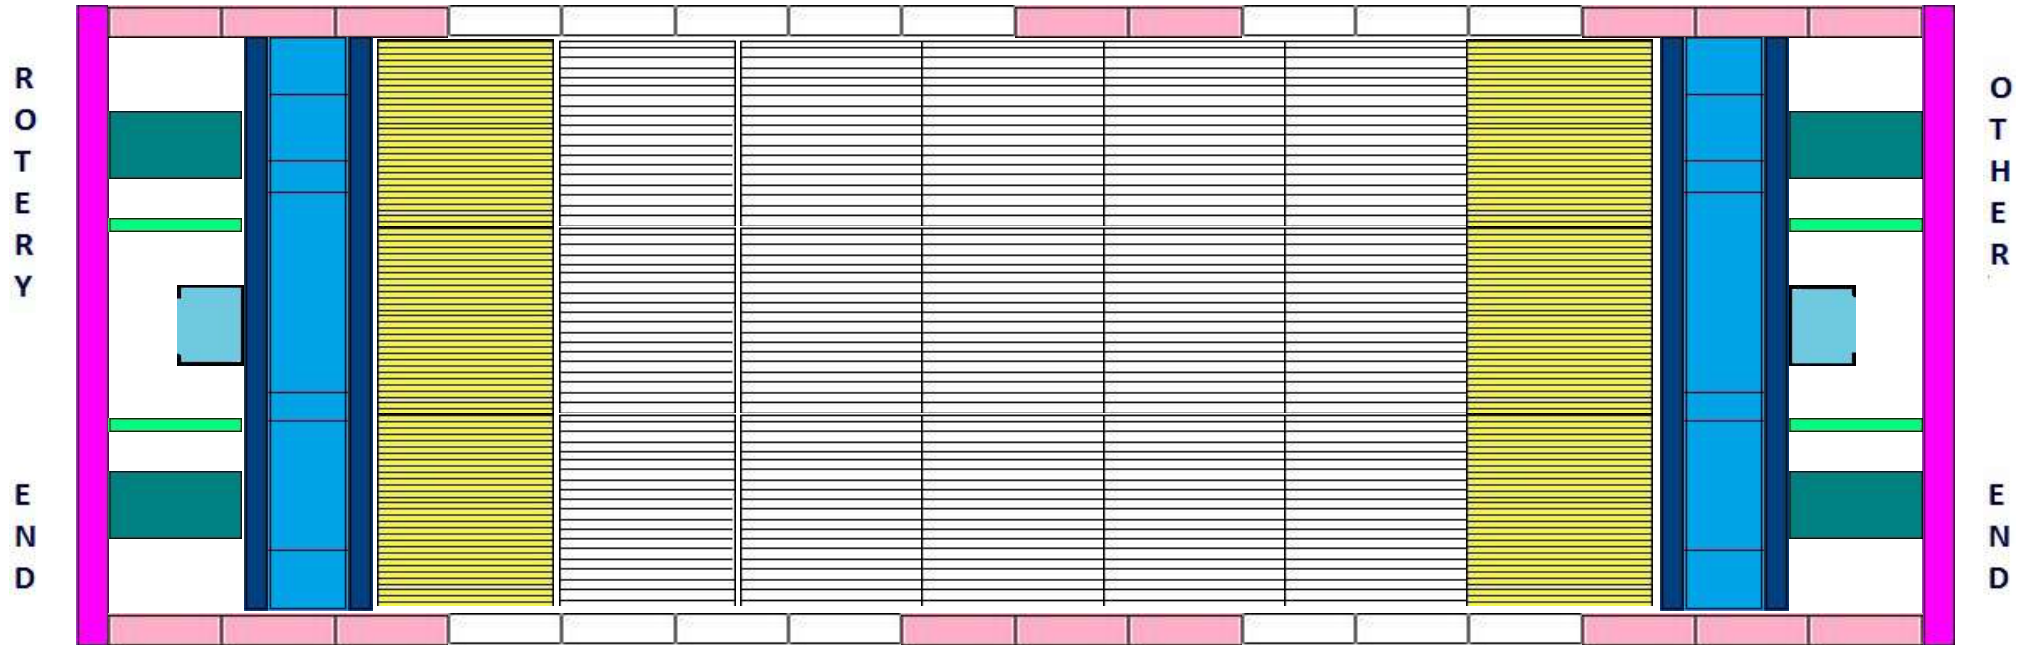
Rotary Side

Color	Particulars	Qty	Per%	Color	Particulars	Qty	Per%	Color	Particulars	Qty	Per%
	Headstock Beam	2	100%		Centre Stiffner for Headstock	4	100%		Floor Stiffner for Headstock	4	100%
	Aux. Head stock	4	100%		Sole Bar	8.5	53%		Draft Gear Bracket	2	100%
	Trough floor	2	29%		Centre plate	2	100%		SoleBar Stiffner	6	100%
	Bottom Wall Part	8.5	53%		Body panel/patch		100%		Door Top/Roof Patch		0%
	Window Module		0%		Window Sill	40	100%		Window Bar	52	29%
	Seat pillar/lav. Partition		100%		UIC end construction		0%

End Drooping: Rotary End - EAST : -4, WEST : -7 Other End - EAST : -7, WEST : -5
Start Date : 07-Jun-2019, Completion Date : 17-Jun-2019, Net Repair Days : 9, Total Man Hours : 1568

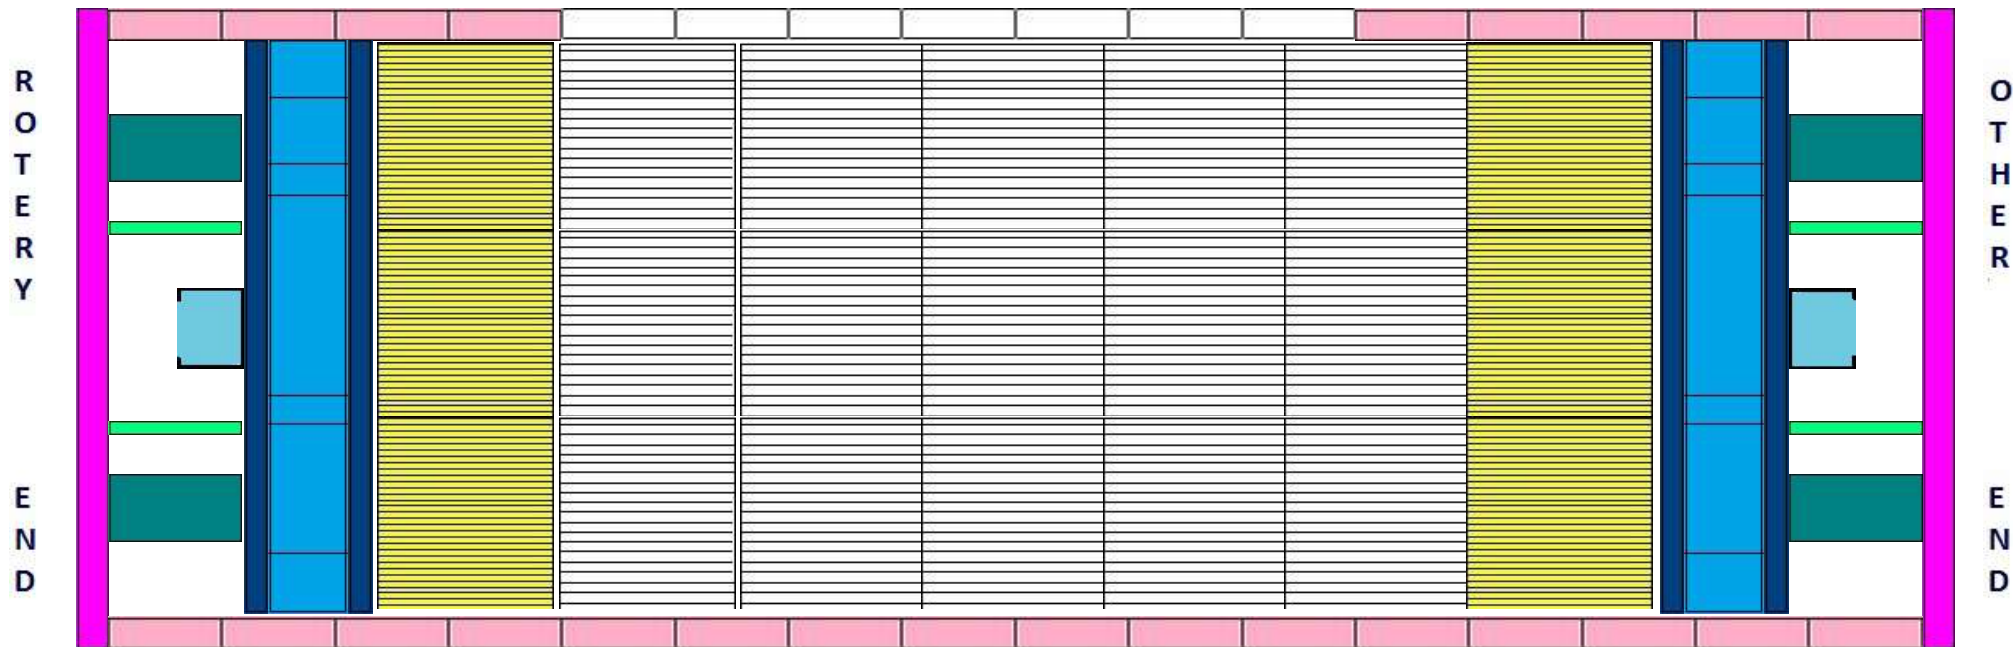
Rotary Side

Color	Particulars	Qty	Per%	Color	Particulars	Qty	Per%	Color	Particulars	Qty	Per%
Yellow	Headstock Beam	2	100%	Dark Green	Centre Stiffner for Headstock	4	100%	Light Green	Floor Stiffner for Headstock	4	100%
Dark Blue	Aux. Head stock	4	100%	Pink	Sole Bar	12.5	78%	Light Blue	Draft Gear Bracket	2	100%
Yellow	Trough floor	2	29%	Light Blue	Centre plate	2	100%		SoleBar Stiffner	4	100%
	Bottom Wall Part	12.5	78%		Body panel/patch		100%		Door Top/Roof Patch		0%
	Window Module		0%		Window Sill	28	70%		Window Bar	40	22%
	Seat pillar/lav. Partition		100%		UIC end construction		0%

End Drooping: Rotary End - EAST : 6, WEST : 4 Other End - EAST : -7, WEST : -4
Start Date : 19-Jul-2019, Completion Date : 30-Jul-2019, Net Repair Days : 10, Total Man Hours : 1440

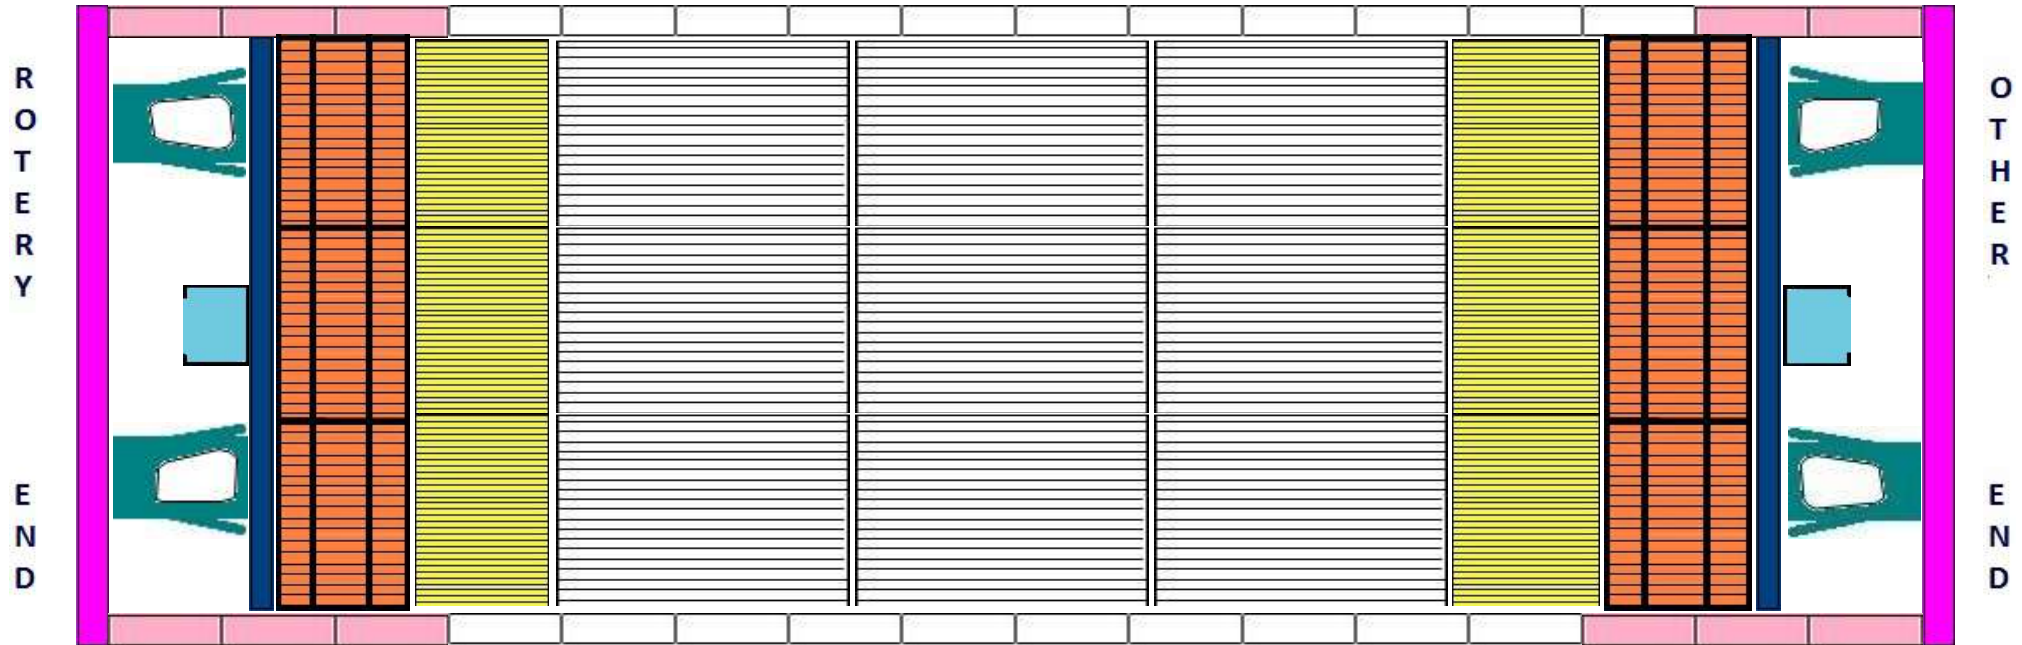
Rotary Side

Color	Particulars	Qty	Per%	Color	Particulars	Qty	Per%	Color	Particulars	Qty	Per%
	Headstock Beam	2	100%		Diagonal	4	100%		Logitudinal Channel Structure	2	100%
	Aux. Head stock	2	100%		Sole Bar	5.5	34%		Draft Gear Bracket	2	100%
	Trough floor	2	40%		Bottom Wall Part	5.5	34%		Body panel/patch		100%
	Door Top/Roof Patch		0%		Seat Bracket Rail		0%		Window Sill	14	35%
	Window Bar	34	18%		Seat pillar/lav. Partition		100%		UIC end construction		0%
	Body Pillar Part	30	100%

End Drooping: Rotary End - EAST : -10, WEST : -8 Other End - EAST : -7, WEST : -10
Start Date : 20-Jun-2019, Completion Date : 29-Jun-2019, Net Repair Days : 9, Total Man Hours : 1292

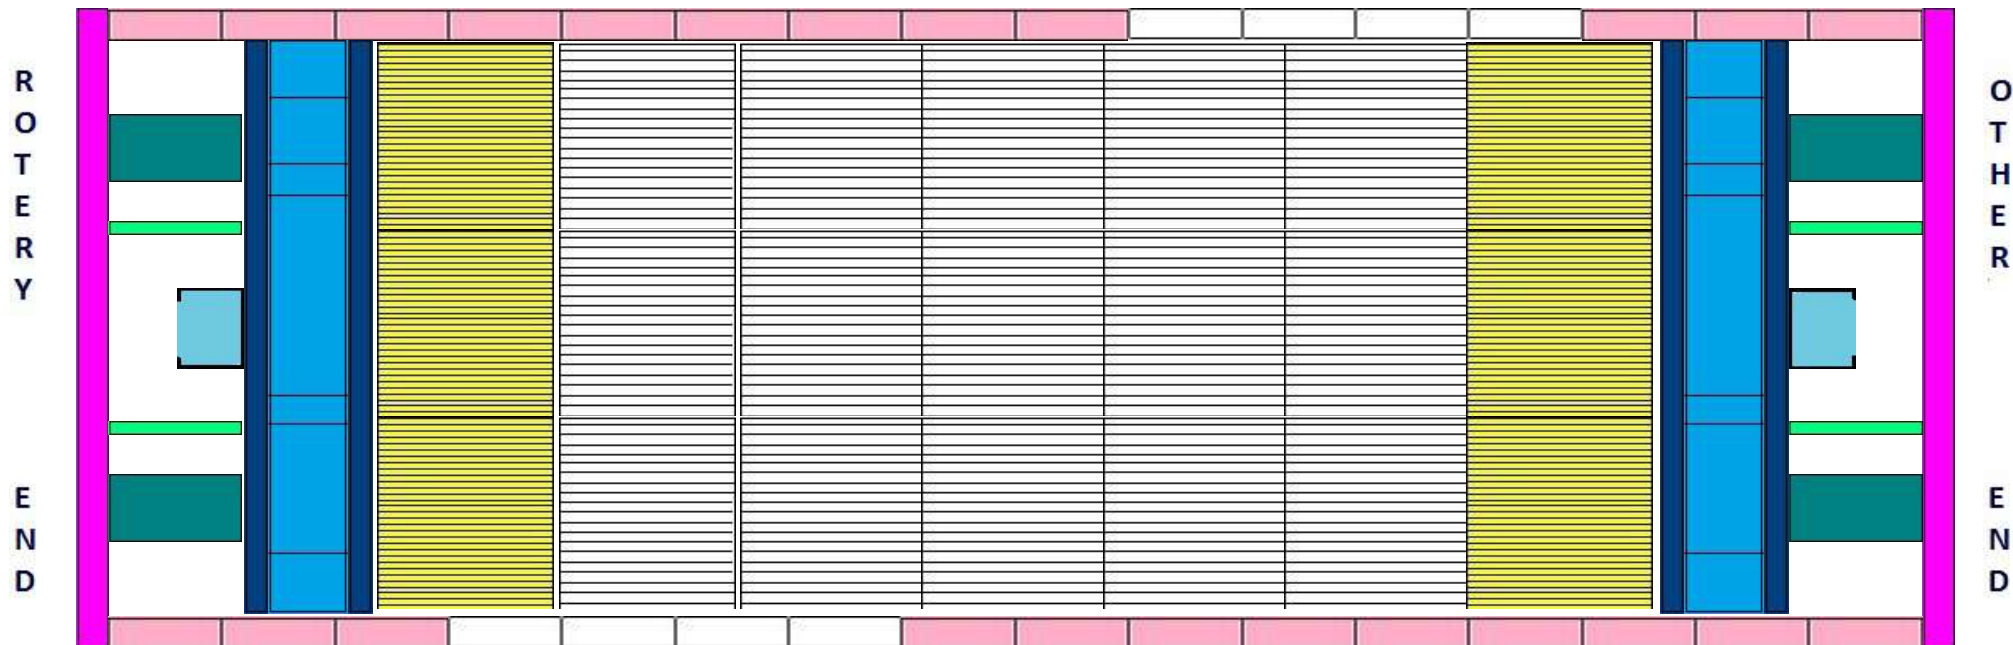
Color	Particulars	Qty	Per%	Color	Particulars	Qty	Per%	Color	Particulars	Qty	Per%
Yellow	Headstock Beam	2	100%	Dark Green	Centre Stiffner for Headstock	4	100%	Light Green	Floor Stiffner for Headstock	4	100%
Dark Blue	Aux. Head stock	4	100%	Pink	Sole Bar	12	75%	Light Blue	Draft Gear Bracket	2	100%
Yellow	Trough floor	2	29%	Light Blue	Centre plate	2	100%		SoleBar Stiffner	4	100%
	Bottom Wall Part	12	75%		Body panel/patch		100%		Door Top/Roof Patch		0%
	Window Module		0%		Window Sill	40	100%		Window Bar	42	23%
	Seat pillar/lav. Partition		100%		UIC end construction		0%

End Drooping: Rotary End - EAST : 0, WEST : 0 Other End - EAST : 0, WEST : 0
Start Date : 25-Jun-2019, Completion Date : 04-Jul-2019, Net Repair Days : 9, Total Man Hours : 0

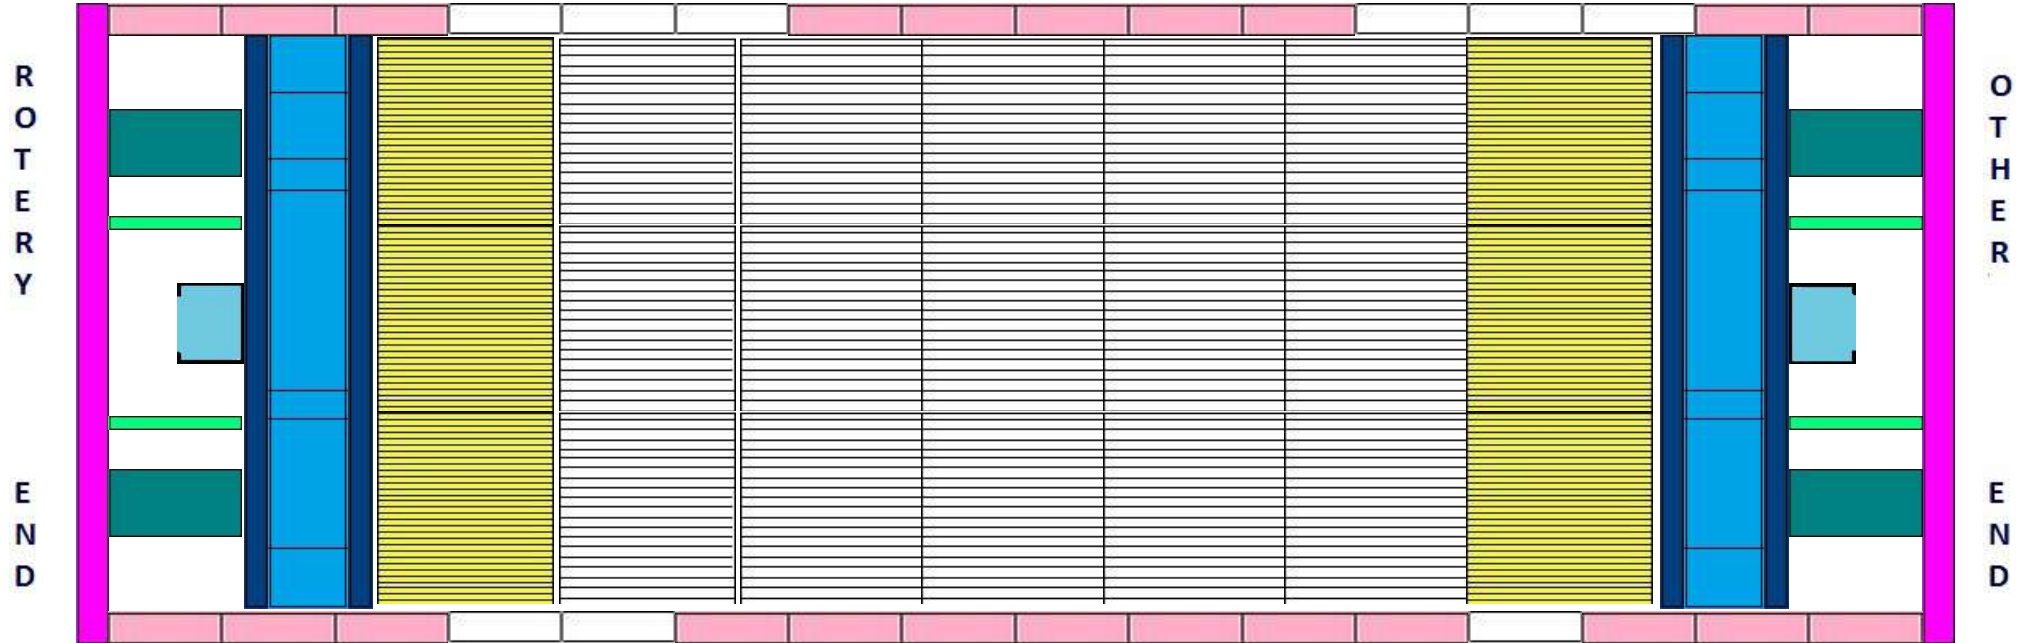
Color	Particulars	Qty	Per%	Color	Particulars	Qty	Per%	Color	Particulars	Qty	Per%
Yellow	Headstock Beam	2	100%	Dark Green	Centre Stiffner for Headstock	4	100%	Light Green	Floor Stiffner for Headstock	4	100%
Dark Blue	Aux. Head stock	4	100%	Pink	Sole Bar	11.5	72%	Light Blue	Draft Gear Bracket	2	100%
Yellow	Trough floor	2	29%	Light Blue	Centre plate	2	100%		SoleBar Stiffner	6	100%
	Bottom Wall Part	11.5	72%		Body panel/patch		100%		Door Top/Roof Patch		0%
	Window Module		0%		Window Sill	40	100%		Window Bar	46	26%
	Seat pillar/lav. Partition		100%		UIC end construction		0%

End Drooping: Rotary End - EAST : 5, WEST : 5 Other End - EAST : -4, WEST : -3
Start Date : 06-Jul-2019, Completion Date : 15-Jul-2019, Net Repair Days : 8, Total Man Hours : 1448
