Coach Rehabilitation Workshop, WC Railway, Bhopal

(An IMS and ISO 50001 Certified Workshop)
Final Inspection Sheet - Details of Corrosion Repair

Coach No. :WR017041

Type : GSLRD

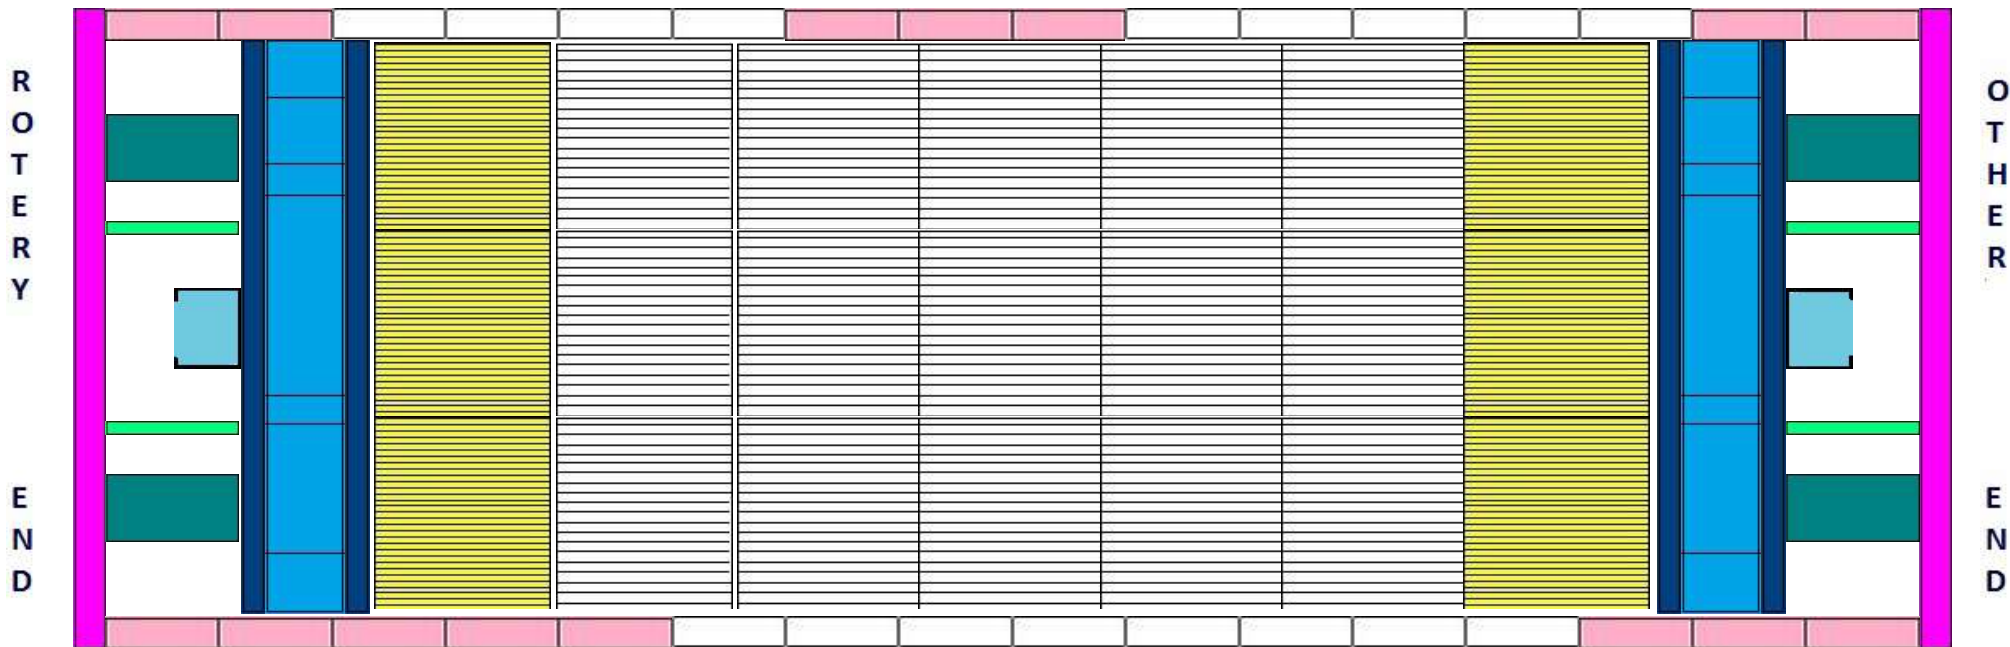
Color	Particulars	Qty	Per%	Color	Particulars	Qty	Per%	Color	Particulars	Qty	Per%
 	Headstock Beam	2	100%	 	Centre Stiffner for Headstock	4	100%	 	Floor Stiffner for Headstock	4	100%
 	Aux. Head stock	4	100%	 	Sole Bar	7.5	47%	 	Draft Gear Bracket	2	100%
 	Trough floor	2	29%	 	Centre plate	2	100%		SoleBar Stiffner	4	100%
	Bottom Wall Part	7.5	47%		Body panel/patch		100%		Door Top/Roof Patch		0%
	Window Module		0%		Window Sill	40	100%		Window Bar	78	42%
	Seat pillar/lav. Partition		100%		UIC end construction		0%

End Drooping: Rotary End - EAST : -5, WEST : 0 Other End - EAST : -6, WEST : -4
Start Date : 28-Jun-2019, Completion Date : 08-Jul-2019, Net Repair Days : 9, Total Man Hours : 1432

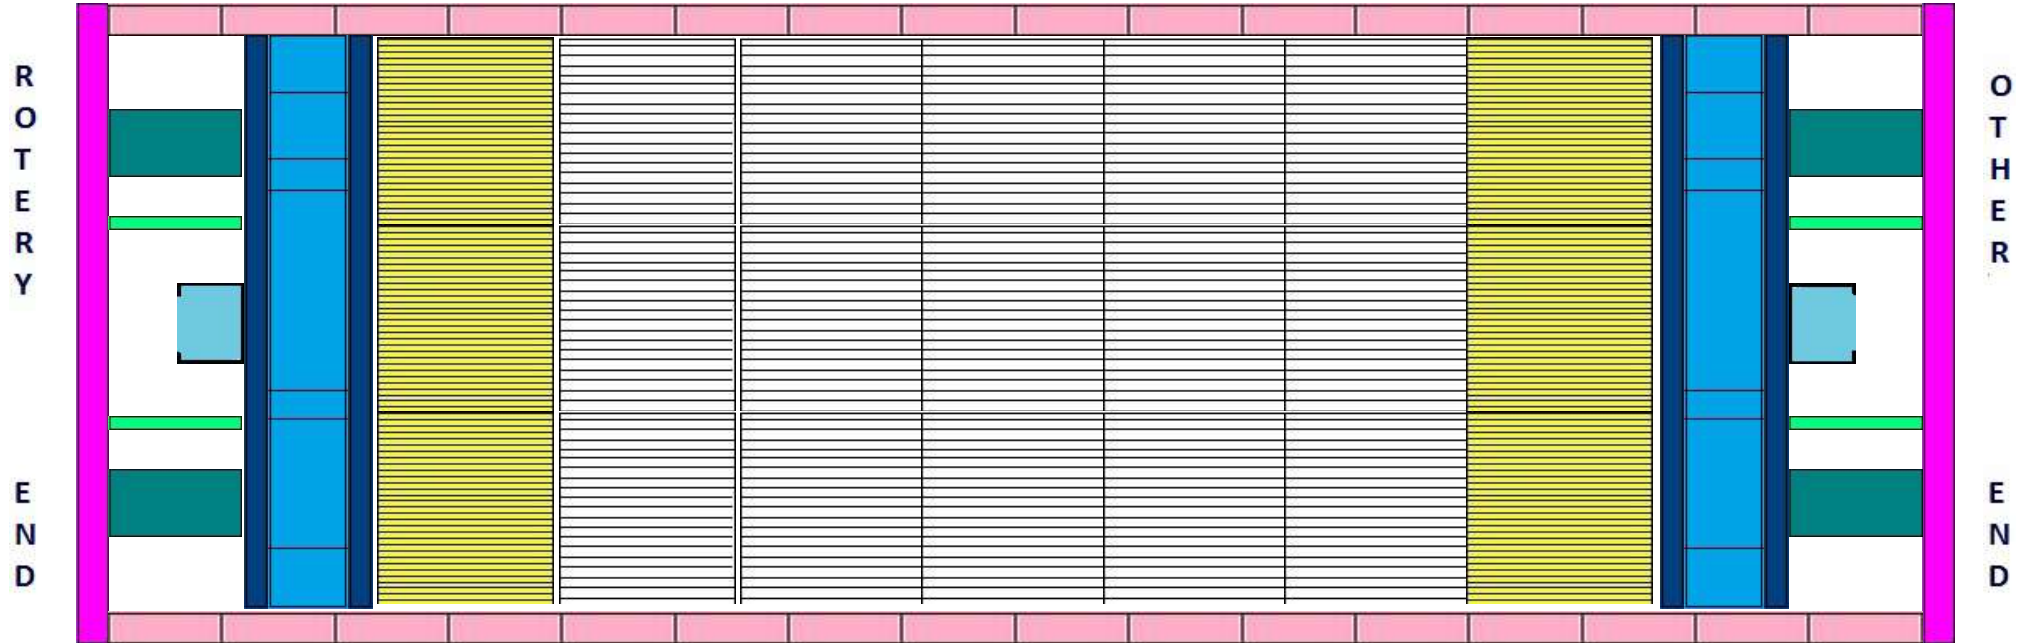
Rotary Side

Color	Particulars	Qty	Per%	Color	Particulars	Qty	Per%	Color	Particulars	Qty	Per%
Yellow	Headstock Beam	2	100%	Dark Green	Centre Stiffner for Headstock	4	100%	Light Green	Floor Stiffner for Headstock	4	100%
Dark Blue	Aux. Head stock	4	100%	Pink	Sole Bar	16	100%	Light Blue	Draft Gear Bracket	2	100%
Yellow	Trough floor	2	29%	Light Blue	Centre plate	2	100%		SoleBar Stiffner	4	100%
	Bottom Wall Part	16	100%		Body panel/patch		100%		Door Top/Roof Patch		0%
	Window Module		0%		Window Sill	34	85%		Window Bar	48	26%
	Seat pillar/lav. Partition		100%		UIC end construction		0%

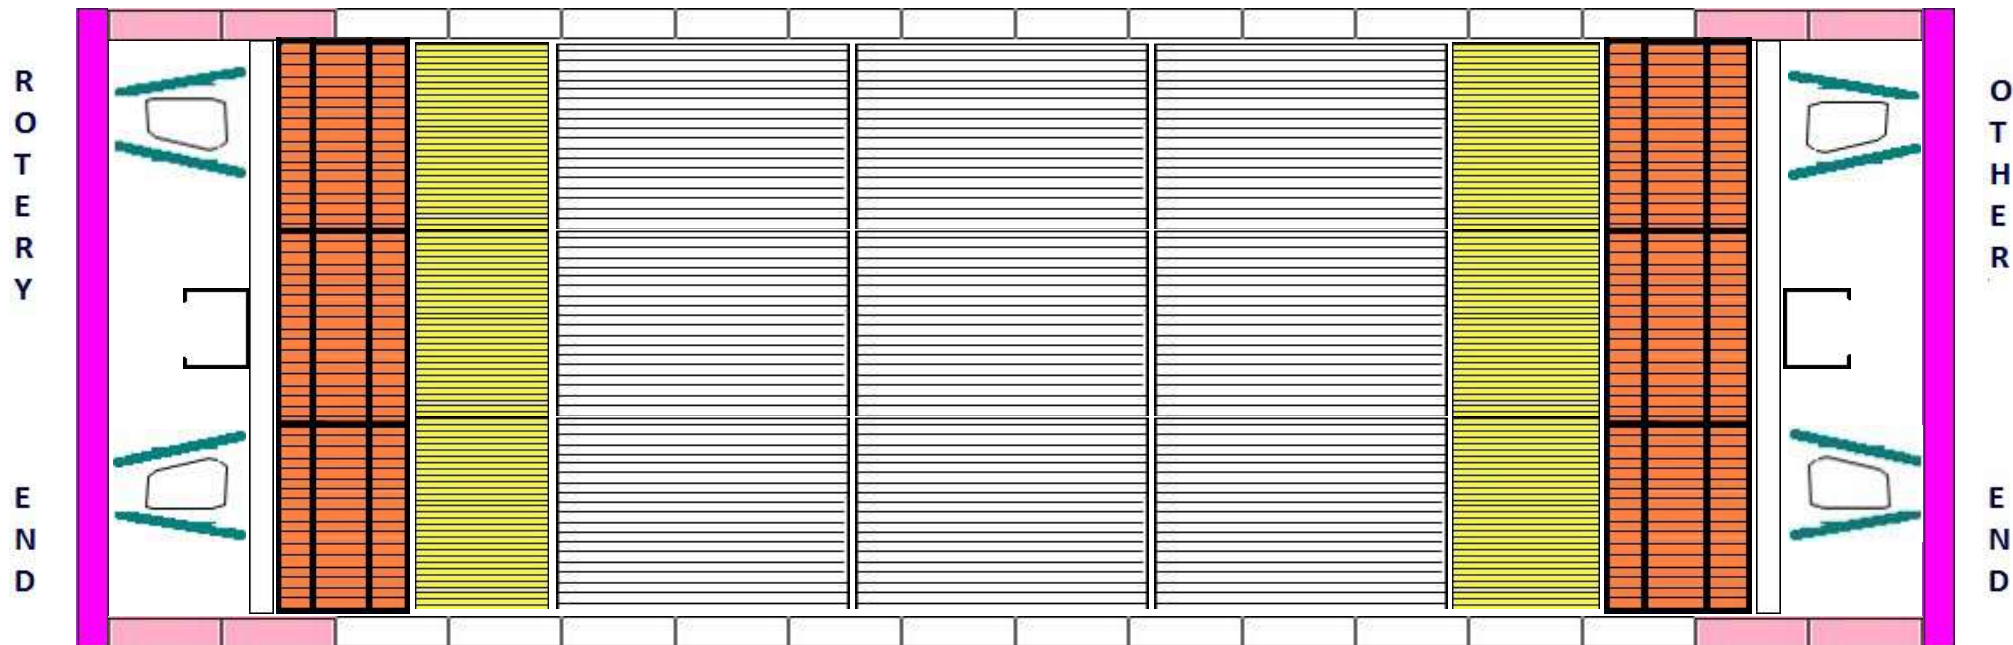
Rotary Side

Color	Particulars	Qty	Per%	Color	Particulars	Qty	Per%	Color	Particulars	Qty	Per%
	Headstock Beam	2	100%		Diagonal	4	100%		Logitudinal Channel Structure	2	100%
	Aux. Head stock	0	0%		Sole Bar	4	25%		Draft Gear Bracket	0	0%
	Trough floor	2	40%		Bottom Wall Part	4	25%		Body panel/patch		100%
	Door Top/Roof Patch		0%		Seat Bracket Rail		0%		Window Sill	4	10%
	Window Bar	18	10%		Seat pillar/lav. Partition		100%		UIC end construction		0%
	Body Pillar Part	0	100%

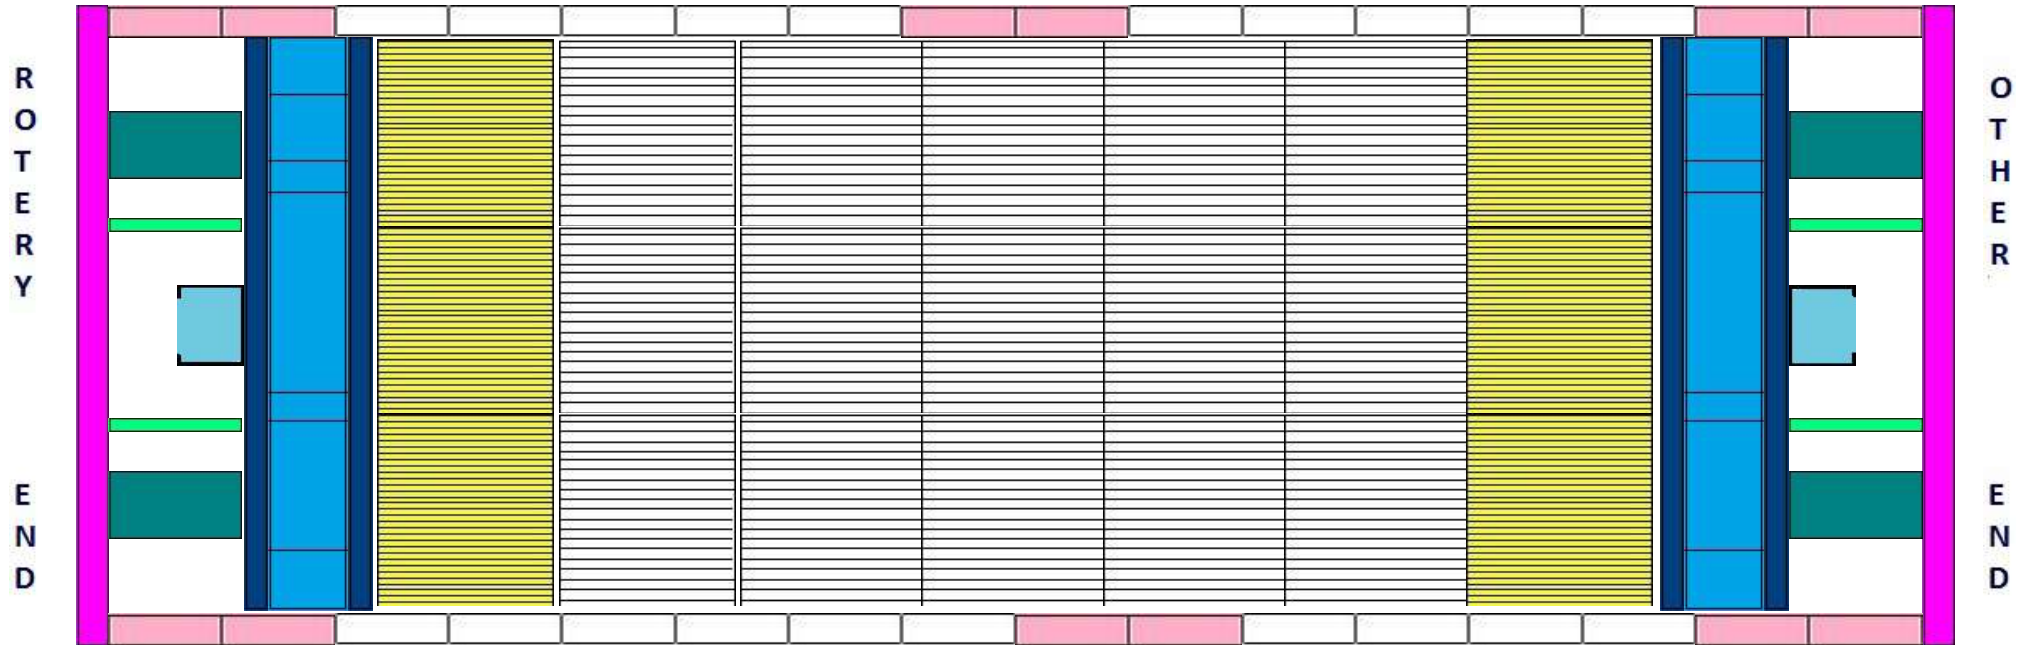
Rotary Side

Color	Particulars	Qty	Per%	Color	Particulars	Qty	Per%	Color	Particulars	Qty	Per%
Pink	Headstock Beam	2	100%	Dark Blue	Centre Stiffner for Headstock	4	100%	Light Green	Floor Stiffner for Headstock	4	100%
Dark Blue	Aux. Head stock	4	100%	Pink	Sole Bar	6	38%	Light Blue	Draft Gear Bracket	2	100%
Yellow	Trough floor	2	29%	Light Blue	Centre plate	2	100%		SoleBar Stiffner	6	100%
	Bottom Wall Part	6	38%		Body panel/patch		100%		Door Top/Roof Patch		0%
	Window Module		0%		Window Sill	40	100%		Window Bar	48	27%
	Seat pillar/lav. Partition		100%		UIC end construction		0%

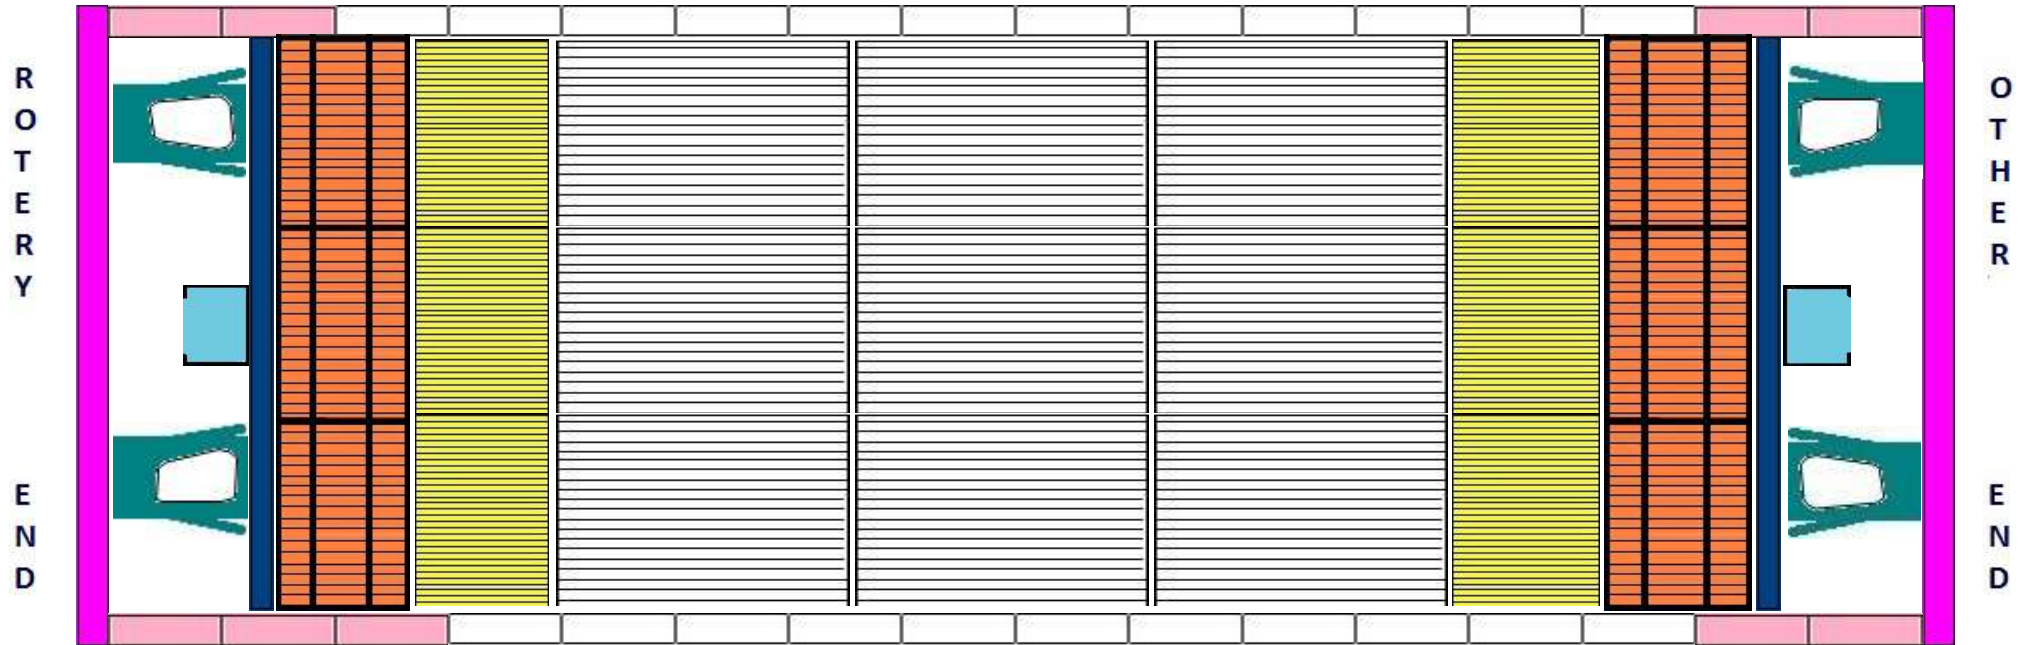
Rotary Side

Color	Particulars	Qty	Per%	Color	Particulars	Qty	Per%	Color	Particulars	Qty	Per%
	Headstock Beam	2	100%		Diagonal	4	100%		Logitudinal Channel Structure	2	100%
	Aux. Head stock	2	100%		Sole Bar	4.5	28%		Draft Gear Bracket	2	100%
	Trough floor	2	40%		Bottom Wall Part	4.5	28%		Body panel/patch		100%
	Door Top/Roof Patch		0%		Seat Bracket Rail		0%		Window Sill	14	35%
	Window Bar	22	12%		Seat pillar/lav. Partition		100%		UIC end construction		0%
	Body Pillar Part	25	100%

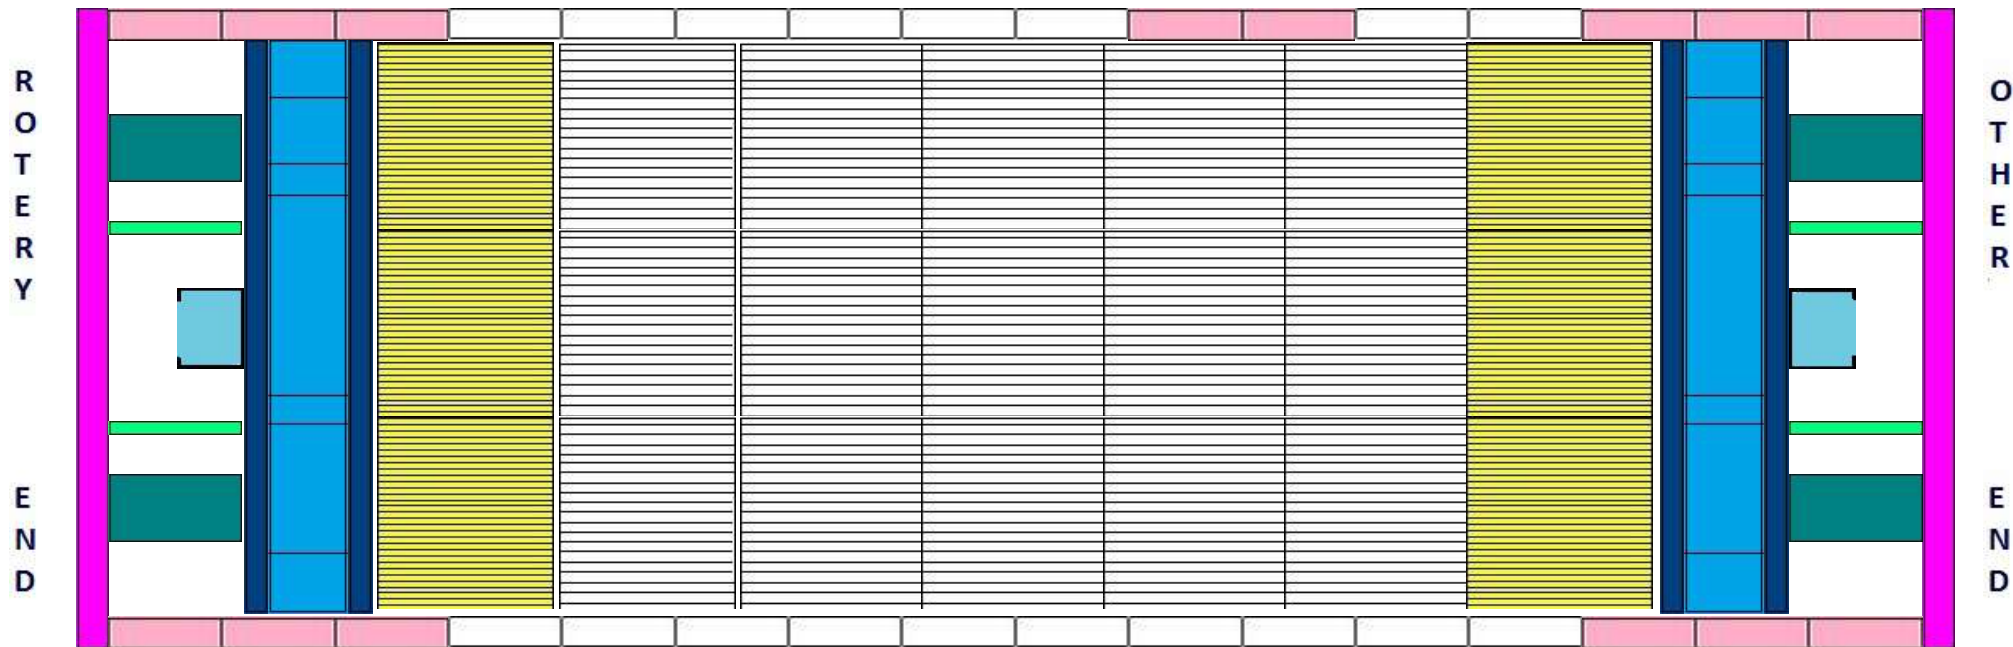
Rotary Side

Color	Particulars	Qty	Per%	Color	Particulars	Qty	Per%	Color	Particulars	Qty	Per%
Pink	Headstock Beam	2	100%	Dark Blue	Centre Stiffner for Headstock	4	100%	Yellow	Floor Stiffner for Headstock	4	100%
Dark Blue	Aux. Head stock	4	100%	Pink	Sole Bar	7	44%	Blue	Draft Gear Bracket	2	100%
Yellow	Trough floor	2	29%	Blue	Centre plate	2	100%		SoleBar Stiffner	4	100%
	Bottom Wall Part	7	44%		Body panel/patch		100%		Door Top/Roof Patch		0%
	Window Module		0%		Window Sill	7	18%		Window Bar	28	15%
	Seat pillar/lav. Partition		100%		UIC end construction		0%

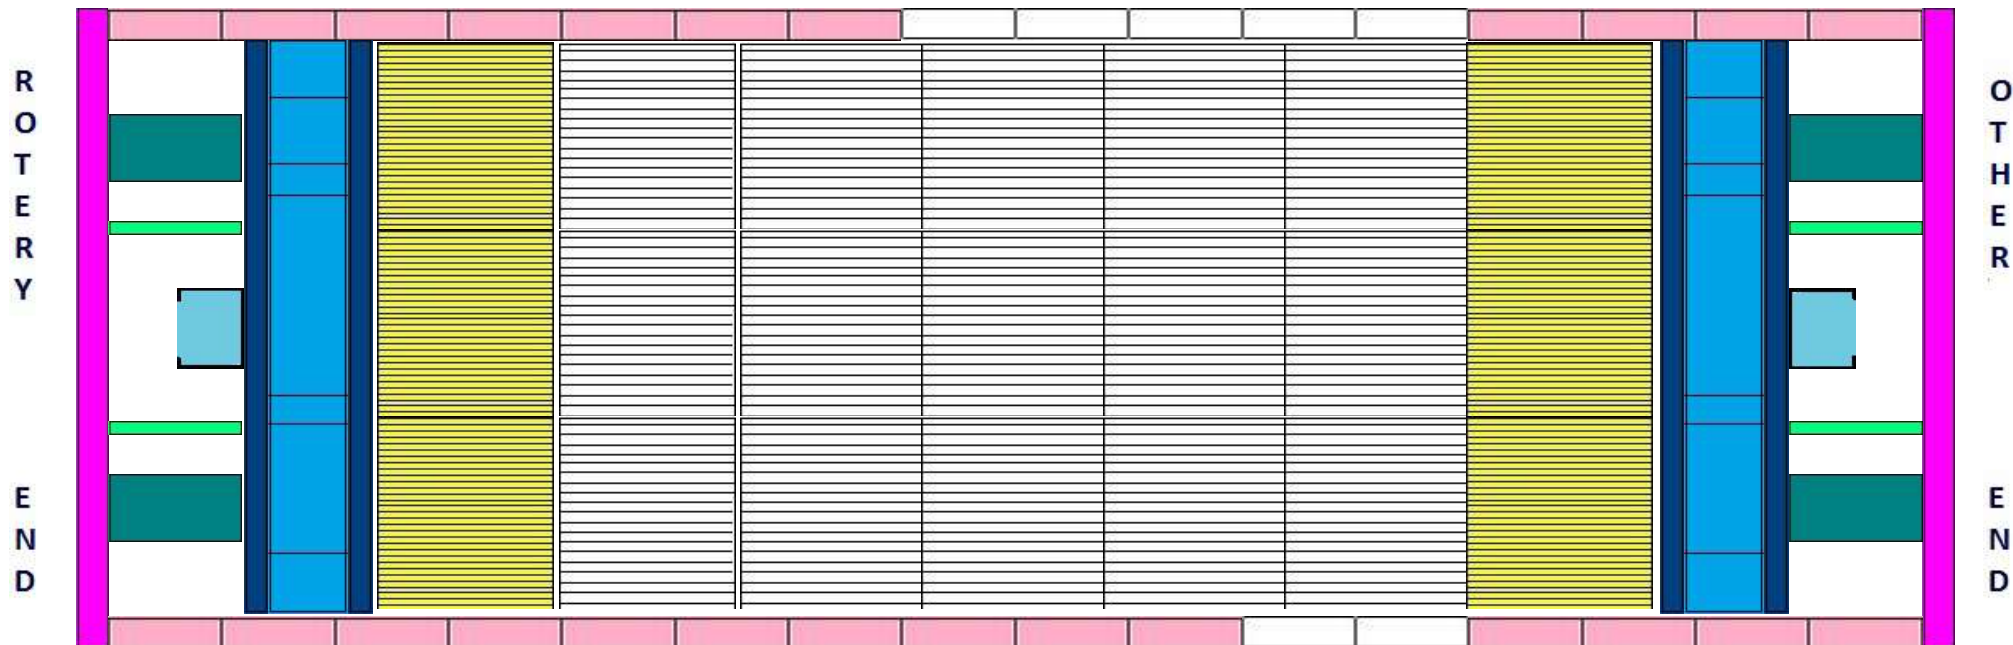
Rotary Side

Color	Particulars	Qty	Per%	Color	Particulars	Qty	Per%	Color	Particulars	Qty	Per%
	Headstock Beam	2	100%		Centre Stiffner for Headstock	4	100%		Floor Stiffner for Headstock	4	100%
	Aux. Head stock	4	100%		Sole Bar	12.5	78%		Draft Gear Bracket	2	100%
	Trough floor	2	29%		Centre plate	2	100%		SoleBar Stiffner	4	100%
	Bottom Wall Part	12.5	78%		Body panel/patch		100%		Door Top/Roof Patch		100%
	Window Module		0%		Window Sill	40	100%		Window Bar	46	25%
	Seat pillar/lav. Partition		100%		UIC end construction		0%

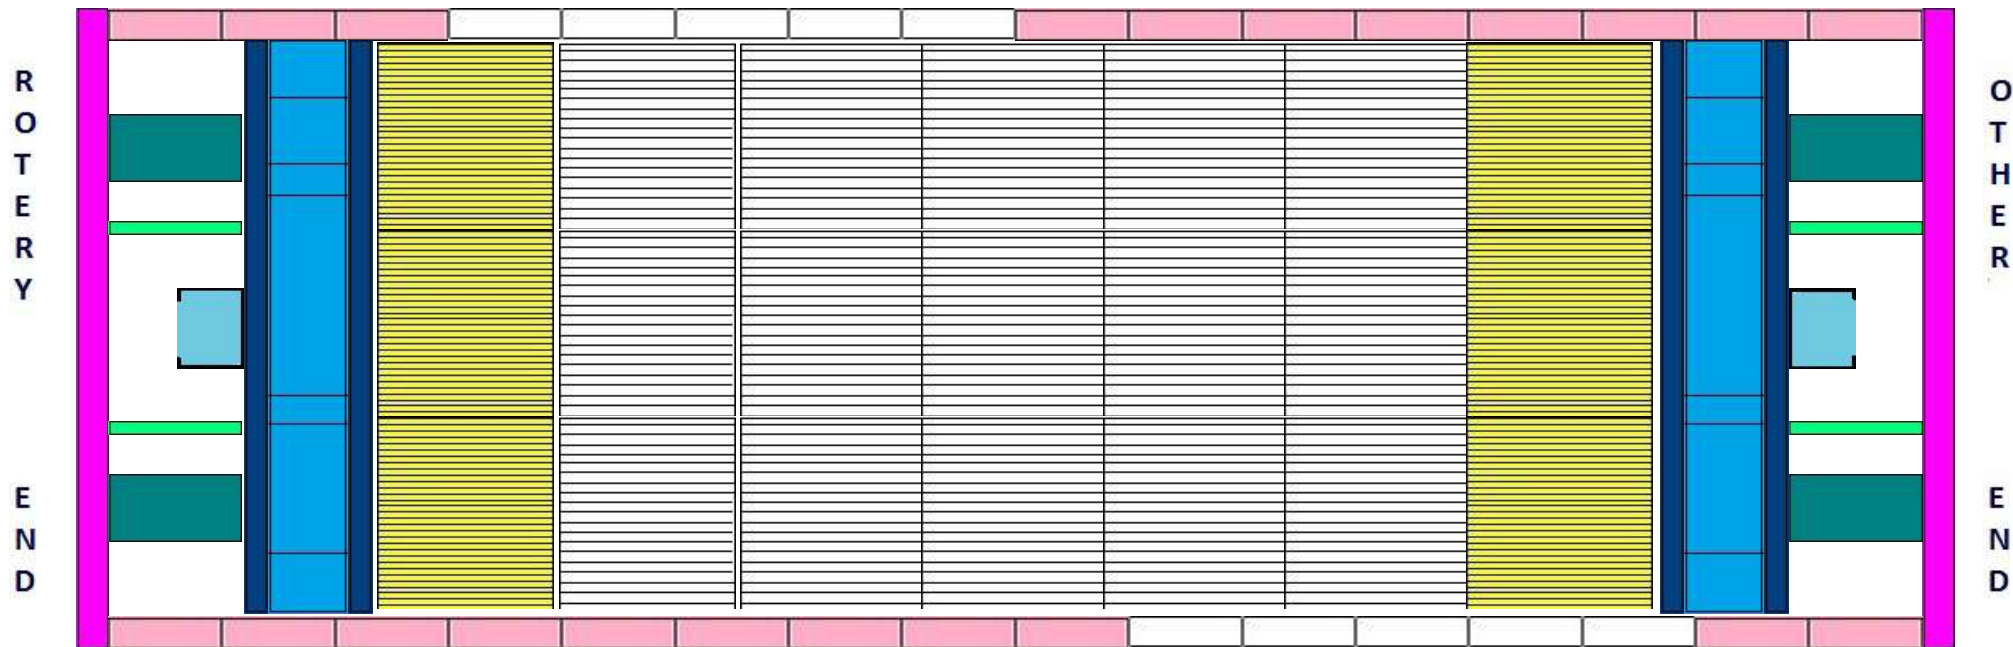
Color	Particulars	Qty	Per%	Color	Particulars	Qty	Per%	Color	Particulars	Qty	Per%
Yellow	Headstock Beam	2	100%	Dark Green	Centre Stiffner for Headstock	4	100%	Light Green	Floor Stiffner for Headstock	4	100%
Dark Blue	Aux. Head stock	4	100%	Pink	Sole Bar	11	69%	Light Blue	Draft Gear Bracket	2	100%
Yellow	Trough floor	2	29%	Light Blue	Centre plate	2	100%		SoleBar Stiffner	6	100%
	Bottom Wall Part	11	69%		Body panel/patch		100%		Door Top/Roof Patch		0%
	Window Module		0%		Window Sill	7	18%		Window Bar	36	20%
	Seat pillar/lav. Partition		100%		UIC end construction		0%

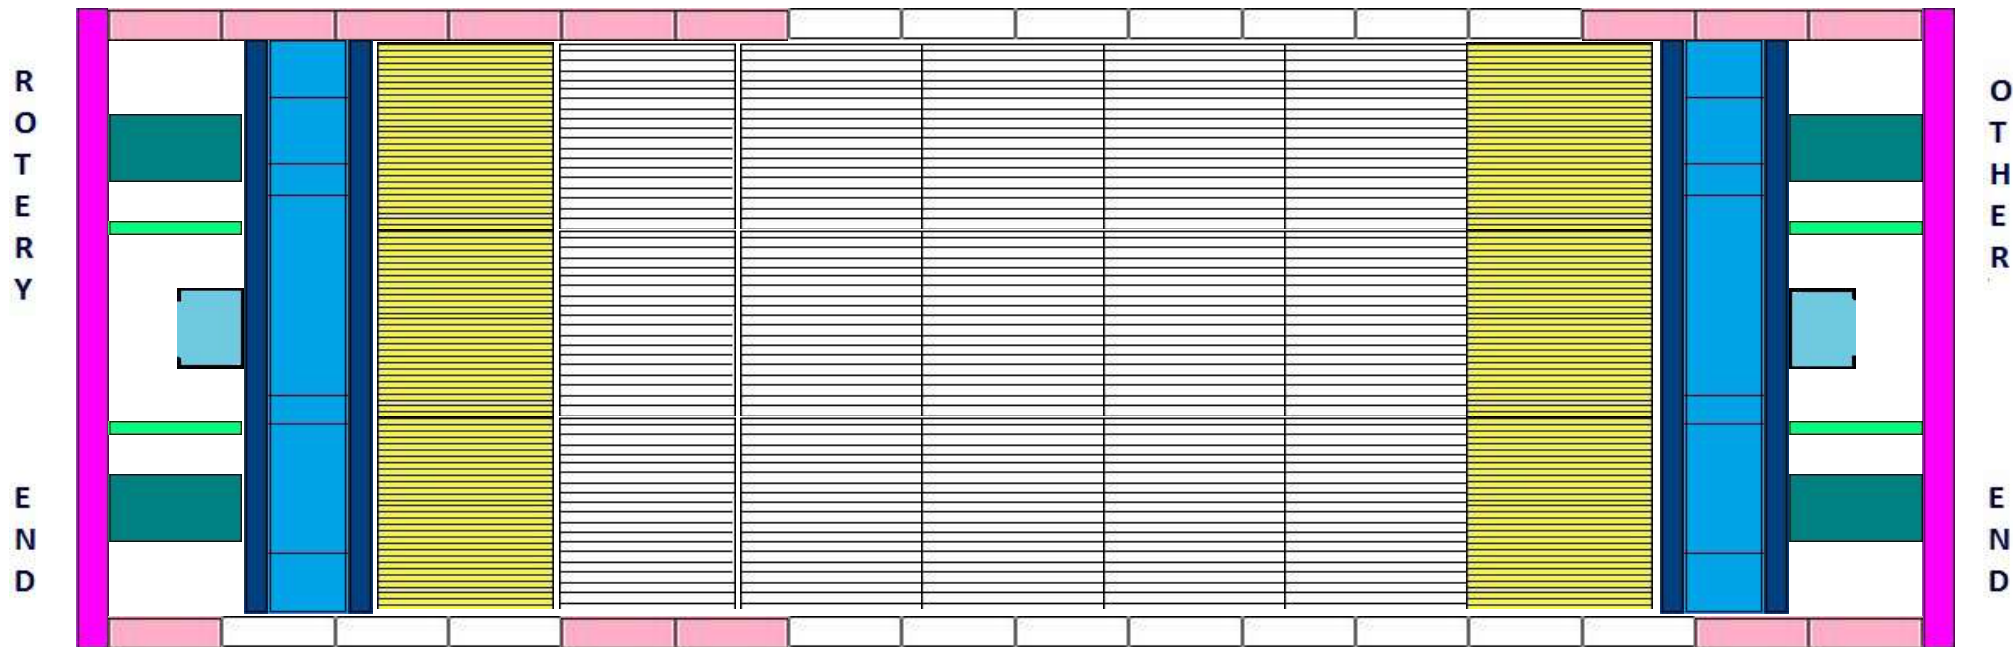
Rotary Side

Color	Particulars	Qty	Per%	Color	Particulars	Qty	Per%	Color	Particulars	Qty	Per%
Pink	Headstock Beam	2	100%	Dark Blue	Centre Stiffner for Headstock	4	100%	Light Green	Floor Stiffner for Headstock	4	100%
Dark Blue	Aux. Head stock	4	100%	Pink	Sole Bar	7	44%	Light Blue	Draft Gear Bracket	2	100%
Yellow	Trough floor	2	29%	Light Blue	Centre plate	2	100%		SoleBar Stiffner	4	100%
	Bottom Wall Part	7	44%		Body panel/patch		100%		Door Top/Roof Patch		0%
	Window Module		0%		Window Sill	34	94%		Window Bar	40	23%
	Seat pillar/lav. Partition		100%		UIC end construction		0%

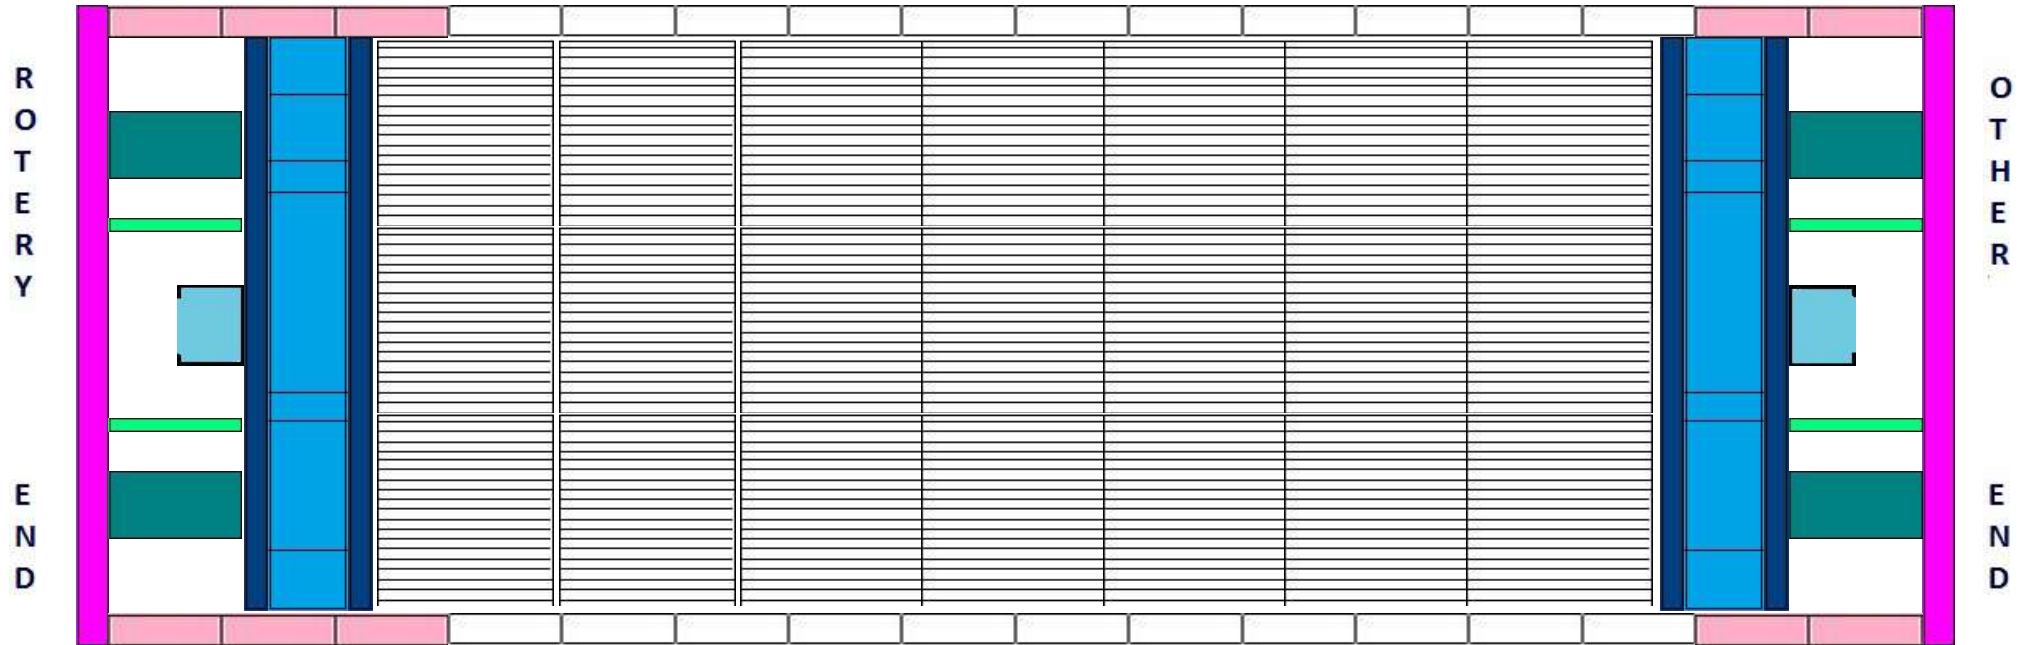
Rotary Side

Color	Particulars	Qty	Per%	Color	Particulars	Qty	Per%	Color	Particulars	Qty	Per%
	Headstock Beam	2	100%		Centre Stiffner for Headstock	4	100%		Floor Stiffner for Headstock	4	100%
	Aux. Head stock	4	100%		Sole Bar	5	31%		Draft Gear Bracket	2	100%
	Trough floor	0	0%		Centre plate	2	100%		SoleBar Stiffner	4	100%
	Bottom Wall Part	5	31%		Body panel/patch		20%		Door Top/Roof Patch		0%
	Window Module		0%		Window Sill	0	0%		Window Bar	0	0%
	Seat pillar/lav. Partition		100%		UIC end construction		0%

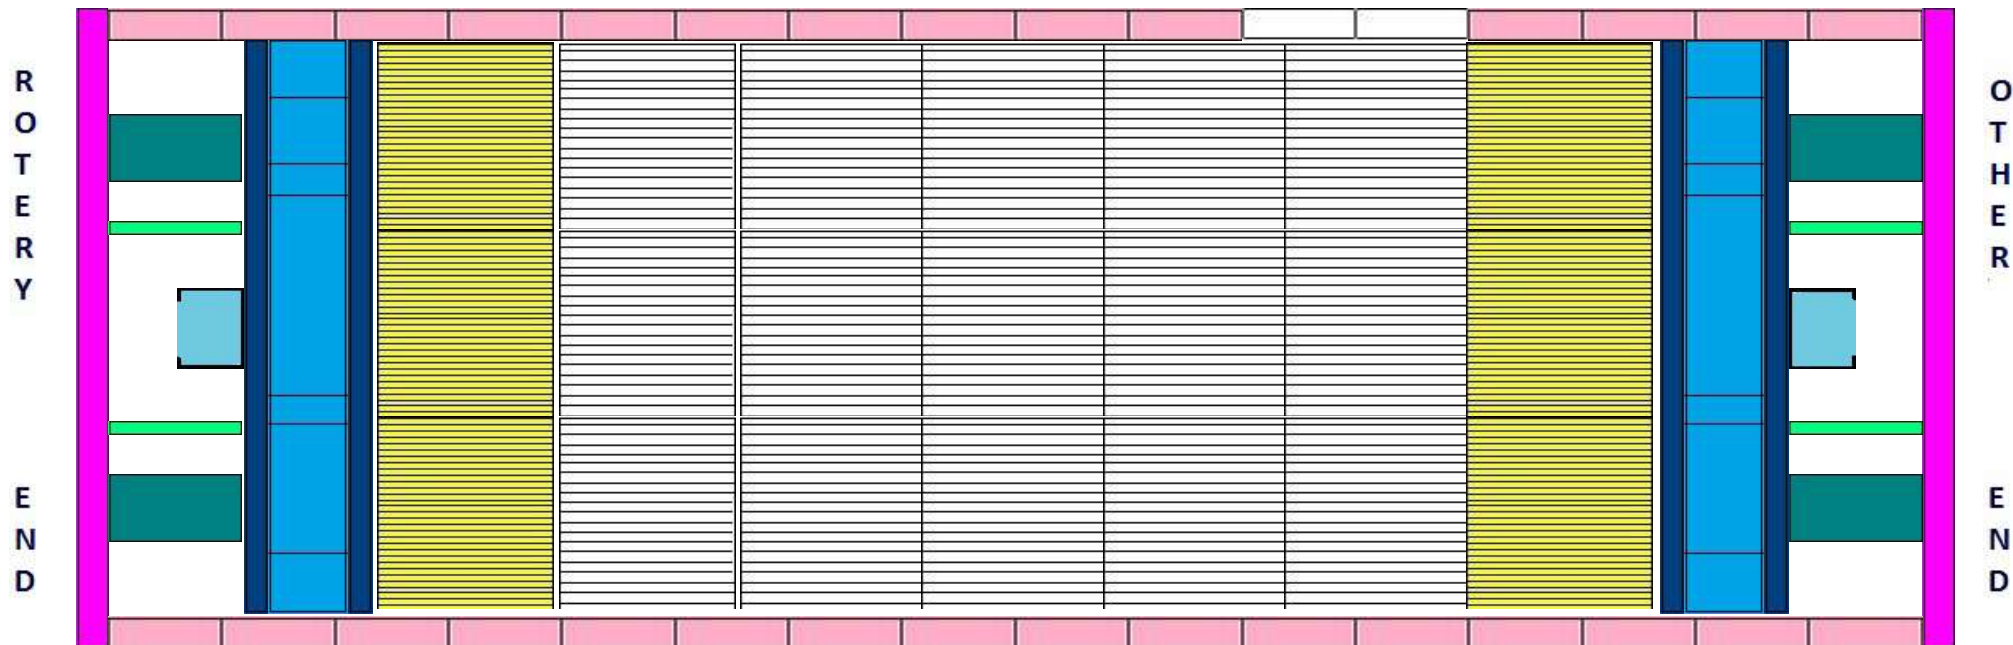
Rotary Side

Color	Particulars	Qty	Per%	Color	Particulars	Qty	Per%	Color	Particulars	Qty	Per%
	Headstock Beam	2	100%		Centre Stiffner for Headstock	4	100%		Floor Stiffner for Headstock	4	100%
	Aux. Head stock	4	100%		Sole Bar	15	94%		Draft Gear Bracket	2	100%
	Trough floor	2	29%		Centre plate	2	100%		SoleBar Stiffner	4	100%
	Bottom Wall Part	15	94%		Body panel/patch		100%		Door Top/Roof Patch		0%
	Window Module		0%		Window Sill	12	63%		Window Bar	30	36%
	Seat pillar/lav. Partition		100%		UIC end construction		0%

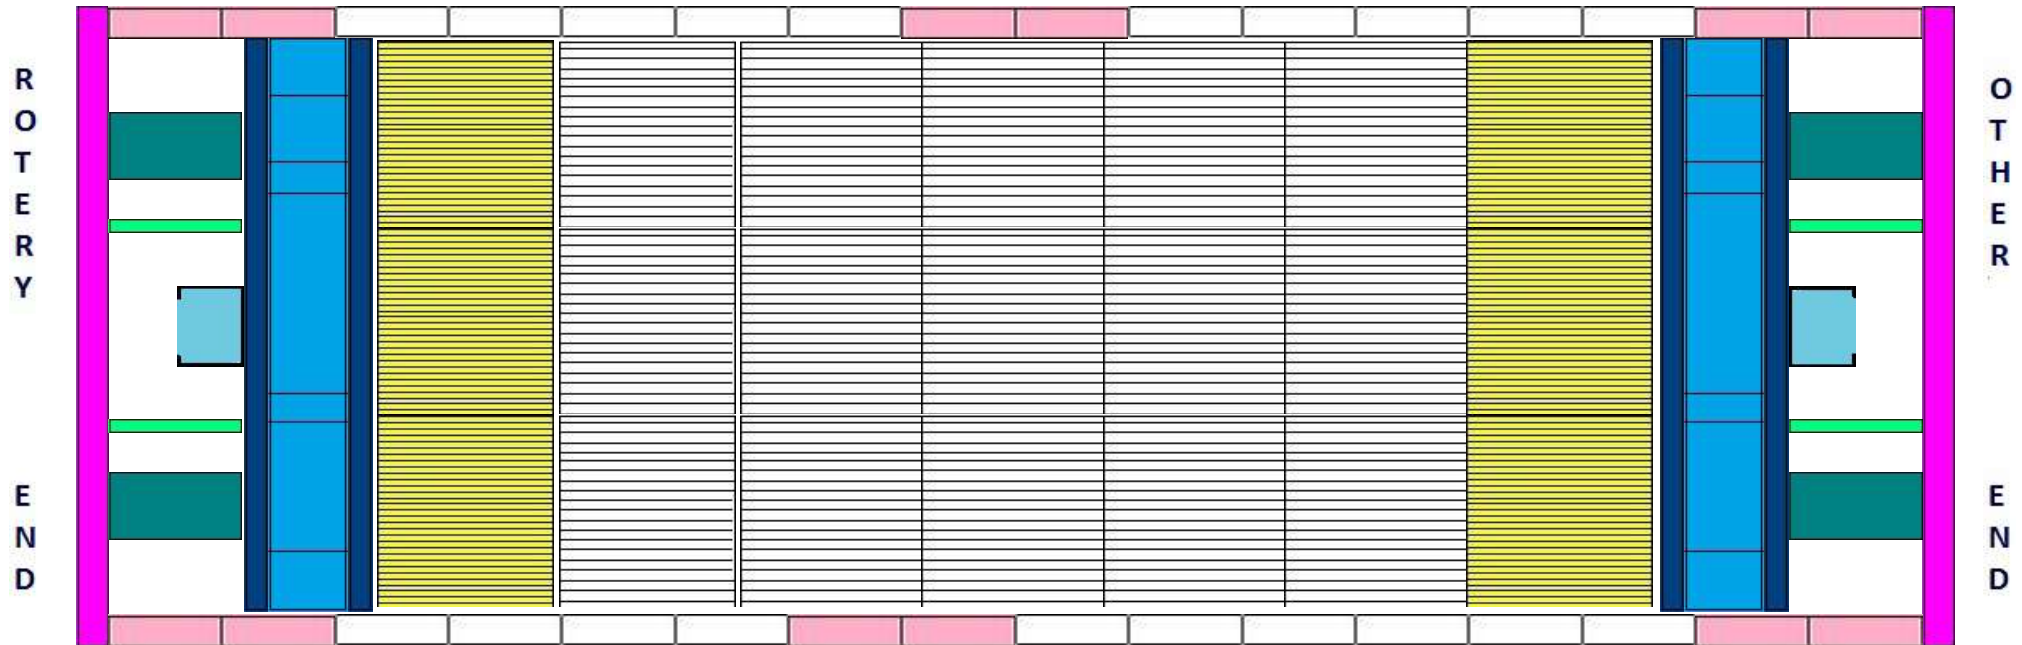
Rotary Side

Color	Particulars	Qty	Per%	Color	Particulars	Qty	Per%	Color	Particulars	Qty	Per%
Yellow	Headstock Beam	2	100%	Blue	Centre Stiffner for Headstock	4	100%	Red	Floor Stiffner for Headstock	4	100%
Dark Blue	Aux. Head stock	4	100%	Light Blue	Sole Bar	6	38%	Light Blue	Draft Gear Bracket	2	100%
Yellow	Trough floor	2	29%	Light Blue	Centre plate	2	100%		SoleBar Stiffner	6	100%
	Bottom Wall Part	6	38%		Body panel/patch		100%		Door Top/Roof Patch		0%
	Window Module		0%		Window Sill	40	100%		Window Bar	46	25%
	Seat pillar/lav. Partition		100%		UIC end construction		0%

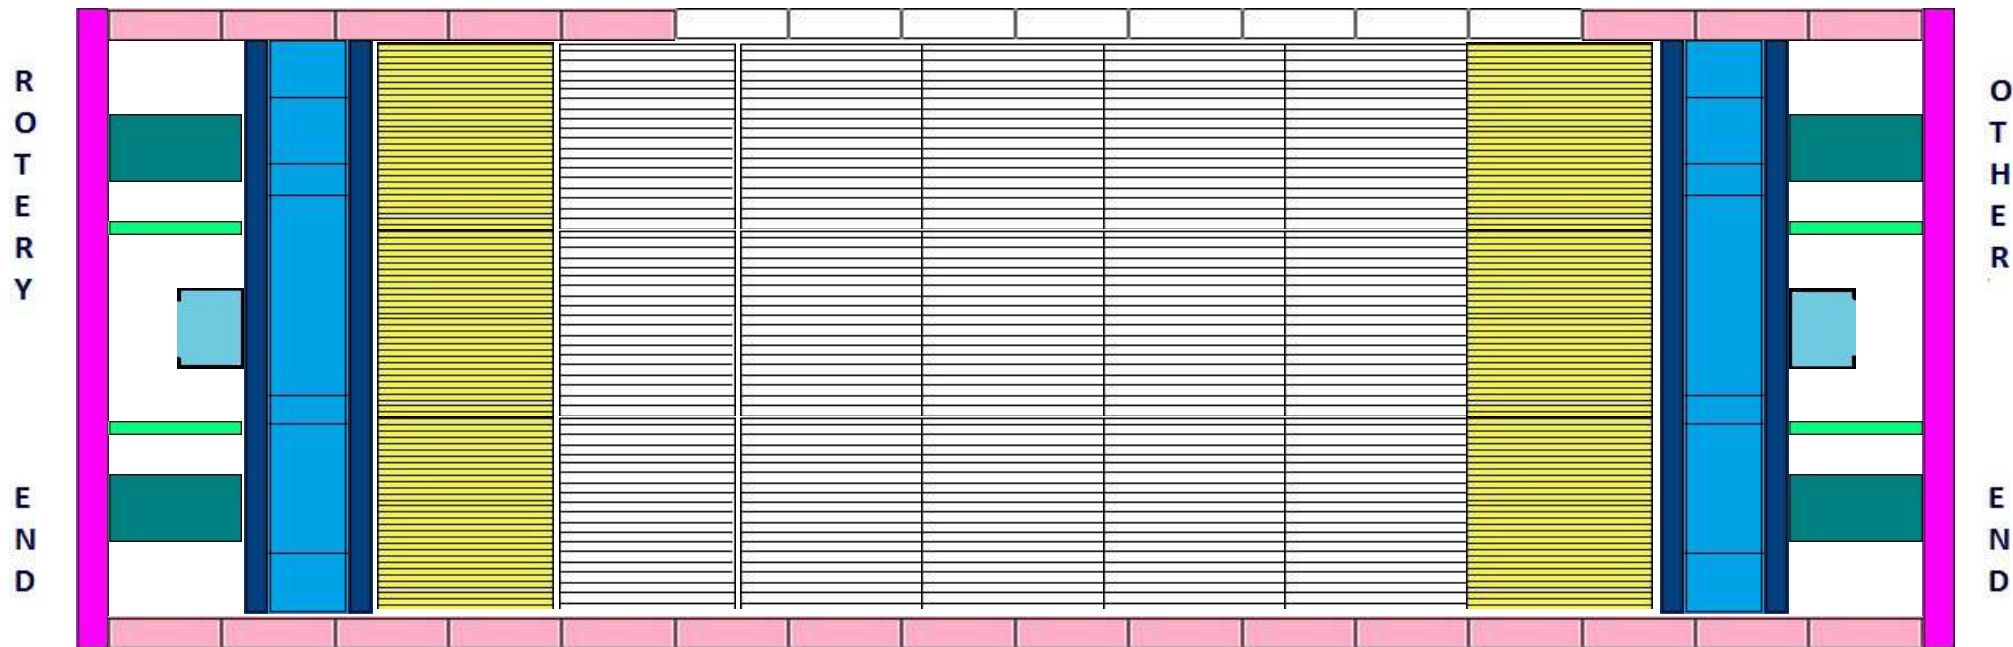
Rotary Side

Color	Particulars	Qty	Per%	Color	Particulars	Qty	Per%	Color	Particulars	Qty	Per%
Yellow	Headstock Beam	2	100%	Dark Green	Centre Stiffner for Headstock	4	100%	Light Green	Floor Stiffner for Headstock	4	100%
Dark Blue	Aux. Head stock	4	100%	Pink	Sole Bar	12	75%	Light Blue	Draft Gear Bracket	2	100%
Yellow	Trough floor	2	29%	Light Blue	Centre plate	2	100%		SoleBar Stiffner	5	83%
	Bottom Wall Part	12	75%		Body panel/patch		100%		Door Top/Roof Patch		0%
	Window Module		0%		Window Sill	40	100%		Window Bar	48	27%
	Seat pillar/lav. Partition		100%		UIC end construction		0%

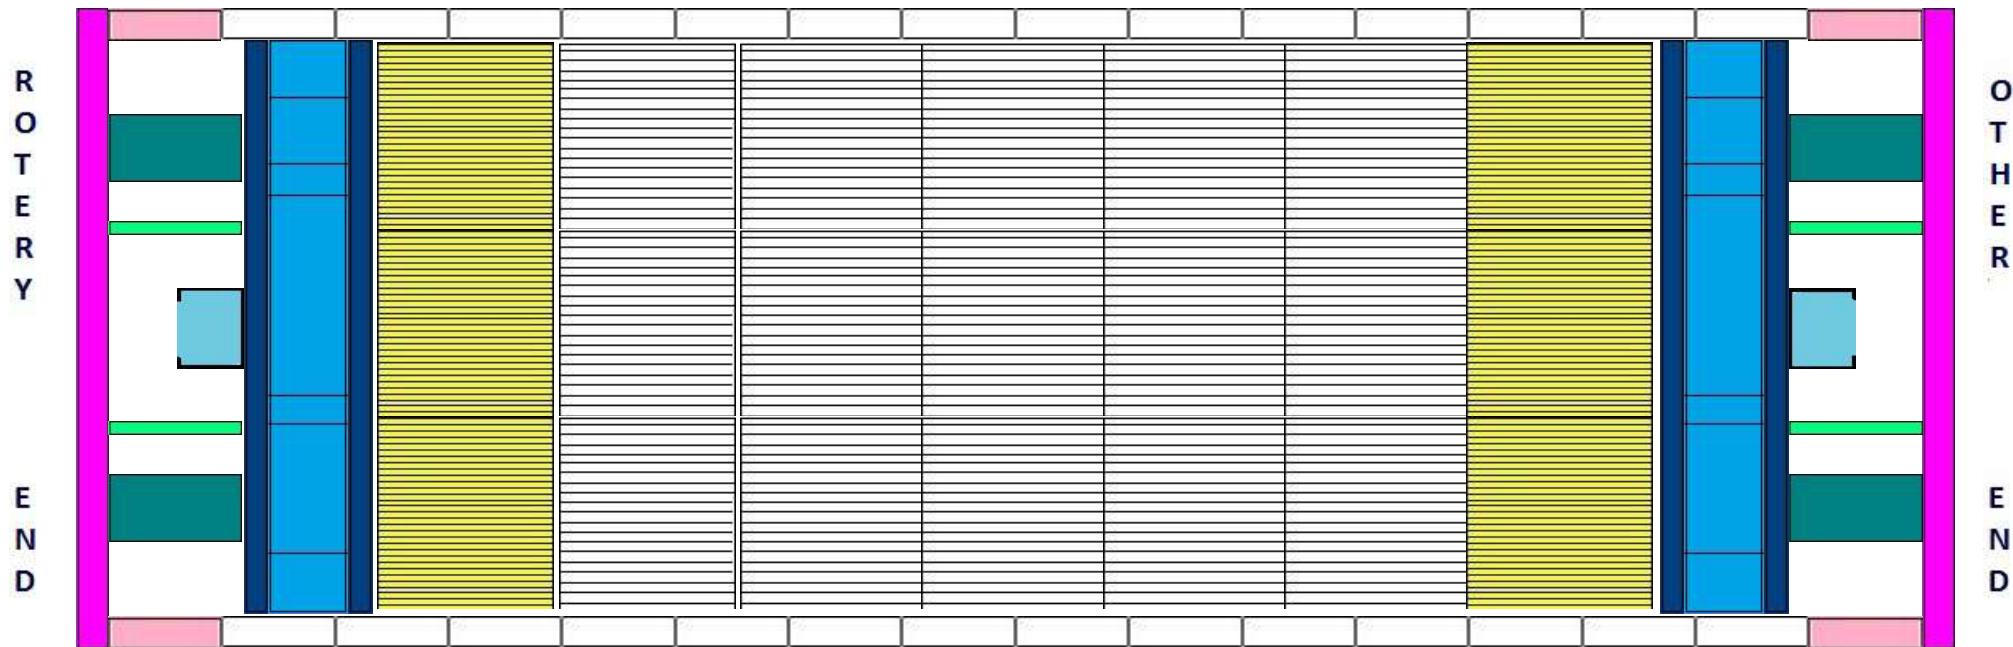
Rotary Side

Color	Particulars	Qty	Per%	Color	Particulars	Qty	Per%	Color	Particulars	Qty	Per%
	Headstock Beam	2	100%		Centre Stiffner for Headstock	4	100%		Floor Stiffner for Headstock	4	100%
	Aux. Head stock	4	100%		Sole Bar	2	13%		Draft Gear Bracket	2	100%
	Trough floor	2	29%		Centre plate	2	100%		SoleBar Stiffner	4	100%
	Bottom Wall Part	2	13%		Body panel/patch		100%		Door Top/Roof Patch		0%
	Window Module		0%		Window Sill	0	0%		Window Bar	0	0%
	Seat pillar/lav. Partition		100%		UIC end construction		0%

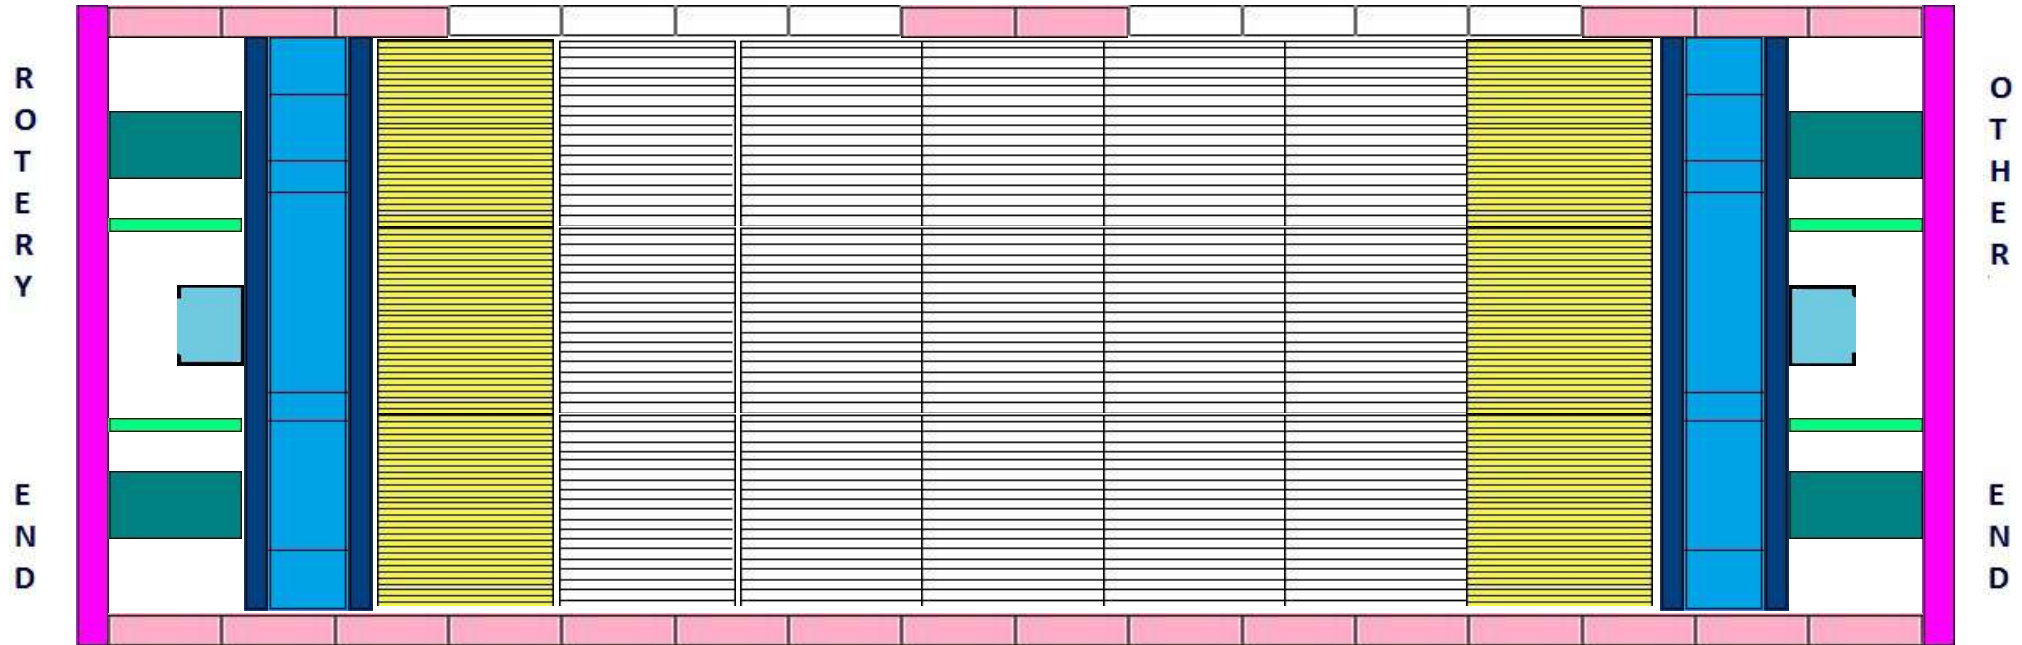
Rotary Side

Color	Particulars	Qty	Per%	Color	Particulars	Qty	Per%	Color	Particulars	Qty	Per%
Yellow	Headstock Beam	2	100%	Dark Green	Centre Stiffner for Headstock	4	100%	Light Green	Floor Stiffner for Headstock	4	100%
Dark Blue	Aux. Head stock	4	100%	Pink	Sole Bar	12	75%	Light Blue	Draft Gear Bracket	2	100%
Yellow	Trough floor	2	29%	Light Blue	Centre plate	2	100%		SoleBar Stiffner	4	100%
	Bottom Wall Part	12	75%		Body panel/patch		100%		Door Top/Roof Patch		0%
	Window Module		0%		Window Sill	40	100%		Window Bar	52	28%
	Seat pillar/lav. Partition		100%		UIC end construction		0%
