Coach Rehabilitation Workshop, WC Railway, Bhopal

(An IMS and ISO 50001 Certified Workshop)
Final Inspection Sheet - Details of Corrosion Repair

Coach No. :WR017041

Type : GSLRD

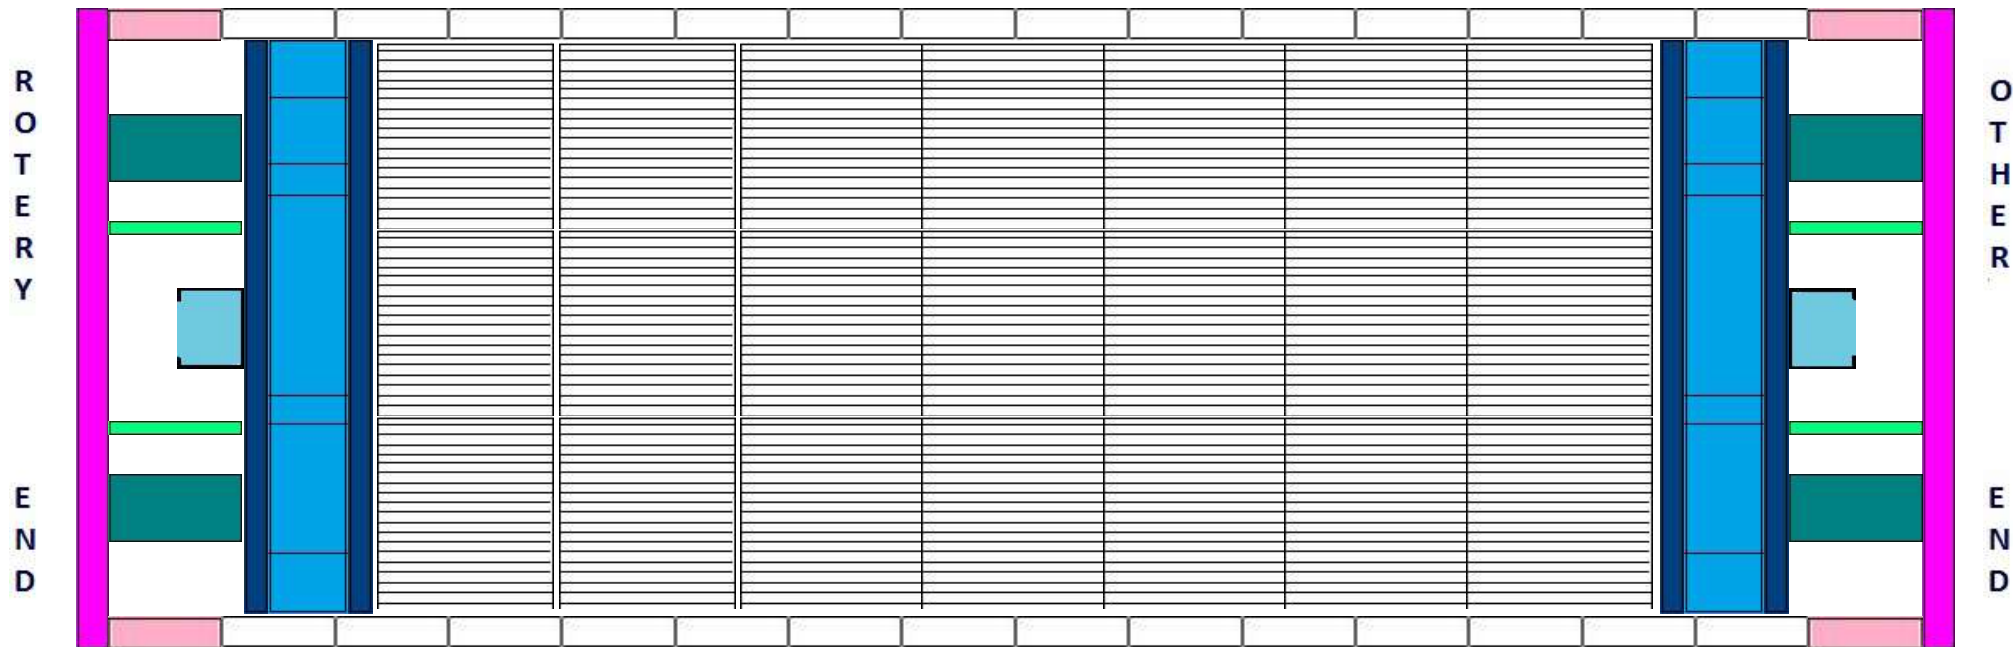
Rotary Side

Color	Particulars	Qty	Per%	Color	Particulars	Qty	Per%	Color	Particulars	Qty	Per%
Yellow	Headstock Beam	2	100%	Dark Blue	Centre Stiffner for Headstock	4	100%	Light Green	Floor Stiffner for Headstock	4	100%
Dark Blue	Aux. Head stock	4	100%	Light Pink	Sole Bar	2	13%	Light Blue	Draft Gear Bracket	2	100%
Yellow	Trough floor	0	0%	Light Blue	Centre plate	2	100%		SoleBar Stiffner	4	100%
	Bottom Wall Part	2	13%		Body panel/patch		0%		Door Top/Roof Patch		0%
	Window Module		0%		Window Sill	0	0%		Window Bar	0	0%
	Seat pillar/lav. Partition		100%		UIC end construction		0%

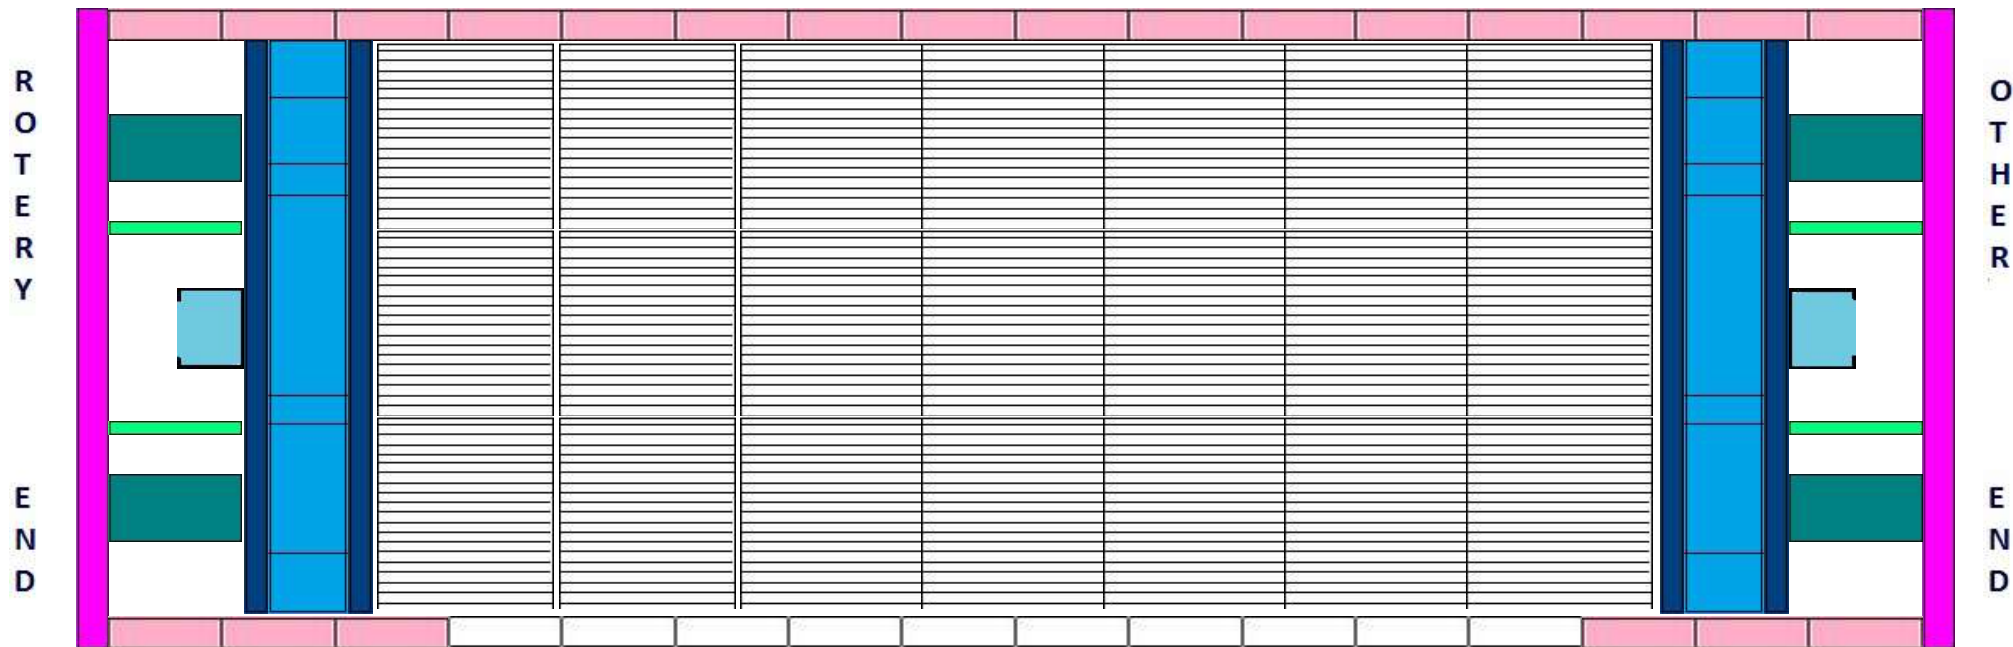
Color	Particulars	Qty	Per%	Color	Particulars	Qty	Per%	Color	Particulars	Qty	Per%
Blue	Headstock Beam	2	100%	Red	Centre Stiffner for Headstock	4	100%	Green	Floor Stiffner for Headstock	4	100%
Black	Aux. Head stock	4	100%	Yellow	Sole Bar	11	69%	Light Blue	Draft Gear Bracket	2	100%
Orange	Trough floor	0	0%	Dark Blue	Centre plate	2	100%		SoleBar Stiffner	4	100%
	Bottom Wall Part	11	69%		Body panel/patch		20%		Door Top/Roof Patch		0%
	Window Module		0%		Window Sill	0	0%		Window Bar	0	0%
	Seat pillar/lav. Partition		100%		UIC end construction		0%

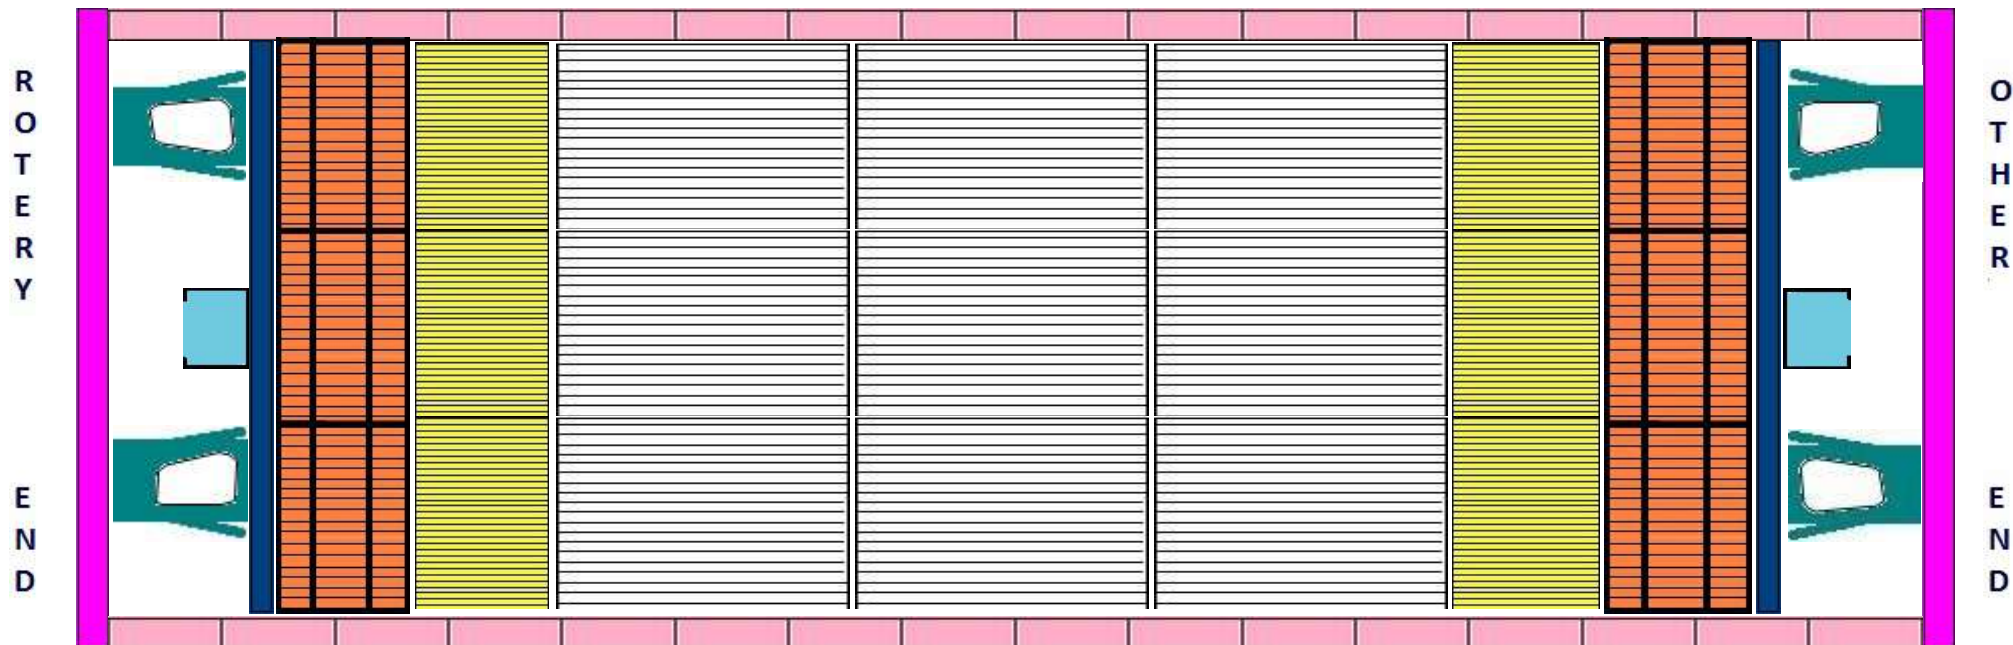
Rotary Side

Color	Particulars	Qty	Per%	Color	Particulars	Qty	Per%	Color	Particulars	Qty	Per%
	Headstock Beam	2	100%		Diagonal	4	100%		Logitudinal Channel Structure	2	100%
	Aux. Head stock	2	100%		Sole Bar	16	100%		Draft Gear Bracket	2	100%
	Trough floor	2	40%		Bottom Wall Part	16	100%		Body panel/patch		100%
	Door Top/Roof Patch		0%		Seat Bracket Rail		0%		Window Sill	12	30%
	Window Bar	32	17%		Seat pillar/lav. Partition		100%		UIC end construction		0%
	Body Pillar Part	88	100%
