Coach Rehabilitation Workshop, WC Railway, Bhopal

(An IMS and ISO 50001 Certified Workshop)
Final Inspection Sheet - Details of Corrosion Repair

Coach No. : EC05057

Type : WGACCW

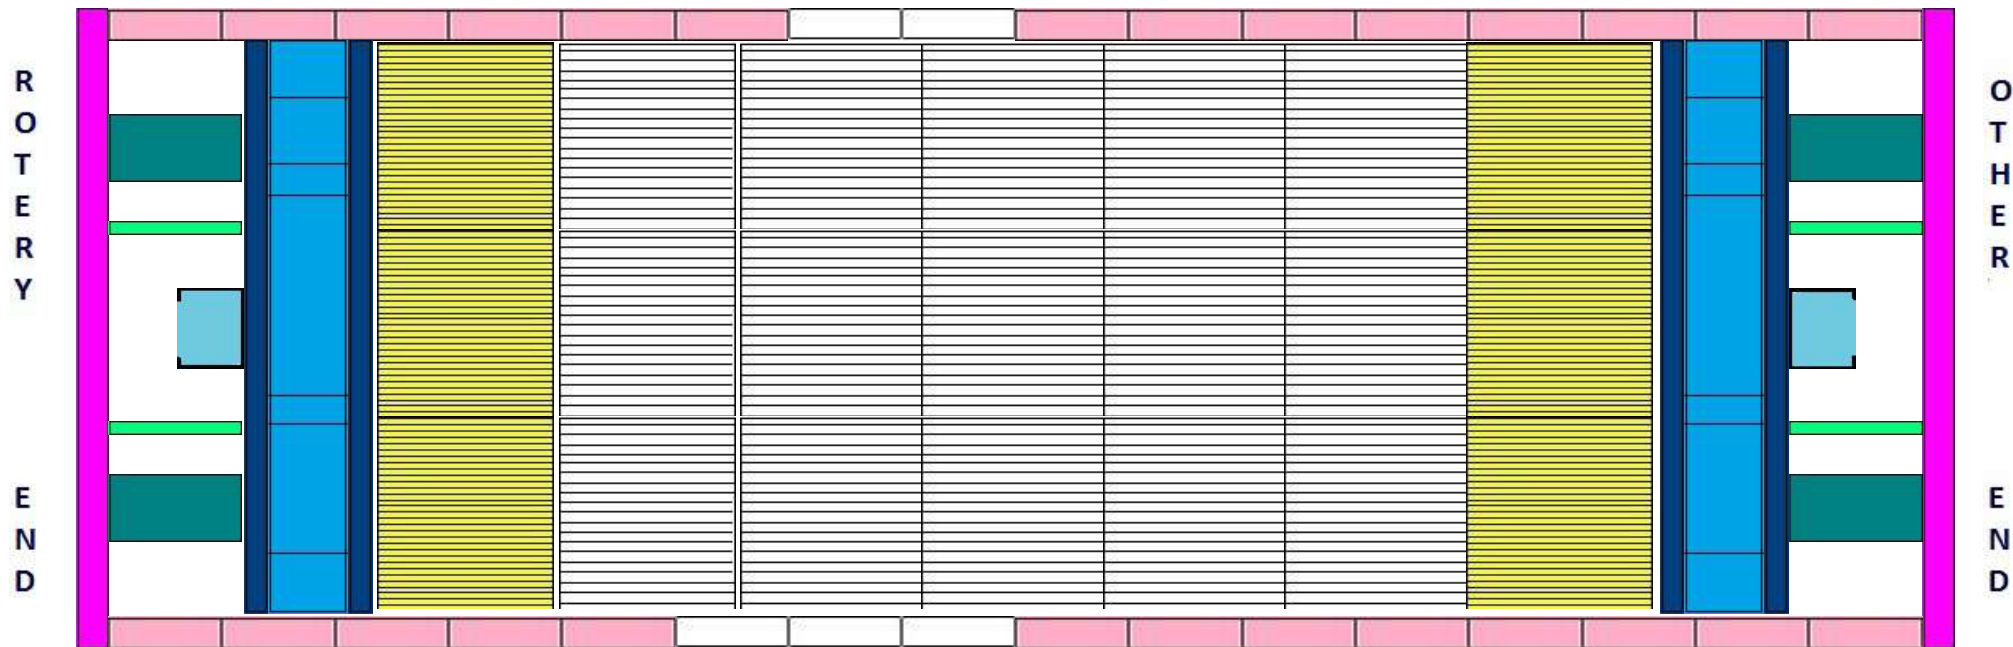
Rotary Side

Color	Particulars	Qty	Per%	Color	Particulars	Qty	Per%	Color	Particulars	Qty	Per%
Yellow	Headstock Beam	2	100%	Dark Green	Centre Stiffner for Headstock	4	100%	Light Green	Floor Stiffner for Headstock	4	100%
Dark Blue	Aux. Head stock	4	100%	Pink	Sole Bar	13.5	84%	Light Blue	Draft Gear Bracket	2	100%
Yellow	Trough floor	2	29%	Light Blue	Centre plate	2	100%		SoleBar Stiffner	6	100%
	Bottom Wall Part	13.5	84%		Body panel/patch		100%		Door Top/Roof Patch		0%
	Window Module		0%		Window Sill	40	100%		Window Bar	48	27%
	Seat pillar/lav. Partition		100%		UIC end construction		0%

End Drooping: Rotary End - EAST : -7, WEST : -5 Other End - EAST : 4, WEST : 3
Start Date : 22-Jul-2019, Completion Date : 27-Jul-2019, Net Repair Days : 6, Total Man Hours : 1420

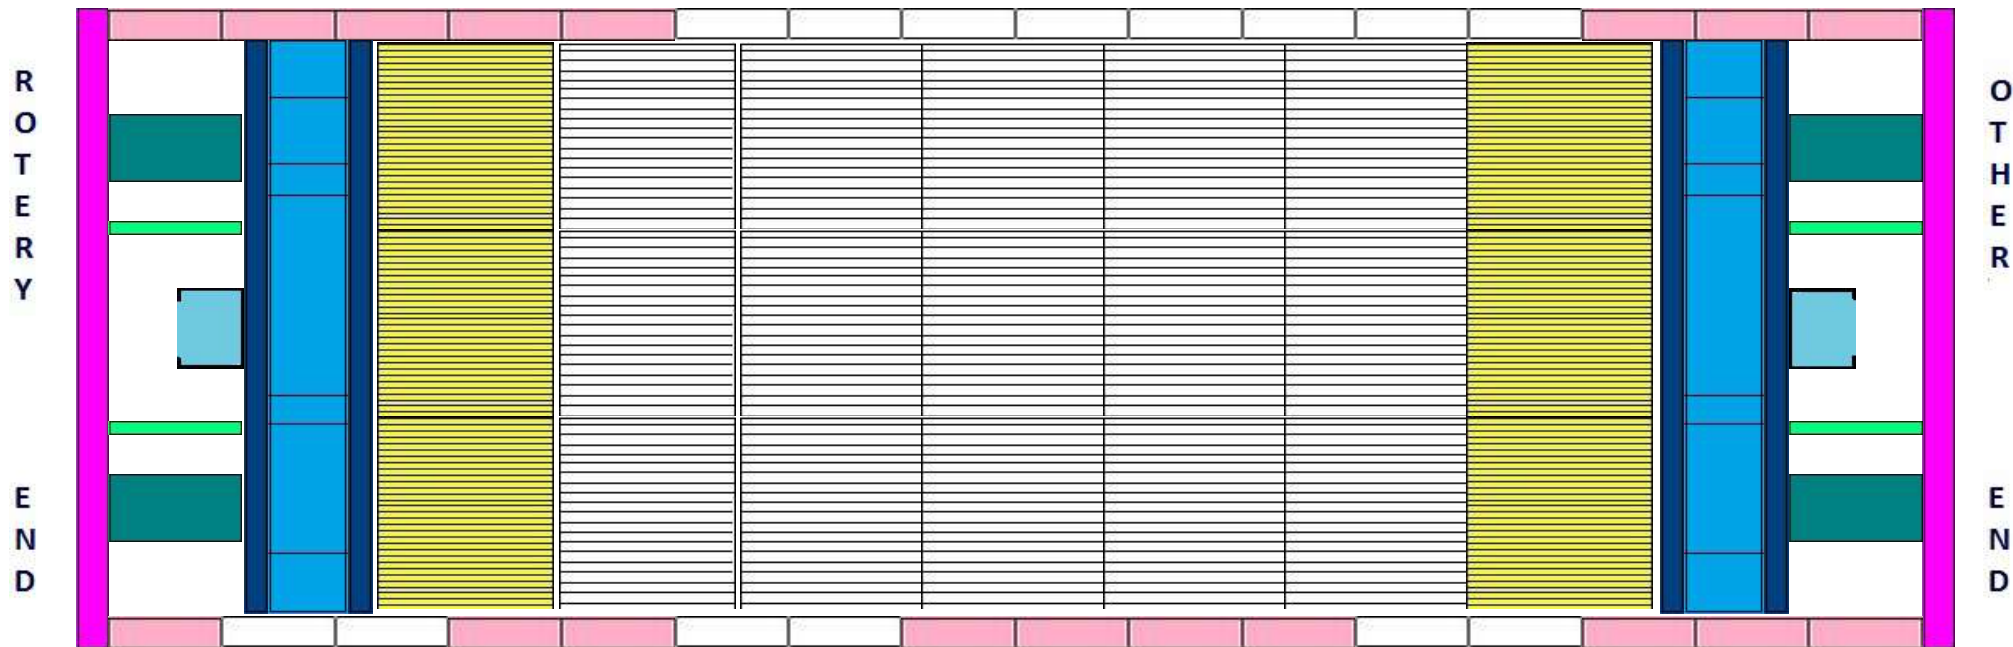
Color	Particulars	Qty	Per%	Color	Particulars	Qty	Per%	Color	Particulars	Qty	Per%
Yellow	Headstock Beam	2	100%	Dark Green	Centre Stiffner for Headstock	4	100%	Light Green	Floor Stiffner for Headstock	4	100%
Dark Blue	Aux. Head stock	4	100%	Pink	Sole Bar	9	56%	Light Blue	Draft Gear Bracket	2	100%
Yellow	Trough floor	2	29%	Light Blue	Centre plate	2	100%		SoleBar Stiffner	4	100%
	Bottom Wall Part	9	56%		Body panel/patch		100%		Door Top/Roof Patch		0%
	Window Module		0%		Window Sill	7	37%		Window Bar	10	12%
	Seat pillar/lav. Partition		100%		UIC end construction		0%

End Drooping: Rotary End - EAST : 2, WEST : 0 Other End - EAST : 2, WEST : 0
Start Date : 24-Jul-2019, Completion Date : 02-Aug-2019, Net Repair Days : 9, Total Man Hours : 1560

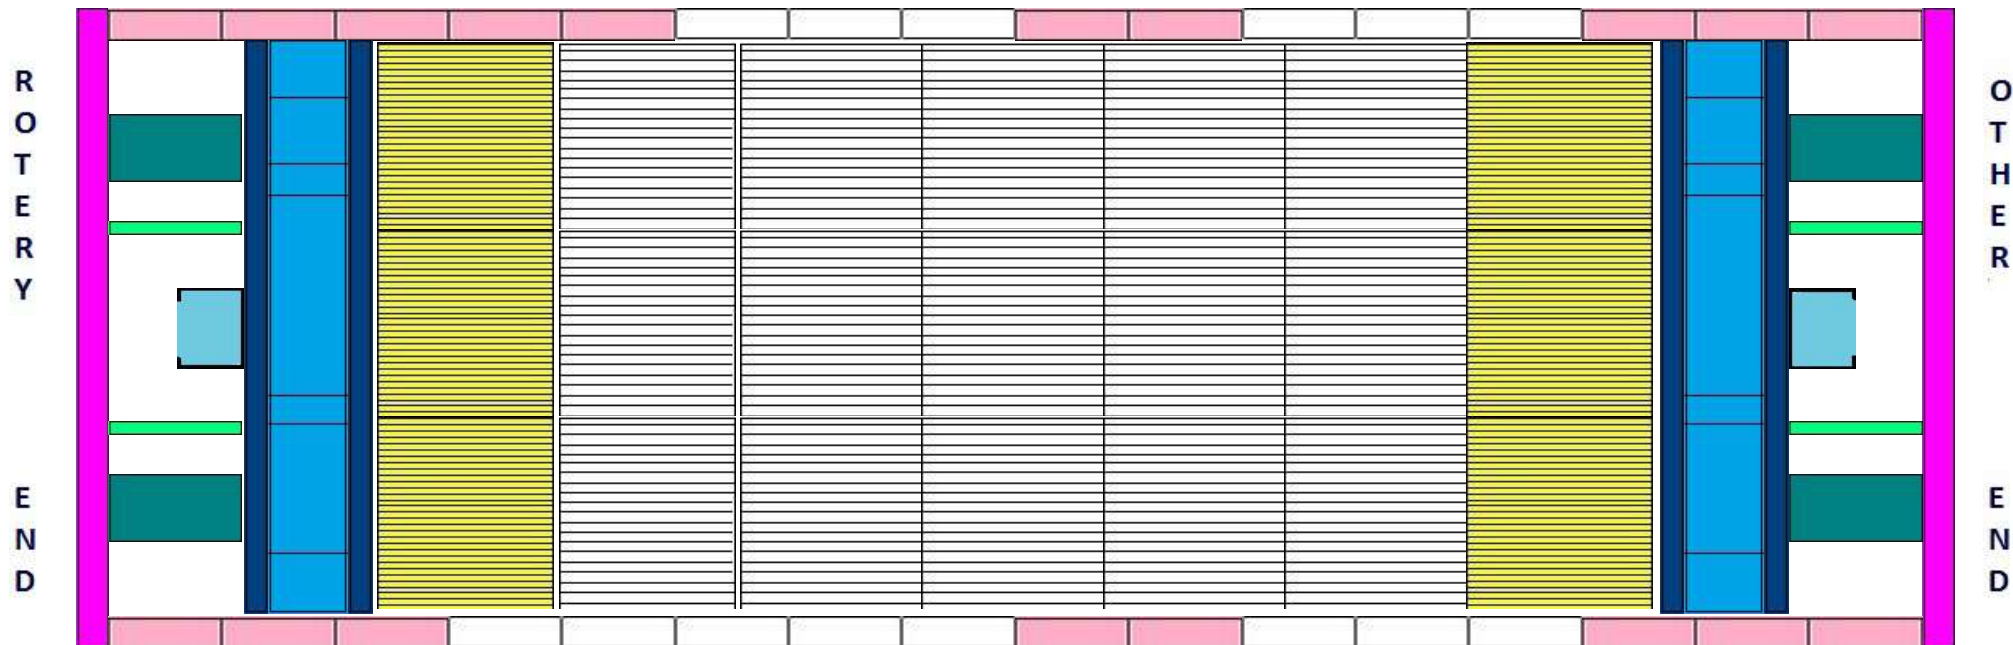
Rotary Side

Color	Particulars	Qty	Per%	Color	Particulars	Qty	Per%	Color	Particulars	Qty	Per%
Yellow	Headstock Beam	2	100%	Dark Green	Centre Stiffner for Headstock	4	100%	Light Green	Floor Stiffner for Headstock	4	100%
Dark Blue	Aux. Head stock	4	100%	Pink	Sole Bar	9	56%	Light Blue	Draft Gear Bracket	2	100%
Yellow	Trough floor	2	29%	Light Blue	Centre plate	2	100%		SoleBar Stiffner	6	100%
	Bottom Wall Part	9	56%		Body panel/patch		100%		Door Top/Roof Patch		0%
	Window Module		0%		Window Sill	28	70%		Window Bar	44	25%
	Seat pillar/lav. Partition		100%		UIC end construction		0%

End Drooping: Rotary End - EAST : -2, WEST : 0 Other End - EAST : -3, WEST : -4
Start Date : 30-Sep-2019, Completion Date : 07-Oct-2019, Net Repair Days : 7, Total Man Hours : 1344

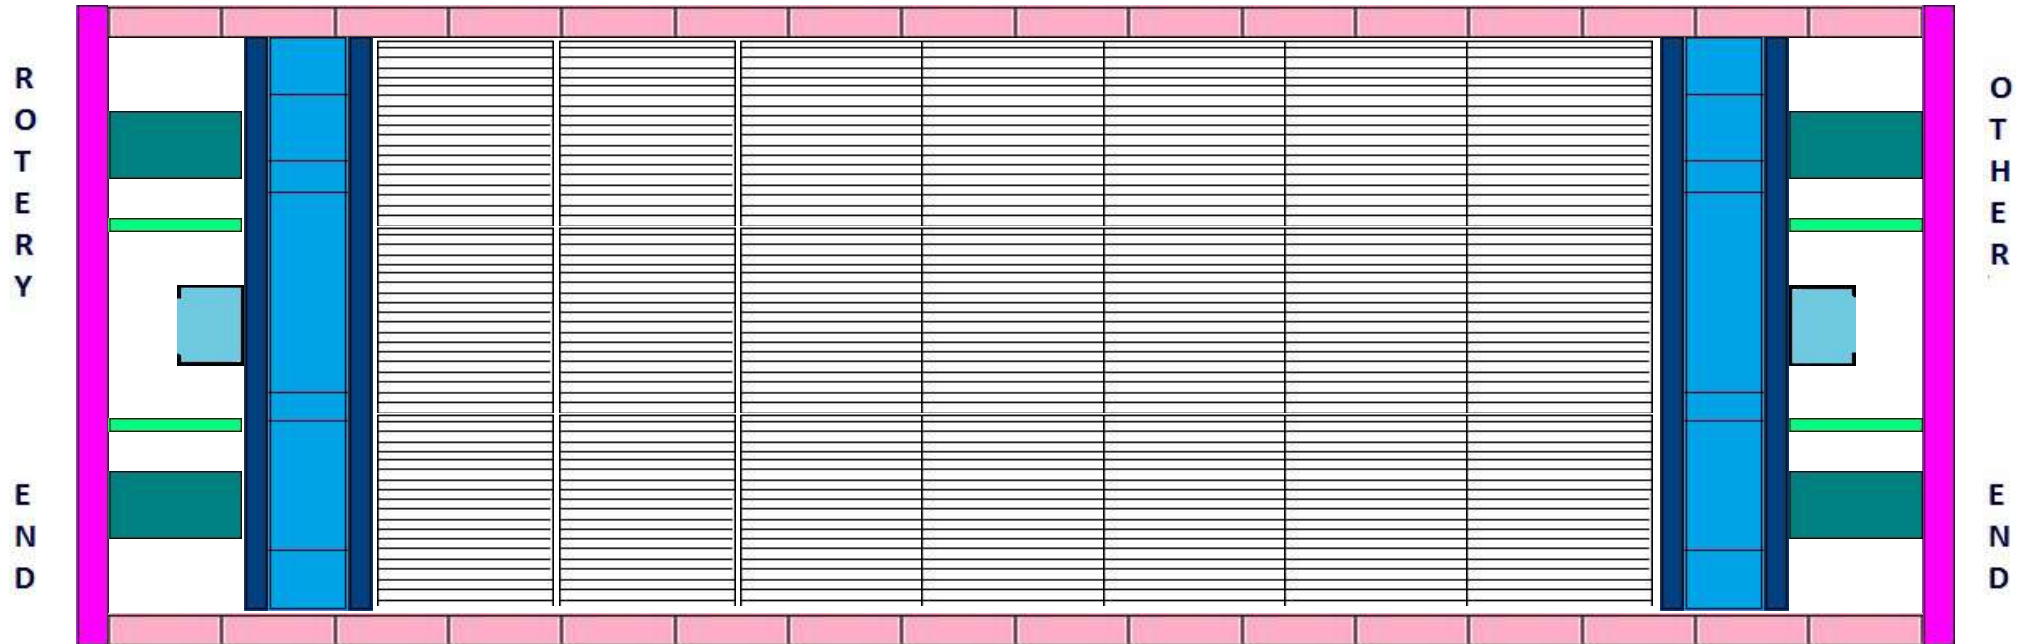
Rotary Side

Color	Particulars	Qty	Per%	Color	Particulars	Qty	Per%	Color	Particulars	Qty	Per%
	Headstock Beam	2	100%		Centre Stiffner for Headstock	4	100%		Floor Stiffner for Headstock	4	100%
	Aux. Head stock	4	100%		Sole Bar	16	100%		Draft Gear Bracket	2	100%
	Trough floor	0	0%		Centre plate	2	100%		SoleBar Stiffner	4	100%
	Bottom Wall Part	16	100%		Body panel/patch		100%		Door Top/Roof Patch		0%
	Window Module		0%		Window Sill	14	39%		Window Bar	24	14%
	Seat pillar/lav. Partition		100%		UIC end construction		0%

End Drooping: Rotary End - EAST : 2, WEST : -3 Other End - EAST : -4, WEST : -3
Start Date : 01-Oct-2019, Completion Date : 11-Oct-2019, Net Repair Days : 10, Total Man Hours : 1600

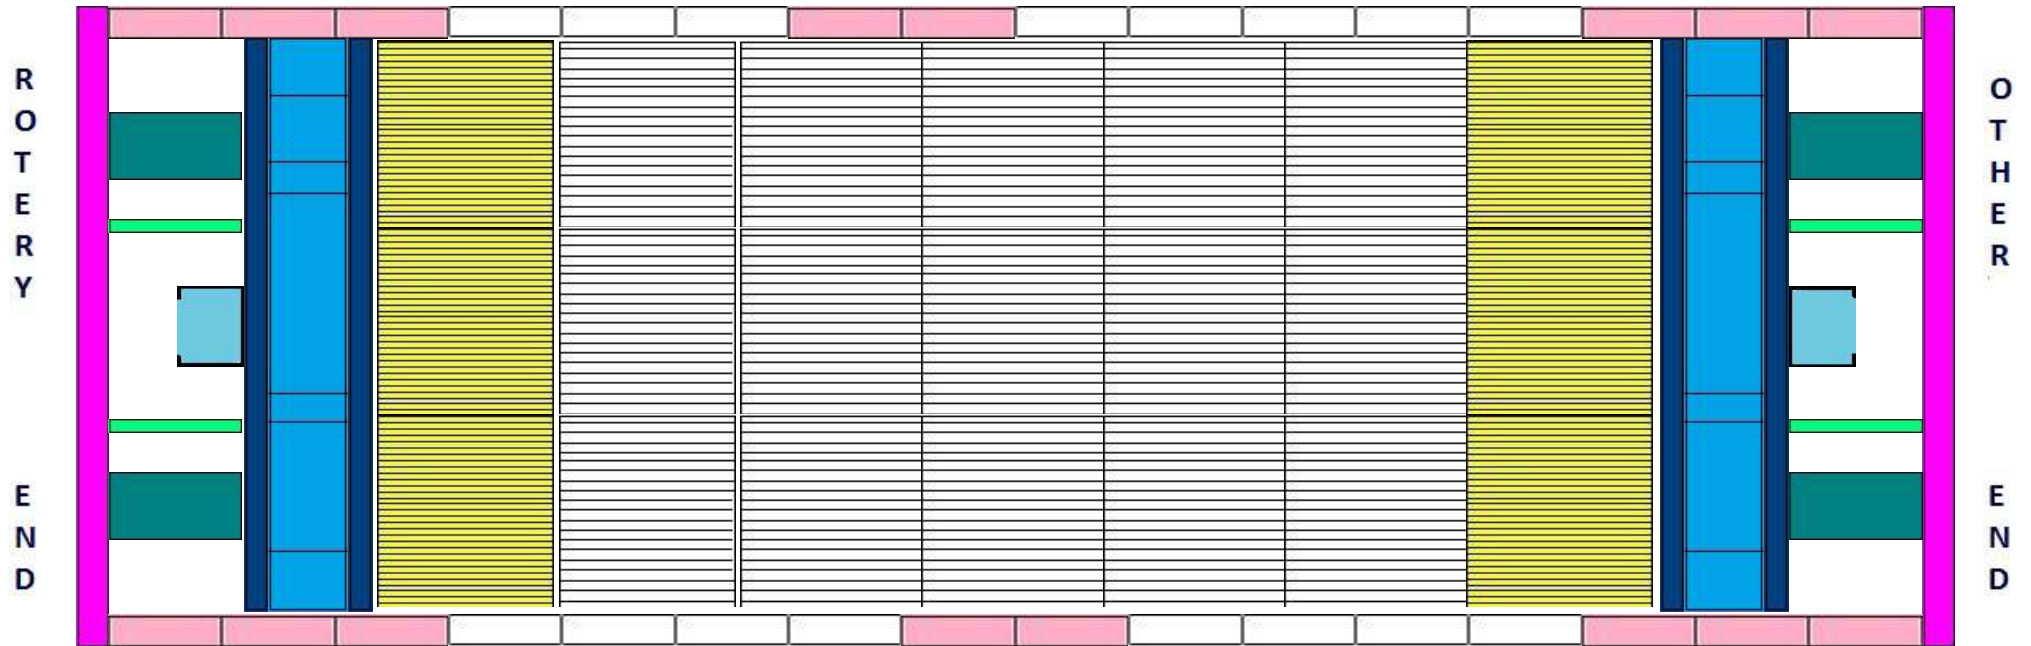
Rotary Side

Color	Particulars	Qty	Per%	Color	Particulars	Qty	Per%	Color	Particulars	Qty	Per%
	Headstock Beam	2	100%		Centre Stiffner for Headstock	4	100%		Floor Stiffner for Headstock	4	100%
	Aux. Head stock	4	100%		Sole Bar	8	50%		Draft Gear Bracket	2	100%
	Trough floor	2	29%		Centre plate	2	100%		SoleBar Stiffner	6	100%
	Bottom Wall Part	8	50%		Body panel/patch		100%		Door Top/Roof Patch		0%
	Window Module		0%		Window Sill	24	60%		Window Bar	44	25%
	Seat pillar/lav. Partition		100%		UIC end construction		0%

End Drooping: Rotary End - EAST : 3, WEST : 0 Other End - EAST : 10, WEST : 4
Start Date : 31-Oct-2019, Completion Date : 09-Nov-2019, Net Repair Days : 9, Total Man Hours : 1088

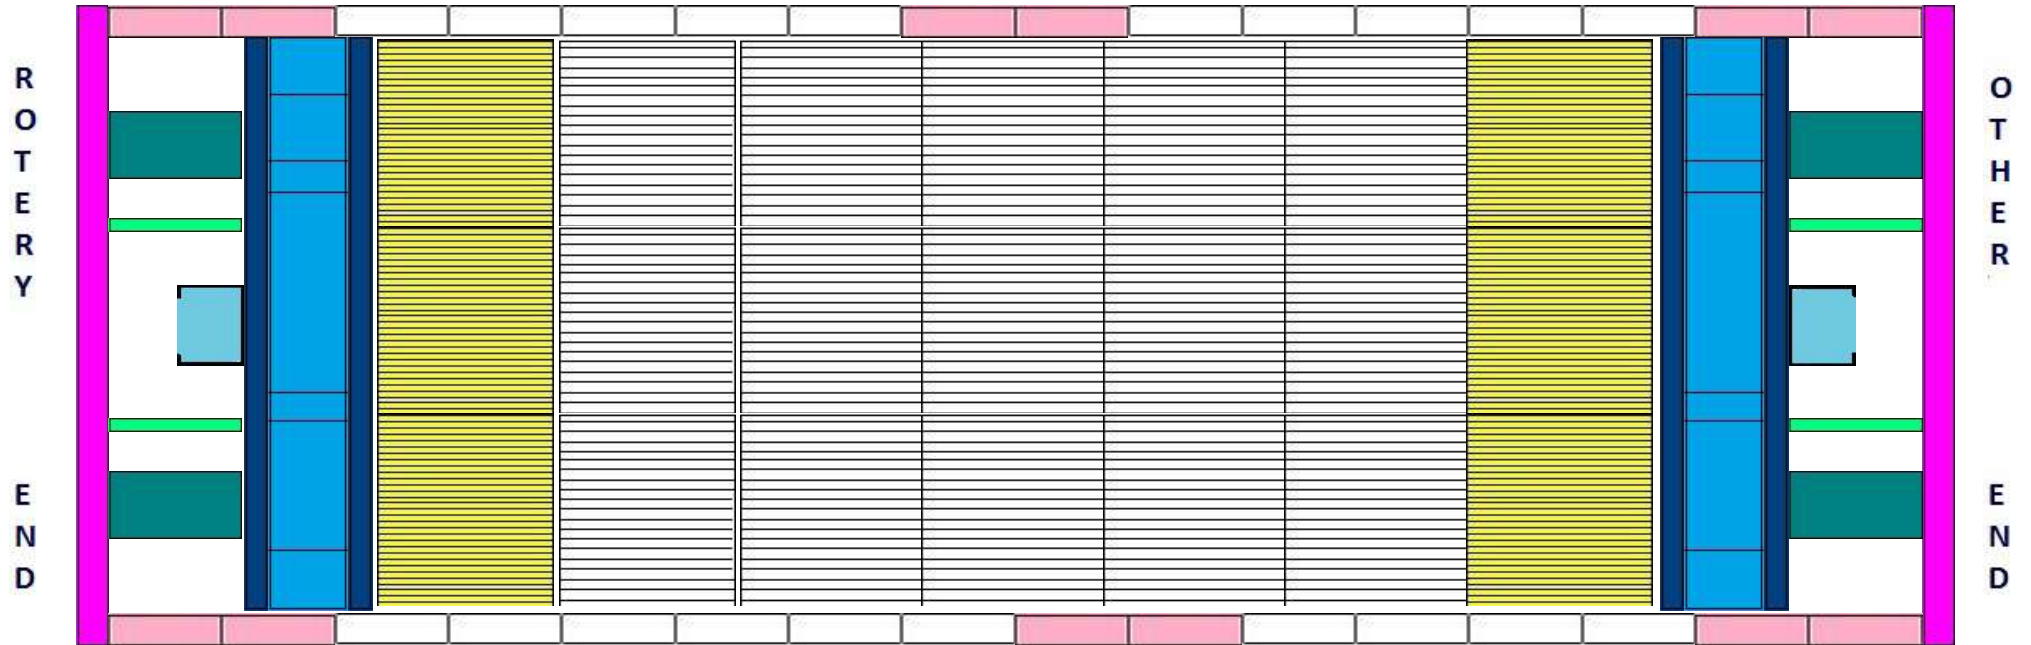
Rotary Side

Color	Particulars	Qty	Per%	Color	Particulars	Qty	Per%	Color	Particulars	Qty	Per%
Pink	Headstock Beam	2	100%	Dark Green	Centre Stiffner for Headstock	4	100%	Light Green	Floor Stiffner for Headstock	4	100%
Dark Blue	Aux. Head stock	4	100%	Pink	Sole Bar	6	38%	Light Blue	Draft Gear Bracket	2	100%
Yellow	Trough floor	2	29%	Light Blue	Centre plate	2	100%		SoleBar Stiffner	6	100%
	Bottom Wall Part	6	38%		Body panel/patch		100%		Door Top/Roof Patch		0%
	Window Module		0%		Window Sill	32	80%		Window Bar	44	25%
	Seat pillar/lav. Partition		100%		UIC end construction		0%

End Drooping: Rotary End - EAST : -5, WEST : -3 Other End - EAST : -5, WEST : 0
Start Date : 16-Aug-2019, Completion Date : 21-Aug-2019, Net Repair Days : 5, Total Man Hours : 1332

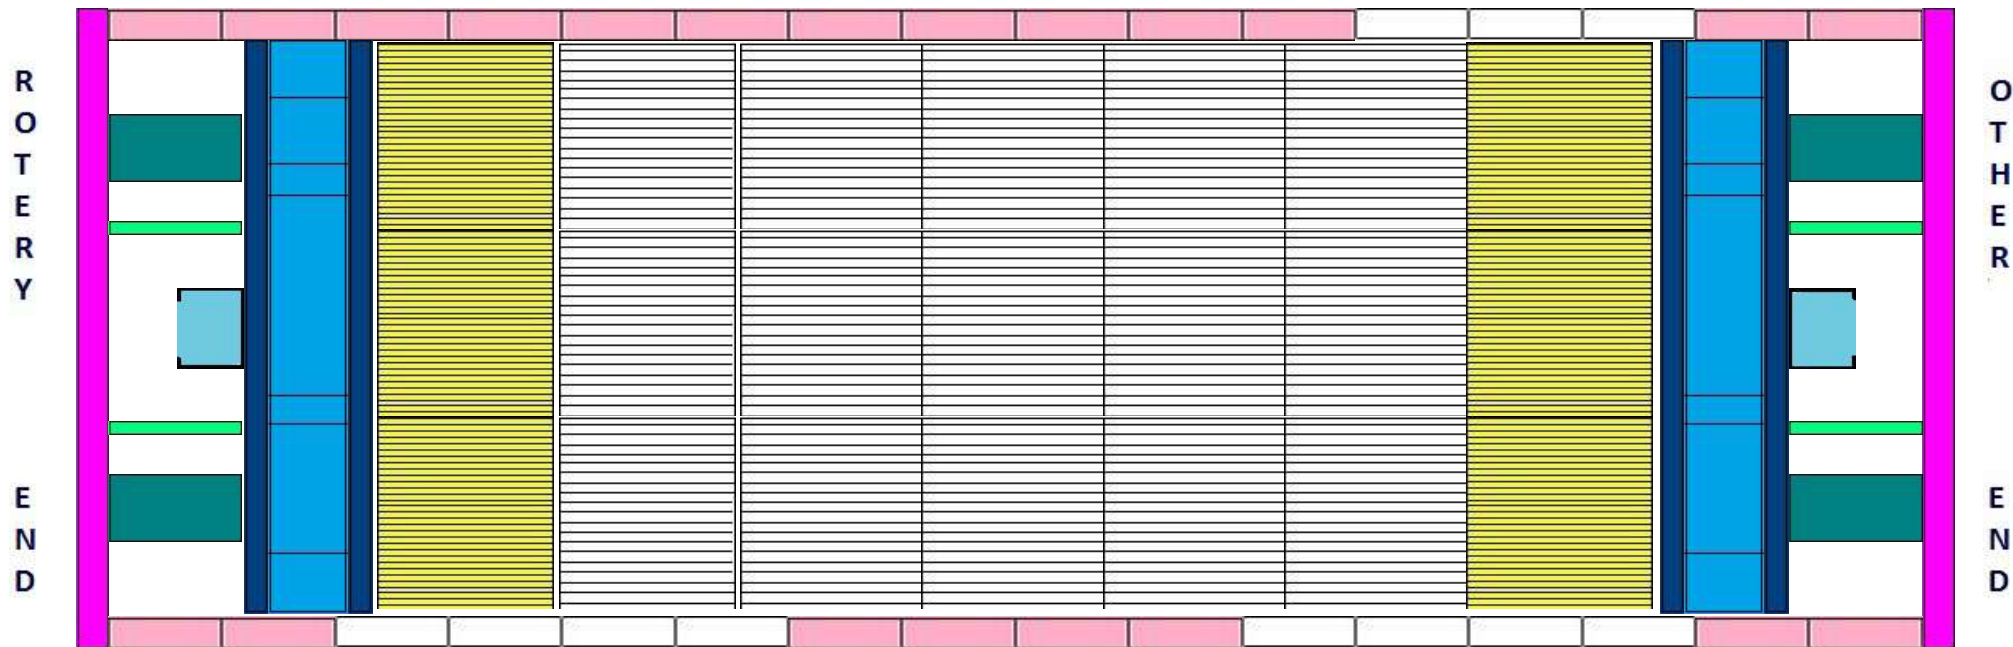
Color	Particulars	Qty	Per%	Color	Particulars	Qty	Per%	Color	Particulars	Qty	Per%
Yellow	Headstock Beam	2	100%	Dark Green	Centre Stiffner for Headstock	4	100%	Light Green	Floor Stiffner for Headstock	4	100%
Dark Blue	Aux. Head stock	4	100%	Pink	Sole Bar	10.5	66%	Light Blue	Draft Gear Bracket	2	100%
Yellow	Trough floor	2	29%	Light Blue	Centre plate	2	100%		SoleBar Stiffner	4	100%
	Bottom Wall Part	10.5	66%		Body panel/patch		100%		Door Top/Roof Patch		0%
	Window Module		0%		Window Sill	20	50%		Window Bar	40	22%
	Seat pillar/lav. Partition		100%		UIC end construction		0%

End Drooping: Rotary End - EAST : 0, WEST : 0 Other End - EAST : 0, WEST : 0
Start Date : 26-Aug-2019, Completion Date : 31-Aug-2019, Net Repair Days : 6, Total Man Hours : 0

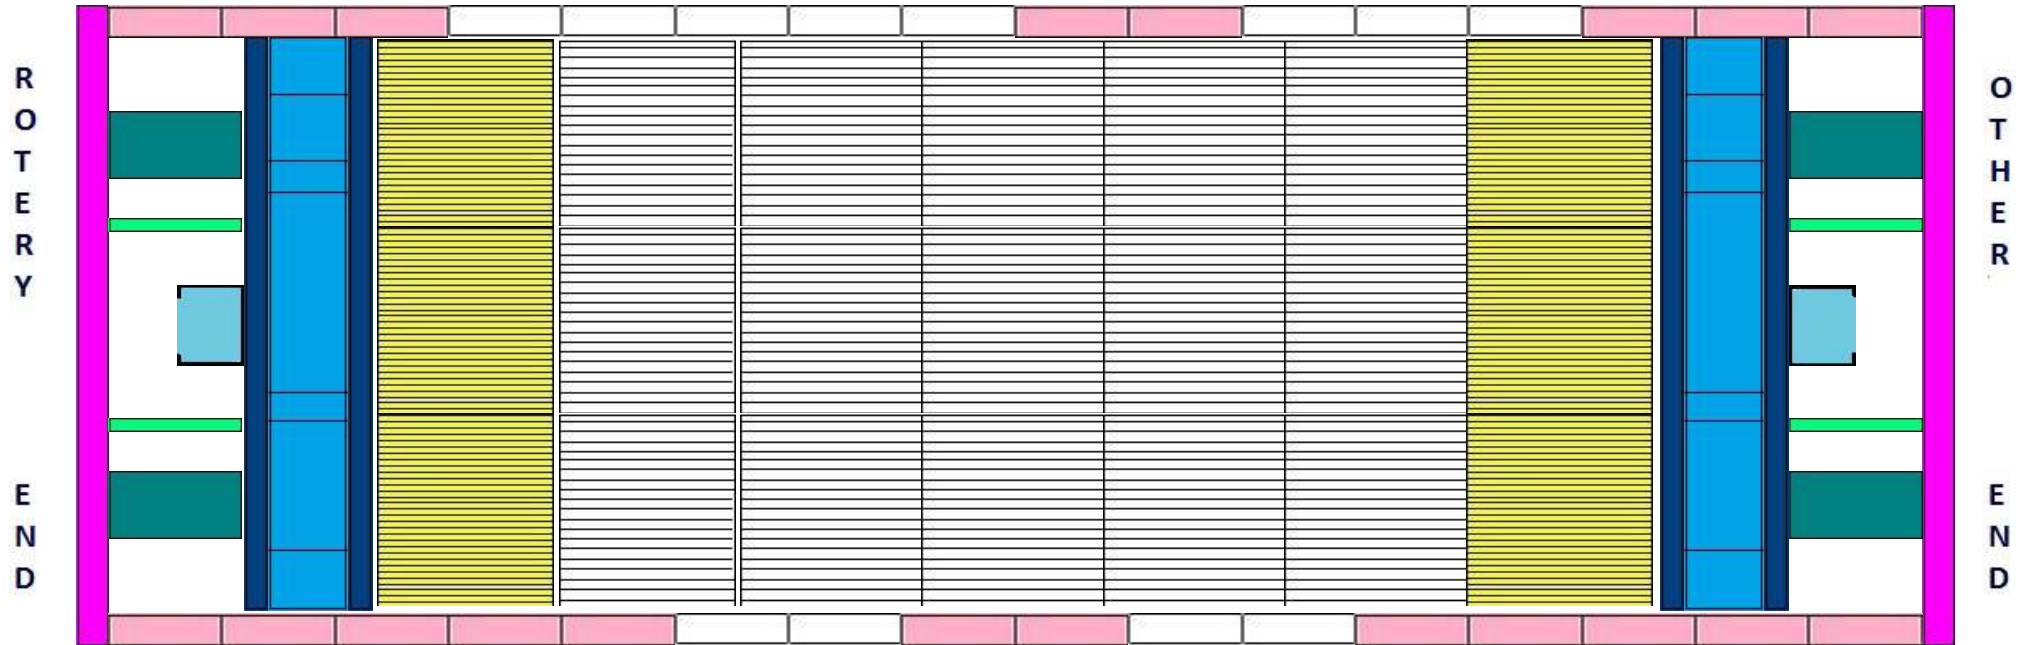
Rotary Side

Color	Particulars	Qty	Per%	Color	Particulars	Qty	Per%	Color	Particulars	Qty	Per%
Pink	Headstock Beam	2	100%	Dark Blue	Centre Stiffner for Headstock	4	100%	Green	Floor Stiffner for Headstock	4	100%
Dark Blue	Aux. Head stock	4	100%	Pink	Sole Bar	10	63%	Light Blue	Draft Gear Bracket	2	100%
Yellow	Trough floor	2	29%	Light Blue	Centre plate	2	100%		SoleBar Stiffner	6	100%
	Bottom Wall Part	10	63%		Body panel/patch		100%		Door Top/Roof Patch		0%
	Window Module		0%		Window Sill	40	100%		Window Bar	46	26%
	Seat pillar/lav. Partition		100%		UIC end construction		0%

Start Date : 28-Aug-2019, Completion Date : 03-Sep-2019, Net Repair Days : 6, Total Man Hours : 1394

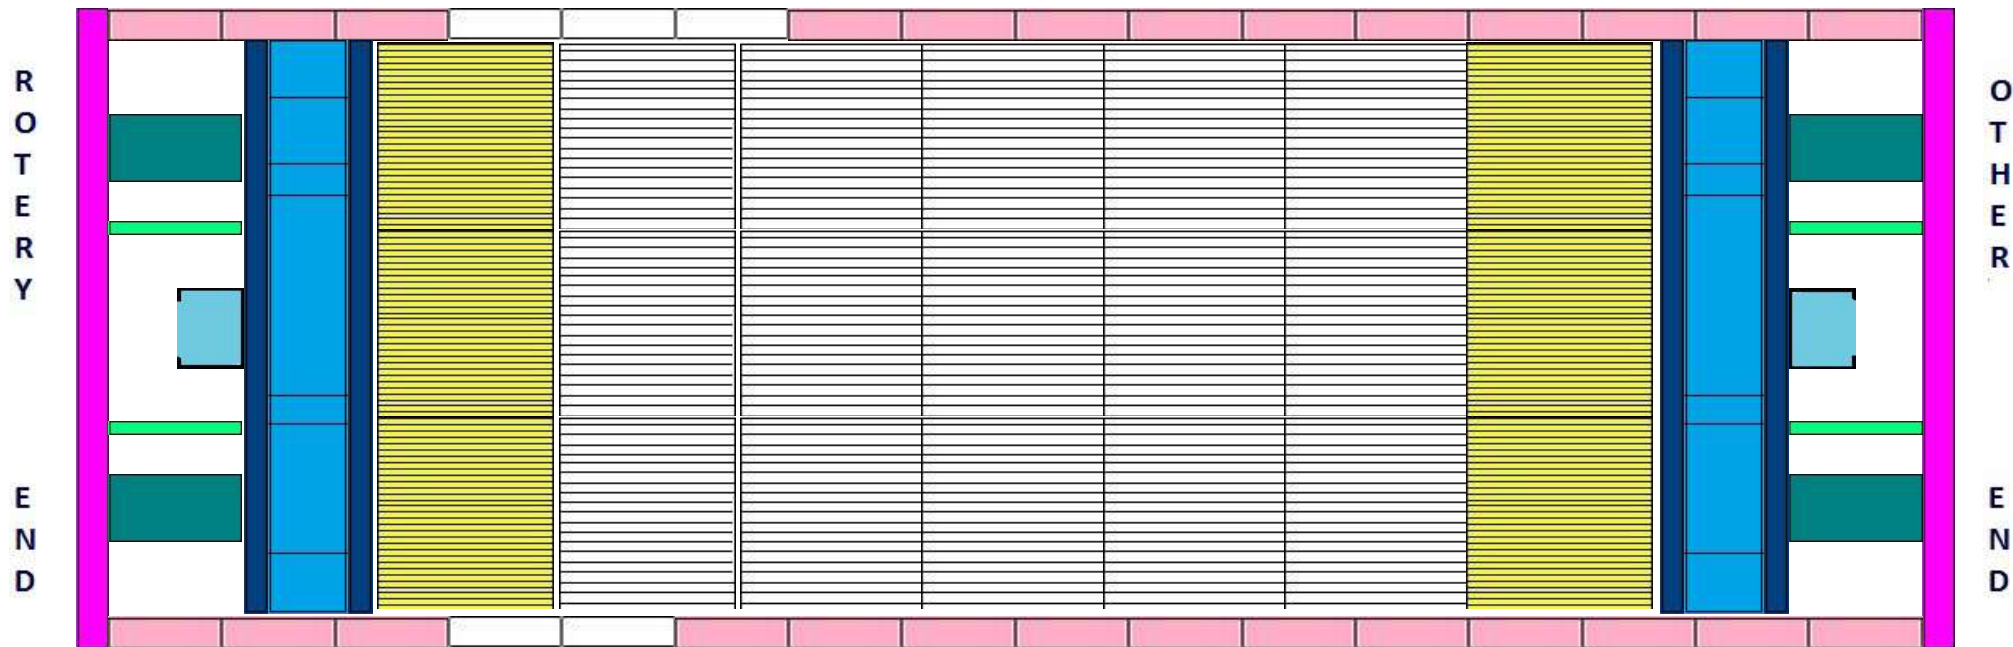
Rotary Side

Color	Particulars	Qty	Per%	Color	Particulars	Qty	Per%	Color	Particulars	Qty	Per%
	Headstock Beam	2	100%		Centre Stiffner for Headstock	4	100%		Floor Stiffner for Headstock	4	100%
	Aux. Head stock	4	100%		Sole Bar	13.5	84%		Draft Gear Bracket	2	100%
	Trough floor	2	29%		Centre plate	2	100%		SoleBar Stiffner	4	100%
	Bottom Wall Part	13.5	84%		Body panel/patch		100%		Door Top/Roof Patch		0%
	Window Module		0%		Window Sill	20	50%		Window Bar	40	22%
	Seat pillar/lav. Partition		100%		UIC end construction		0%

Start Date : 23-Aug-2019, Completion Date : 02-Sep-2019, Net Repair Days : 9, Total Man Hours : 1616

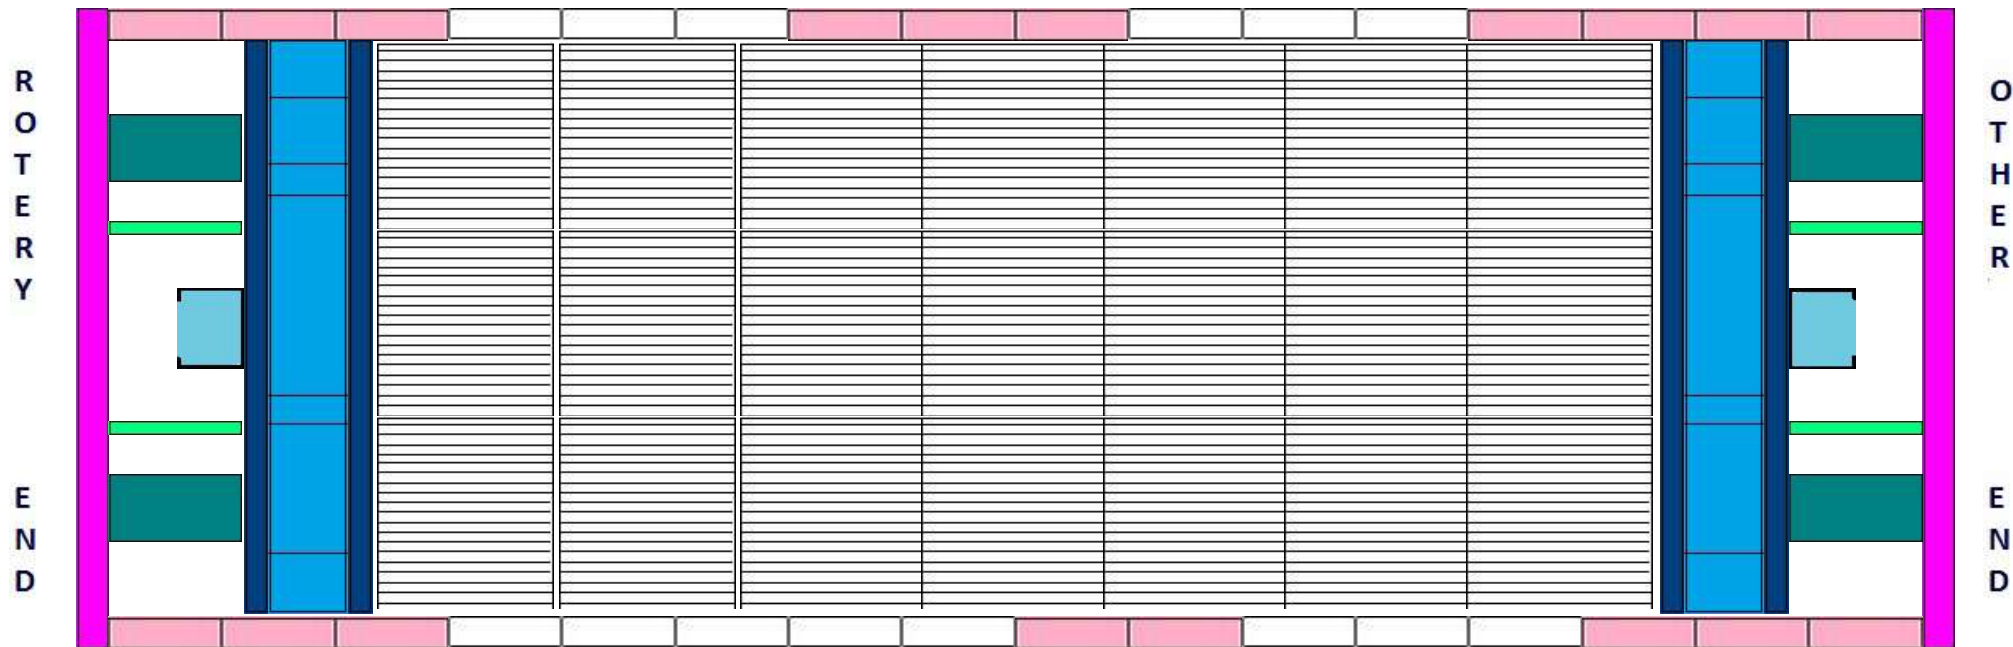
Rotary Side

Color	Particulars	Qty	Per%	Color	Particulars	Qty	Per%	Color	Particulars	Qty	Per%
Blue	Headstock Beam	2	100%	Red	Centre Stiffner for Headstock	4	100%	Green	Floor Stiffner for Headstock	4	100%
Black	Aux. Head stock	4	100%	Yellow	Sole Bar	9	56%	Light Blue	Draft Gear Bracket	2	100%
Orange	Trough floor	0	0%	Dark Blue	Centre plate	2	100%		SoleBar Stiffner	6	100%
	Bottom Wall Part	9	56%		Body panel/patch		100%		Door Top/Roof Patch		0%
	Window Module		0%		Window Sill	28	70%		Window Bar	40	22%
	Seat pillar/lav. Partition		100%		UIC end construction		0%

End Drooping: Rotary End - EAST : 8, WEST : 2 Other End - EAST : -10, WEST : -8
Start Date : 17-Jul-2019, Completion Date : 24-Jul-2019, Net Repair Days : 7, Total Man Hours : 1200

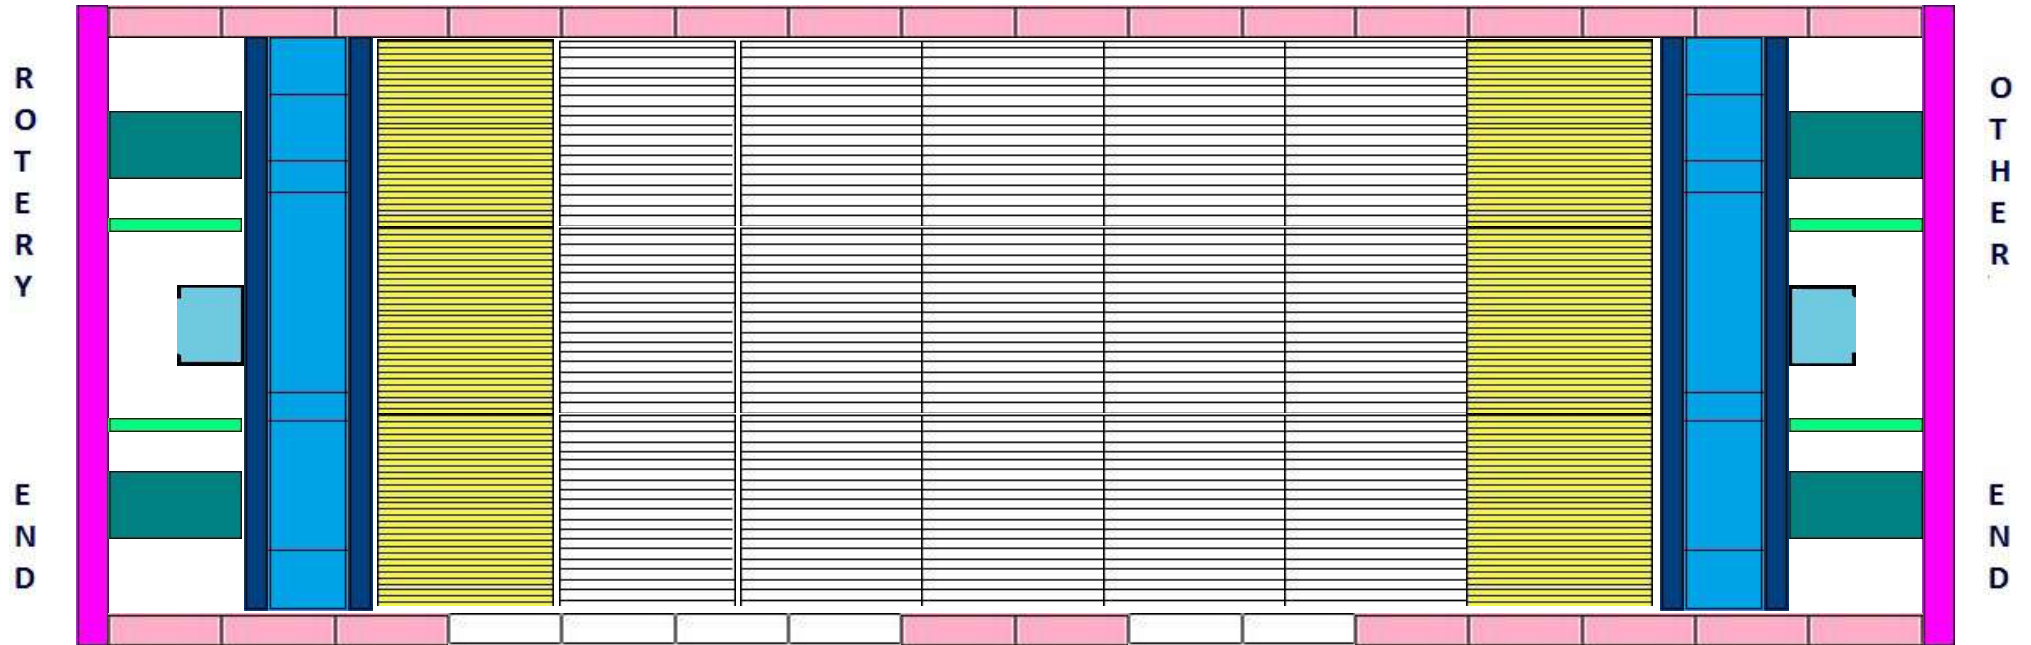
Color	Particulars	Qty	Per%	Color	Particulars	Qty	Per%	Color	Particulars	Qty	Per%
Yellow	Headstock Beam	2	100%	Dark Green	Centre Stiffner for Headstock	4	100%	Light Green	Floor Stiffner for Headstock	4	100%
Dark Blue	Aux. Head stock	4	100%	Pink	Sole Bar	13	81%	Light Blue	Draft Gear Bracket	2	100%
Yellow	Trough floor	2	29%	Light Blue	Centre plate	2	100%		SoleBar Stiffner	6	100%
	Bottom Wall Part	13	81%		Body panel/patch		100%		Door Top/Roof Patch		0%
	Window Module		0%		Window Sill	40	100%		Window Bar	48	27%
	Seat pillar/lav. Partition		100%		UIC end construction		0%

End Drooping: Rotary End - EAST : 5, WEST : 4 Other End - EAST : -5, WEST : -4

Start Date : 06-Dec-2019, Completion Date : 12-Dec-2019, Net Repair Days : 6, Total Man Hours : 1820

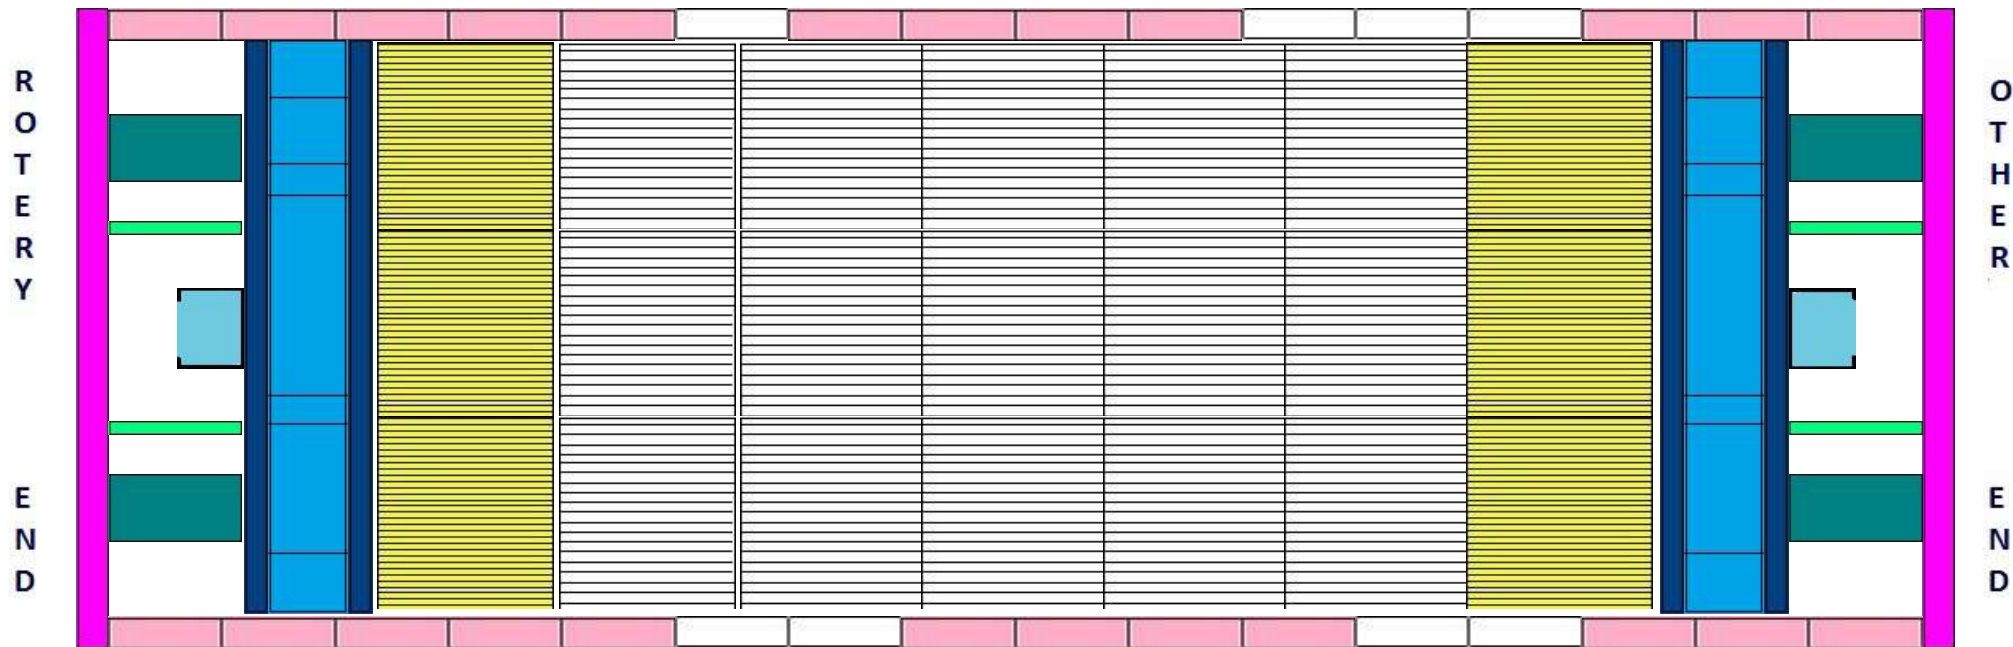
Rotary Side

Color	Particulars	Qty	Per%	Color	Particulars	Qty	Per%	Color	Particulars	Qty	Per%
Yellow	Headstock Beam	2	100%	Dark Green	Centre Stiffner for Headstock	4	100%	Light Green	Floor Stiffner for Headstock	4	100%
Dark Blue	Aux. Head stock	4	100%	Pink	Sole Bar	12	75%	Light Blue	Draft Gear Bracket	2	100%
Yellow	Trough floor	2	29%	Light Blue	Centre plate	2	100%		SoleBar Stiffner	4	100%
	Bottom Wall Part	12	75%		Body panel/patch		100%		Door Top/Roof Patch		0%
	Window Module		0%		Window Sill	8	42%		Window Bar	14	17%
	Seat pillar/lav. Partition		100%		UIC end construction		0%

End Drooping: Rotary End - EAST : 5, WEST : 5 Other End - EAST : -10, WEST : -10
Start Date : 27-Jun-2019, Completion Date : 03-Jul-2019, Net Repair Days : 6, Total Man Hours : 1696

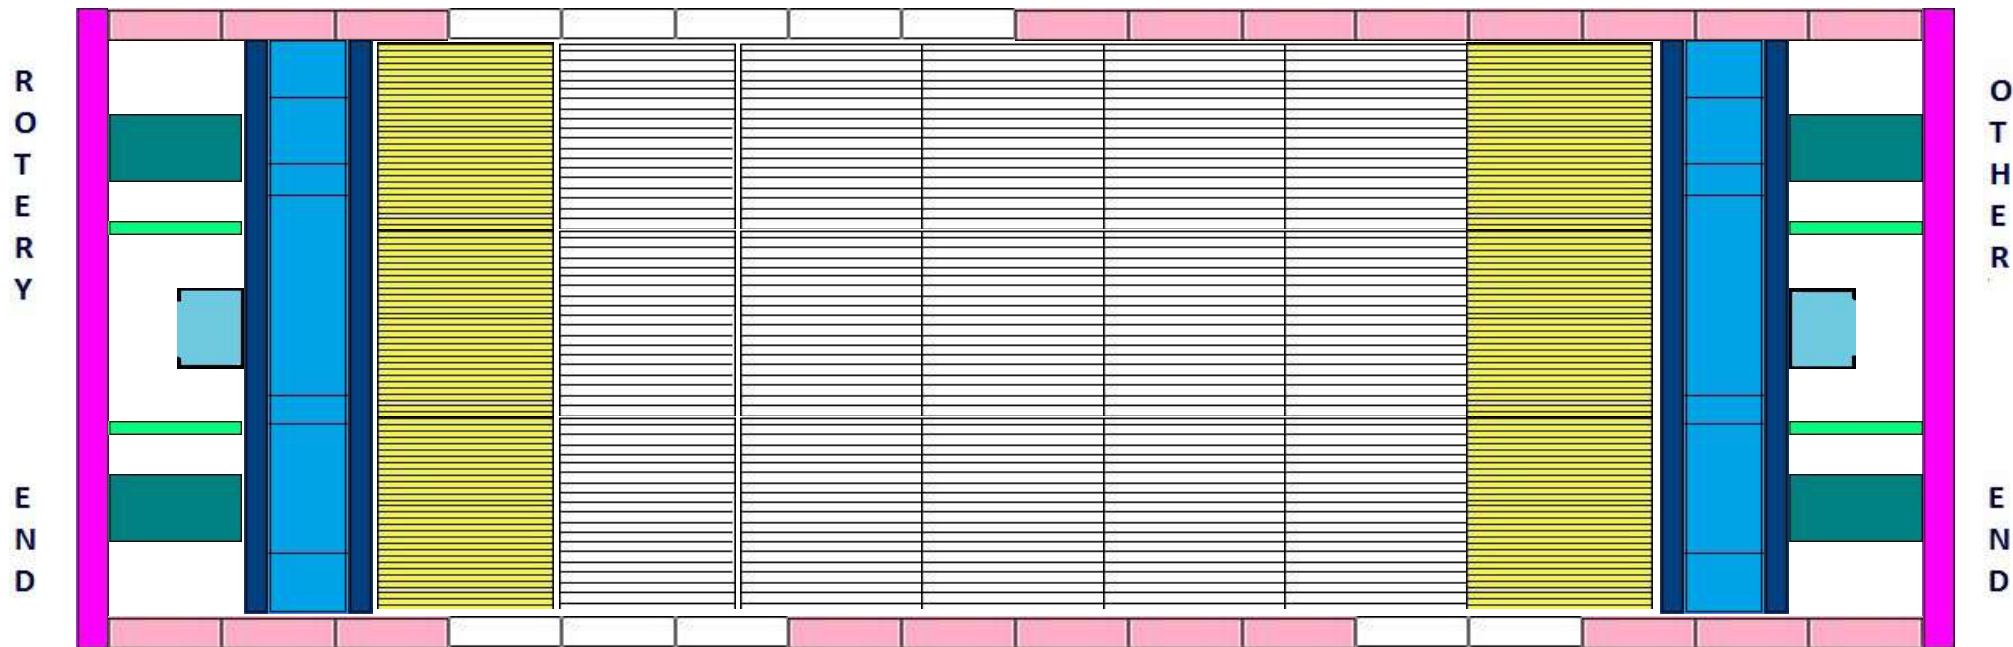
Color	Particulars	Qty	Per%	Color	Particulars	Qty	Per%	Color	Particulars	Qty	Per%
Yellow	Headstock Beam	2	100%	Dark Green	Centre Stiffner for Headstock	4	100%	Light Green	Floor Stiffner for Headstock	4	100%
Dark Blue	Aux. Head stock	4	100%	Pink	Sole Bar	11	69%	Light Blue	Draft Gear Bracket	2	100%
Yellow	Trough floor	2	29%	Light Blue	Centre plate	2	100%		SoleBar Stiffner	4	100%
	Bottom Wall Part	11	69%		Body panel/patch		100%		Door Top/Roof Patch		0%
	Window Module		0%		Window Sill	40	100%		Window Bar	46	25%
	Seat pillar/lav. Partition		100%		UIC end construction		0%

End Drooping: Rotary End - EAST : 0, WEST : 0 Other End - EAST : 0, WEST : 0
Start Date : 22-Aug-2019, Completion Date : 30-Aug-2019, Net Repair Days : 8, Total Man Hours : 0

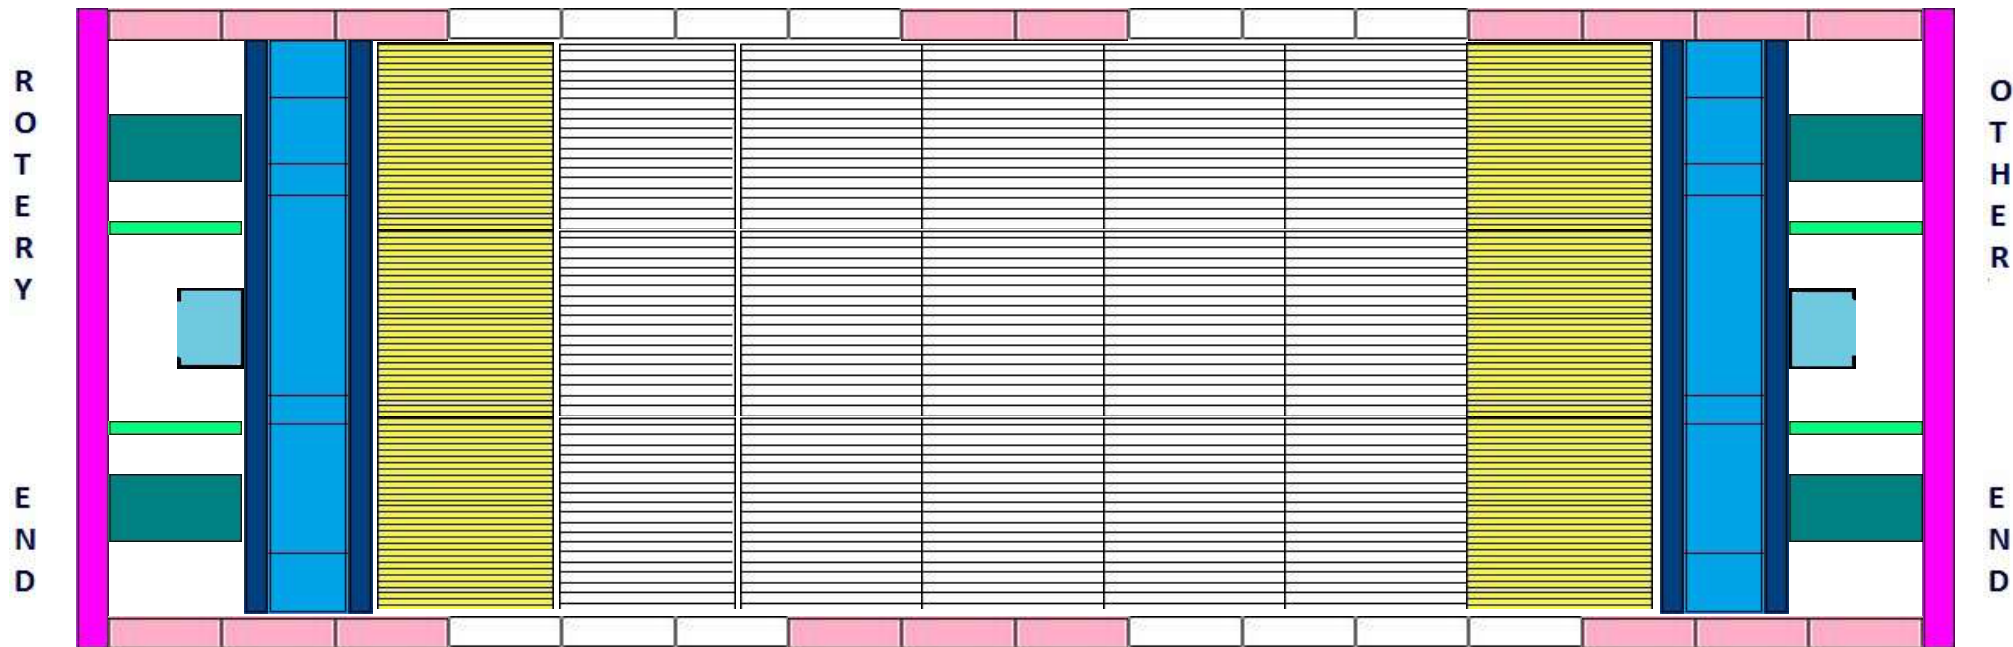
Rotary Side

Color	Particulars	Qty	Per%	Color	Particulars	Qty	Per%	Color	Particulars	Qty	Per%
	Headstock Beam	2	100%		Centre Stiffner for Headstock	4	100%		Floor Stiffner for Headstock	4	100%
	Aux. Head stock	4	100%		Sole Bar	9	56%		Draft Gear Bracket	2	100%
	Trough floor	2	29%		Centre plate	2	100%		SoleBar Stiffner	6	100%
	Bottom Wall Part	9	56%		Body panel/patch		100%		Door Top/Roof Patch		0%
	Window Module		0%		Window Sill	30	75%		Window Bar	44	25%
	Seat pillar/lav. Partition		100%		UIC end construction		0%

End Drooping: Rotary End - EAST : -5, WEST : -5 Other End - EAST : 7, WEST : 5
Start Date : 24-Sep-2019, Completion Date : 03-Oct-2019, Net Repair Days : 9, Total Man Hours : 1292

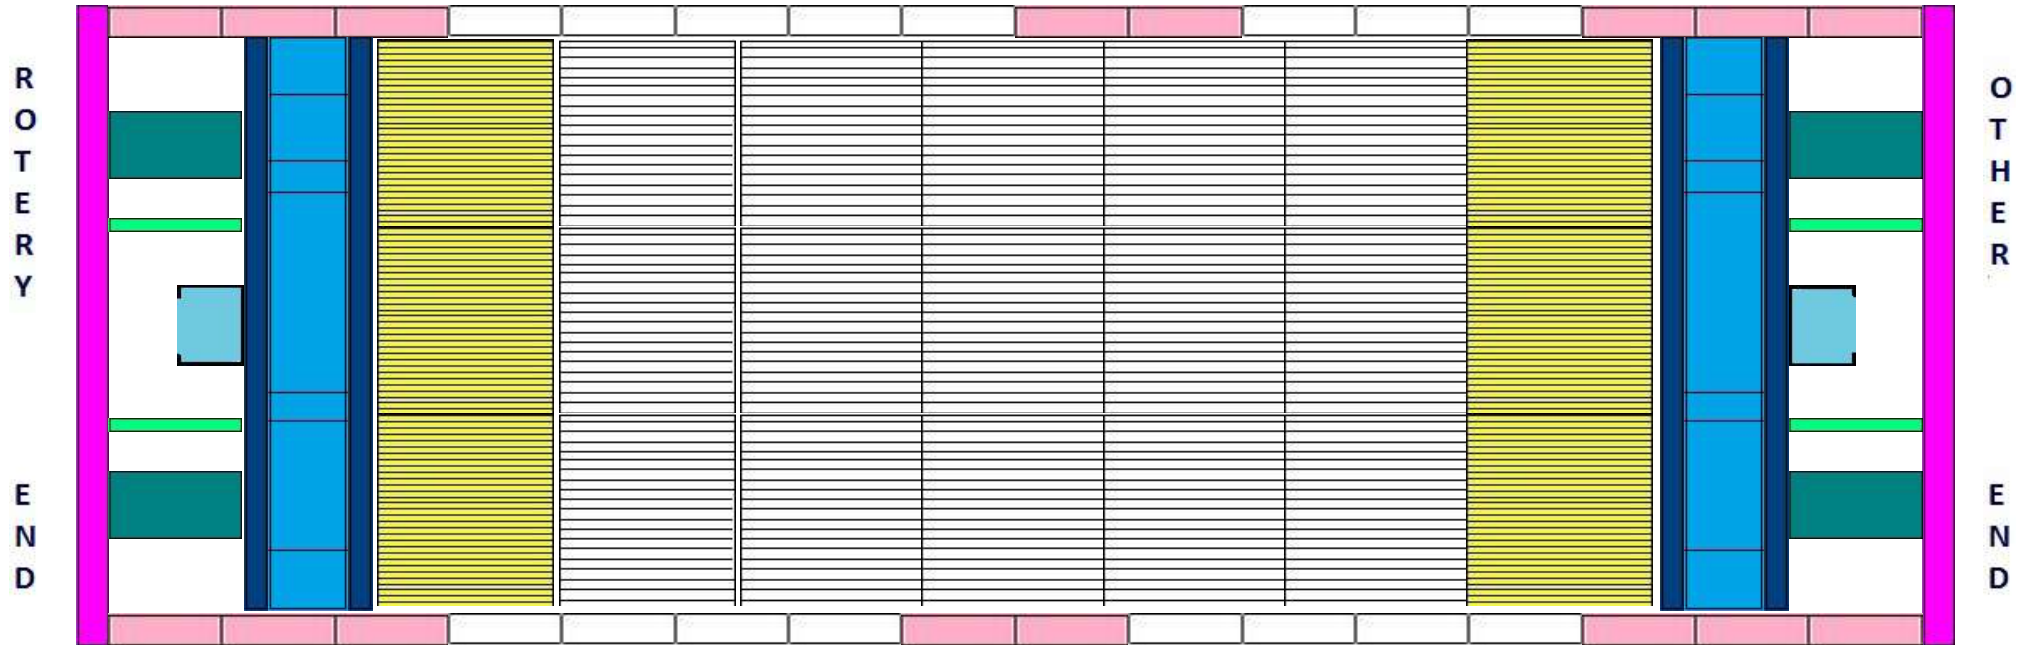
Rotary Side

Color	Particulars	Qty	Per%	Color	Particulars	Qty	Per%	Color	Particulars	Qty	Per%
	Headstock Beam	2	100%		Centre Stiffner for Headstock	4	100%		Floor Stiffner for Headstock	4	100%
	Aux. Head stock	4	100%		Sole Bar	8	50%		Draft Gear Bracket	2	100%
	Trough floor	2	29%		Centre plate	2	100%		SoleBar Stiffner	6	100%
	Bottom Wall Part	8	50%		Body panel/patch		100%		Door Top/Roof Patch		0%
	Window Module		0%		Window Sill	0	0%		Window Bar	0	0%
	Seat pillar/lav. Partition		100%		UIC end construction		0%

End Drooping: Rotary End - EAST : -4, WEST : -4 Other End - EAST : 0, WEST : -4
Start Date : 26-Jul-2019, Completion Date : 03-Aug-2019, Net Repair Days : 8, Total Man Hours : 1404
