Coach Rehabilitation Workshop, WC Railway, Bhopal

(An IMS and ISO 50001 Certified Workshop)
Final Inspection Sheet - Details of Corrosion Repair

Coach No. : EC05057

Type : WGACCW

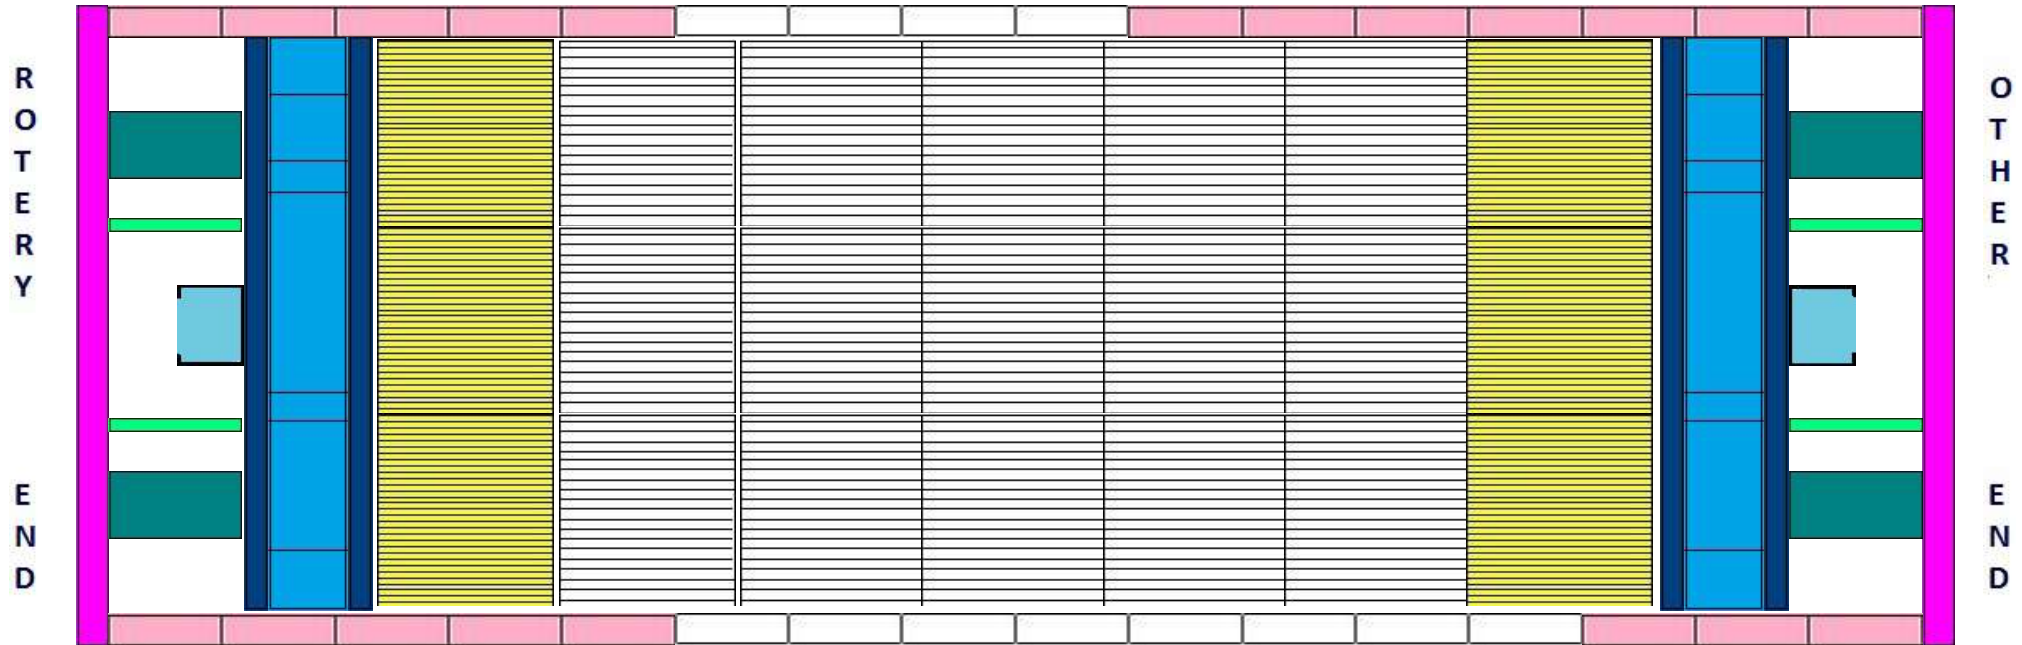
Color	Particulars	Qty	Per%	Color	Particulars	Qty	Per%	Color	Particulars	Qty	Per%
Yellow	Headstock Beam	2	100%	Dark Green	Centre Stiffner for Headstock	4	100%	Light Green	Floor Stiffner for Headstock	4	100%
Dark Blue	Aux. Head stock	4	100%	Pink	Sole Bar	10	63%	Light Blue	Draft Gear Bracket	2	100%
Yellow	Trough floor	2	29%	Light Blue	Centre plate	2	100%		SoleBar Stiffner	4	100%
	Bottom Wall Part	10	63%		Body panel/patch		100%		Door Top/Roof Patch		0%
	Window Module		0%		Window Sill	40	100%		Window Bar	64	35%
	Seat pillar/lav. Partition		100%		UIC end construction		0%

End Drooping: Rotary End - EAST : -10, WEST : -10 Other End - EAST : 0, WEST : -5
Start Date : 06-Aug-2019, Completion Date : 19-Aug-2019, Net Repair Days : 12, Total Man Hours : 1608

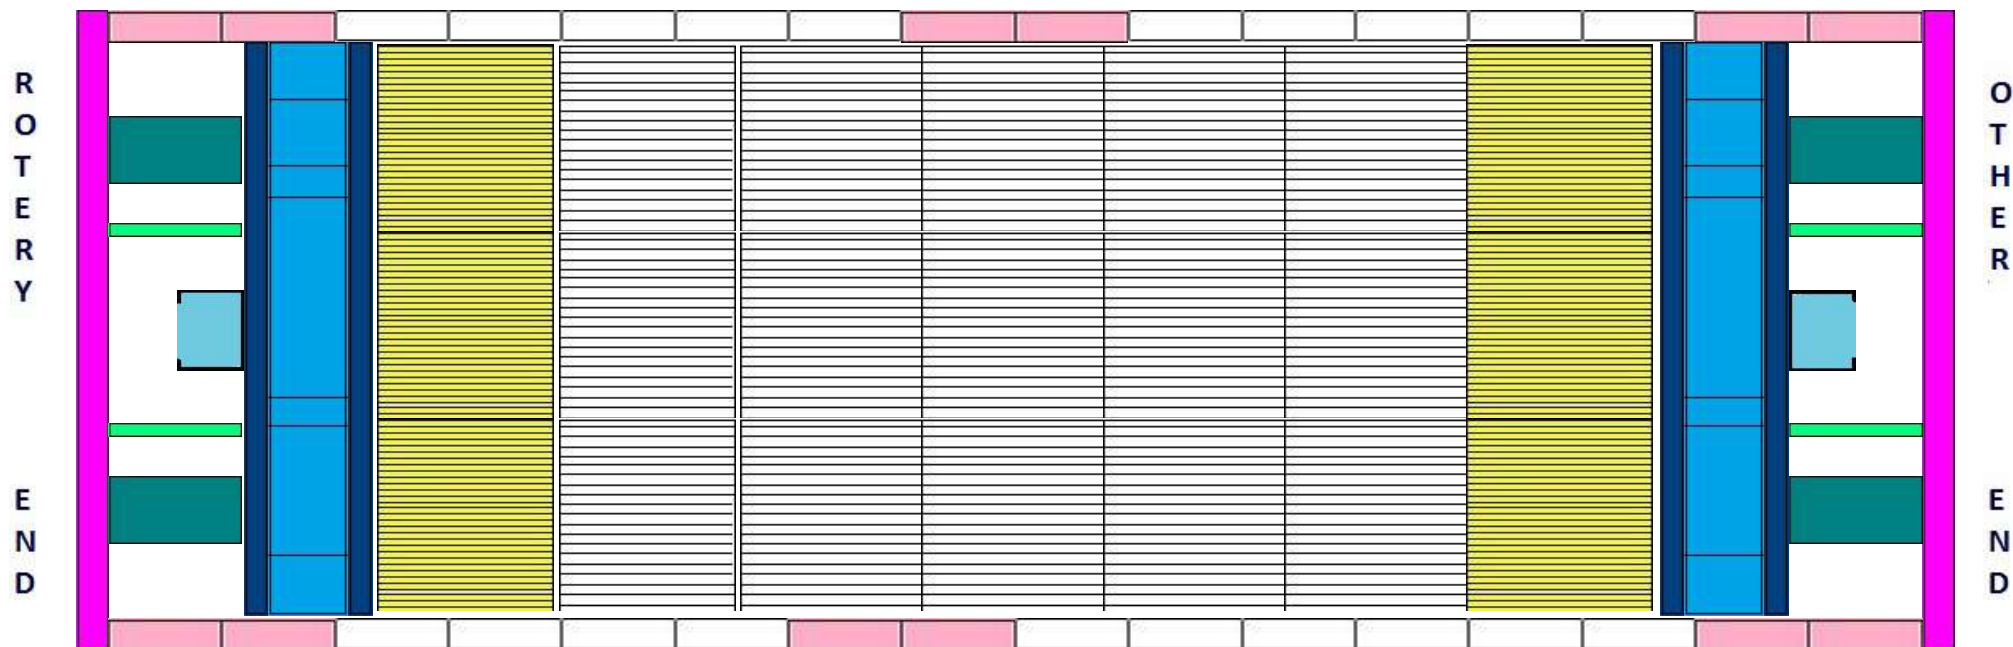
Rotary Side

Color	Particulars	Qty	Per%	Color	Particulars	Qty	Per%	Color	Particulars	Qty	Per%
	Headstock Beam	2	100%		Centre Stiffner for Headstock	4	100%		Floor Stiffner for Headstock	4	100%
	Aux. Head stock	4	100%		Sole Bar	6	38%		Draft Gear Bracket	2	100%
	Trough floor	2	29%		Centre plate	2	100%		SoleBar Stiffner	6	100%
	Bottom Wall Part	6	38%		Body panel/patch		100%		Door Top/Roof Patch		0%
	Window Module		0%		Window Sill	14	35%		Window Bar	44	25%
	Seat pillar/lav. Partition		100%		UIC end construction		0%

End Drooping: Rotary End - EAST : 6, WEST : 0 Other End - EAST : 4, WEST : 0
Start Date : 27-Jul-2019, Completion Date : 03-Aug-2019, Net Repair Days : 7, Total Man Hours : 1192

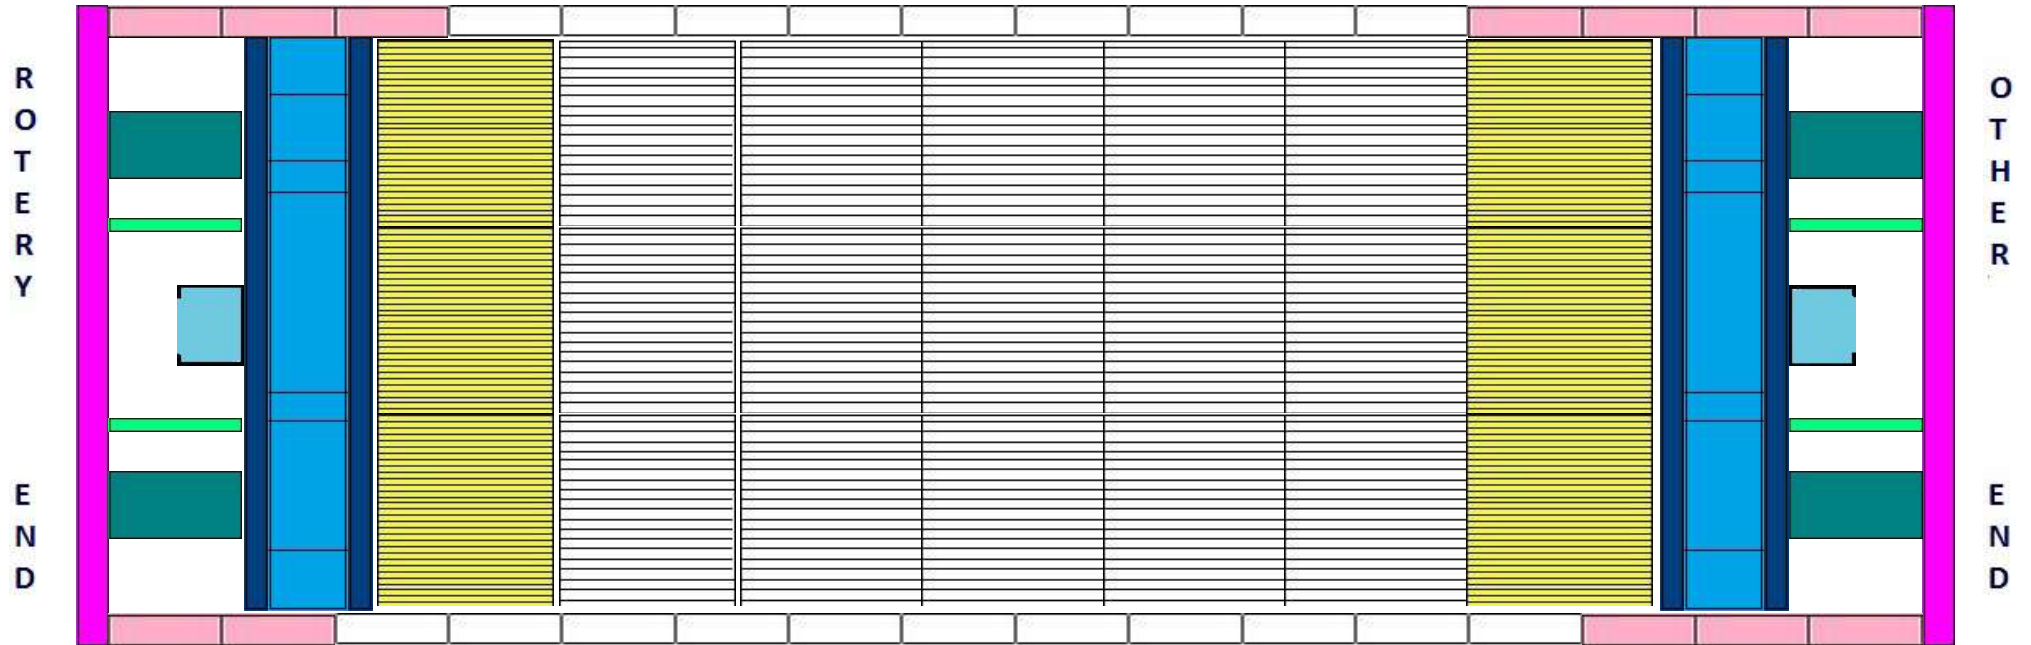
Rotary Side

Color	Particulars	Qty	Per%	Color	Particulars	Qty	Per%	Color	Particulars	Qty	Per%
	Headstock Beam	2	100%		Centre Stiffner for Headstock	4	100%		Floor Stiffner for Headstock	4	100%
	Aux. Head stock	4	100%		Sole Bar	6	38%		Draft Gear Bracket	2	100%
	Trough floor	2	29%		Centre plate	2	100%		SoleBar Stiffner	4	100%
	Bottom Wall Part	6	38%		Body panel/patch		100%		Door Top/Roof Patch		0%
	Window Module		0%		Window Sill	14	35%		Window Bar	44	24%
	Seat pillar/lav. Partition		100%		UIC end construction		0%

End Drooping: Rotary End - EAST : 0, WEST : -4 Other End - EAST : -3, WEST : -5
Start Date : 29-Jul-2019, Completion Date : 05-Aug-2019, Net Repair Days : 7, Total Man Hours : 1241

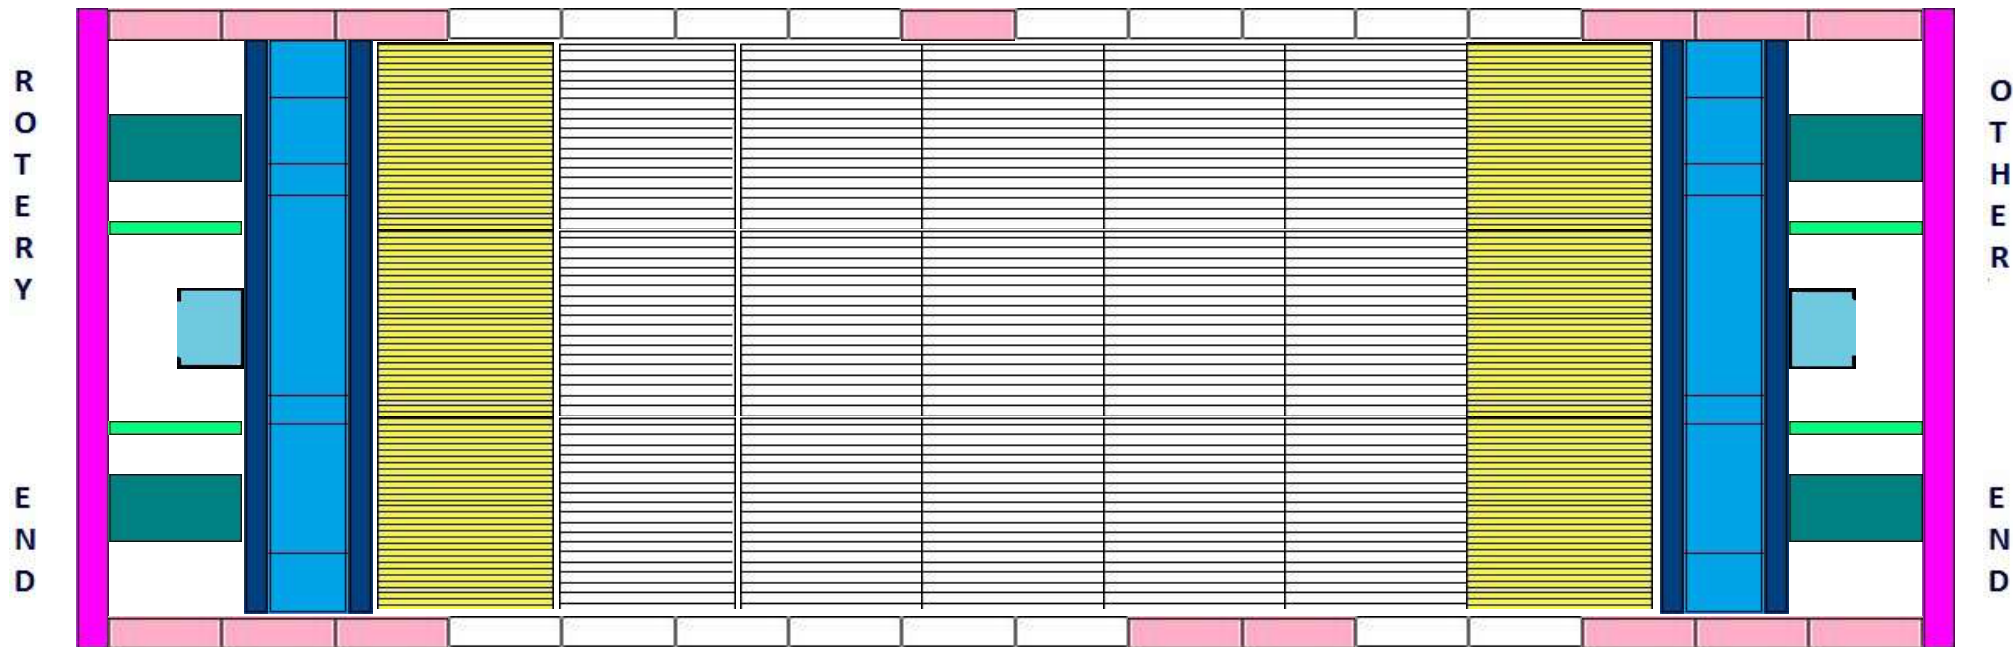
Rotary Side

Color	Particulars	Qty	Per%	Color	Particulars	Qty	Per%	Color	Particulars	Qty	Per%
Pink	Headstock Beam	2	100%	Green	Centre Stiffner for Headstock	4	100%	Yellow	Floor Stiffner for Headstock	4	100%
Dark Blue	Aux. Head stock	4	100%	Pink	Sole Bar	7.5	47%	Light Blue	Draft Gear Bracket	2	100%
Yellow	Trough floor	2	29%	Blue	Centre plate	2	100%		SoleBar Stiffner	4	100%
	Bottom Wall Part	7.5	47%		Body panel/patch		100%		Door Top/Roof Patch		0%
	Window Module		0%		Window Sill	22	55%		Window Bar	44	24%
	Seat pillar/lav. Partition		100%		UIC end construction		0%

End Drooping: Rotary End - EAST : 3, WEST : 3 Other End - EAST : -2, WEST : -6
Start Date : 01-Aug-2019, Completion Date : 08-Aug-2019, Net Repair Days : 7, Total Man Hours : 1312

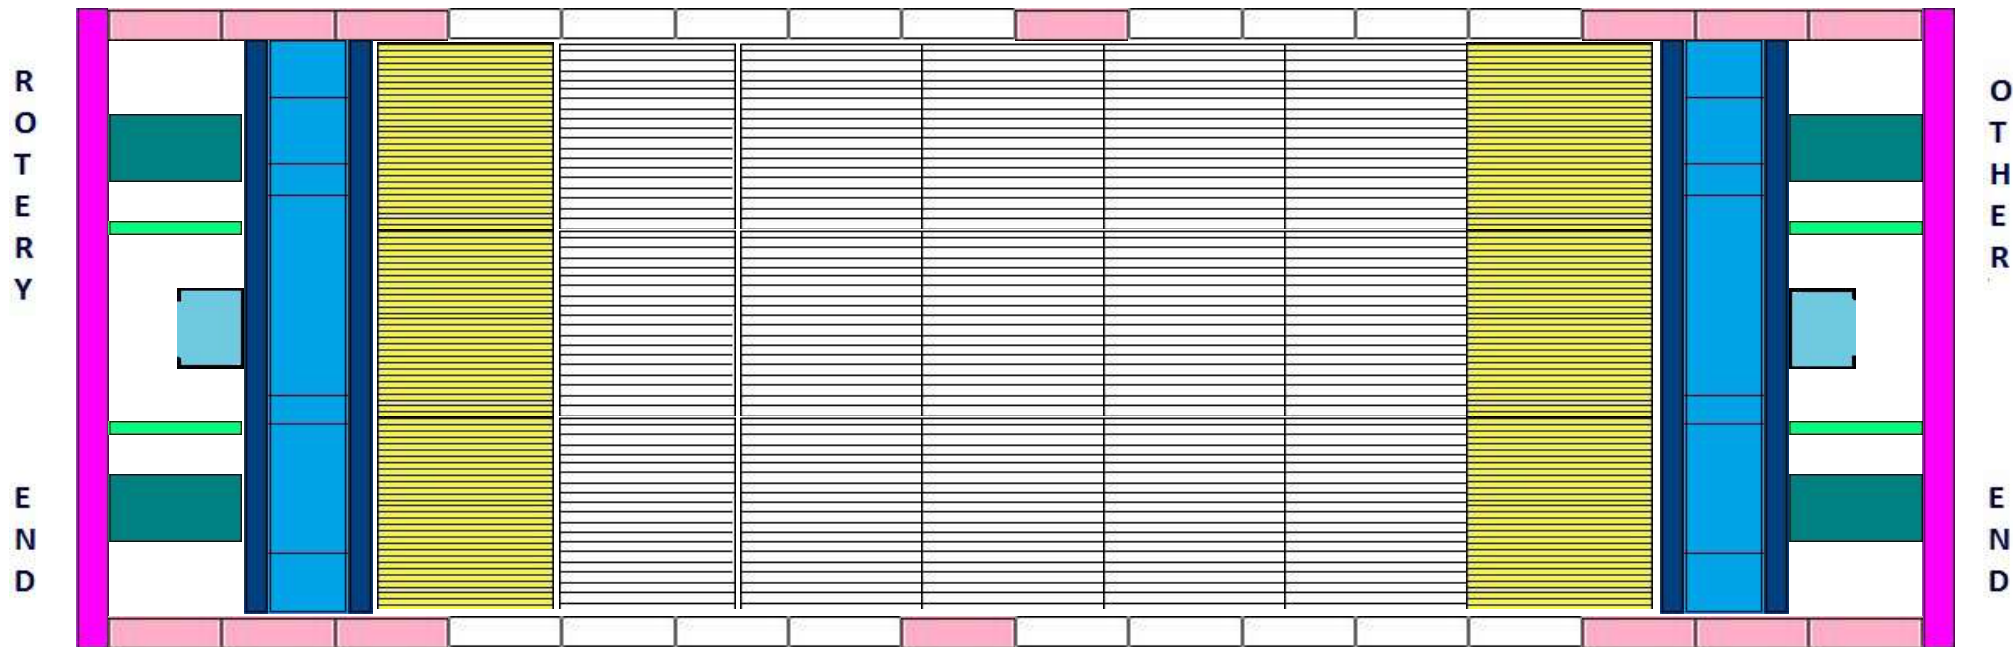
Color	Particulars	Qty	Per%	Color	Particulars	Qty	Per%	Color	Particulars	Qty	Per%
Yellow	Headstock Beam	2	100%	Dark Green	Centre Stiffner for Headstock	4	100%	Light Green	Floor Stiffner for Headstock	4	100%
Dark Blue	Aux. Head stock	4	100%	Pink	Sole Bar	7	44%	Light Blue	Draft Gear Bracket	2	100%
Yellow	Trough floor	2	29%	Light Blue	Centre plate	2	100%		SoleBar Stiffner	4	100%
	Bottom Wall Part	7	44%		Body panel/patch		100%		Door Top/Roof Patch		0%
	Window Module		0%		Window Sill	24	60%		Window Bar	44	25%
	Seat pillar/lav. Partition		100%		UIC end construction		0%

End Drooping: Rotary End - EAST : -6, WEST : -5 Other End - EAST : -4, WEST : -4
Start Date : 30-Jul-2019, Completion Date : 09-Aug-2019, Net Repair Days : 10, Total Man Hours : 1080

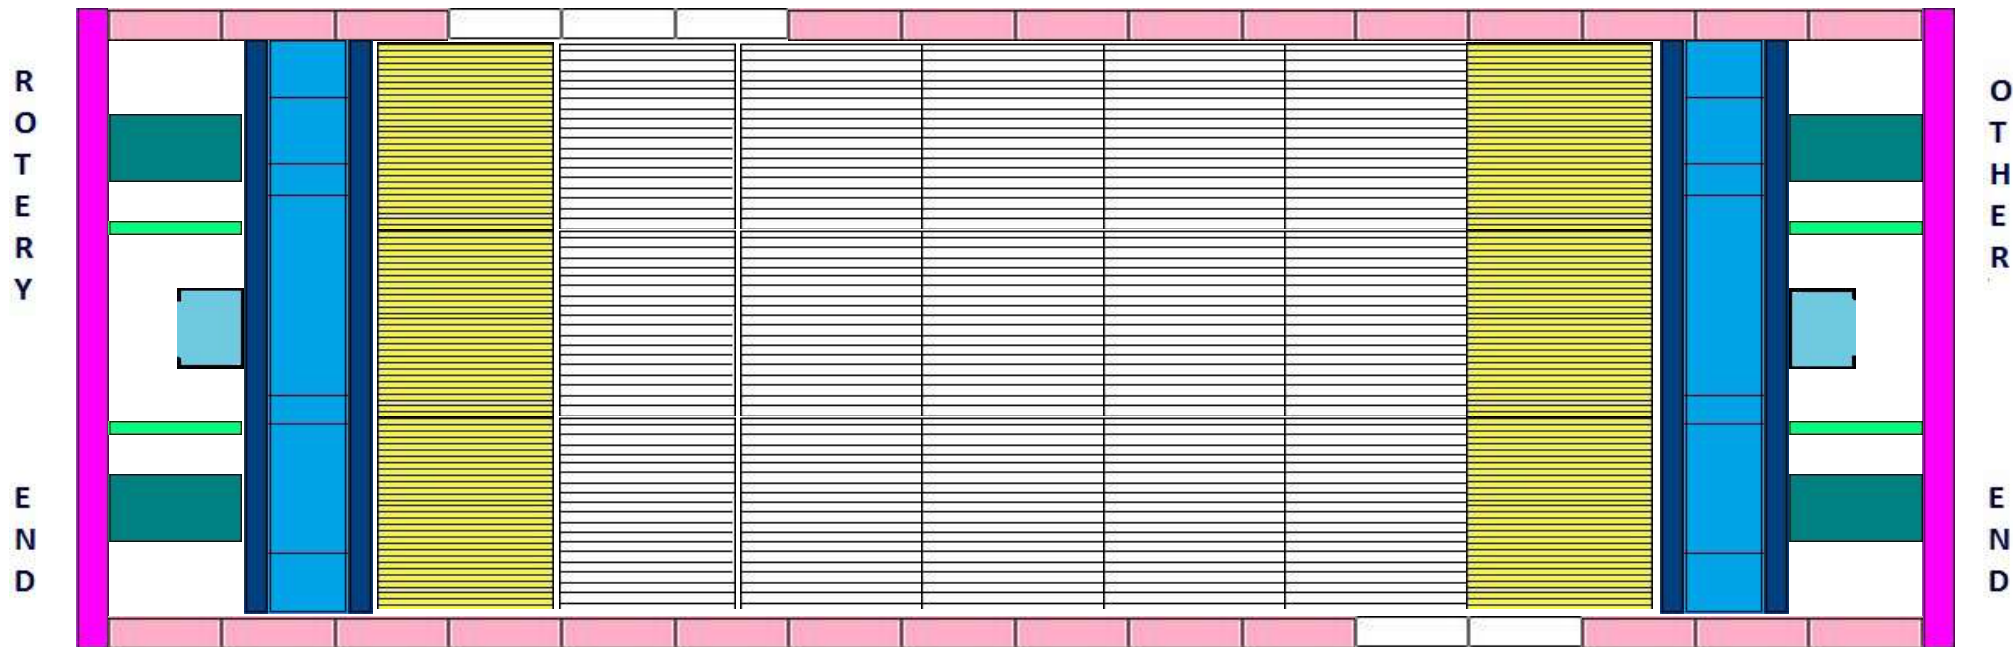
Rotary Side

Color	Particulars	Qty	Per%	Color	Particulars	Qty	Per%	Color	Particulars	Qty	Per%
Yellow	Headstock Beam	2	100%	Dark Green	Centre Stiffner for Headstock	4	100%	Light Green	Floor Stiffner for Headstock	4	100%
Dark Blue	Aux. Head stock	4	100%	Pink	Sole Bar	13.5	84%	Light Blue	Draft Gear Bracket	2	100%
Yellow	Trough floor	2	29%	Light Blue	Centre plate	2	100%		SoleBar Stiffner	6	100%
	Bottom Wall Part	13.5	84%		Body panel/patch		100%		Door Top/Roof Patch		0%
	Window Module		0%		Window Sill	24	60%		Window Bar	44	25%
	Seat pillar/lav. Partition		100%		UIC end construction		0%

Start Date : 01-Aug-2019, Completion Date : 07-Aug-2019, Net Repair Days : 6, Total Man Hours : 1373

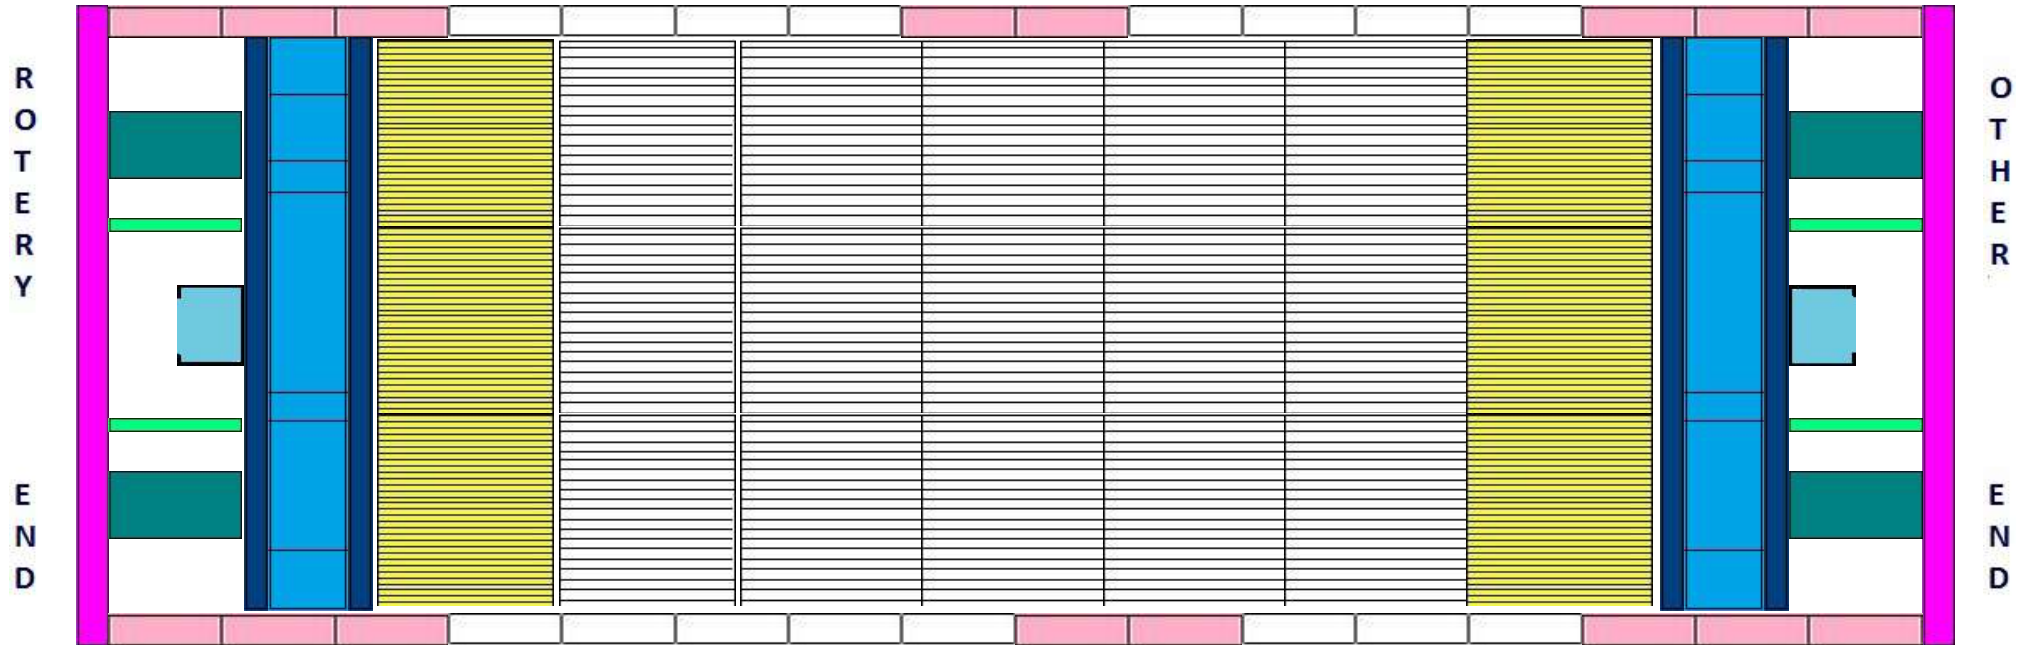
Rotary Side

Color	Particulars	Qty	Per%	Color	Particulars	Qty	Per%	Color	Particulars	Qty	Per%
	Headstock Beam	2	100%		Centre Stiffner for Headstock	4	100%		Floor Stiffner for Headstock	4	100%
	Aux. Head stock	4	100%		Sole Bar	8	50%		Draft Gear Bracket	2	100%
	Trough floor	2	29%		Centre plate	2	100%		SoleBar Stiffner	6	100%
	Bottom Wall Part	8	50%		Body panel/patch		100%		Door Top/Roof Patch		0%
	Window Module		0%		Window Sill	37	93%		Window Bar	48	27%
	Seat pillar/lav. Partition		100%		UIC end construction		0%

End Drooping: Rotary End - EAST : 3, WEST : 6 Other End - EAST : 3, WEST : 3
Start Date : 05-Aug-2019, Completion Date : 10-Aug-2019, Net Repair Days : 6, Total Man Hours : 1448

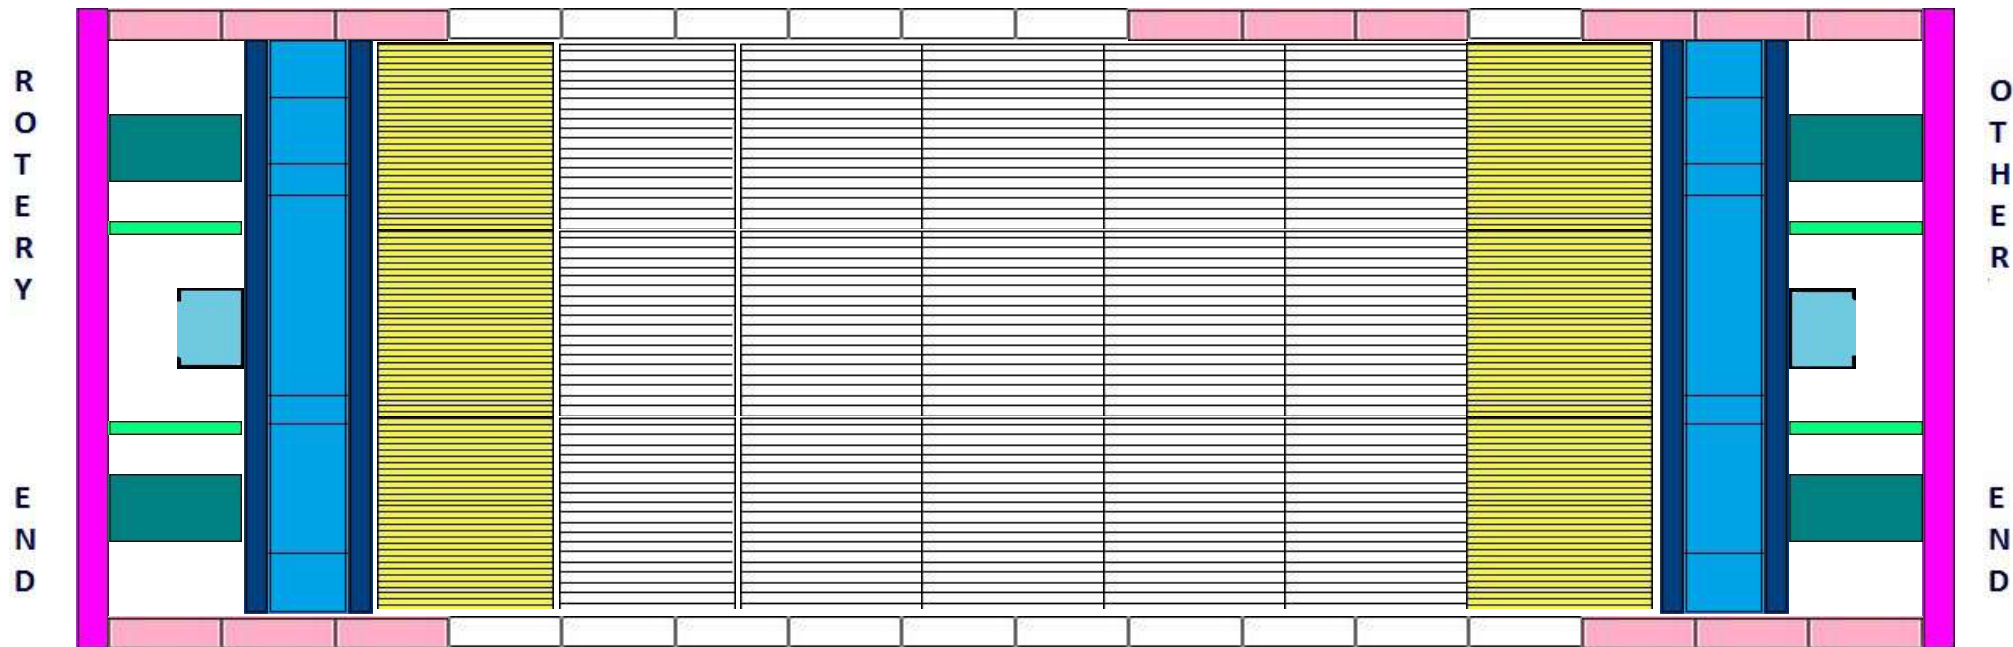
Rotary Side

Color	Particulars	Qty	Per%	Color	Particulars	Qty	Per%	Color	Particulars	Qty	Per%
Pink	Headstock Beam	2	100%	Dark Blue	Centre Stiffner for Headstock	4	100%	Green	Floor Stiffner for Headstock	4	100%
Dark Blue	Aux. Head stock	4	100%	Pink	Sole Bar	7.5	47%	Light Blue	Draft Gear Bracket	2	100%
Yellow	Trough floor	2	29%	Light Blue	Centre plate	2	100%		SoleBar Stiffner	4	100%
	Bottom Wall Part	7.5	47%		Body panel/patch		100%		Door Top/Roof Patch		0%
	Window Module		0%		Window Sill	32	80%		Window Bar	40	22%
	Seat pillar/lav. Partition		100%		UIC end construction		0%

End Drooping: Rotary End - EAST : 0, WEST : 0 Other End - EAST : 0, WEST : 0
Start Date : 20-Aug-2019, Completion Date : 26-Aug-2019, Net Repair Days : 6, Total Man Hours : 0

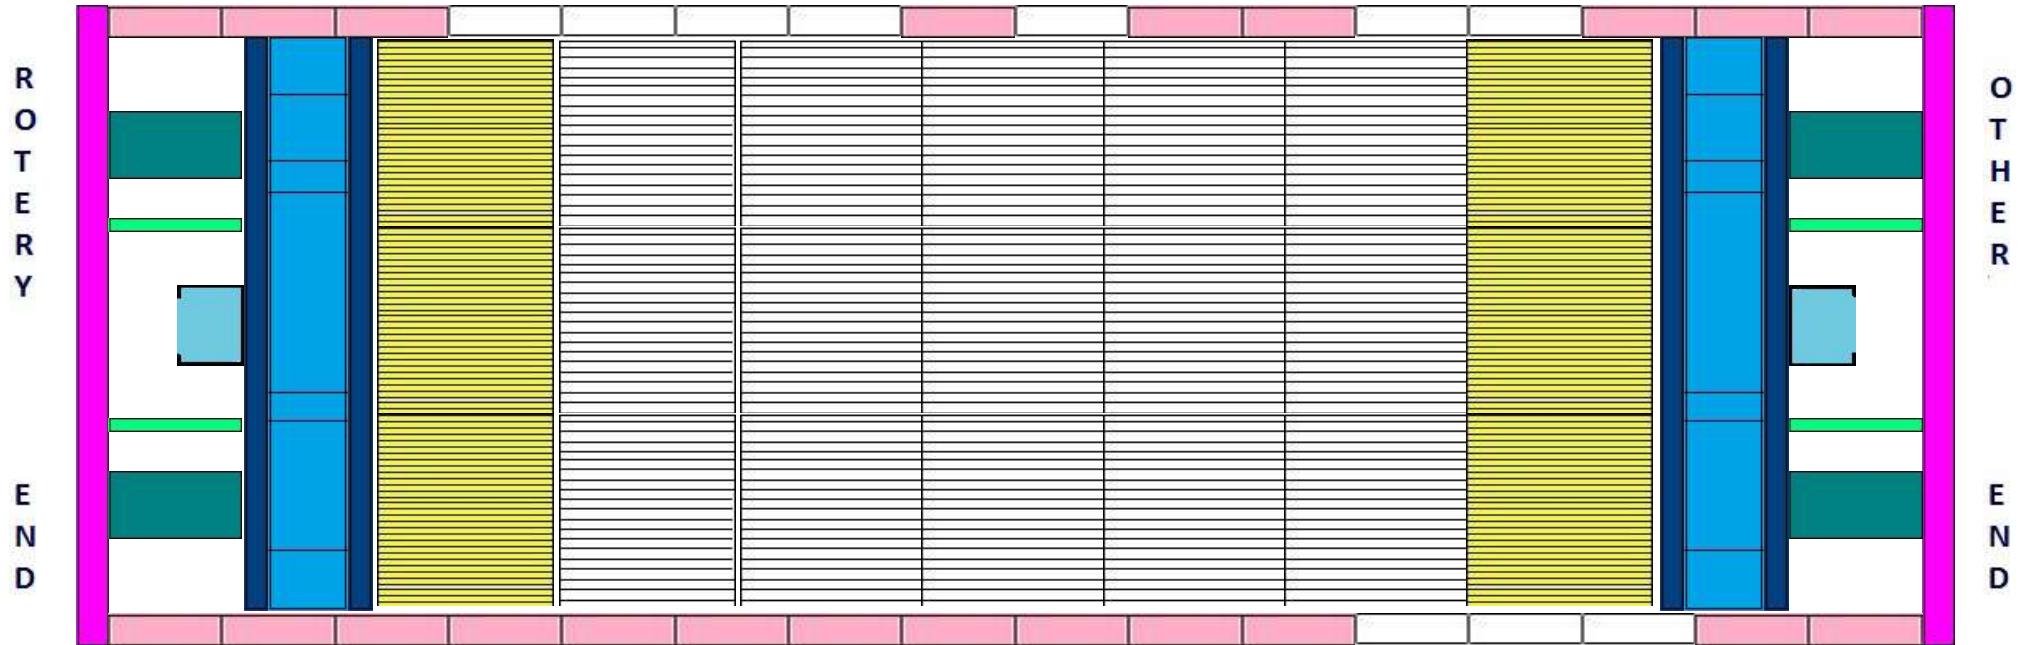
Rotary Side

Color	Particulars	Qty	Per%	Color	Particulars	Qty	Per%	Color	Particulars	Qty	Per%
	Headstock Beam	2	100%		Centre Stiffner for Headstock	4	100%		Floor Stiffner for Headstock	4	100%
	Aux. Head stock	4	100%		Sole Bar	11	69%		Draft Gear Bracket	2	100%
	Trough floor	2	29%		Centre plate	2	100%		SoleBar Stiffner	4	100%
	Bottom Wall Part	11	69%		Body panel/patch		100%		Door Top/Roof Patch		0%
	Window Module		0%		Window Sill	28	70%		Window Bar	44	24%
	Seat pillar/lav. Partition		100%		UIC end construction		0%

Start Date : 10-Aug-2019, Completion Date : 20-Aug-2019, Net Repair Days : 9, Total Man Hours : 1512

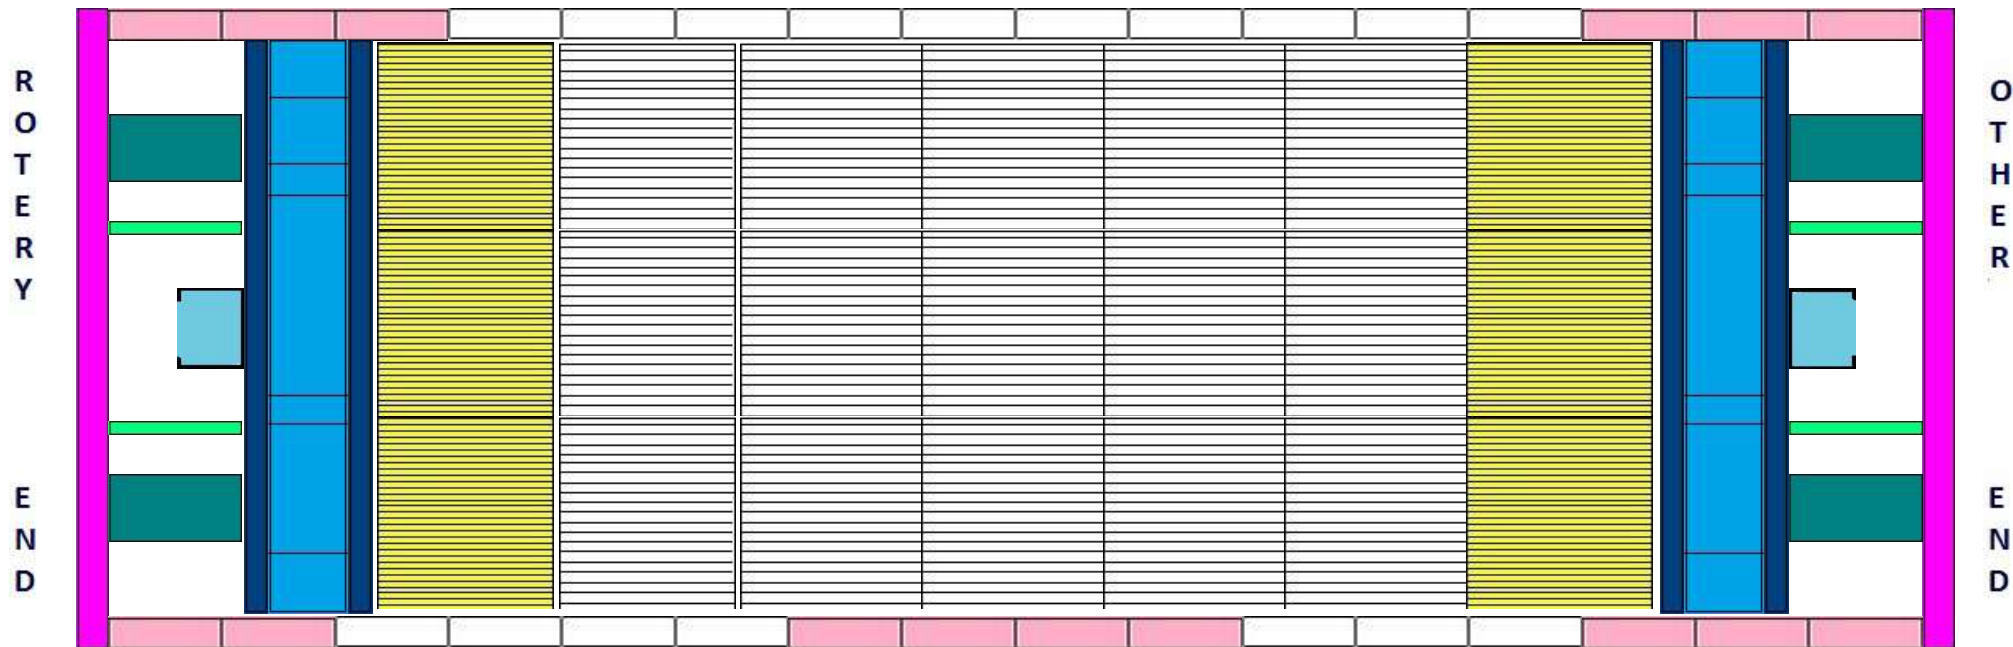
Color	Particulars	Qty	Per%	Color	Particulars	Qty	Per%	Color	Particulars	Qty	Per%
Yellow	Headstock Beam	2	100%	Dark Green	Centre Stiffner for Headstock	4	100%	Light Green	Floor Stiffner for Headstock	4	100%
Dark Blue	Aux. Head stock	4	100%	Pink	Sole Bar	7.5	47%	Light Blue	Draft Gear Bracket	2	100%
Yellow	Trough floor	2	29%	Light Blue	Centre plate	2	100%		SoleBar Stiffner	4	100%
	Bottom Wall Part	7.5	47%		Body panel/patch		100%		Door Top/Roof Patch		0%
	Window Module		0%		Window Sill	32	80%		Window Bar	42	23%
	Seat pillar/lav. Partition		100%		UIC end construction		0%

End Drooping: Rotary End - EAST : 7, WEST : 3 Other End - EAST : 3, WEST : -4

Start Date : 28-Aug-2019, Completion Date : 03-Sep-2019, Net Repair Days : 6, Total Man Hours : 1256
