Coach Rehabilitation Workshop, WC Railway, Bhopal

(An IMS and ISO 50001 Certified Workshop)
Final Inspection Sheet - Details of Corrosion Repair

Coach No. :NW05026

Type : WGFACCW

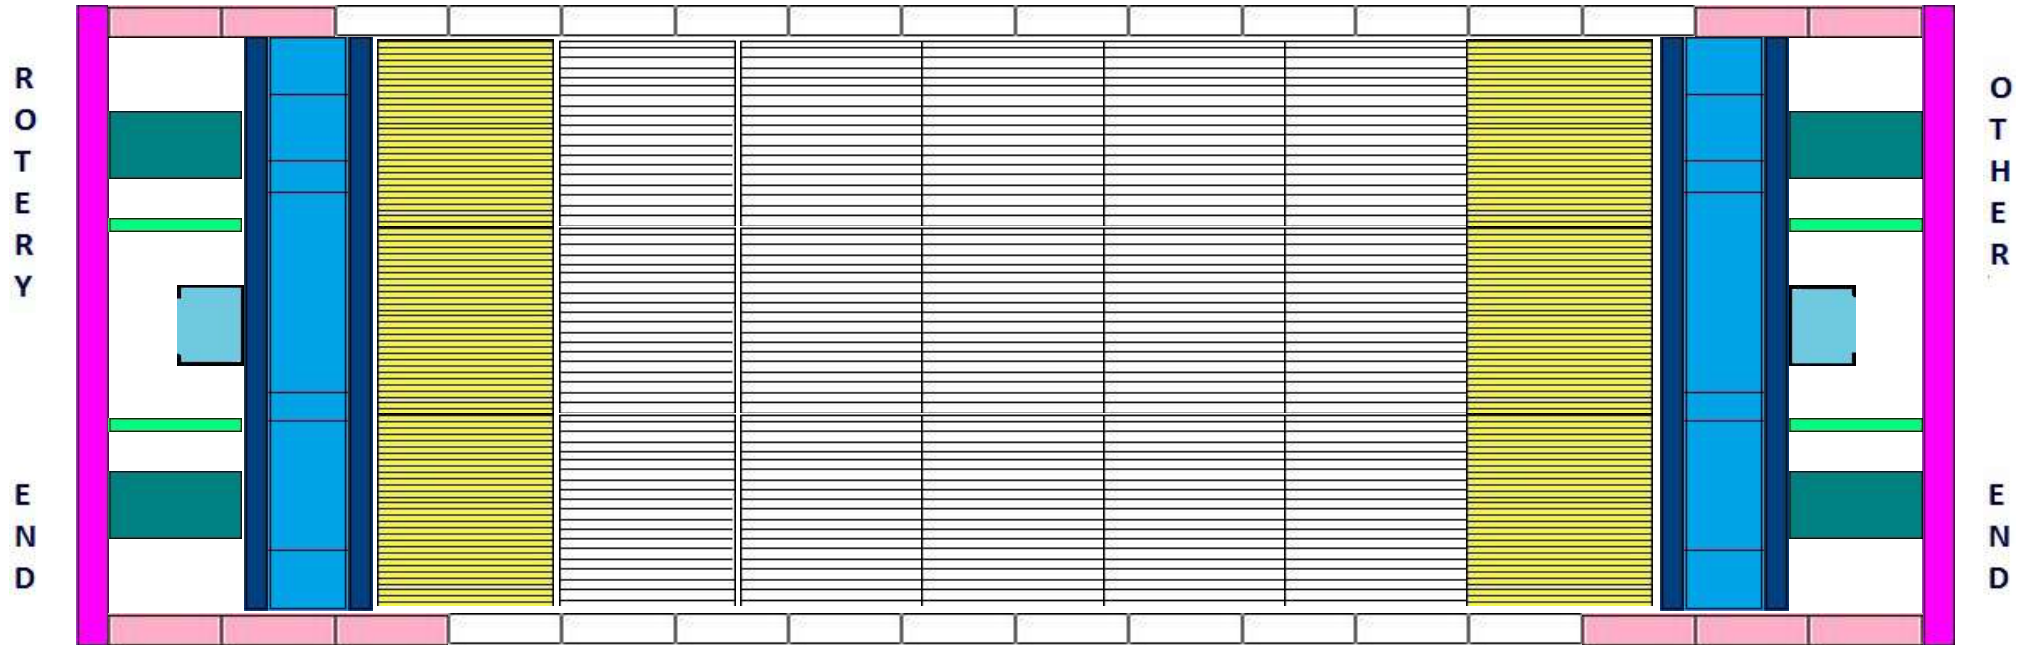
Rotary Side

Color	Particulars	Qty	Per%	Color	Particulars	Qty	Per%	Color	Particulars	Qty	Per%
	Headstock Beam	2	100%		Centre Stiffner for Headstock	4	100%		Floor Stiffner for Headstock	4	100%
	Aux. Head stock	4	100%		Sole Bar	5	31%		Draft Gear Bracket	2	100%
	Trough floor	2	29%		Centre plate	2	100%		SoleBar Stiffner	4	100%
	Bottom Wall Part	5	31%		Body panel/patch		100%		Door Top/Roof Patch		0%
	Window Module		4%		Window Sill	0	0%		Window Bar	0	0%
	Seat pillar/lav. Partition		100%		UIC end construction		0%

End Drooping: Rotary End - EAST : -2, WEST : -2 Other End - EAST : -3, WEST : -5
Start Date : 04-Apr-2019, Completion Date : 15-Apr-2019, Net Repair Days : 10, Total Man Hours : 1344

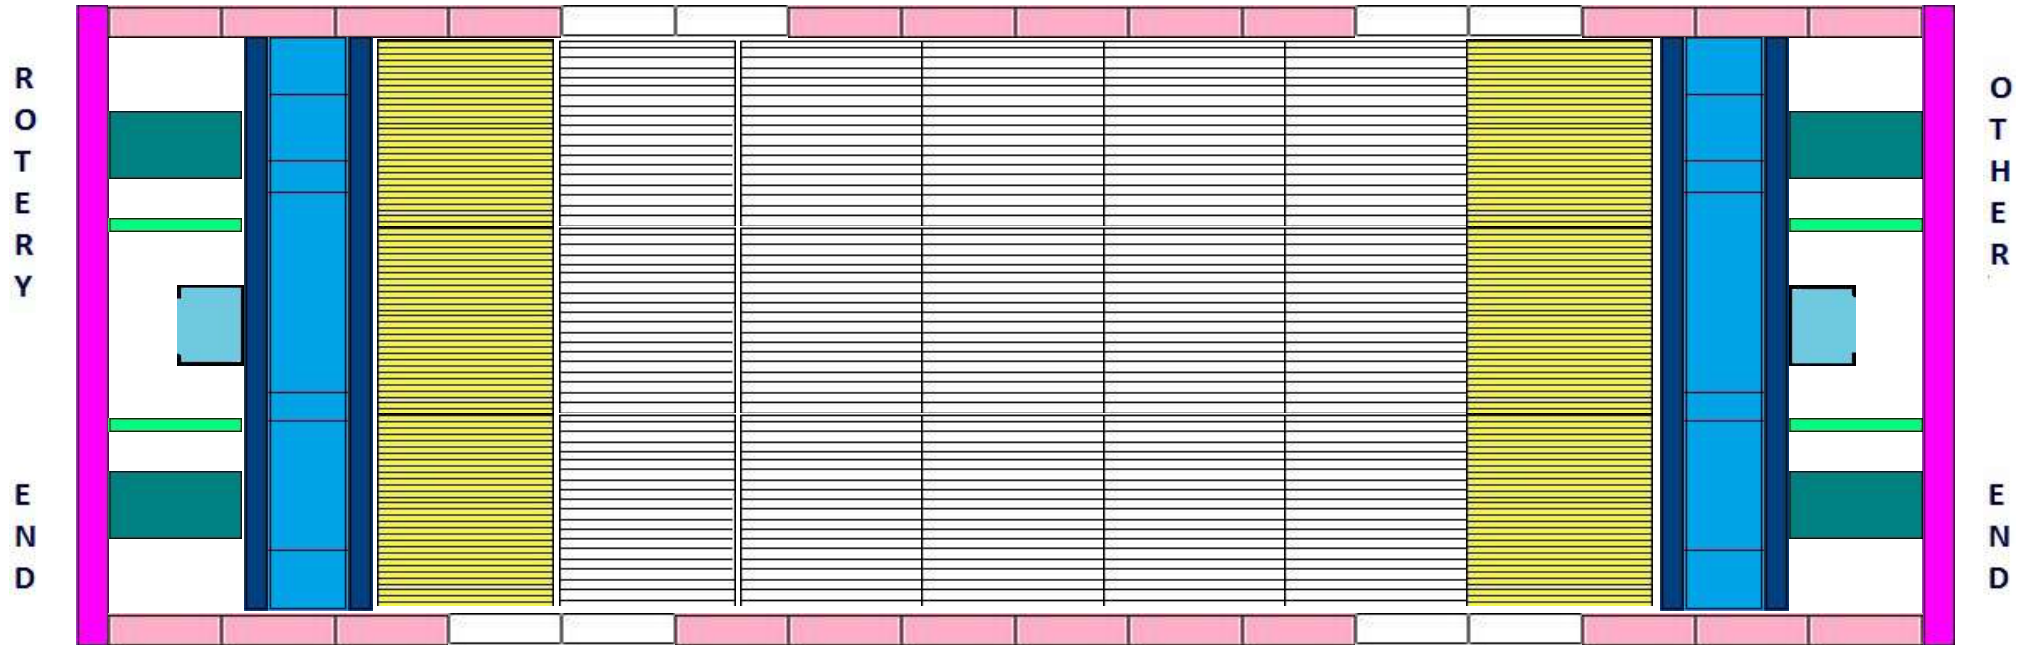
Color	Particulars	Qty	Per%	Color	Particulars	Qty	Per%	Color	Particulars	Qty	Per%
Yellow	Headstock Beam	2	100%	Dark Green	Centre Stiffner for Headstock	4	100%	Light Green	Floor Stiffner for Headstock	4	100%
Dark Blue	Aux. Head stock	4	100%	Pink	Sole Bar	12	75%	Light Blue	Draft Gear Bracket	2	100%
Yellow	Trough floor	2	29%	Light Blue	Centre plate	2	100%		SoleBar Stiffner	4	100%
	Bottom Wall Part	12	75%		Body panel/patch		100%		Door Top/Roof Patch		0%
	Window Module		0%		Window Sill	19	100%		Window Bar	30	36%
	Seat pillar/lav. Partition		100%		UIC end construction		0%

End Drooping: Rotary End - EAST : 6, WEST : 0 Other End - EAST : 5, WEST : 0
Start Date : 10-May-2019, Completion Date : 27-May-2019, Net Repair Days : 15, Total Man Hours : 1760

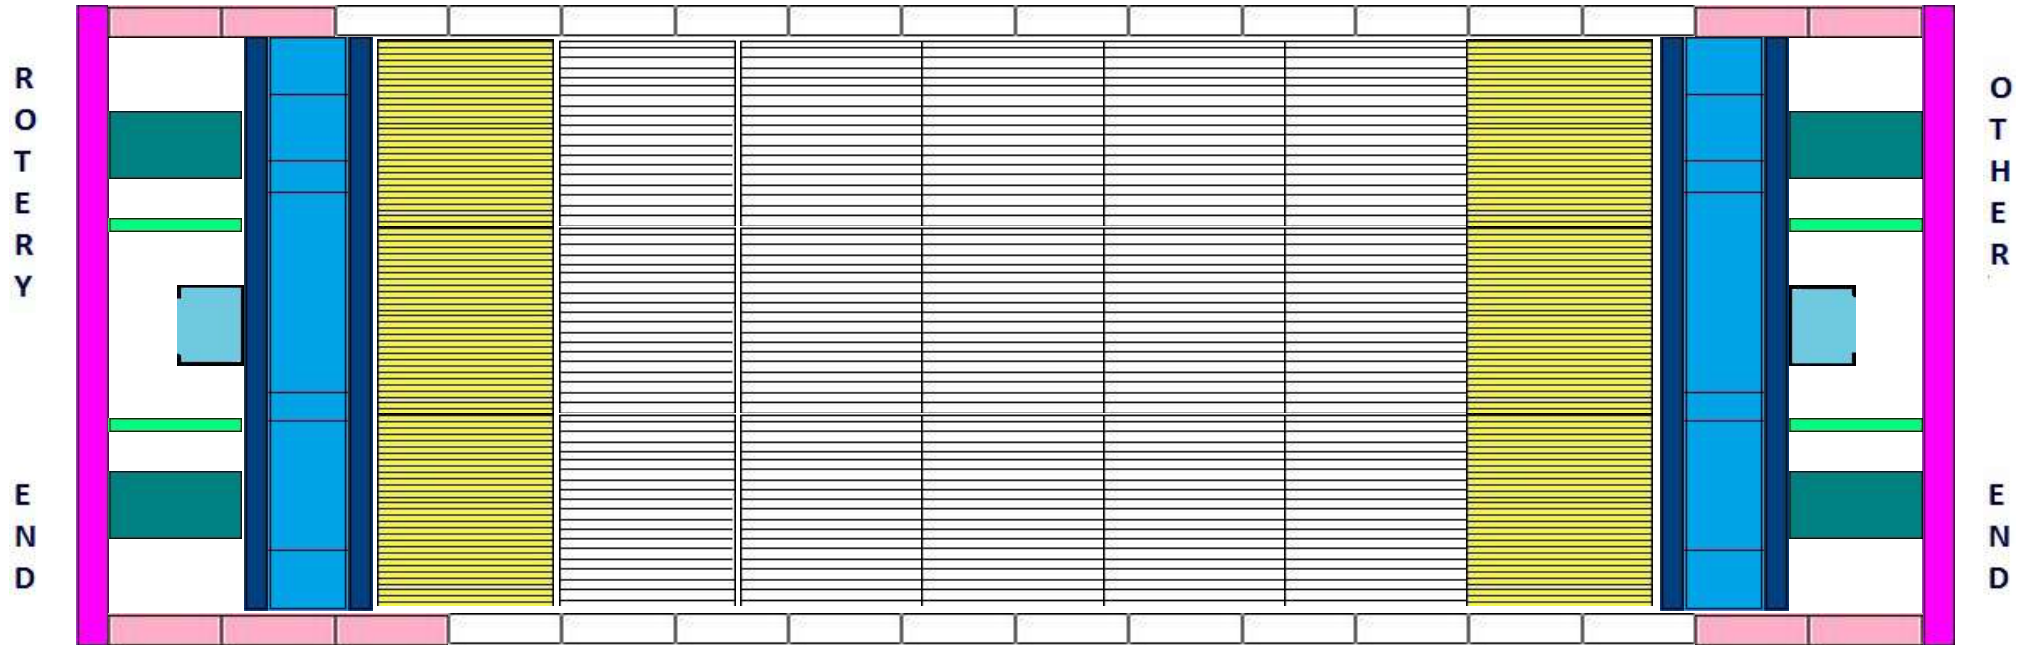
Rotary Side

Color	Particulars	Qty	Per%	Color	Particulars	Qty	Per%	Color	Particulars	Qty	Per%
	Headstock Beam	2	100%		Centre Stiffner for Headstock	4	100%		Floor Stiffner for Headstock	4	100%
	Aux. Head stock	4	100%		Sole Bar	4.5	28%		Draft Gear Bracket	2	100%
	Trough floor	2	29%		Centre plate	2	100%		SoleBar Stiffner	4	100%
	Bottom Wall Part	4.5	28%		Body panel/patch		100%		Door Top/Roof Patch		0%
	Window Module		4%		Window Sill	0	0%		Window Bar	0	0%
	Seat pillar/lav. Partition		100%		UIC end construction		0%

End Drooping: Rotary End - EAST : 7, WEST : 0 Other End - EAST : 5, WEST : 0
Start Date : 18-Sep-2019, Completion Date : 23-Sep-2019, Net Repair Days : 5, Total Man Hours : 1173

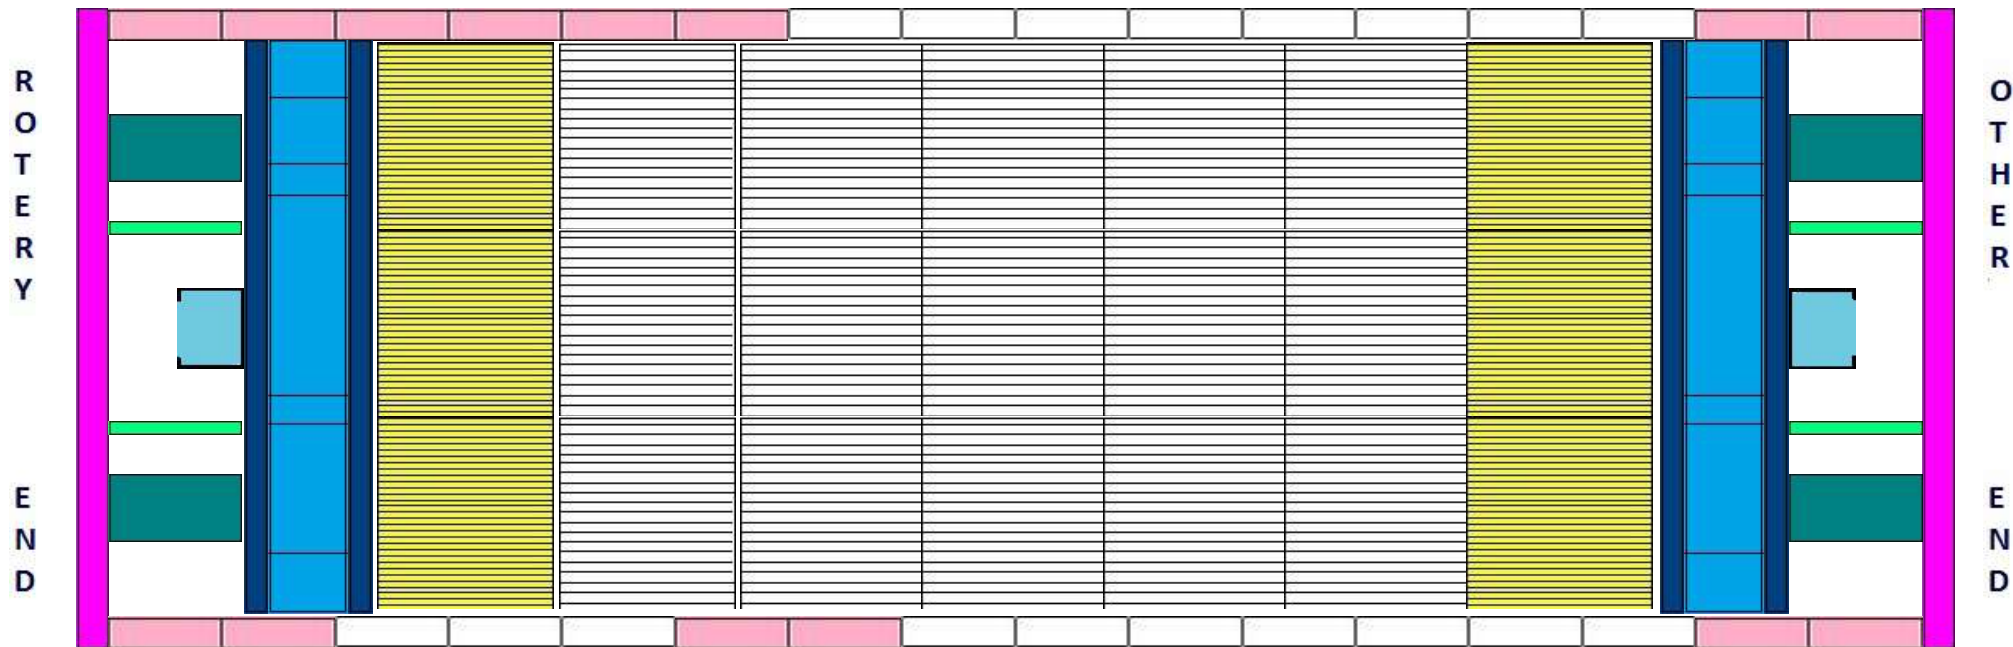
Color	Particulars	Qty	Per%	Color	Particulars	Qty	Per%	Color	Particulars	Qty	Per%
Yellow	Headstock Beam	2	100%	Dark Green	Centre Stiffner for Headstock	4	100%	Light Green	Floor Stiffner for Headstock	4	100%
Dark Blue	Aux. Head stock	4	100%	Pink	Sole Bar	7	44%	Light Blue	Draft Gear Bracket	2	100%
Yellow	Trough floor	2	29%	Light Blue	Centre plate	2	100%		SoleBar Stiffner	4	100%
	Bottom Wall Part	7	44%		Body panel/patch		100%		Door Top/Roof Patch		0%
	Window Module		0%		Window Sill	30	83%		Window Bar	42	24%
	Seat pillar/lav. Partition		100%		UIC end construction		0%

End Drooping: Rotary End - EAST : -8, WEST : -10 Other End - EAST : 0, WEST : 0
Start Date : 10-Oct-2019, Completion Date : 17-Oct-2019, Net Repair Days : 7, Total Man Hours : 1333

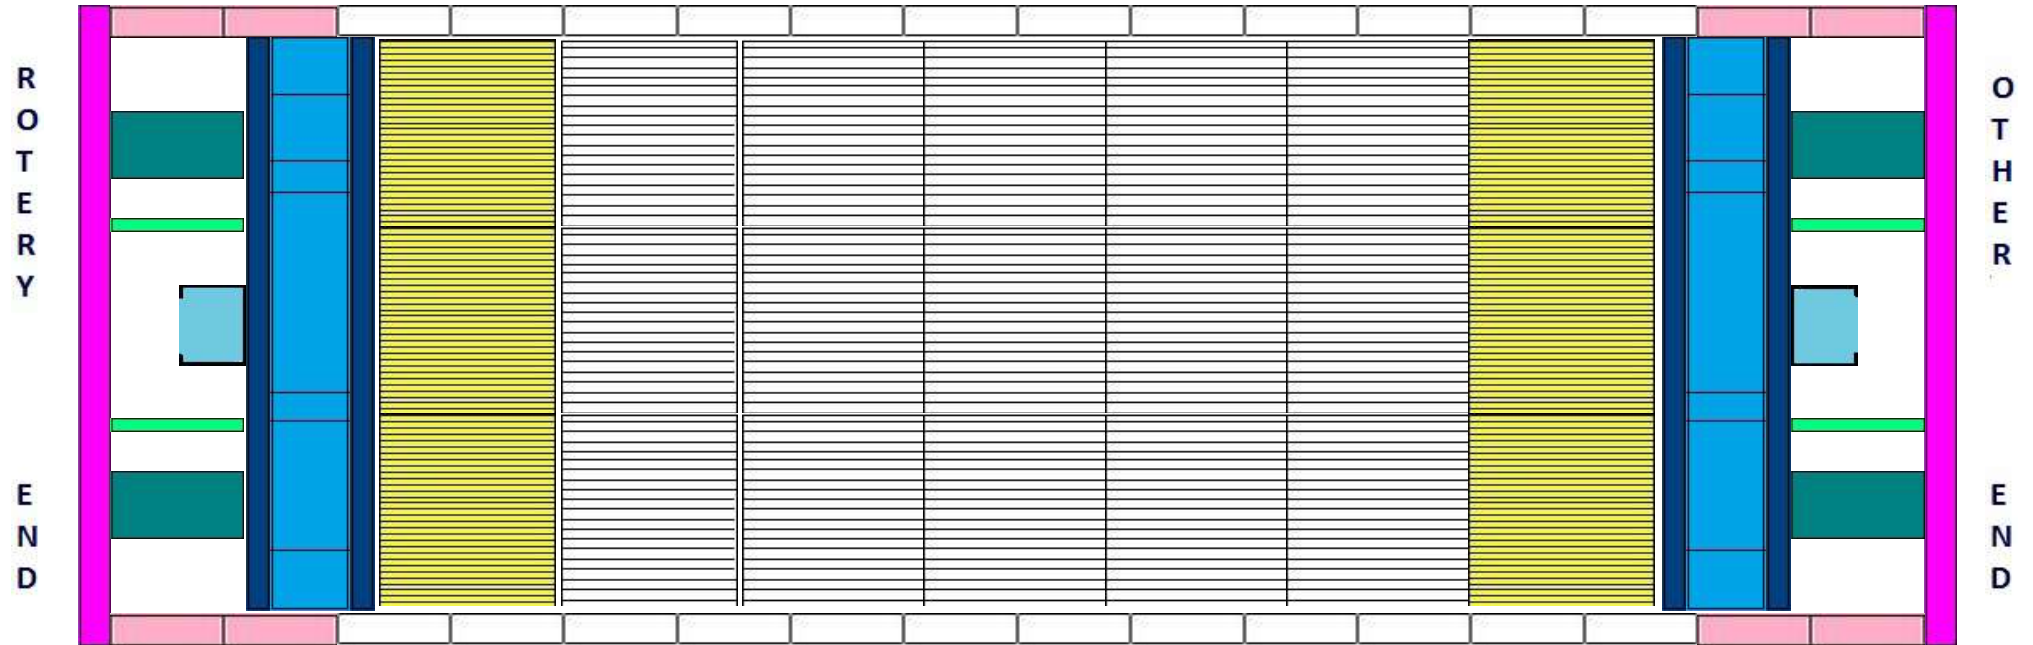
Rotary Side

Color	Particulars	Qty	Per%	Color	Particulars	Qty	Per%	Color	Particulars	Qty	Per%
	Headstock Beam	2	100%		Centre Stiffner for Headstock	4	100%		Floor Stiffner for Headstock	4	100%
	Aux. Head stock	4	100%		Sole Bar	4	25%		Draft Gear Bracket	2	100%
	Trough floor	2	29%		Centre plate	2	100%		SoleBar Stiffner	4	67%
	Bottom Wall Part	4	25%		Body panel/patch		100%		Door Top/Roof Patch		0%
	Window Module		0%		Window Sill	20	50%		Window Bar	44	25%
	Seat pillar/lav. Partition		100%		UIC end construction		0%

End Drooping: Rotary End - EAST : -3, WEST : 0 Other End - EAST : -6, WEST : -3
Start Date : 18-Oct-2019, Completion Date : 31-Oct-2019, Net Repair Days : 12, Total Man Hours : 1004

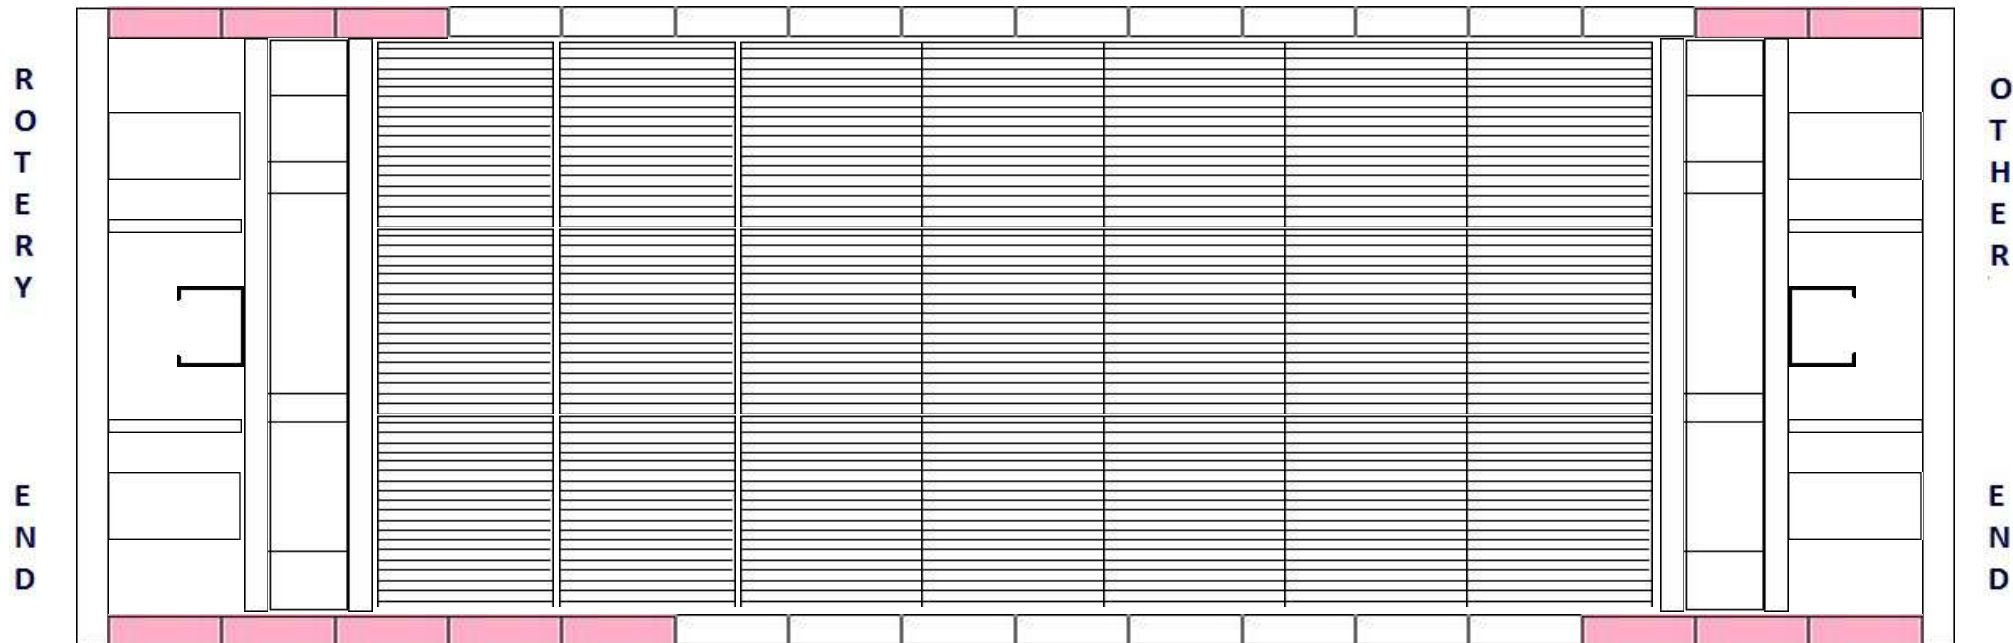
Rotary Side

Color	Particulars	Qty	Per%	Color	Particulars	Qty	Per%	Color	Particulars	Qty	Per%
	Headstock Beam	0	0%		Centre Stiffner for Headstock	0	0%		Floor Stiffner for Headstock	0	0%
	Aux. Head stock	0	0%		Sole Bar	6.5	41%		Draft Gear Bracket	0	0%
	Trough floor	0	0%		Centre plate	0	0%		SoleBar Stiffner	4	67%
	Bottom Wall Part	6.5	41%		Body panel/patch		100%		Door Top/Roof Patch		0%
	Window Module		0%		Window Sill	28	70%		Window Bar	44	25%
	Seat pillar/lav. Partition		100%		UIC end construction		0%

End Drooping: Rotary End - EAST : 4, WEST : 6 Other End - EAST : 2, WEST : 0
Start Date : 07-Dec-2019, Completion Date : 13-Dec-2019, Net Repair Days : 6, Total Man Hours : 1360

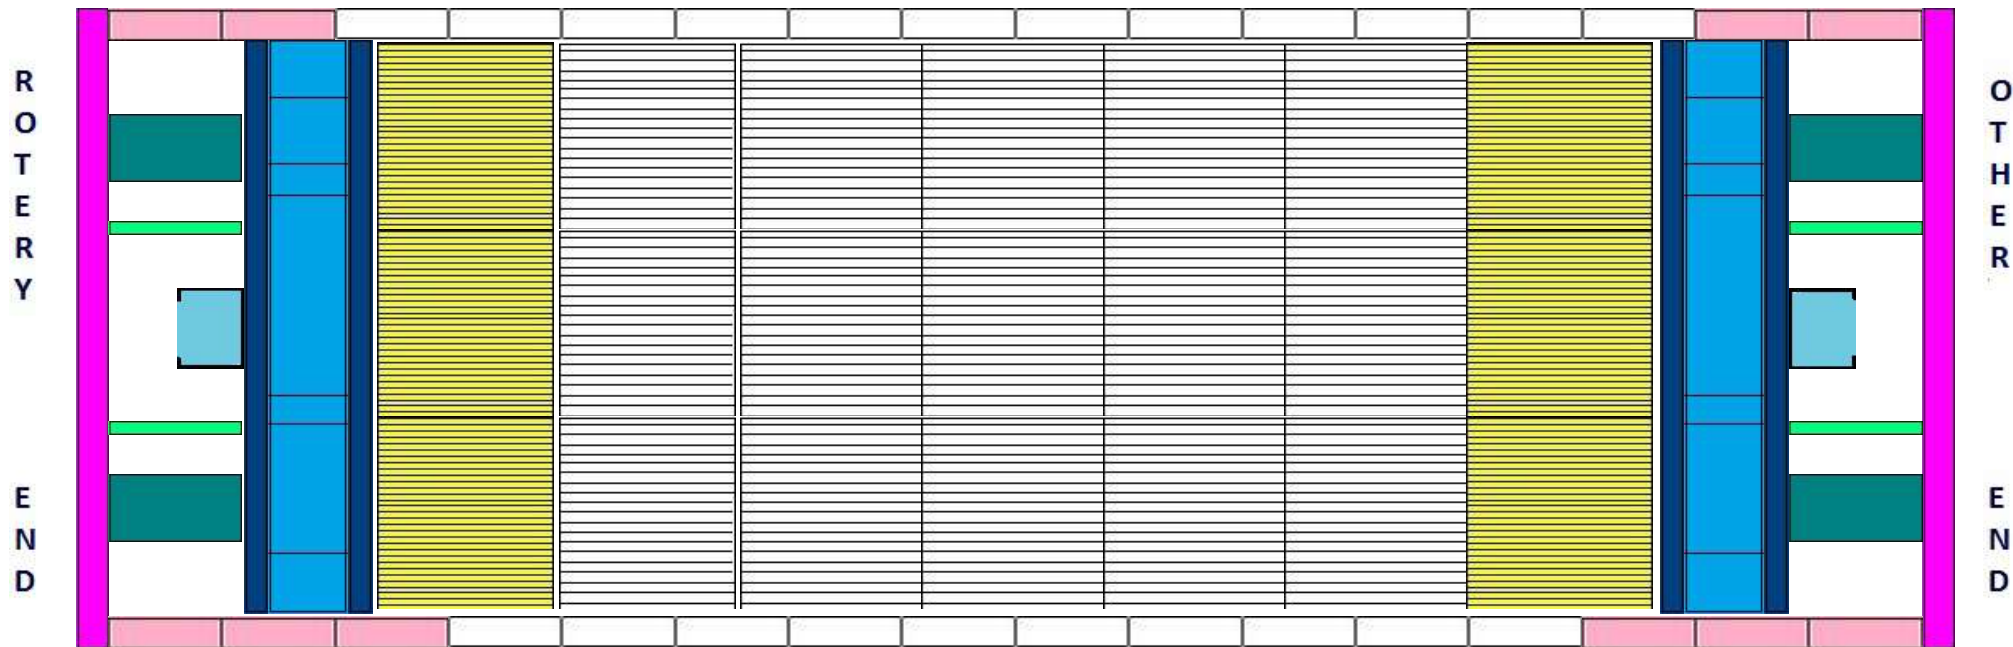
Rotary Side

Color	Particulars	Qty	Per%	Color	Particulars	Qty	Per%	Color	Particulars	Qty	Per%
	Headstock Beam	2	100%		Centre Stiffner for Headstock	4	100%		Floor Stiffner for Headstock	4	100%
	Aux. Head stock	4	100%		Sole Bar	5	31%		Draft Gear Bracket	2	100%
	Trough floor	2	29%		Centre plate	2	100%		SoleBar Stiffner	4	100%
	Bottom Wall Part	5	31%		Body panel/patch		100%		Door Top/Roof Patch		0%
	Window Module		3%		Window Sill	0	0%		Window Bar	0	0%
	Seat pillar/lav. Partition		100%		UIC end construction		0%

End Drooping: Rotary End - EAST : -10, WEST : -9 Other End - EAST : -4, WEST : -4
Start Date : 01-Apr-2019, Completion Date : 09-Apr-2019, Net Repair Days : 8, Total Man Hours : 1232

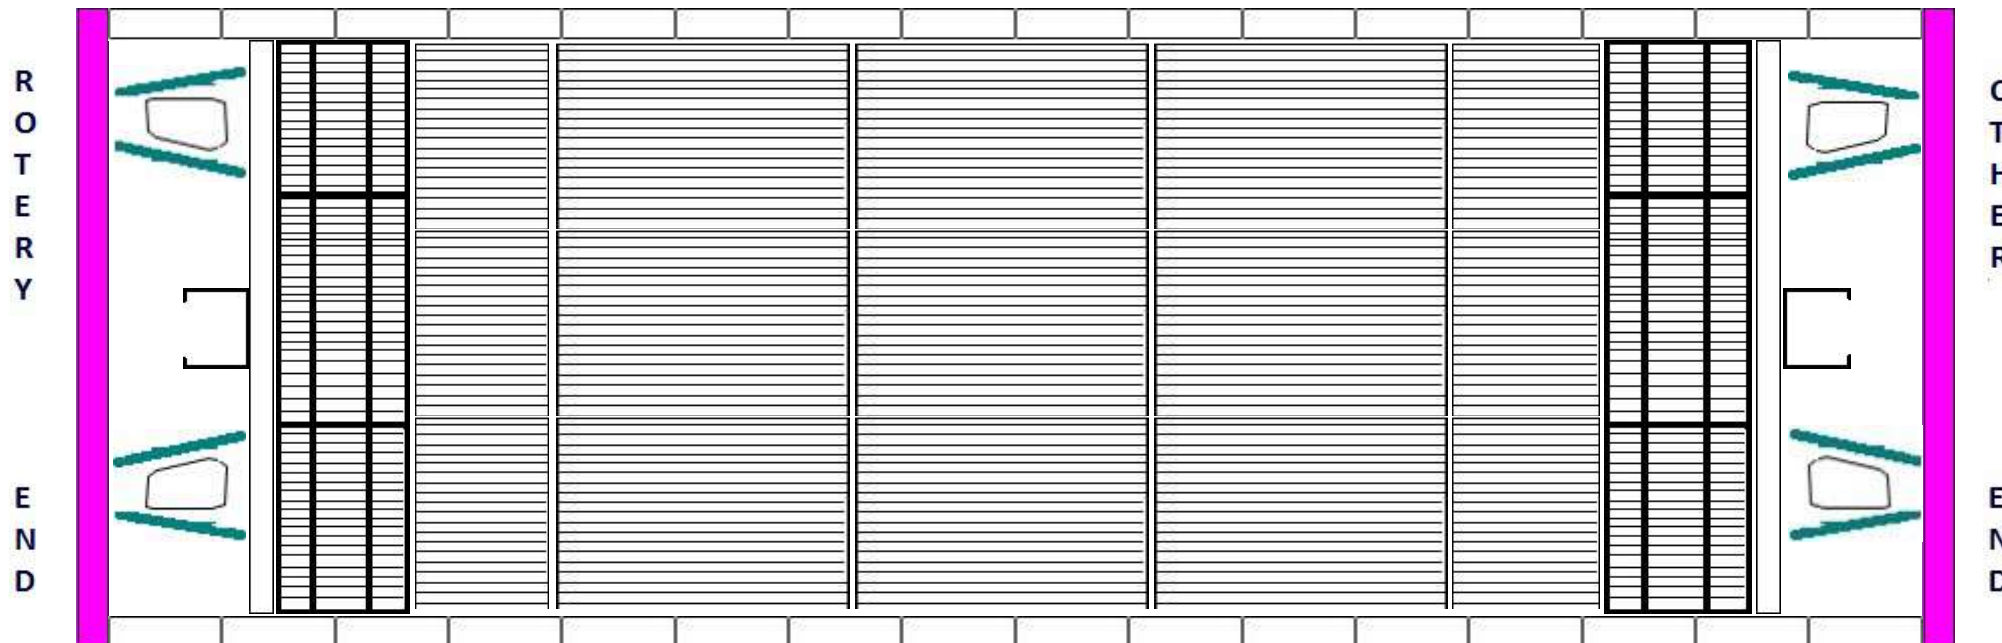
Rotary Side

Color	Particulars	Qty	Per%	Color	Particulars	Qty	Per%	Color	Particulars	Qty	Per%
	Headstock Beam	0	0%		Diagonal	4	100%		Logitudinal Channel Structure	0	0%
	Aux. Head stock	0	0%		Sole Bar	0	0%		Draft Gear Bracket	0	0%
	Trough floor	0	0%		Bottom Wall Part	0	0%		Body panel/patch		100%
	Door Top/Roof Patch		0%		Seat Bracket Rail		0%		Window Sill	8	20%
	Window Bar	10	5%		Seat pillar/lav. Partition		100%		UIC end construction		0%
	Body Pillar Part	0	100%

End Drooping: Rotary End - EAST : 0, WEST : 3 Other End - EAST : 5, WEST : 7
Start Date : 11-Apr-2019, Completion Date : 18-Apr-2019, Net Repair Days : 7, Total Man Hours : 656

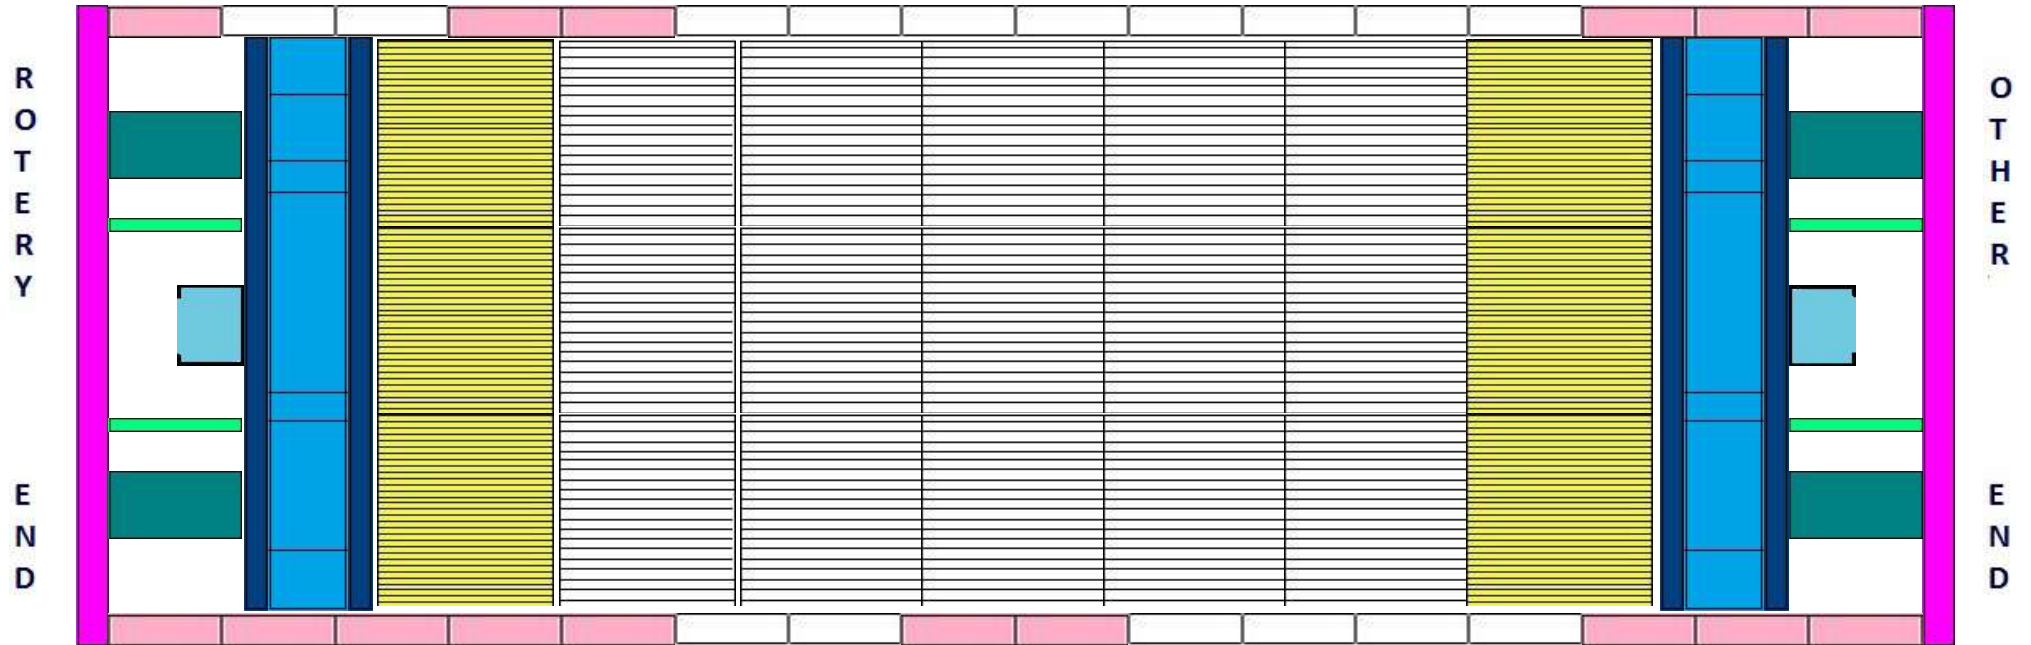
Color	Particulars	Qty	Per%	Color	Particulars	Qty	Per%	Color	Particulars	Qty	Per%
Yellow	Headstock Beam	2	100%	Dark Green	Centre Stiffner for Headstock	4	100%	Light Green	Floor Stiffner for Headstock	4	100%
Dark Blue	Aux. Head stock	4	100%	Pink	Sole Bar	8	50%	Light Blue	Draft Gear Bracket	2	100%
Yellow	Trough floor	2	29%	Light Blue	Centre plate	2	100%		SoleBar Stiffner	4	100%
	Bottom Wall Part	8	50%		Body panel/patch		100%		Door Top/Roof Patch		0%
	Window Module		0%		Window Sill	10	53%		Window Bar	16	19%
	Seat pillar/lav. Partition		100%		UIC end construction		0%

End Drooping: Rotary End - EAST : 2, WEST : 5 Other End - EAST : -3, WEST : -5
Start Date : 01-Jun-2019, Completion Date : 11-Jun-2019, Net Repair Days : 9, Total Man Hours : 1416

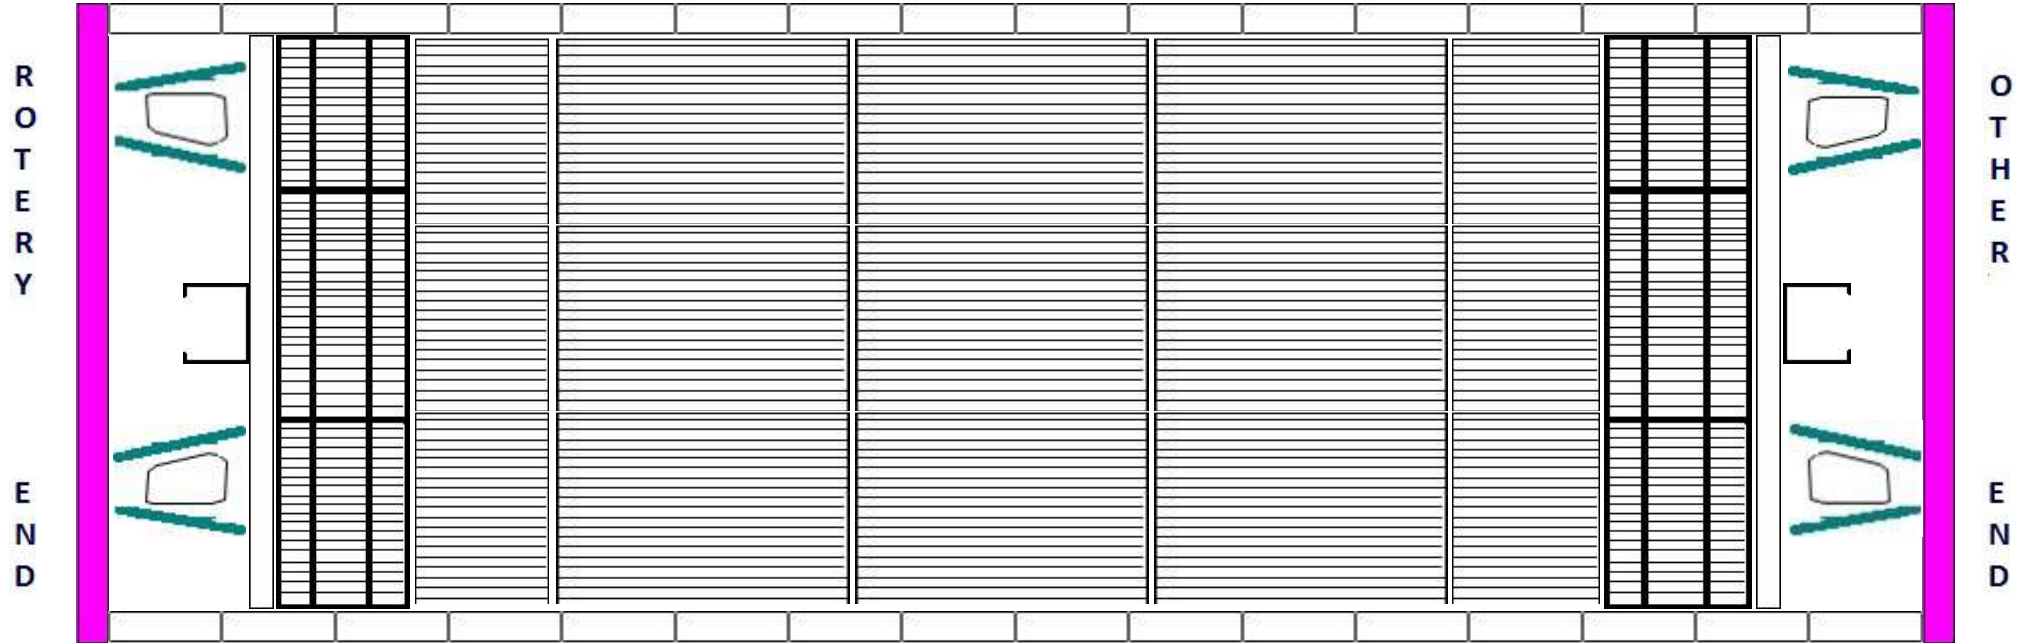
Color	Particulars	Qty	Per%	Color	Particulars	Qty	Per%	Color	Particulars	Qty	Per%
	Headstock Beam	0	0%		Diagonal	4	100%		Logitudinal Channel Structure	0	0%
	Aux. Head stock	0	0%		Sole Bar	0	0%		Draft Gear Bracket	0	0%
	Trough floor	0	0%		Bottom Wall Part	0	0%		Body panel/patch		100%
	Door Top/Roof Patch		0%		Seat Bracket Rail		0%		Window Sill	0	0%
	Window Bar	0	0%		Seat pillar/lav. Partition		100%		UIC end construction		0%
	Body Pillar Part	0	100%

End Drooping: Rotary End - EAST : -7, WEST : -2 Other End - EAST : -6, WEST : -4
Start Date : 10-May-2019, Completion Date : 17-May-2019, Net Repair Days : 7, Total Man Hours : 568

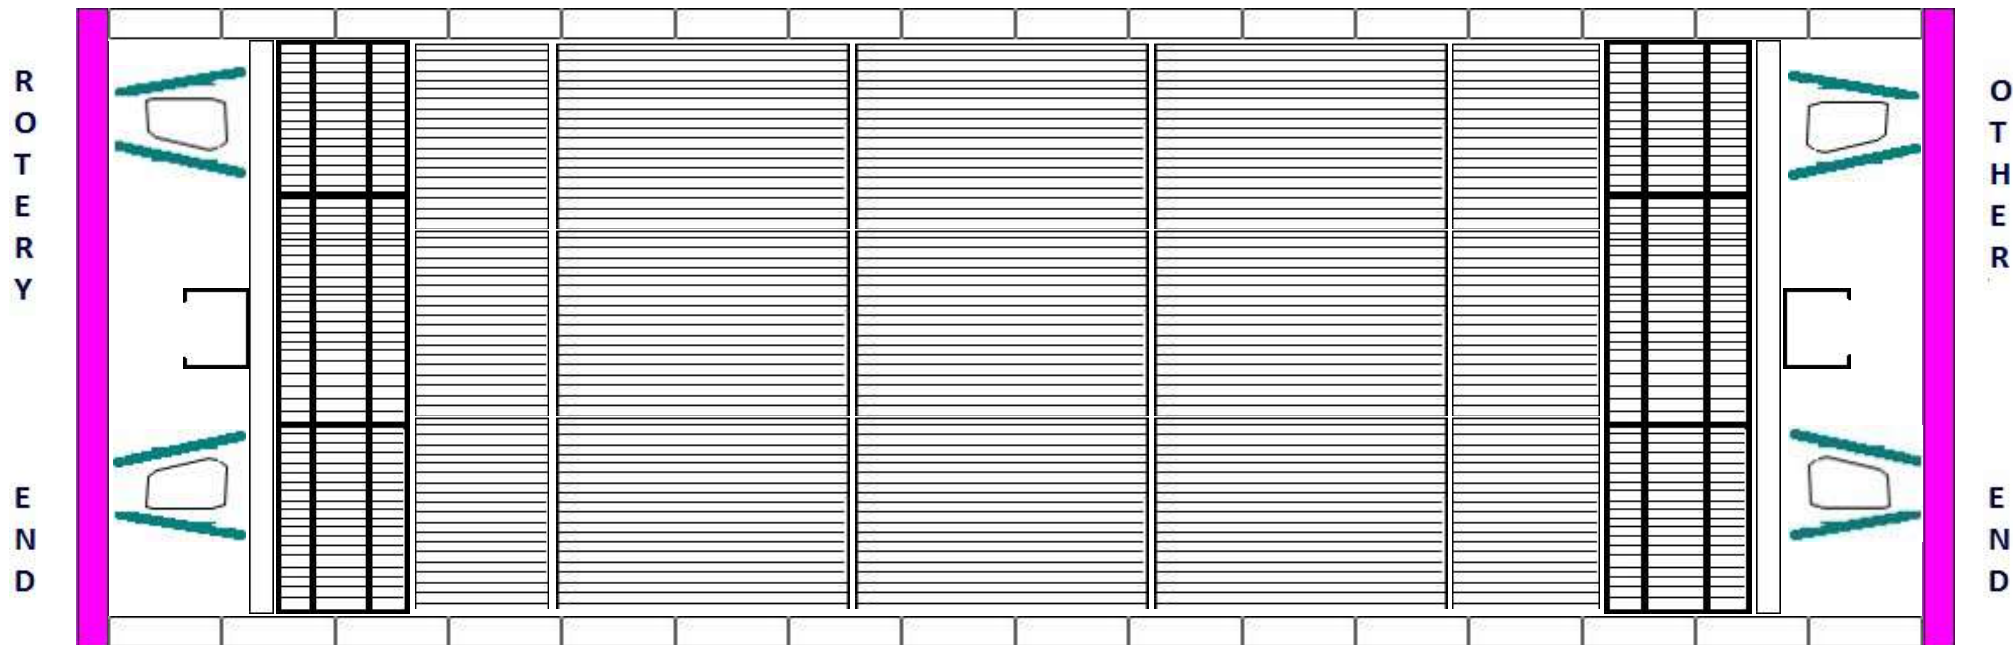
Rotary Side

Color	Particulars	Qty	Per%	Color	Particulars	Qty	Per%	Color	Particulars	Qty	Per%
	Headstock Beam	0	0%		Diagonal	4	100%		Logitudinal Channel Structure	0	0%
	Aux. Head stock	0	0%		Sole Bar	0	0%		Draft Gear Bracket	0	0%
	Trough floor	0	0%		Bottom Wall Part	0	0%		Body panel/patch		100%
	Door Top/Roof Patch		0%		Seat Bracket Rail		0%		Window Sill	5	13%
	Window Bar	10	5%		Seat pillar/lav. Partition		100%		UIC end construction		0%
	Body Pillar Part	0	100%

End Drooping: Rotary End - EAST : -8, WEST : -7 Other End - EAST : -4, WEST : -6
Start Date : 25-Apr-2019, Completion Date : 02-May-2019, Net Repair Days : 7, Total Man Hours : 0

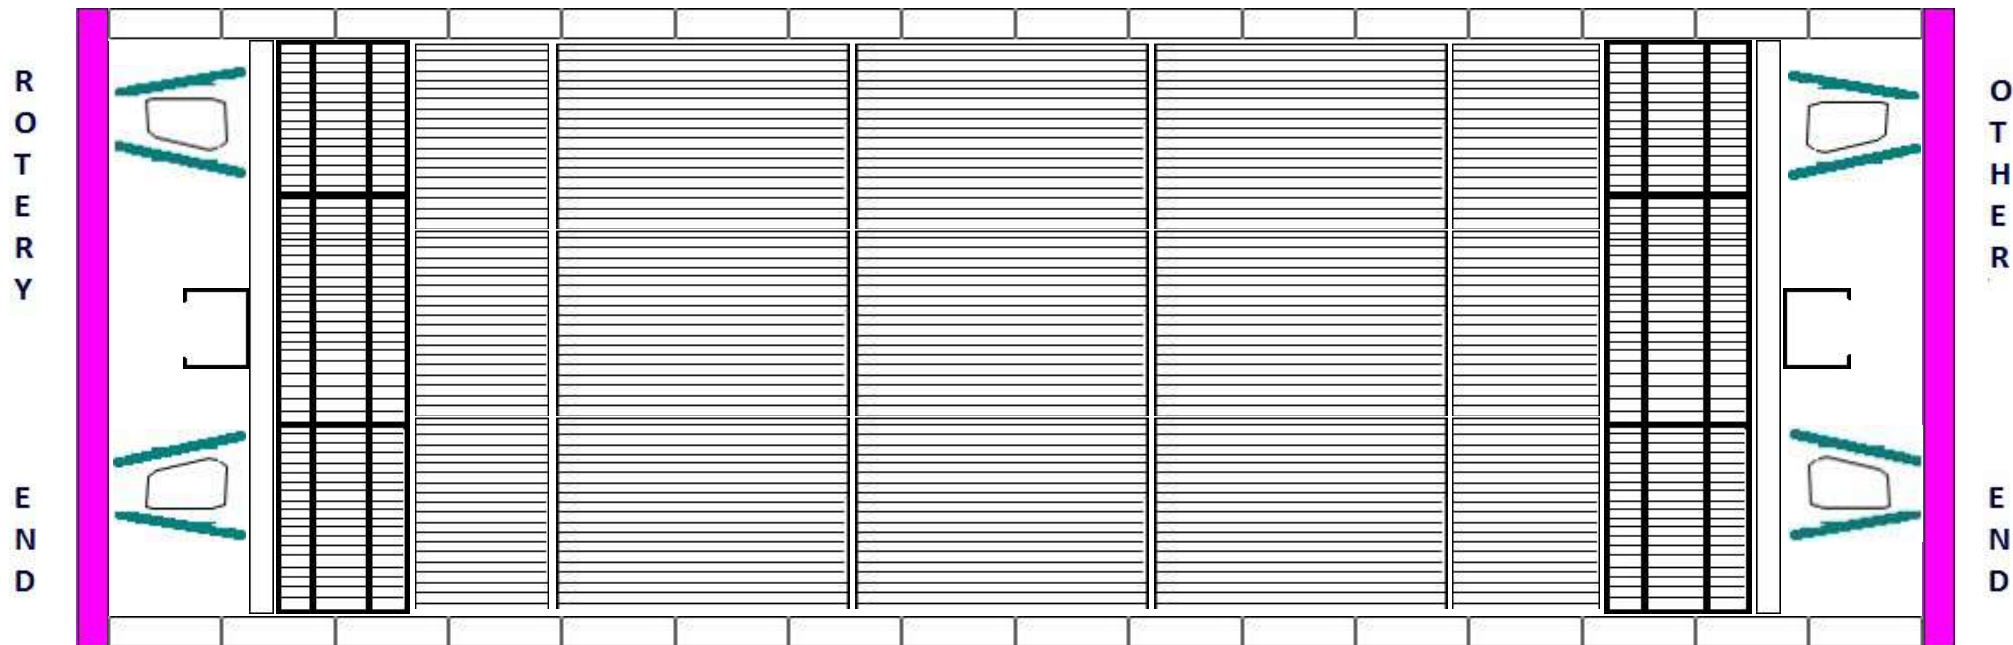
Rotary Side

Color	Particulars	Qty	Per%	Color	Particulars	Qty	Per%	Color	Particulars	Qty	Per%
	Headstock Beam	0	0%		Diagonal	4	100%		Logitudinal Channel Structure	0	0%
	Aux. Head stock	0	0%		Sole Bar	0	0%		Draft Gear Bracket	0	0%
	Trough floor	0	0%		Bottom Wall Part	0	0%		Body panel/patch		100%
	Door Top/Roof Patch		0%		Seat Bracket Rail		0%		Window Sill	0	0%
	Window Bar	0	0%		Seat pillar/lav. Partition		100%		UIC end construction		0%
	Body Pillar Part	0	100%

End Drooping: Rotary End - EAST : 0, WEST : -2 Other End - EAST : 0, WEST : 0
Start Date : 13-Apr-2019, Completion Date : 20-Apr-2019, Net Repair Days : 7, Total Man Hours : 644

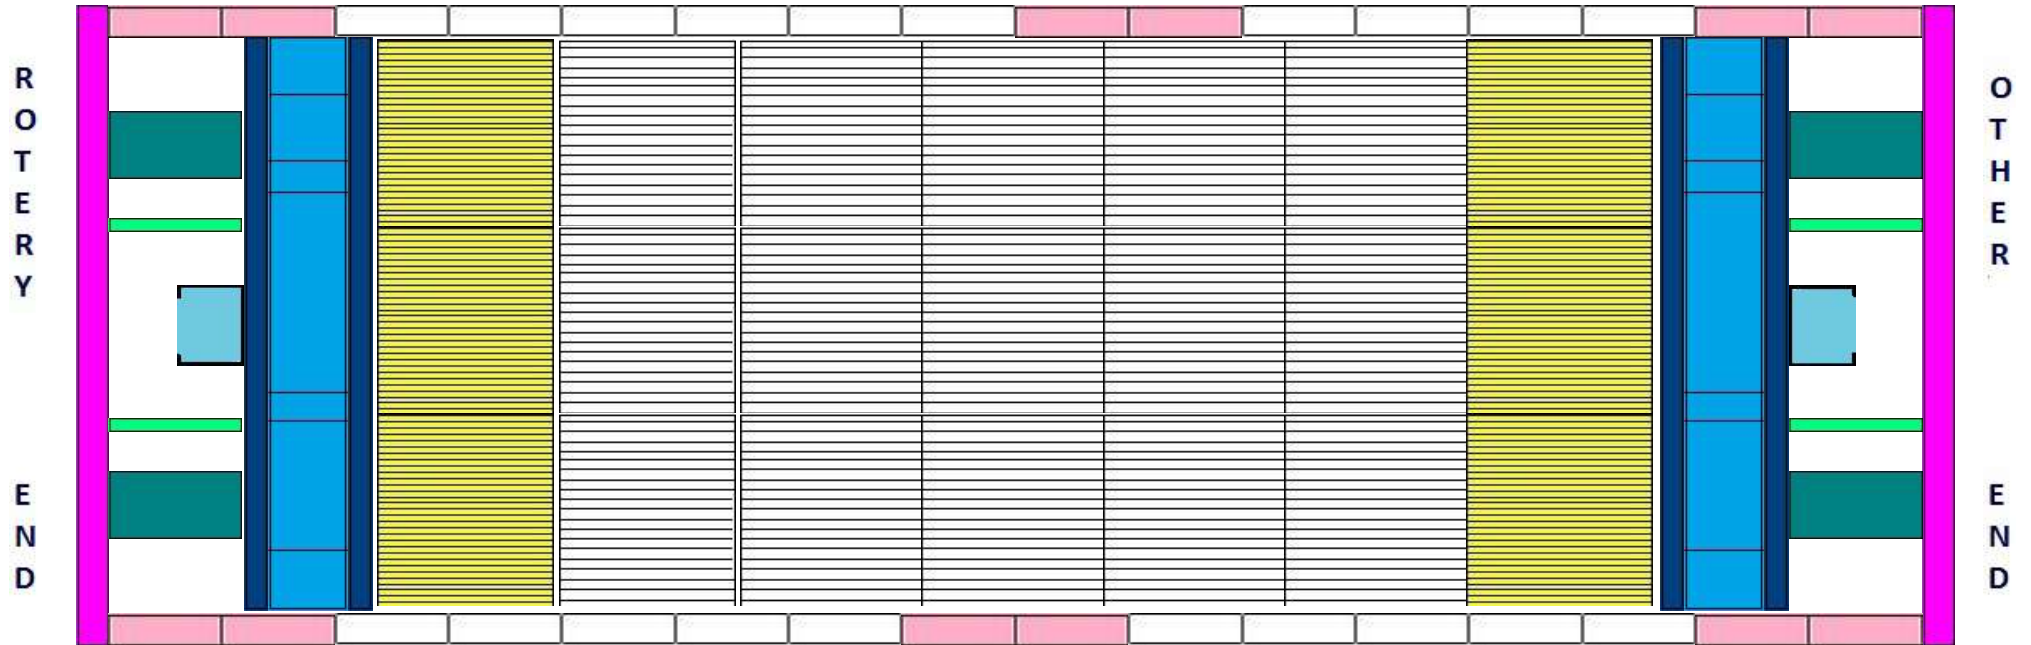
Rotary Side

Color	Particulars	Qty	Per%	Color	Particulars	Qty	Per%	Color	Particulars	Qty	Per%
	Headstock Beam	2	100%		Centre Stiffner for Headstock	4	100%		Floor Stiffner for Headstock	4	100%
	Aux. Head stock	4	100%		Sole Bar	6	38%		Draft Gear Bracket	2	100%
	Trough floor	2	29%		Centre plate	2	100%		SoleBar Stiffner	6	100%
	Bottom Wall Part	6	38%		Body panel/patch		100%		Door Top/Roof Patch		0%
	Window Module		0%		Window Sill	14	35%		Window Bar	48	27%
	Seat pillar/lav. Partition		100%		UIC end construction		0%

End Drooping: Rotary End - EAST : -2, WEST : -6 Other End - EAST : -2, WEST : 5
Start Date : 08-May-2019, Completion Date : 16-May-2019, Net Repair Days : 8, Total Man Hours : 1204

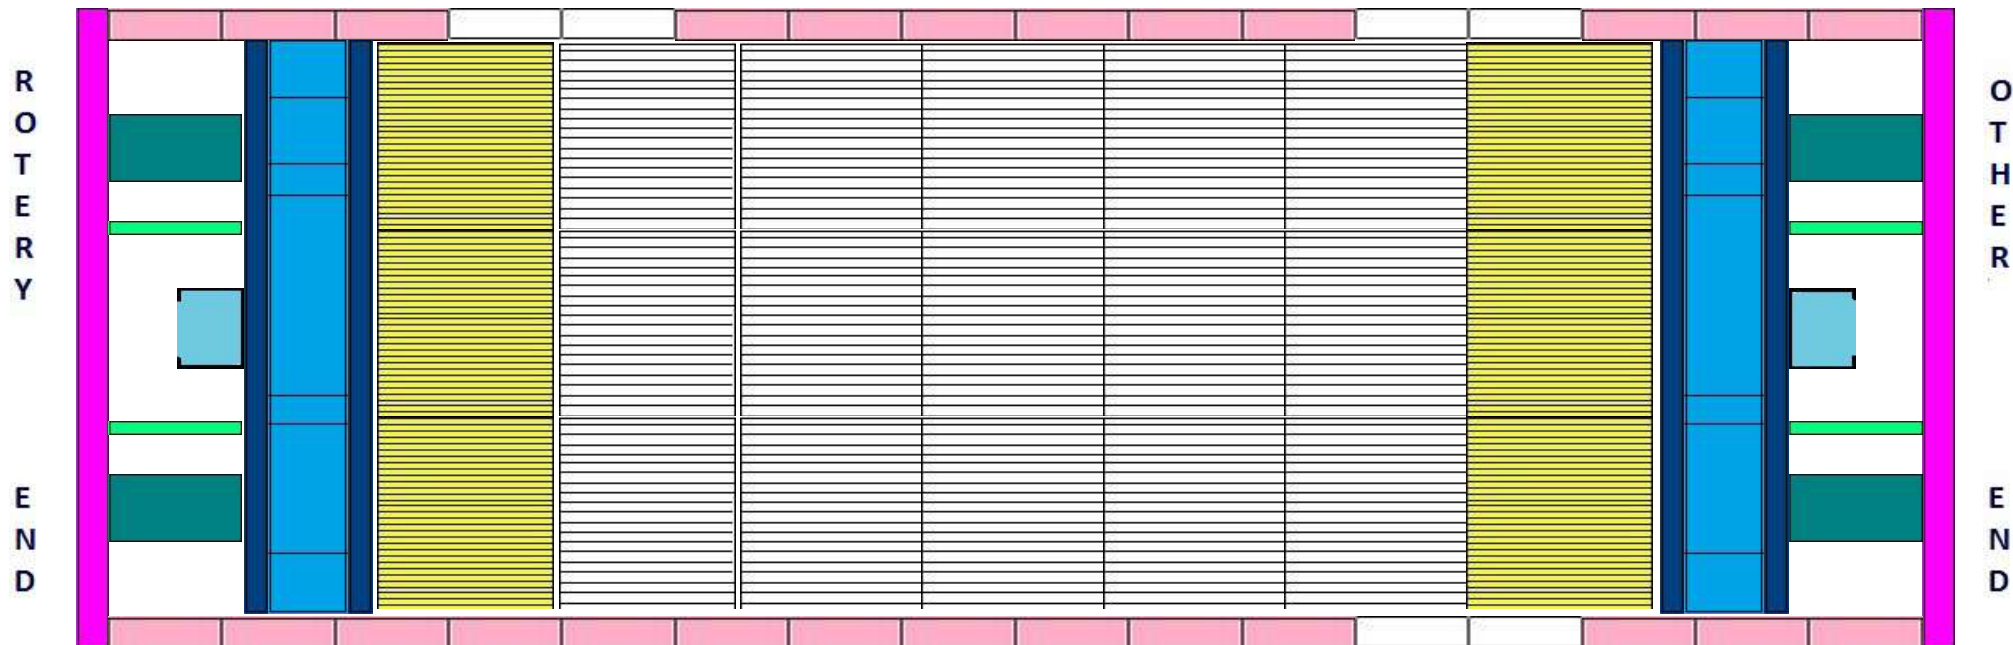
Color	Particulars	Qty	Per%	Color	Particulars	Qty	Per%	Color	Particulars	Qty	Per%
Yellow	Headstock Beam	2	100%	Dark Green	Centre Stiffner for Headstock	4	100%	Light Green	Floor Stiffner for Headstock	4	100%
Dark Blue	Aux. Head stock	4	100%	Pink	Sole Bar	13	81%	Light Blue	Draft Gear Bracket	2	100%
Yellow	Trough floor	2	29%	Light Blue	Centre plate	2	100%		SoleBar Stiffner	4	100%
	Bottom Wall Part	13	81%		Body panel/patch		100%		Door Top/Roof Patch		0%
	Window Module		0%		Window Sill	10	53%		Window Bar	20	24%
	Seat pillar/lav. Partition		100%		UIC end construction		0%

End Drooping: Rotary End - EAST : -8, WEST : -6 Other End - EAST : -6, WEST : -6
Start Date : 31-May-2019, Completion Date : 11-Jun-2019, Net Repair Days : 10, Total Man Hours : 1688

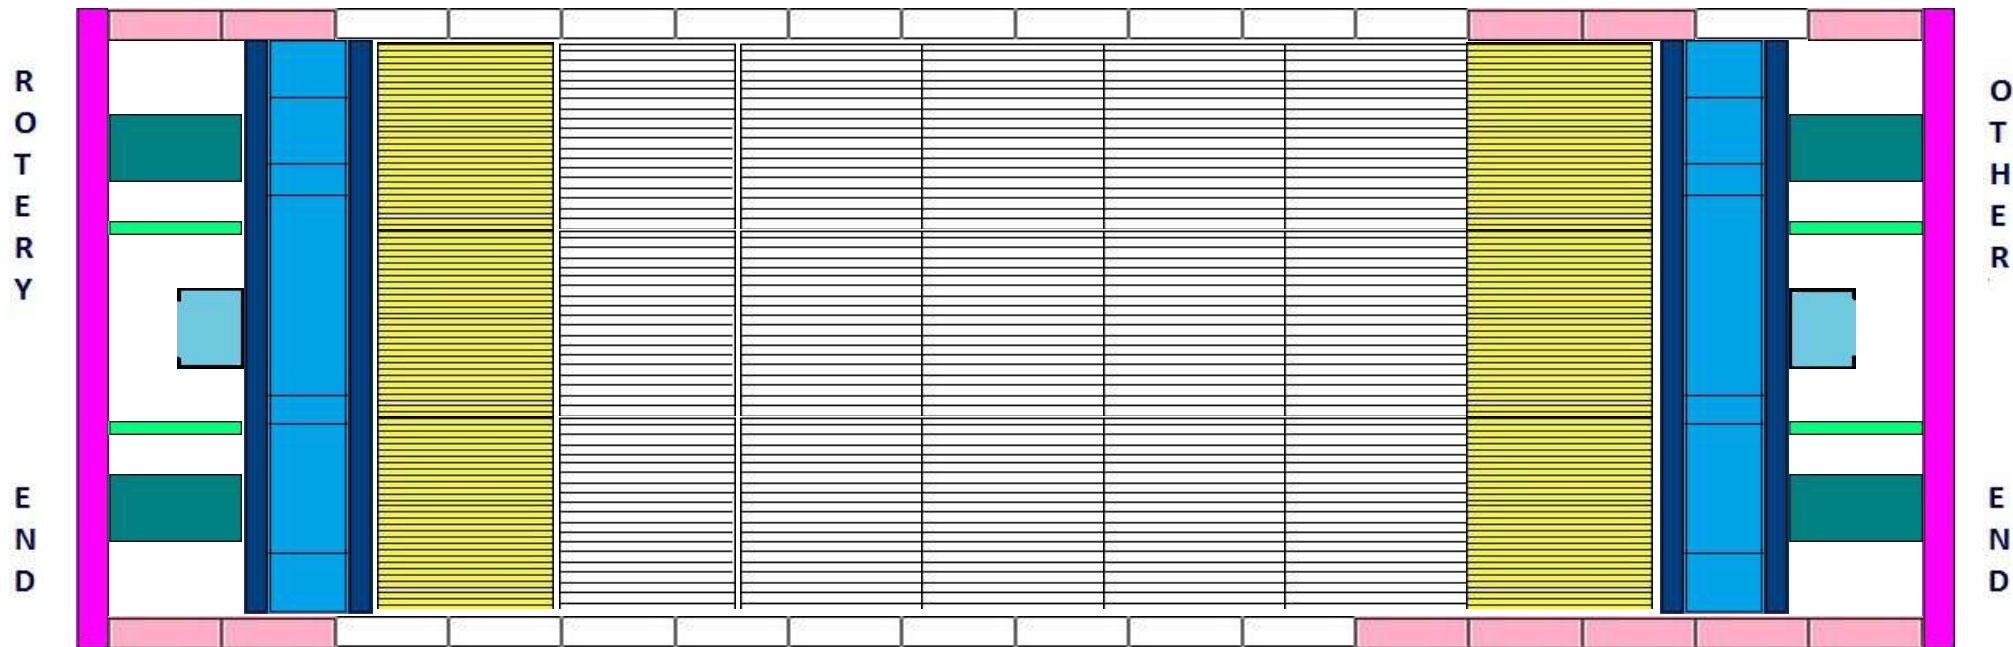
Rotary Side

Color	Particulars	Qty	Per%	Color	Particulars	Qty	Per%	Color	Particulars	Qty	Per%
	Headstock Beam	2	100%		Centre Stiffner for Headstock	4	100%		Floor Stiffner for Headstock	4	100%
	Aux. Head stock	4	100%		Sole Bar	6	38%		Draft Gear Bracket	2	100%
	Trough floor	2	29%		Centre plate	2	100%		SoleBar Stiffner	4	100%
	Bottom Wall Part	6	38%		Body panel/patch		100%		Door Top/Roof Patch		0%
	Window Module		0%		Window Sill	12	63%		Window Bar	18	21%
	Seat pillar/lav. Partition		100%		UIC end construction		0%

End Drooping: Rotary End - EAST : 4, WEST : 3 Other End - EAST : 0, WEST : -3
Start Date : 26-Aug-2019, Completion Date : 31-Aug-2019, Net Repair Days : 6, Total Man Hours : 1289
