Coach Rehabilitation Workshop, WC Railway, Bhopal

(An IMS and ISO 50001 Certified Workshop)
Final Inspection Sheet - Details of Corrosion Repair

Coach No. :NW05026

Type : WGFACCW

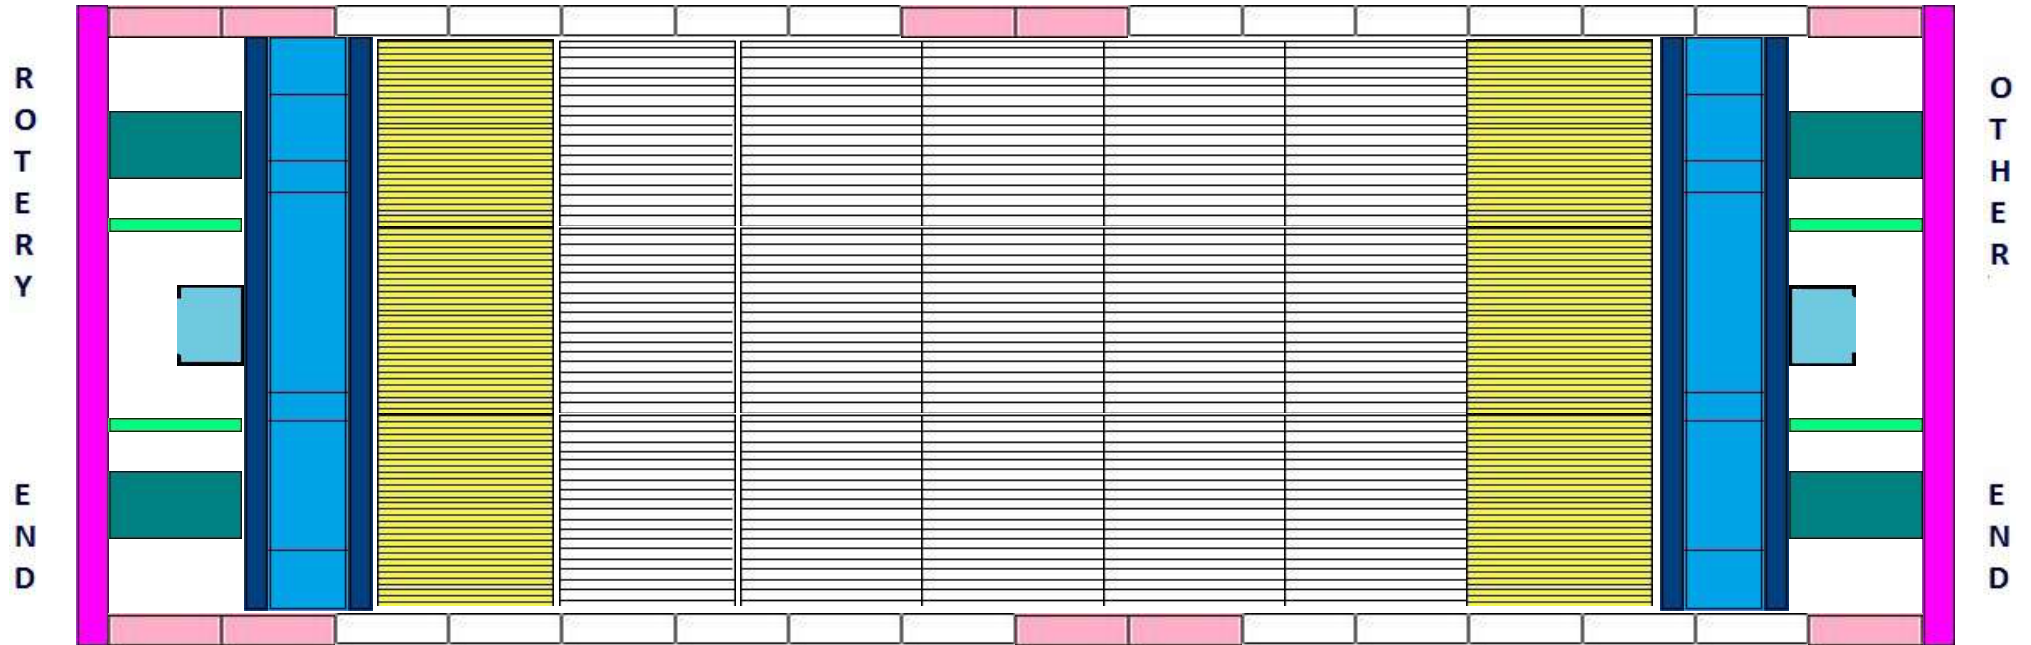
Rotary Side

Color	Particulars	Qty	Per%	Color	Particulars	Qty	Per%	Color	Particulars	Qty	Per%
	Headstock Beam	2	100%		Centre Stiffner for Headstock	4	100%		Floor Stiffner for Headstock	4	100%
	Aux. Head stock	4	100%		Sole Bar	5	31%		Draft Gear Bracket	2	100%
	Trough floor	2	29%		Centre plate	2	100%		SoleBar Stiffner	4	100%
	Bottom Wall Part	5	31%		Body panel/patch		100%		Door Top/Roof Patch		0%
	Window Module		0%		Window Sill	19	48%		Window Bar	32	17%
	Seat pillar/lav. Partition		100%		UIC end construction		0%

End Drooping: Rotary End - EAST : 6, WEST : 8 Other End - EAST : -5, WEST : -4
Start Date : 30-Jul-2019, Completion Date : 06-Aug-2019, Net Repair Days : 7, Total Man Hours : 1266

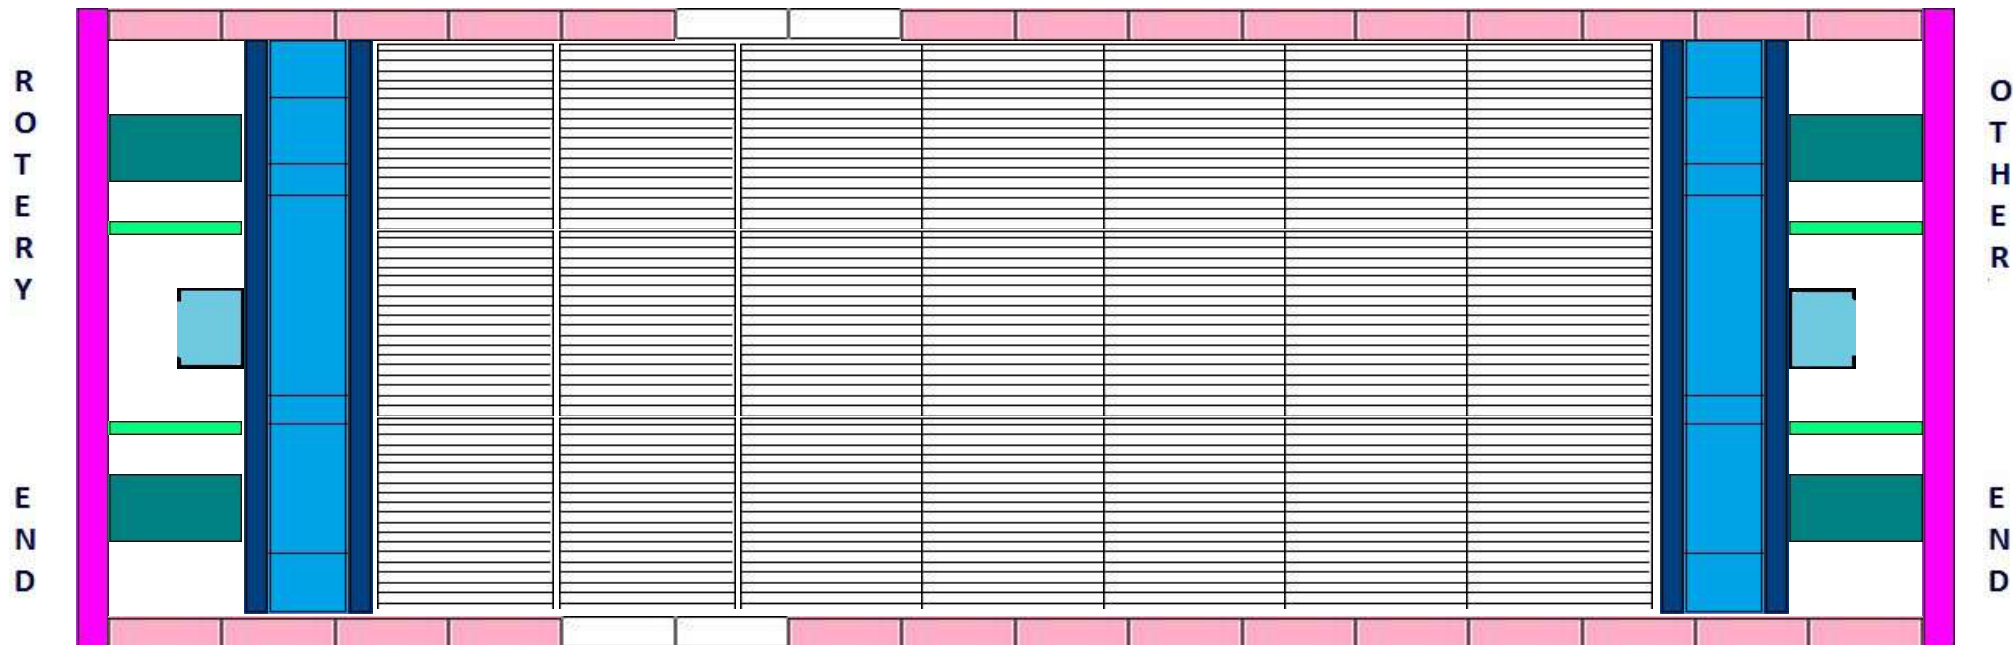
Rotary Side

Color	Particulars	Qty	Per%	Color	Particulars	Qty	Per%	Color	Particulars	Qty	Per%
Pink	Headstock Beam	2	100%	Dark Green	Centre Stiffner for Headstock	4	100%	Light Green	Floor Stiffner for Headstock	4	100%
Dark Blue	Aux. Head stock	4	100%	Pink	Sole Bar	14	88%	Light Blue	Draft Gear Bracket	2	100%
Yellow	Trough floor	0	0%	Light Blue	Centre plate	2	100%		SoleBar Stiffner	4	100%
	Bottom Wall Part	14	88%		Body panel/patch		100%		Door Top/Roof Patch		0%
	Window Module		0%		Window Sill	9	47%		Window Bar	14	17%
	Seat pillar/lav. Partition		100%		UIC end construction		0%

End Drooping: Rotary End - EAST : 2, WEST : -6 Other End - EAST : -3, WEST : -4
Start Date : 04-May-2019, Completion Date : 10-May-2019, Net Repair Days : 6, Total Man Hours : 0

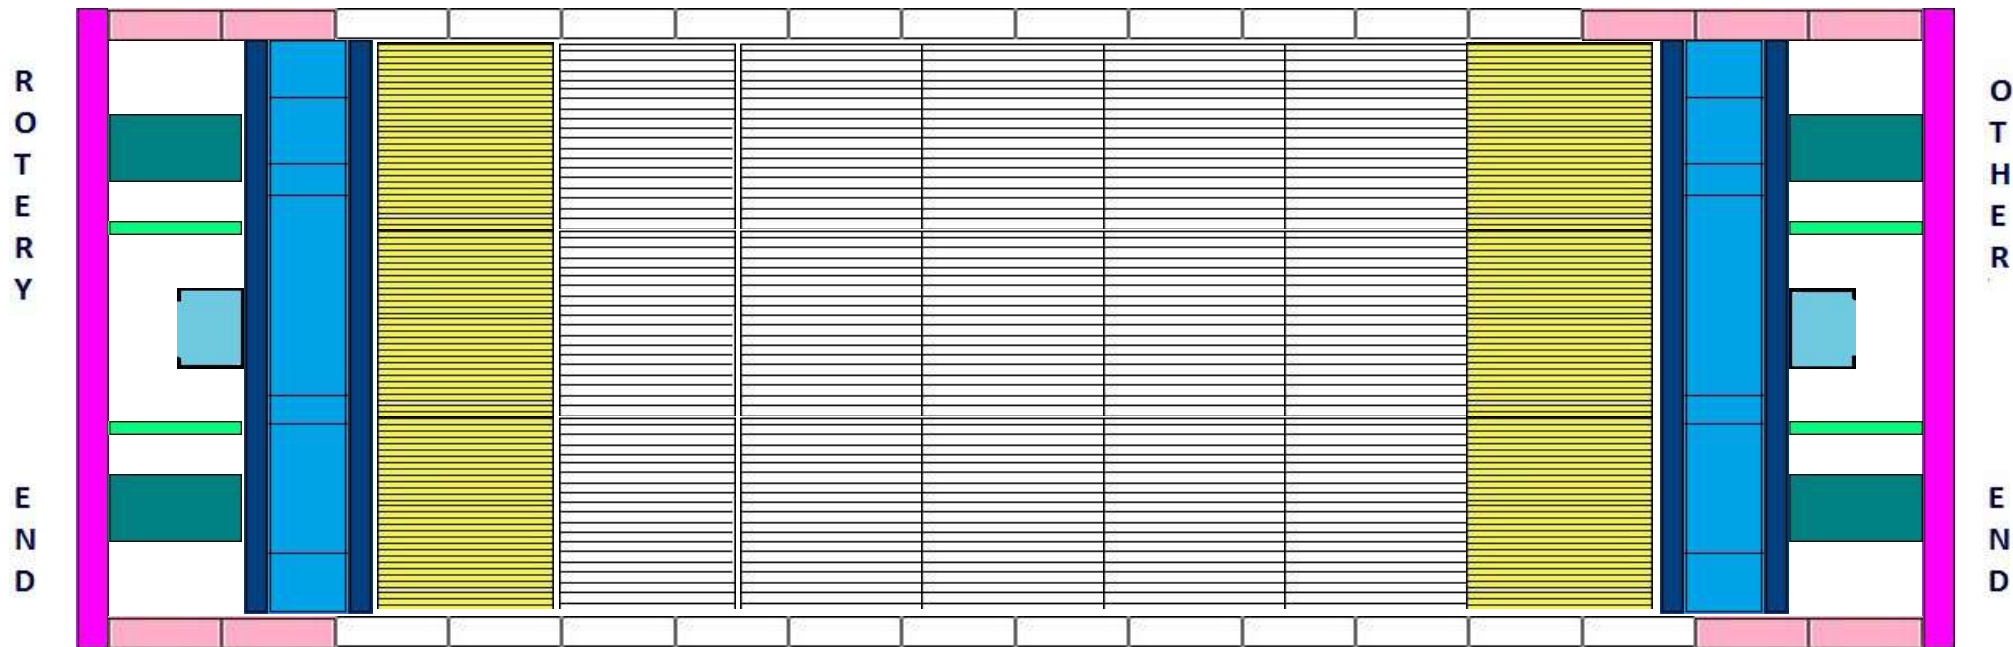
Rotary Side

Color	Particulars	Qty	Per%	Color	Particulars	Qty	Per%	Color	Particulars	Qty	Per%
	Headstock Beam	2	100%		Centre Stiffner for Headstock	4	100%		Floor Stiffner for Headstock	4	100%
	Aux. Head stock	4	100%		Sole Bar	4.5	28%		Draft Gear Bracket	2	100%
	Trough floor	2	29%		Centre plate	2	100%		SoleBar Stiffner	4	100%
	Bottom Wall Part	4.5	28%		Body panel/patch		100%		Door Top/Roof Patch		0%
	Window Module		0%		Window Sill	40	100%		Window Bar	44	24%
	Seat pillar/lav. Partition		100%		UIC end construction		0%

End Drooping: Rotary End - EAST : 2, WEST : 0 Other End - EAST : -8, WEST : -4
Start Date : 26-Jun-2019, Completion Date : 03-Jul-2019, Net Repair Days : 7, Total Man Hours : 1076

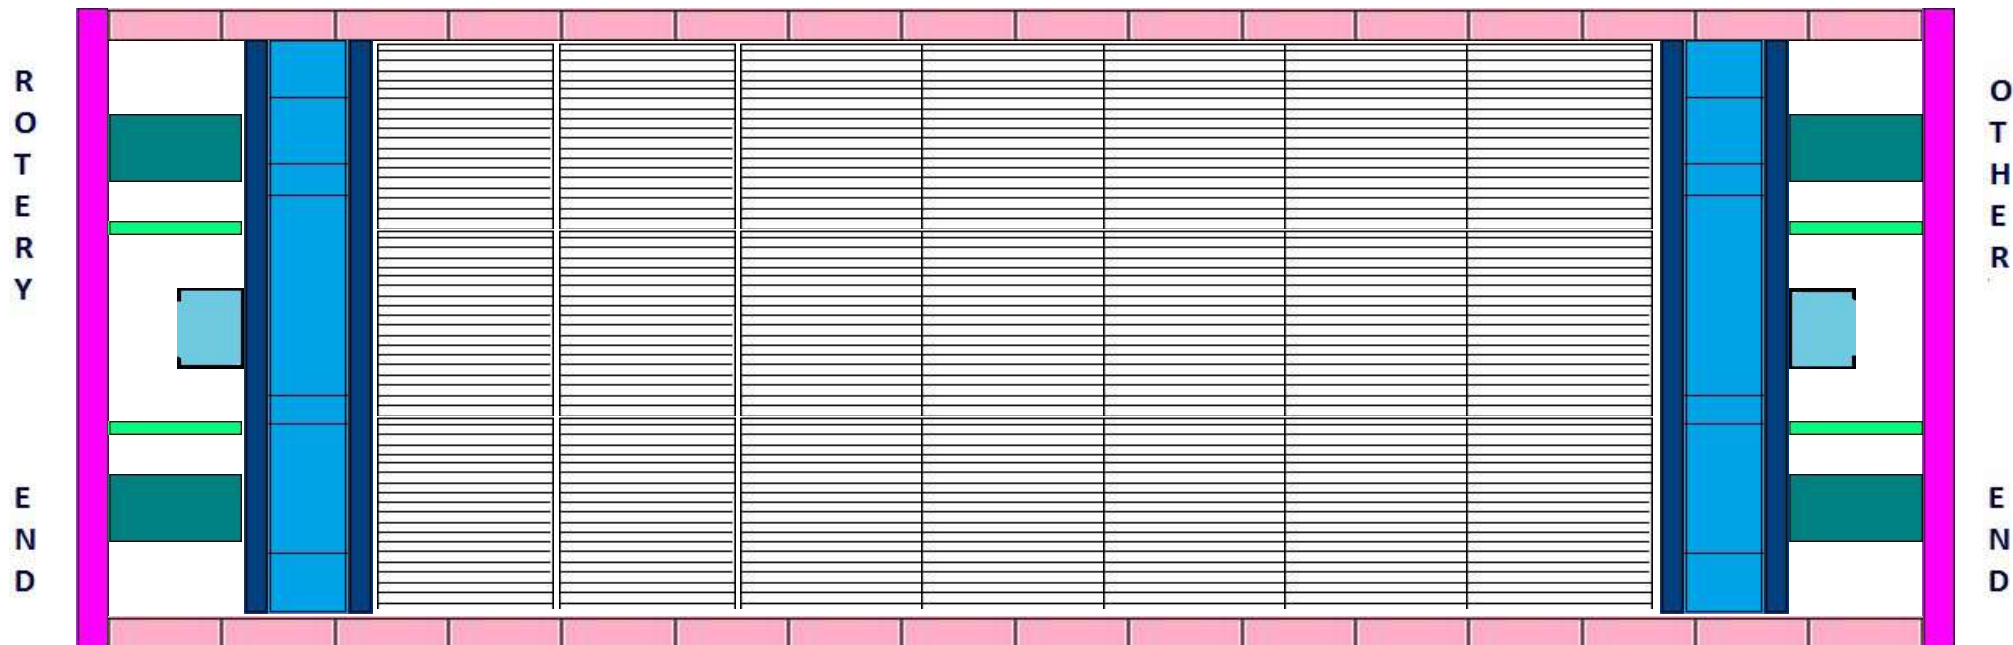
Rotary Side

Color	Particulars	Qty	Per%	Color	Particulars	Qty	Per%	Color	Particulars	Qty	Per%
	Headstock Beam	2	100%		Centre Stiffner for Headstock	4	100%		Floor Stiffner for Headstock	4	100%
	Aux. Head stock	4	100%		Sole Bar	16	100%		Draft Gear Bracket	2	100%
	Trough floor	0	0%		Centre plate	2	100%		SoleBar Stiffner	4	100%
	Bottom Wall Part	16	100%		Body panel/patch		100%		Door Top/Roof Patch		0%
	Window Module		0%		Window Sill	8	42%		Window Bar	12	14%
	Seat pillar/lav. Partition		100%		UIC end construction		0%

End Drooping: Rotary End - EAST : 0, WEST : 4 Other End - EAST : 0, WEST : 0
Start Date : 30-Apr-2019, Completion Date : 07-May-2019, Net Repair Days : 7, Total Man Hours : 1480

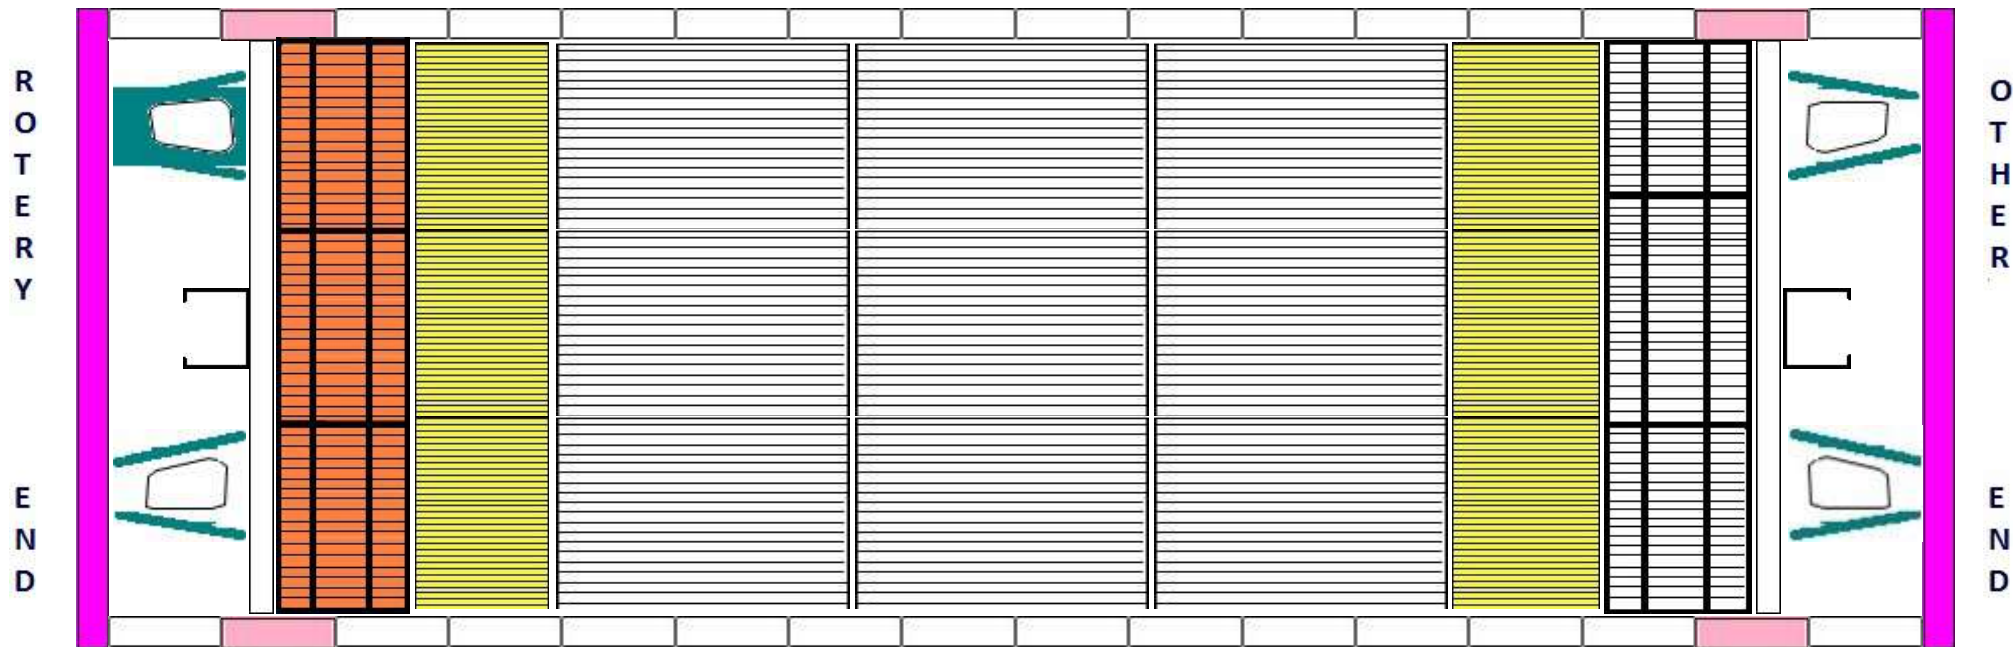
Rotary Side

Color	Particulars	Qty	Per%	Color	Particulars	Qty	Per%	Color	Particulars	Qty	Per%
	Headstock Beam	0	0%		Diagonal	4	100%		Logitudinal Channel Structure	1	50%
	Aux. Head stock	0	0%		Sole Bar	2	13%		Draft Gear Bracket	0	0%
	Trough floor	2	40%		Bottom Wall Part	2	13%		Body panel/patch		100%
	Door Top/Roof Patch		0%		Seat Bracket Rail		0%		Window Sill	2	5%
	Window Bar	5	3%		Seat pillar/lav. Partition		100%		UIC end construction		0%
	Body Pillar Part	11	100%

End Drooping: Rotary End - EAST : -5, WEST : -6 Other End - EAST : -3, WEST : -4
Start Date : 24-Apr-2019, Completion Date : 04-May-2019, Net Repair Days : 10, Total Man Hours : 0

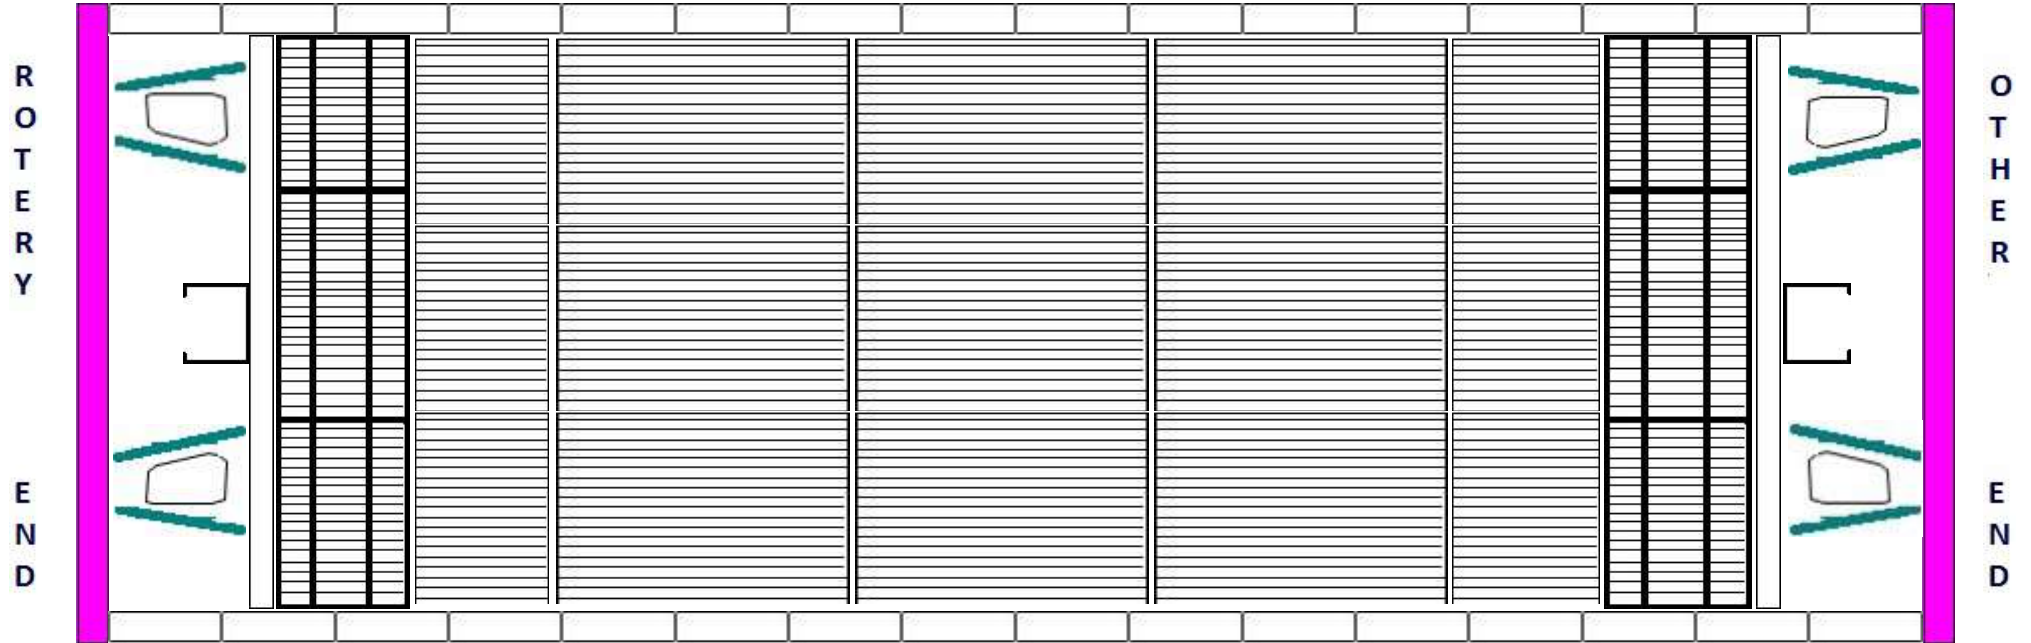
Rotary Side

Color	Particulars	Qty	Per%	Color	Particulars	Qty	Per%	Color	Particulars	Qty	Per%
	Headstock Beam	0	0%		Diagonal	4	100%		Logitudinal Channel Structure	0	0%
	Aux. Head stock	0	0%		Sole Bar	0	0%		Draft Gear Bracket	0	0%
	Trough floor	0	0%		Bottom Wall Part	0	0%		Body panel/patch		100%
	Door Top/Roof Patch		0%		Seat Bracket Rail		0%		Window Sill	0	0%
	Window Bar	0	0%		Seat pillar/lav. Partition		100%		UIC end construction		0%
	Body Pillar Part	0	100%

End Drooping: Rotary End - EAST : 2, WEST : 3 Other End - EAST : -4, WEST : -5
Start Date : 29-Apr-2019, Completion Date : 03-May-2019, Net Repair Days : 5, Total Man Hours : 584

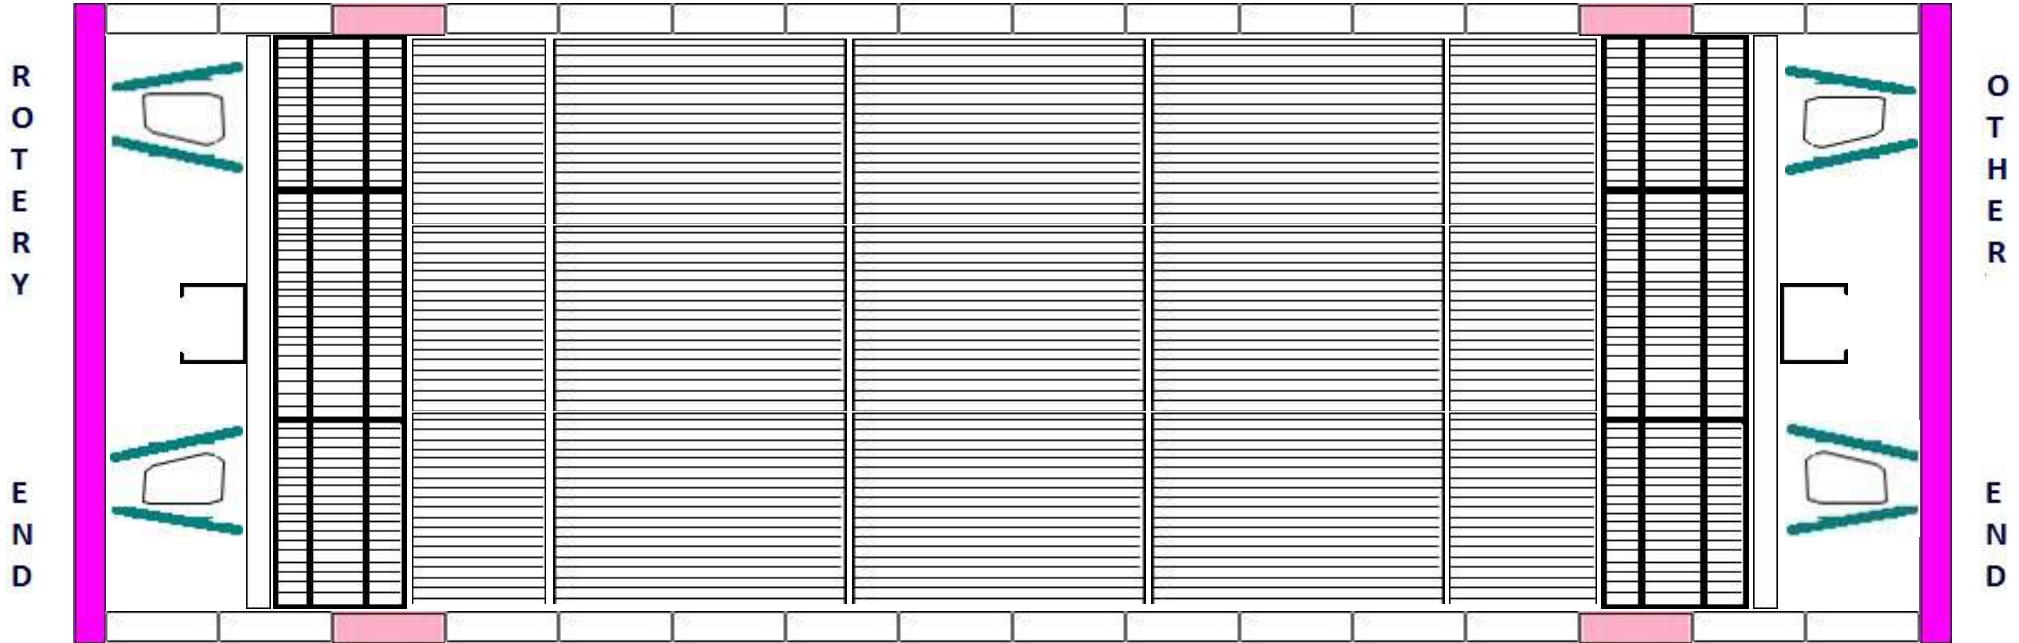
Rotary Side

Color	Particulars	Qty	Per%	Color	Particulars	Qty	Per%	Color	Particulars	Qty	Per%
	Headstock Beam	0	0%		Diagonal	4	100%		Logitudinal Channel Structure	0	0%
	Aux. Head stock	0	0%		Sole Bar	2	13%		Draft Gear Bracket	0	0%
	Trough floor	0	0%		Bottom Wall Part	2	13%		Body panel/patch		100%
	Door Top/Roof Patch		0%		Seat Bracket Rail		0%		Window Sill	0	0%
	Window Bar	0	0%		Seat pillar/lav. Partition		100%		UIC end construction		0%
	Body Pillar Part	11	100%

End Drooping: Rotary End - EAST : 2, WEST : 5 Other End - EAST : 7, WEST : 7
Start Date : 30-Apr-2019, Completion Date : 08-May-2019, Net Repair Days : 8, Total Man Hours : 600

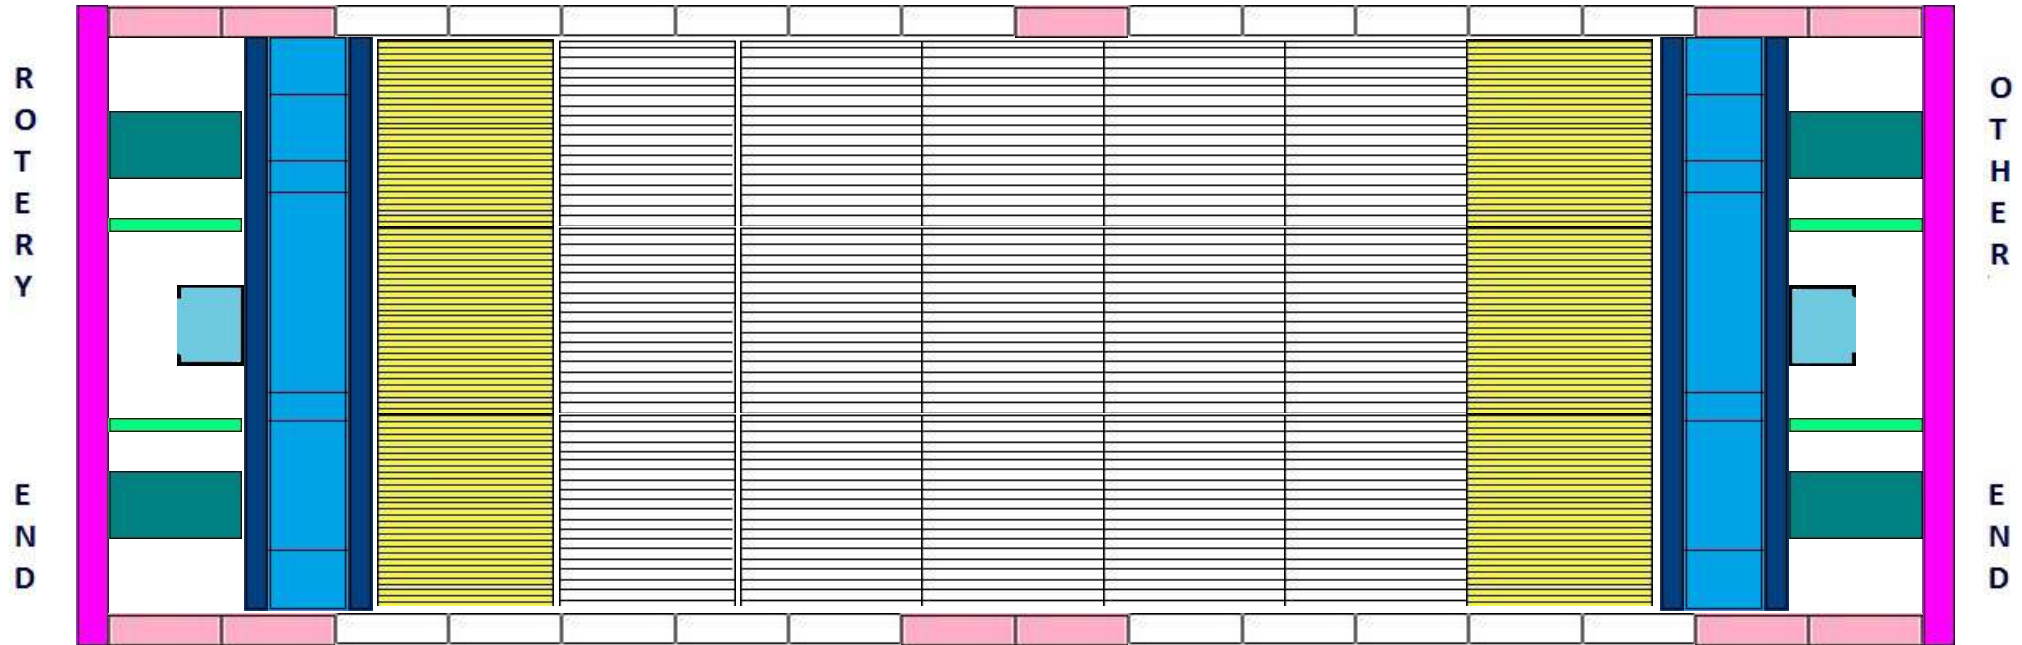
Rotary Side

Color	Particulars	Qty	Per%	Color	Particulars	Qty	Per%	Color	Particulars	Qty	Per%
	Headstock Beam	2	100%		Centre Stiffner for Headstock	4	100%		Floor Stiffner for Headstock	4	100%
	Aux. Head stock	4	100%		Sole Bar	5.5	34%		Draft Gear Bracket	2	100%
	Trough floor	2	29%		Centre plate	2	100%		SoleBar Stiffner	4	100%
	Bottom Wall Part	5.5	34%		Body panel/patch		100%		Door Top/Roof Patch		0%
	Window Module		0%		Window Sill	24	60%		Window Bar	40	22%
	Seat pillar/lav. Partition		100%		UIC end construction		0%

End Drooping: Rotary End - EAST : 0, WEST : 0 Other End - EAST : 0, WEST : 0
Start Date : 19-Aug-2019, Completion Date : 26-Aug-2019, Net Repair Days : 7, Total Man Hours : 0

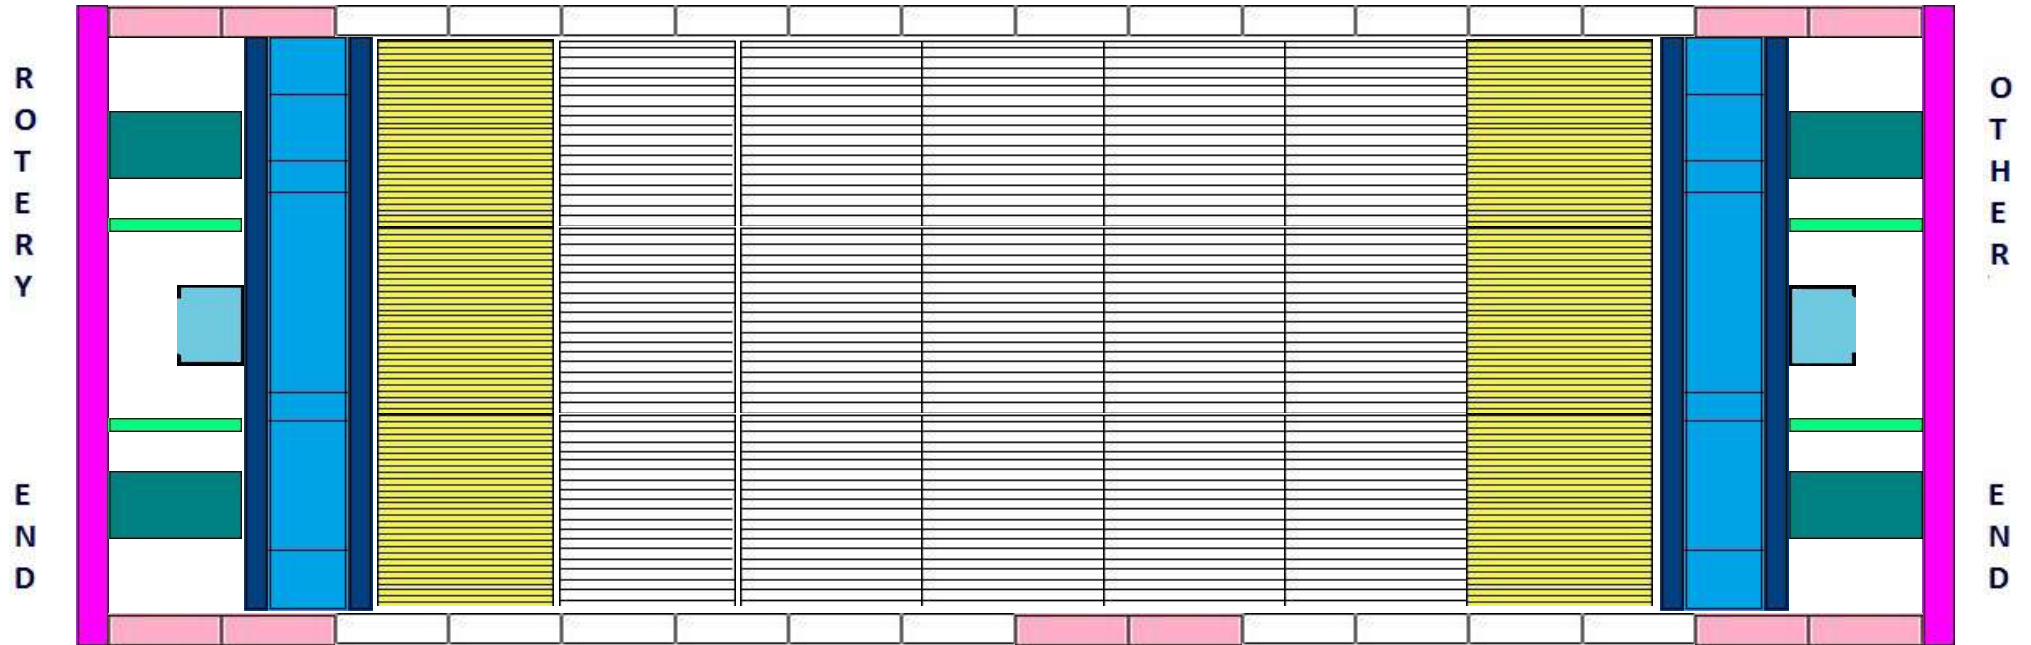
Rotary Side

Color	Particulars	Qty	Per%	Color	Particulars	Qty	Per%	Color	Particulars	Qty	Per%
Yellow	Headstock Beam	2	100%	Dark Green	Centre Stiffner for Headstock	4	100%	Light Green	Floor Stiffner for Headstock	4	100%
Dark Blue	Aux. Head stock	4	100%	Pink	Sole Bar	5	31%	Light Blue	Draft Gear Bracket	2	100%
Yellow	Trough floor	2	29%	Light Blue	Centre plate	2	100%		SoleBar Stiffner	4	100%
	Bottom Wall Part	5	31%		Body panel/patch		100%		Door Top/Roof Patch		0%
	Window Module		0%		Window Sill	22	55%		Window Bar	40	22%
	Seat pillar/lav. Partition		100%		UIC end construction		0%

End Drooping: Rotary End - EAST : 6, WEST : 6 Other End - EAST : -3, WEST : 6
Start Date : 20-Aug-2019, Completion Date : 24-Aug-2019, Net Repair Days : 5, Total Man Hours : 1088

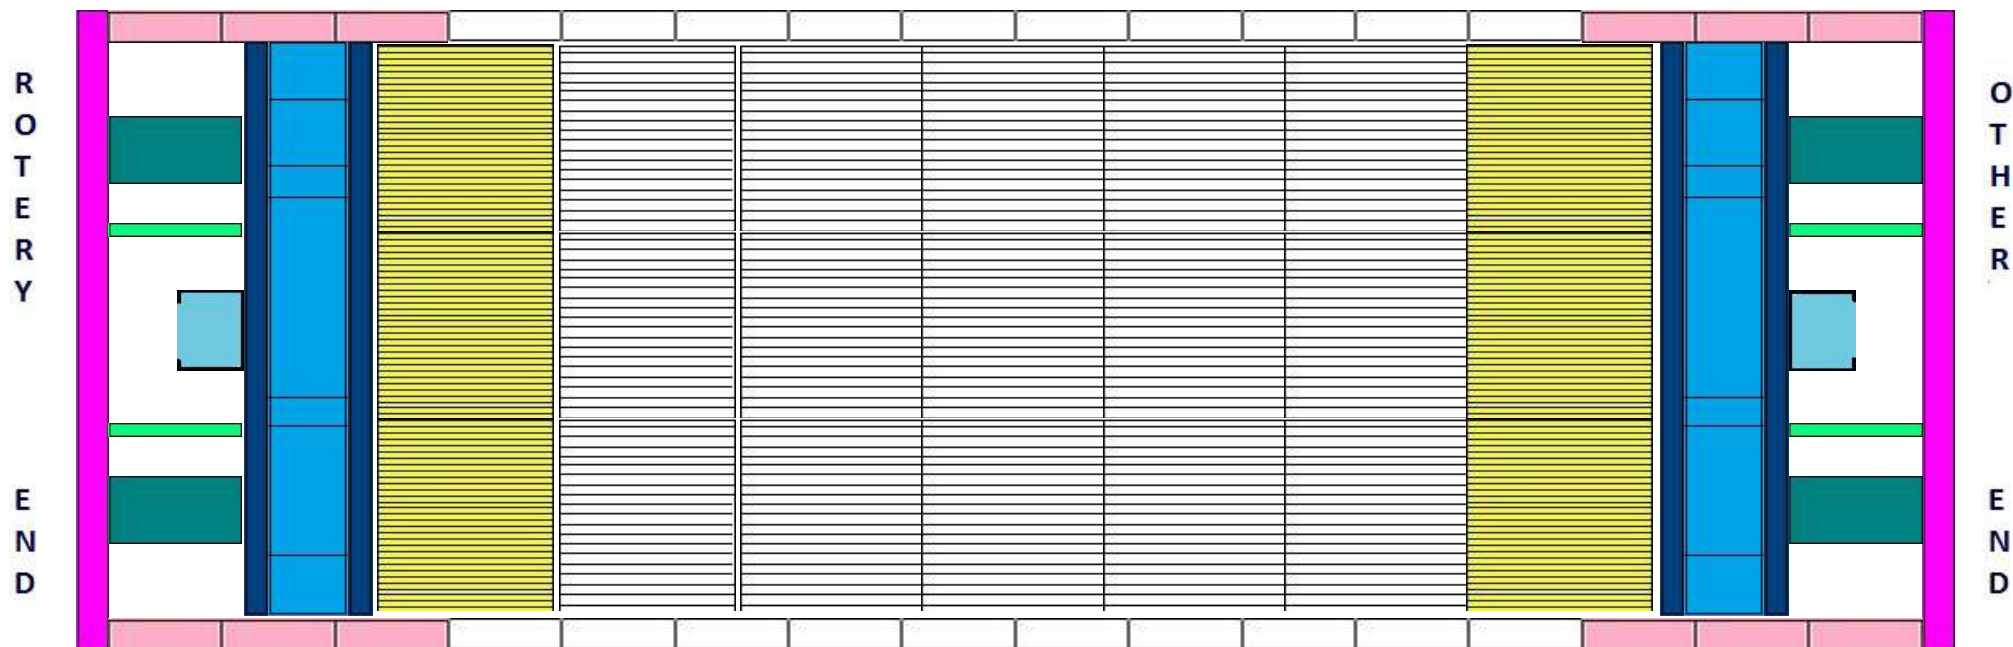
Rotary Side

Color	Particulars	Qty	Per%	Color	Particulars	Qty	Per%	Color	Particulars	Qty	Per%
	Headstock Beam	2	100%		Centre Stiffner for Headstock	4	100%		Floor Stiffner for Headstock	4	100%
	Aux. Head stock	4	100%		Sole Bar	6	38%		Draft Gear Bracket	2	100%
	Trough floor	2	29%		Centre plate	2	100%		SoleBar Stiffner	4	100%
	Bottom Wall Part	6	38%		Body panel/patch		100%		Door Top/Roof Patch		0%
	Window Module		0%		Window Sill	32	80%		Window Bar	48	26%
	Seat pillar/lav. Partition		100%		UIC end construction		0%

End Drooping: Rotary End - EAST : -5, WEST : -5 Other End - EAST : 4, WEST : 0
Start Date : 20-Dec-2019, Completion Date : 01-Jan-2020, Net Repair Days : 11, Total Man Hours : 1024

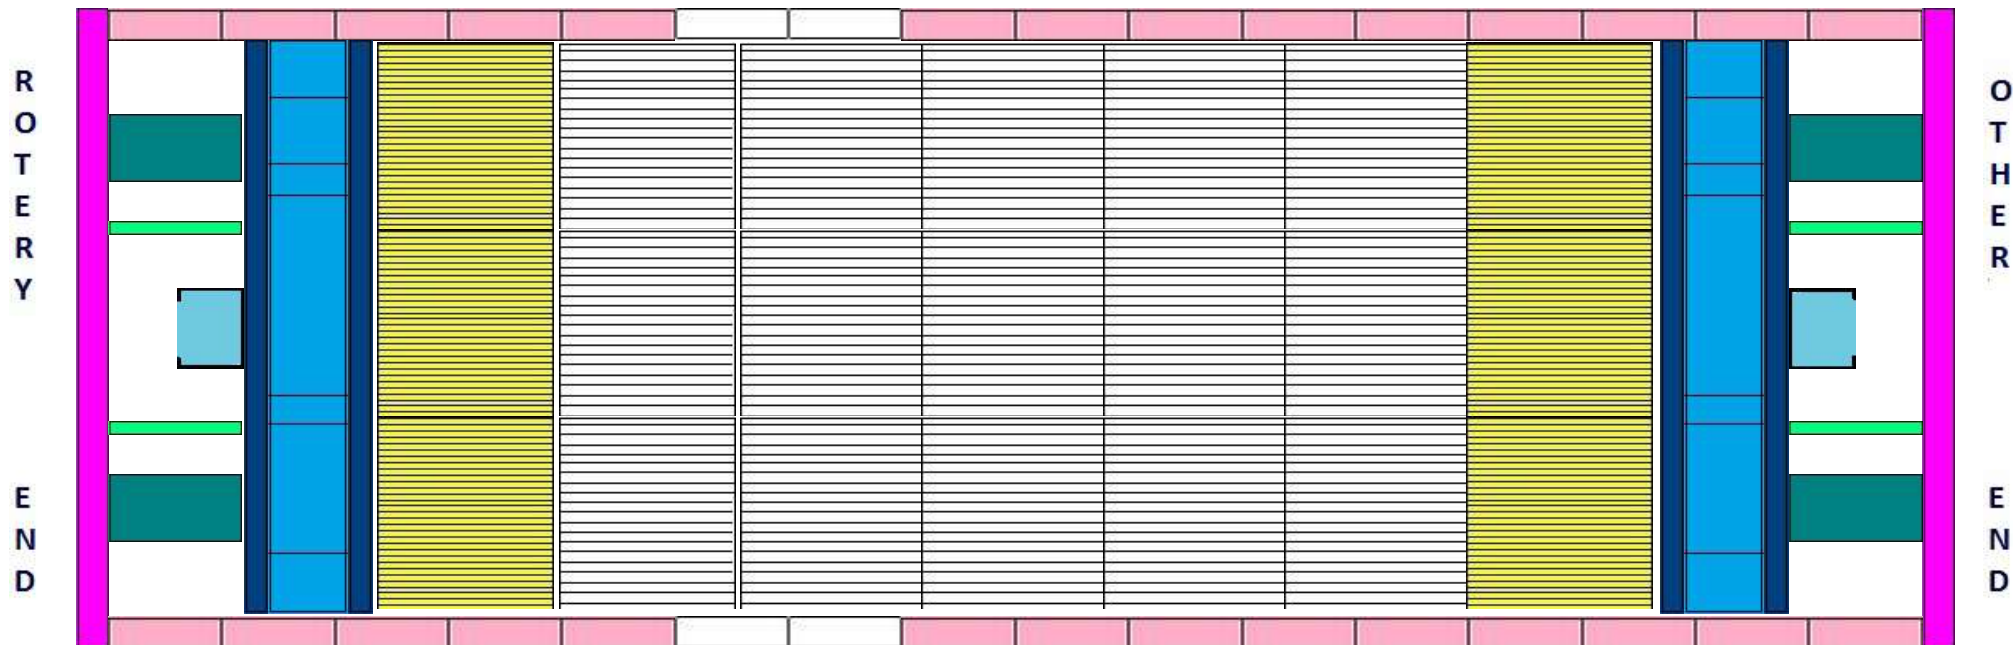
Rotary Side

Color	Particulars	Qty	Per%	Color	Particulars	Qty	Per%	Color	Particulars	Qty	Per%
Yellow	Headstock Beam	2	100%	Dark Green	Centre Stiffner for Headstock	4	100%	Light Green	Floor Stiffner for Headstock	4	100%
Dark Blue	Aux. Head stock	4	100%	Pink	Sole Bar	14	88%	Light Blue	Draft Gear Bracket	2	100%
Yellow	Trough floor	2	29%	Light Blue	Centre plate	2	100%		SoleBar Stiffner	4	100%
	Bottom Wall Part	14	88%		Body panel/patch		100%		Door Top/Roof Patch		0%
	Window Module		0%		Window Sill	7	37%		Window Bar	20	24%
	Seat pillar/lav. Partition		100%		UIC end construction		0%

Start Date : 16-Dec-2019, Completion Date : 24-Dec-2019, Net Repair Days : 8, Total Man Hours : 2182

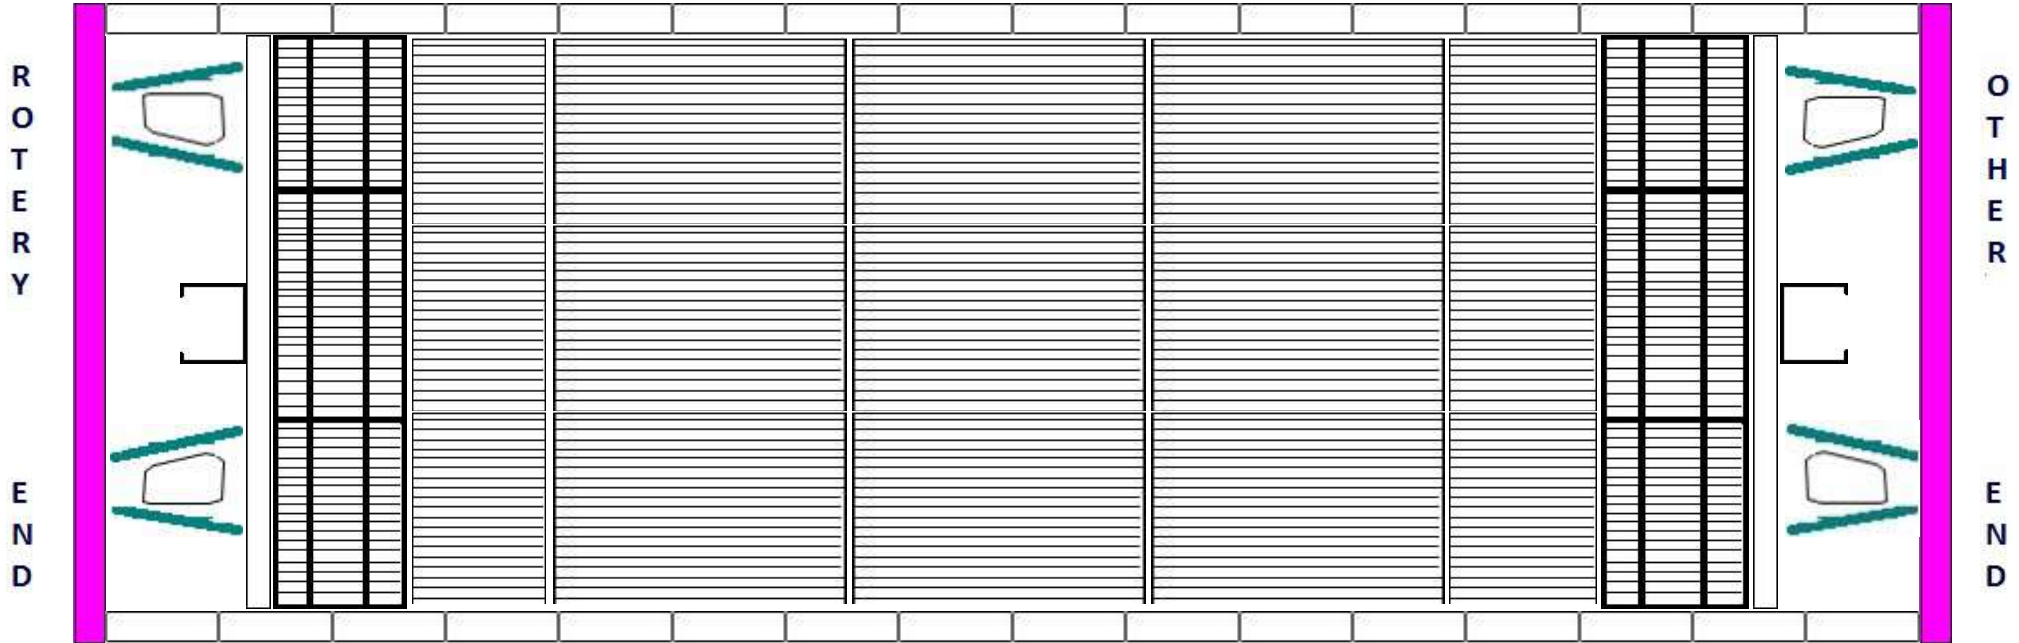
Rotary Side

Color	Particulars	Qty	Per%	Color	Particulars	Qty	Per%	Color	Particulars	Qty	Per%
	Headstock Beam	0	0%		Diagonal	4	100%		Logitudinal Channel Structure	0	0%
	Aux. Head stock	0	0%		Sole Bar	0	0%		Draft Gear Bracket	0	0%
	Trough floor	0	0%		Bottom Wall Part	0	0%		Body panel/patch		100%
	Door Top/Roof Patch		0%		Seat Bracket Rail		0%		Window Sill	10	25%
	Window Bar	18	10%		Seat pillar/lav. Partition		100%		UIC end construction		0%
	Body Pillar Part	0	100%

End Drooping: Rotary End - EAST : -8, WEST : -6 Other End - EAST : -6, WEST : -8
Start Date : 10-Apr-2019, Completion Date : 16-Apr-2019, Net Repair Days : 6, Total Man Hours : 696

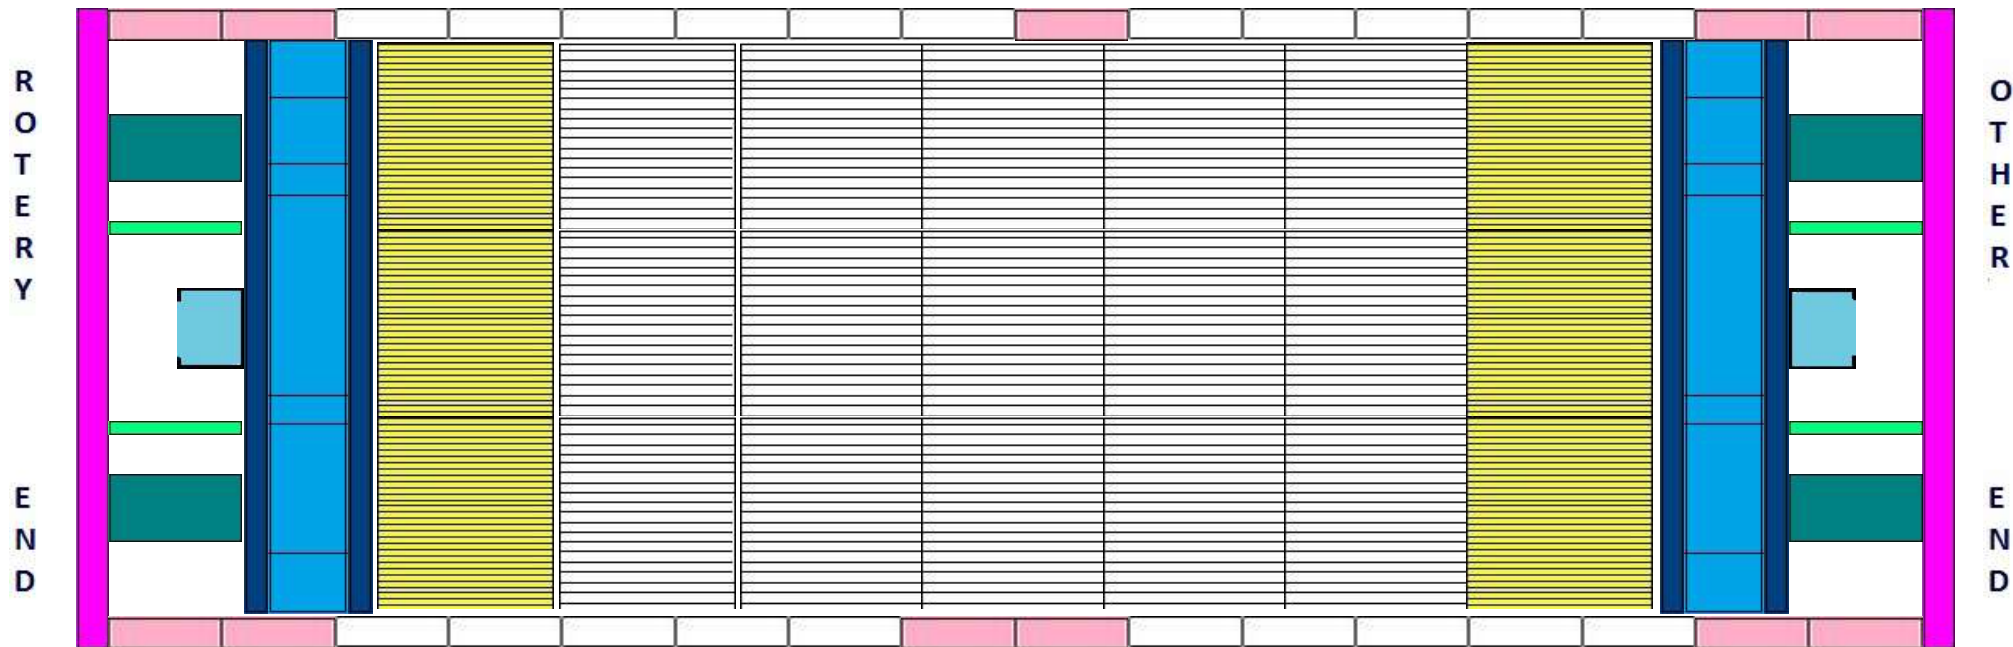
Rotary Side

Color	Particulars	Qty	Per%	Color	Particulars	Qty	Per%	Color	Particulars	Qty	Per%
Pink	Headstock Beam	2	100%	Dark Blue	Centre Stiffner for Headstock	4	100%	Green	Floor Stiffner for Headstock	4	100%
Dark Blue	Aux. Head stock	4	100%	Pink	Sole Bar	5.5	34%	Light Blue	Draft Gear Bracket	2	100%
Yellow	Trough floor	2	29%	Light Blue	Centre plate	2	100%		SoleBar Stiffner	6	100%
	Bottom Wall Part	5.5	34%		Body panel/patch		100%		Door Top/Roof Patch		0%
	Window Module		0%		Window Sill	14	35%		Window Bar	44	25%
	Seat pillar/lav. Partition		100%		UIC end construction		0%

End Drooping: Rotary End - EAST : 10, WEST : 10 Other End - EAST : 7, WEST : 8
Start Date : 10-Sep-2019, Completion Date : 14-Sep-2019, Net Repair Days : 5, Total Man Hours : 1162

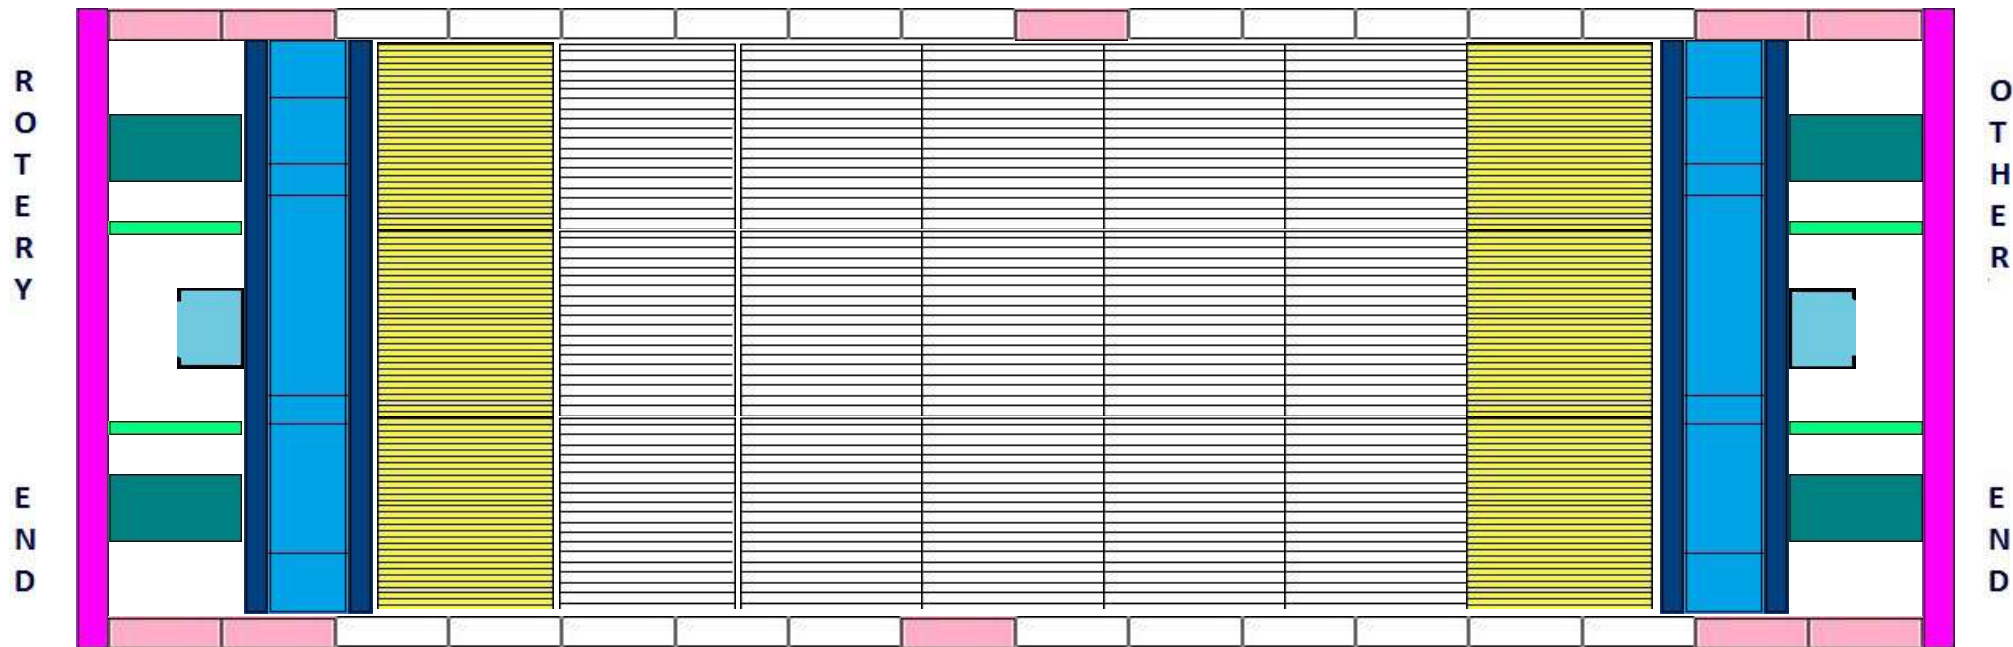
Rotary Side

Color	Particulars	Qty	Per%	Color	Particulars	Qty	Per%	Color	Particulars	Qty	Per%
Yellow	Headstock Beam	2	100%	Dark Green	Centre Stiffner for Headstock	4	100%	Light Green	Floor Stiffner for Headstock	4	100%
Dark Blue	Aux. Head stock	4	100%	Pink	Sole Bar	5	31%	Light Blue	Draft Gear Bracket	2	100%
Yellow	Trough floor	2	29%	Light Blue	Centre plate	2	100%		SoleBar Stiffner	6	100%
	Bottom Wall Part	5	31%		Body panel/patch		100%		Door Top/Roof Patch		0%
	Window Module		0%		Window Sill	28	70%		Window Bar	44	25%
	Seat pillar/lav. Partition		100%		UIC end construction		0%

End Drooping: Rotary End - EAST : 6, WEST : 4 Other End - EAST : -3, WEST : -6
Start Date : 26-Jul-2019, Completion Date : 02-Aug-2019, Net Repair Days : 7, Total Man Hours : 1237

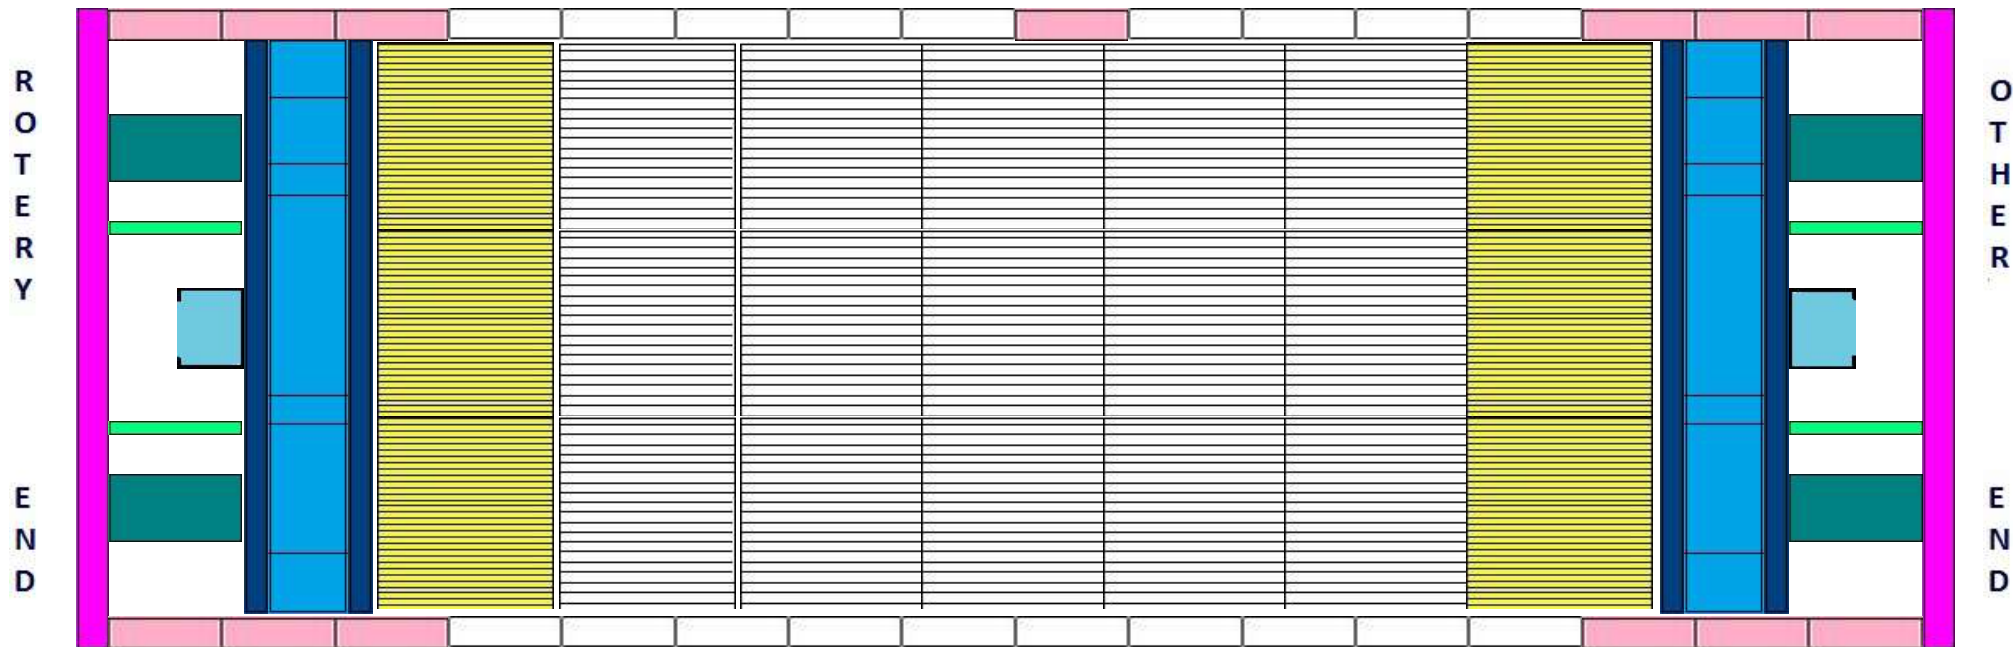
Color	Particulars	Qty	Per%	Color	Particulars	Qty	Per%	Color	Particulars	Qty	Per%
Yellow	Headstock Beam	2	100%	Dark Green	Centre Stiffner for Headstock	4	100%	Light Green	Floor Stiffner for Headstock	4	100%
Dark Blue	Aux. Head stock	4	100%	Pink	Sole Bar	6.5	41%	Light Blue	Draft Gear Bracket	2	100%
Yellow	Trough floor	2	29%	Light Blue	Centre plate	2	100%		SoleBar Stiffner	4	100%
	Bottom Wall Part	6.5	41%		Body panel/patch		100%		Door Top/Roof Patch		0%
	Window Module		4%		Window Sill	0	0%		Window Bar	0	0%
	Seat pillar/lav. Partition		100%		UIC end construction		0%

End Drooping: Rotary End - EAST : 10, WEST : 5 Other End - EAST : 10, WEST : 10
Start Date : 04-Sep-2019, Completion Date : 11-Sep-2019, Net Repair Days : 7, Total Man Hours : 1260
