Coach Rehabilitation Workshop, WC Railway, Bhopal

(An IMS and ISO 50001 Certified Workshop)
Final Inspection Sheet - Details of Corrosion Repair

Coach No. :NW05026

Type : WGFACCW

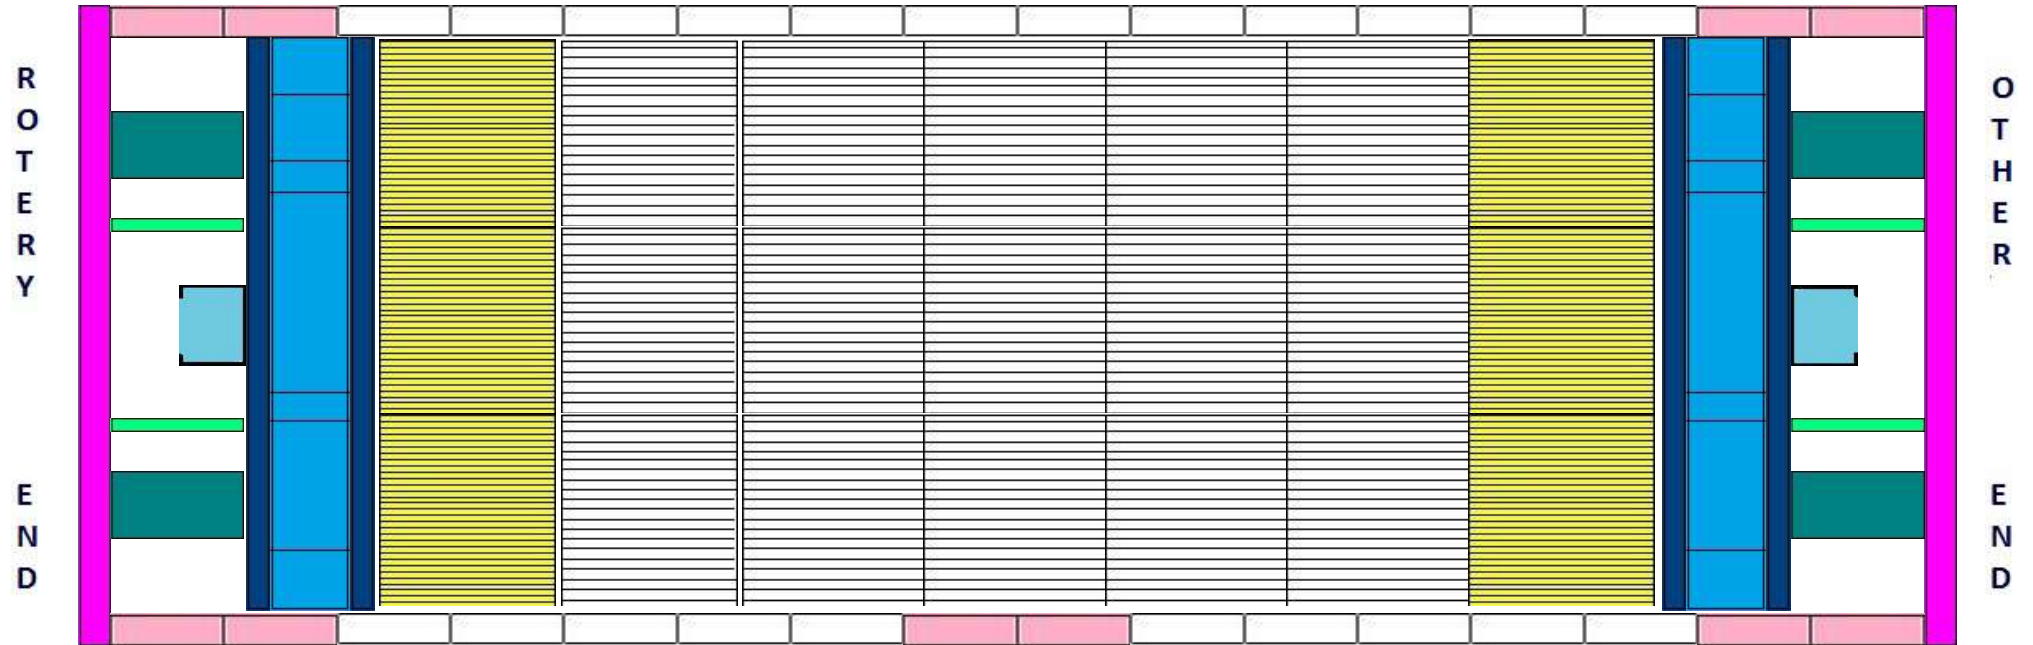
Rotary Side

Color	Particulars	Qty	Per%	Color	Particulars	Qty	Per%	Color	Particulars	Qty	Per%
Blue	Headstock Beam	2	100%	Green	Centre Stiffner for Headstock	4	100%	Red	Floor Stiffner for Headstock	4	100%
Black	Aux. Head stock	4	100%	Yellow	Sole Bar	5	31%	Light Blue	Draft Gear Bracket	2	100%
Orange	Trough floor	2	29%	Dark Blue	Centre plate	2	100%		SoleBar Stiffner	6	100%
	Bottom Wall Part	5	31%		Body panel/patch		100%		Door Top/Roof Patch		0%
	Window Module		0%		Window Sill	40	100%		Window Bar	44	24%
	Seat pillar/lav. Partition		100%		UIC end construction		0%

End Drooping: Rotary End - EAST : 2, WEST : 0 Other End - EAST : 2, WEST : 0
Start Date : 09-Aug-2019, Completion Date : 17-Aug-2019, Net Repair Days : 8, Total Man Hours : 1368

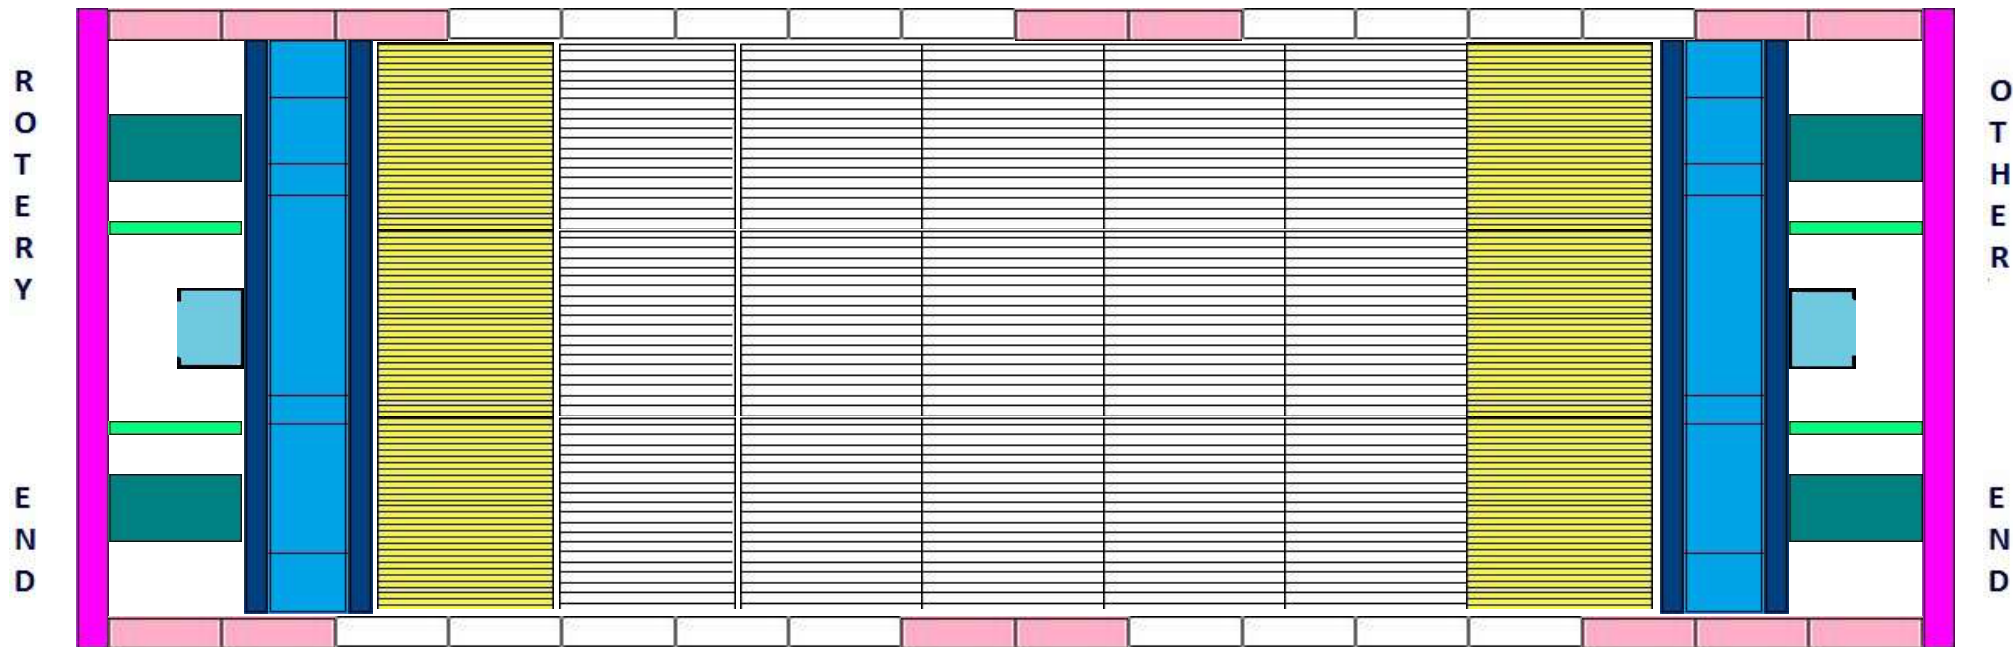
Rotary Side

Color	Particulars	Qty	Per%	Color	Particulars	Qty	Per%	Color	Particulars	Qty	Per%
	Headstock Beam	2	100%		Centre Stiffner for Headstock	4	100%		Floor Stiffner for Headstock	4	100%
	Aux. Head stock	4	100%		Sole Bar	7	44%		Draft Gear Bracket	2	100%
	Trough floor	2	29%		Centre plate	2	100%		SoleBar Stiffner	6	100%
	Bottom Wall Part	7	44%		Body panel/patch		100%		Door Top/Roof Patch		0%
	Window Module		0%		Window Sill	22	55%		Window Bar	42	24%
	Seat pillar/lav. Partition		100%		UIC end construction		0%

Start Date : 04-Sep-2019, Completion Date : 13-Sep-2019, Net Repair Days : 9, Total Man Hours : 1139

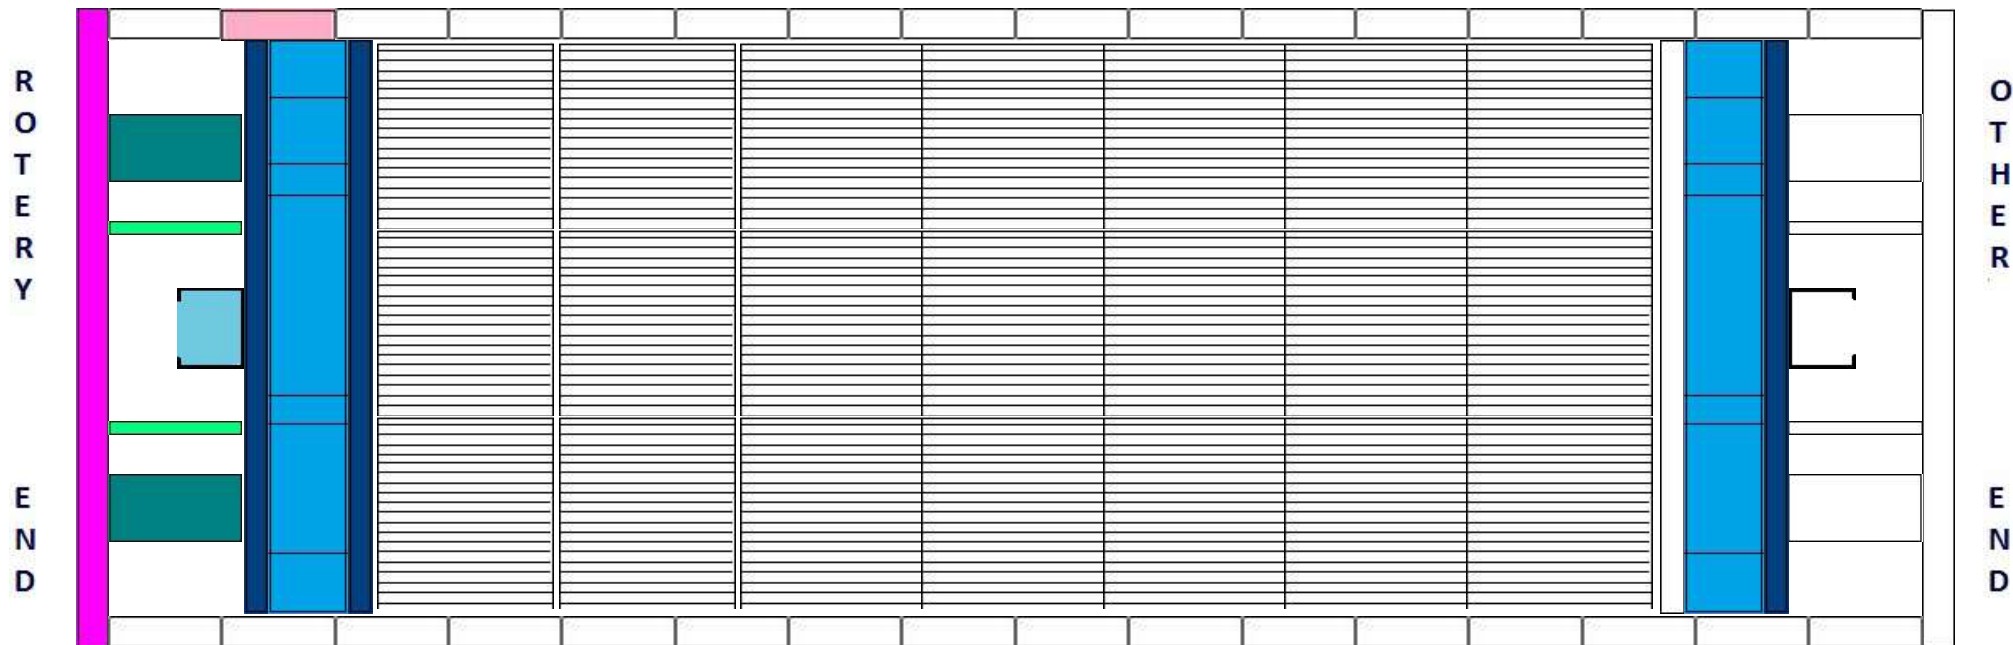
Rotary Side

Color	Particulars	Qty	Per%	Color	Particulars	Qty	Per%	Color	Particulars	Qty	Per%
	Headstock Beam	1	50%		Centre Stiffner for Headstock	2	50%		Floor Stiffner for Headstock	2	50%
	Aux. Head stock	2	50%		Sole Bar	0.5	3%		Draft Gear Bracket	1	50%
	Trough floor	0	0%		Centre plate	1	50%		SoleBar Stiffner	4	100%
	Bottom Wall Part	0.5	3%		Body panel/patch		20%		Door Top/Roof Patch		0%
	Window Module		0%		Window Sill	0	0%		Window Bar	0	0%
	Seat pillar/lav. Partition		100%		UIC end construction		0%

End Drooping: Rotary End - EAST : 0, WEST : 0 Other End - EAST : 0, WEST : 0
Start Date : 15-Feb-2020, Completion Date : 24-Feb-2020, Net Repair Days : 8, Total Man Hours : 1144

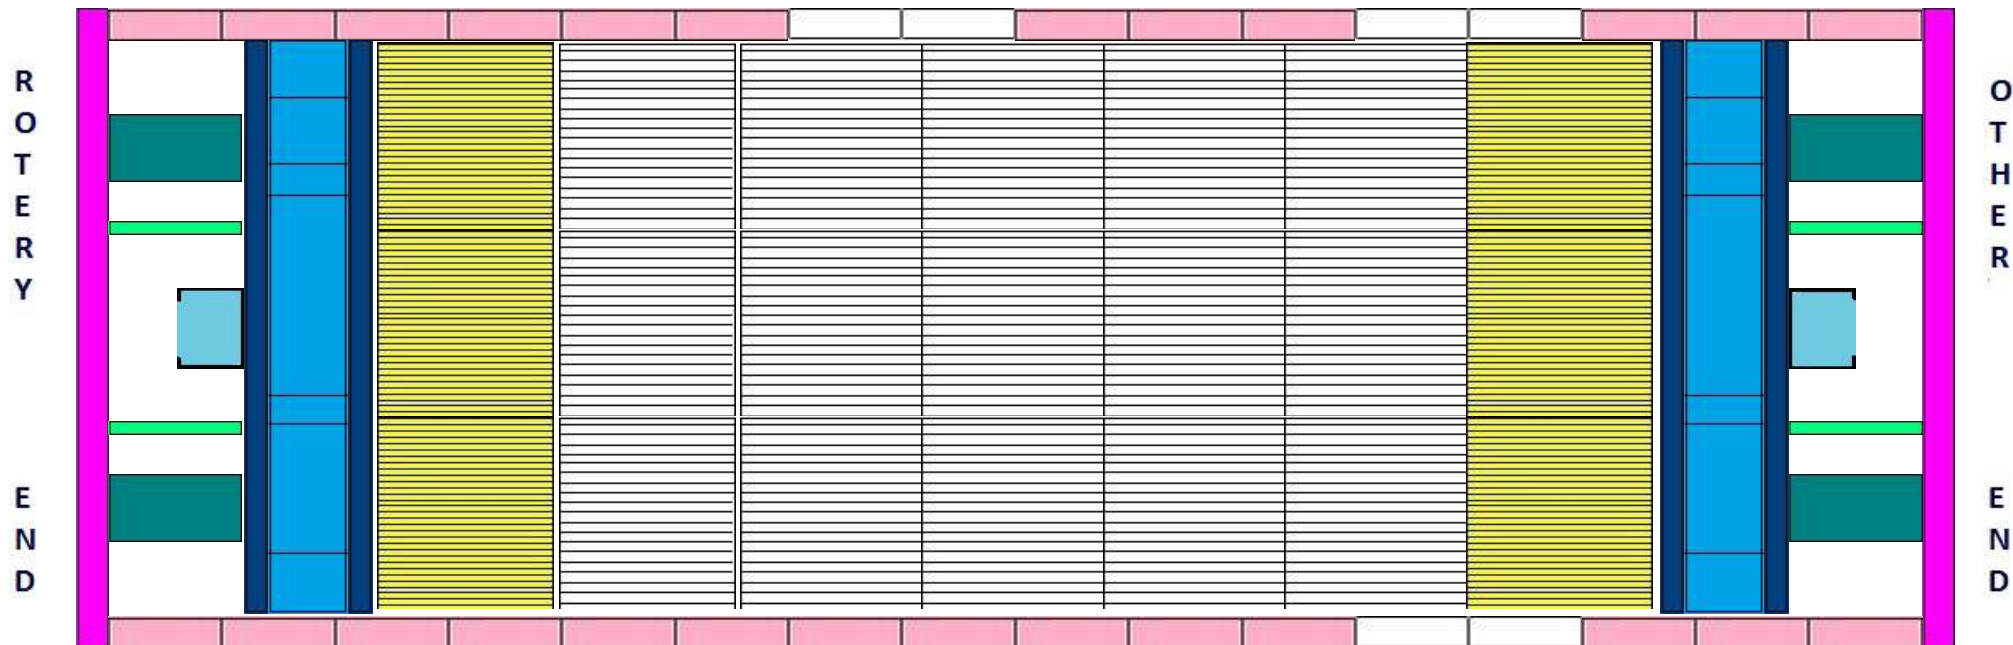
Rotary Side

Color	Particulars	Qty	Per%	Color	Particulars	Qty	Per%	Color	Particulars	Qty	Per%
Yellow	Headstock Beam	2	100%	Dark Green	Centre Stiffner for Headstock	4	100%	Light Green	Floor Stiffner for Headstock	4	100%
Dark Blue	Aux. Head stock	4	100%	Pink	Sole Bar	13	81%	Light Blue	Draft Gear Bracket	2	100%
Yellow	Trough floor	2	29%	Light Blue	Centre plate	2	100%		SoleBar Stiffner	4	100%
	Bottom Wall Part	13	81%		Body panel/patch		100%		Door Top/Roof Patch		0%
	Window Module		0%		Window Sill	10	53%		Window Bar	14	17%
	Seat pillar/lav. Partition		100%		UIC end construction		0%

Start Date : 01-Nov-2019, Completion Date : 08-Nov-2019, Net Repair Days : 7, Total Man Hours : 1508

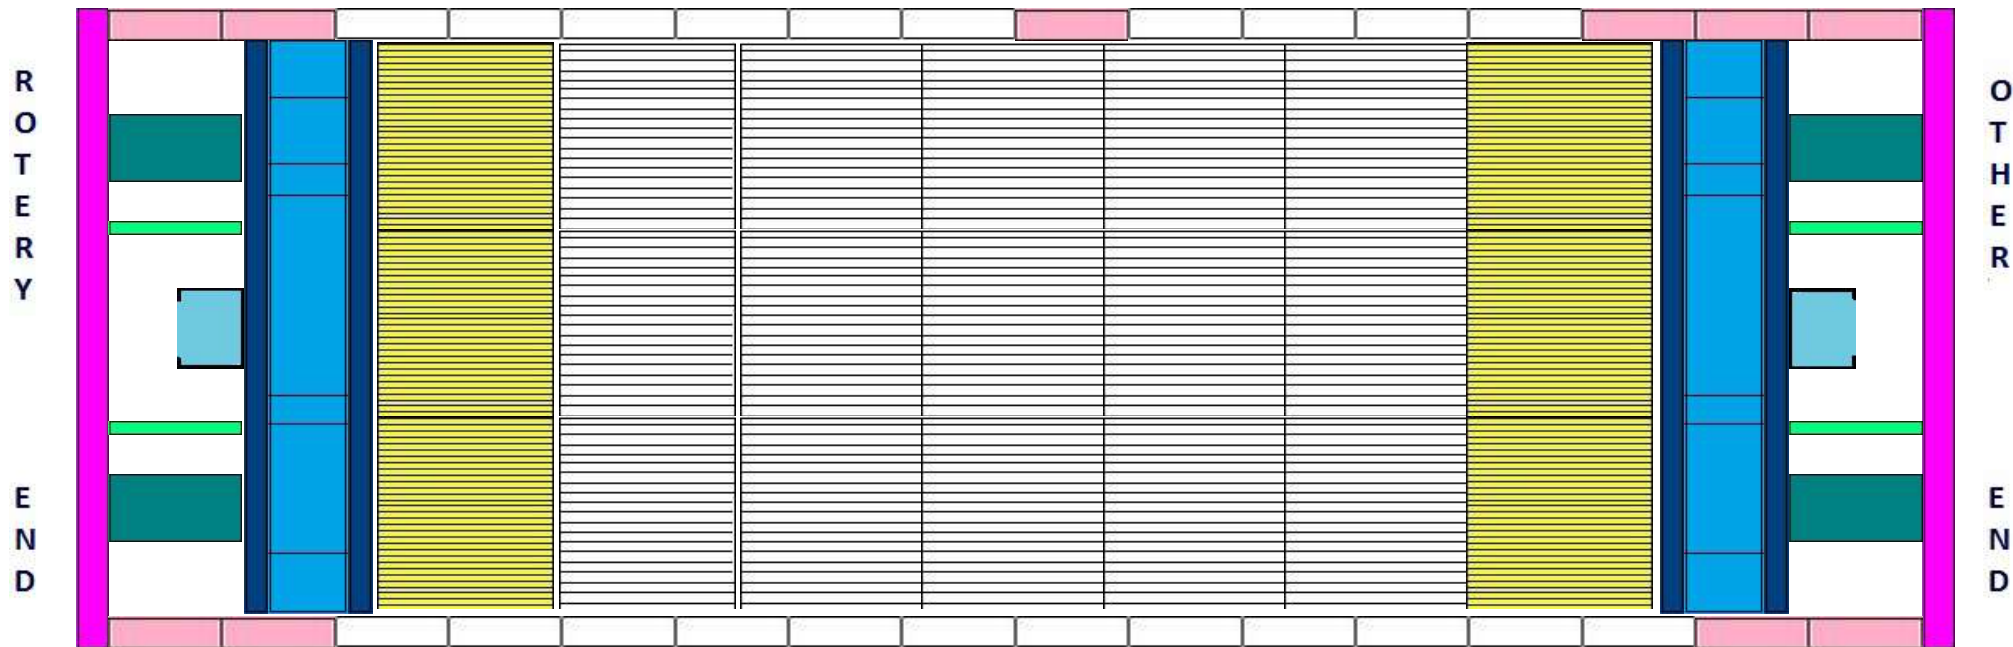
Rotary Side

Color	Particulars	Qty	Per%	Color	Particulars	Qty	Per%	Color	Particulars	Qty	Per%
	Headstock Beam	2	100%		Centre Stiffner for Headstock	4	100%		Floor Stiffner for Headstock	4	100%
	Aux. Head stock	4	100%		Sole Bar	5	31%		Draft Gear Bracket	2	100%
	Trough floor	2	29%		Centre plate	2	100%		SoleBar Stiffner	4	100%
	Bottom Wall Part	5	31%		Body panel/patch		100%		Door Top/Roof Patch		0%
	Window Module		0%		Window Sill	40	100%		Window Bar	44	25%
	Seat pillar/lav. Partition		100%		UIC end construction		0%

End Drooping: Rotary End - EAST : 0, WEST : 4 Other End - EAST : -3, WEST : -5
Start Date : 06-Dec-2019, Completion Date : 12-Dec-2019, Net Repair Days : 6, Total Man Hours : 1561

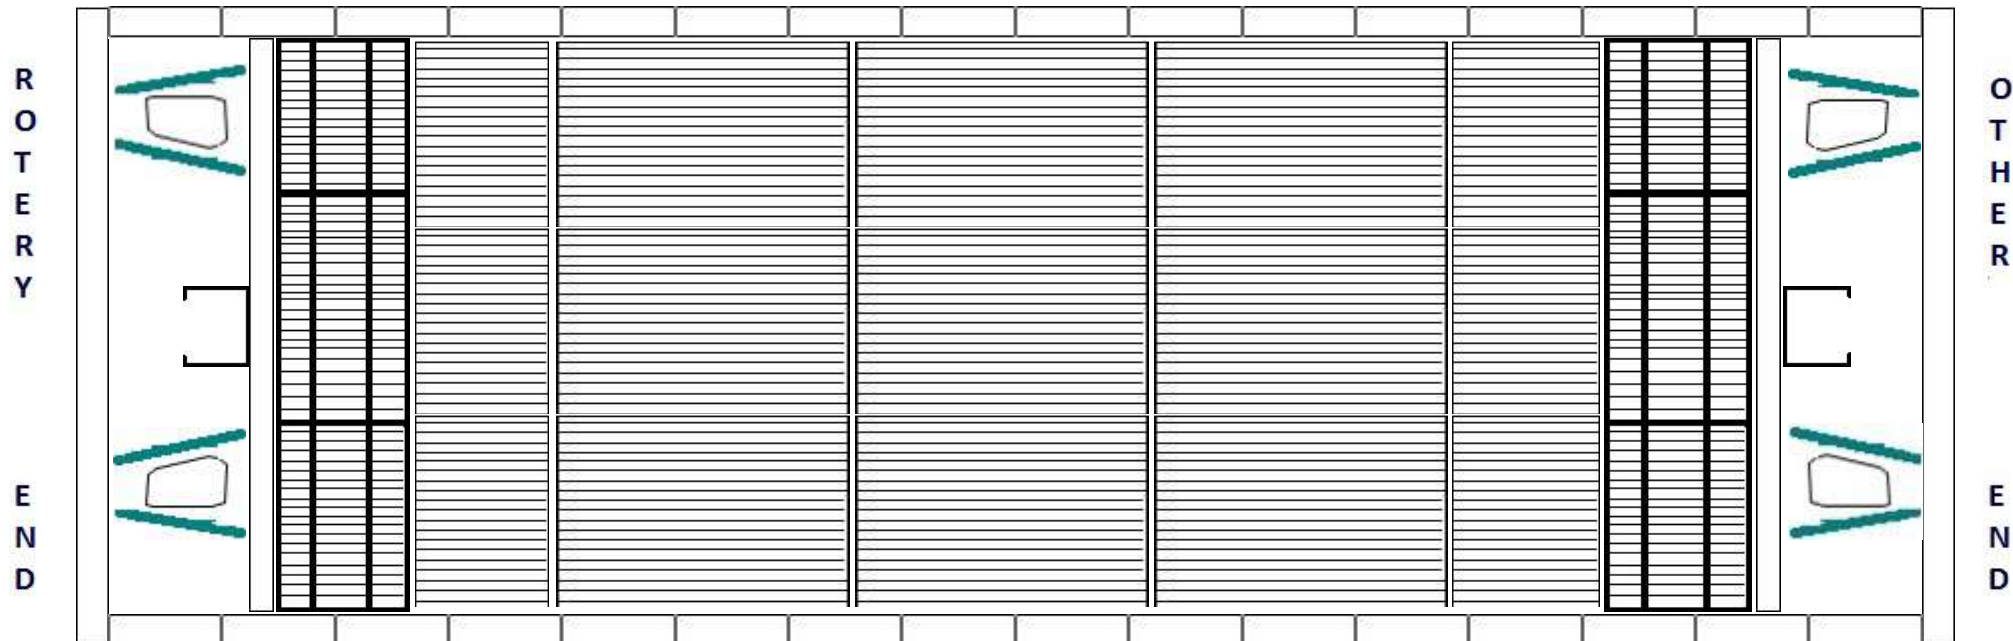
Rotary Side

Color	Particulars	Qty	Per%	Color	Particulars	Qty	Per%	Color	Particulars	Qty	Per%
	Headstock Beam	0	0%		Diagonal	4	100%		Logitudinal Channel Structure	0	0%
	Aux. Head stock	0	0%		Sole Bar	0	0%		Draft Gear Bracket	0	0%
	Trough floor	0	0%		Bottom Wall Part	0	0%		Body panel/patch		100%
	Door Top/Roof Patch		0%		Seat Bracket Rail		0%		Window Sill	14	35%
	Window Bar	20	11%		Seat pillar/lav. Partition		100%		UIC end construction		0%
	Body Pillar Part	0	100%

End Drooping: Rotary End - EAST : -2, WEST : -3 Other End - EAST : -3, WEST : -4
Start Date : 08-Nov-2019, Completion Date : 14-Nov-2019, Net Repair Days : 6, Total Man Hours : 948

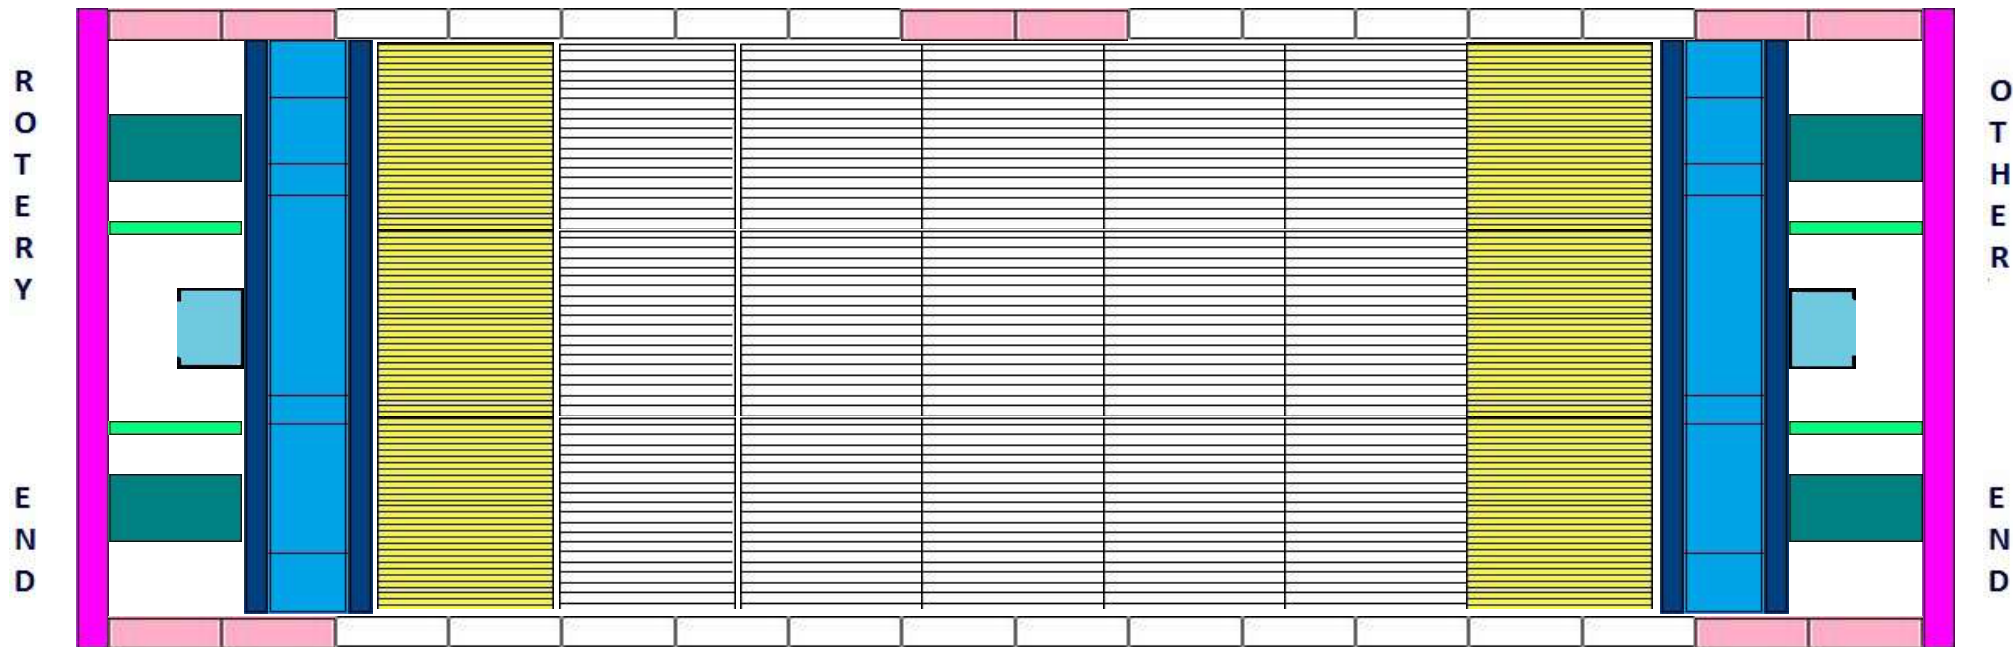
Rotary Side

Color	Particulars	Qty	Per%	Color	Particulars	Qty	Per%	Color	Particulars	Qty	Per%
	Headstock Beam	2	100%		Centre Stiffner for Headstock	4	100%		Floor Stiffner for Headstock	4	100%
	Aux. Head stock	4	100%		Sole Bar	5	31%		Draft Gear Bracket	2	100%
	Trough floor	2	29%		Centre plate	2	100%		SoleBar Stiffner	5	83%
	Bottom Wall Part	5	31%		Body panel/patch		100%		Door Top/Roof Patch		0%
	Window Module		0%		Window Sill	40	100%		Window Bar	46	26%
	Seat pillar/lav. Partition		100%		UIC end construction		0%

End Drooping: Rotary End - EAST : 3, WEST : 2 Other End - EAST : 2, WEST : 0
Start Date : 23-Nov-2019, Completion Date : 30-Nov-2019, Net Repair Days : 7, Total Man Hours : 1192

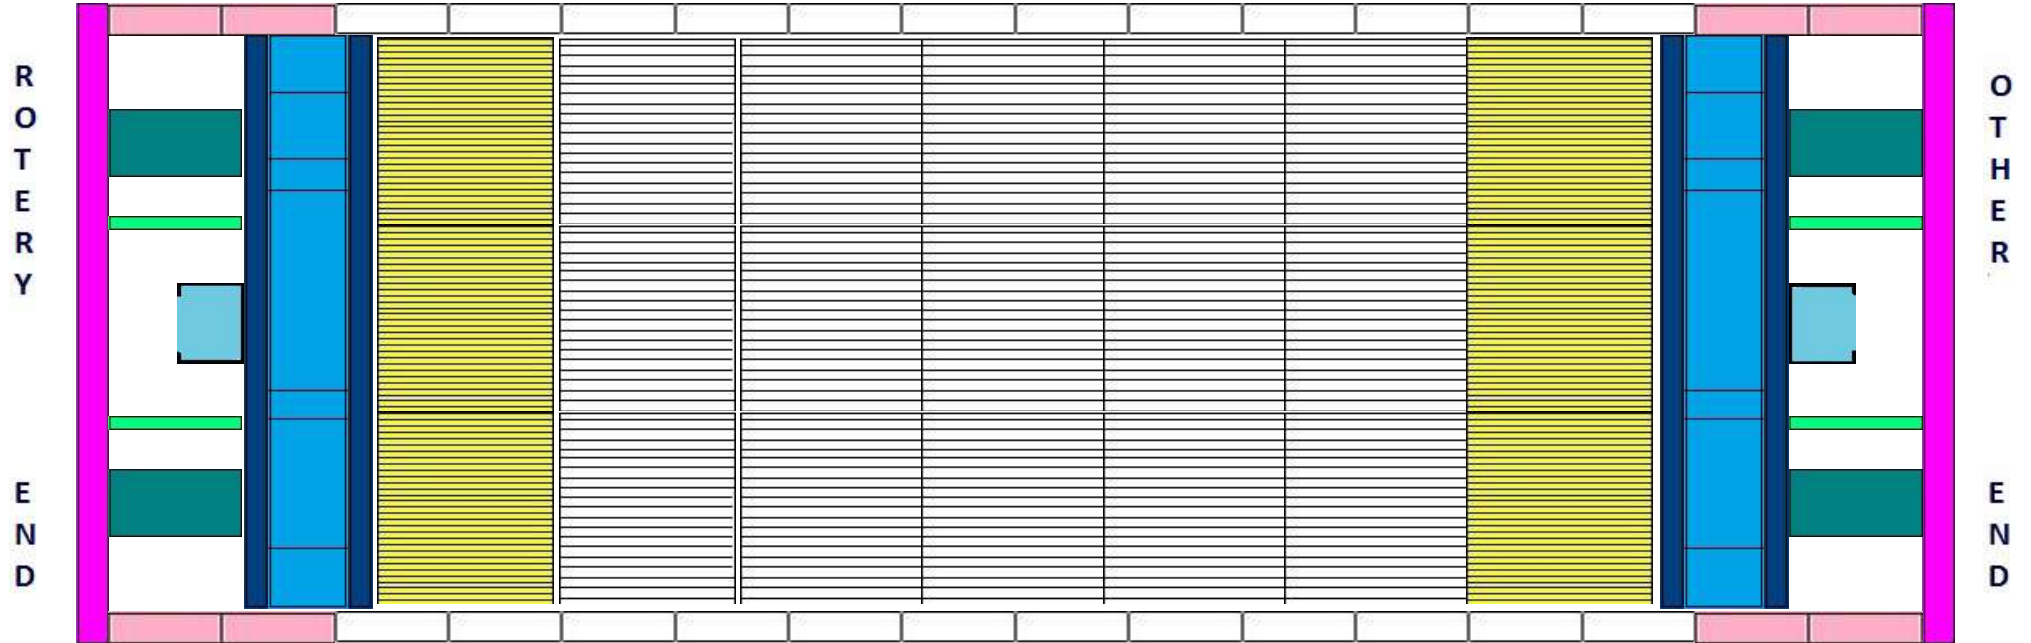
Rotary Side

Color	Particulars	Qty	Per%	Color	Particulars	Qty	Per%	Color	Particulars	Qty	Per%
	Headstock Beam	2	100%		Centre Stiffner for Headstock	4	100%		Floor Stiffner for Headstock	4	100%
	Aux. Head stock	4	100%		Sole Bar	4	25%		Draft Gear Bracket	2	100%
	Trough floor	2	29%		Centre plate	2	100%		SoleBar Stiffner	4	100%
	Bottom Wall Part	4	25%		Body panel/patch		100%		Door Top/Roof Patch		0%
	Window Module		0%		Window Sill	40	100%		Window Bar	48	26%
	Seat pillar/lav. Partition		100%		UIC end construction		0%

End Drooping: Rotary End - EAST : 6, WEST : 0 Other End - EAST : 0, WEST : 3
Start Date : 08-Nov-2019, Completion Date : 16-Nov-2019, Net Repair Days : 8, Total Man Hours : 953

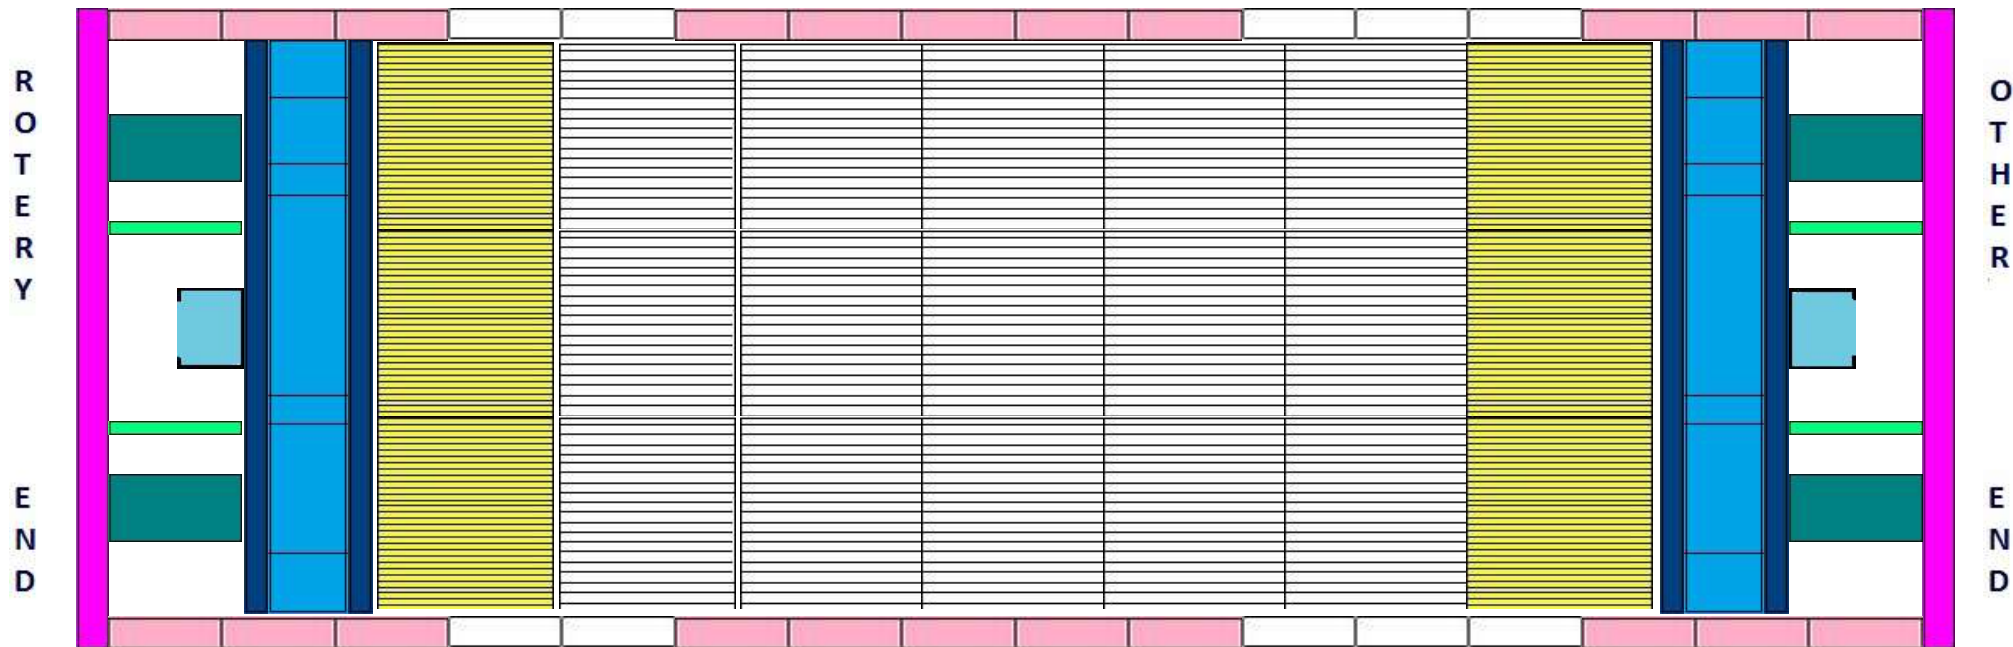
Rotary Side

Color	Particulars	Qty	Per%	Color	Particulars	Qty	Per%	Color	Particulars	Qty	Per%
	Headstock Beam	2	100%		Centre Stiffner for Headstock	4	100%		Floor Stiffner for Headstock	4	100%
	Aux. Head stock	4	100%		Sole Bar	11	69%		Draft Gear Bracket	2	100%
	Trough floor	2	29%		Centre plate	2	100%		SoleBar Stiffner	4	100%
	Bottom Wall Part	11	69%		Body panel/patch		100%		Door Top/Roof Patch		0%
	Window Module		0%		Window Sill	10	53%		Window Bar	16	19%
	Seat pillar/lav. Partition		100%		UIC end construction		0%

Start Date : 15-Nov-2019, Completion Date : 21-Nov-2019, Net Repair Days : 6, Total Man Hours : 1618

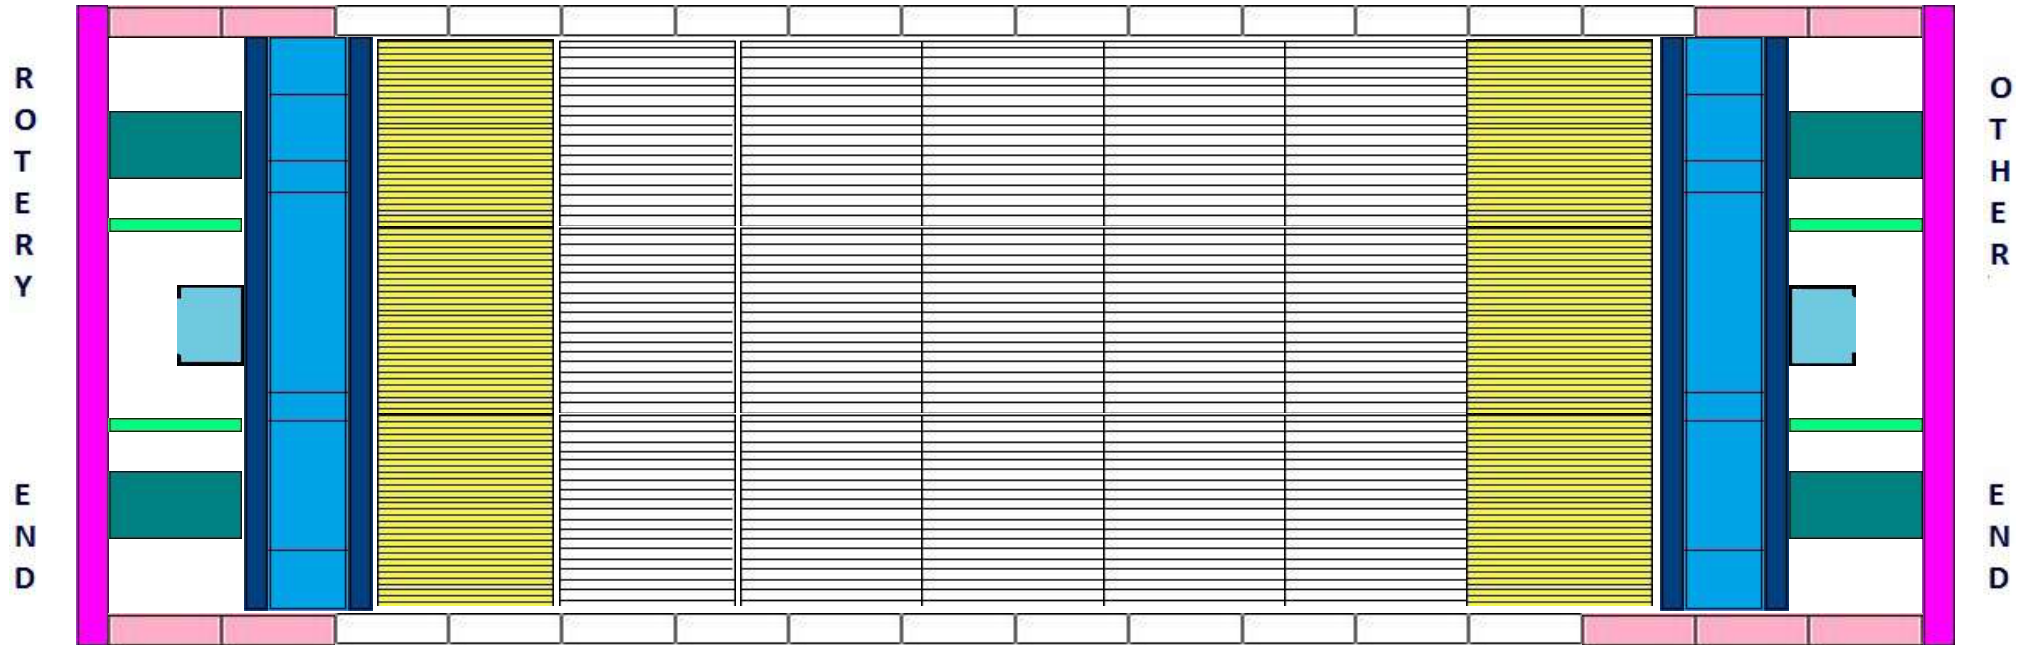
Rotary Side

Color	Particulars	Qty	Per%	Color	Particulars	Qty	Per%	Color	Particulars	Qty	Per%
	Headstock Beam	2	100%		Centre Stiffner for Headstock	4	100%		Floor Stiffner for Headstock	4	100%
	Aux. Head stock	4	100%		Sole Bar	4.5	28%		Draft Gear Bracket	2	100%
	Trough floor	2	29%		Centre plate	2	100%		SoleBar Stiffner	4	100%
	Bottom Wall Part	4.5	28%		Body panel/patch		100%		Door Top/Roof Patch		0%
	Window Module		0%		Window Sill	40	100%		Window Bar	42	23%
	Seat pillar/lav. Partition		100%		UIC end construction		0%

End Drooping: Rotary End - EAST : -4, WEST : -3 Other End - EAST : 2, WEST : 0
Start Date : 28-Sep-2019, Completion Date : 05-Oct-2019, Net Repair Days : 7, Total Man Hours : 1216

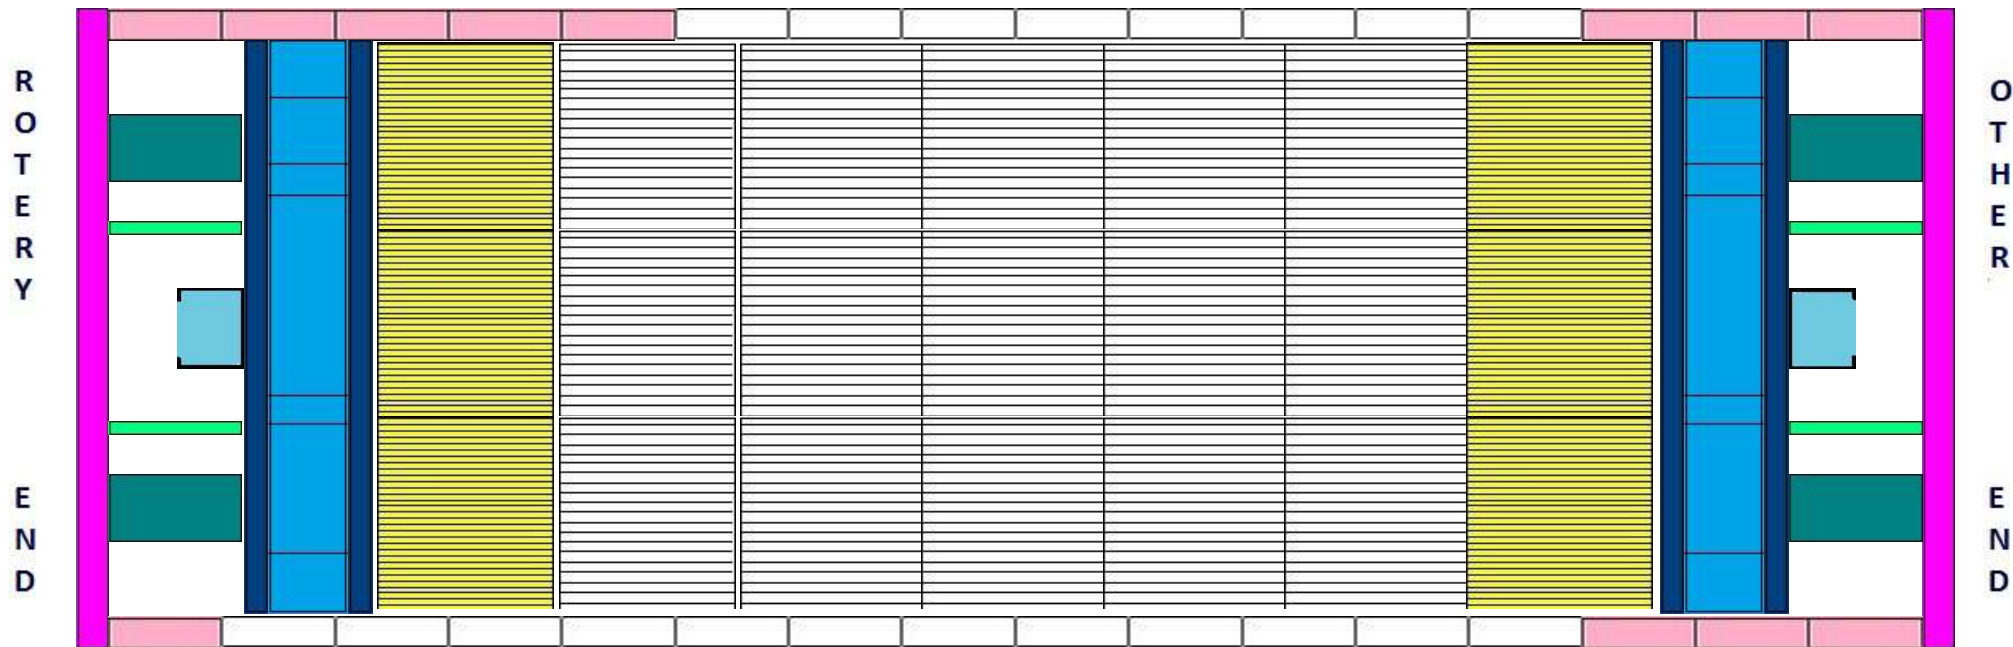
Color	Particulars	Qty	Per%	Color	Particulars	Qty	Per%	Color	Particulars	Qty	Per%
Yellow	Headstock Beam	2	100%	Dark Green	Centre Stiffner for Headstock	4	100%	Light Green	Floor Stiffner for Headstock	4	100%
Dark Blue	Aux. Head stock	4	100%	Pink	Sole Bar	6	38%	Light Blue	Draft Gear Bracket	2	100%
Yellow	Trough floor	2	29%	Light Blue	Centre plate	2	100%		SoleBar Stiffner	4	100%
	Bottom Wall Part	6	38%		Body panel/patch		100%		Door Top/Roof Patch		0%
	Window Module		0%		Window Sill	10	53%		Window Bar	18	21%
	Seat pillar/lav. Partition		100%		UIC end construction		0%

End Drooping: Rotary End - EAST : -10, WEST : -10 Other End - EAST : 7, WEST : 2
Start Date : 18-Oct-2019, Completion Date : 24-Oct-2019, Net Repair Days : 6, Total Man Hours : 1420

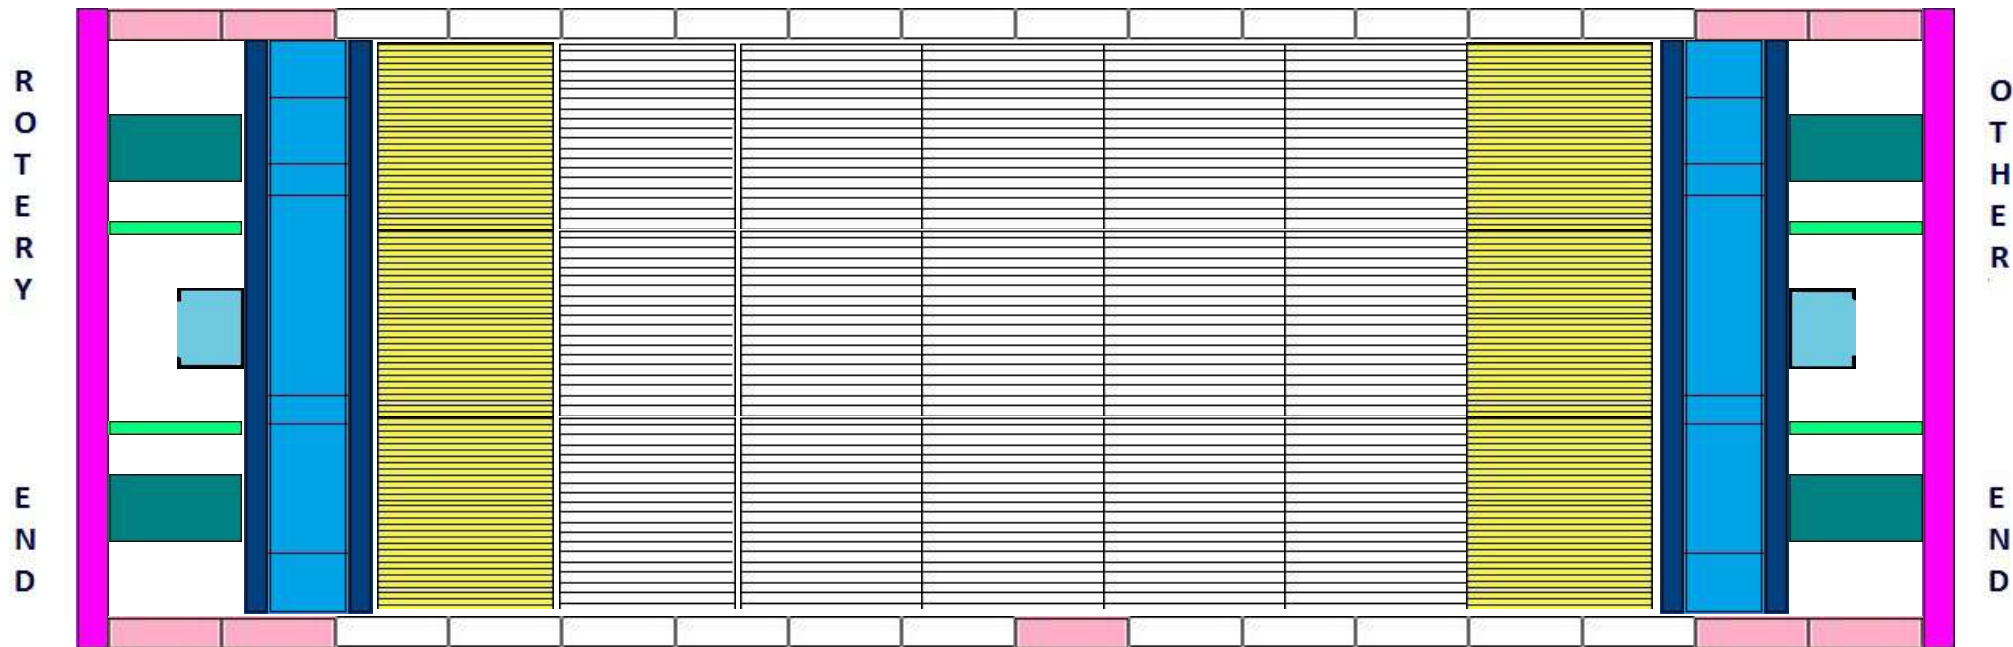
Rotary Side

Color	Particulars	Qty	Per%	Color	Particulars	Qty	Per%	Color	Particulars	Qty	Per%
	Headstock Beam	2	100%		Centre Stiffner for Headstock	4	100%		Floor Stiffner for Headstock	4	100%
	Aux. Head stock	4	100%		Sole Bar	4.5	28%		Draft Gear Bracket	2	100%
	Trough floor	2	29%		Centre plate	2	100%		SoleBar Stiffner	5	83%
	Bottom Wall Part	4.5	28%		Body panel/patch		100%		Door Top/Roof Patch		0%
	Window Module		0%		Window Sill	26	65%		Window Bar	46	26%
	Seat pillar/lav. Partition		100%		UIC end construction		0%

End Drooping: Rotary End - EAST : -8, WEST : -5 Other End - EAST : -6, WEST : -8
Start Date : 14-Oct-2019, Completion Date : 19-Oct-2019, Net Repair Days : 6, Total Man Hours : 1192

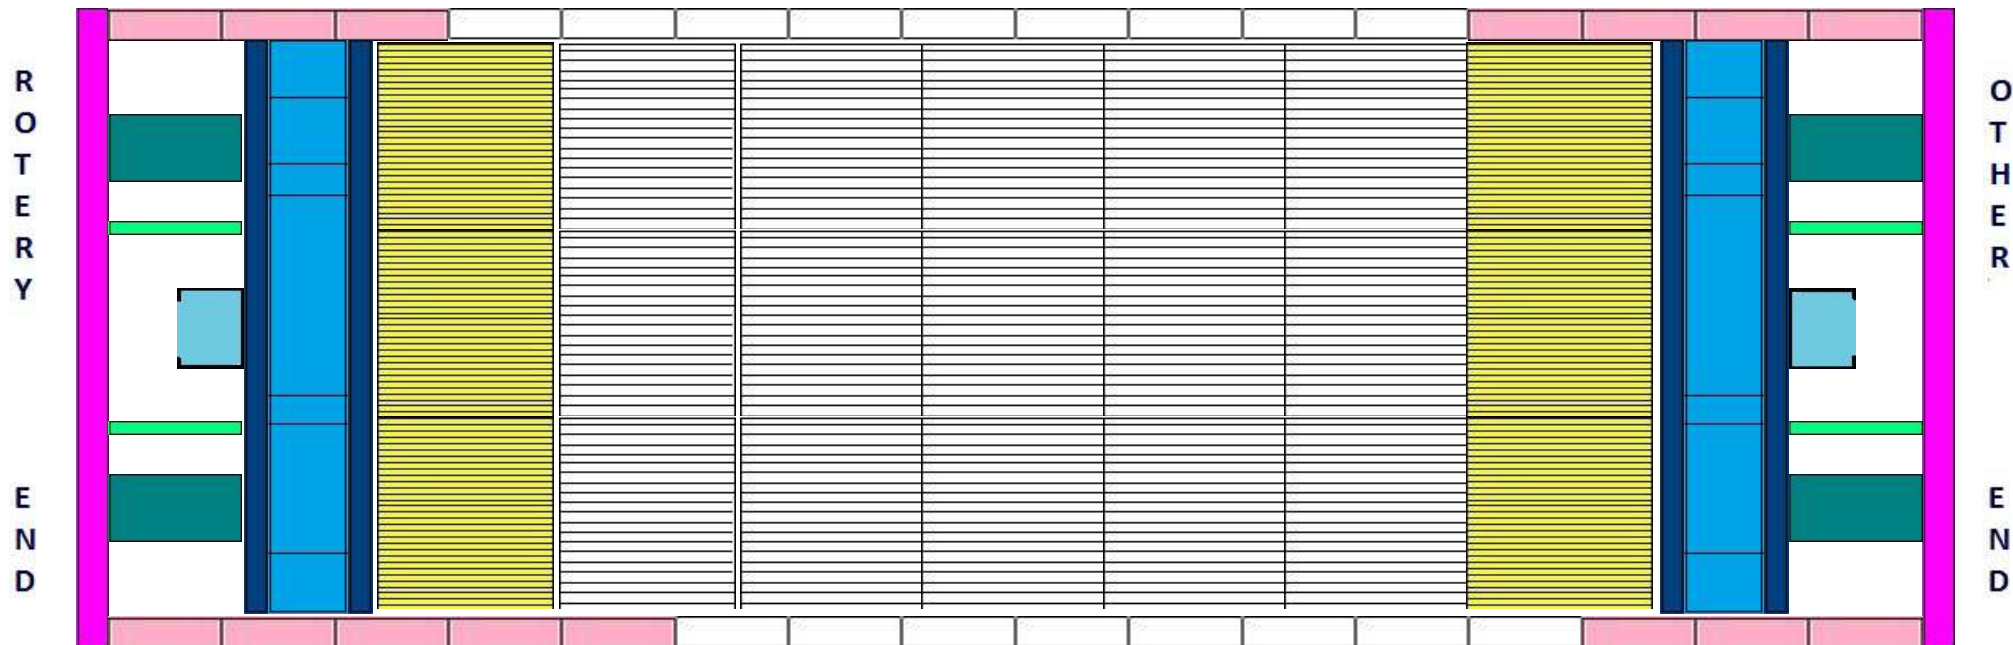
Color	Particulars	Qty	Per%	Color	Particulars	Qty	Per%	Color	Particulars	Qty	Per%
Yellow	Headstock Beam	2	100%	Dark Green	Centre Stiffner for Headstock	4	100%	Light Green	Floor Stiffner for Headstock	4	100%
Dark Blue	Aux. Head stock	4	100%	Pink	Sole Bar	7.5	47%	Light Blue	Draft Gear Bracket	2	100%
Yellow	Trough floor	2	29%	Light Blue	Centre plate	2	100%		SoleBar Stiffner	4	100%
	Bottom Wall Part	7.5	47%		Body panel/patch		100%		Door Top/Roof Patch		100%
	Window Module		0%		Window Sill	20	50%		Window Bar	40	22%
	Seat pillar/lav. Partition		100%		UIC end construction		0%

End Drooping: Rotary End - EAST : -6, WEST : 2 Other End - EAST : -10, WEST : -10
Start Date : 05-Oct-2019, Completion Date : 17-Oct-2019, Net Repair Days : 11, Total Man Hours : 1259

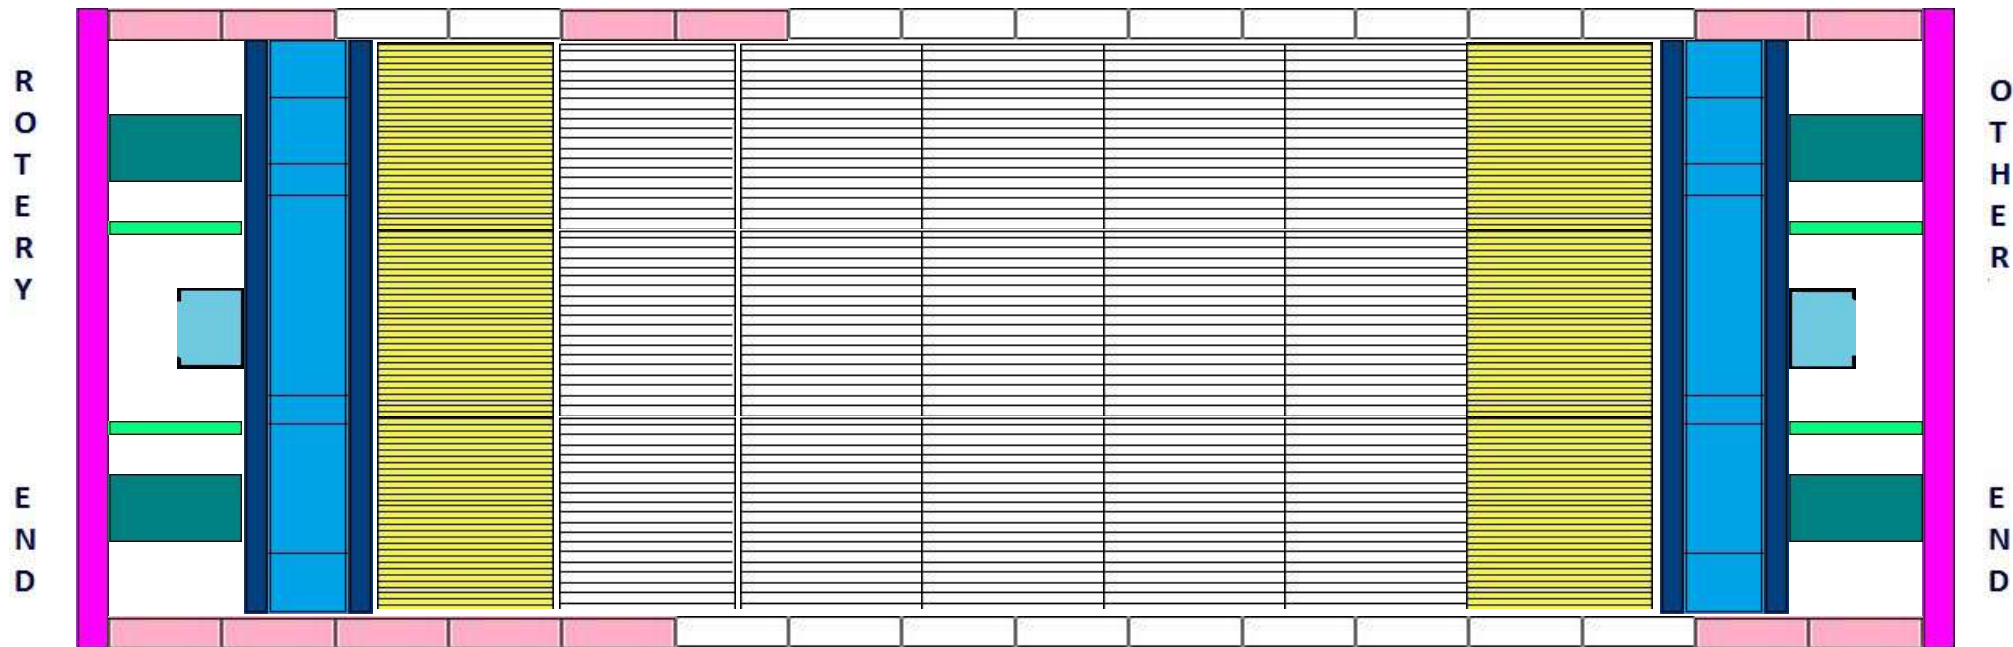
Rotary Side

Color	Particulars	Qty	Per%	Color	Particulars	Qty	Per%	Color	Particulars	Qty	Per%
	Headstock Beam	2	100%		Centre Stiffner for Headstock	4	100%		Floor Stiffner for Headstock	4	100%
	Aux. Head stock	4	100%		Sole Bar	6.5	41%		Draft Gear Bracket	2	100%
	Trough floor	2	29%		Centre plate	2	100%		SoleBar Stiffner	4	100%
	Bottom Wall Part	6.5	41%		Body panel/patch		100%		Door Top/Roof Patch		0%
	Window Module		0%		Window Sill	22	61%		Window Bar	44	26%
	Seat pillar/lav. Partition		100%		UIC end construction		0%

End Drooping: Rotary End - EAST : -10, WEST : -9 Other End - EAST : -3, WEST : -4
Start Date : 12-Oct-2019, Completion Date : 21-Oct-2019, Net Repair Days : 8, Total Man Hours : 1240

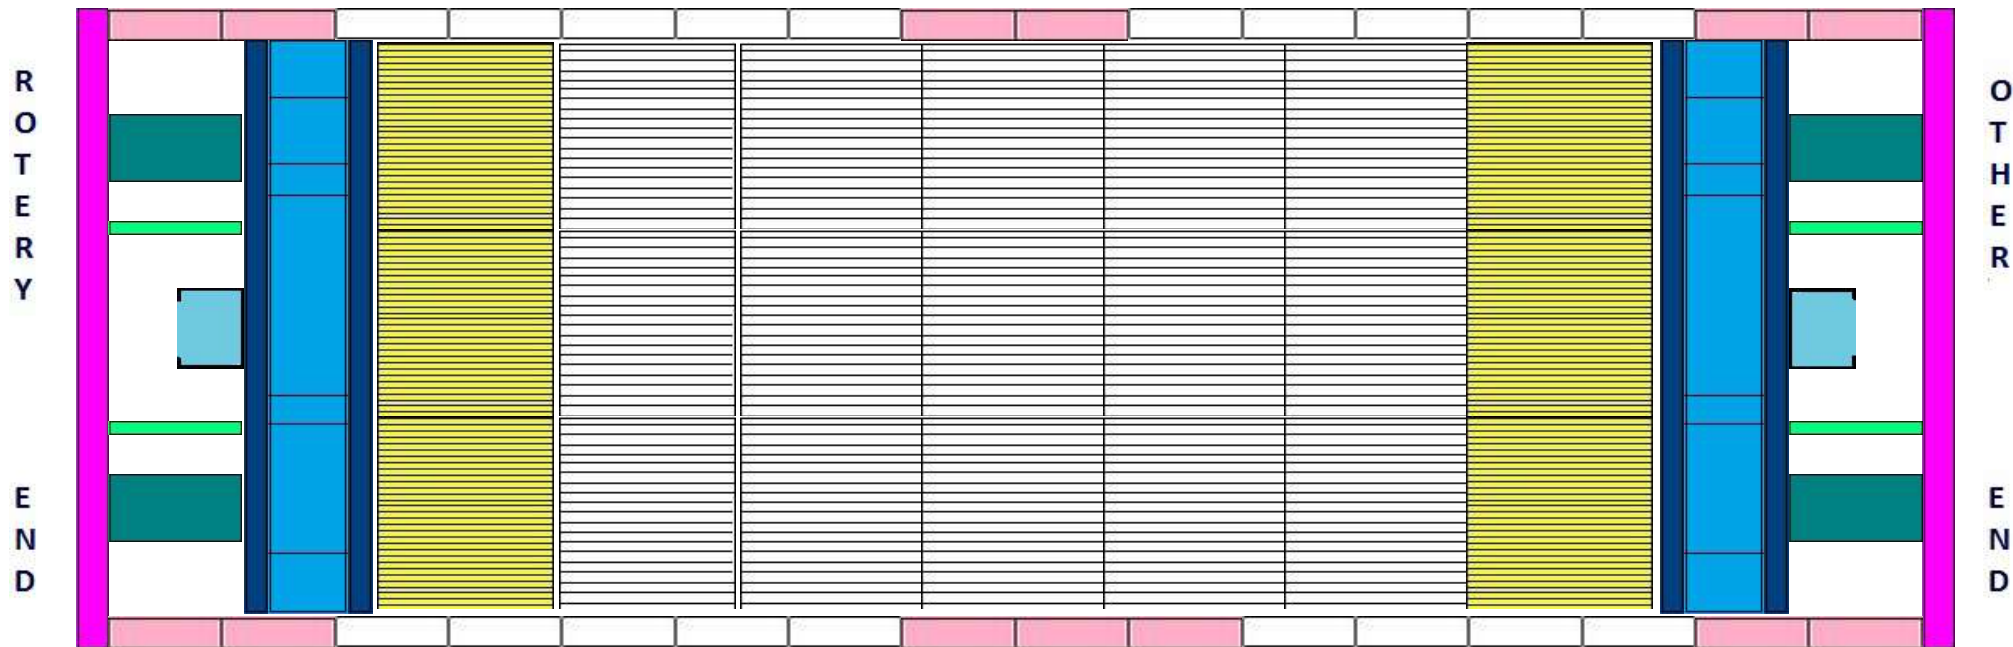
Rotary Side

Color	Particulars	Qty	Per%	Color	Particulars	Qty	Per%	Color	Particulars	Qty	Per%
	Headstock Beam	2	100%		Centre Stiffner for Headstock	4	100%		Floor Stiffner for Headstock	4	100%
	Aux. Head stock	4	100%		Sole Bar	6.5	41%		Draft Gear Bracket	2	100%
	Trough floor	2	29%		Centre plate	2	100%		SoleBar Stiffner	6	100%
	Bottom Wall Part	6.5	41%		Body panel/patch		100%		Door Top/Roof Patch		0%
	Window Module		0%		Window Sill	40	100%		Window Bar	60	34%
	Seat pillar/lav. Partition		100%		UIC end construction		0%

End Drooping: Rotary End - EAST : 5, WEST : 3 Other End - EAST : -2, WEST : -2
Start Date : 17-Oct-2019, Completion Date : 25-Oct-2019, Net Repair Days : 8, Total Man Hours : 1384
