Coach Rehabilitation Workshop, WC Railway, Bhopal

(An IMS and ISO 50001 Certified Workshop)
Final Inspection Sheet - Details of Corrosion Repair

Coach No. :NW05026

Type : WGFACCW

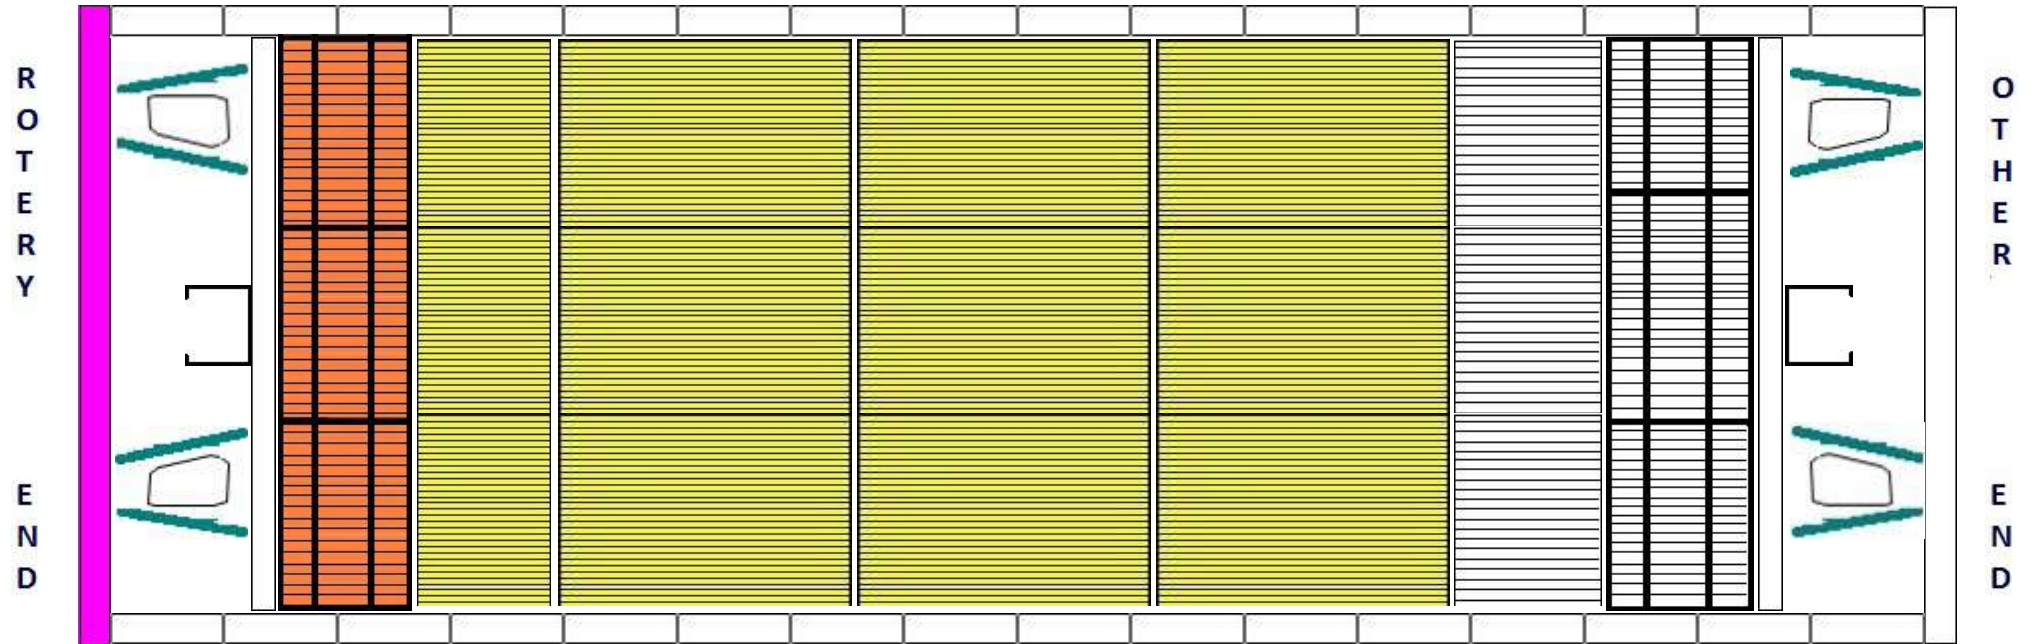
Rotary Side

Color	Particulars	Qty	Per%	Color	Particulars	Qty	Per%	Color	Particulars	Qty	Per%
	Headstock Beam	1	50%		Diagonal	4	100%		Logitudinal Channel Structure	1	50%
	Aux. Head stock	0	0%		Sole Bar	0	0%		Draft Gear Bracket	0	0%
	Trough floor	4	80%		Bottom Wall Part	0	0%		Body panel/patch		30%
	Door Top/Roof Patch		0%		Seat Bracket Rail		0%		Window Sill	0	0%
	Window Bar	0	0%		Seat pillar/lav. Partition		100%		UIC end construction		0%
	Body Pillar Part	0	100%

End Drooping: Rotary End - EAST : 0, WEST : 0 Other End - EAST : 0, WEST : 0
Start Date : 12-Feb-2020, Completion Date : 21-Feb-2020, Net Repair Days : 9, Total Man Hours : 0

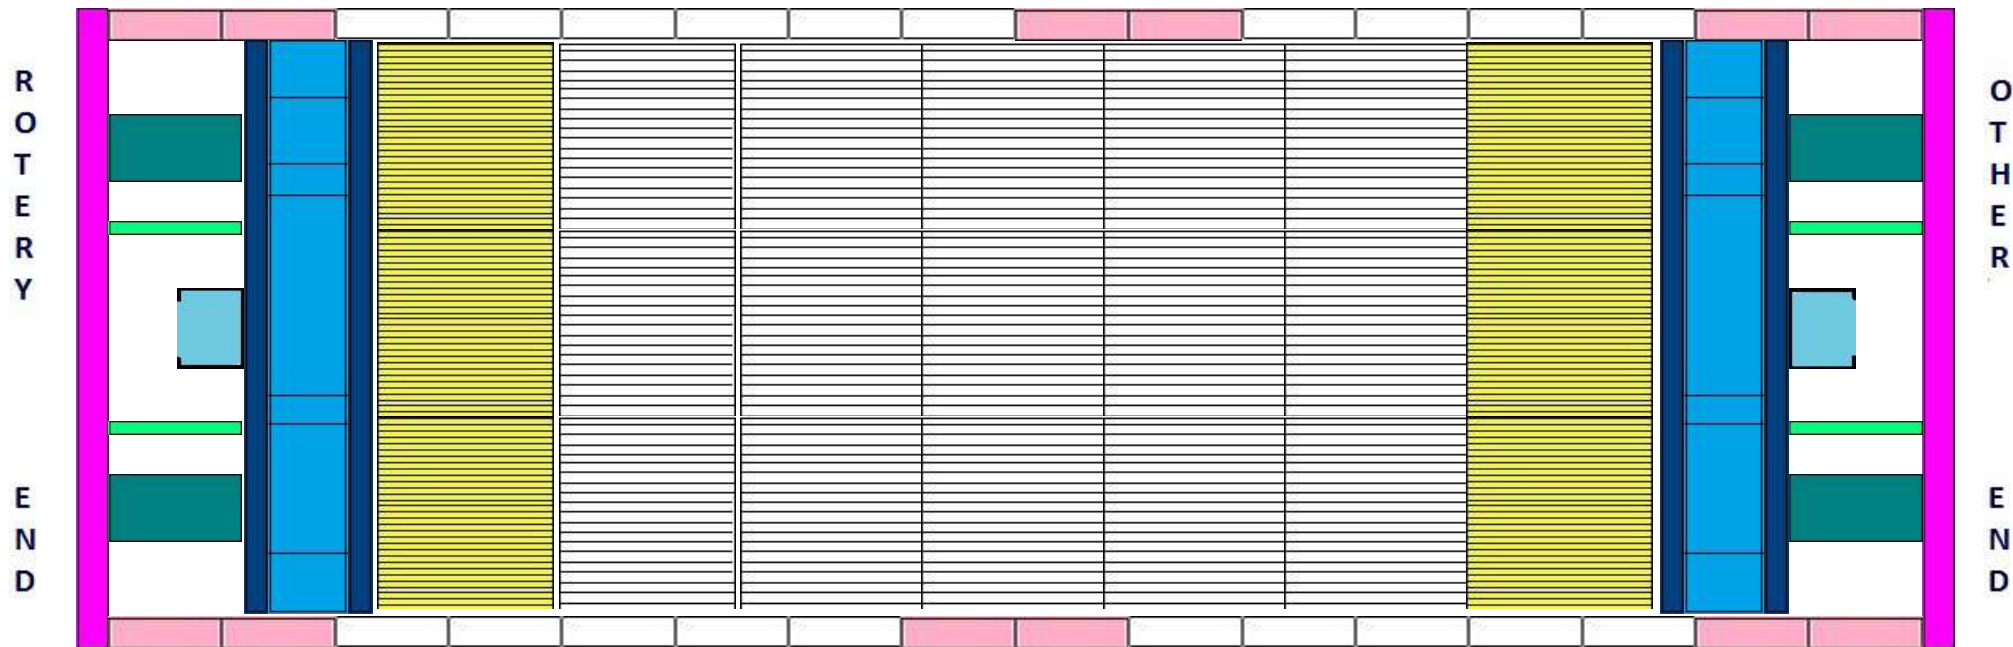
Rotary Side

Color	Particulars	Qty	Per%	Color	Particulars	Qty	Per%	Color	Particulars	Qty	Per%
	Headstock Beam	2	100%		Centre Stiffner for Headstock	4	100%		Floor Stiffner for Headstock	4	100%
	Aux. Head stock	4	100%		Sole Bar	6	38%		Draft Gear Bracket	2	100%
	Trough floor	2	29%		Centre plate	2	100%		SoleBar Stiffner	6	100%
	Bottom Wall Part	6	38%		Body panel/patch		100%		Door Top/Roof Patch		0%
	Window Module		0%		Window Sill	40	100%		Window Bar	50	28%
	Seat pillar/lav. Partition		100%		UIC end construction		0%

End Drooping: Rotary End - EAST : 3, WEST : -2 Other End - EAST : -4, WEST : -4
Start Date : 21-May-2019, Completion Date : 29-May-2019, Net Repair Days : 8, Total Man Hours : 1100
