Coach Rehabilitation Workshop, WC Railway, Bhopal

(An IMS and ISO 50001 Certified Workshop)
Final Inspection Sheet - Details of Corrosion Repair

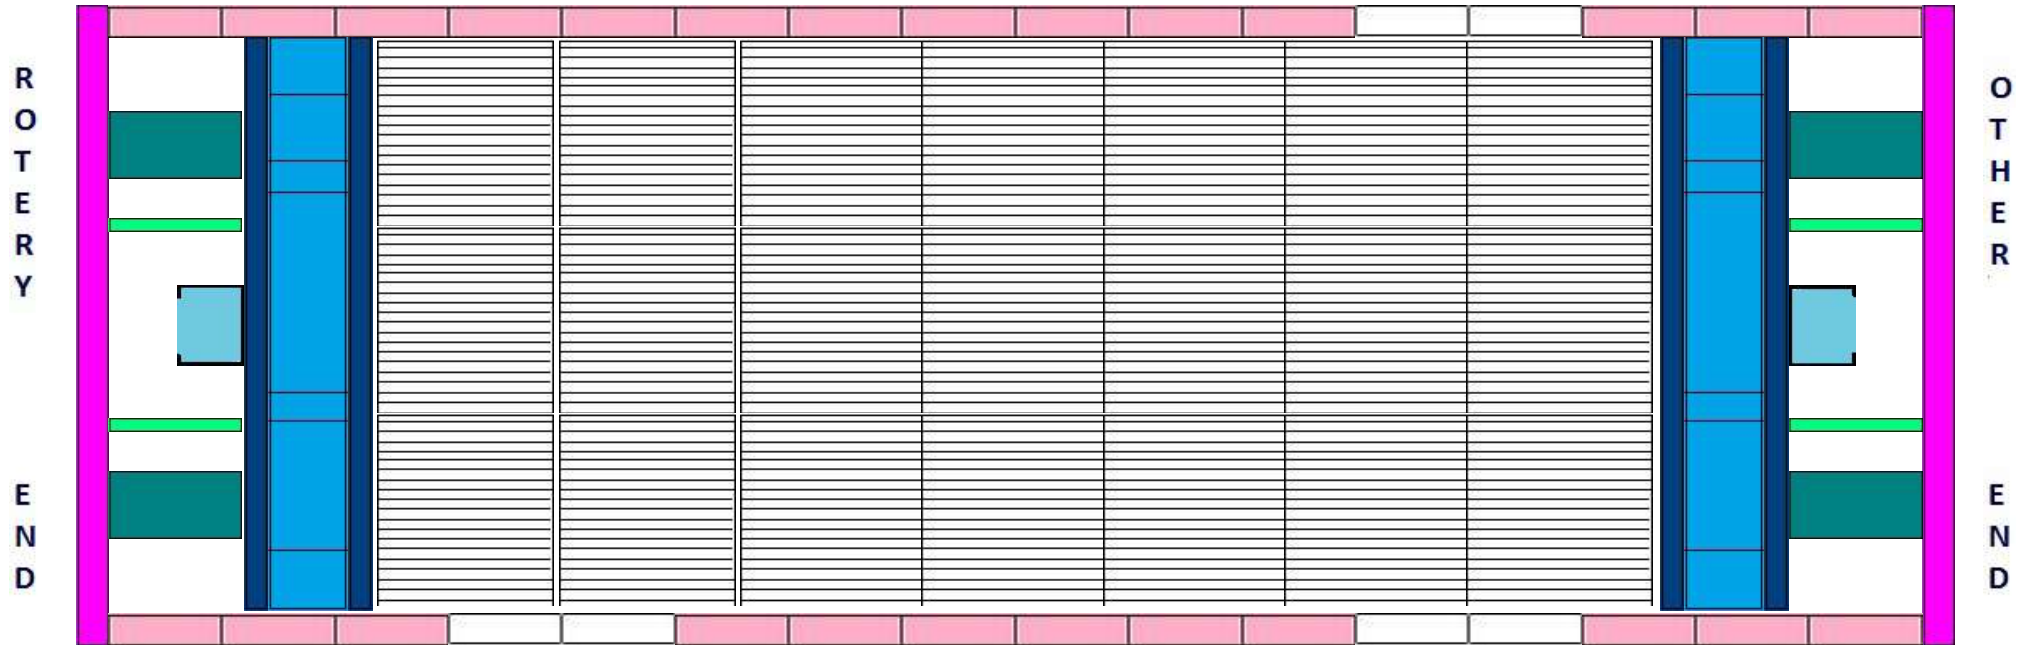
Rotary Side

Color	Particulars	Qty	Per%	Color	Particulars	Qty	Per%	Color	Particulars	Qty	Per%
Pink	Headstock Beam	2	100%	Dark Blue	Centre Stiffner for Headstock	4	100%	Light Green	Floor Stiffner for Headstock	4	100%
Dark Blue	Aux. Head stock	4	100%	Pink	Sole Bar	13	81%	Light Blue	Draft Gear Bracket	2	100%
Yellow	Trough floor	0	0%	Light Blue	Centre plate	2	100%		SoleBar Stiffner	4	100%
	Bottom Wall Part	13	81%		Body panel/patch		100%		Door Top/Roof Patch		0%
	Window Module		0%		Window Sill	8	42%		Window Bar	12	14%
	Seat pillar/lav. Partition		100%		UIC end construction		0%

End Drooping: Rotary End - EAST : -5, WEST : -4 Other End - EAST : -6, WEST : -3
Start Date : 29-Apr-2019, Completion Date : 08-May-2019, Net Repair Days : 9, Total Man Hours : 0

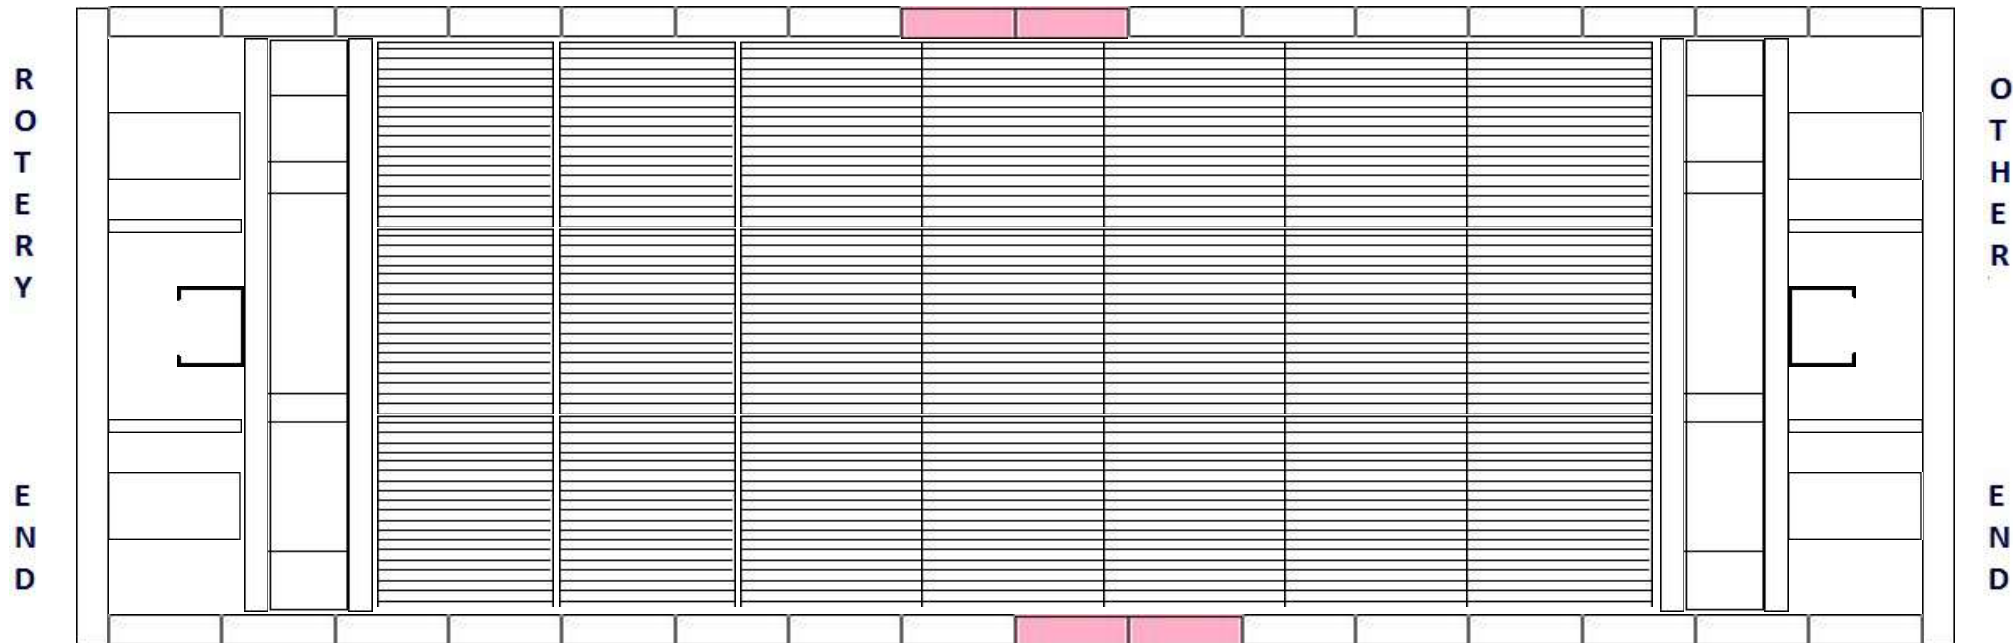
Coach No. :WC08708

Color	Particulars	Qty	Per%	Color	Particulars	Qty	Per%	Color	Particulars	Qty	Per%
	Headstock Beam	0	0%		Centre Stiffner for Headstock	0	0%		Floor Stiffner for Headstock	0	0%
	Aux. Head stock	0	0%		Sole Bar	2	13%		Draft Gear Bracket	0	0%
	Trough floor	0	0%		Centre plate	0	0%		SoleBar Stiffner	4	100%
	Bottom Wall Part	2	13%		Body panel/patch		100%		Door Top/Roof Patch		0%
	Window Module		0%		Window Sill	0	0%		Window Bar	0	0%
	Seat pillar/lav. Partition		100%		UIC end construction		0%

End Drooping: Rotary End - EAST : 0, WEST : 0 Other End - EAST : 0, WEST : 0
Start Date : 15-Jun-2019, Completion Date : 19-Jun-2019, Net Repair Days : 4, Total Man Hours : 460

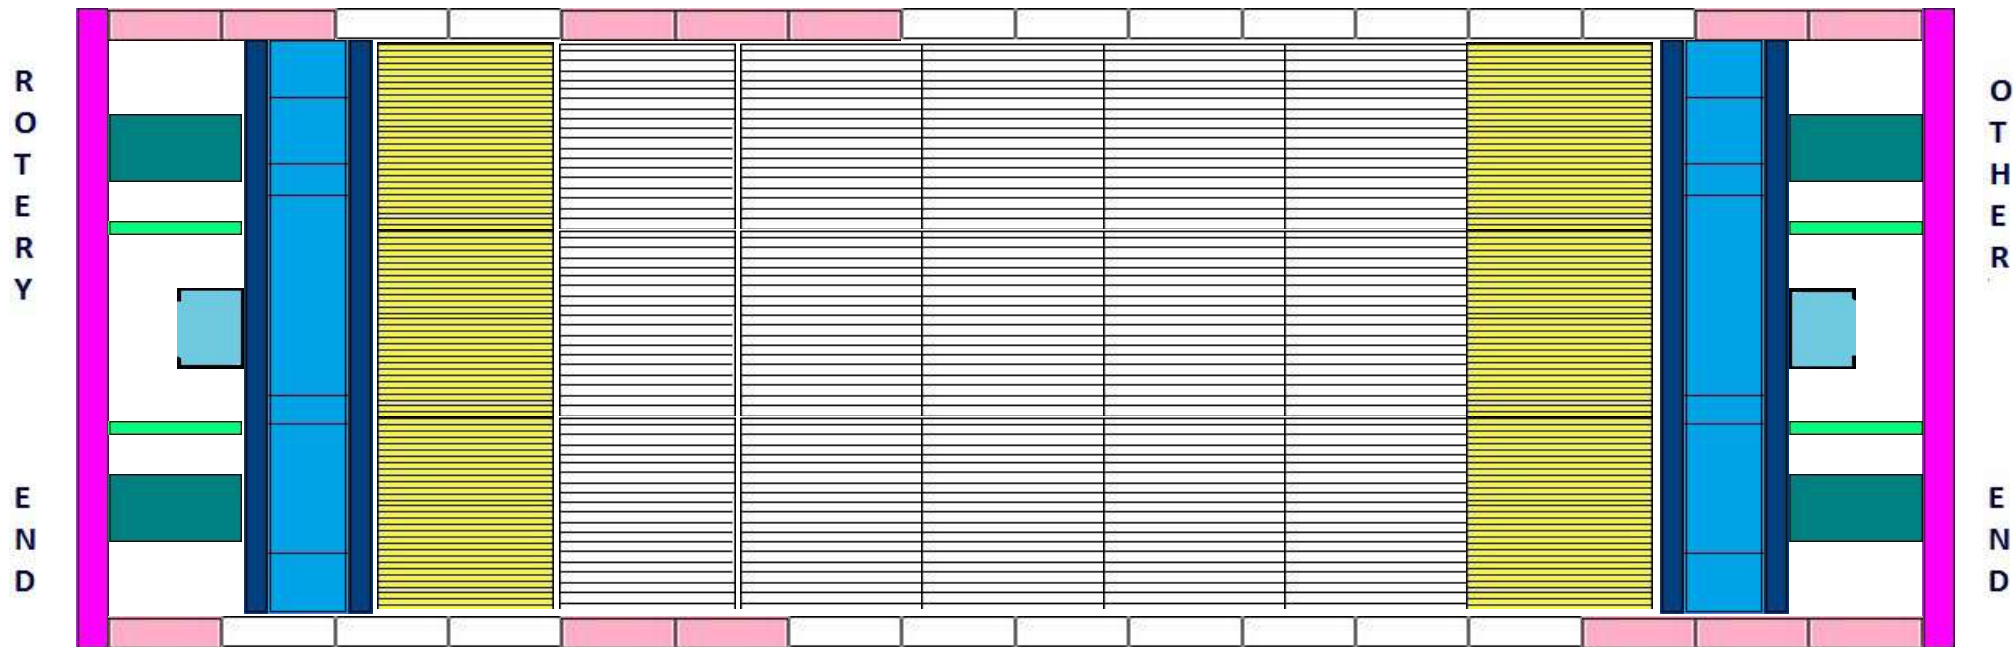
Rotary Side

Color	Particulars	Qty	Per%	Color	Particulars	Qty	Per%	Color	Particulars	Qty	Per%
	Headstock Beam	2	100%		Centre Stiffner for Headstock	4	100%		Floor Stiffner for Headstock	4	100%
	Aux. Head stock	4	100%		Sole Bar	6.5	41%		Draft Gear Bracket	2	100%
	Trough floor	2	29%		Centre plate	2	100%		SoleBar Stiffner	4	100%
	Bottom Wall Part	6.5	41%		Body panel/patch		100%		Door Top/Roof Patch		0%
	Window Module		0%		Window Sill	10	53%		Window Bar	16	19%
	Seat pillar/lav. Partition		100%		UIC end construction		0%

End Drooping: Rotary End - EAST : 4, WEST : 0 Other End - EAST : -2, WEST : -5
Start Date : 28-Jun-2019, Completion Date : 06-Jul-2019, Net Repair Days : 8, Total Man Hours : 976

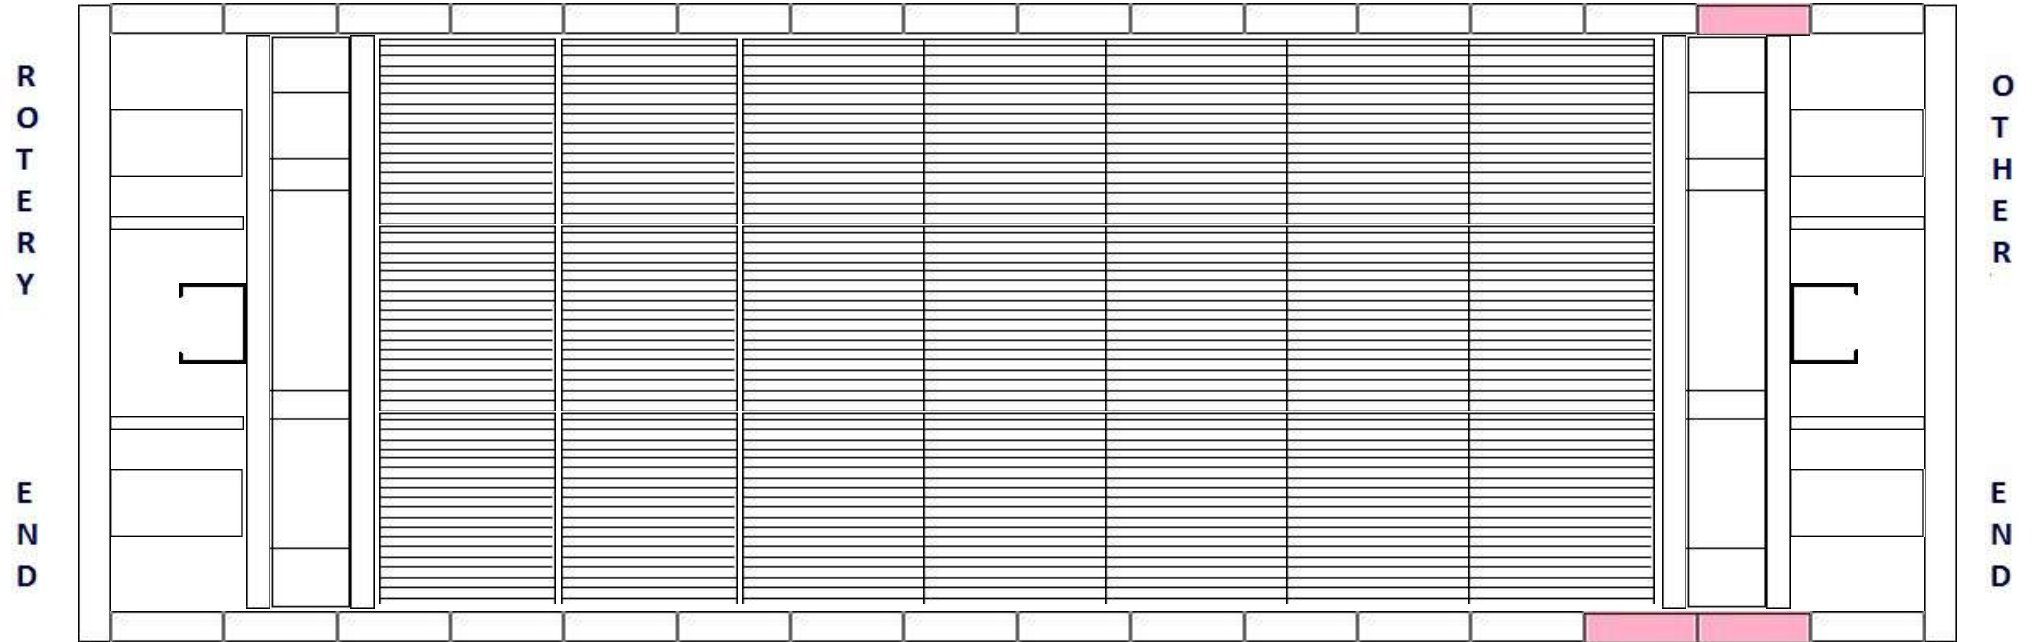
Rotary Side

Color	Particulars	Qty	Per%	Color	Particulars	Qty	Per%	Color	Particulars	Qty	Per%
	Headstock Beam	0	0%		Centre Stiffner for Headstock	0	0%		Floor Stiffner for Headstock	0	0%
	Aux. Head stock	0	0%		Sole Bar	1.5	9%		Draft Gear Bracket	0	0%
	Trough floor	0	0%		Centre plate	0	0%		SoleBar Stiffner	4	100%
	Bottom Wall Part	1.5	9%		Body panel/patch		30%		Door Top/Roof Patch		0%
	Window Module		0%		Window Sill	0	0%		Window Bar	0	0%
	Seat pillar/lav. Partition		100%		UIC end construction		0%

End Drooping: Rotary End - EAST : 0, WEST : 0 Other End - EAST : 0, WEST : 0
Start Date : 31-Jul-2019, Completion Date : 03-Aug-2019, Net Repair Days : 4, Total Man Hours : 240

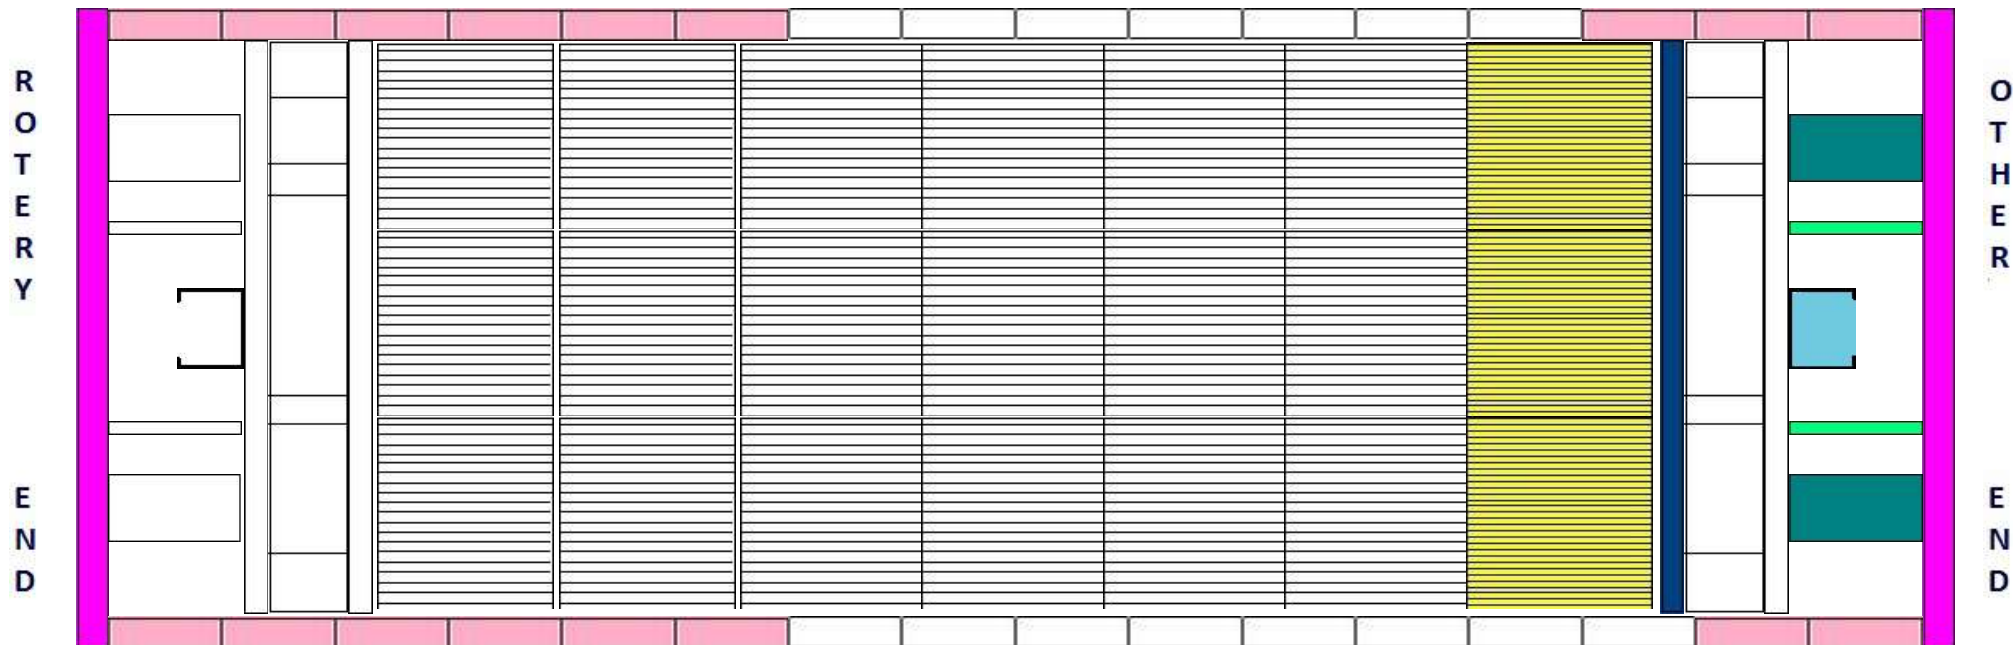
Color	Particulars	Qty	Per%	Color	Particulars	Qty	Per%	Color	Particulars	Qty	Per%
Pink	Headstock Beam	2	100%	Dark Blue	Centre Stiffner for Headstock	2	50%	Yellow	Floor Stiffner for Headstock	2	50%
Dark Blue	Aux. Head stock	2	50%	Pink	Sole Bar	8.5	53%	Light Blue	Draft Gear Bracket	1	50%
Yellow	Trough floor	1	14%	Light Blue	Centre plate	1	50%		SoleBar Stiffner	4	100%
	Bottom Wall Part	8.5	53%		Body panel/patch		100%		Door Top/Roof Patch		0%
	Window Module		0%		Window Sill	14	39%		Window Bar	34	20%
	Seat pillar/lav. Partition		100%		UIC end construction		0%

End Drooping: Rotary End - EAST : 0, WEST : 0 Other End - EAST : 0, WEST : 0
Start Date : 14-Aug-2019, Completion Date : 23-Aug-2019, Net Repair Days : 9, Total Man Hours : 0

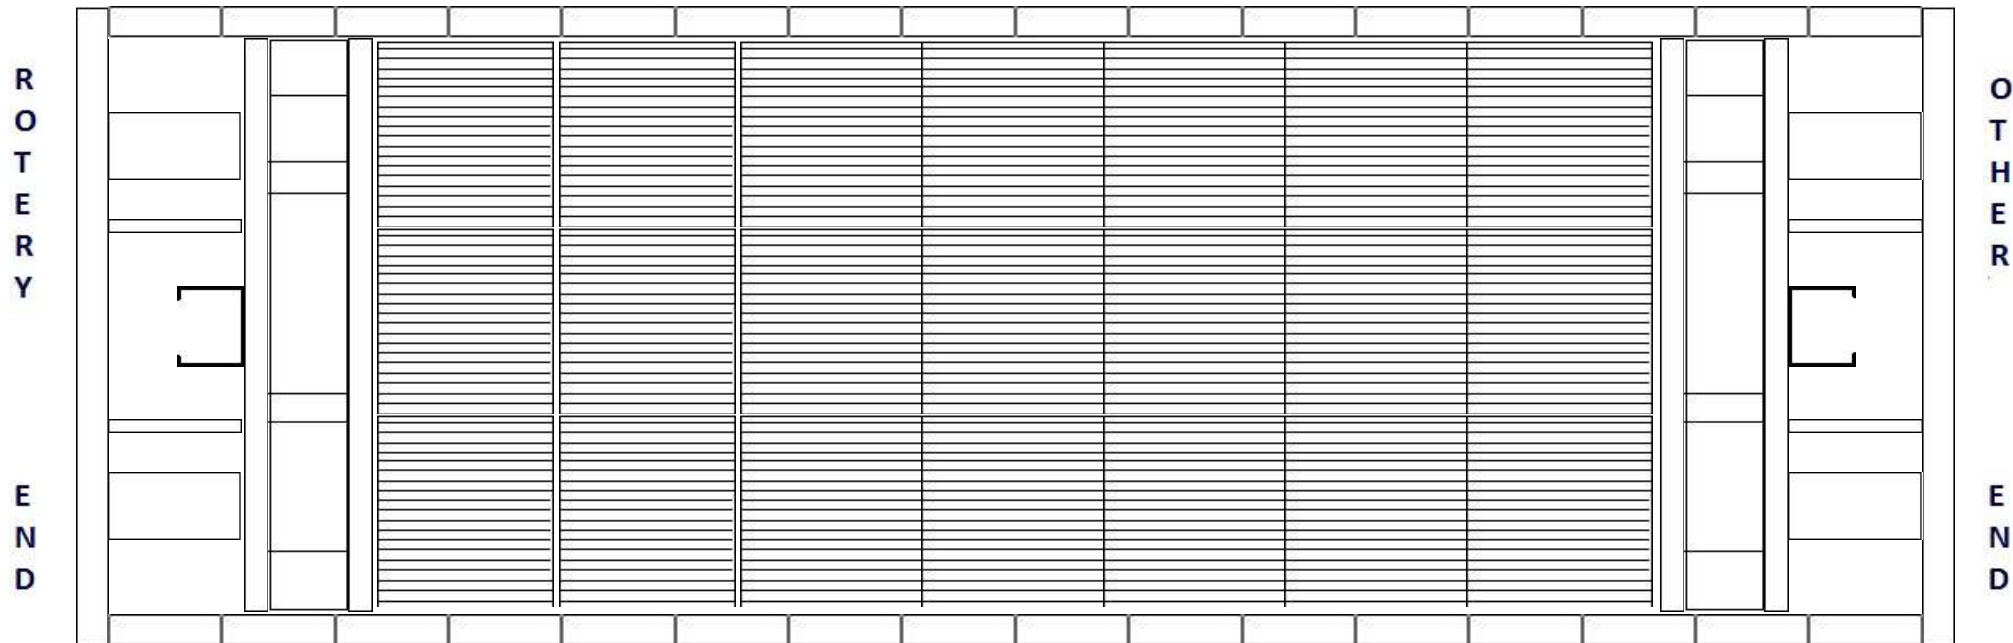
Color	Particulars	Qty	Per%	Color	Particulars	Qty	Per%	Color	Particulars	Qty	Per%
Blue	Headstock Beam	0	0%	Red	Centre Stiffner for Headstock	0	0%	Green	Floor Stiffner for Headstock	0	0%
Black	Aux. Head stock	0	0%	Pink	Sole Bar	0	0%	Light Blue	Draft Gear Bracket	0	0%
Yellow	Trough floor	0	0%	Light Blue	Centre plate	0	0%		SoleBar Stiffner	4	100%
	Bottom Wall Part	0	0%		Body panel/patch		100%		Door Top/Roof Patch		0%
	Window Module		0%		Window Sill	0	0%		Window Bar	0	0%
	Seat pillar/lav. Partition		100%		UIC end construction		0%

End Drooping: Rotary End - EAST : 0, WEST : 0 Other End - EAST : 0, WEST : 0
Start Date : 28-Aug-2019, Completion Date : 02-Sep-2019, Net Repair Days : 5, Total Man Hours : 344

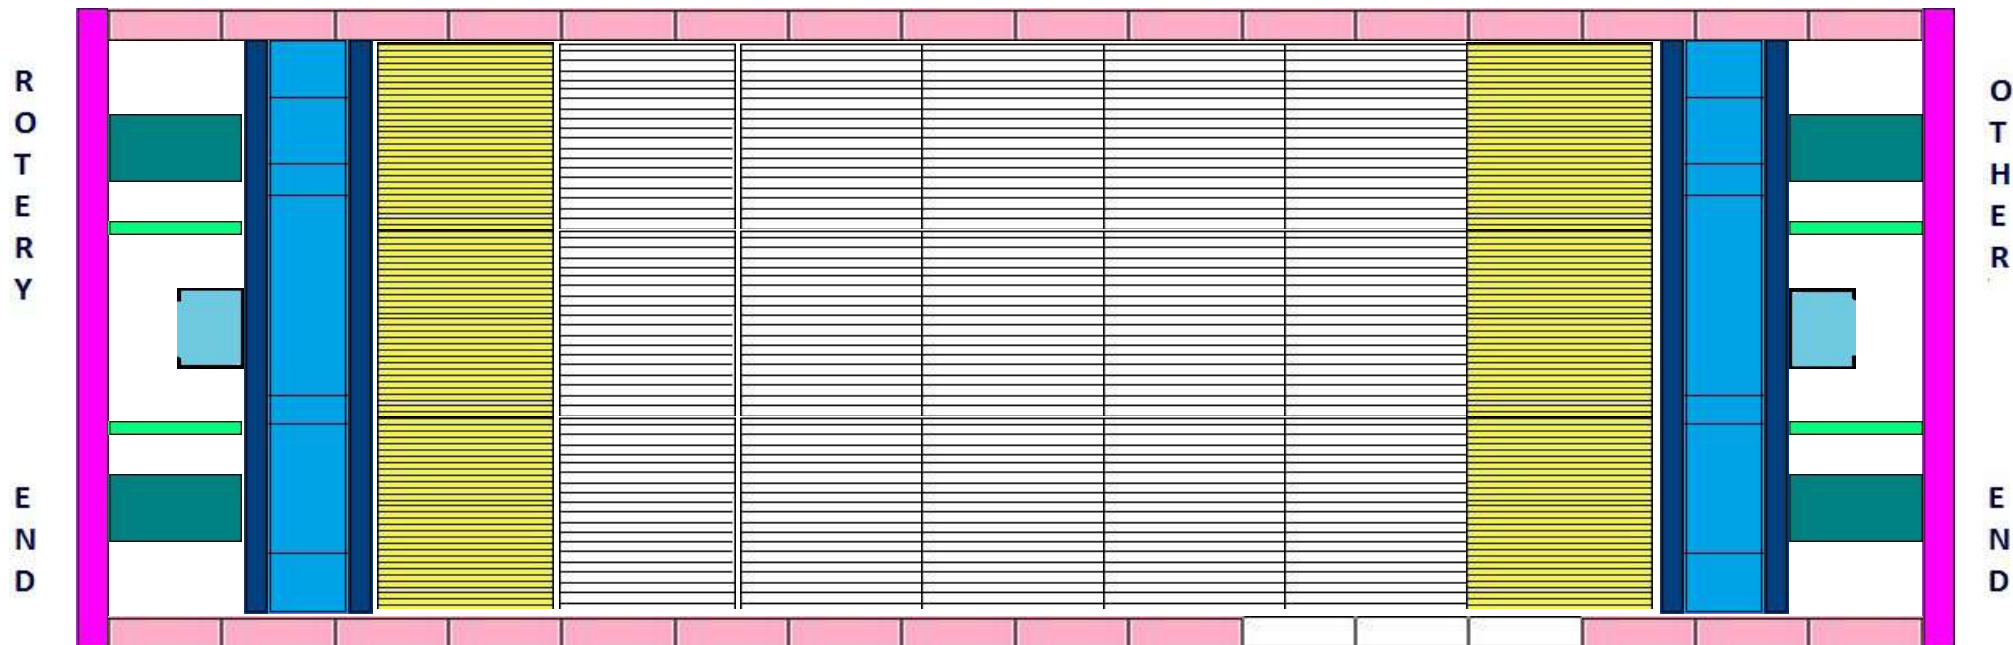
Color	Particulars	Qty	Per%	Color	Particulars	Qty	Per%	Color	Particulars	Qty	Per%
Yellow	Headstock Beam	2	100%	Dark Green	Centre Stiffner for Headstock	4	100%	Light Green	Floor Stiffner for Headstock	4	100%
Dark Blue	Aux. Head stock	4	100%	Pink	Sole Bar	14.5	91%	Light Blue	Draft Gear Bracket	2	100%
Yellow	Trough floor	2	29%	Light Blue	Centre plate	2	100%		SoleBar Stiffner	6	100%
	Bottom Wall Part	14.5	91%		Body panel/patch		100%		Door Top/Roof Patch		0%
	Window Module		0%		Window Sill	28	70%		Window Bar	48	27%
	Seat pillar/lav. Partition		100%		UIC end construction		0%

End Drooping: Rotary End - EAST : 0, WEST : -3 Other End - EAST : -5, WEST : -4
Start Date : 24-Aug-2019, Completion Date : 30-Aug-2019, Net Repair Days : 6, Total Man Hours : 1588

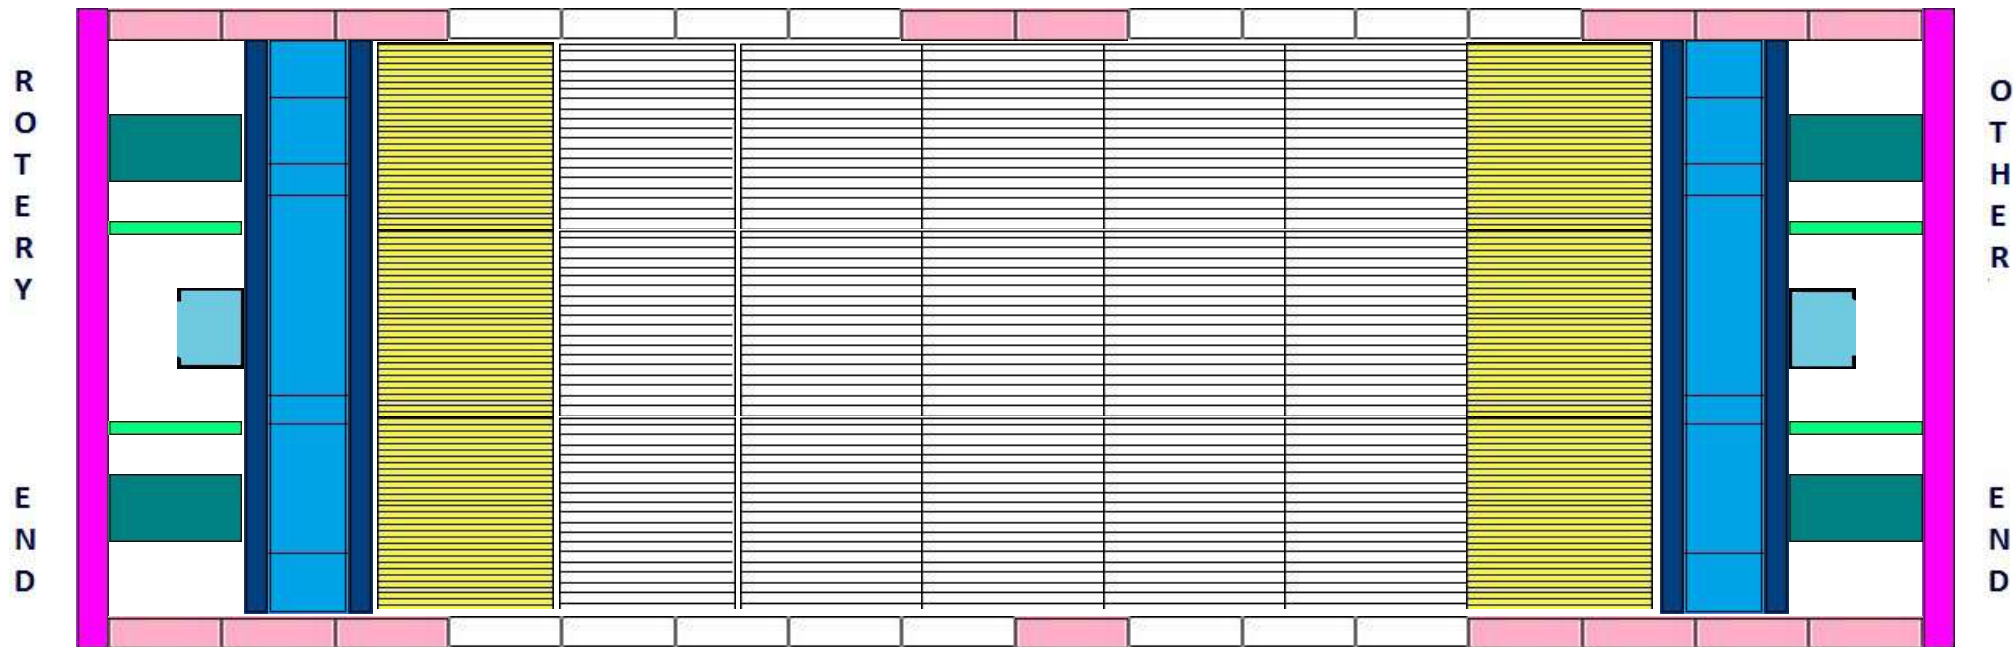
Rotary Side

Color	Particulars	Qty	Per%	Color	Particulars	Qty	Per%	Color	Particulars	Qty	Per%
	Headstock Beam	2	100%		Centre Stiffner for Headstock	4	100%		Floor Stiffner for Headstock	4	100%
	Aux. Head stock	4	100%		Sole Bar	8	50%		Draft Gear Bracket	2	100%
	Trough floor	2	29%		Centre plate	2	100%		SoleBar Stiffner	6	100%
	Bottom Wall Part	8	50%		Body panel/patch		100%		Door Top/Roof Patch		0%
	Window Module		0%		Window Sill	28	70%		Window Bar	44	25%
	Seat pillar/lav. Partition		100%		UIC end construction		0%

End Drooping: Rotary End - EAST : -6, WEST : 5 Other End - EAST : -3, WEST : -4
Start Date : 21-Oct-2019, Completion Date : 26-Oct-2019, Net Repair Days : 6, Total Man Hours : 1192

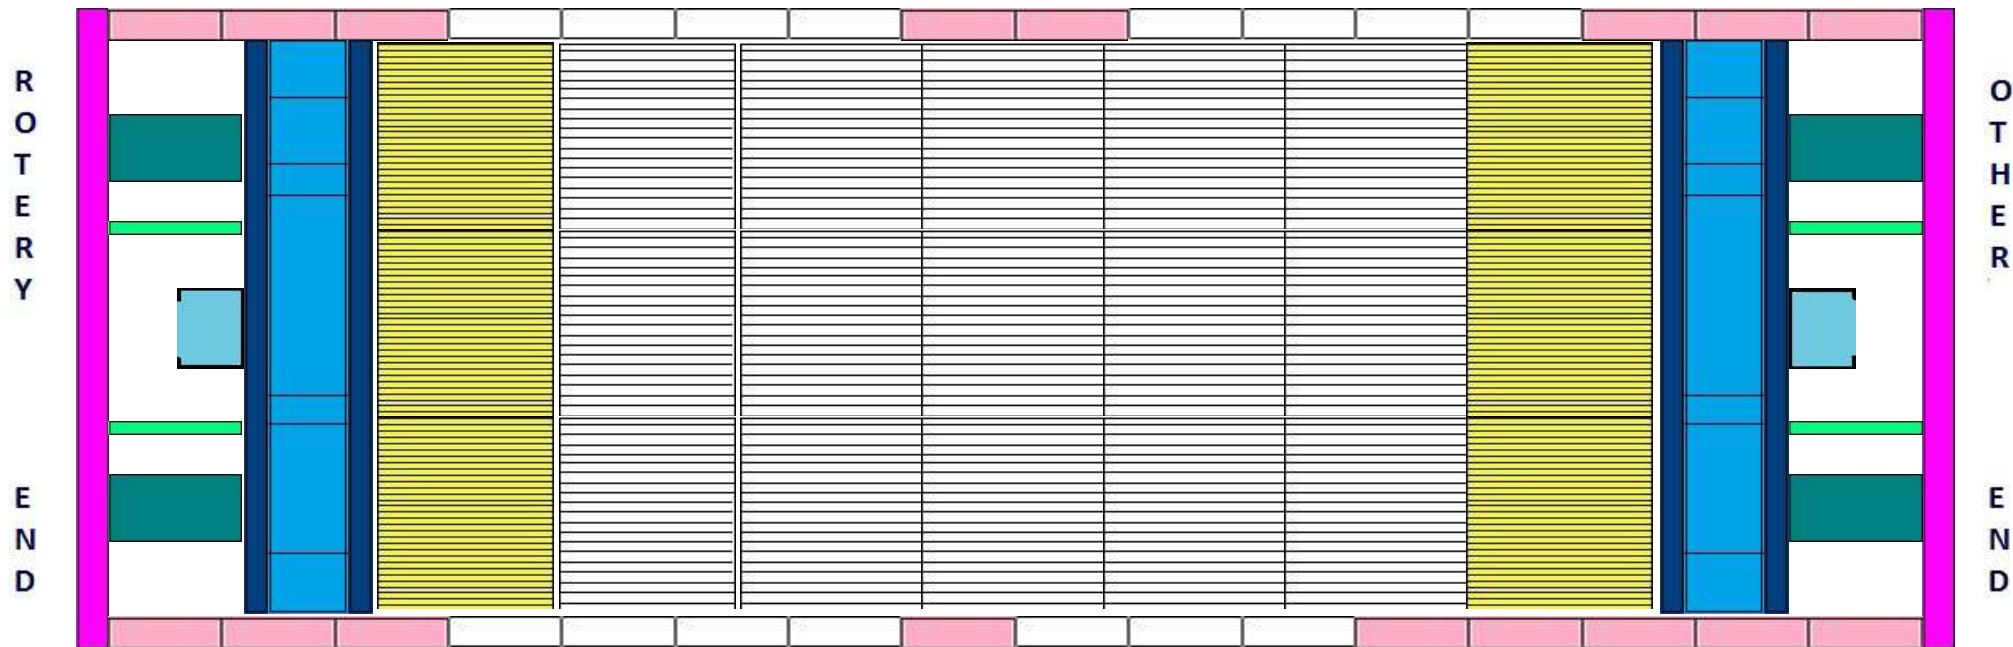
Rotary Side

Color	Particulars	Qty	Per%	Color	Particulars	Qty	Per%	Color	Particulars	Qty	Per%
Yellow	Headstock Beam	2	100%	Dark Green	Centre Stiffner for Headstock	4	100%	Light Green	Floor Stiffner for Headstock	4	100%
Dark Blue	Aux. Head stock	4	100%	Pink	Sole Bar	9	56%	Light Blue	Draft Gear Bracket	2	100%
Yellow	Trough floor	2	29%	Light Blue	Centre plate	2	100%		SoleBar Stiffner	6	100%
	Bottom Wall Part	9	56%		Body panel/patch		100%		Door Top/Roof Patch		0%
	Window Module		0%		Window Sill	21	53%		Window Bar	44	25%
	Seat pillar/lav. Partition		100%		UIC end construction		0%

End Drooping: Rotary End - EAST : -3, WEST : 2 Other End - EAST : 0, WEST : -2
Start Date : 06-Nov-2019, Completion Date : 15-Nov-2019, Net Repair Days : 9, Total Man Hours : 968

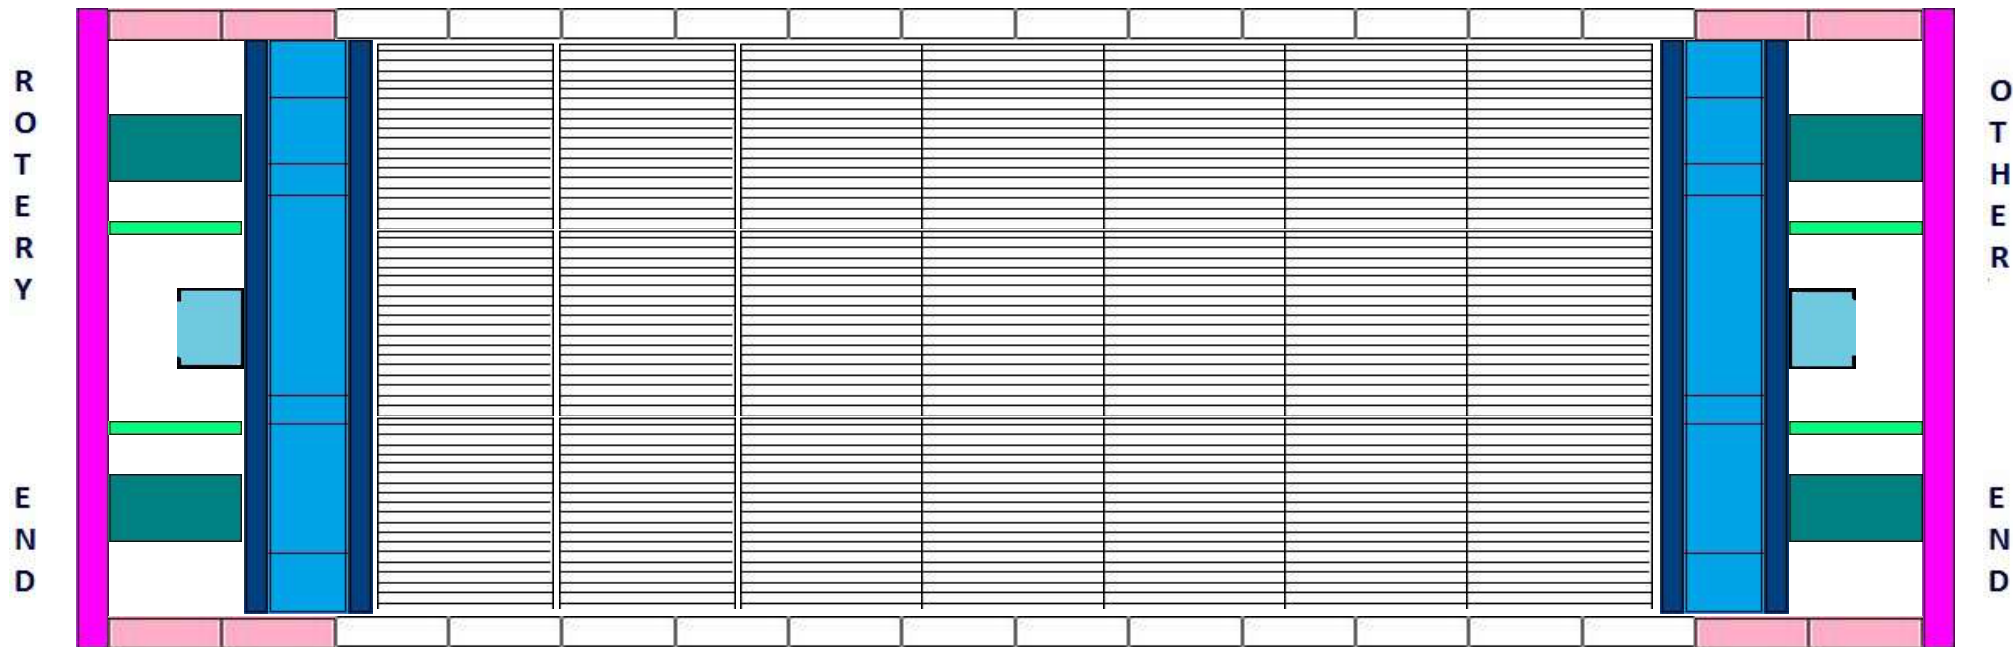
Rotary Side

Color	Particulars	Qty	Per%	Color	Particulars	Qty	Per%	Color	Particulars	Qty	Per%
	Headstock Beam	2	100%		Centre Stiffner for Headstock	4	100%		Floor Stiffner for Headstock	4	100%
	Aux. Head stock	4	100%		Sole Bar	4	25%		Draft Gear Bracket	2	100%
	Trough floor	0	0%		Centre plate	2	100%		SoleBar Stiffner	4	100%
	Bottom Wall Part	4	25%		Body panel/patch		0%		Door Top/Roof Patch		100%
	Window Module		0%		Window Sill	0	0%		Window Bar	0	0%
	Seat pillar/lav. Partition		100%		UIC end construction		0%

End Drooping: Rotary End - EAST : -6, WEST : -4 Other End - EAST : 0, WEST : 0
Start Date : 11-Oct-2019, Completion Date : 16-Oct-2019, Net Repair Days : 5, Total Man Hours : 208

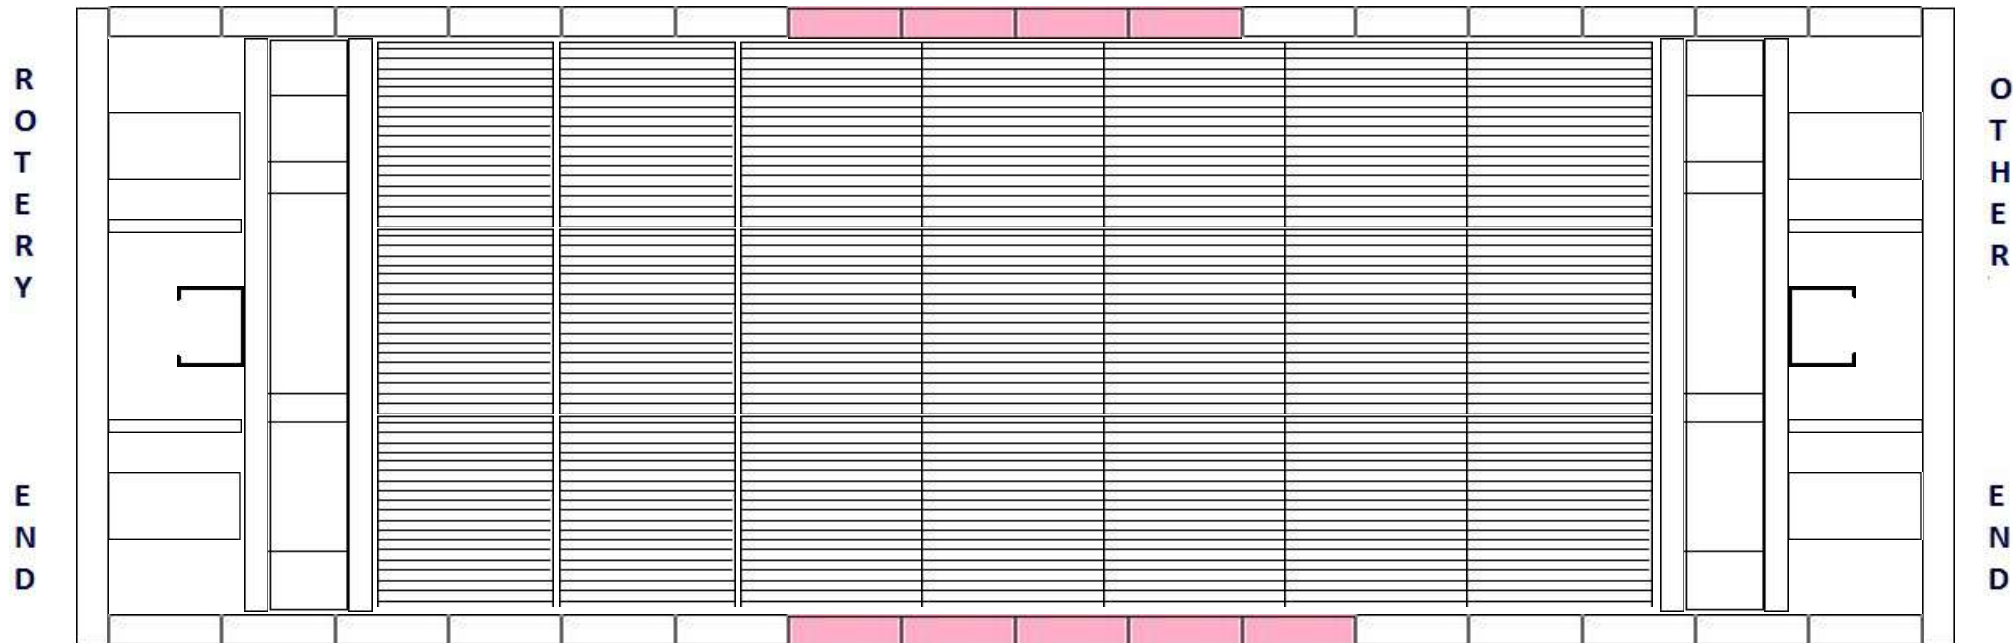
Color	Particulars	Qty	Per%	Color	Particulars	Qty	Per%	Color	Particulars	Qty	Per%
	Headstock Beam	0	0%		Centre Stiffner for Headstock	0	0%		Floor Stiffner for Headstock	0	0%
	Aux. Head stock	0	0%		Sole Bar	4.5	28%		Draft Gear Bracket	0	0%
	Trough floor	0	0%		Centre plate	0	0%		SoleBar Stiffner	4	100%
	Bottom Wall Part	4.5	28%		Body panel/patch		0%		Door Top/Roof Patch		100%
	Window Module		0%		Window Sill	0	0%		Window Bar	0	0%
	Seat pillar/lav. Partition		100%		UIC end construction		0%

End Drooping: Rotary End - EAST : 0, WEST : 0 Other End - EAST : 0, WEST : 0
Start Date : 10-Jan-2020, Completion Date : 20-Jan-2020, Net Repair Days : 9, Total Man Hours : 0

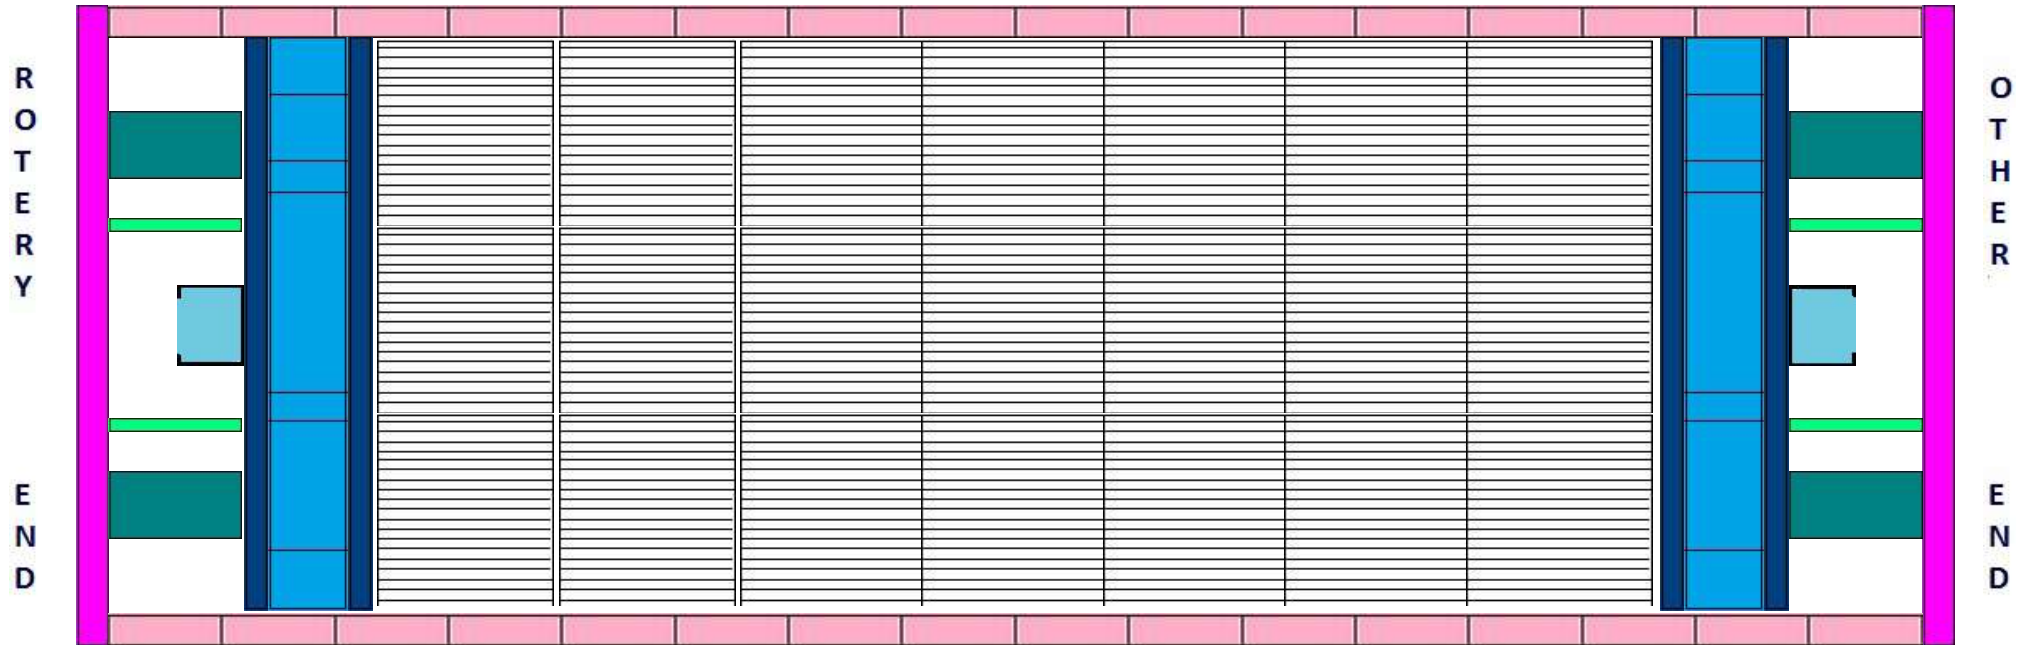
Rotary Side

Color	Particulars	Qty	Per%	Color	Particulars	Qty	Per%	Color	Particulars	Qty	Per%
Blue	Headstock Beam	2	100%	Green	Centre Stiffner for Headstock	4	100%	Yellow	Floor Stiffner for Headstock	4	100%
Dark Blue	Aux. Head stock	4	100%	Pink	Sole Bar	16	100%	Light Blue	Draft Gear Bracket	2	100%
Yellow	Trough floor	0	0%	Light Blue	Centre plate	2	100%		SoleBar Stiffner	6	100%
	Bottom Wall Part	16	100%		Body panel/patch		100%		Door Top/Roof Patch		0%
	Window Module		0%		Window Sill	28	70%		Window Bar	52	29%
	Seat pillar/lav. Partition		100%		UIC end construction		0%

End Drooping: Rotary End - EAST : -8, WEST : -6 Other End - EAST : -6, WEST : -8
Start Date : 04-Apr-2019, Completion Date : 11-Apr-2019, Net Repair Days : 7, Total Man Hours : 1500

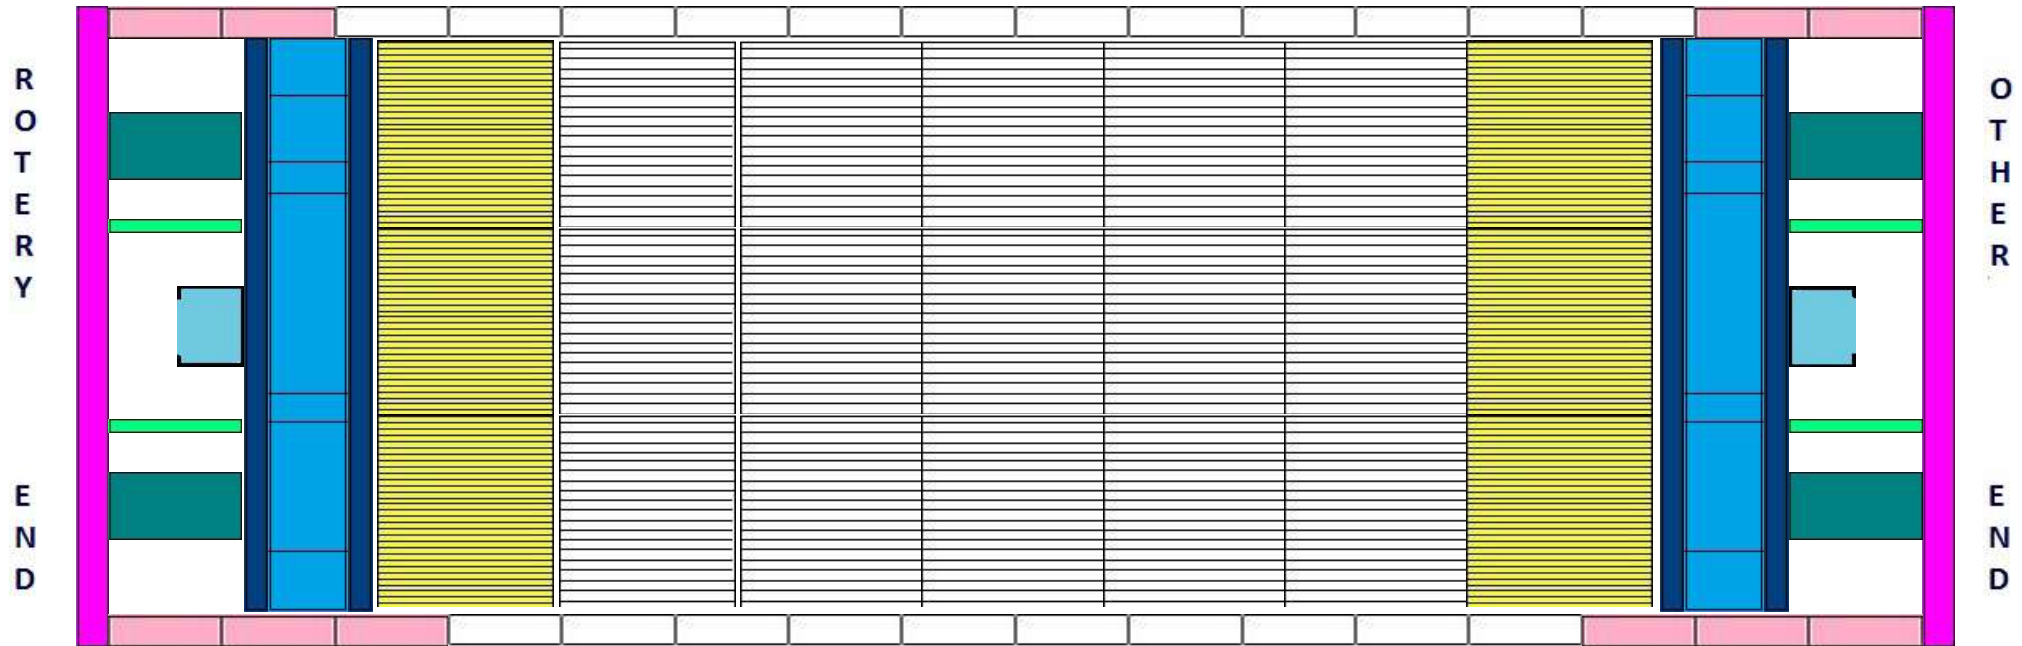
Rotary Side

Color	Particulars	Qty	Per%	Color	Particulars	Qty	Per%	Color	Particulars	Qty	Per%
Blue	Headstock Beam	2	100%	Green	Centre Stiffner for Headstock	4	100%	Red	Floor Stiffner for Headstock	4	100%
Black	Aux. Head stock	4	100%	Yellow	Sole Bar	5	31%	Grey	Draft Gear Bracket	2	100%
Orange	Trough floor	2	29%	Light Blue	Centre plate	2	100%		SoleBar Stiffner	4	67%
	Bottom Wall Part	5	31%		Body panel/patch		100%		Door Top/Roof Patch		0%
	Window Module		0%		Window Sill	32	80%		Window Bar	52	29%
	Seat pillar/lav. Partition		100%		UIC end construction		0%

End Drooping: Rotary End - EAST : 6, WEST : 6 Other End - EAST : 5, WEST : 5
Start Date : 10-Apr-2019, Completion Date : 18-Apr-2019, Net Repair Days : 8, Total Man Hours : 1168

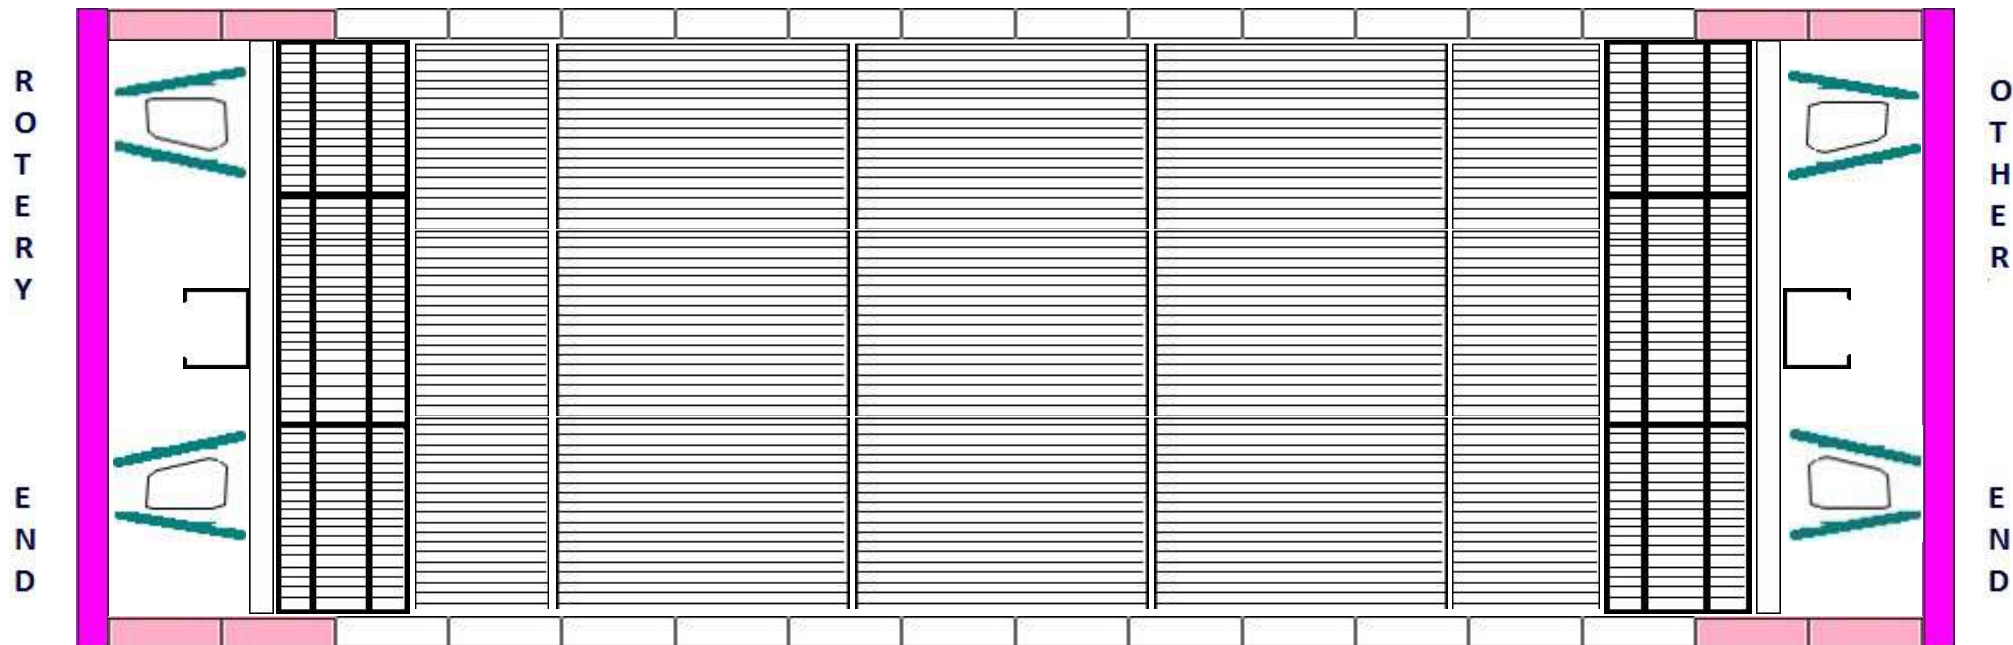
Color	Particulars	Qty	Per%	Color	Particulars	Qty	Per%	Color	Particulars	Qty	Per%
	Headstock Beam	0	0%		Diagonal	4	100%		Logitudinal Channel Structure	0	0%
	Aux. Head stock	0	0%		Sole Bar	4	25%		Draft Gear Bracket	0	0%
	Trough floor	0	0%		Bottom Wall Part	4	25%		Body panel/patch		100%
	Door Top/Roof Patch		0%		Seat Bracket Rail		0%		Window Sill	4	10%
	Window Bar	10	5%		Seat pillar/lav. Partition		100%		UIC end construction		0%
	Body Pillar Part	22	100%

End Drooping: Rotary End - EAST : -8, WEST : -5 Other End - EAST : -4, WEST : -7
Start Date : 08-May-2019, Completion Date : 15-May-2019, Net Repair Days : 7, Total Man Hours : 568

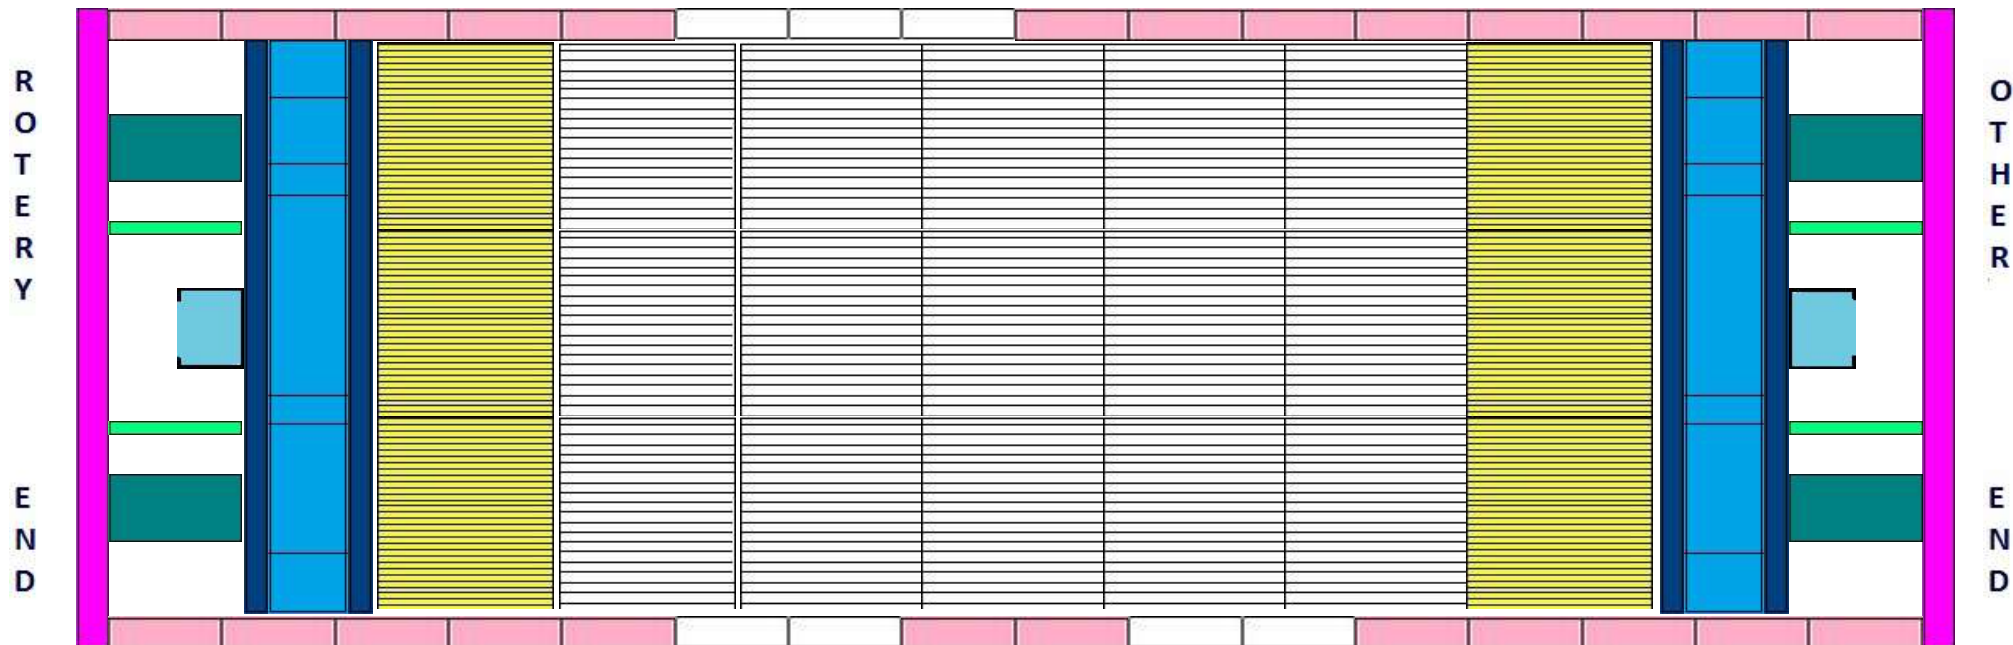
Color	Particulars	Qty	Per%	Color	Particulars	Qty	Per%	Color	Particulars	Qty	Per%
Yellow	Headstock Beam	2	100%	Dark Green	Centre Stiffner for Headstock	4	100%	Light Green	Floor Stiffner for Headstock	4	100%
Dark Blue	Aux. Head stock	4	100%	Pink	Sole Bar	12.5	78%	Light Blue	Draft Gear Bracket	2	100%
Yellow	Trough floor	2	29%	Light Blue	Centre plate	2	100%		SoleBar Stiffner	4	100%
	Bottom Wall Part	12.5	78%		Body panel/patch		100%		Door Top/Roof Patch		0%
	Window Module		0%		Window Sill	14	35%		Window Bar	48	27%
	Seat pillar/lav. Partition		100%		UIC end construction		0%

End Drooping: Rotary End - EAST : -2, WEST : -3 Other End - EAST : 6, WEST : -2
Start Date : 31-Dec-2019, Completion Date : 09-Jan-2020, Net Repair Days : 9, Total Man Hours : 945
