Coach Rehabilitation Workshop, WC Railway, Bhopal

(An IMS and ISO 50001 Certified Workshop)
Final Inspection Sheet - Details of Corrosion Repair

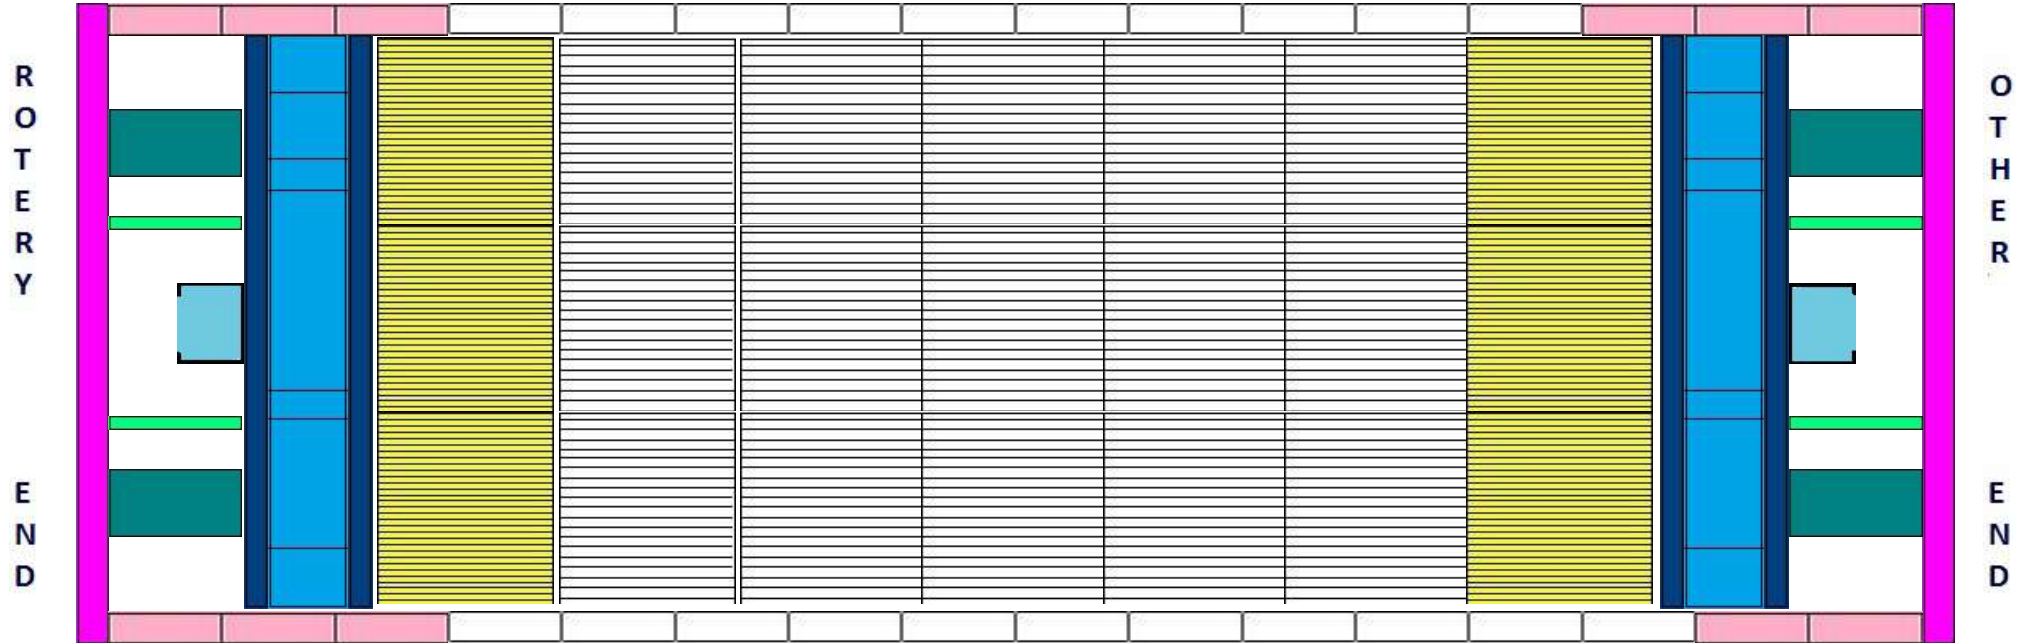
Rotary Side

Color	Particulars	Qty	Per%	Color	Particulars	Qty	Per%	Color	Particulars	Qty	Per%
 	Headstock Beam	2	100%	 	Centre Stiffner for Headstock	4	100%	 	Floor Stiffner for Headstock	4	100%
 	Aux. Head stock	4	100%	 	Sole Bar	5.5	34%	 	Draft Gear Bracket	2	100%
 	Trough floor	2	29%	 	Centre plate	2	100%		SoleBar Stiffner	4	100%
	Bottom Wall Part	5.5	34%		Body panel/patch		100%		Door Top/Roof Patch		100%
	Window Module		2%		Window Sill	0	0%		Window Bar	0	0%
	Seat pillar/lav. Partition		100%		UIC end construction		0%

End Drooping: Rotary End - EAST : -10, WEST : -8 Other End - EAST : 6, WEST : 4
Start Date : 11-Jul-2019, Completion Date : 17-Jul-2019, Net Repair Days : 6, Total Man Hours : 1242

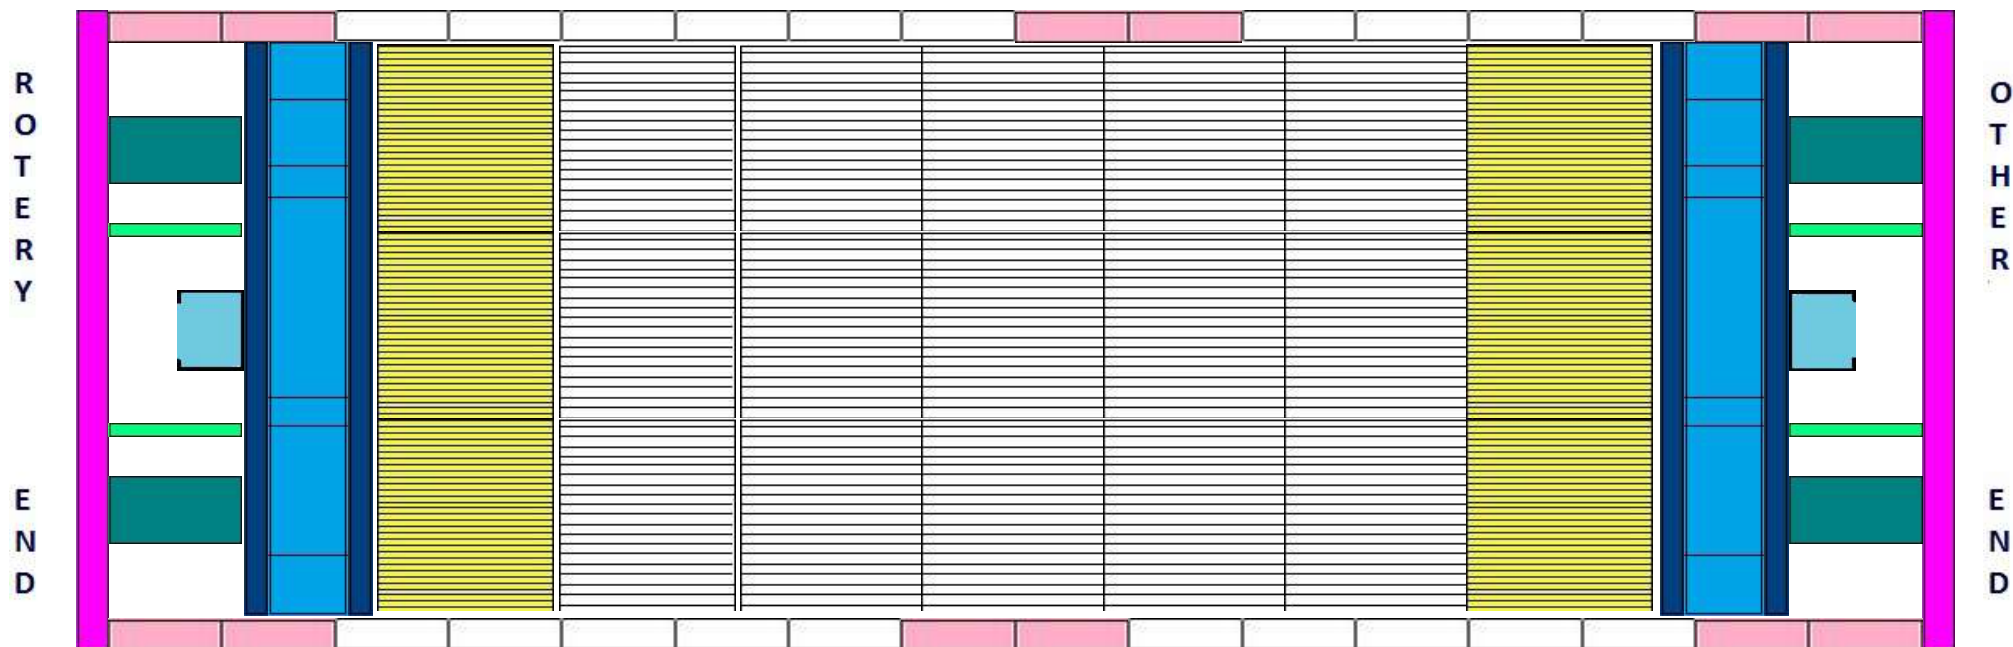
Rotary Side

Color	Particulars	Qty	Per%	Color	Particulars	Qty	Per%	Color	Particulars	Qty	Per%
	Headstock Beam	2	100%		Centre Stiffner for Headstock	4	100%		Floor Stiffner for Headstock	4	100%
	Aux. Head stock	4	100%		Sole Bar	6	38%		Draft Gear Bracket	2	100%
	Trough floor	2	29%		Centre plate	2	100%		SoleBar Stiffner	6	100%
	Bottom Wall Part	6	38%		Body panel/patch		100%		Door Top/Roof Patch		0%
	Window Module		0%		Window Sill	40	100%		Window Bar	48	27%
	Seat pillar/lav. Partition		100%		UIC end construction		0%

End Drooping: Rotary End - EAST : 3, WEST : 4 Other End - EAST : -2, WEST : -3
Start Date : 22-Aug-2019, Completion Date : 27-Aug-2019, Net Repair Days : 5, Total Man Hours : 1358

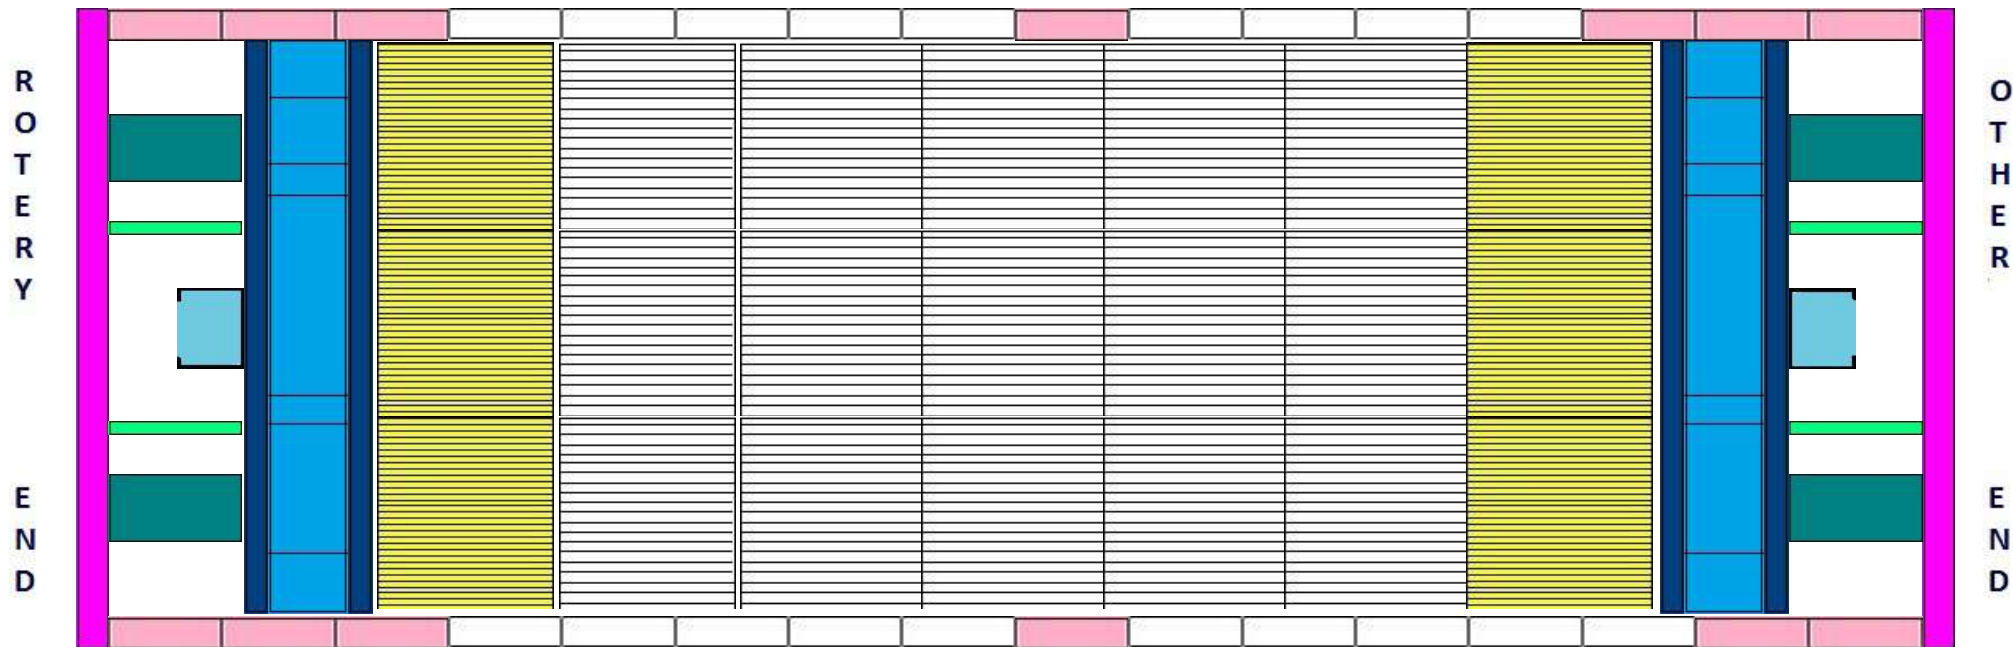
Color	Particulars	Qty	Per%	Color	Particulars	Qty	Per%	Color	Particulars	Qty	Per%
Yellow	Headstock Beam	2	100%	Dark Green	Centre Stiffner for Headstock	4	100%	Light Green	Floor Stiffner for Headstock	4	100%
Dark Blue	Aux. Head stock	4	100%	Pink	Sole Bar	7.5	47%	Light Blue	Draft Gear Bracket	2	100%
Yellow	Trough floor	2	29%	Light Blue	Centre plate	2	100%		SoleBar Stiffner	6	100%
	Bottom Wall Part	7.5	47%		Body panel/patch		100%		Door Top/Roof Patch		0%
	Window Module		0%		Window Sill	14	29%		Window Bar	46	25%
	Seat pillar/lav. Partition		100%		UIC end construction		0%

End Drooping: Rotary End - EAST : 0, WEST : -3 Other End - EAST : -3, WEST : 0

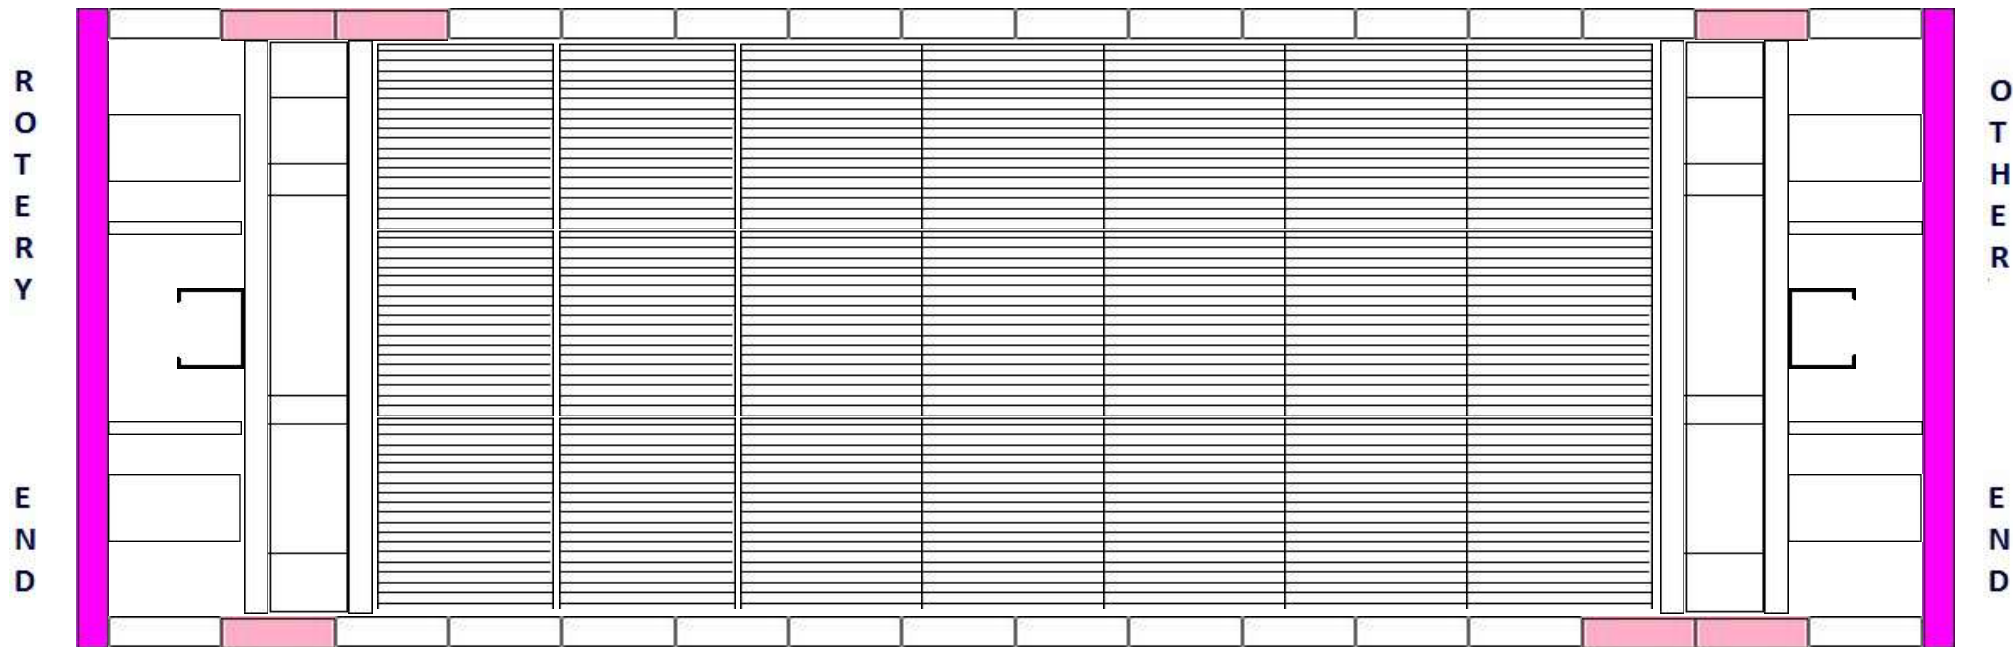
Rotary Side

Color	Particulars	Qty	Per%	Color	Particulars	Qty	Per%	Color	Particulars	Qty	Per%
	Headstock Beam	0	0%		Centre Stiffner for Headstock	0	0%		Floor Stiffner for Headstock	0	0%
	Aux. Head stock	0	0%		Sole Bar	3	19%		Draft Gear Bracket	0	0%
	Trough floor	0	0%		Centre plate	0	0%		SoleBar Stiffner	4	100%
	Bottom Wall Part	3	19%		Body panel/patch		100%		Door Top/Roof Patch		100%
	Window Module		0%		Window Sill	0	0%		Window Bar	0	0%
	Seat pillar/lav. Partition		100%		UIC end construction		0%

End Drooping: Rotary End - EAST : -4, WEST : 0 Other End - EAST : -3, WEST : 0
Start Date : 19-Jun-2019, Completion Date : 25-Jun-2019, Net Repair Days : 6, Total Man Hours : 988

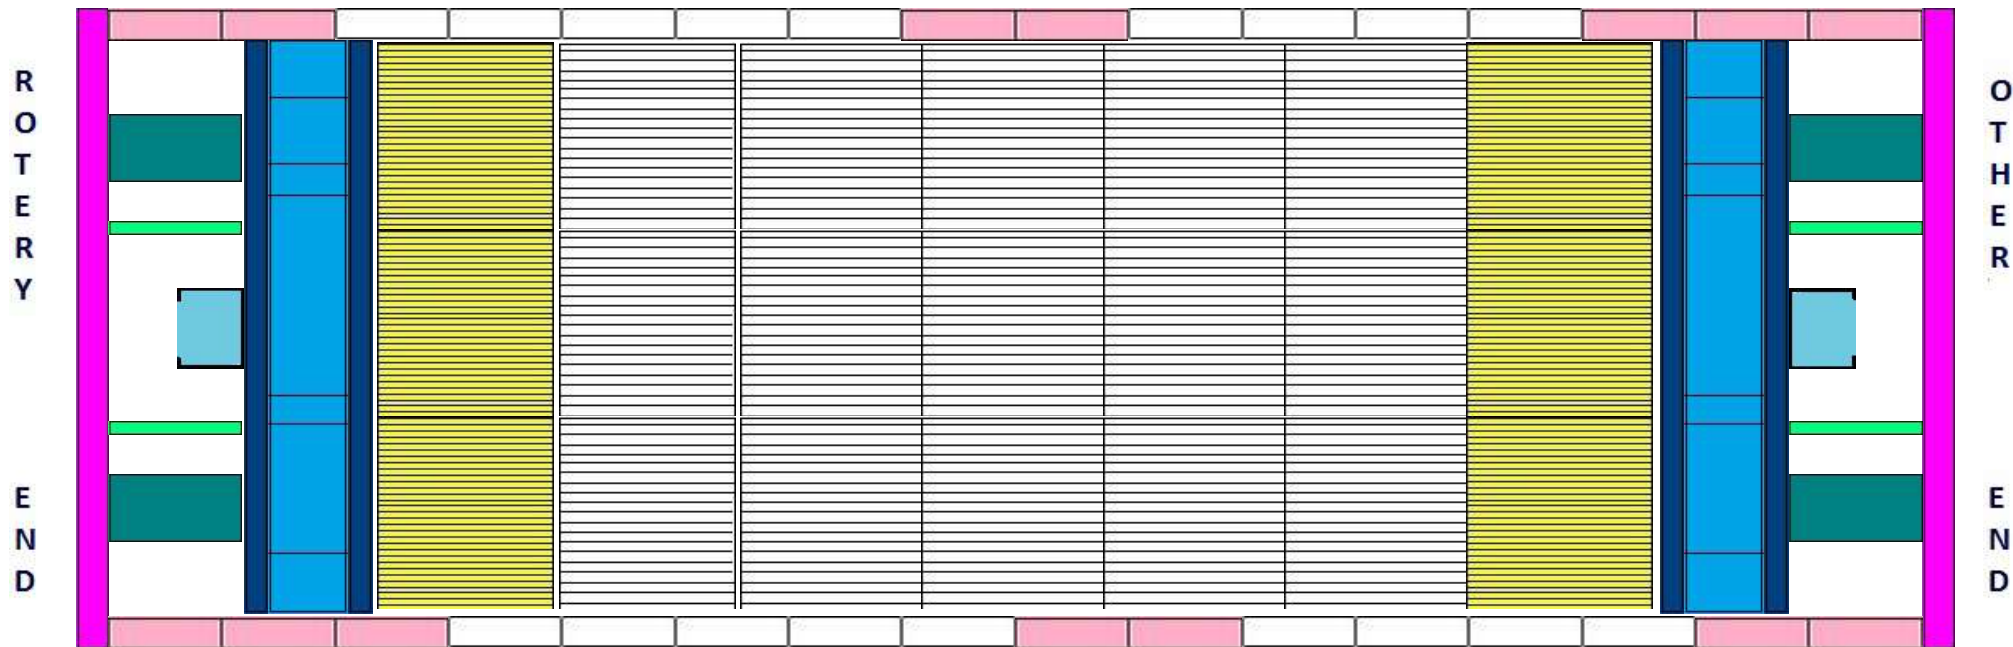
Rotary Side

Color	Particulars	Qty	Per%	Color	Particulars	Qty	Per%	Color	Particulars	Qty	Per%
Pink	Headstock Beam	2	100%	Dark Green	Centre Stiffner for Headstock	4	100%	Light Green	Floor Stiffner for Headstock	4	100%
Dark Blue	Aux. Head stock	4	100%	Light Blue	Sole Bar	7	44%	Light Blue	Draft Gear Bracket	2	100%
Yellow	Trough floor	2	29%	Light Blue	Centre plate	2	100%		SoleBar Stiffner	6	100%
	Bottom Wall Part	7	44%		Body panel/patch		100%		Door Top/Roof Patch		0%
	Window Module		0%		Window Sill	18	45%		Window Bar	44	25%
	Seat pillar/lav. Partition		100%		UIC end construction		0%

End Drooping: Rotary End - EAST : -6, WEST : 0 Other End - EAST : -2, WEST : -8
Start Date : 26-Jun-2019, Completion Date : 04-Jul-2019, Net Repair Days : 8, Total Man Hours : 1296

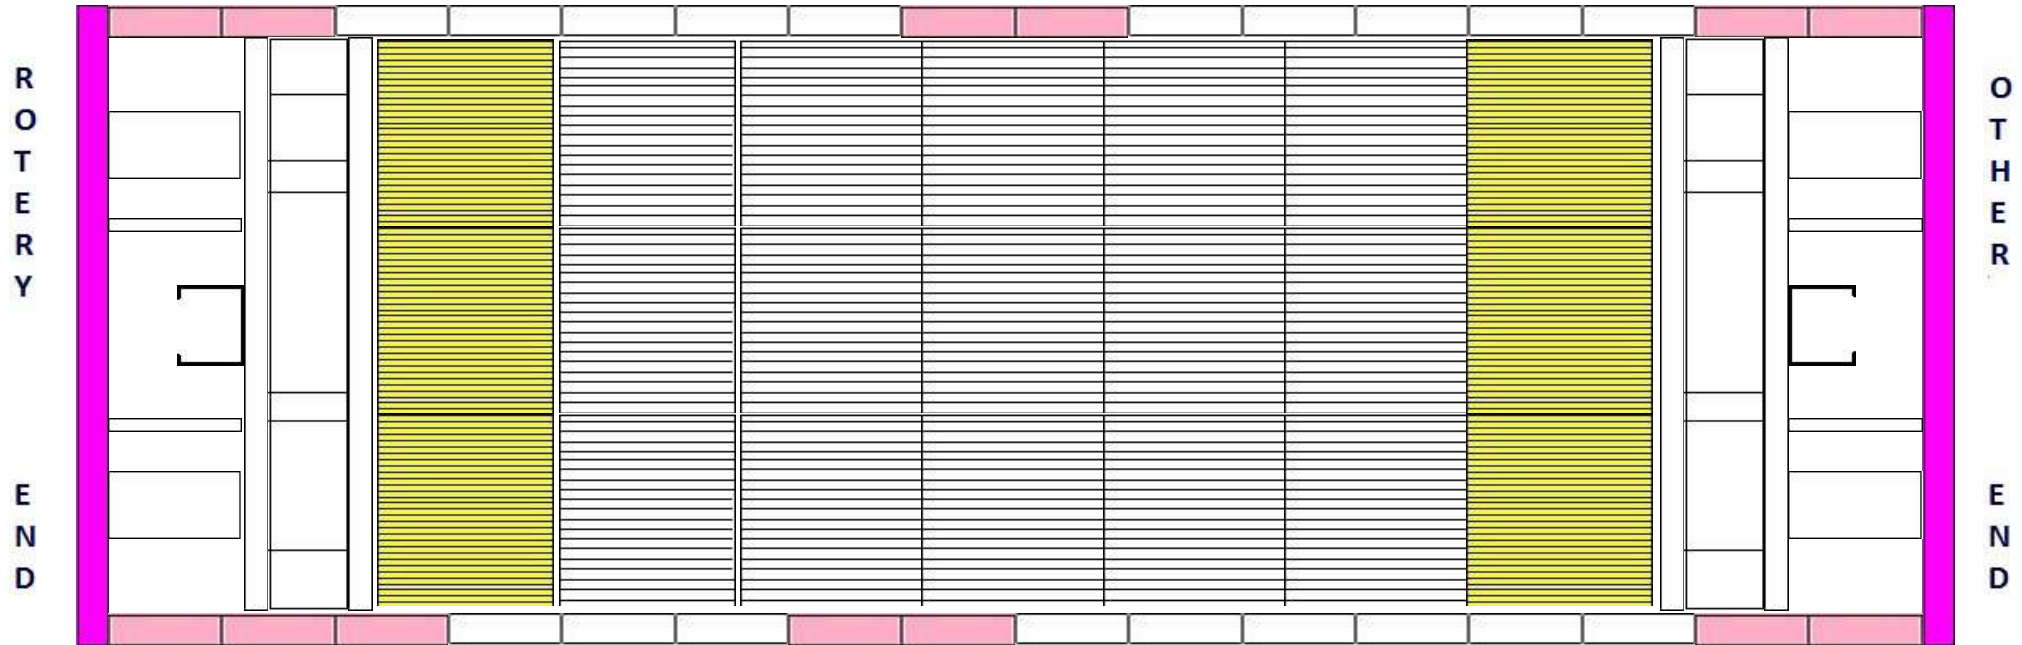
Rotary Side

Color	Particulars	Qty	Per%	Color	Particulars	Qty	Per%	Color	Particulars	Qty	Per%
	Headstock Beam	0	0%		Centre Stiffner for Headstock	0	0%		Floor Stiffner for Headstock	0	0%
	Aux. Head stock	0	0%		Sole Bar	6.5	41%		Draft Gear Bracket	0	0%
	Trough floor	2	29%		Centre plate	0	0%		SoleBar Stiffner	6	100%
	Bottom Wall Part	6.5	41%		Body panel/patch		100%		Door Top/Roof Patch		0%
	Window Module		0%		Window Sill	40	100%		Window Bar	44	25%
	Seat pillar/lav. Partition		100%		UIC end construction		0%

End Drooping: Rotary End - EAST : -5, WEST : 3 Other End - EAST : -8, WEST : -5
Start Date : 13-May-2019, Completion Date : 21-May-2019, Net Repair Days : 8, Total Man Hours : 904

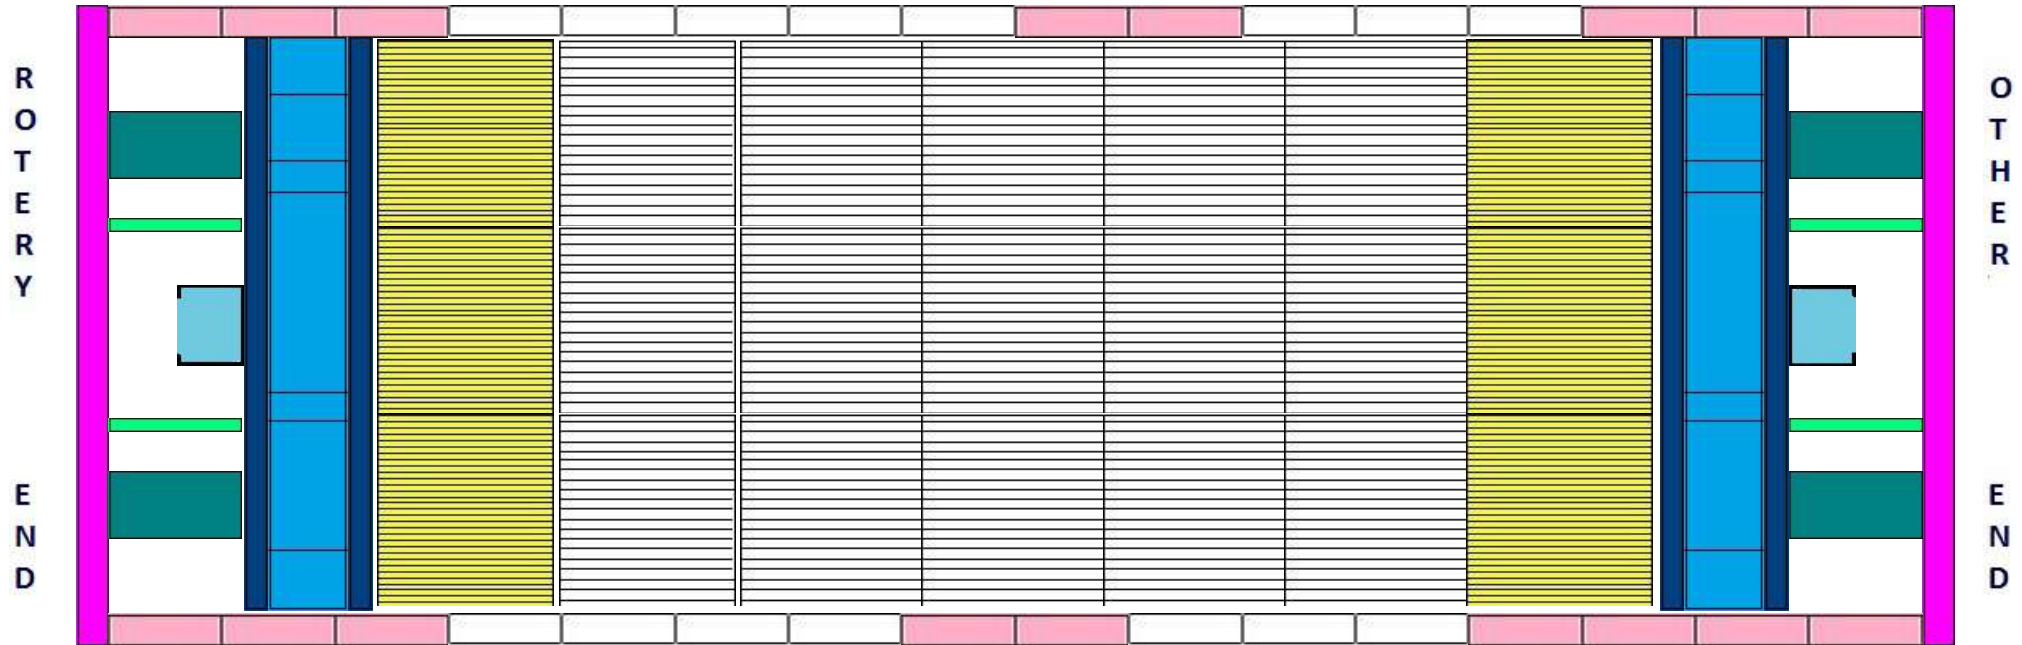
Rotary Side

Color	Particulars	Qty	Per%	Color	Particulars	Qty	Per%	Color	Particulars	Qty	Per%
	Headstock Beam	2	100%		Centre Stiffner for Headstock	4	100%		Floor Stiffner for Headstock	4	100%
	Aux. Head stock	4	100%		Sole Bar	8.5	53%		Draft Gear Bracket	2	100%
	Trough floor	2	29%		Centre plate	2	100%		SoleBar Stiffner	6	100%
	Bottom Wall Part	8.5	53%		Body panel/patch		100%		Door Top/Roof Patch		0%
	Window Module		0%		Window Sill	18	45%		Window Bar	40	22%
	Seat pillar/lav. Partition		100%		UIC end construction		0%

End Drooping: Rotary End - EAST : -10, WEST : -7 Other End - EAST : 0, WEST : 5
Start Date : 08-Apr-2019, Completion Date : 13-Apr-2019, Net Repair Days : 6, Total Man Hours : 1162

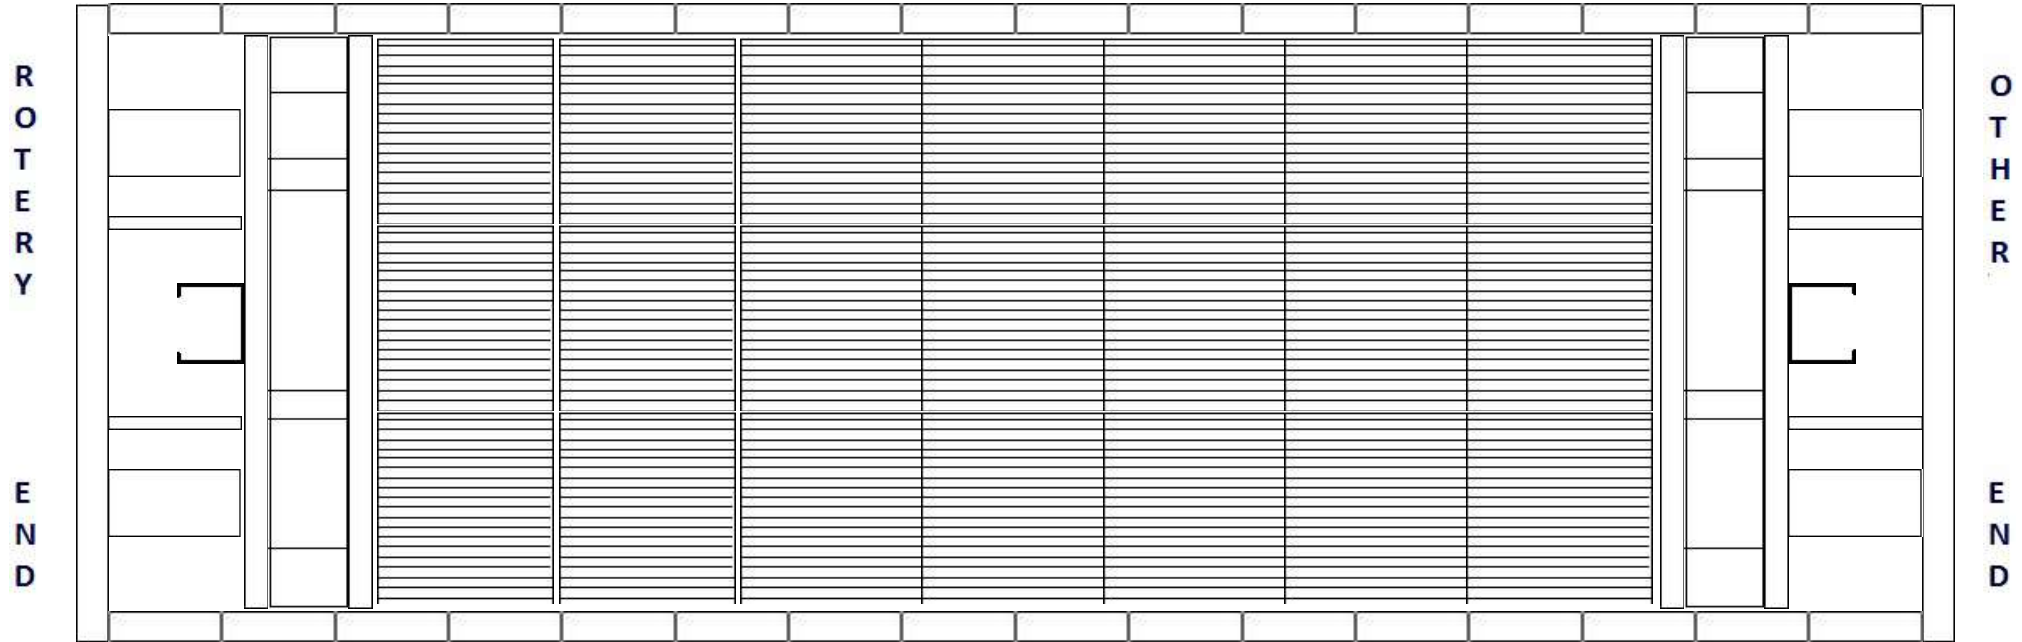
Color	Particulars	Qty	Per%	Color	Particulars	Qty	Per%	Color	Particulars	Qty	Per%
	Headstock Beam	0	0%		Centre Stiffner for Headstock	0	0%		Floor Stiffner for Headstock	0	0%
	Aux. Head stock	0	0%		Sole Bar	0	0%		Draft Gear Bracket	0	0%
	Trough floor	0	0%		Centre plate	0	0%		SoleBar Stiffner	4	100%
	Bottom Wall Part	0	0%		Body panel/patch		0%		Door Top/Roof Patch		100%
	Window Module		0%		Window Sill	0	0%		Window Bar	0	0%
	Seat pillar/lav. Partition		100%		UIC end construction		0%

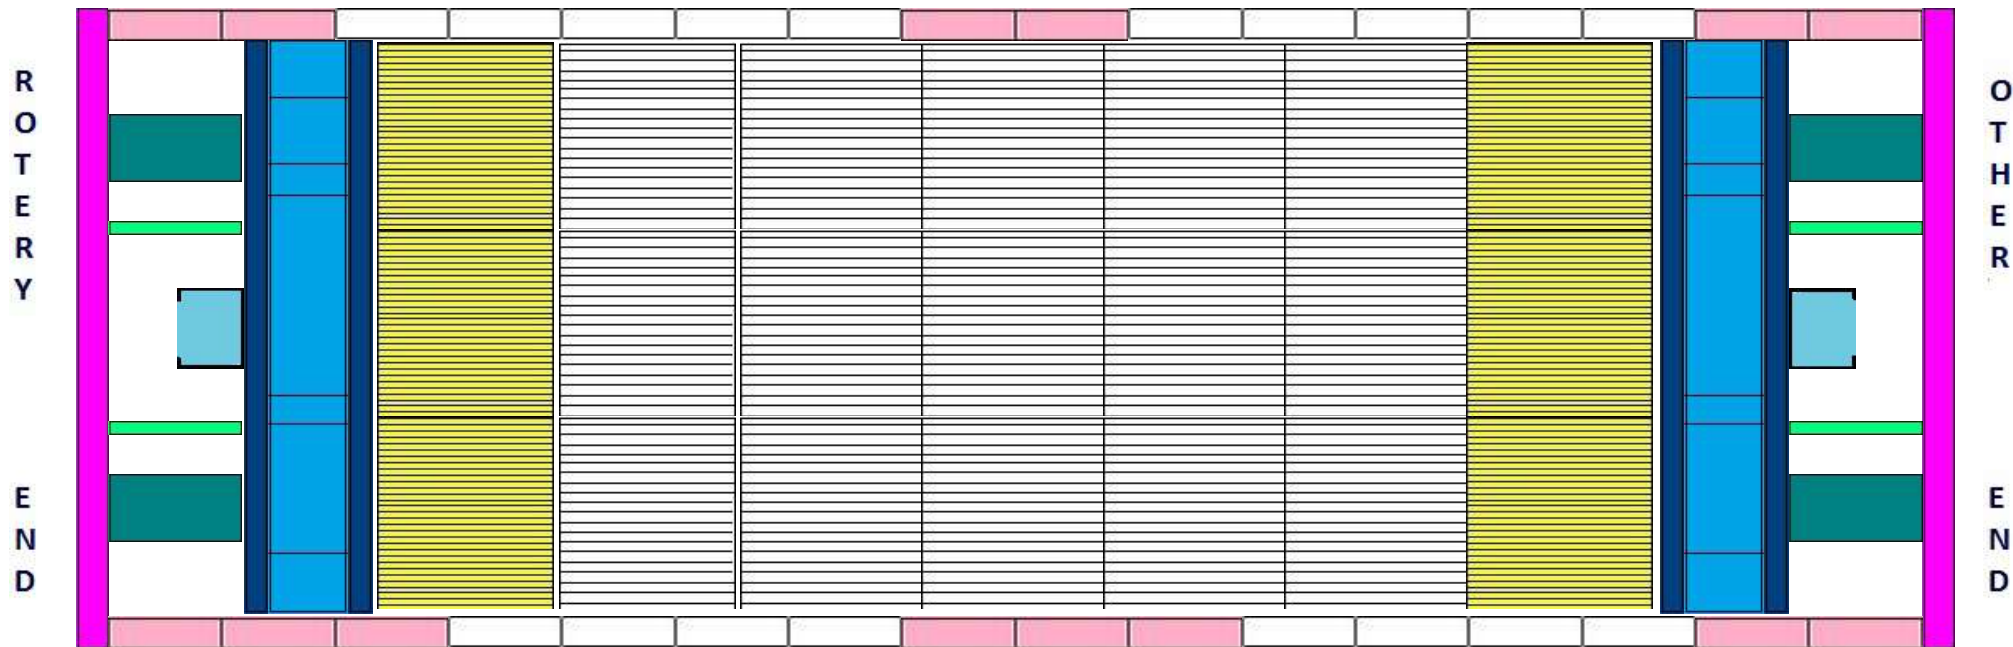
Rotary Side

End Drooping: Rotary End - EAST : 0, WEST : 3 Other End - EAST : 2, WEST : 6
Start Date : 09-May-2019, Completion Date : 20-May-2019, Net Repair Days : 10, Total Man Hours : 0

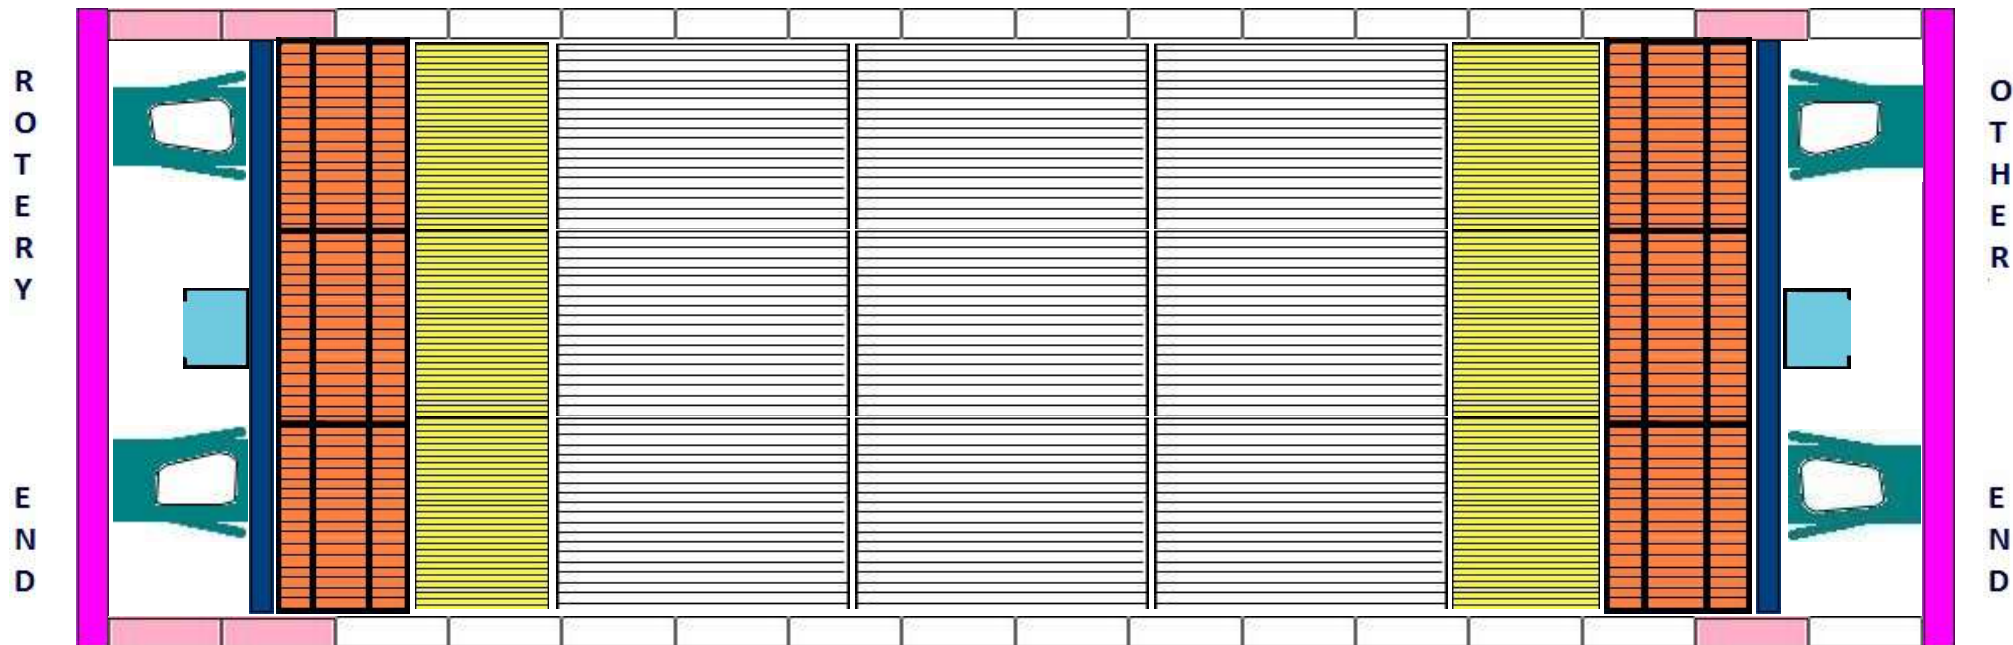
Color	Particulars	Qty	Per%	Color	Particulars	Qty	Per%	Color	Particulars	Qty	Per%
	Headstock Beam	2	100%		Diagonal	4	100%		Logitudinal Channel Structure	2	100%
	Aux. Head stock	2	100%		Sole Bar	3	19%		Draft Gear Bracket	2	100%
	Trough floor	2	40%		Bottom Wall Part	3	19%		Body panel/patch		0%
	Door Top/Roof Patch		100%		Seat Bracket Rail		0%		Window Sill	0	0%
	Window Bar	6	3%		Seat pillar/lav. Partition		100%		UIC end construction		0%
	Body Pillar Part	17	100%

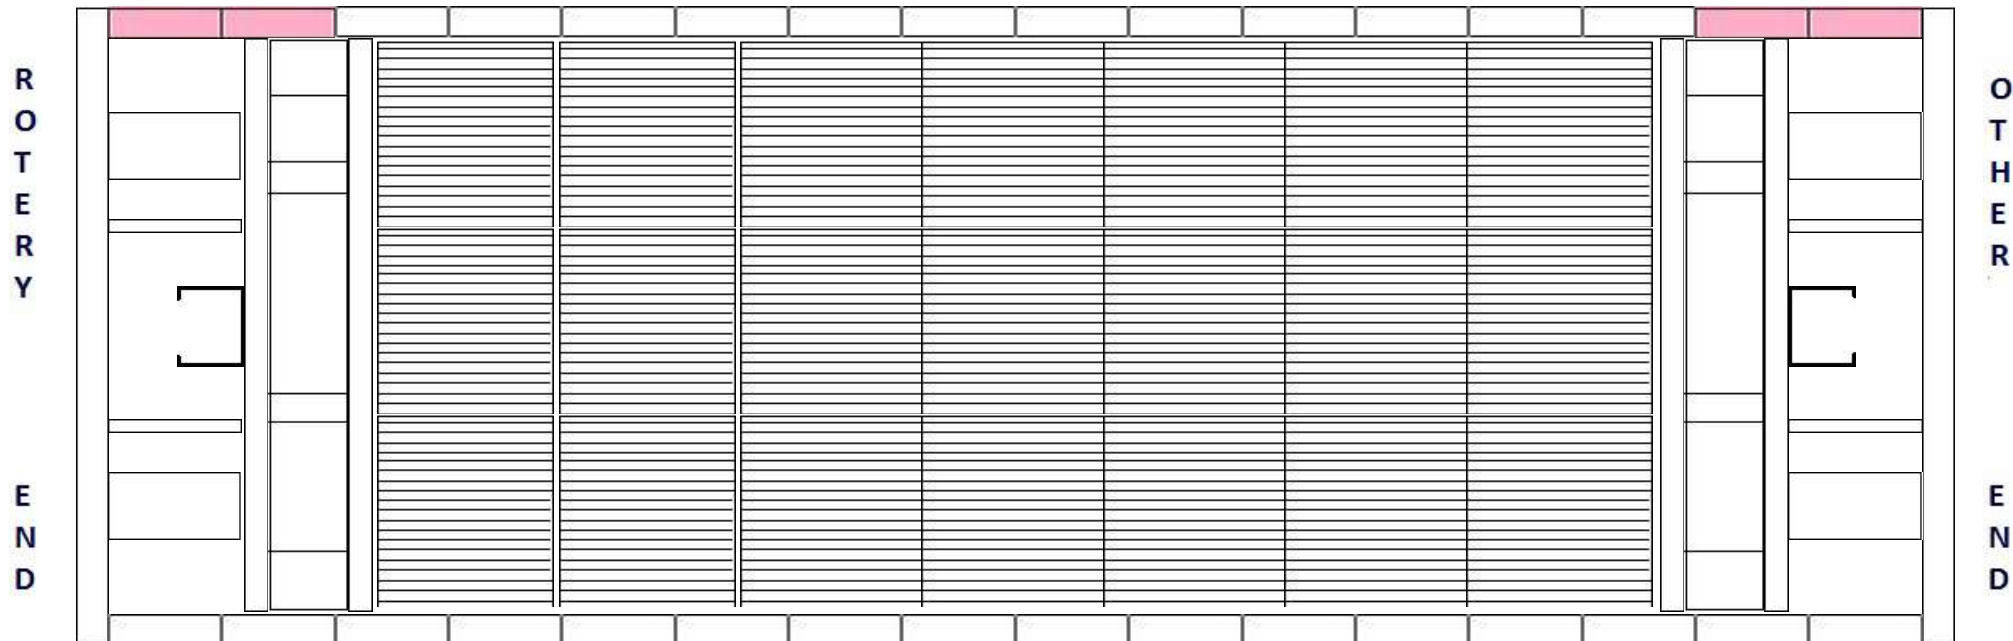
Color	Particulars	Qty	Per%	Color	Particulars	Qty	Per%	Color	Particulars	Qty	Per%
	Headstock Beam	0	0%		Centre Stiffner for Headstock	0	0%		Floor Stiffner for Headstock	0	0%
	Aux. Head stock	0	0%		Sole Bar	2	13%		Draft Gear Bracket	0	0%
	Trough floor	0	0%		Centre plate	0	0%		SoleBar Stiffner	4	100%
	Bottom Wall Part	2	13%		Body panel/patch		30%		Door Top/Roof Patch		100%
	Window Module		0%		Window Sill	0	0%		Window Bar	0	0%
	Seat pillar/lav. Partition		100%		UIC end construction		0%

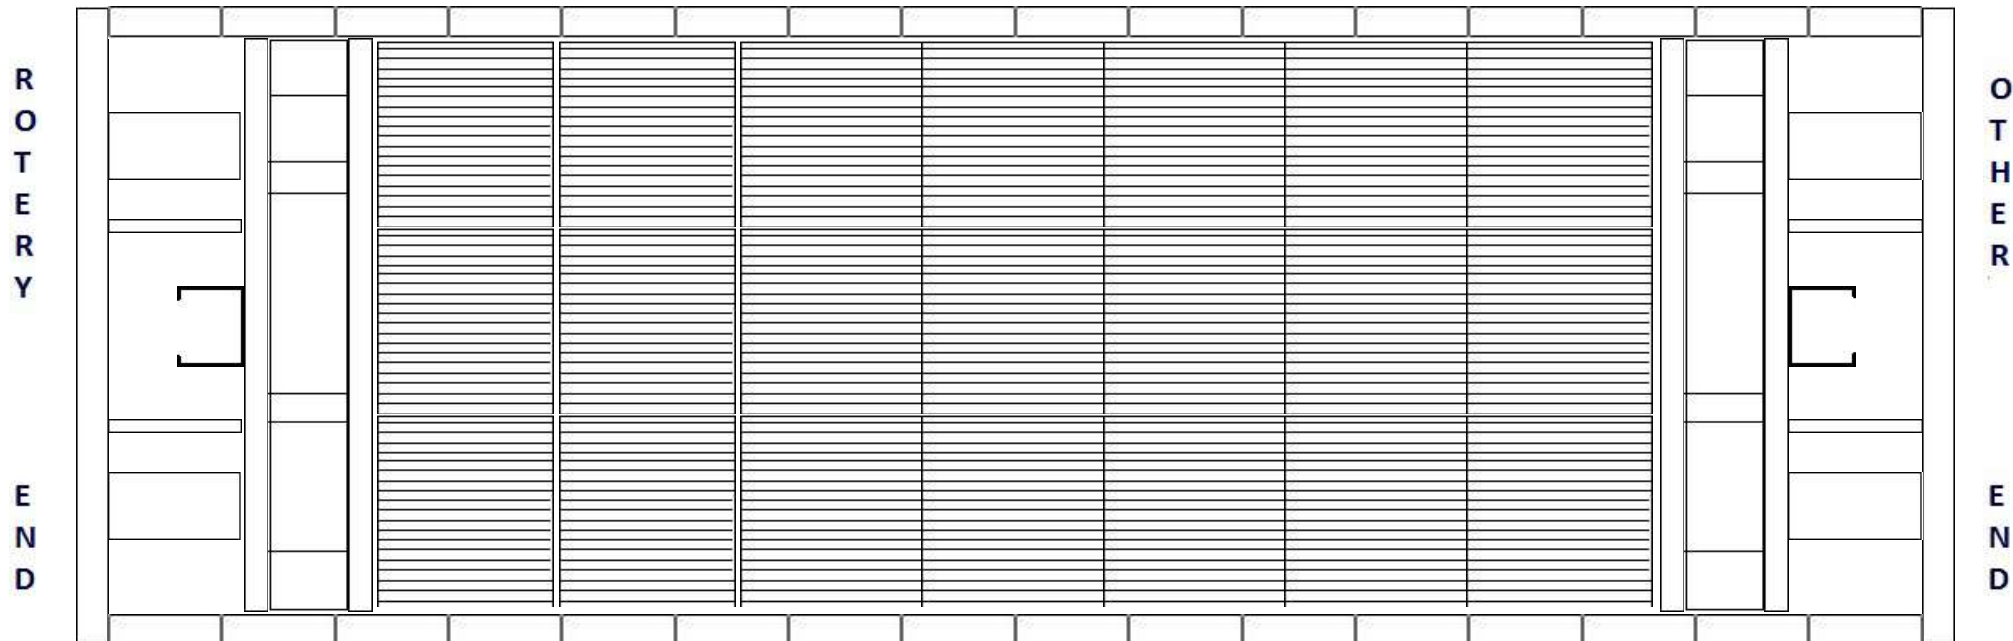
Color	Particulars	Qty	Per%	Color	Particulars	Qty	Per%	Color	Particulars	Qty	Per%
	Headstock Beam	0	0%		Centre Stiffner for Headstock	0	0%		Floor Stiffner for Headstock	0	0%
	Aux. Head stock	0	0%		Sole Bar	0	0%		Draft Gear Bracket	0	0%
	Trough floor	0	0%		Centre plate	0	0%		SoleBar Stiffner	4	100%
	Bottom Wall Part	0	0%		Body panel/patch		0%		Door Top/Roof Patch		0%
	Window Module		0%		Window Sill	0	0%		Window Bar	0	0%
	Seat pillar/lav. Partition		100%		UIC end construction		0%

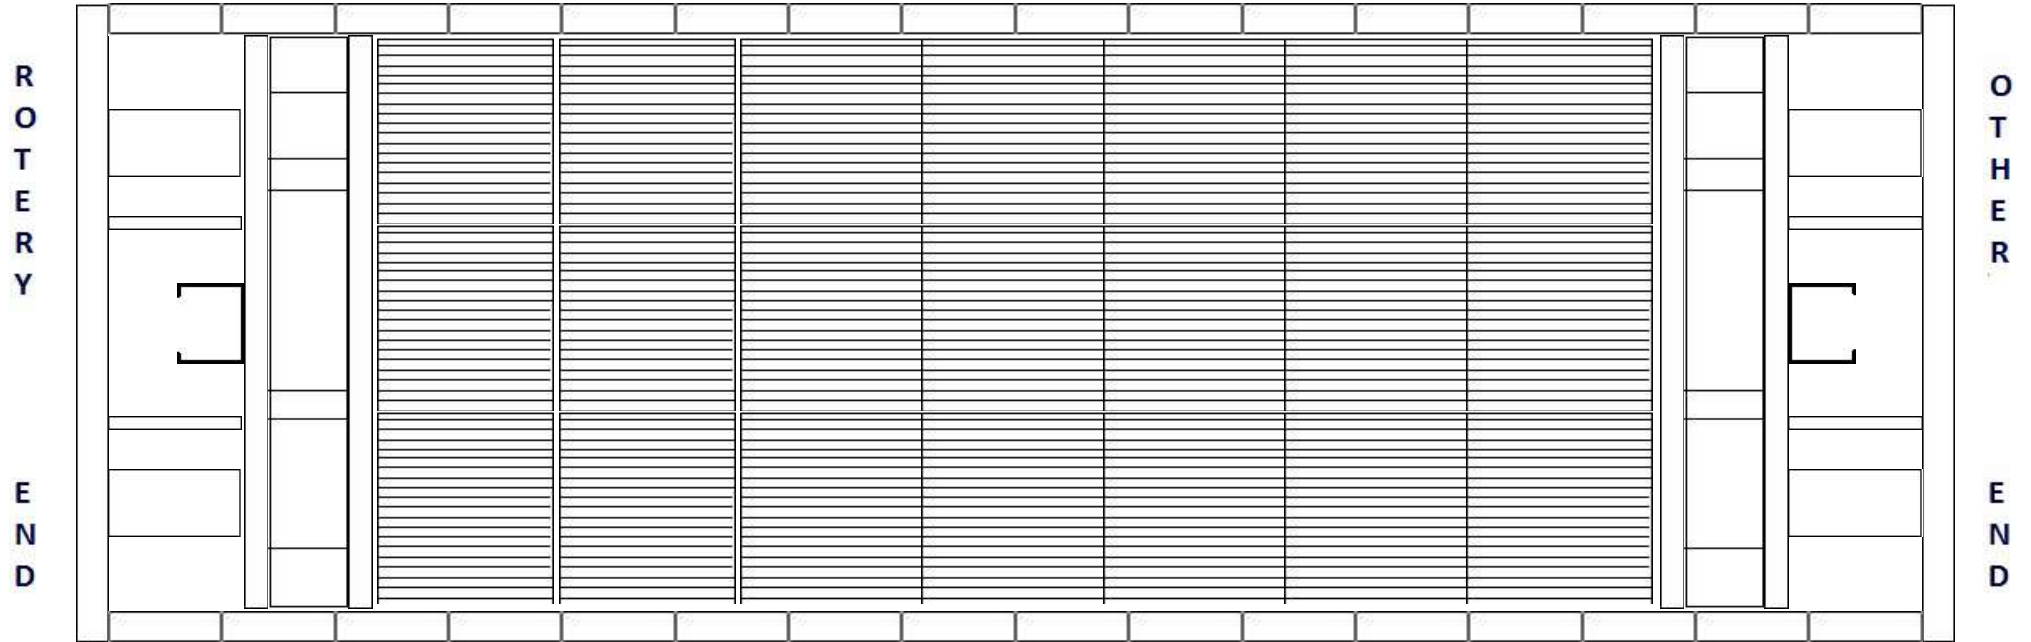
Color	Particulars	Qty	Per%	Color	Particulars	Qty	Per%	Color	Particulars	Qty	Per%
	Headstock Beam	0	0%		Centre Stiffner for Headstock	0	0%		Floor Stiffner for Headstock	0	0%
	Aux. Head stock	0	0%		Sole Bar	0	0%		Draft Gear Bracket	0	0%
	Trough floor	0	0%		Centre plate	0	0%		SoleBar Stiffner	4	100%
	Bottom Wall Part	0	0%		Body panel/patch		25%		Door Top/Roof Patch		0%
	Window Module		0%		Window Sill	0	0%		Window Bar	0	0%
	Seat pillar/lav. Partition		100%		UIC end construction		0%

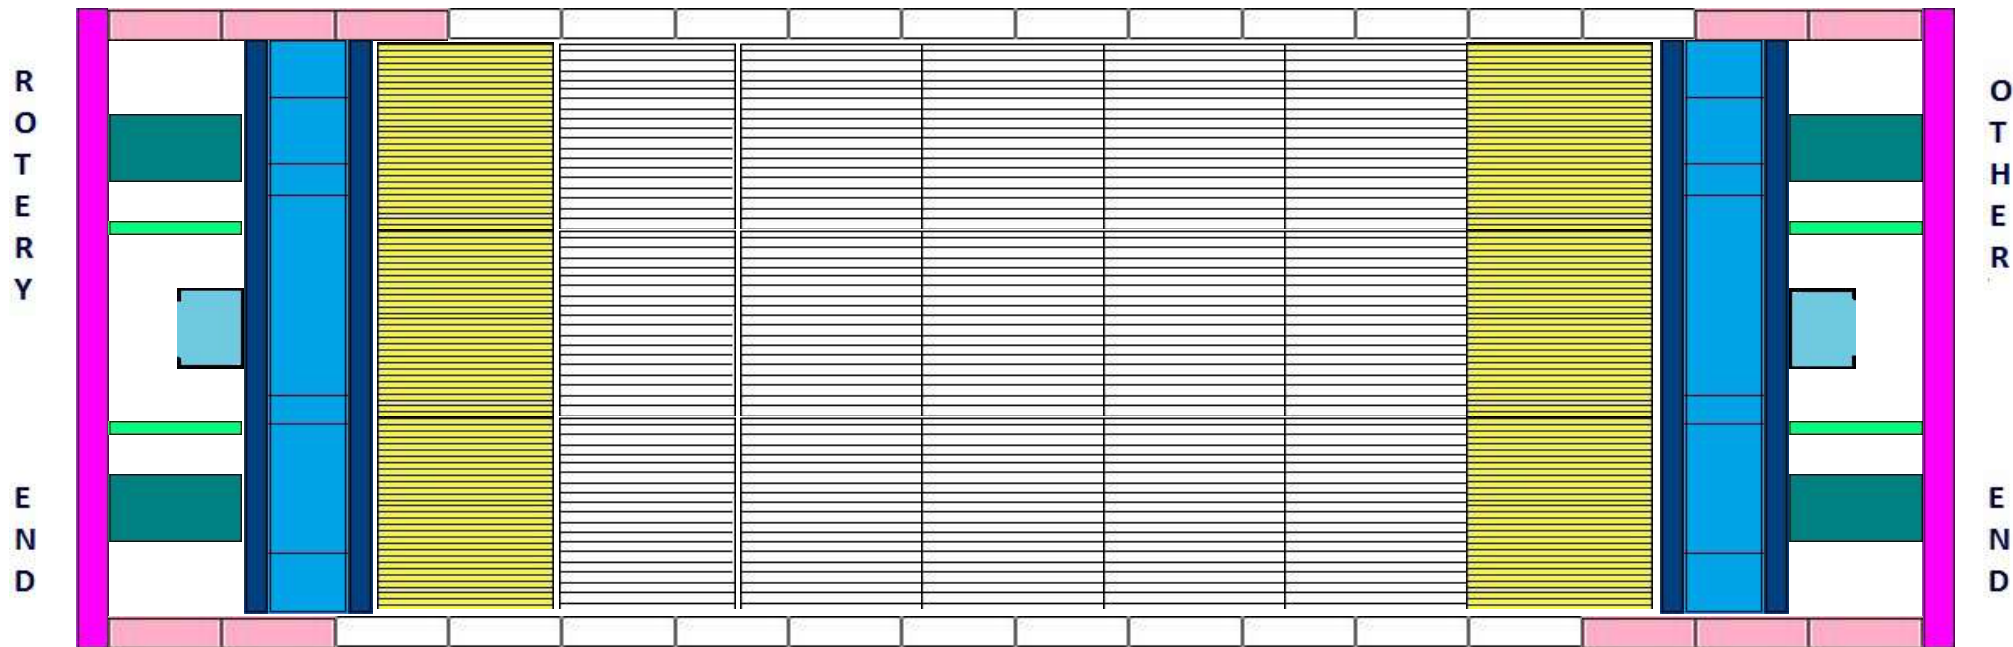
Color	Particulars	Qty	Per%	Color	Particulars	Qty	Per%	Color	Particulars	Qty	Per%
	Headstock Beam	2	100%		Centre Stiffner for Headstock	4	100%		Floor Stiffner for Headstock	4	100%
	Aux. Head stock	4	100%		Sole Bar	5	31%		Draft Gear Bracket	2	100%
	Trough floor	2	29%		Centre plate	2	100%		SoleBar Stiffner	4	100%
	Bottom Wall Part	5	31%		Body panel/patch		100%		Door Top/Roof Patch		0%
	Window Module		0%		Window Sill	14	35%		Window Bar	78	42%
	Seat pillar/lav. Partition		100%		UIC end construction		0%

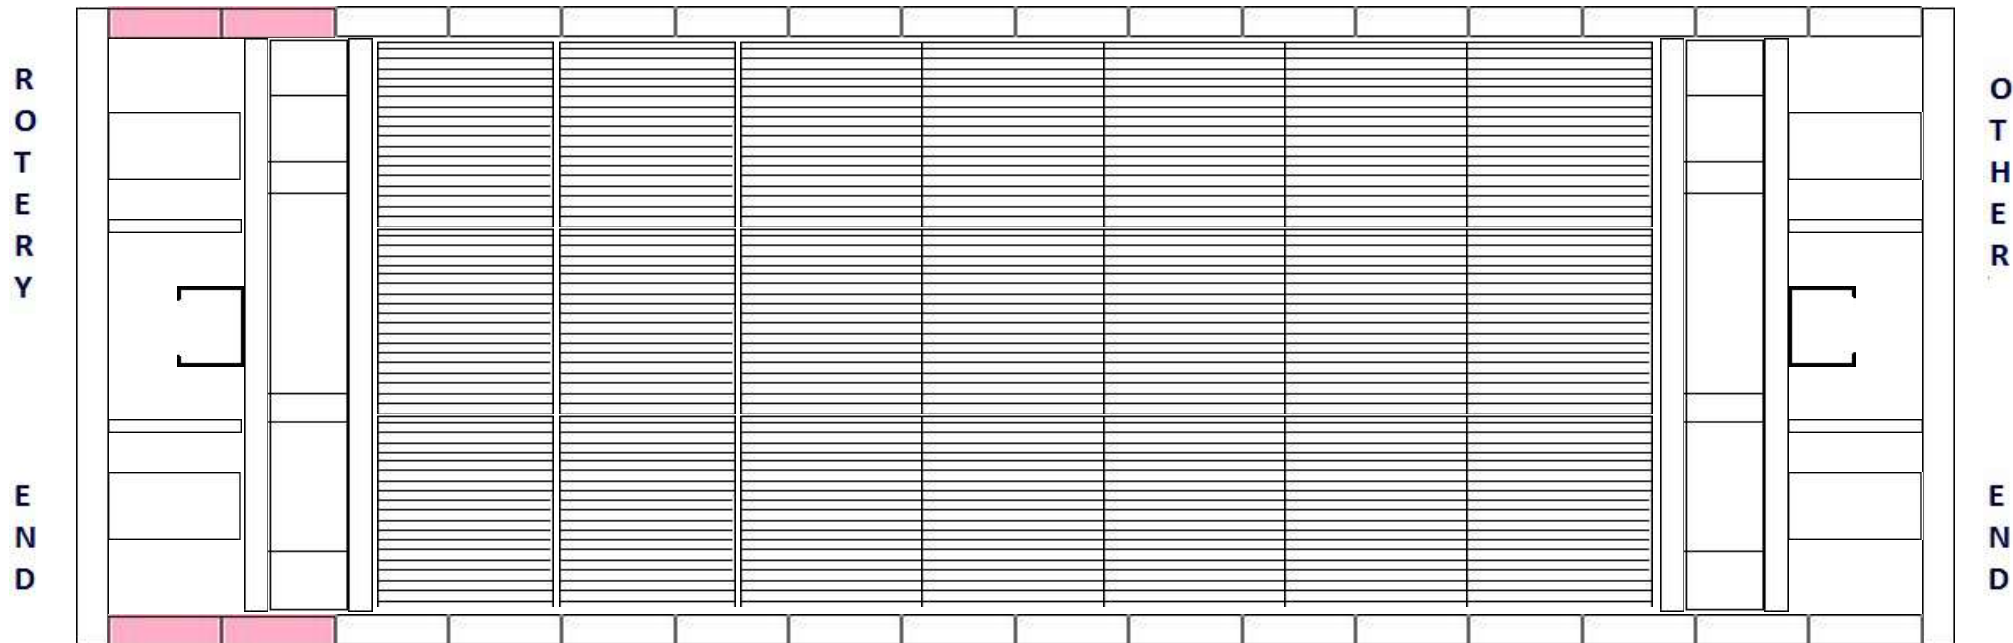
Color	Particulars	Qty	Per%	Color	Particulars	Qty	Per%	Color	Particulars	Qty	Per%
	Headstock Beam	0	0%		Centre Stiffner for Headstock	0	0%		Floor Stiffner for Headstock	0	0%
	Aux. Head stock	0	0%		Sole Bar	2	13%		Draft Gear Bracket	0	0%
	Trough floor	0	0%		Centre plate	0	0%		SoleBar Stiffner	4	100%
	Bottom Wall Part	2	13%		Body panel/patch		0%		Door Top/Roof Patch		0%
	Window Module		0%		Window Sill	0	0%		Window Bar	0	0%
	Seat pillar/lav. Partition		100%		UIC end construction		0%
