Coach Rehabilitation Workshop, WC Railway, Bhopal

(An IMS and ISO 50001 Certified Workshop)
Final Inspection Sheet - Details of Corrosion Repair

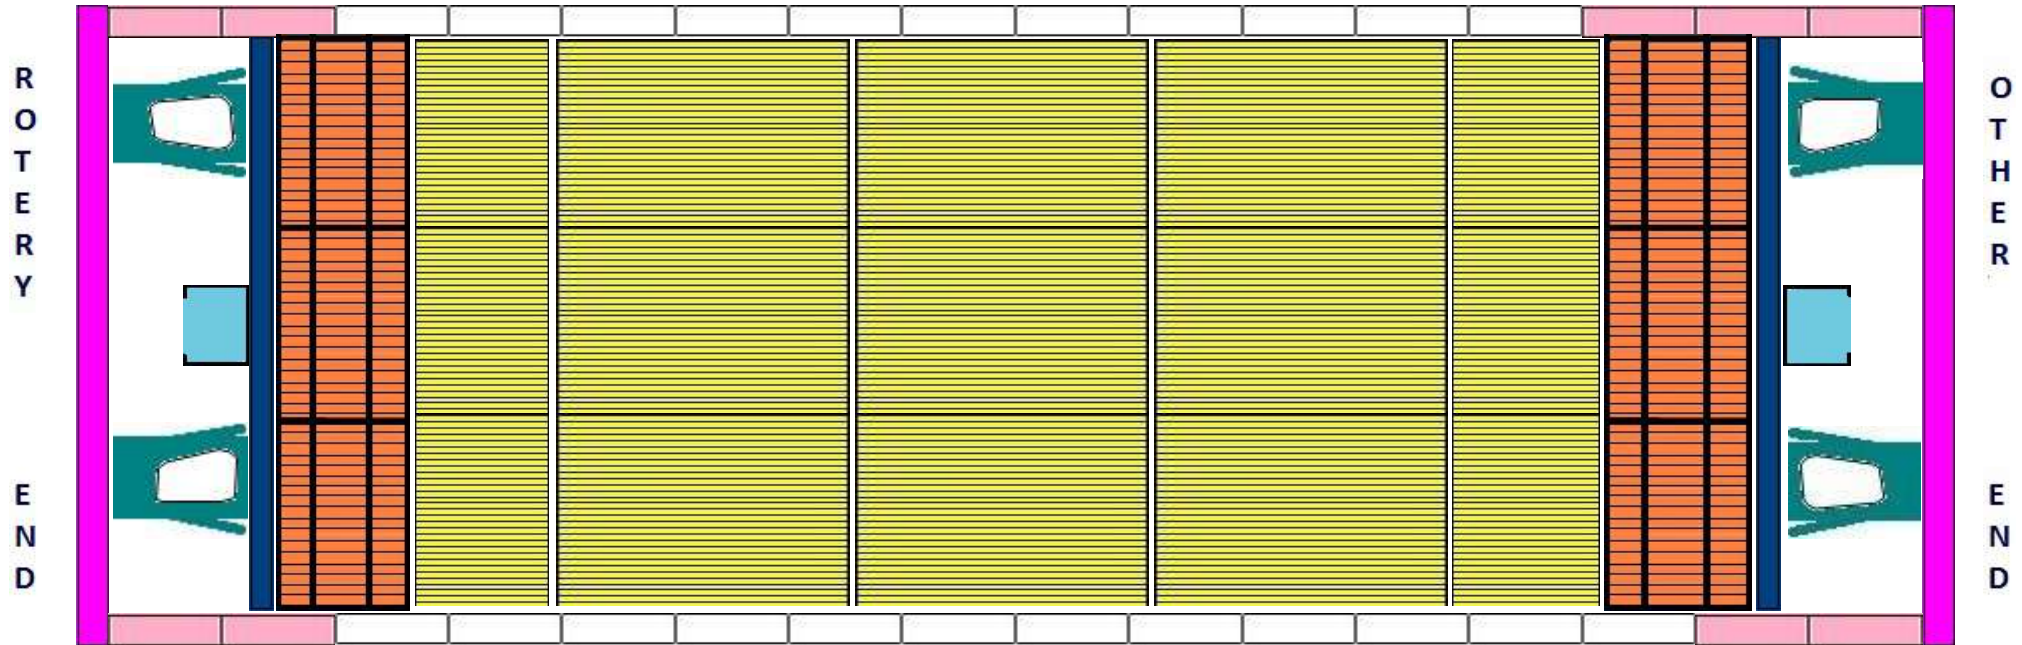
Color	Particulars	Qty	Per%	Color	Particulars	Qty	Per%	Color	Particulars	Qty	Per%
	Headstock Beam	2	100%		Diagonal	4	100%		Logitudinal Channel Structure	2	100%
	Aux. Head stock	2	100%		Sole Bar	4.5	28%		Draft Gear Bracket	2	100%
	Trough floor	7	100%		Bottom Wall Part	4.5	28%		Body panel/patch		100%
	Door Top/Roof Patch		0%		Seat Bracket Rail		0%		Window Sill	10	25%
	Window Bar	22	12%		Seat pillar/lav. Partition		100%		UIC end construction		0%
	Body Pillar Part	25	100%

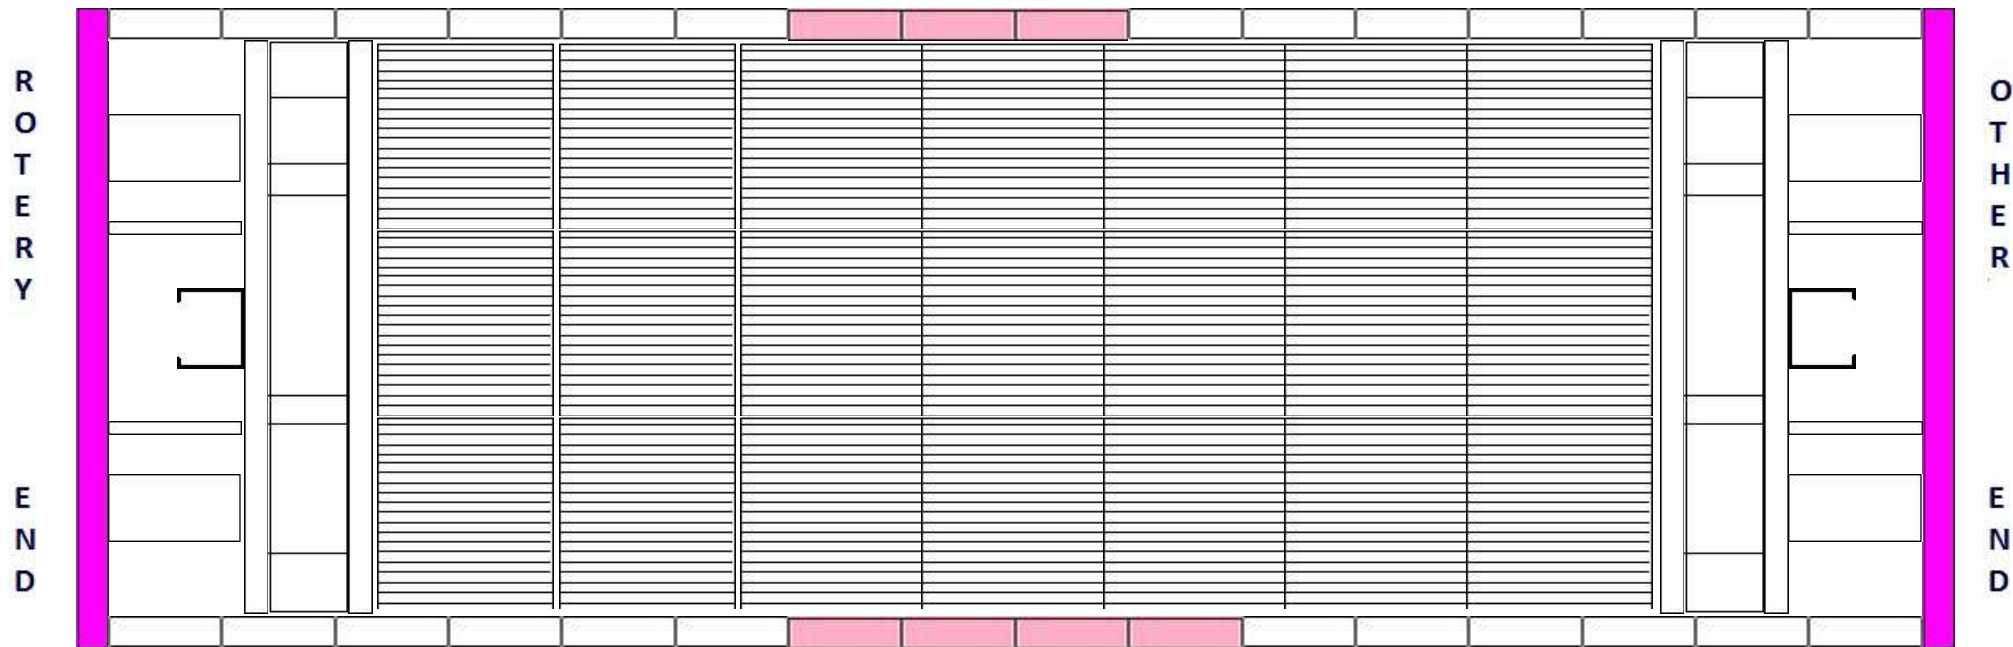
Color	Particulars	Qty	Per%	Color	Particulars	Qty	Per%	Color	Particulars	Qty	Per%
	Headstock Beam	0	0%		Centre Stiffner for Headstock	0	0%		Floor Stiffner for Headstock	0	0%
	Aux. Head stock	0	0%		Sole Bar	3.5	22%		Draft Gear Bracket	0	0%
	Trough floor	0	0%		Centre plate	0	0%		SoleBar Stiffner	4	100%
	Bottom Wall Part	3.5	22%		Body panel/patch		100%		Door Top/Roof Patch		0%
	Window Module		0%		Window Sill	0	0%		Window Bar	0	0%
	Seat pillar/lav. Partition		100%		UIC end construction		0%

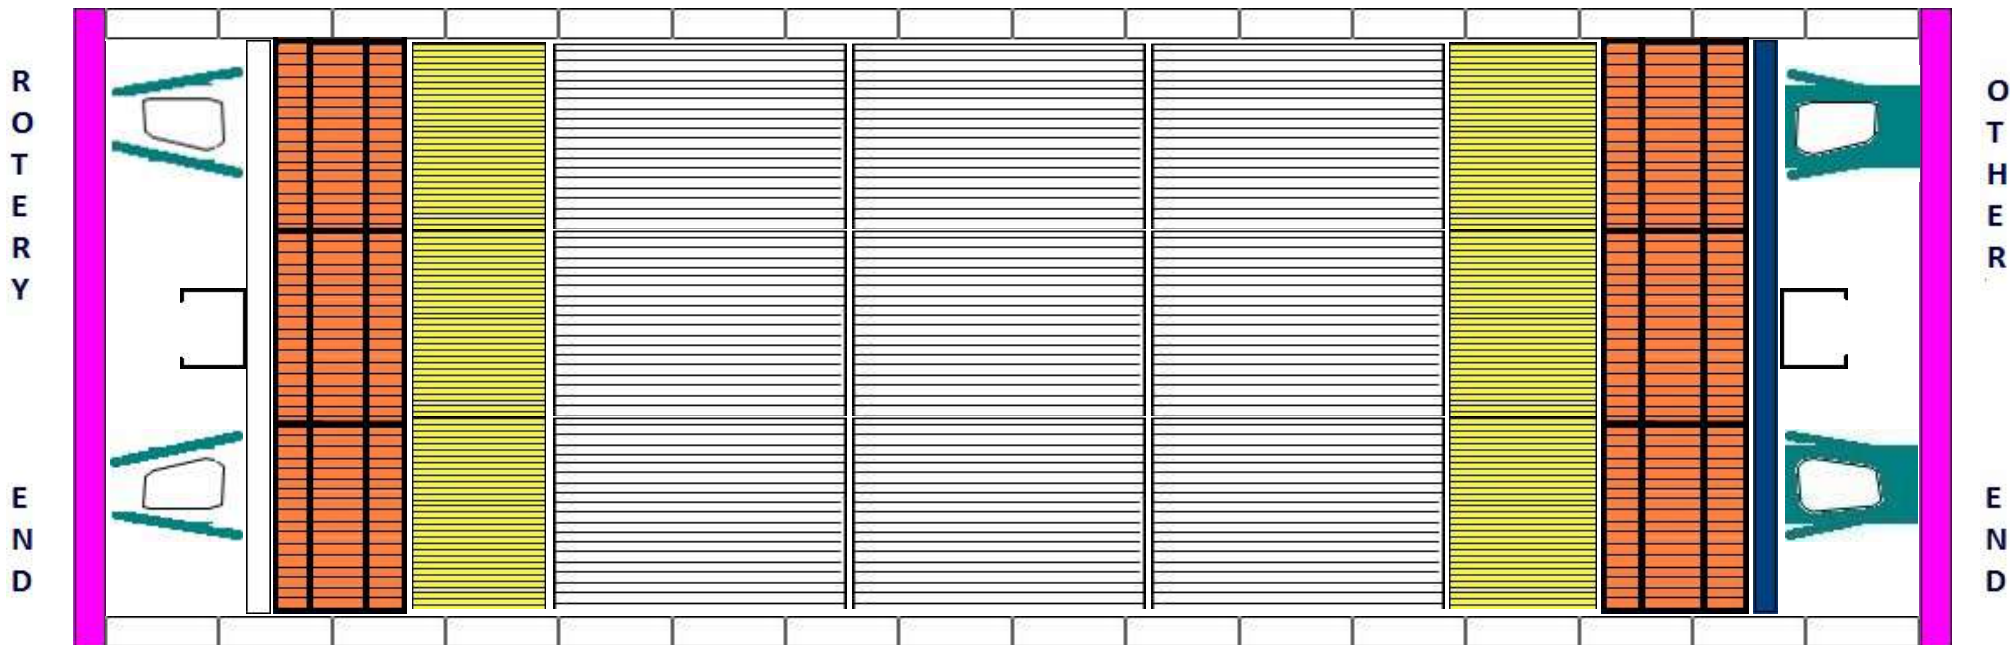
Color	Particulars	Qty	Per%	Color	Particulars	Qty	Per%	Color	Particulars	Qty	Per%
	Headstock Beam	1	50%		Diagonal	4	100%		Logitudinal Channel Structure	2	100%
	Aux. Head stock	1	50%		Sole Bar	0	0%		Draft Gear Bracket	1	50%
	Trough floor	2	40%		Bottom Wall Part	0	0%		Body panel/patch		100%
	Door Top/Roof Patch		0%		Seat Bracket Rail		0%		Window Sill	0	0%
	Window Bar	0	0%		Seat pillar/lav. Partition		100%		UIC end construction		0%
	Body Pillar Part	0	100%

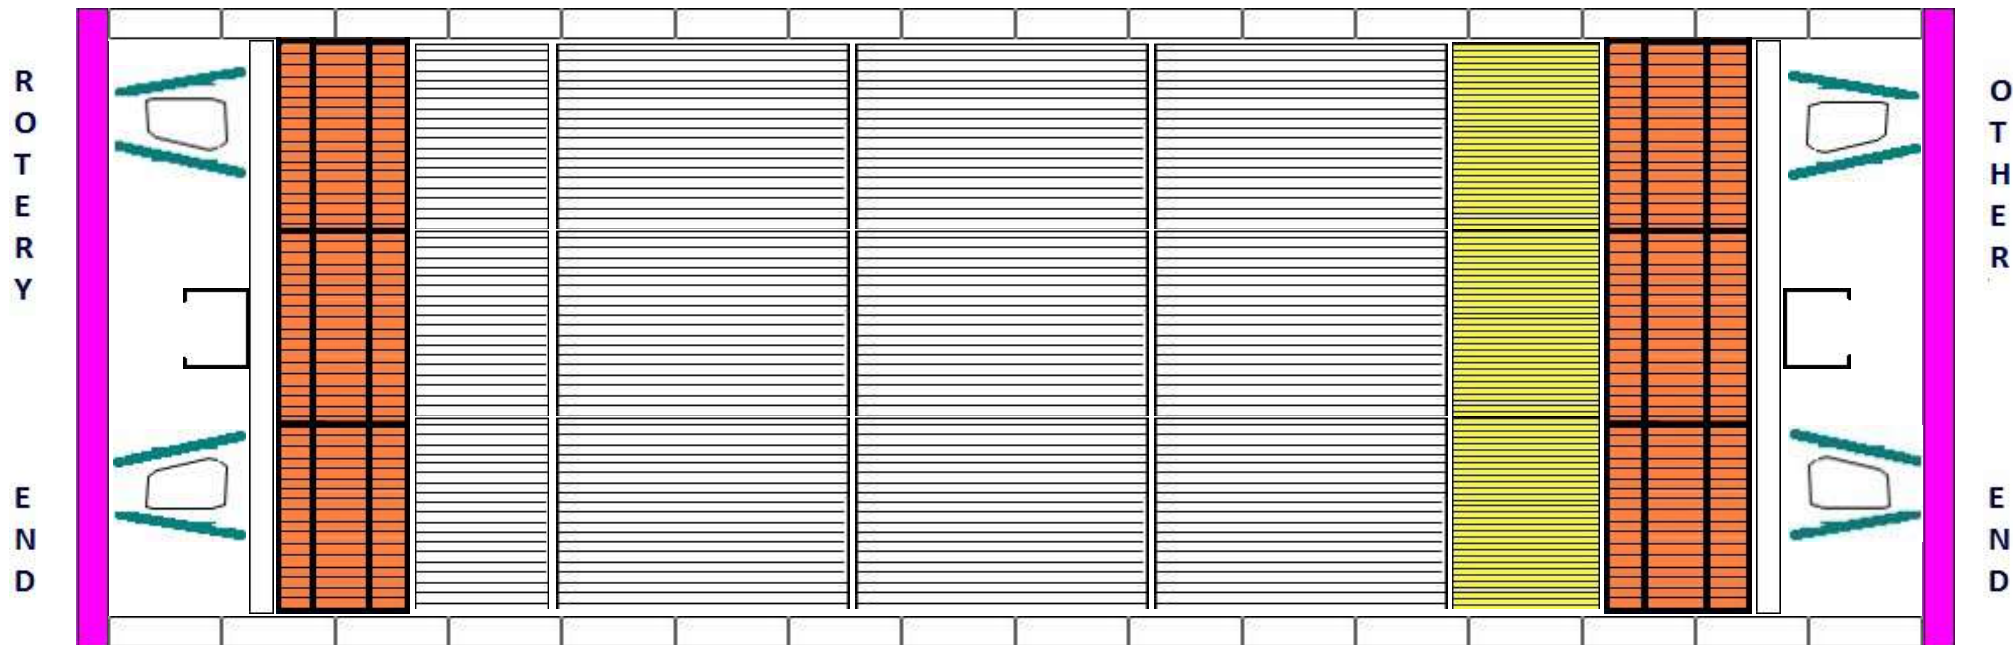
Color	Particulars	Qty	Per%	Color	Particulars	Qty	Per%	Color	Particulars	Qty	Per%
	Headstock Beam	0	0%		Diagonal	4	100%		Logitudinal Channel Structure	2	100%
	Aux. Head stock	0	0%		Sole Bar	0	0%		Draft Gear Bracket	0	0%
	Trough floor	1	20%		Bottom Wall Part	0	0%		Body panel/patch		100%
	Door Top/Roof Patch		0%		Seat Bracket Rail		0%		Window Sill	8	20%
	Window Bar	10	5%		Seat pillar/lav. Partition		100%		UIC end construction		0%
	Body Pillar Part	0	100%

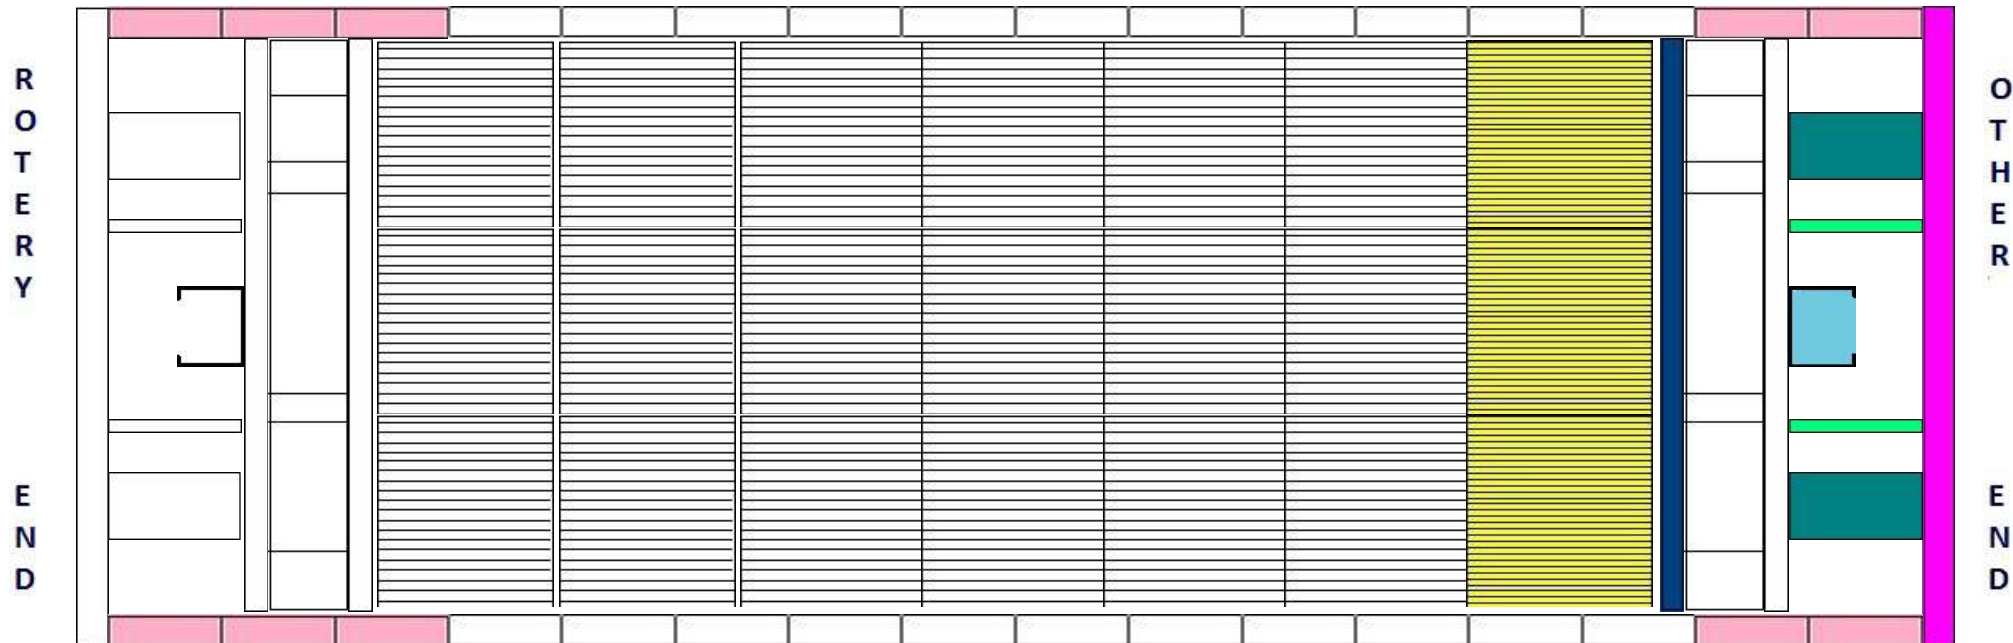
Color	Particulars	Qty	Per%	Color	Particulars	Qty	Per%	Color	Particulars	Qty	Per%
	Headstock Beam	1	50%		Centre Stiffner for Headstock	2	50%		Floor Stiffner for Headstock	2	50%
	Aux. Head stock	2	50%		Sole Bar	5	31%		Draft Gear Bracket	1	50%
	Trough floor	1	14%		Centre plate	1	50%		SoleBar Stiffner	4	100%
	Bottom Wall Part	5	31%		Body panel/patch		100%		Door Top/Roof Patch		0%
	Window Module		0%		Window Sill	7	37%		Window Bar	20	24%
	Seat pillar/lav. Partition		100%		UIC end construction		0%

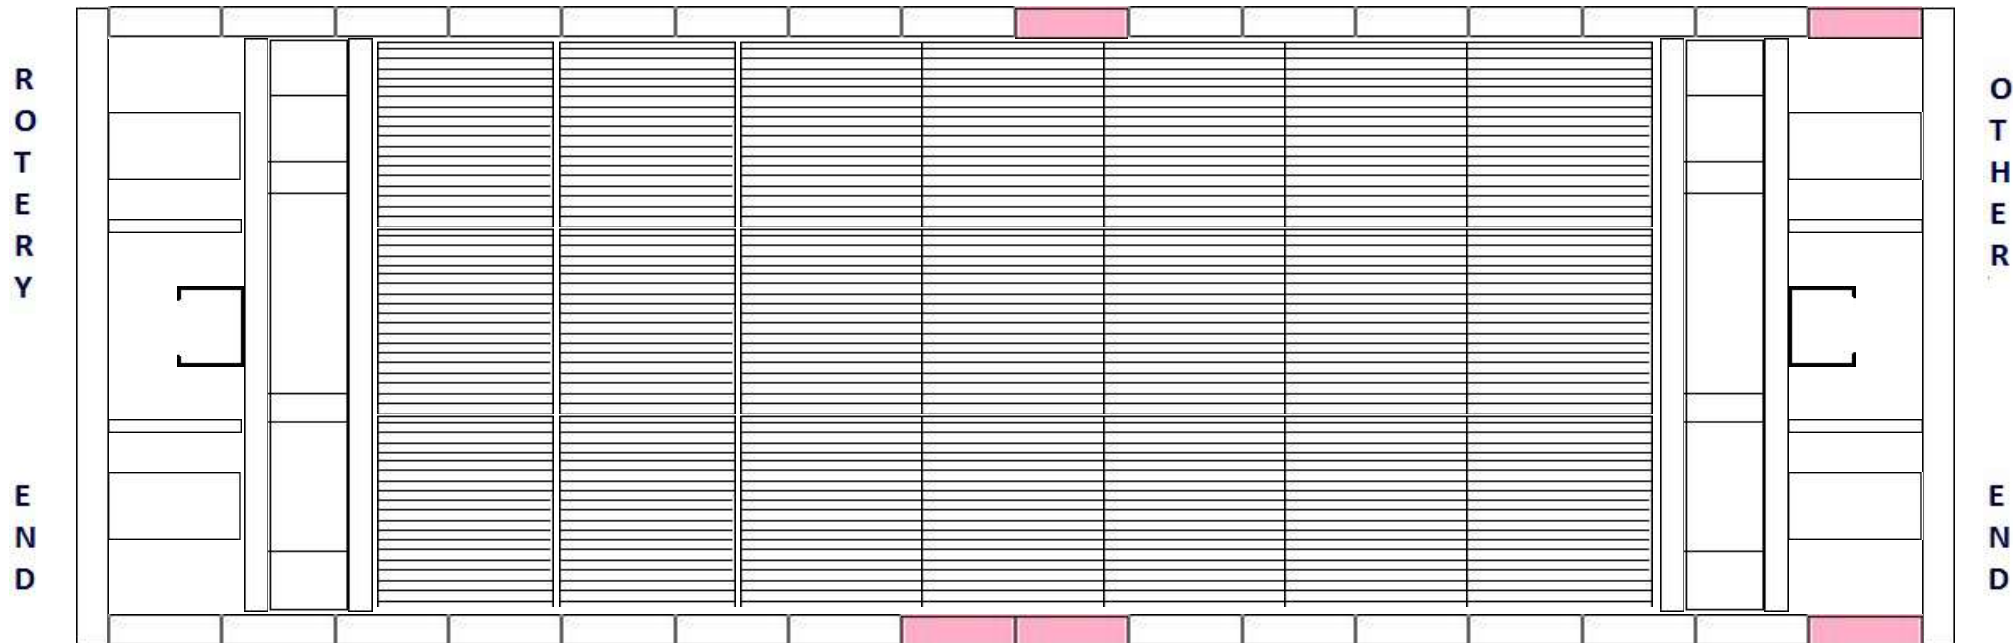
Color	Particulars	Qty	Per%	Color	Particulars	Qty	Per%	Color	Particulars	Qty	Per%
	Headstock Beam	0	0%		Centre Stiffner for Headstock	0	0%		Floor Stiffner for Headstock	0	0%
	Aux. Head stock	0	0%		Sole Bar	2.5	16%		Draft Gear Bracket	0	0%
	Trough floor	0	0%		Centre plate	0	0%		SoleBar Stiffner	4	100%
	Bottom Wall Part	2.5	16%		Body panel/patch		30%		Door Top/Roof Patch		0%
	Window Module		0%		Window Sill	7	18%		Window Bar	84	49%
	Seat pillar/lav. Partition		100%		UIC end construction		0%

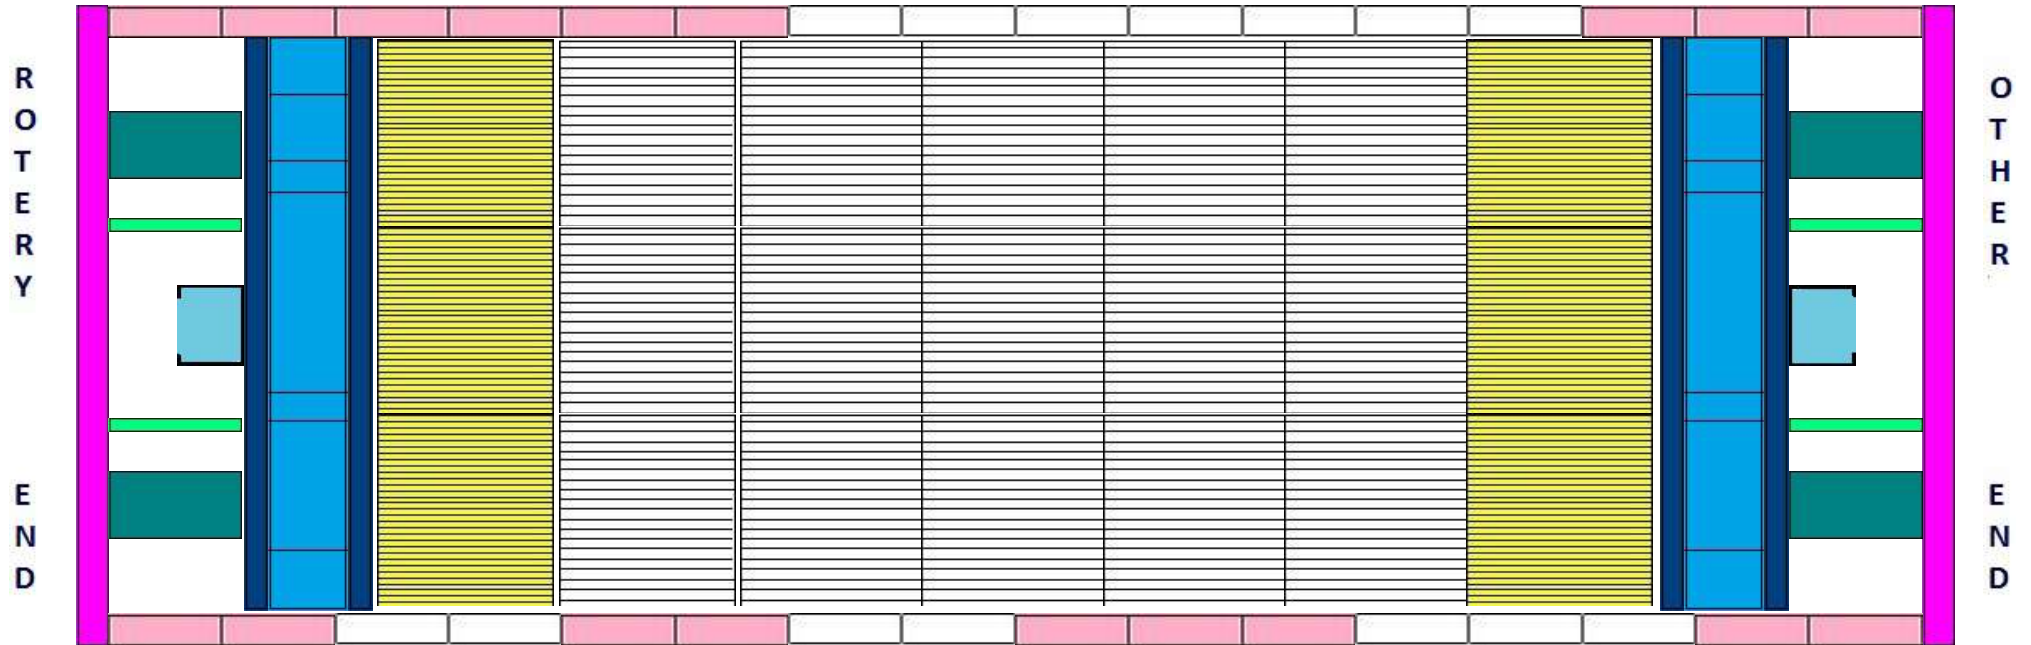
Color	Particulars	Qty	Per%	Color	Particulars	Qty	Per%	Color	Particulars	Qty	Per%
Pink	Headstock Beam	2	100%	Dark Green	Centre Stiffner for Headstock	4	100%	Bright Green	Floor Stiffner for Headstock	4	100%
Dark Blue	Aux. Head stock	4	100%	Pink	Sole Bar	9	56%	Light Blue	Draft Gear Bracket	2	100%
Yellow	Trough floor	2	29%	Blue	Centre plate	2	100%		SoleBar Stiffner	6	100%
	Bottom Wall Part	9	56%		Body panel/patch		100%		Door Top/Roof Patch		0%
	Window Module		0%		Window Sill	20	50%		Window Bar	46	26%
	Seat pillar/lav. Partition		100%		UIC end construction		0%

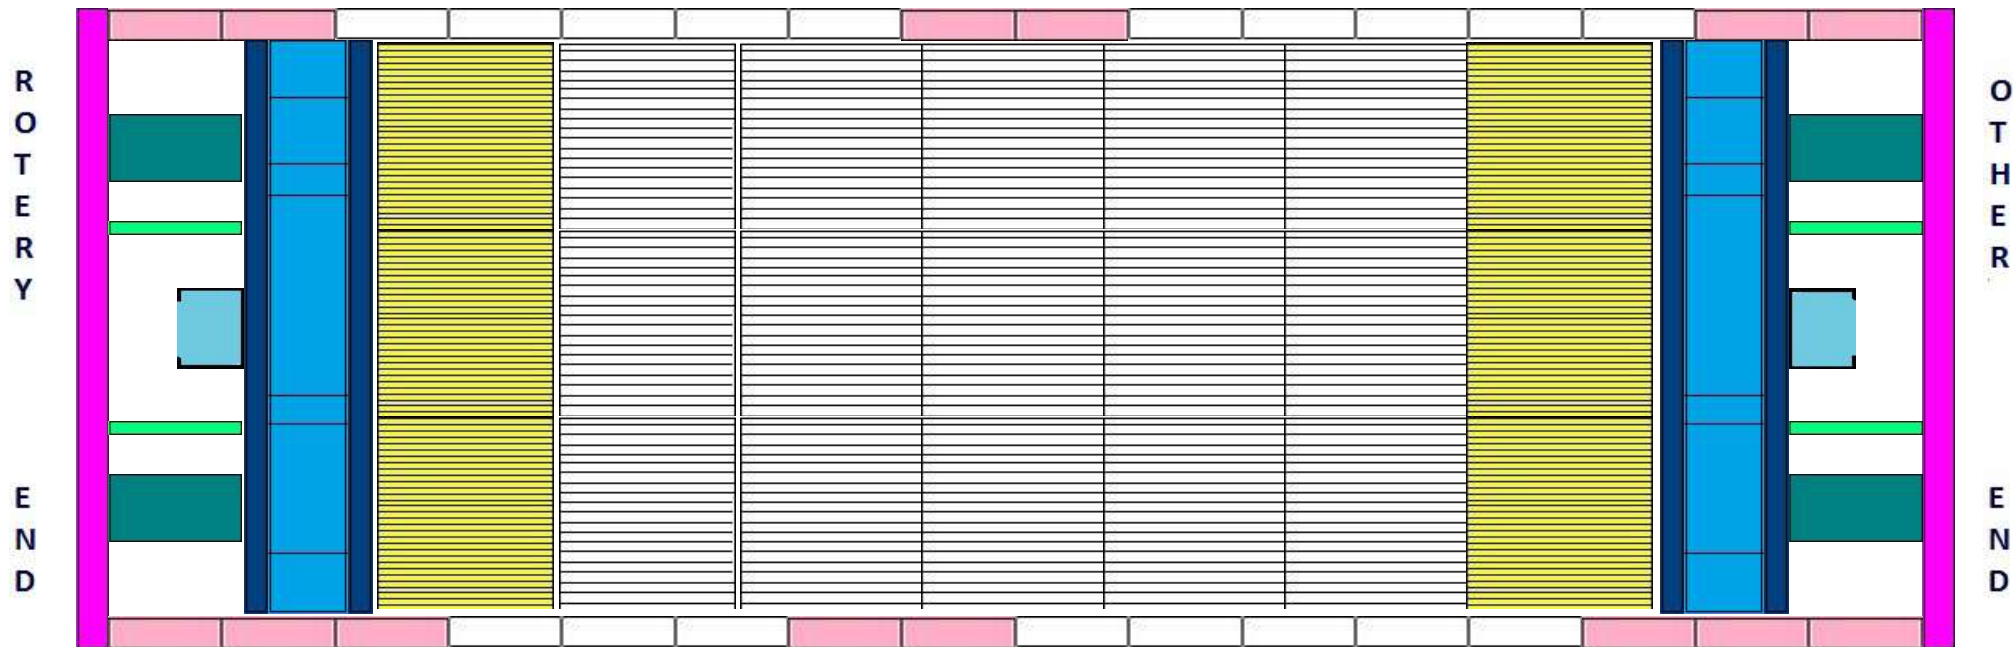
Color	Particulars	Qty	Per%	Color	Particulars	Qty	Per%	Color	Particulars	Qty	Per%
Yellow	Headstock Beam	2	100%	Dark Green	Centre Stiffner for Headstock	4	100%	Light Green	Floor Stiffner for Headstock	4	100%
Dark Blue	Aux. Head stock	4	100%	Pink	Sole Bar	7	44%	Light Blue	Draft Gear Bracket	2	100%
Yellow	Trough floor	2	29%	Light Blue	Centre plate	2	100%		SoleBar Stiffner	6	100%
	Bottom Wall Part	7	44%		Body panel/patch		100%		Door Top/Roof Patch		0%
	Window Module		0%		Window Sill	14	35%		Window Bar	40	23%
	Seat pillar/lav. Partition		100%		UIC end construction		0%

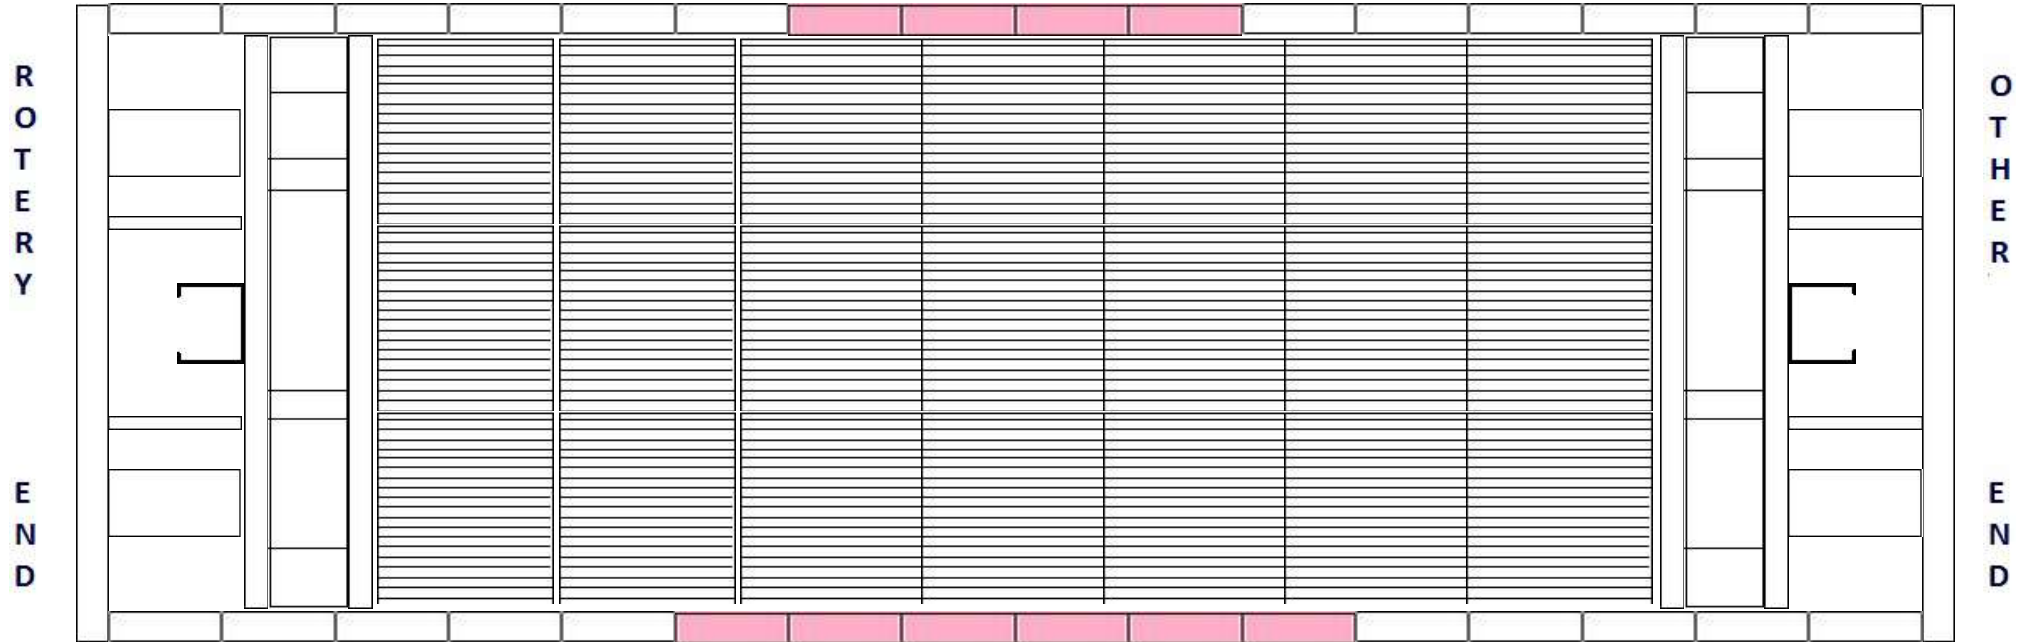
Color	Particulars	Qty	Per%	Color	Particulars	Qty	Per%	Color	Particulars	Qty	Per%
Blue	Headstock Beam	0	0%	Red	Centre Stiffner for Headstock	0	0%	Green	Floor Stiffner for Headstock	0	0%
Black	Aux. Head stock	0	0%	Pink	Sole Bar	5	31%	Light Blue	Draft Gear Bracket	0	0%
Yellow	Trough floor	0	0%	Light Blue	Centre plate	0	0%		SoleBar Stiffner	4	100%
	Bottom Wall Part	5	31%		Body panel/patch		30%		Door Top/Roof Patch		0%
	Window Module		0%		Window Sill	0	0%		Window Bar	0	0%
	Seat pillar/lav. Partition		100%		UIC end construction		0%

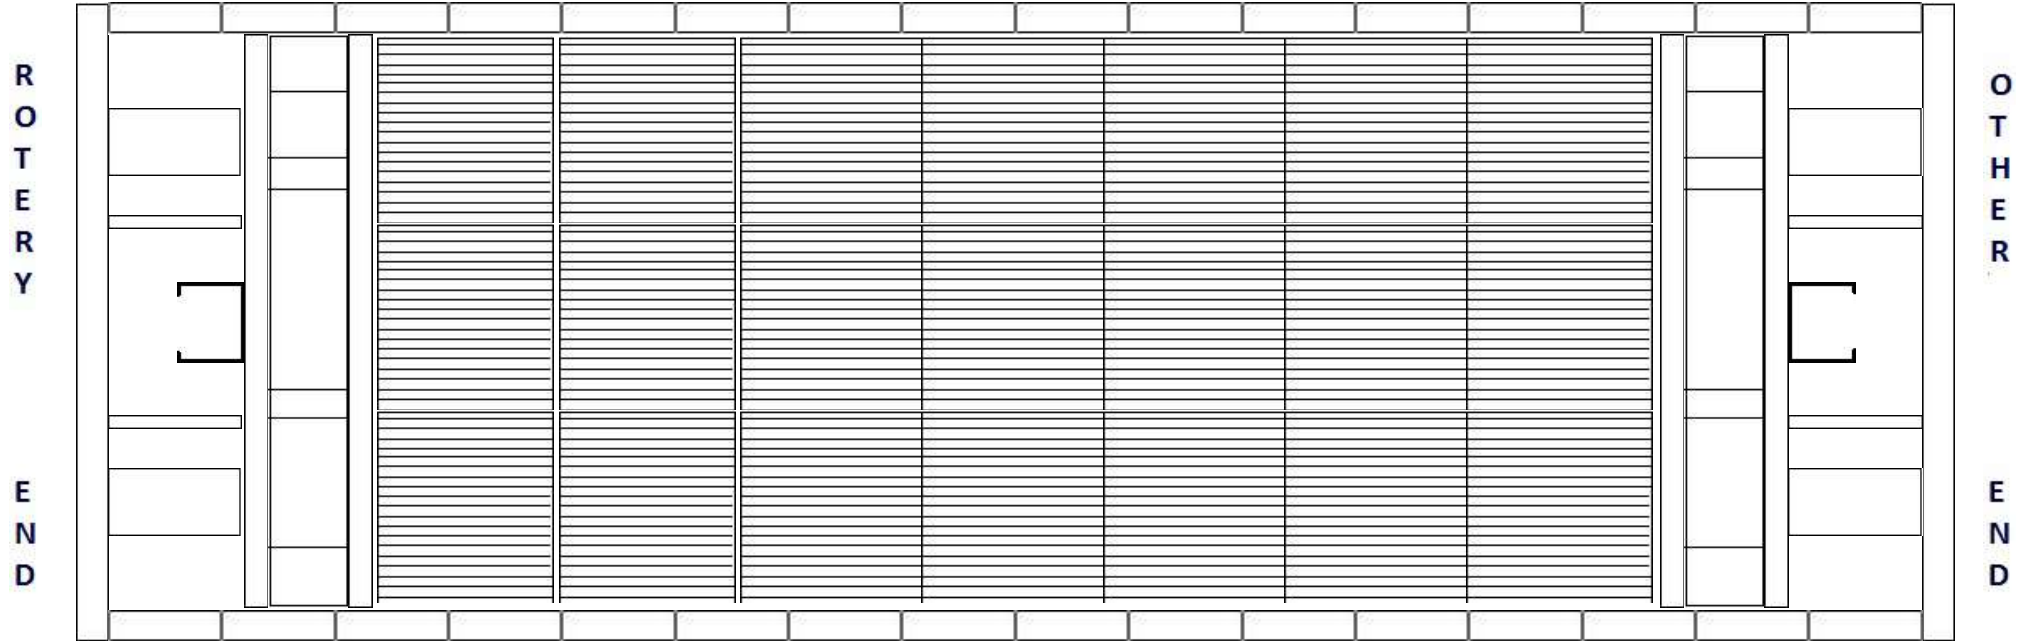
Color	Particulars	Qty	Per%	Color	Particulars	Qty	Per%	Color	Particulars	Qty	Per%
	Headstock Beam	0	0%		Centre Stiffner for Headstock	0	0%		Floor Stiffner for Headstock	0	0%
	Aux. Head stock	0	0%		Sole Bar	0	0%		Draft Gear Bracket	0	0%
	Trough floor	0	0%		Centre plate	0	0%		SoleBar Stiffner	4	100%
	Bottom Wall Part	0	0%		Body panel/patch		20%		Door Top/Roof Patch		0%
	Window Module		0%		Window Sill	0	0%		Window Bar	0	0%
	Seat pillar/lav. Partition		100%		UIC end construction		0%

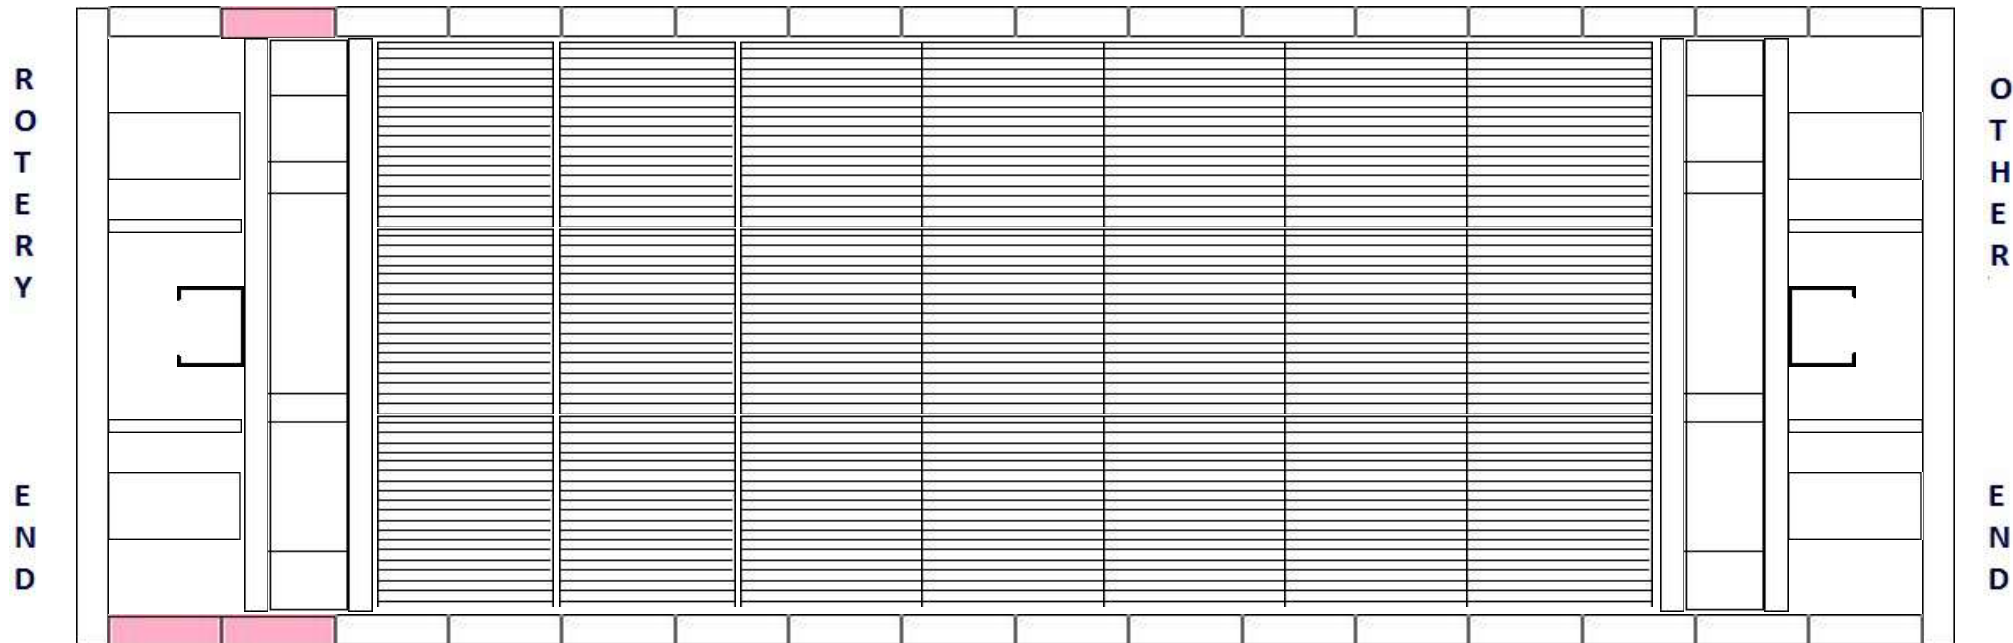
Color	Particulars	Qty	Per%	Color	Particulars	Qty	Per%	Color	Particulars	Qty	Per%
	Headstock Beam	0	0%		Centre Stiffner for Headstock	0	0%		Floor Stiffner for Headstock	0	0%
	Aux. Head stock	0	0%		Sole Bar	1.5	9%		Draft Gear Bracket	0	0%
	Trough floor	0	0%		Centre plate	0	0%		SoleBar Stiffner	4	100%
	Bottom Wall Part	1.5	9%		Body panel/patch		20%		Door Top/Roof Patch		0%
	Window Module		0%		Window Sill	0	0%		Window Bar	0	0%
	Seat pillar/lav. Partition		100%		UIC end construction		0%

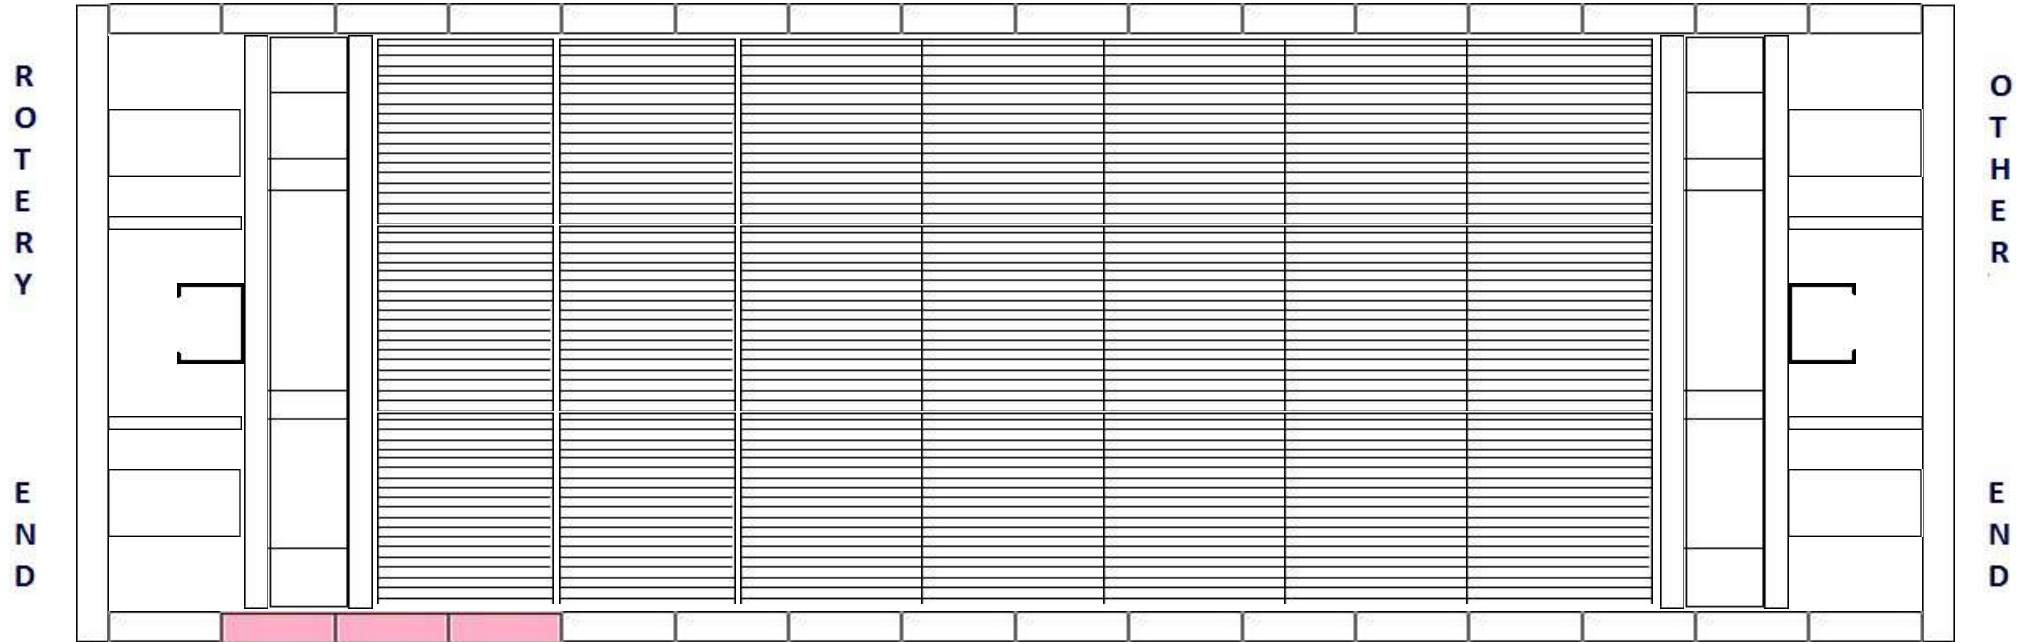
Color	Particulars	Qty	Per%	Color	Particulars	Qty	Per%	Color	Particulars	Qty	Per%
Yellow	Headstock Beam	0	0%	Red	Centre Stiffner for Headstock	0	0%	Green	Floor Stiffner for Headstock	0	0%
Blue	Aux. Head stock	0	0%	Pink	Sole Bar	1.5	9%	Light Blue	Draft Gear Bracket	0	0%
Orange	Trough floor	0	0%	Light Blue	Centre plate	0	0%		SoleBar Stiffner	4	100%
	Bottom Wall Part	1.5	9%		Body panel/patch		20%		Door Top/Roof Patch		0%
	Window Module		0%		Window Sill	0	0%		Window Bar	0	0%
	Seat pillar/lav. Partition		100%		UIC end construction		0%

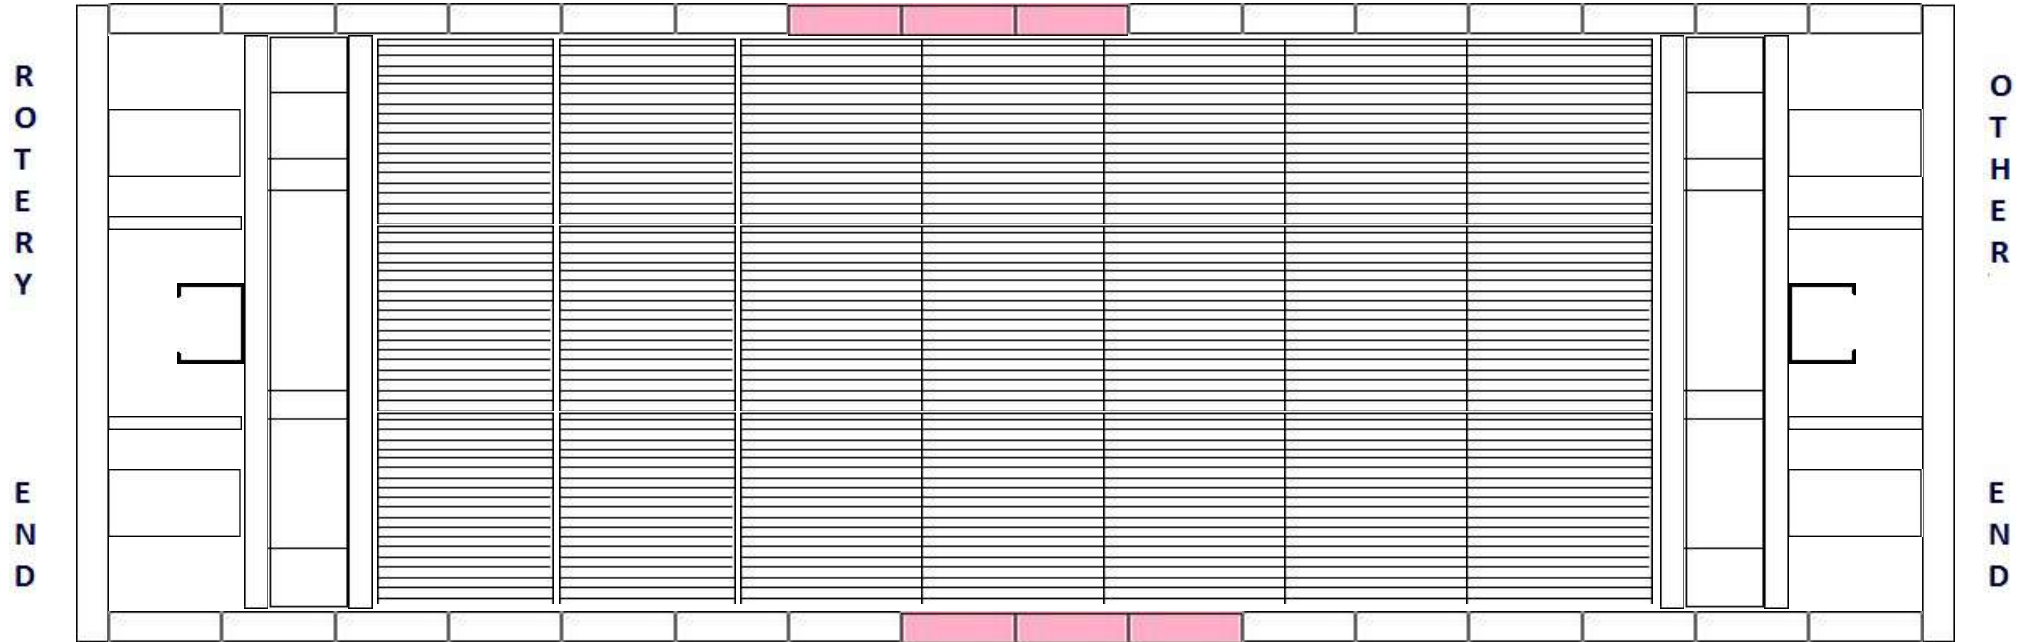
Rotary Side

Color	Particulars	Qty	Per%	Color	Particulars	Qty	Per%	Color	Particulars	Qty	Per%
	Headstock Beam	0	0%		Centre Stiffner for Headstock	0	0%		Floor Stiffner for Headstock	0	0%
	Aux. Head stock	0	0%		Sole Bar	3	19%		Draft Gear Bracket	0	0%
	Trough floor	0	0%		Centre plate	0	0%		SoleBar Stiffner	4	100%
	Bottom Wall Part	3	19%		Body panel/patch		30%		Door Top/Roof Patch		0%
	Window Module		0%		Window Sill	0	0%		Window Bar	0	0%
	Seat pillar/lav. Partition		100%		UIC end construction		0%

End Drooping: Rotary End - EAST : 0, WEST : 0 Other End - EAST : 0, WEST : 0
Start Date : 29-Jan-2020, Completion Date : 01-Feb-2020, Net Repair Days : 4, Total Man Hours : 0

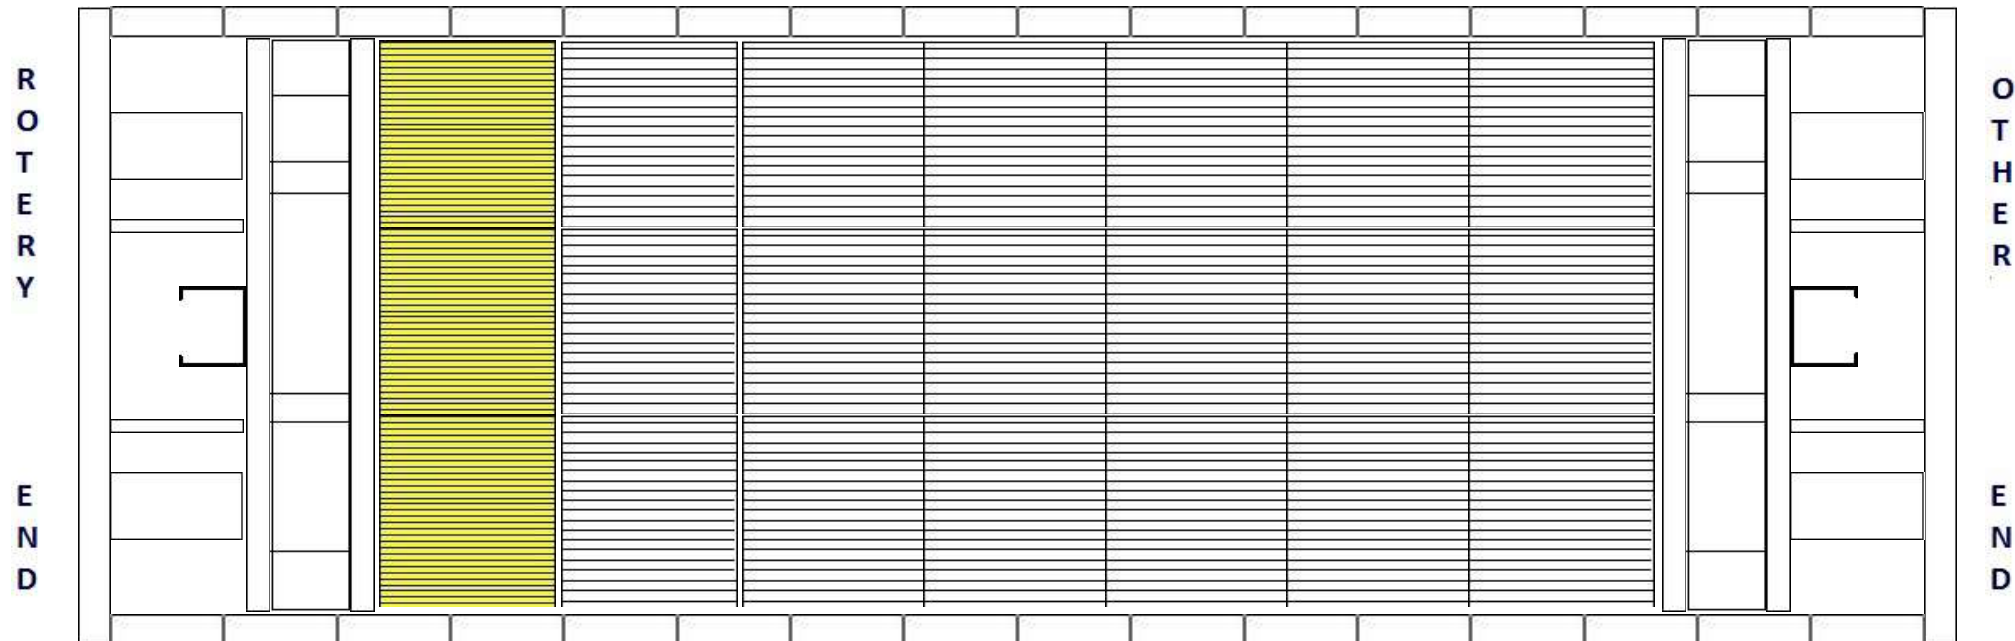
Rotary Side

Color	Particulars	Qty	Per%	Color	Particulars	Qty	Per%	Color	Particulars	Qty	Per%
	Headstock Beam	0	0%		Centre Stiffner for Headstock	0	0%		Floor Stiffner for Headstock	0	0%
	Aux. Head stock	0	0%		Sole Bar	0	0%		Draft Gear Bracket	0	0%
	Trough floor	1	14%		Centre plate	0	0%		SoleBar Stiffner	4	100%
	Bottom Wall Part	0	0%		Body panel/patch		20%		Door Top/Roof Patch		0%
	Window Module		0%		Window Sill	0	0%		Window Bar	0	0%
	Seat pillar/lav. Partition		100%		UIC end construction		0%

End Drooping: Rotary End - EAST : 0, WEST : 0 Other End - EAST : 0, WEST : 0
Start Date : 09-Aug-2019, Completion Date : 13-Aug-2019, Net Repair Days : 4, Total Man Hours : 388

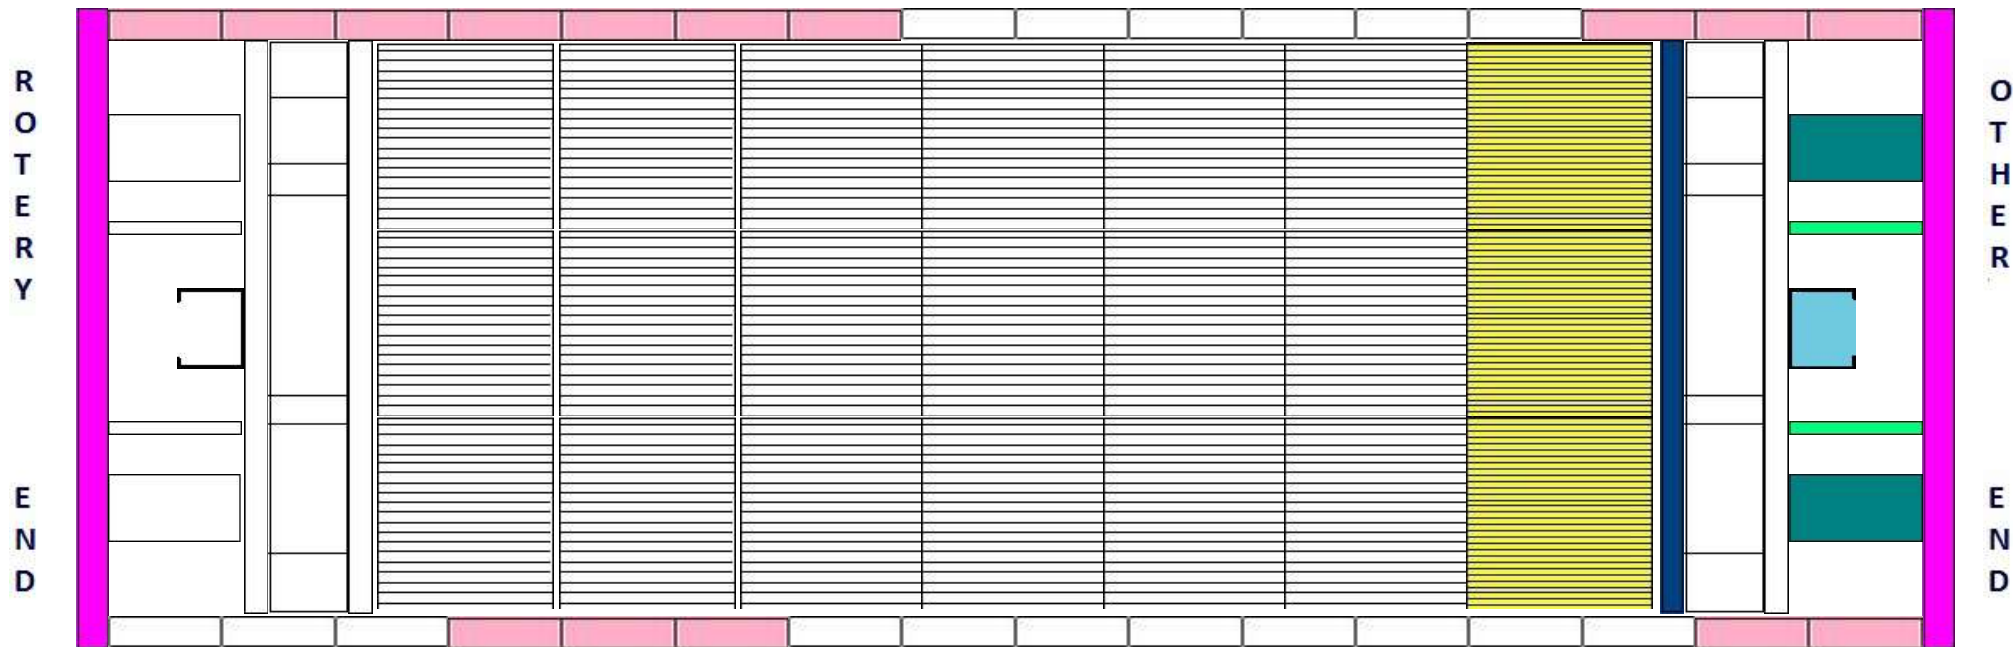
Rotary Side

Color	Particulars	Qty	Per%	Color	Particulars	Qty	Per%	Color	Particulars	Qty	Per%
Yellow	Headstock Beam	2	100%	Green	Centre Stiffner for Headstock	2	50%	Blue	Floor Stiffner for Headstock	2	50%
Pink	Aux. Head stock	2	50%	Blue	Sole Bar	7.5	47%	Yellow	Draft Gear Bracket	1	50%
Blue	Trough floor	1	14%	Blue	Centre plate	1	50%	Blue	SoleBar Stiffner	4	100%
Blue	Bottom Wall Part	7.5	47%	Blue	Body panel/patch		100%	Blue	Door Top/Roof Patch		0%
Blue	Window Module		0%	Blue	Window Sill	20	67%	Blue	Window Bar	18	21%
Blue	Seat pillar/lav. Partition		100%	Blue	UIC end construction		0%

End Drooping: Rotary End - EAST : -5, WEST : -4 Other End - EAST : -6, WEST : -5
Start Date : 06-Aug-2019, Completion Date : 14-Aug-2019, Net Repair Days : 8, Total Man Hours : 1168
