Coach Rehabilitation Workshop, WC Railway, Bhopal

(An IMS and ISO 50001 Certified Workshop)
Final Inspection Sheet - Details of Corrosion Repair

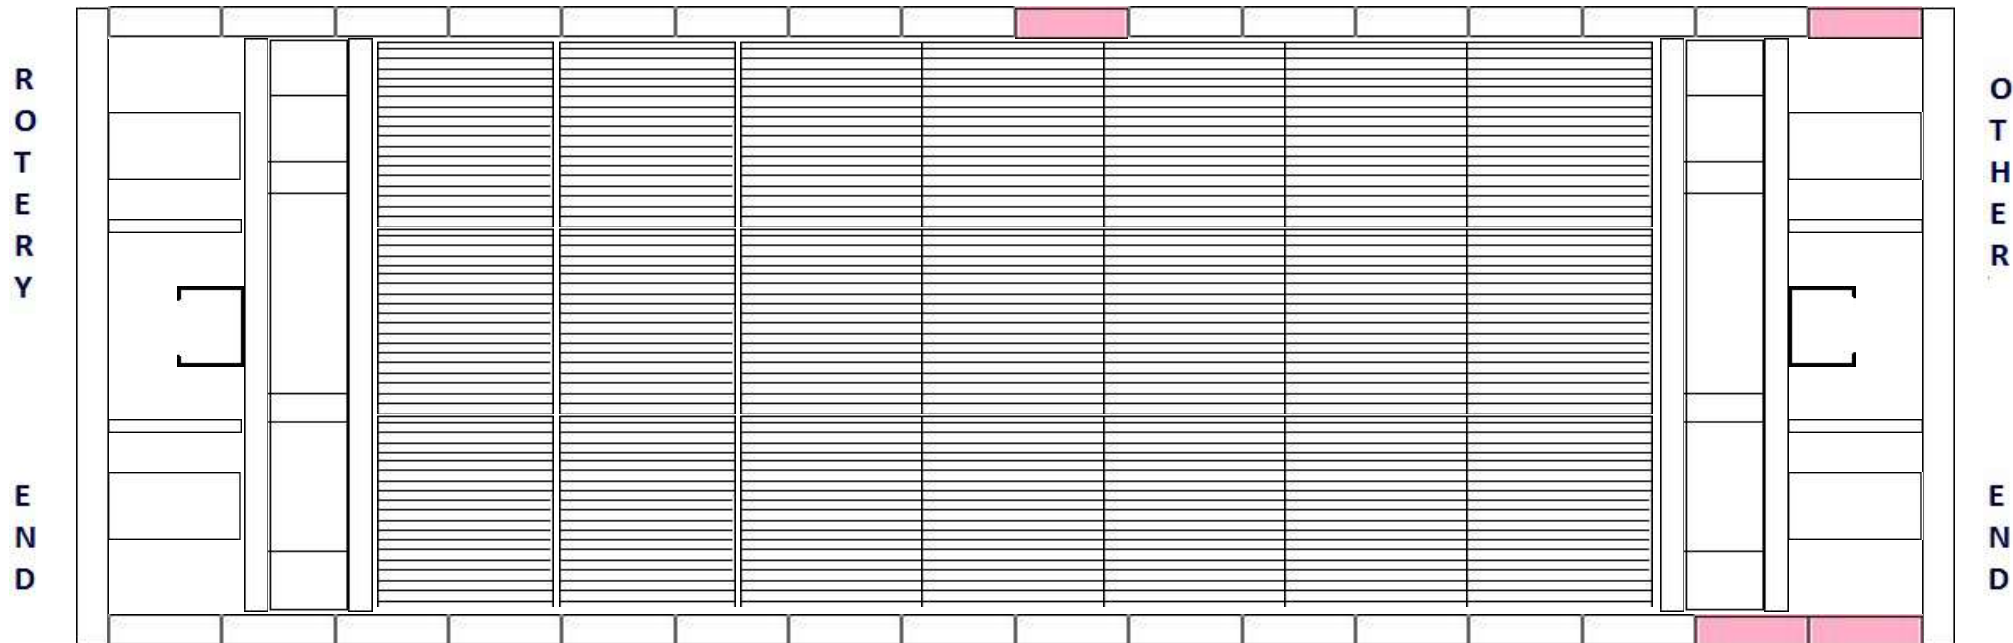
Rotary Side

Color	Particulars	Qty	Per%	Color	Particulars	Qty	Per%	Color	Particulars	Qty	Per%
	Headstock Beam	0	0%		Centre Stiffner for Headstock	0	0%		Floor Stiffner for Headstock	0	0%
	Aux. Head stock	0	0%		Sole Bar	2	13%		Draft Gear Bracket	0	0%
	Trough floor	0	0%		Centre plate	0	0%		SoleBar Stiffner	4	100%
	Bottom Wall Part	2	13%		Body panel/patch		30%		Door Top/Roof Patch		0%
	Window Module		0%		Window Sill	0	0%		Window Bar	0	0%
	Seat pillar/lav. Partition		100%		UIC end construction		0%

End Drooping: Rotary End - EAST : 0, WEST : 0 Other End - EAST : 0, WEST : 0
Start Date : 07-Aug-2019, Completion Date : 10-Aug-2019, Net Repair Days : 4, Total Man Hours : 0

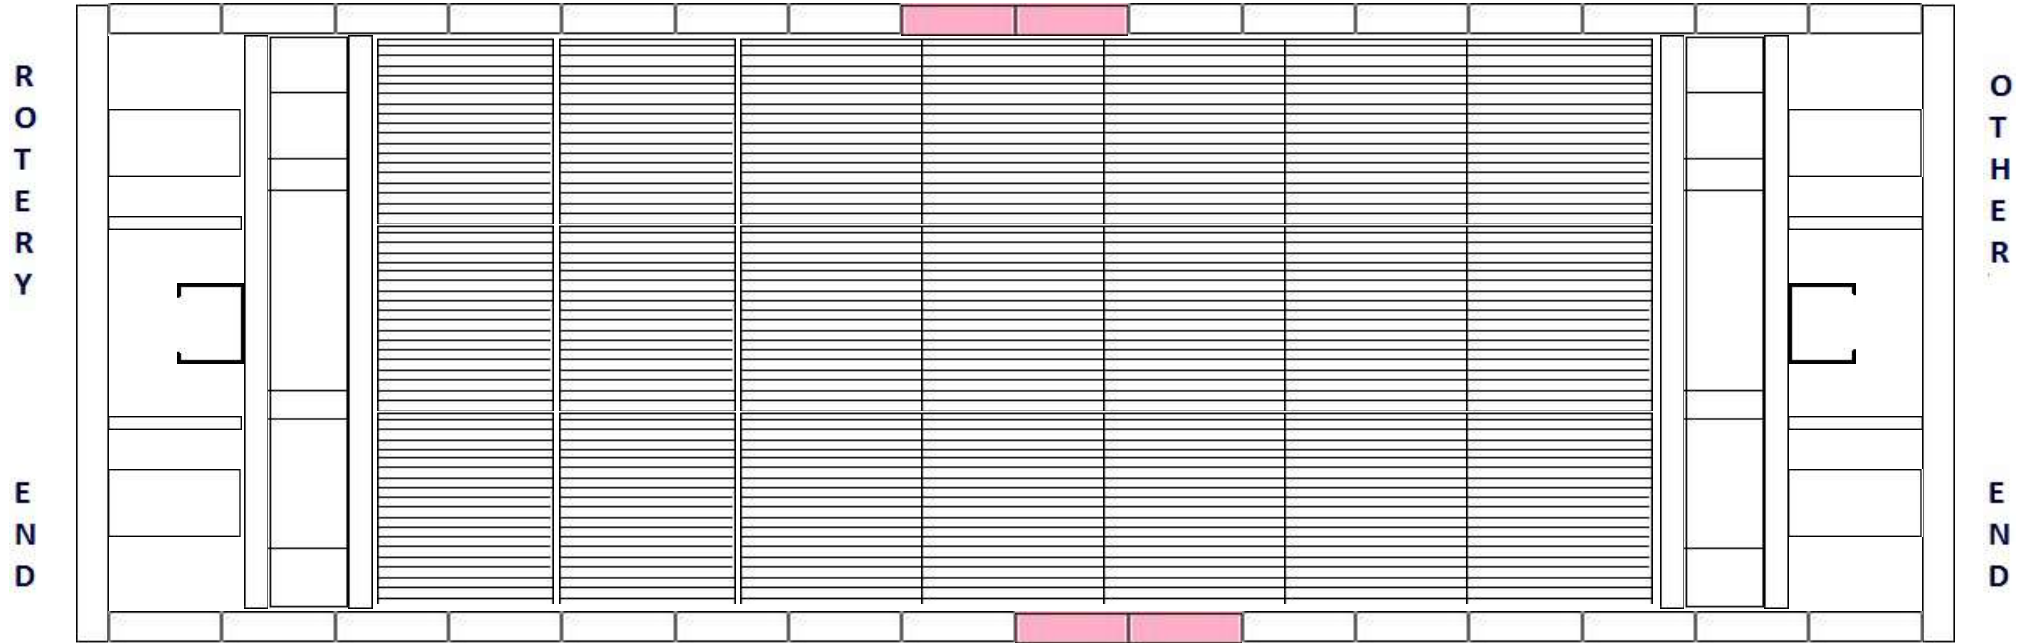
Rotary Side

Color	Particulars	Qty	Per%	Color	Particulars	Qty	Per%	Color	Particulars	Qty	Per%
	Headstock Beam	0	0%		Centre Stiffner for Headstock	0	0%		Floor Stiffner for Headstock	0	0%
	Aux. Head stock	0	0%		Sole Bar	2	13%		Draft Gear Bracket	0	0%
	Trough floor	0	0%		Centre plate	0	0%		SoleBar Stiffner	4	100%
	Bottom Wall Part	2	13%		Body panel/patch		100%		Door Top/Roof Patch		0%
	Window Module		0%		Window Sill	0	0%		Window Bar	0	0%
	Seat pillar/lav. Partition		100%		UIC end construction		0%

End Drooping: Rotary End - EAST : 0, WEST : 0 Other End - EAST : 0, WEST : 0
Start Date : 31-Aug-2019, Completion Date : 02-Sep-2019, Net Repair Days : 2, Total Man Hours : 486

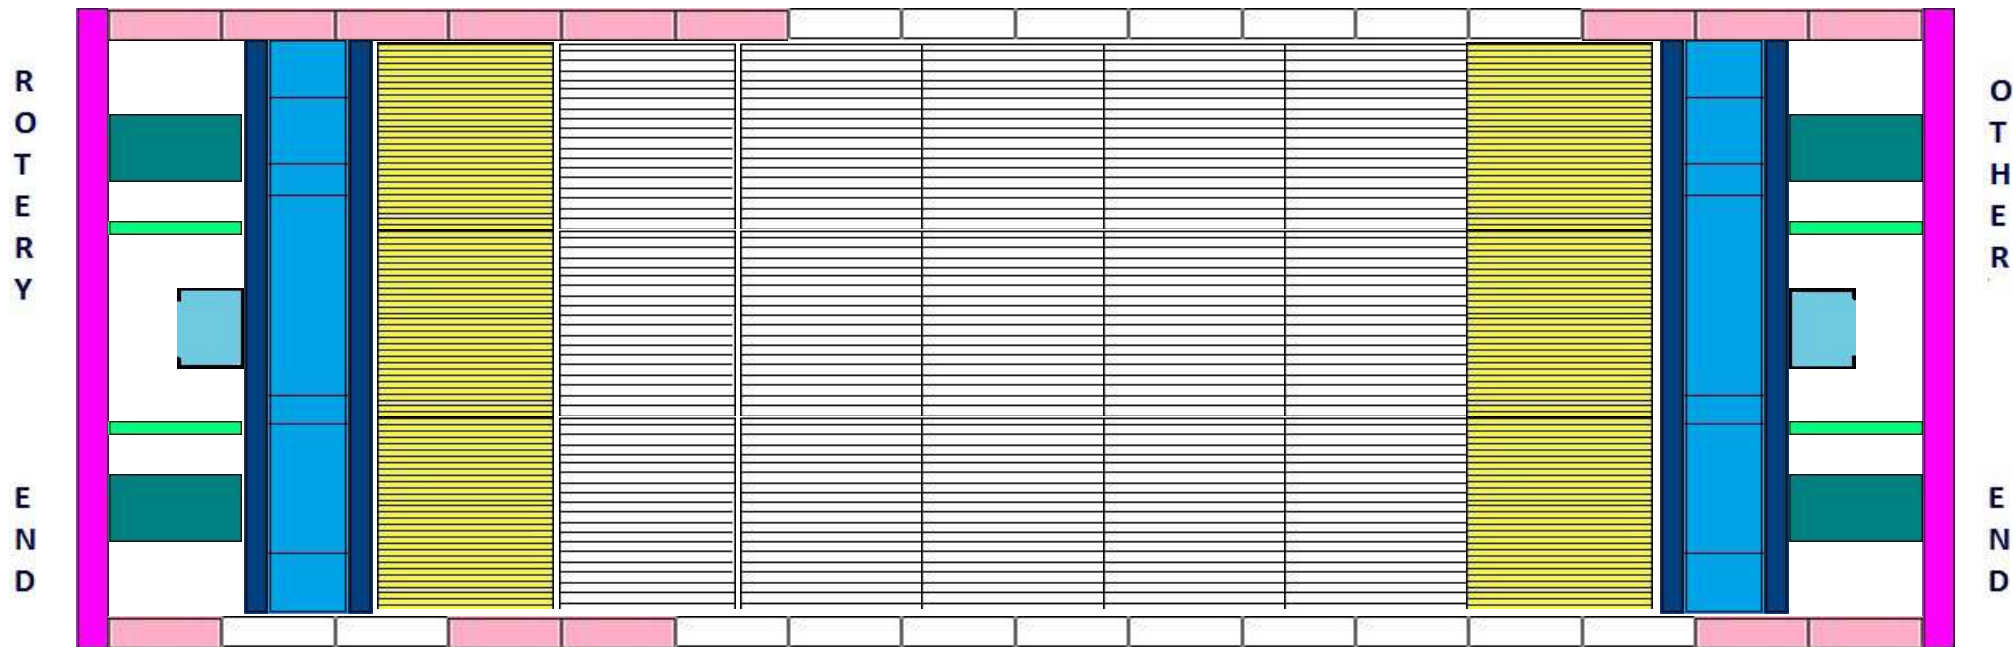
Rotary Side

Color	Particulars	Qty	Per%	Color	Particulars	Qty	Per%	Color	Particulars	Qty	Per%
	Headstock Beam	2	100%		Centre Stiffner for Headstock	4	100%		Floor Stiffner for Headstock	4	100%
	Aux. Head stock	4	100%		Sole Bar	7	44%		Draft Gear Bracket	2	100%
	Trough floor	2	29%		Centre plate	2	100%		SoleBar Stiffner	4	100%
	Bottom Wall Part	7	44%		Body panel/patch		100%		Door Top/Roof Patch		0%
	Window Module		0%		Window Sill	18	50%		Window Bar	28	16%
	Seat pillar/lav. Partition		100%		UIC end construction		0%

End Drooping: Rotary End - EAST : 2, WEST : 6 Other End - EAST : 4, WEST : -3
Start Date : 02-Sep-2019, Completion Date : 07-Sep-2019, Net Repair Days : 6, Total Man Hours : 1244

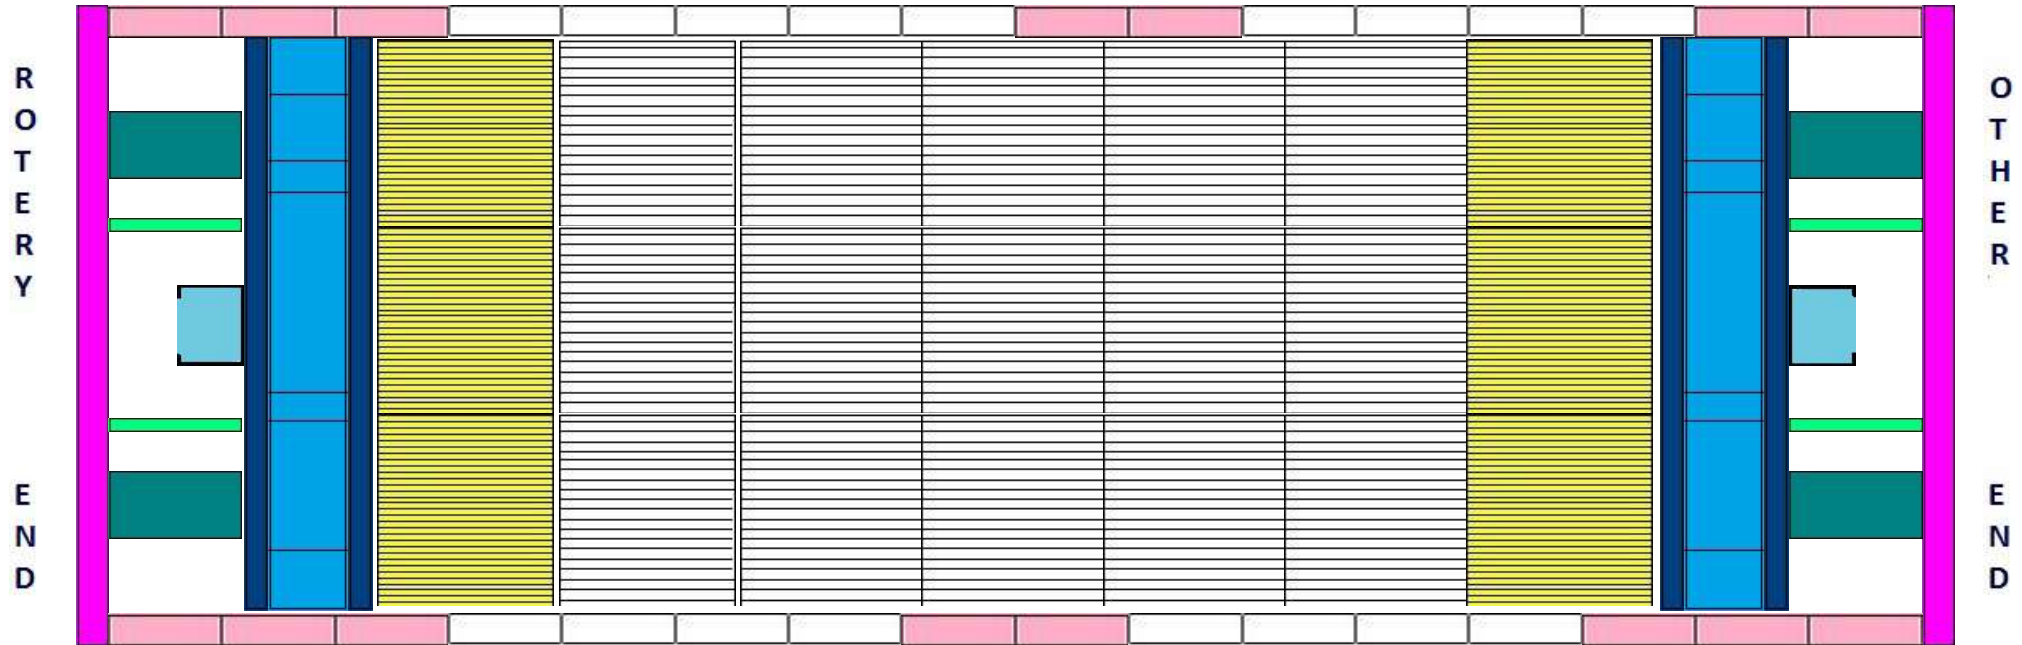
Color	Particulars	Qty	Per%	Color	Particulars	Qty	Per%	Color	Particulars	Qty	Per%
Yellow	Headstock Beam	2	100%	Dark Green	Centre Stiffner for Headstock	4	100%	Light Green	Floor Stiffner for Headstock	4	100%
Dark Blue	Aux. Head stock	4	100%	Pink	Sole Bar	7.5	47%	Light Blue	Draft Gear Bracket	2	100%
Yellow	Trough floor	2	29%	Light Blue	Centre plate	2	100%		SoleBar Stiffner	6	100%
	Bottom Wall Part	7.5	47%		Body panel/patch		100%		Door Top/Roof Patch		0%
	Window Module		0%		Window Sill	40	100%		Window Bar	48	27%
	Seat pillar/lav. Partition		100%		UIC end construction		0%

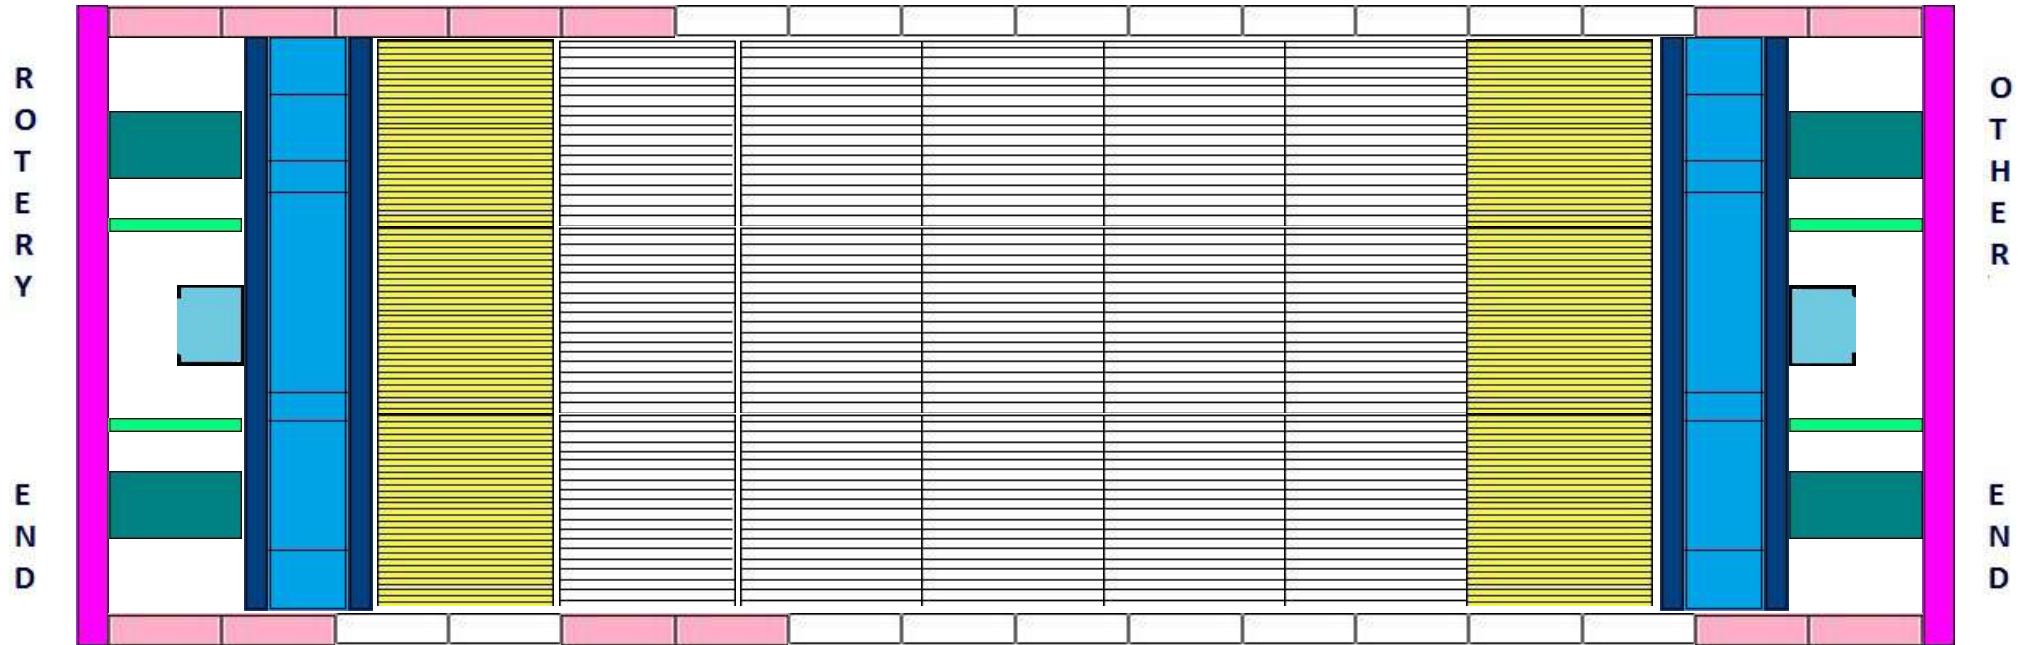
Rotary Side

Color	Particulars	Qty	Per%	Color	Particulars	Qty	Per%	Color	Particulars	Qty	Per%
	Headstock Beam	2	100%		Centre Stiffner for Headstock	4	100%		Floor Stiffner for Headstock	4	100%
	Aux. Head stock	4	100%		Sole Bar	6.5	41%		Draft Gear Bracket	2	100%
	Trough floor	2	29%		Centre plate	2	100%		SoleBar Stiffner	4	100%
	Bottom Wall Part	6.5	41%		Body panel/patch		100%		Door Top/Roof Patch		0%
	Window Module		0%		Window Sill	18	55%		Window Bar	40	28%
	Seat pillar/lav. Partition		100%		UIC end construction		0%

End Drooping: Rotary End - EAST : -5, WEST : -7 Other End - EAST : 5, WEST : 5
Start Date : 26-Nov-2019, Completion Date : 03-Dec-2019, Net Repair Days : 7, Total Man Hours : 1416

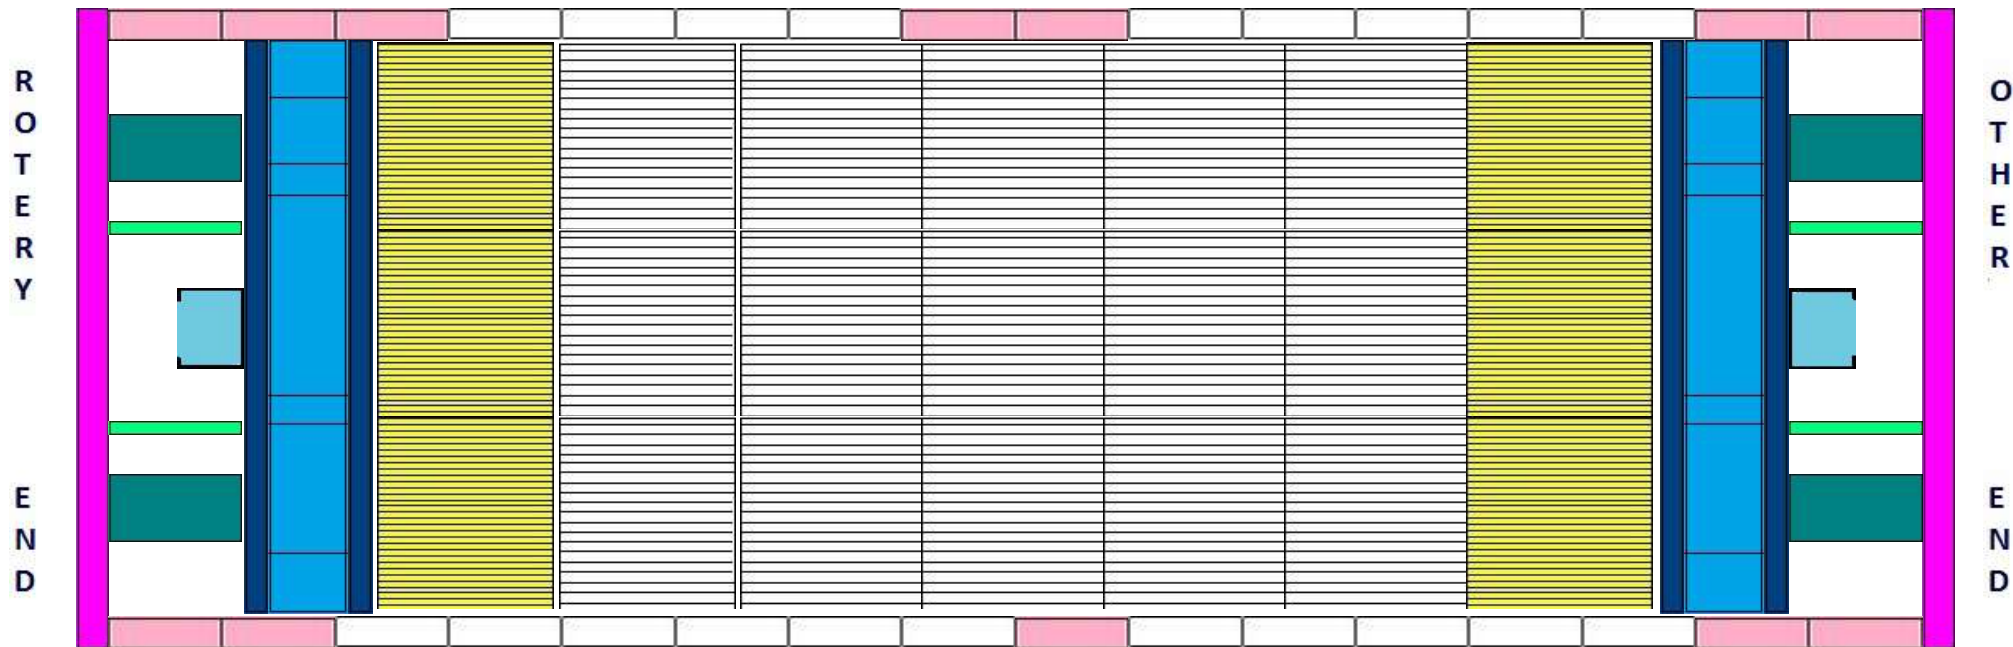
Rotary Side

Color	Particulars	Qty	Per%	Color	Particulars	Qty	Per%	Color	Particulars	Qty	Per%
	Headstock Beam	2	100%		Centre Stiffner for Headstock	4	100%		Floor Stiffner for Headstock	4	100%
	Aux. Head stock	4	100%		Sole Bar	6	38%		Draft Gear Bracket	2	100%
	Trough floor	2	29%		Centre plate	2	100%		SoleBar Stiffner	6	100%
	Bottom Wall Part	6	38%		Body panel/patch		100%		Door Top/Roof Patch		0%
	Window Module		0%		Window Sill	40	100%		Window Bar	44	25%
	Seat pillar/lav. Partition		100%		UIC end construction		0%

End Drooping: Rotary End - EAST : 4, WEST : -6 Other End - EAST : -4, WEST : -2
Start Date : 05-Nov-2019, Completion Date : 14-Nov-2019, Net Repair Days : 9, Total Man Hours : 1228

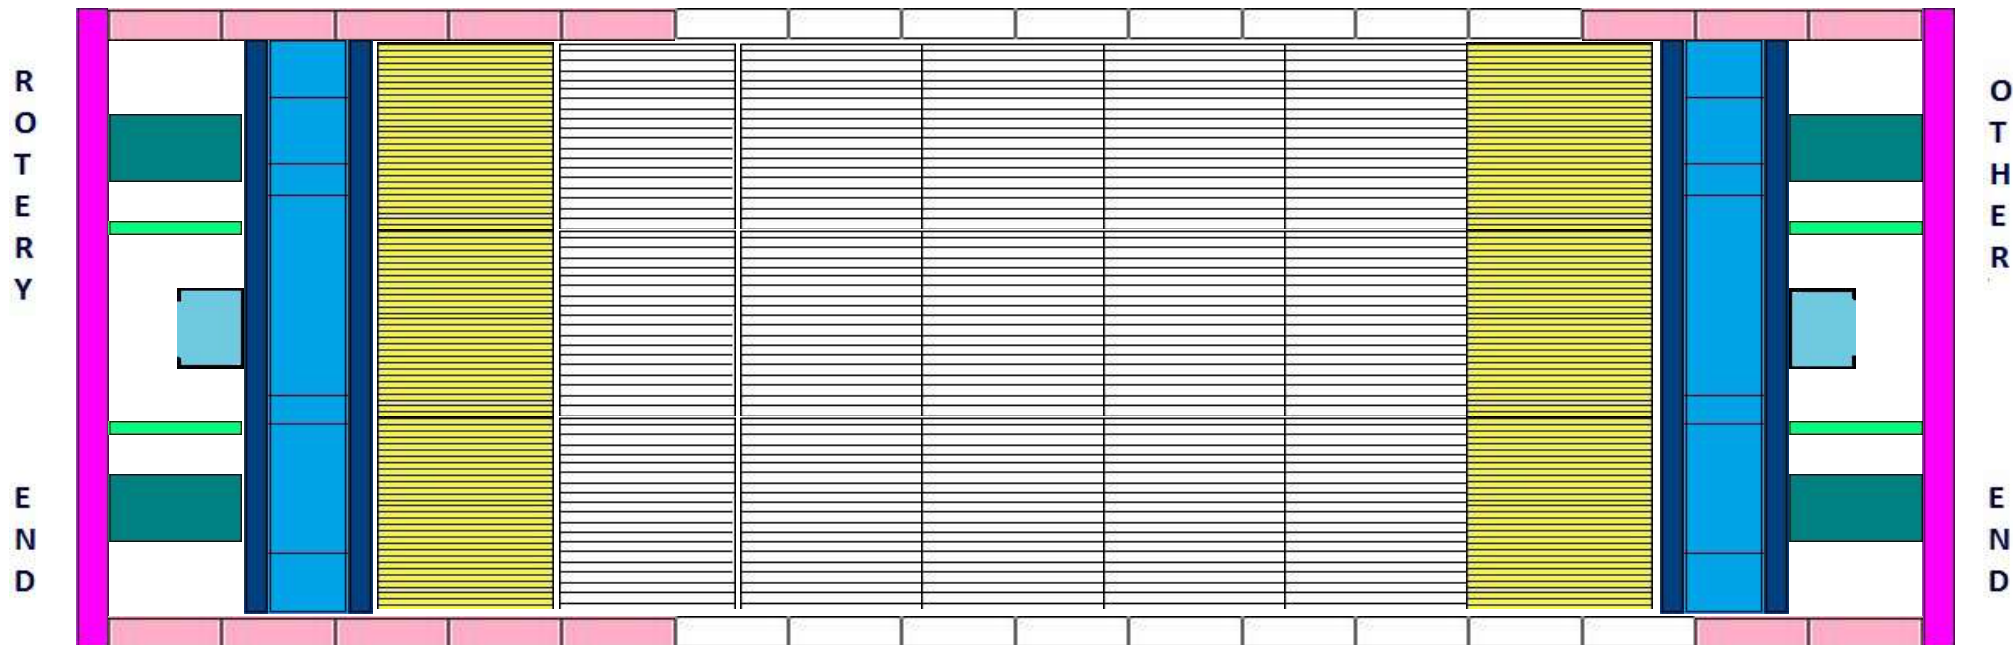
Color	Particulars	Qty	Per%	Color	Particulars	Qty	Per%	Color	Particulars	Qty	Per%
Yellow	Headstock Beam	2	100%	Dark Green	Centre Stiffner for Headstock	4	100%	Light Green	Floor Stiffner for Headstock	4	100%
Dark Blue	Aux. Head stock	4	100%	Pink	Sole Bar	7.5	47%	Light Blue	Draft Gear Bracket	2	100%
Yellow	Trough floor	2	29%	Light Blue	Centre plate	2	100%		SoleBar Stiffner	4	100%
	Bottom Wall Part	7.5	47%		Body panel/patch		100%		Door Top/Roof Patch		0%
	Window Module		0%		Window Sill	24	67%		Window Bar	44	27%
	Seat pillar/lav. Partition		100%		UIC end construction		0%

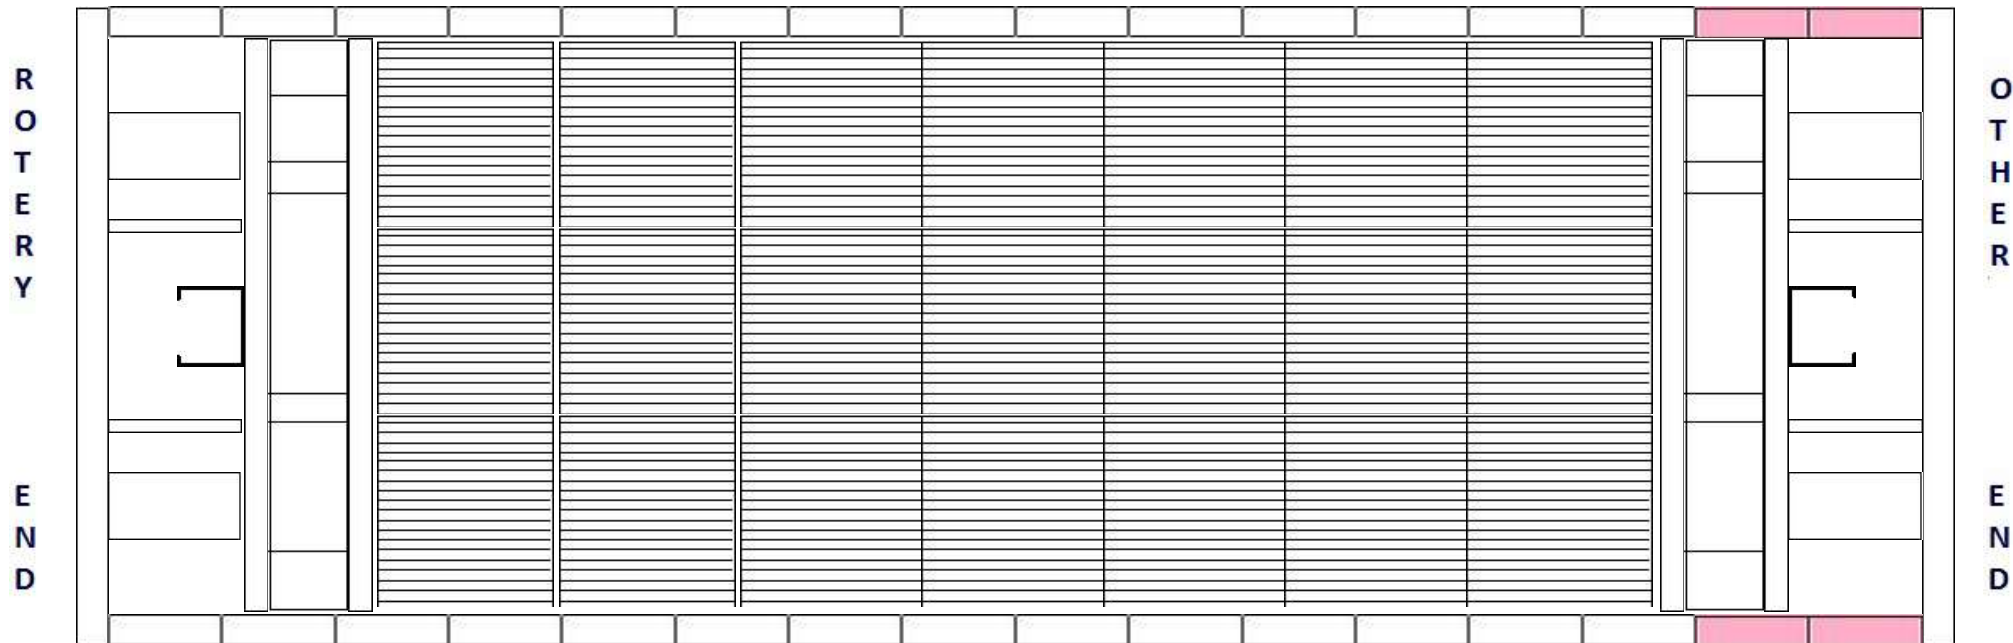
Rotary Side

Color	Particulars	Qty	Per%	Color	Particulars	Qty	Per%	Color	Particulars	Qty	Per%
	Headstock Beam	0	0%		Centre Stiffner for Headstock	0	0%		Floor Stiffner for Headstock	0	0%
	Aux. Head stock	0	0%		Sole Bar	2	13%		Draft Gear Bracket	0	0%
	Trough floor	0	0%		Centre plate	0	0%		SoleBar Stiffner	4	100%
	Bottom Wall Part	2	13%		Body panel/patch		15%		Door Top/Roof Patch		0%
	Window Module		0%		Window Sill	0	0%		Window Bar	0	0%
	Seat pillar/lav. Partition		100%		UIC end construction		0%

End Drooping: Rotary End - EAST : 0, WEST : 0 Other End - EAST : 0, WEST : 0
Start Date : 04-Oct-2019, Completion Date : 07-Oct-2019, Net Repair Days : 3, Total Man Hours : 528

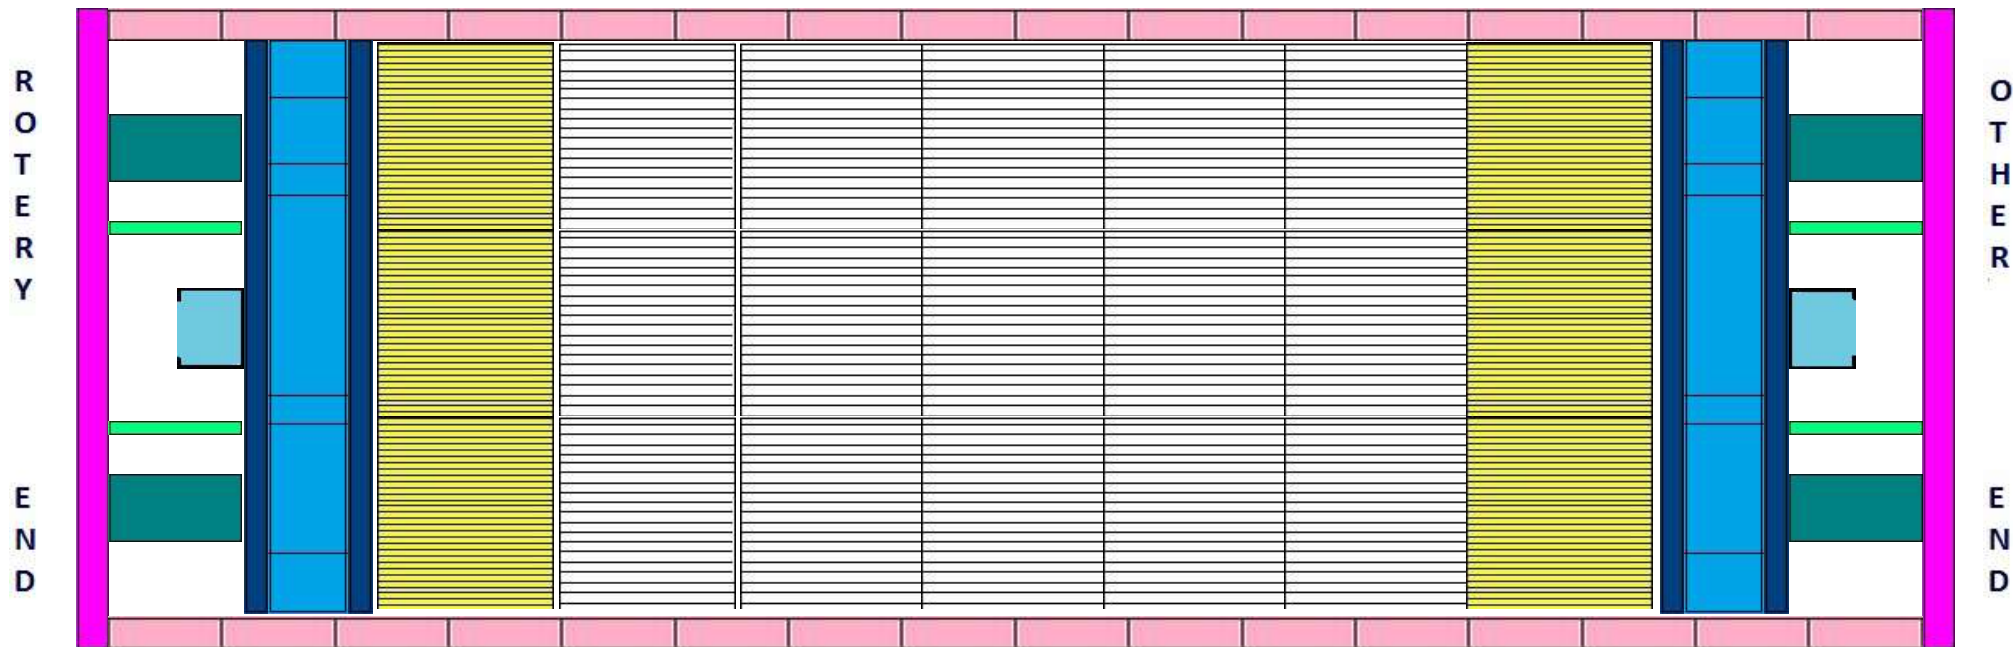
Rotary Side

Color	Particulars	Qty	Per%	Color	Particulars	Qty	Per%	Color	Particulars	Qty	Per%
Yellow	Headstock Beam	2	100%	Dark Green	Centre Stiffner for Headstock	4	100%	Light Green	Floor Stiffner for Headstock	4	100%
Dark Blue	Aux. Head stock	4	100%	Pink	Sole Bar	16	100%	Light Blue	Draft Gear Bracket	2	100%
Yellow	Trough floor	2	29%	Light Blue	Centre plate	2	100%		SoleBar Stiffner	6	100%
	Bottom Wall Part	16	100%		Body panel/patch		100%		Door Top/Roof Patch		0%
	Window Module		0%		Window Sill	24	60%		Window Bar	44	25%
	Seat pillar/lav. Partition		100%		UIC end construction		0%

End Drooping: Rotary End - EAST : 5, WEST : 6 Other End - EAST : -2, WEST : -5
Start Date : 09-Jan-2020, Completion Date : 16-Jan-2020, Net Repair Days : 7, Total Man Hours : 1104

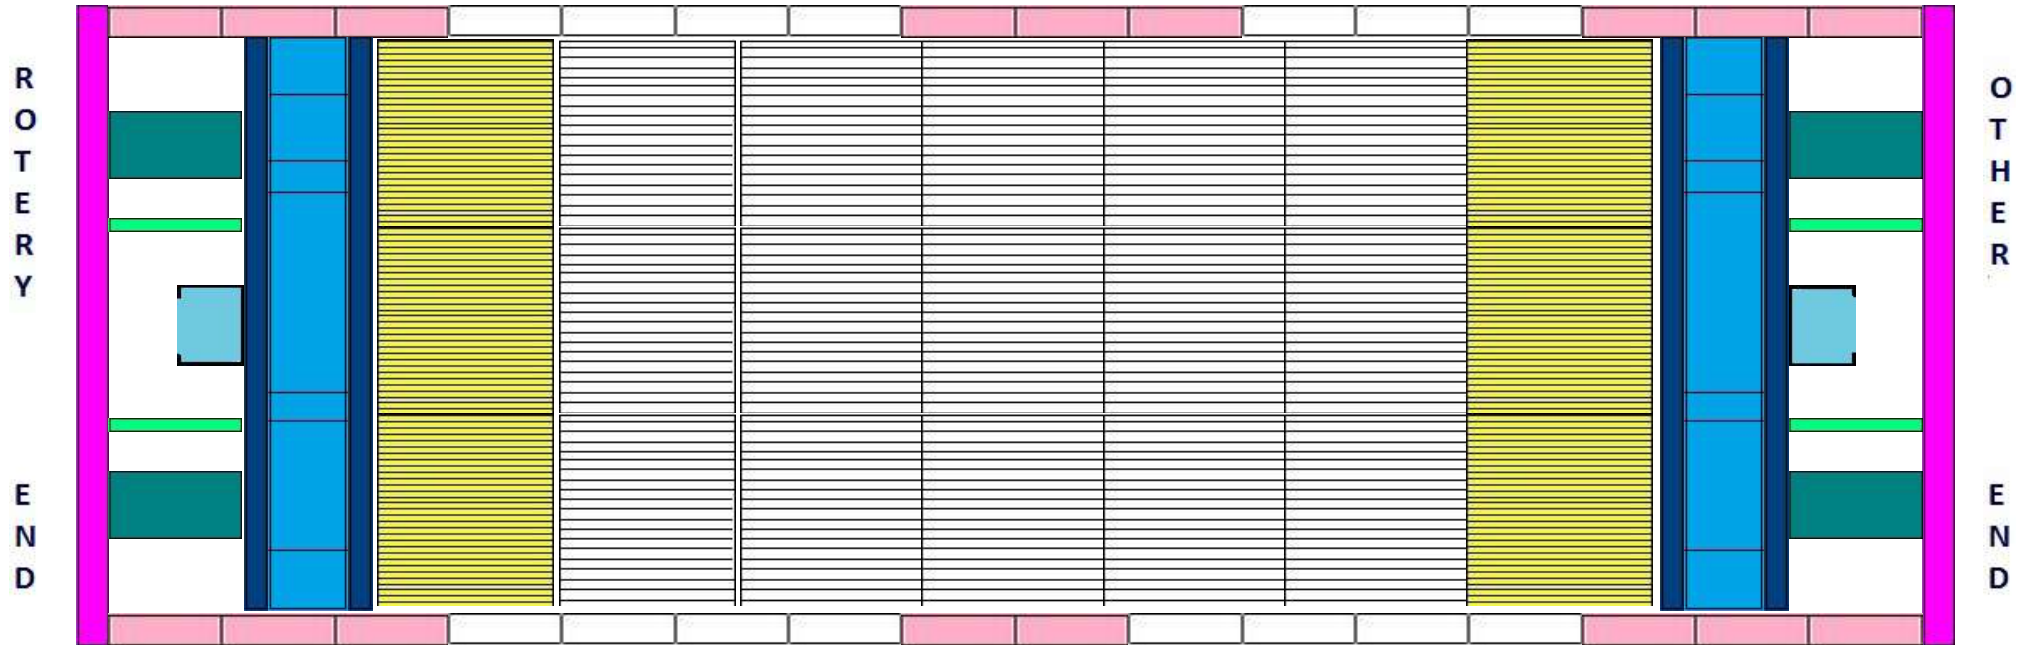
Rotary Side

Color	Particulars	Qty	Per%	Color	Particulars	Qty	Per%	Color	Particulars	Qty	Per%
Yellow	Headstock Beam	2	100%	Dark Green	Centre Stiffner for Headstock	4	100%	Light Green	Floor Stiffner for Headstock	4	100%
Dark Blue	Aux. Head stock	4	100%	Pink	Sole Bar	8.5	53%	Light Blue	Draft Gear Bracket	2	100%
Yellow	Trough floor	2	29%	Light Blue	Centre plate	2	100%		SoleBar Stiffner	6	100%
	Bottom Wall Part	8.5	53%		Body panel/patch		100%		Door Top/Roof Patch		0%
	Window Module		0%		Window Sill	14	35%		Window Bar	44	25%
	Seat pillar/lav. Partition		100%		UIC end construction		0%

End Drooping: Rotary End - EAST : 3, WEST : 5 Other End - EAST : 5, WEST : 2
Start Date : 09-Jan-2020, Completion Date : 17-Jan-2020, Net Repair Days : 8, Total Man Hours : 752

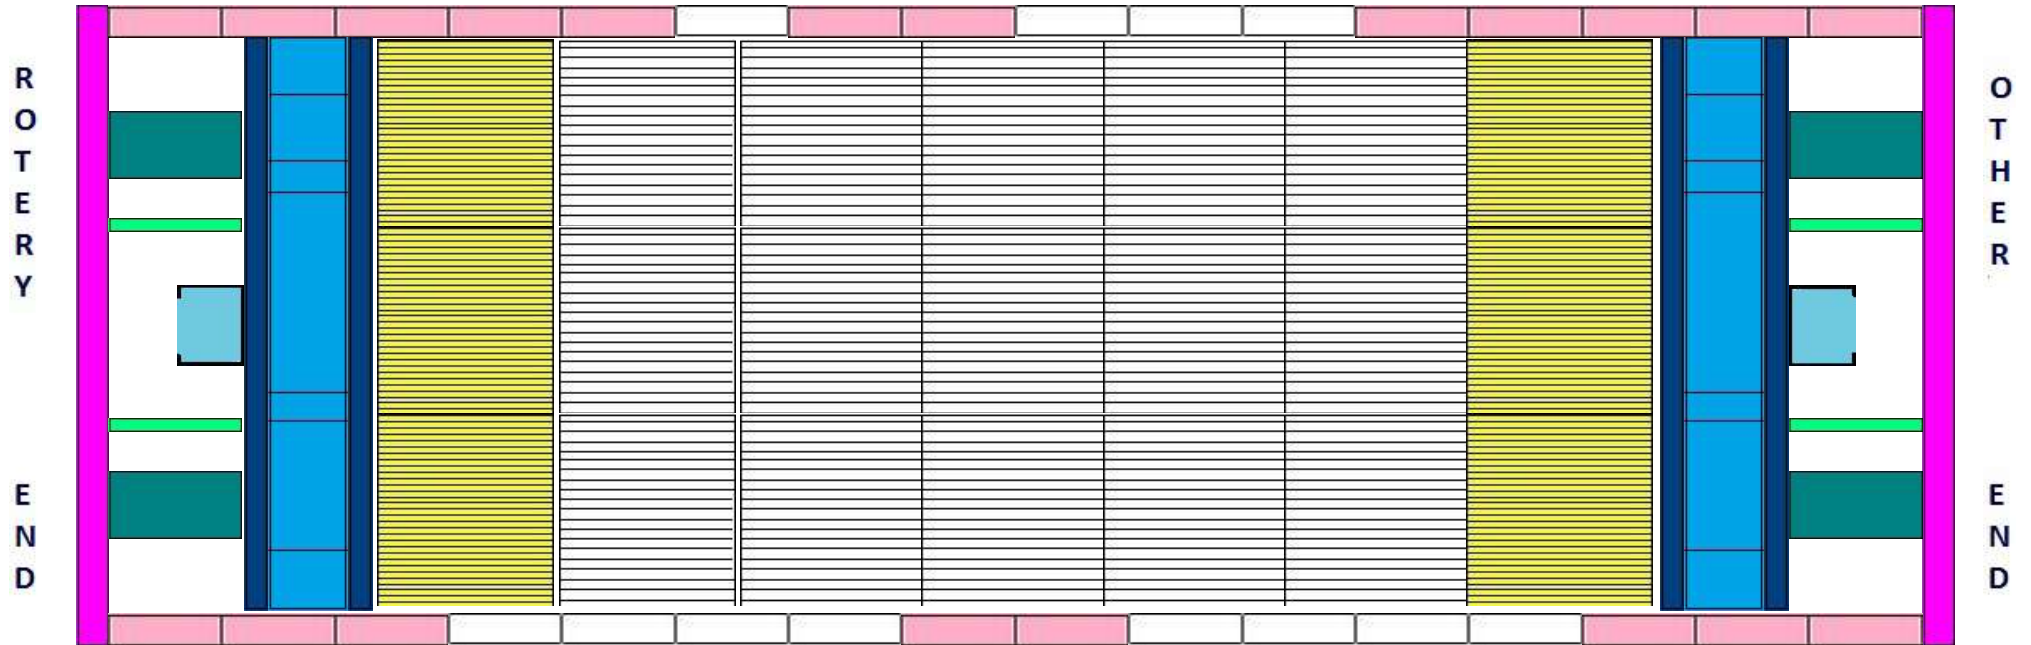
Rotary Side

Color	Particulars	Qty	Per%	Color	Particulars	Qty	Per%	Color	Particulars	Qty	Per%
	Headstock Beam	2	100%		Centre Stiffner for Headstock	4	100%		Floor Stiffner for Headstock	4	100%
	Aux. Head stock	4	100%		Sole Bar	10	63%		Draft Gear Bracket	2	100%
	Trough floor	2	29%		Centre plate	2	100%		SoleBar Stiffner	6	100%
	Bottom Wall Part	10	63%		Body panel/patch		100%		Door Top/Roof Patch		0%
	Window Module		0%		Window Sill	7	18%		Window Bar	40	23%
	Seat pillar/lav. Partition		100%		UIC end construction		0%

End Drooping: Rotary End - EAST : 3, WEST : 5 Other End - EAST : 0, WEST : 5
Start Date : 22-Jan-2020, Completion Date : 01-Feb-2020, Net Repair Days : 10, Total Man Hours : 824

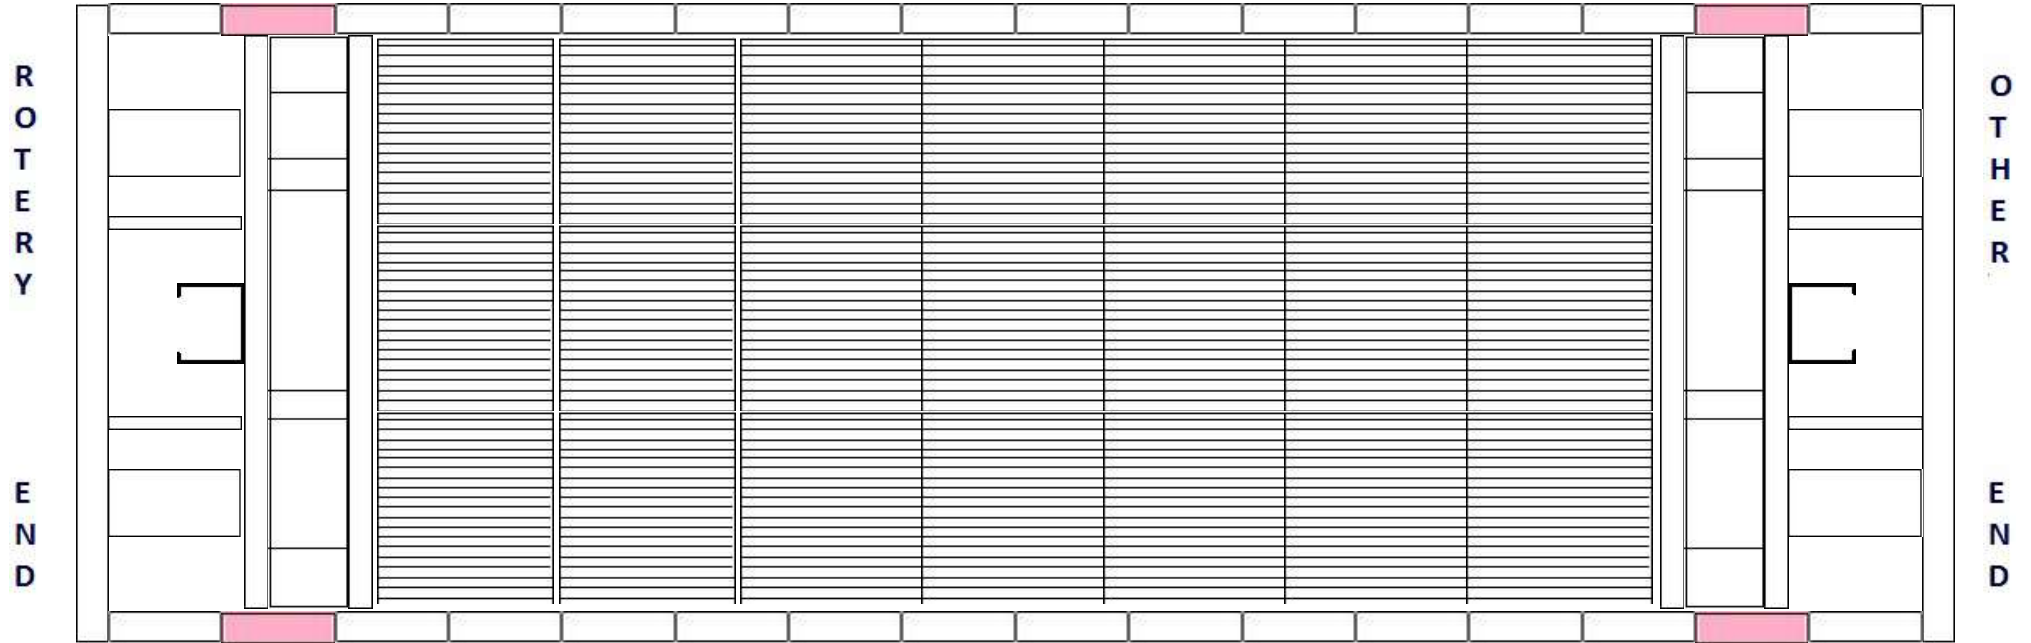
Rotary Side

Color	Particulars	Qty	Per%	Color	Particulars	Qty	Per%	Color	Particulars	Qty	Per%
	Headstock Beam	0	0%		Centre Stiffner for Headstock	0	0%		Floor Stiffner for Headstock	0	0%
	Aux. Head stock	0	0%		Sole Bar	2	13%		Draft Gear Bracket	0	0%
	Trough floor	0	0%		Centre plate	0	0%		SoleBar Stiffner	4	100%
	Bottom Wall Part	2	13%		Body panel/patch		20%		Door Top/Roof Patch		0%
	Window Module		0%		Window Sill	0	0%		Window Bar	0	0%
	Seat pillar/lav. Partition		100%		UIC end construction		0%

End Drooping: Rotary End - EAST : 0, WEST : 0 Other End - EAST : 0, WEST : 0
Start Date : 06-Feb-2020, Completion Date : 10-Feb-2020, Net Repair Days : 4, Total Man Hours : 0

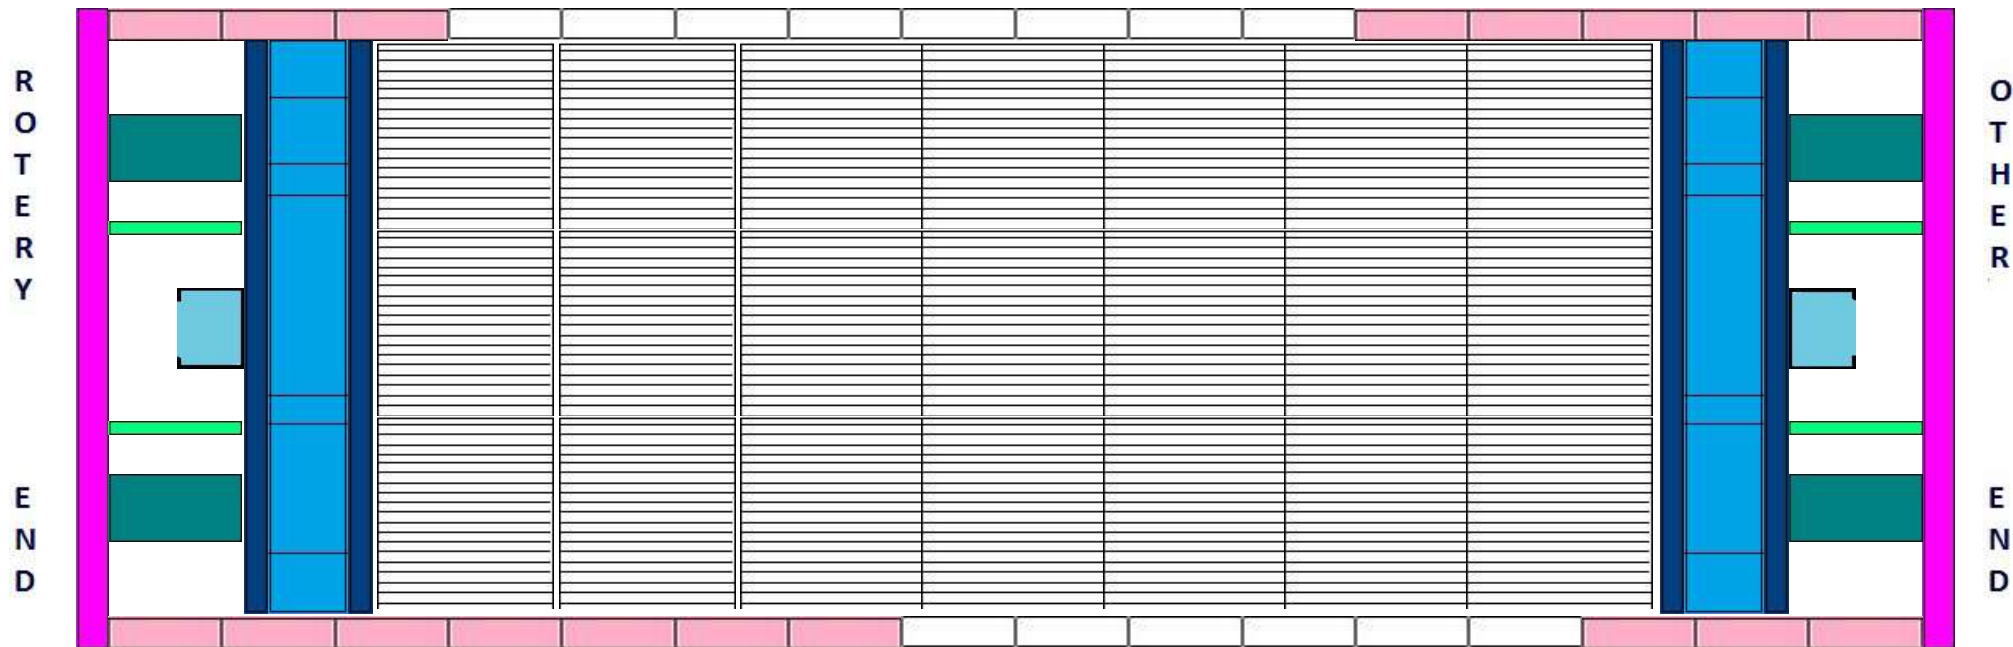
Rotary Side

Color	Particulars	Qty	Per%	Color	Particulars	Qty	Per%	Color	Particulars	Qty	Per%
	Headstock Beam	2	100%		Centre Stiffner for Headstock	4	100%		Floor Stiffner for Headstock	4	100%
	Aux. Head stock	4	100%		Sole Bar	9	56%		Draft Gear Bracket	2	100%
	Trough floor	0	0%		Centre plate	2	100%		SoleBar Stiffner	4	100%
	Bottom Wall Part	9	56%		Body panel/patch		100%		Door Top/Roof Patch		0%
	Window Module		2%		Window Sill	0	0%		Window Bar	0	0%
	Seat pillar/lav. Partition		100%		UIC end construction		0%

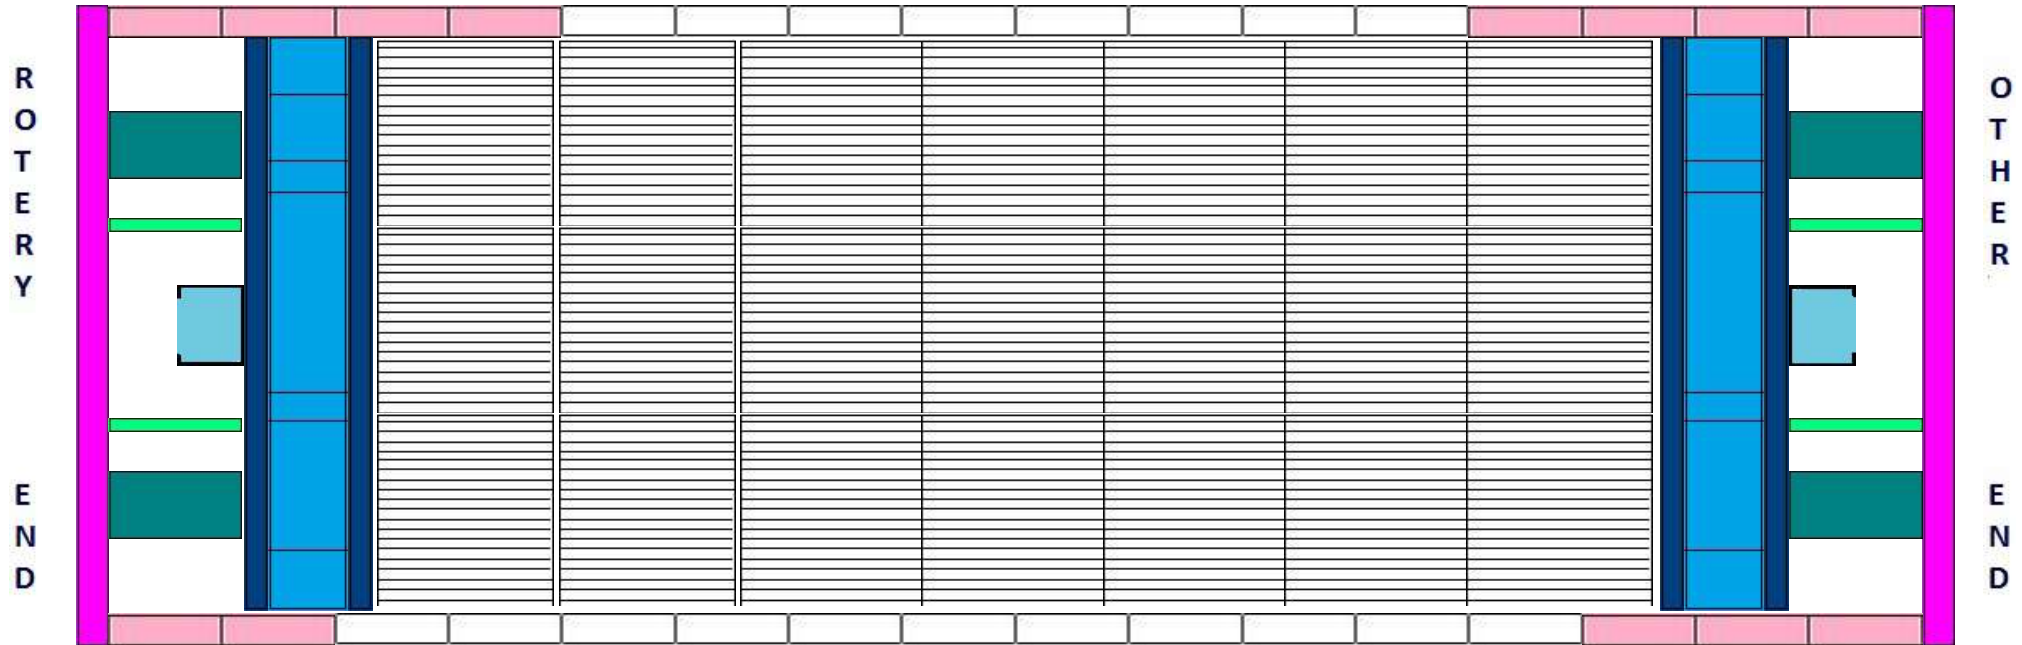
Rotary Side

Color	Particulars	Qty	Per%	Color	Particulars	Qty	Per%	Color	Particulars	Qty	Per%
Blue	Headstock Beam	2	100%	Red	Centre Stiffner for Headstock	4	100%	Green	Floor Stiffner for Headstock	4	100%
Black	Aux. Head stock	4	100%	Blue	Sole Bar	6.5	41%	Yellow	Draft Gear Bracket	2	100%
Orange	Trough floor	0	0%	Red	Centre plate	2	100%	Black	SoleBar Stiffner	4	100%
	Bottom Wall Part	6.5	41%		Body panel/patch		100%		Door Top/Roof Patch		0%
	Window Module		5%		Window Sill	0	0%		Window Bar	0	0%
	Seat pillar/lav. Partition		100%		UIC end construction		0%

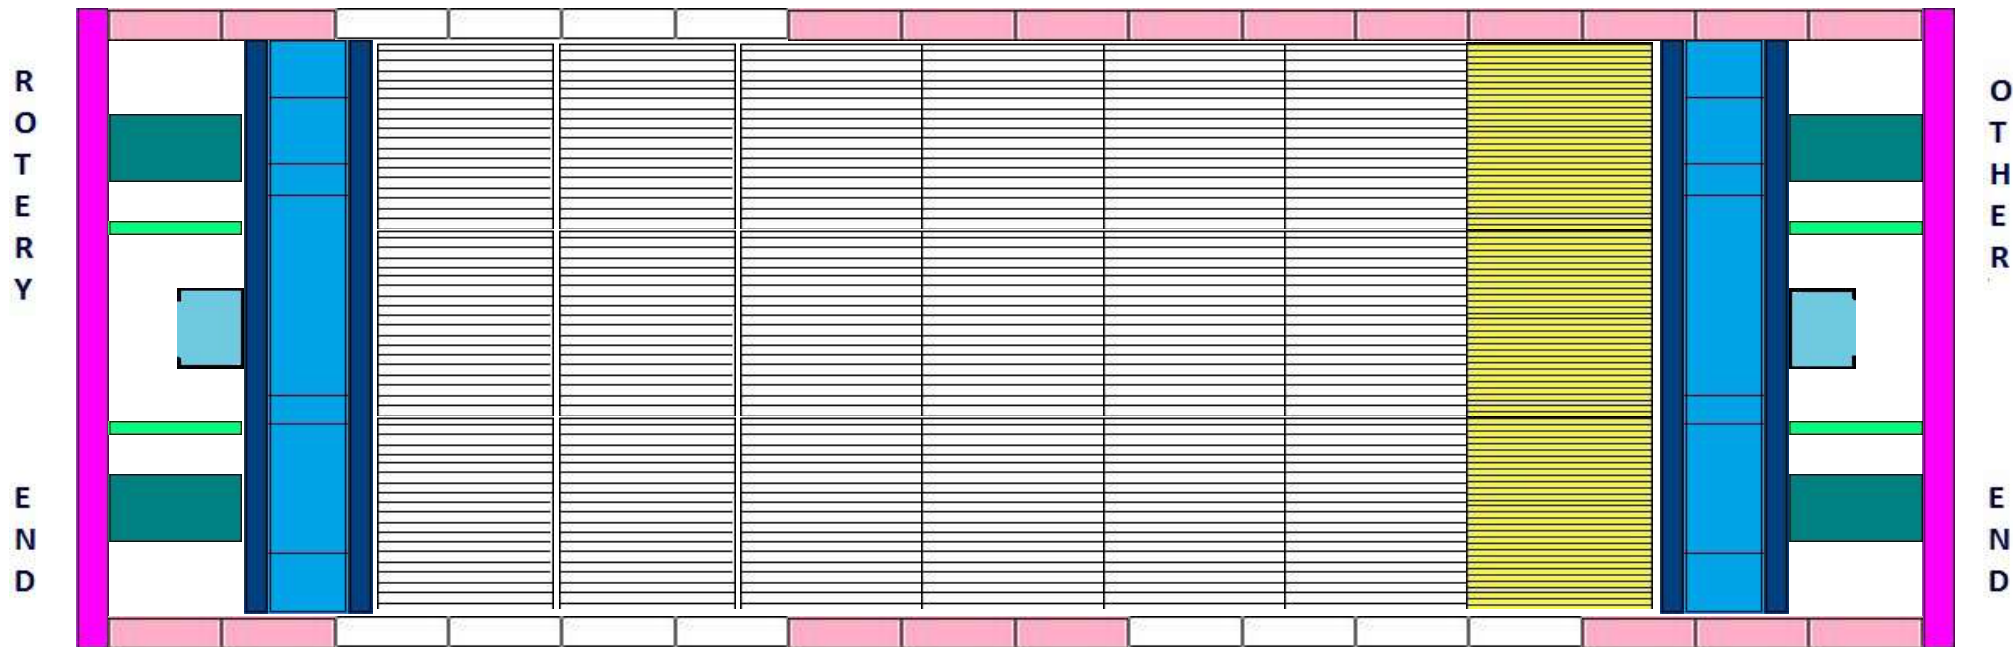
Color	Particulars	Qty	Per%	Color	Particulars	Qty	Per%	Color	Particulars	Qty	Per%
Blue	Headstock Beam	2	100%	Red	Centre Stiffner for Headstock	4	100%	Green	Floor Stiffner for Headstock	4	100%
Black	Aux. Head stock	4	100%	Yellow	Sole Bar	10	63%	Light Blue	Draft Gear Bracket	2	100%
Orange	Trough floor	1	14%	Dark Blue	Centre plate	2	100%		SoleBar Stiffner	4	100%
	Bottom Wall Part	10	63%		Body panel/patch		100%		Door Top/Roof Patch		0%
	Window Module		2%		Window Sill	0	0%		Window Bar	0	0%
	Seat pillar/lav. Partition		100%		UIC end construction		0%
