Coach Rehabilitation Workshop, WC Railway, Bhopal

(An IMS and ISO 50001 Certified Workshop)
Final Inspection Sheet - Details of Corrosion Repair

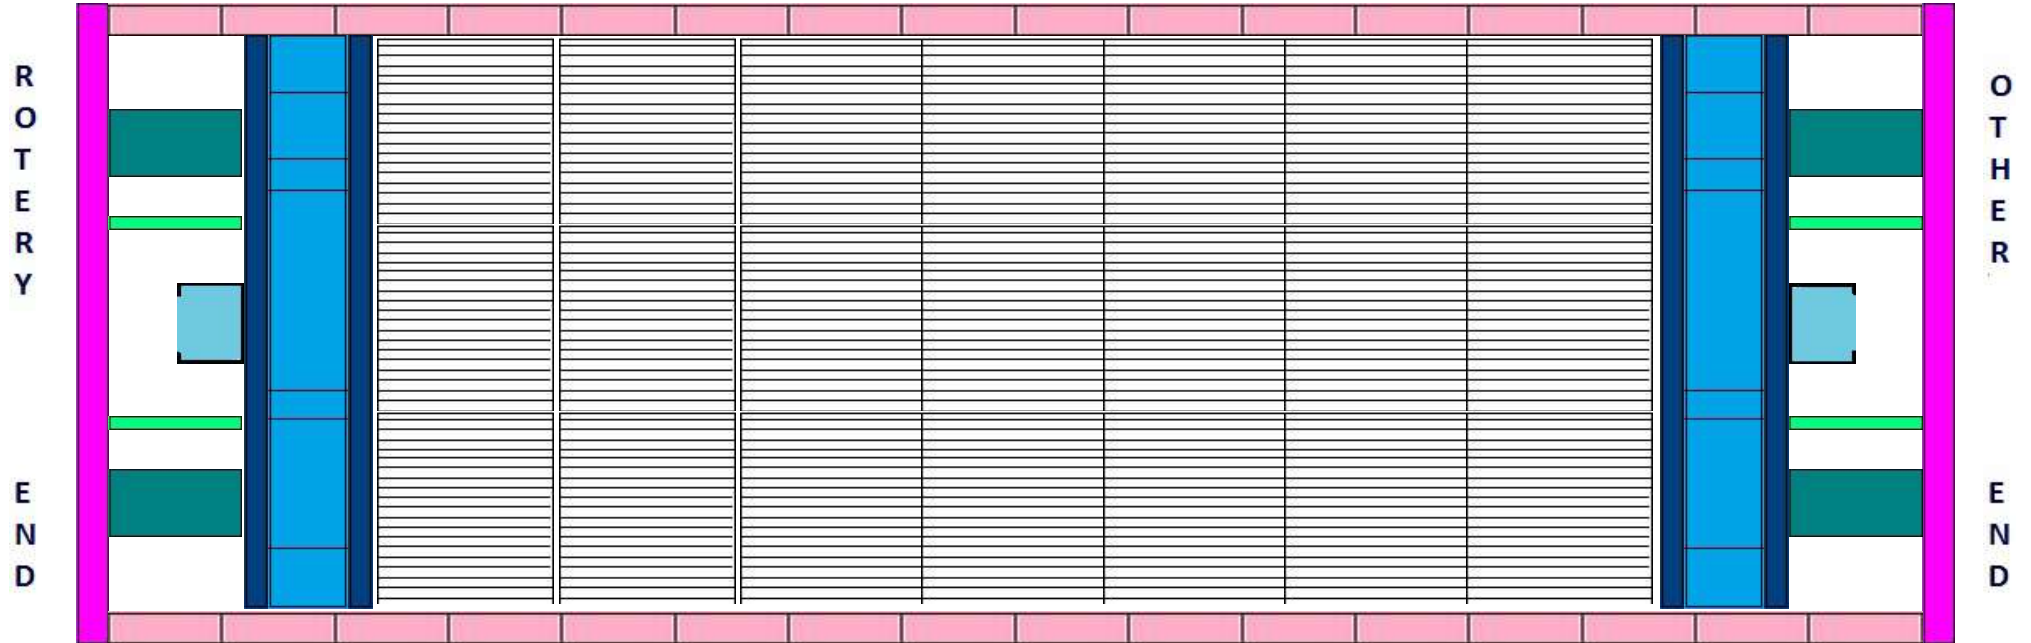
Rotary Side

Color	Particulars	Qty	Per%	Color	Particulars	Qty	Per%	Color	Particulars	Qty	Per%
Yellow	Headstock Beam	2	100%	Blue	Centre Stiffner for Headstock	4	100%	Red	Floor Stiffner for Headstock	4	100%
Green	Aux. Head stock	4	100%	Yellow	Sole Bar	16	100%	Blue	Draft Gear Bracket	2	100%
Red	Trough floor	0	0%	Blue	Centre plate	2	100%		SoleBar Stiffner	4	100%
	Bottom Wall Part	16	100%		Body panel/patch		100%		Door Top/Roof Patch		0%
	Window Module		0%		Window Sill	0	0%		Window Bar	0	0%
	Seat pillar/lav. Partition		100%		UIC end construction		0%

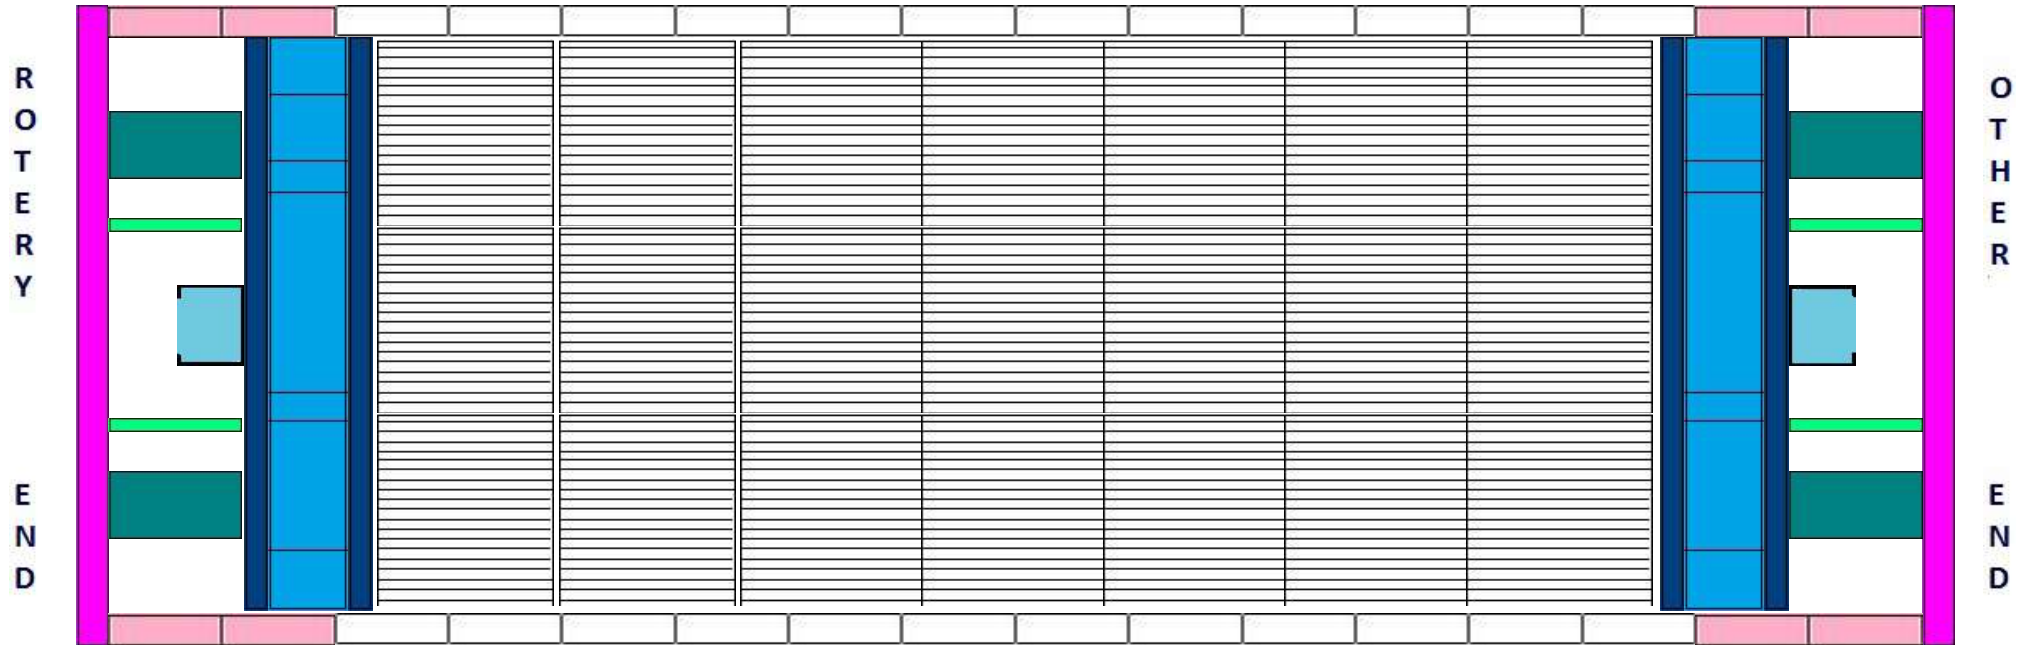
Rotary Side

Color	Particulars	Qty	Per%	Color	Particulars	Qty	Per%	Color	Particulars	Qty	Per%
Blue	Headstock Beam	2	100%	Red	Centre Stiffner for Headstock	4	100%	Green	Floor Stiffner for Headstock	4	100%
Black	Aux. Head stock	4	100%	Yellow	Sole Bar	4	25%	Light Blue	Draft Gear Bracket	2	100%
Orange	Trough floor	0	0%	Dark Blue	Centre plate	2	100%		SoleBar Stiffner	4	100%
	Bottom Wall Part	4	25%		Body panel/patch		100%		Door Top/Roof Patch		0%
	Window Module		0%		Window Sill	0	0%		Window Bar	0	0%
	Seat pillar/lav. Partition		100%		UIC end construction		0%

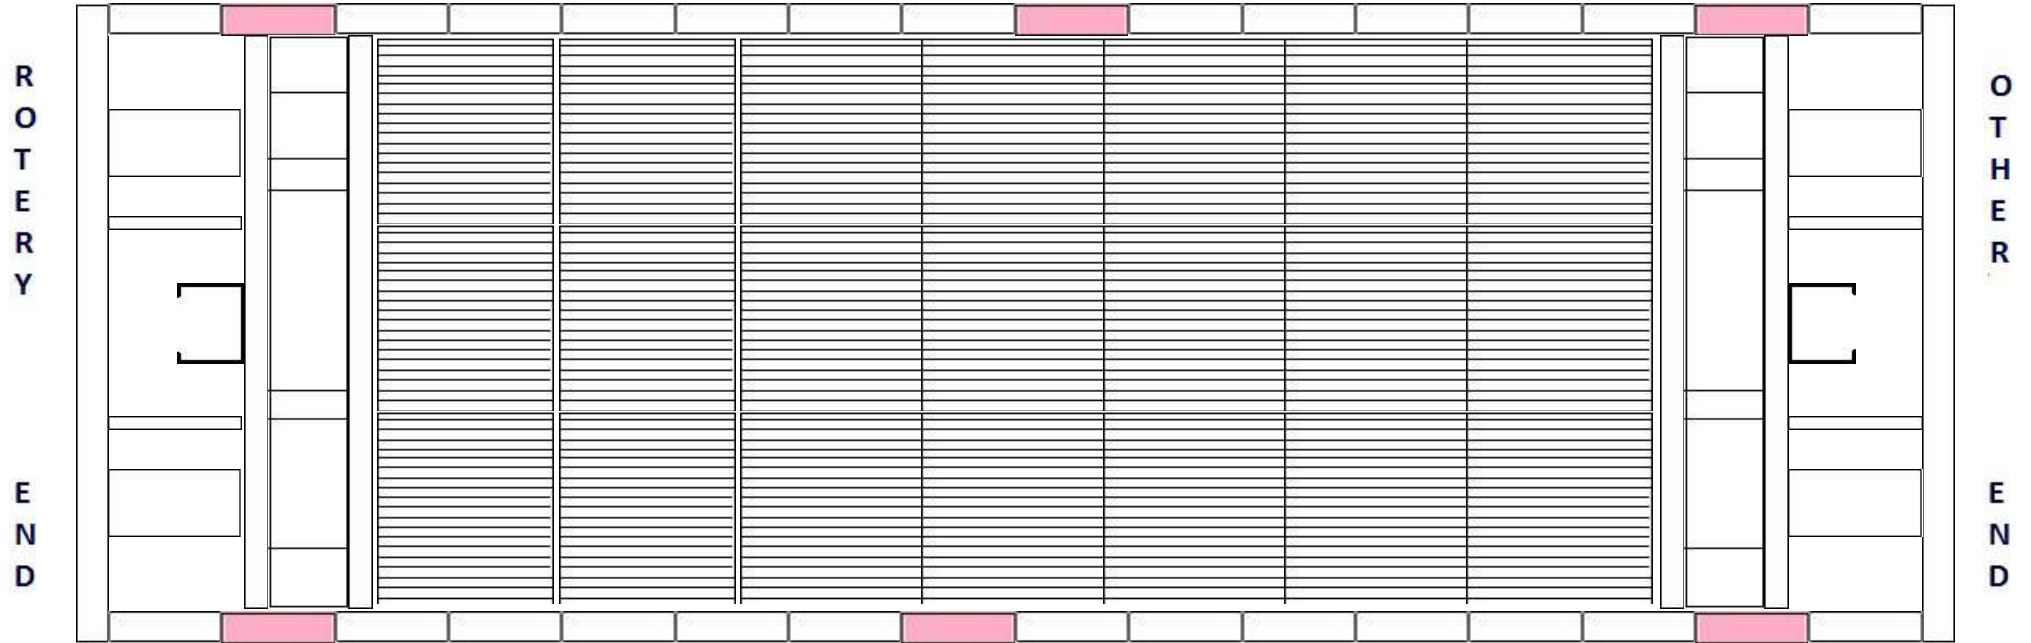
Rotary Side

Color	Particulars	Qty	Per%	Color	Particulars	Qty	Per%	Color	Particulars	Qty	Per%
	Headstock Beam	0	0%		Centre Stiffner for Headstock	0	0%		Floor Stiffner for Headstock	0	0%
	Aux. Head stock	0	0%		Sole Bar	3	19%		Draft Gear Bracket	0	0%
	Trough floor	0	0%		Centre plate	0	0%		SoleBar Stiffner	4	100%
	Bottom Wall Part	3	19%		Body panel/patch		0%		Door Top/Roof Patch		100%
	Window Module		0%		Window Sill	0	0%		Window Bar	0	0%
	Seat pillar/lav. Partition		100%		UIC end construction		0%

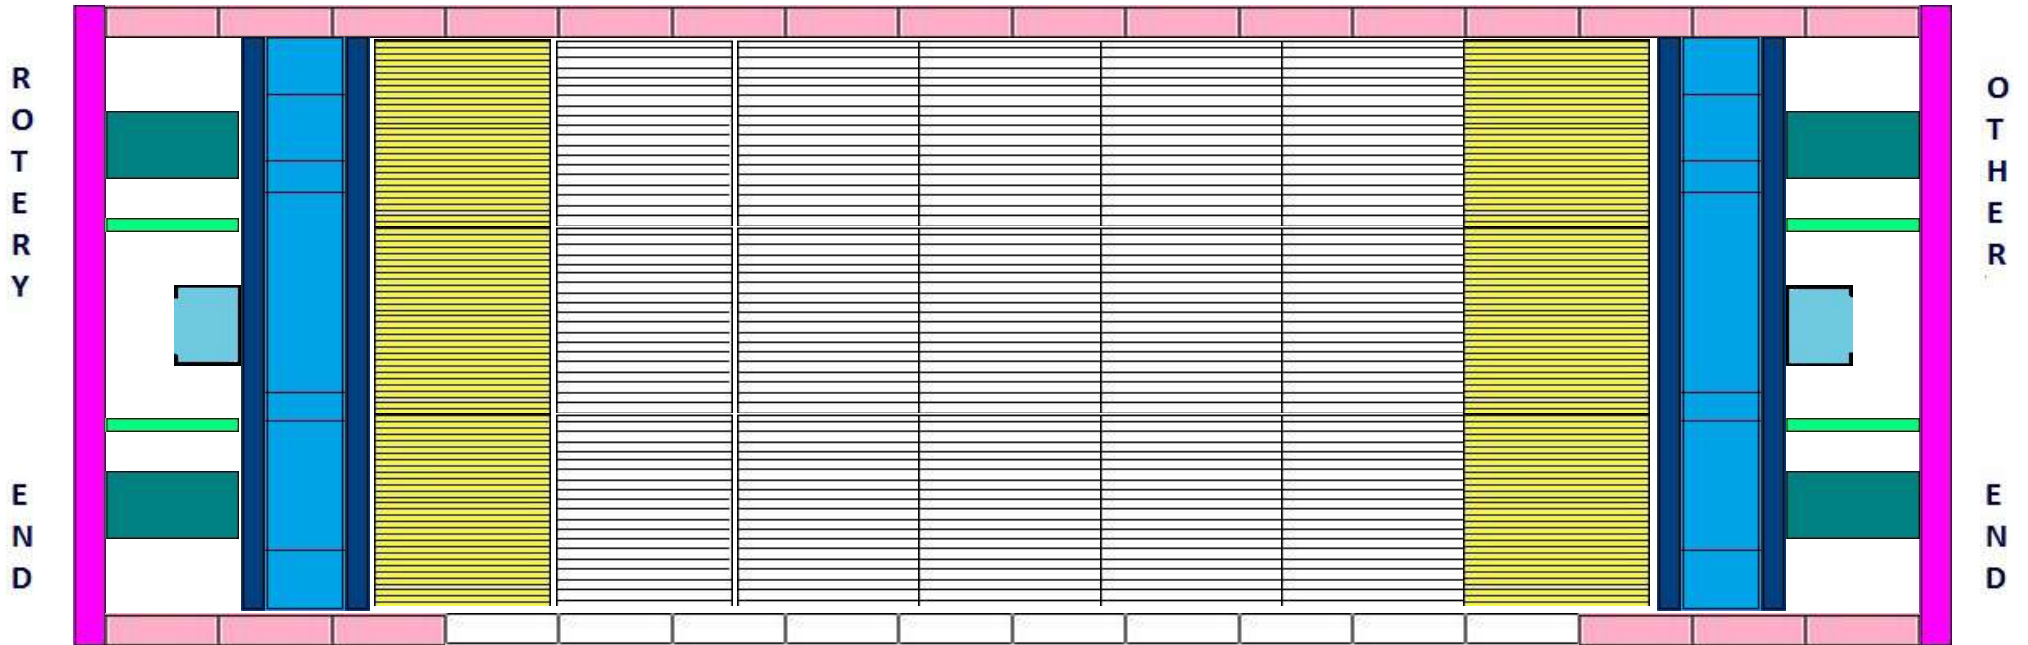
Rotary Side

Color	Particulars	Qty	Per%	Color	Particulars	Qty	Per%	Color	Particulars	Qty	Per%
Blue	Headstock Beam	2	100%	Green	Centre Stiffner for Headstock	4	100%	Red	Floor Stiffner for Headstock	4	100%
Black	Aux. Head stock	4	100%	Yellow	Sole Bar	11	69%	Light Blue	Draft Gear Bracket	2	100%
Orange	Trough floor	2	29%	Dark Blue	Centre plate	2	100%		SoleBar Stiffner	4	100%
	Bottom Wall Part	11	69%		Body panel/patch		100%		Door Top/Roof Patch		0%
	Window Module		5%		Window Sill	0	0%		Window Bar	0	0%
	Seat pillar/lav. Partition		100%		UIC end construction		0%

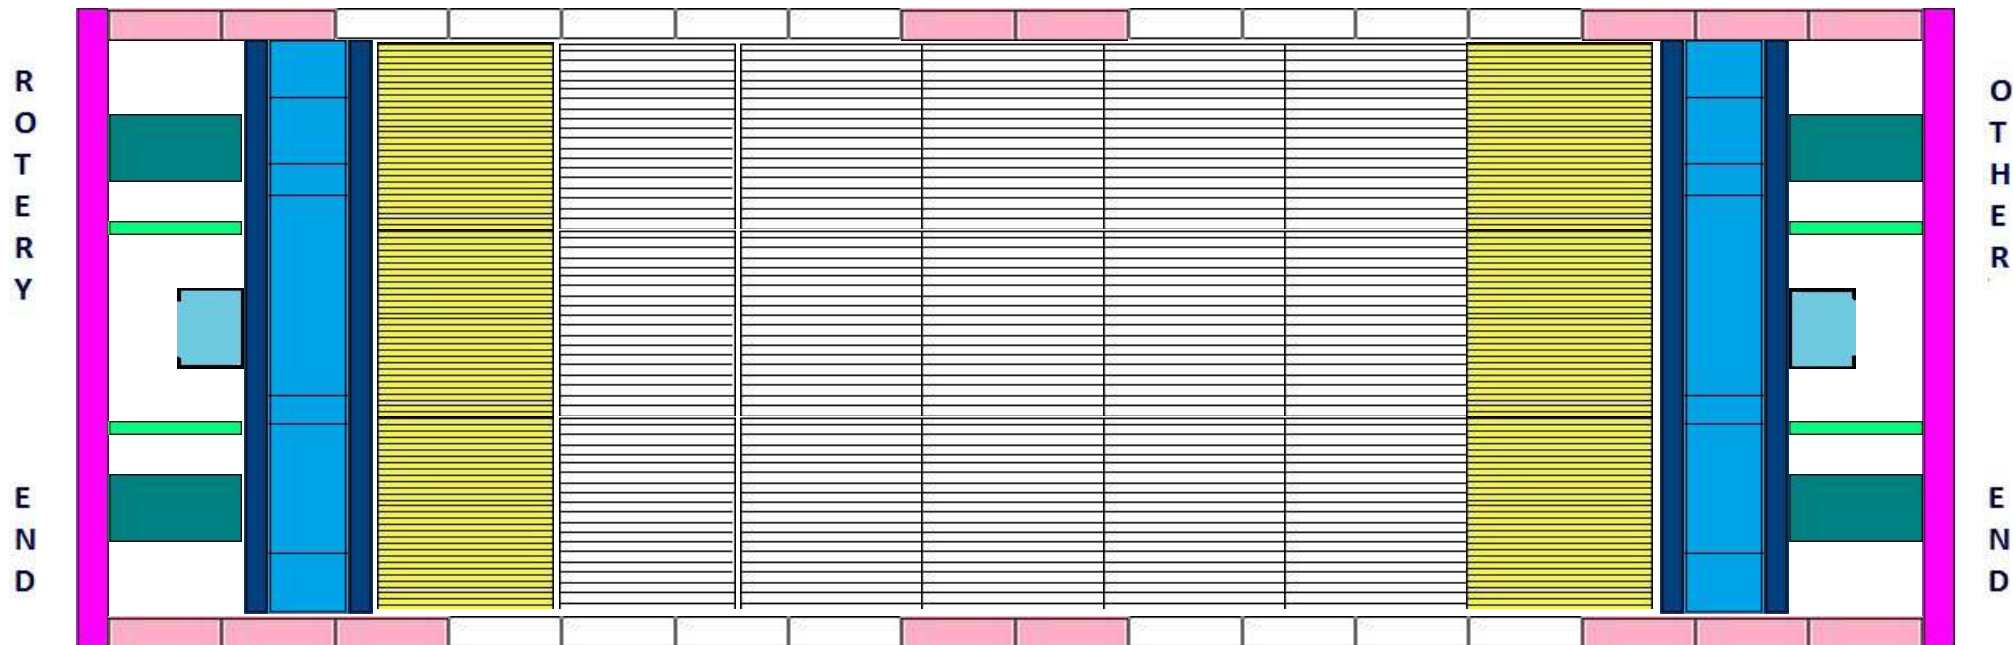
Color	Particulars	Qty	Per%	Color	Particulars	Qty	Per%	Color	Particulars	Qty	Per%
Yellow	Headstock Beam	2	100%	Dark Green	Centre Stiffner for Headstock	4	100%	Light Green	Floor Stiffner for Headstock	4	100%
Dark Blue	Aux. Head stock	4	100%	Pink	Sole Bar	7.5	47%	Light Blue	Draft Gear Bracket	2	100%
Yellow	Trough floor	2	29%	Light Blue	Centre plate	2	100%		SoleBar Stiffner	6	100%
	Bottom Wall Part	7.5	47%		Body panel/patch		100%		Door Top/Roof Patch		0%
	Window Module		0%		Window Sill	18	45%		Window Bar	40	23%
	Seat pillar/lav. Partition		100%		UIC end construction		0%

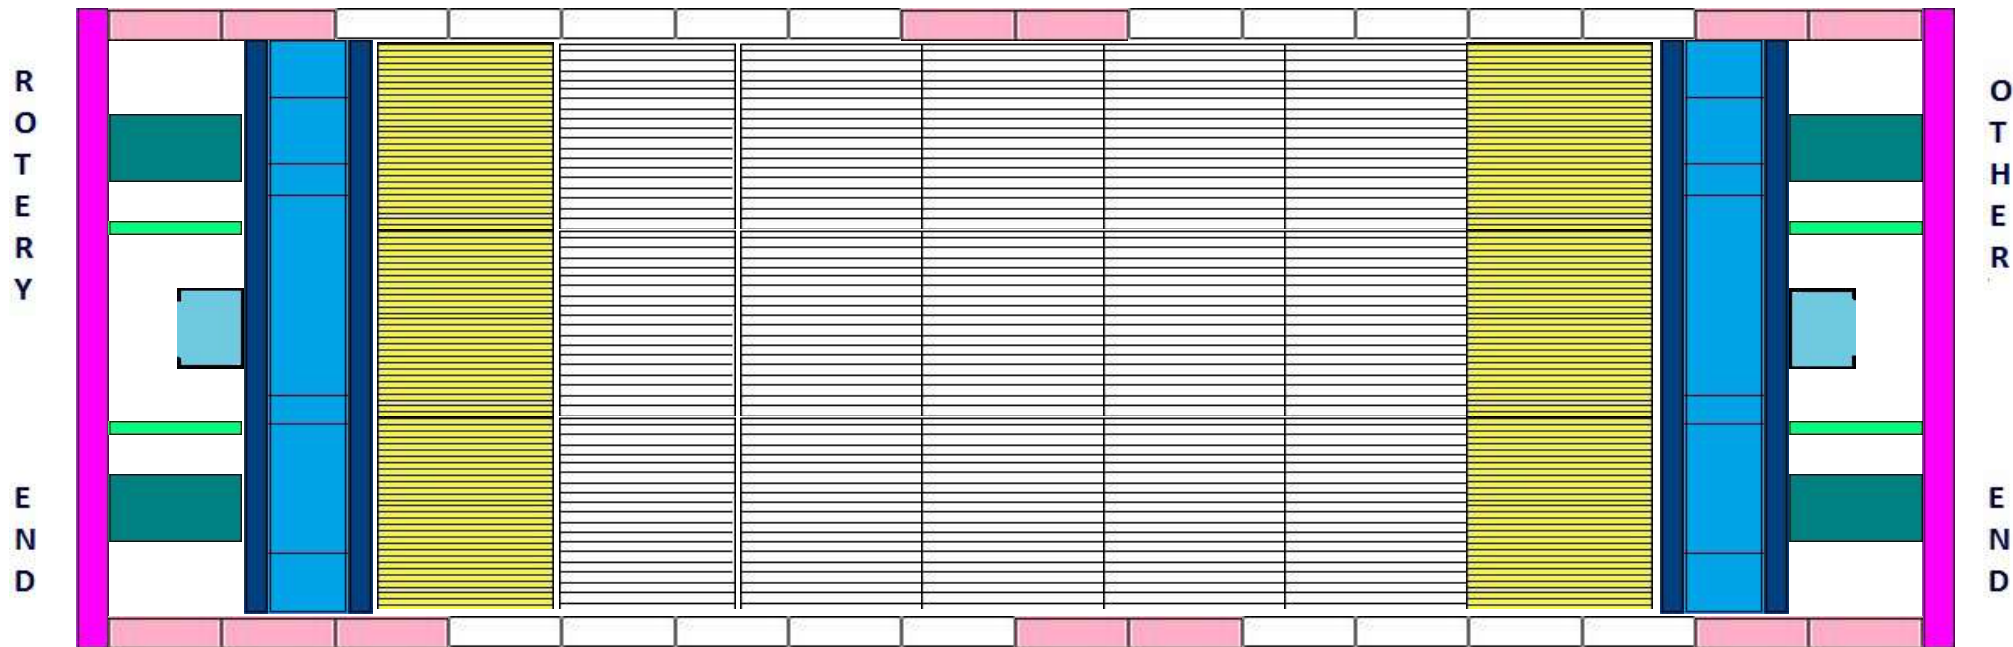
Rotary Side

Color	Particulars	Qty	Per%	Color	Particulars	Qty	Per%	Color	Particulars	Qty	Per%
 	Headstock Beam	2	100%	 	Centre Stiffner for Headstock	4	100%	 	Floor Stiffner for Headstock	4	100%
 	Aux. Head stock	4	100%	 	Sole Bar	6.5	41%	 	Draft Gear Bracket	2	100%
 	Trough floor	2	29%	 	Centre plate	2	100%		SoleBar Stiffner	6	100%
	Bottom Wall Part	6.5	41%		Body panel/patch		100%		Door Top/Roof Patch		0%
	Window Module		0%		Window Sill	28	70%		Window Bar	46	26%
	Seat pillar/lav. Partition		100%		UIC end construction		0%

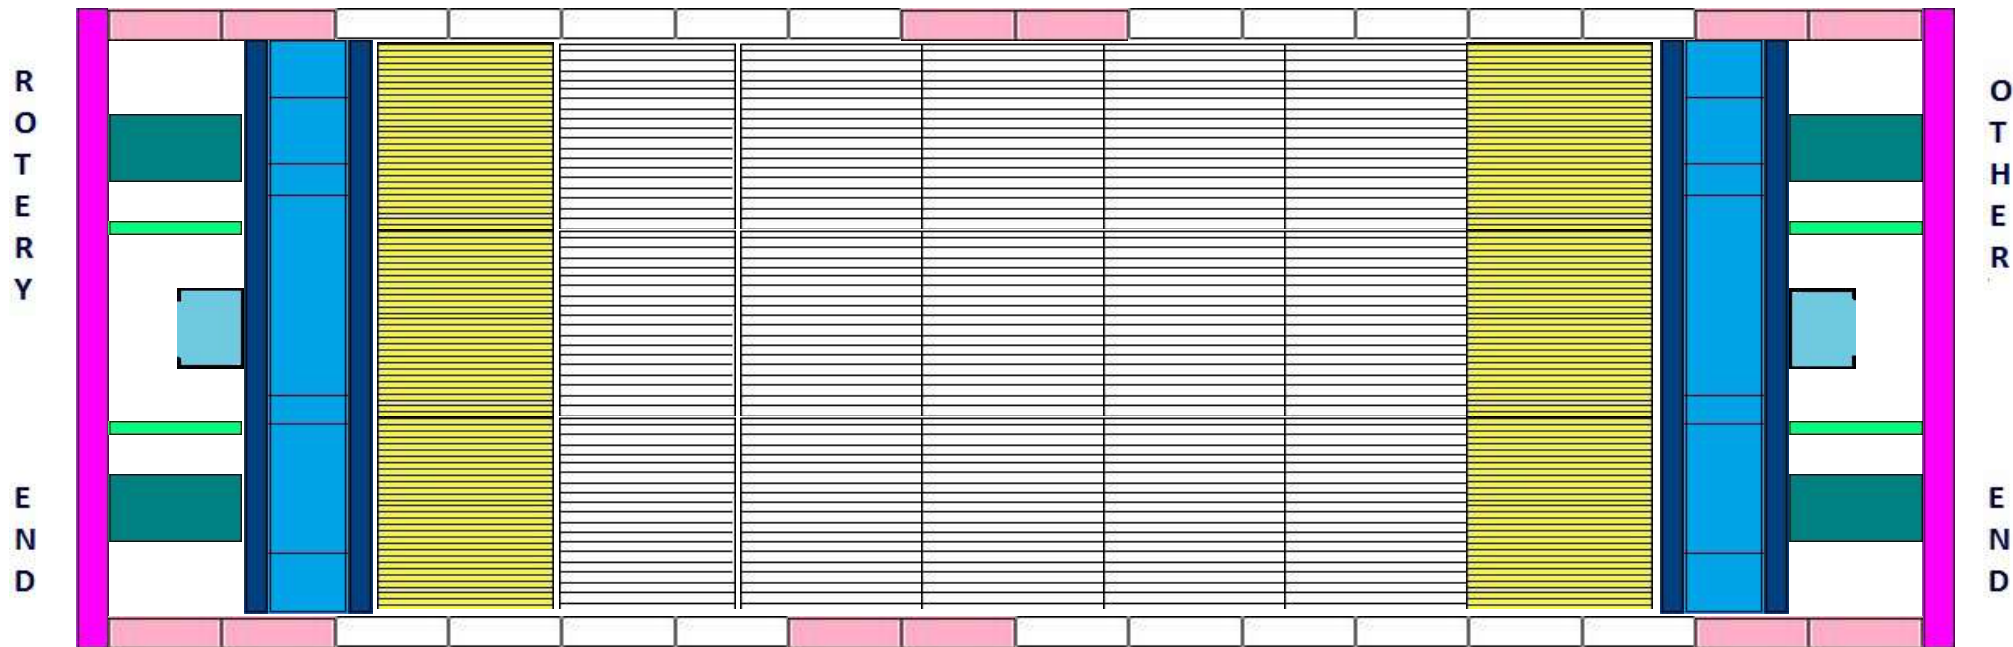
Rotary Side

Color	Particulars	Qty	Per%	Color	Particulars	Qty	Per%	Color	Particulars	Qty	Per%
	Headstock Beam	2	100%		Centre Stiffner for Headstock	4	100%		Floor Stiffner for Headstock	4	100%
	Aux. Head stock	4	100%		Sole Bar	6	38%		Draft Gear Bracket	2	100%
	Trough floor	2	29%		Centre plate	2	100%		SoleBar Stiffner	6	100%
	Bottom Wall Part	6	38%		Body panel/patch		100%		Door Top/Roof Patch		0%
	Window Module		0%		Window Sill	24	60%		Window Bar	48	27%
	Seat pillar/lav. Partition		100%		UIC end construction		0%

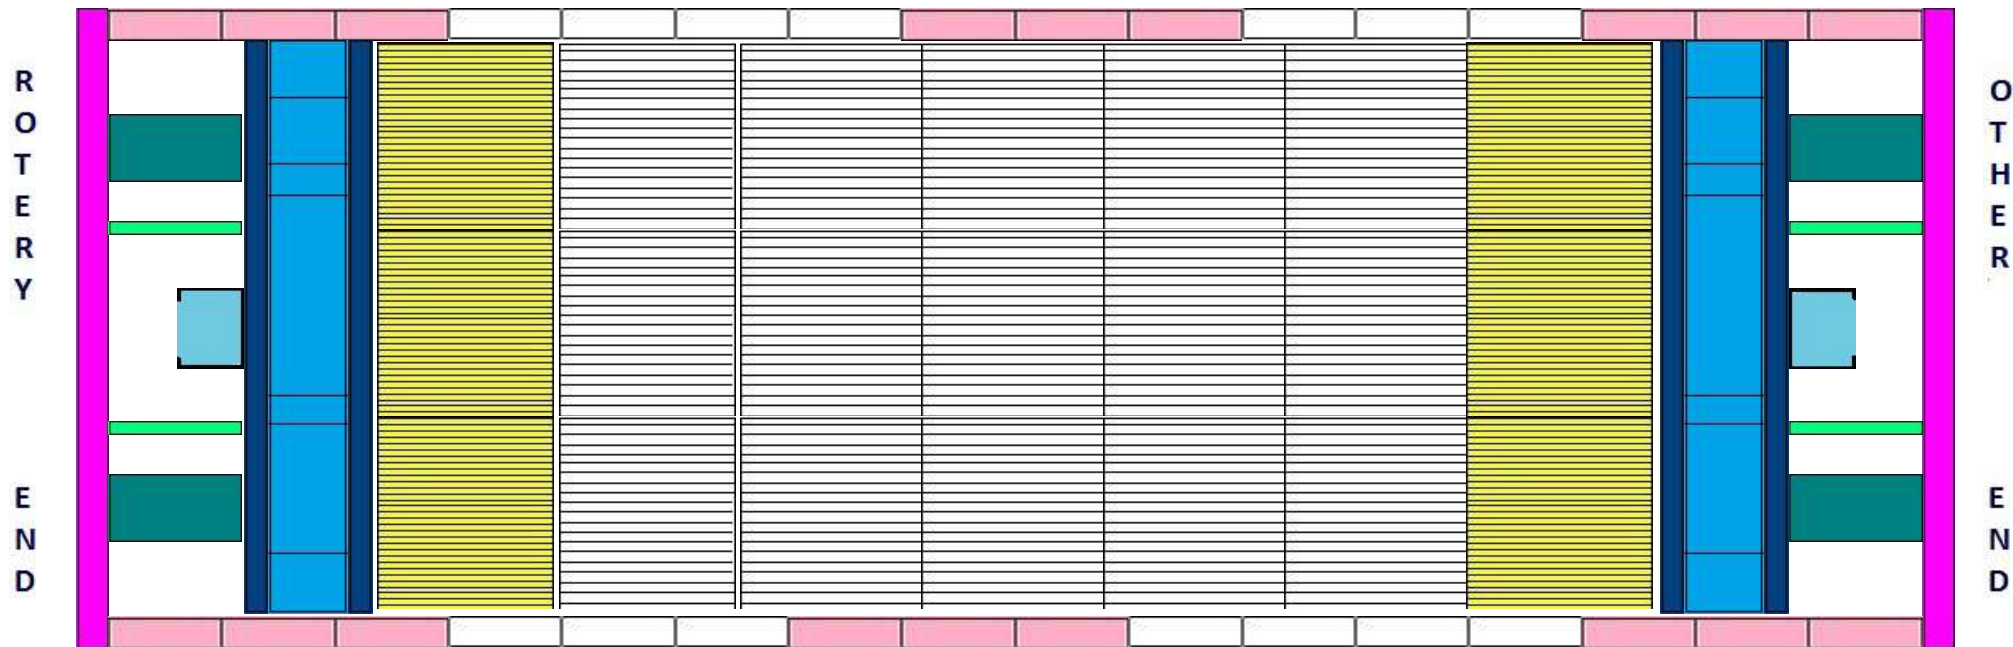
Rotary Side

Color	Particulars	Qty	Per%	Color	Particulars	Qty	Per%	Color	Particulars	Qty	Per%
	Headstock Beam	2	100%		Centre Stiffner for Headstock	4	100%		Floor Stiffner for Headstock	4	100%
	Aux. Head stock	4	100%		Sole Bar	9	56%		Draft Gear Bracket	2	100%
	Trough floor	2	29%		Centre plate	2	100%		SoleBar Stiffner	6	100%
	Bottom Wall Part	9	56%		Body panel/patch		100%		Door Top/Roof Patch		0%
	Window Module		0%		Window Sill	30	75%		Window Bar	50	28%
	Seat pillar/lav. Partition		100%		UIC end construction		0%

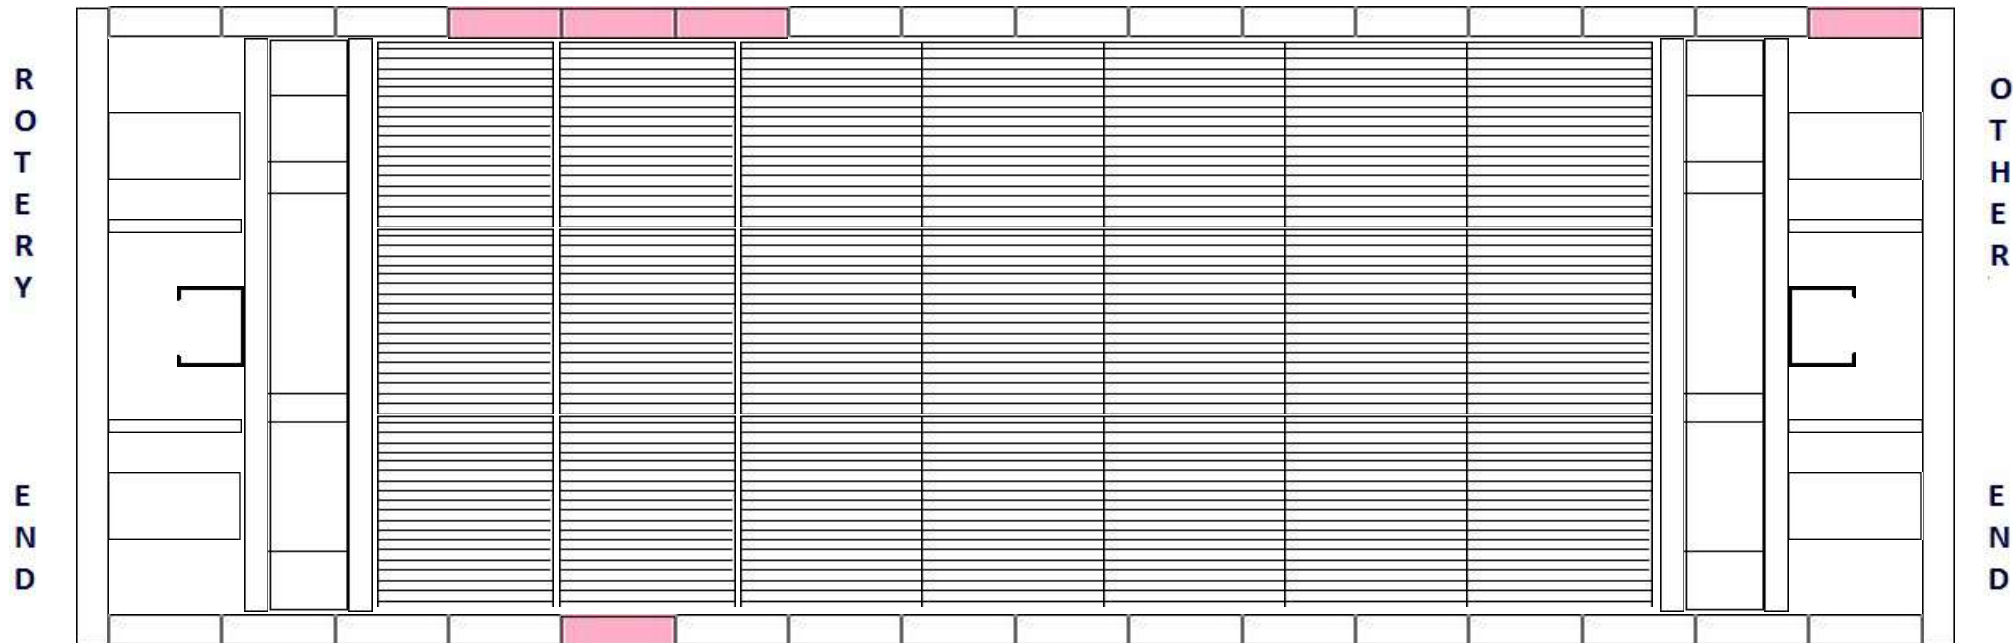
Rotary Side

Color	Particulars	Qty	Per%	Color	Particulars	Qty	Per%	Color	Particulars	Qty	Per%
	Headstock Beam	0	0%		Centre Stiffner for Headstock	0	0%		Floor Stiffner for Headstock	0	0%
	Aux. Head stock	0	0%		Sole Bar	2.5	16%		Draft Gear Bracket	0	0%
	Trough floor	0	0%		Centre plate	0	0%		SoleBar Stiffner	4	100%
	Bottom Wall Part	2.5	16%		Body panel/patch		20%		Door Top/Roof Patch		0%
	Window Module		0%		Window Sill	7	37%		Window Bar	30	18%
	Seat pillar/lav. Partition		100%		UIC end construction		0%

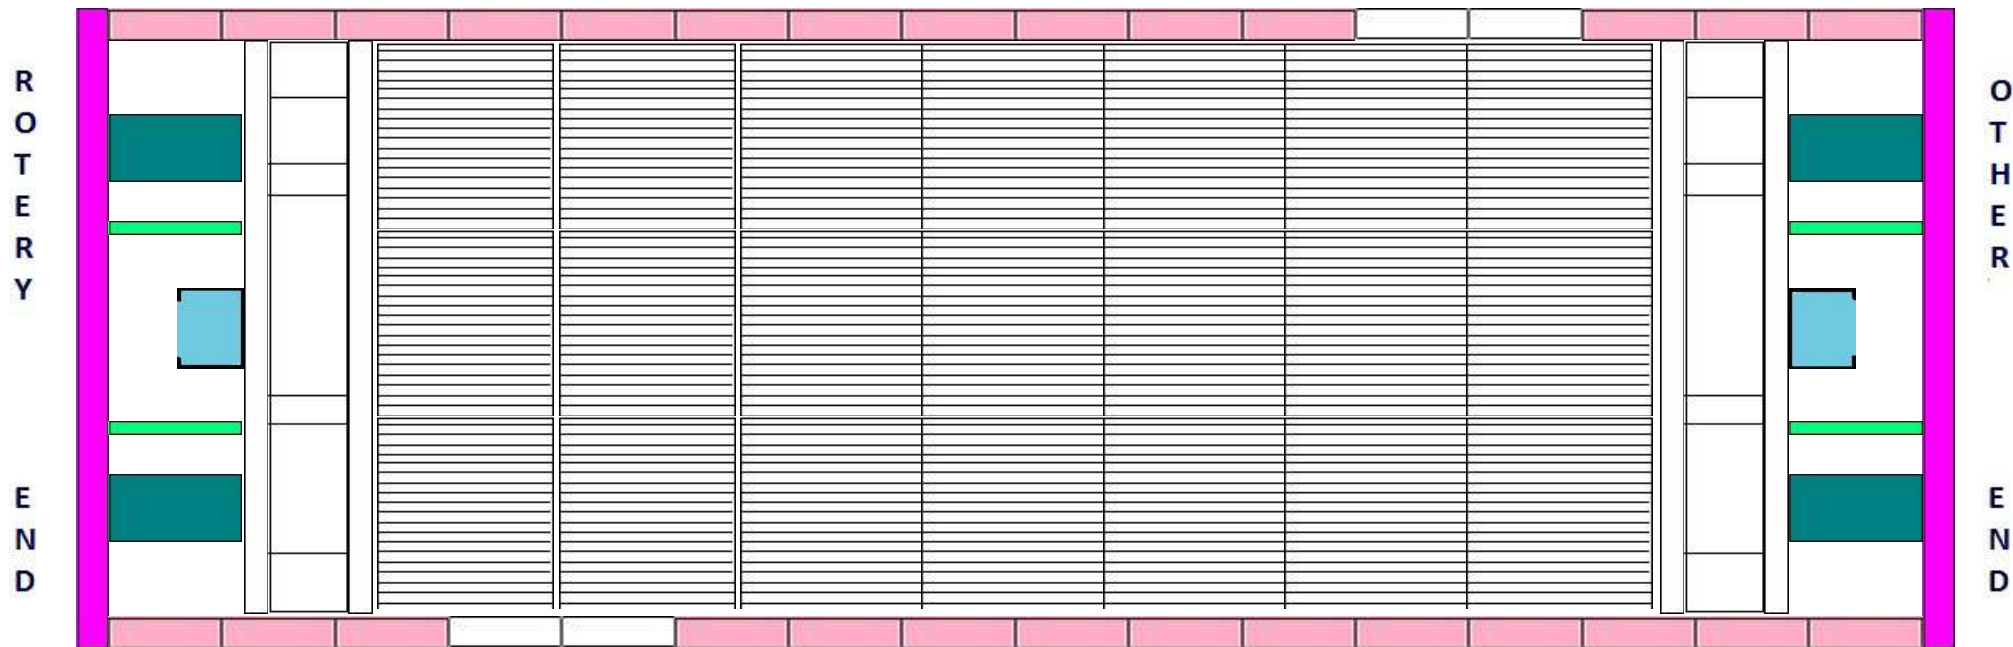
Rotary Side

Color	Particulars	Qty	Per%	Color	Particulars	Qty	Per%	Color	Particulars	Qty	Per%
Pink	Headstock Beam	2	100%	Dark Blue	Centre Stiffner for Headstock	4	100%	Green	Floor Stiffner for Headstock	4	100%
Dark Blue	Aux. Head stock	0	0%	Pink	Sole Bar	14	88%	Light Blue	Draft Gear Bracket	2	100%
Yellow	Trough floor	0	0%	Light Blue	Centre plate	0	0%		SoleBar Stiffner	4	100%
	Bottom Wall Part	14	88%		Body panel/patch		100%		Door Top/Roof Patch		0%
	Window Module		0%		Window Sill	9	47%		Window Bar	12	14%
	Seat pillar/lav. Partition		100%		UIC end construction		0%

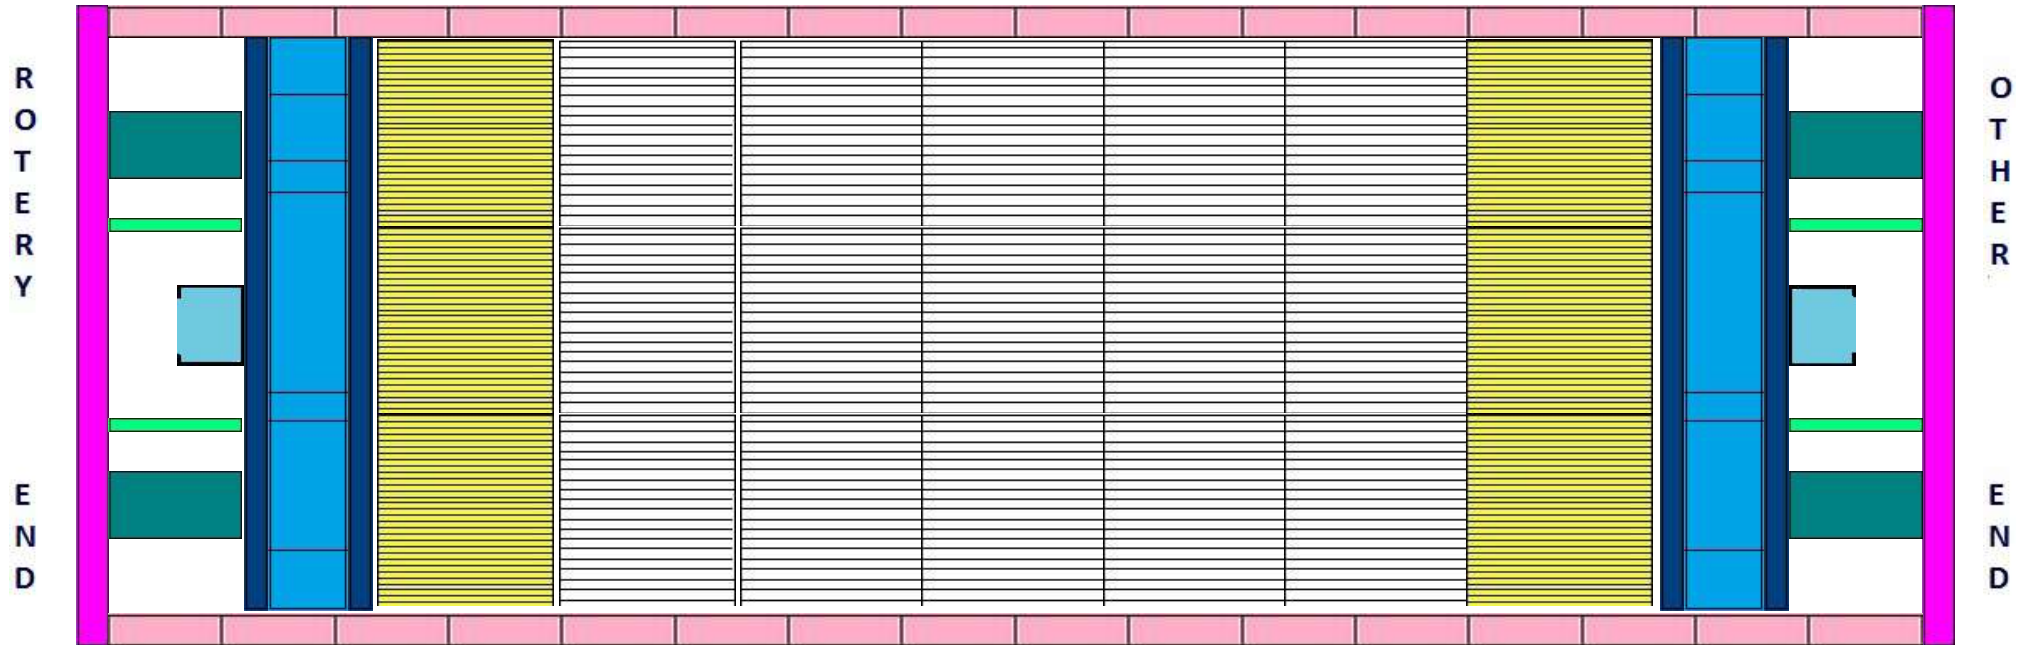
Rotary Side

Color	Particulars	Qty	Per%	Color	Particulars	Qty	Per%	Color	Particulars	Qty	Per%
Pink	Headstock Beam	2	100%	Dark Green	Centre Stiffner for Headstock	4	100%	Light Blue	Floor Stiffner for Headstock	4	100%
Dark Blue	Aux. Head stock	4	100%	Pink	Sole Bar	16	100%	Light Blue	Draft Gear Bracket	2	100%
Yellow	Trough floor	2	29%	Light Blue	Centre plate	2	100%		SoleBar Stiffner	6	100%
	Bottom Wall Part	16	100%		Body panel/patch		100%		Door Top/Roof Patch		0%
	Window Module		0%		Window Sill	40	100%		Window Bar	68	39%
	Seat pillar/lav. Partition		100%		UIC end construction		0%

End Drooping: Rotary End - EAST : 0, WEST : 0 Other End - EAST : 0, WEST : 0
Start Date : 08-Jan-2020, Completion Date : 18-Jan-2020, Net Repair Days : 10, Total Man Hours : 0

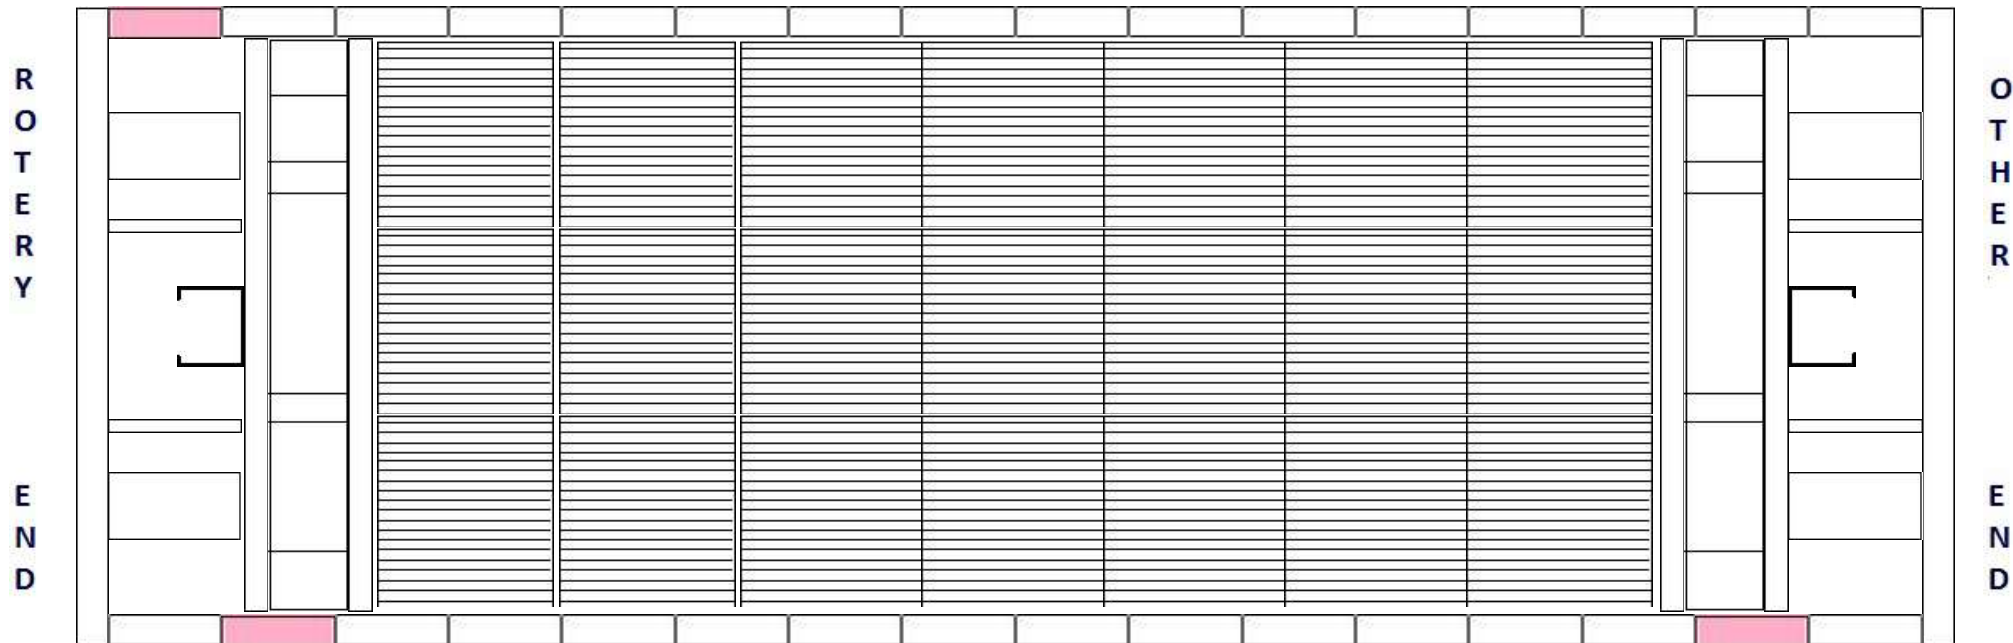
Rotary Side

Color	Particulars	Qty	Per%	Color	Particulars	Qty	Per%	Color	Particulars	Qty	Per%
Blue	Headstock Beam	0	0%	Red	Centre Stiffner for Headstock	0	0%	Green	Floor Stiffner for Headstock	0	0%
Black	Aux. Head stock	0	0%	Pink	Sole Bar	1.5	9%	Light Blue	Draft Gear Bracket	0	0%
Yellow	Trough floor	0	0%	Light Blue	Centre plate	0	0%		SoleBar Stiffner	4	100%
	Bottom Wall Part	1.5	9%		Body panel/patch		100%		Door Top/Roof Patch		0%
	Window Module		0%		Window Sill	0	0%		Window Bar	0	0%
	Seat pillar/lav. Partition		100%		UIC end construction		0%

End Drooping: Rotary End - EAST : 0, WEST : 0 Other End - EAST : 0, WEST : 0
Start Date : 08-Jul-2019, Completion Date : 11-Jul-2019, Net Repair Days : 4, Total Man Hours : 632

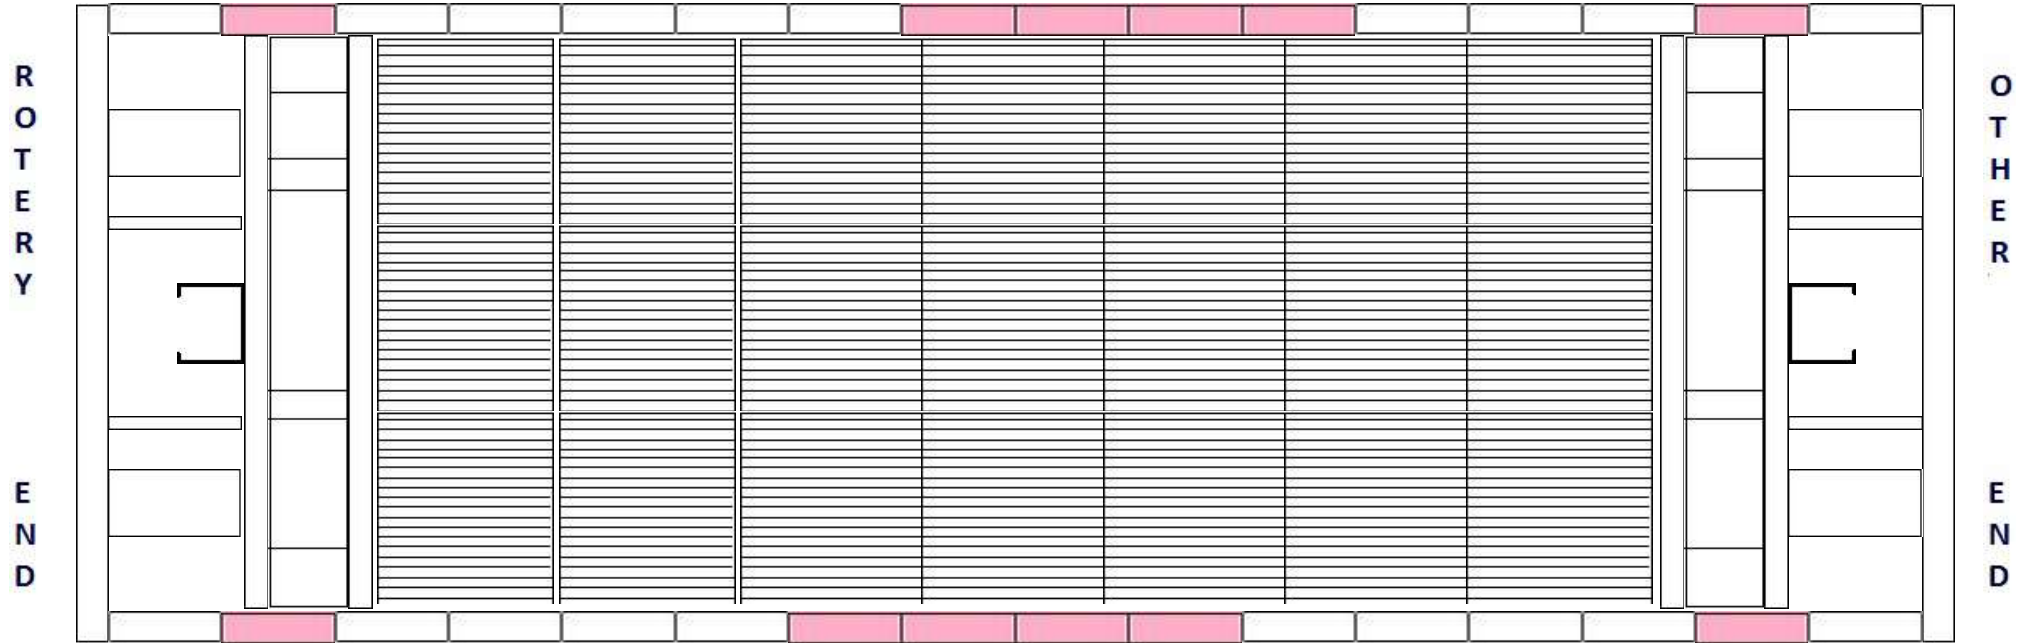
Rotary Side

Color	Particulars	Qty	Per%	Color	Particulars	Qty	Per%	Color	Particulars	Qty	Per%
	Headstock Beam	0	0%		Centre Stiffner for Headstock	0	0%		Floor Stiffner for Headstock	0	0%
	Aux. Head stock	0	0%		Sole Bar	6	38%		Draft Gear Bracket	0	0%
	Trough floor	0	0%		Centre plate	0	0%		SoleBar Stiffner	4	100%
	Bottom Wall Part	6	38%		Body panel/patch		20%		Door Top/Roof Patch		0%
	Window Module		0%		Window Sill	0	0%		Window Bar	0	0%
	Seat pillar/lav. Partition		100%		UIC end construction		0%

End Drooping: Rotary End - EAST : 0, WEST : 0 Other End - EAST : 0, WEST : 0
Start Date : 10-Feb-2020, Completion Date : 18-Mar-2020, Net Repair Days : 33, Total Man Hours : 0

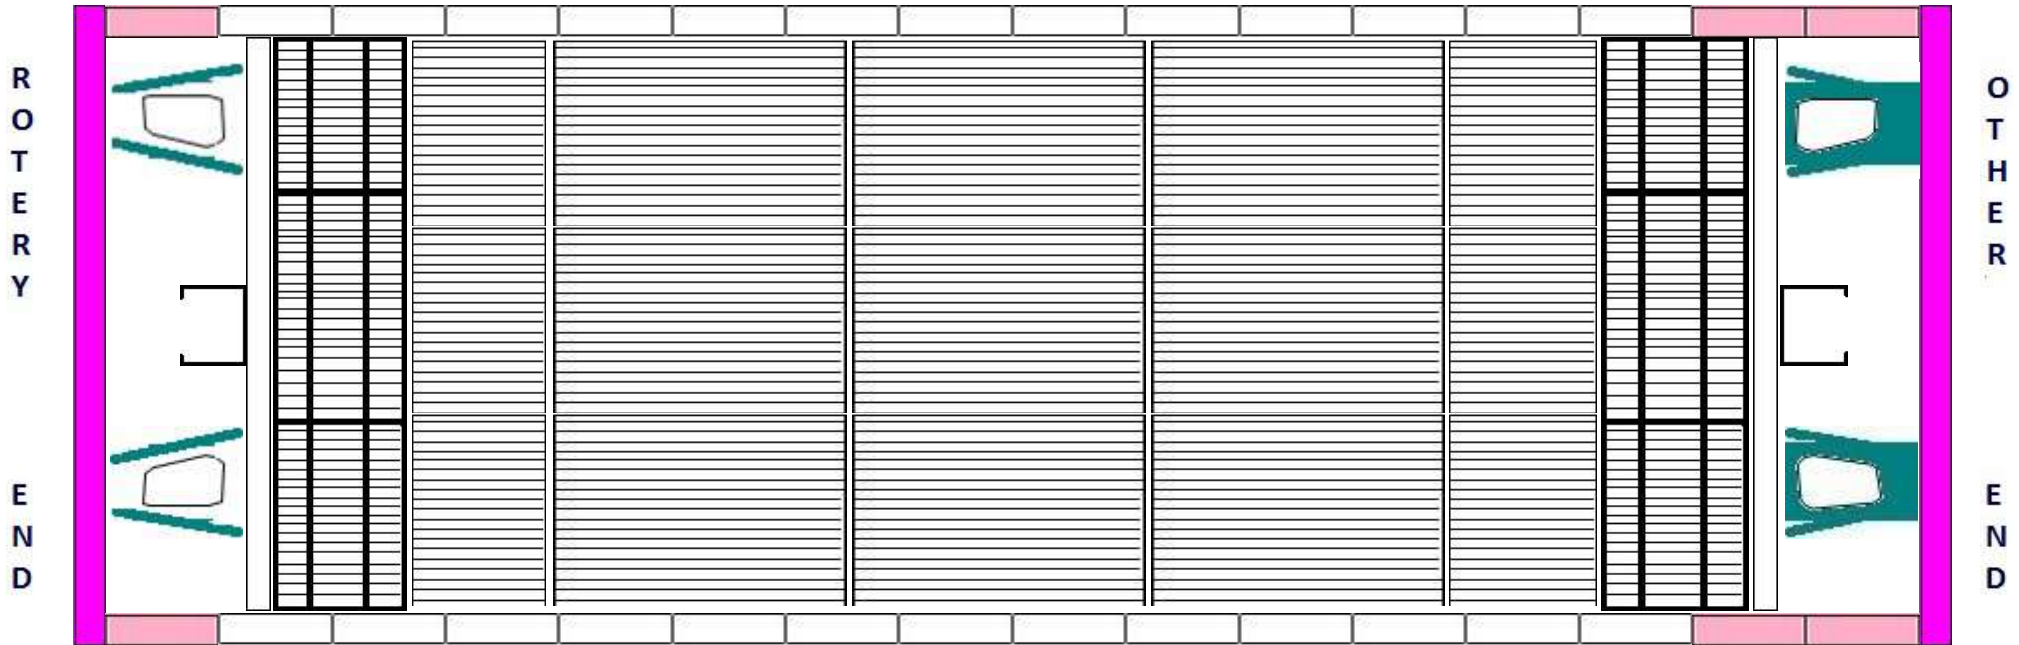
Rotary Side

Color	Particulars	Qty	Per%	Color	Particulars	Qty	Per%	Color	Particulars	Qty	Per%
	Headstock Beam	0	0%		Diagonal	4	100%		Logitudinal Channel Structure	0	0%
	Aux. Head stock	0	0%		Sole Bar	3	19%		Draft Gear Bracket	1	50%
	Trough floor	0	0%		Bottom Wall Part	3	19%		Body panel/patch		100%
	Door Top/Roof Patch		0%		Seat Bracket Rail		0%		Window Sill	0	0%
	Window Bar	0	0%		Seat pillar/lav. Partition		100%		UIC end construction		0%
	Body Pillar Part	17	100%

End Drooping: Rotary End - EAST : -6, WEST : -7 Other End - EAST : -6, WEST : -5
Start Date : 25-Jun-2019, Completion Date : 03-Jul-2019, Net Repair Days : 8, Total Man Hours : 988

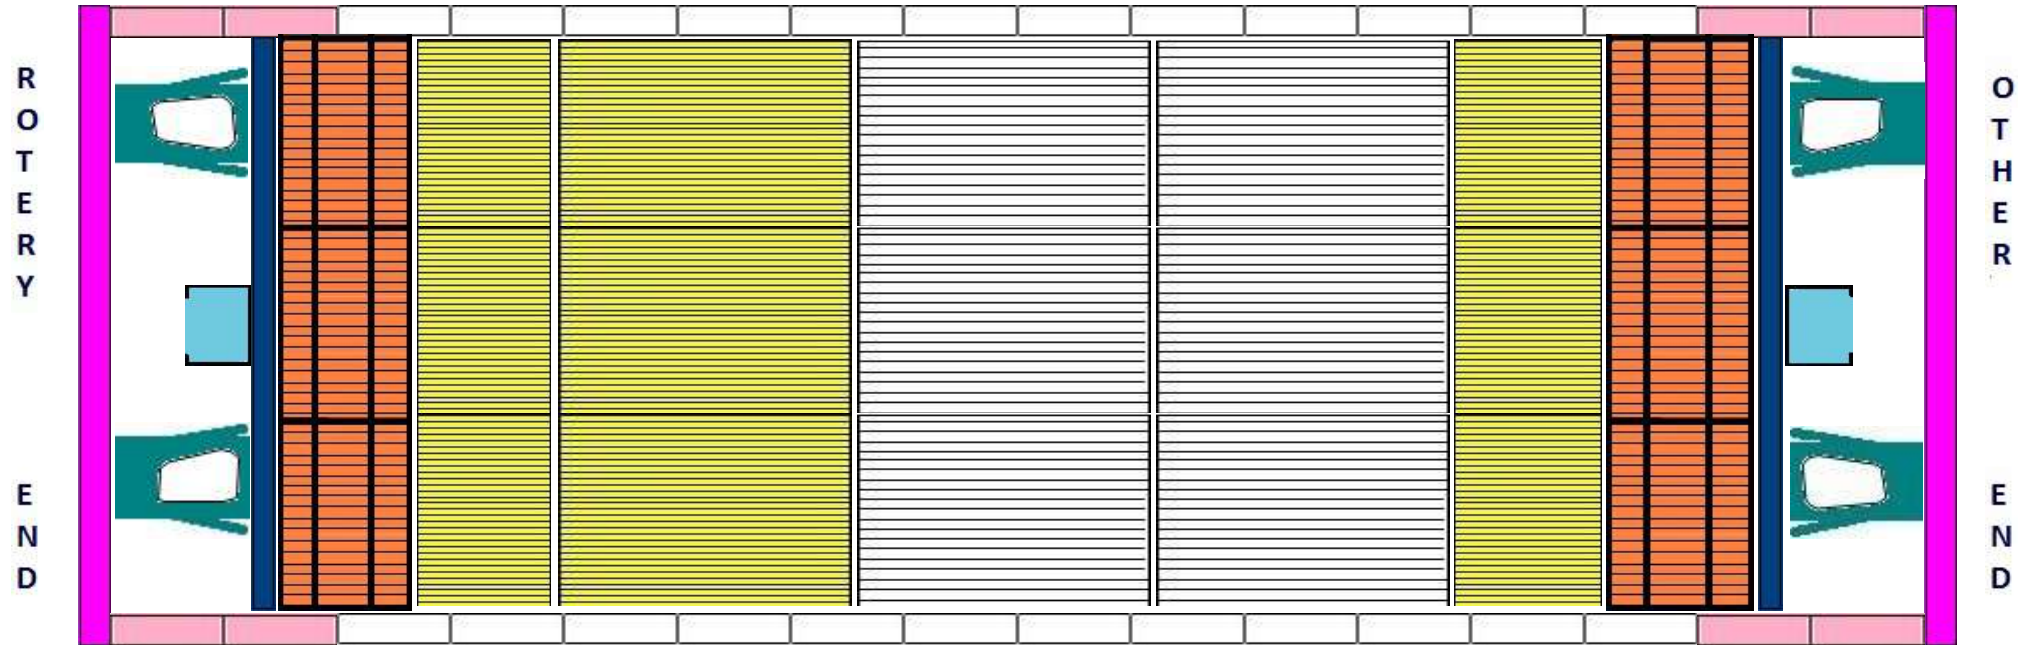
Rotary Side

Color	Particulars	Qty	Per%	Color	Particulars	Qty	Per%	Color	Particulars	Qty	Per%
	Headstock Beam	2	100%		Diagonal	4	100%		Logitudinal Channel Structure	2	100%
	Aux. Head stock	2	100%		Sole Bar	4	25%		Draft Gear Bracket	2	100%
	Trough floor	3	60%		Bottom Wall Part	4	25%		Body panel/patch		100%
	Door Top/Roof Patch		0%		Seat Bracket Rail		0%		Window Sill	5	13%
	Window Bar	14	8%		Seat pillar/lav. Partition		100%		UIC end construction		0%
	Body Pillar Part	22	100%

End Drooping: Rotary End - EAST : -10, WEST : -10 Other End - EAST : -9, WEST : -9
Start Date : 03-May-2019, Completion Date : 14-May-2019, Net Repair Days : 10, Total Man Hours : 1032
