Coach Rehabilitation Workshop, WC Railway, Bhopal

(An IMS and ISO 50001 Certified Workshop)
Final Inspection Sheet - Details of Corrosion Repair

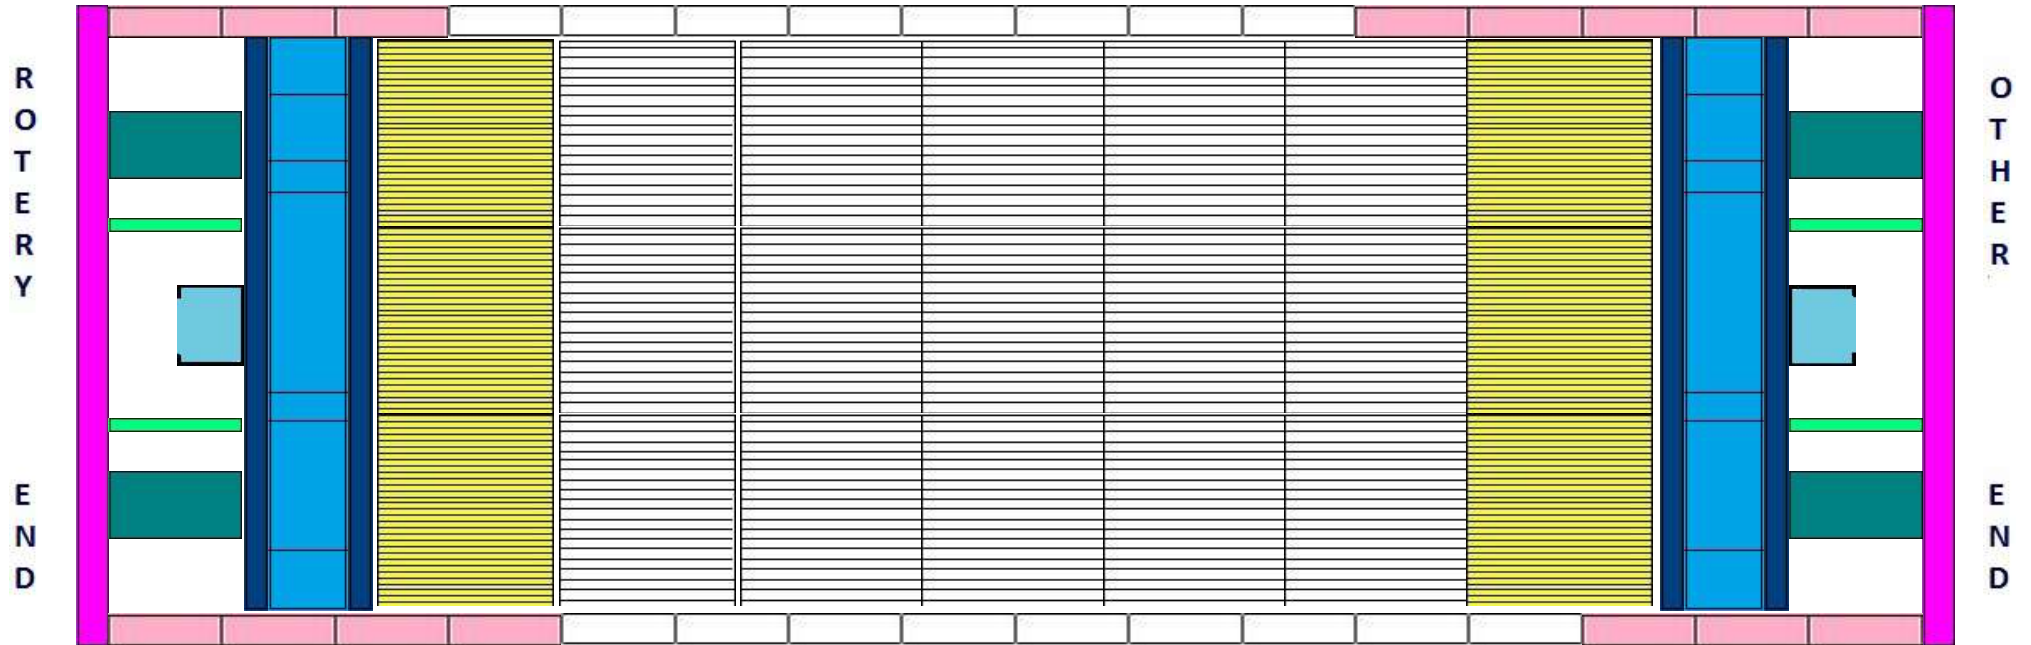
Rotary Side

Color	Particulars	Qty	Per%	Color	Particulars	Qty	Per%	Color	Particulars	Qty	Per%
Yellow	Headstock Beam	2	100%	Dark Green	Centre Stiffner for Headstock	4	100%	Light Green	Floor Stiffner for Headstock	4	100%
Dark Blue	Aux. Head stock	4	100%	Pink	Sole Bar	7.5	47%	Light Blue	Draft Gear Bracket	2	100%
Yellow	Trough floor	2	29%	Light Blue	Centre plate	2	100%		SoleBar Stiffner	4	100%
	Bottom Wall Part	7.5	47%		Body panel/patch		0%		Door Top/Roof Patch		100%
	Window Module		0%		Window Sill	28	70%		Window Bar	42	23%
	Seat pillar/lav. Partition		100%		UIC end construction		0%

End Drooping: Rotary End - EAST : -5, WEST : 5 Other End - EAST : -5, WEST : -5
Start Date : 30-Apr-2019, Completion Date : 07-May-2019, Net Repair Days : 7, Total Man Hours : 0

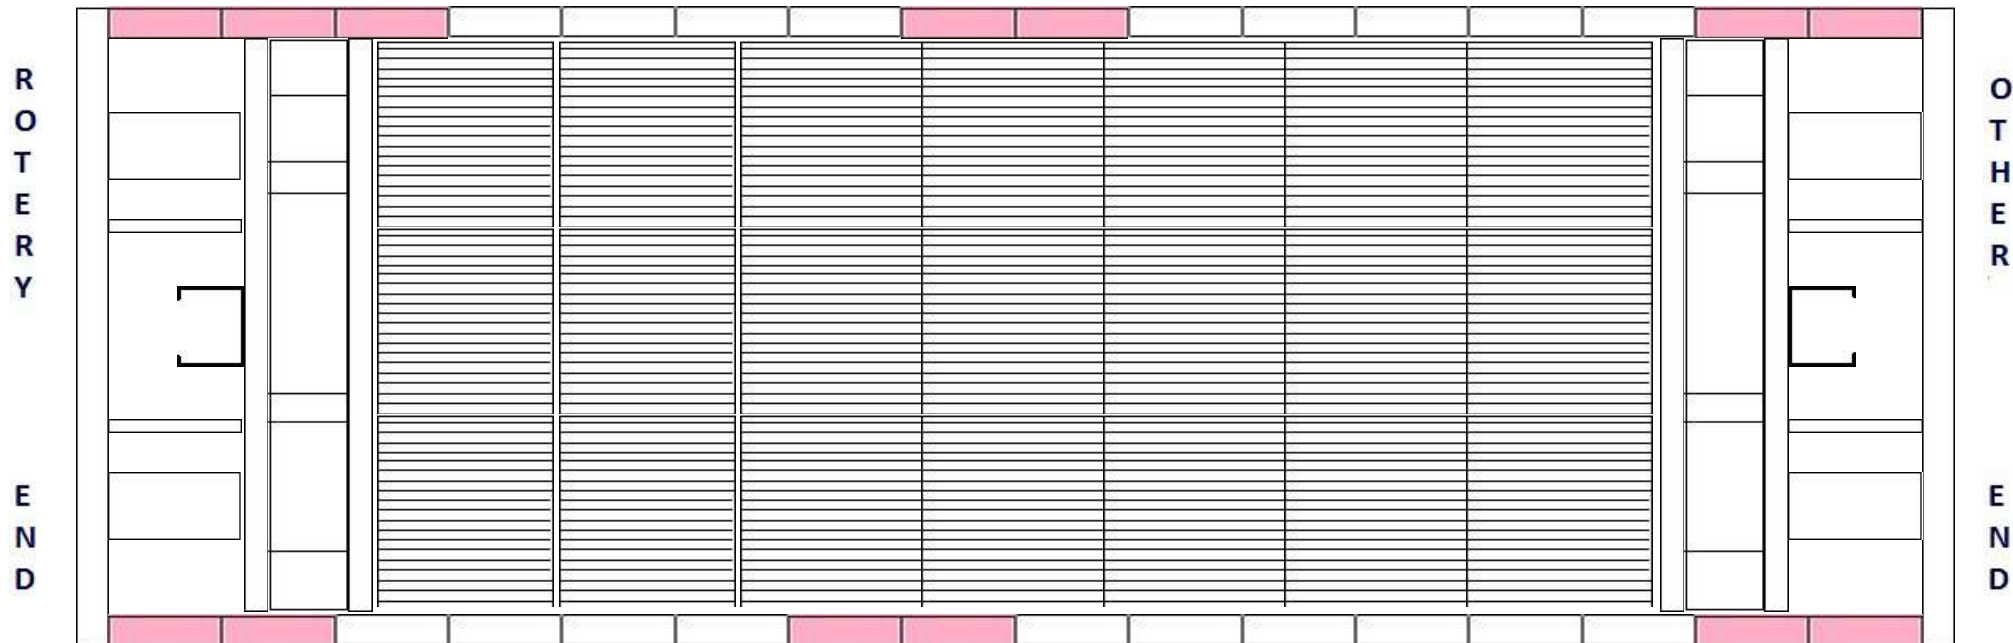
Rotary Side

Color	Particulars	Qty	Per%	Color	Particulars	Qty	Per%	Color	Particulars	Qty	Per%
	Headstock Beam	0	0%		Centre Stiffner for Headstock	0	0%		Floor Stiffner for Headstock	0	0%
	Aux. Head stock	0	0%		Sole Bar	6.5	41%		Draft Gear Bracket	0	0%
	Trough floor	0	0%		Centre plate	0	0%		SoleBar Stiffner	6	100%
	Bottom Wall Part	6.5	41%		Body panel/patch		40%		Door Top/Roof Patch		0%
	Window Module		0%		Window Sill	0	0%		Window Bar	0	0%
	Seat pillar/lav. Partition		100%		UIC end construction		0%

End Drooping: Rotary End - EAST : 0, WEST : 0 Other End - EAST : 0, WEST : 0
Start Date : 07-Feb-2020, Completion Date : 15-Feb-2020, Net Repair Days : 8, Total Man Hours : 0

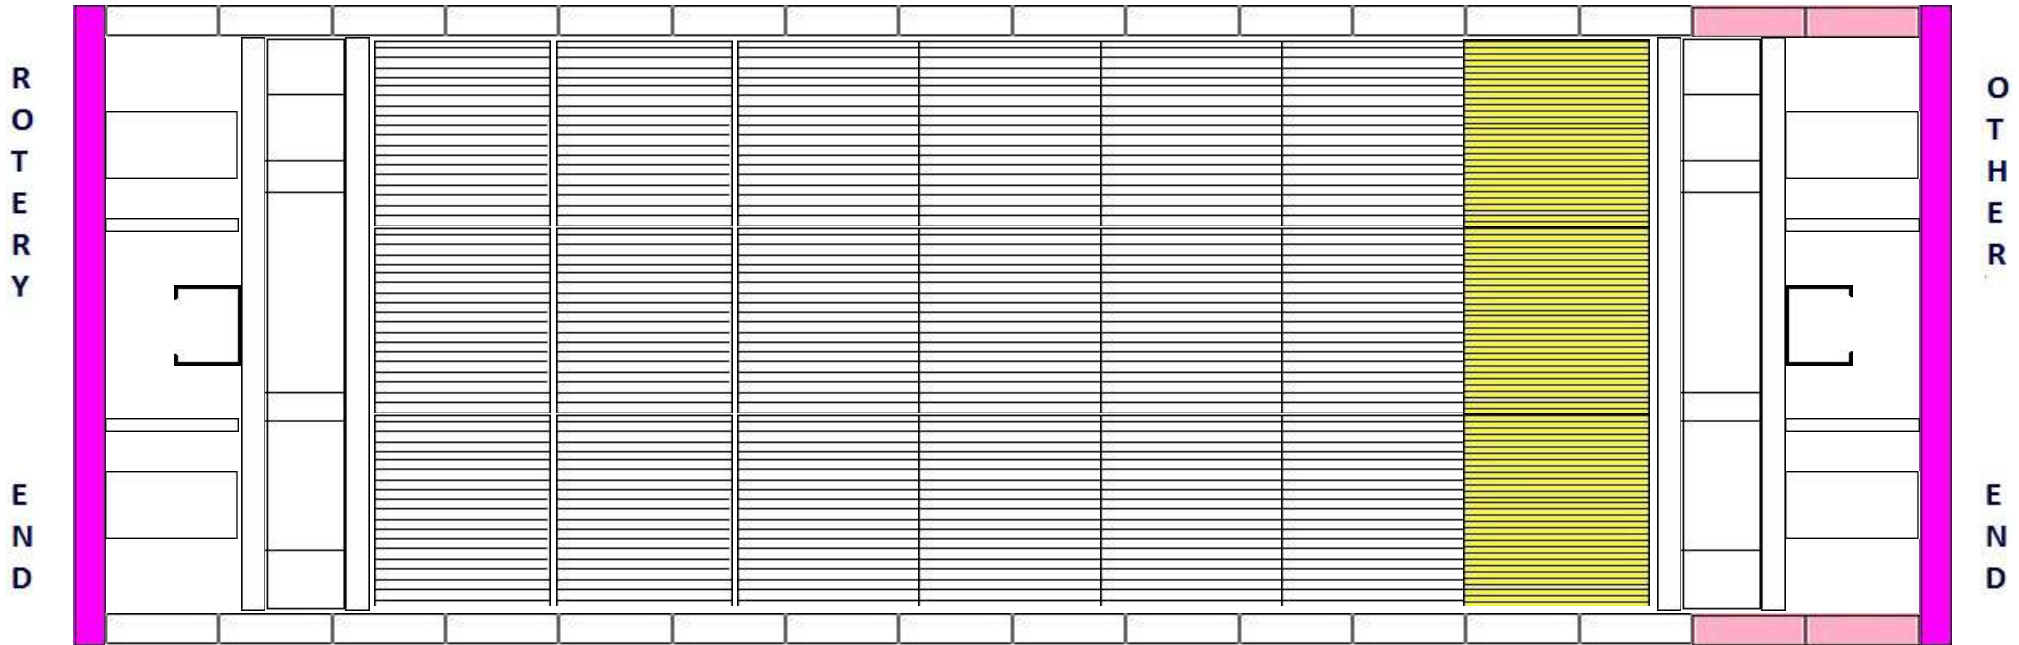
Rotary Side

Color	Particulars	Qty	Per%	Color	Particulars	Qty	Per%	Color	Particulars	Qty	Per%
Blue	Headstock Beam	0	0%	Red	Centre Stiffner for Headstock	0	0%	Green	Floor Stiffner for Headstock	0	0%
Black	Aux. Head stock	0	0%	Pink	Sole Bar	2	13%	Light Blue	Draft Gear Bracket	0	0%
Yellow	Trough floor	1	14%	Cyan	Centre plate	0	0%		SoleBar Stiffner	4	100%
	Bottom Wall Part	2	13%		Body panel/patch		15%		Door Top/Roof Patch		100%
	Window Module		0%		Window Sill	0	0%		Window Bar	0	0%
	Seat pillar/lav. Partition		100%		UIC end construction		0%

End Drooping: Rotary End - EAST : 0, WEST : 0 Other End - EAST : 0, WEST : 0
Start Date : 03-Jul-2019, Completion Date : 10-Jul-2019, Net Repair Days : 7, Total Man Hours : 428

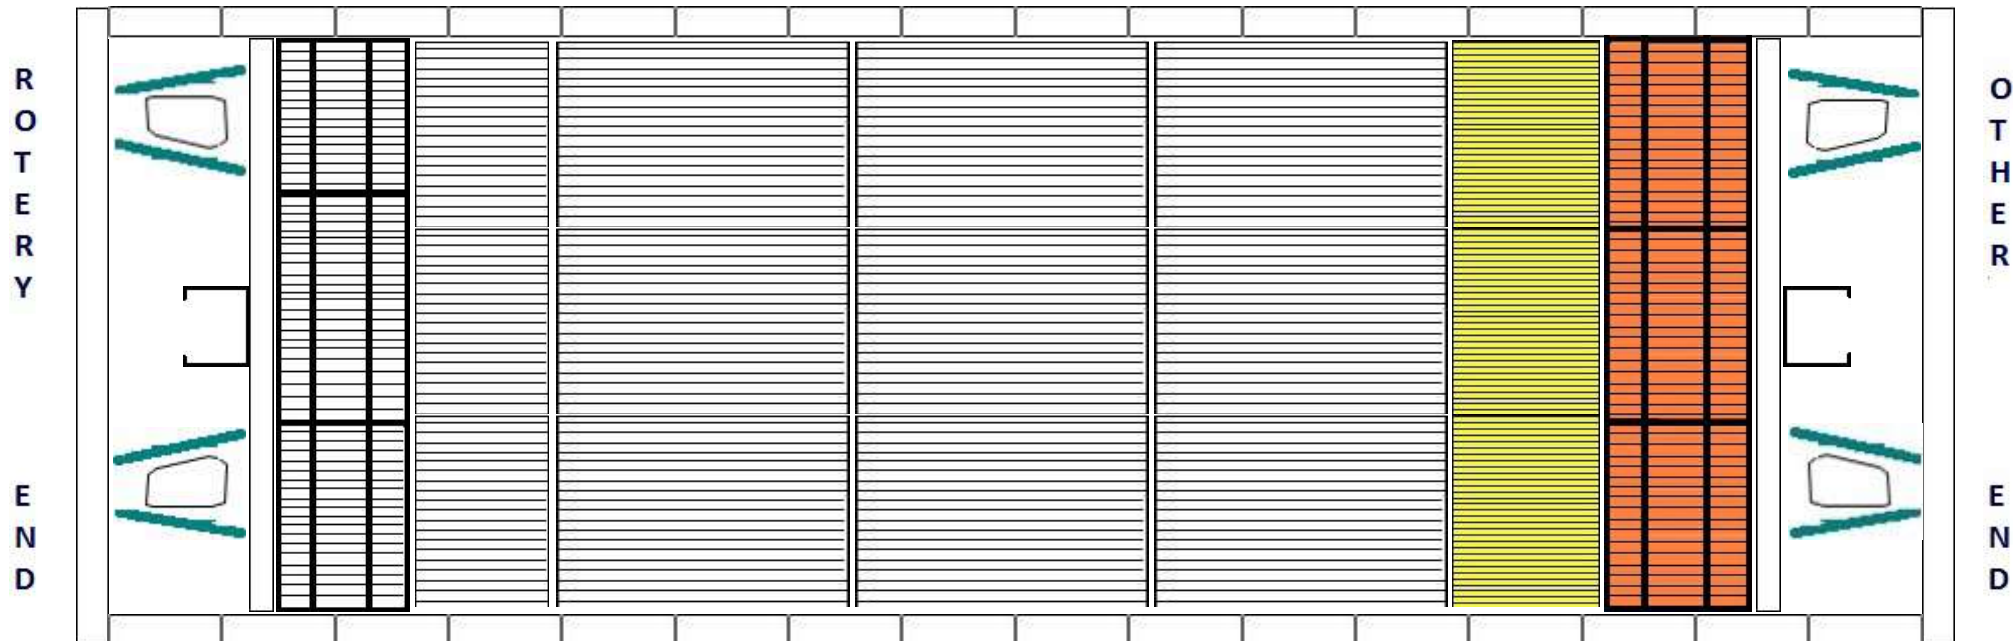
Rotary Side

Color	Particulars	Qty	Per%	Color	Particulars	Qty	Per%	Color	Particulars	Qty	Per%
	Headstock Beam	0	0%		Diagonal	4	100%		Logitudinal Channel Structure	1	50%
	Aux. Head stock	0	0%		Sole Bar	0	0%		Draft Gear Bracket	0	0%
	Trough floor	1	20%		Bottom Wall Part	0	0%		Body panel/patch		20%
	Door Top/Roof Patch		0%		Seat Bracket Rail		0%		Window Sill	0	0%
	Window Bar	0	0%		Seat pillar/lav. Partition		100%		UIC end construction		0%
	Body Pillar Part	0	100%

End Drooping: Rotary End - EAST : 0, WEST : 0 Other End - EAST : 0, WEST : 0
Start Date : 22-Aug-2019, Completion Date : 24-Aug-2019, Net Repair Days : 3, Total Man Hours : 402

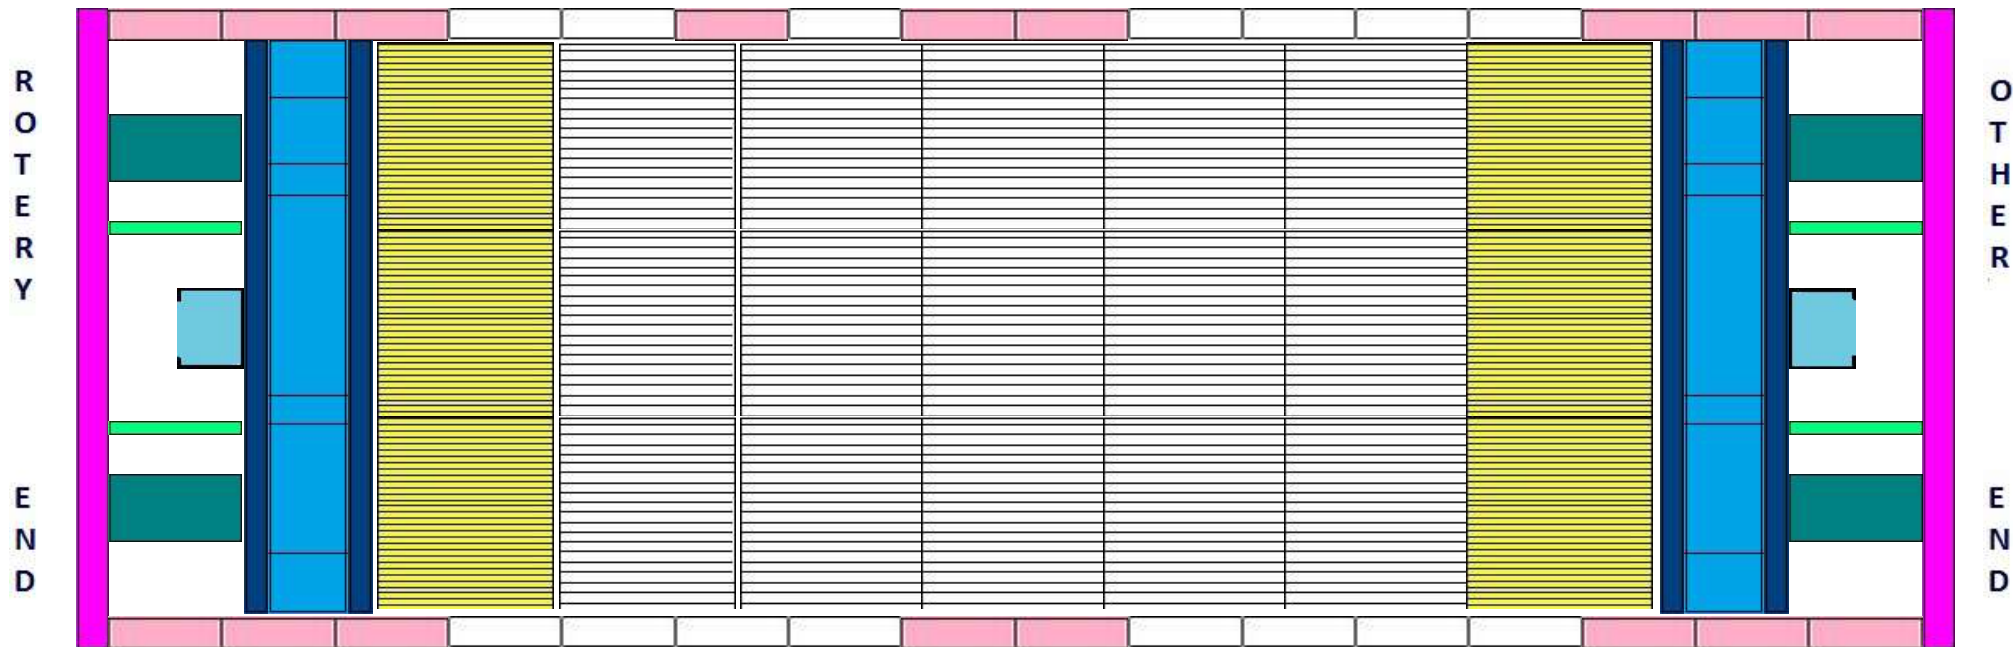
Rotary Side

Color	Particulars	Qty	Per%	Color	Particulars	Qty	Per%	Color	Particulars	Qty	Per%
	Headstock Beam	2	100%		Centre Stiffner for Headstock	4	100%		Floor Stiffner for Headstock	4	100%
	Aux. Head stock	4	100%		Sole Bar	8.5	53%		Draft Gear Bracket	2	100%
	Trough floor	2	29%		Centre plate	2	100%		SoleBar Stiffner	6	100%
	Bottom Wall Part	8.5	53%		Body panel/patch		100%		Door Top/Roof Patch		0%
	Window Module		0%		Window Sill	28	70%		Window Bar	48	27%
	Seat pillar/lav. Partition		100%		UIC end construction		0%

End Drooping: Rotary End - EAST : -6, WEST : 0 Other End - EAST : 5, WEST : 0
Start Date : 12-Jul-2019, Completion Date : 19-Jul-2019, Net Repair Days : 7, Total Man Hours : 1400

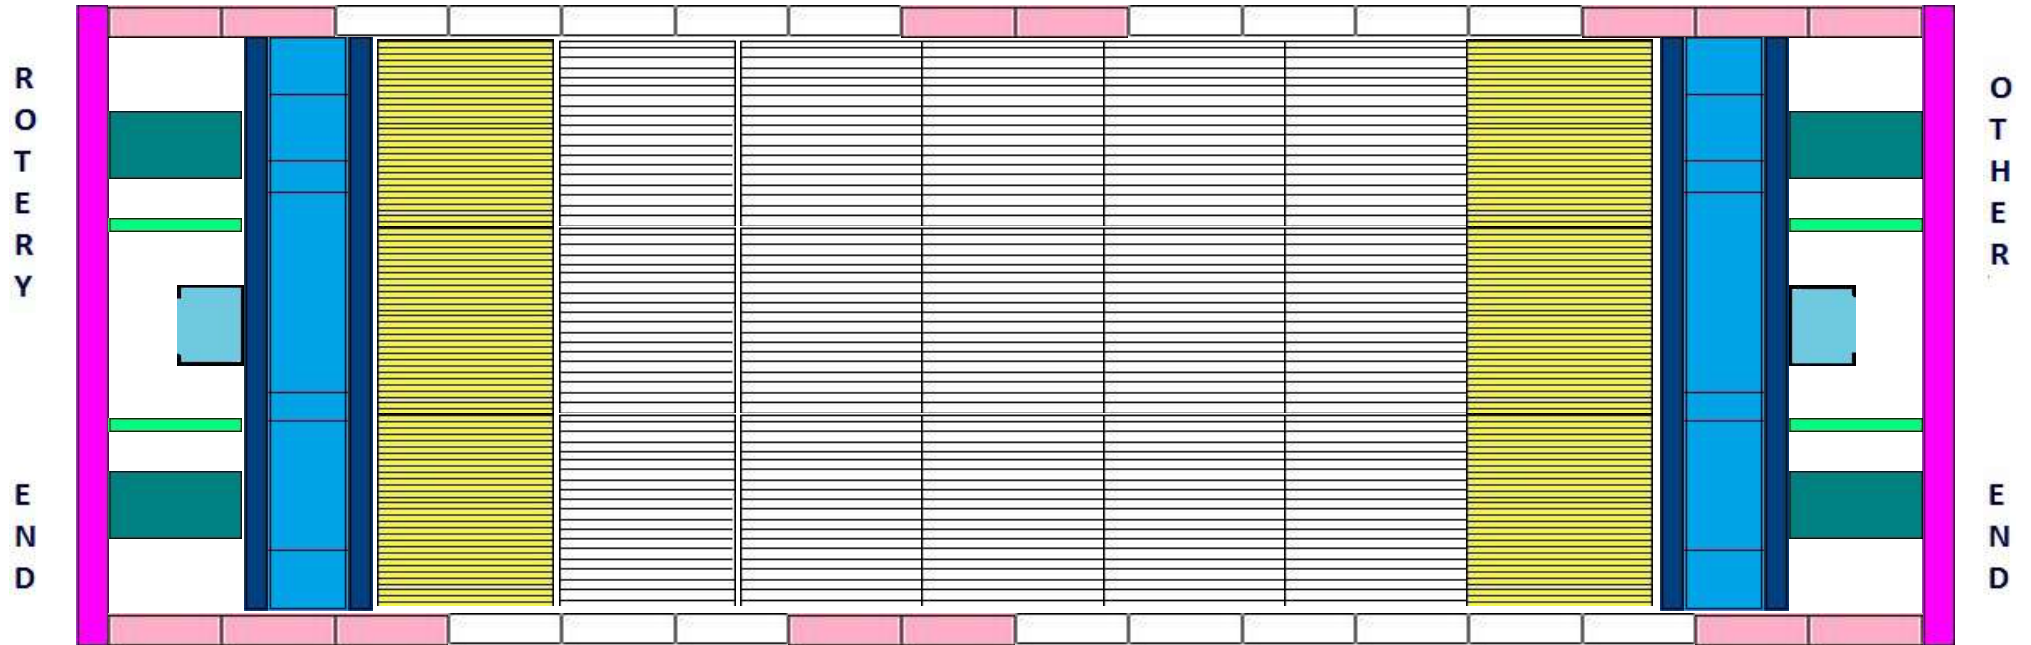
Rotary Side

Color	Particulars	Qty	Per%	Color	Particulars	Qty	Per%	Color	Particulars	Qty	Per%
	Headstock Beam	2	100%		Centre Stiffner for Headstock	4	100%		Floor Stiffner for Headstock	4	100%
	Aux. Head stock	4	100%		Sole Bar	7	44%		Draft Gear Bracket	2	100%
	Trough floor	2	29%		Centre plate	2	100%		SoleBar Stiffner	6	100%
	Bottom Wall Part	7	44%		Body panel/patch		100%		Door Top/Roof Patch		0%
	Window Module		0%		Window Sill	18	45%		Window Bar	48	27%
	Seat pillar/lav. Partition		100%		UIC end construction		0%

End Drooping: Rotary End - EAST : 0, WEST : 0 Other End - EAST : 0, WEST : 0
Start Date : 25-Jun-2019, Completion Date : 04-Jul-2019, Net Repair Days : 9, Total Man Hours : 0
